AIRCRAFT ACCIDENT REPORT 1/2006

**Civil Aviation Department
Hong Kong**

**Report on the accident to Eurocopter EC155B1 helicopter,
B-HRX, operated by the Government Flying Service of Hong Kong
near Hong Kong International Airport
on 26 August 2003**

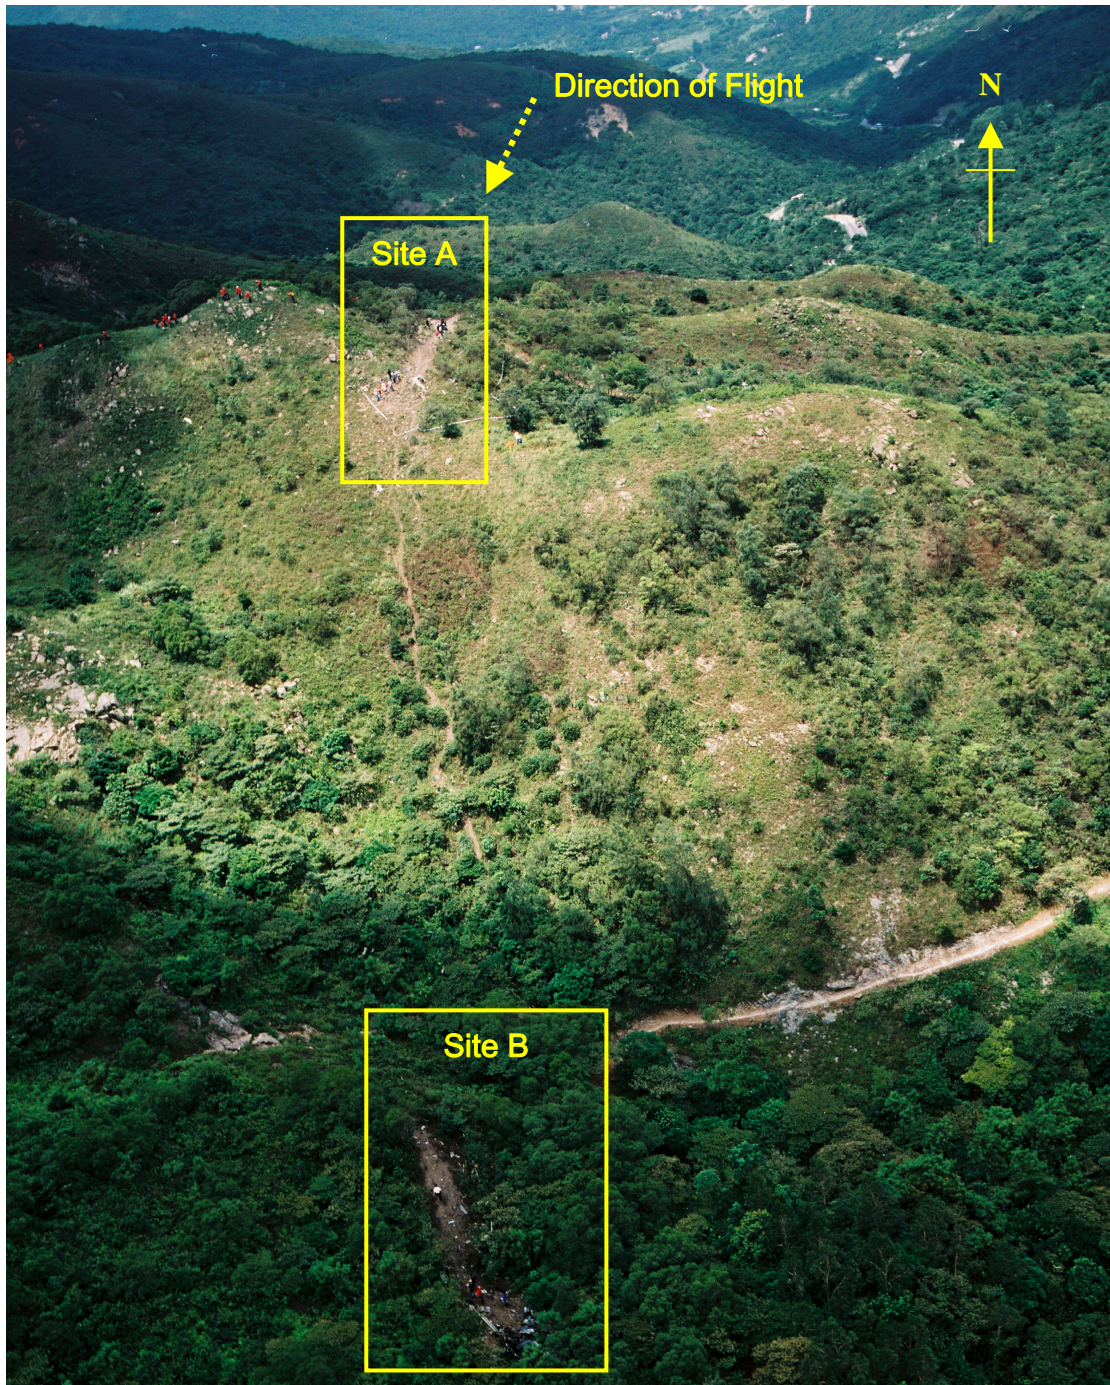
Figure 1

The helicopter fuselage continued to travel forward in close contact with the ground surface and approximately in line with the flight path, for around 45 metres (see site 'A' in Appendix D). The duration of ground contact lasted for approximately 0.88 seconds (see Appendix L). All main rotor blades were severed within the first few metres of travel through contact with small trees and rocks. The underside and right side of the fuselage were damaged substantially. At the end of the 45 metre run, the terrain fell away moderately sharply. As a consequence, the helicopter became airborne again in an uncontrolled fashion and travelled a horizontal distance of approximately 100 metres whilst falling through a vertical height of some 100 feet before impacting with terrain for a second time in a nose high attitude at around 1,150 feet AMSL. The main body of the wreckage finally came to rest after travelling forward in contact with the surface for a further 30 metres (see site 'B' in Appendix D).

General view of Wreckage Sites A and B

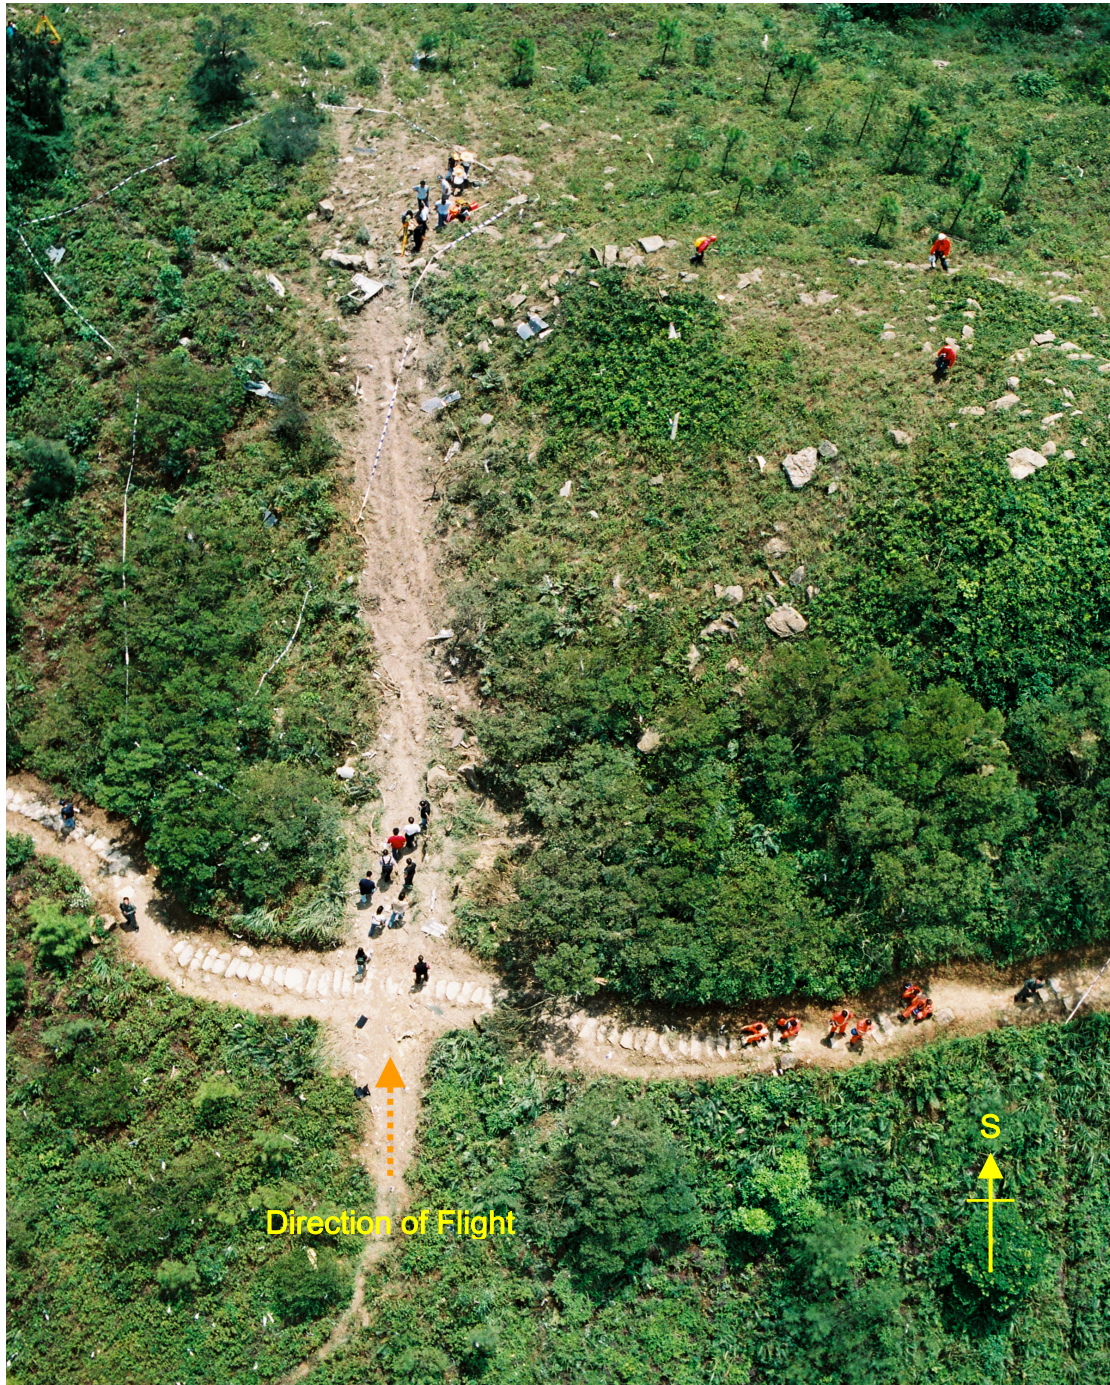
Figure 3

Various parts of the aircraft structure became detached at this time and rupturing of the fuel tanks was followed by a rapid and massive leakage of fuel. After 45 metres, the terrain fell away into a small valley. A considerable amount of debris from the fuel system was located at the end and down slope side of the score-mark at Site 'A'.

Wreckage Site A

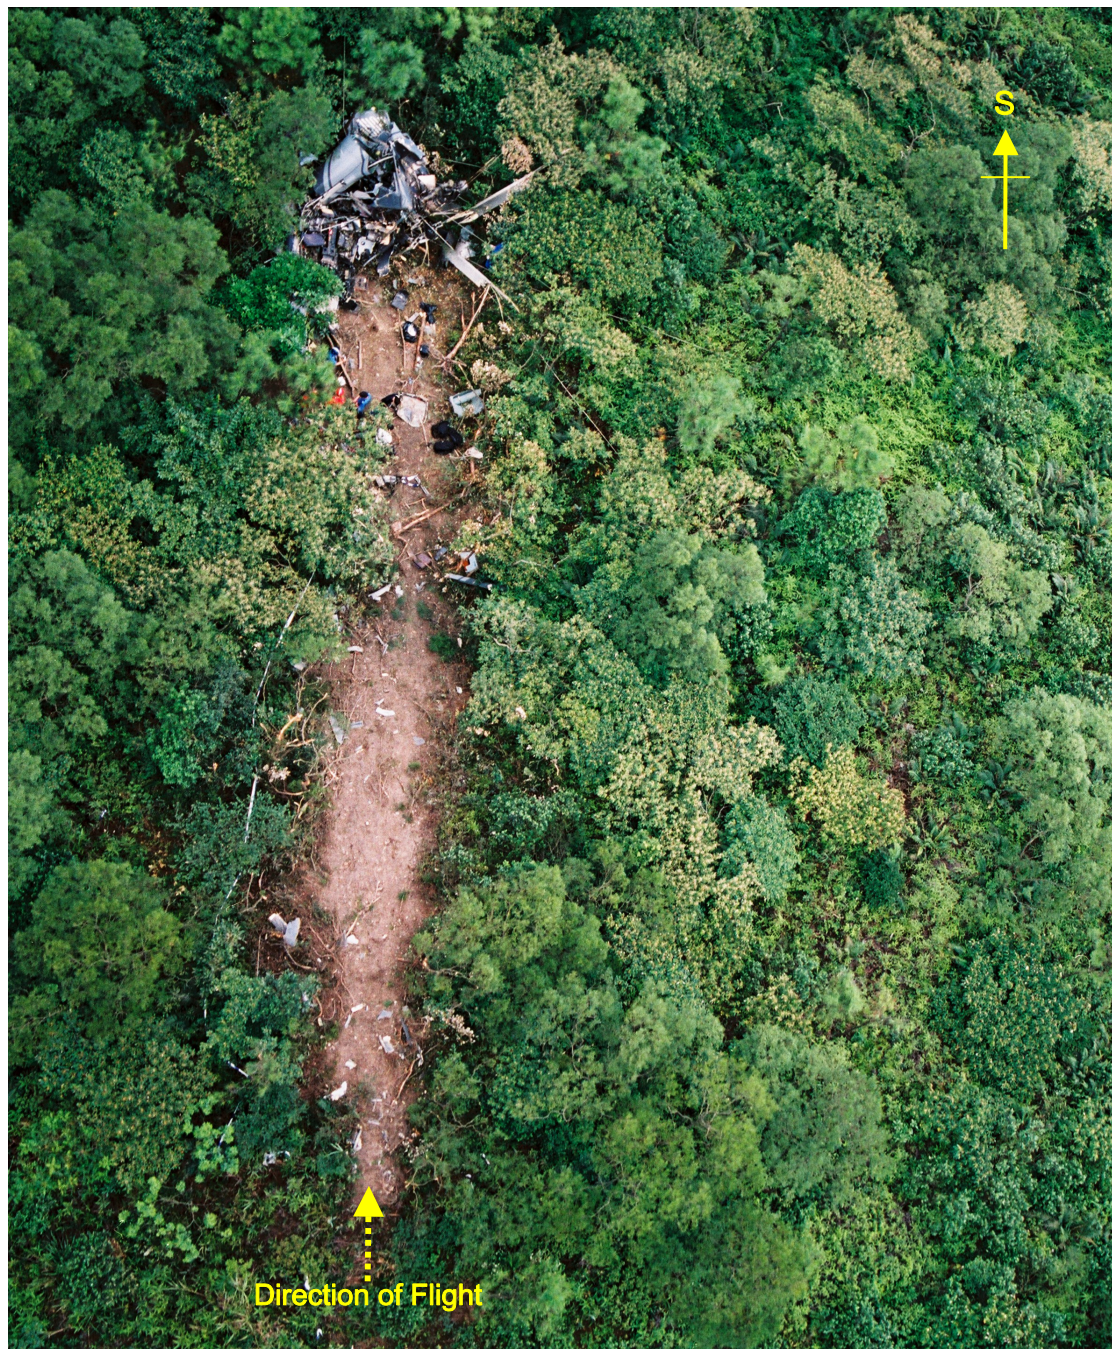
Figure 4

Leakage of residual fuel had occurred in the area of the wreckage at Site 'B' but there was no evidence of a post-impact fire except for a small flash fire at the forward top area of module two around the fuel valve assembly of the right hand (number two) engine.

Wreckage Site B

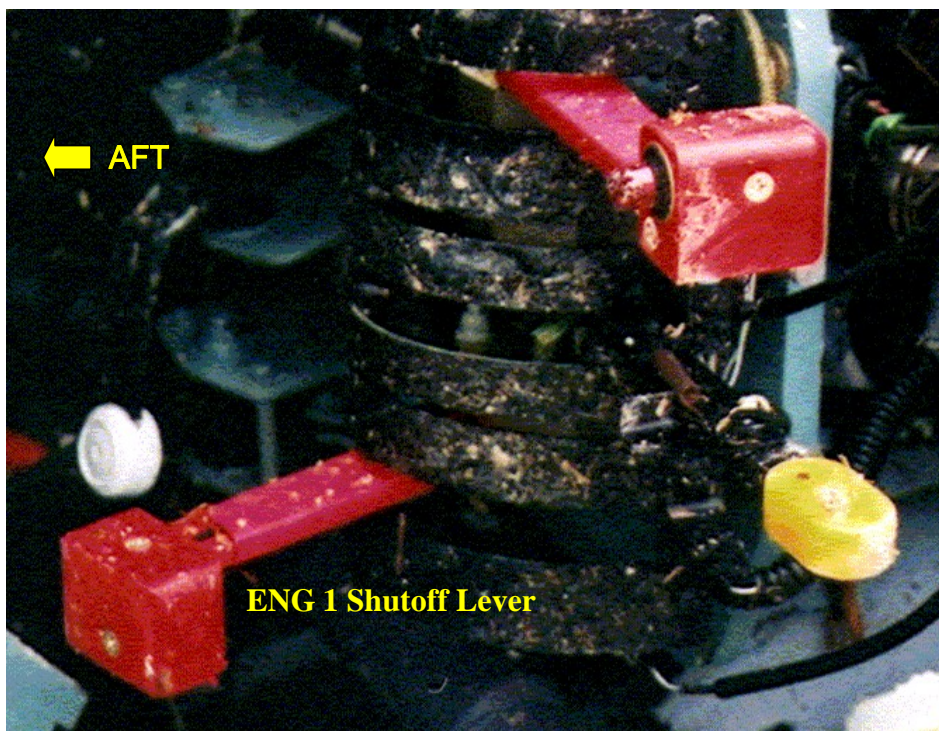
Figure 2

- The fuel shut off control lever was in the aft ('shutoff') position.
- The safety device for the engine control switch was in the 'unsafe' position and the switch was in the centre (IDLE) position.
- The DC emergency cut off on the overhead panel was in the PWR OFF ('power off') position.

Left hand engine (ENG 1) Shutoff Lever at aft position as observed on the accident helicopter

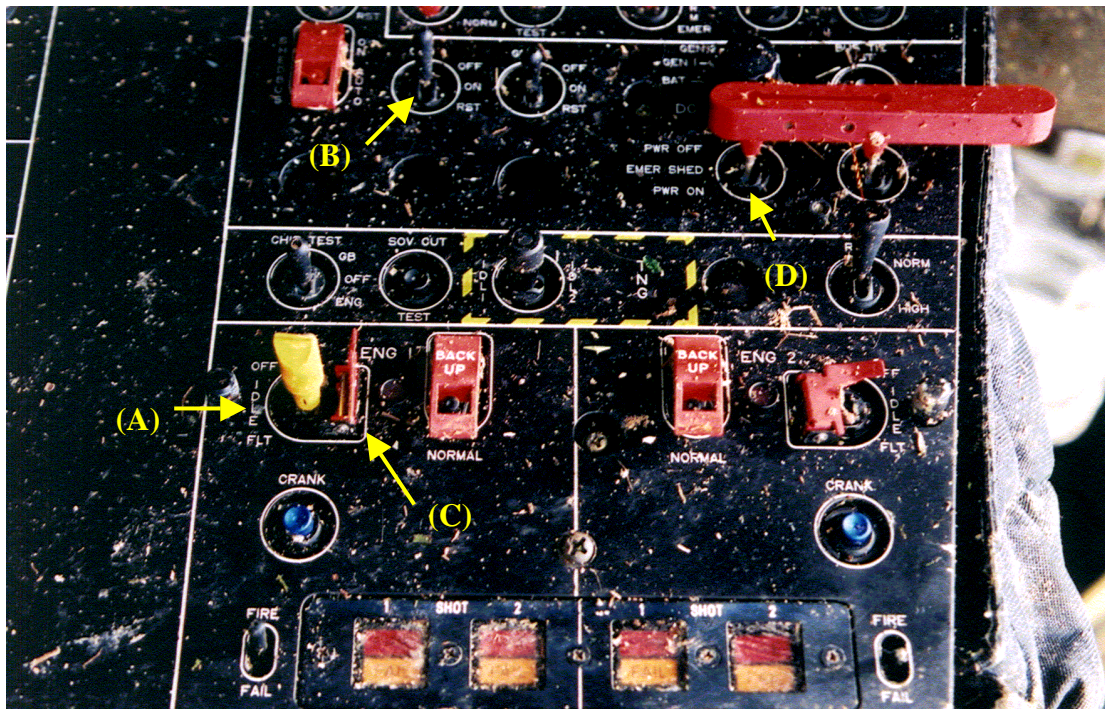
Figure 4

Engine 1 – IDLE (A), Generator 1 – OFF (B)
 Safety Device – Unsafe Position (C), Emergency Cut Off – PWR OFF (D)

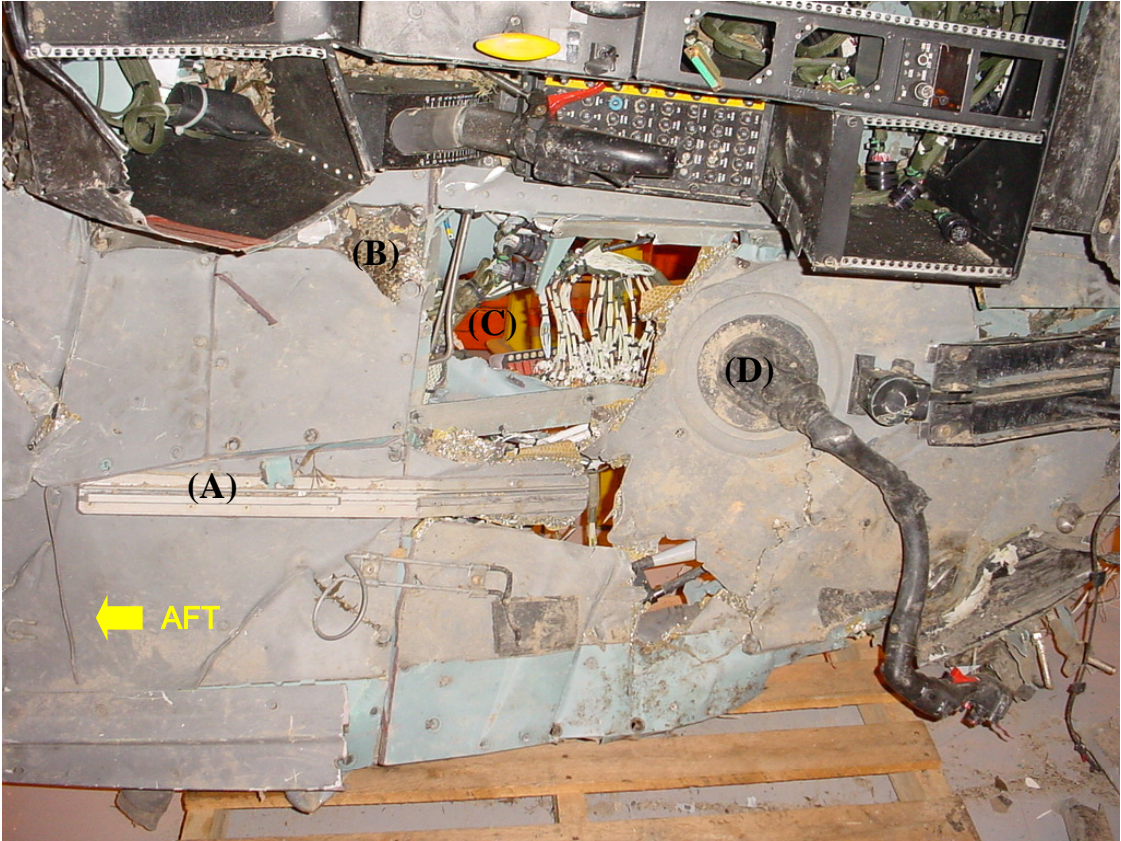
The structure of the cockpit and cabin failed during this accident (see Appendix F). One of the major lines of

failure ran laterally through the floor of the rear cabin, resulting in the fuselage folding double. The pilot's seat and the running rails on which the seat was mounted were severely damaged as a result of the accident. The back of the seat was broken and displaced forwards. This breakage would have seriously degraded the restraint offered by the five-point harness even had the seat remained attached to the aircraft floor. The two 65 cm long seat mounting rails were each attached to the composite sandwich panel floor of the aircraft by 18 crosshead screws, nine each side of the rail, through countersunk holes in the base plate. The screws located with inset nuts cemented into the composite sandwich panels. None of the fixings was made to a hard structure.

The pilot's seat inner rail was found to have broken 42 cm behind the cyclic stick, at a point coinciding exactly with a joint in the floor panel. The 36 cm x 25 cm piece of floor panel immediately in front of this break was found completely detached, along with the front end of the seat rail. The back portion of the rail, which was also detached completely from the floor, had a retained portion of the broken seat runner still attached to it.

Aircraft floor showing the position of the outer seat mounting rail (A), area of missing back portion of inner seat rail (B), missing panel (C), and cyclic control (D)

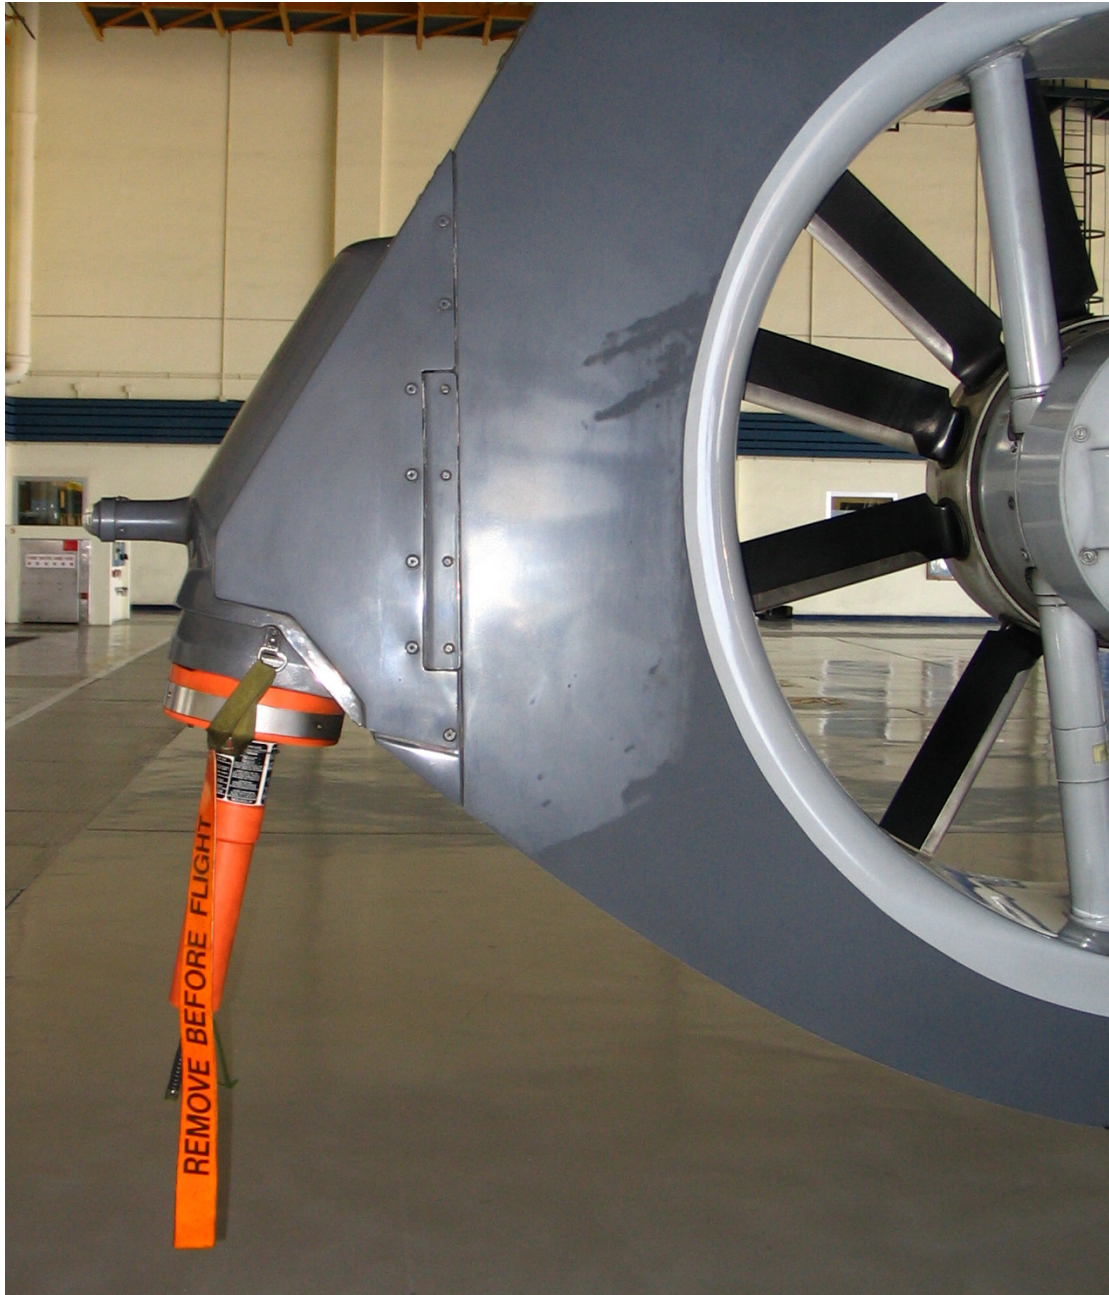
In the accident aircraft, a Cospas-Sarsat 406 MHz compliant ADELTA, model Caledonian Airborne Systems CPT-609 equipped with an automatic release mechanism, was installed at the rear end of the tail boom (see Appendix G). Deployment of this device was designed to take place via the breakage of any one of four frangible switches or the operation of a hydrostatic switch under water pressure or a saline switch that would operate on contact with fresh or saline water. However, this ADELTA was not designed

At the second point of impact, the antenna of the device separated from the main body, which remained in its mounting bracket at the end of the tail cone. The ADELT master switch in the cockpit was found in the ARM position but the squib of the deployment circuit had not been activated. The Rescue Coordination

ADELT Installation on GFS EC155B1 Helicopter
