AIRCRAFT ACCIDENT REPORT 1/2010

**Civil Aviation Department
Hong Kong**

**Report on the accident to
Robinson R22 helicopter, B-LAT,
at a parking lot adjacent to the Hong Kong Aviation Club Limited,
Sung Wong Toi Road, Hong Kong
on 1 May 2009**

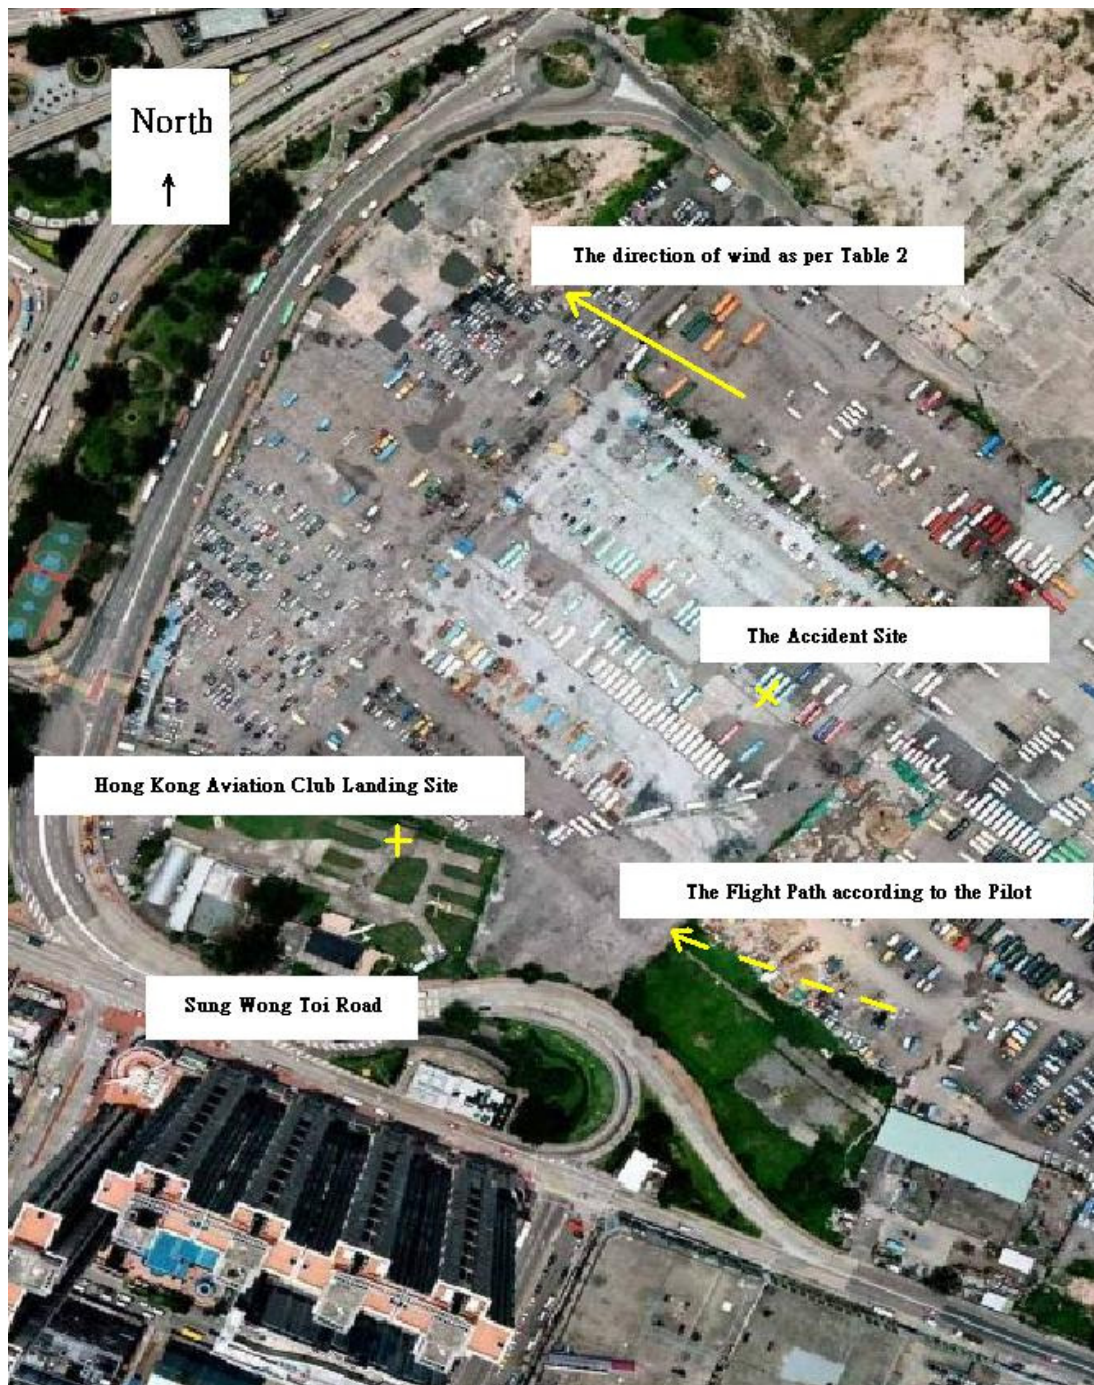
Photograph 1 Aerial View of the Accident Site

to lose altitude and drifted in a northerly direction until it impacted the windscreen of a coach parked in the parking lot adjacent to Sung Wong Toi Road. At the time of the accident, one person was working inside the coach.

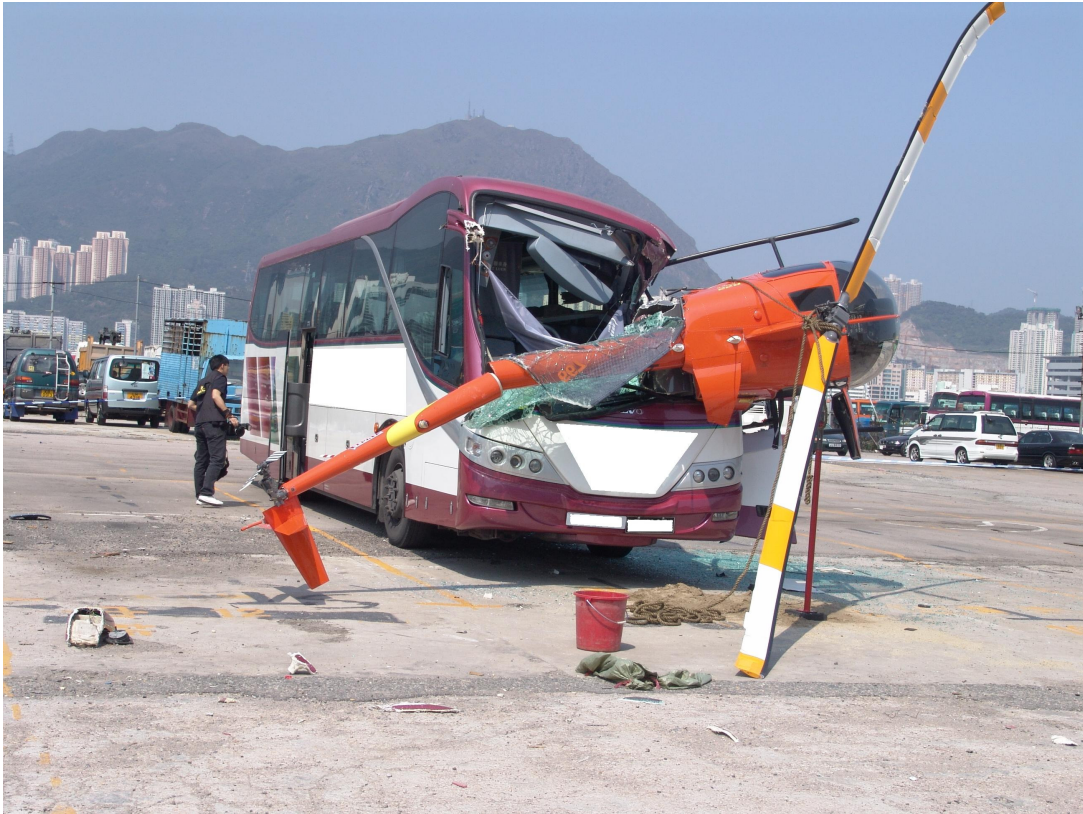
Photograph 2 Helicopter and the Damaged Coach – Front View

The front section of the parked coach was damaged.

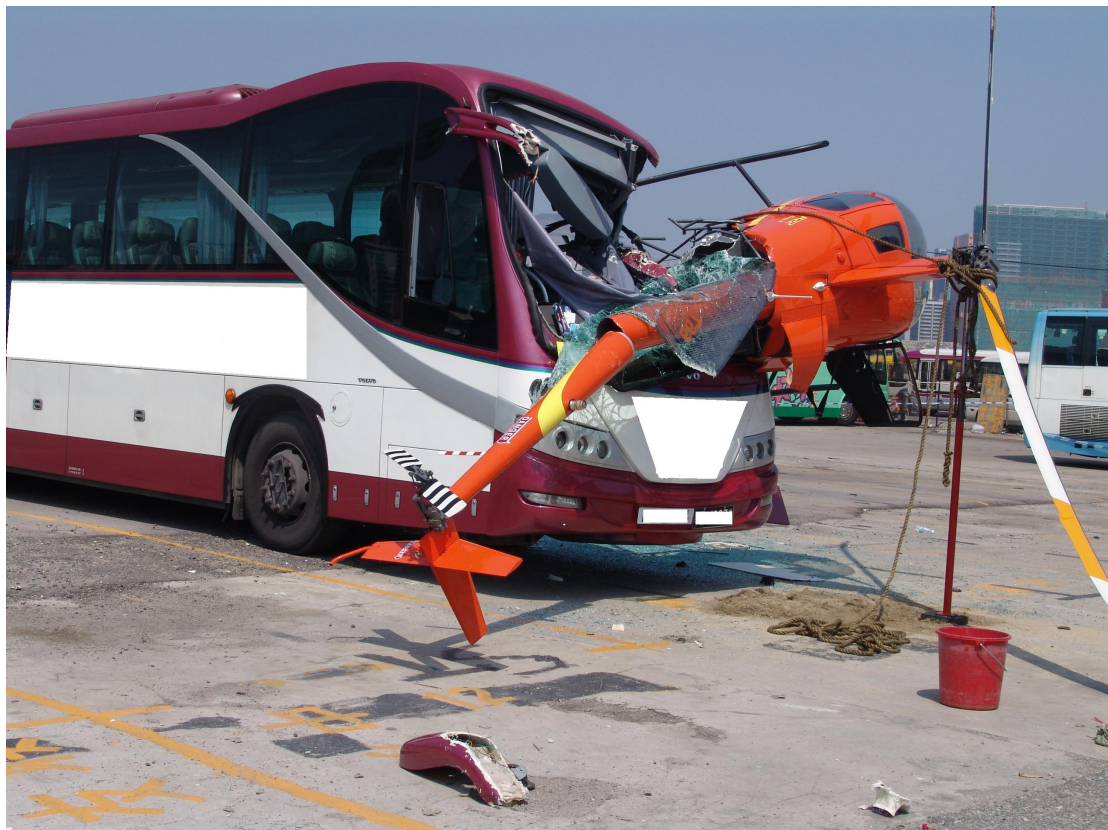
Photograph 4 The Wreckage

1.12.1 The helicopter crashed into a coach at approximately level attitude. The left-hand side skid struck through the windscreen of the parked coach. The helicopter came to rest on the left-hand side top corner of the coach with the right-hand side skid struck through the entry door. (Photograph 4)

1.12.2 The main rotor blades were distorted with signs of impact at the tips. The blades had signs of rupture at the mid span areas. The tail rotor and the blades were intact with no sign of impact damage. The tail cone was broken at the mid section.

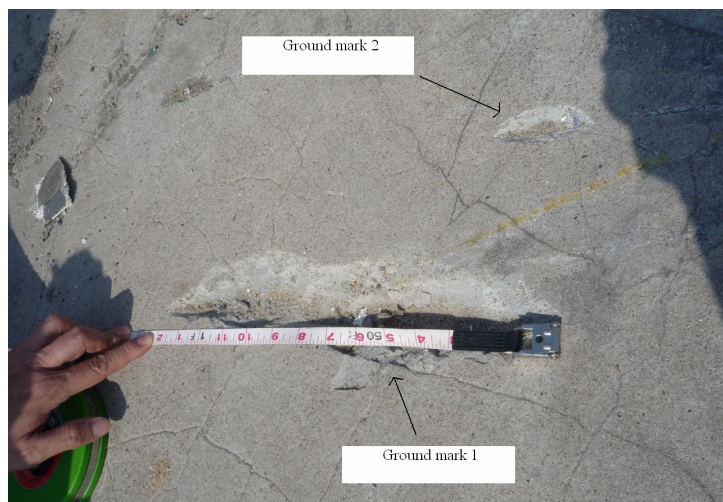
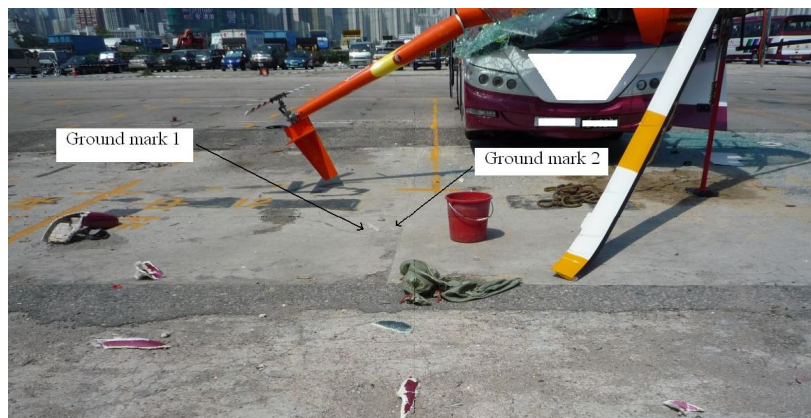
1.12.3 There were two ground marks made by the main rotor blades when they struck the ground. The bigger ground mark was measured 35.6cm x 6.4cm x 1.9cm and the smaller one was measured 6.4cm x 2.5cm x 0.6cm. (Photographs 5 and 6).

Photograph 5 Ground Marks – Close View

Photograph 6 Ground Marks – Relative to the Wreckage

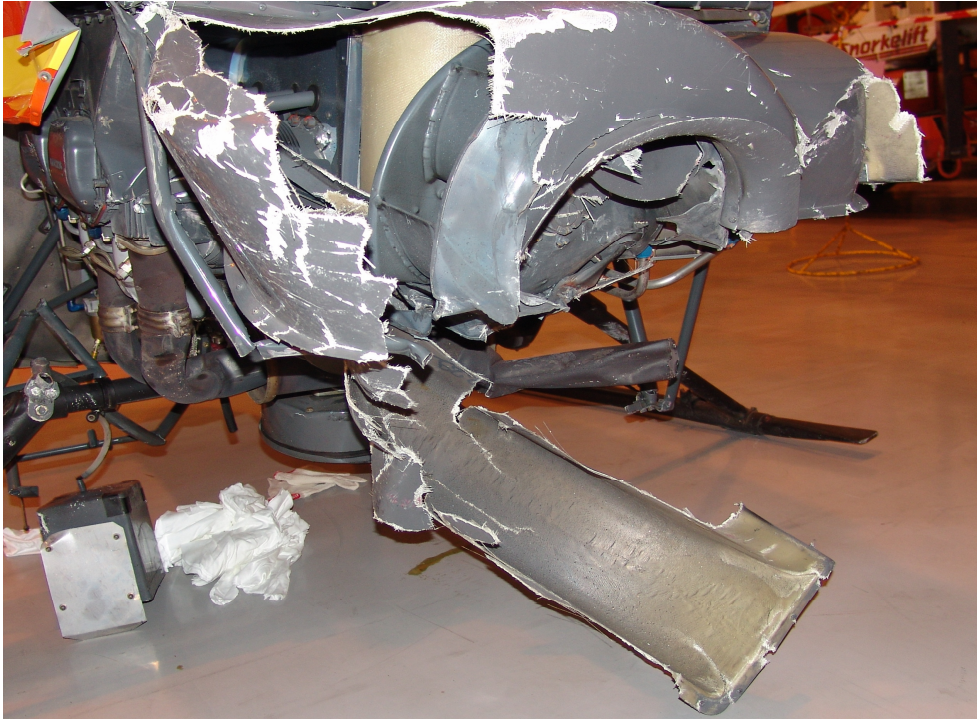
Photograph 8 The Centrifugal Cooling Scroll and Fanwheel

1.12.4.4 The centrifugal cooling scroll and fanwheel were severely damaged. (Photograph 8)

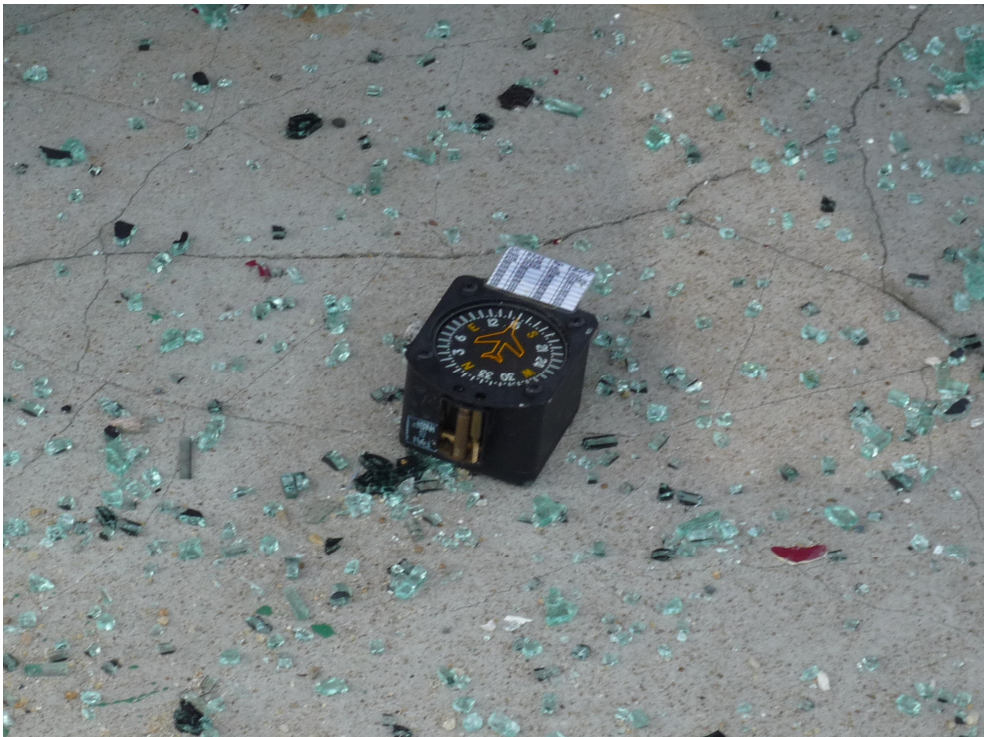
Photograph 9 The Magnetic Compass

1.12.4.5 The magnetic compass was detached from the helicopter.
(Photograph 9)

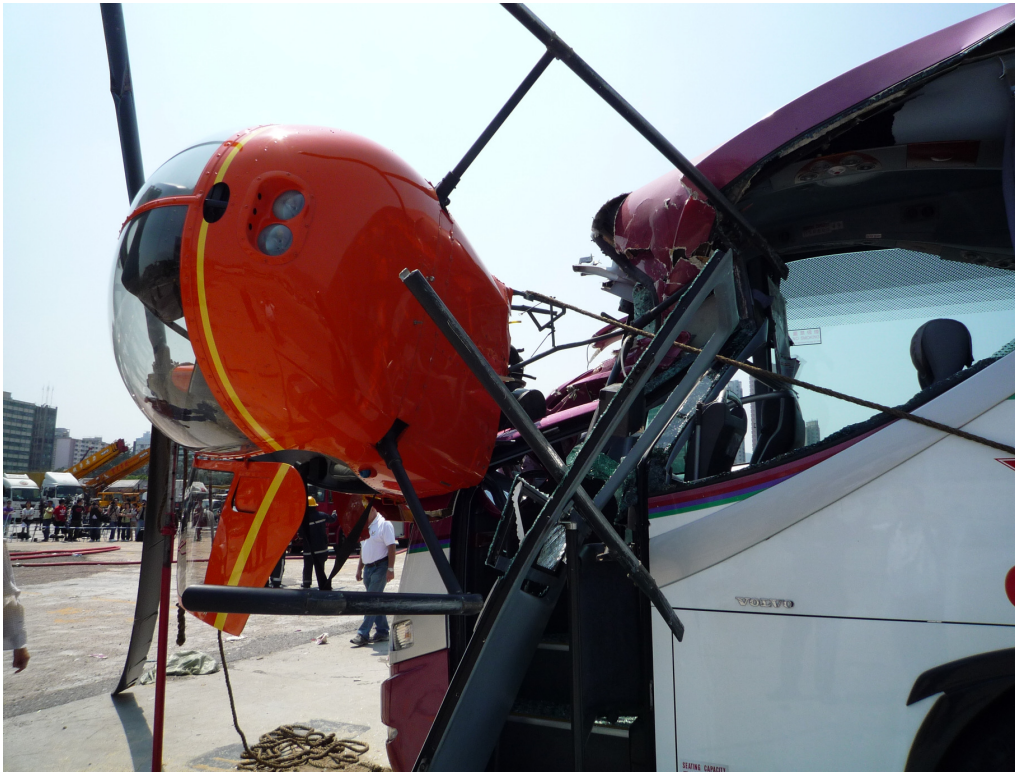
Photograph 10 Side-view on the damaged helicopter

The general shape and dimensions of the control cabin were preserved, no obvious damages were found on the perspex canopy following the impact. Impact damages were mainly on the skids and from the middle to rear portion of the helicopter. There was no evidence of any injury caused by

protruding objects. (Photograph 10)

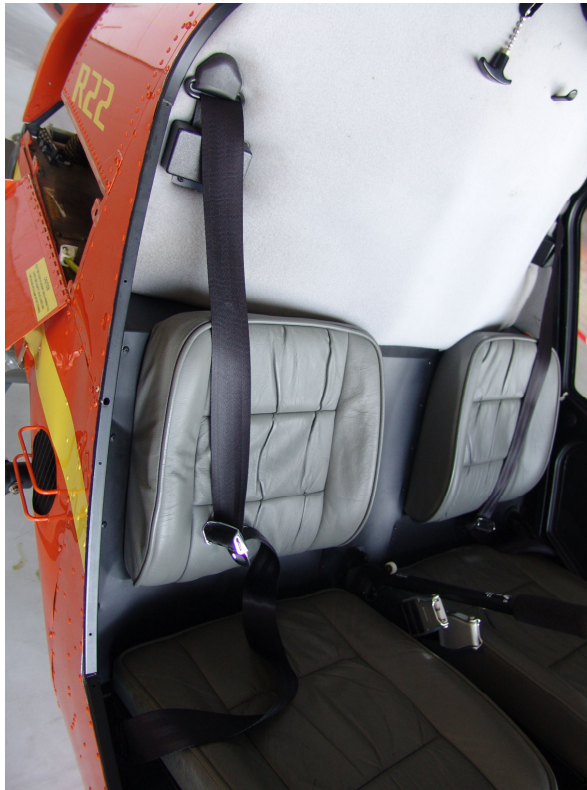
Photograph 11 The Harnesses

The three-point inertia-reel harnesses restrained the pilot and passenger. These harnesses were attached wholly to the helicopter cockpit frame structure and were fastened by standard flap release buckles mounted on short straps attached to the frame. The pilot and passenger seats were constructed integrally with the floor and comprised a pressed-sheet aluminium frame and seat cushion backed by aluminium plate. It was concluded that the three-point harnesses functioned normally and did not contribute to any injury or entrapment of the occupants. (Photograph 11)
