AIRCRAFT ACCIDENT REPORT 2/2014

ACCIDENT INVESTIGATION DIVISION

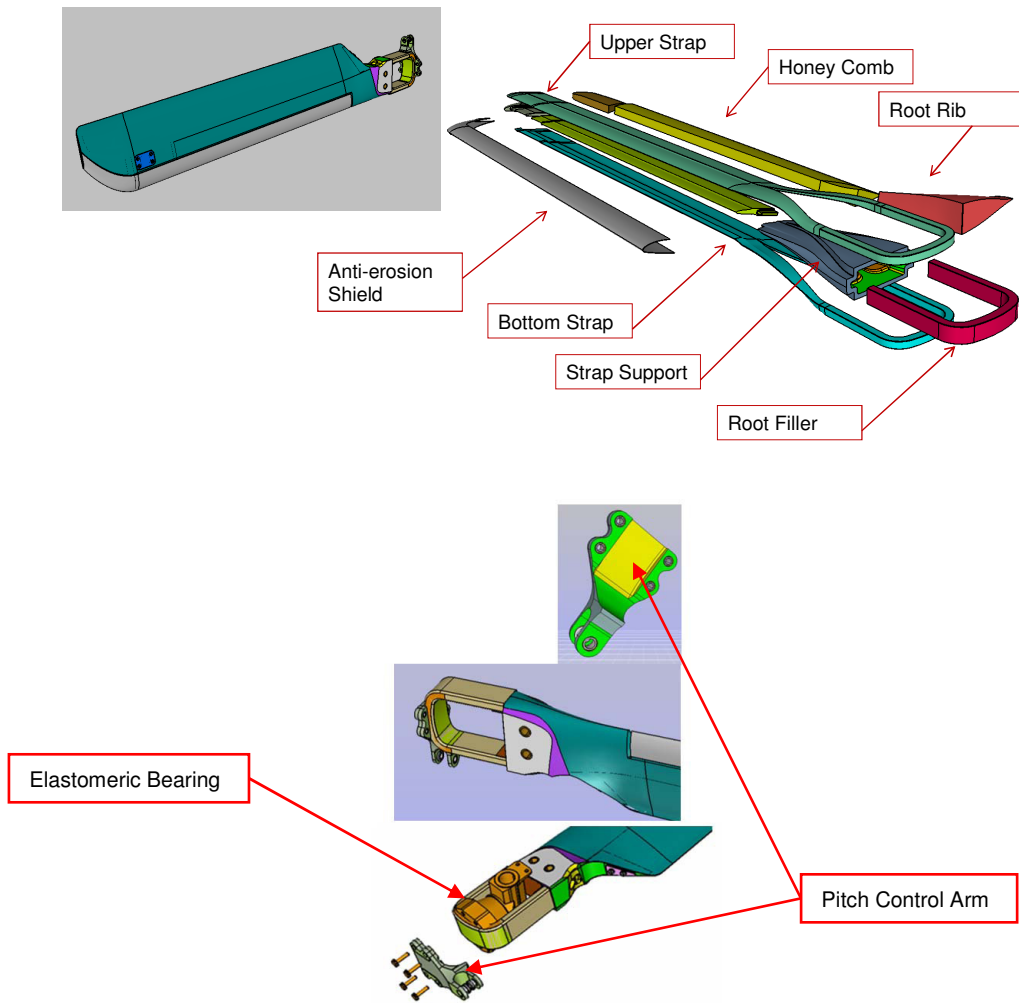
Figure 3 - Tail rotor blade structure

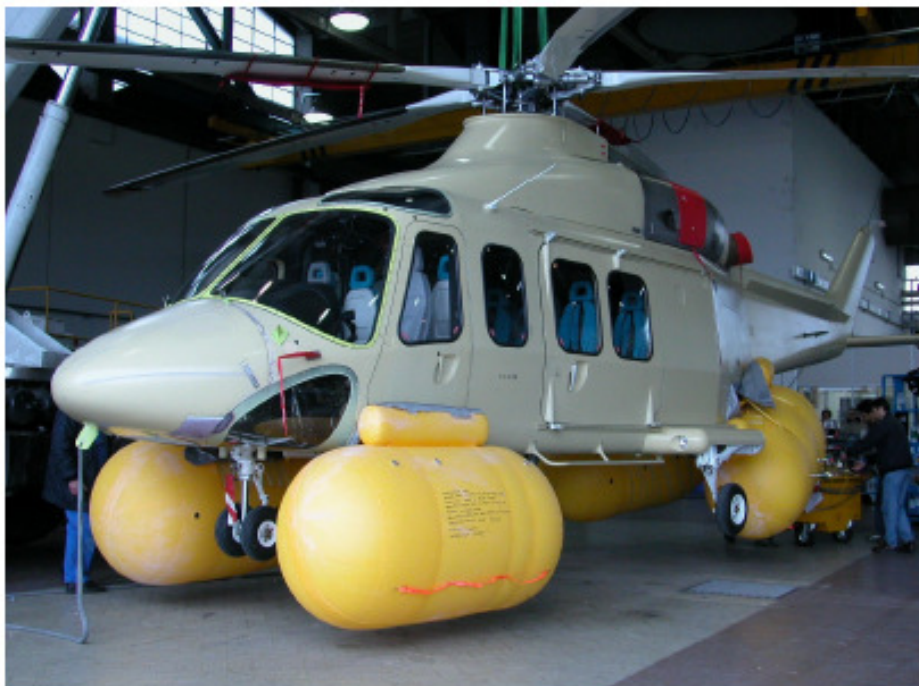
Figure 5 – AW139 Emergency Flotation System

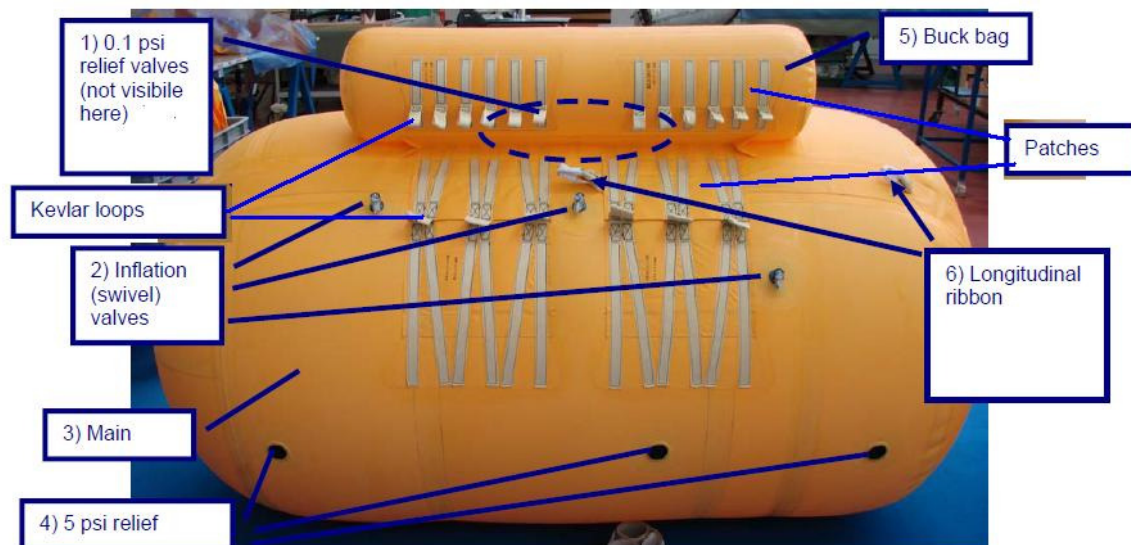
Figure 6 - Forward floatation bag and buck bag

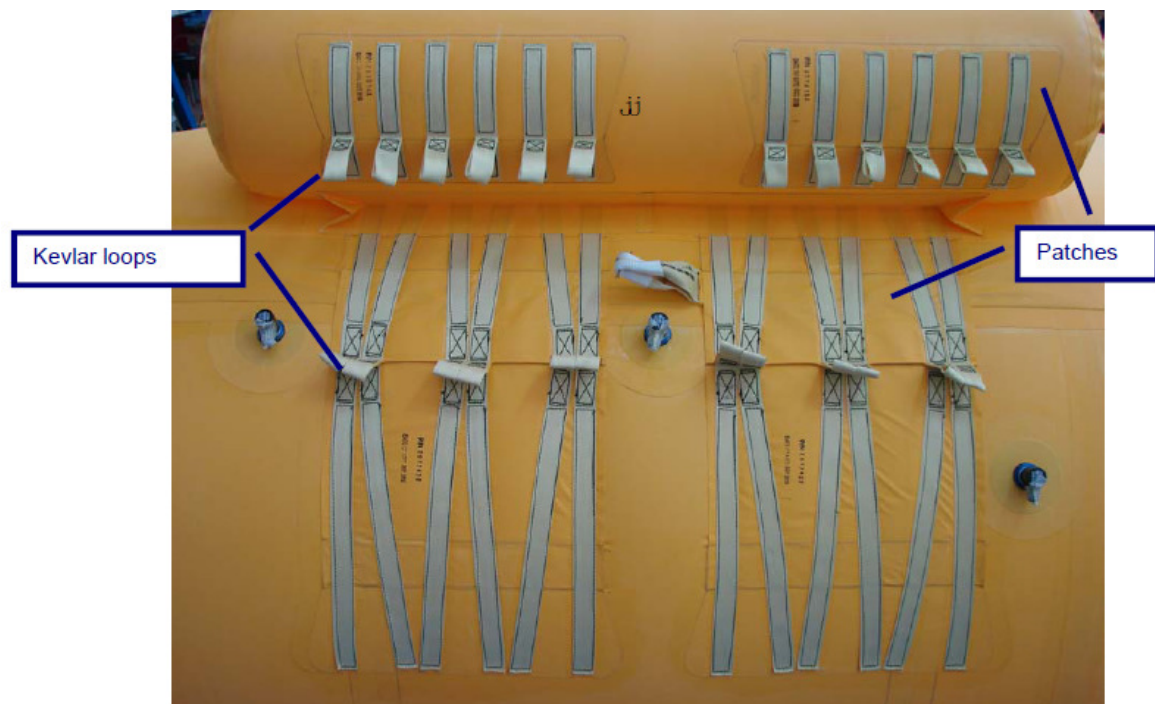
Figure 7 – Kevlar loops and patches

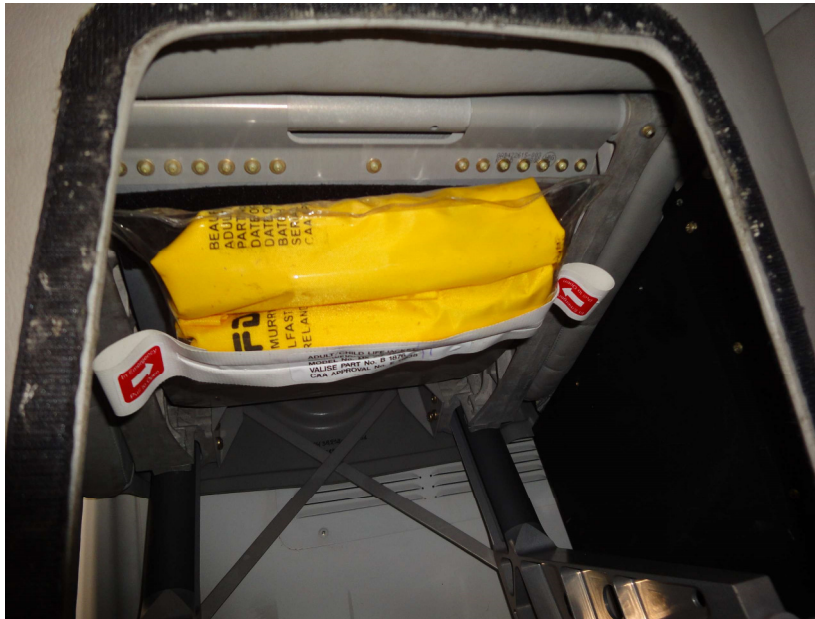
Figure 9 – A typical installation of passenger life jacket

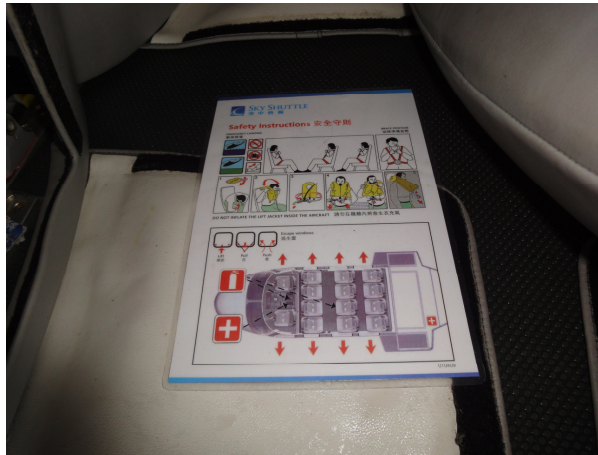
Figure 10 – Safety Instructions Placard

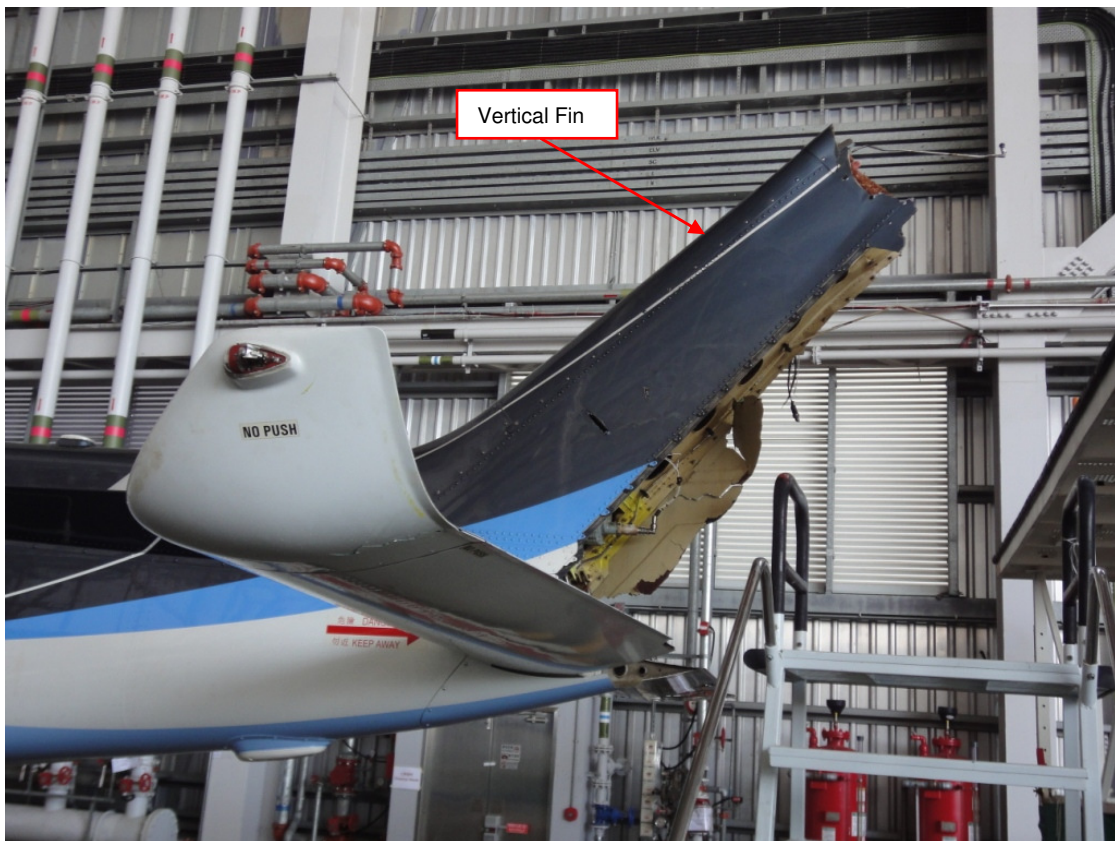
Figure 13 – Damage on vertical fin (side view)

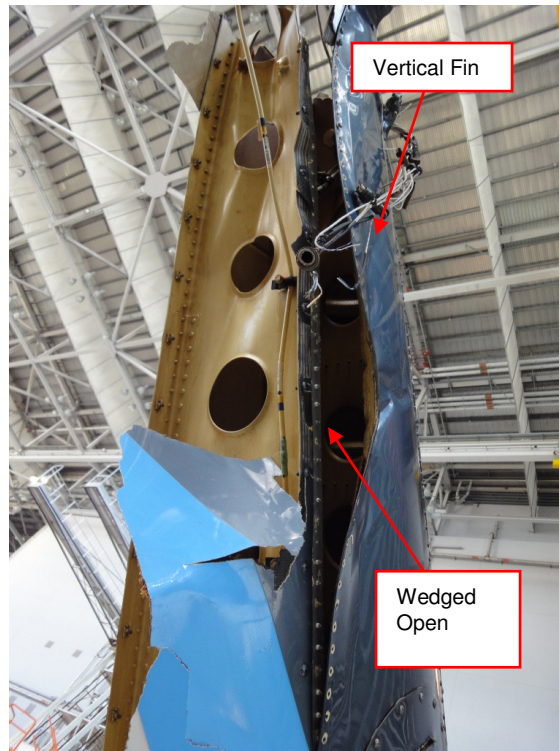
Figure 14 – Damage on vertical fin (rear view)

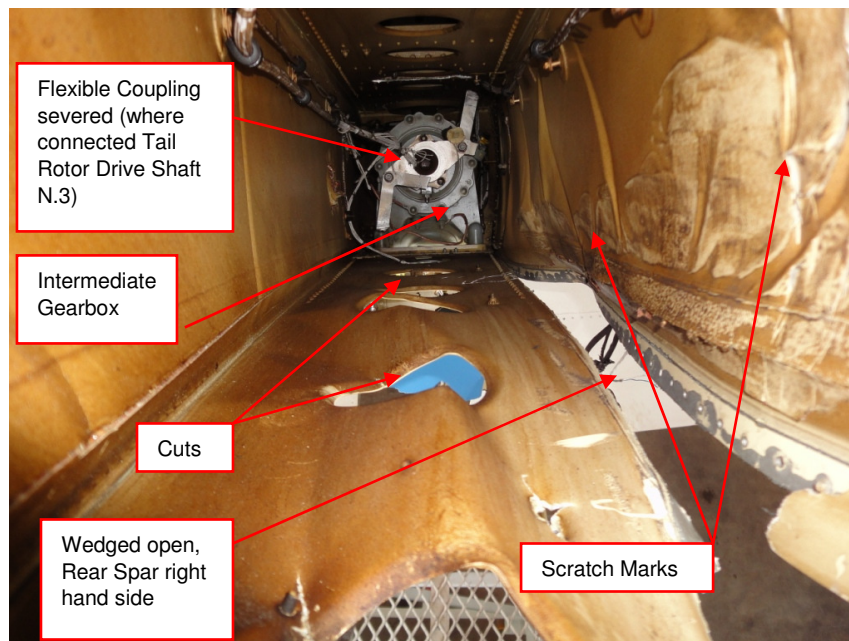
Figure 15 – Damage on vertical fin (view on interior surfaces)

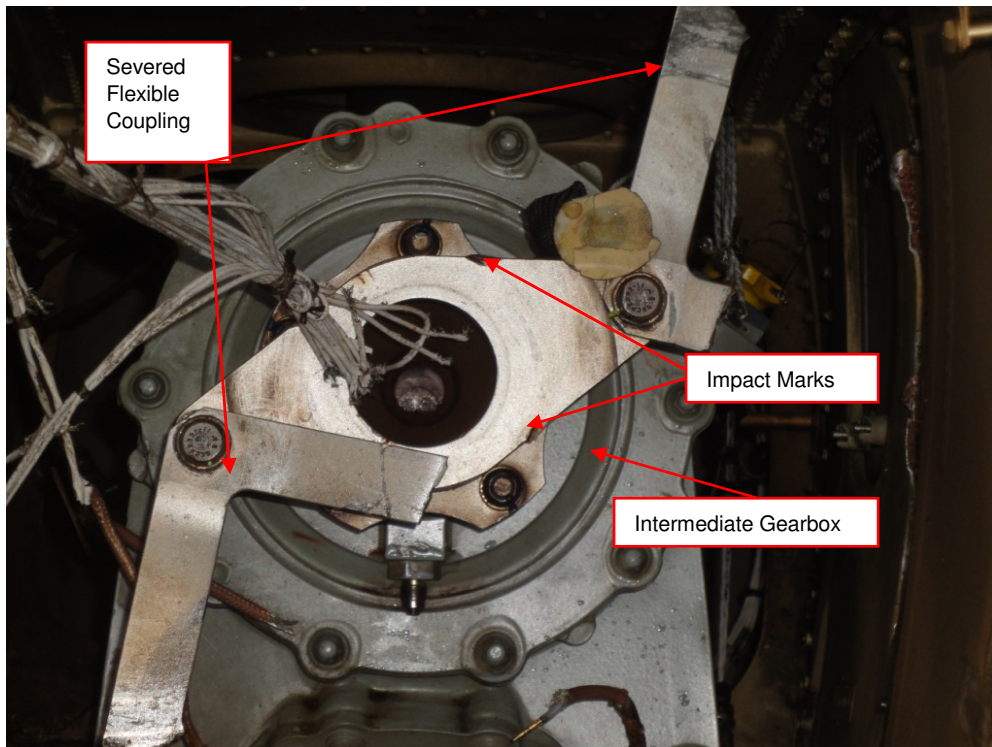
Figure 16 – Impact marks on flexible coupling of intermediate gearbox

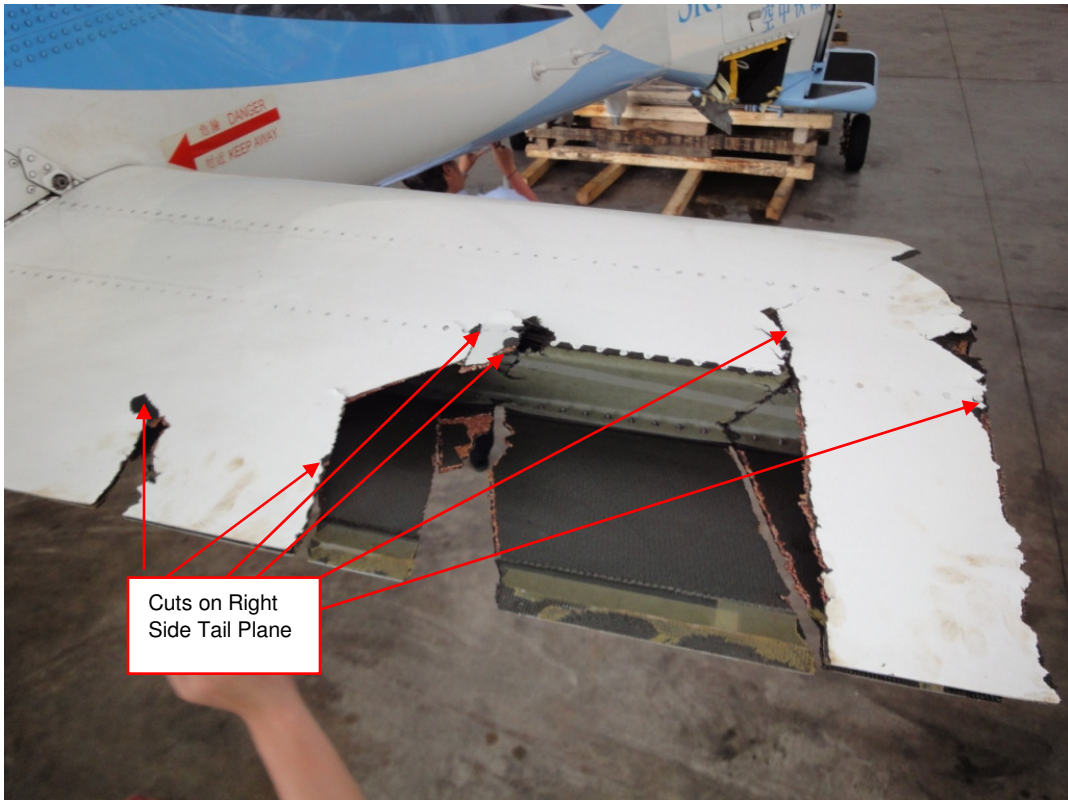
Figure 17 – Cuts on right side tail plane (upper surface)

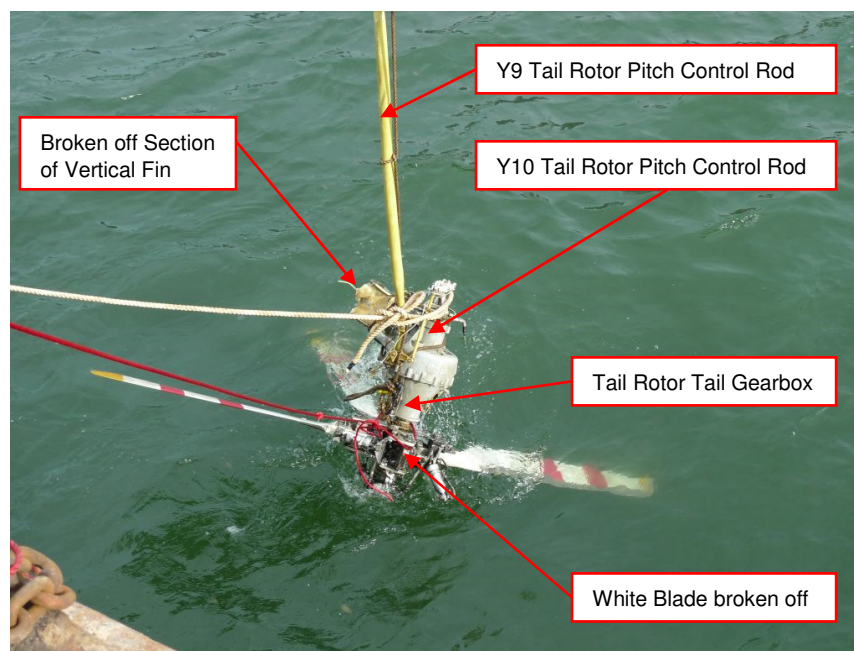
Figure 19 – Salvage of tail rotor and attachment structure

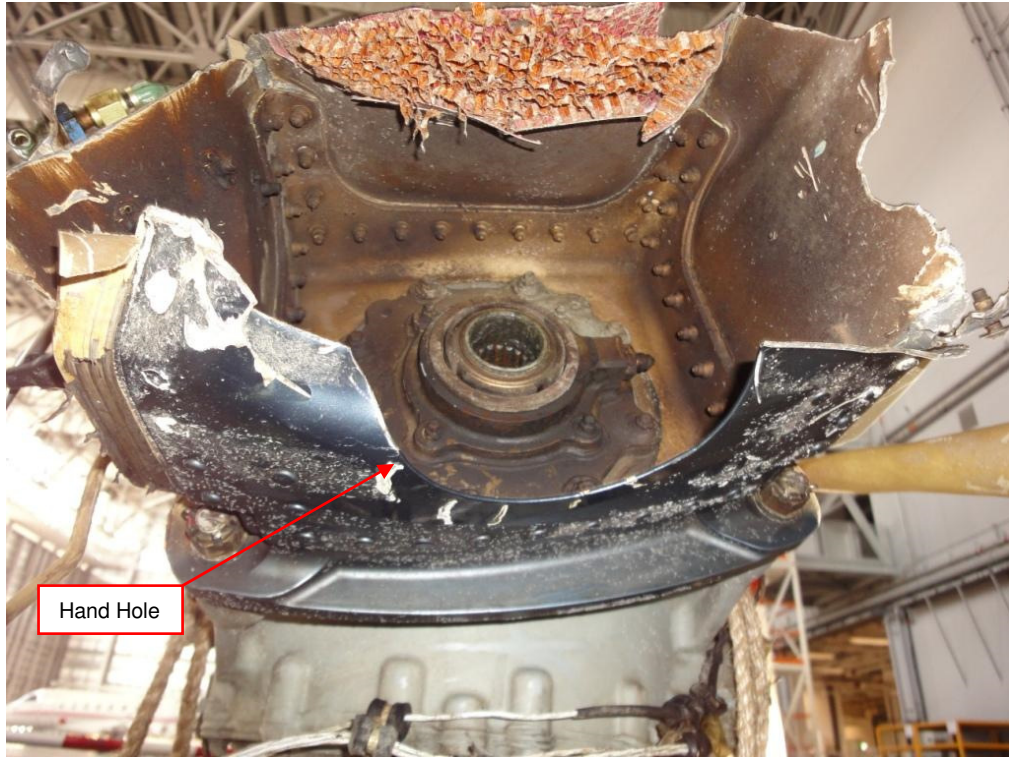
Figure 20 – Broken off section of vertical fin

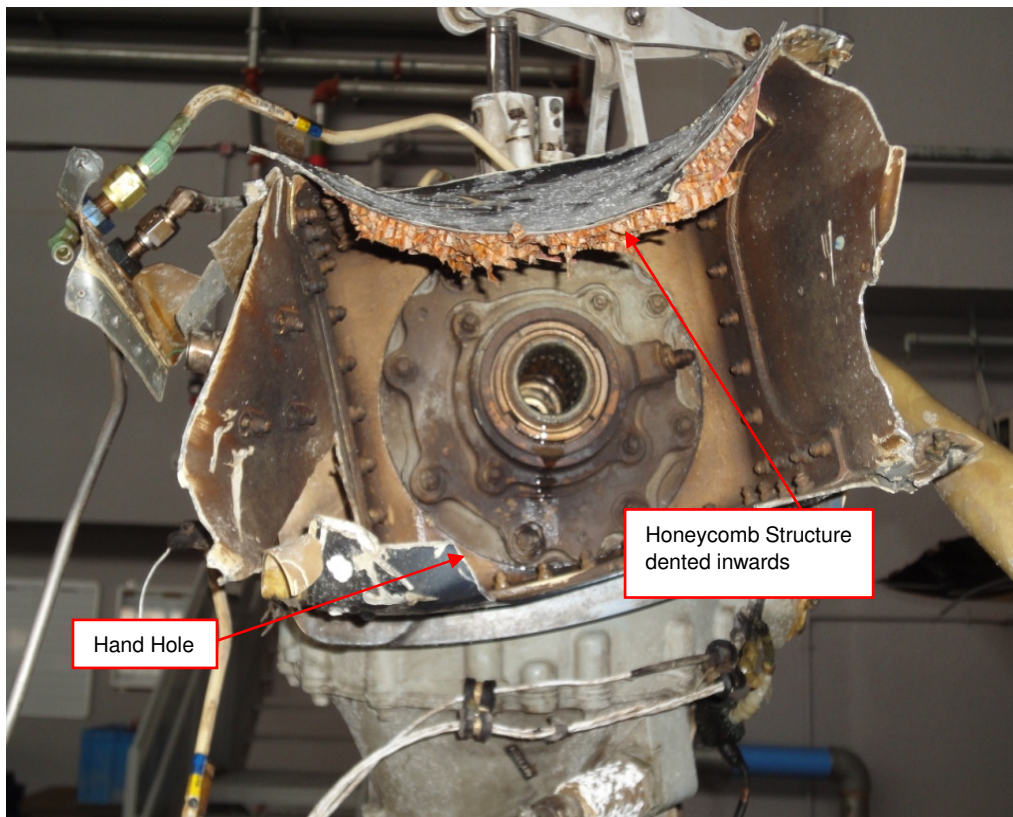
Figure 21 – Broken off section of vertical fin

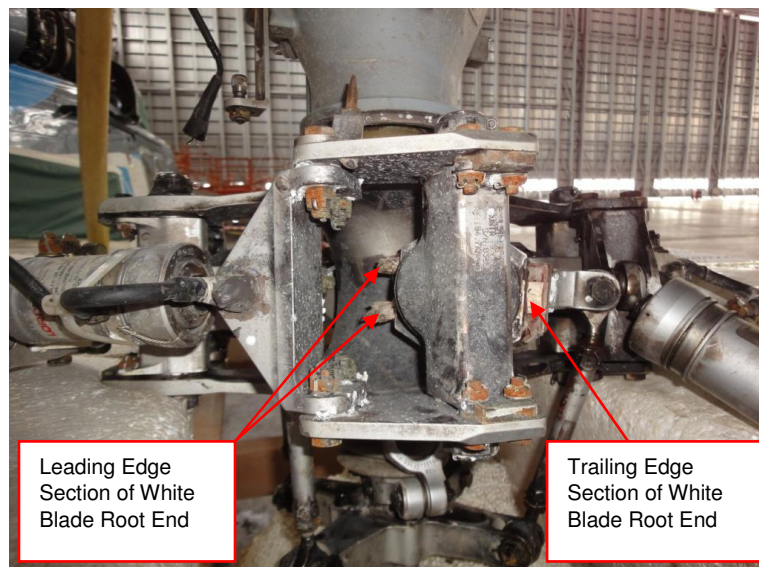
Figure 22 – Remains of White blade beneath elastomeric bearing

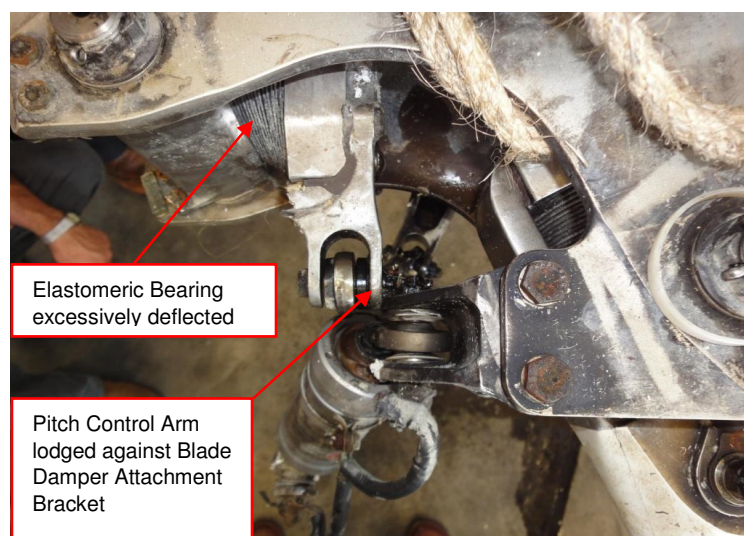
Figure 23 – White blade pitch control arm lodged against blade damper attachment bracket

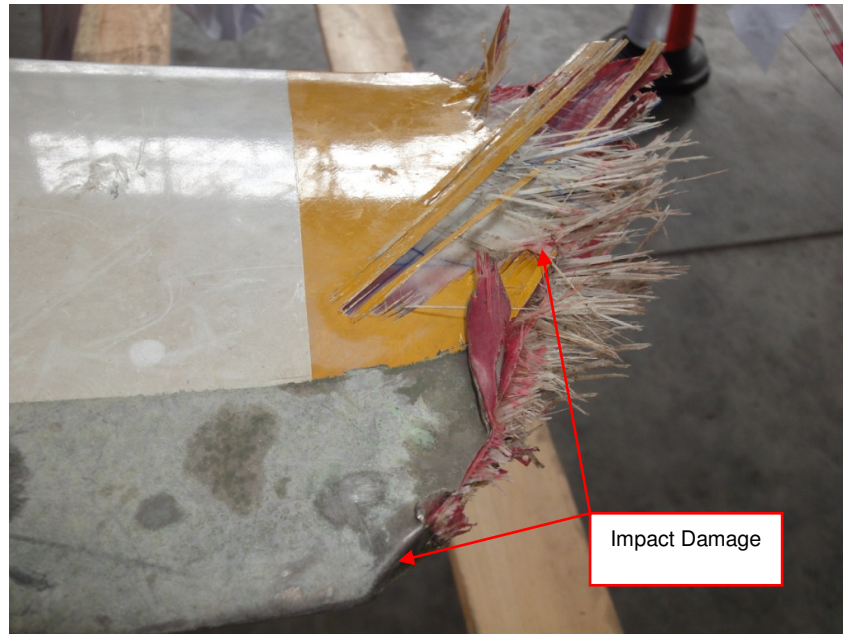
Figure 24 – Impact damage on Blue blade

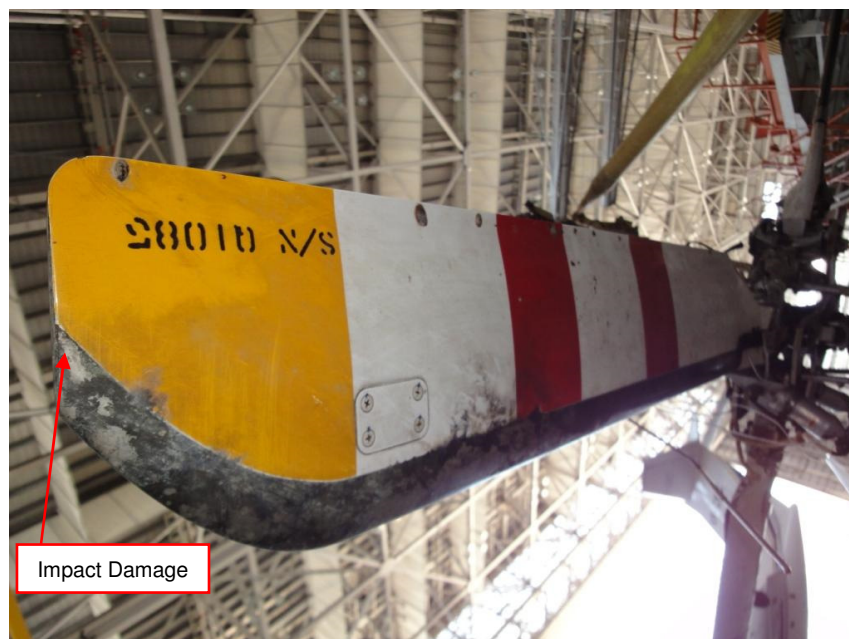
Figure 25 – Impact damage on Yellow blade

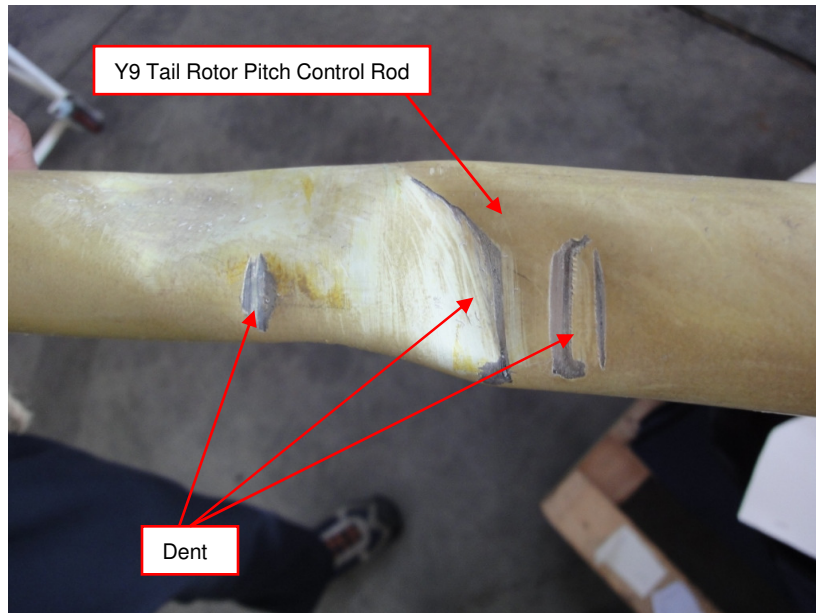
Figure 26 – Impact damage on tail rotor pitch control rod Y9 (facing aft)

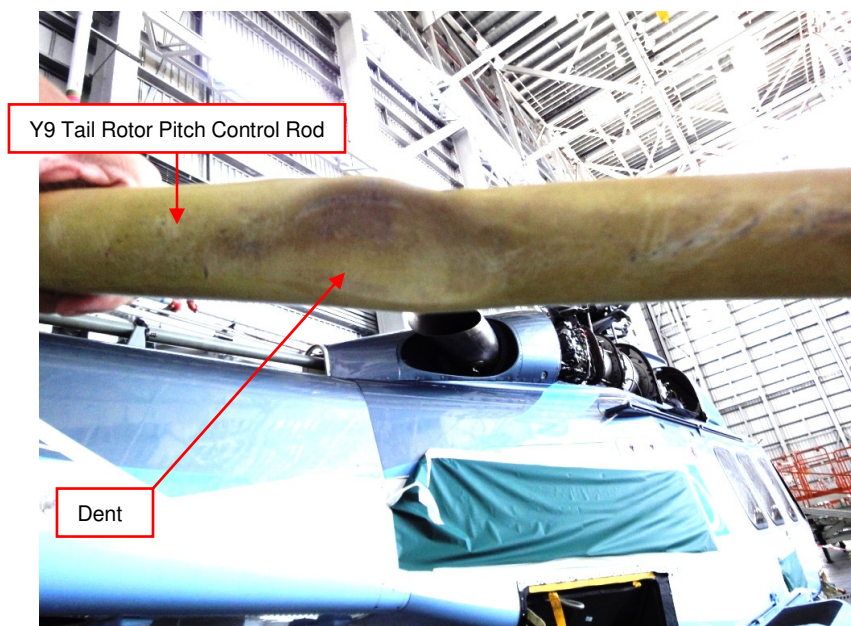
Figure 27 – Impact damage on tail rotor pitch control rod Y9 (facing forward)

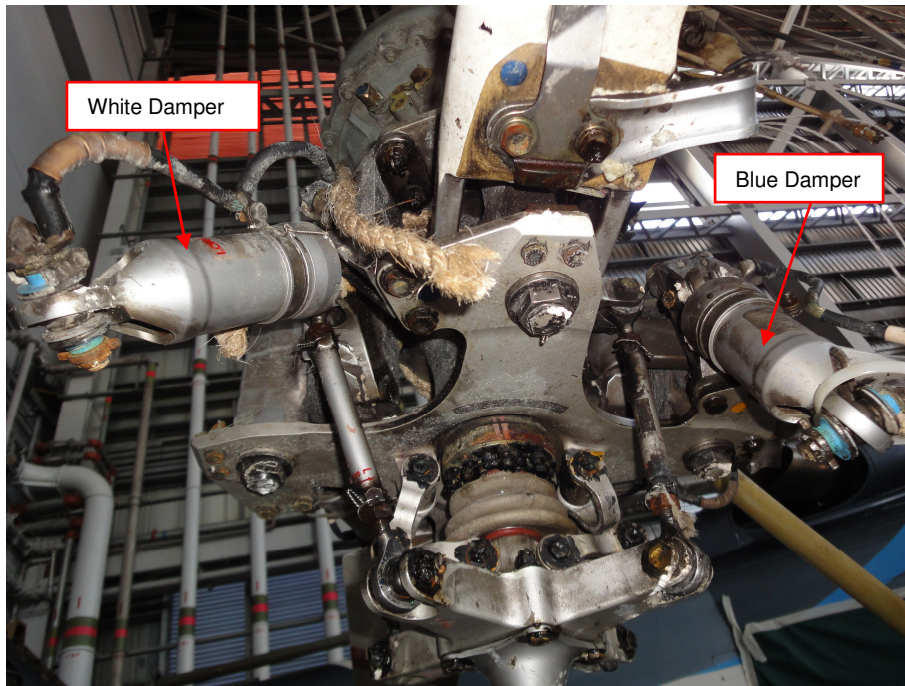
Figure 28 – White and Blue blade dampers

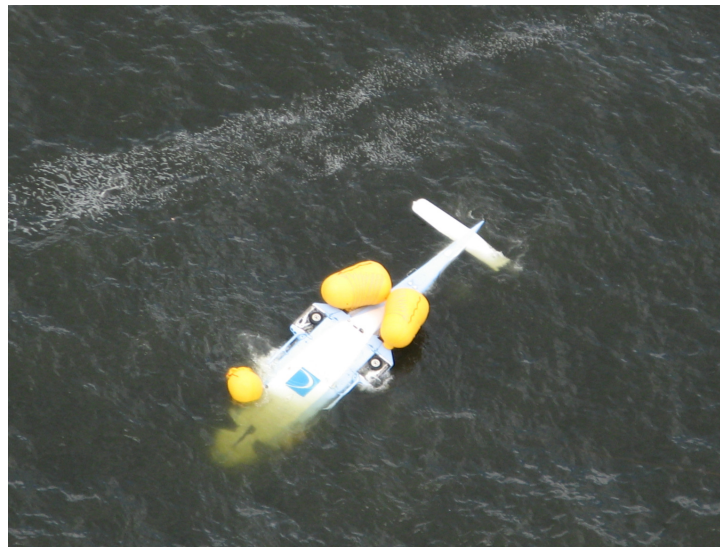
Figure 29 – B-MHJ overturned and remained in floating condition

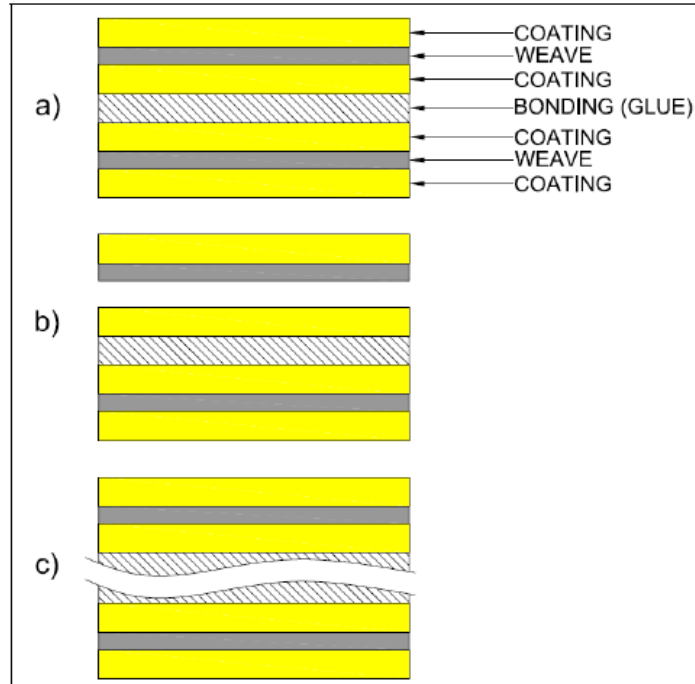
Figure 30 – Sectional views showing:
a) an intact bond between patch and floatation bag, b) and c) a detached patch

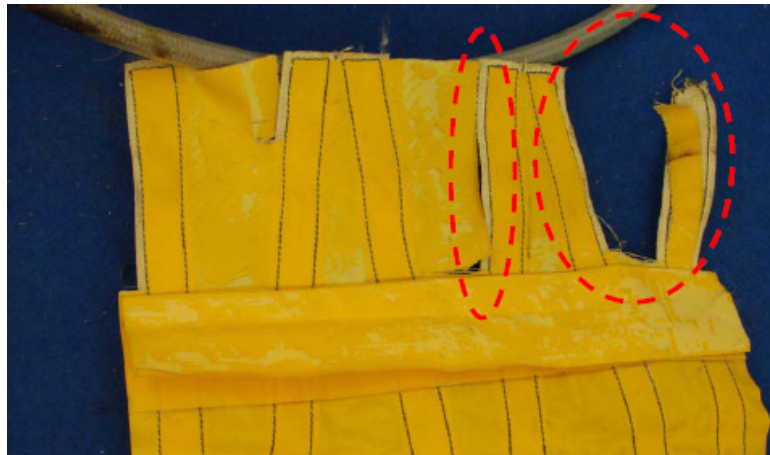
Figure 31 – Fabric torn along stitching

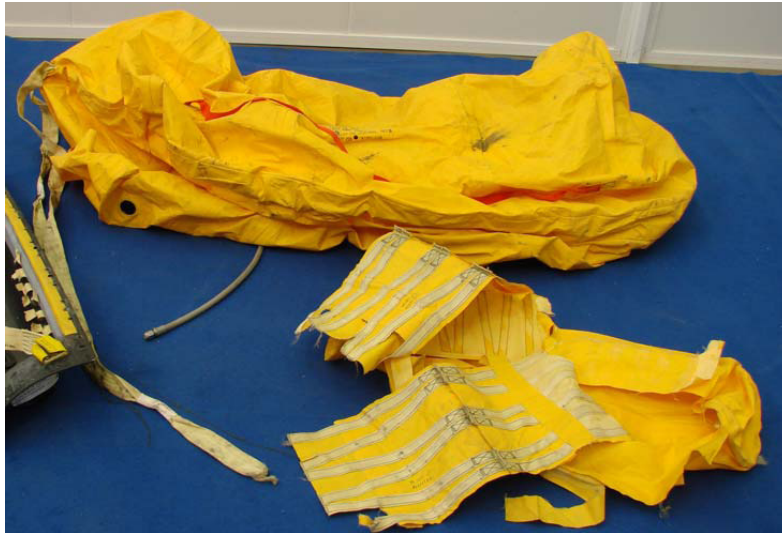
Figure 32 – Buck bag detached from the floatation bag

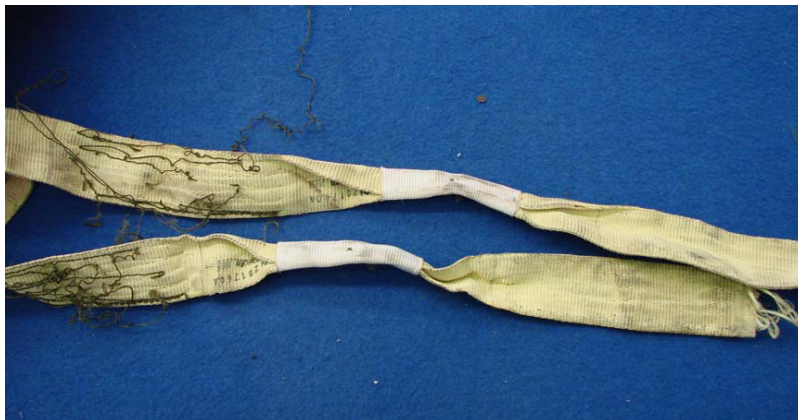
Figure 33 – Failed longitudinal ribbon (Right Forward Float Assembly)

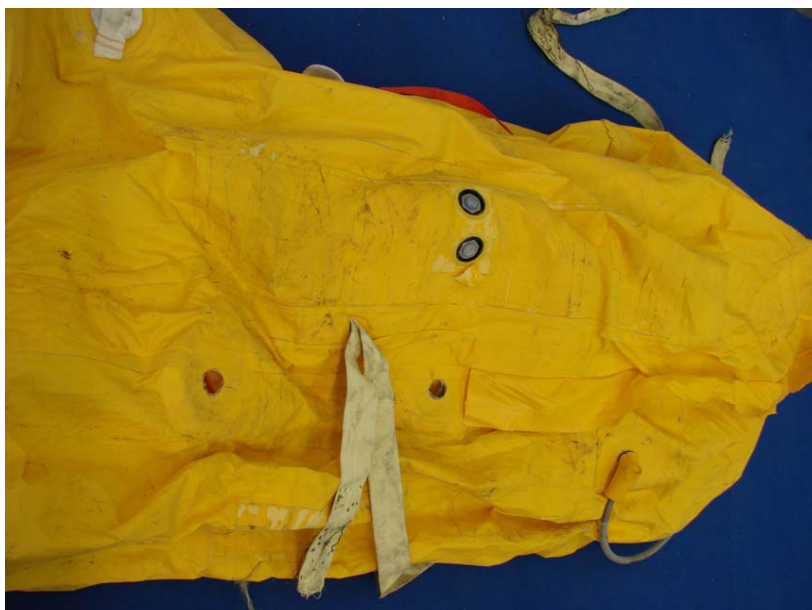
Figure 34 – Holes for Inflate (swivel) valves

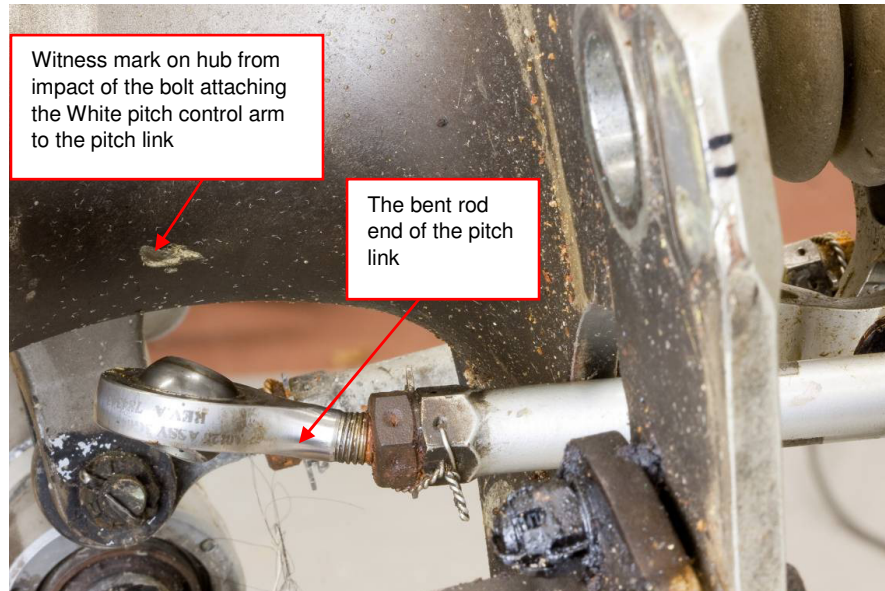
Figure 37 – Witness mark on tail rotor hub

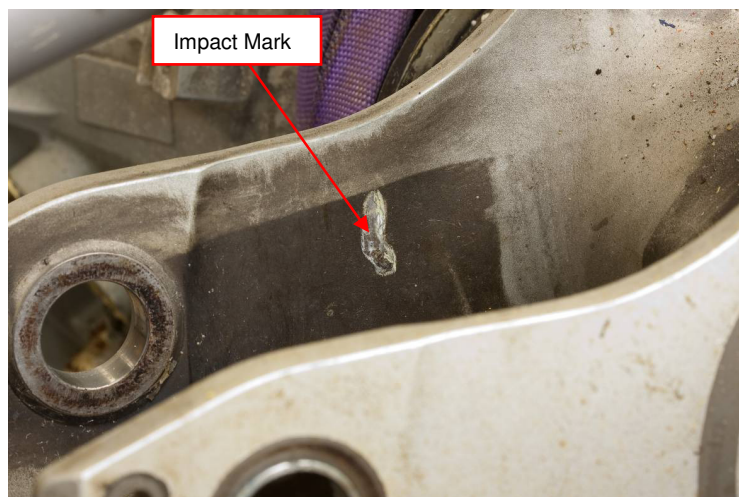
Figure 38 – Witness mark caused by flapping of White blade

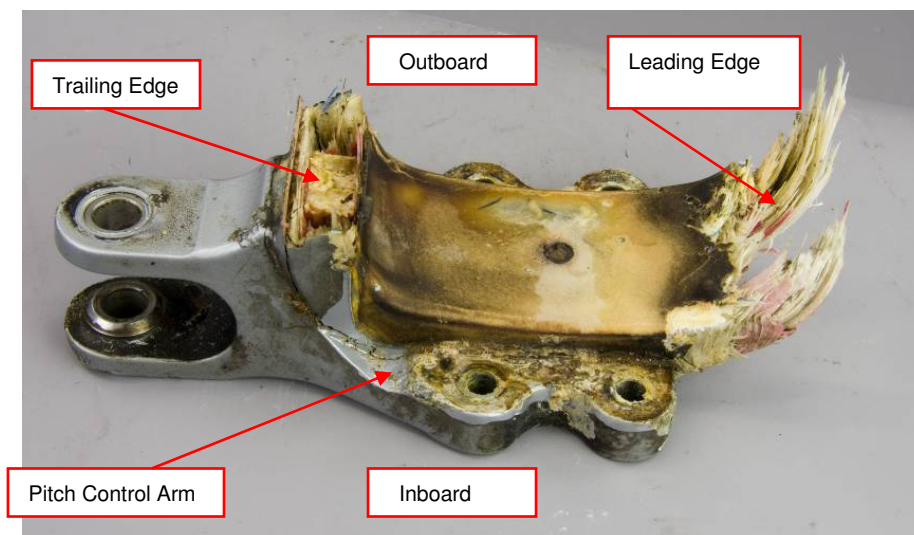
Figure 39 – Remains of White blade with pitch control arm attached

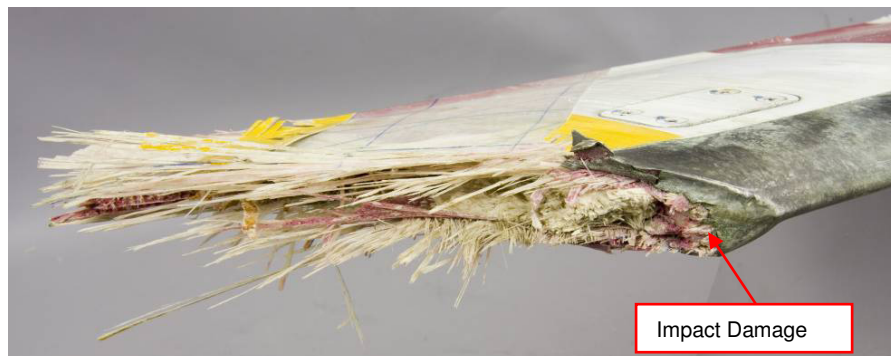
Figure 40 – Impact damage at tip of Blue blade

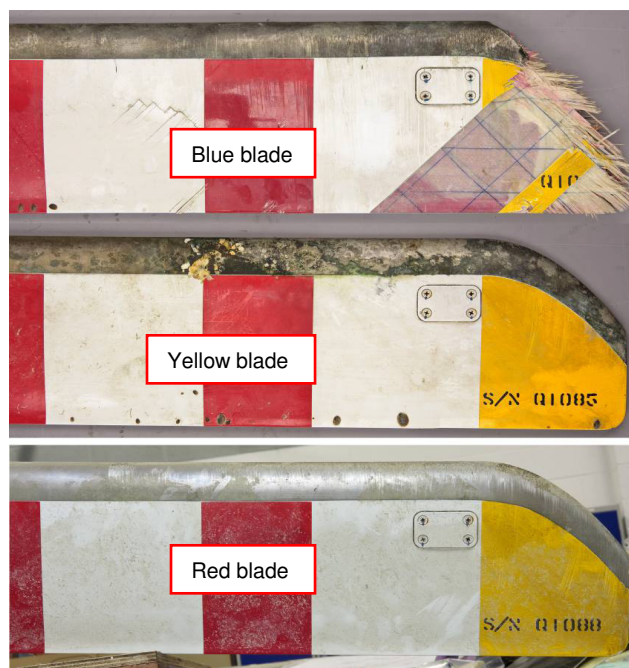
Figure 41 – Blue, Yellow and Red blades

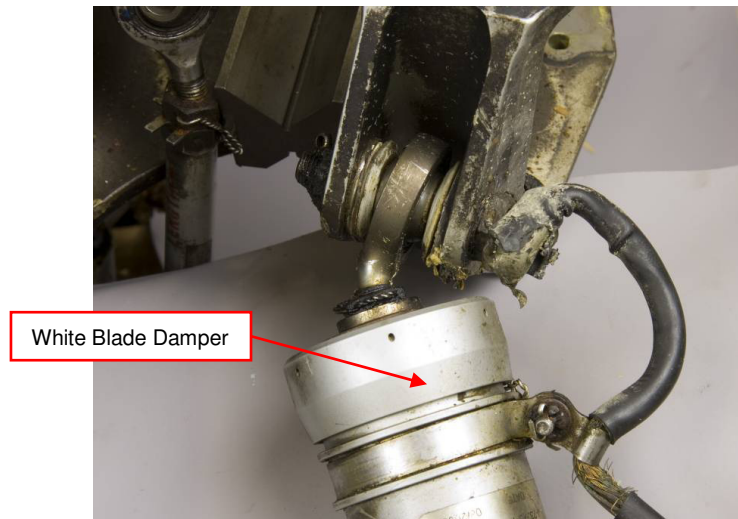
Figure 42 – Bent rod end on White blade damper and damage on hub damper bracket

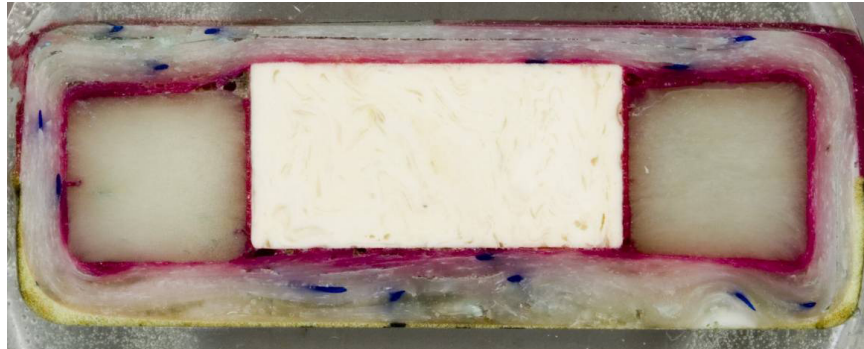
Figure 44 – Cross-section through the root end of the White blade

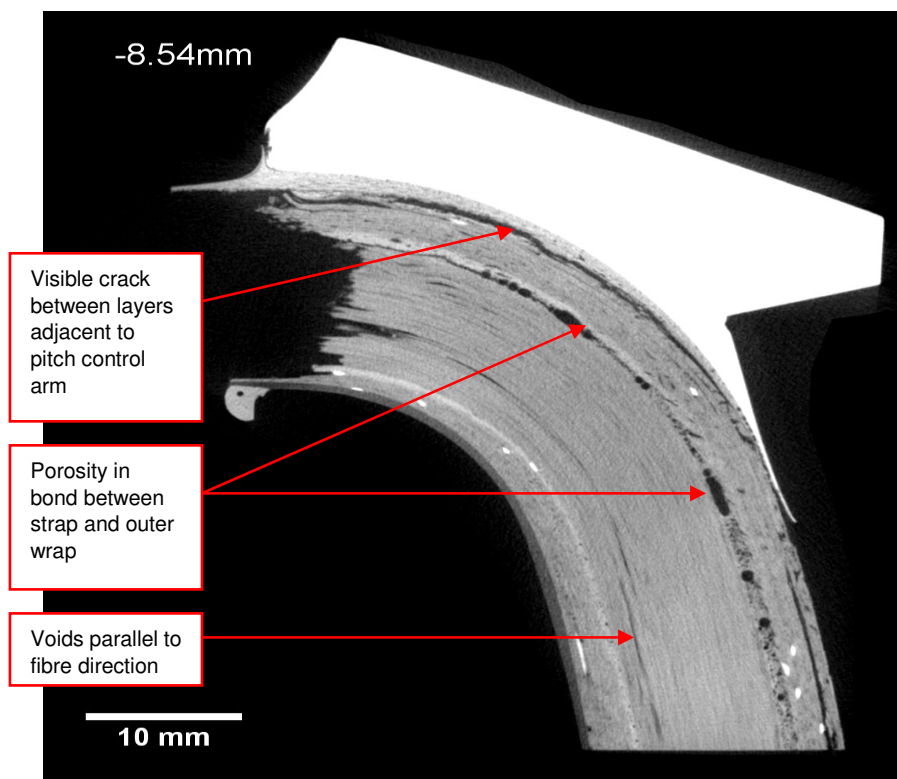
Figure 45 – Section through White blade strap using X-ray tomography

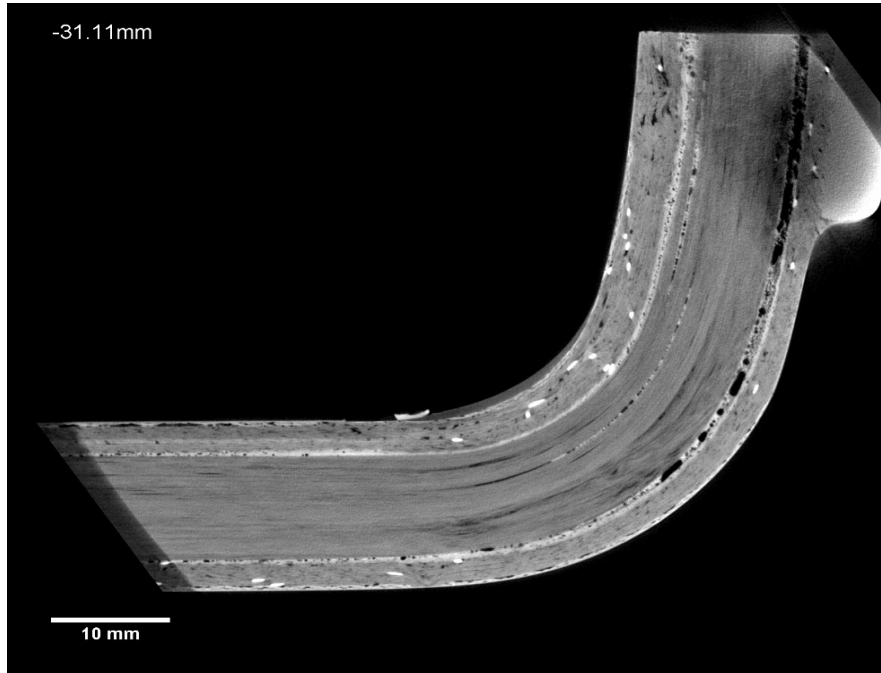
Figure 46 – Section through Blue blade strap using X-ray tomography, showing porosity and cracks parallel to the fibres and in the adhesive layer

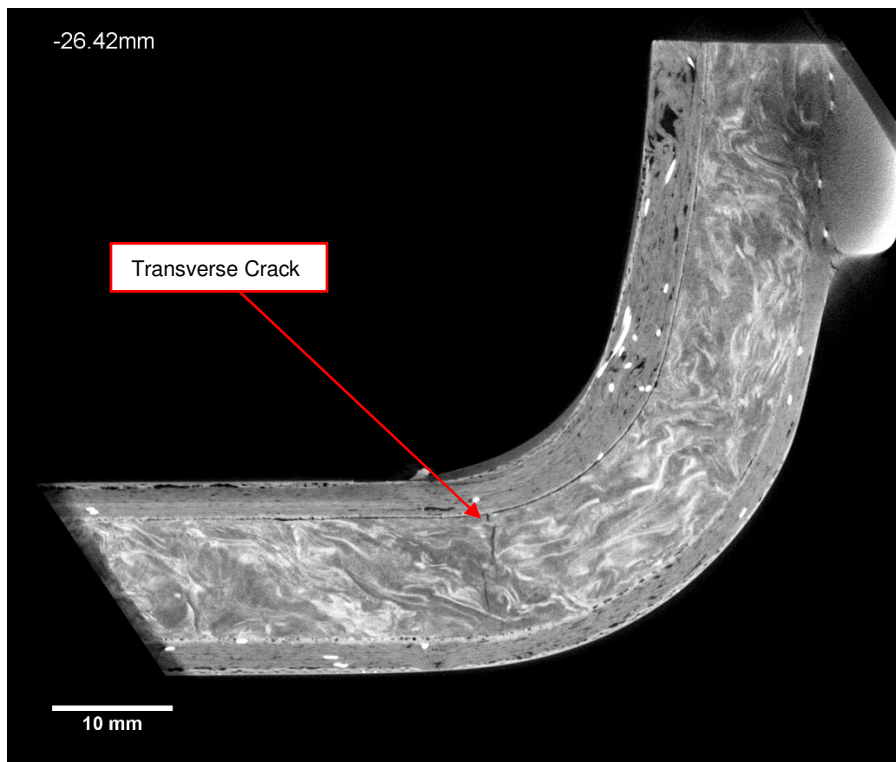
Figure 47 – Section through Blue blade root filler using X-ray tomography, showing transverse crack

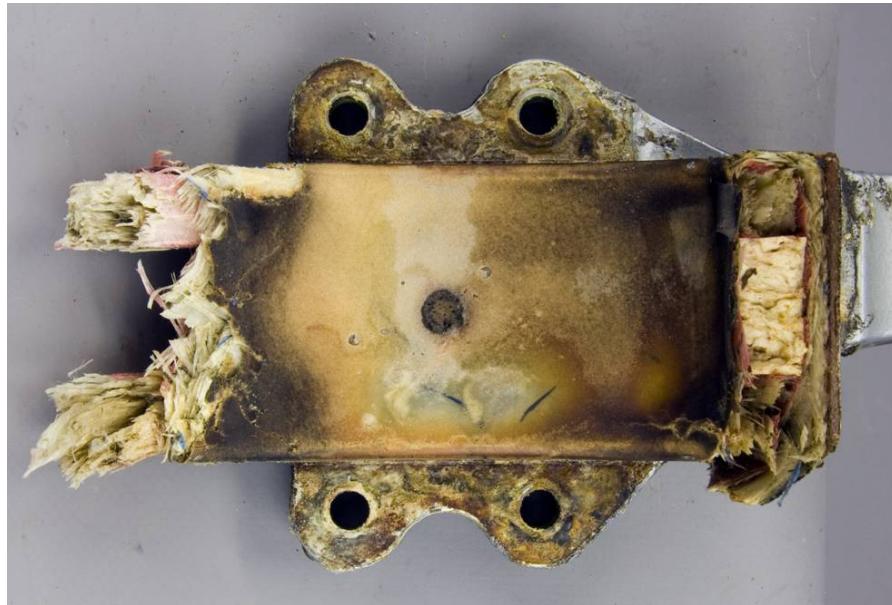
Figure 48 – Fracture surfaces of the White blade

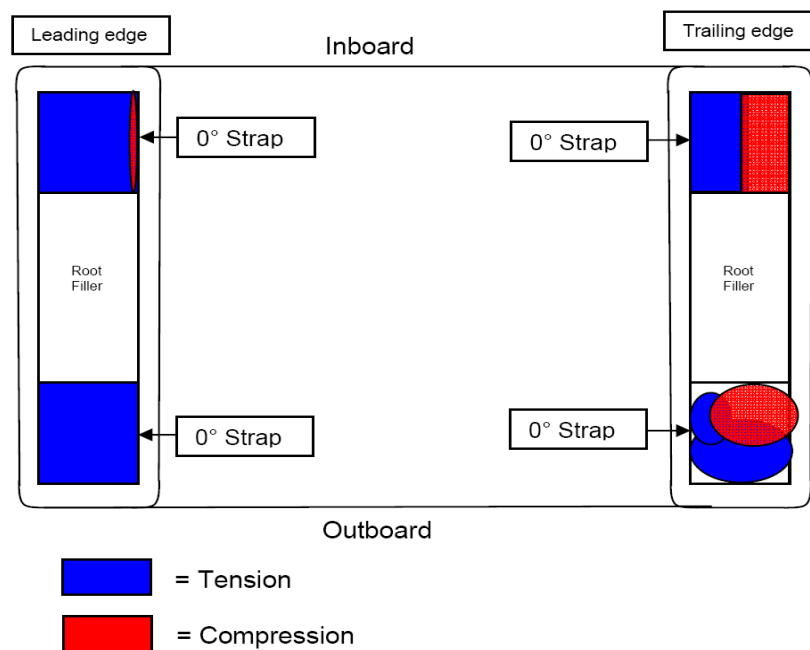
Figure 49 – Approximate zones of compressive and tensile failure

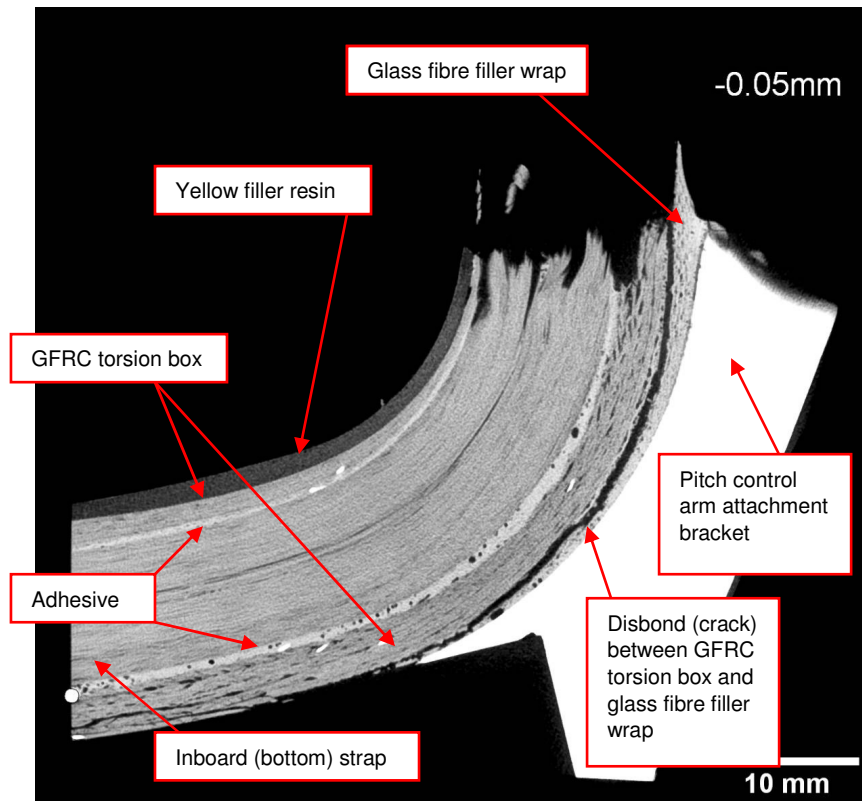
Figure 50 – X-ray tomography image showing a side-view slice through the bottom (inboard) strap of the White blade, trailing edge fracture location, approximately 3.5 mm from the inboard edge of the blade arm
