AIRCRAFT ACCIDENT REPORT 2/2014

ACCIDENT INVESTIGATION DIVISION

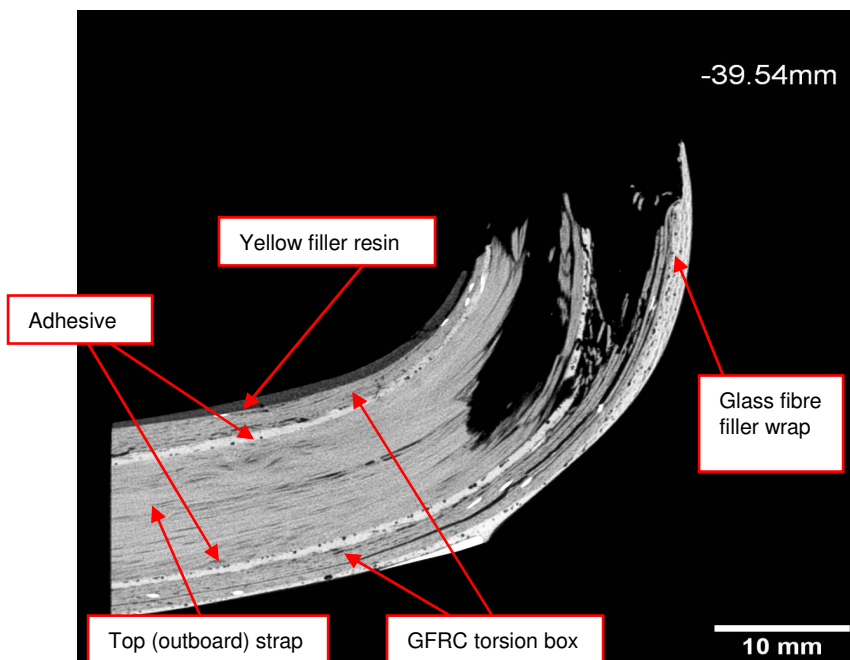
Figure 51 – X-ray tomography image showing side-view slice through the top (outboard) strap of the White blade, trailing edge fracture location, approximately 4 mm from the outboard edge of the blade arm

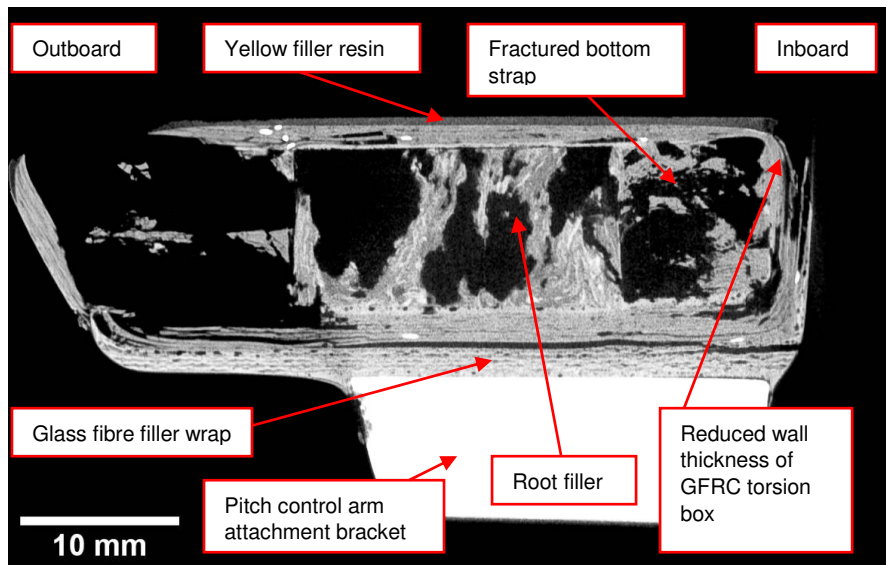
Figure 52 – X-ray tomography image showing a plan-view slice through the fractured trailing edge arm of the White blade, fracture zone approximately 4.1 mm below the top of the pitch control arm horn

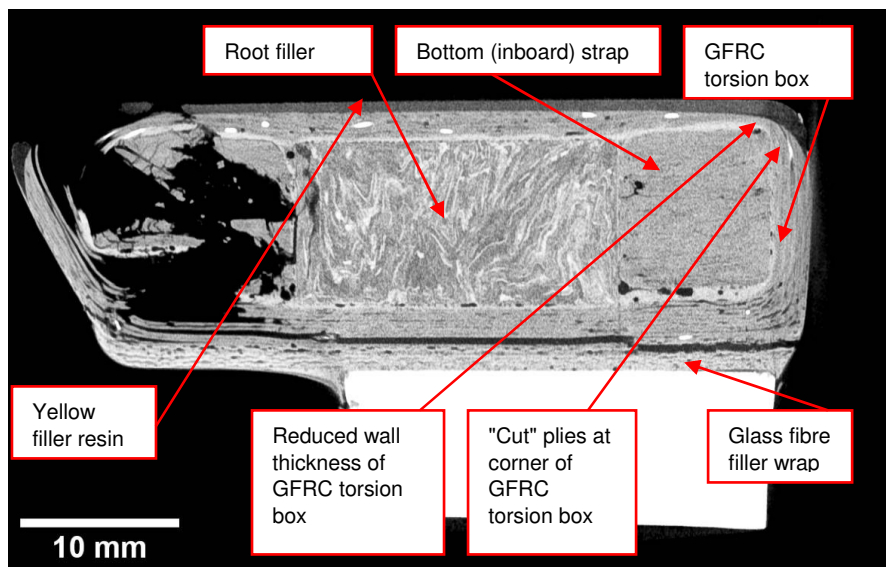
Figure 53 – X-ray tomography image showing a plan-view slice through the fractured trailing edge arm of the White blade; slice taken just below fracture zone approximately 8 mm below the top of the pitch control arm horn

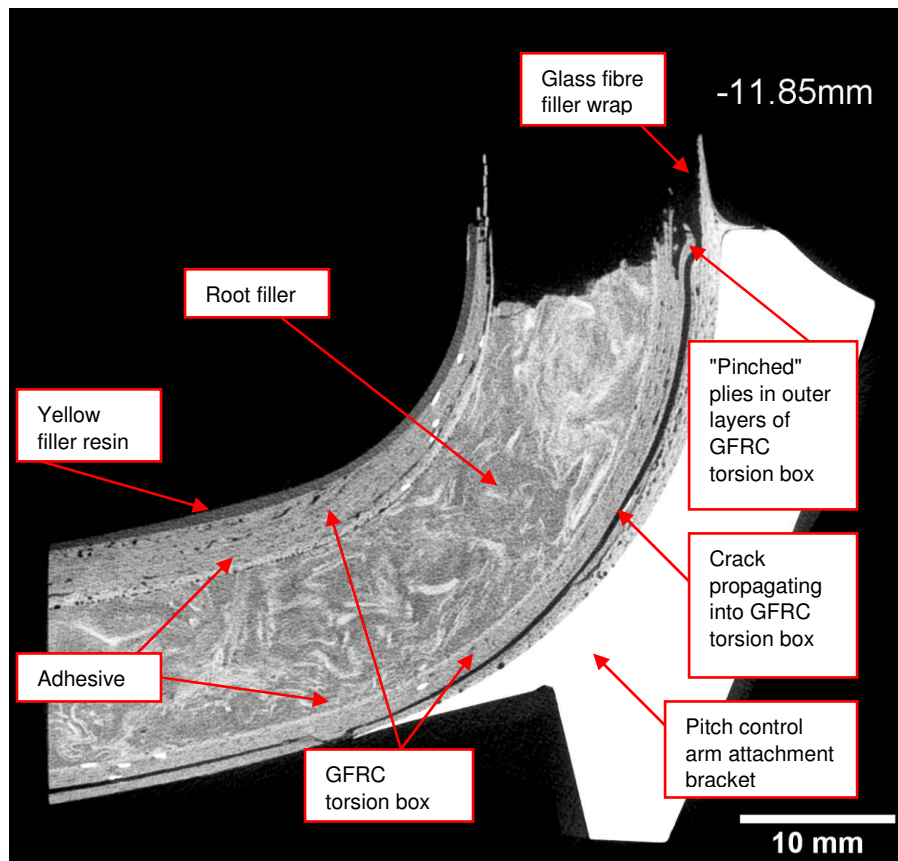
Figure 54 – X-ray tomography image showing a side-view slice through the root filler of the White blade, trailing edge fracture location, approximately 15.4 mm from the inboard edge of the blade arm

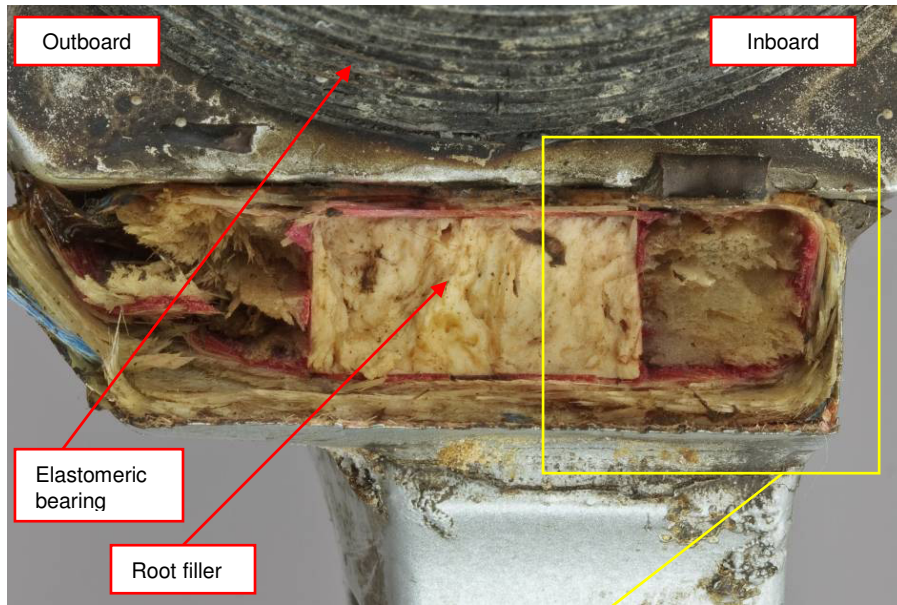
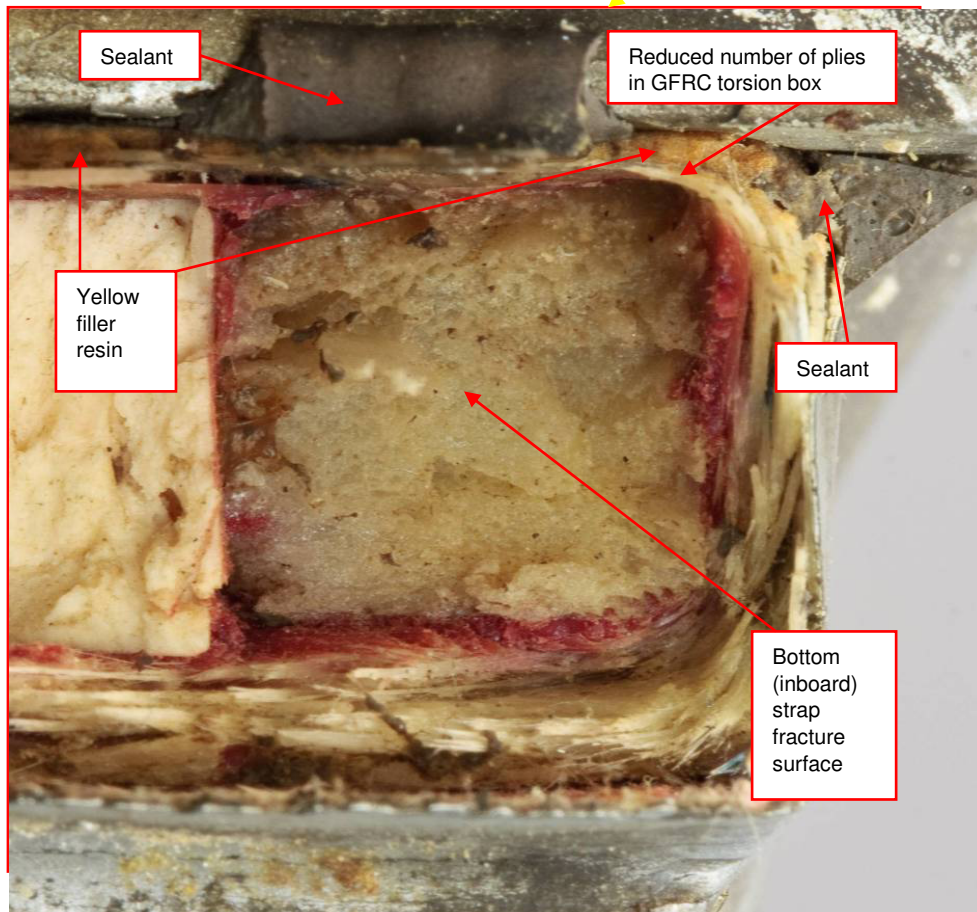
Figure 55 - Photographs showing the trailing edge fracture surfaces of the White blade prior to the removal of the elastomeric bearing, the insert photograph shows detail of the bottom (inboard) strap illustrating a reduced number of plies in the GFRC torsion box at the inner surface of the root.

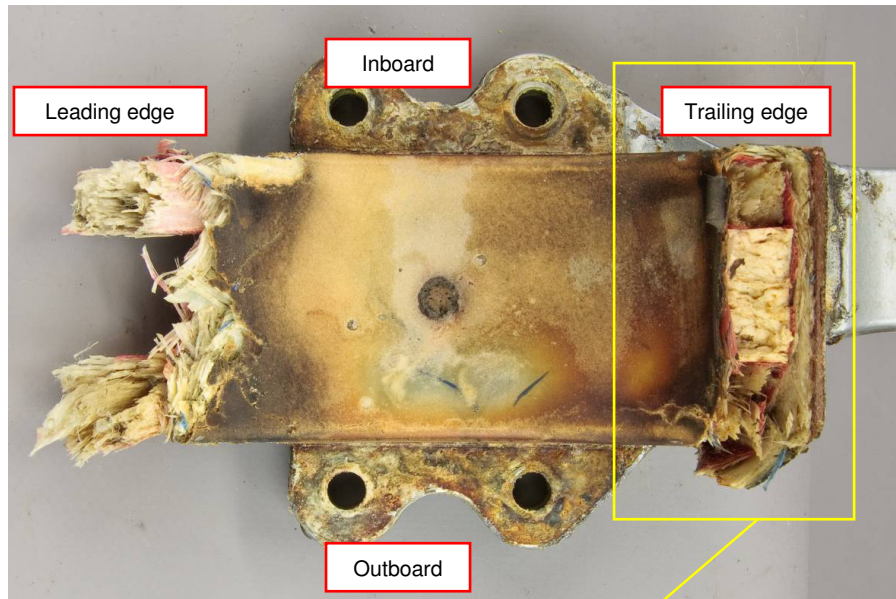
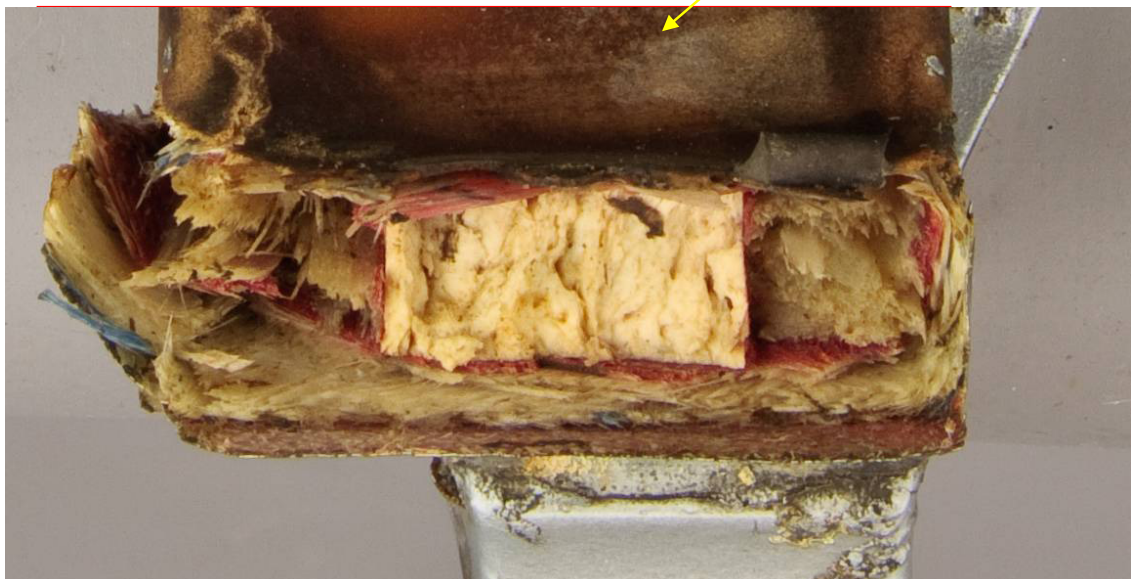
Figure 56 - Photographs showing a plan view of the fractured root area of the White blade after removal of the elastomeric bearing, with detail of the fractured trailing edge arm shown in the bottom insert image

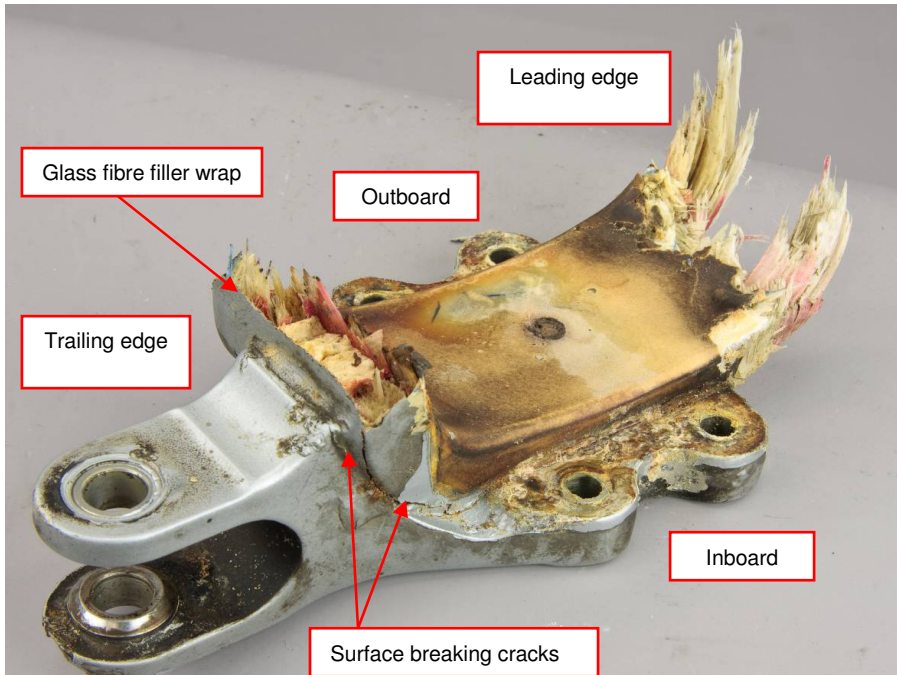
Figure 57 - Photograph showing the fractured root area of the White blade after removal of the elastomeric bearing

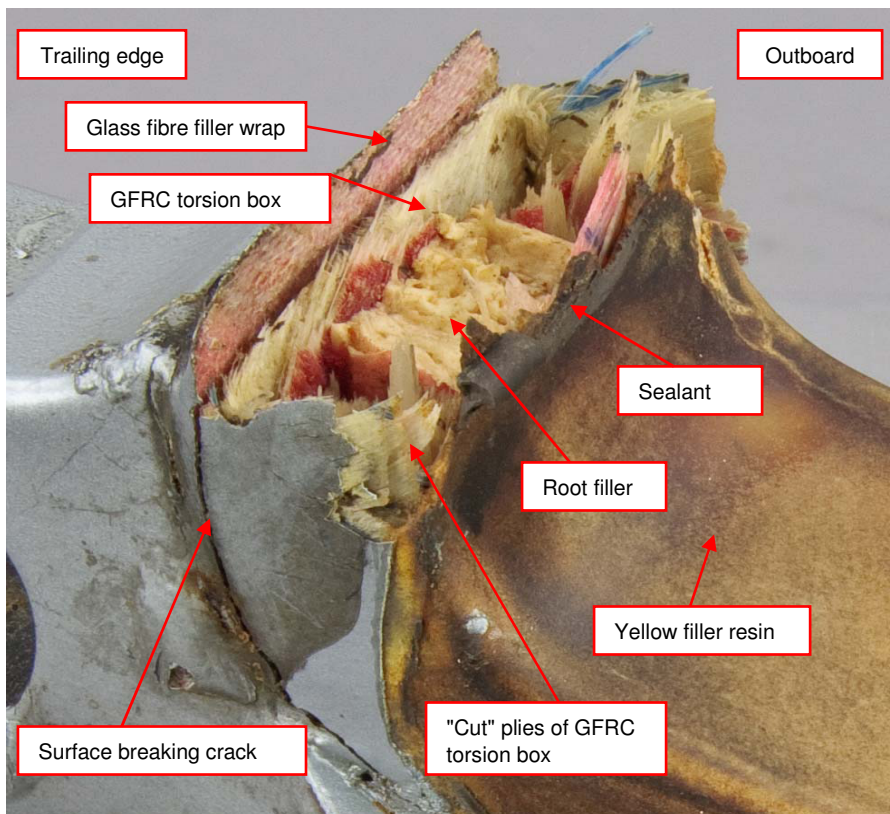
Figure 58 - Macro photograph showing detail of the White blade trailing edge arm fracture after the removal of the elastomeric bearing

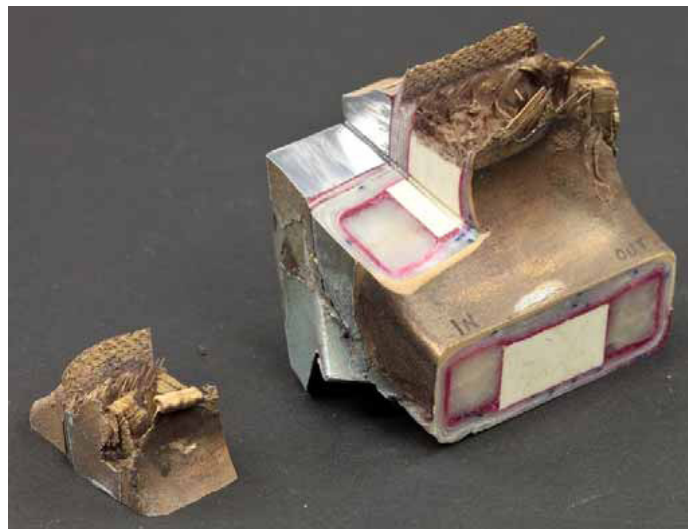
Figure 59 - Section cut from inboard trailing edge of the White blade for detailed fractographic examination

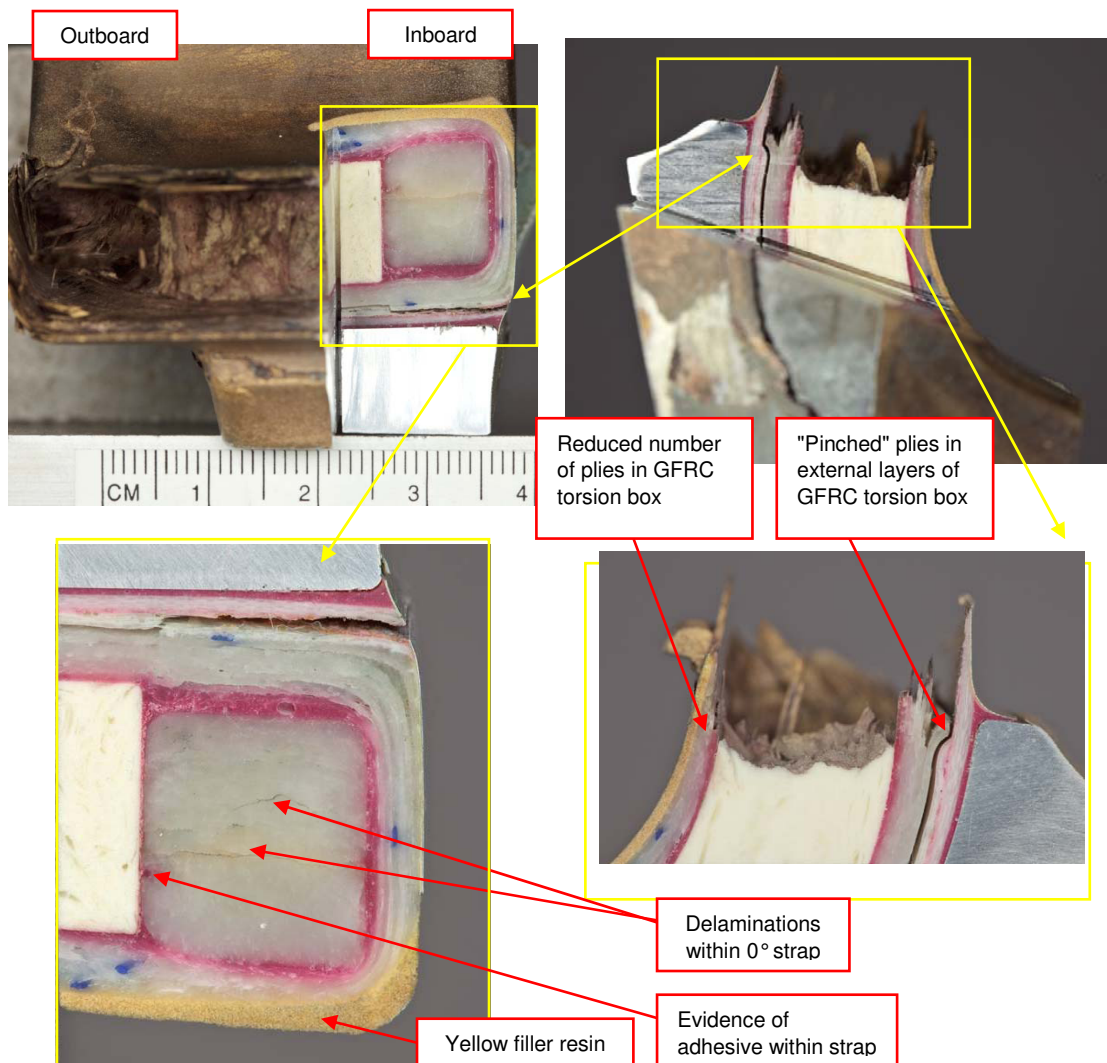
Figure 60 - View of section cut from trailing edge of White blade showing delaminations within the strap, cracking associated with ‘pinched’ plies and reduced ply thickness on inner radii

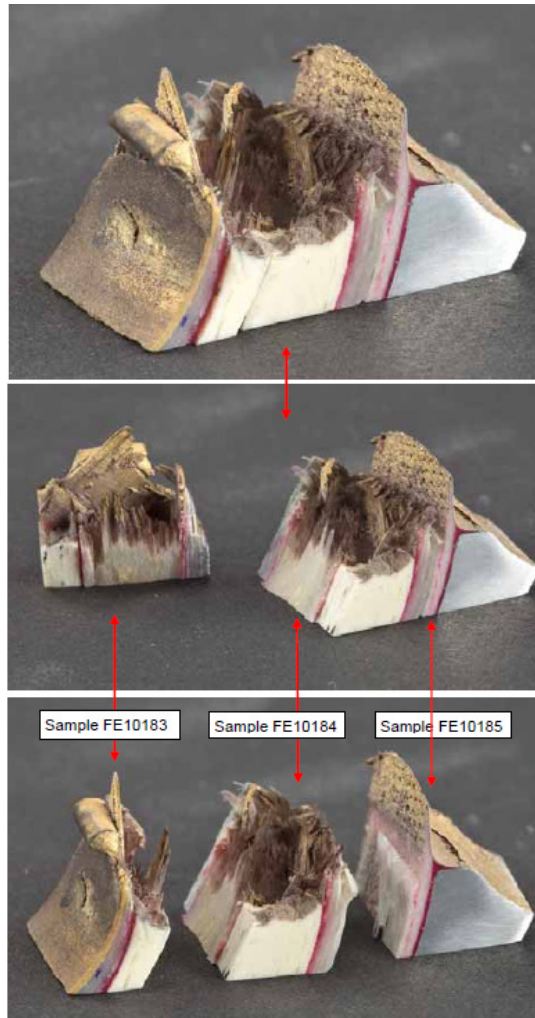
Figure 61 – Samples FE1083, FE1084 and FE1085 (Left to Right)

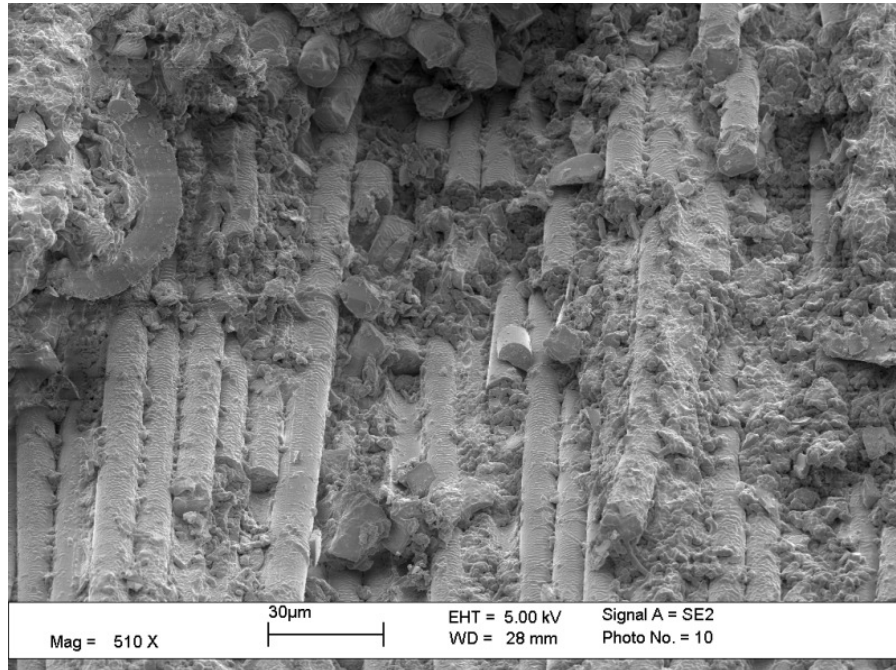
Figure 62 - Electron micrograph of delaminated surface (sample FE1084) within the strap showing close-up view of fretting debris

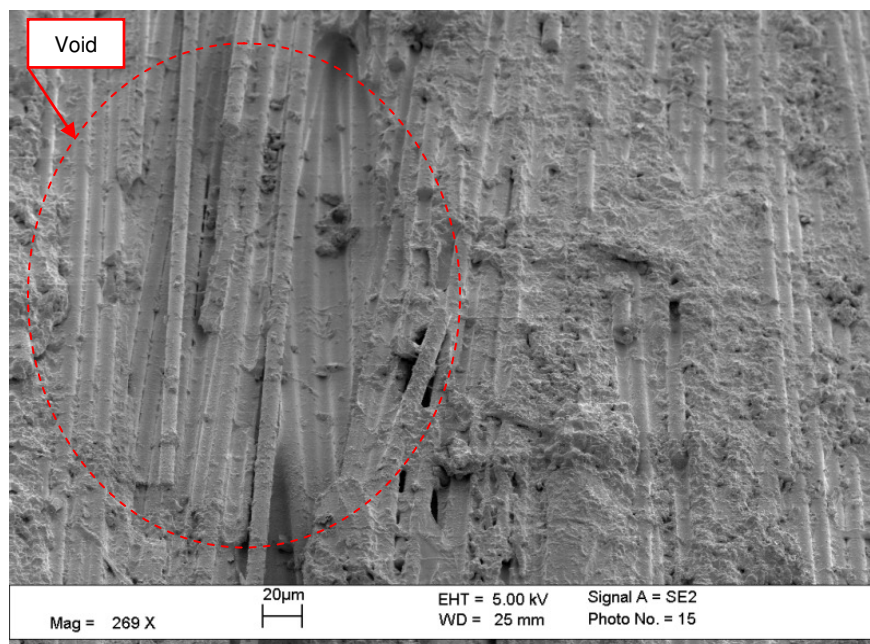
Figure 63 - Electron micrograph of delaminated surface (sample FE1084) within the strap showing close-up view of fretting debris and void within strap

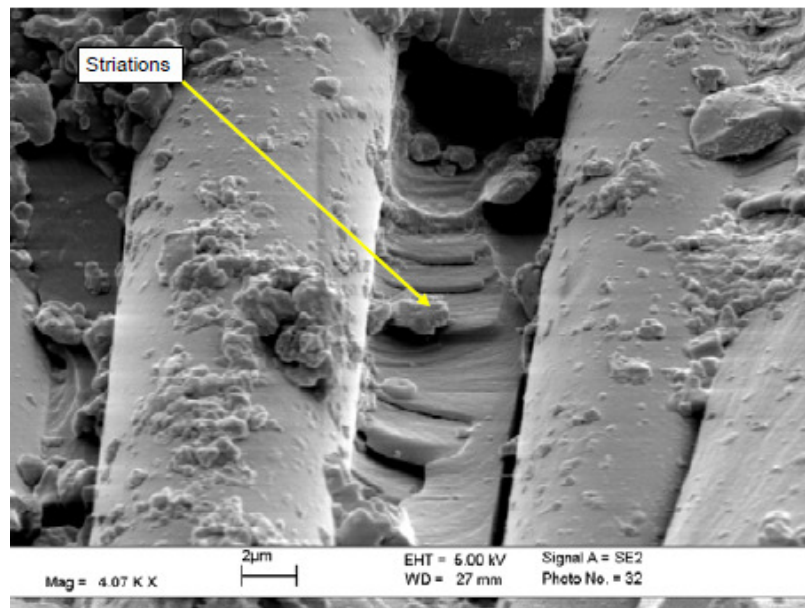
Figure 64 - Electron micrograph of delaminated surface (sample FE1084) within the strap showing close-up view of fretting debris and striations

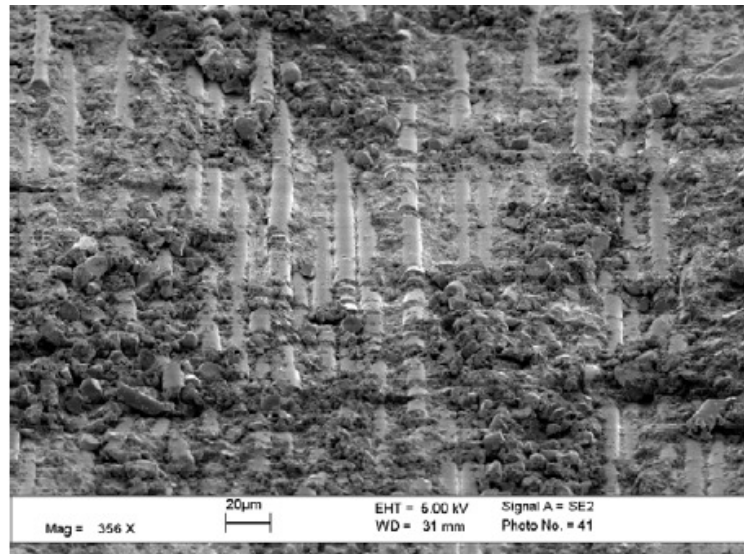
Figure 65 - Electron micrograph of delaminated surface (sample FE1084) within the strap showing close-up view of fretting debris and damage to fibres

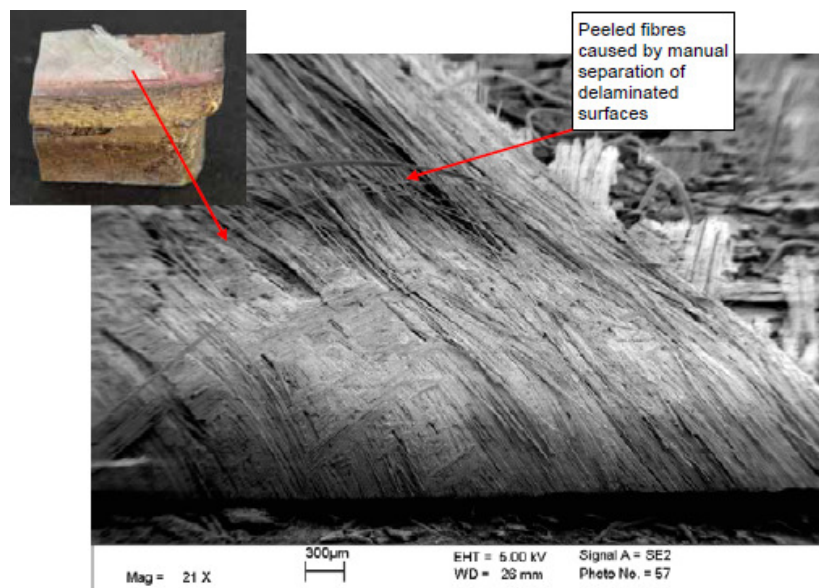
Figure 66 - Electron micrograph of delaminated surface (sample FE1085) within $\pm 45^\circ$ 'pinched' ply

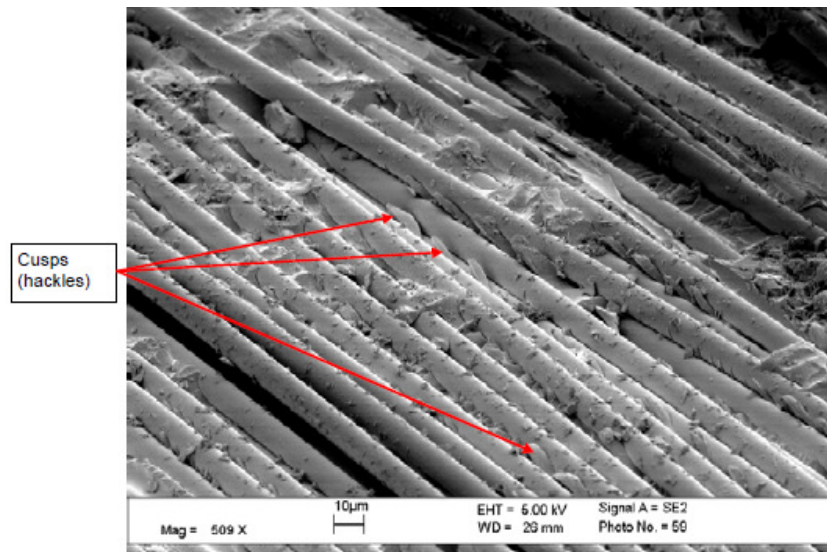
Figure 67 - Electron micrograph of delaminated surface (sample FE1085) within $\pm 45^\circ$ 'pinched' ply

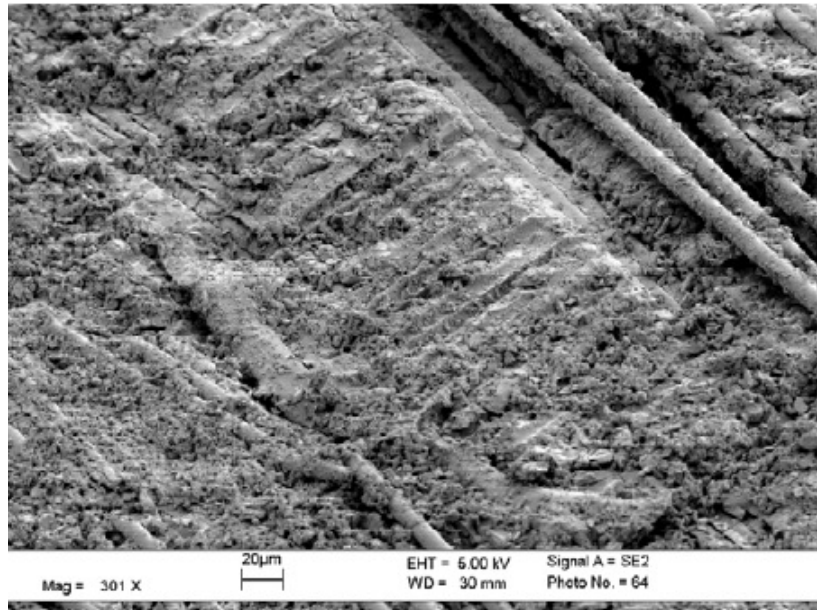
Figure 68 - Electron micrograph of delaminated surface (sample FE1085) within $\pm 45^\circ$ 'pinched' ply showing fretting

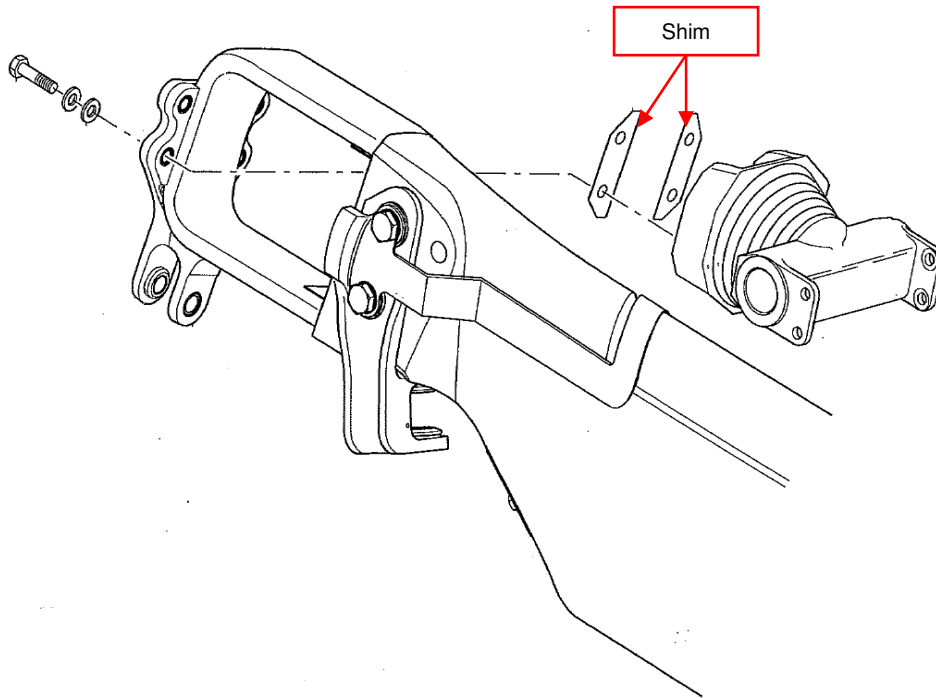
Figure 71 - Elastomeric bearing shim installation

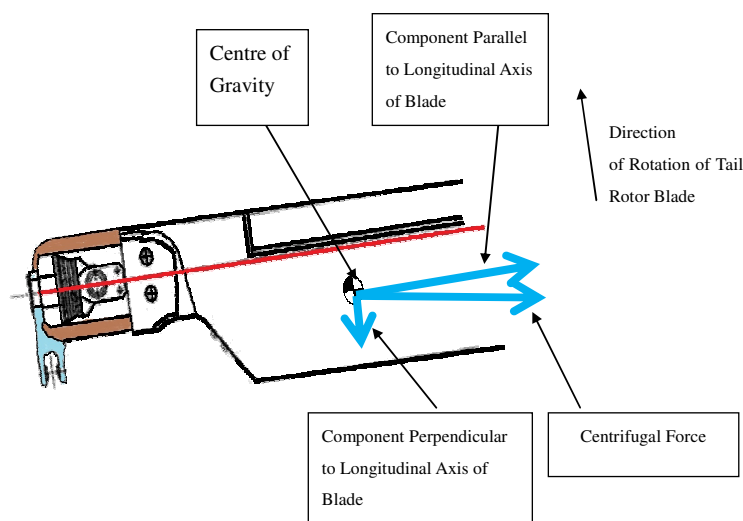
Figure 72 – Bending moment associated with centrifugal force application

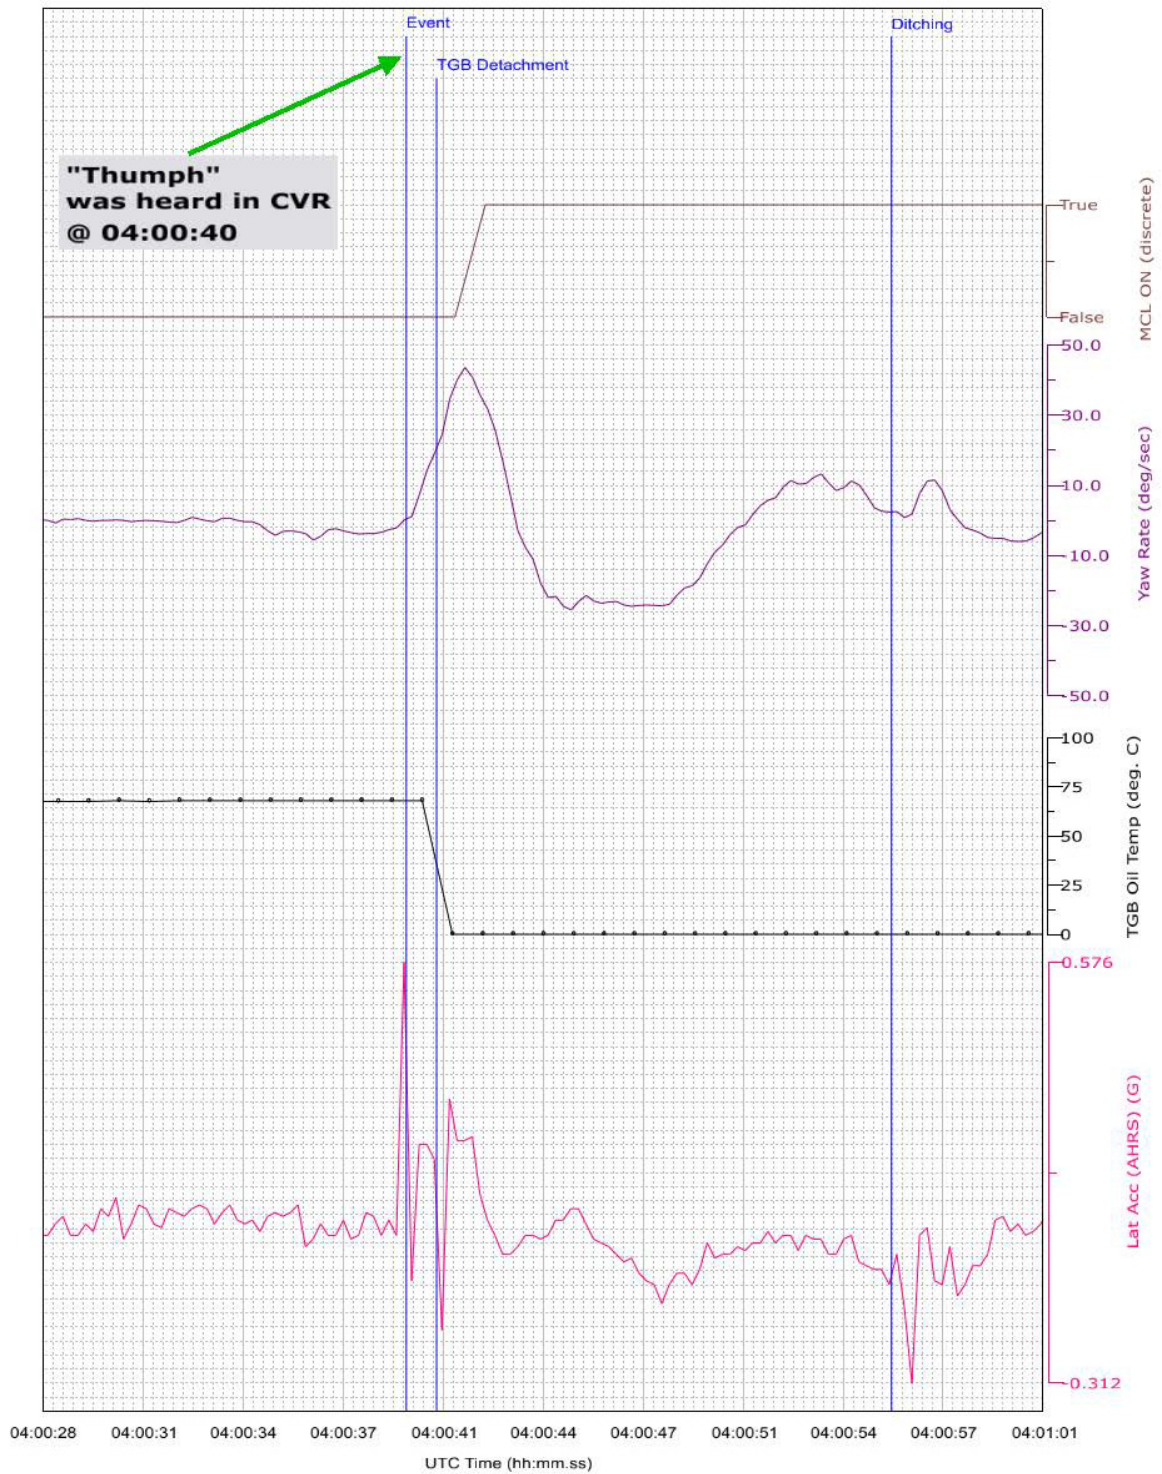
MPFR Data Showing Abrupt Changes in Lateral Acceleration, Yaw Rate and TGB Oil Temperature

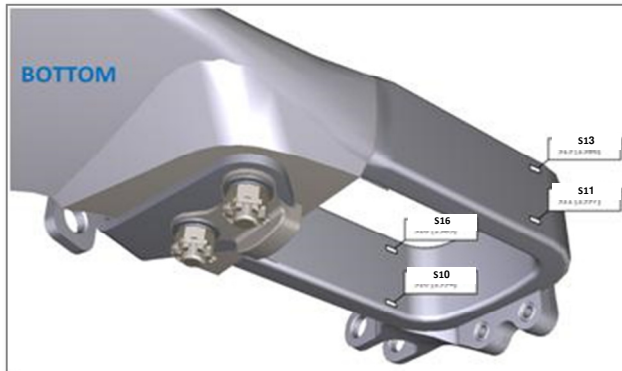
Strain gauges position (Bottom View)

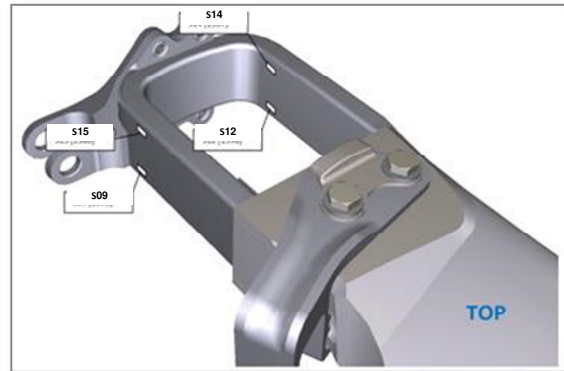
Strain gauges position (Top View)

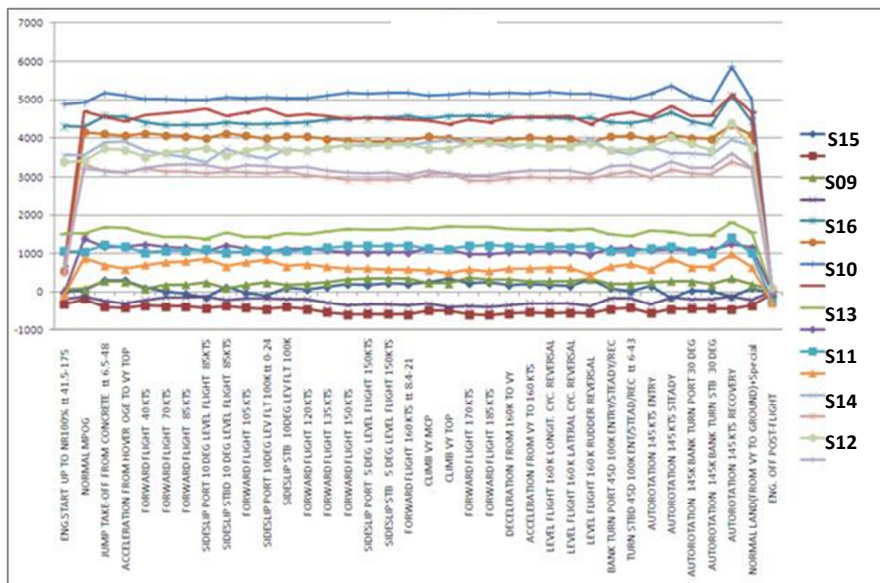
Flight stress survey

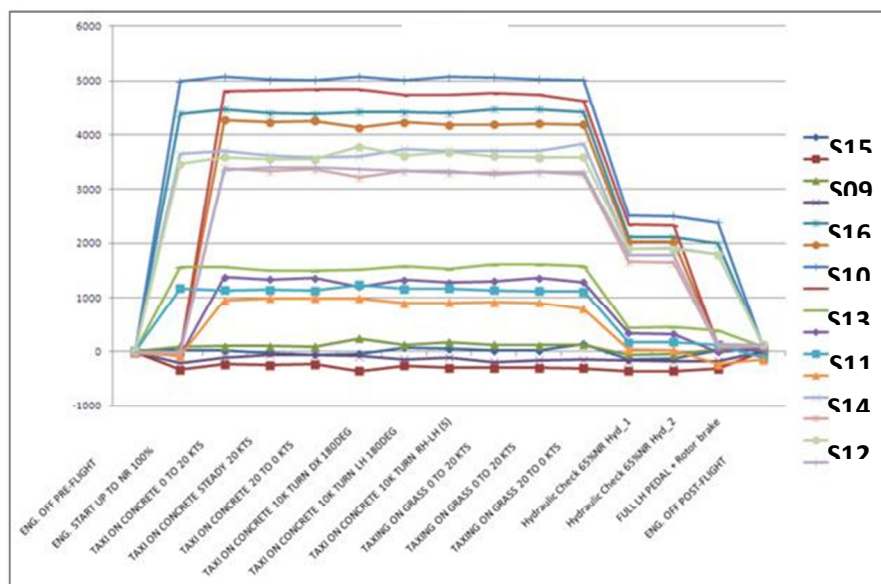
Ground stress survey

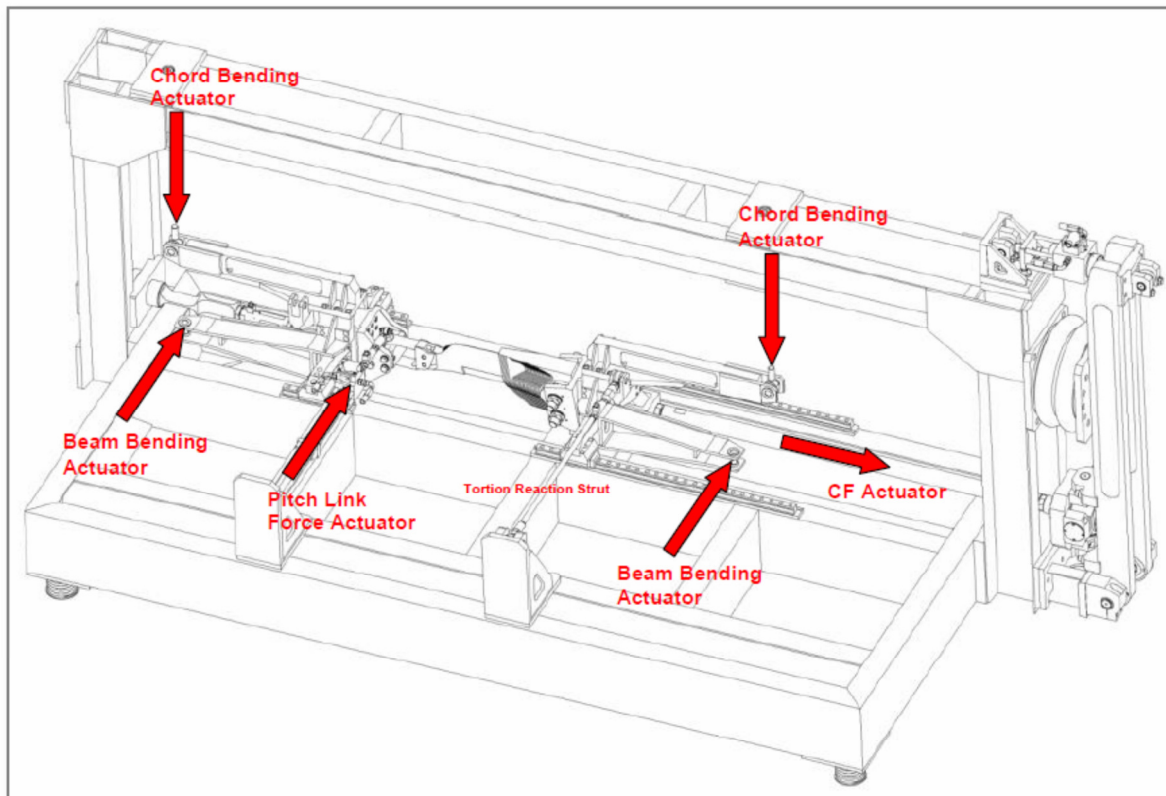
Blade static stress test rig

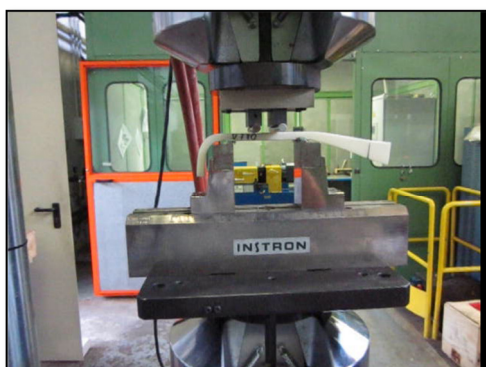
The proper curve shape was obtained by dedicated coupon fatigue tests performed at $R=0.1$ load condition representative of GAG cycle. The coupons have been directly obtained by production strap root area and have been fatigue tested in a four point bending condition

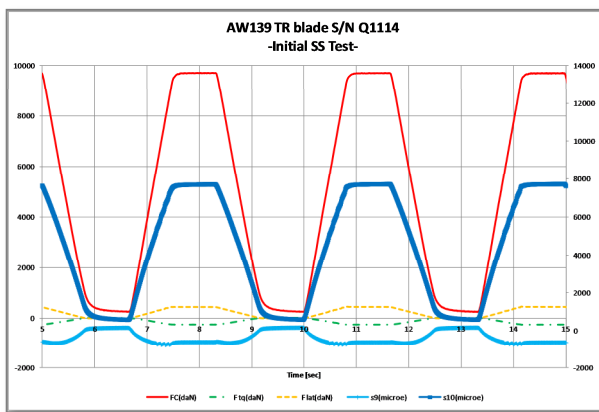
Pitch change arm debonding was assessed in a test stress survey identifying the relevant stress raiser effect in the trailing edge bottom strap area. In detail, a pitch change arm debonding in the curved root area resulted in about 40% of nominal stress increasing (see blue curve of the plots below)

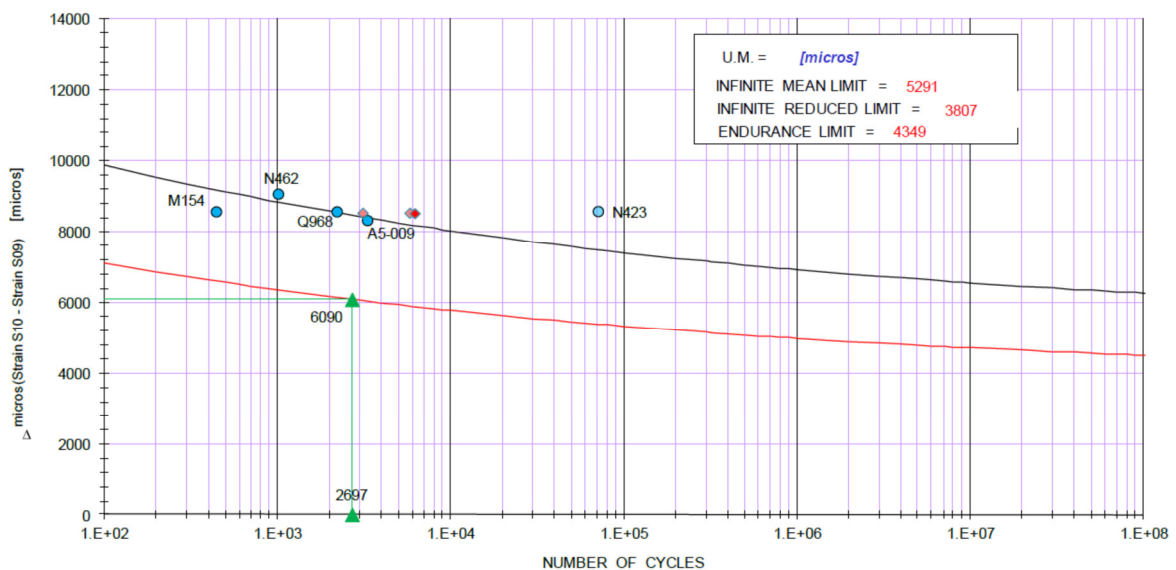
The 25FH periodic inspection requirement of the BT139-265, aimed to detect torsion box degradation and pitch change arm disbonding, provides relevant additional safety margin to the actual quarantine limitation.

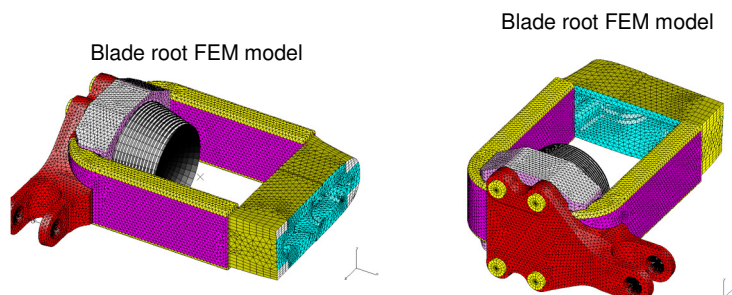
A very detailed FEM of the root blade area was developed; the more detailed model was able to properly represent stress/strain condition in the root area including the local bending in the trailing edge bottom strap.

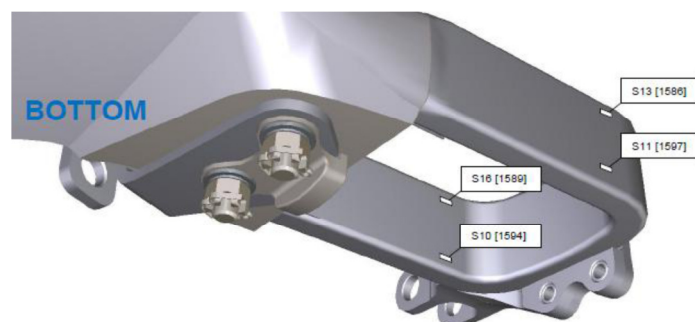
with the values recorded at the same locations on an instrumented tail rotor blades installed on the helicopter (see table below) :
