WRECKAGE INFORMATION

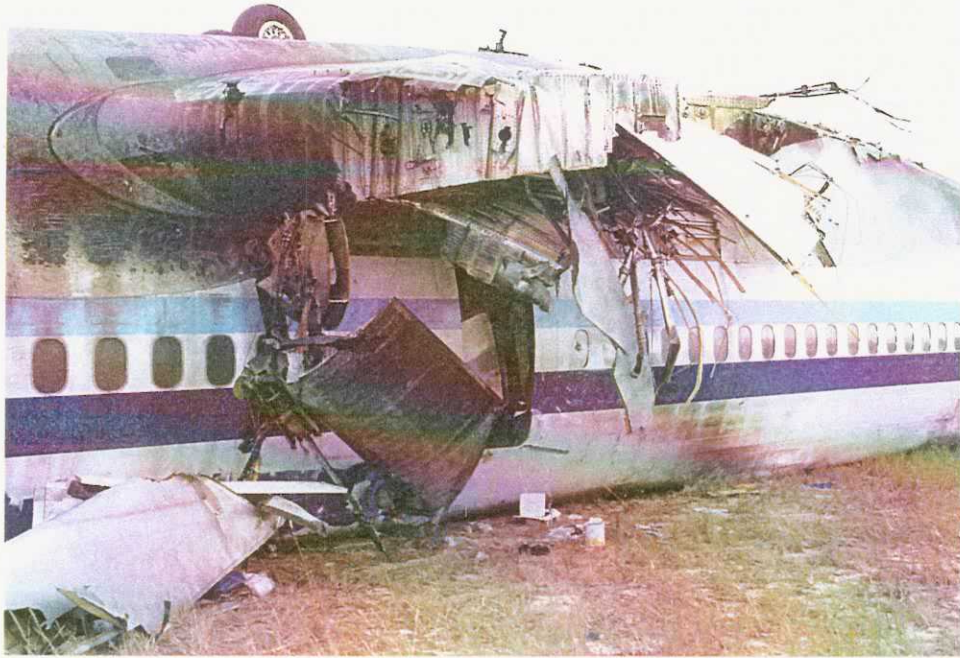
Right Wing Root Section (Figure 3)

About a 10-foot section of the right wing upper and lower skins with front and rear spars remained attached to the fuselage (Figure 3). The trapezoid fitting which connects the fixed and folding retractable side brace of the right main landing gear remained attached to the fuselage. This fitting suffered no fire damage and was fractured in tension at the brace connection. The fractured surface exhibited overload features. This fracture surface area was cut from the fitting for detailed metallurgical examination. The right main landing gear had separated from the wing and fuselage point and was found near the aft right side of the fuselage under the right horizontal stabilizer (Figure 4).

The right wing fractured between the no. 3 engine nacelle and the right side fuselage at Station 163 on the leading edge and Station 197 at the rear spar (Figure 3). About a 15-foot section of the front spar and a six-foot section of the rear spar remained attached to the fuselage. The upper and the lower skins

between the front and the rear spar of the inboard section remained attached to the fuselage and exhibited upwards bending. About a six-foot section of the outboard front spar separated from the upper skin near the fractured end and the spar cap was cracked. The remaining nine-foot section remained attached to the upper skin and exhibited no bending. The stringers between the front and rear spar exhibited upward bending. The fractured surface exhibited overload features. There was evidence of slight fire damage and soot damage on the front spar and associated structure. Some of the fractured surfaces were sooted. The soot/fire damage was not very significant as compared to the outboard section of the wing.

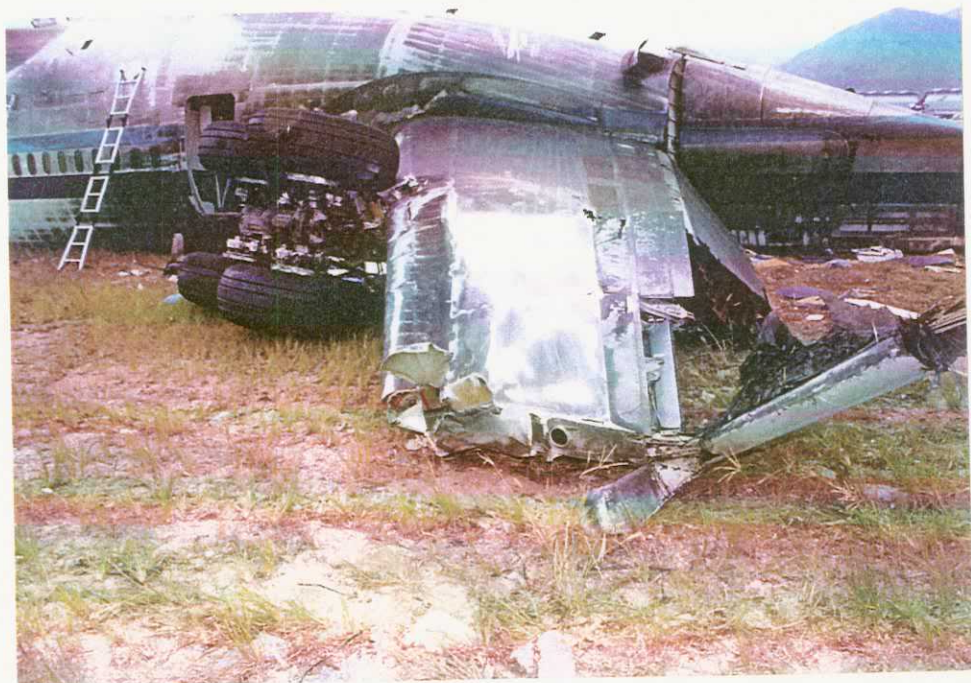
Right Main Landing Gear and Right Horizontal Stabilizer (Figure 4)

The right horizontal stabilizer remained attached to the empennage with severe impact damage (Figure 4). The section outboard of Station 292 was bent down. The inboard section remained attached to the empennage. The right stabilizer suffered soot damage on the leading edge, upper and lower skins. The leading edge and lower skin exhibited

severe scrape marks and these scrape marks were on top of the sooted leading edge and skin. The scrape marks were in three distinct directions. One set of scrape marks near the leading edge ran in span-wise direction. The second set was about 30 degrees anti-clockwise from the span-wise direction (view looking down), while the third one was about 70 degrees anti-clockwise from the span-wise direction (view looking down). There were other scrape marks in various directions. These scrape marks are indication of runway contact. The leading edge of the stabilizer was dented and crushed at various locations. The outboard end of the leading edge was crushed aft. The inboard and outboard elevators remained attached to the horizontal stabilizer and suffered severe fire damage.

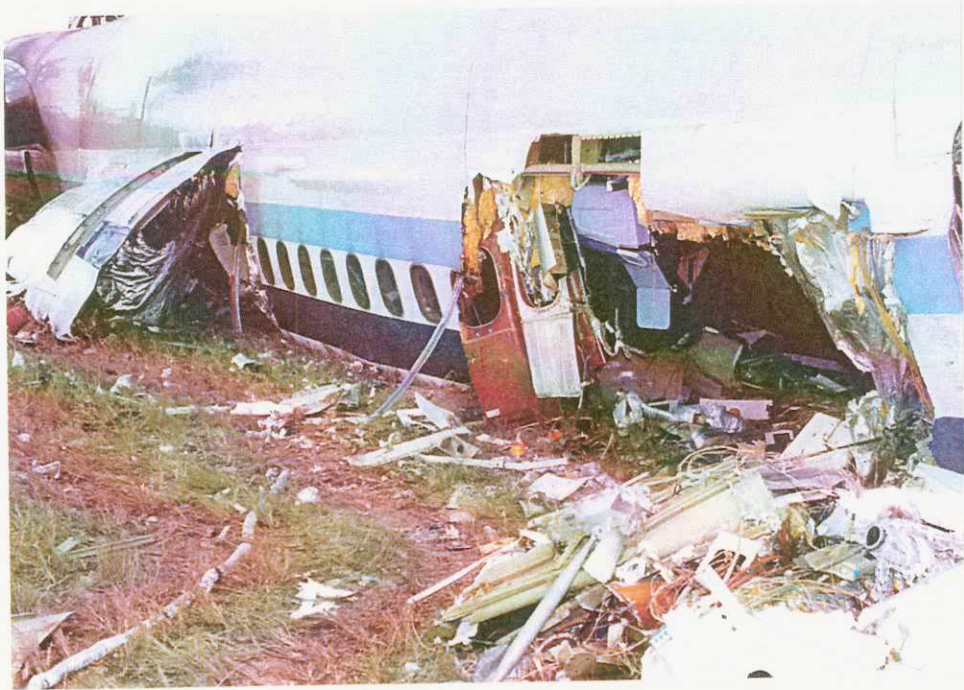
Left Forward Fuselage (Figure 5)

The left fuselage suffered crushing damage just aft and forward of the L1 entry door. A large section of the fuselage common to L2 door from Station 735 to Station 1059 was pushed out (Figure 5). The remaining portion of the fuselage remained intact with minor impact damage. The aft section of fuselage suffered external fire damage and soot damage on left and right sides.

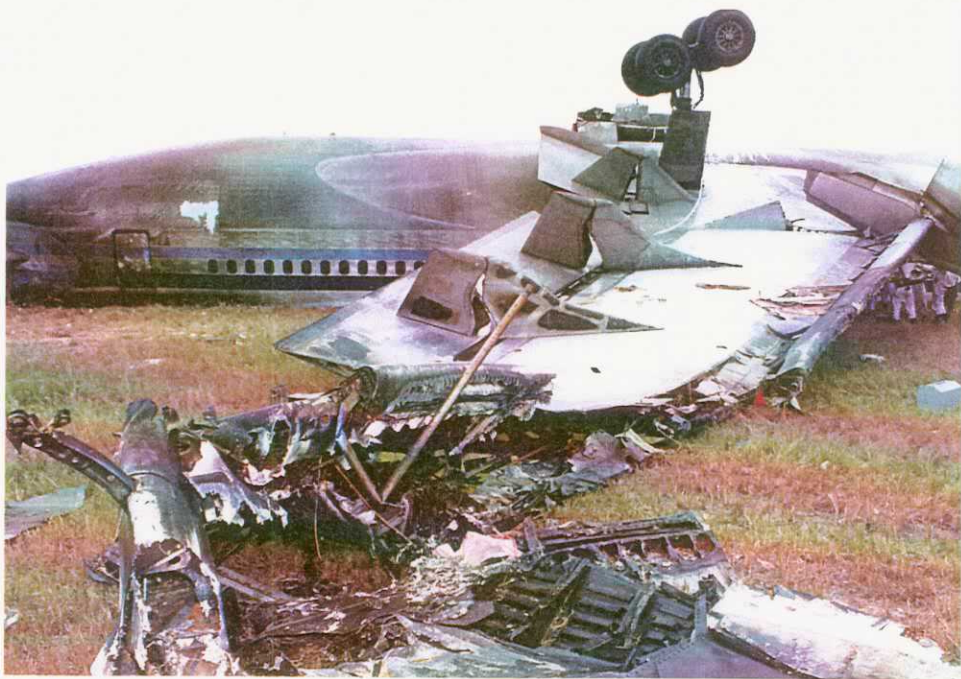
Left Wing (Figure 6)

The left wing remained attached to the fuselage and was found at the main wreckage (Figure 6). The inboard section of the wing exhibited evidence of sooting. There was evidence of scrape marks on the upper wing skin in a span-wise direction outboard of no.1 engine location. The leading edge at the inboard section was slightly damaged and suffered fire damage. The leading edge at the no.1 engine location was crushed aft and slightly upwards. The inboard slats remained attached to the wing and were found in extended position (approximately 30 degrees position). The leading edge outboard of the no.1 engine suffered severe impact and fire damage at various locations. The slats outboard of the no. 1 engine remained attached to the wing and were in the extended position. The outboard end of the slat suffered fire damage. The wing structure outboard from Station 855 suffered severe fire damage with the structure exhibiting melting. The front and the rear spars of the outboard section suffered severe fire damage and had sagged. The wing tip suffered severe fire damage. The outboard aileron and the wing-lets were consumed by fire. The spoilers remained intact with no apparent damage.

The inboard flap and the inboard aileron remained attached to the wing structure. There was evidence of slight scrape marks on the upper surface of the flap. The outboard flap remained attached with minimum damage. The left main landing gear remained attached to the attachment fitting on the wing. There was no damage to the attachment fitting.

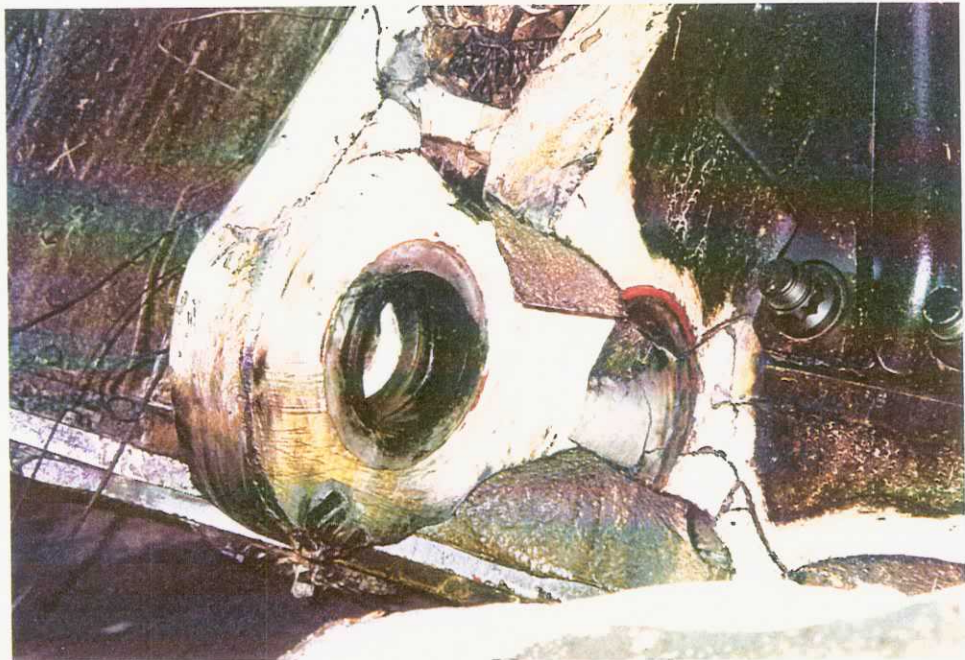
Right Main Landing Gear (RMLG) Forward Attachment Fitting (Figure 8)

The forward and aft main landing gear attach fitting suffered severe damage. The aft lug of the forward mount fractured between 4 o'clock to 10 o'clock position (view looking forward - see Figure 8). The fractured surface exhibited soot accumulation and slight discoloration. The forward mount was cracked and exhibited impact damage in an upward direction. The forward mount shear pin was sheared off and a portion of the shear pin remained with the forward lug (Figure 9). The remaining piece was attached to the landing gear. The fractured surface on the shear pin was heavily sooted. The aft mount was fractured, and both the lugs along with a large piece of fitting remained attached to the landing gear including the shear pin (Figure 10). The entire area of the main landing gear fitting and fractured surfaces exhibited evidence of sooting. The piece of the head-end of the main landing gear actuator remained attached to the fitting.

The right main landing gear was separated from its mount. The forward shear pin was sheared off from the forward mount and half of the shear pin remained in the forward lug of the forward mount. This section of the shear pin was pushed out and exhibited severe soot damage on the fracture surface. The remaining portion of the shear pin remained on the forward lug of the landing gear and exhibited some bending. The fractured surface on this portion exhibited surface rust and the fractured surfaces could not be examined. The aft lug of the forward mount fractured between the 4 o'clock and 10 o'clock positions. This section of the lug fractured into two pieces and was found on the runway between the touchdown point and the main wreckage. The mating fractured surface on the wing forward mount aft lug exhibited some discoloration but the mating fractured surface of the lug that was found on the runway did not exhibit any discoloration. All surfaces on the aft lug exhibited evidence of overload features. There was no evidence of fire or soot on the pieces of lug found on the runway. The forward fitting that remained attached to the landing gear fitting suffered soot damage. The forward mount fractured in the middle and exhibited impact damage in an upward direction (Figure 8).

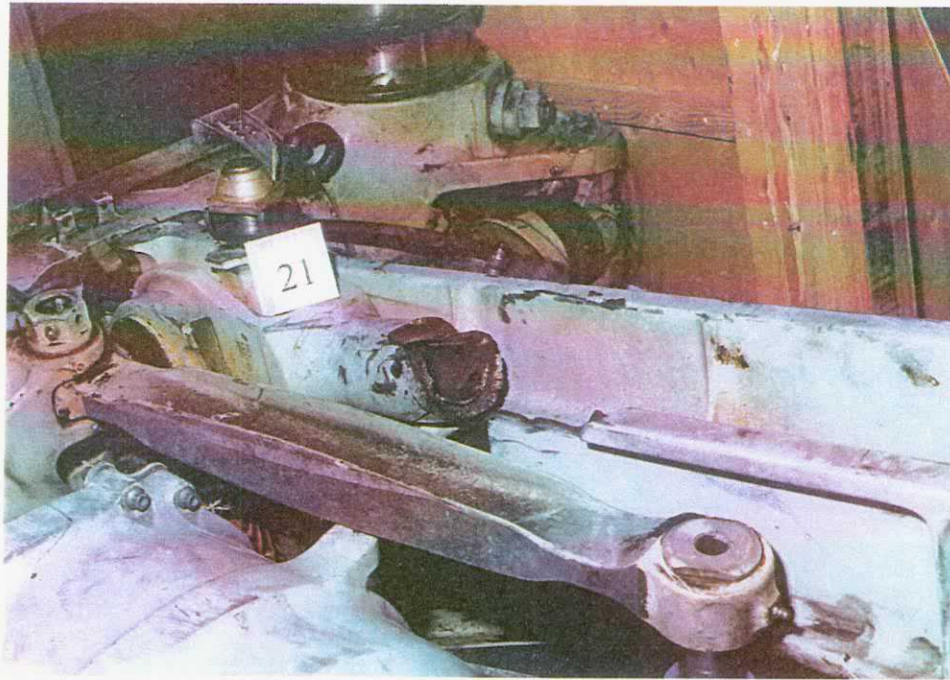
Fractured Fixed Side-Brace (Figure 11)

The right main landing gear strut remained intact and was fully extended at the main wreckage site. The strut was deflated later for safe handling. The folding side brace remained attached to the gear. The upper rib of the folding side brace was fractured and twisted near the end that attached to the fuselage. A small

section of the fixed brace remained attached to the trapezoidal fitting along with the folding side brace (Figure 11). The trapezoidal fitting fractured from the trapezoidal panel that attached to the fuselage (Figure 12). The trapezoidal panel pillow block remained attached to the fixed and folding brace. The fractured surface exhibited evidence of overload features. There was no evidence of fire damage or soot damage to the right main landing gear.

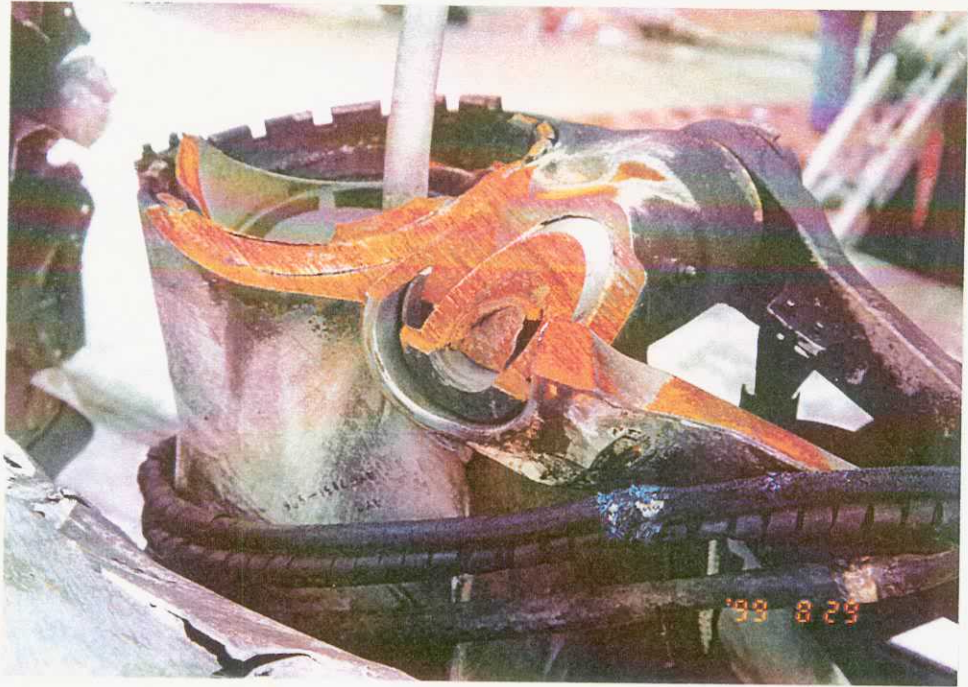
Fractured Center Landing Gear Oleo (Figure 13)

The centre landing gear fractured at the bottom of the cylinder (oleo) near the axle (Figure 13). The fractured surface exhibited overload features with a 45-degree shear lip and was severely rusted. The wheel truck with tyres was found on the runway near the main wreckage. There was evidence of heavy impact damage on the right hydraulic brake reservoir that attached on the wheel. The heavy impact mark was a 3/8-inch wide indentation and ranged up to 1/2 inch deep. There was no evidence of any fire damage or soot damage to the centre gear truck assembly. Only one tyre was inflated and did not exhibit any scuff mark on the inner or outer side. The other tyre was deflated and suffered severe sharp cuts on its side.

The strut remained attached to the fuselage with the inner cylinder (oleo) compressed all the way in. The lower end of the strut exhibited grinding consistent with runway contact. These grind marks was approximately at 45 degrees with respect to airplane centreline and about 30 degrees nose left. These grind marks covered about 50% of the circumferential surface. The body gear remained attached to the fuselage. There was no evidence of any damage to the

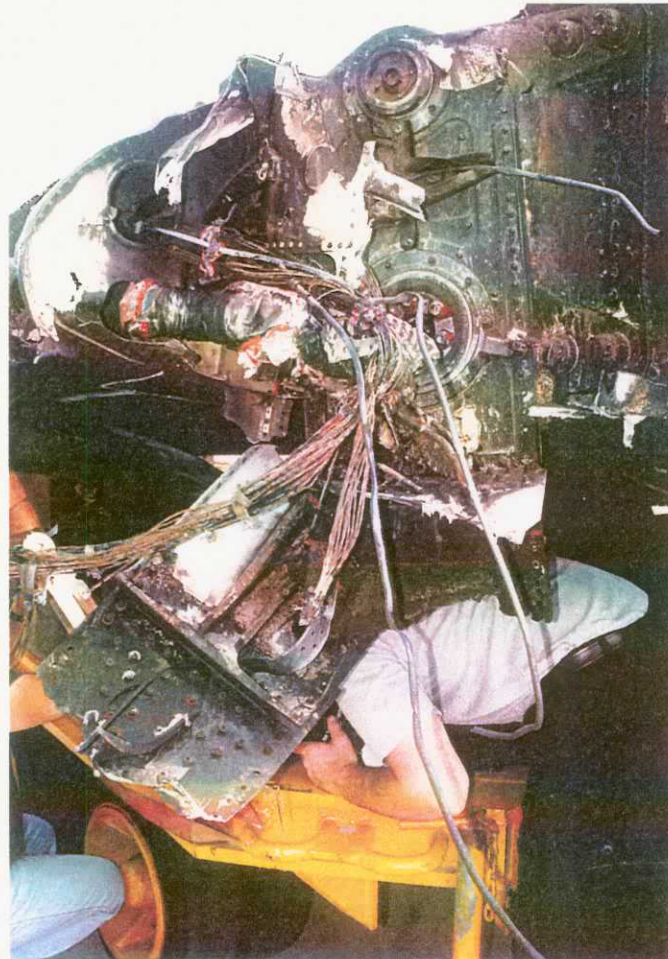
No. 3 Engine Pylon to Wing Forward Attachment Structure (Figure 14)

The no. 3 engine separated from the wing at its pylon attachment points and was found in the grassy area near the right wing (Figure 14). The front (tombstone fitting) pylon mount fractured about 24 inches from the upper wing skin. This fitting suffered severe fire damage and the web and the cap was bent aft at the fractured end. The tombstone fitting was attached to the wing front spar and pulled out of the pylon about five inches below the pylon upper spar. The upper spar that the front links were attached, was broken out of the pylon and attached to the wing mount. A large section of the tombstone fitting remained with the engine pylon. The web and the cap were bent forward with slight twisting. The rear engine mount and bulkhead separated from the pylon in one piece and remained attached to the wing. The rear engine mount separated from the left and right pylon skin and all the fasteners were pulled out of the skin. The upper spar cap at the outboard side of the pylon was bent in a "U" shape and the web/ skin separated from the cap indicating that the pylon was experiencing loads in the inboard direction. The upper spar cap at the inboard side remained attached to the web with no noticeable bending. The inboard pylon skin was bent inboard.

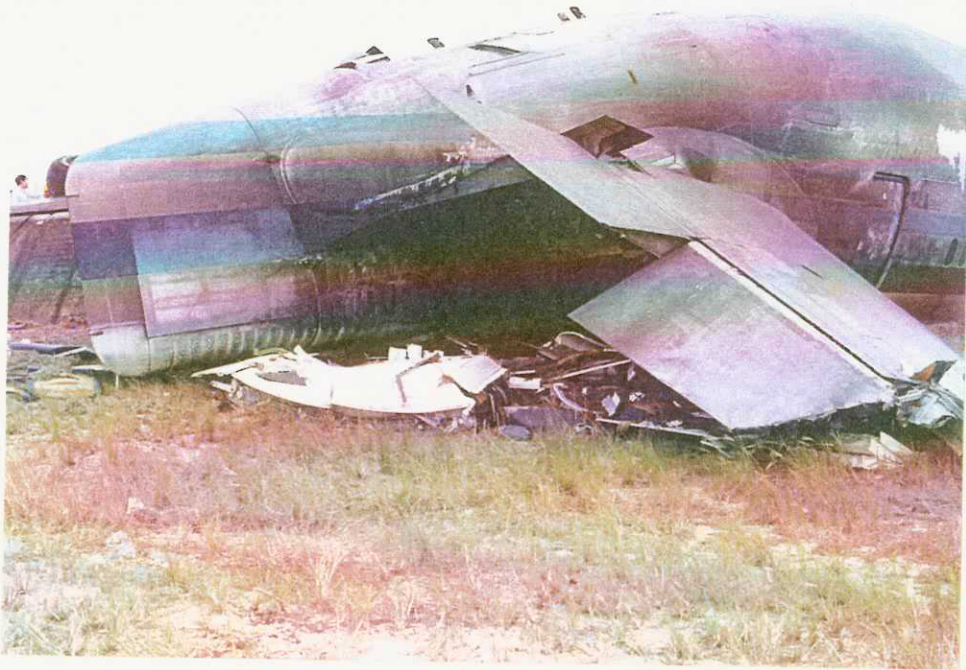
Left Horizontal Stabilizer (Figure 15)

The left horizontal stabilizer fractured at Station 290 (Figure 15). The inboard section remained attached to the empennage with upper skin. This section exhibited upward bending. The lower skin was fractured at the root in a jagged fracture pattern. The front spar and the associated structure at the fractured location were bent aft. The upper and lower skin suffered soot damage. The inboard elevator remained attached with no impact damage but exhibited severe soot damage. The outboard elevator fractured at Station 290. There was no scrape marks observed on the inboard section of the horizontal stabilizer.

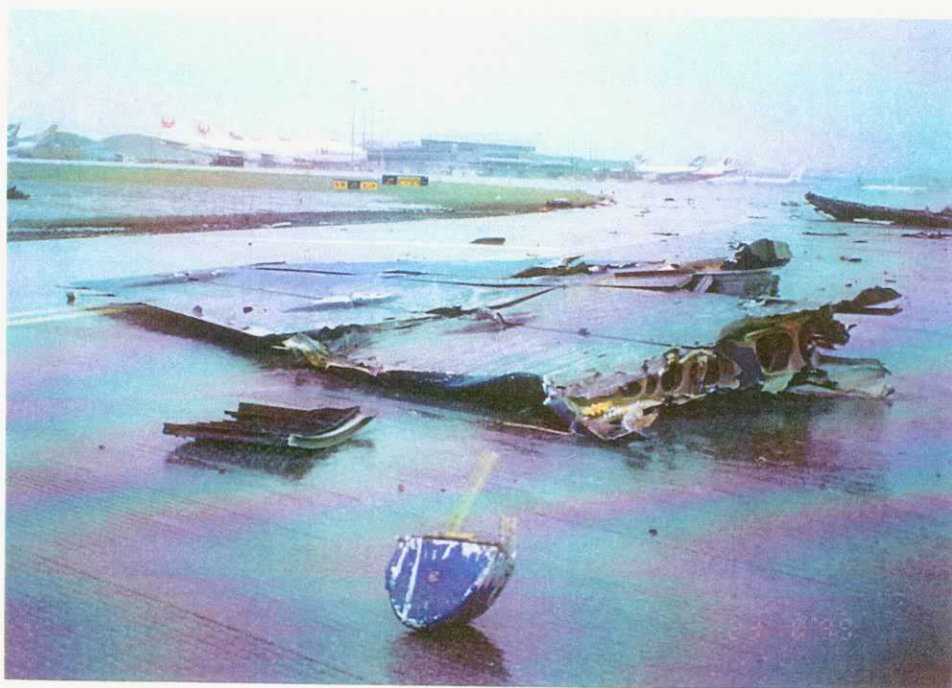
Vertical Stabilizer (Figure 16)

The vertical stabilizer right skin fractured approximately at Station 525 and at Station 426 on the left side (Figure 16). The left skin and the associated structure were bent to the left. The front spar fractured at Station 525 and the lower section of the front spar web was missing. The front spar at the fracture was bent slightly to the left. The rear spar fractured at Station 525 and was bent aft. The second fracture on the rear spar was at Station 444. At this location the spar was bent aft. The left skin from Station 525 was still attached to the upper vertical stabilizer but the right skin was missing. The upper forward and aft rudders remained attached to the vertical. The lower forward and aft rudders fractured at approximately Station 426. The rudder section below this station suffered severe fire damage. A portion of the lower vertical stabilizer (lower from Station 426) remained with the lower rudder and suffered fire damage. The vertical stabilizer fractured at the base just above the no.2 engine. The rear spar and aft centre spar fractured about 10 inches above the base and was bent aft. The forward centre and

front spar attachment point fractured six inches above the base and exhibited no bending. All the fractured surfaces exhibited evidence of overload.

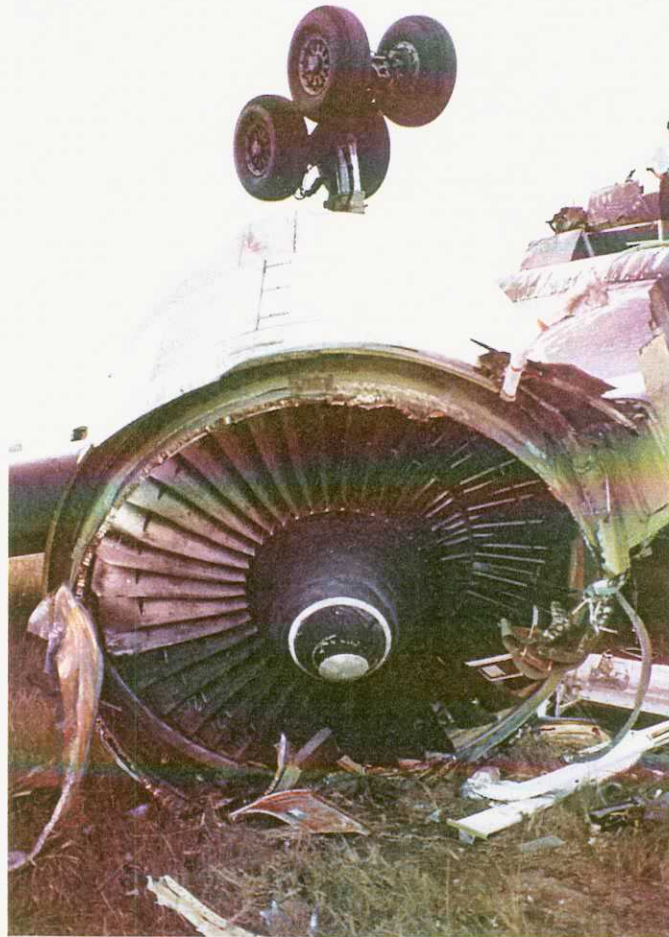
No.1 Engine (Figure 17)

After the accident, no. 1 engine remained attached to the pylon structure. The engine and pylon had separated from the left wing at the front and rear pylon mounts. The engine was inverted, along with the wing, with the 12 o'clock position of the fan case resting on the ground. The inlet structure was separated from the engine forward of A-flange. The fan rotor and fan blades were intact. Fifteen of the fan blades were slightly bent opposite the direction of rotation. The other 21 fan blades were not significantly bent while two fan blades were slightly bent in the direction of rotation. The fan case showed signs of fan blade tip contact with the fan case attrition material. The Low Pressure Compressor (LPC) inlet vanes were intact and did not show signs of distress. No significant damage was found to the LPC blades and vanes that could be seen from the LPC inlet. The fan exit guide vanes were intact. The fan cowl doors were separated from the nacelle. The thrust reverser doors were found in the stowed position. The rear stages of the low-pressure turbine were intact and showed no indication of distress. No indication of engine failure or debris was found in the turbine exhaust case. The exhaust nozzle and tail cone remained intact and were not significantly distressed. There were no indications of any scrape marks on the engine nacelle.

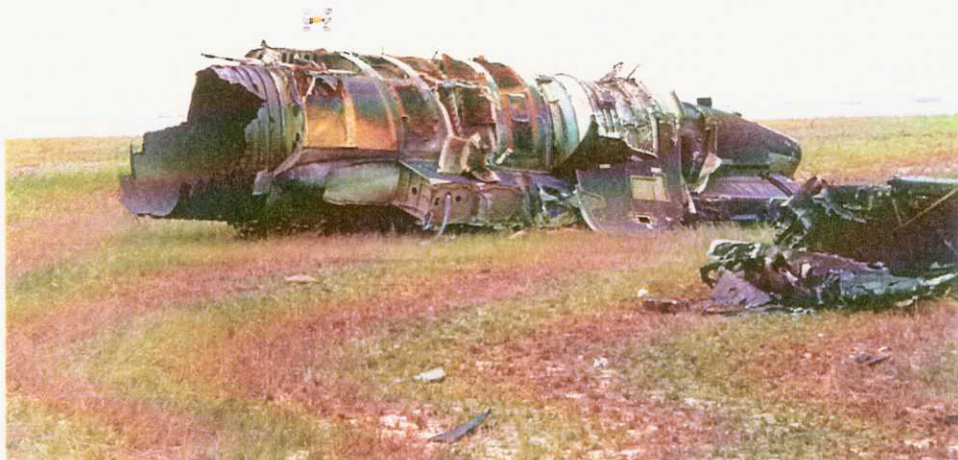
No.2 Engine (Figure 18)

After the accident, no. 2 engine remained attached to the inlet and engine mounting structure. The engine, inlet, and mounting structure separated from the aircraft along the diverter structure of the vertical stabilizer. The inlet duct was breached radially inward and forward of the fan face. Debris was found in the inlet duct in front of the fan face. The fan rotor and fan blades were intact. Foreign object impact damage was observed on the fan blades in the form of nicks and local deformations of the fan blade leading edges. The inlet, fan section, LPC, and bypass air surfaces were thinly covered in soot, consistent with the external, post-accident fire. No damage beyond slight foreign object damage was observed on the LPC inlet vanes or blades. The fan exit guide vanes remained intact. The fan cowl doors were separated from the fan case, one of which was found on the side of the runway. The bypass and core cowl doors remained on the engine and showed impact damage from external directions. The thrust reverser doors were found in the stowed position. No indication of engine distress was found on the 6th stage LPC blades or in the turbine exhaust case. The exhaust tail cone and nozzle remained attached to the engine.

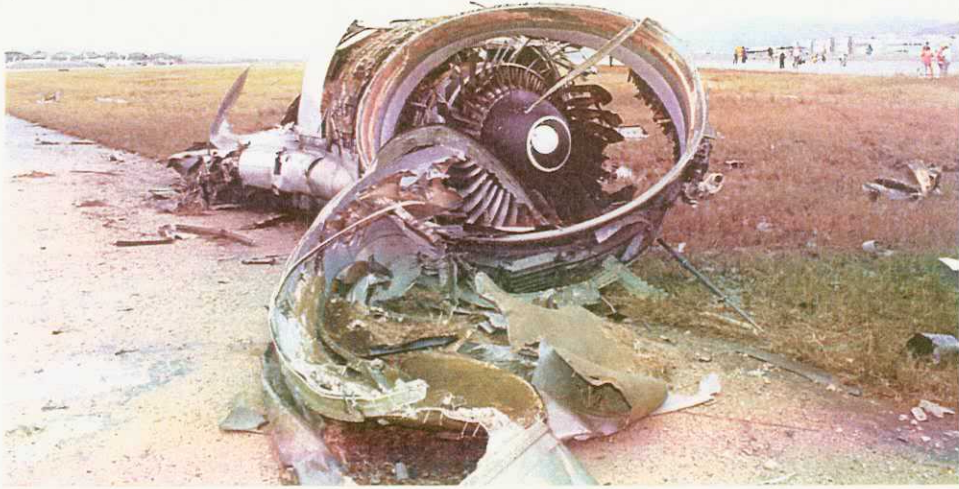
No.3 Engine (Figure 19)

After the accident, no. 3 engine remained attached to the pylon structure. The engine and pylon structure was separated from the right wing at both the front and rear pylon mounts. The engine mounts did not exhibit any signs of distress. The inlet duct separated from the engine immediately forward of A-flange. The inlet exhibited abrasion marks at the 6 o'clock position. The fan case separated from the engine at C-flange, just behind the fan exit guide vane outer platform mounts. The separated fan case structure showed no signs of non-containment. Engine externals mounted near the 6 o'clock position of the fan case exhibited abrasion marks. The fan containment belt, yellow in color, displayed heavy fraying in the 6 o'clock region. Fragments of the belt material were found on the runway. The fan hub was intact and contained all 38 fan blade attachments. Three fan blades

were fractured at roughly 50% span while 25 fan blades were fractured at the part-span shroud location. The remaining 10 fan blades were of full length and bent opposite the direction of fan rotation. The LPC shroud was intact, with the 1st stage LPC stators showing signs of foreign object damage. Ground debris was found throughout the bypass ducts and the LPC.

The upper intermediate case struts were deformed rearward, while the lower struts were crushed into the engine core cowl. The outer structure of the bypass duct, including the thrust reverser, was collapsed radially inward on both the left and right sides of the nacelle. Scuff marks consisting of gray paint were found at the 10 & 11 o'clock positions. Two pieces were removed for further examination. The right thrust reverser door was in the stowed position. The left thrust reverser door was separated from the engine, along with the thrust reverser cascades. The thrust reverser cascades were in place on the right side of the engine. The lowest external region of the thrust reverser doors exhibited two distinct patterns of abrasion or grinding. One of the patterns of abrasion was oriented roughly along the engine centreline in the fore to aft direction. The second pattern of abrasion was oriented approximately 35 degrees right of engine centreline, also in the fore to aft direction. The 6th stage low-pressure turbine blades showed no signs of distress. The lower third of the turbine exhaust case was crushed radially inward at T-flange; however, P-flange was only slightly deformed. No engine debris was found in the turbine exhaust case. The exhaust nozzle was separated from T-flange. The exhaust tail cone suffered radial impact at the 6 o'clock position, but remained attached to the turbine exhaust case.
