Enclosure to: B-H200-17041-ASI

MDC-00K1121

**Sequence and Characteristics of the Structural Failure of the Mandarin Airlines  
(China Airlines) MD-11 Fuselage Number 518 – August 22, 1999 Accident at  
Hong Kong International Airport**

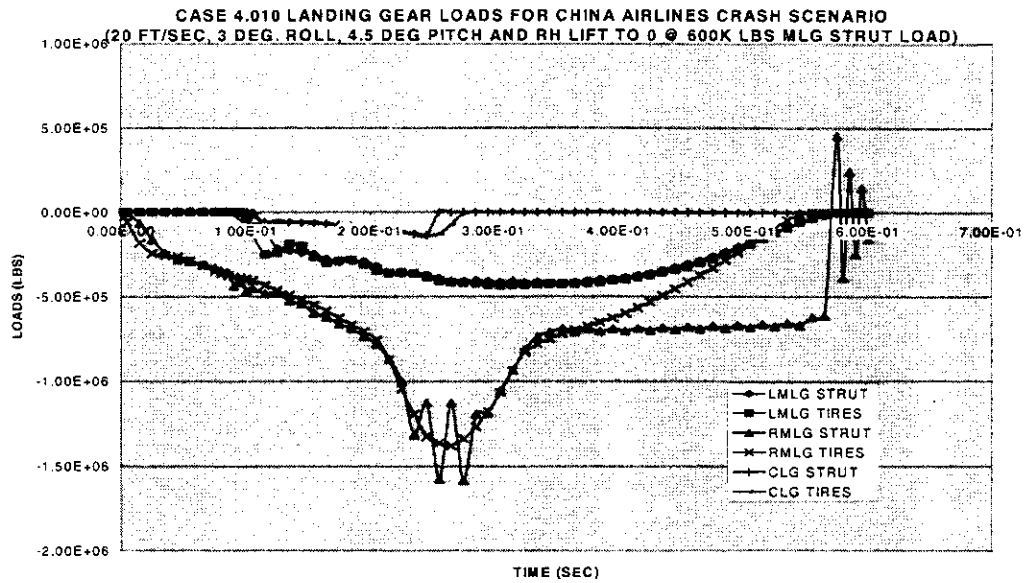
Figure 3. Case 4.010 Landing Gear Loads for China Airlines Crash Scenario

Figure 3 displays the landing gear strut and tire loads for the China Airlines baseline case (Case 4.010). The structure responds linearly for this case and it is assumed that all of the lift on the right-hand wing is lost when the right main landing gear load reaches 600,000 lbs. (This assumption is consistent with analyses that were run for the FedEx crash simulations, which used ADAMS to dynamically calculate wing lift as a function of local angle of twist). For the China Airlines analysis, both the left main landing gear and the center landing gear pick up load well before the right main landing gear reaches its peak load.

The strut and total-tire load time histories should be equal for a given gear (note that the right main landing gear strut load oscillates near its peak and separates after the peak due to NASTRAN convergence problems). These convergence problems do not have a significant effect on the time history of the other gear loads or the peak value of the right main landing gear total-tire load.

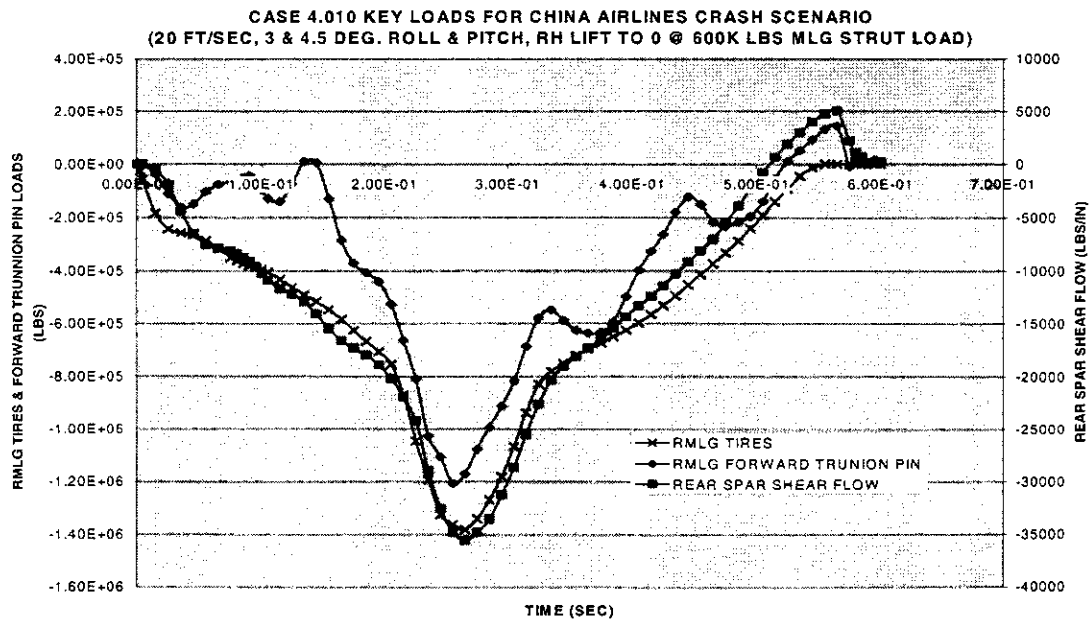
Figure 4. Case 4.010 Landing Gear Loads for China Airlines Crash Scenario

Time histories of key loads from Case 4.010 are plotted in Figure 4. From the figure, the right main landing gear strut load peaks at 1.4 million pounds, the peak rear spar shear flow is 35,000 lbs/in, and the peak load on the right main landing gear forward trunnion bolt is 1.2 million pounds. The rear spar shear flow is well in excess of what is required to fail the rear spar shear web and the forward trunnion bolt load is roughly that which is required to fail it.

The results of this analysis, although not rigorous, confirm that loads high enough to fail the forward trunnion bolt and the rear spar shear web are feasible, and that the failure sequence described in the following sections is reasonable.

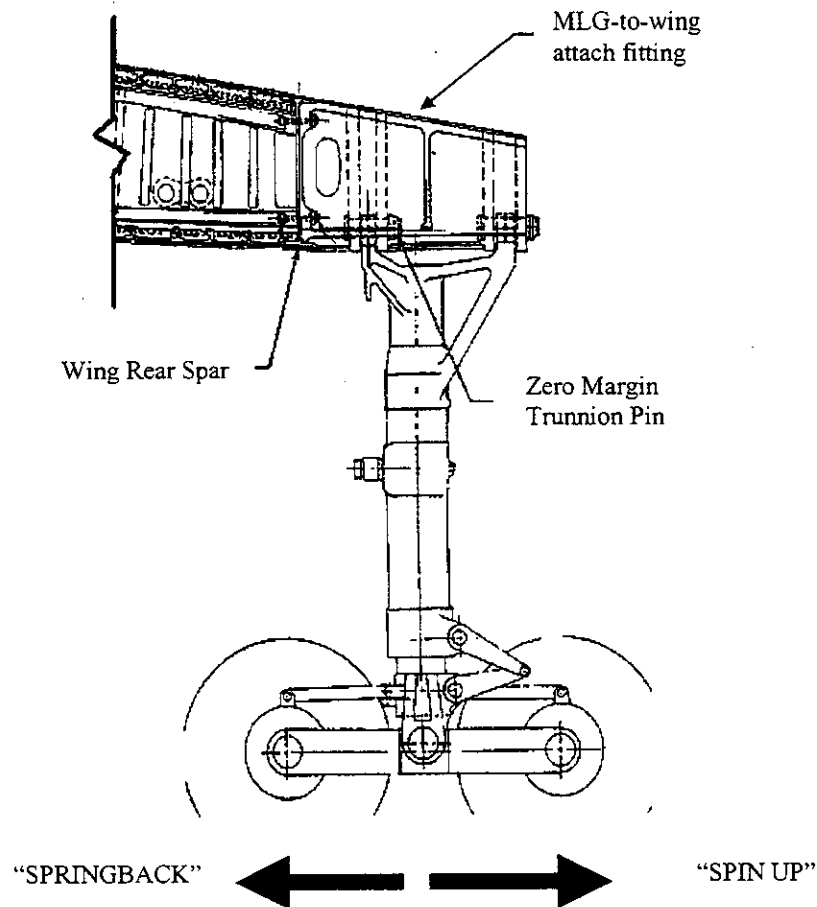
Figure 5. Main-Landing-Gear-to-Wing Attach Arrangement

The first structural element thought to have failed in this accident is the forward trunnion bolt, also known as the “zero margin trunnion pin”. This bolt is designed to reliably shear at a predetermined load (approximately 1.2 million lbs) and acts as a “fuse” when the main landing gear is subjected to excessive drag loads. Figure 5 shows the location of the zero margin trunnion pin.

When acting as a fuse against excessive drag load the zero margin trunnion pin fails by shearing downwards (i.e. the forward trunnion of the main landing gear moves downward relative to the wing attach fitting). In this accident this bolt failed in the *upwards* direction due to a combination of high landing gear vertical load, and a high “springback” moment. Both the high vertical load and the high “springback” moment were a result of the excessive (18-20 ft/sec) sink rate.

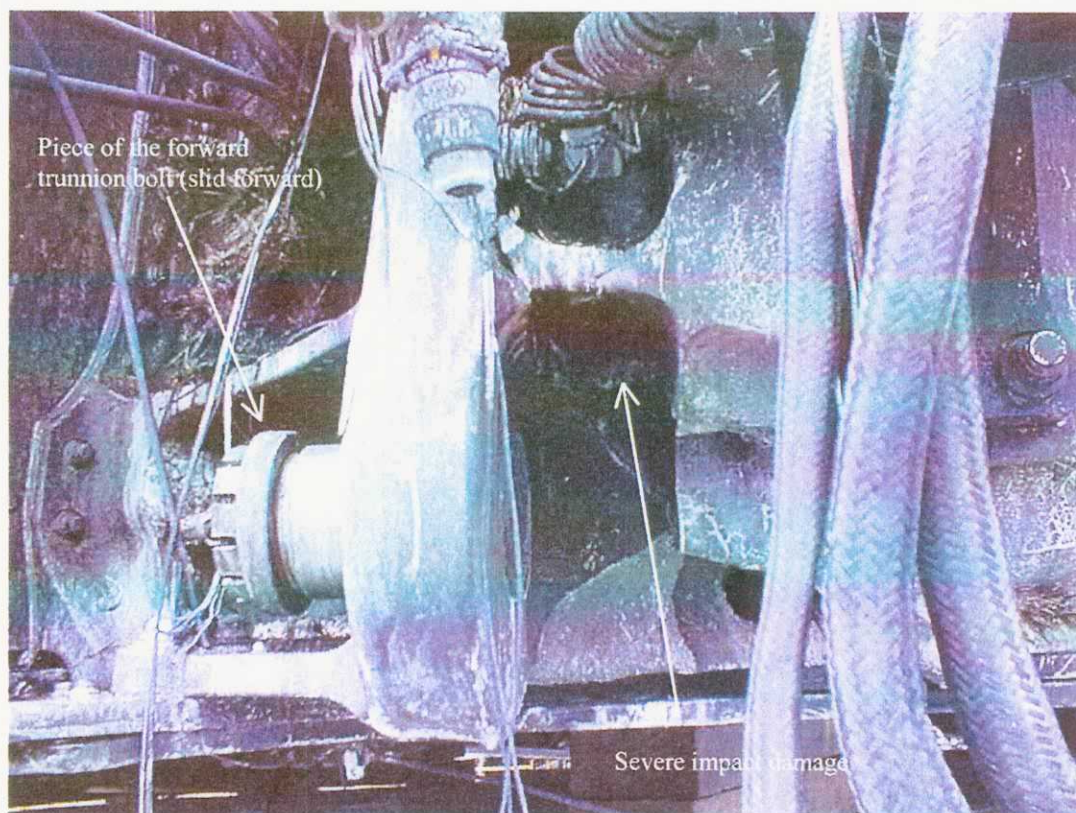
Figure 6. Damage to MLG-to-Wing Attach Fitting at the forward lugs

After shearing the forward trunnion bolt at the forward zero-margin groove, the forward trunnion of the right main landing gear was driven upwards and contacted the wing attach fitting, damaging the fitting. This is clearly evident in a photograph taken at the crash site (Figure 6) and in Figures 34 and 35 of the Materials and Process Engineering Report (Reference 2).

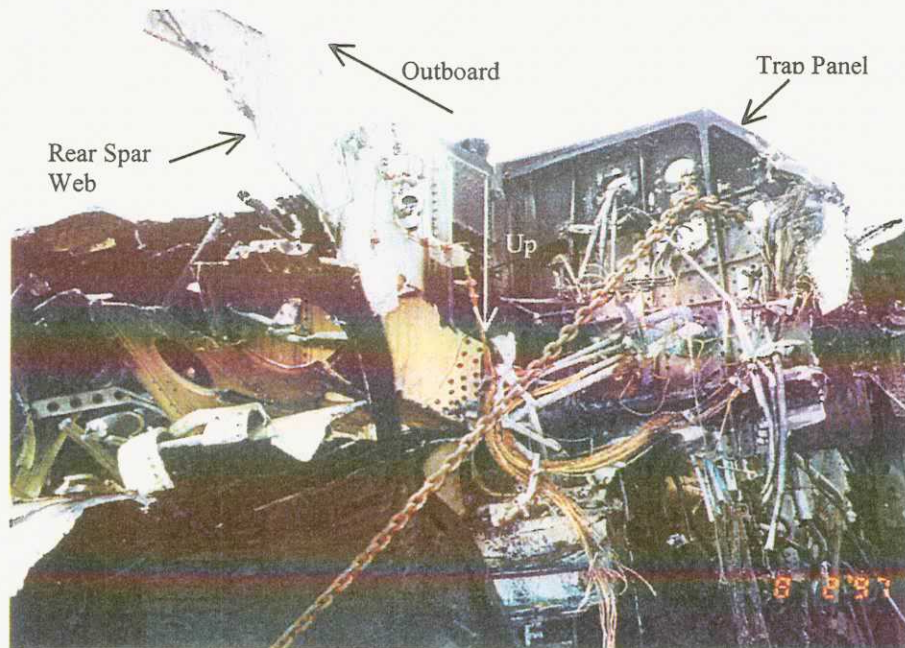
Figure 7. Right Wing Rear Spar Web Fracture from Ship 553 (FedEx - Newark)

The rear spar web was identified as the first structural element thought to have failed in the FedEx accident that occurred in Newark, New Jersey on August 31<sup>st</sup>, 1997. A significant amount of analysis was conducted to validate the FedEx failure sequence, so this failure mode was quickly recognized when the wreckage of the China Airlines aircraft was examined.

A photograph of the FedEx aircraft showing the right wing rear spar web fracture is included as Figure 7. Note that the aircraft is inverted in this photograph.

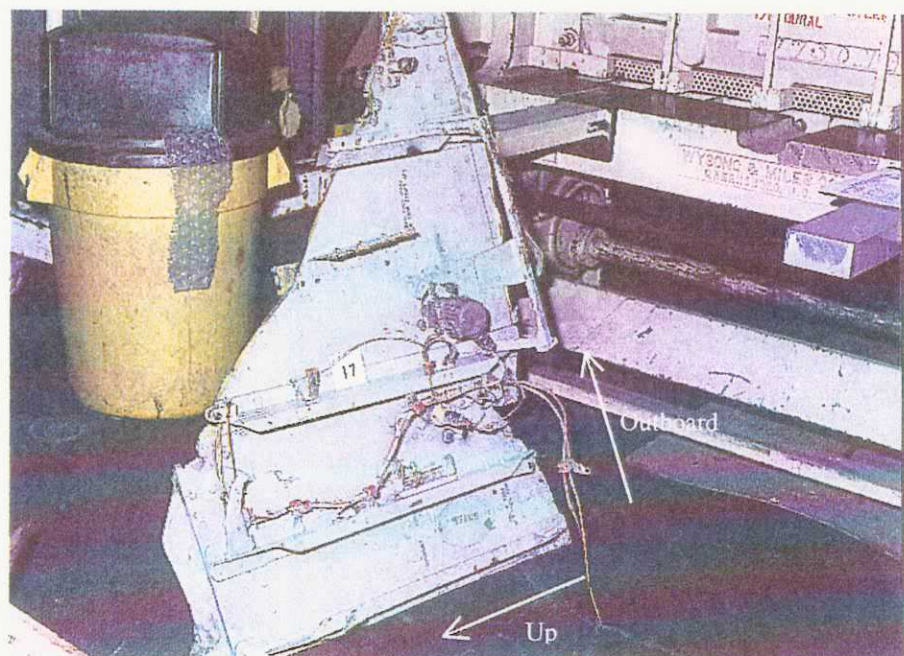
Figure 8. Right Wing Rear Spar Web Fracture from Ship 518 (China Airlines)

With the forward trunnion bolt sheared, and the forward trunnion of the right main landing gear jammed upwards into the wing attach fitting, the vertical load on the gear was driven into the wing rear spar. Both rear spar webs fractured (in this area the web is doubled for failsafe reasons), along with the upper and lower rear spar caps. The rear spar web fractures were oriented roughly 45 degrees relative to the spar caps, as is typical of shear overload of a beam web.

A lab photograph of the right wing rear spar web which was cut from the China Airlines aircraft is included as Figure 8. When examined closely it was observed that the rear spar web fractures from the two accidents occurred at almost identical locations.

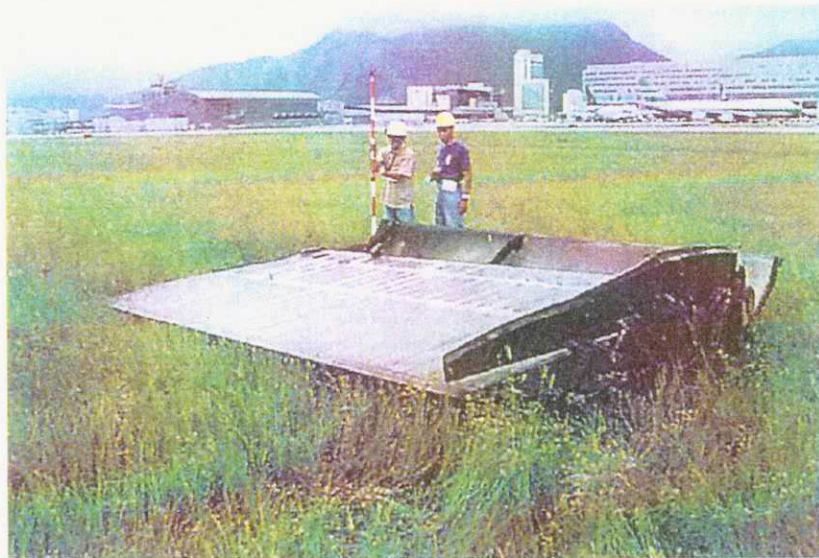
Figure 15. Right Inboard Flap from Ship 518 (China Airlines)

As was the case for the wing rear spar failure mode, there are some observed similarities in the FedEx and China Airlines inboard flap failures. Both inboard flaps were found near the beginning of the debris field, were relatively intact (having almost no lower surface damage), and evidenced local shear-out failures of the flap track lips at the side roller locations.

The China Airlines inboard flap was found off to the left of the runway and is thought to have been carried there by the crosswind (which was blowing right-to-left) after it departed the aircraft. The flap, as it was found, is pictured in Figure 15. The FedEx inboard flap was found on a taxiway to the right of the runway (Figure 16); note there was little or no crosswind present when the FedEx accident occurred.

It is viewed as significant that the lower surfaces of these flaps suffered no significant damage. The inboard flap would have been directly in the path of the main landing gear had the gear separated before the flap and would have been badly damaged. It is clear then, that the main landing gear did *not* "knock" the inboard flap off the aircraft.

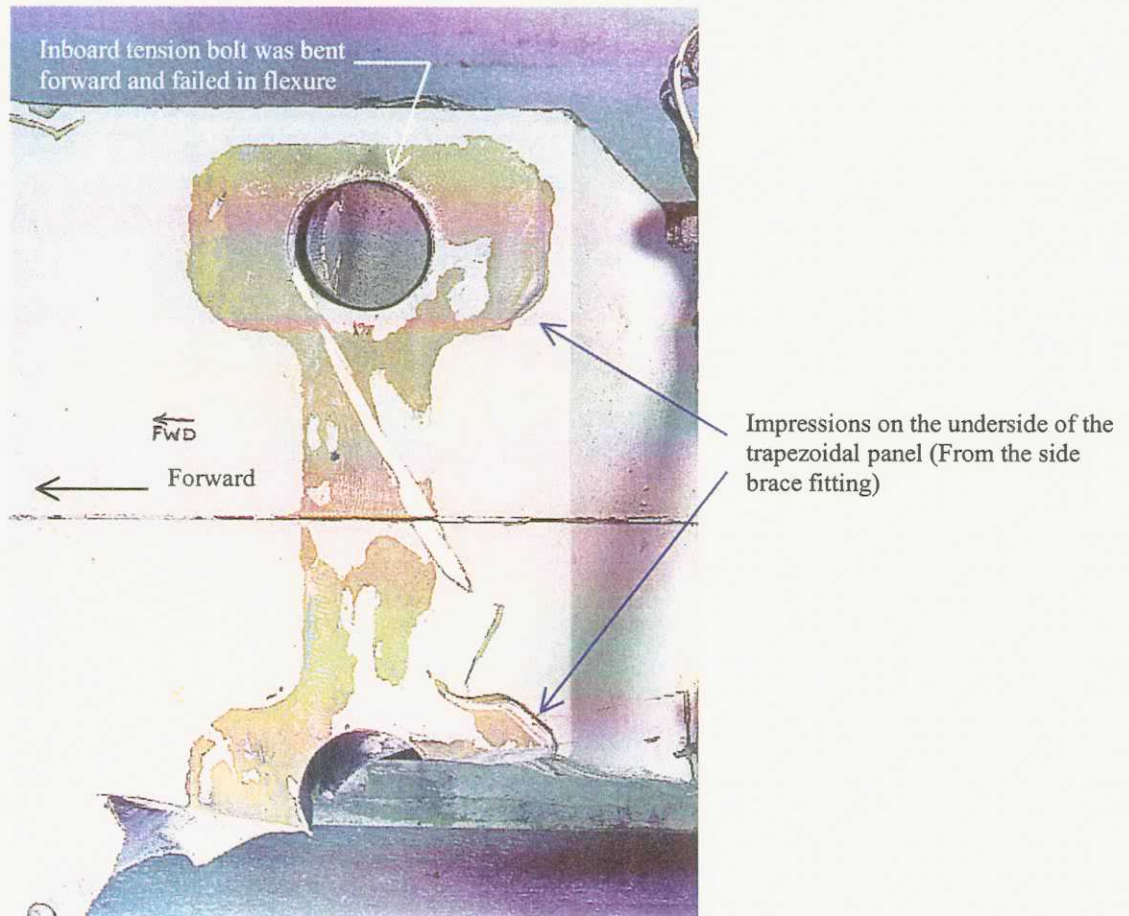
Figure 21. Underside of the right trapezoidal panel

As was the case for the for inboard flap's departure, the damage to the S-B-F-T-T-P joint was the result of large relative displacements between attach points on the wing and on the fuselage. After the right wing rear spar failed, the MLG-to-wing attach fitting moved up (relative to the fuselage) and the outboard wing twisted severely nose-down. This motion effectively tilted the truss formed by the MLG strut, and the fixed and folding side braces, and applied a nose-down twist to the S-B-F-T-T-P joint. This applied twist rocked the side brace fitting (bottom-end-aft) and resulted in "impressions" on the lower surface of the trap panel (Figure 21). Similar impressions were observed on the underside of the trap panel from the FedEx-Newark accident aircraft.

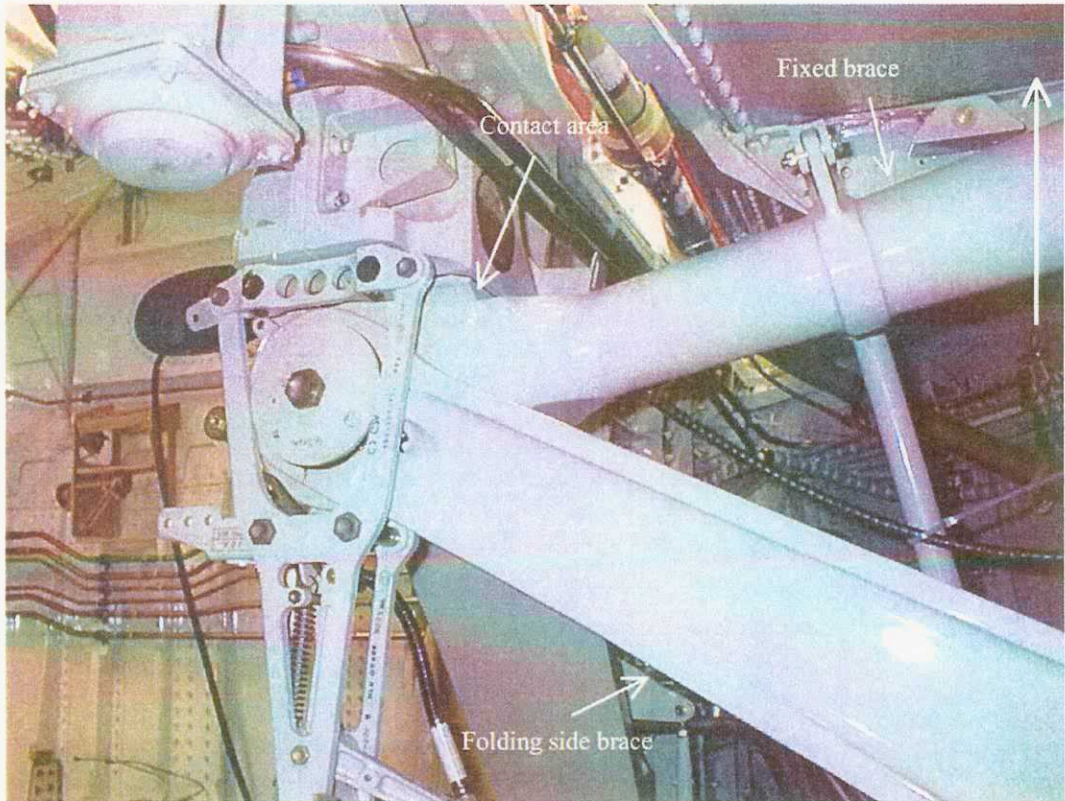
Figure 22. Side-brace-fitting-to-trap-panel joint (from aft and outside the right wheel well)

Figure 22 is another photograph of the S-B-F-T-T-P joint area. The photograph is annotated to point out the limited clearance between the clevis end of the fixed brace and the side brace fitting. Excessive upward motion of the outboard end of the fixed brace (which is connected to the MLG-to-wing attach fitting) results in contact in the noted area, and creates a "short couple" prying load at the joint. Evidence of contact in this area for parts taken from the China Airlines accident aircraft is seen in Figure 23. Similar evidence was also noted for the FedEx-Newark accident aircraft.

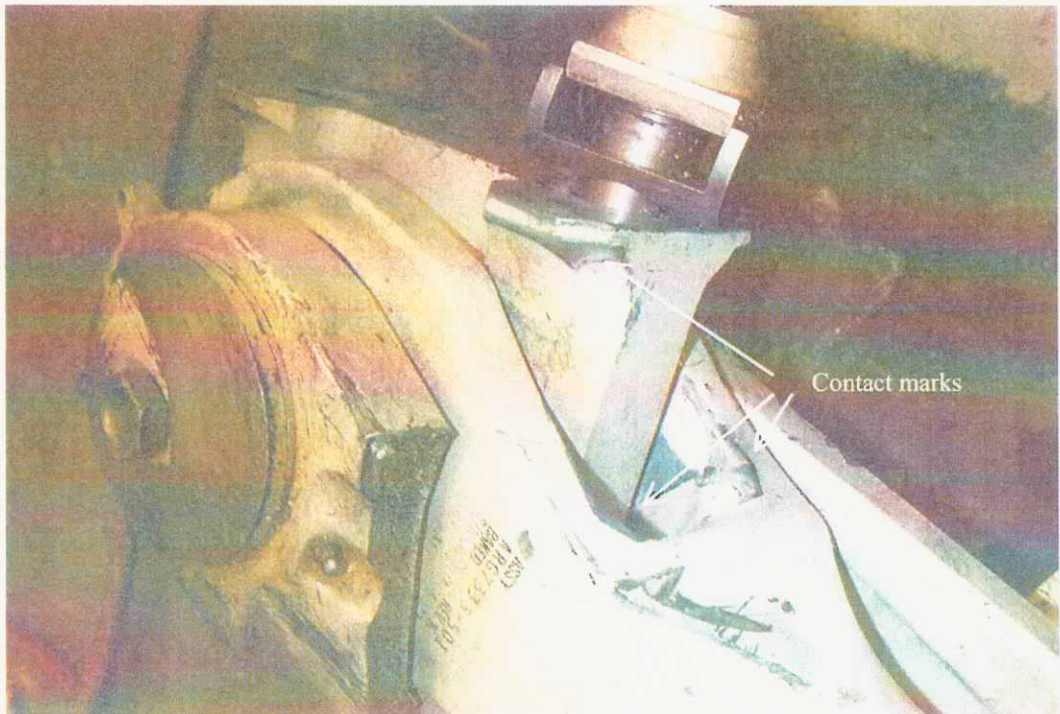
Figure 23. Evidence of contact between the fixed brace and the side brace fitting

The presence of a large prying load at the S-B-F-T-T-P joint results in severe distress to this joint. This manifests itself as localized high bending (flexure) at the outboard end of the fixed brace, and a large tension load on the inboard of the two tension bolts attaching the side brace fitting to the trap panel. Evidence of flexural distress of the fixed brace was observed in parts taken from both the China Airlines and FedEx-Newark accident aircraft. The fixed brace from the China Airlines aircraft failed completely (Figure 24). The fixed brace from the FedEx-Newark aircraft was bent and suffered a stress corrosion fracture (Figure 25). The stress corrosion fracture is attributed to residual stress resulting from a high flexural load. Note also in Figure 25 the evidence of local contact with the side brace fitting.

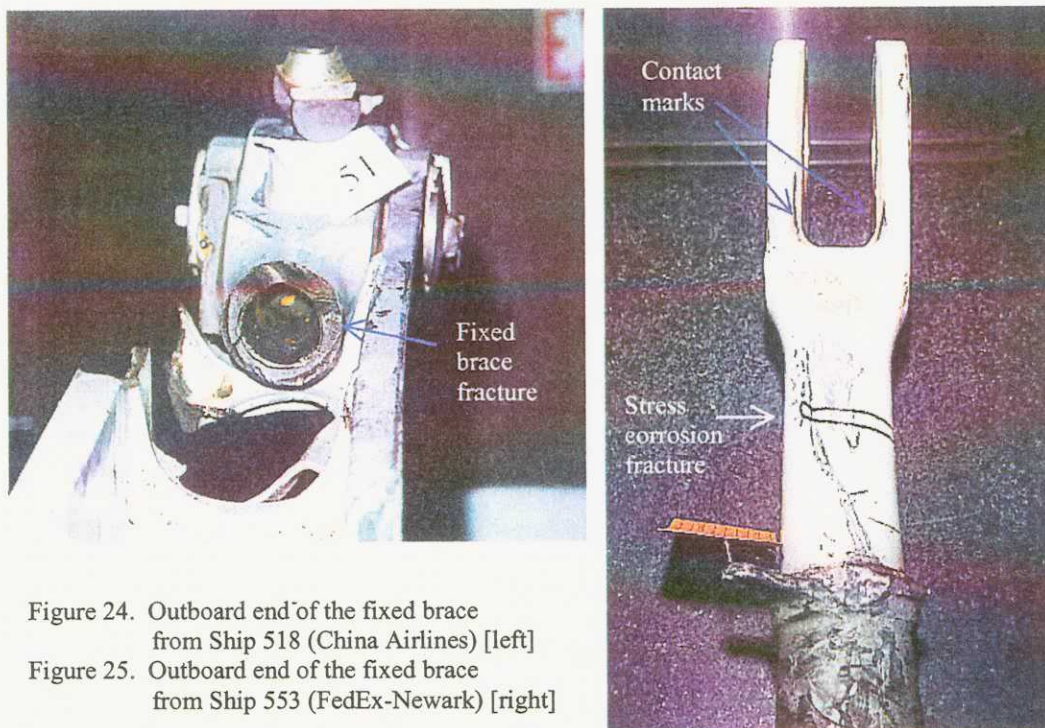
Figure 24. Outboard end of the fixed brace from Ship 518 (China Airlines) [left]

Figure 25. Outboard end of the fixed brace from Ship 553 (FedEx-Newark) [right]

Figure 24 also shows damage to the upper folding side brace. The upper folding side brace is an I-section "laid on its side" with lightening holes in the web (Figure 19). The fixed brace after it failed in flexure, appears to have dropped down into the upward facing "channel" of the I. Relative motion between the outboard wing and the fuselage then appears to have "punched" the inboard end of the fixed brace through the web and aft cap of the upper folding side brace.

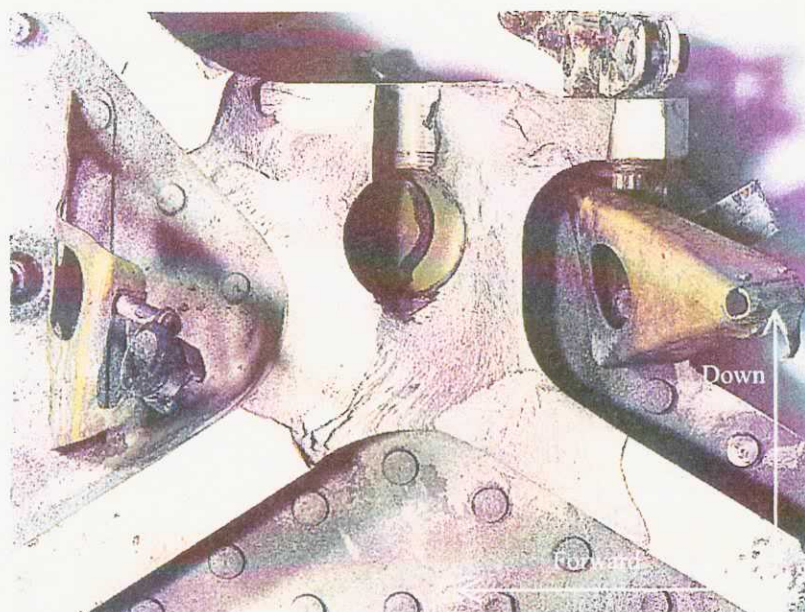
Figure 26. Outboard trap panel failure at the S-B-F-T-T-P joint

The final two failures at the S-B-F-T-T-P joint involve the two tension bolts that attach the side brace fitting to the trap panel, and the trap panel itself. The inboard of the two tension bolts failed in flexure and was bent lower-end-forward (Figure 21 and also Figure 15 of Reference 2). This is thought to have been a consequence of the fixed brace having previously failed, coupled with the lower end of the main landing gear strut moving aft. The folding side brace, acting as a lever, would then apply a twist about the vertical axis of the S-B-F-T-T-P joint. Presuming the outboard tension bolt is acting as a pivot, this would tend to bend the inboard bolt forward.

The outboard tension bolt did not fail. Instead a portion of the outboard face of the trap panel appears to have "split off", releasing the outboard barrel nut and tension bolt (Figure 26). This is thought to have occurred *after* the inboard bolt had failed and appears to have been the result of a prying load applied by the outboard tension bolt, the prying load resulting from the folding side brace pulling outboard on the side brace fitting. (Note the photograph is upside-down relative to the normal position in the aircraft).

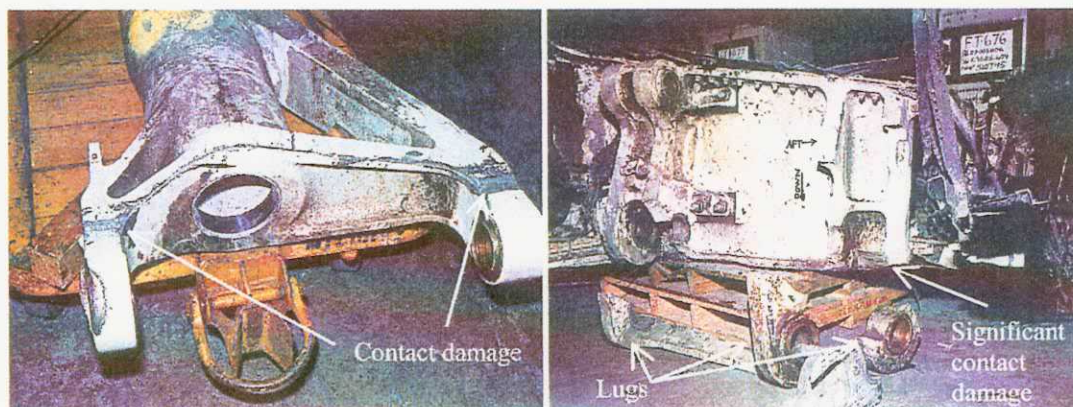
There is clear evidence that the right main landing gear strut, once released at the S-B-F-T-T-P joint, rotated outboard and contacted its wing attach fitting. Similar observations were made for the parts from the FedEx-Newark accident aircraft (see Figures 27 and 28). This type of contact creates a “short couple” prying action that easily breaks the gear loose from the fitting.

Figure 27. Right main landing gear strut from Ship 553 (FedEx-Newark) [left]

Figure 28. Right MLG-to-wing attach fitting from Ship 553 (FedEx-Newark) [right]

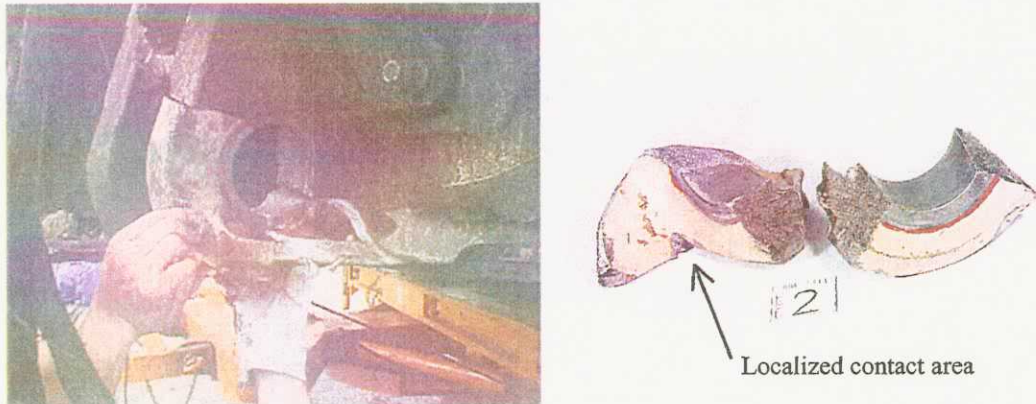
In the case of the China Airlines accident the markings indicating contact between the right main landing gear strut and the wing attach fitting are slightly different (and not quite as clear). This is primarily due to the fact that the forward trunnion connection was partially failed (See Section 5.0) before the strut rotated outboard. The contact area for the forward trunnion was therefore very localized, and quickly resulted in the fracture of the remaining connection (the aft lug). See Figures 29 and 30. The two lugs that support the *aft* trunnion, the fowardmost still connected to a large piece of the wing fitting, also

Figure 29. Wing fitting lugs that support the MLG forward trunnion [left]

Figure 30. Separated pieces of the aft wing fitting lugs that support the MLG forward trunnion [right]

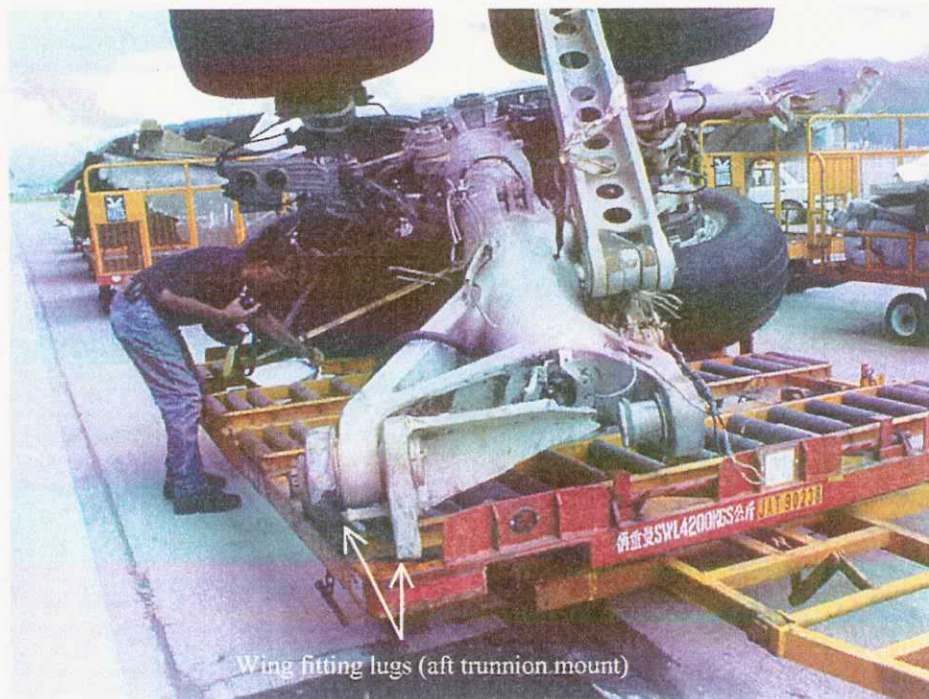
Figure 31. Right main landing gear assembly

cracked off as a result of the gear rotating outboard (Figure 31). This separated the right main landing gear from the aircraft. The contact area on the aft trunnion arm is shown in Figure 32. A photograph of the wing fitting, showing the mating area for the two aft trunnion support lugs, is included as Figure 33.

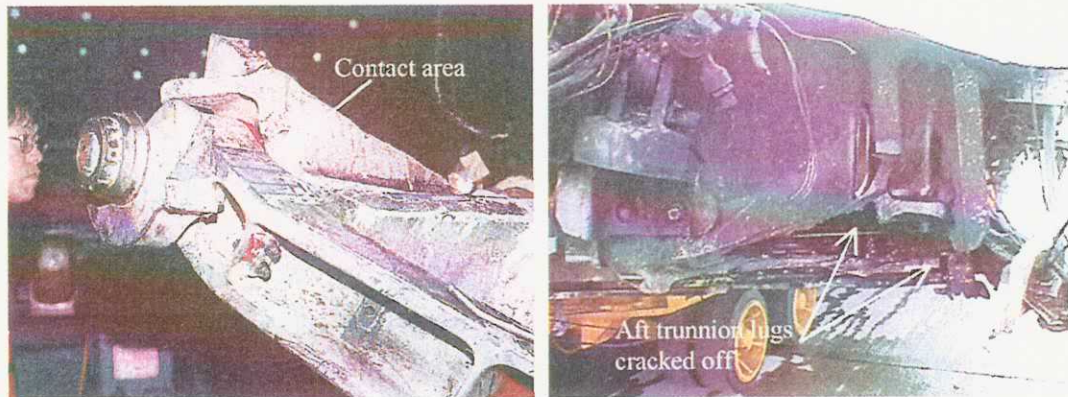
Figure 32. Aft trunnion arm of the right main landing gear strut [left]  
 Figure 33. Right MLG-to-wing attach fitting from Ship 518 (China Airlines) [right]

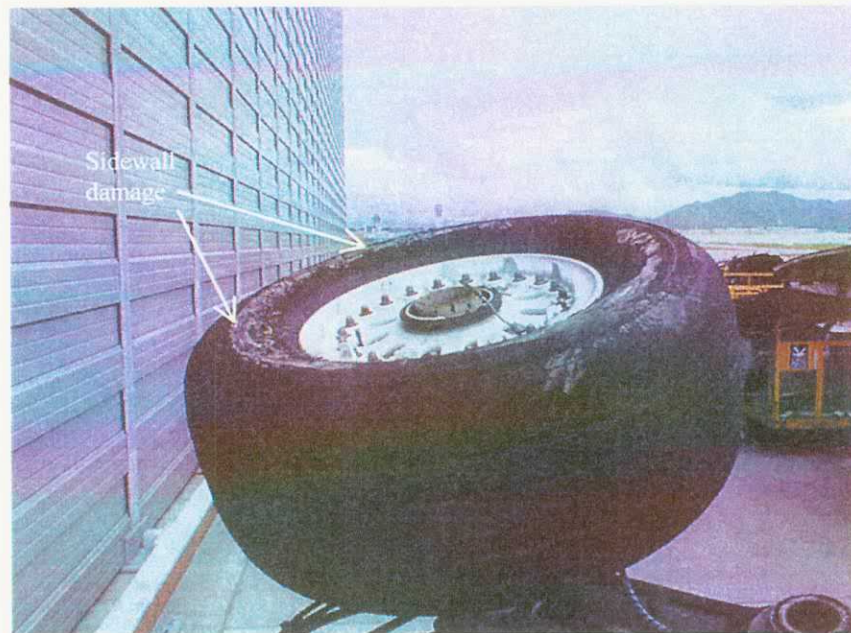
Figure 34. Inboard aft tire from the right main landing gear

Substantial sidewall abrasion was noted on the inboard sidewall of the aft inboard tire on the right main landing gear truck (Figure 34). This evidence further supports the theory that the gear rotated outboard putting the inboard sidewalls of the inboard tires in contact with the ground.

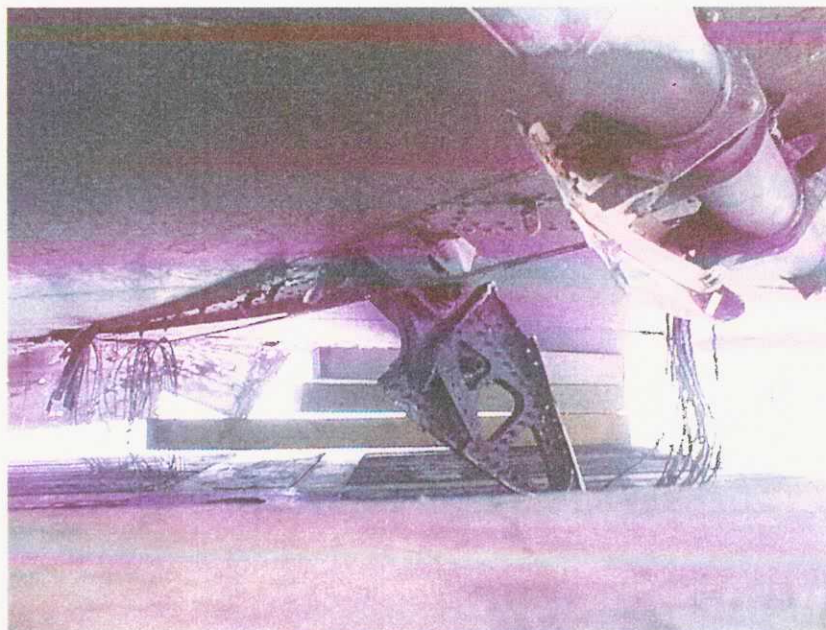
Figure 37. Right engine pylon aft-attach bulkhead still attached to the right wing

Figure 37 shows that the right pylon failure mode was different for the China Airlines accident aircraft; the right engine pylon aft-attach bulkhead is still attached to the right wing. Figure 38 shows the right engine pylon. The observed failures suggest that the loads on the nacelle included a significant sideways

component. This is thought to have occurred because the outboard wing, as the failure progressed, began to sweep further and further aft.
