China Airlines
MD-11 Accident, August 22, 1999
At Hong Kong International Airport,
Hong Kong

Comments on the draft final report

Aviation Safety Council

Submitted June 2002

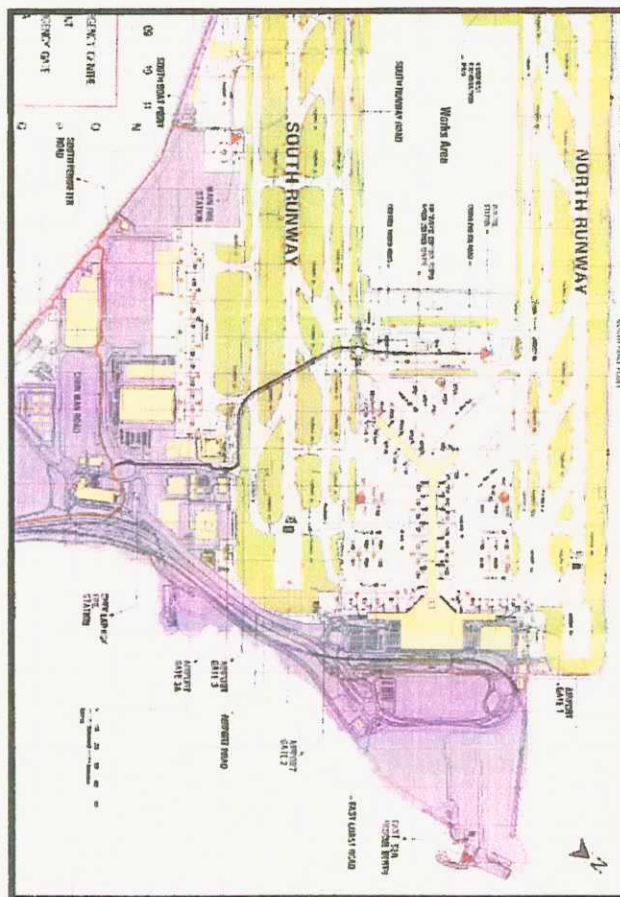
- a) The Hong Kong draft Final Report minimizes the significance of the absence of high capability wind shear warning detection system at Chap-Lap-Kok Airport. The improvement of wind shear detecting system is a major challenge confronting the world aviation industry.
- b) The Hong Kong draft Final Report also minimizes the finding of the three very valuable simulator lessons tested at Boeing facility, Long Beach, California.
- c) The Hong Kong draft Final Report does not adequately address the RWY 25L and 25R wind difference analysis attributed from passenger terminal building. It should be considered in that context. See Figure 1 below.

Figure 1. Runway 25L approach area in the lee of the Passenger Terminal Building

5. Appendix A5-3-2 in Reference A shows a variation in TDZ wind direction of between 314° and 326° with speeds from 39kt to 43kt (Runway 25R) in comparison to a variation in TDZ wind direction of between 283° and 339° at 14kt to 28kt (Runway 25L) in the lee of the Passenger Terminal Building. This kind of wind change will affect the landing to a great extent.

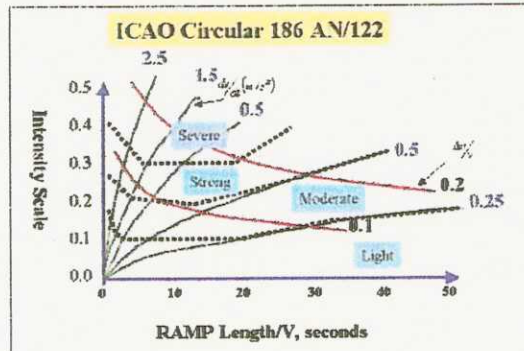
Figure 3: Wind Shear Intensity classification

Based on table 3 data for calculating wind shear intensity, the result showed CI642 encountered a strong to severe wind shear below 200 feet. The intensity of wind shear varied with radio altitude is plotted in figure 3.

- (1) a zone: 300 ft~ 245ft: Light to **moderate** wind shear [25 ~ 19sec. Prior to touch down]
- (2) b zone: 245 ft~ 186ft: **Moderate** to Light wind shear [19 ~ 13sec. Prior to touch down]
- (3) c zone: 186 ft~ 117 ft: Light to **Strong** wind shear [13 ~ 9sec. Prior to touch down]
- (4) d zone: 117 ft~ 59 ft: **Strong** to Moderate wind shear [9 ~ 6sec. Prior to touch down]
- (5) e zone: 45 ft~ -1 ft: Moderate to **Severe** wind shear [6 ~ 1sec. Prior to touch down]

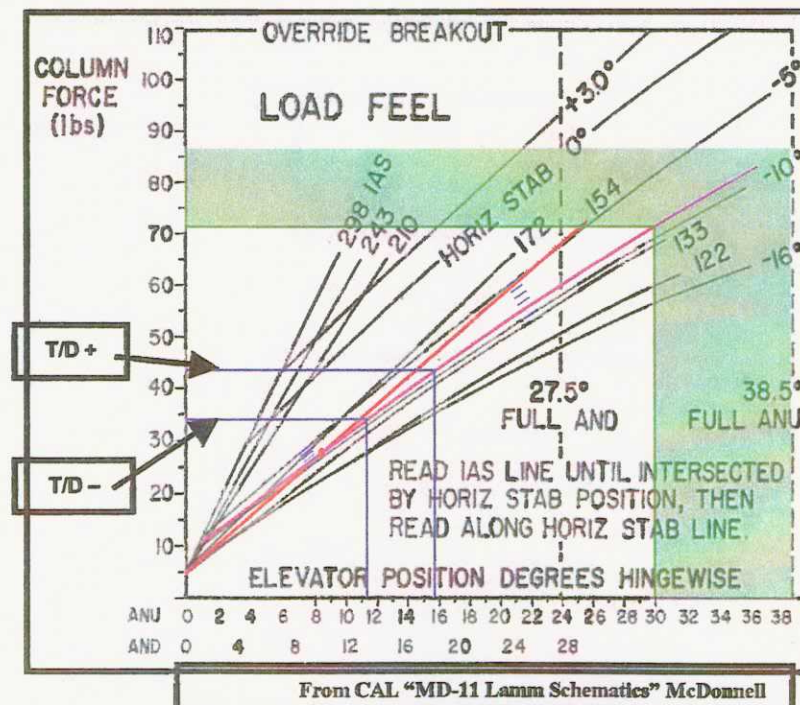
Figure 4. MD-11 Elevator Load Feel force Gradient

3.2.3.1 Elevator control forces required achieving the large deflections necessary to arrest the descent rate in time, which were well in need of large input from the pilot (with one hand on the control wheel, See Figure.4 below).
