**Slope Upgrading Works at
Feature No. 11SW-A/R526,
King's College,
Bonham Road, Hong Kong**

Project Profile for Slope Upgrading Works at
Feature No. 11SW-A/R526, King's College

May 2018

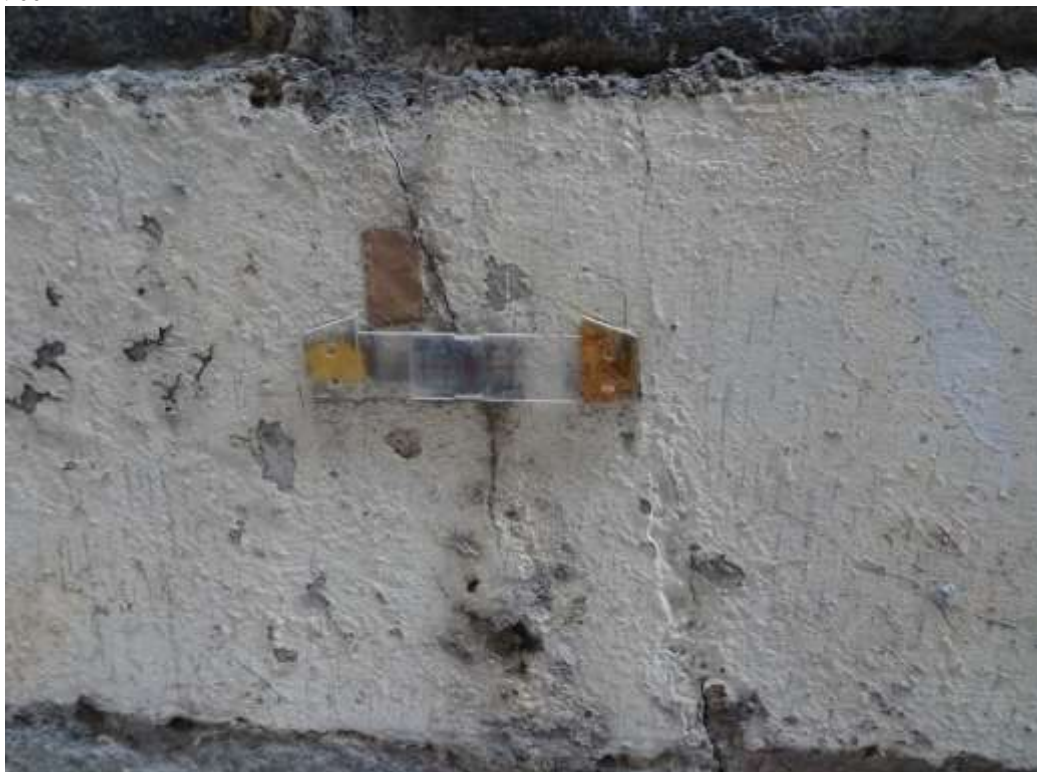
General View No. GV14 **Description** General view of tell-tale crack gauge on north retaining wall

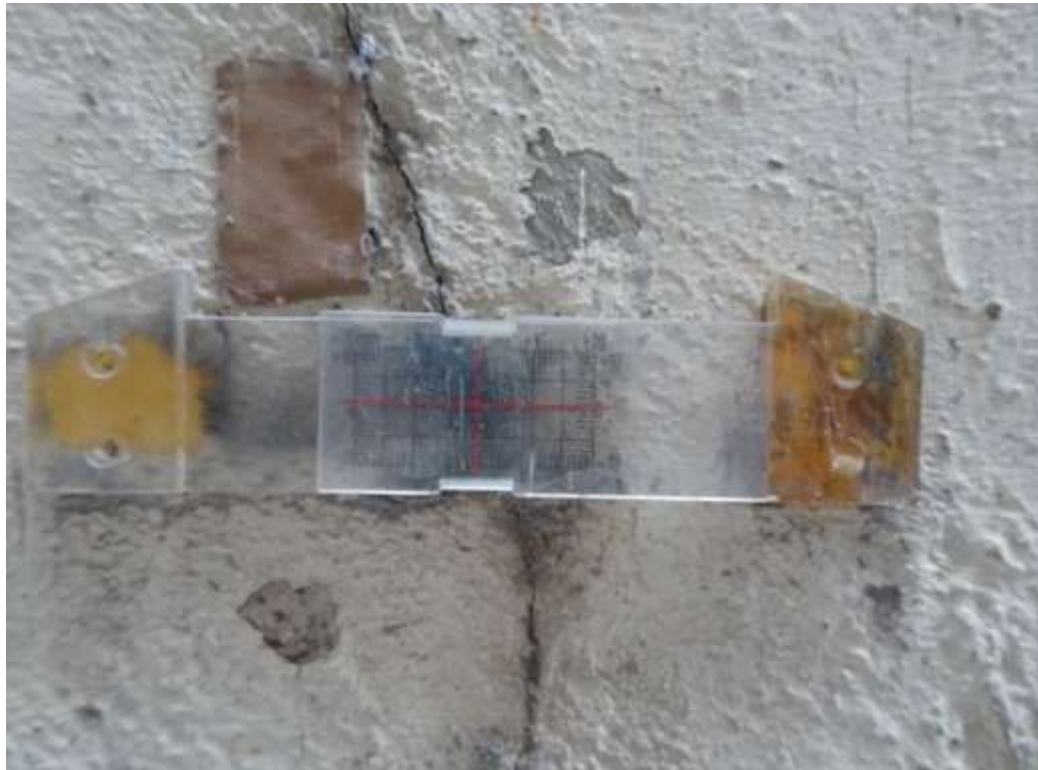
General View No. GV15 **Description** General view of tell-tale crack gauge on north retaining wall

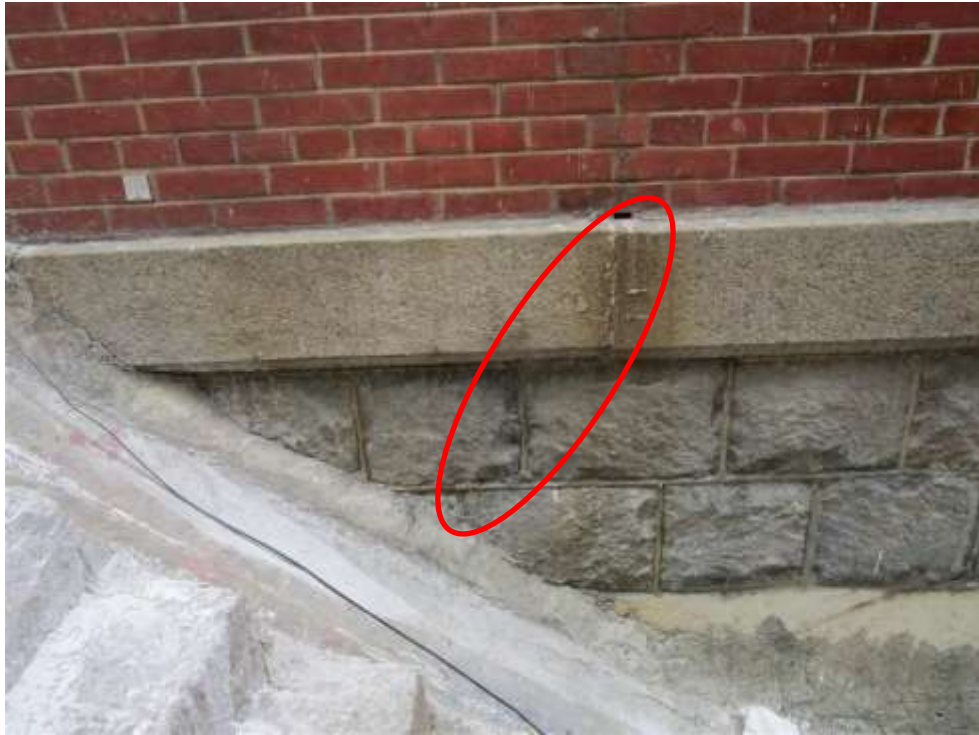
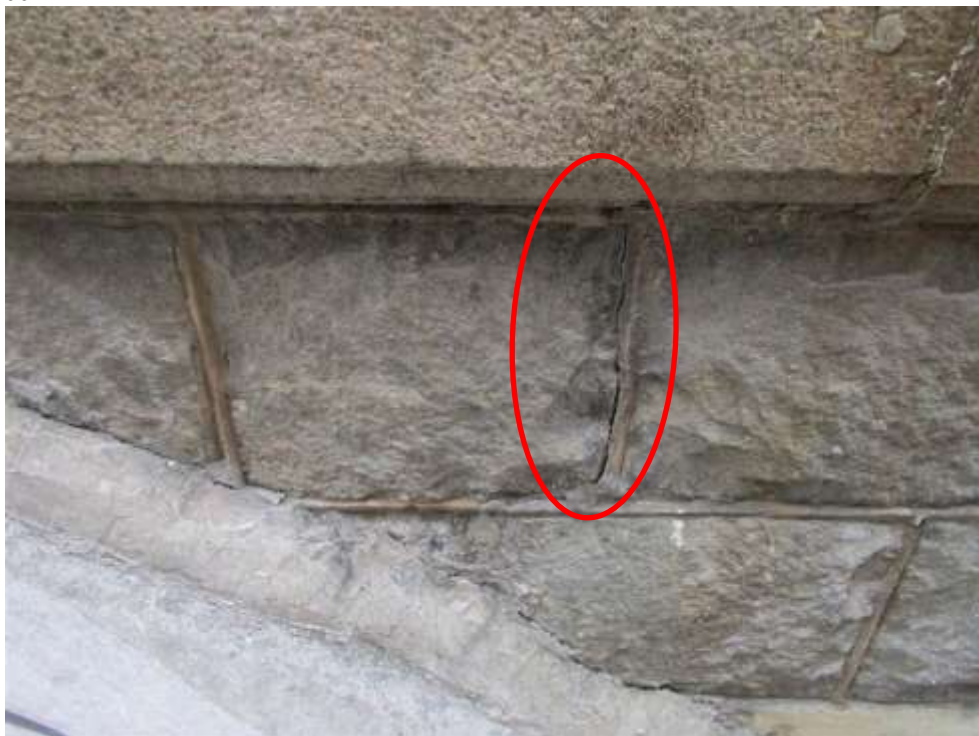
Defect No.	1	Location	North wing, North elevation exterior	Component	retaining wall
-------------------	---	-----------------	--------------------------------------	------------------	----------------

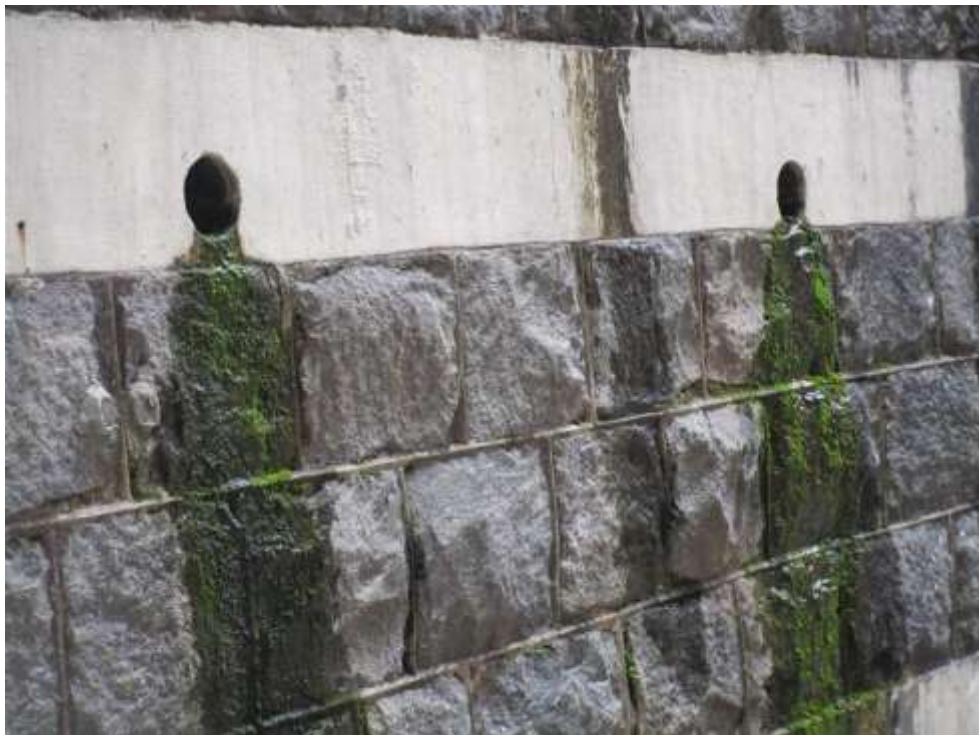
Defect No.	3	Location	North wing, North elevation exterior	Component	retaining wall
-------------------	---	-----------------	--------------------------------------	------------------	----------------

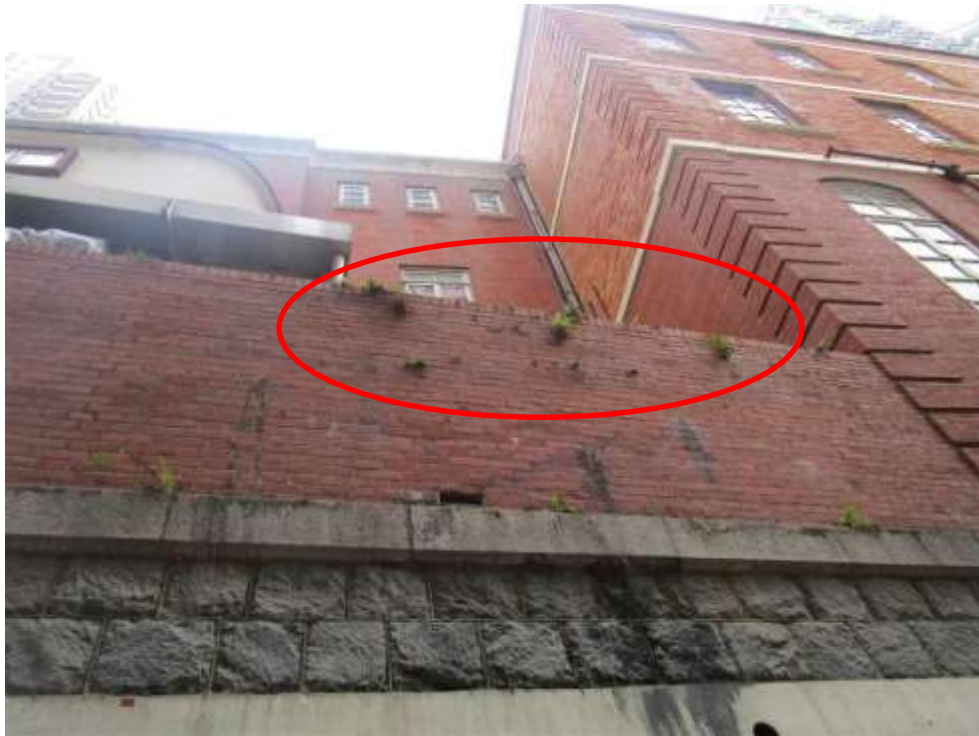
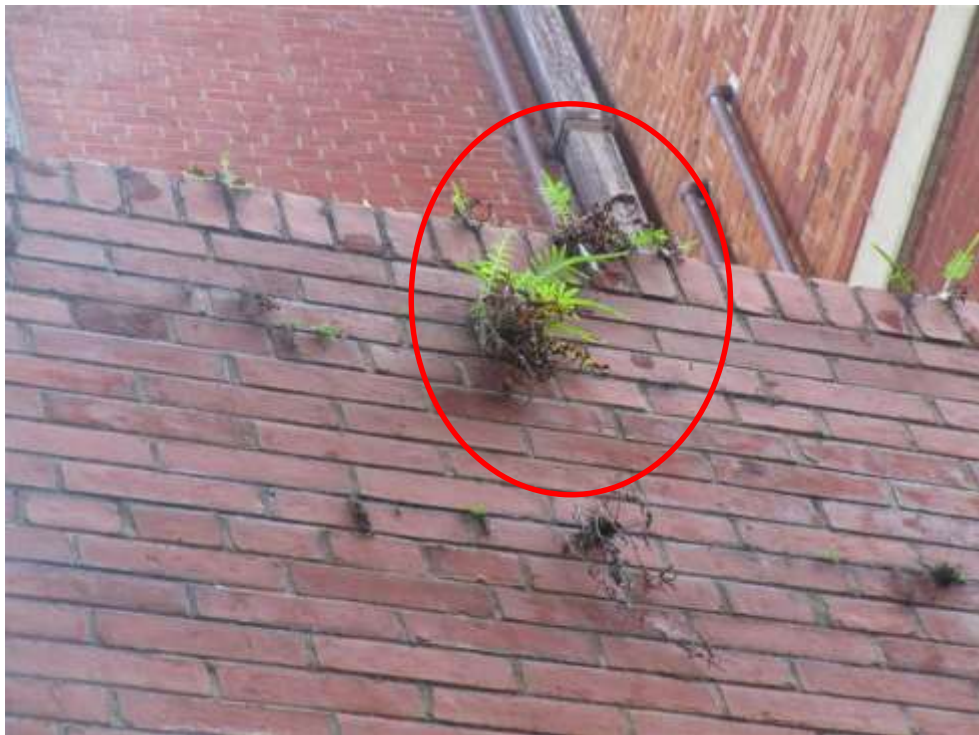
Defect No.	4	Location	North wing, North elevation exterior	Component	retaining wall
-------------------	---	-----------------	--------------------------------------	------------------	----------------

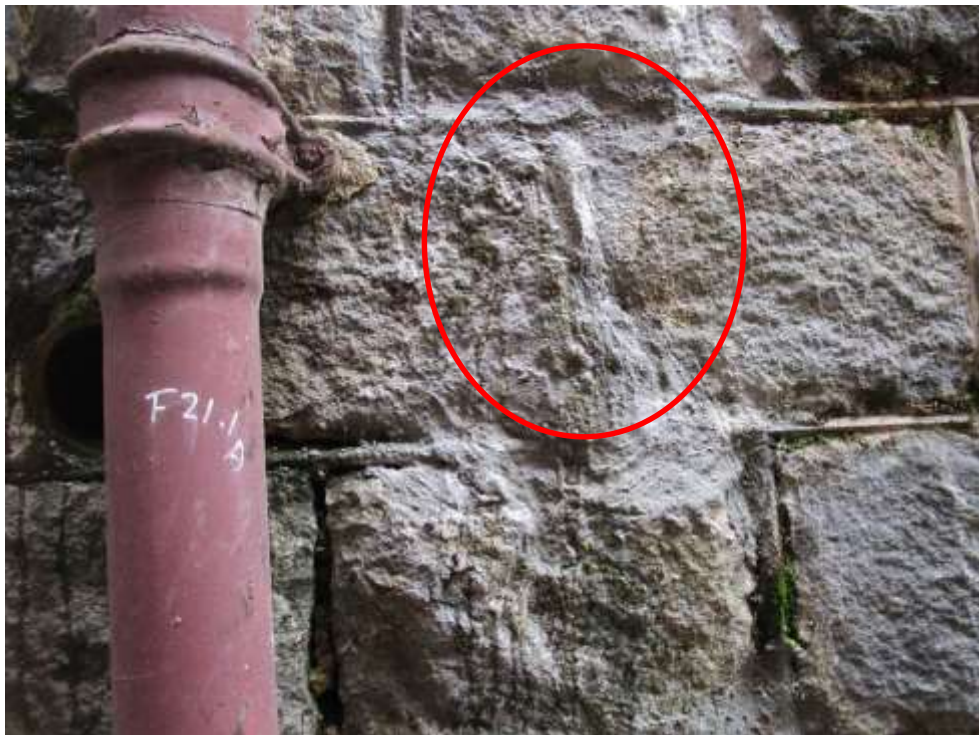
Defect No.	6	Location	North wing, North elevation exterior	Component	retaining wall
-------------------	---	-----------------	--------------------------------------	------------------	----------------

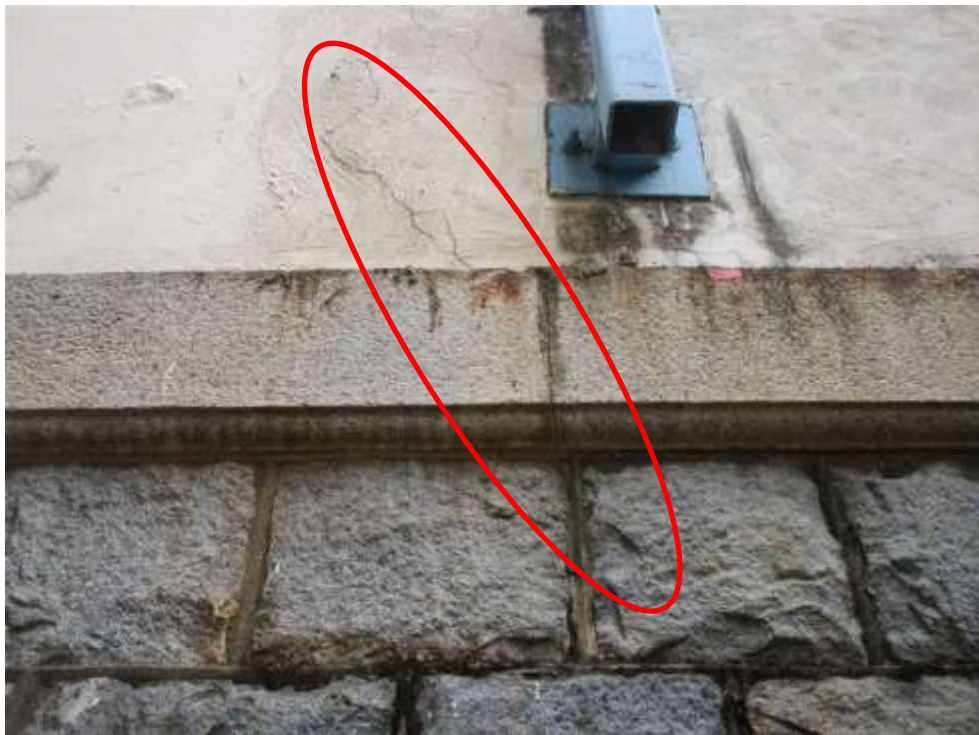
Defect No.	9	Location	North wing, North elevation exterior	Component	retaining wall
-------------------	---	-----------------	--------------------------------------	------------------	----------------

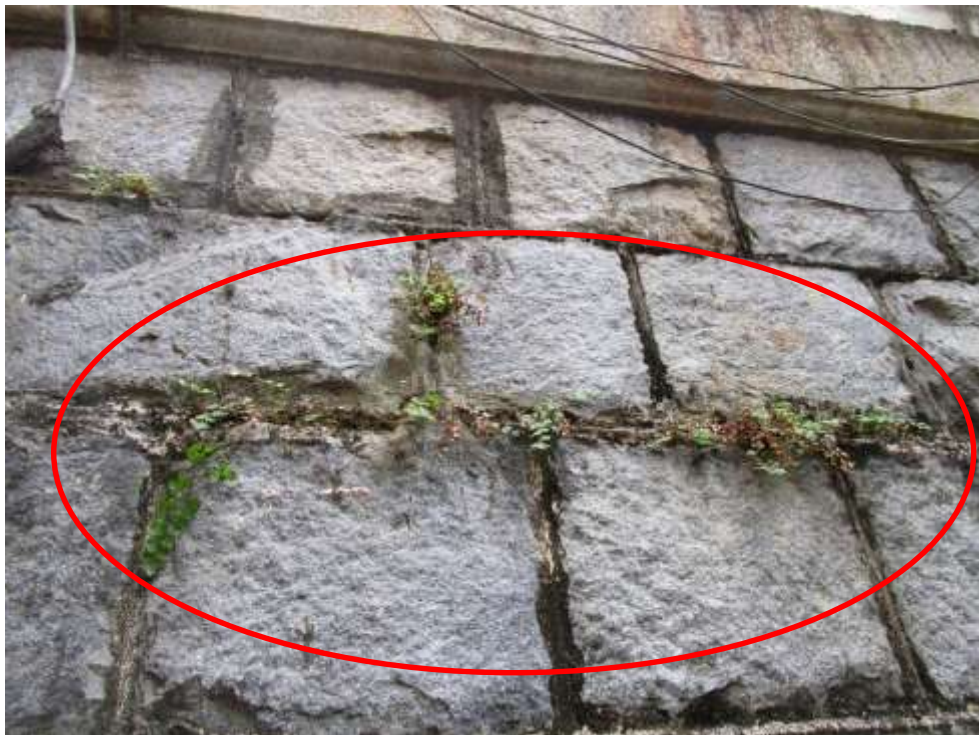
Defect No.	10	Location	North wing, North elevation exterior	Component	retaining wall
-------------------	----	-----------------	--------------------------------------	------------------	----------------

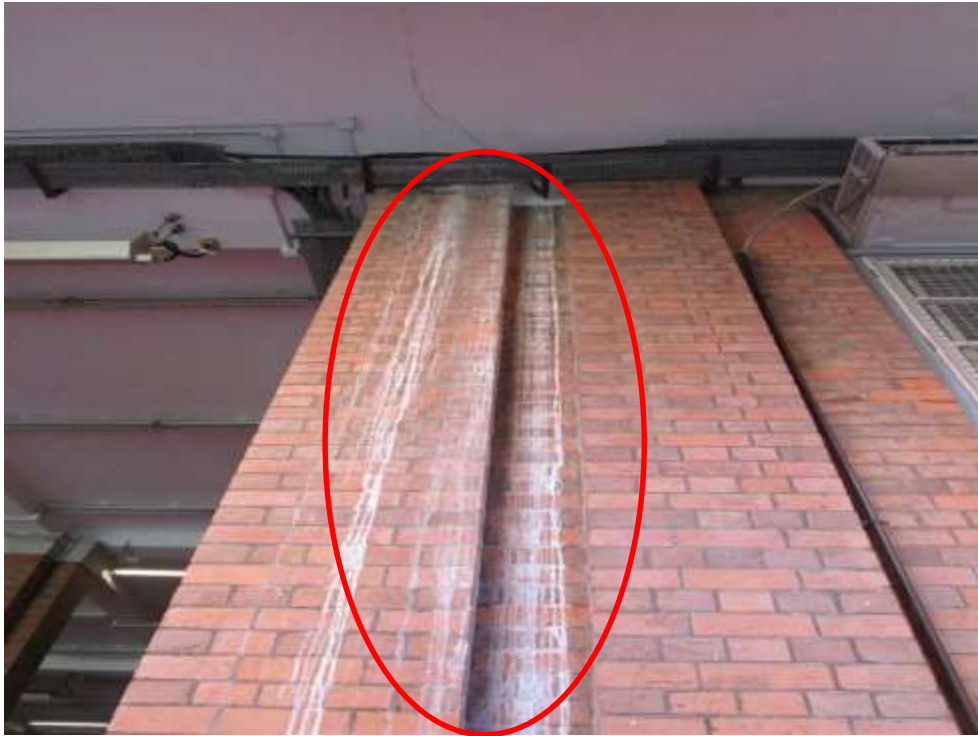
Defect No. 188	Location LG/F East wing, Corridor	Component brick column
Description Leaching stain was observed on brick column

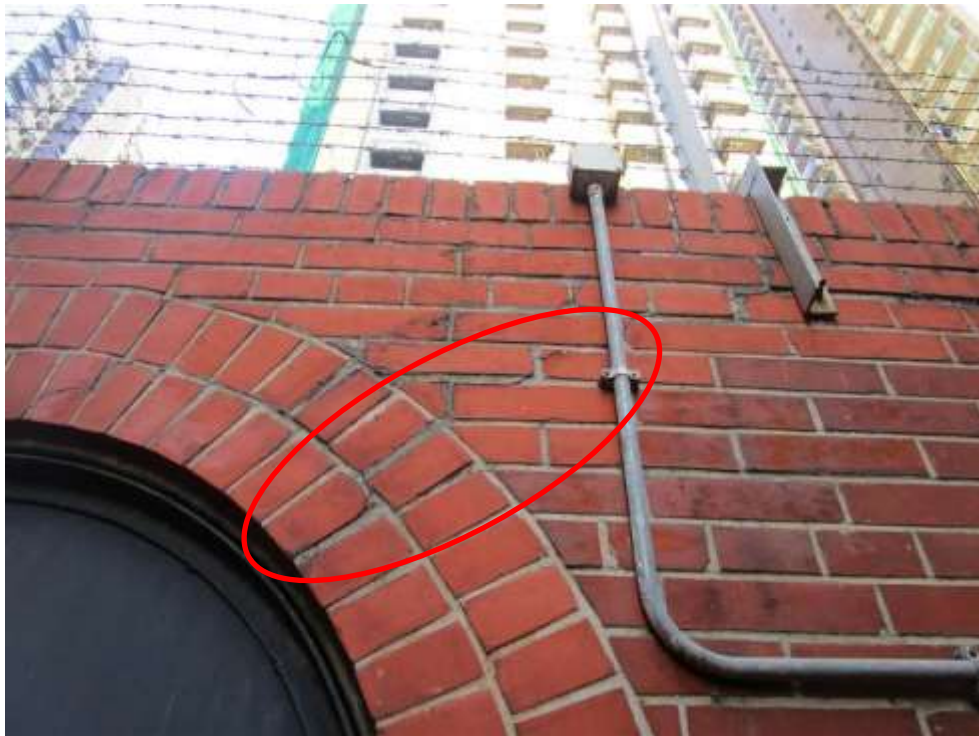
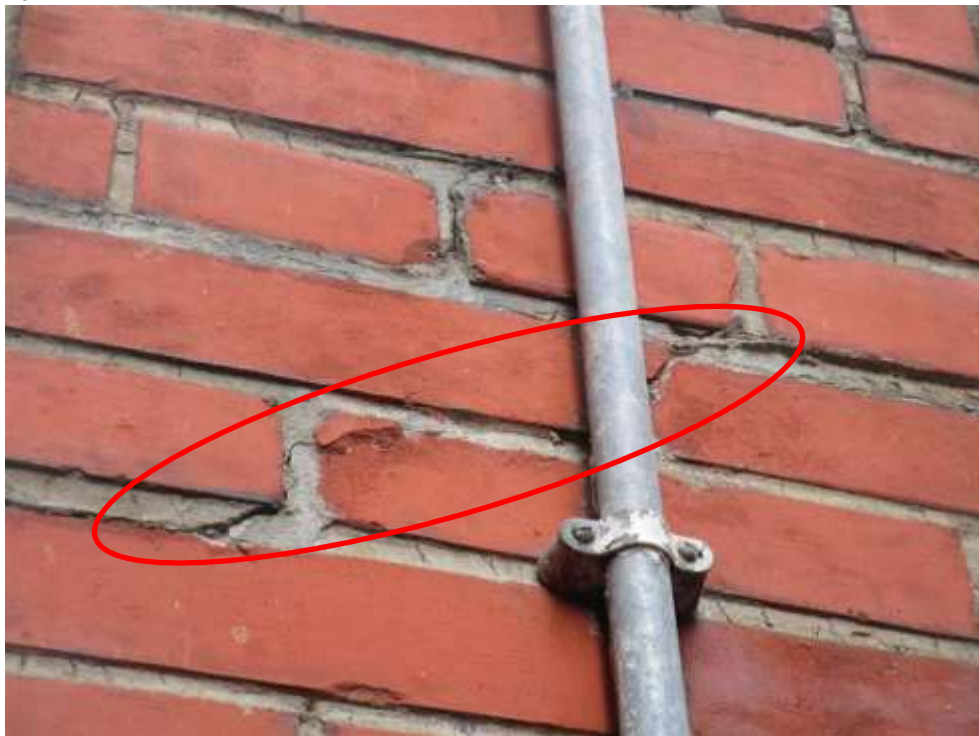
Defect No. 232 **Location** LG/F North wing, Staff quarter **Component** brick wall
