# The Hong Kong Golf Centre - Kau Sai Chau

Environmental Summary Report For  
 the Advisory Committee on the Environment (ACE)  
 March 1995

**THE HONG KONG GOLF CENTRE KAU SAI CHAU  
ENVIRONMENTAL SUMMARY REPORT  
FOR THE ADVISORY COMMITTEE ON THE ENVIRONMENT (ACE)**

**4 MARCH 1995**

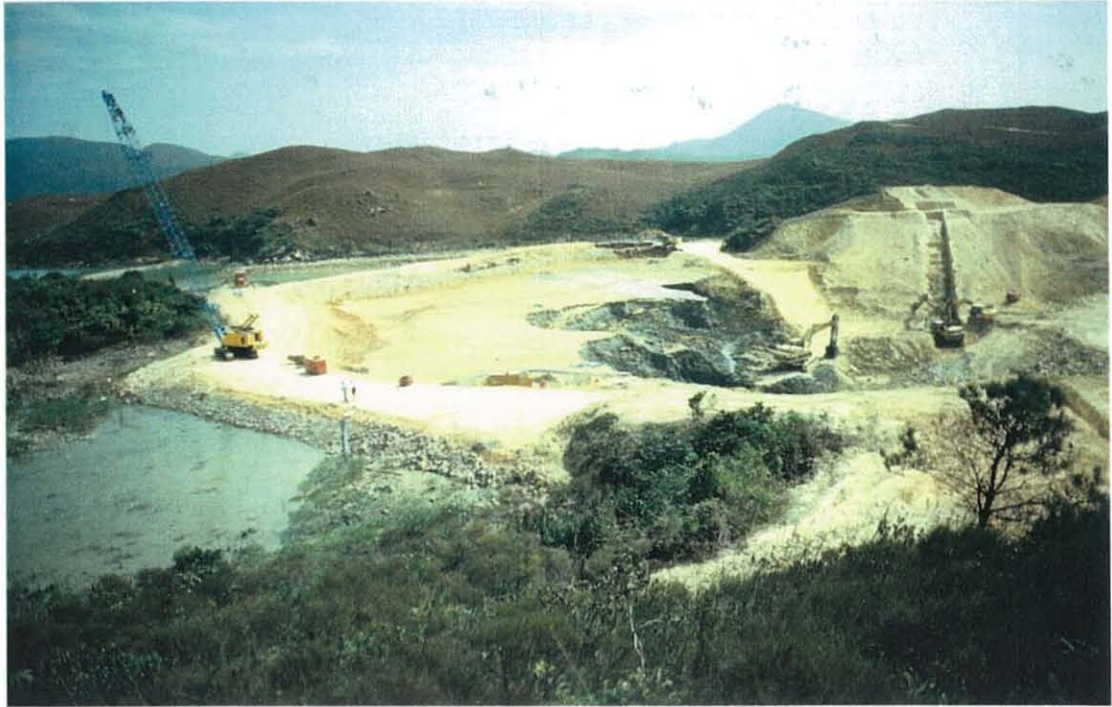
**Plate 1**

In December the main construction activities included excavation for the main dam foundations; earthworks, shaping and drainage installation for the golf courses; and the construction of drainage and foundation work for the clubhouse. Photographic Plate No.1 shows the main dam excavation work and the alignment of the downstream cofferdam.

**Shows the downstream cofferdam alignment and the excavation work for the main dam foundations**

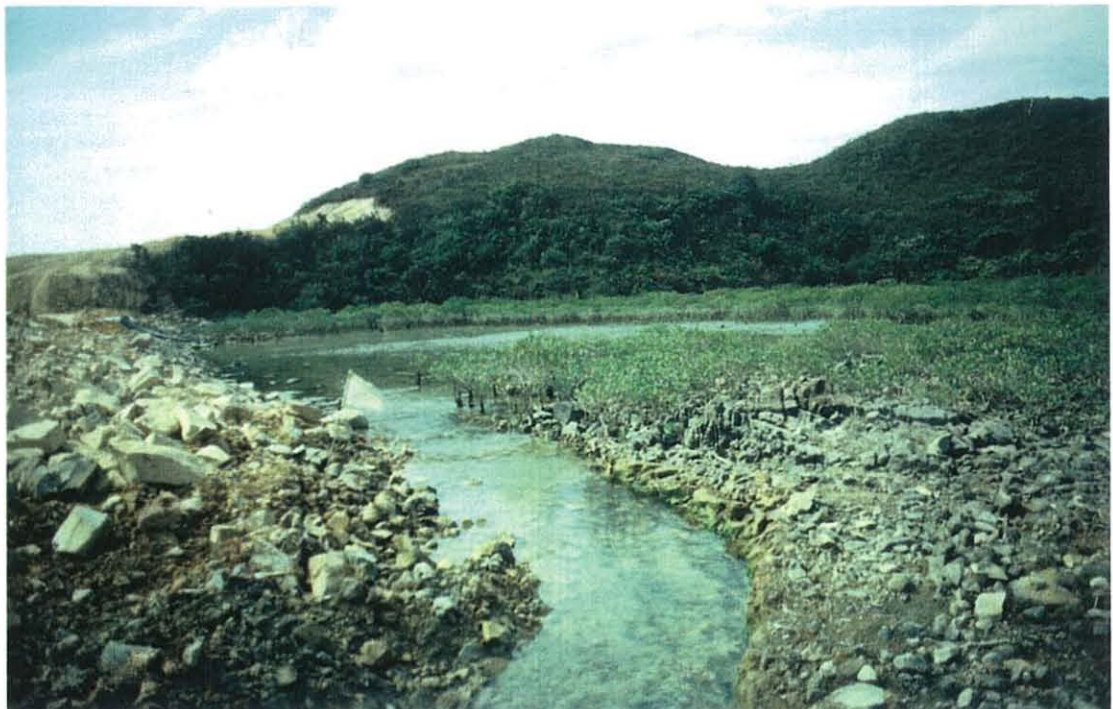
**Plate 2**

Construction of the extended portion of the downstream cofferdam commenced on the 9th November as required to protect the area of existing and planted mangroves downstream of the main dam. AXIS worked closely with the Contractor and the Dam Engineer to ensure a suitable marine water supply to the mangrove area. This is shown in Plate 2 (discussed below).

Protection of the mangroves in front of the main dam was proving very successful. The survival and growth of these plants was monitored on a regular basis, including inspection of the marine water supply. The mangrove conservation work represents a good example of positive environmental protection work in Hong Kong. Photographic Plate No.2 shows the mangrove area and the channel feeding in the salt water supply.

**The mangrove area immediately north of the main dam. Showing the input channel providing a tidal supply of salt water**

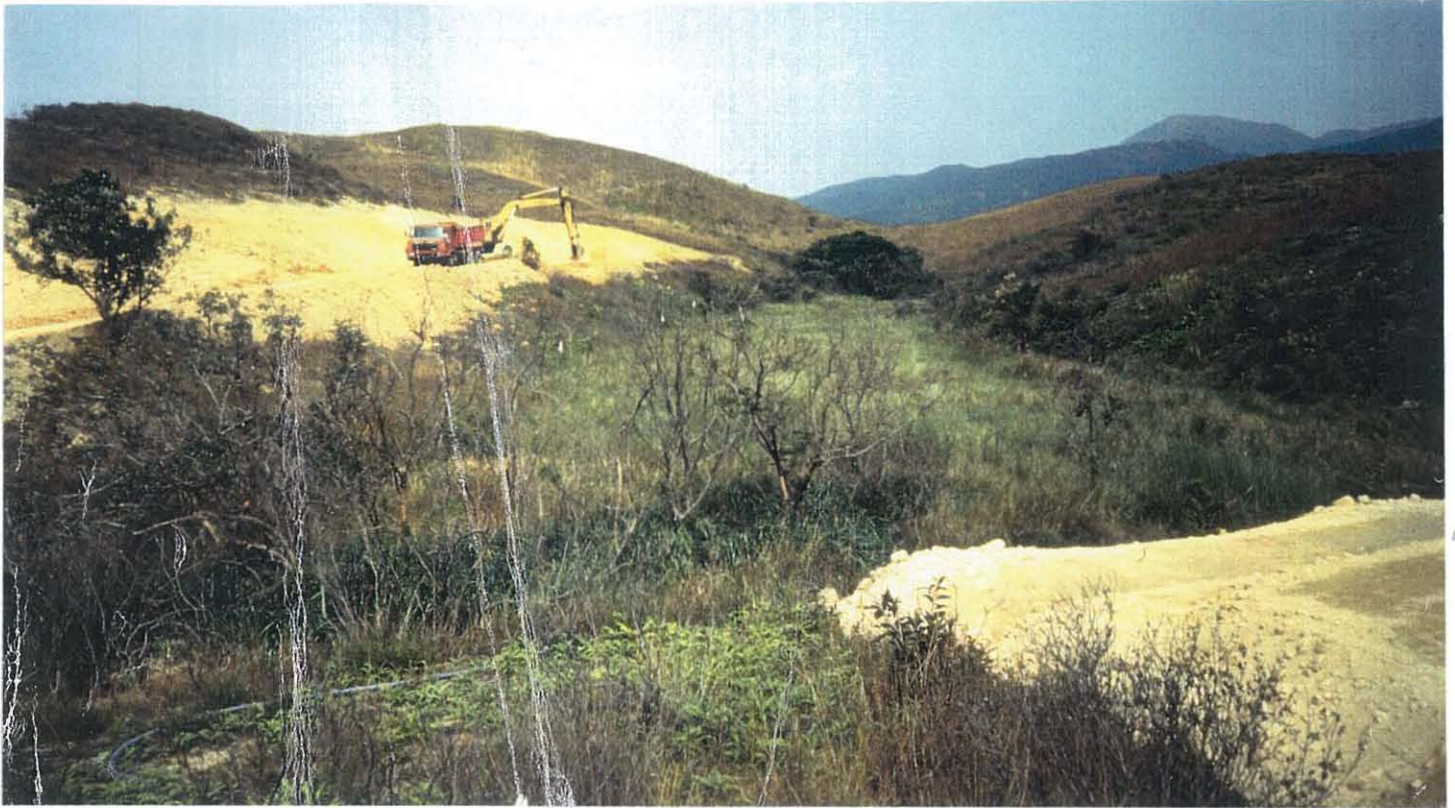
**Plate 3**

Construction commenced on the geotextile wall at hole 15, and this work is progressing well without any impact on the adjacent wetland. Photographic Plate No.3 shows the area in question and the construction in progress. This is a further example of significant environmental achievement for the project.

**Preliminary work on the construction of a supporting geotextile wall at hole 15. Showing the marsh/wetland area and associated shrubs which will remain undisturbed.**

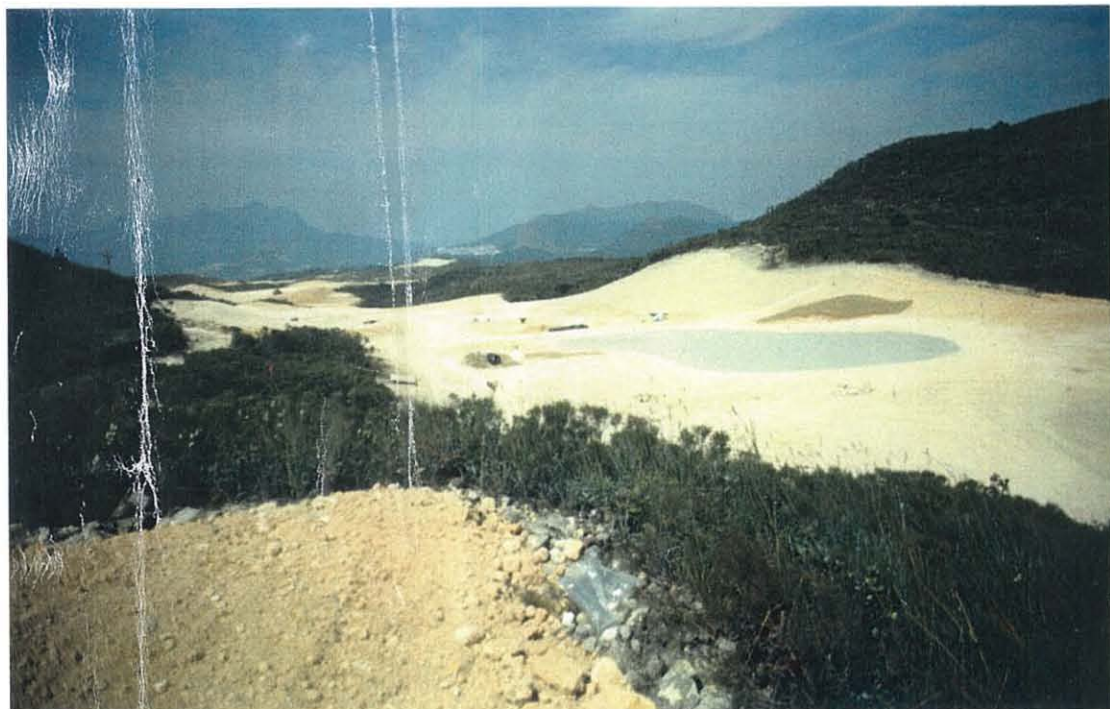
**Plate 4**

By January planting works were completed to holes 2,3 and 4. Irrigation and drainage works were completed for holes 5,6 and 7 and greens 5 and 6 were piped and tiled. Final shaping was underway on holes 24, 25, 31 and 32. Golf course work was continuing without impacting on those areas of natural vegetation outside the playing surface. These natural areas will be retained as a central part of the golf course landscape. Photographic Plate No.4 providing a view down hole 31, illustrates the success of the project in minimising disturbance to natural vegetation outside of the golf playing area.

**A view down hole 31 illustrating the success of the project objective to minimise disturbance to natural vegetation outside the golf playing area**
