Environmental
Permit No.:
EP-129/2002/B
環境許可證編號:
EP-129/2002/B

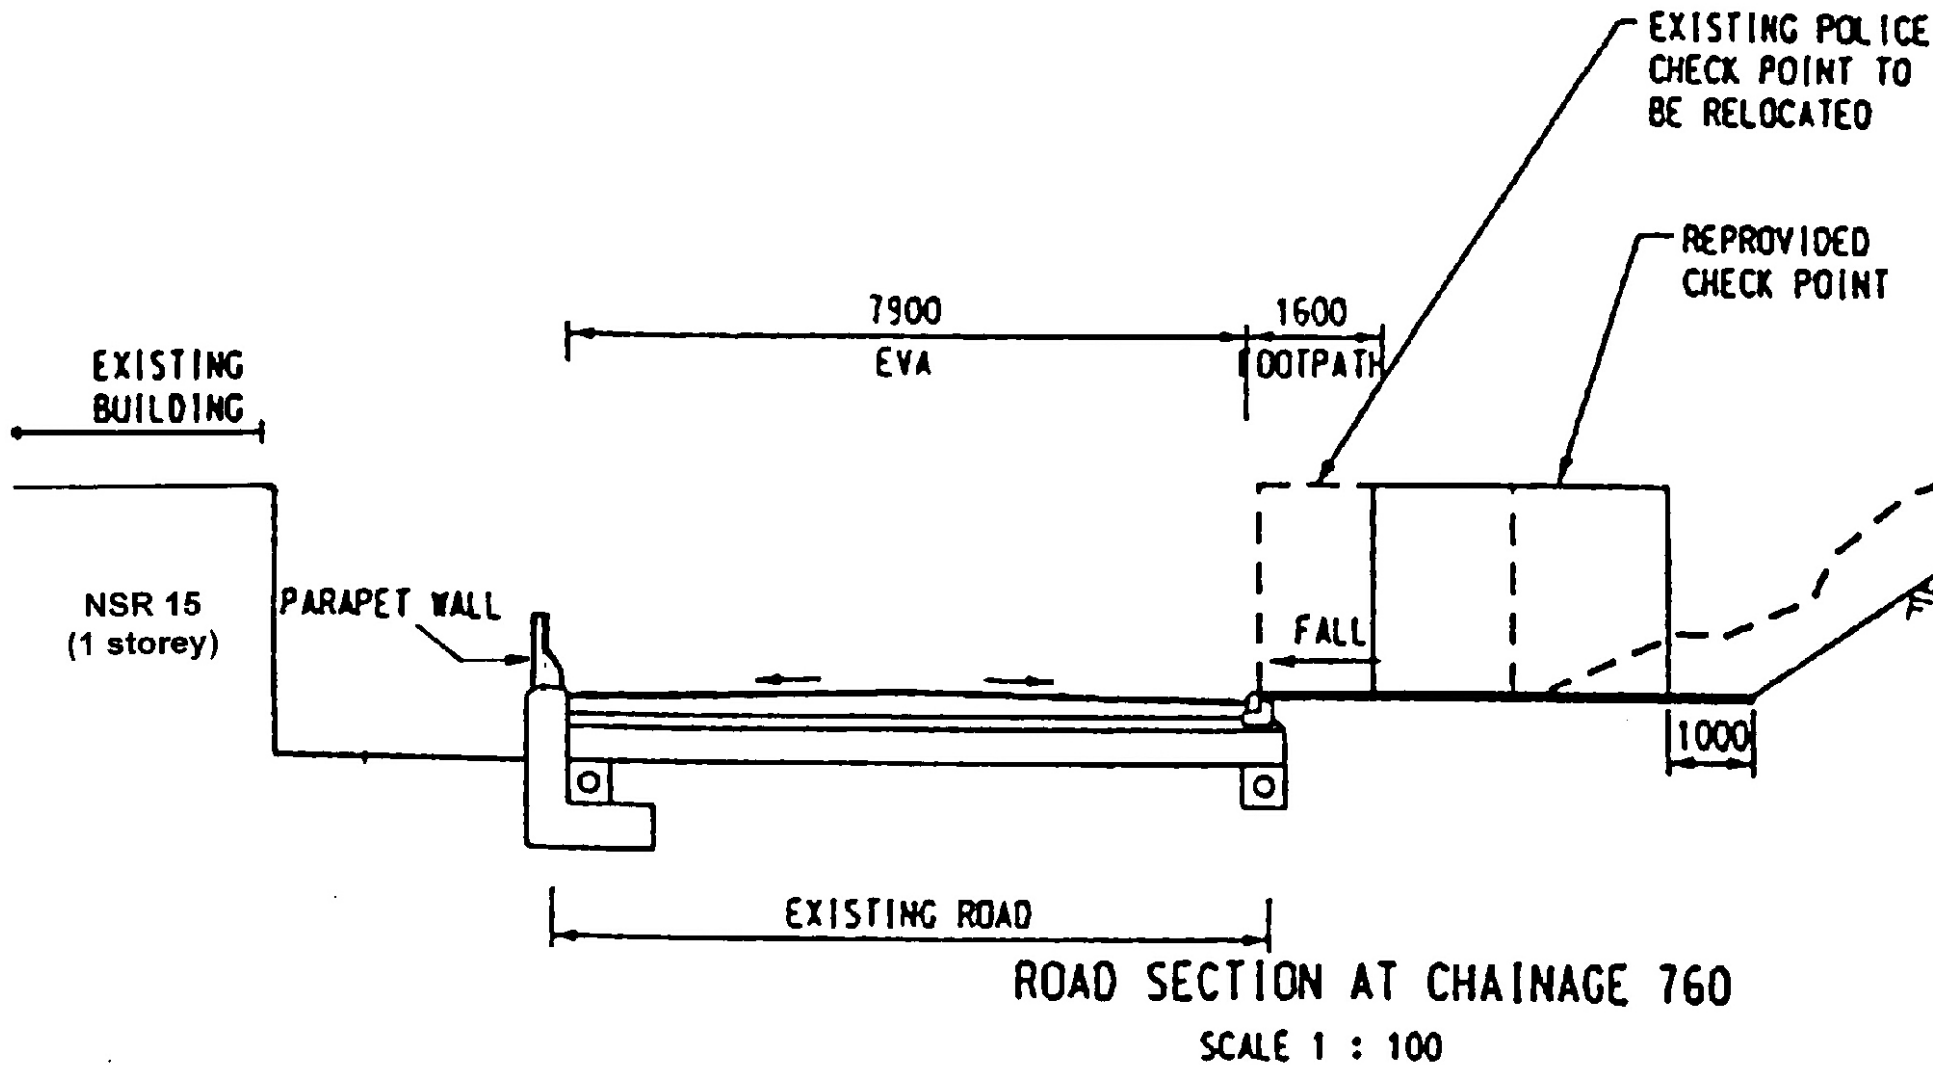
Figure 14 - Cross section of Lok Ma Chau Road with the 0.8m high parapet wall described in Condition 3.36 of the Permit

圖十四 - 兵T3.36 : 0.8m 高 毀 輔 牆 : 絹 右 瓜
