Agreement No. CE 31/2004 (GE) Natural Terrain Hazard Mitigation Works in Kwai Chung, Victoria Road and Luk Keng Village -Design and Construction

Natural Terrain Hazard Mitigation Works in Luk Keng Wong Uk (Project Profile)

June 2006

Ove Arup & Partners Hong Kong Ltd

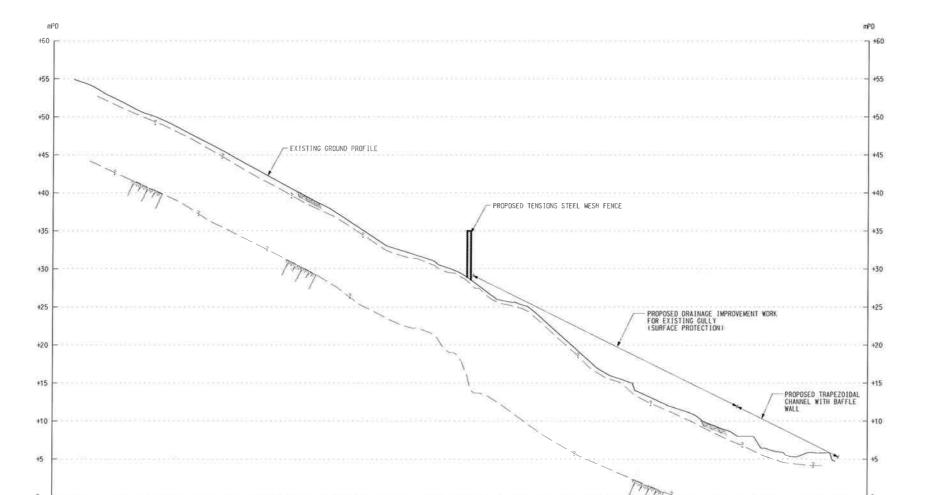
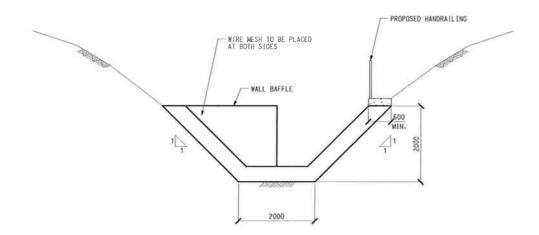
PROPOSED NATURAL TERRAIN HAZARD MITIGATION WORKS - SECTIONS & TRAPEZOIDAL

TYPICAL DETAILS OF TRAPEZOIDAL CHANNEL

- 4.1.13 Trapezoidal channel (drainage improvement) would be formed for an existing gully within the woodland, near FW 6 & FW 7. The gully will be partially re-shaped and engineered with reinforced concrete. The extent of improvements would be limited to the lowest 10m of the gully, which had already been concreted previously. This could prevent the disturbance or damage to the individuals of Cibotium barometz (the Lamb of Tartary) recorded near the banks of the upper section of the gully. There should also be flexibility on the alignment of the re-shaped gully. Although the boundary of the trapezoidal channel would be close to the location of one Incense Tree as shown in Figure 4-1b,, it should be feasible to avoid this Incense Tree. The engineer for the Project had confirmed that no Incense Tree would be felled or damaged in the Project.

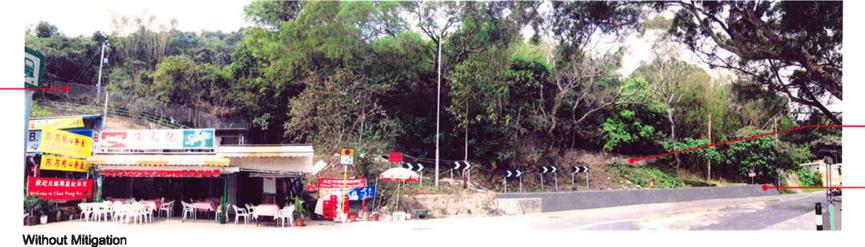
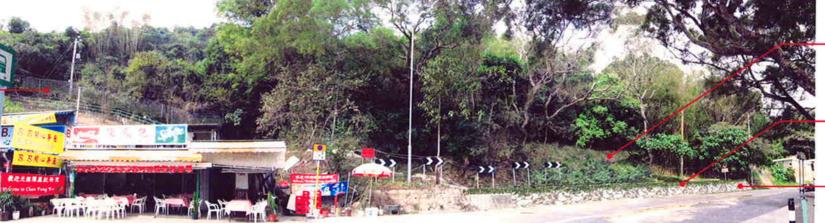
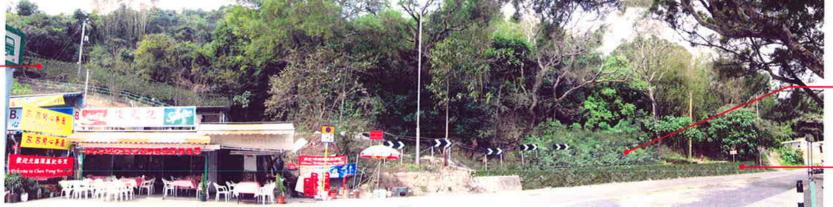
FLEXIBLE BARRIERS

BASE SOIL AFTER CONSTRUCTION OF SOIL NAILS

CONCRETE WALL

CLIMBERS Uvaria macrophylla LA PLANTED AT THE BASE OF FLEXIBLE BARRIER

HYDROSEEDING AND NATIVE SHRUB PLANTING TO COVER BASE SOIL

CREEPING PLANT Ficus pumila PLANTED AT THE TOP OF THE WALL

CLIMBERS AFTER 10 YEARS
