**Agreement No. CE 26/2011(GE)  
Landslip Prevention and Mitigation Programme, 2011, Package H  
Natural Terrain Hazard Mitigation Works  
Investigation, Design and Construction**

Natural Terrain Hazard Mitigation Works at  
Study Area 11NE-B/SA3, Razor Hill, Clear Water Bay Road  
Project Profile

**Fugro (Hong Kong) Limited  
for  
Civil Engineering and Development Department**

**February 2018**

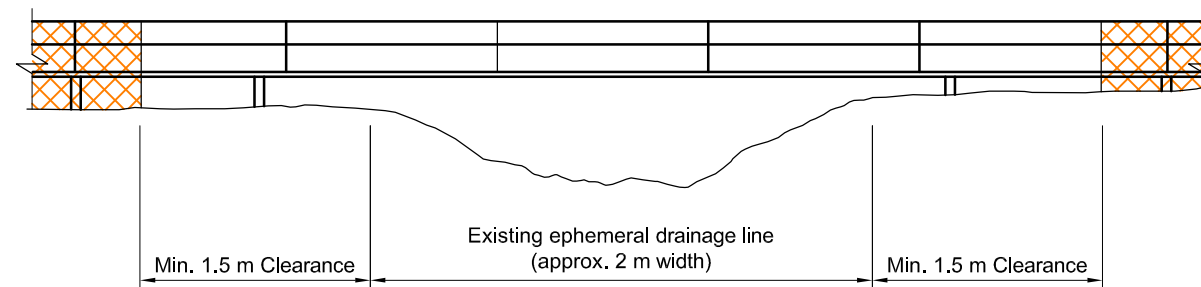
Scale :	N.T.S.		
Drawn by :	Date :	Checked :	Approved :
HON	FEB-2016		
Job No. :	120141	Figure No :	9

**PLAN VIEW**

**ELEVATION OF TEMPORARY ACCESS BRIDGE OVER PORTION**

1. **Site preparation:** involves general site clearance and erection of hoarding/ chain link fence.
2. **Installation of soil nails:** involves drilling into soil/rock, followed by installation of steel bar and grouting at required locations. The methodology for installation of soil nails is given in **Appendix H**.
3. **Construction of flexible barriers and provision of maintenance access/ staircases:** involves the erection of tensioned wire mesh fences across posts supported on anchor foundation. The anchor foundation will be formed by drilling into soil/rock, followed by installation of steel bar and grouting. Steel maintenance access / staircases with subdued colour paint are preferably be adopted. The steel access / staircases are very flexible method which can be constructed to “bridge over” the area where extensive tree roots are identified on site.

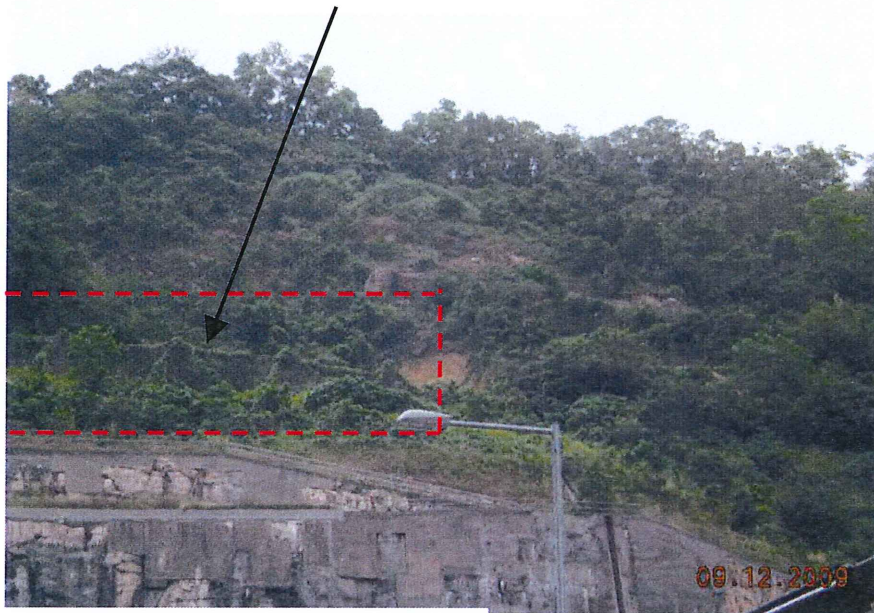
General View of the Flexible Barrier

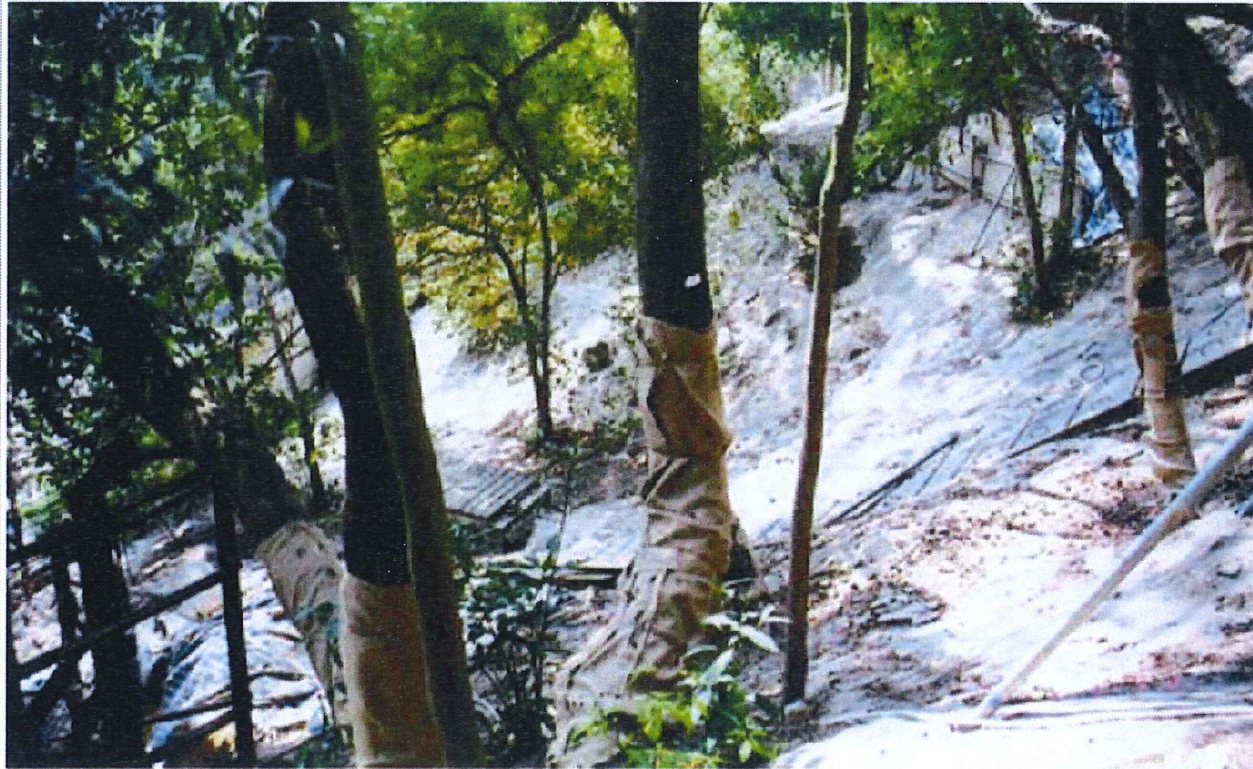
Protective wrapping around tree trunks  
 (Source: GEO Publication No. 1/2011)

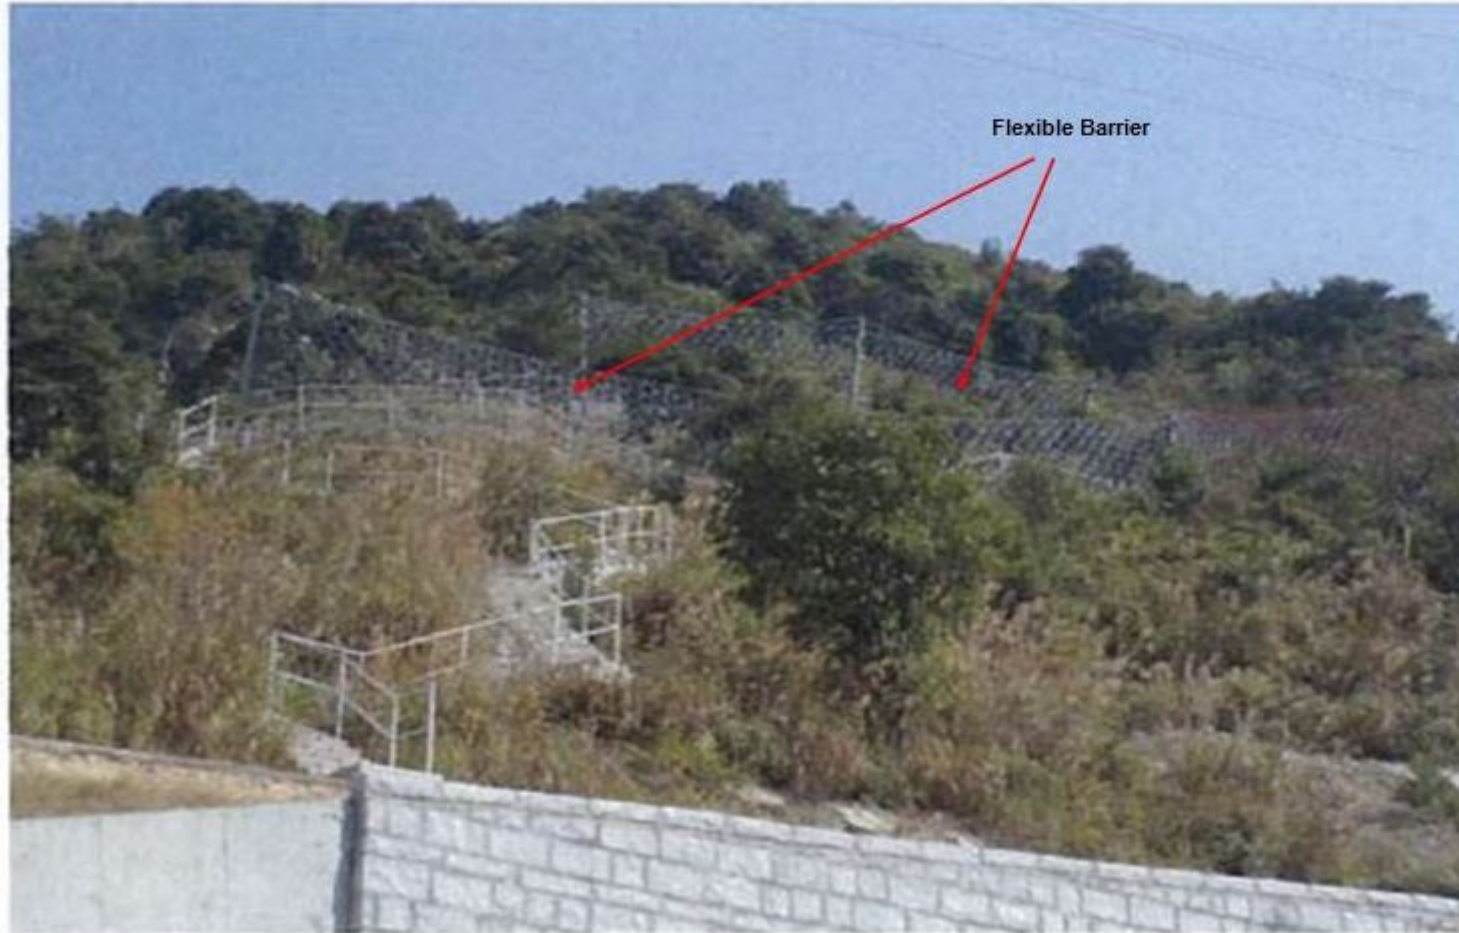
Job No. 120141      Figure No. : A1

Flexible Barrier

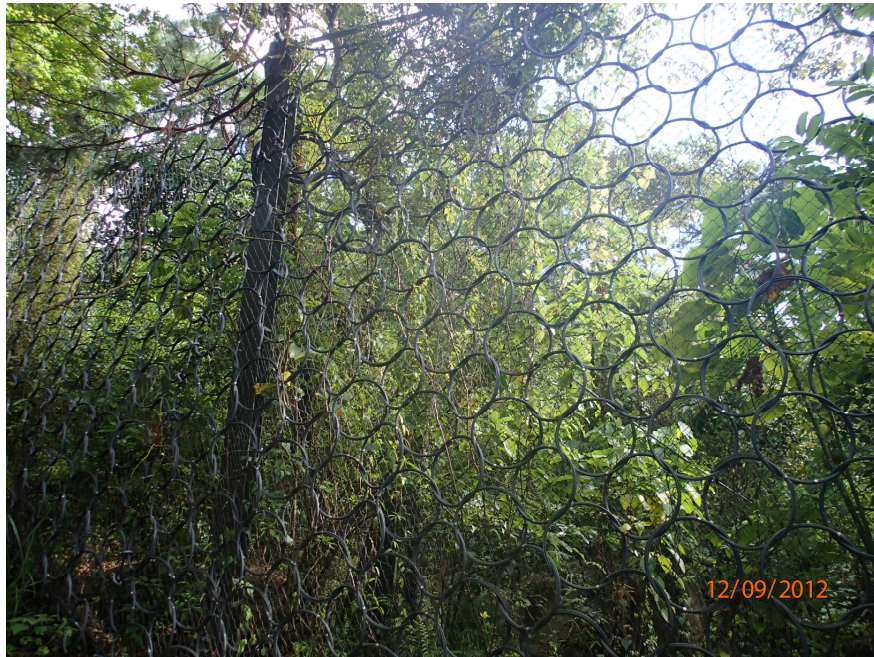
Close-up View of Flexible Barrier and Supporting Post

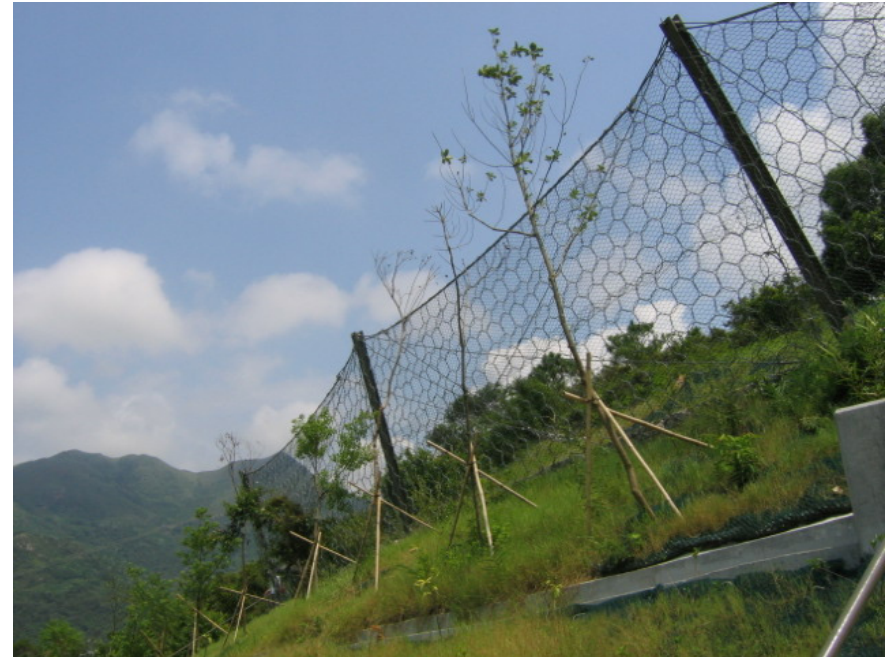
Details of Flexible Barrier

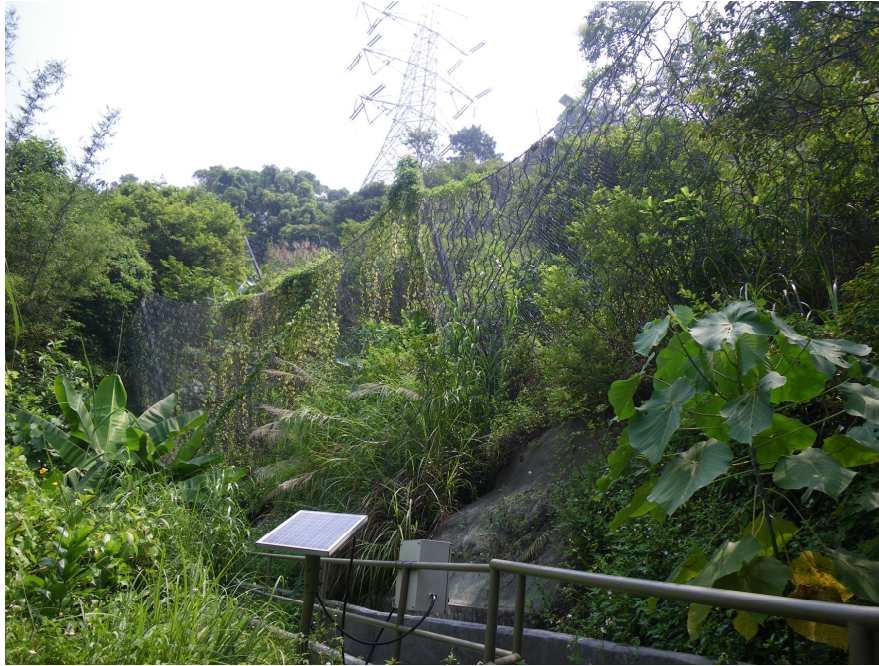
View of Flexible Barriers and access with painted handrails

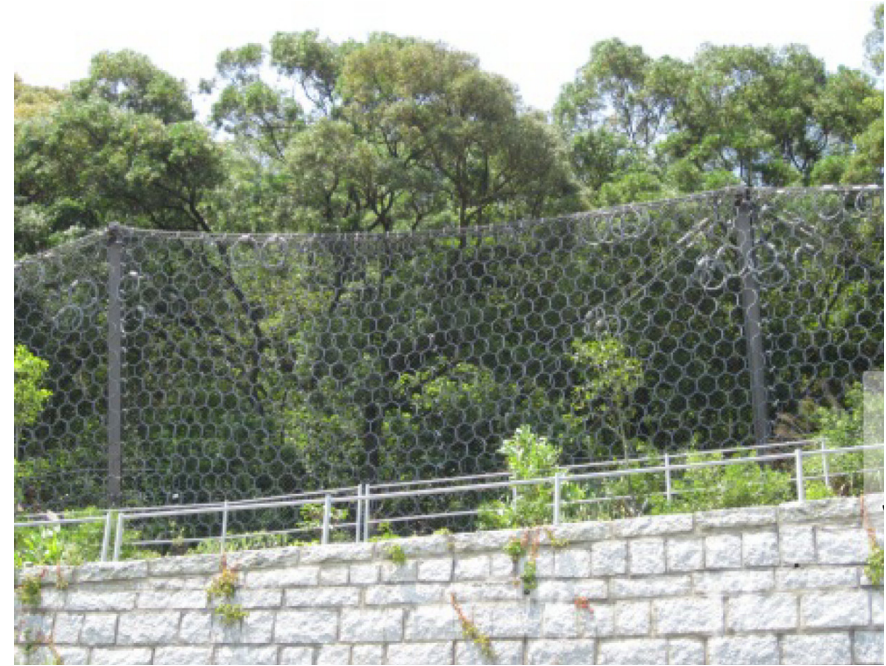
View of Flexible Barriers above Tung Chung Road

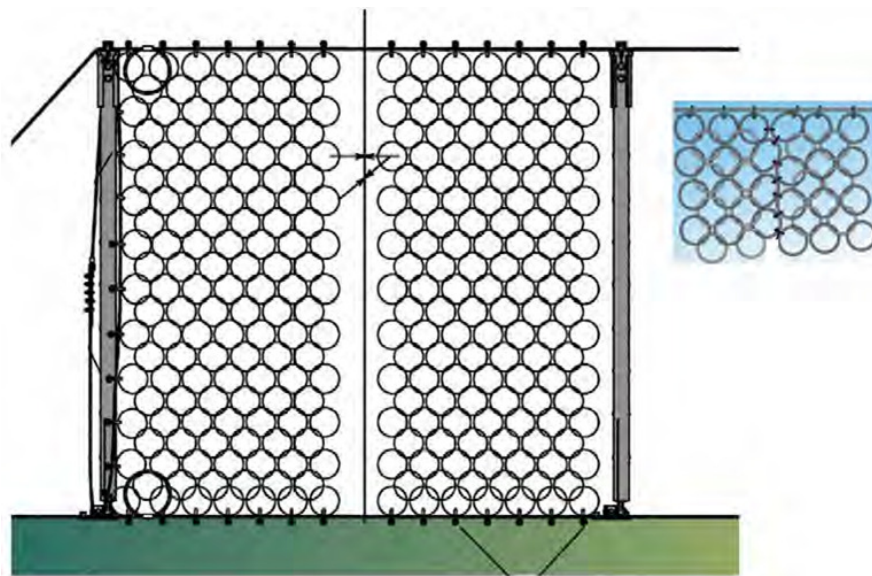
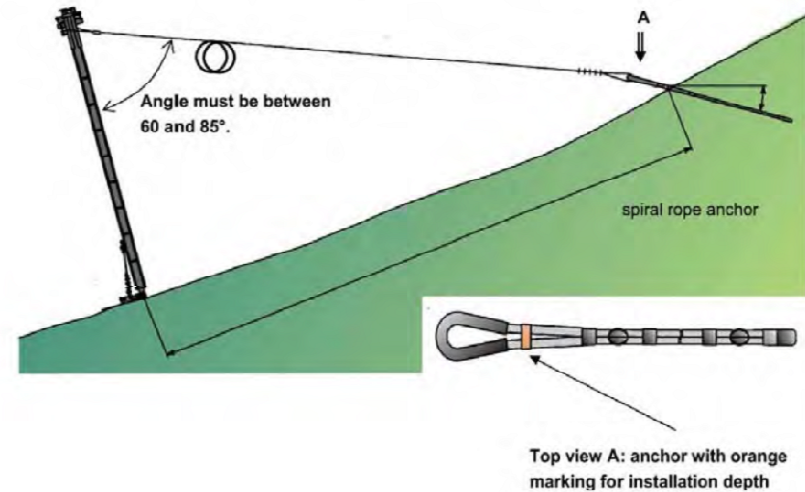
Installation of Flexible Barrier

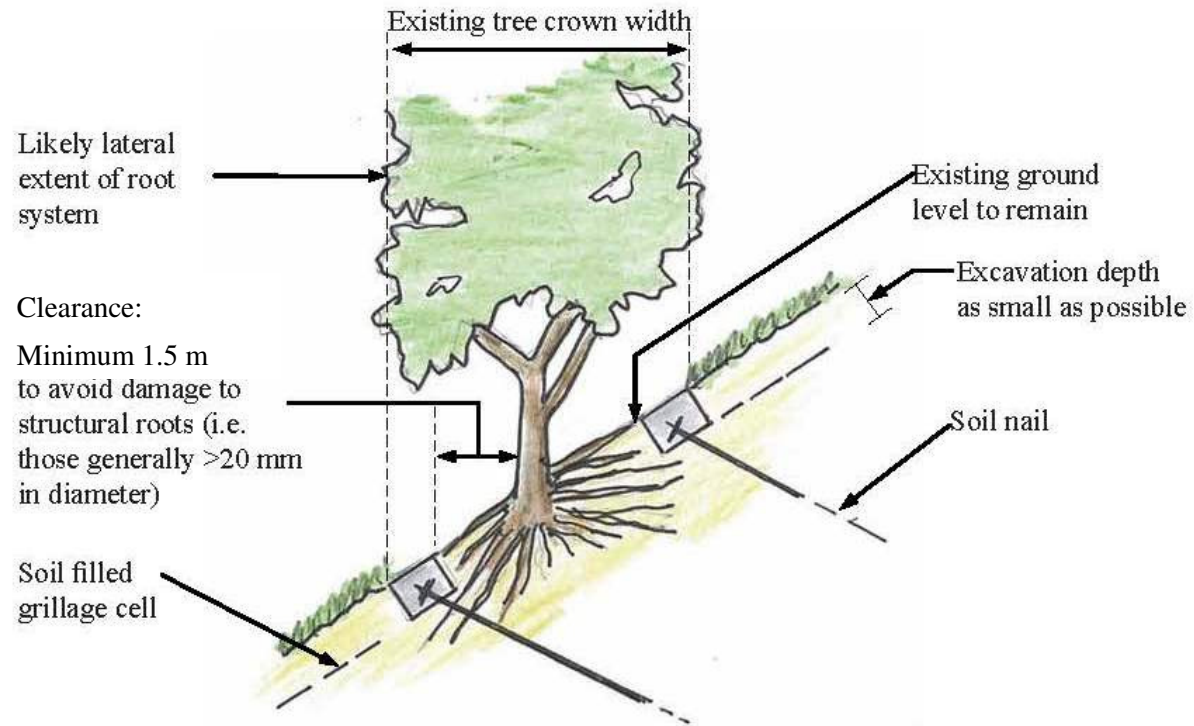
Installation of Soil Nail in Vicinity of Existing Tree Roots

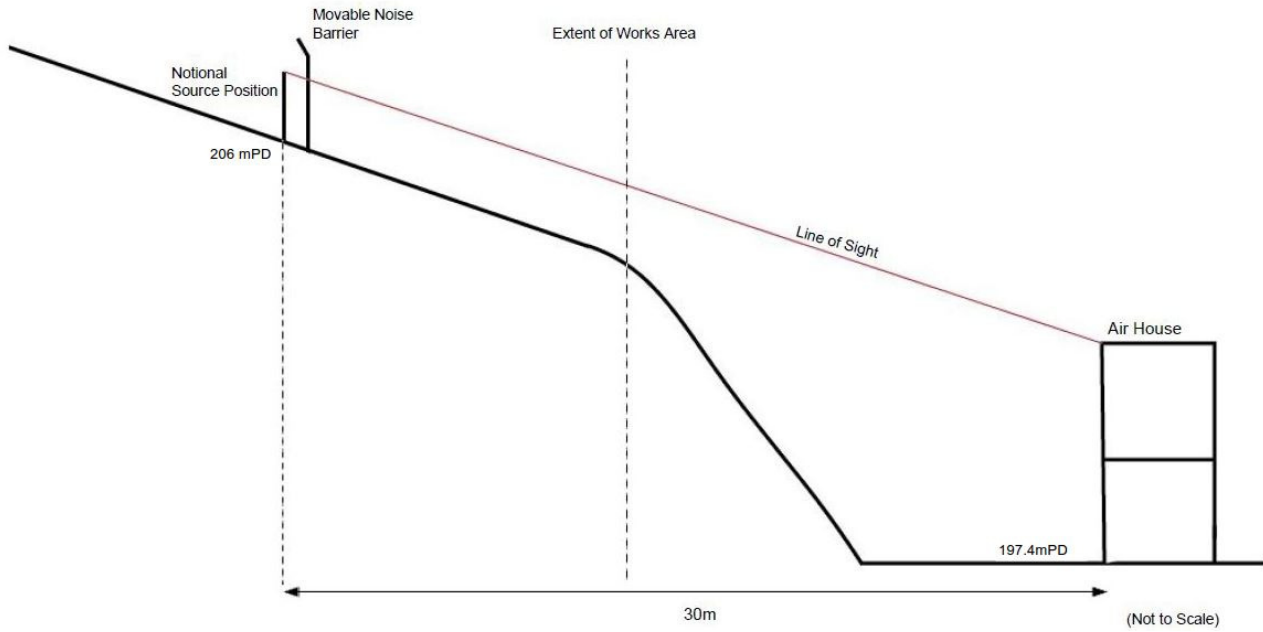
### Proposed Movable Noise Barrier for PME
