9.0 HERITAGE IMPACT ASSESSMENT

9.1 Objectives of the Heritage Impact Assessment

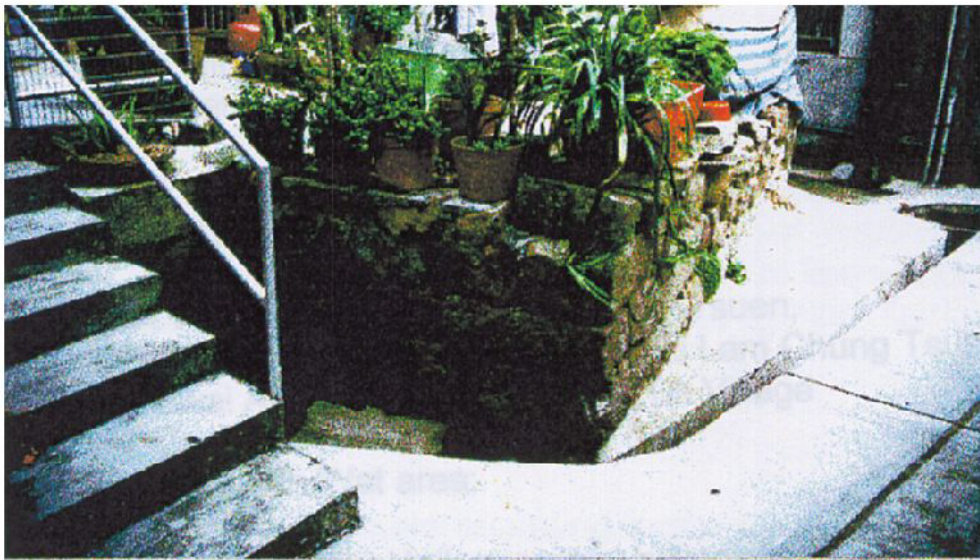
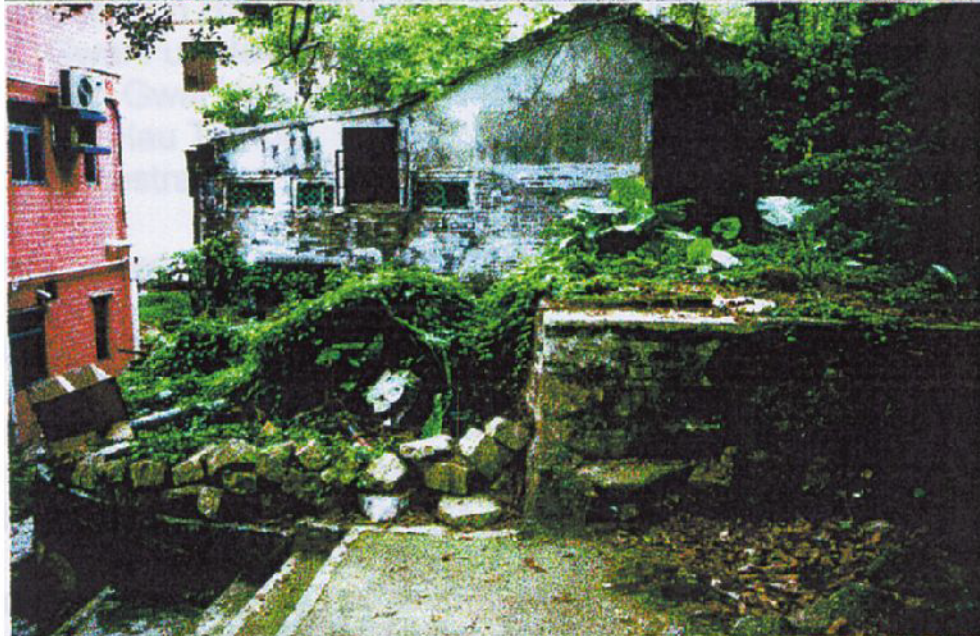
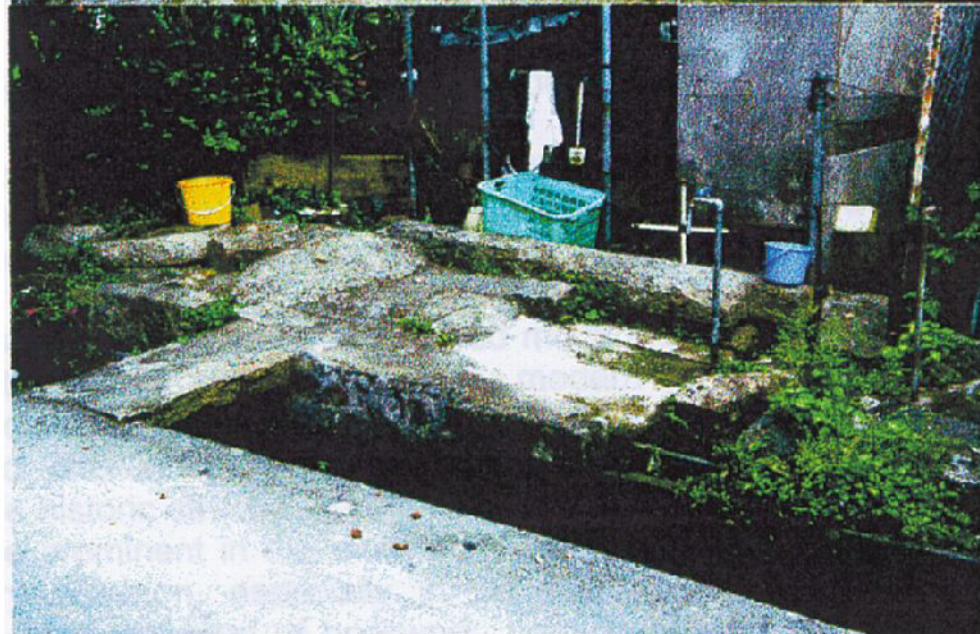
Examples of re-used stone blocks at So Kwun Wat

- 9.4.1 At the end of the 17th Century under the Manchu regime, people were encouraged to settle in the coastal regions of southern China. The village of So Kwun Wat, located in the western New Territories was originally founded, under light of this proposal, by members of two Hakka families, the Chan's from Tai Woo, Kiang Si and the Lee's from Tam Shui, Kwantung. At a later date, two more Hakka families, the Ching's and the Deng's, both from Fujian province, also founded villages in the immediate vicinity of So Kwun Wat, under the name of So Kwun Wat San Tseun and Ching Ka Tsuen. The Ching family village is currently located to the rear of modern So Kwun Wat, whilst the Deng village was abandoned at some point in the past, with only heavily overgrown ruins being visible today. Throughout the inhabited village areas, secondary usage of cut stones, sometimes substantial in size, can be seen, incorporated into buildings and other pieces of village architecture, such as, benches and walls and even scattered around the village in loose piles, awaiting reuse, as shown in Drawing 9.1. It is quite possible that this pattern of reuse was the result of the close proximity of the abandoned village as an easy source of building materials.

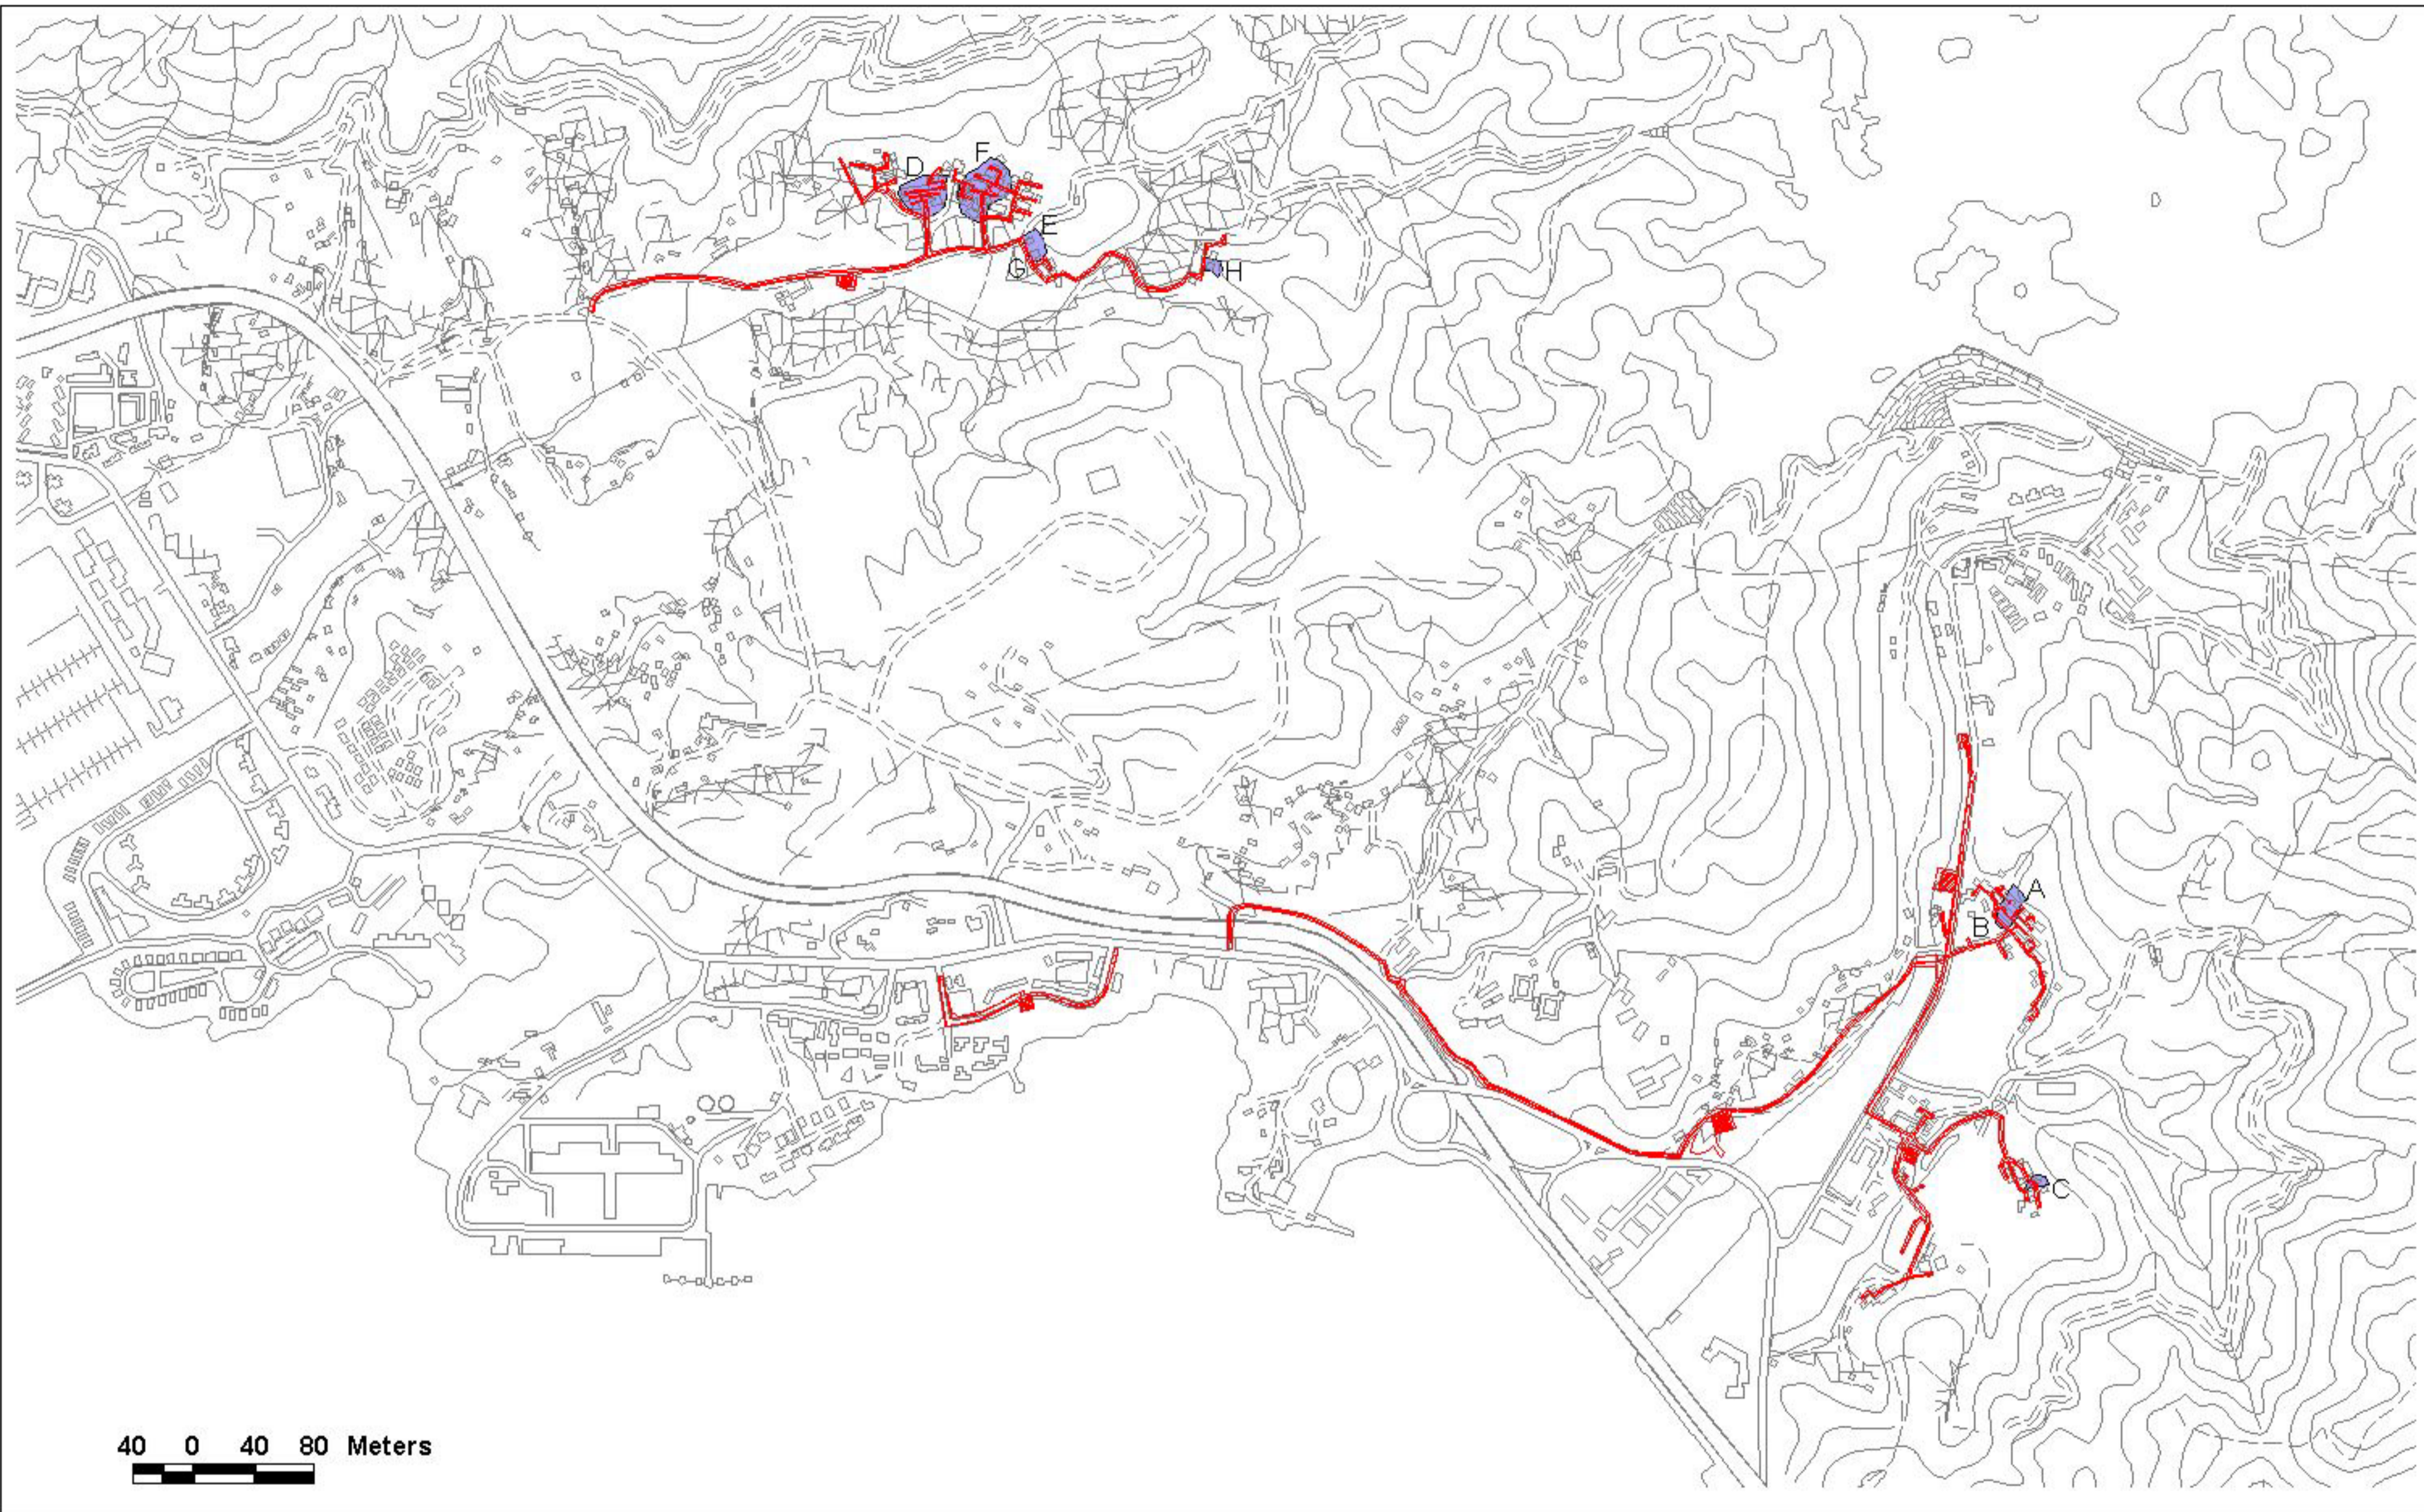
Drawing 9.2

Historic Buildings

- 9.4.3 The recent Historic Buildings Survey of the areas noted four buildings in the Tai Lam Chung area, three of which fall within the study area, as shown in Drawing 9.2. These are as follows:

- A. Wu Fat Wong Temple, Tai Lam Chung Tsuen;
 - B. An Ding Ga Suk (Place of worship), Tai Lam Chung Tsuen; and
 - C. Wong Gwai An Tang Temple, Wong Uk Village.

- 9.4.4 Five buildings, which all fall within the study area, were also noted in the So Kwun Wat area, as follows:
- D. Dun Bun Hall-An Bu Hall, ancestral hall to the Li Family;

- E. Gwai Fuk Hall, ancestral hall to the Chan Family;
 - F. Him Gwai Hall, ancestral hall to the Chan Family;
 - G. Tin Hau Temple; and
 - H. Ancestral Home to the Tsin Family.

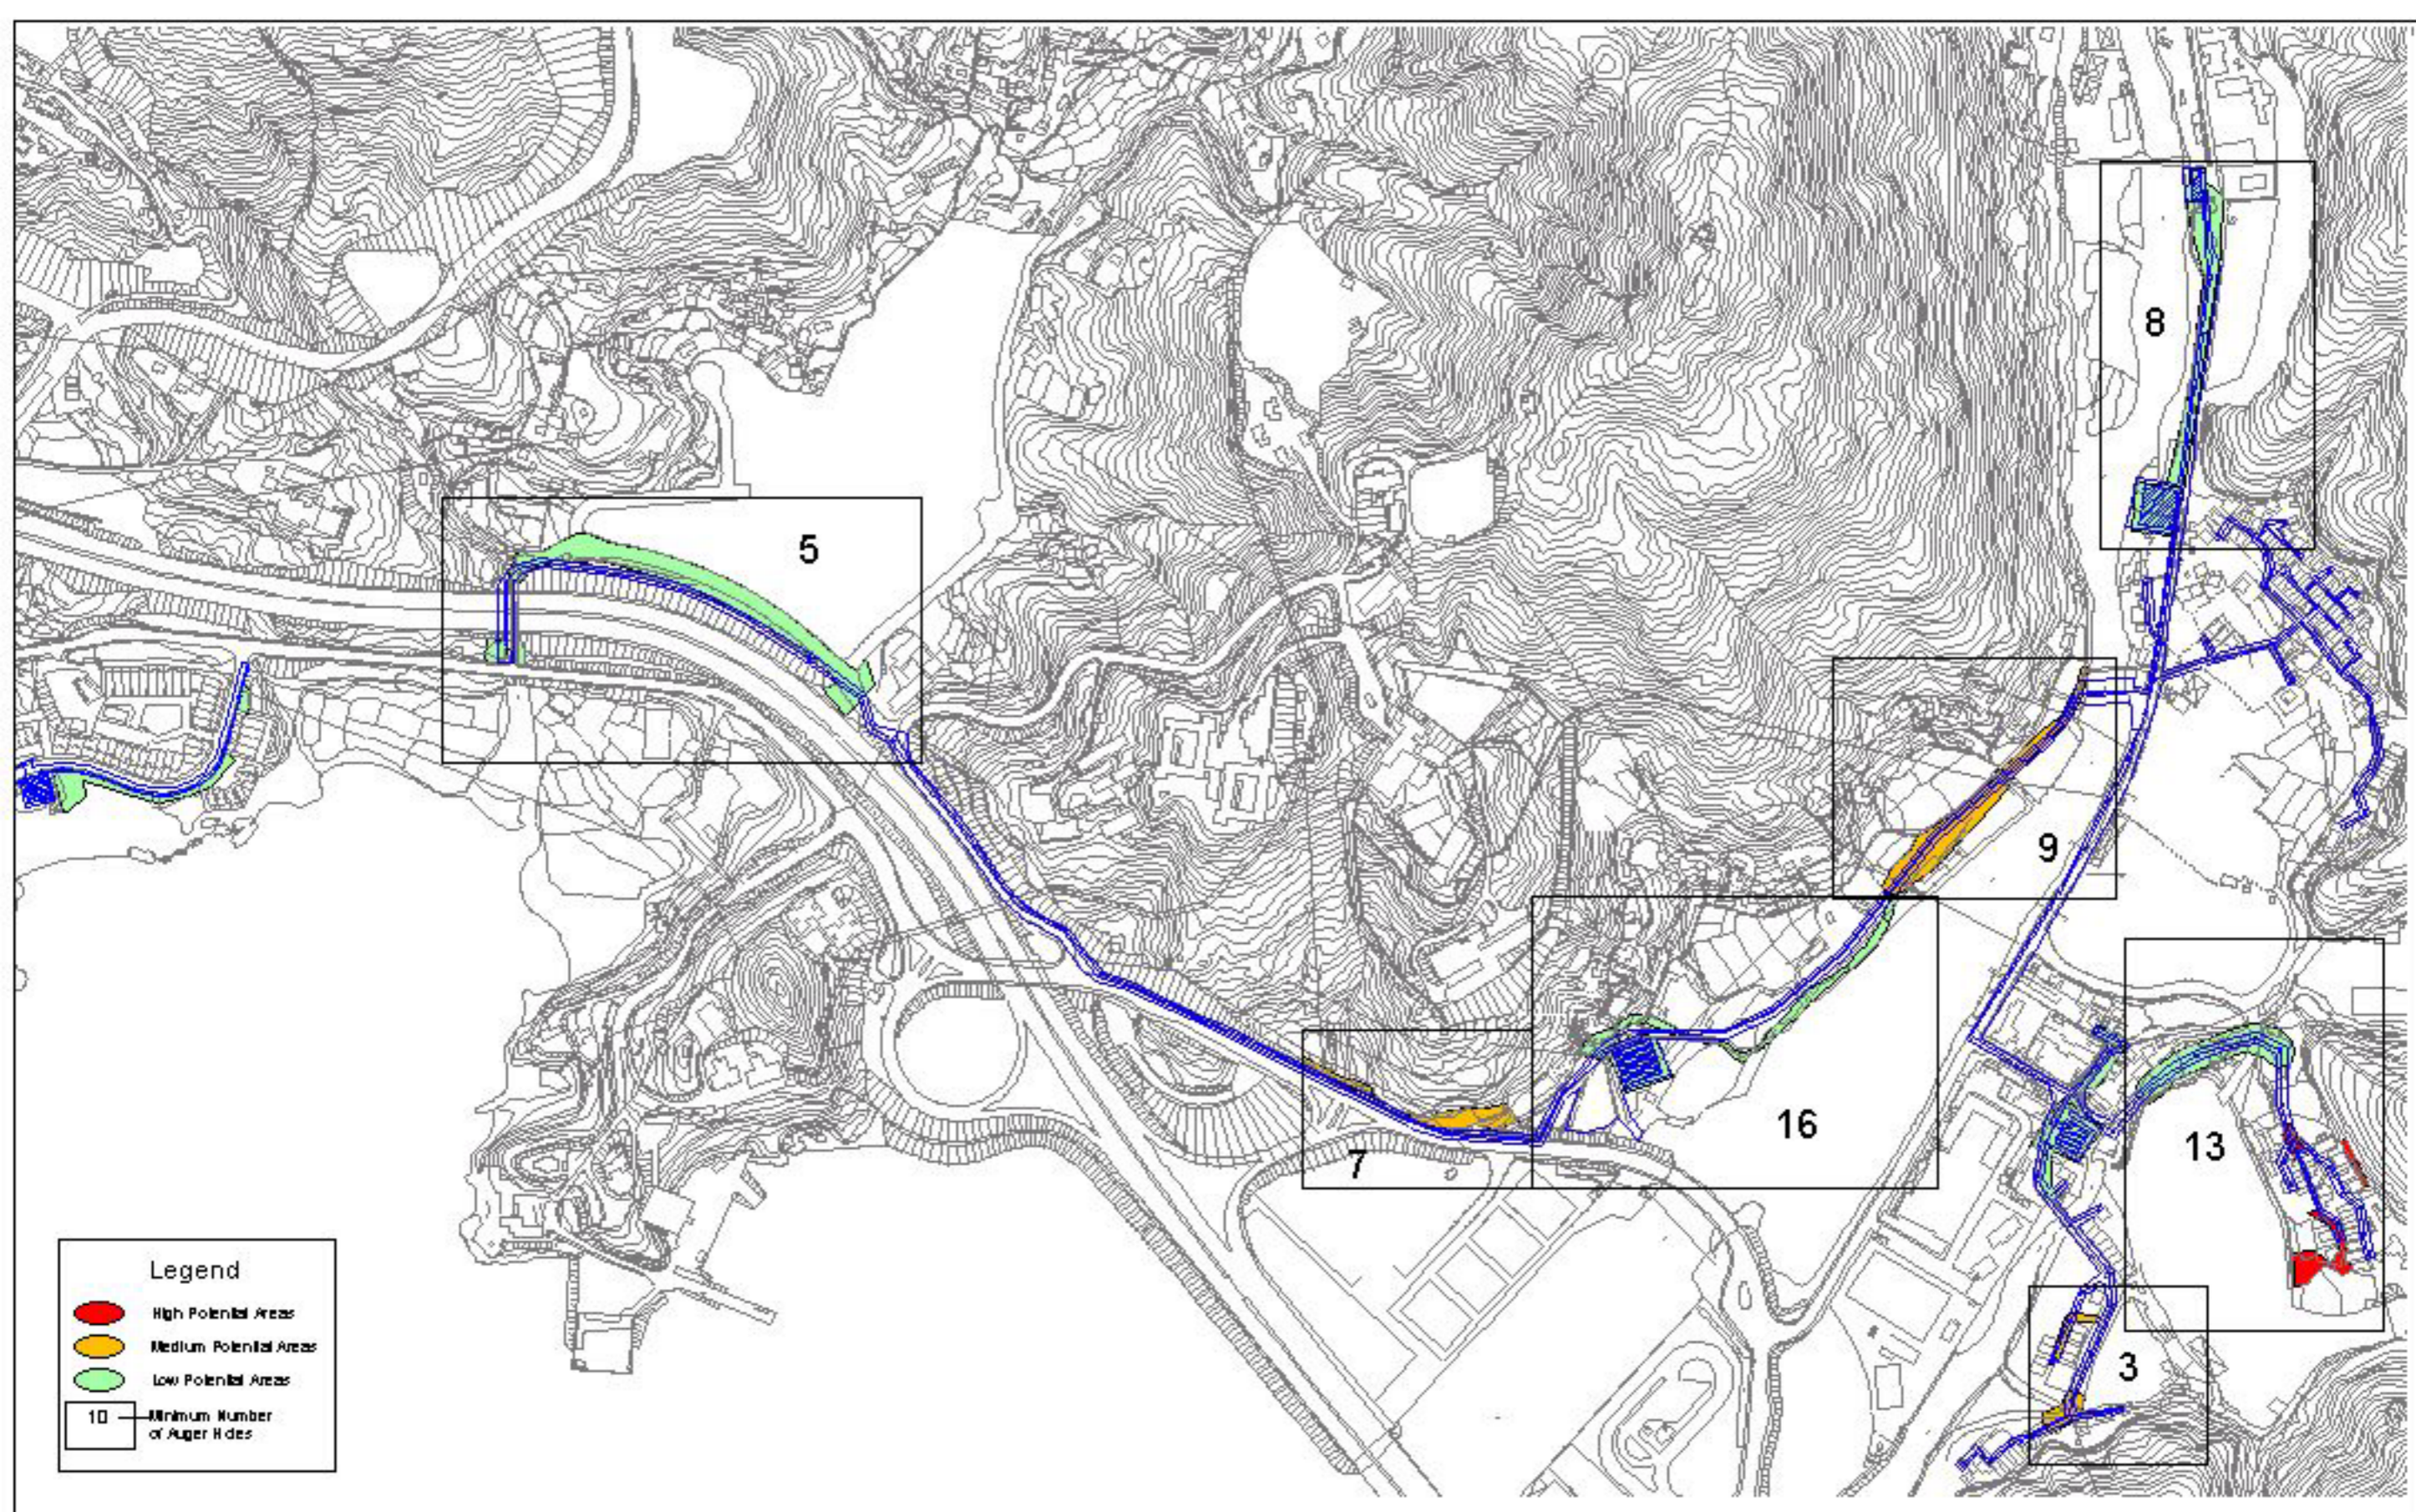
Location of High, Medium and Low Potential Areas of Archaeological Interest

9.5.6 The study area has been divided into a number of linear land parcels as shown in Drawings 9.3a and 9.3b. The identified parcels of land have been ranked as High, Medium and Low Potential Areas for the purposes of the sewer alignment investigation. Guidelines used for ranking criteria and requirement for each test are presented below:

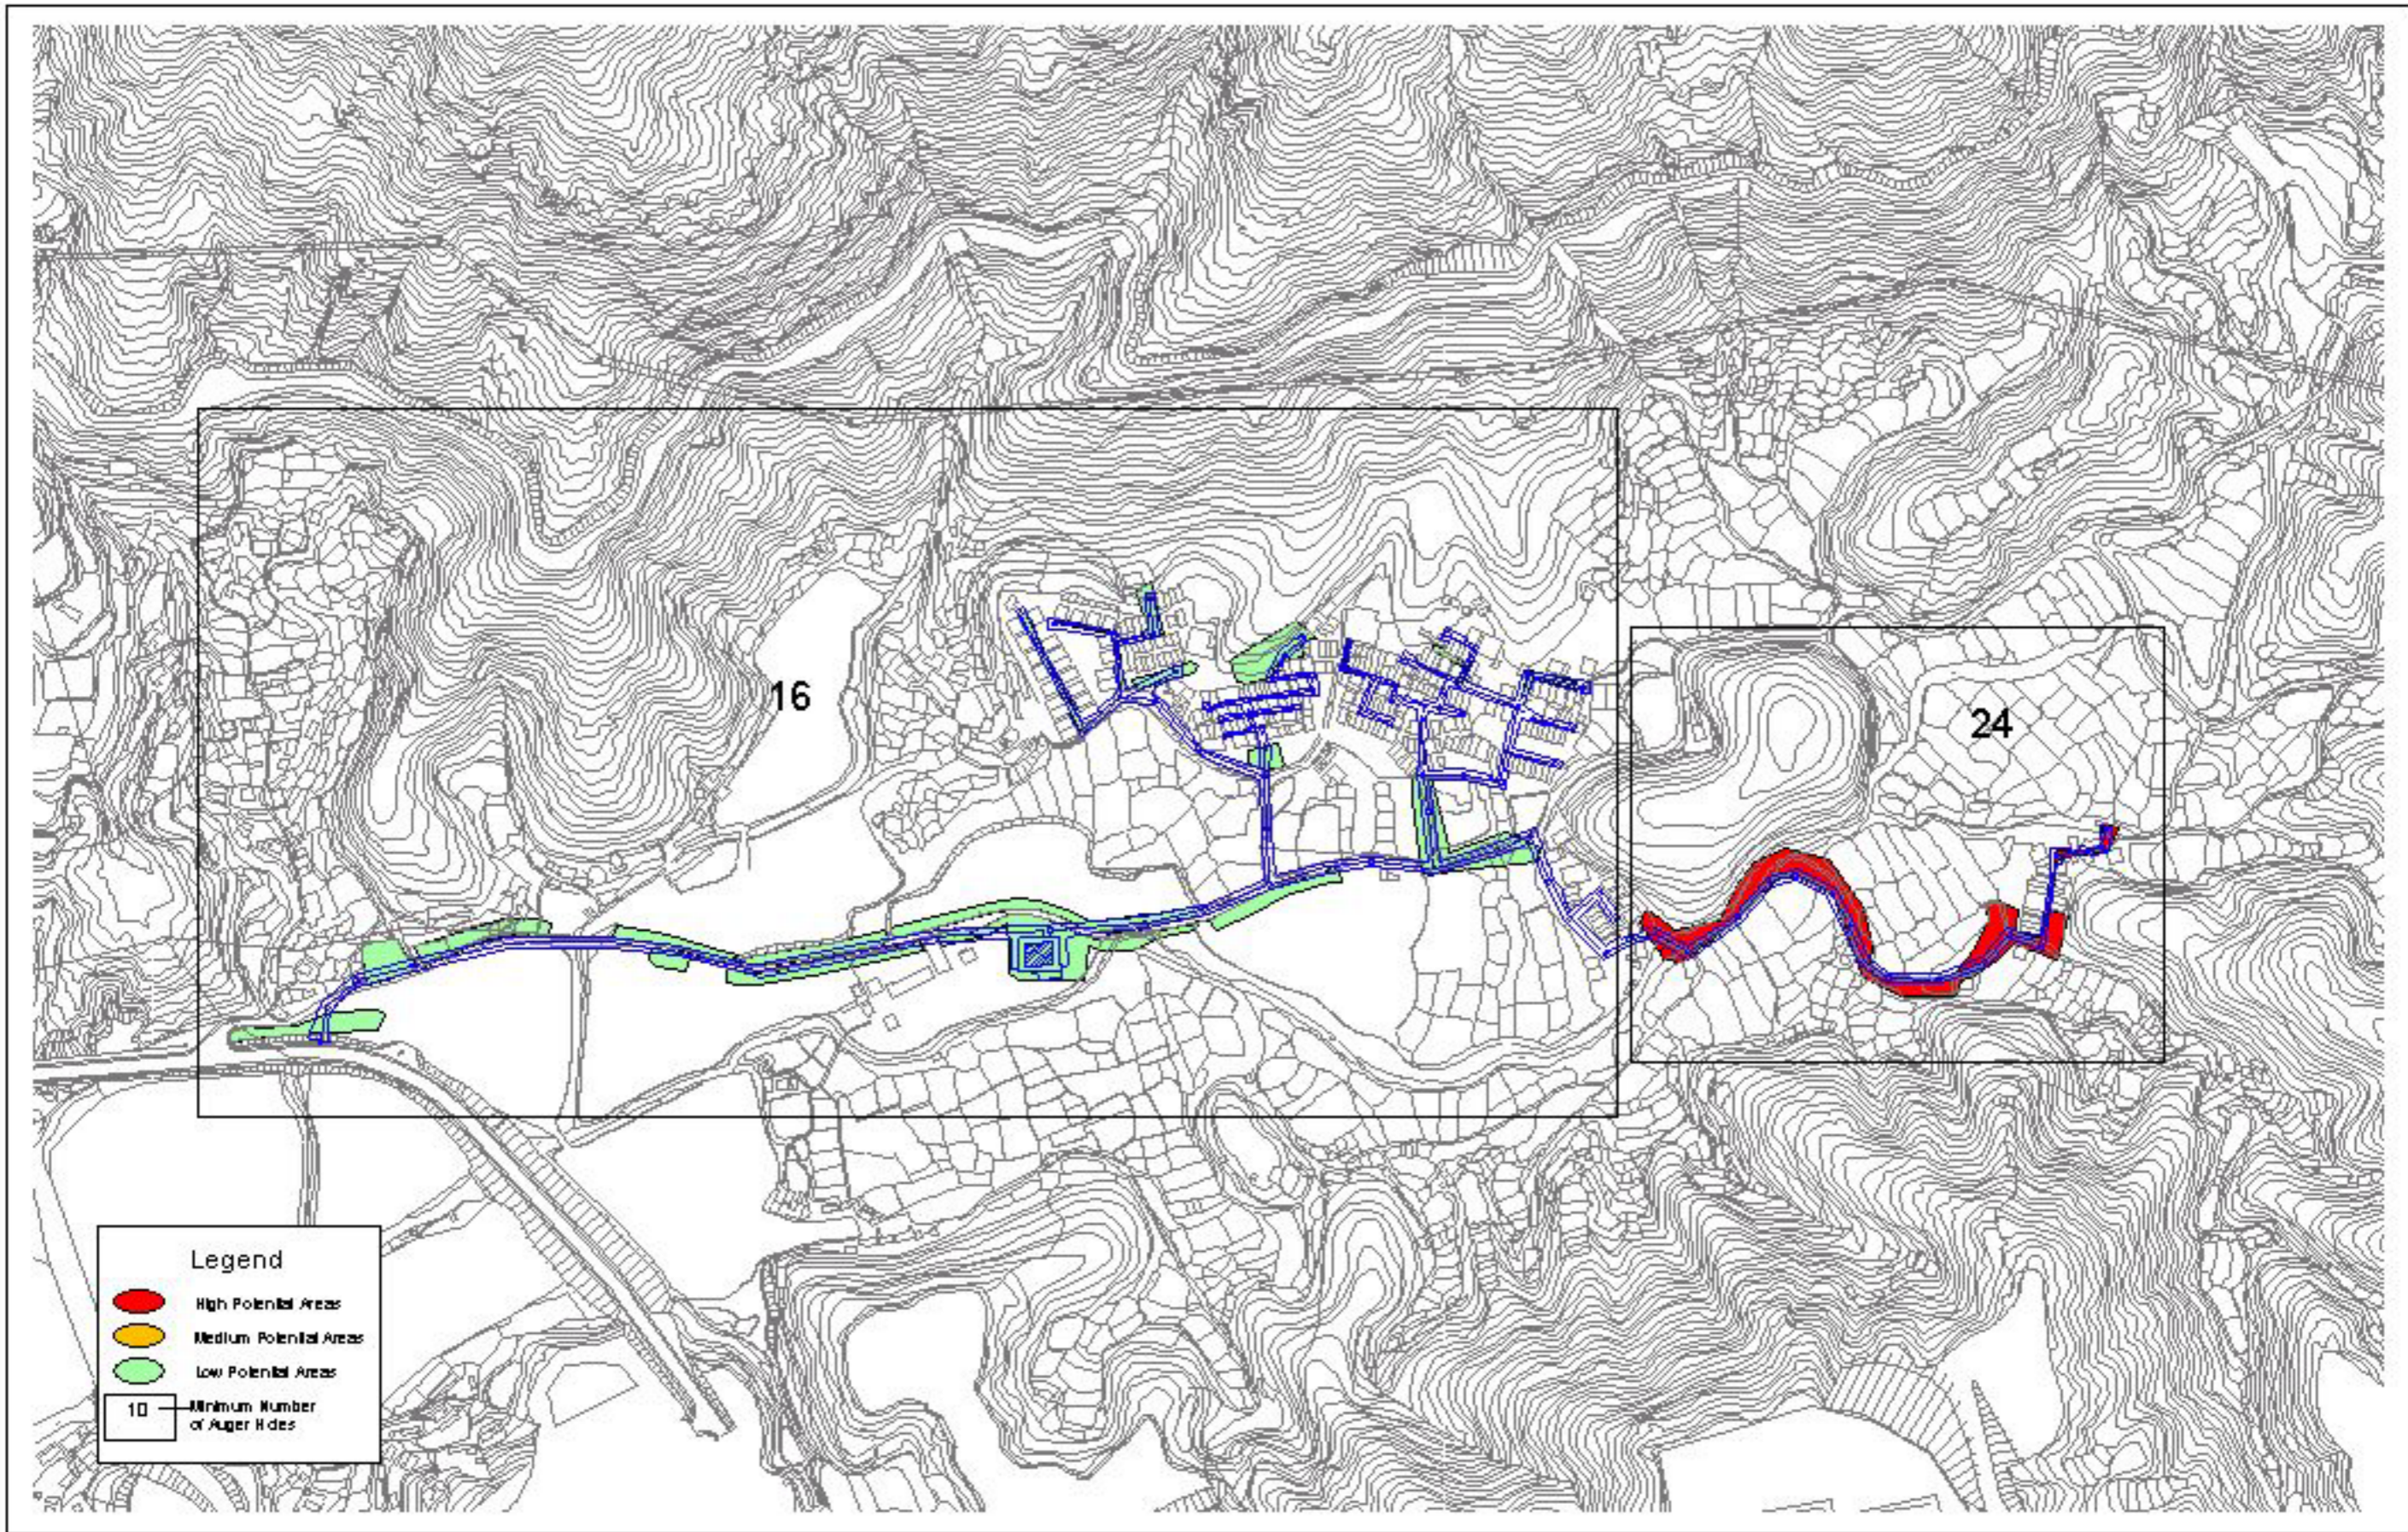
Location of High, Medium and Low Potential Areas of Archaeological Interest

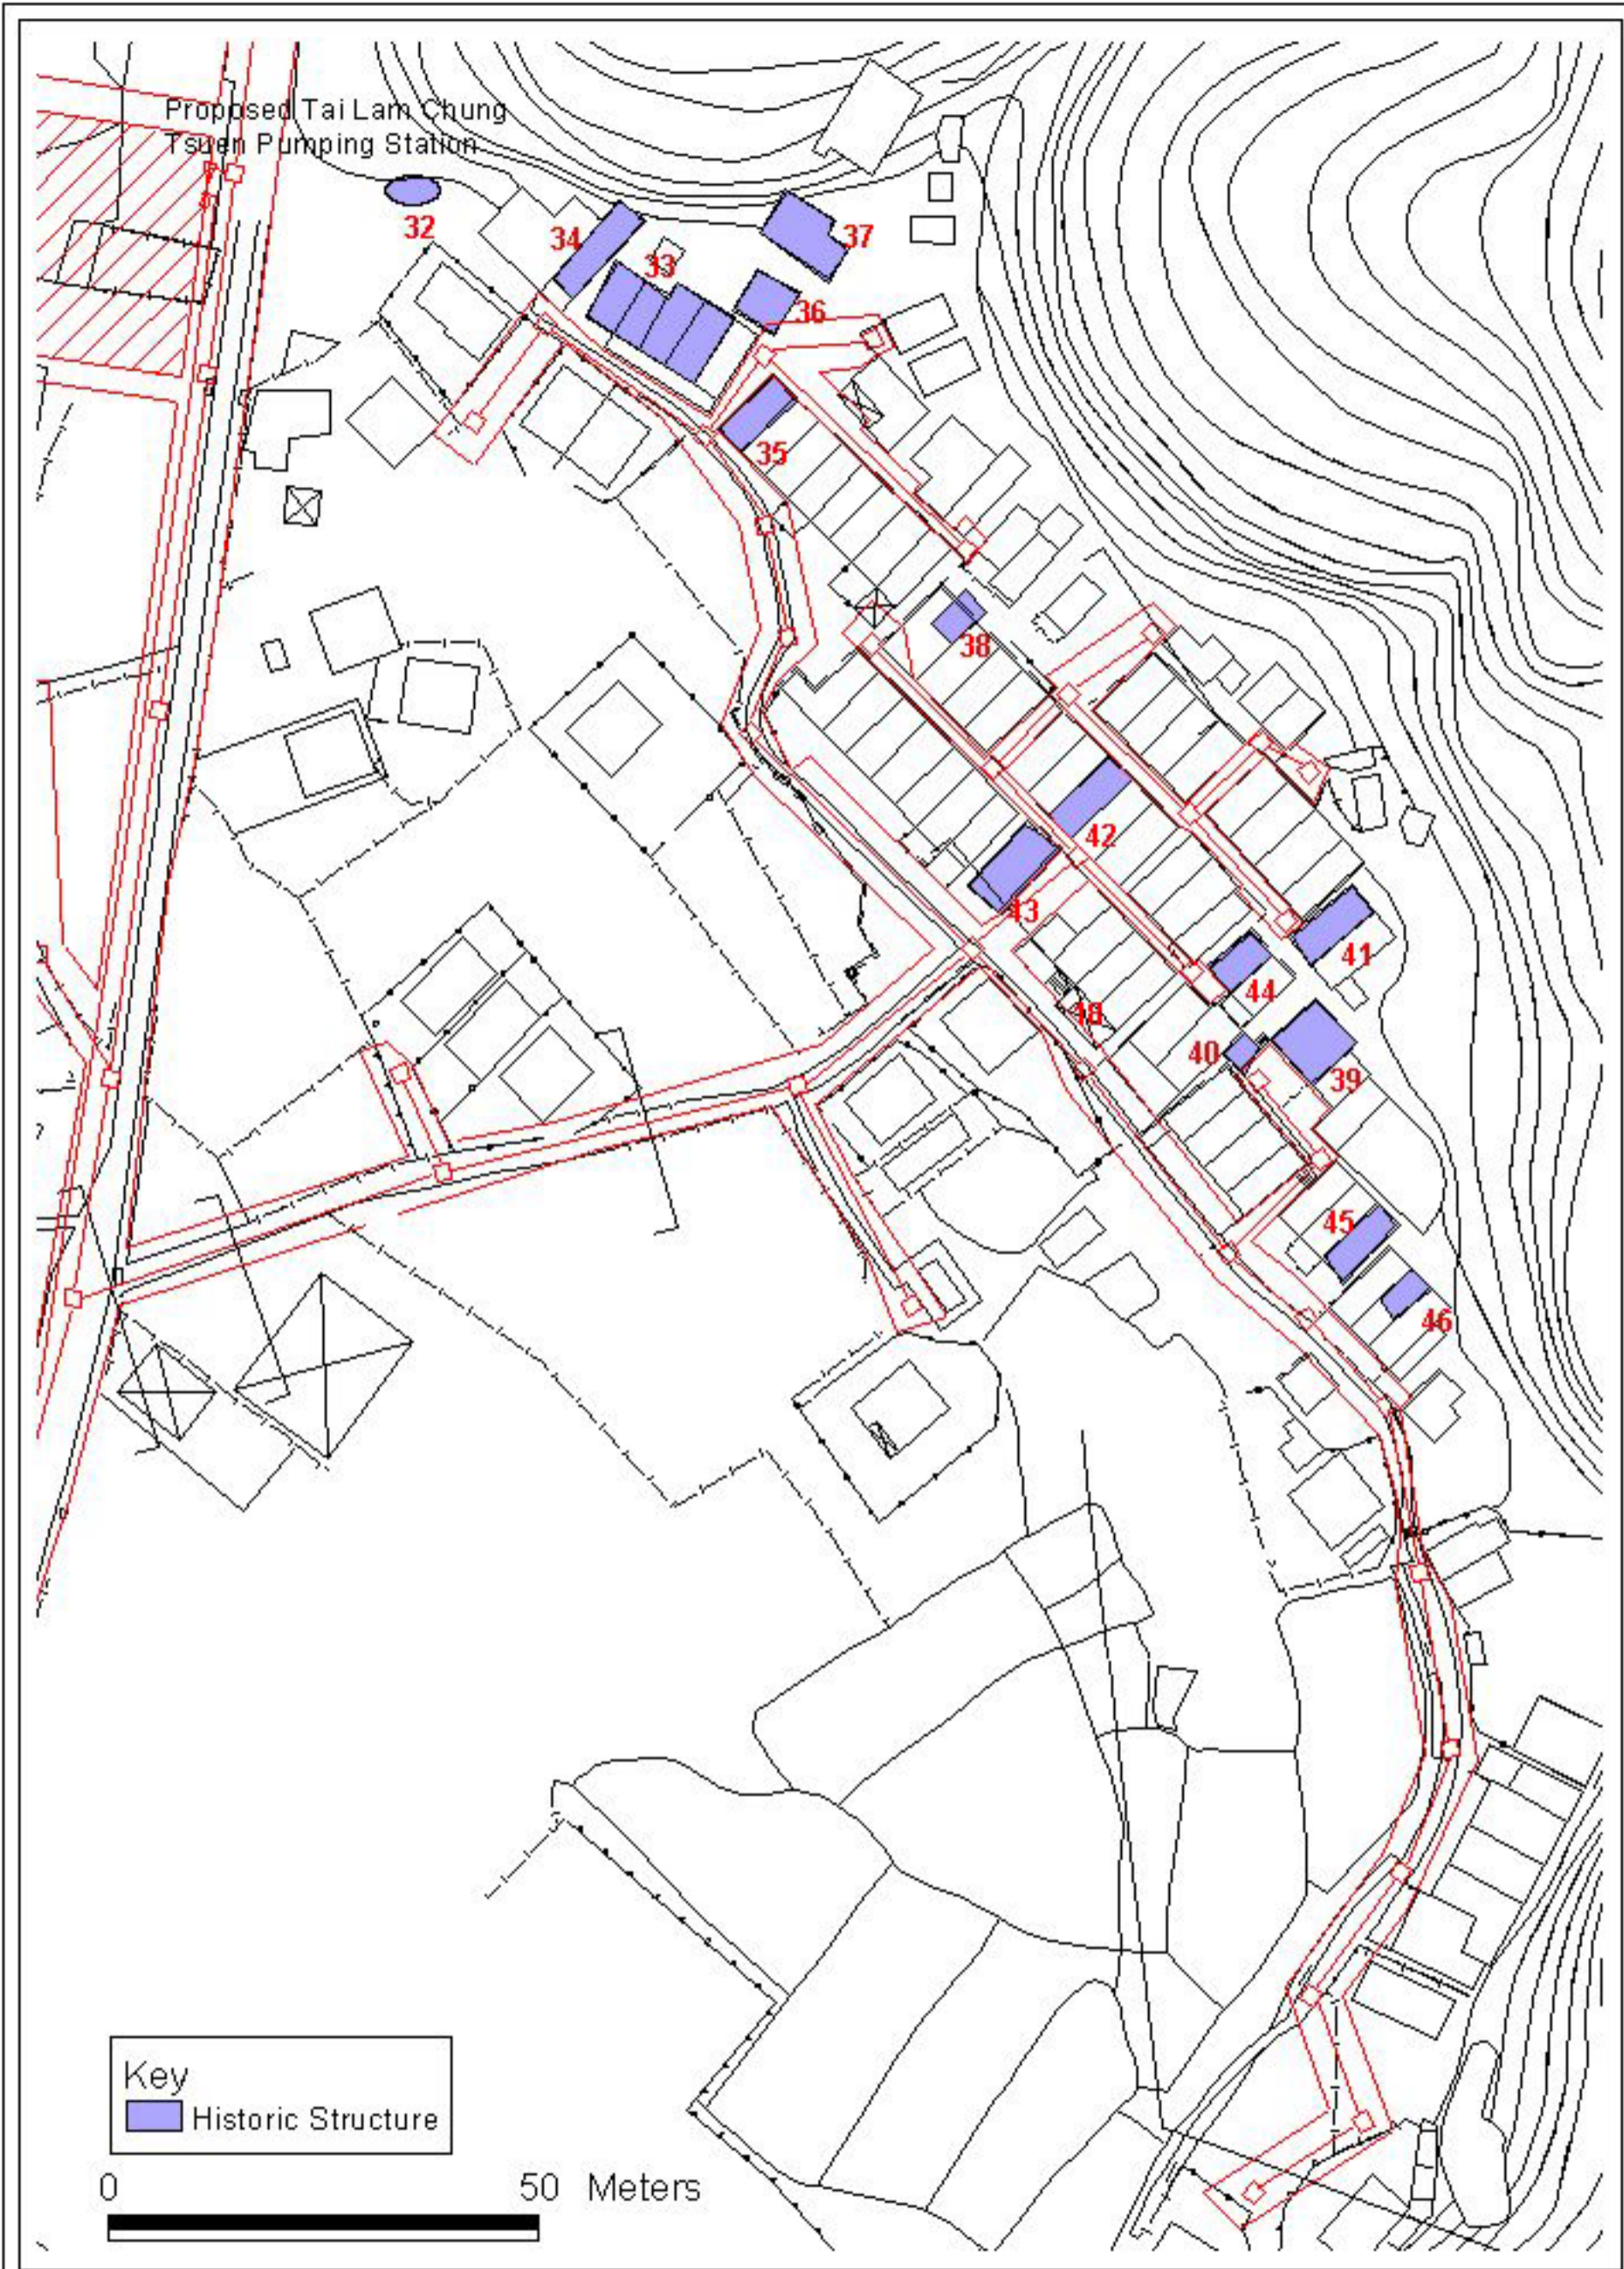
Drawing No. 9.7

Historical Building Locations in Tai Lam Chung Tsuen

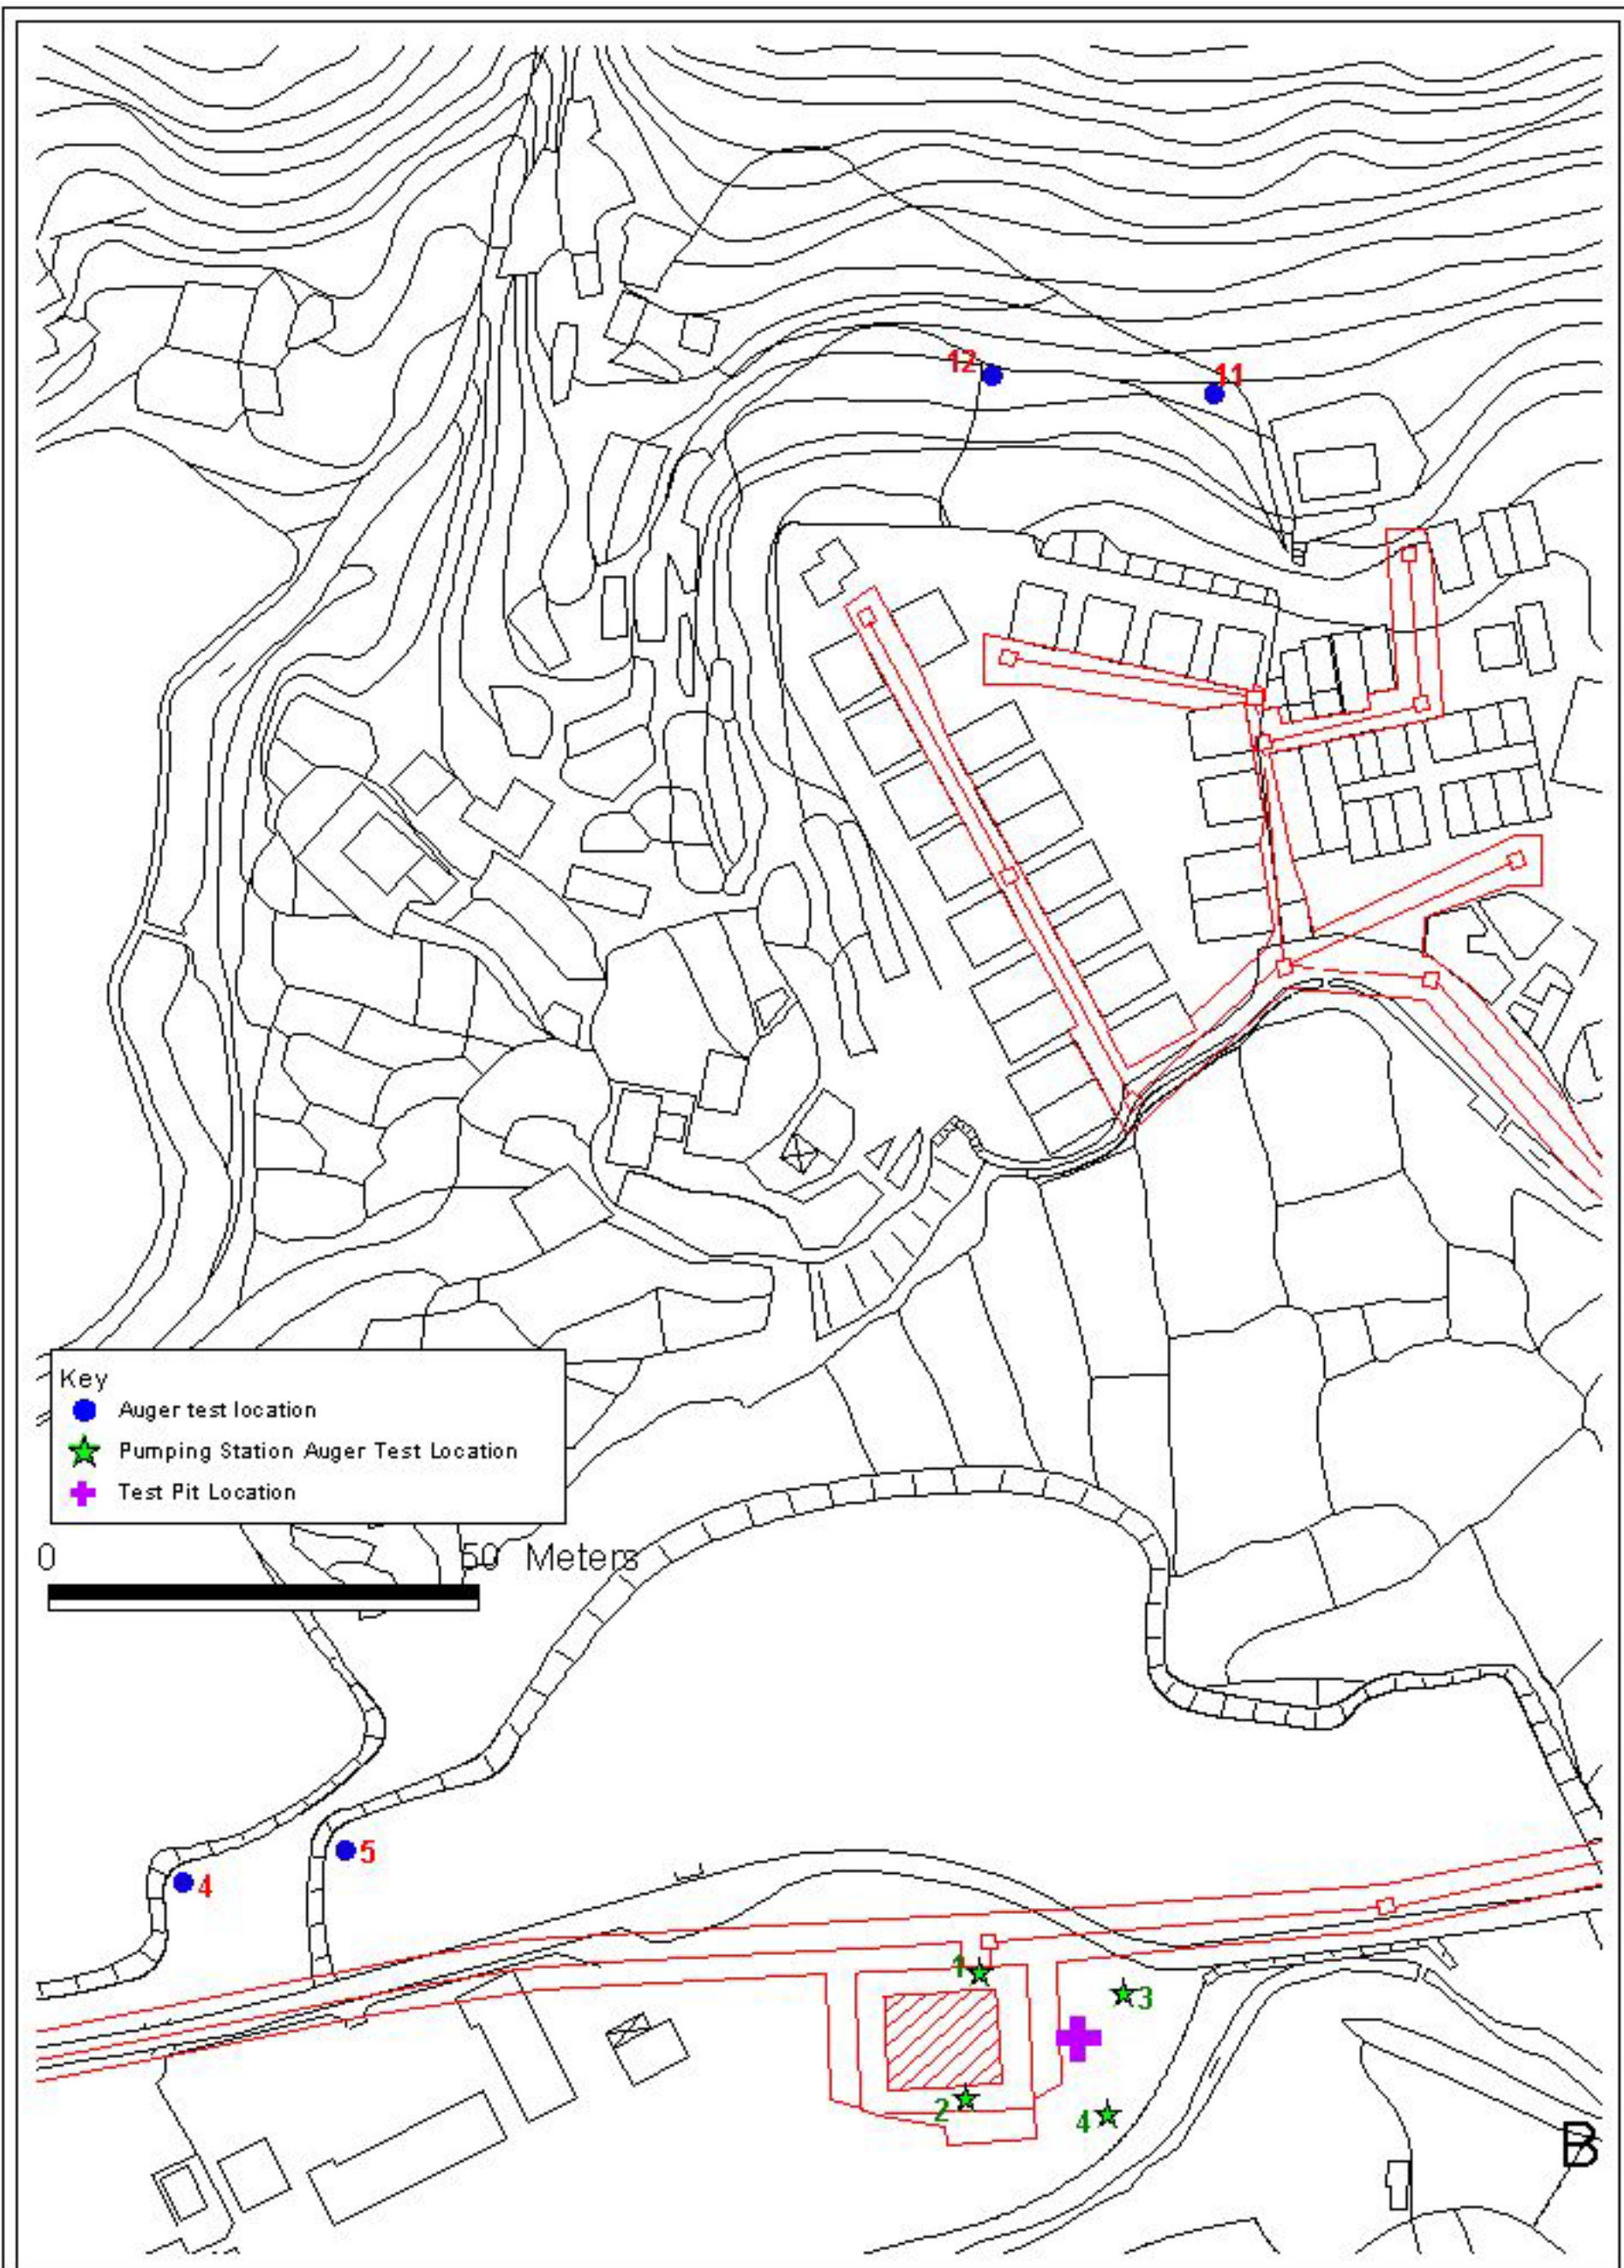
Sector 2B: Auger Hole Locations and Test Pit Location in So Kwun Wat Tsuen Layout

9.7.26 Four auger holes were attempted on the site at the locations shown in Drawing 9.13. However, the ground surface proved to be impermeable and the test could not be completed. A test pit, measuring 2 by 1.5 metres, was excavated and was located between the So Kwun Wat Access road and the river in a truck park near a tree with a shrine, as indicated on Drawing 9.13. The details of the test pit are given in Appendix G. A stratigraphical section and photograph of the test pit are also provided in Drawings 9.22 and 9.23 respectively. No archaeological deposits or artefacts were found during the survey. Subsequent to undertaking the investigation, the pumping station location was shifted slightly to the west but due to the proximity of the new site, it is considered that the tests carried out are representative for the new location.
