9.0 HERITAGE IMPACT ASSESSMENT

9.1 Objectives of the Heritage Impact Assessment

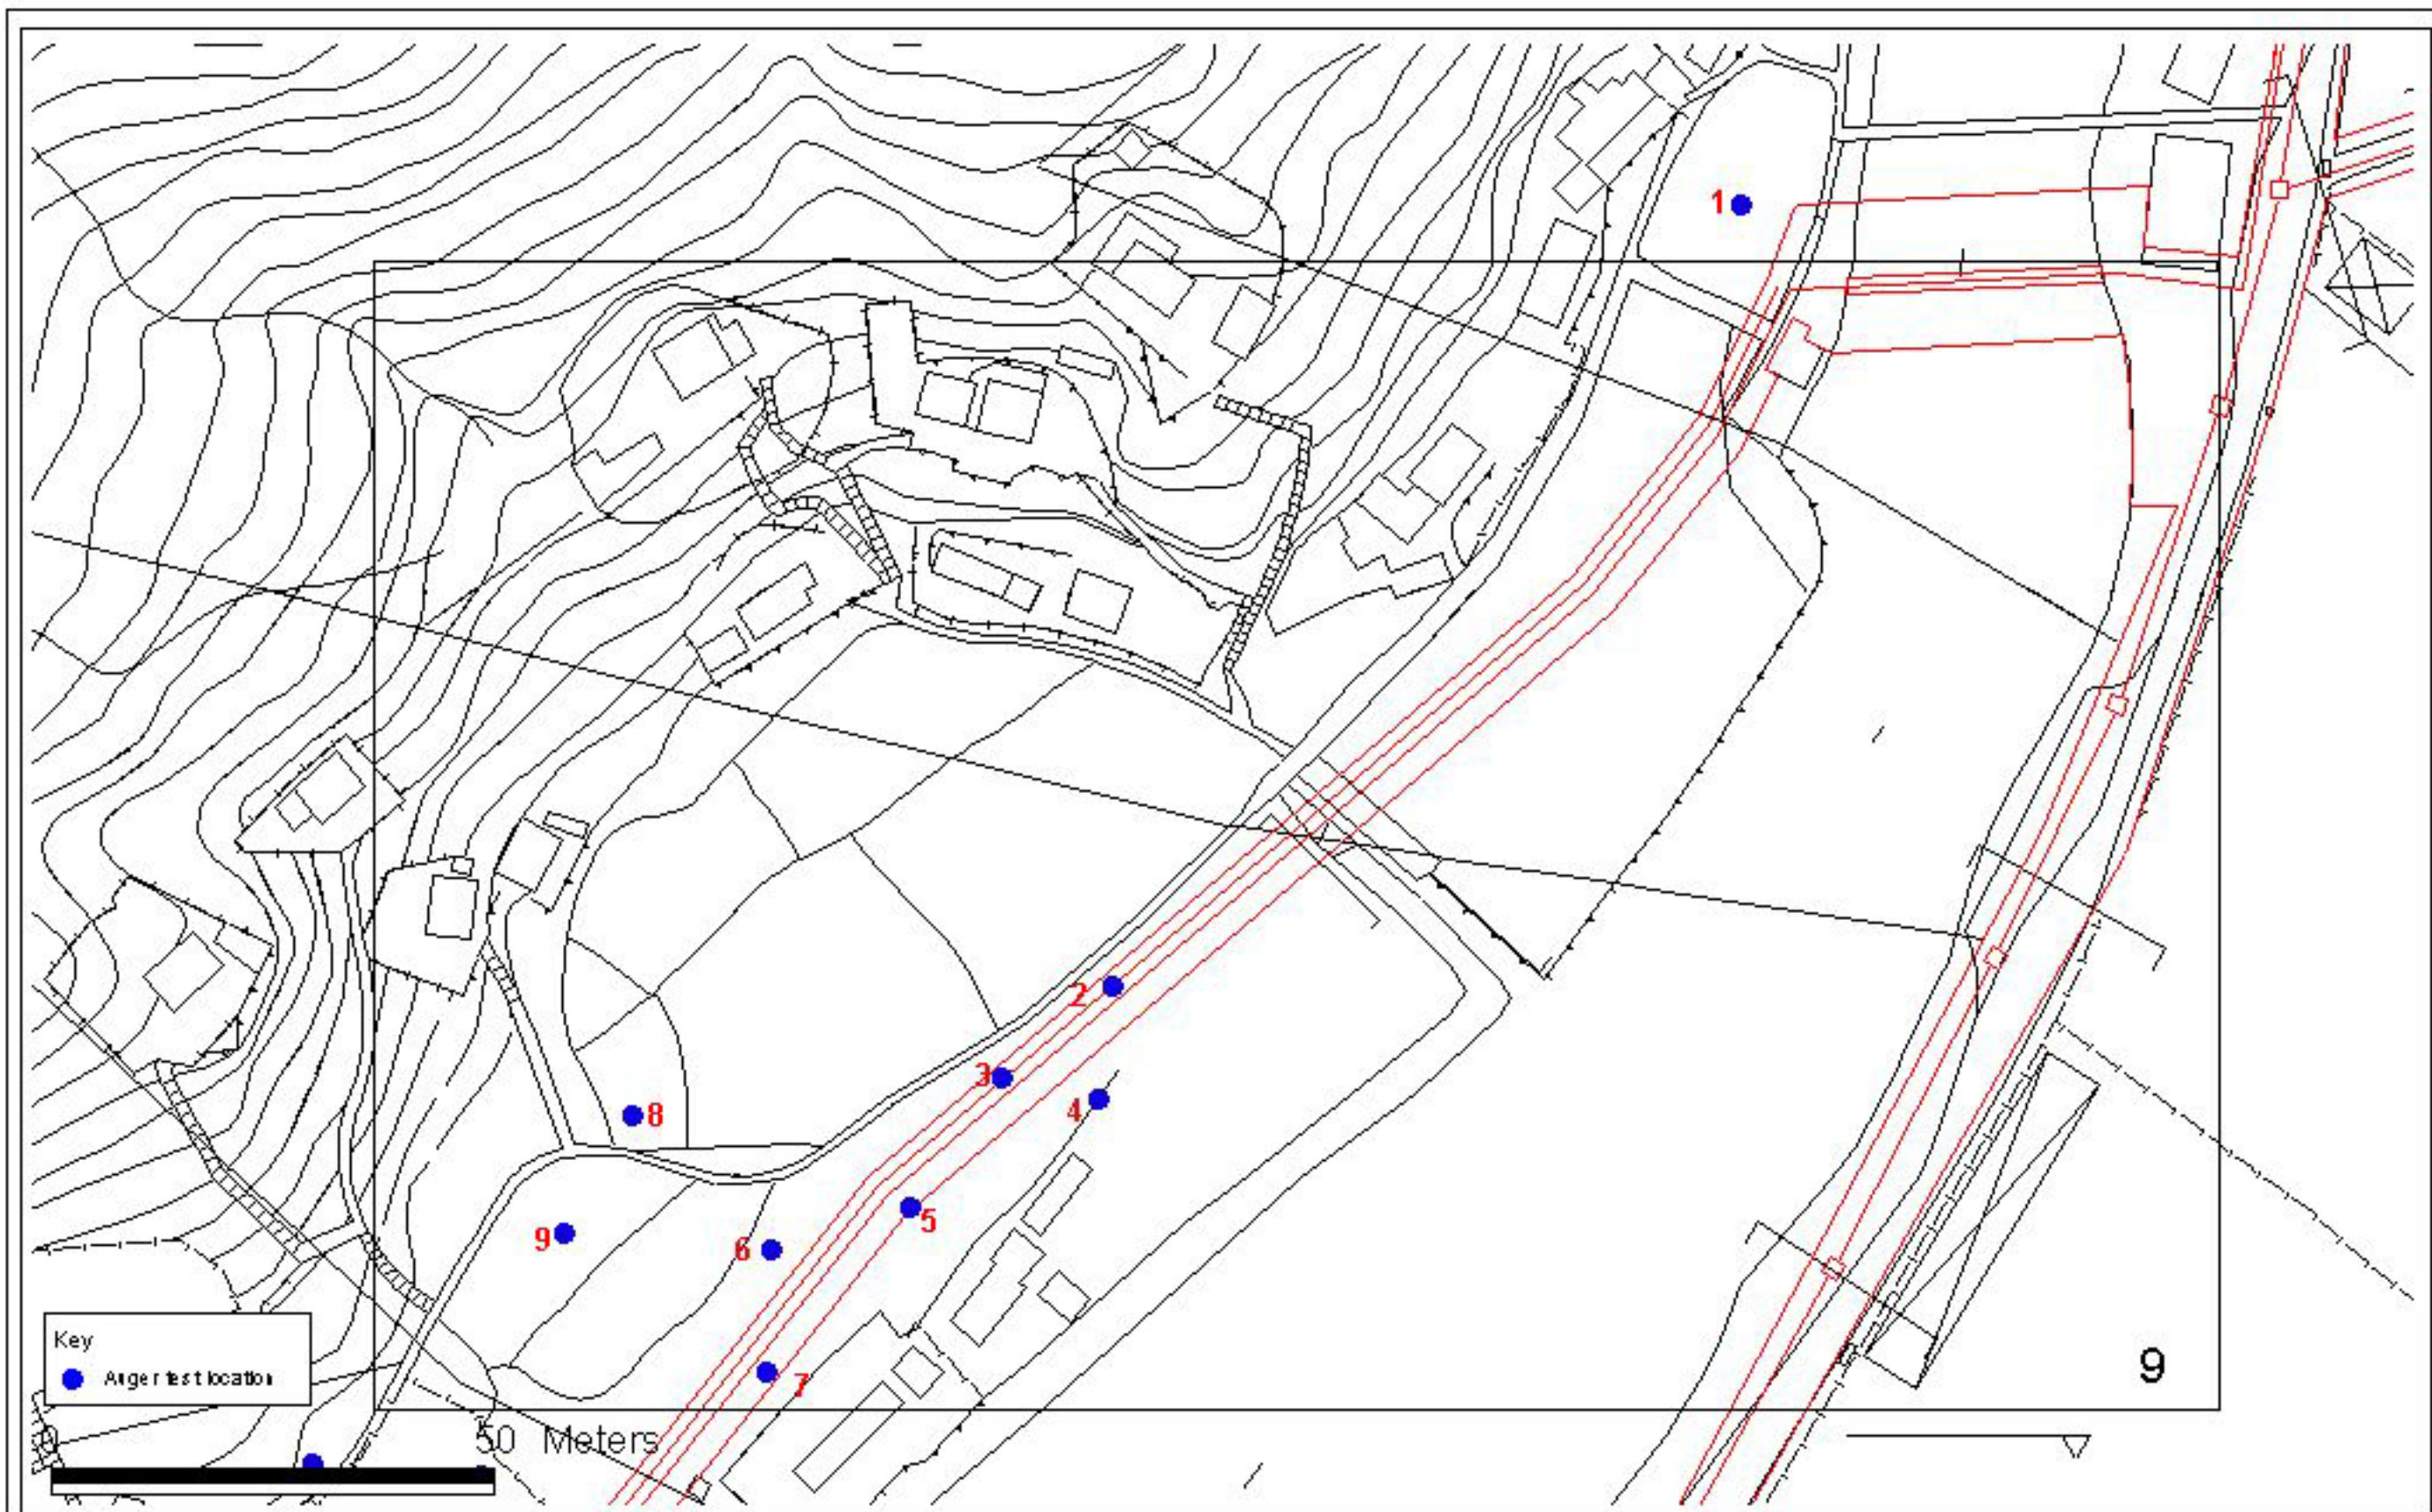
Sector 6: Auger Hole Locations in Tai Lam Chung Valley (North West)

9.7.14 This sector is located to the west of the Tai Lam Chung River and is the most northern sector on this side. The details of this area are shown in Drawing 9.18. The lower foot hills are built up or show bedrock on the surface, while on the flat area some abandoned houses and fields were noted. A concrete path runs through the sector.

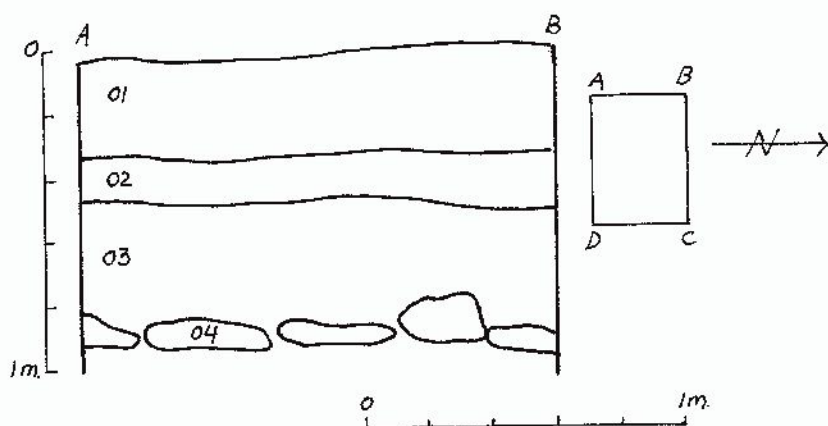
2. Tai Lam Chung Test Pit; West Section

9.7.28 Four auger tests were conducted in the area of the proposed pumping station, together with a test pit measuring 2 by 1.5 meters, which was located between the Tai Lam Chung Road and the river in a neglected garden with a few banana trees. The location of the test pit and auger tests can be seen in Drawing 9.19. A stratigraphical section and photograph of the test pit are also provided in Drawings 9.22 and 9.23 respectively. No archaeological deposits or artefacts were found during the survey.

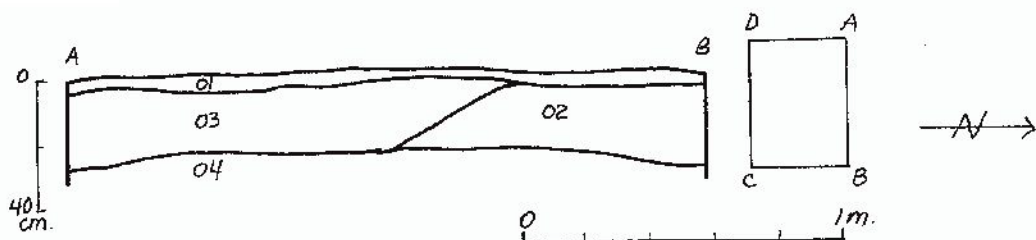
3. So Kwun Wat Test; North Section

9.7.26 Four auger holes were attempted on the site at the locations shown in Drawing 9.13. However, the ground surface proved to be impermeable and the test could not be completed. A test pit, measuring 2 by 1.5 metres, was excavated and was located between the So Kwun Wat Access road and the river in a truck park near a tree with a shrine, as indicated on Drawing 9.13. The details of the test pit are given in Appendix G. A stratigraphical section and photograph of the test pit are also provided in Drawings 9.22 and 9.23 respectively. No archaeological deposits or artefacts were found during the survey. Subsequent to undertaking the investigation, the pumping station location was shifted slightly to the west but due to the proximity of the new site, it is considered that the tests carried out are representative for the new location.
