GENERAL LAYOUT OF PROPOSED WORKS

AGREEMENT No. CE 41/98
ENVIRONMENTAL AND DRAINAGE
IMPACT ASSESSMENT FOR
TAI O SHELTERED BOAT ANCHORAGE

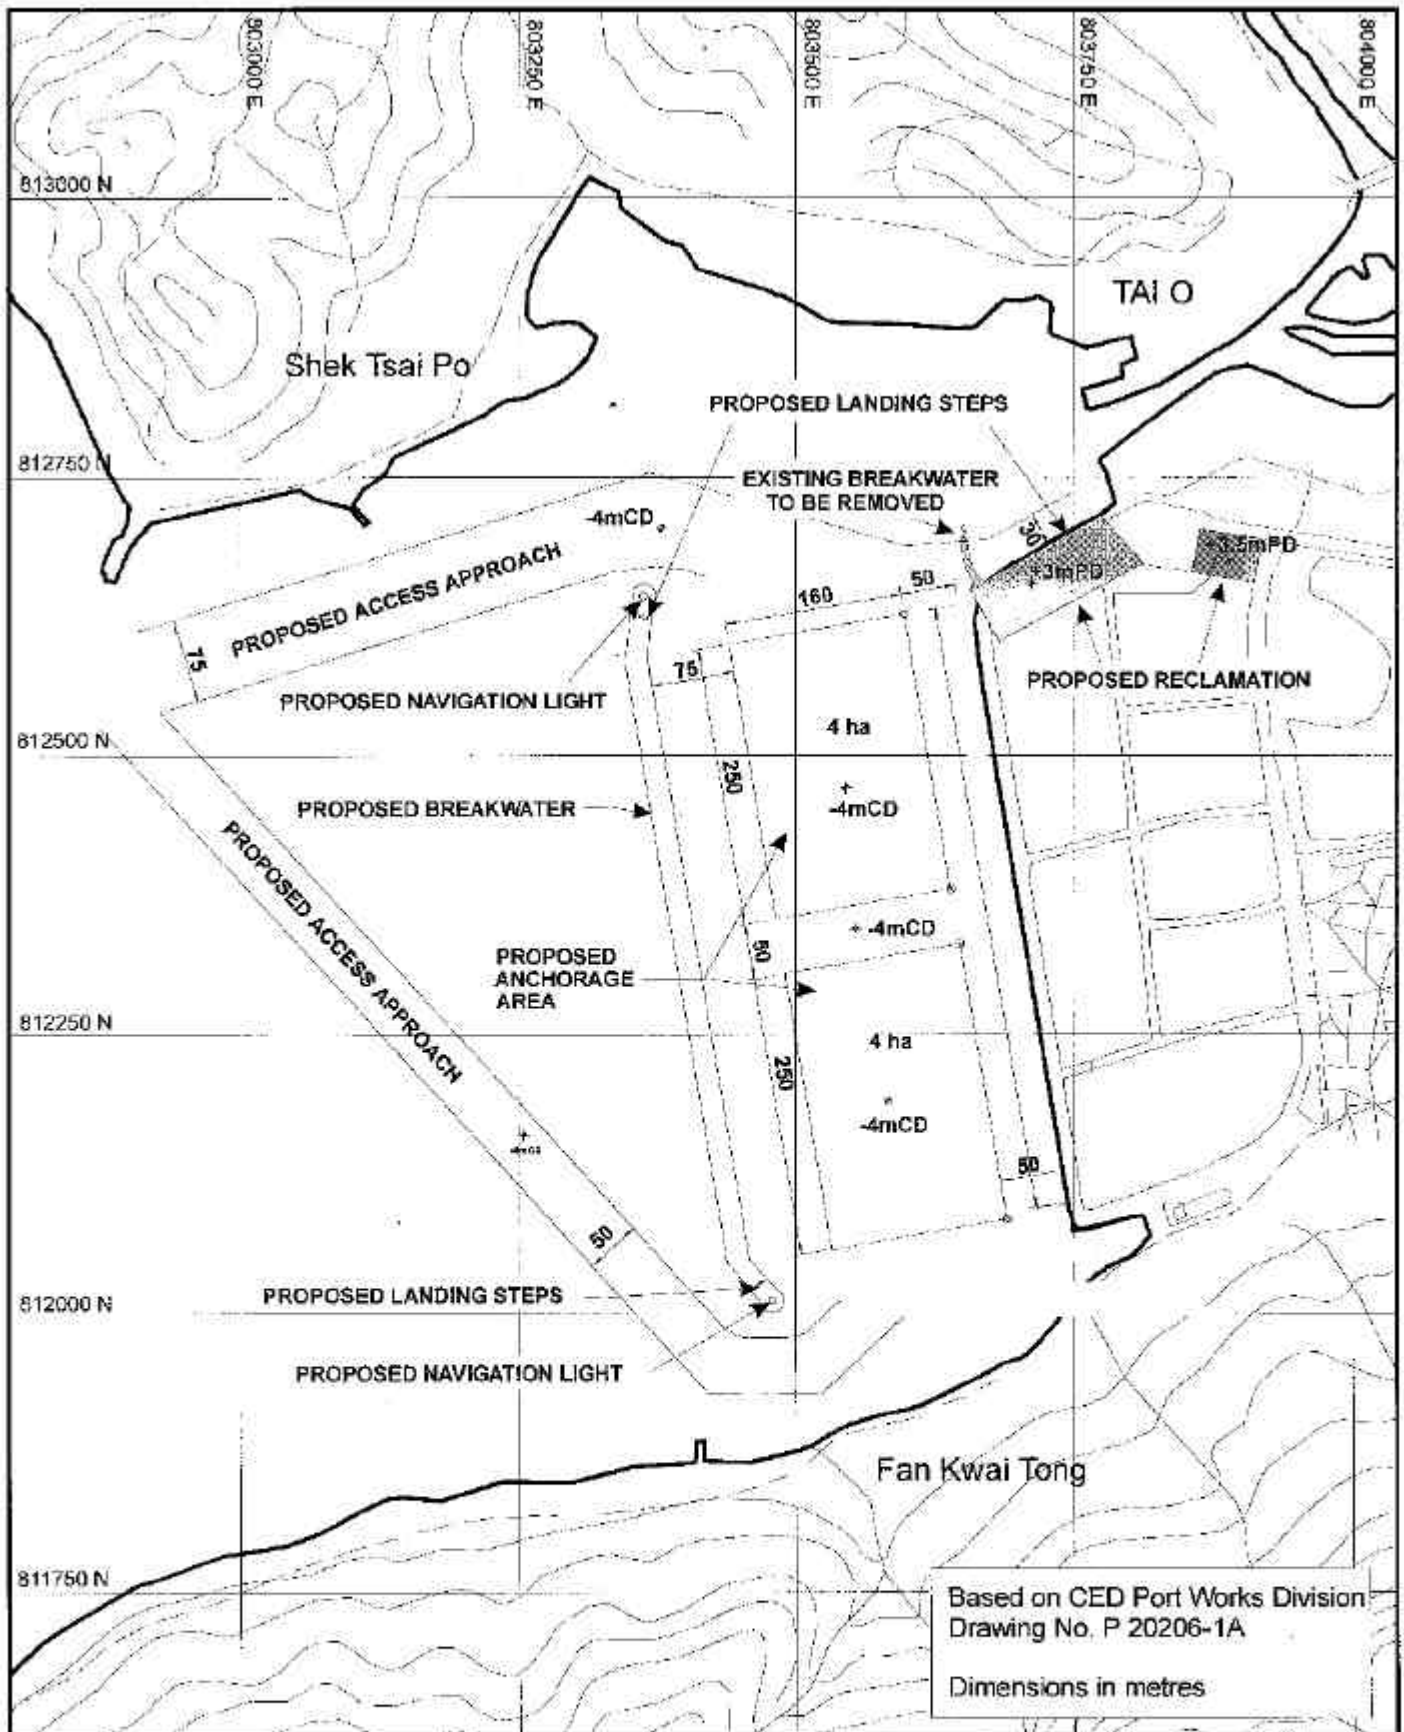
Figure No.	2.1	
Scale	N.T.S.	
Drawn JML	Approved	Revised
Checked JML	Date	Date

Based on CED Port Works Division
Drawing No. P 20206-1A

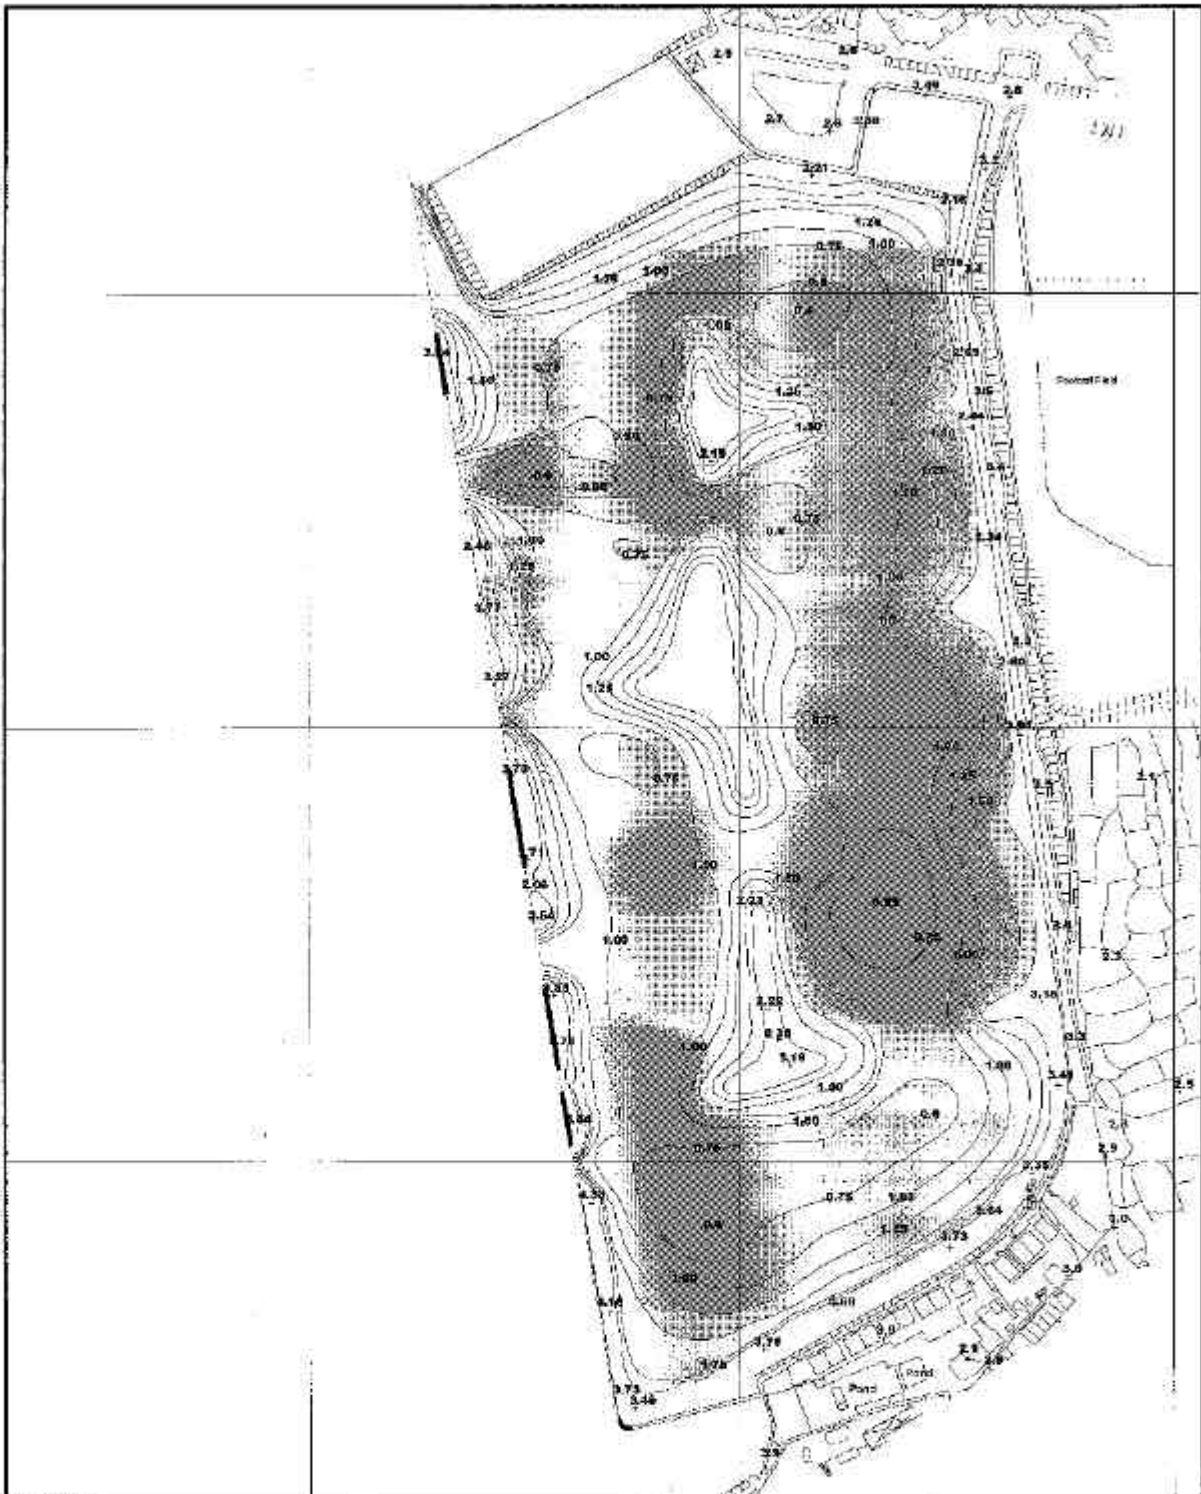
Figure No.	2.2	
Scale	N.T.S.	
Drawn JML	Approved	Revised
Checked JML	Date	Date

**RECOMMENDED MANGROVE
LAYOUT PLAN**

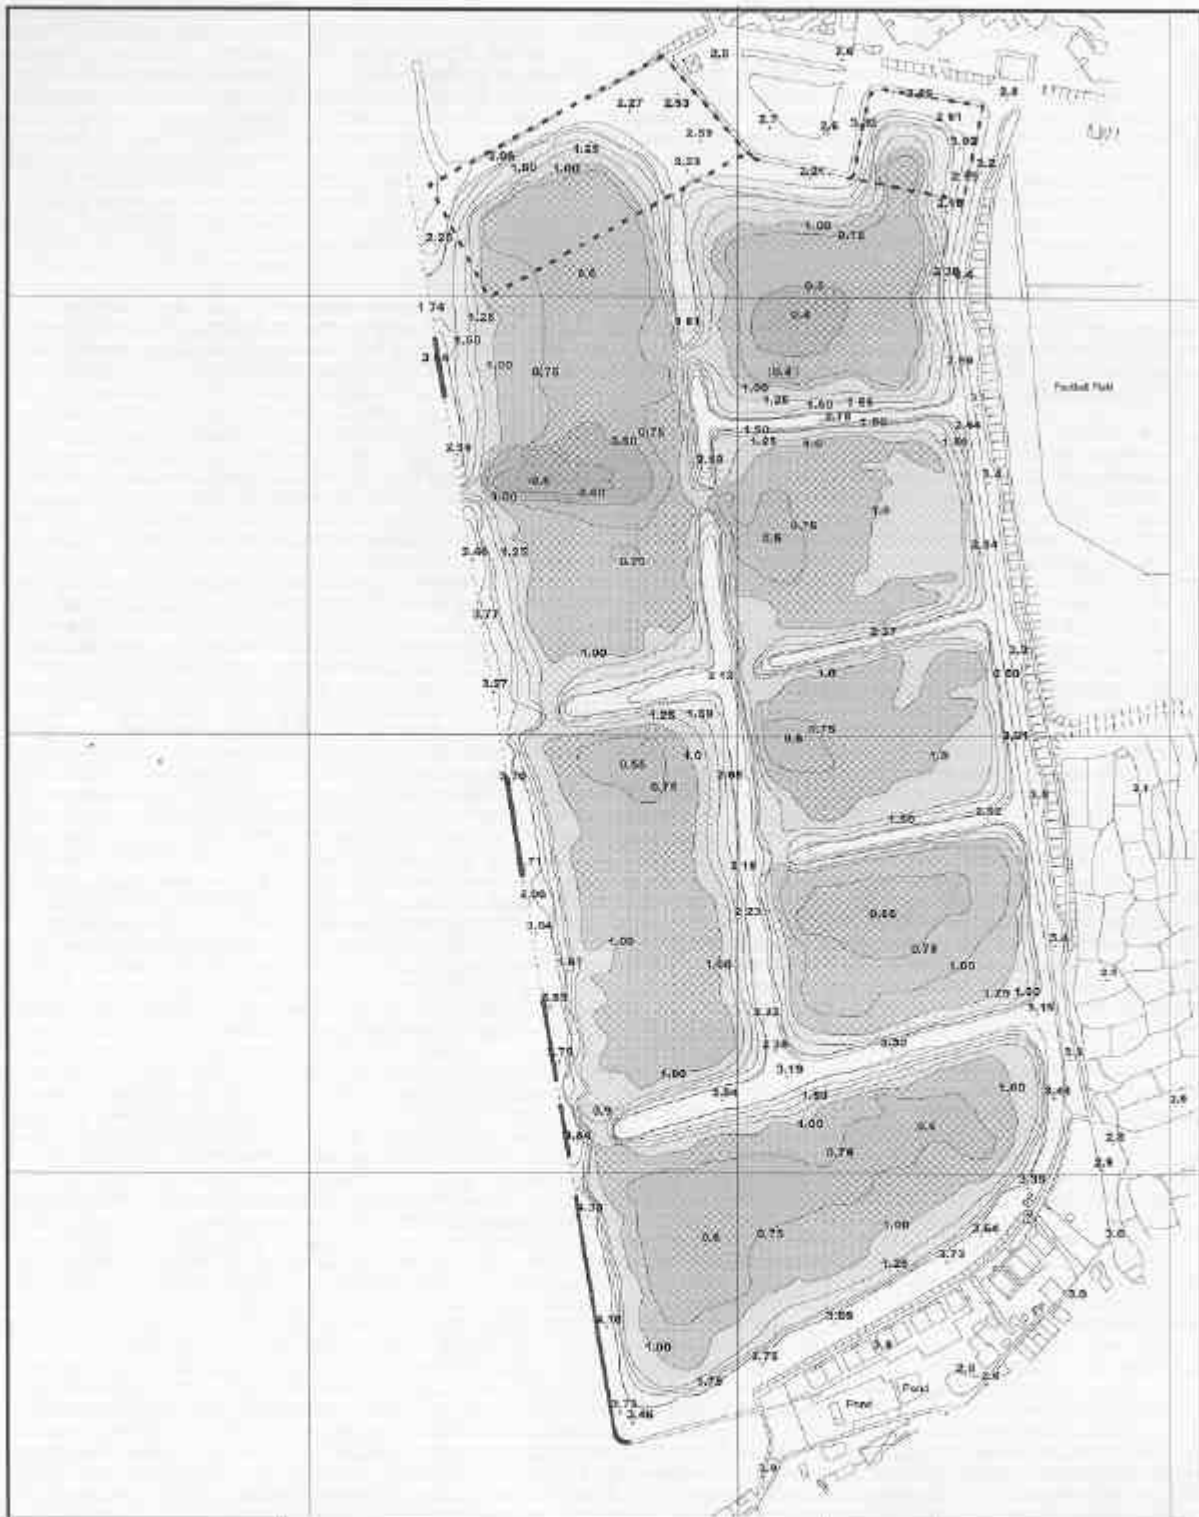
EXISTING LEVELS IN SALT PANS		Figure No.	2.4	
	AGREEMENT No. CE 41/98 ENVIRONMENTAL AND DRAINAGE IMPACT ASSESSMENT FOR TAI O SHELTERED BOAT ANCHORAGE		Scale	N.T.S.	
			Drawn	Approved	Revised
			JML		
			Checked	Date	Date
			JML

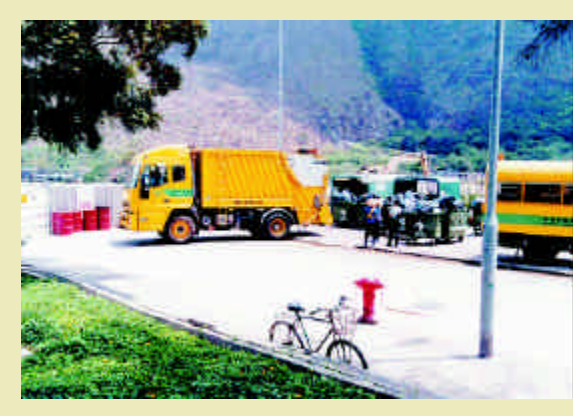
Existing temporary refuse collection point near Tin Ning House. Refuse is collected by RCV and taken to Mui Wo.

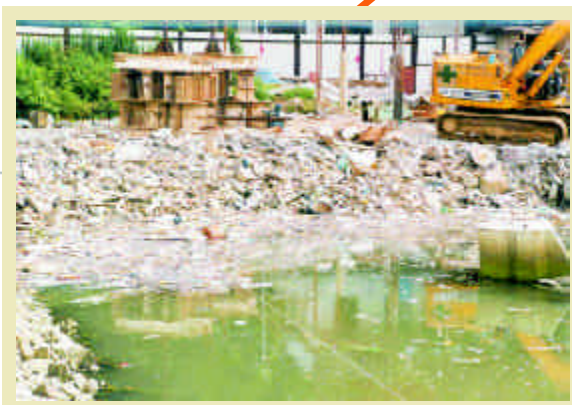
Flots and floating refuse stranded at data worksite

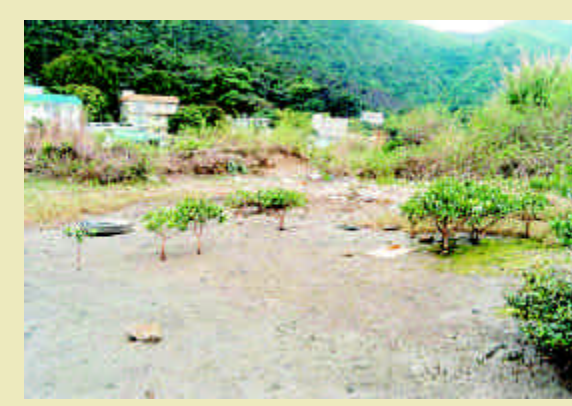
Existing accumulations of refuse in salt pan area.

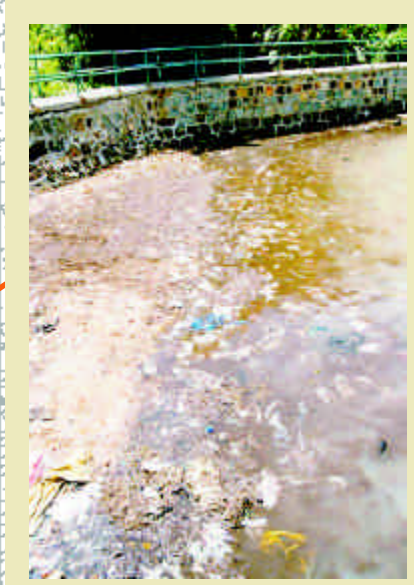
Floating and littoral refuse adjacent to salt pan presents a nuisance and visual eye-sore.
