Renewable Energy by a Wind
Turbine System on
Lamma Island:
*Final Environmental Impact
Assessment*

The Hongkong Electric Co Ltd

Renewable Energy by a Wind
Turbine System on Lamma Island:
Final Environmental Impact Assessment Report

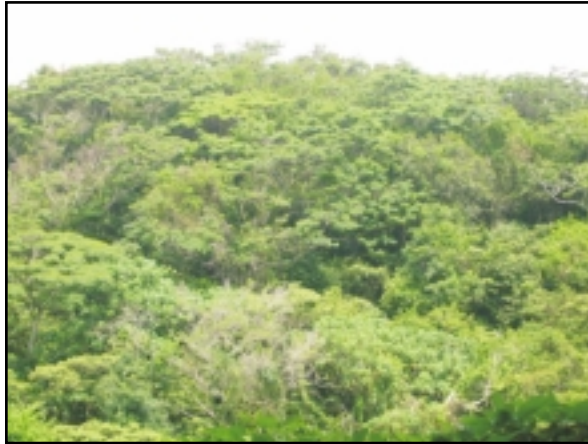
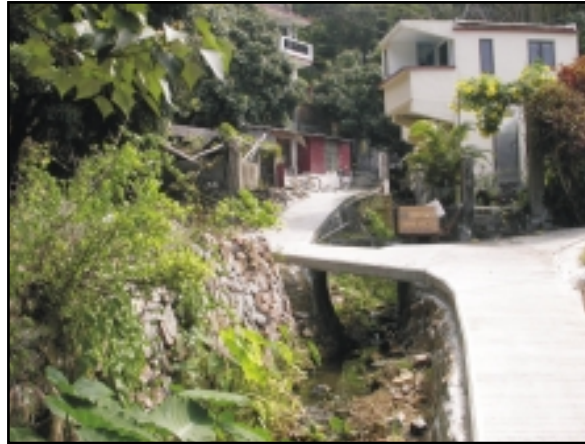
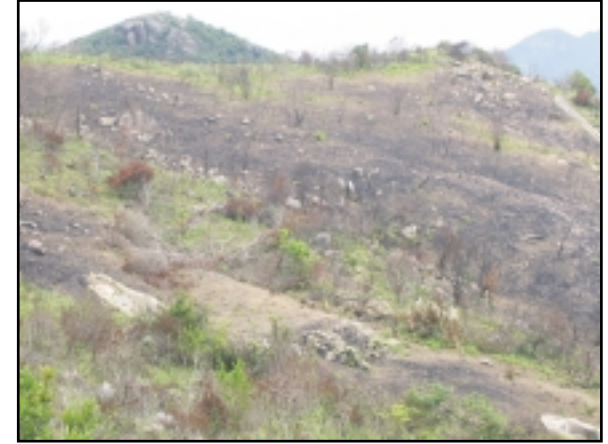
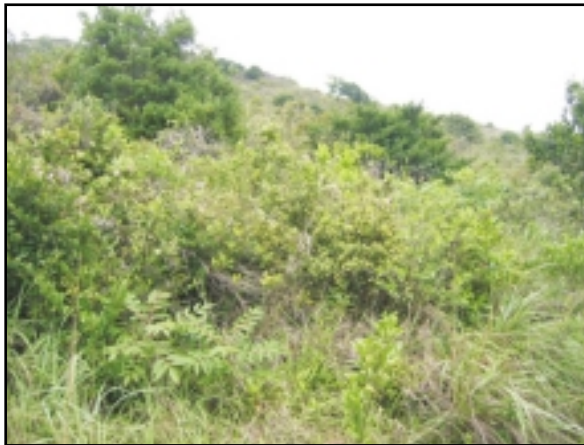
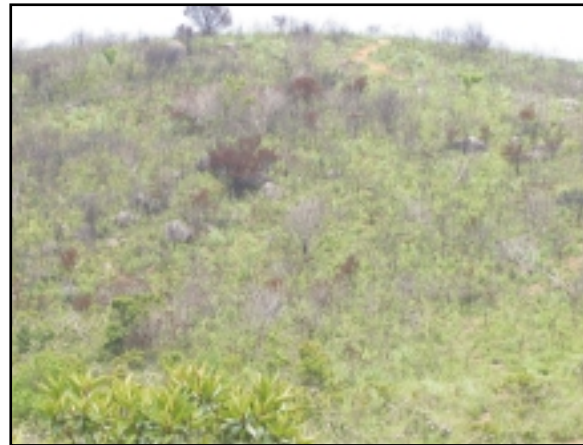
Figure 5.3

Secondary Woodland

Village/Developed Area

Shrubby grassland, are expected to be originated from the shrubland, which located in the vicinity of the Project Area

Shrubland

Shrubby Grassland

Photographic Record of Different Habitats within the Study Area

Most of the Study Area remained natural with some areas partly disturbed by rural/village developments. Habitats found within the Study Area include secondary woodland, shrubland, shrubby grassland, village/developed area and streams (Figure 5.2). Colour photographs of all recorded habitat types, as well as other features and species of conservation interest, are presented in Figures 5.3 to 5.7.

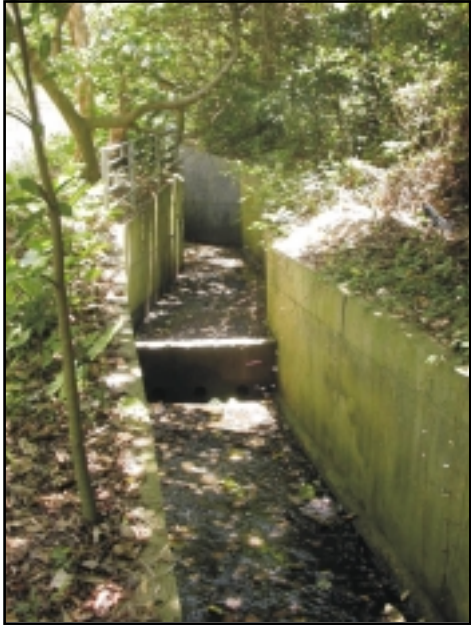
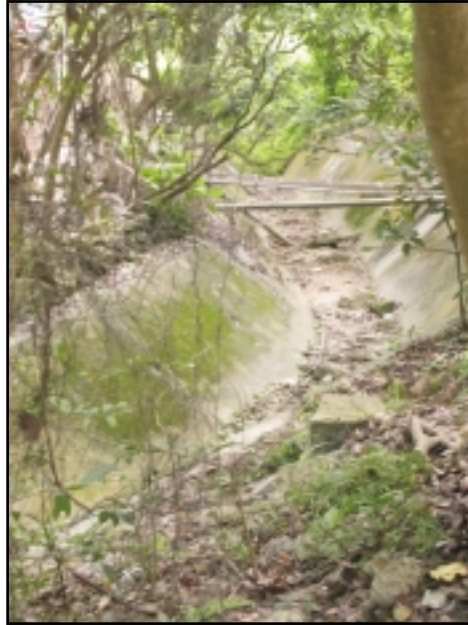
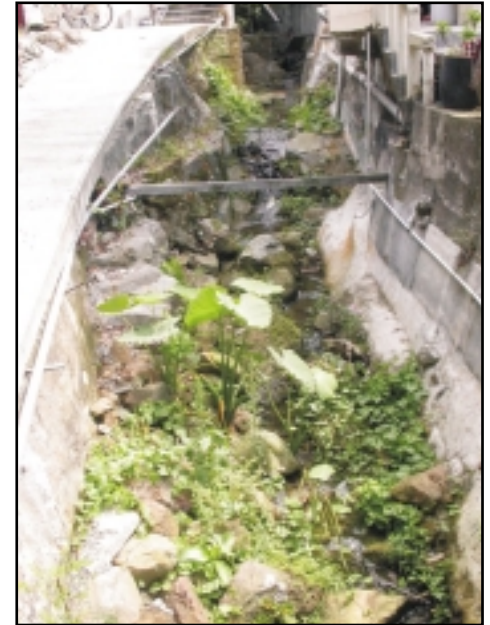
Figure 5.4

Stream 1

Stream 2 - Upper Course

Stream 2 - Lower Course

Photographic Records of Stream Habitats within the Study Area

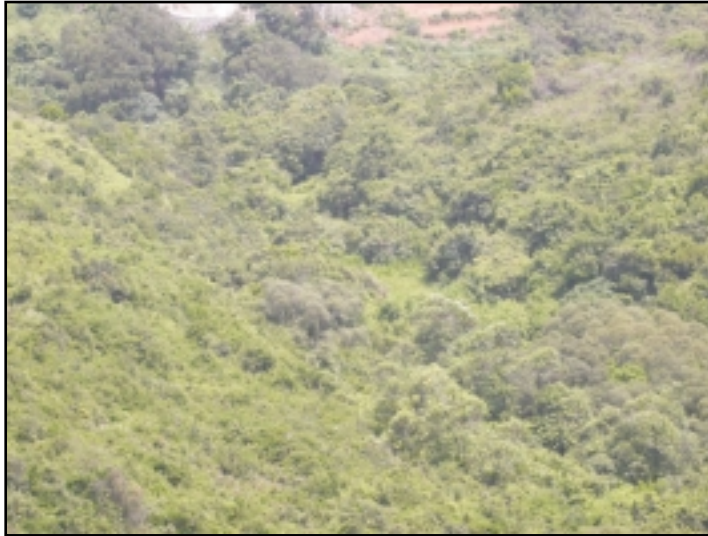
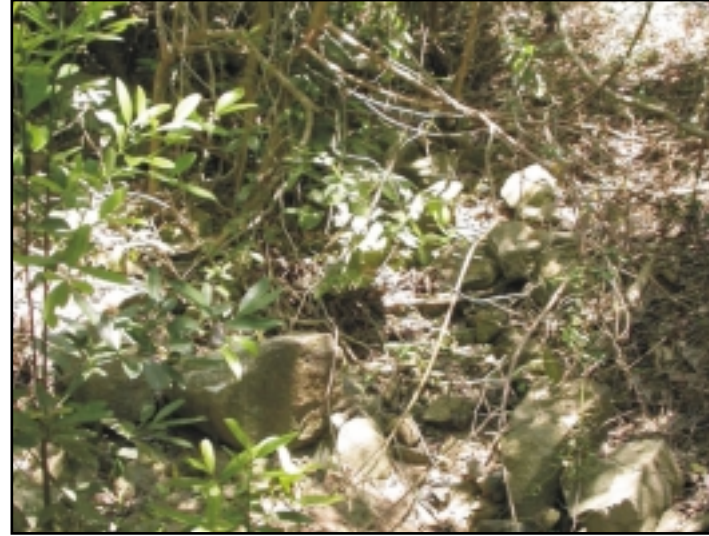
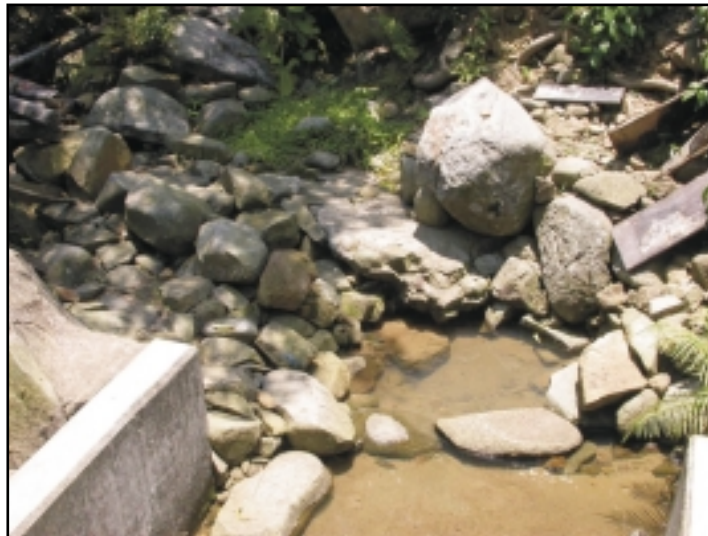
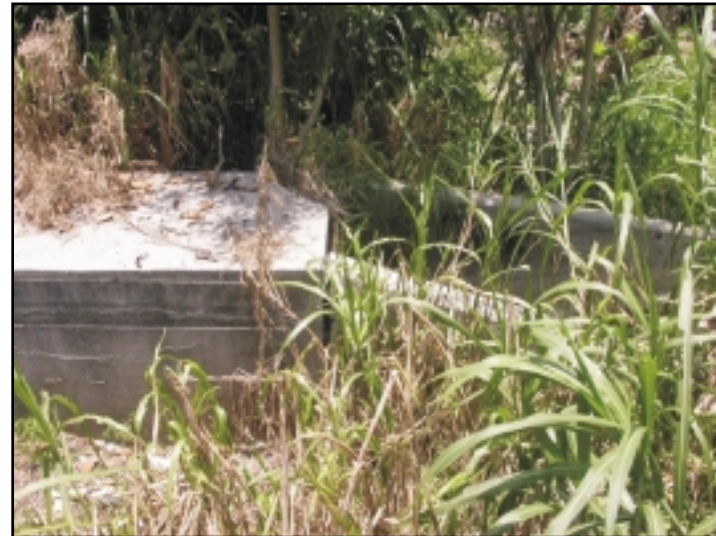
Figure 5.5

Stream 3

Stream 4 - Upper Course

Stream 4 - Middle Course

Stream 4 - Lower Course

Photographic Record of Stream Habitats within the Study Area

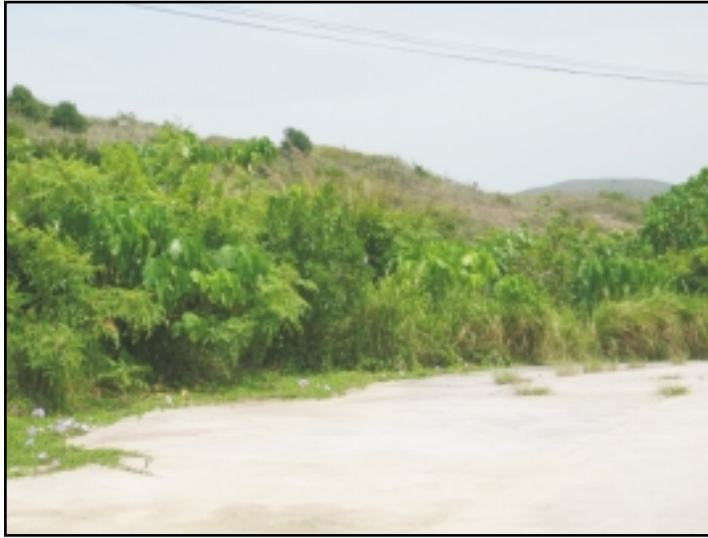
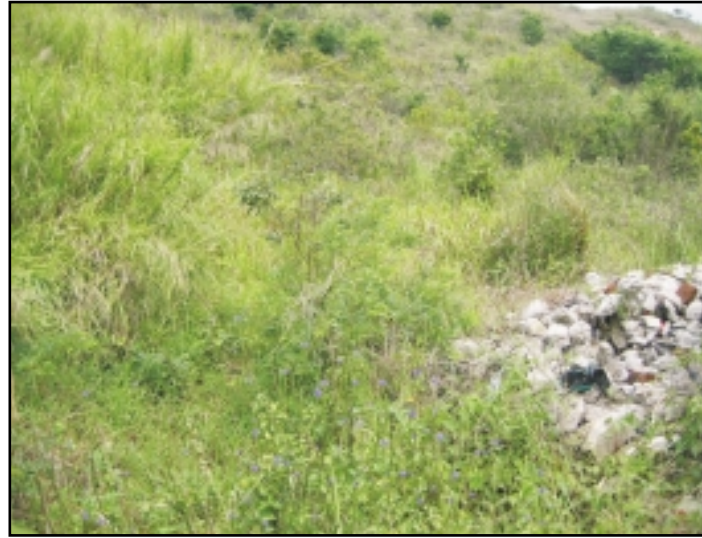
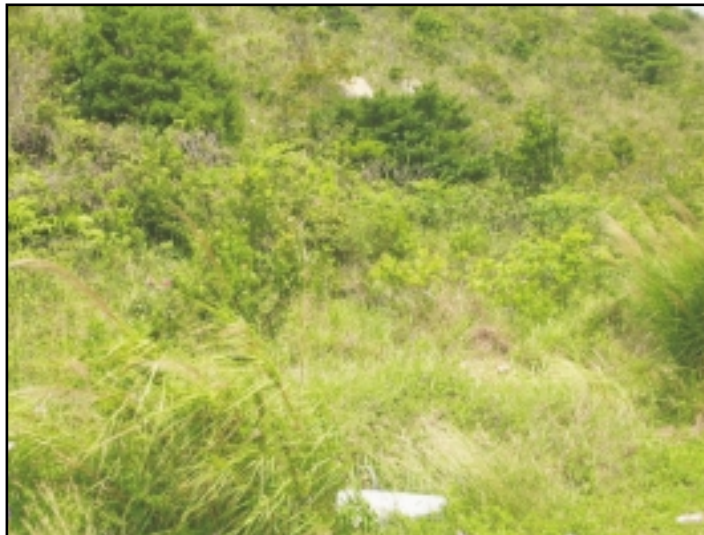
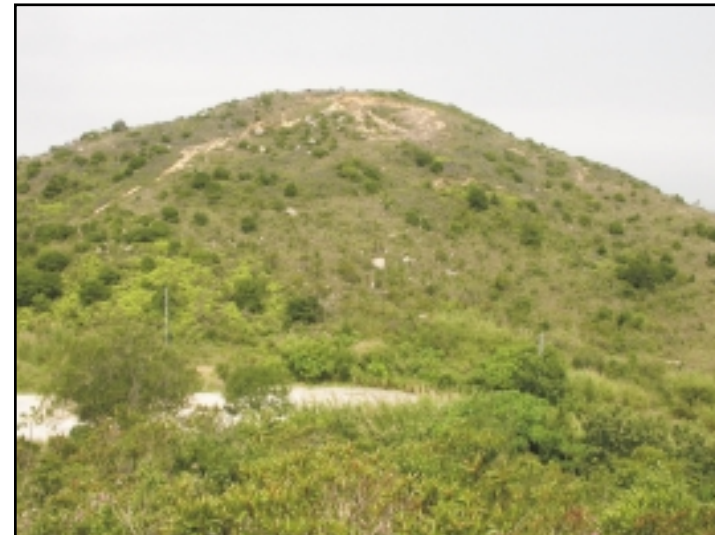
Figure 5.14

Project area located adjacent to the 275kV Cable Route

Project area was dominated by shrubby grassland. Littering and dumping was recorded on site

Shrubby grassland within the project area was dominated by *Ischaemum aristatum*

Project area dominated by shrubby grassland

The habitats recorded in the Project Area were mainly shrubland with a small patch of shrubby grassland (*Figures 5.14 & 5.15*). The shrubland and shrubby grassland were under human disturbance such as littering, dumping and hill fire. The shrubland has a canopy of about 1.5 meters in height dominated by native species such as *Rhodomyrtus tomentosa*, *Embelia laeta* and *Cratoxylum cochinchinensis*. The shrubby grassland was 1 m in height and dominated by *Ischaemum aristatum*. A total of 25 plant species were recorded within the Project Area. All of the recorded plant species are common or very common in Hong Kong.

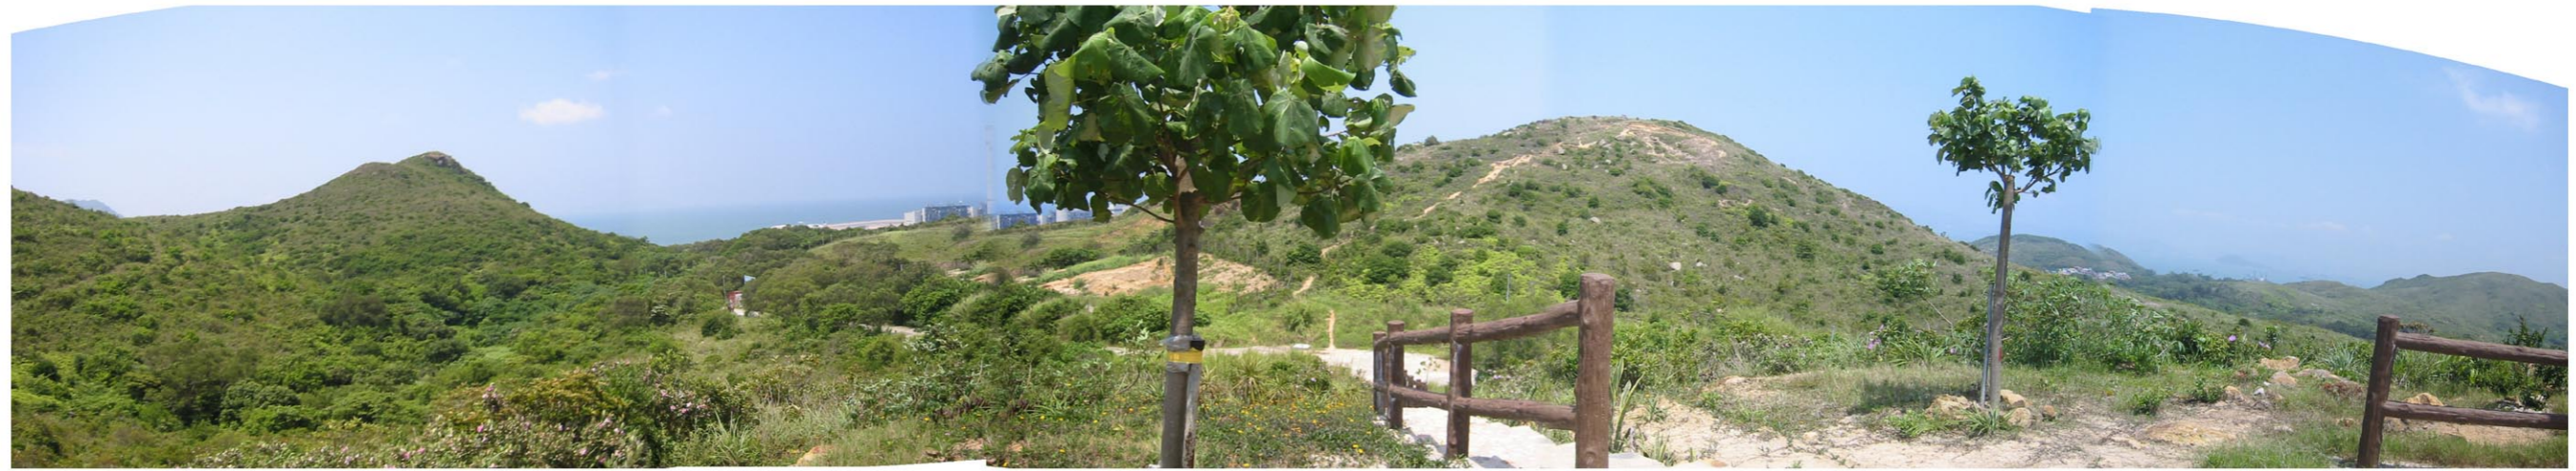
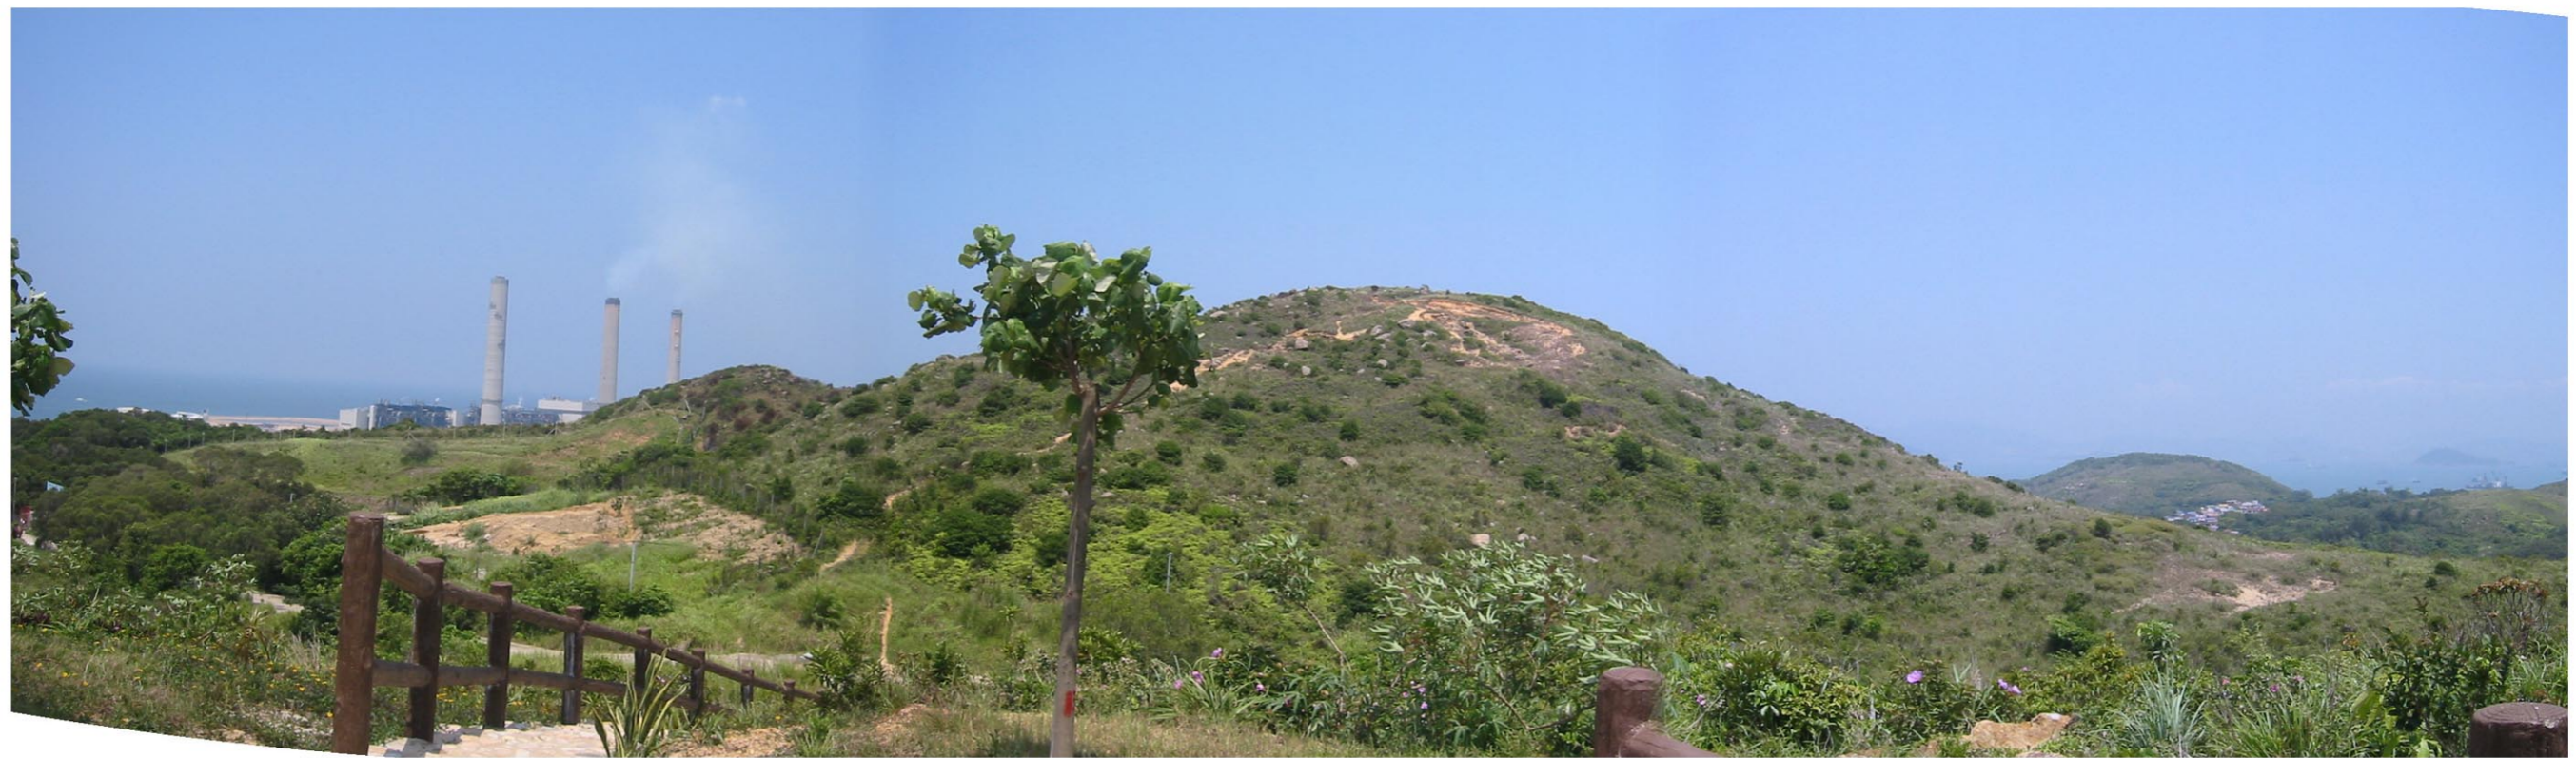
Figure 6.4 - Topography of Existing Landscape Character Area

The topography of this area consists of rolling and sometimes hilly ridges, spurs and hillsides with isolated boulders and crags protruding above the scattered trees/tree clumps, woodland scrub and grasslands (*Figure 6.4*). It tends to be steeper on the eastern slopes which fall directly to the east lamma channel. The area is undeveloped except for small villages at Lo Tik Wan (*Figure 6.5*). Western slopes, in comparison, are criss-crossed by footpaths and a trail between Yung Shue Wan and Sok Kwu Wan. The slopes are also traversed by a 5.5m wide cable trench running from the power station to the sea off Luk Chau Wan in the south and Pak Kok in the north. Hills are of a similar height, ranging from 138mPD at Pak Kok Shan in the north to 135 mPD in the south. Landuse within the hills is characterised by pockets of semi-abandoned fields and village development (*Figure 6.6*), a service reservoir in the centre and the Lamma Island Youth Hostel to the south.

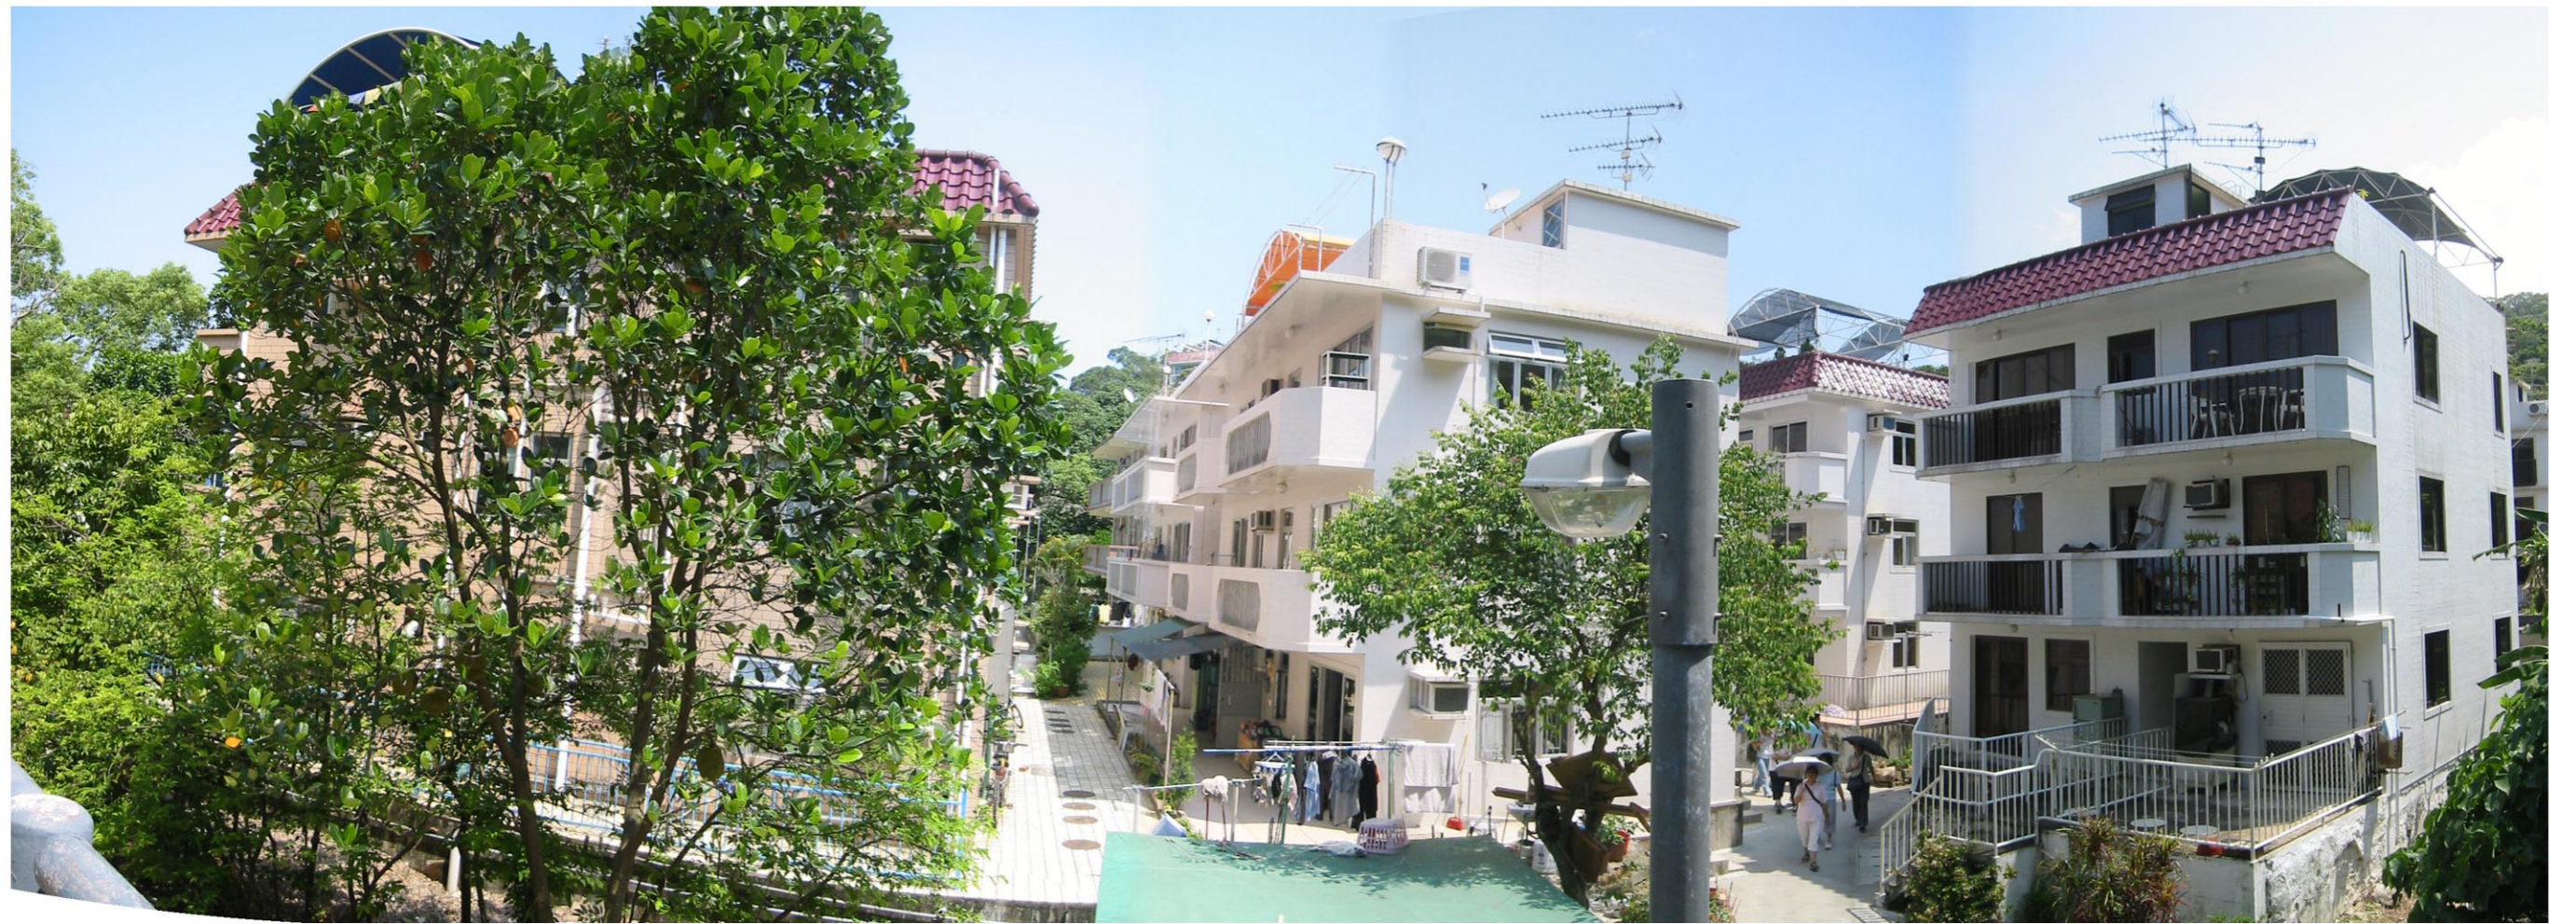
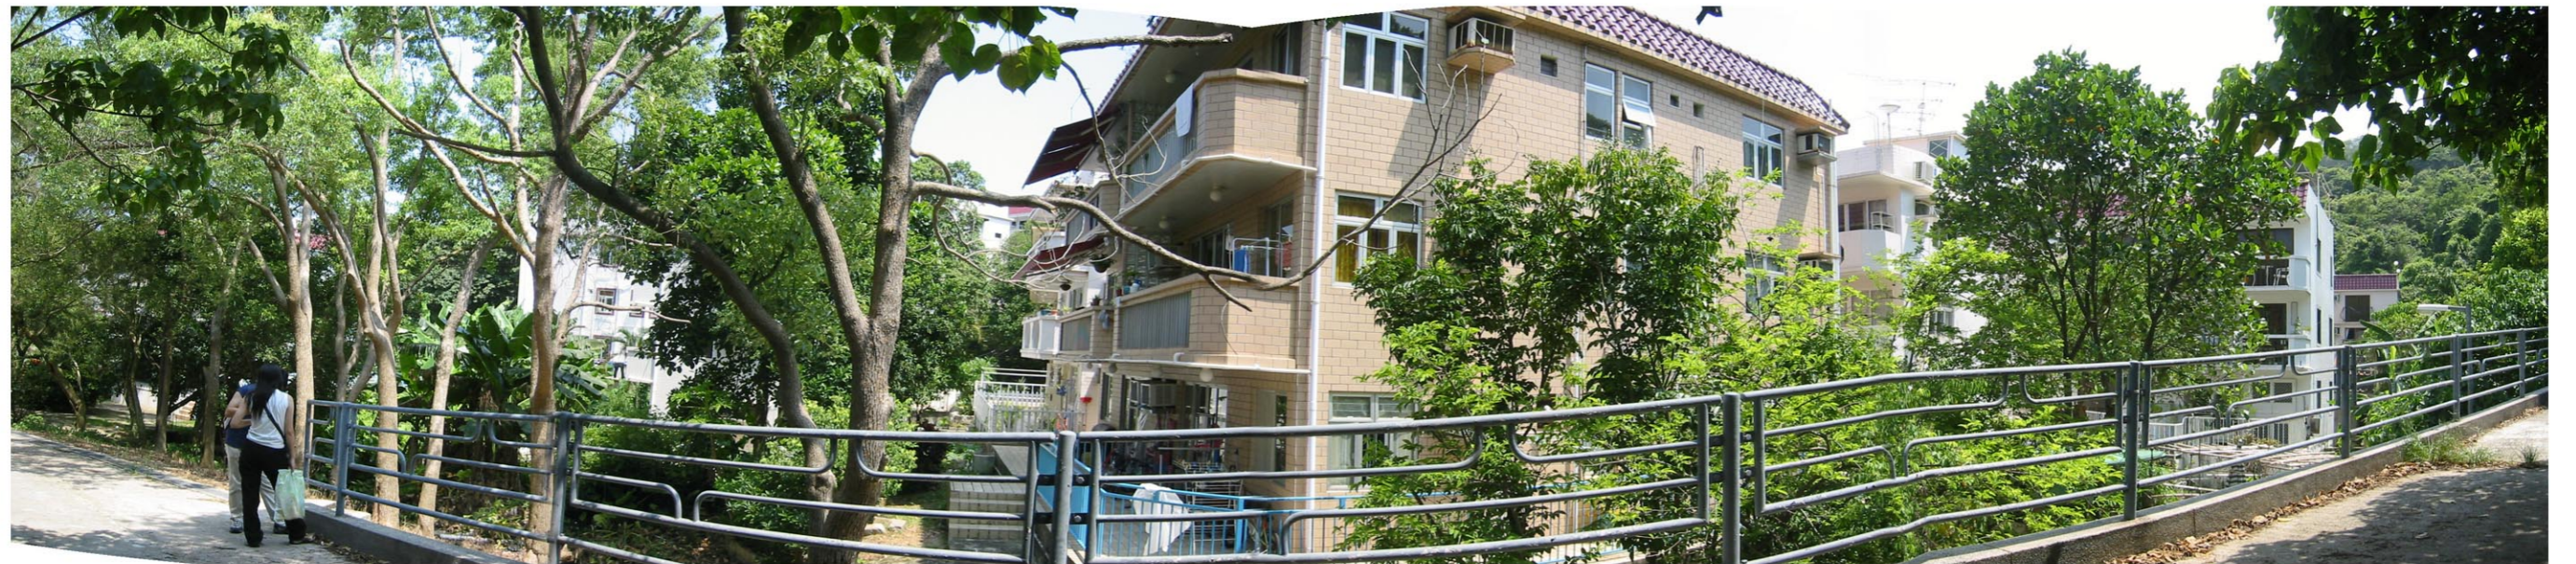
Figure 6.6 - Village Development within LCA1

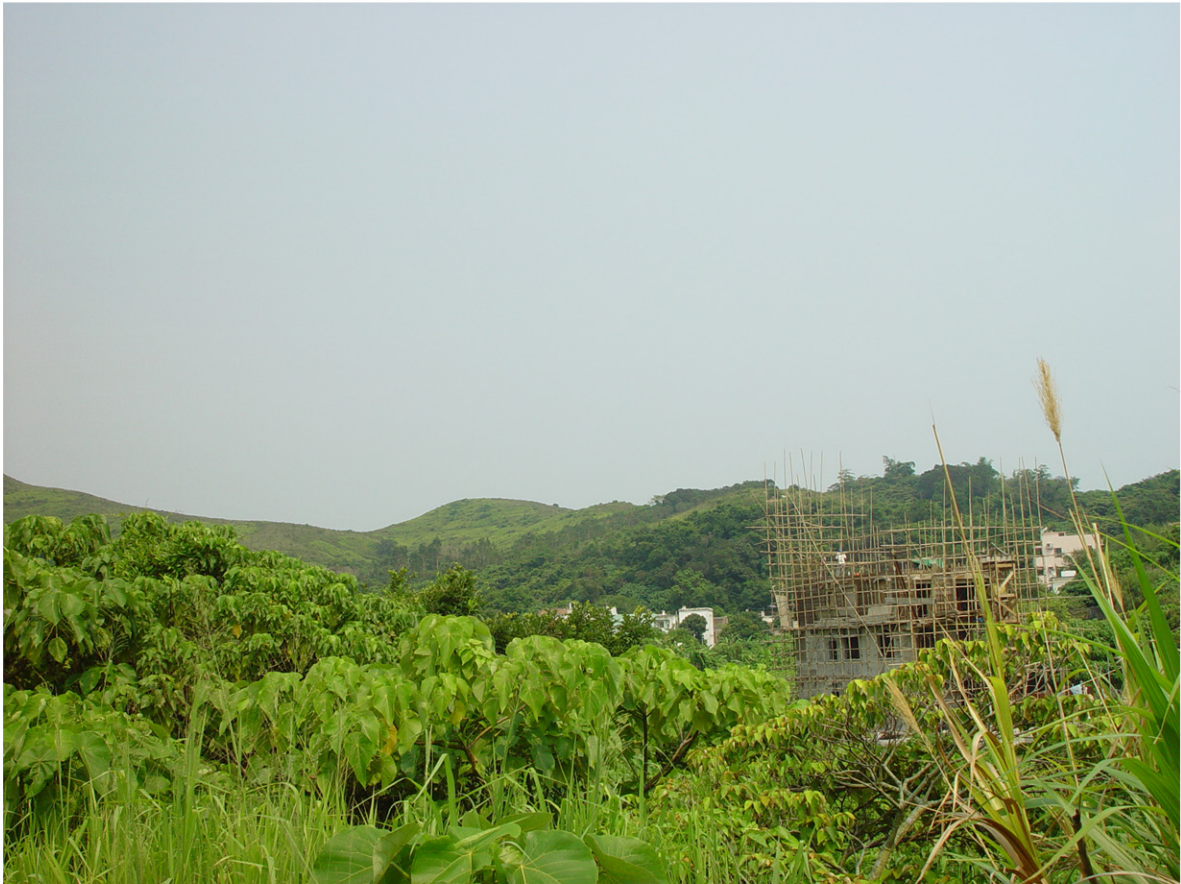
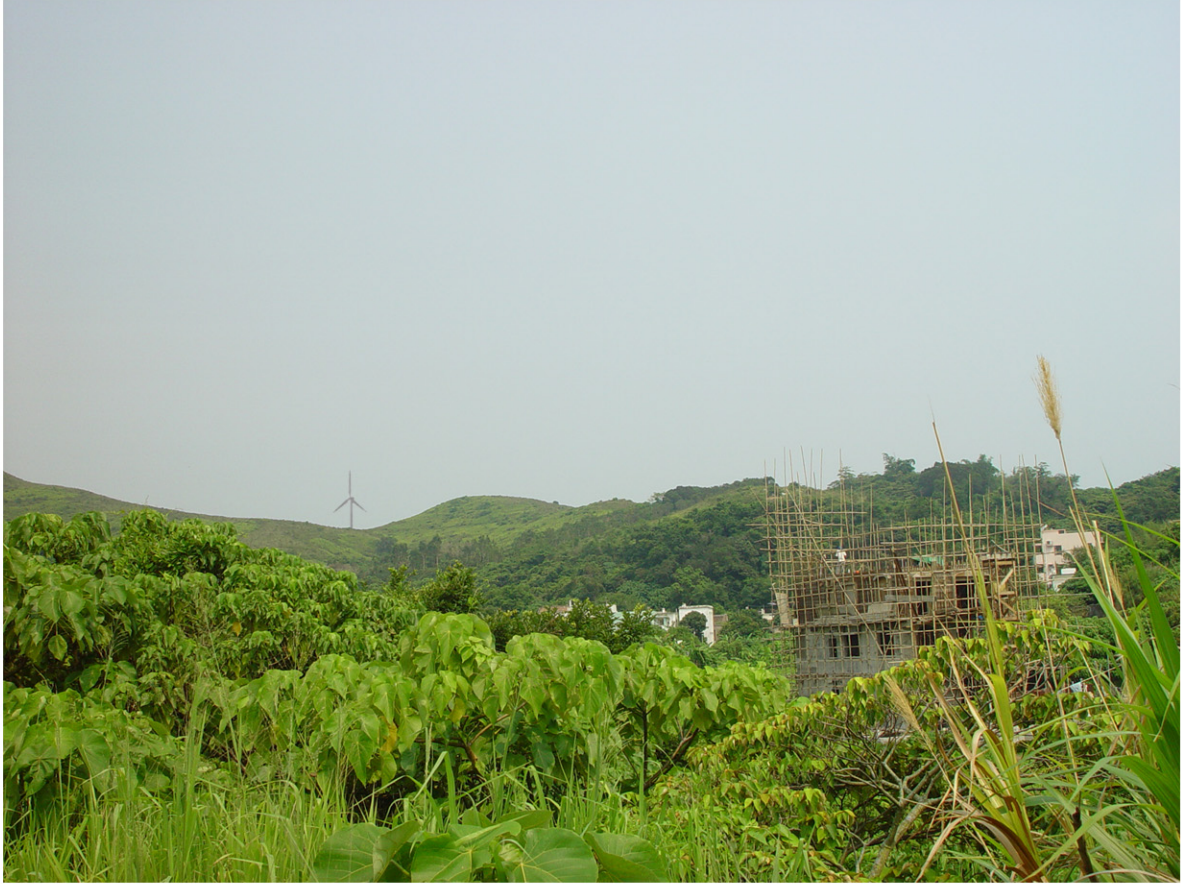
Figure 6.7 - VSR1 View from Pak Kok San Tsuen (over 1km)

Figure 6.7.1 - Existing View

Figure 6.7.2 - Future View

However, the proposed wind turbine would be visible from the villages of Pak Kok San Tsuen, the beaches of Tai Wan To and the nearby Long Tsai Tsuen and the pier of Yung Shu Wan, with a middle ground view from a distance within 1.3 km. In addition, the proposed wind turbine would also be visible to the hikers on the relatively higher ridgelines of the Lamma Island hiking trails and one of the four pavilions along the hiking route between Yung She Wan and Sok Kwu Wan. Existing views are shown in *Figures 6.7 to 6.11*.

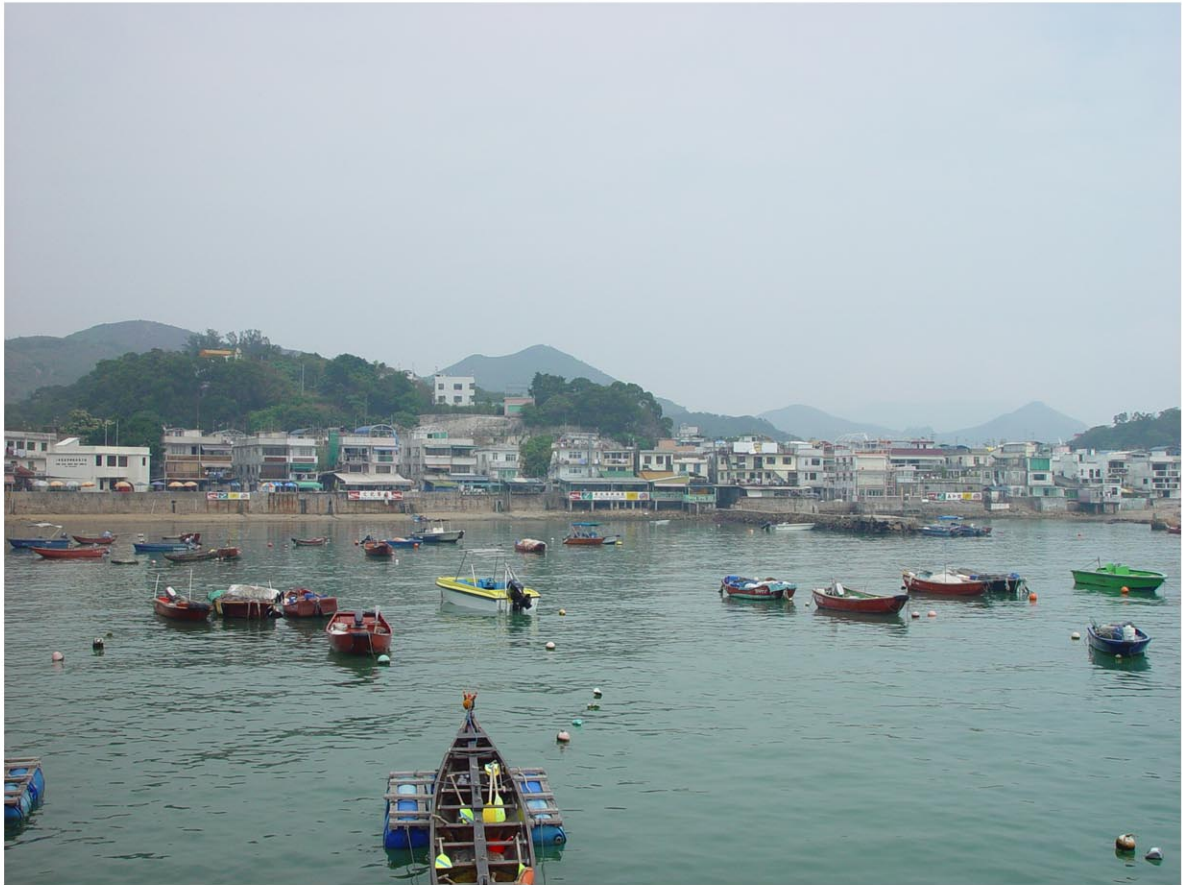
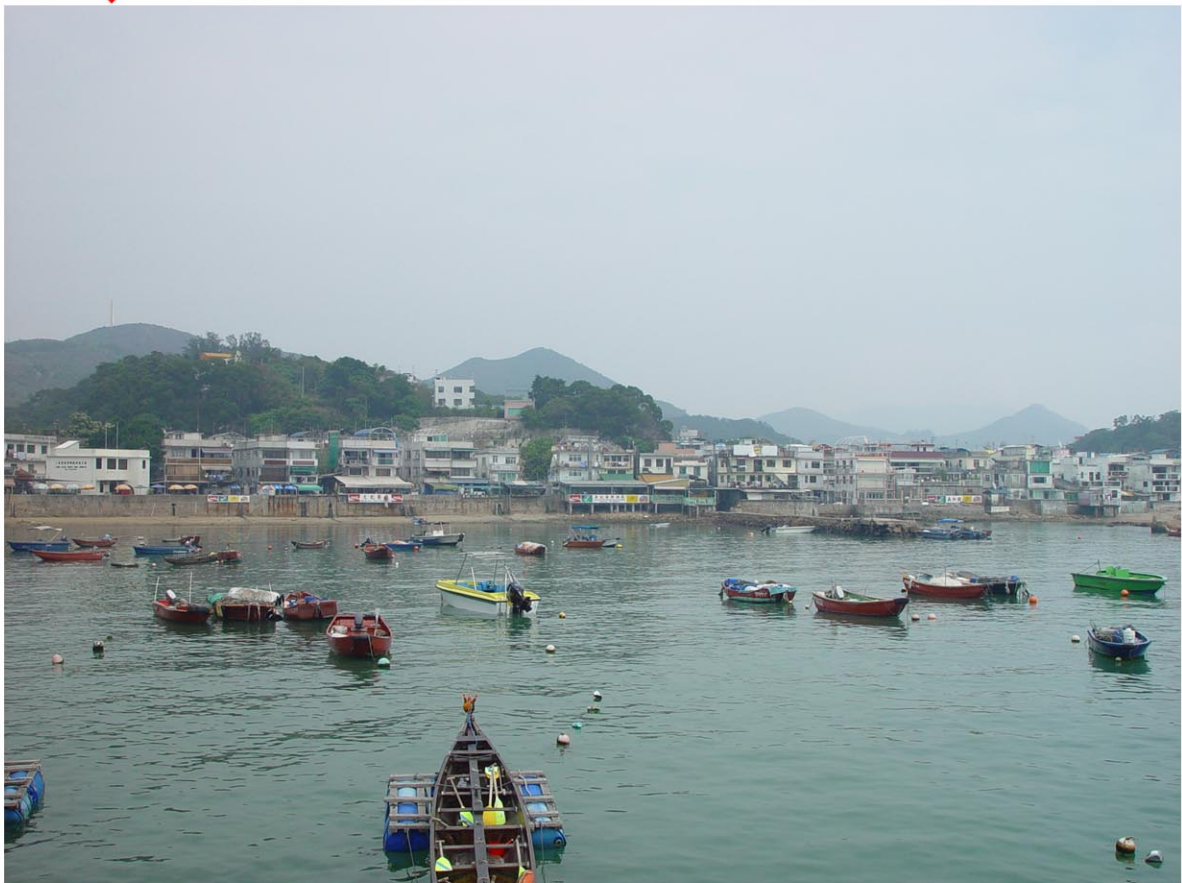
Figure 6.8 - VSR2 View from Yung Shu Wan Pier/Shu Po New Village/
Sha Po Old Village/Tai Yuen Village (over 1km)

Figure 6.8.1 - Existing View

Figure 6.8.2 - Future View

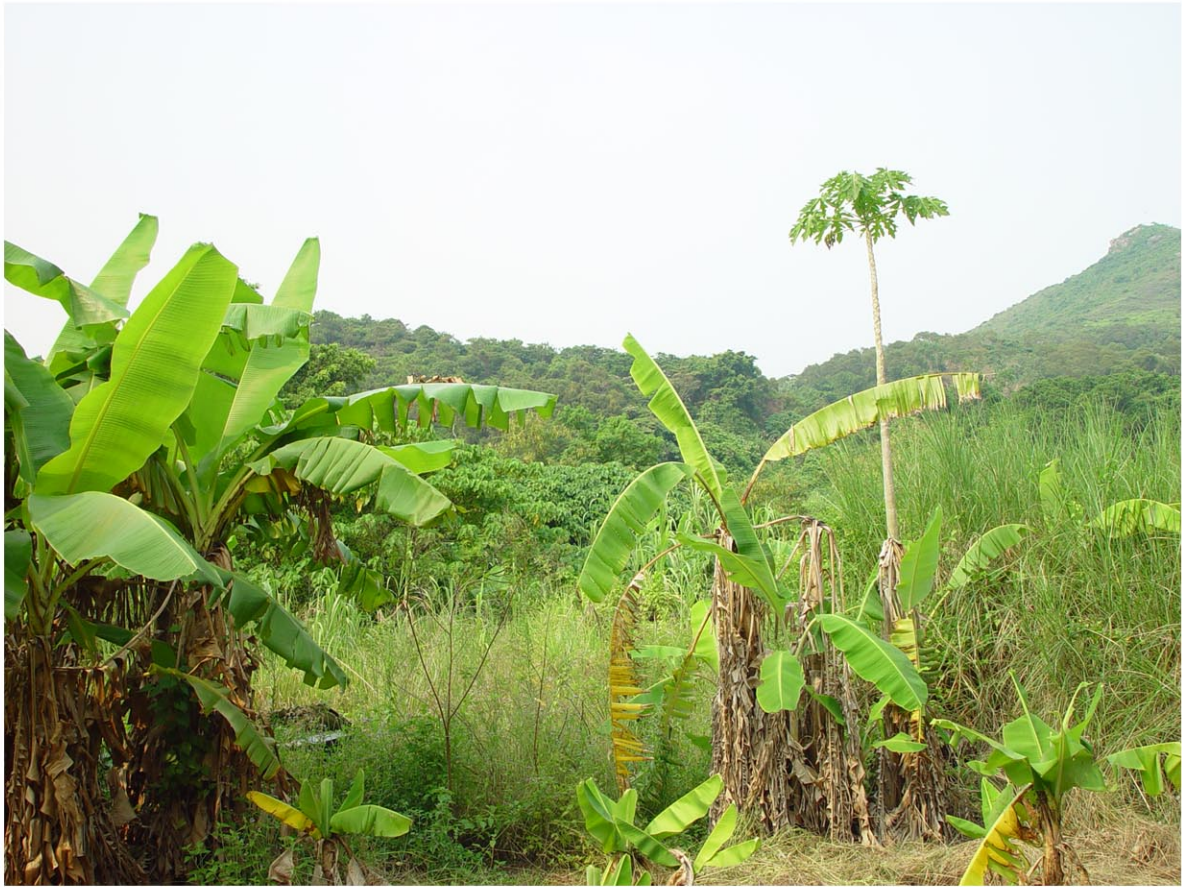
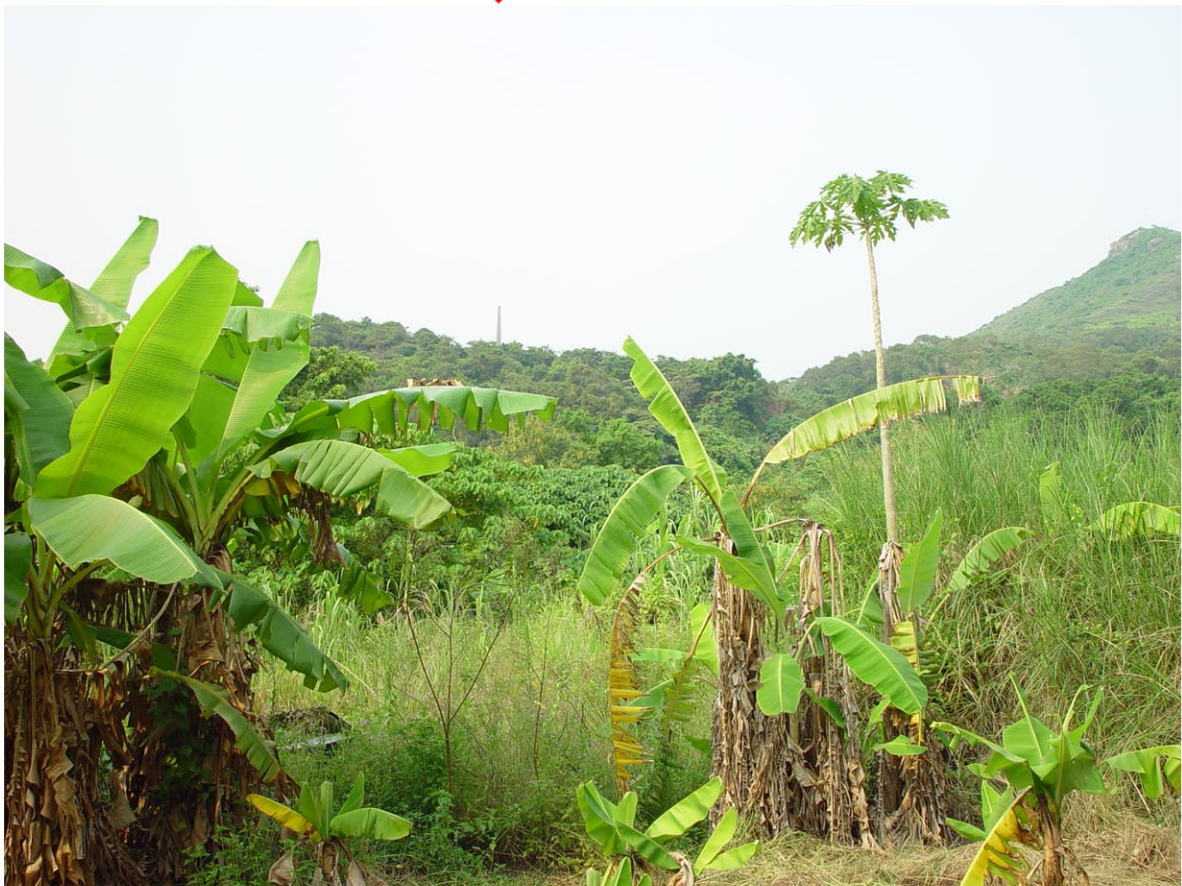
Figure 6.9 - VSR3 View from Tai Wan To (750m)

Figure 6.9.1 - Existing View

Figure 6.9.2 - Future View

VSR	Name	Nature of Viewer Group/ no. of receivers	Distance to Proposed Works	Analysis of view towards proposed development Source of impact	Sensitivity to change and visual intrusion
VSR 1	Pak Kok San Tsuen	Residents <i>Approximate number of receivers: small</i>	over 1km	Partially obstructed views with the rotor blades of the wind turbine protruding out on the ridgeline as illustrated in <i>Figure 6.7</i> . <i>Proposed wind turbine</i>	Medium
VSR 2	Yung Shu Wan Pier/Sha Po New Village/Sha Po Old Village/Tai Yuen Village	Residents, passenger & boat travellers <i>Approximate number of receivers: small</i>	over 1km	Partially obstructed views with the rotor blades of the wind turbine protruding out on the ridgeline as illustrated in <i>Figure 6.8</i> . <i>Rotor blades of wind turbine</i>	Medium
VSR 3	Tai Wan To/Long Tsai Tsuen	Hikers and residents in transit <i>Approximate number of receivers: small</i>	750m	Partially obstructed views with the rotor blades of the wind turbine protruding out on the ridgeline as illustrated in <i>Figure 6.9</i> . <i>Rotor blades of wind turbine</i>	Medium

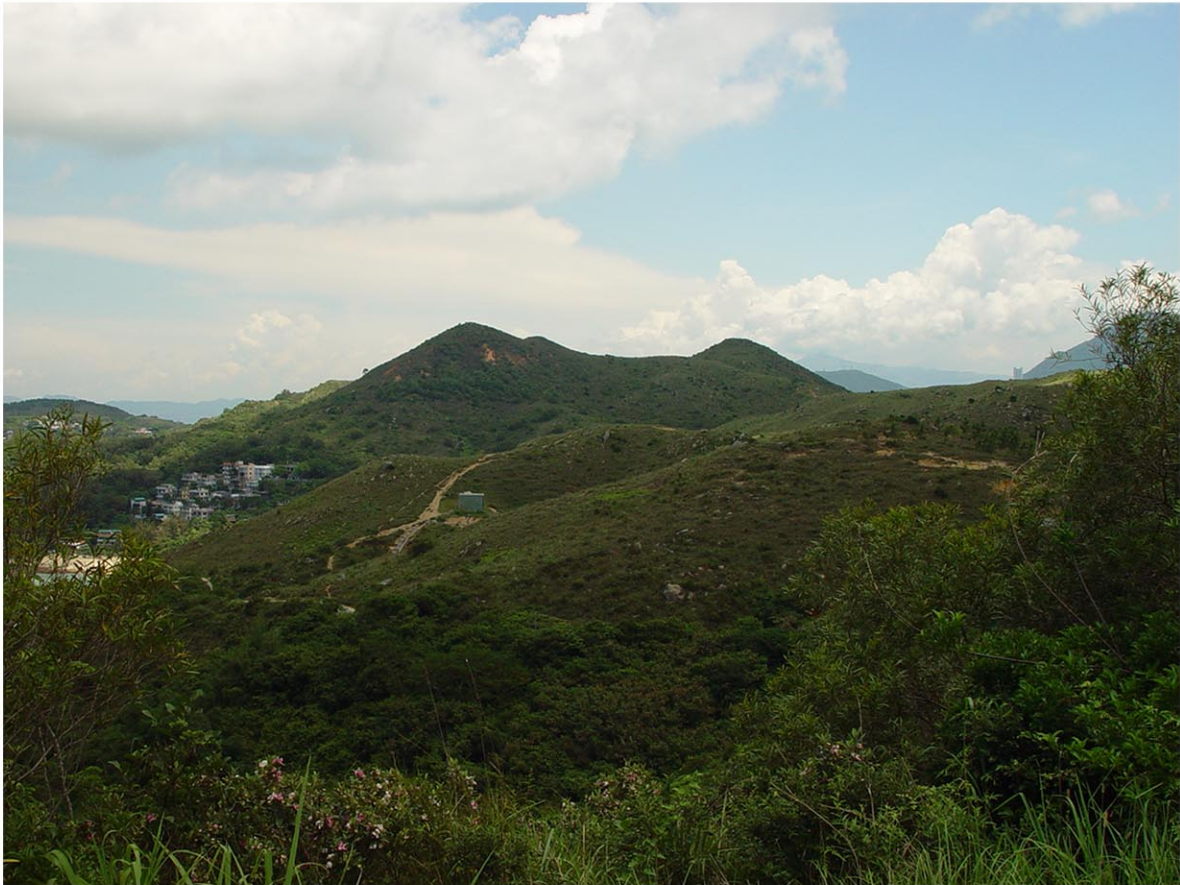
Figure 6.10 - VSR4 View from Hiking Trail on Lamma Island (Pavilion) (over 1.5km)

Figure 6.10.1 - Existing View

VSR 4	Hiking Trail on Lamma Island (Pavilion)	Hikers <i>Approximate number of receivers: small</i>	over 1.5km	Partially obstructed views towards the rotor blades of the wind turbine at the relatively higher points of the trail as illustrated in <i>Figure 6.10</i> and fully obstructed views by the Lamma topographical headland along a large proportion of hiking trail. <i>Rotor blades of wind turbine</i>	Low
VSR 5	Hiking Trail on Lamma Island	Hikers <i>Approximate number of receivers: small</i>	over 2.5km	Partially obstructed views towards the rotor blades of the wind turbine at the relatively higher points of the trail as illustrated in <i>Figure 6.11</i> and fully obstructed views by the Lamma topographical headland along a large proportion of hiking trail. <i>Rotor blades of wind turbine</i>	Low
