Renewable Energy by a Wind
Turbine System on
Lamma Island:
*Final Environmental Impact
Assessment*

The Hongkong Electric Co Ltd

Renewable Energy by a Wind
Turbine System on Lamma Island:
Final Environmental Impact Assessment Report

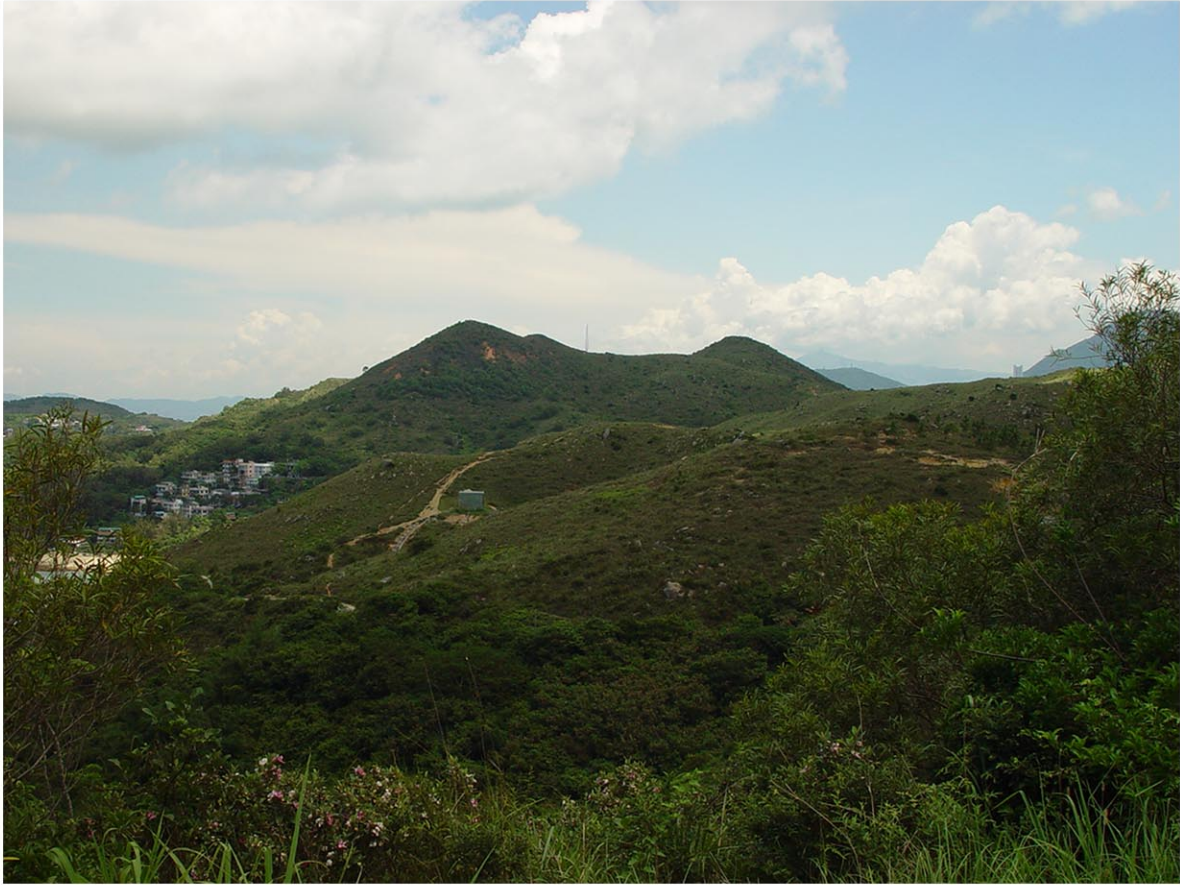
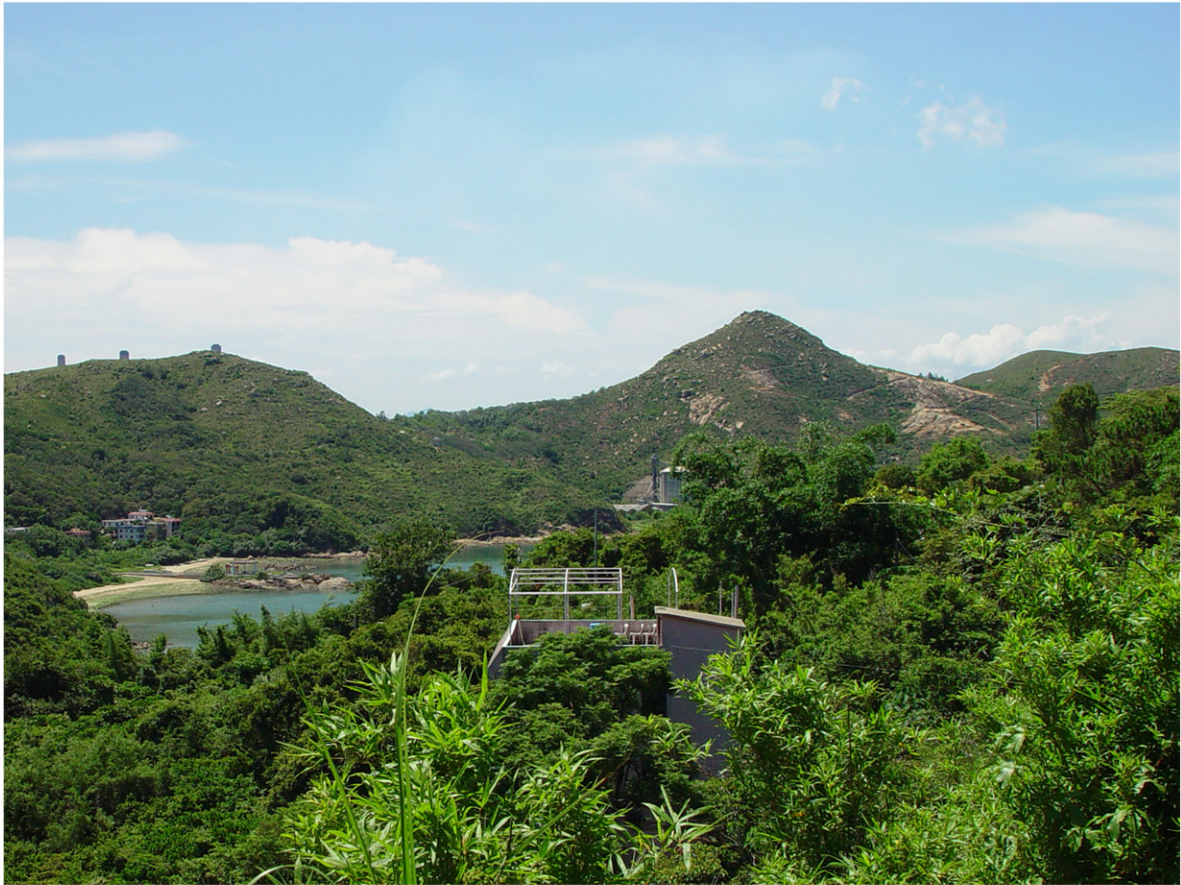
Figure 6.10 - VSR4 View from Hiking Trail on Lamma Island (Pavilion) (over 1.5km)

Figure 6.10.1 - Existing View

Figure 6.10.2 - Future View

VSR 4	Hiking Trail on Lamma Island (Pavilion)	Hikers <i>Approximate number of receivers: small</i>	over 1.5km	Partially obstructed views towards the rotor blades of the wind turbine at the relatively higher points of the trail as illustrated in <i>Figure 6.10</i> and fully obstructed views by the Lamma topographical headland along a large proportion of hiking trail. <i>Rotor blades of wind turbine</i>	Low
VSR 5	Hiking Trail on Lamma Island	Hikers <i>Approximate number of receivers: small</i>	over 2.5km	Partially obstructed views towards the rotor blades of the wind turbine at the relatively higher points of the trail as illustrated in <i>Figure 6.11</i> and fully obstructed views by the Lamma topographical headland along a large proportion of hiking trail. <i>Rotor blades of wind turbine</i>	Low

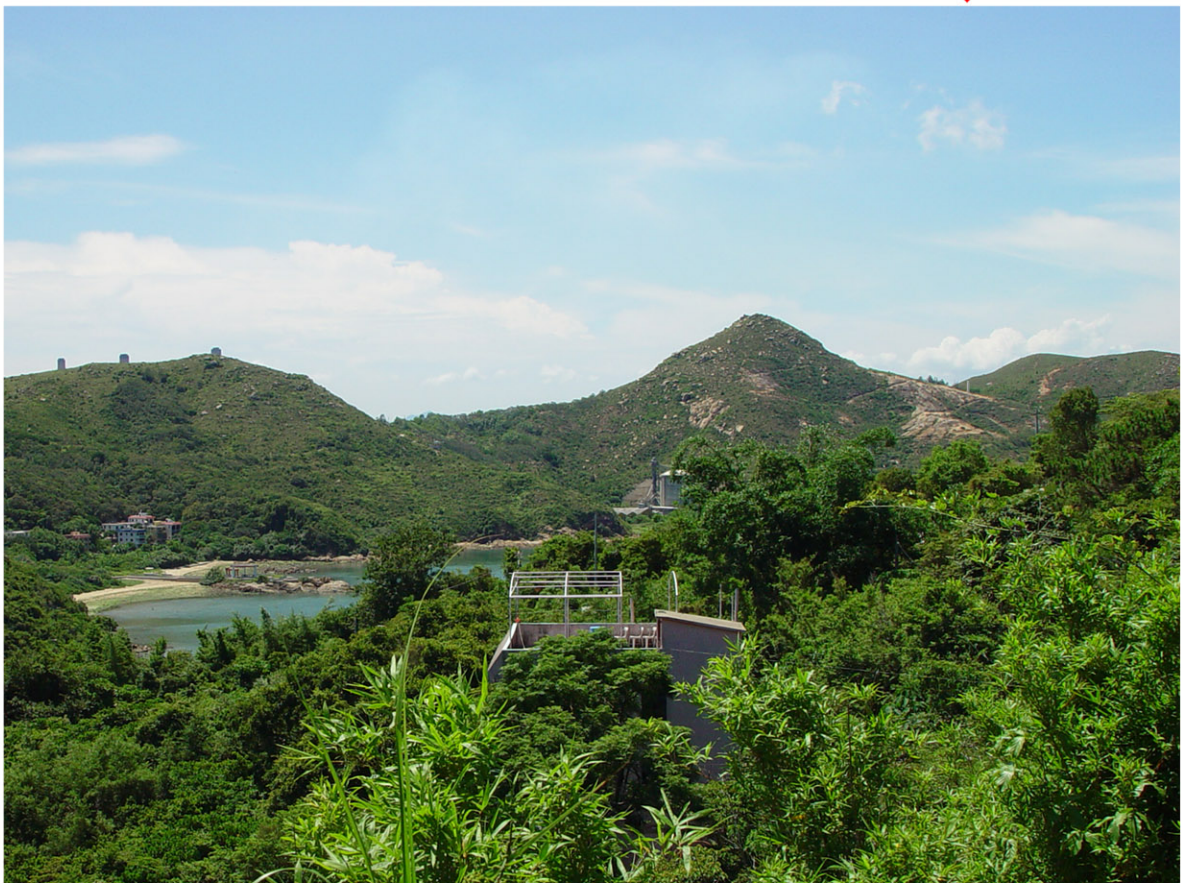
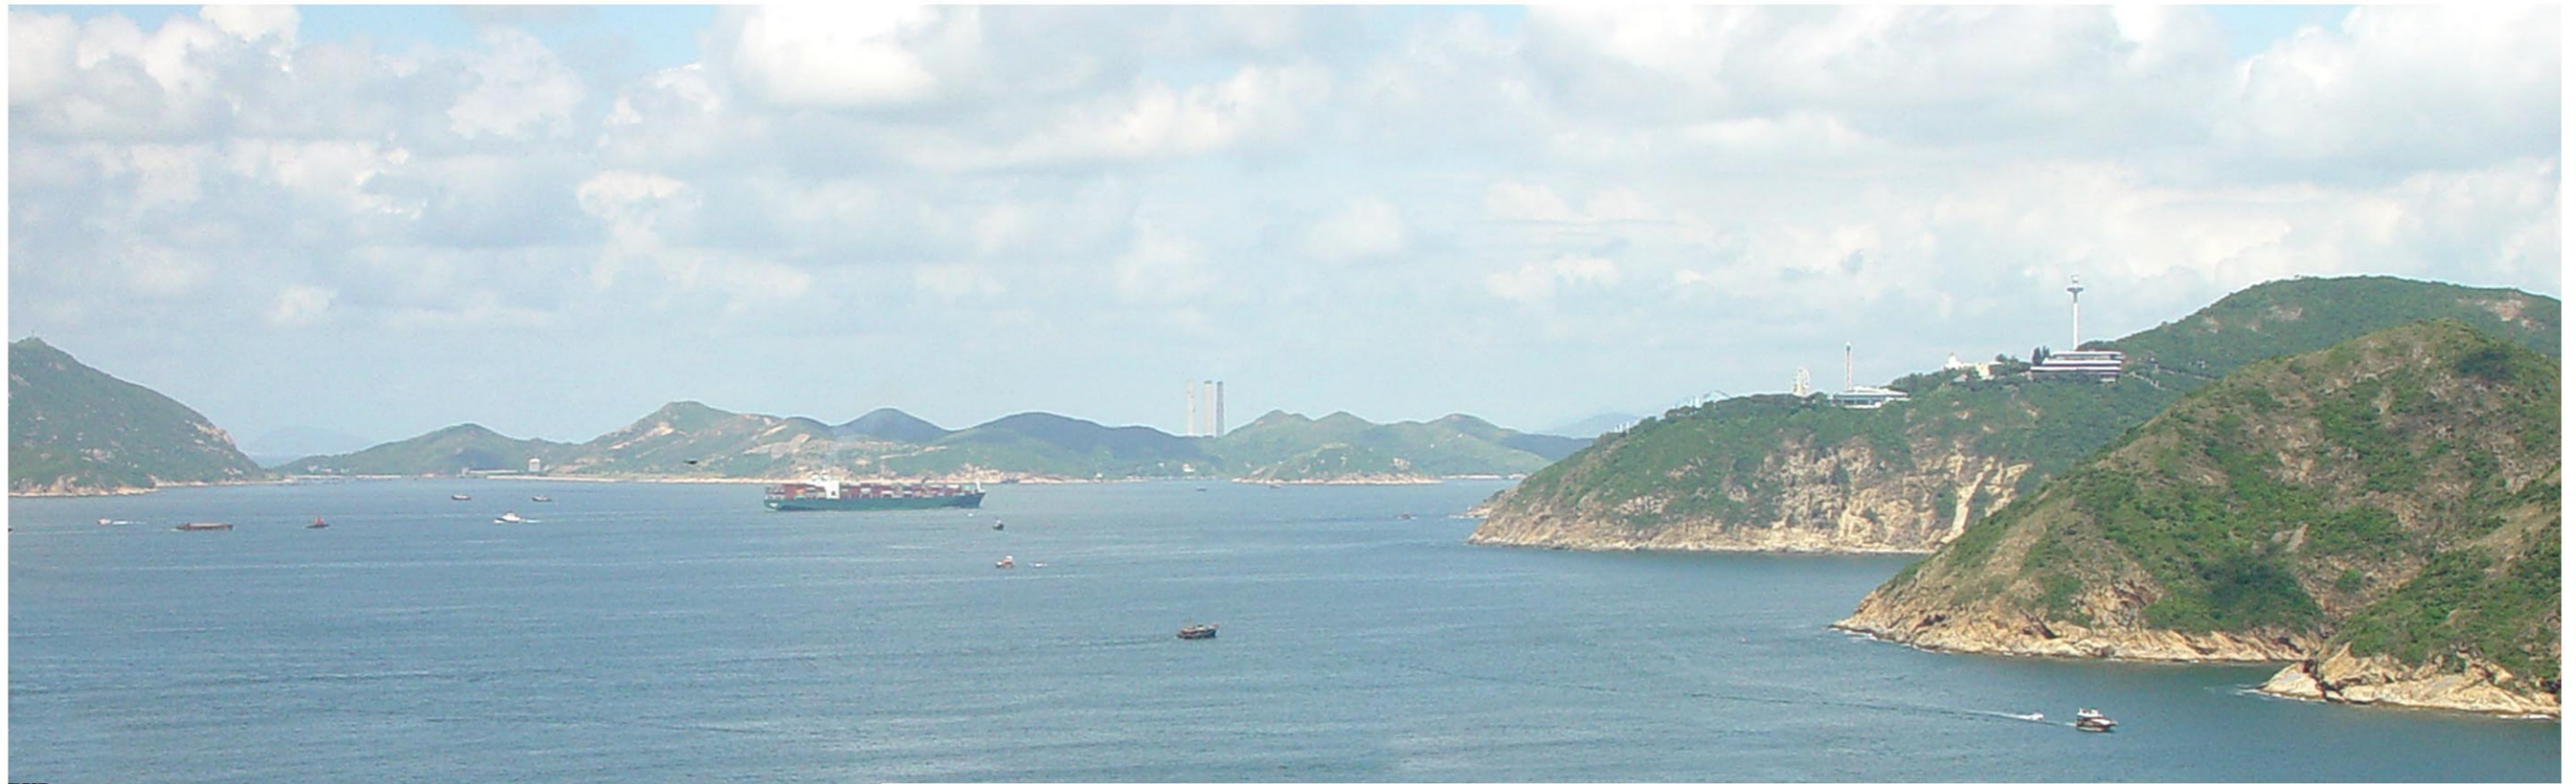
Figure 6.11 - VSR5 View from Hiking Route in Lamma Island(over 2.5km)

Figure 6.11.1 - Existing View

Figure 6.11.2 - Future View

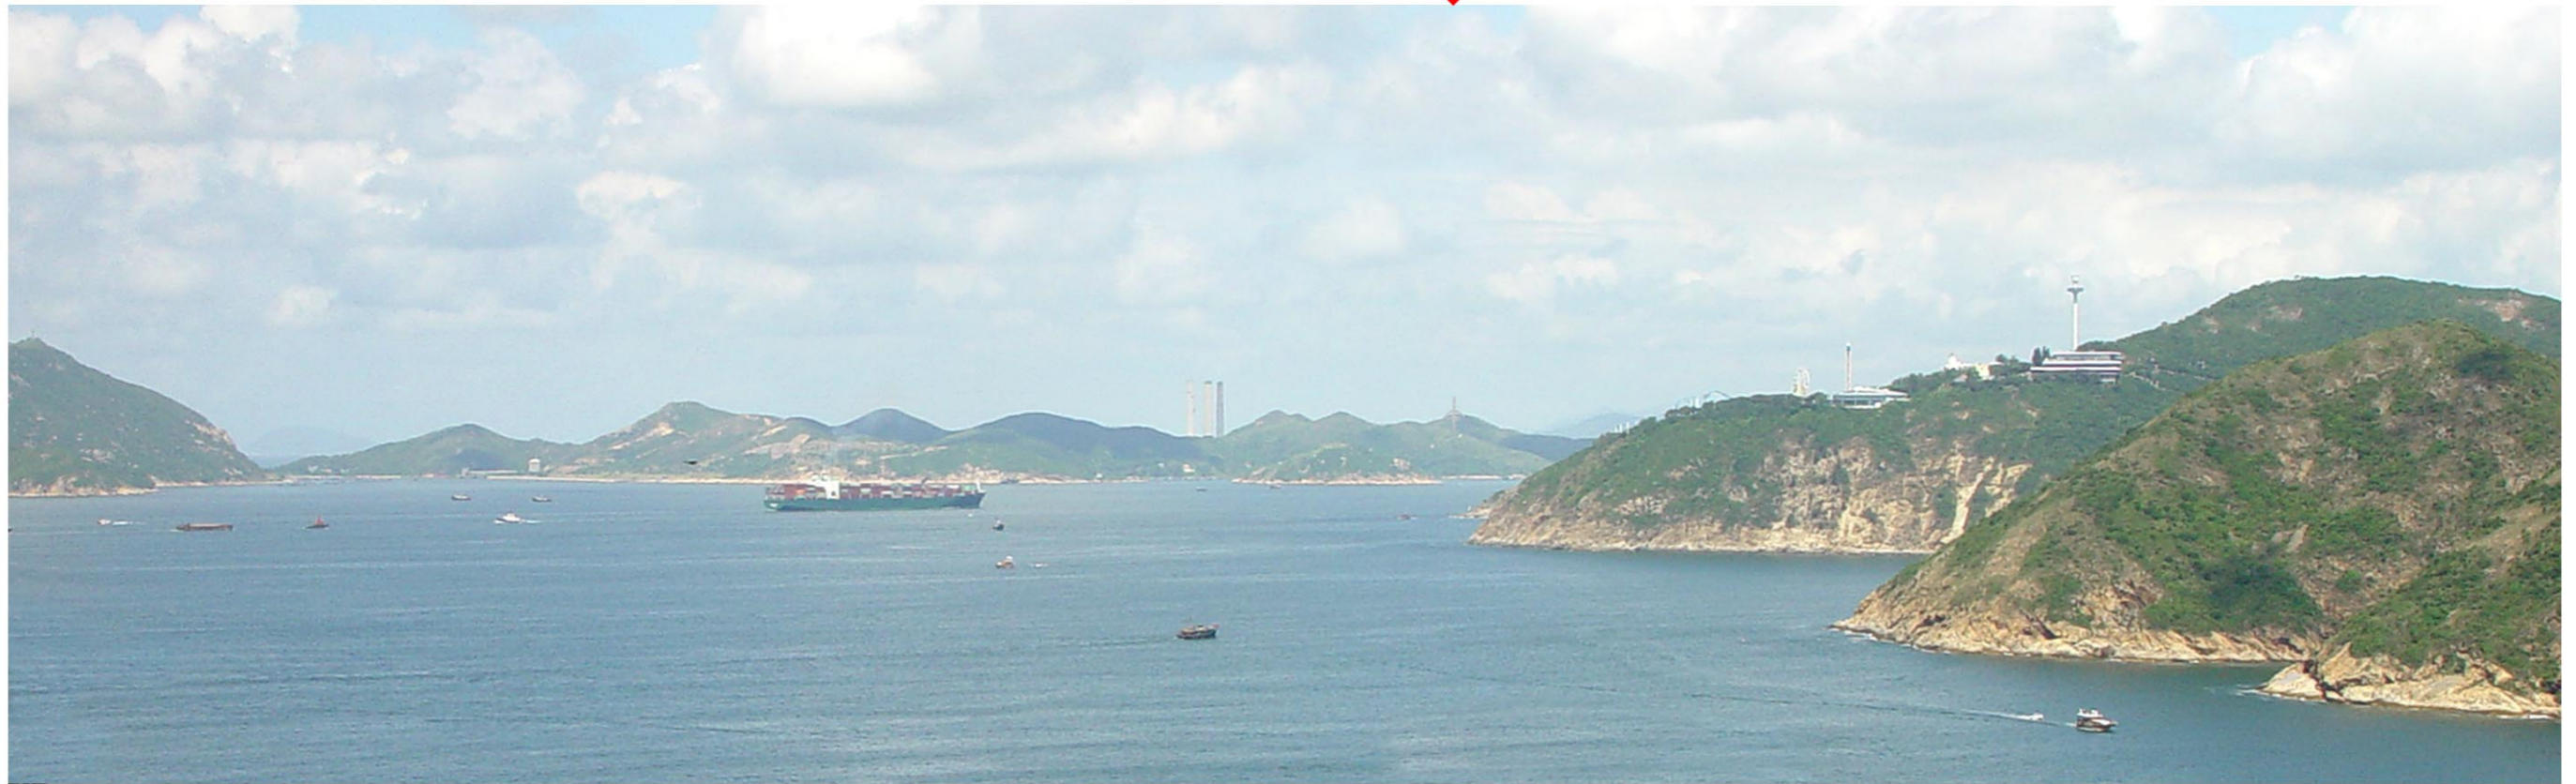
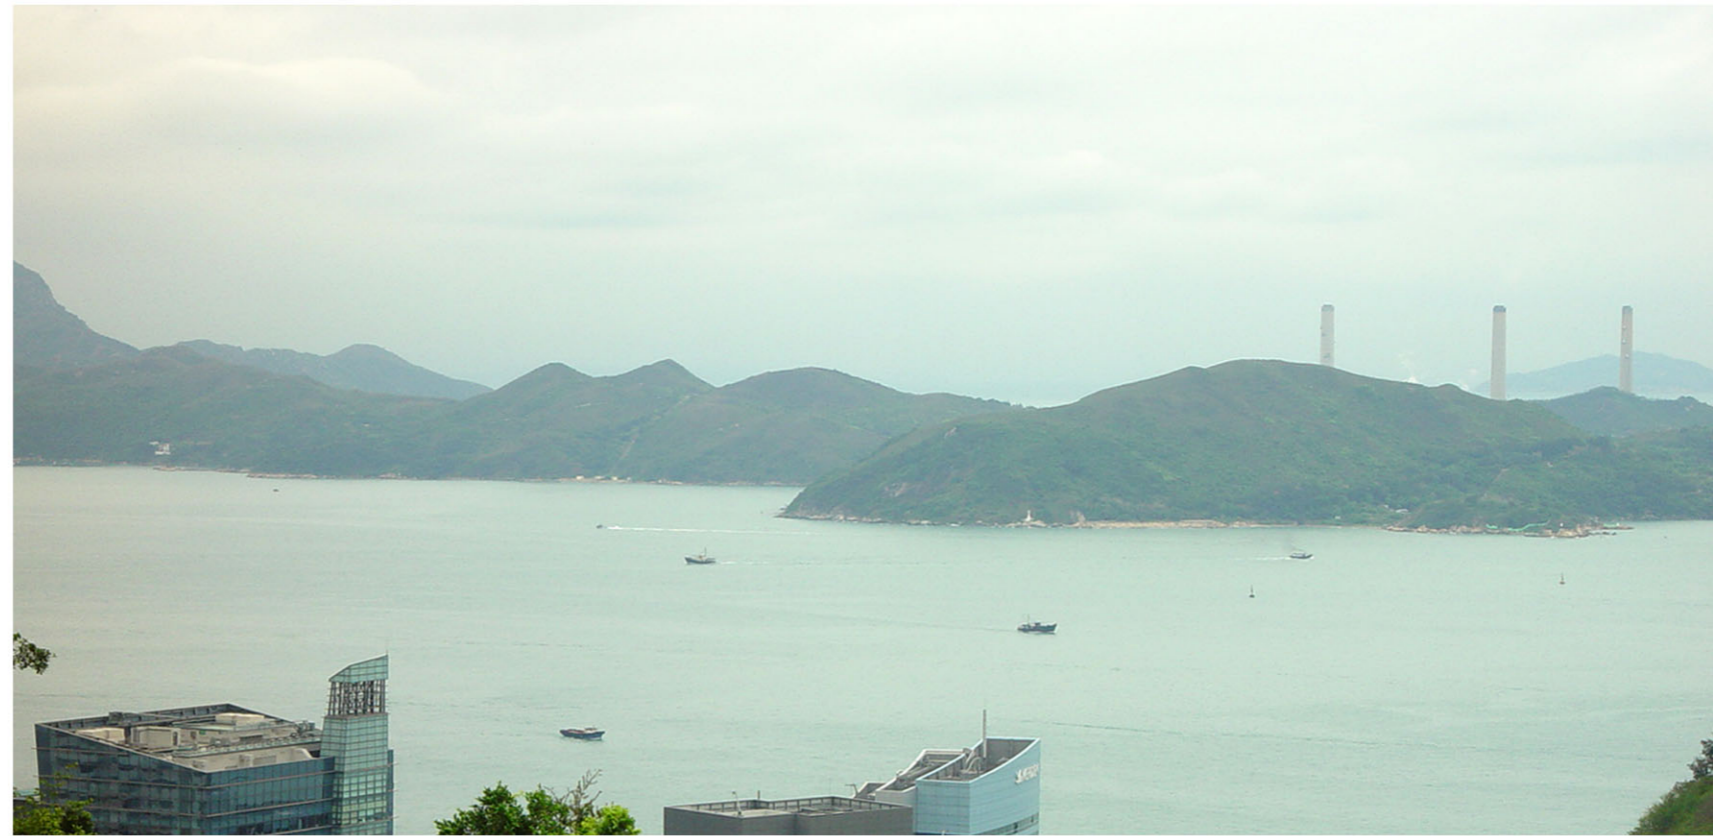
Figure 6.12 - VSR6 View from Repulse Bay(over 8km)

Figure 6.12.1 - Existing View

Figure 6.12.2 - Future View

VSR	Name	Nature of Viewer Group/ no. of receivers	Distance to Proposed Works	Analysis of of view towards proposed development Source of impact	Sensitivity to change and visual intrusion
VSR 6	Repulse Bay	Residents and tourists <i>Approximate number of receivers: Intermediate</i>	over 8km	Open and very distant views towards the upper part of wind turbine which would be relatively very small as illustrated in Figure 6.12. <i>Proposed wind turbine</i>	Medium
VSR 7	Pok Fu Lam Road	Residents <i>Approximate number of receivers: Many</i>	over 4km	Open, unobstructed and distant views towards the wind turbine which would be relatively small as illustrated in Figure 6.13. <i>Proposed wind turbine</i>	High
VSR 8	The Peak	Residents and tourists <i>Approximate number of receivers: Intermediate</i>	over 5km	Open, unobstructed and distant views towards the wind turbine which would be relatively small as illustrated in Figure 6.14. <i>Proposed wind turbine</i>	Medium

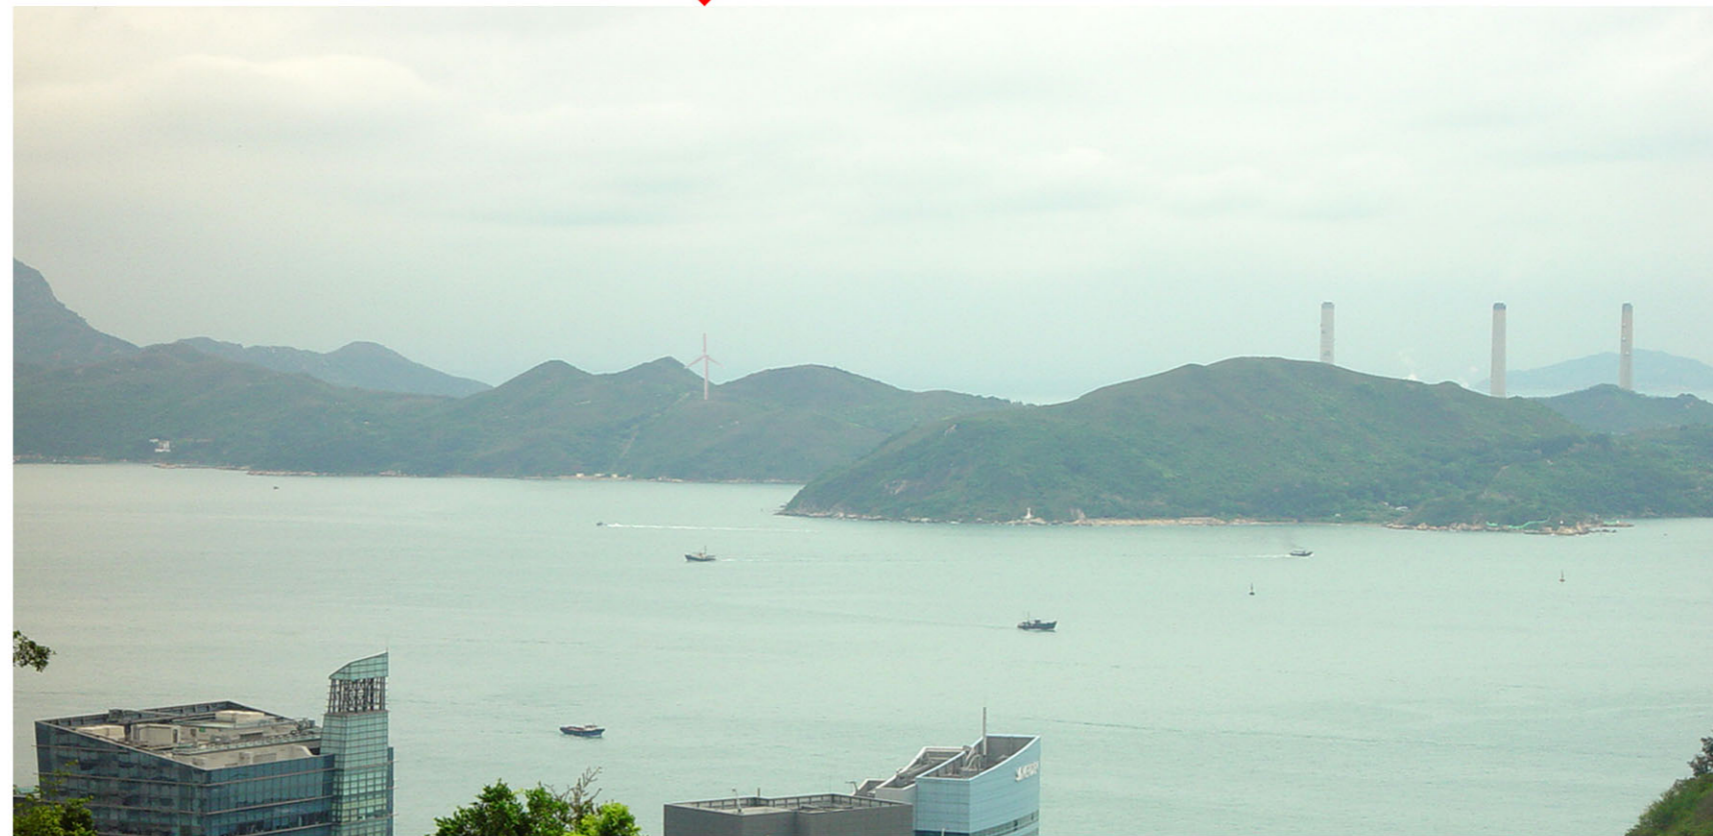
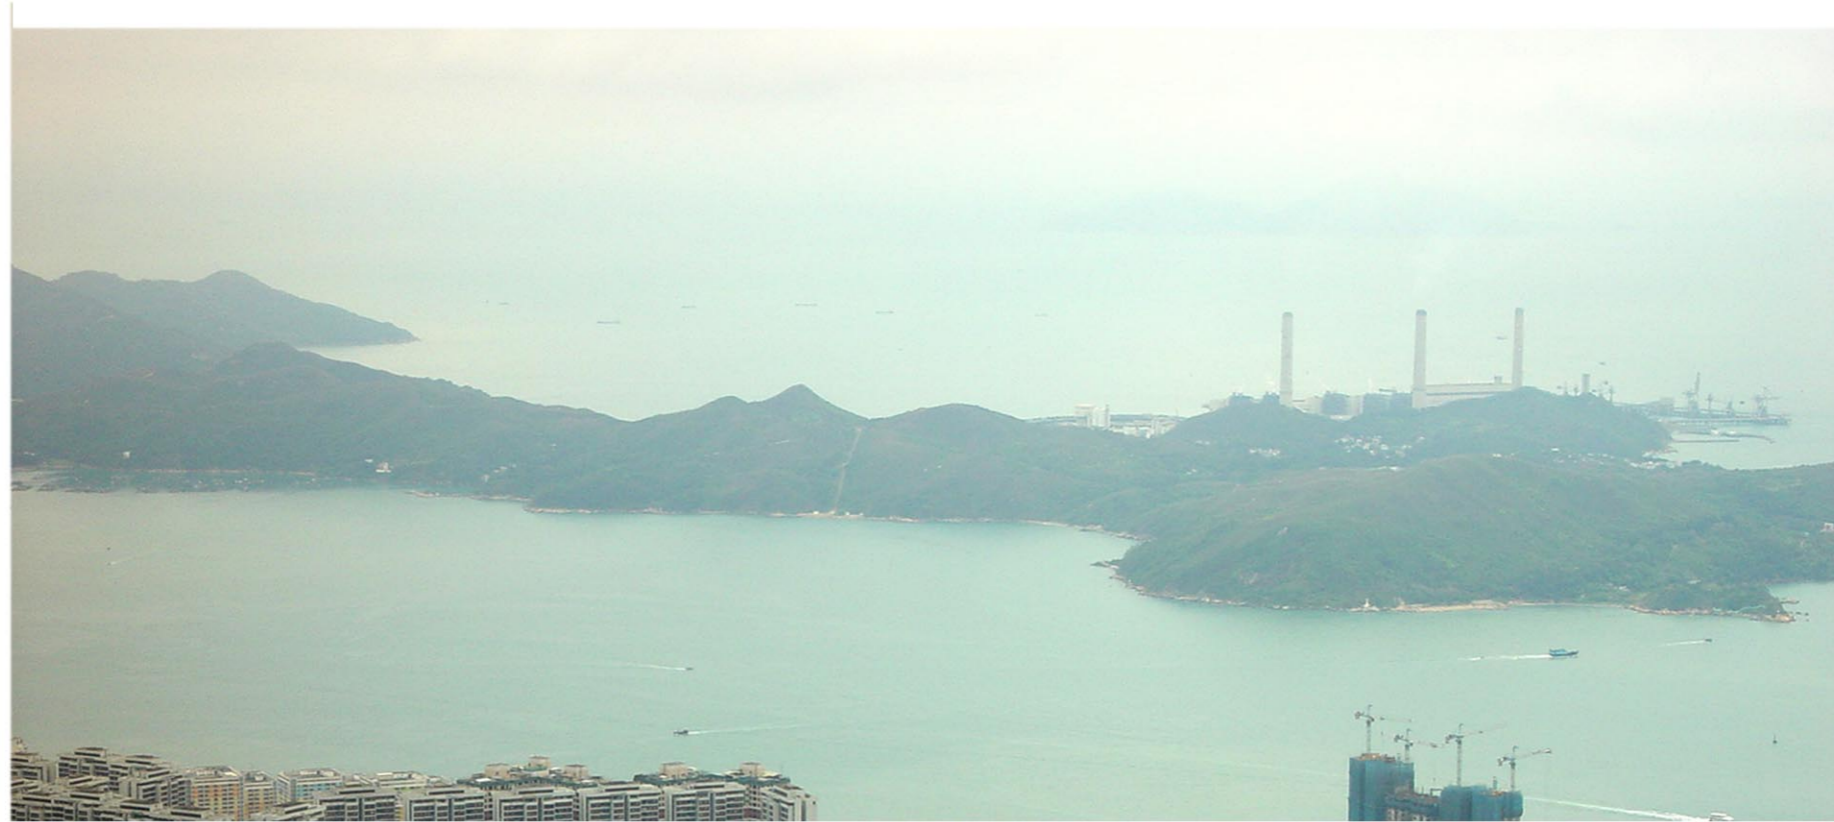
Figure 6.13 - VSR7 View from Pok Fu Lam Road(over 4km)

Figure 6.13.1 - Existing View

Figure 6.13.2 - Future View

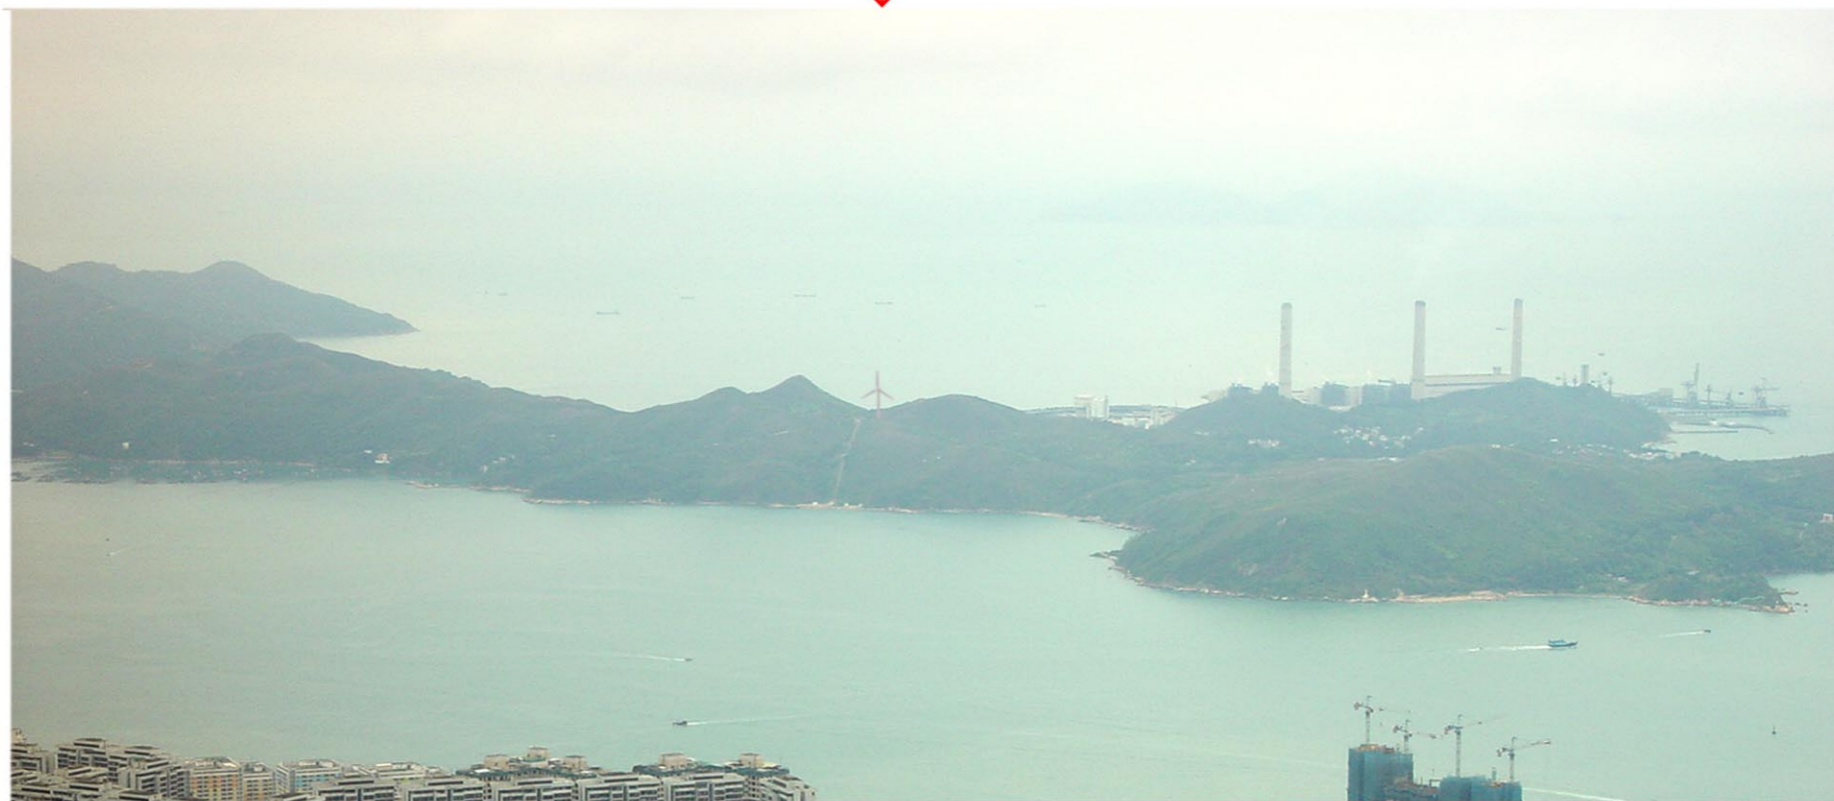
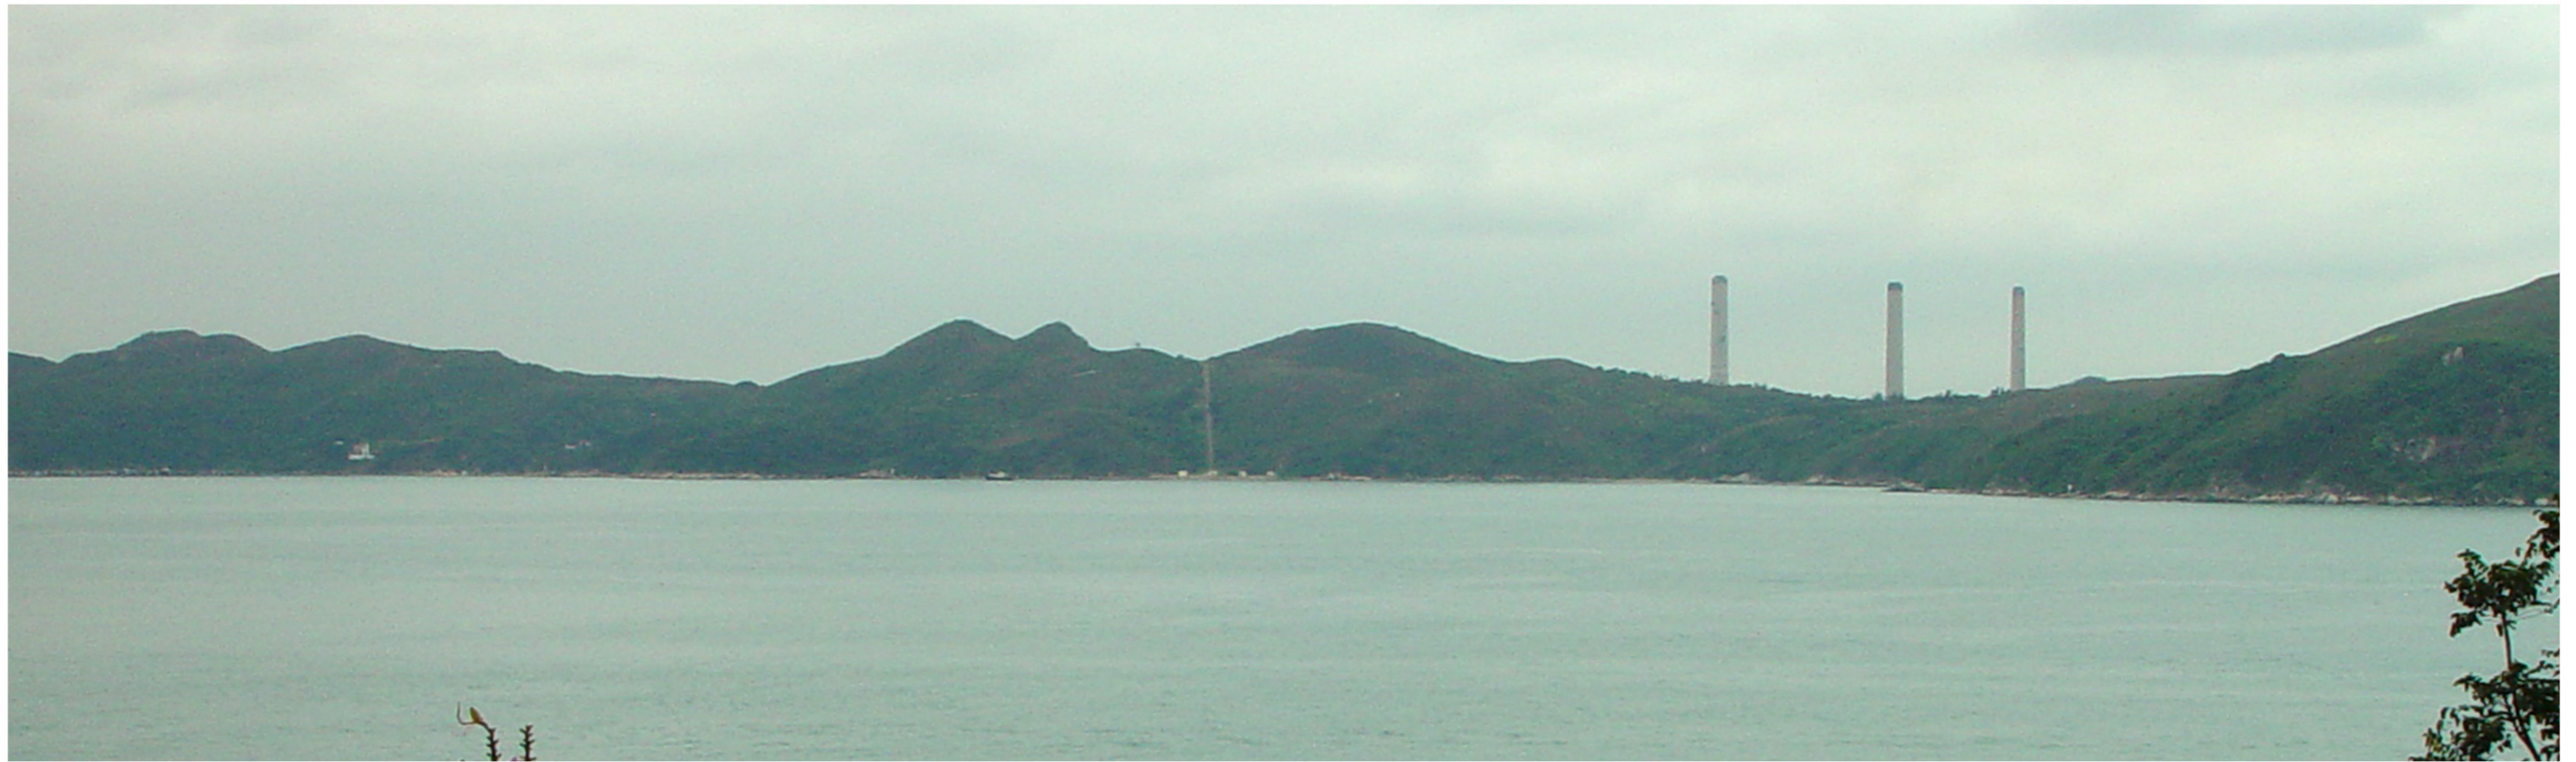
Figure 6.14 - VSR8 View from The Peak (over 5km)

Figure 6.14.1 - Existing View

Figure 6.14.2 - Future View

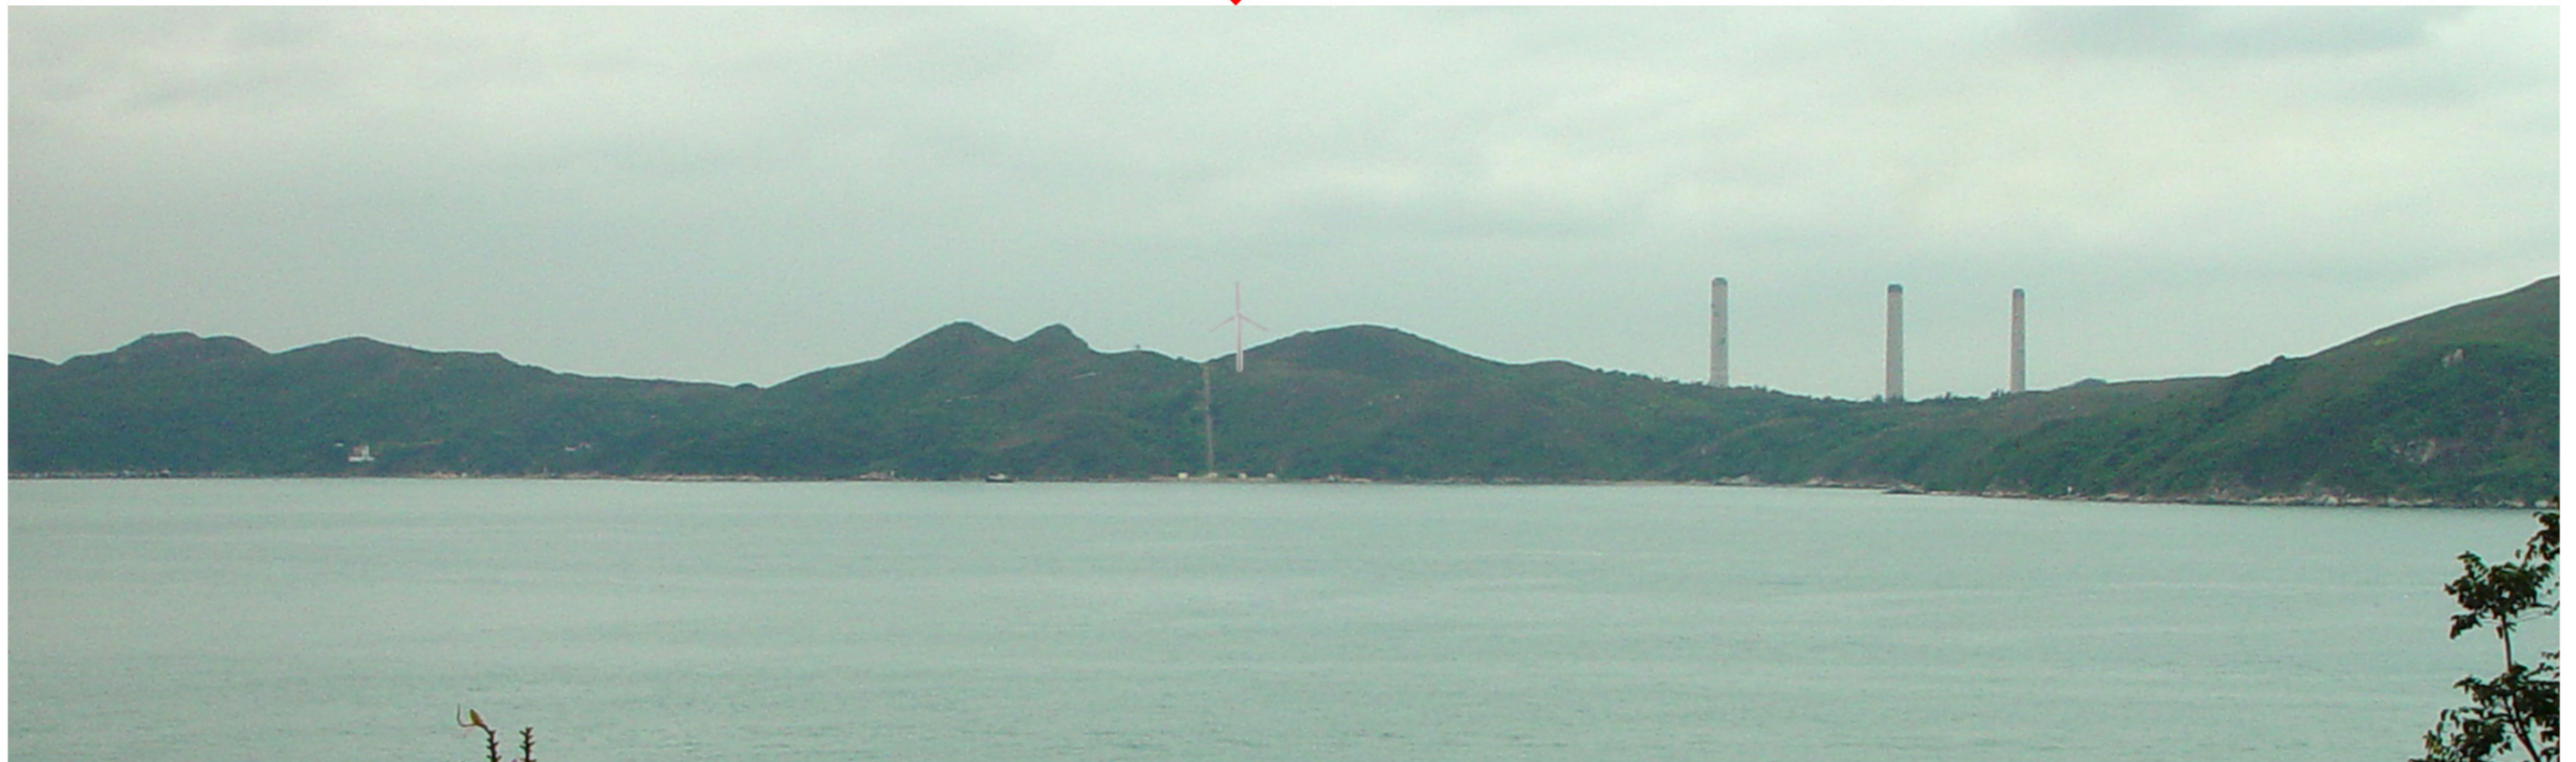
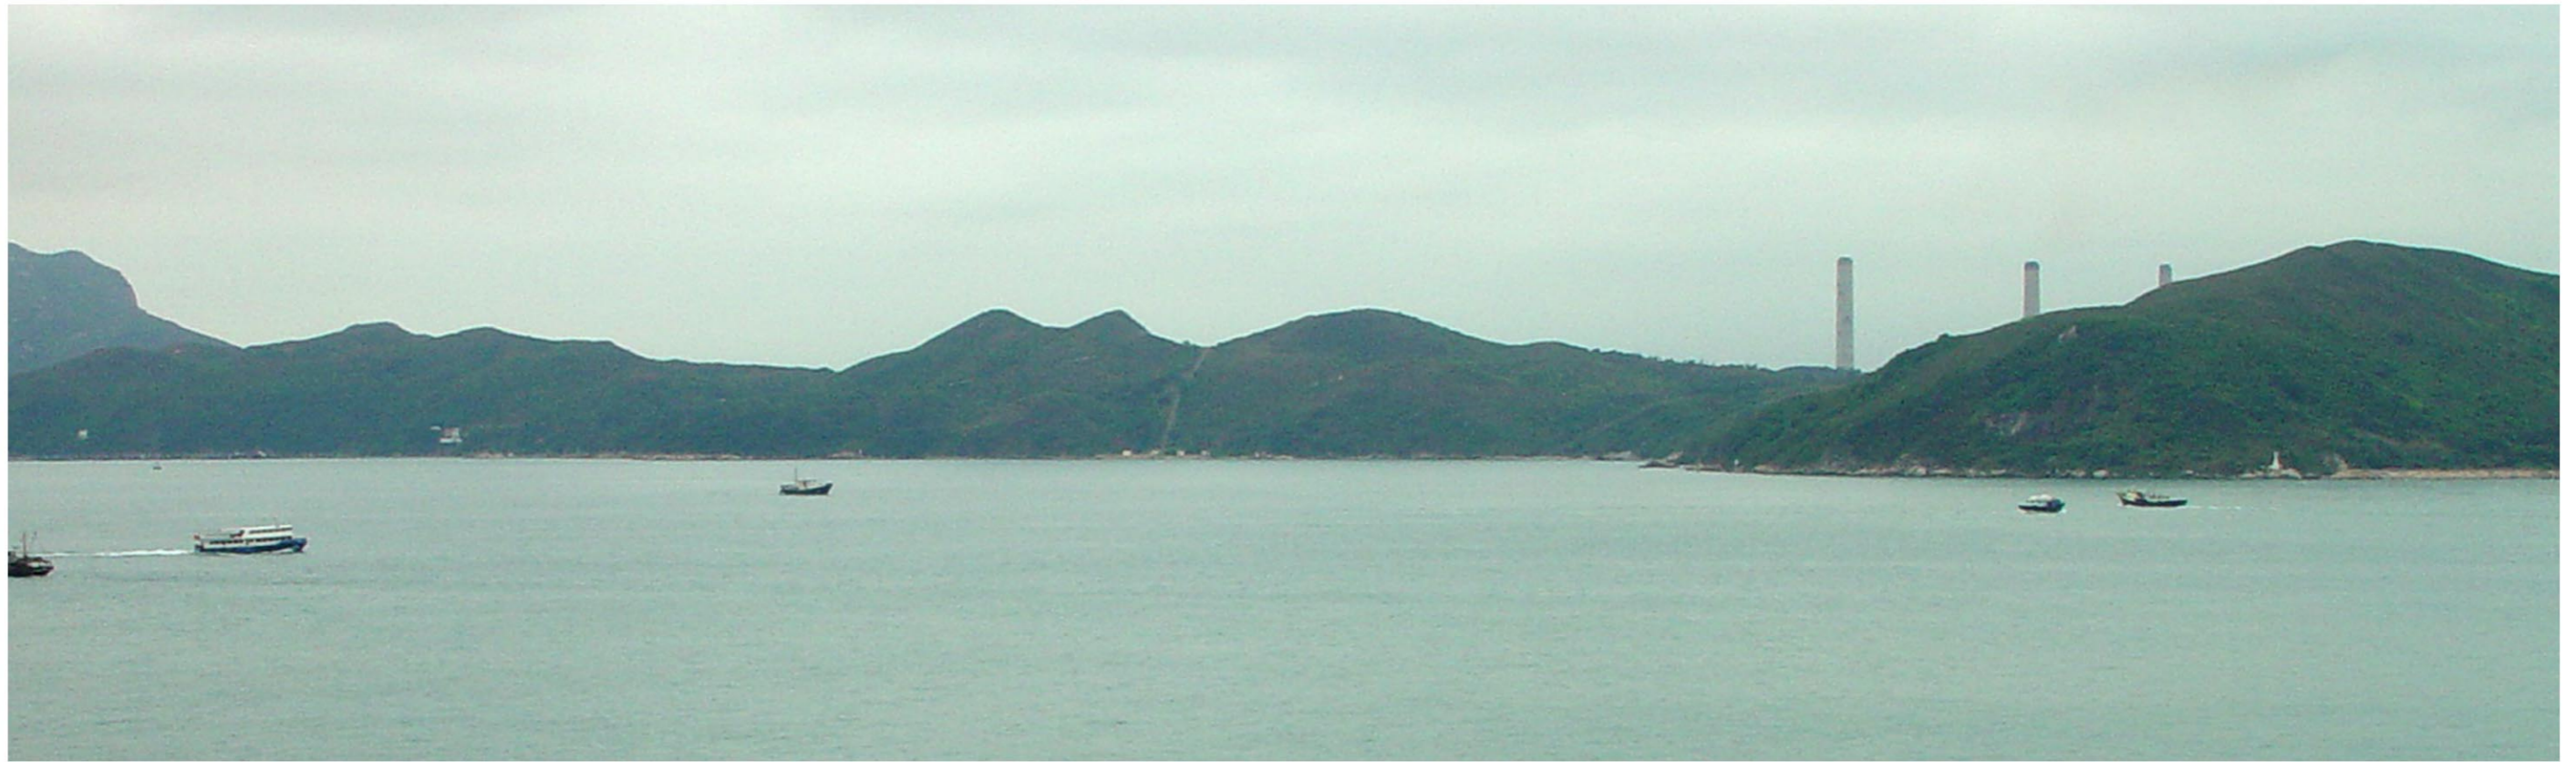
Figure 6.15 - VSR9 View from Wah Fu (over 3km)

Figure 6.15.1 - Existing View

Figure 6.15.2 - Future View

VSR 9	Wah Fu	Residents <i>Approximate number of receivers: Many</i>	over 3km	Open and unobstructed views towards the wind turbine which would be seen clearly situated near the top of the ridgeline as illustrated in Figure 6.15. <i>Proposed wind turbine</i>	High
VSR 10	Cyberport	Residents & office occupants <i>Approximate number of receivers: Many</i>	over 3km	Open and unobstructed views towards the wind turbine which would be clearly situated near the top of the ridgeline as illustrated in Figure 6.16. <i>Proposed wind turbine</i>	High
