Renewable Energy by a Wind
Turbine System on
Lamma Island:
*Final Environmental Impact
Assessment*

The Hongkong Electric Co Ltd

Renewable Energy by a Wind
Turbine System on Lamma Island:
Final Environmental Impact Assessment Report

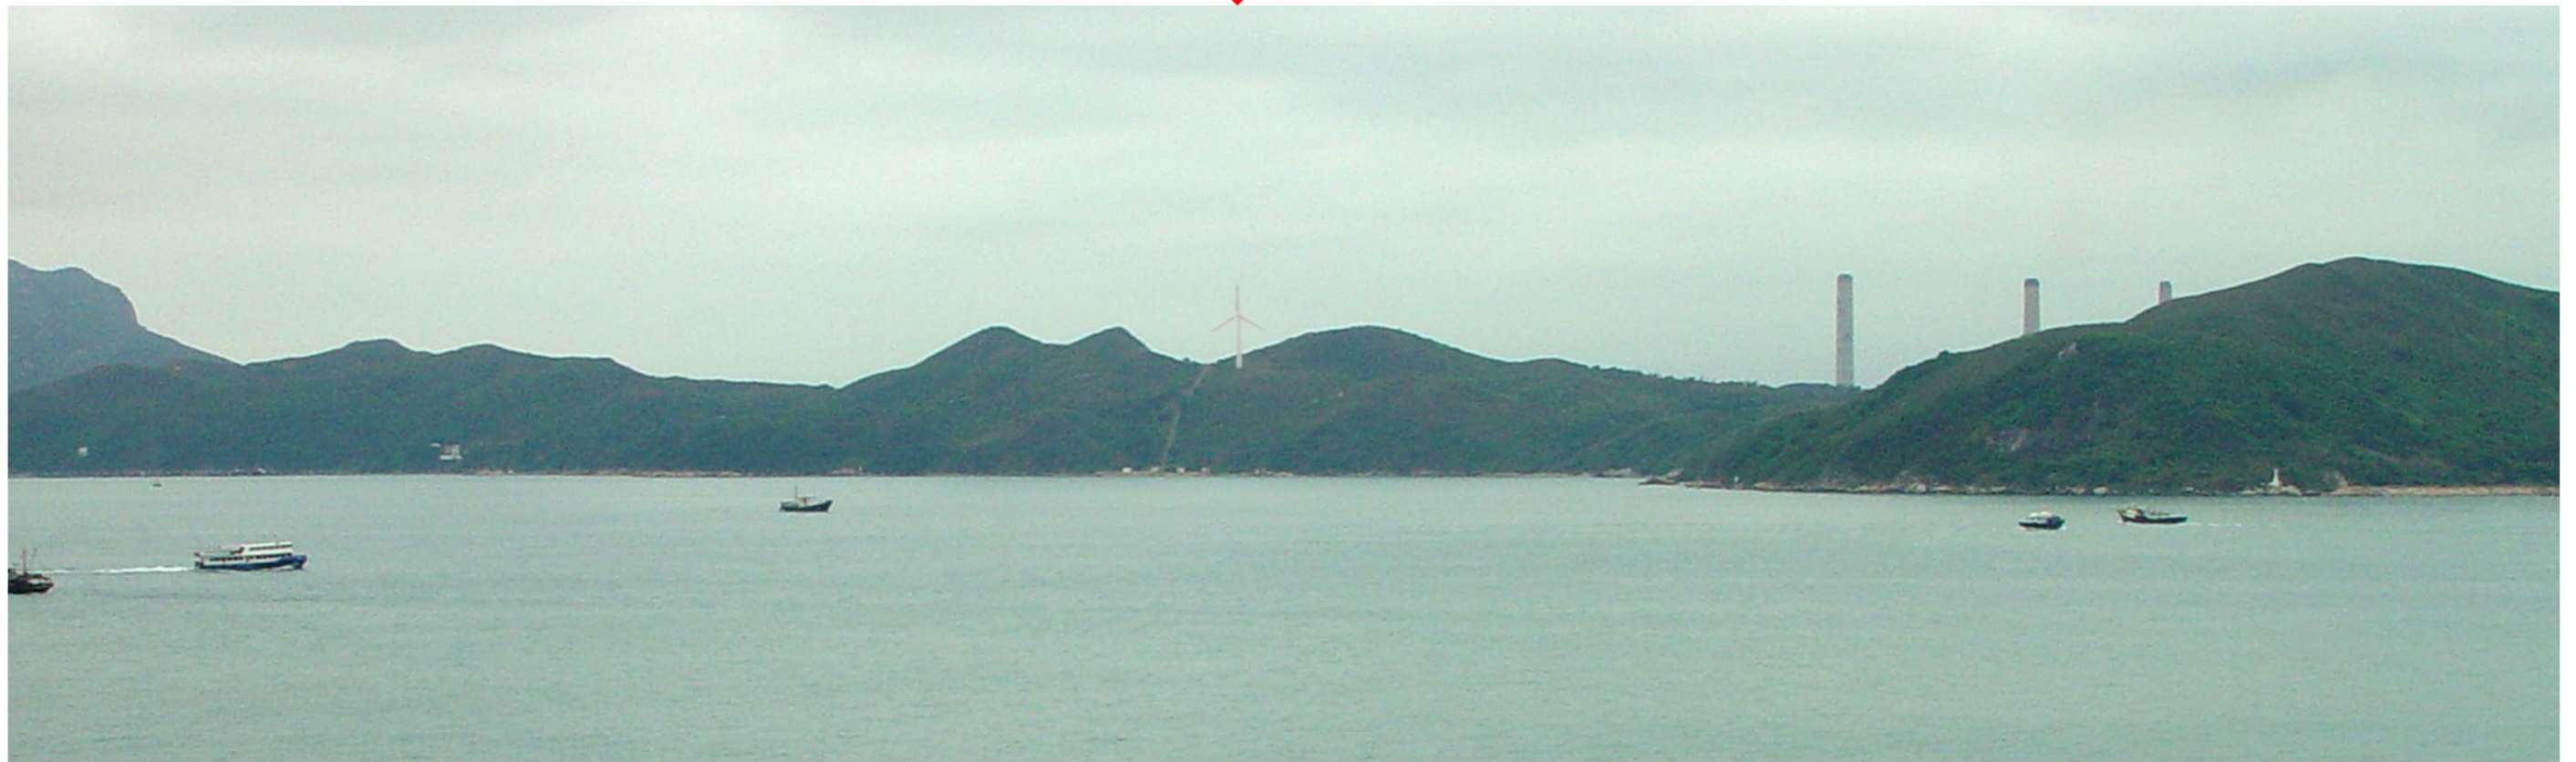
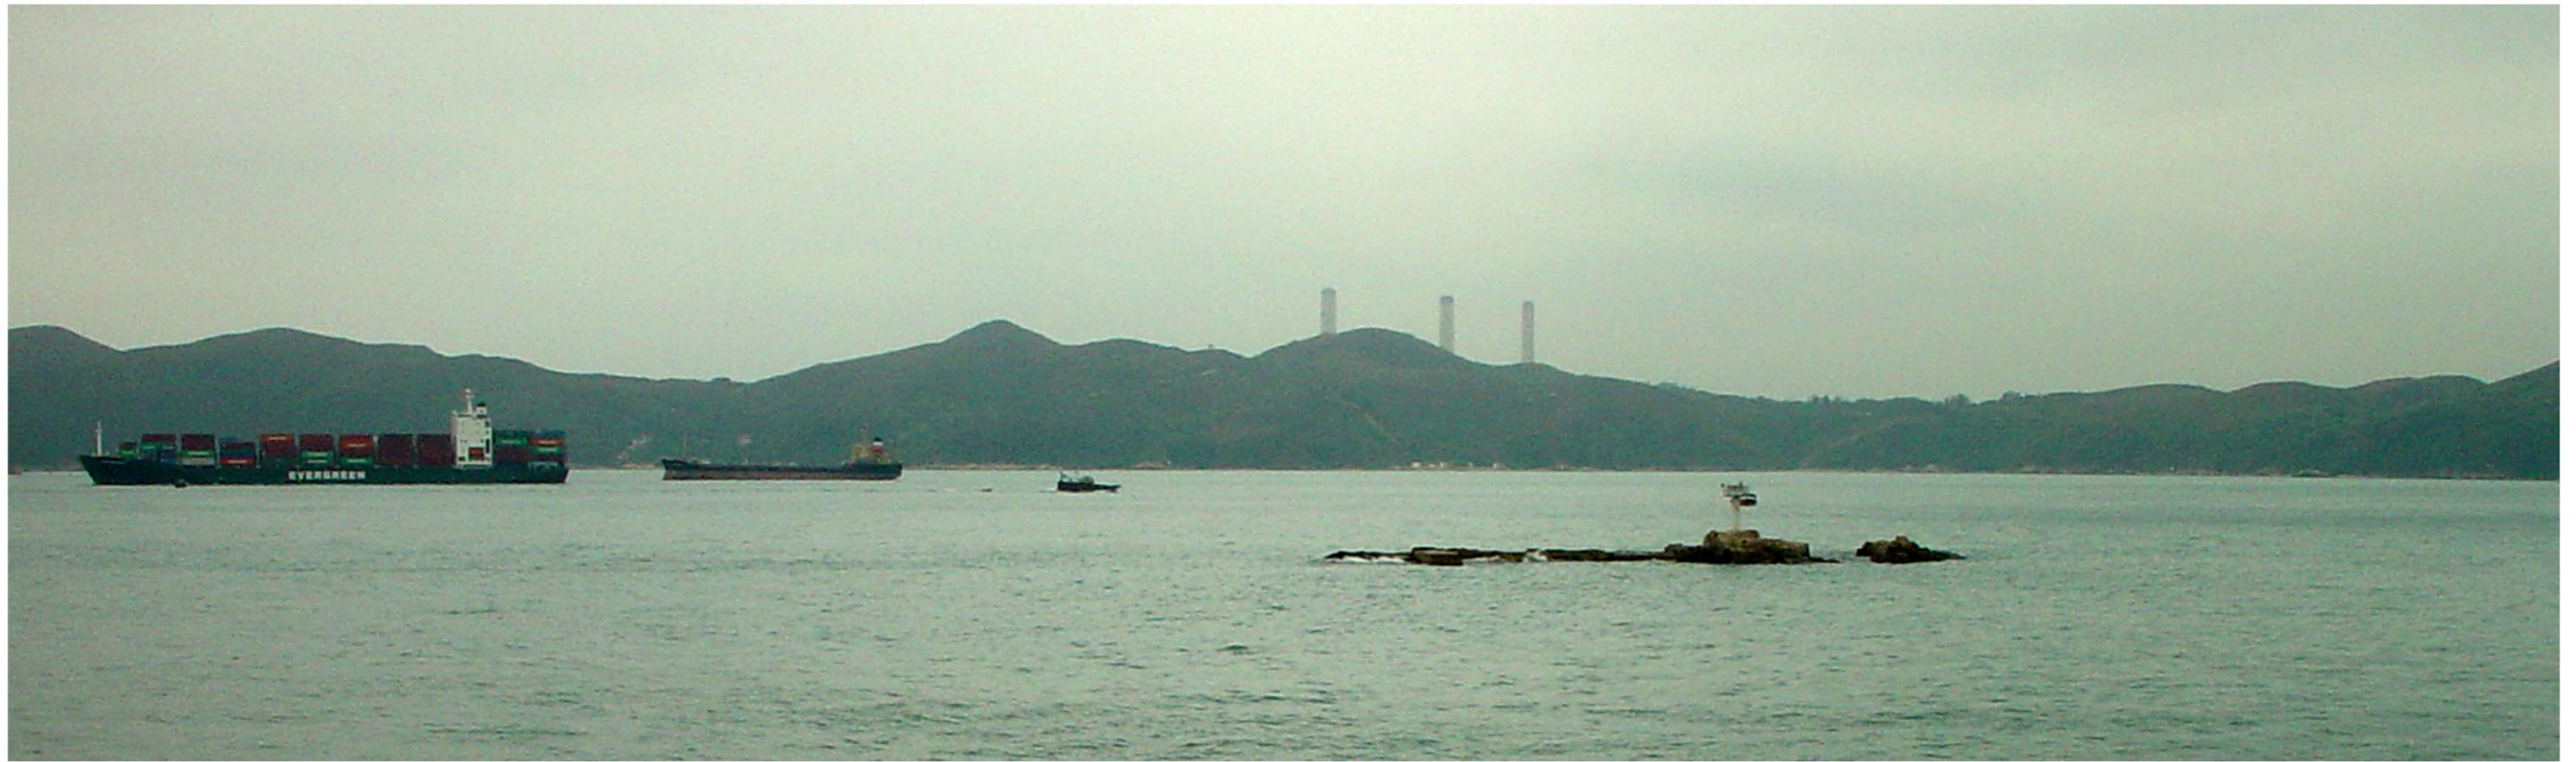
Figure 6.16 - VSR10 View from Cyberport (over 3km)

Figure 6.16.1 - Existing View

Figure 6.16.2 - Future View

VSR 9	Wah Fu	Residents <i>Approximate number of receivers: Many</i>	over 3km	Open and unobstructed views towards the wind turbine which would be seen clearly situated near the top of the ridgeline as illustrated in Figure 6.15. <i>Proposed wind turbine</i>	High
VSR 10	Cyberport	Residents & office occupants <i>Approximate number of receivers: Many</i>	over 3km	Open and unobstructed views towards the wind turbine which would be clearly situated near the top of the ridgeline as illustrated in Figure 6.16. <i>Proposed wind turbine</i>	High

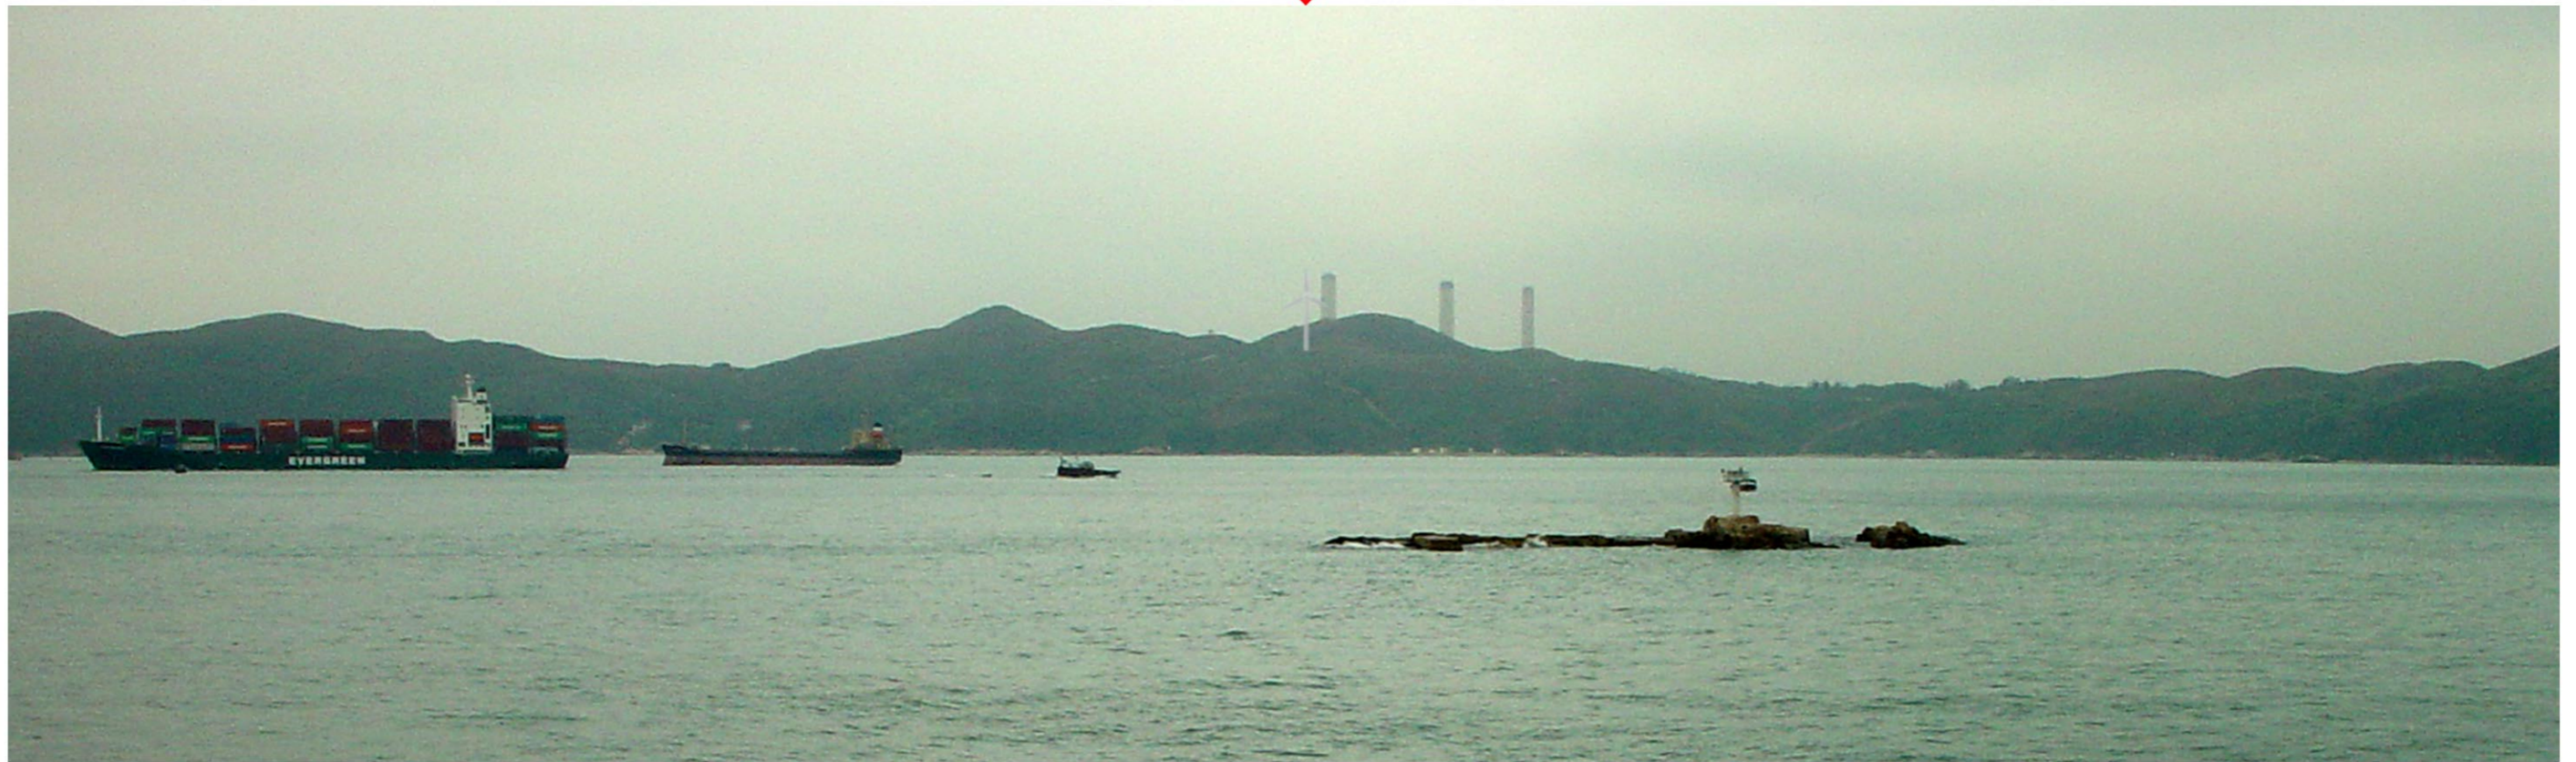
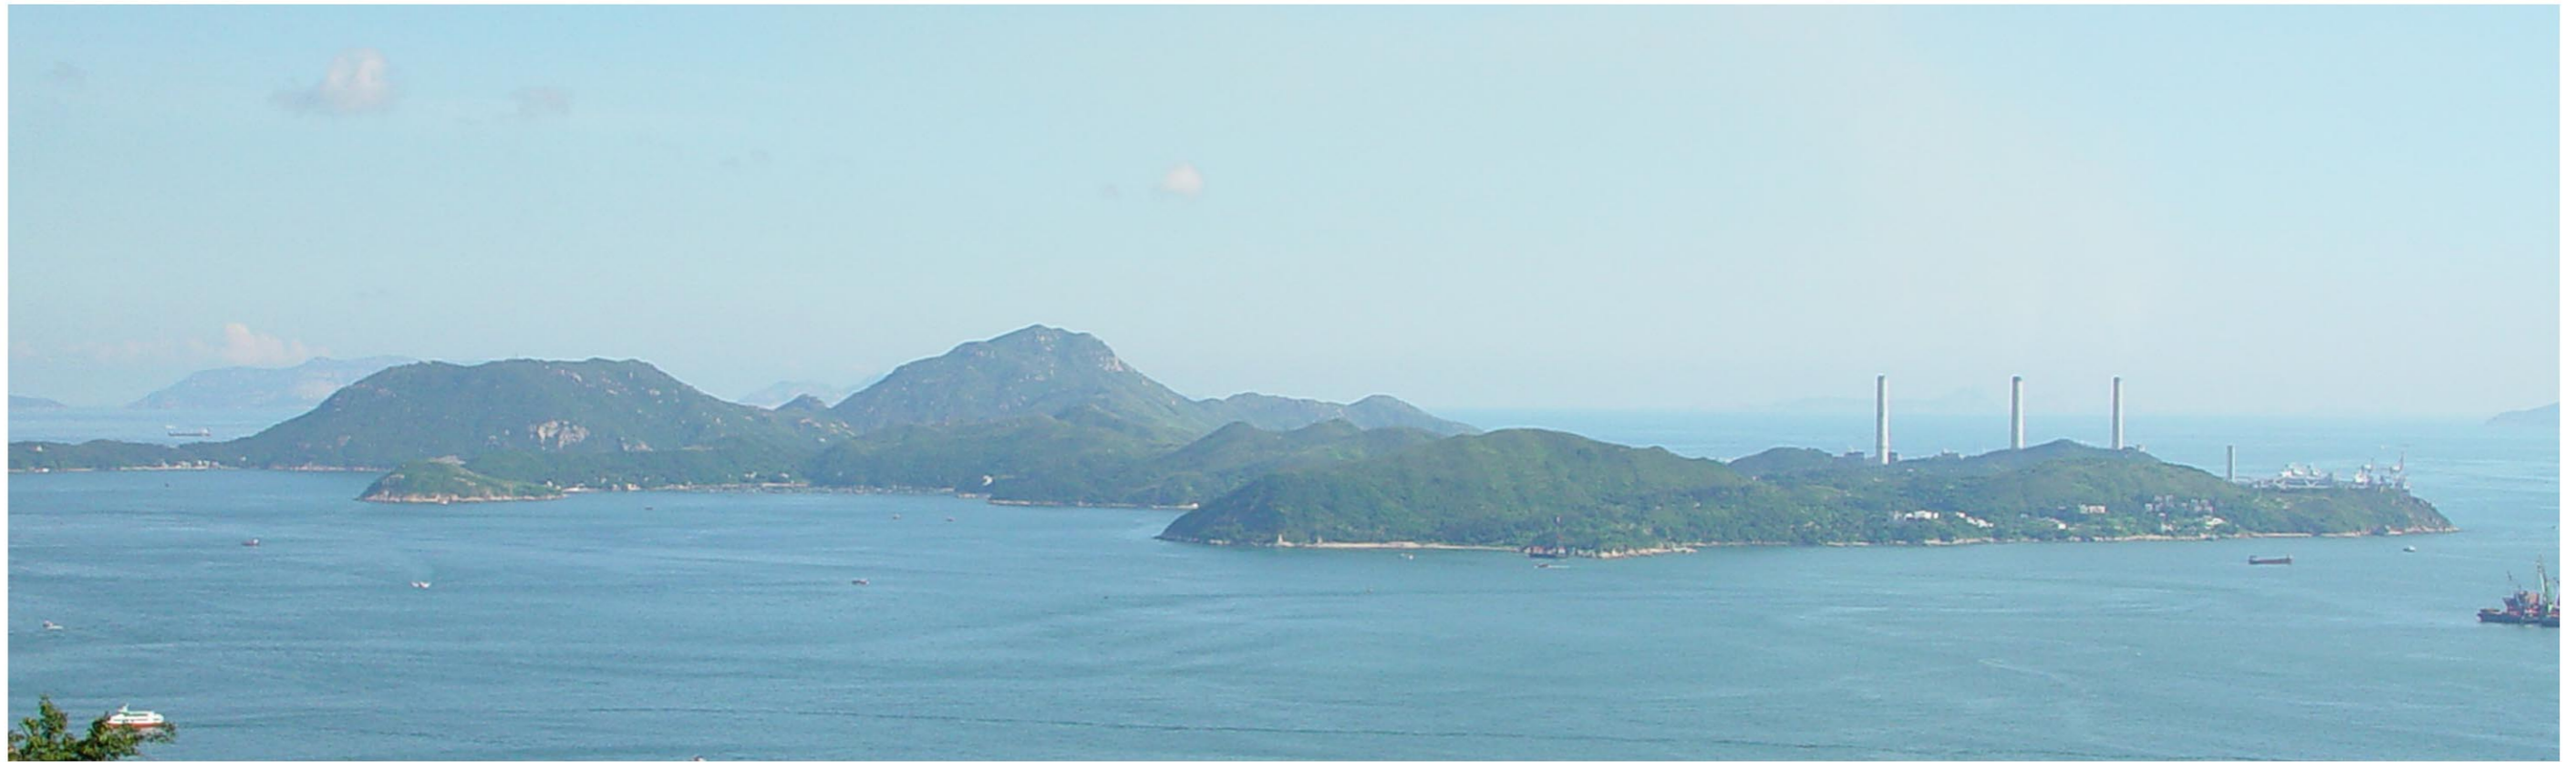
Figure 6.17 - VSR11 View from Ap Lei Chau (over 3km)

Figure 6.17.1 - Existing View

Figure 6.17.2 - Future View

<i>VSR</i>	<i>Name</i>	<i>Nature of Viewer Group/ no. of receivers</i>	<i>Distance to Proposed Works</i>	<i>Analysis of of view towards proposed development Source of impact</i>	<i>Sensitivity to change and visual intrusion</i>
VSR 11	Ap Lei Chau	Residents	over 3km	Open and unobstructed views towards the wind turbine which would be clearly situated near the top of the ridgeline as illustrated in <i>Figure 6.17</i> .	High
		<i>Approximate number of receivers: Many</i>		<i>Proposed wind turbine</i>	
VSR 12	Mount Davis	Residents and tourists	over 5km	Open and very distant views towards the wind turbine against the backdrop of the Lamma hilly landscape behind. The wind turbine would be relatively small as illustrated in <i>Figure 6.18</i> .	Medium
		<i>Approximate number of receivers: Small</i>		<i>Proposed wind turbine</i>	
VSR 13	Chung Hom Kok	Residents and tourists	over 8km	Open and very distant views towards the wind turbine which would be relatively very small as illustrated in <i>Figure 6.19</i> .	Medium

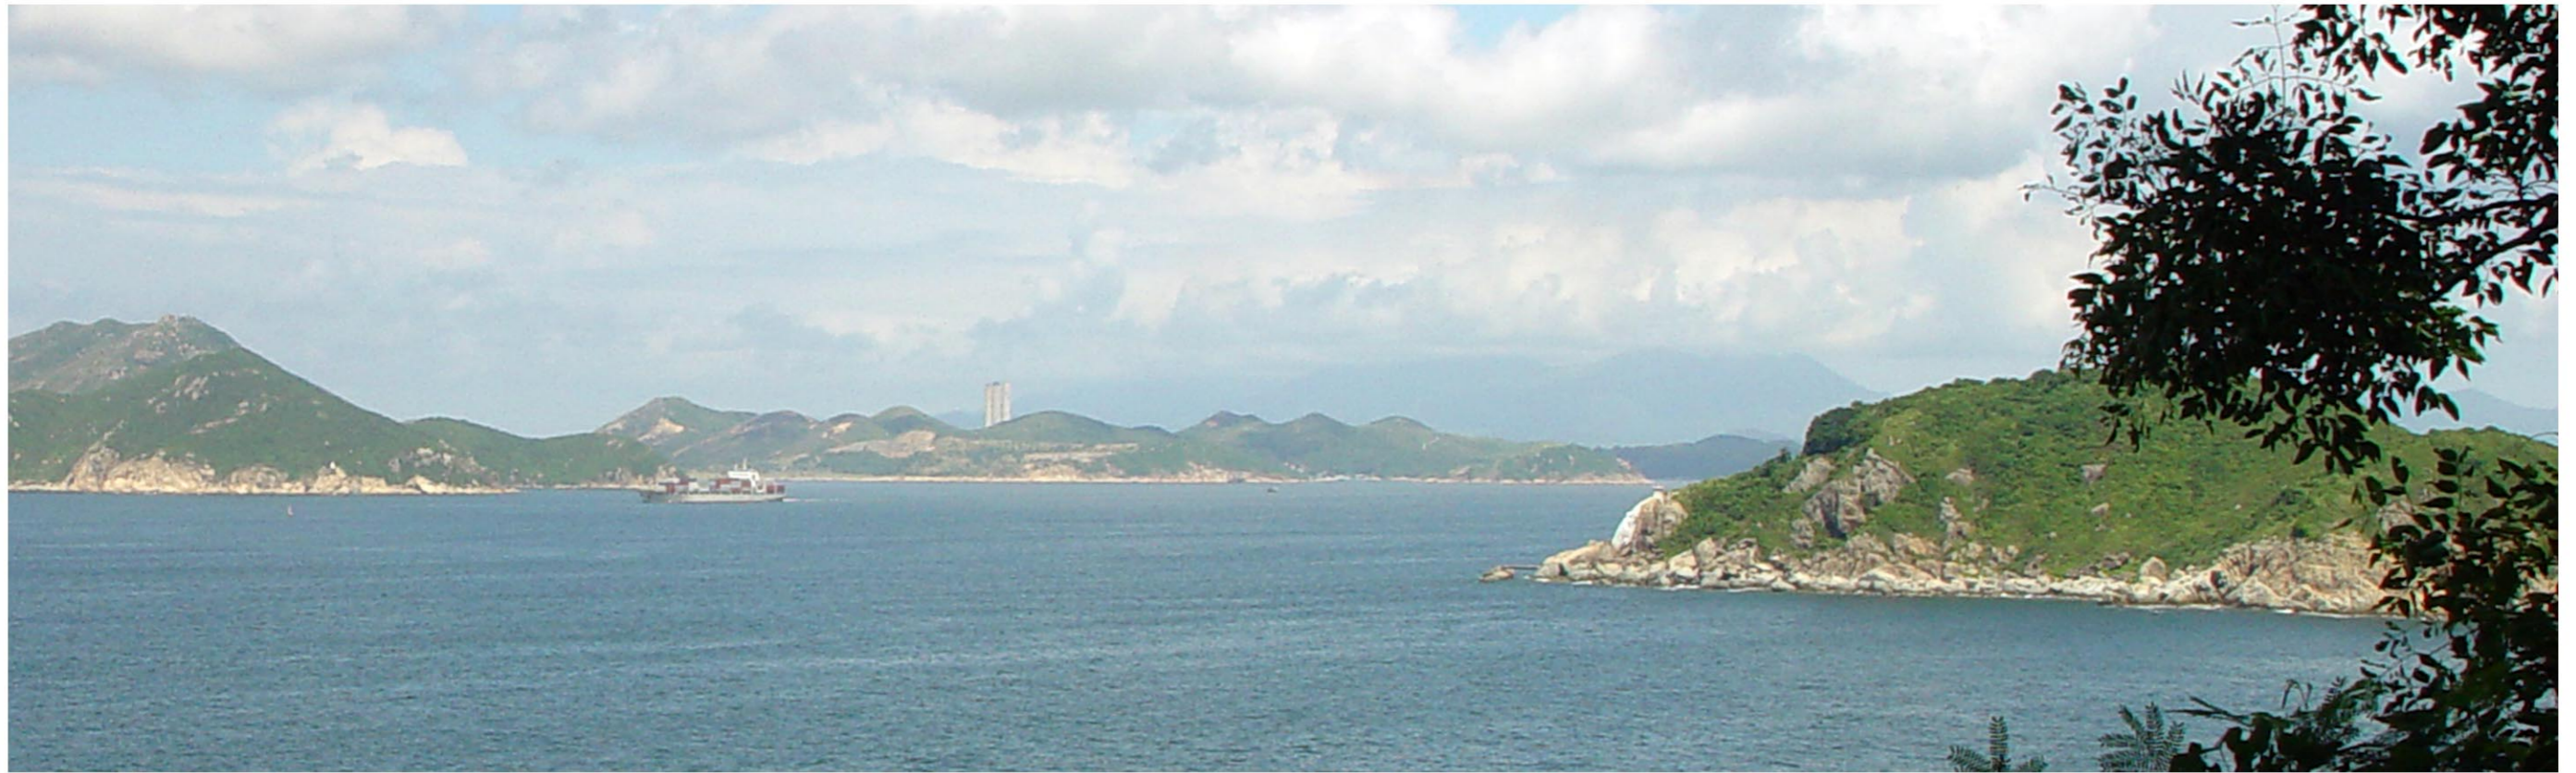
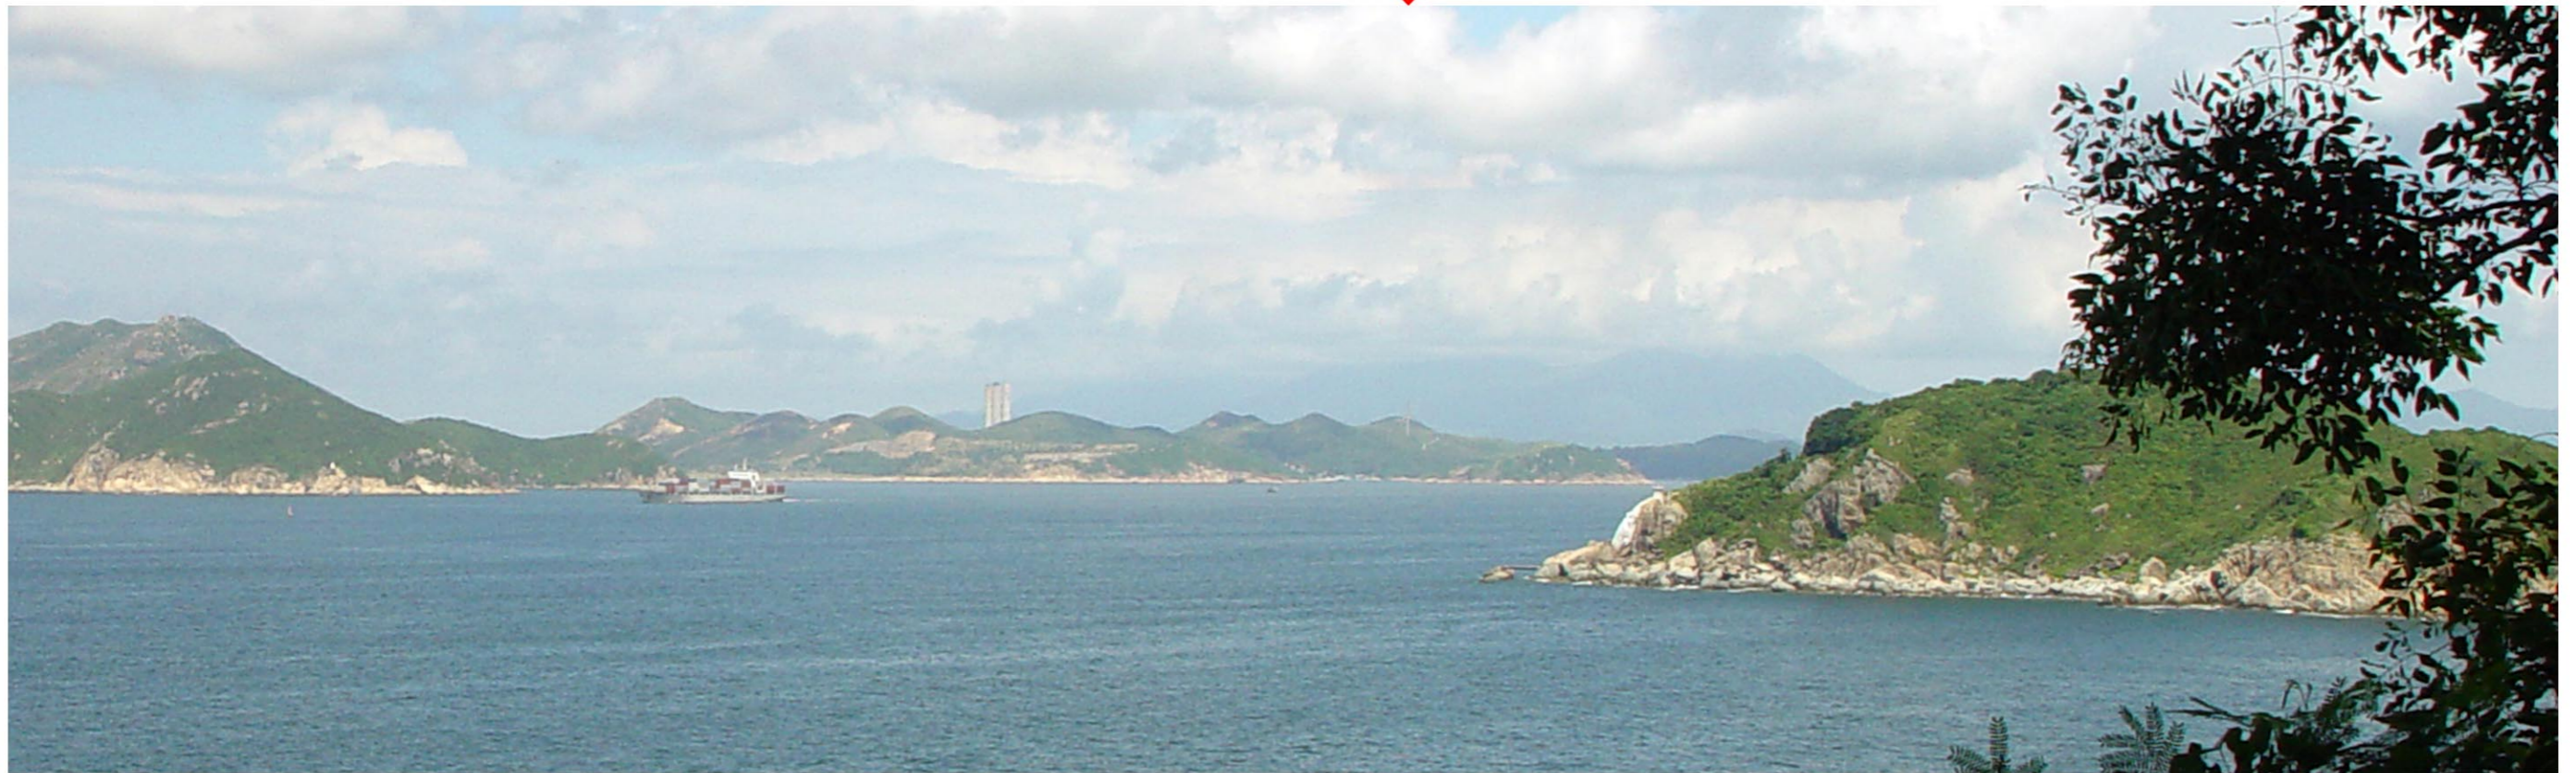
Figure 6.19 - VSR13 View from Chung Hom Kok (over 8km)

Figure 6.19.1 - Existing View

Figure 6.19.2 - Future View

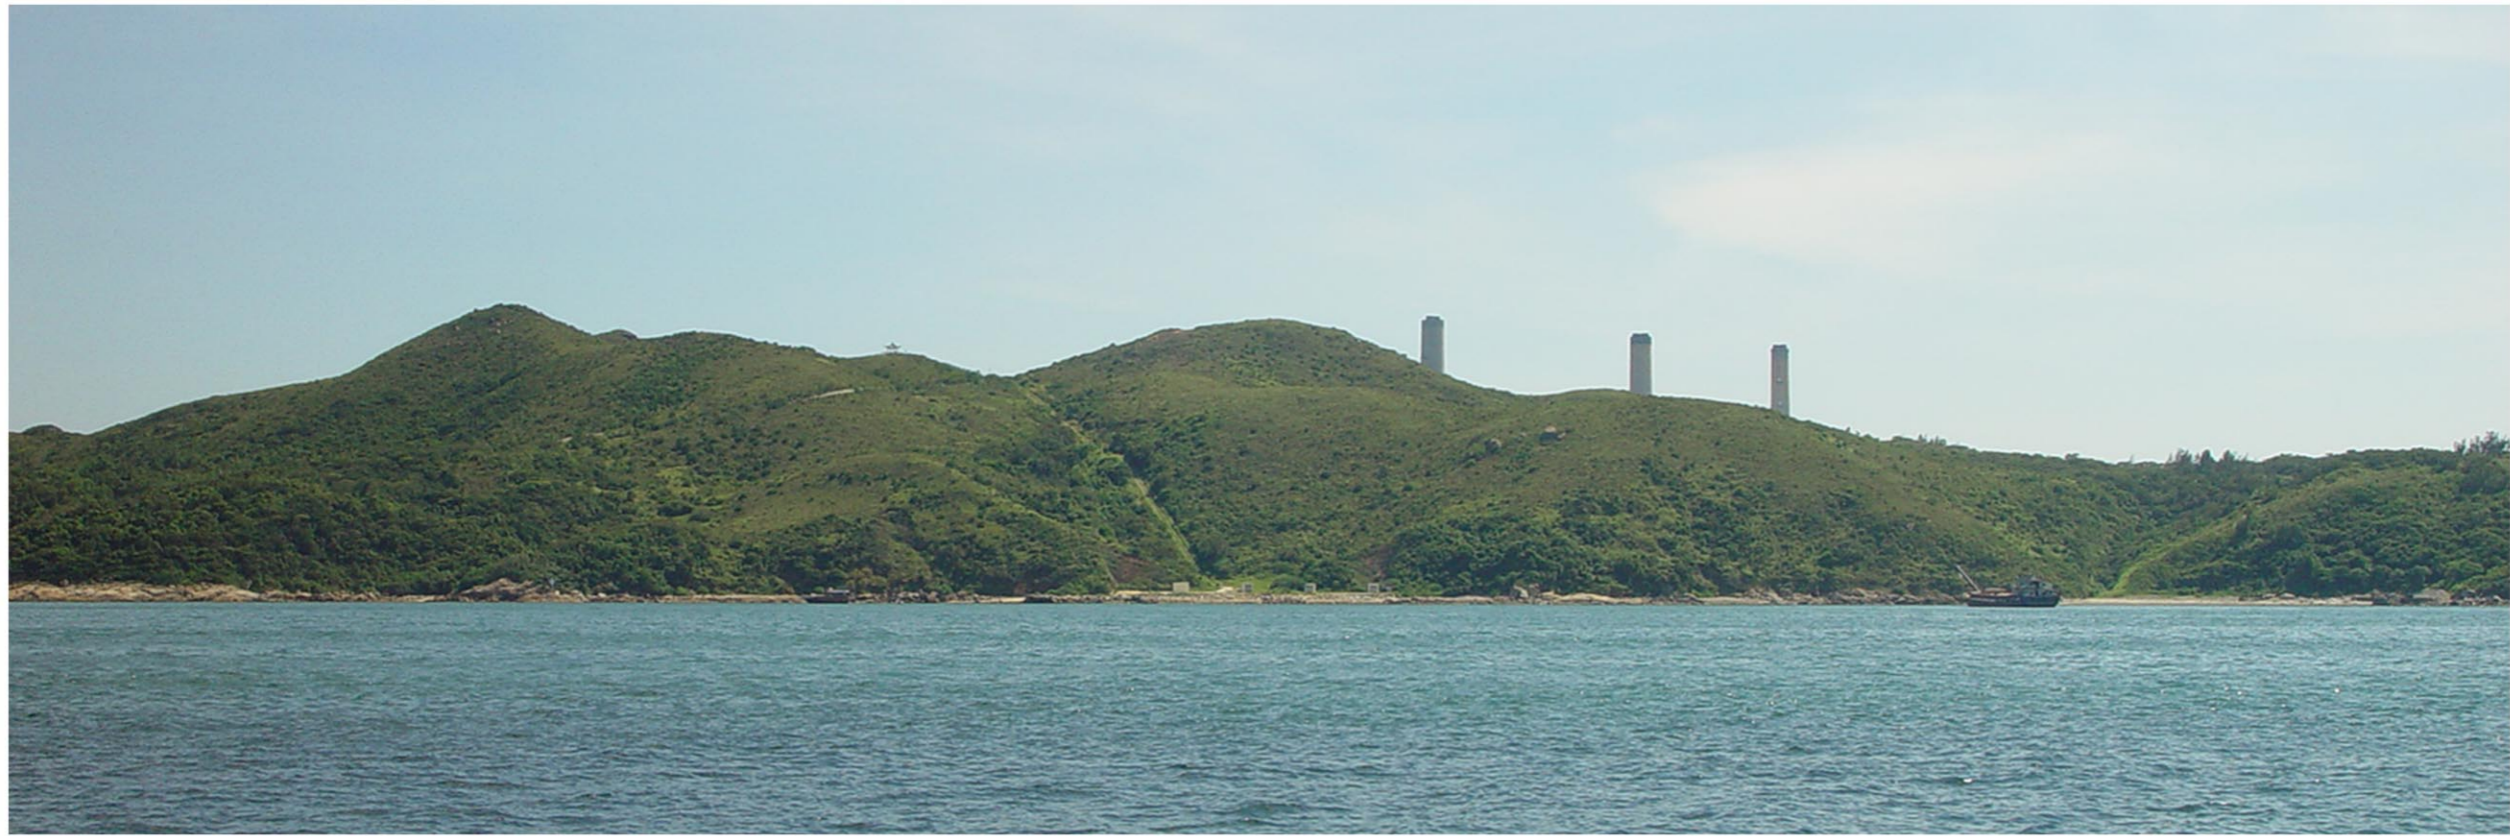
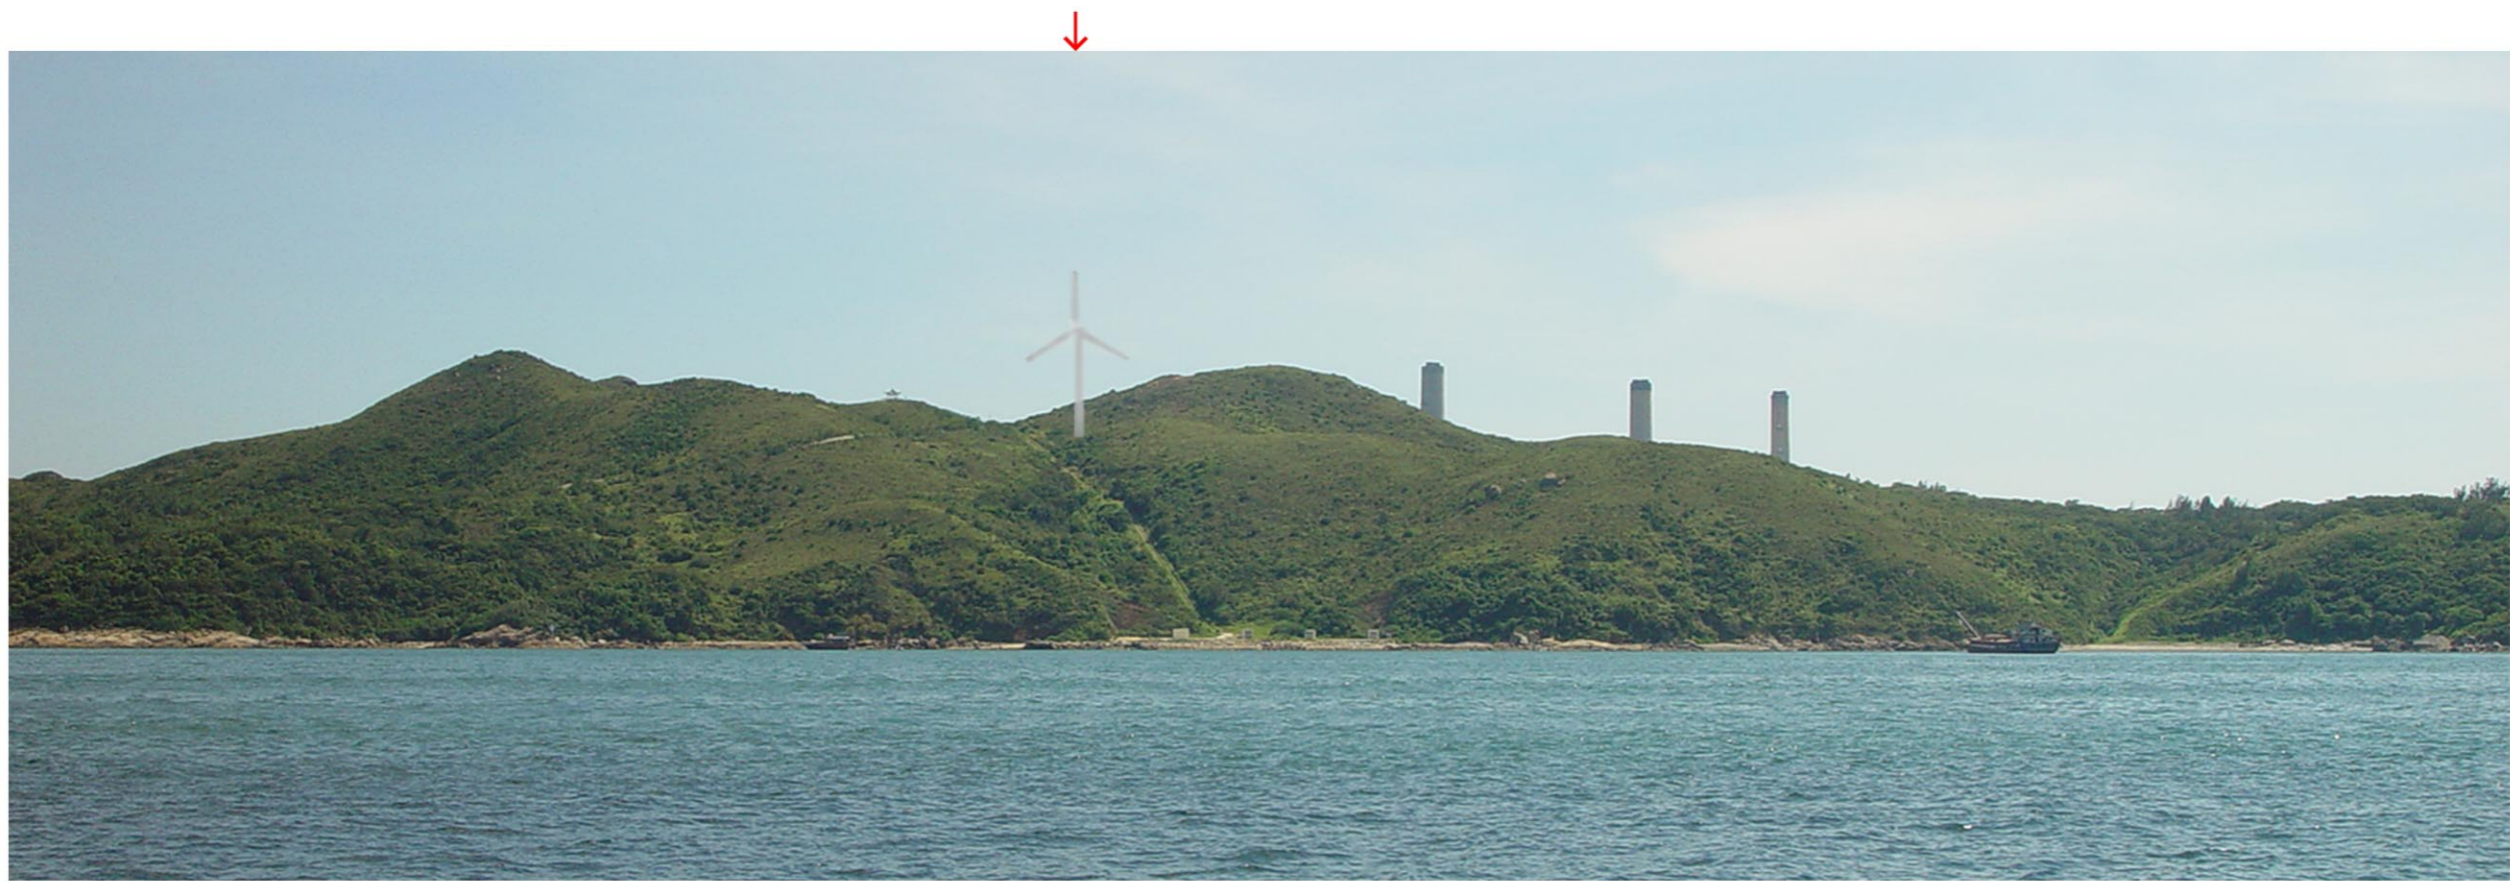
Figure 6.20 - VSR14 View from Lamma East Channel (over 1.5km)

Figure 6.20.1 - Existing View

Figure 6.20.2 - Future View

<i>Approximate number of receivers: small</i>		<i>Proposed wind turbine</i>	
VSR 14	Lamma East Channel	Ferry users	over 1.5km	Open and unobstructed views towards the wind turbine which would be clearly situated in the headland as illustrated in <i>Figure 6.20</i> .	Low
		<i>Approximate number of receivers: small</i>		<i>Proposed wind turbine</i>	
VSR 15	Ocean Park	Visitors/ Tourists	over 3km	Open and unobstructed views towards the wind turbine which would be clearly situated near the top of the ridgeline as illustrated in <i>Figure 6.21</i> .	Medium
		<i>Approximate number of receivers: Many</i>		<i>Proposed wind turbine</i>

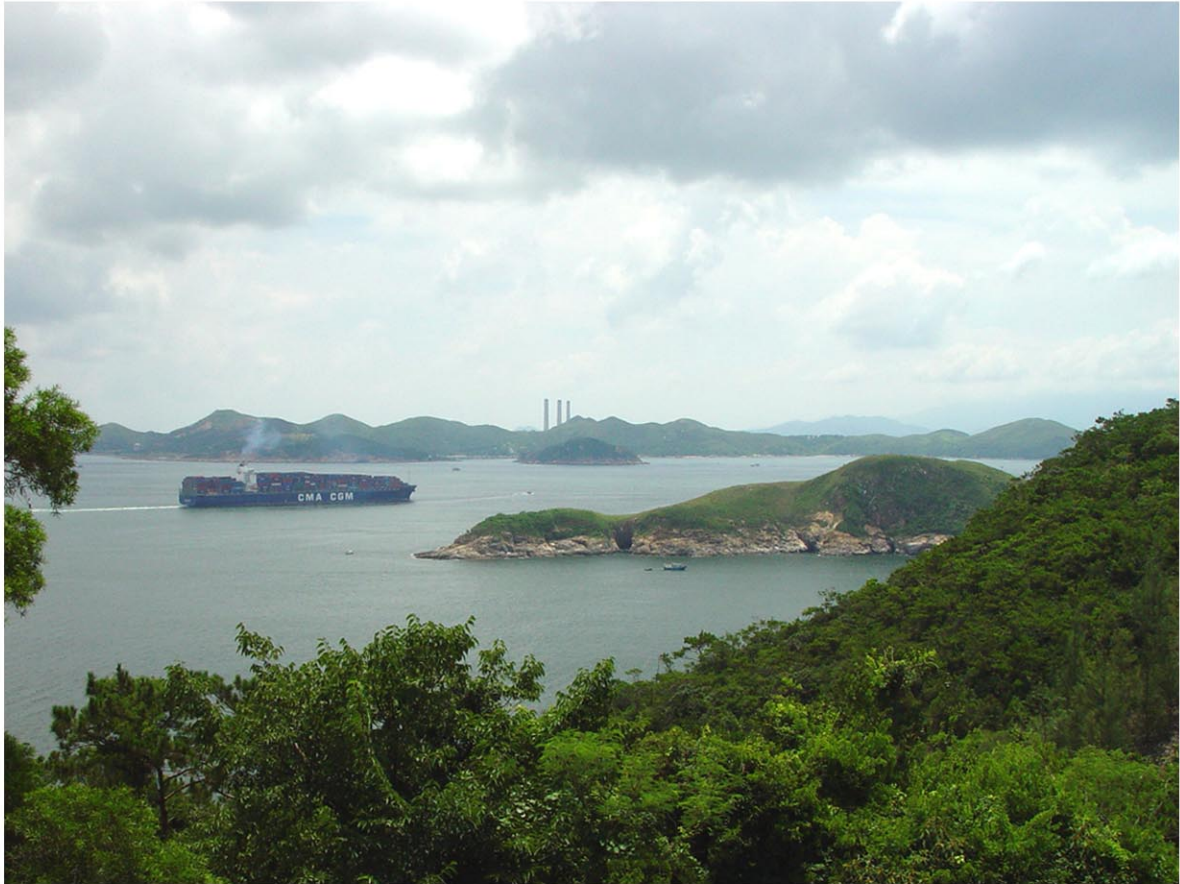
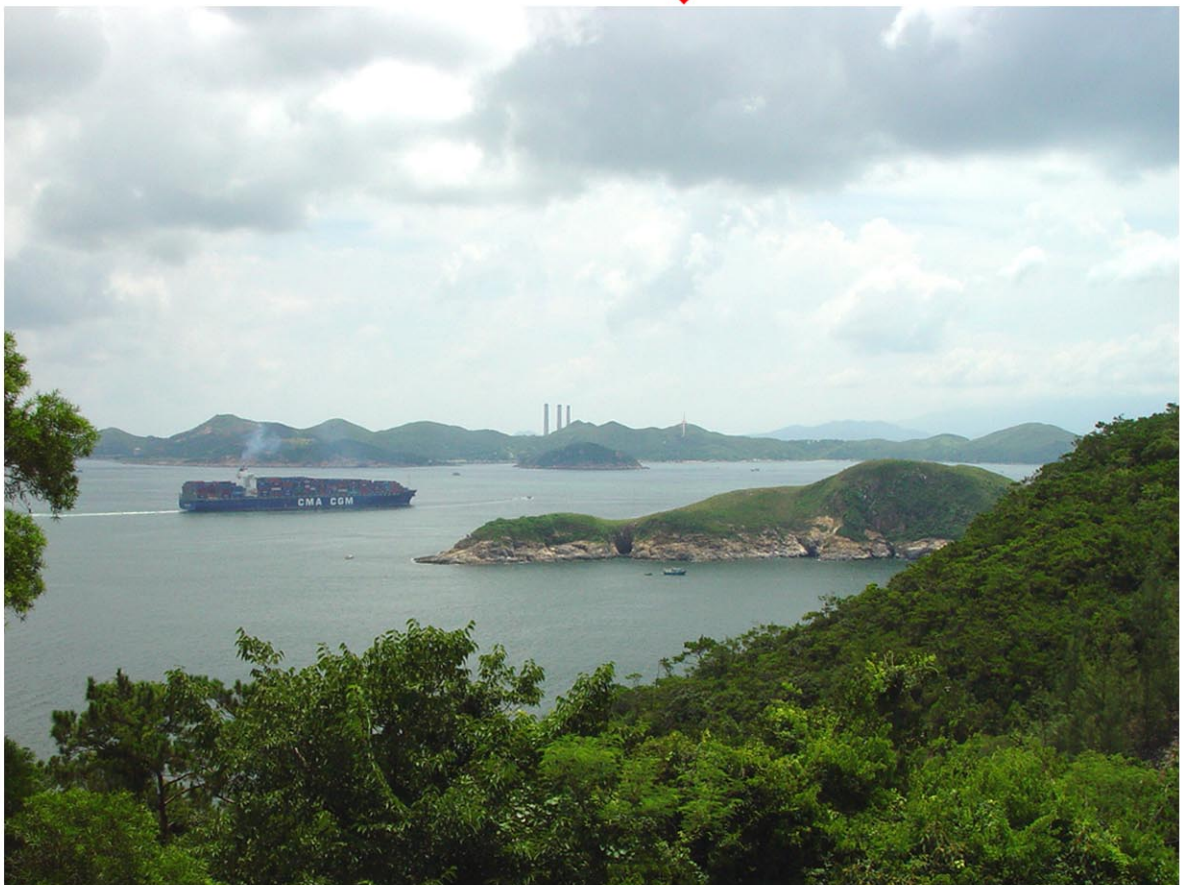
Figure 6.21 - VSR15 View from Ocean Park (over 3km)

Figure 6.21.1 - Existing View

Figure 6.21.2 - Future View
