Renewable Energy by a Wind
Turbine System on
Lamma Island:
*Final Environmental Impact
Assessment*

The Hongkong Electric Co Ltd

Renewable Energy by a Wind
Turbine System on Lamma Island:
Final Environmental Impact Assessment Report

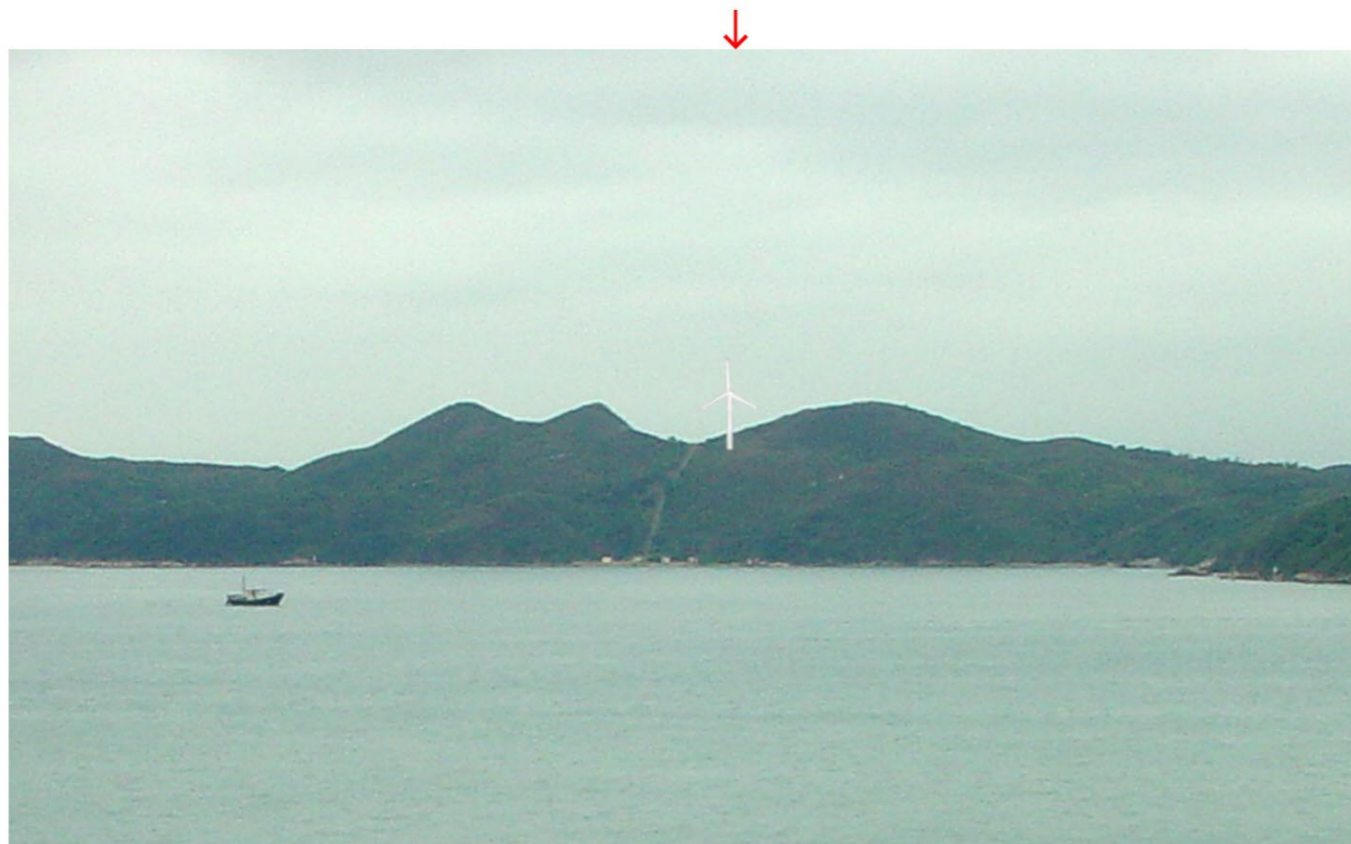
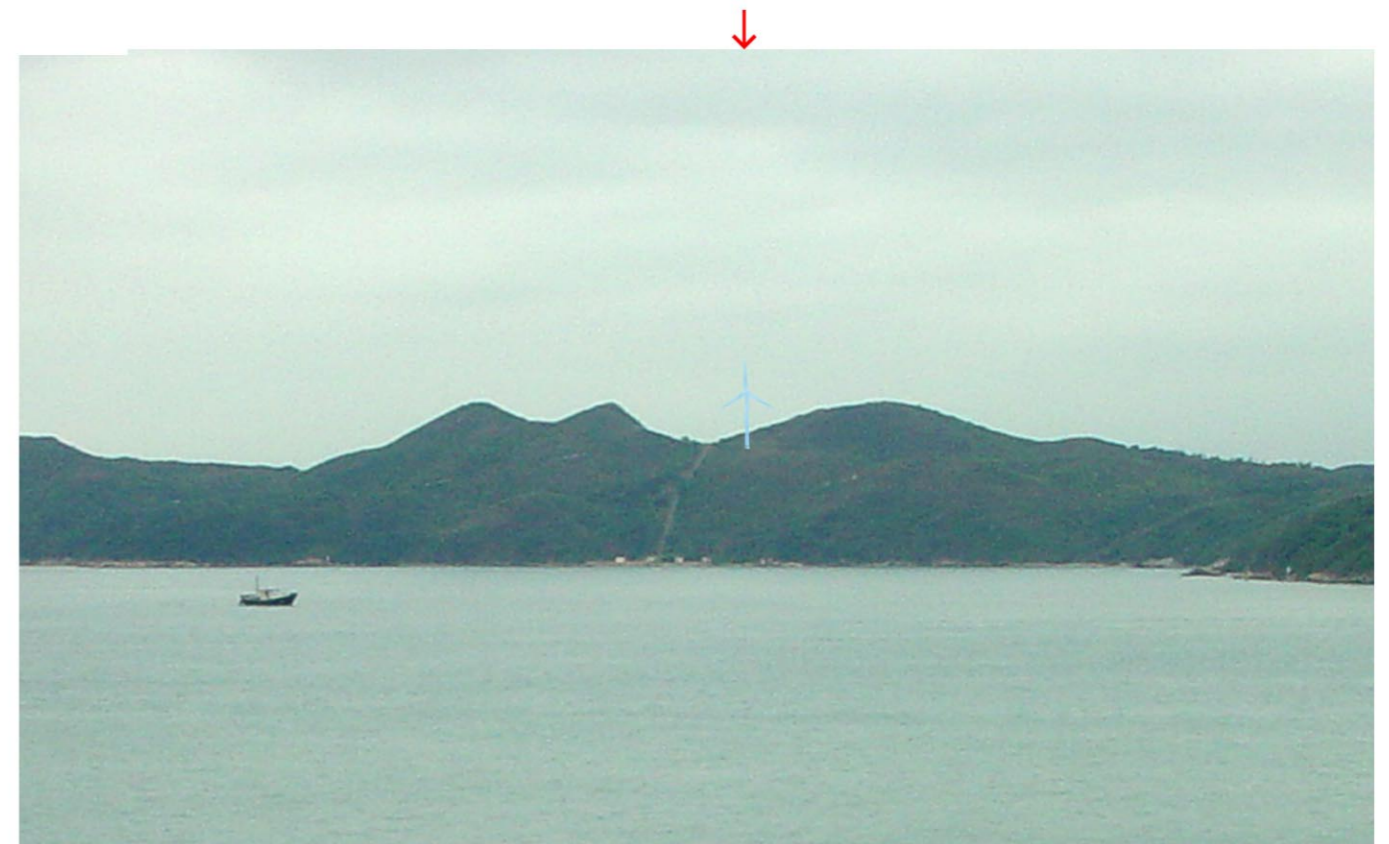
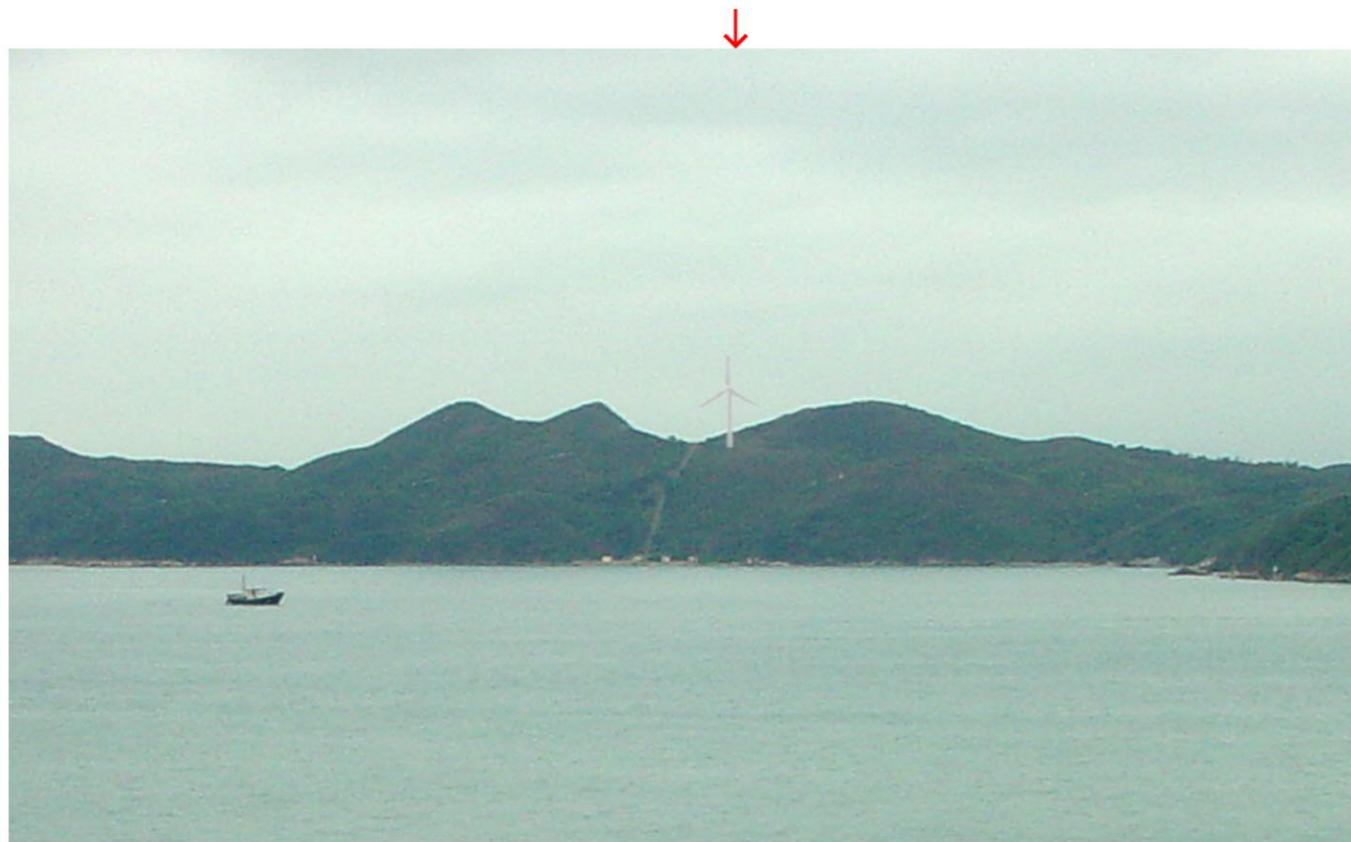
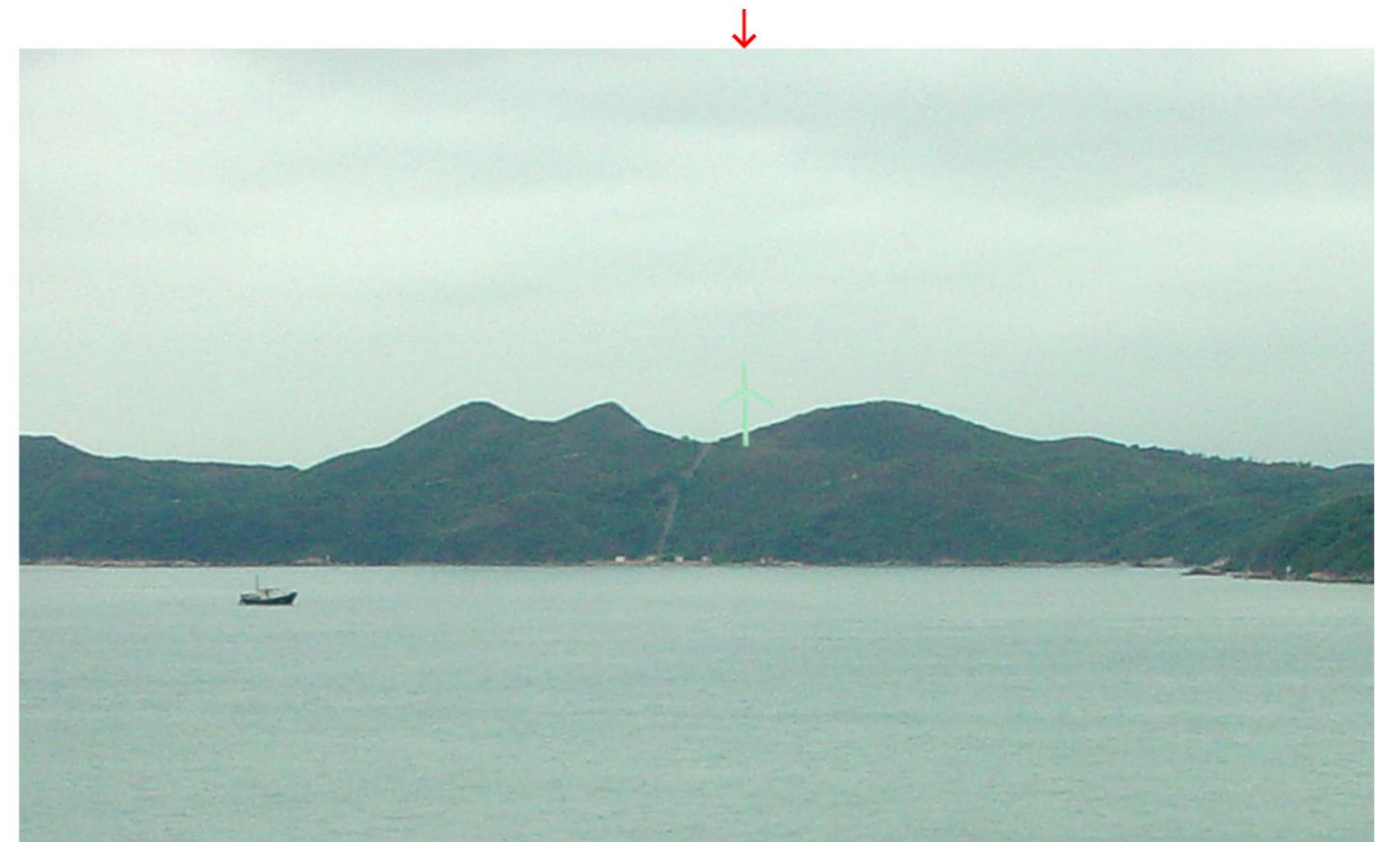
Figure 6.22 - Colour Selection

Figure 6.22.1 - Wind Turbine in White Colour

Figure 6.22.3 - Wind Turbine in Light Green Colour

Figure 6.22.2 - Wind Turbine in Light Grey Colour

Figure 6.22.4 - Wind Turbine in Light Blue Colour

MM3	A light grey non-reflective colour scheme will be used to enable the proposed wind turbine to blend in well with natural surroundings and minimise the visual intrusion.	✓	✓	✓	<ul style="list-style-type: none"> Project proponent Contractor 	Project proponent
MM4	Existing soil resources on site from the cut slope will be re-used for backfilling at site as far as practicable to minimize the need to import or export soils.	✓	✓		<ul style="list-style-type: none"> Project proponent Contractor 	N/A
MM5	Selection of low rotating speed machine to minimize the visual disturbance.	✓	✓	✓	<ul style="list-style-type: none"> Project proponent Contractor 	Project proponent

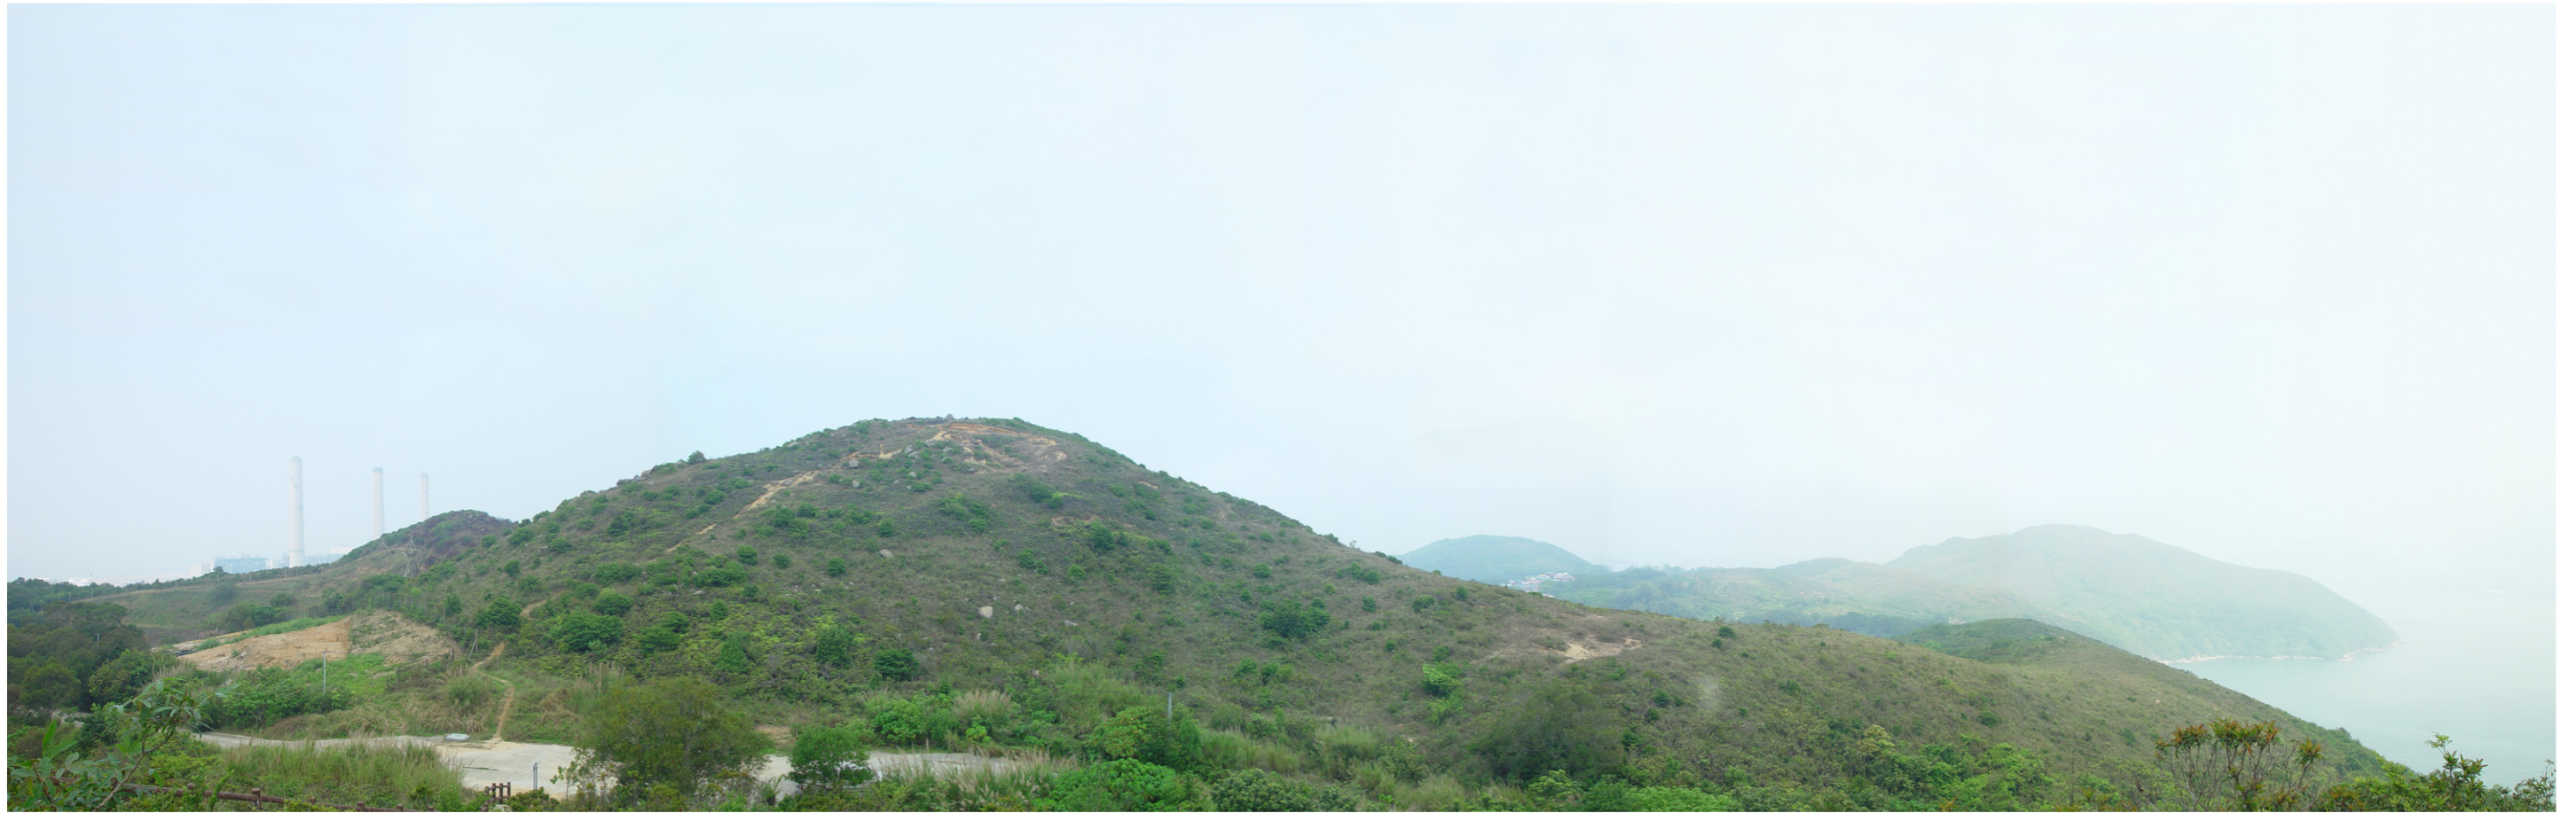
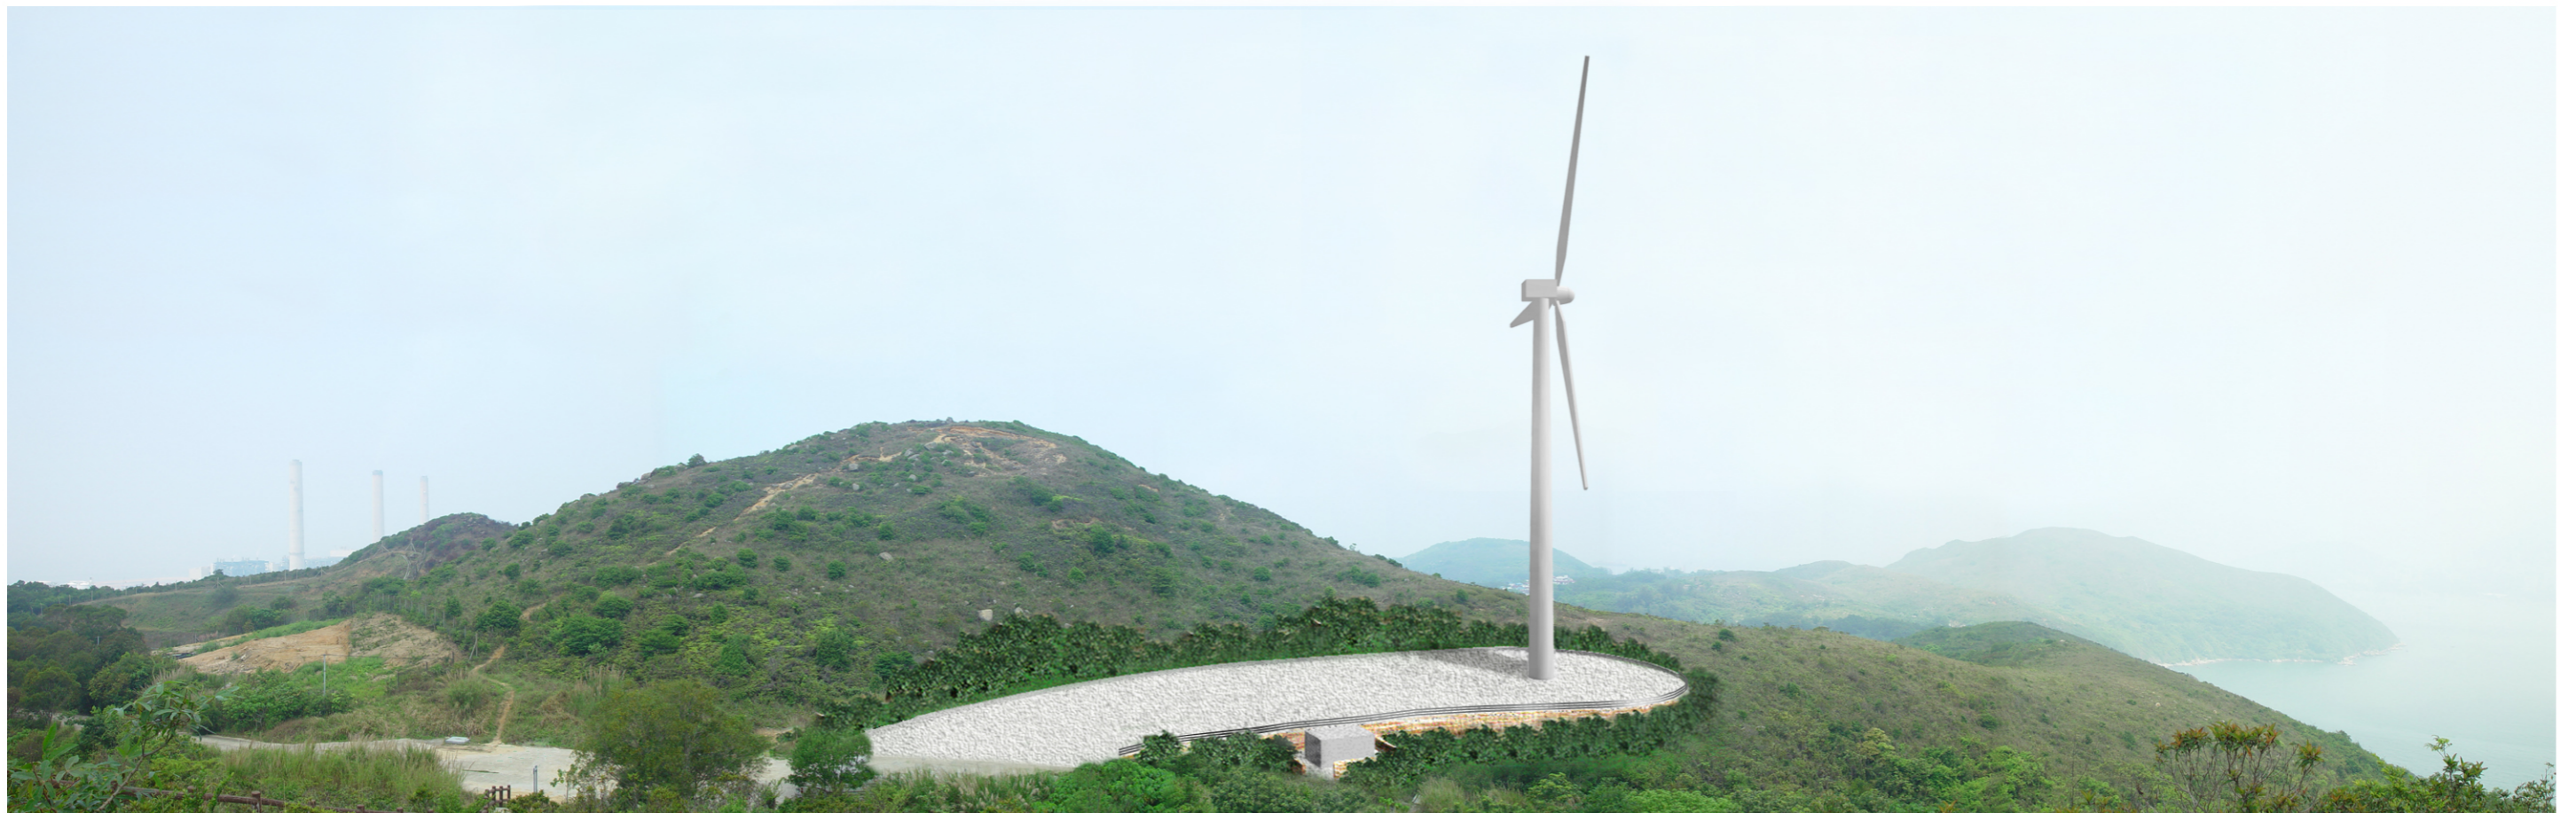
Figure 6.23 - VSR16 View from Tai Ling (Pavilion)

Figure 6.23.1 Existing View

Figure 6.23.2 Future View

On a closer scale, the Project Site is dominated by grass with some small shrubs and occasional trees. East of the site a footpath is located leading up to Tai Ling Pavilion overlooking the northeastern part of Lamma Island. This pavilion is located less than 100m from the Wind Turbine at the level of approximately 104m P.D. half-way between the Wind Turbine platform and the top of the southeastern knoll. The pavilion is an important lookout point to Hong Kong Island. The view from this pavilion towards the proposed wind turbine is shown on *Figure 6.23*.

The proposed wind turbine would be most visible from visitors and hikers to the track and pavilion next to the site. From the track the entire wind turbine would be visible and from the pavilion the wind turbine shaft would be visible whilst the blades would be hidden from view by the pavilion roof. Existing view is shown in *Figure 6.23*.

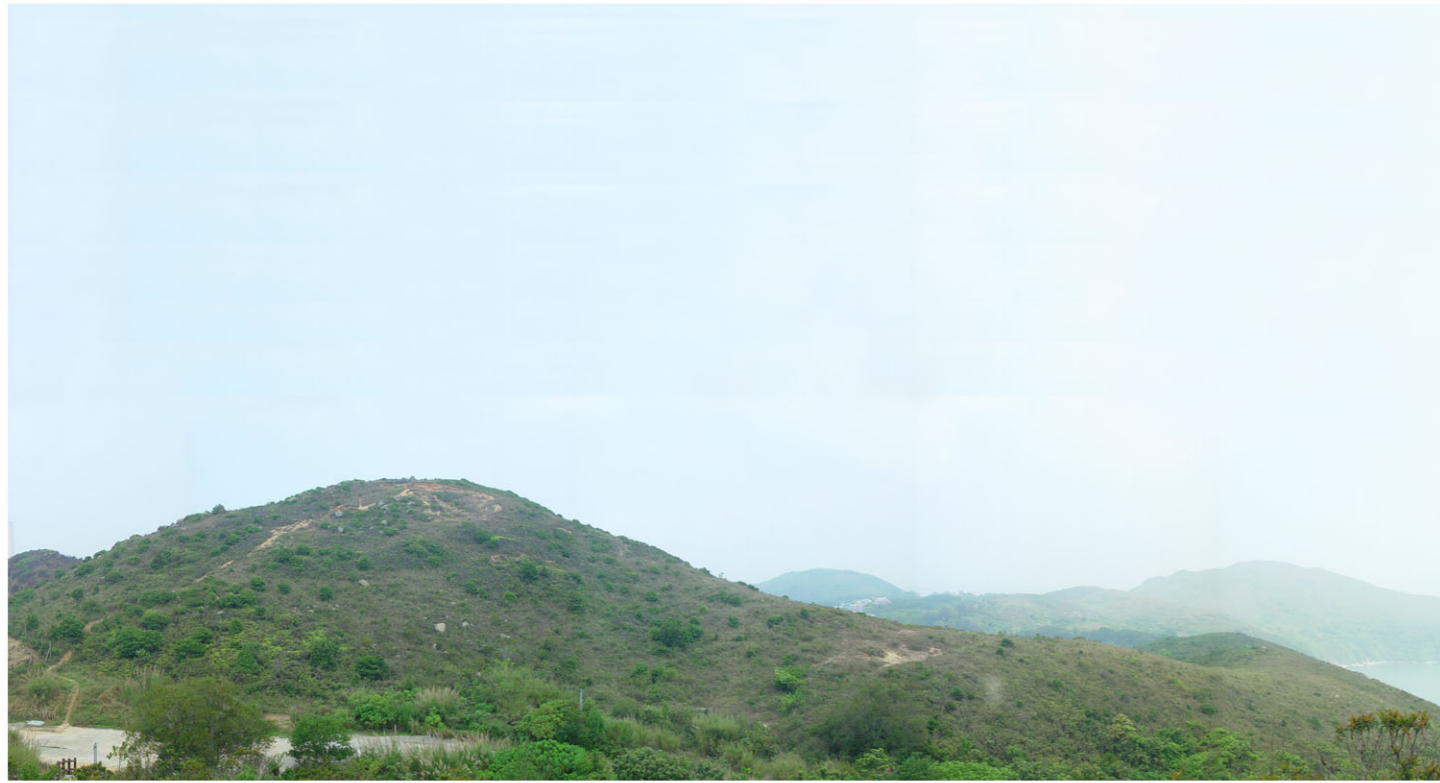
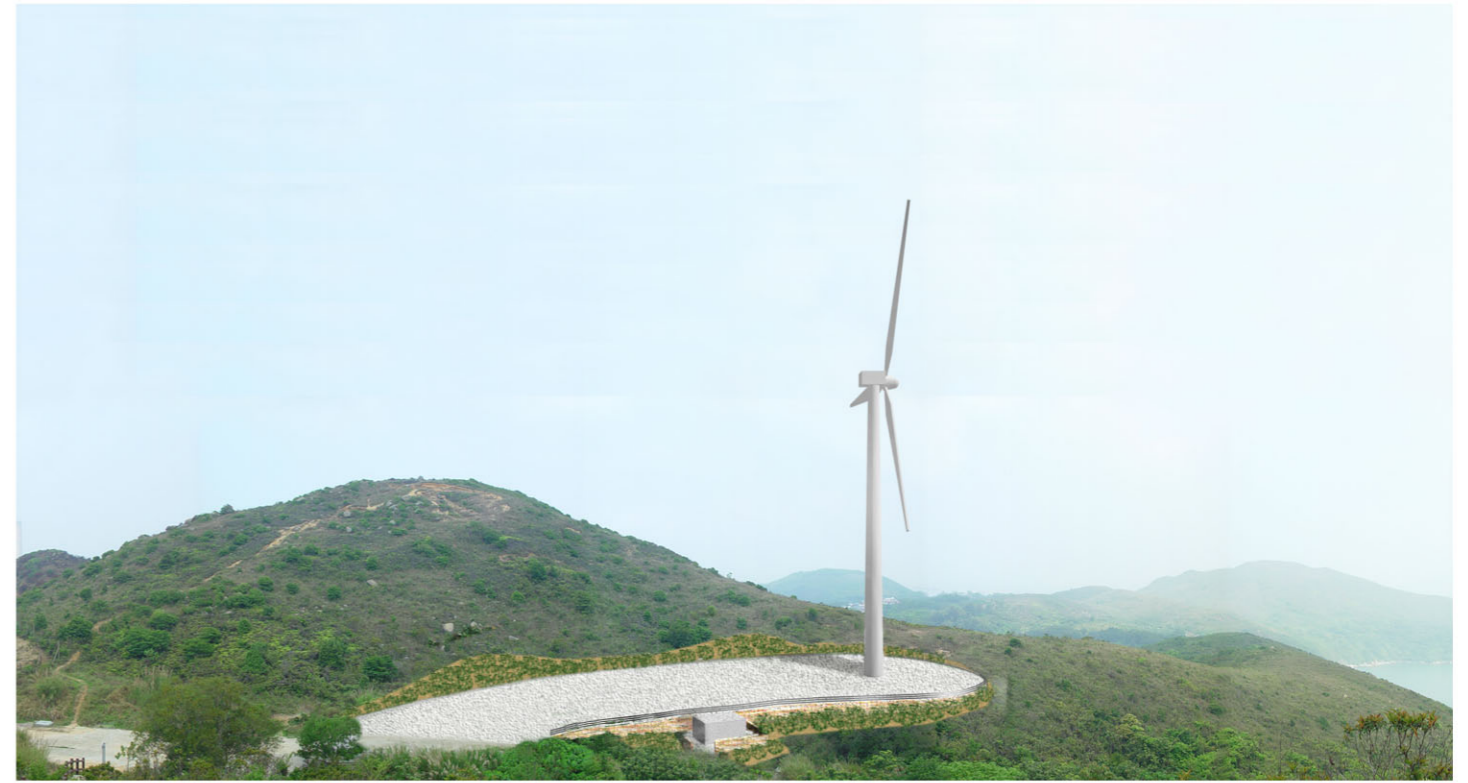
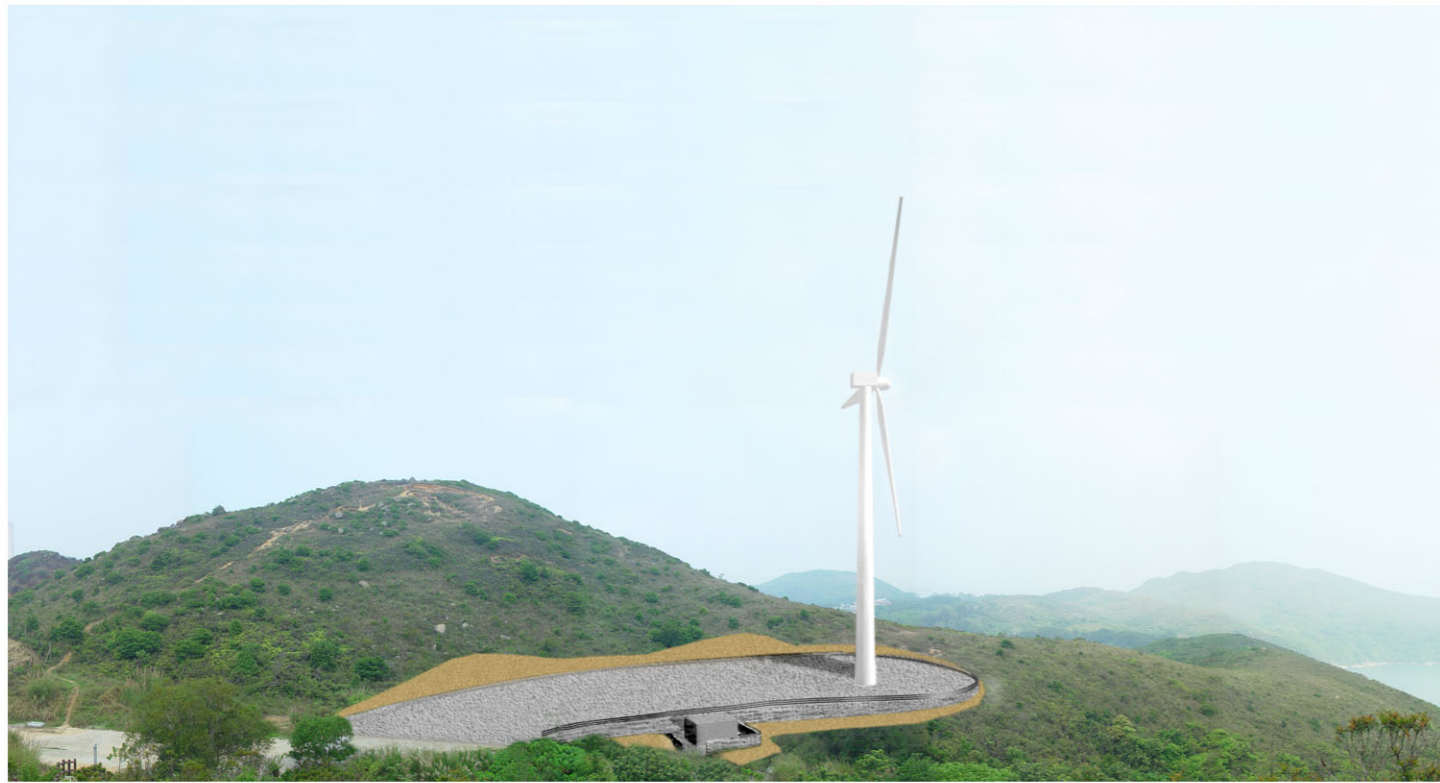
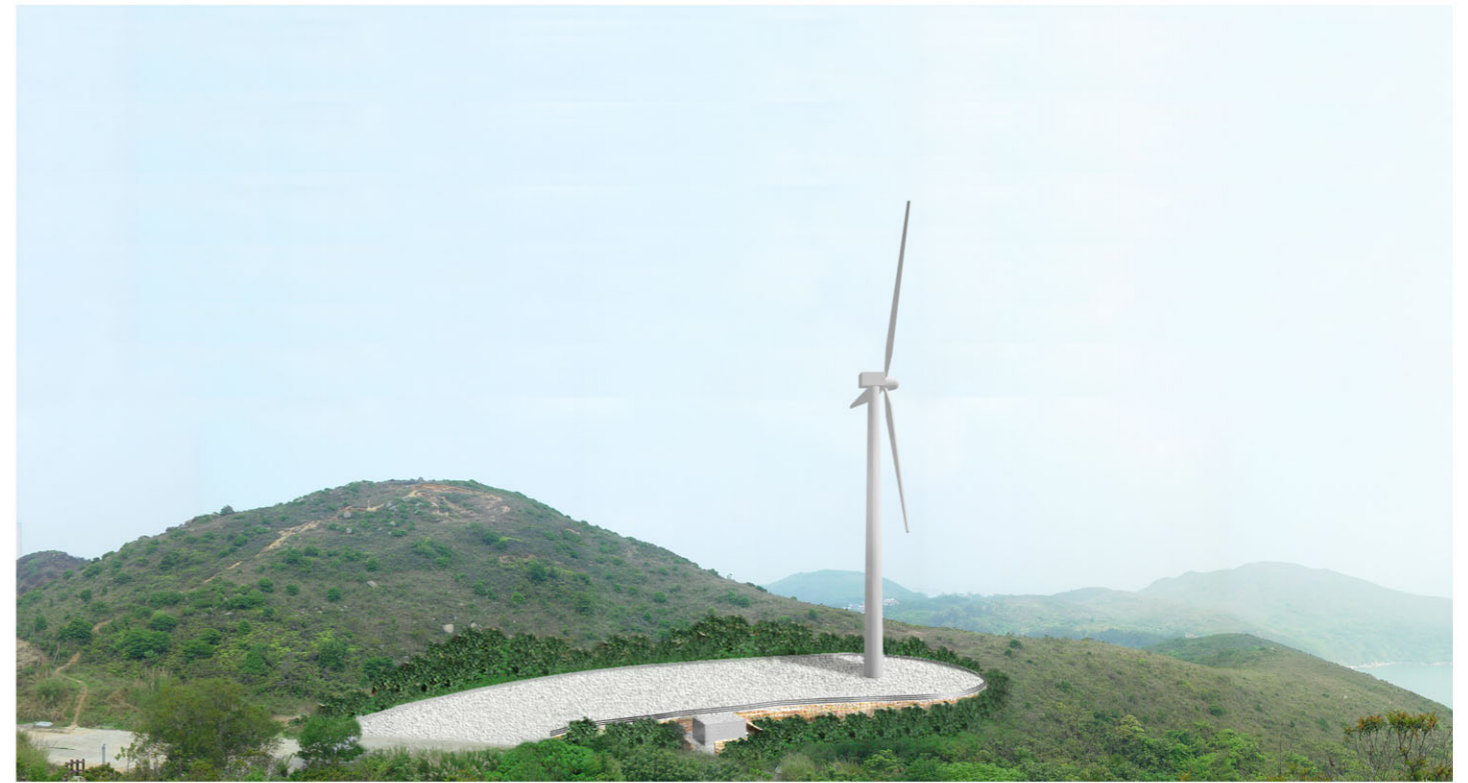
Figure 6.25 - Mitigation Measures (Photomontage)

ICI colour code 1369
North Beach 50BG 72/011

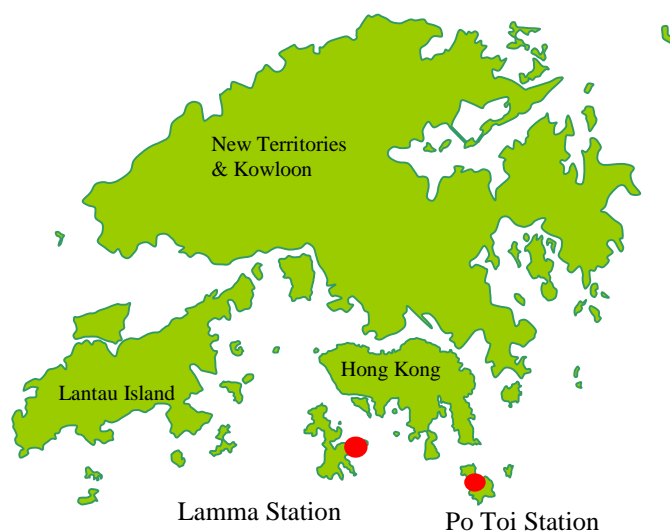
Fig. 1 - Location of Wind Monitoring Stations

HEC have commenced a feasibility study in April 1999 to collect wind data on Po Toi and Lamma Island to evaluate the wind potential in southern part of the Hong Kong territory. Two wind monitoring stations, one on Po Toi and another on Lamma Island, were set up in April and November 2001 respectively to record one-year wind profile (Fig. 1). Wind vanes and anemometers were installed at regular intervals up to 50m above ground to simulate typical hub height of modern wind turbines. The wind data were logged every second and integrated to a 10-minute average. The collected wind data were stored temporarily in a data logger and periodically downloaded for analysis.

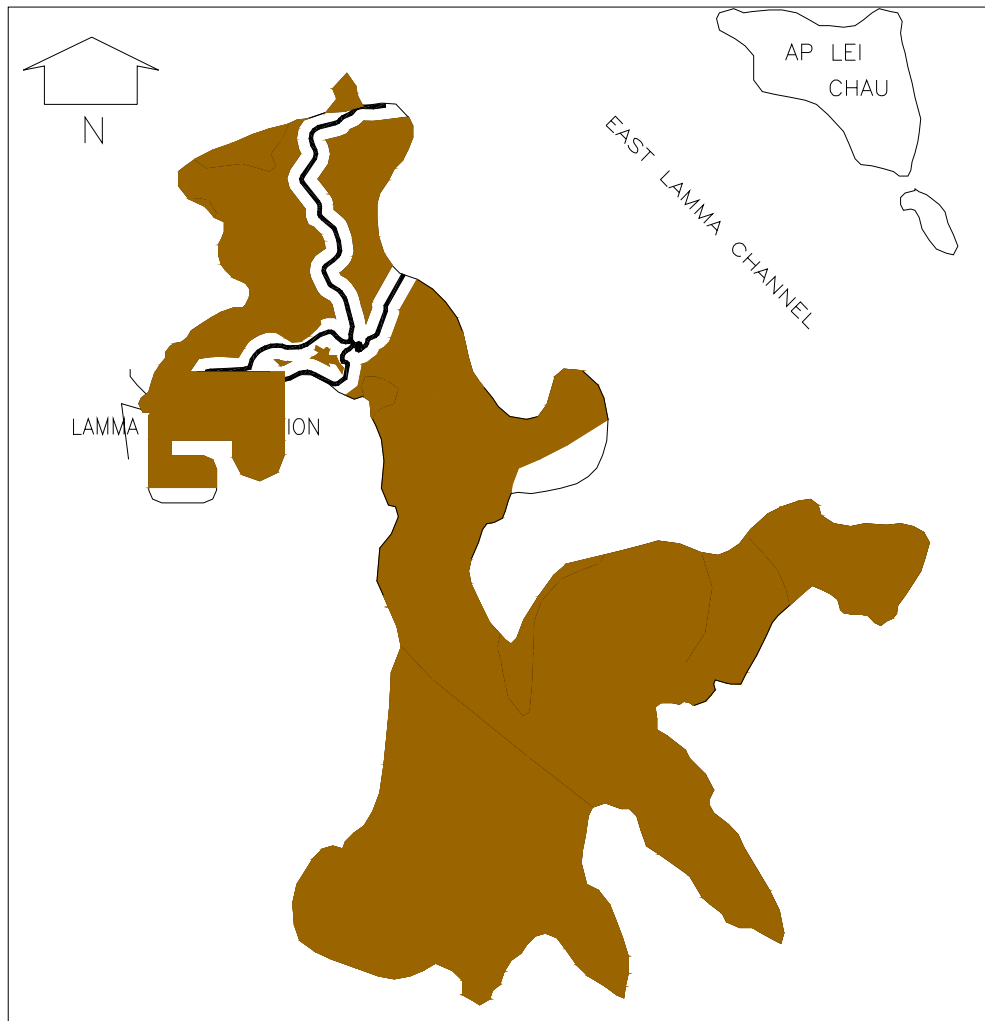
Fig. 9 - Composite Map of Constrained Area

The constraints mapped, and described above, have been brought together to produce a composite map (see Figure 9) showing the unconstrained areas for the search of potential site. The unconstrained areas have been scrutinized to determine potential locations for the 600kW or 1MW class wind turbine depending on height restriction.

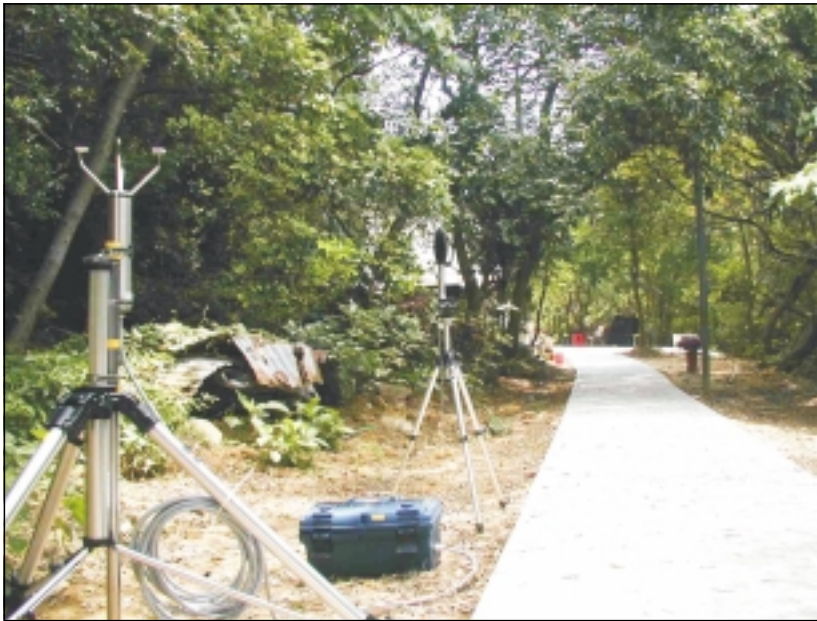
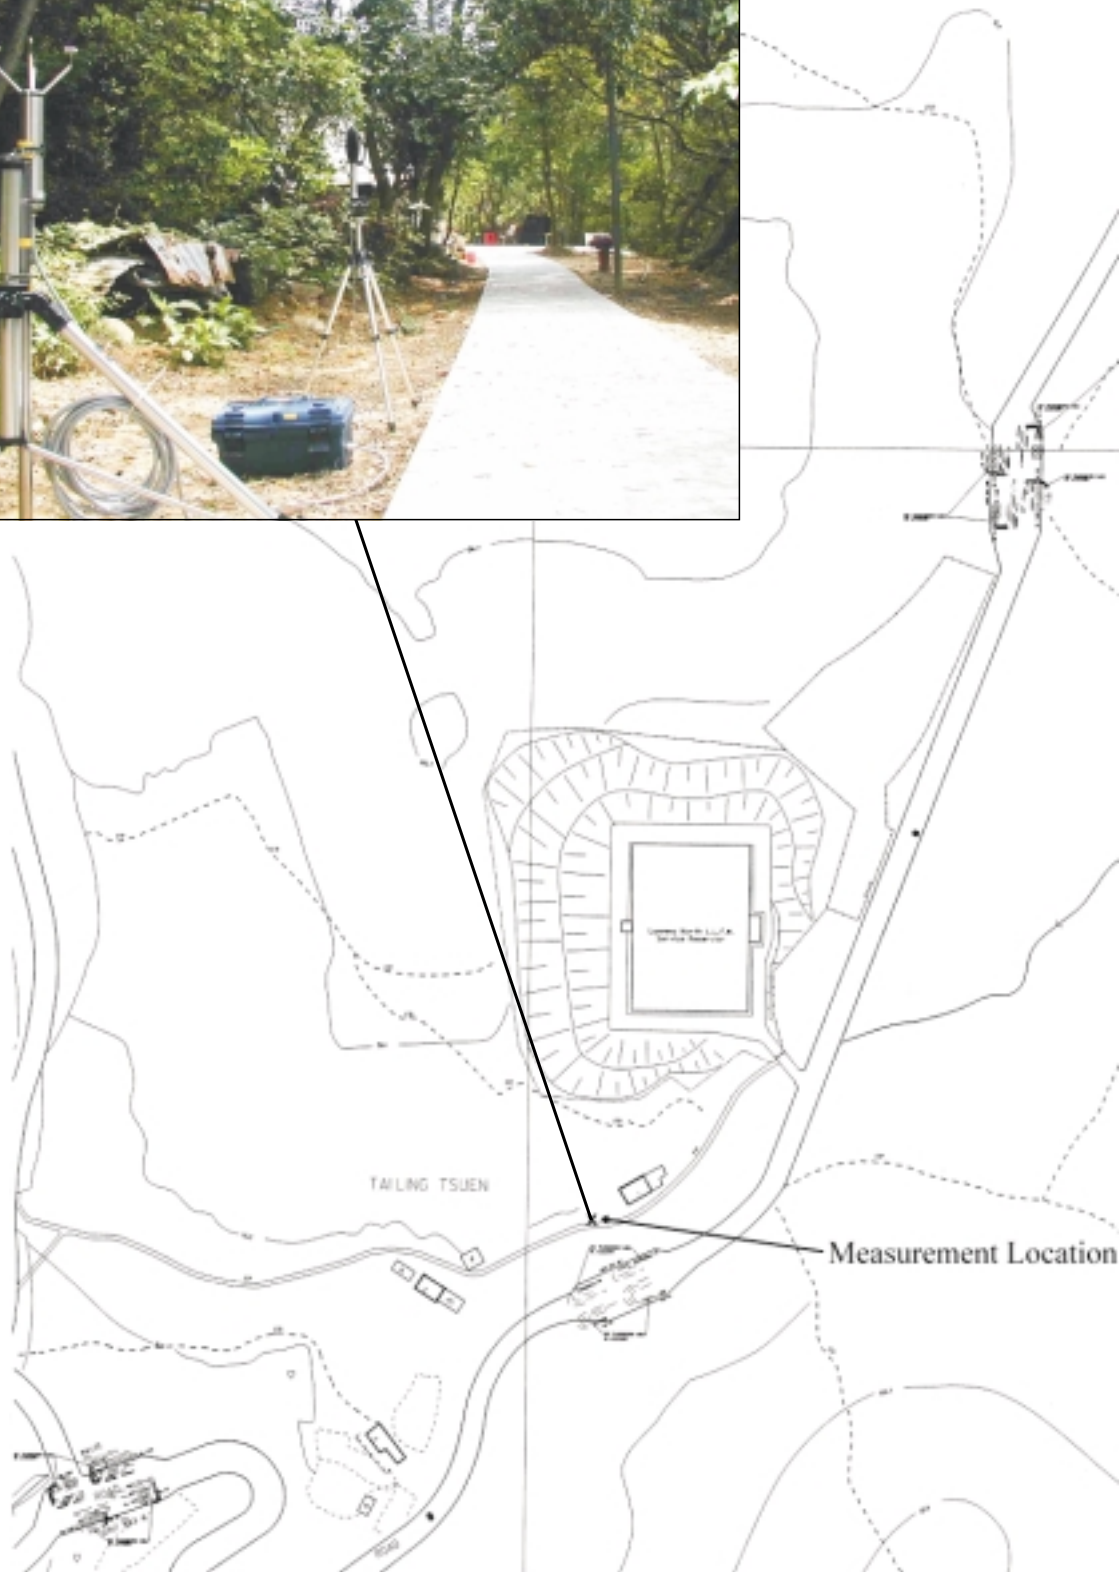
Figure B1

MEASUREMENT LOCATION
