### **Test Pit Excavation Results and Section Drawings**

**Agreement No. CE 67/98  
Yuen Long, Kam Tin, Ngau Tam Mei &  
Tin Shui Wai  
Drainage Improvement, Stage 1  
Environmental Impact Assessment**

Cultural Heritage Impact Assessment: KT 13

**Test Pit Excavation Results  
and Section Drawings**

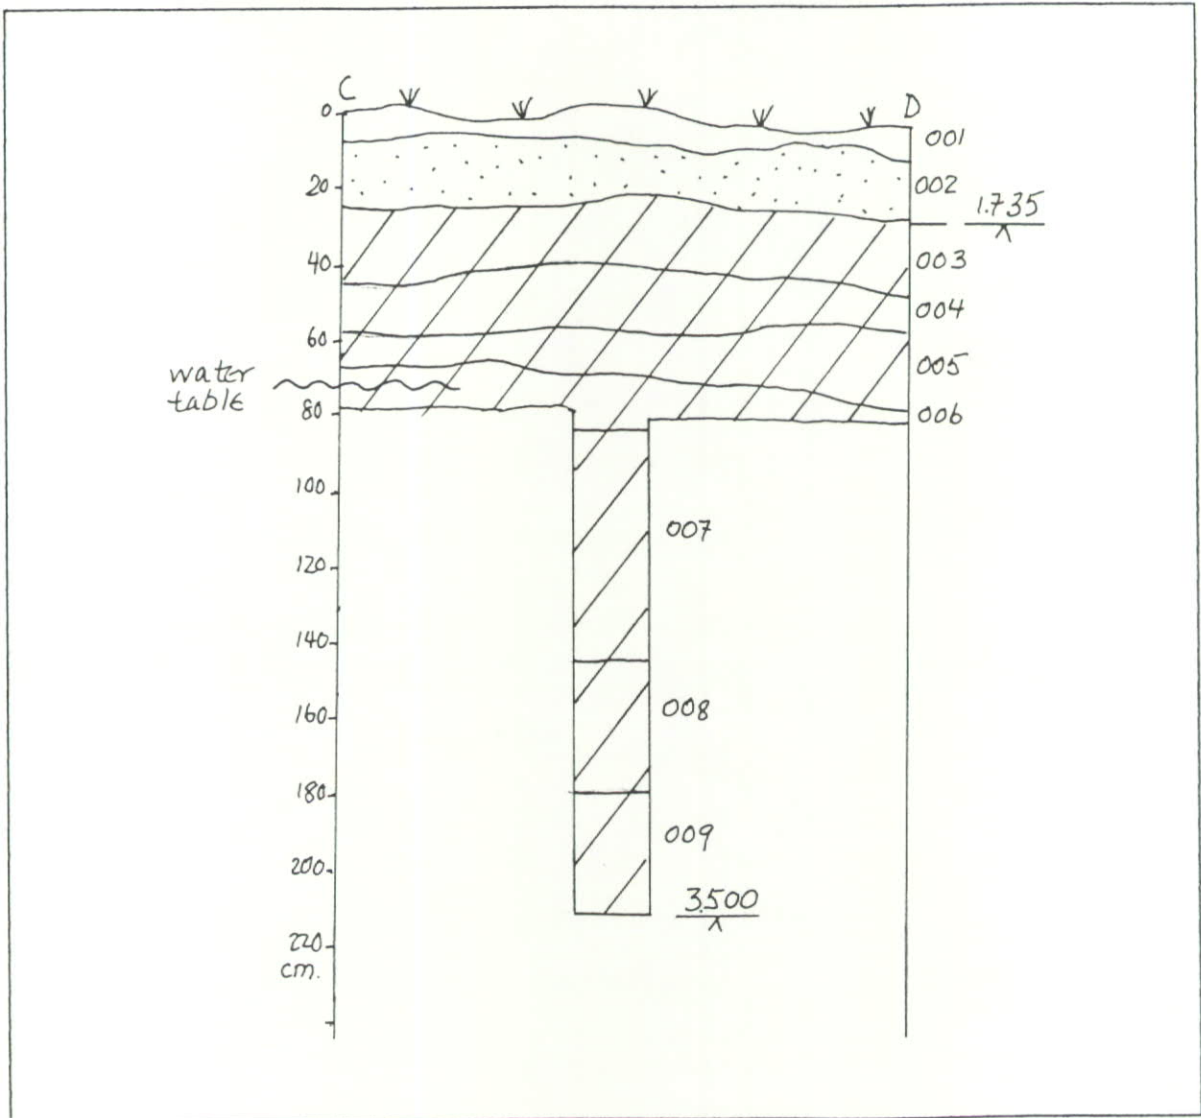
Test Pit Section Drawing

Test Pit 2 was excavated in an abandoned field to the south of the stream in Unit 1. The area is lower ( 14 m PD ) and wet. The test pit measured 1.5 m x 1.5m. The TBM was taken from the base of a large boulder beside the path to the south of the nearby house. Depths are given here in cms. below point C.

Layer	Depth (in cms)	Soil description	Colour	Interpretation
01	0-5	Brown SILT, slightly clayey and very slightly sandy, sub-angular to sub-rounded, very rooty.	10 YR 4/3	Top soil
02	5-14	Brown SILT, very slightly clayey and very slightly sandy, sub-angular to sub-rounded, with roots. [ Bag TP2(1)]	10 YR 5/3	Subsoil
03	14-28	Light olive brown SILT, very slightly clayey, slightly gravelly and slightly sandy, sub-angular to sub-rounded, with sherds. [ Bag TP2 (2)]	2.5 Y 5/3	Alluvium
04	28 -34	Olive brown SILT, sandy, slightly gravelly and slightly clayey, sub-angular to sub-rounded. [ Bag TP2 (3)]	5 Y 5/2	Alluvium
05	34-65	Light olive brown SILT, slightly clayey, sandy and slightly gravelly, sub-angular to sub-rounded, with quartz. [ Bag TP2 (4)]	2.5 Y 5/6	Alluvium
06	65-75	Light yellowish brown GRAVEL, very slightly clayey, sub-angular to sub-rounded, water table at 74 cm.	2.5 Y 6/4	Alluvium
07	75-138	Light olive brown CLAY, slightly silty and slightly sandy. The excavation of the test pit was halted at 106cm due to safety measures. An auger hole test was carried out to further verify the stratigraphy.	2.5 Y 5/4	Alluvium

08	138-172	Grey CLAY, slightly sandy and slightly gravelly, sub-angular to sub-rounded.	2.5 Y 5/1	Alluvium
09	172-202	Brownish yellow GRAVEL, very slightly sandy, angular to sub-angular.	10 YR 6/8	Alluvium
	202	Abandoned due to soil no longer staying in bucket.	--	-

Test Pit Number: 2  
Scale: 1:20  
TBM 0.430

Section: South Section  
Date: 30.05.00

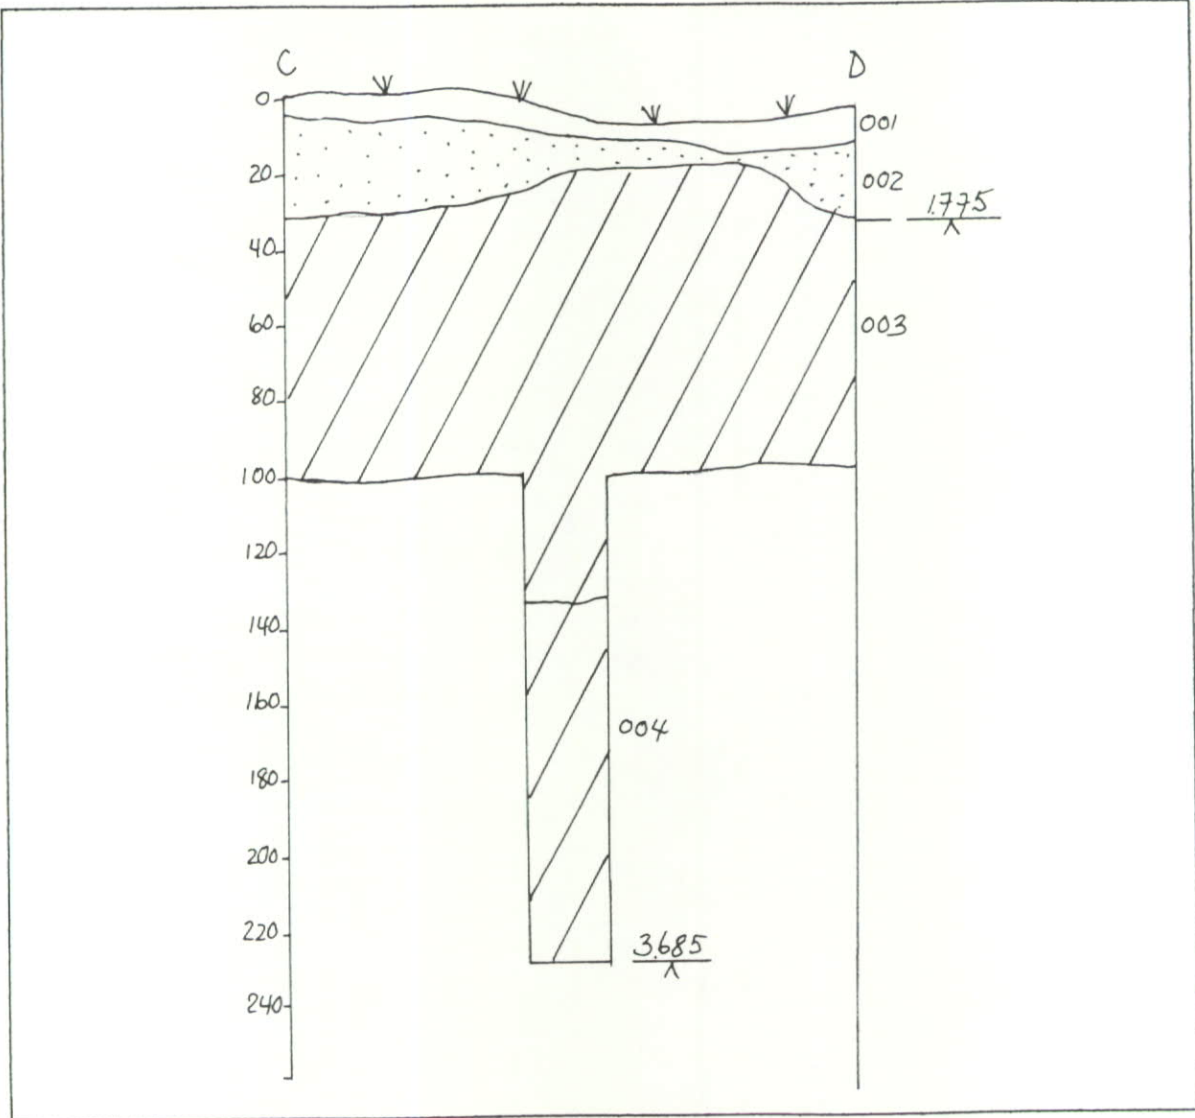
**Test Pit Section Drawing**

Test Pit 3 was situated in Unit 2 in abandoned fields east of the stream at approx. 13.7 m PD. The test pit measured 1.5m x 1.5m. TBM was taken from the base of the electricity pole beside the path to the south of the test pit. Depths are given here in cms. below point C.

Layer	Depth (in cms)	Soil description	Colour	Interpretation
01	0-4	Light olive brown SILT, very slightly sandy, angular to sub-angular. Roots and modern sherds [ Bag TP3(1) ]	2.5Y 5/3	Top soil
02	4 - 32	Light olive brown SILT, very slightly sandy, angular to sub-angular. Modern sherds [ Bag TP3(2) ]	2.5Y 5/4	Subsoil
03	32 -131	Yellowish brown CLAY. silty, very slightly sandy, very slightly gravelly, sub-angular to sub-rounded. The excavation of the test pit was halted at 105 cm due to safety measures. An auger hole test was carried out to further verify the stratigraphy.	10 YR 5/6	Alluvium
04	131-218	Brownish yellow CLAY, slightly silty, very slightly sandy, angular to sub-angular. Increasing amount of parent material with depth.	10YR 6/8	Alluvium
	218	Abandoned due to end of auger	--	--

Test Pit Number: 3 Section: **South Section**

Scale: 1:20 Date: 03.06.00

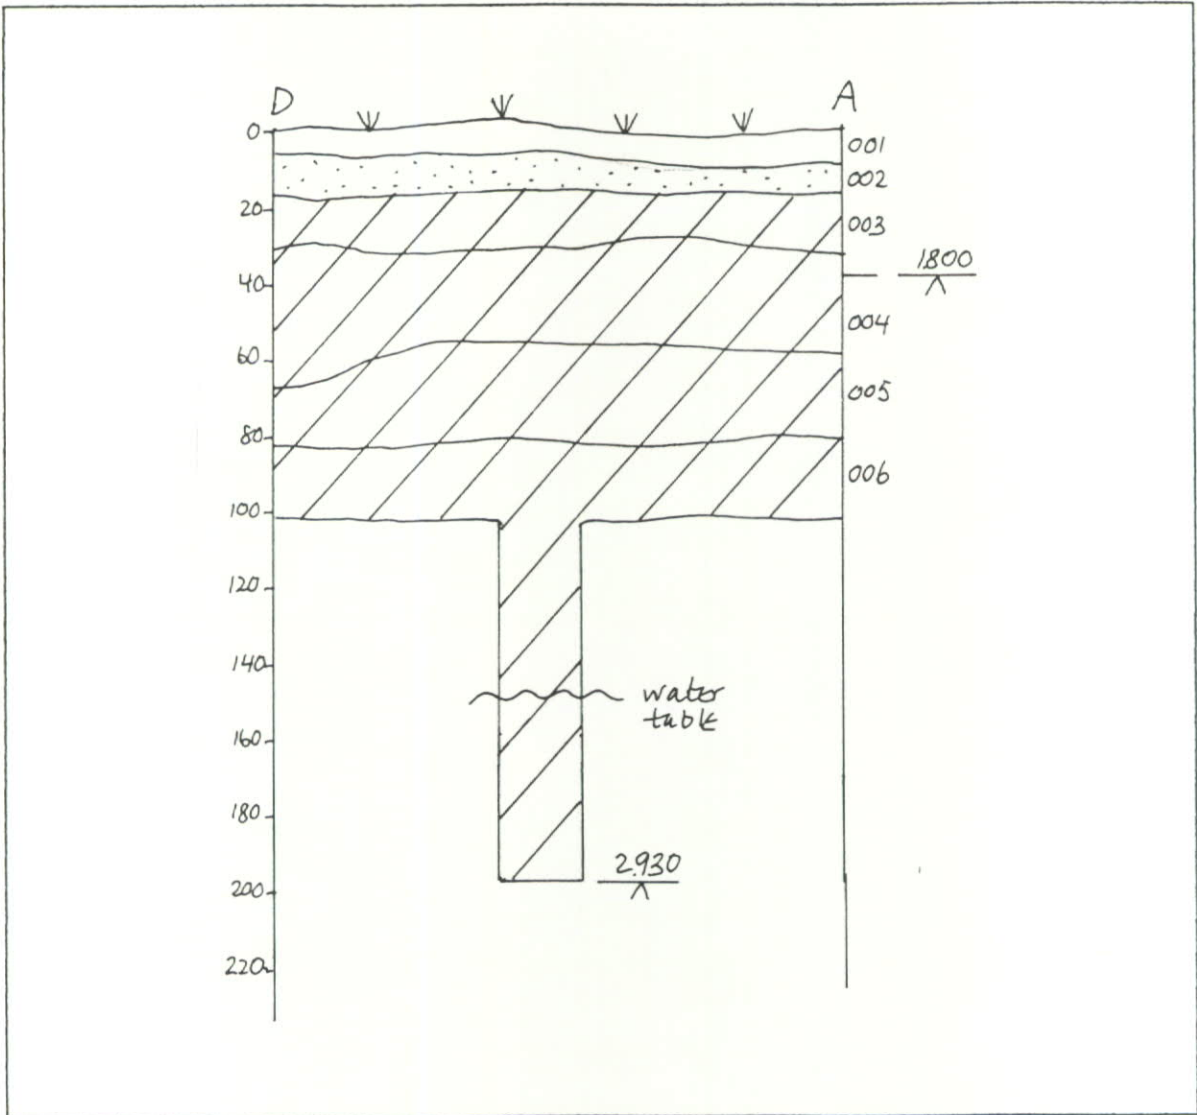
**Test Pit Section Drawing**

Test Pit 4 was located to the west of the stream in Unit 2 in an abandoned portion of the nursery. It lay at approx. 11m PD and measured 1.5m x 1.5m. TBM was taken from the base of a large tree in the nursery to the south of the test pit. All depths are measured from point D.

Layer	Depth (in cms)	Soil description	Colour	Interpretation
01	0-7	Light olive brown SILT with roots and organic material.	2.5Y 5/4	Topsoil
02	7-16	Olive Yellow SILT with modern sherds and tile [ Bag TP4(1) ]	2.5Y 6/6	Subsoil
03	16 -26	Light olive brown SILT, slightly sandy, sub-angular to sub-rounded; modern sherds [ Bag TP4(2) ]	2.5Y 5/6	Alluvium
04	26 – 64	Olive yellow SILT, slightly sandy, angular to sub-angular, modern sherds [ Bag TP4(3) ]	5Y 6/6	Alluvium
05	64 -88	Greyish brown SILT, very clayey, slightly sandy, angular to sub-angular, modern sherds [ Bag TP4 (4) ]	10YR 5/2	Alluvium
06	88 - 202	Light olive brown CLAY, slightly sandy, slightly silty, sub-angular to sub-rounded.  The excavation of the test pit was halted at 195 cm. due to safety measures. An auger hole test was carried out to further verify the stratigraphy. Water table at 144 cm.	10YR 5/6	Alluvium
	202	Augering ceased due to failure of waterlogged clay to hold in the auger bucket.	--	--

Test Pit Number: 4 Section: West Section

Scale: 1:20 Date: 05.06.00

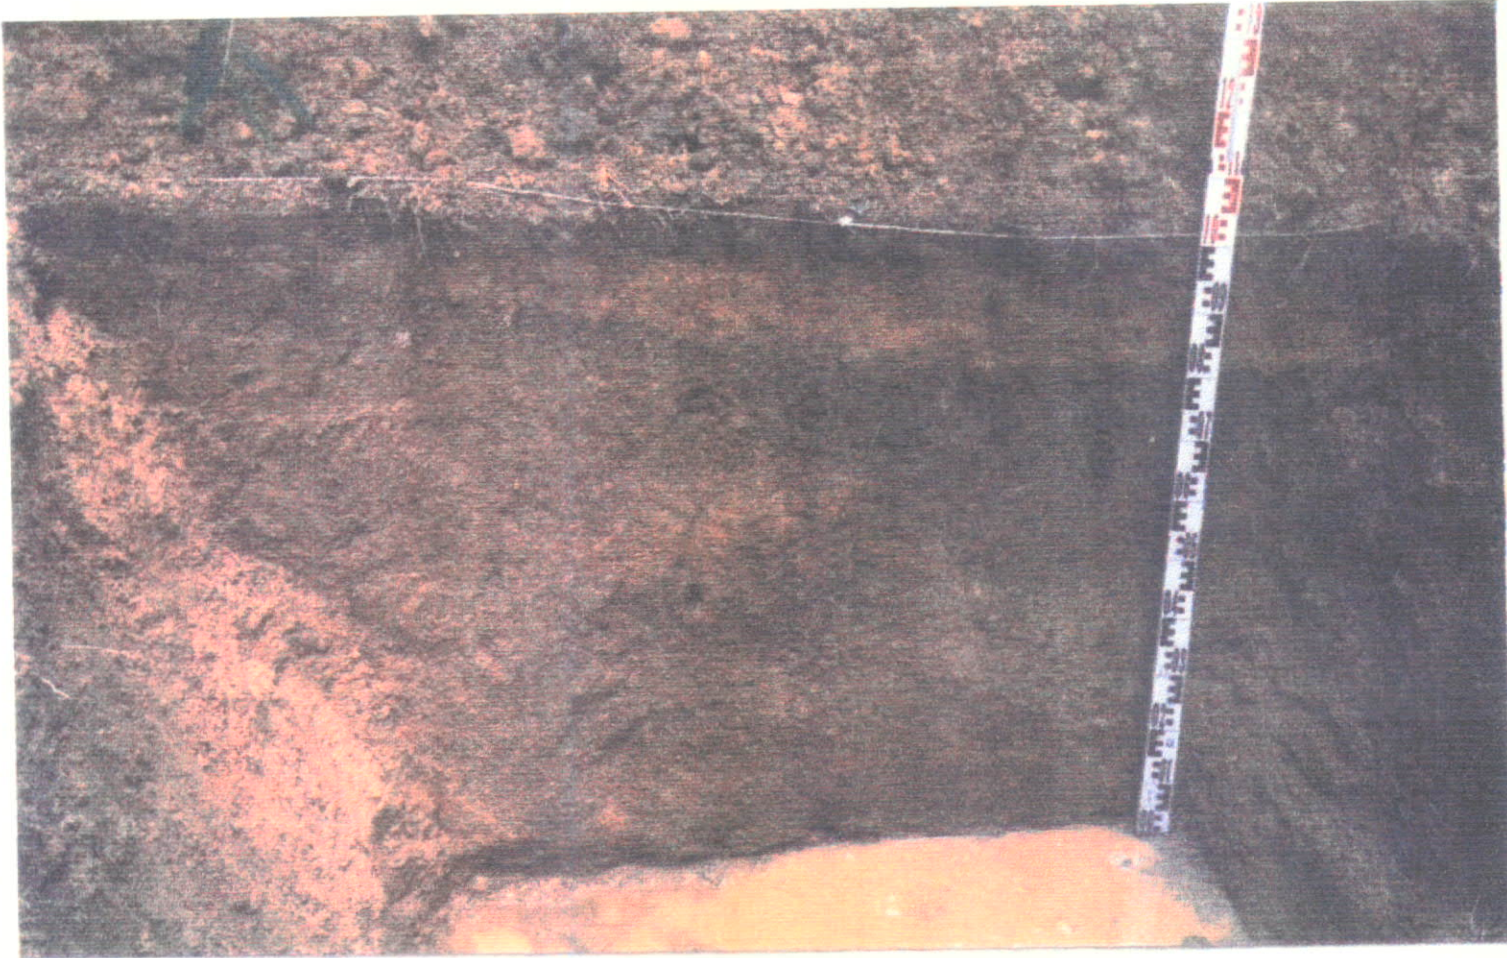
Test Pit 5. Ma On Kong  
North section.

Layer	Level (in cms.)	Soil description	Colour	Interpretation
01	A: 0 B: - 22 C: - 21.5 D: + 8	Yellowish brown SILT, very clayey and sandy, with some medium sized rocks	10 YR 5/6	Topsoil
02	A: - 3.5 B: - 28 C: - 28 D: - 1	Yellowish brown GRAVEL, very clayey and silty	10 YR 5/6	Hill Wash
03	A: - 17 B: - 39.5 C: - 43.5 D: - 23	Brown CLAY, gravely and silty, sub-angular to sub-rounded	10 YR 4/3	Topsoil
04	A: - 19.5 B: - 38 C: - 28 D: - 28	Brown CLAY, gravely and silty, sub-angular to sub-rounded	10 YR 5/3	Agricultural Soil
05	A: - 61 B: - 70 C: - 65 D: - 62	Yellowish brown GRAVEL, clayey and very silty	10 YR 5/4	Cultural Soil
06	A: - 73 B: - 97 C: - 93.5 D: - 73.5	Dark yellowish brown CLAY, gravely and motley, angular to sub-angular to sub-rounded, with rocks	10 YR 4/2	Decomposing Rock
BT	A: - 122 B: - 121 C: - 121.5 D: - 121	The excavation of the test pit was halted at these levels due to water table.	--	--

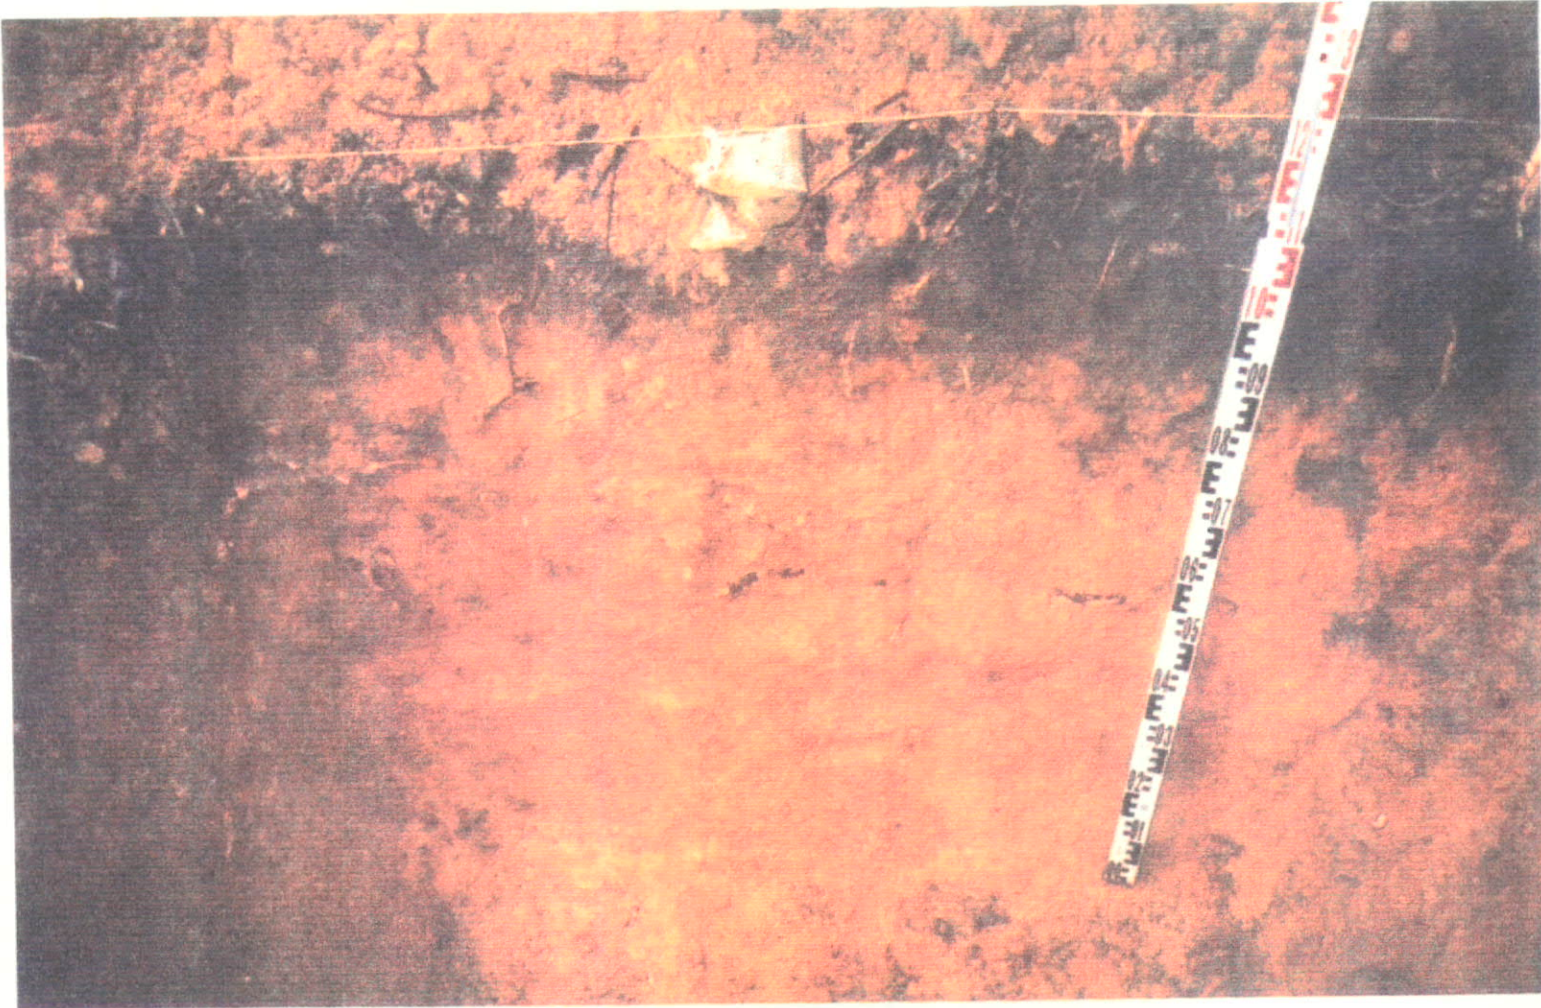
Test Pit 6. Ma On Kong  
North section.

Layer	Level (in cms.)	Soil description	Colour	Interpretation
01	A: 0 B: - 21 C: - 7 D: + 6	Brown SILT, gravely, slightly clayey and slightly sandy, sub-angular to sub-rounded, with roots	10 YR 4/3	Topsoil
02	A: - 10 B: - 28 C: - 20 D: - 10	Dark brown SILT, clayey, sandy and slightly gravely, sub-angular to sub-rounded, with rocks and roots	10 YR 3/3	Subsoil
03	A: - 47 B: - 55 C: - 62 D: - 48	Yellowish brown GRAVEL, clayey and very slightly silty, sub-angular to sub-rounded	10 YR 5/8	Fill ?
04		Greyish brown GRAVEL, very silty and clayey	10 YR 5/2	Soil in Pot
05	A: - 90 B: - 95 C: - 97 D: - 90	Olive yellow GRAVEL, very clayey and silty, sub-angular to sub-rounded	2.5 Y 6/8	Colluvium
BT	A: - 125 B: - 123 C: - 127 D: - 125	The excavation of the test pit was halted at these levels due to safety measures. An auger hole test was carried out to further verify the stratigraphy	--	--
05	X: - 260	Abandoned due to end of auger	--	--
