## **Appendix I2**

### **Historical Buildings and Structure Catalogue**

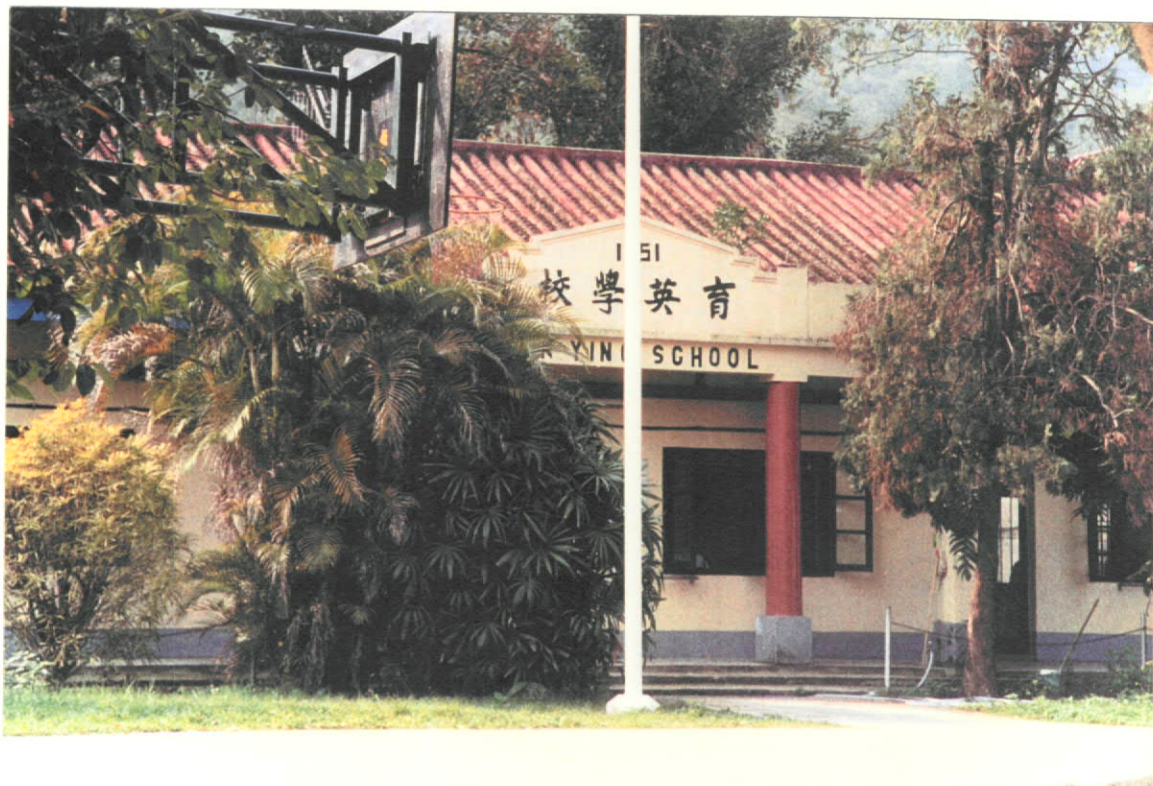
Construction Date / 建造日期	1951	Known / 有記載 <input checked="" type="checkbox"/>	Estimated / 估計
Architect / 建築師		Builder / 營造商	
Current Usage / 現有用途	SCHOOL	Original / Past Usage(s) / 原有/ 舊有用途 SCHOOL	
Comments / Observations / 評語/ 觀察	in use, very good condition

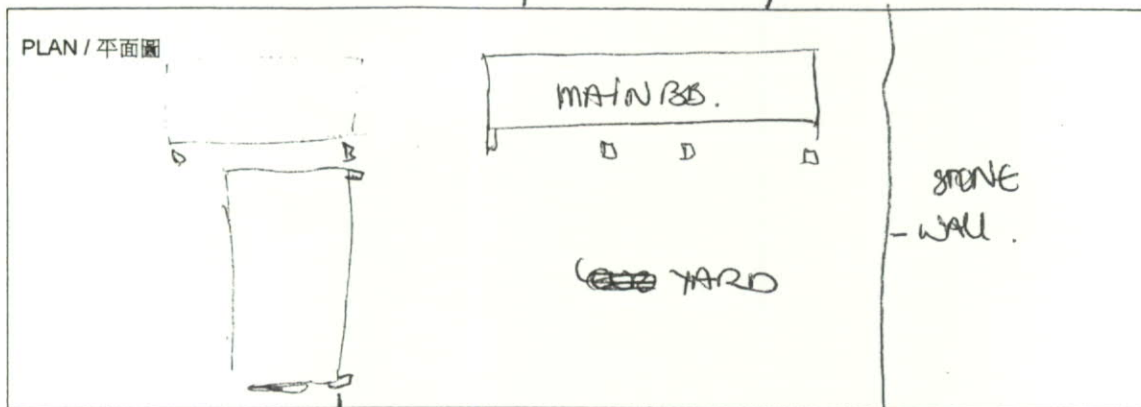
Style / 風格
Basic Shape / 基本形狀 RECTANGULARS (3 BUILDINGS)
Stories / 層 ONE STOREY BUILDINGS

walls are painted

Description/ Remarks / 說明/ 備註:  
main BBB has parapet with name + date of 1813.

all windows have metal grilles, and glass in window has dividers

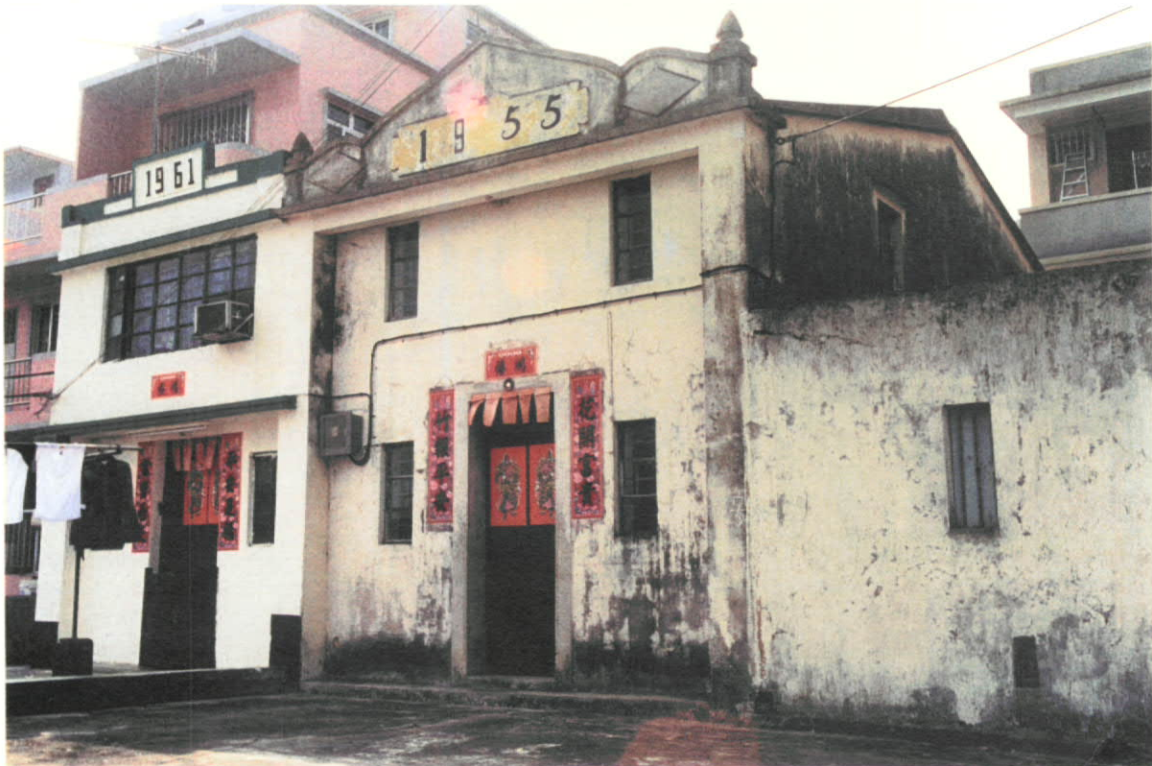
Location / 位置	HO PUI
Type / 種類	VILLAGE + HOUSE(S)
Map Ref. / 地圖參考檔號	#8, #9
Arch. Assessment Ref. / 考古通參考檔號	KT13-00 03
AMO Ref. / 古物古蹟辦事處參考檔號	
Photographic Ref. / 照片參考檔號	#3724(14)

<ul style="list-style-type: none"> <li>• plain ridged roof</li> <li>• all windows look modified = SET IN CR.</li> <li>• HOUSE = ABANDONED BUT FAIR CONDITION.</li> </ul>
Right front entrance:	ST FRAME LINTEL STEPS W. door FRAME.		
Left front door:	ST STEP W. door frame lintel.		
ST CORNER STONES			
ON LEFT SIDE + VISIBLE	7 COURSES OF ROUGH GRANITE STONE FOUNDATION		
GREEN BRICK B&B			
tile + CR roof	front part brick part wooden beam under eaves

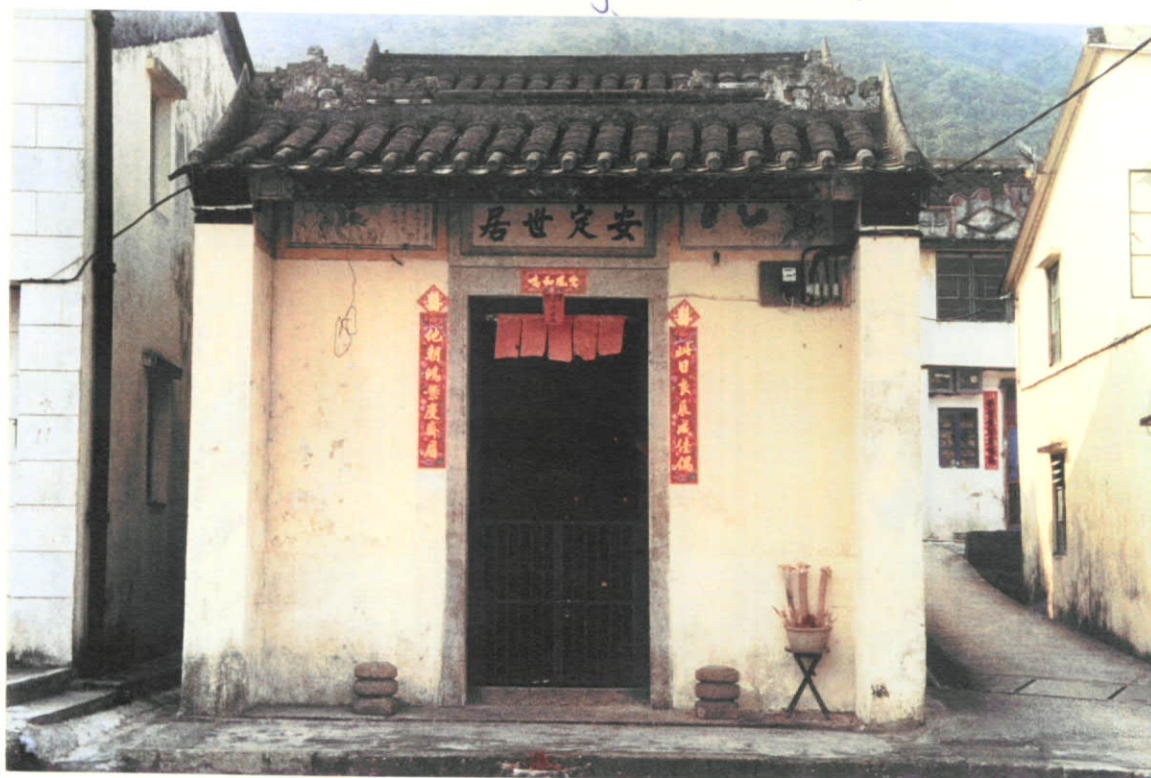
Location / 位置	Ho Pui
Type / 種類	Ancestral Hall (Fan) 范氏家祠
Map Ref. / 地圖參考編號	#13
Arch. Assessment Ref. / 考古通參考編號	KT13-00 : 05
AMO Ref. / 古物古蹟辦事處參考編號	
Photographic Ref. / 照片參考編號	#3724 (16)

Description / 說明	Renovated building on traditional site. Painted with AH to the east. Stone walls with clad facade. Courtyard style with single chamber. Tile & concrete roof & ornate roof ridge. Formerly decorated below (Associated dong bai) eaves. Concrete forecourt.
------------------	---

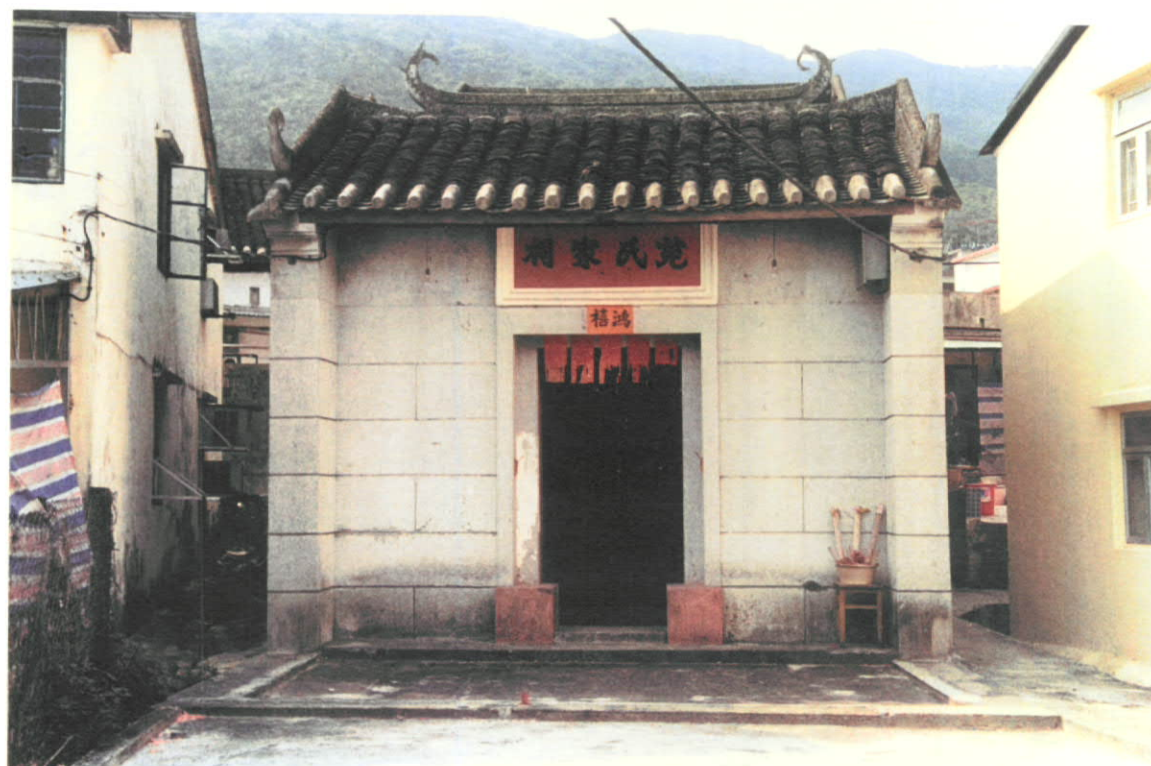
Location / 位置	MO PUI
Type / 種類	TERRACED VILLAGE HOUSES (ORIGINALLY 4)
Map Ref. / 地圖參考編號	(Fan Family) #14, 15, 16
Arch. Assessment Ref. / 考古通參考編號	KT.13.00 -06
AMO Ref. / 古物古蹟辦事處參考編號	
Photographic Ref. / 照片參考編號	#3724(17)

Description / 說明	• HIGHLY MODIFIED BUT ORIGINALLY OLD
	◦ <u>2 BY 2</u> WITH FRONT COURTYARD LINED WITH LOW CR WALLS
	◦ <u>LEFT 2</u> • Parapet date 1965
	• FRONT COMPLETELY MODERN <sup>ONE ENTRANCE</sup> BUT KEPT DIVISION THROUGH HALF PILASTER OF 2 HOUSES.
	◦ <u>BOTH</u> plain ridged roof; rectangular plan
	◦ <u>RIGHT 2</u> • ONE PARAPET PAINTED + MOLDING
	• 2 WOODEN DOORS + FRAMES; CR STEPS.
	• UPSTAIRS 2 LARGE METAL GRILLE WINDOWS.

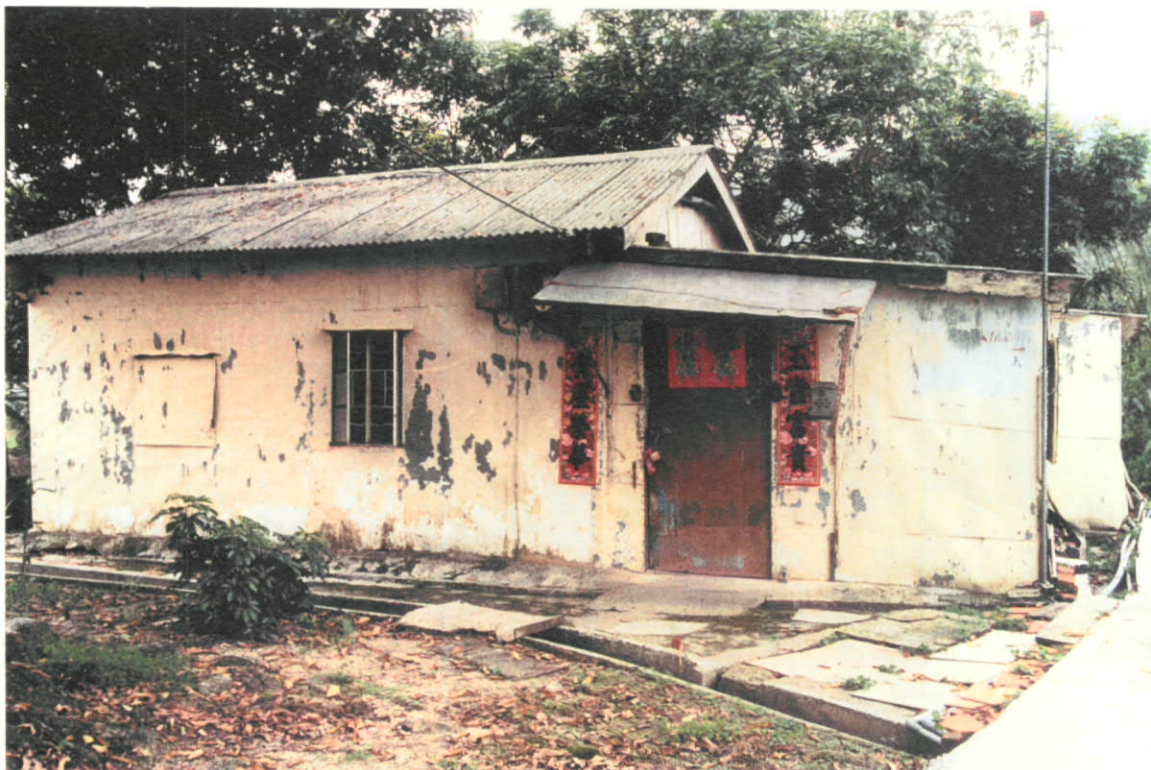
Location / 位置	Ho Pui
Type / 種類	Group of 3 sheds
Map Ref. / 地圖參考檔號	64A and two unnumbered Structures
Arch. Assessment Ref. / 考古通參考檔號	KTSL3.00:09
AMO Ref. / 古物古蹟辦事處參考檔號	
Photographic Ref. / 照片參考檔號	#3724 (20)

Reported to be 60 years old - heavily renovated. Walls mud brick with plaster/cement. Two with metal shed roofing third with metal pitched roof. No decorative features. Modern doors & windows

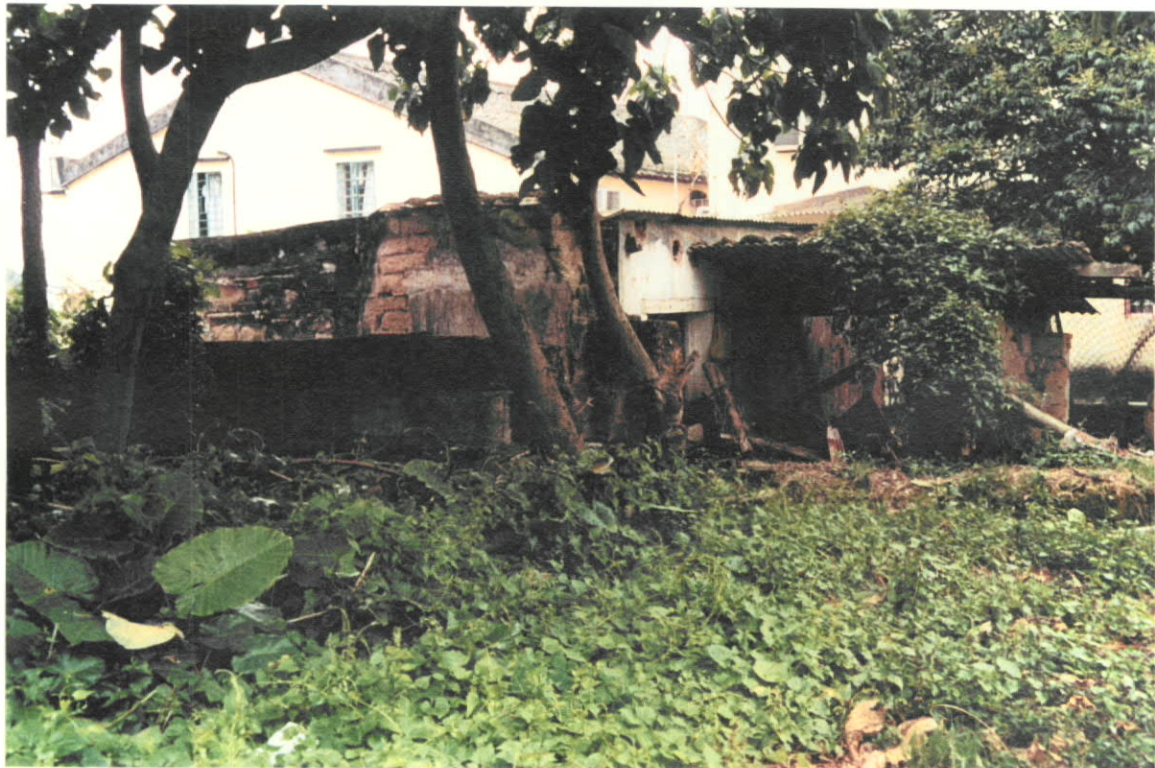
Remains of mud brick shed / animal pen  
with low shed roof (metal)  
Series of openings at ground level in  
extant walls, probably drainage.  
Age uncertain

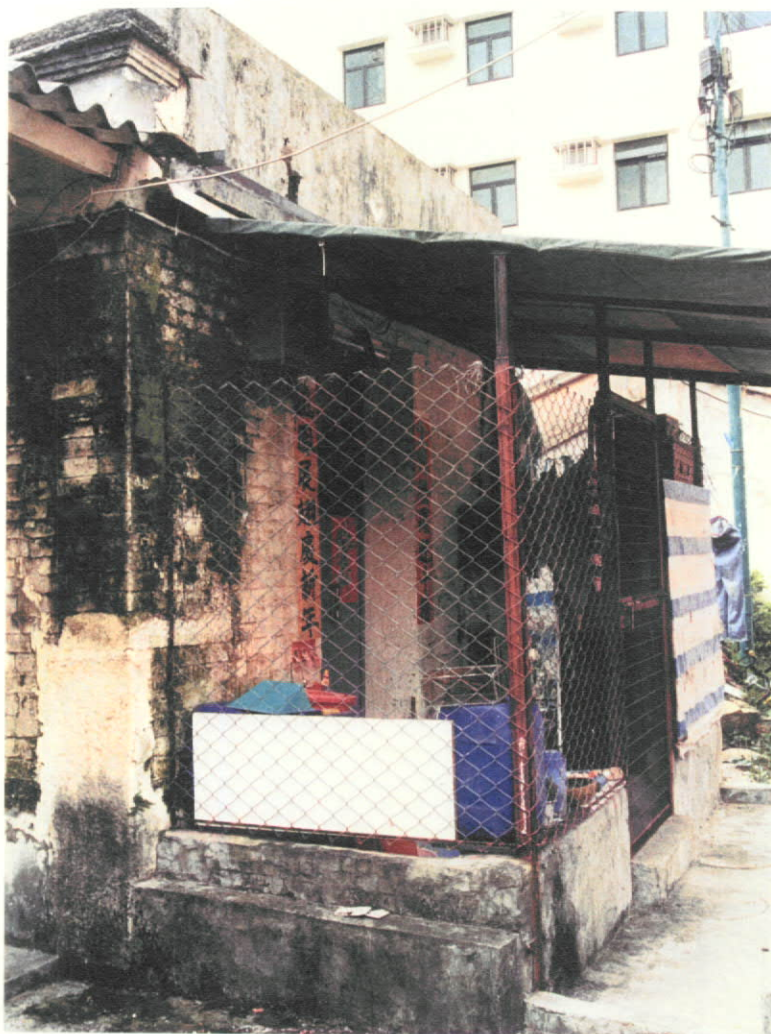
Location / 位置	ho poi
Type / 種類	COURTYARD HOUSE (?)
Map Ref. / 地圖參考檔號	#22
Arch. Assessment Ref. / 考古通參考檔號	KT13-00-13
AMO Ref. / 古物古蹟辦事處參考檔號	
Photographic Ref. / 照片參考檔號	#3724 (25)

- brown to blue bricks
- ST foundation
- W. door + frame
- ST STEP
- front roof = modern
- low house
- plain ridged roof

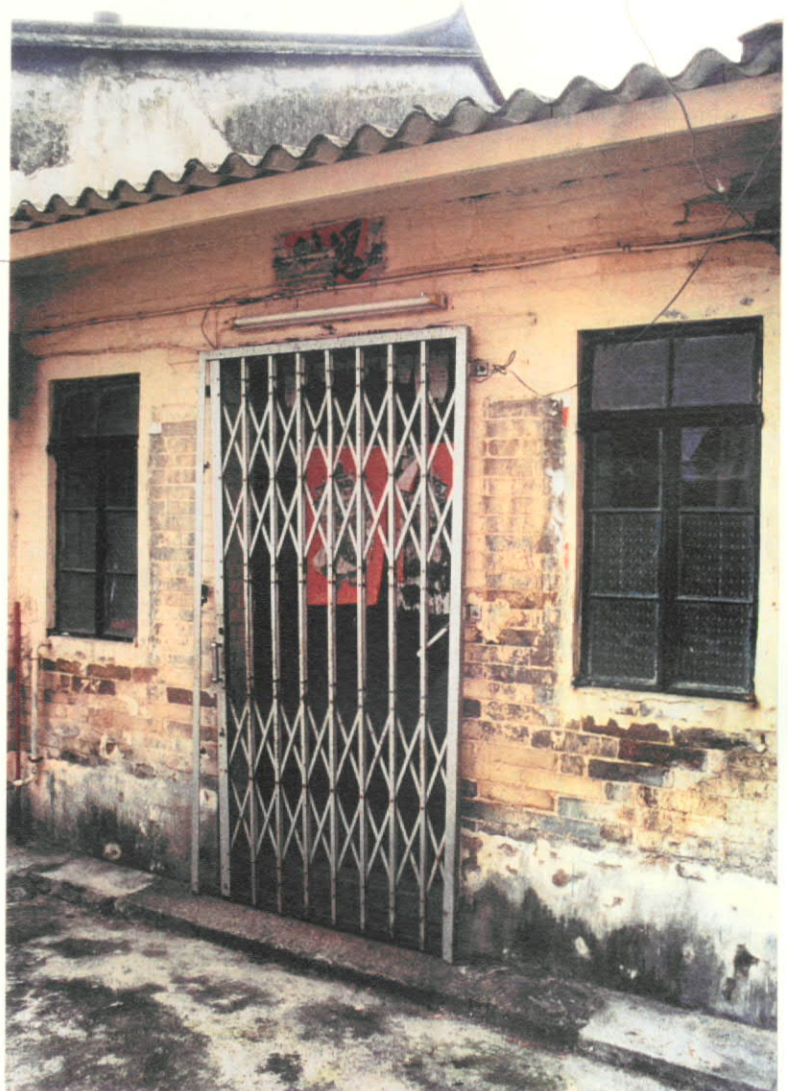
Location / 位置	H.O. PU!
Type / 種類	TERRACED HOUSE
Map Ref. / 地圖參考檔號	#23
Arch. Assessment Ref. / 考古通參考檔號	KT13.00-14
AMO Ref. / 古物古蹟辦事處參考檔號	
Photographic Ref. / 照片參考檔號	#3724(26)

- green brick
- abandoned
- ST STEP
- W. DOOR + FRAME
- WIRE
- STONE ROUGH FOUNDATION
- borders under eaves
- tile + ce roof
- plain ridged roof
- STONE CORNER STONES

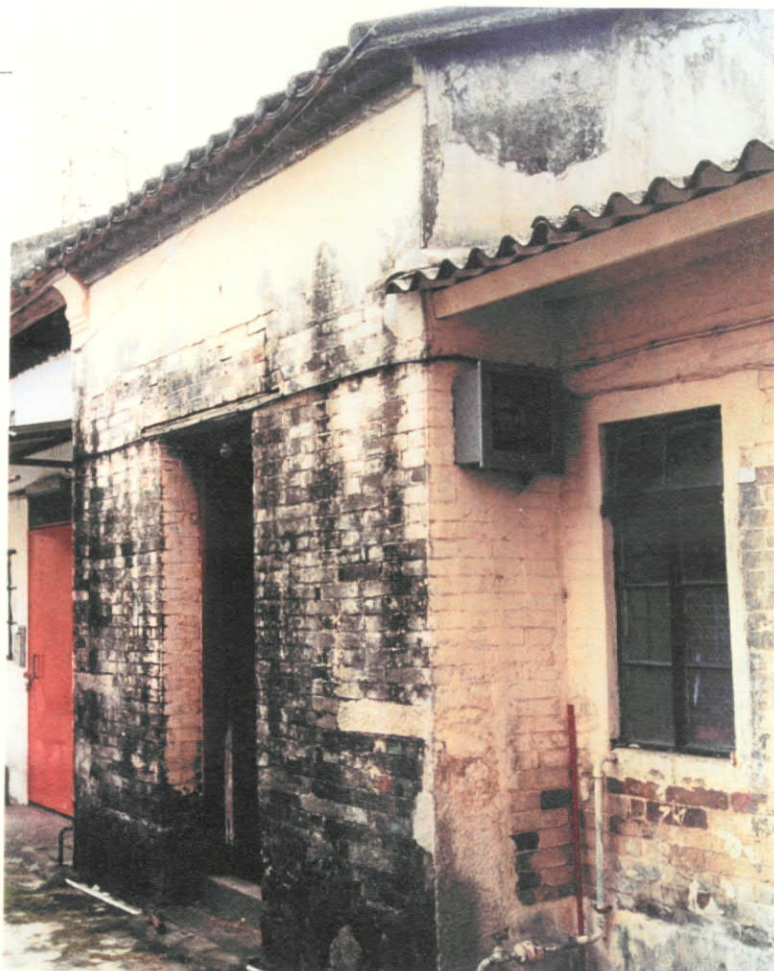
Location / 位置	HUO PUI
Type / 種類	TERRACED HOUSE
Map Ref. / 地圖參考檔號	#24 <span style="float: right;">24</span>
Arch. Assessment Ref. / 考古通參考檔號	KTIB:00-15-B
AMO Ref. / 古物古蹟辦事處參考檔號	
Photographic Ref. / 照片參考檔號	#3724(28)

Description / 說明	BRICK + 3 COURSE ST FOUNDATION FRONT
- MODERN DOOR	
- PLAN

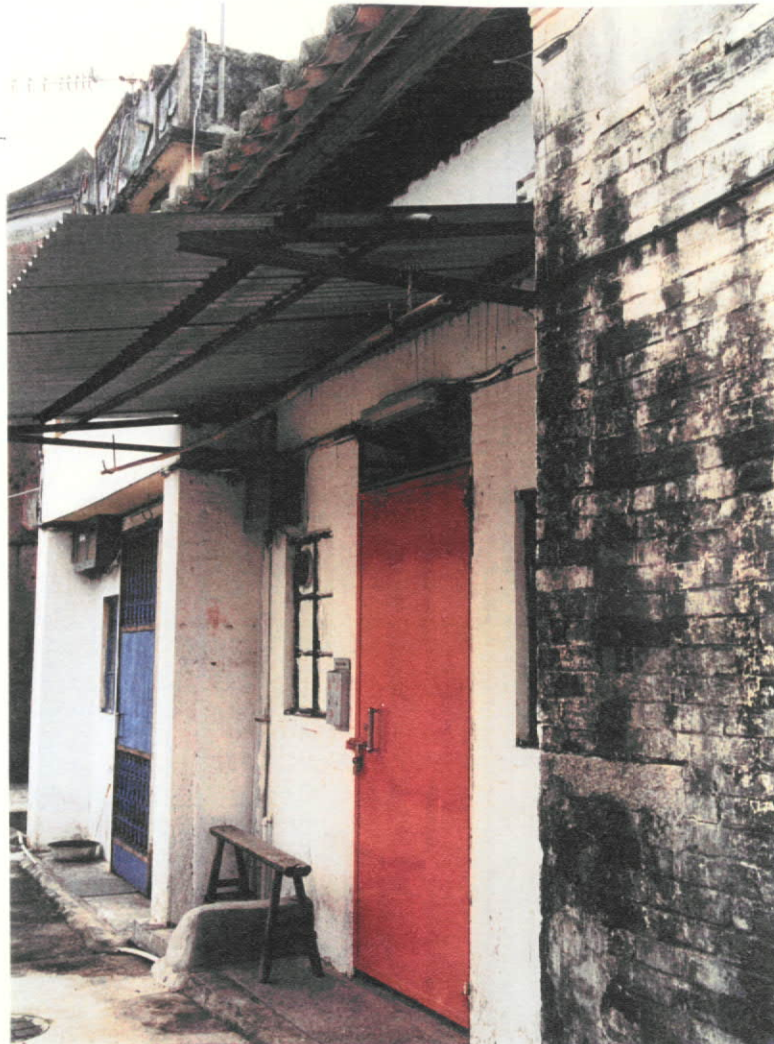
stone platform
	• w beam under eave
	Tile + CE ROOF
	• Plain house in use ; quite altered.
	• UP Fung shui wall in front of house.

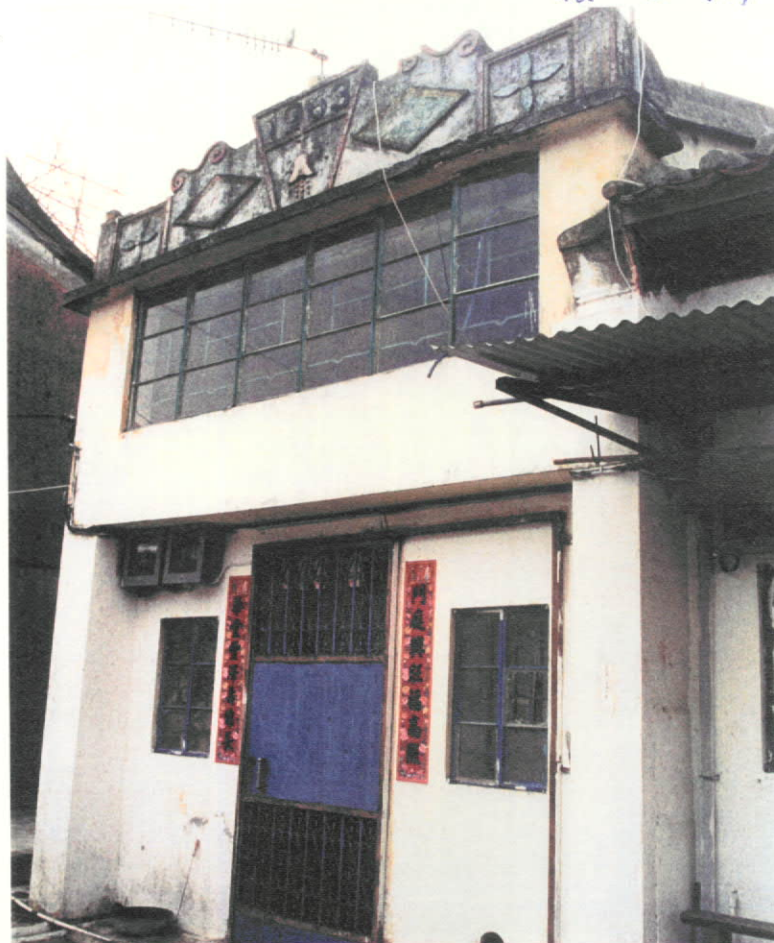
- HOUSE WITH AIRRAPER 1963
- large window  1st Floor
- modern gate
- W. DOOR + FRAME
- ST. STEP.
- rectangular plan
- painted fresco mde.
- OR pink walls.
- bricks under eaves rear (actually whole row 12-16 !!)

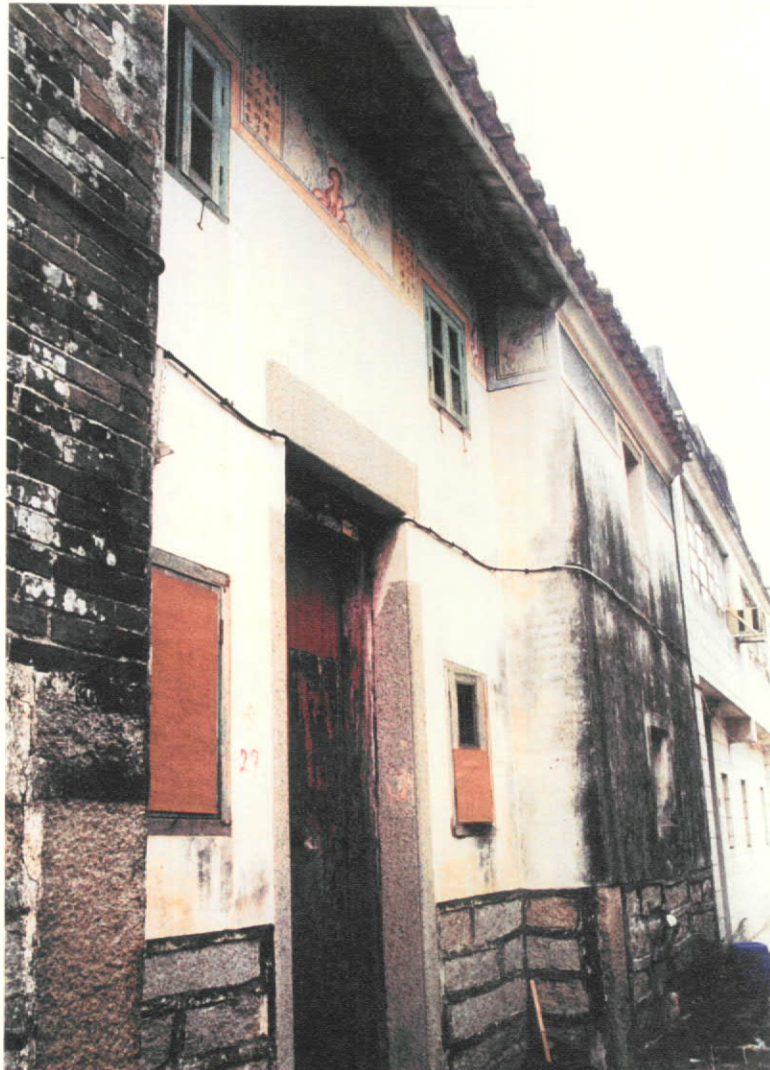
2 story house with granite slab lower walls [5 courses] & corner posts, lintels & jambs. & threshold. Original (?) wood windows. & front door. (very tall). Tile & wood roof. Courtyard.  
Upper walls mud brick + plaster. Painted frieze at top of walls - couplets + floral motifs. No interior access.

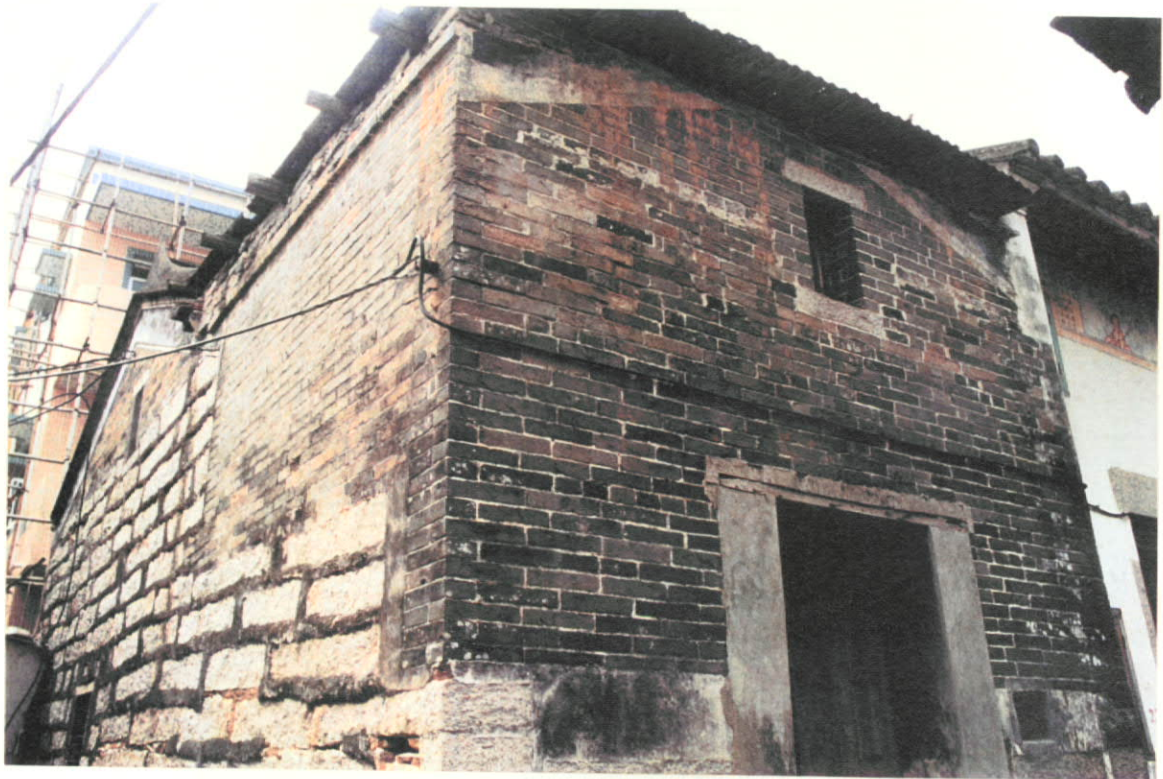
Description / 說明	<p>Lower walls of granite blocks; roughly mounted                  7 courses + corner slabs. concrete door                  frame, but old wooden door. Upper walls green brick.                  2 storeys. Small central 2nd floor facade window                  with granite block frame + metal bars.                  Rear has 17 courses of rough stone masonry                  &amp; green brick above. Tile &amp; concrete rear                  roof, front metal sheet. Top floor window                  in side as in front; lower window</p> <p>NO interior access.</p>
------------------	--

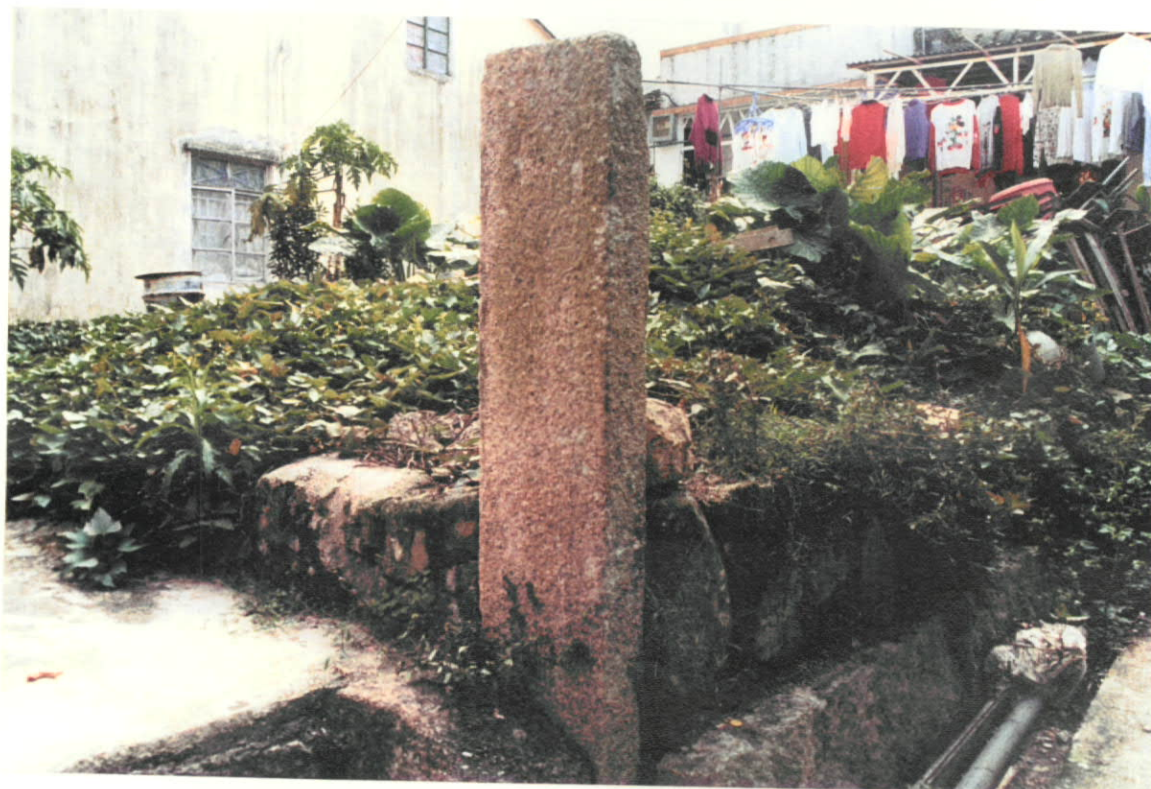
Location / 位置	KOPOI
Type / 種類	COURTYARD HOUSE
Map Ref. / 地圖參考權號	#35
Arch. Assessment Ref. / 考古通參考權號	K13-00-20
AMO Ref. / 古物古蹟辦事處參考權號	
Photographic Ref. / 照片參考權號	#3724(34)

Description / 說明	- brick house
	- Rough stone foundation very large at rear
	- Front granite corner masonry
	- tile + CR roof plain ridged roof
	- masonry corner eaves
	- st step
	lintel
	- modern door
	- brick under eaves

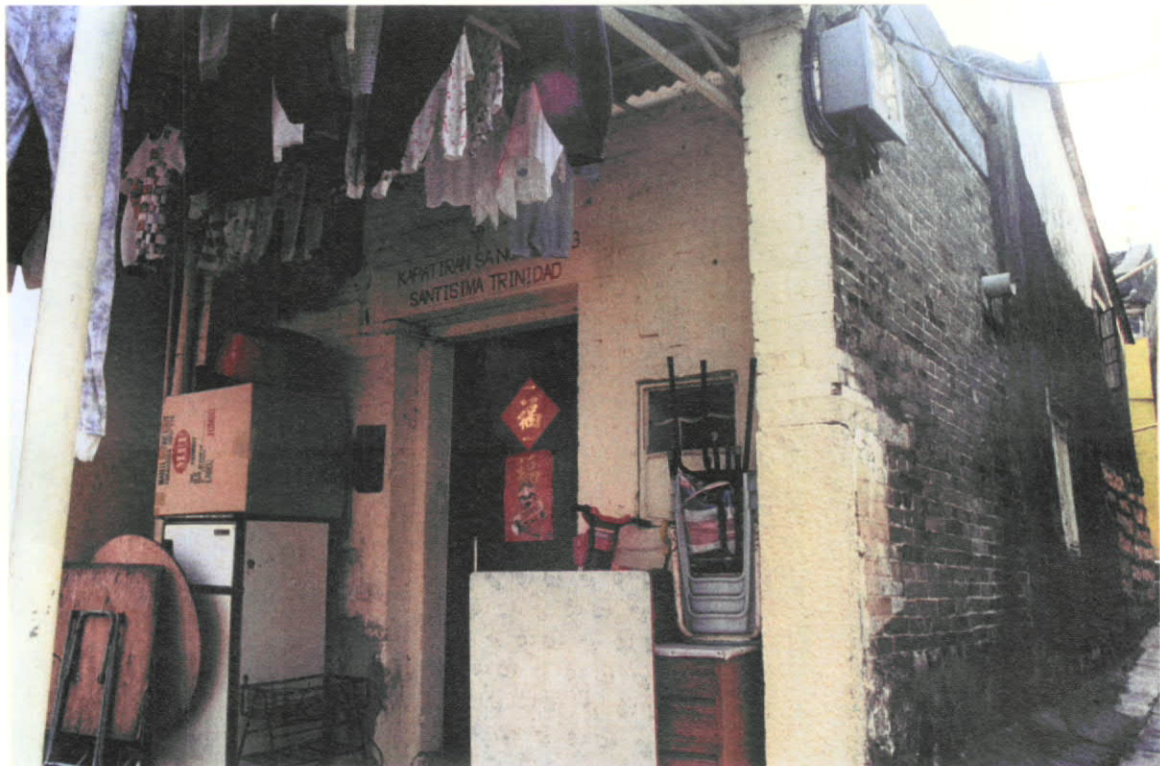
Location / 位置	HO PUI
Type / 種類	COURTYARD HOUSE
Map Ref. / 地圖參考權號	# 34
Arch. Assessment Ref. / 考古通參考權號	KT13.00.21
AMO Ref. / 古物古蹟辦事處參考權號	
Photographic Ref. / 照片參考權號	#3724 (35)

Description / 說明 brick oven - blue  
- bricks under eaves rear  
- rubble foundations  
- front completely modern  
- plain ridged roof tile tile

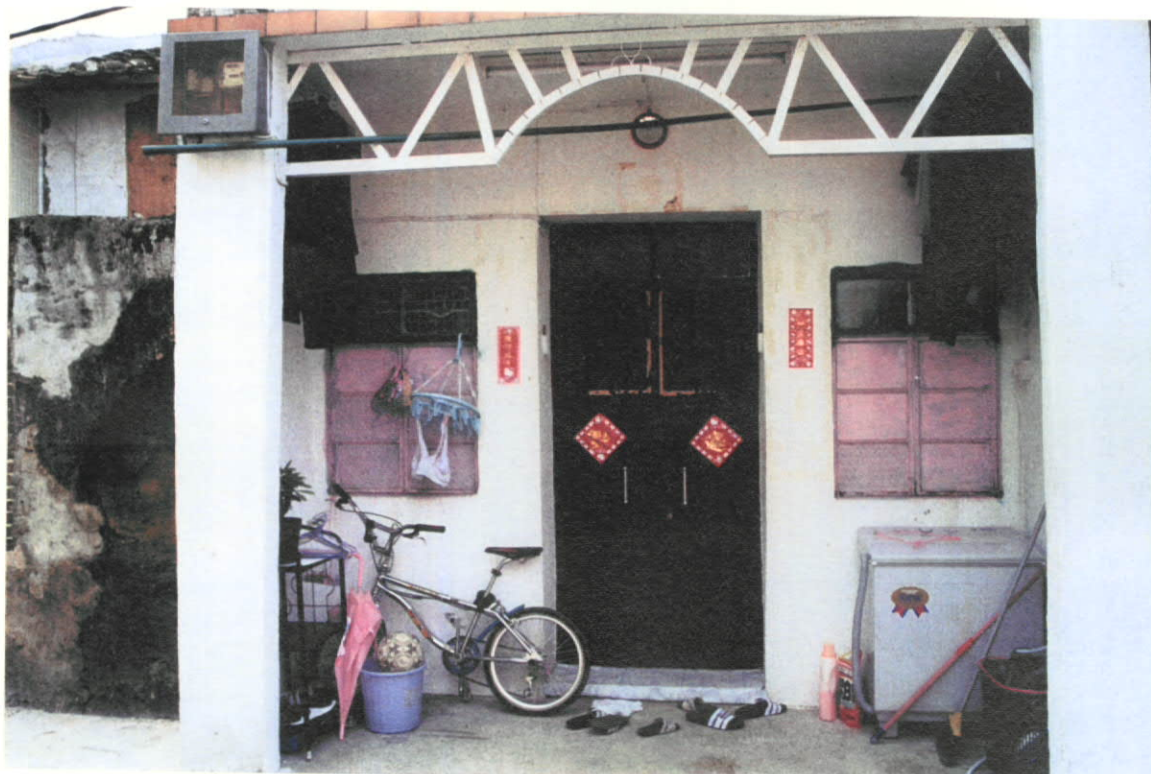
Location / 位置	Ho Pui
Type / 種類	COURTYARD HOUSES
Map Ref. / 地圖參考檔號	# 33
Arch. Assessment Ref. / 考古通參考檔號	KT53-00 -22
AMO Ref. / 古物古蹟辦事處參考檔號	
Photographic Ref. / 照片參考檔號	# 3724(36)

Description / 說明
<ul style="list-style-type: none"><li>- part part no longer in use + wall gone</li><li>- tile + ck roof bricks under eave rear front Ravel w beam</li><li>- modern door + frame.</li><li>- rubble stone foundation</li></ul>

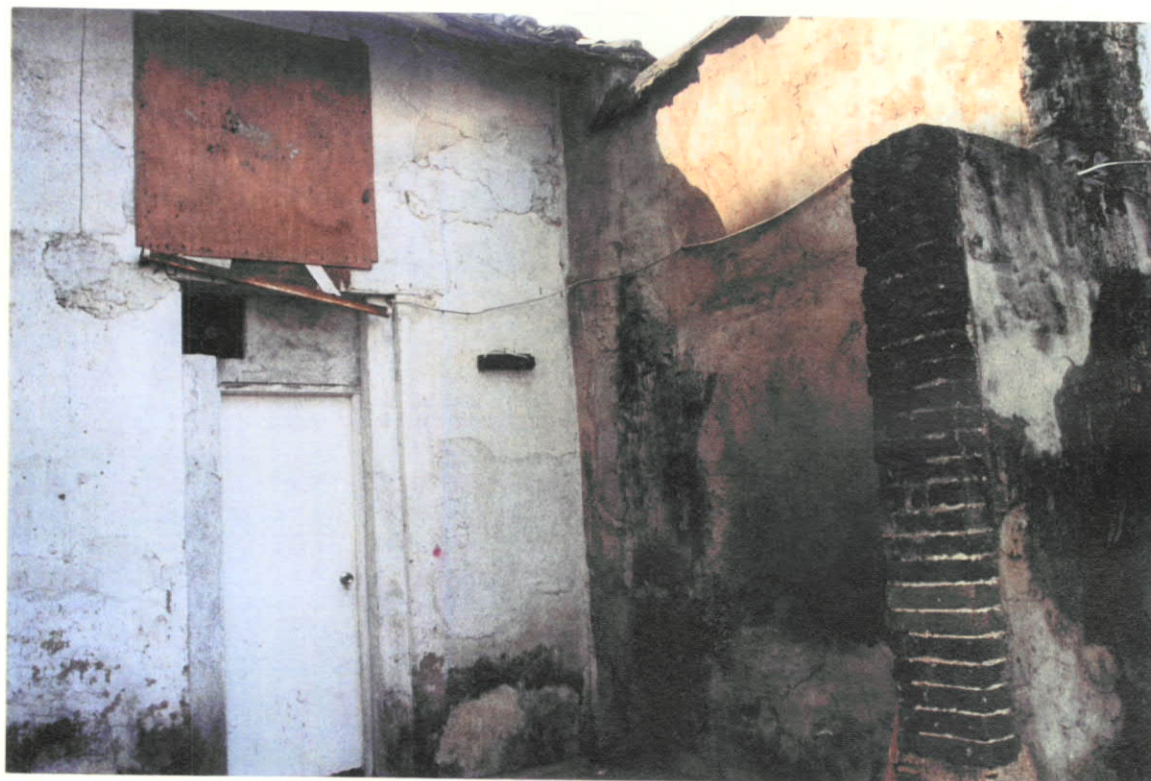
Location / 位置	HOPUI
Type / 種類	TERRACED HOUSES (2)
Map Ref. / 地圖參考編號	# 41, 42
Arch. Assessment Ref. / 考古通參考編號	KT13-00-23
AMO Ref. / 古物古蹟辦事處參考編號	
Photographic Ref. / 照片參考編號	#3723 (1,3)

Description / 說明	2 HOUSES: A - B GREEN BRICK HOUSES BOTH PAINTED; PLAIN PROJECTING ROOFS.
A.	<input type="checkbox"/> LOWER FRONT COMPLETELY MODERN 2 ROUND W. BEAM UNDER FRONT GAVE TILE - OR ROOF PAINTED FRIEZE WITH INSCRIPTION ARCHITRAVE. + 2 WINDOWS
B.	<input type="checkbox"/> PAINTED YELLOW 3 COURSES OF PINE W. STONE FRONT FOUNDATION MODERN DOOR PAINTED TOP FRIEZE FRONT WALL.

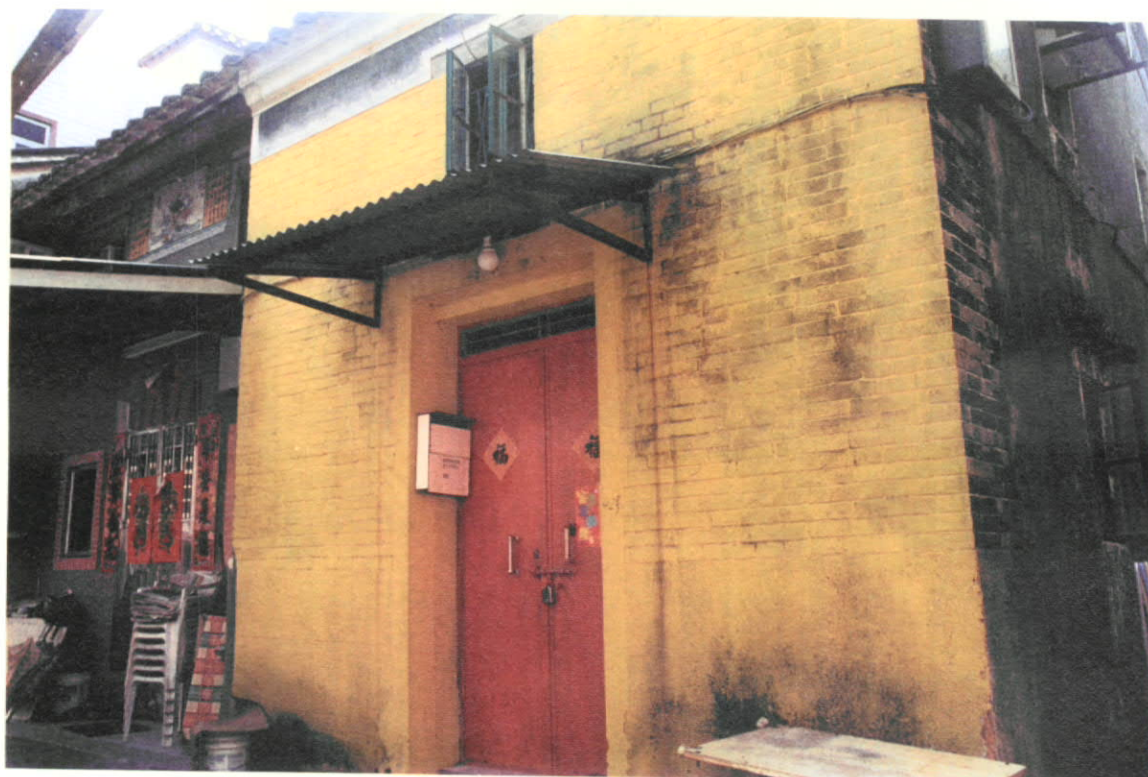
Location / 位置	HLO PUJ
Type / 種類	TERRACED HOUSE
Map Ref. / 地圖參考檔號	40
Arch. Assessment Ref. / 考古通參考檔號	KT13-00-24
AMO Ref. / 古物古蹟辦事處參考檔號	
Photographic Ref. / 照片參考檔號	#3723 (2)

Description / 說明	IN USE
W. DOOR + FRAME	
8T STEP + FRAME	
3 COURSE STONE FOUNDATION	
2 ROUND W BEAMS UNDER EAVES	
PAINTED TOP FRIEZE FRONT WALL	
TILE FOR ROOF	
MOLDINGS UNDER EAVES AT CORNERS	
MODERN WINDOWS

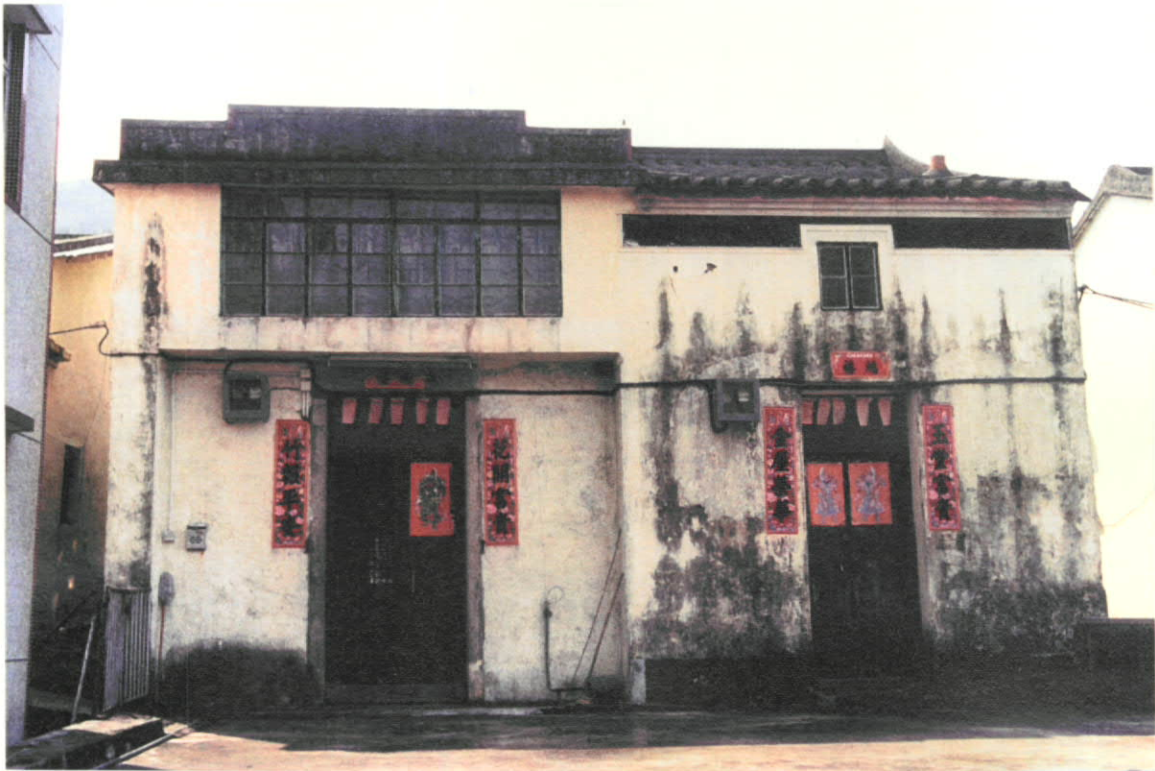
Location / 位置	Hb Pui
Type / 種類	Terrace Village Houses (Kan)
Map Ref. / 地圖參考檔號	#54, 55, 56
Arch. Assessment Ref. / 考古通參考檔號	K113.00 - <del>26</del> 26
AMO Ref. / 古物古蹟辦事處參考檔號	
Photographic Ref. / 照片參考檔號	#2723 (5, 11)

Description / 說明  
3 terraced houses with smaller one on right hand side.  
green brick with - 60's style parapets on facades.  
middle 2 doorways fairly unaltered stone frames  
Large granite corner slabs.  
Right end unit has original's tile roof - round timber over facade.  
Some rubble foundation.  
Moulded leaves  
In Use - reported as ~200 years old.

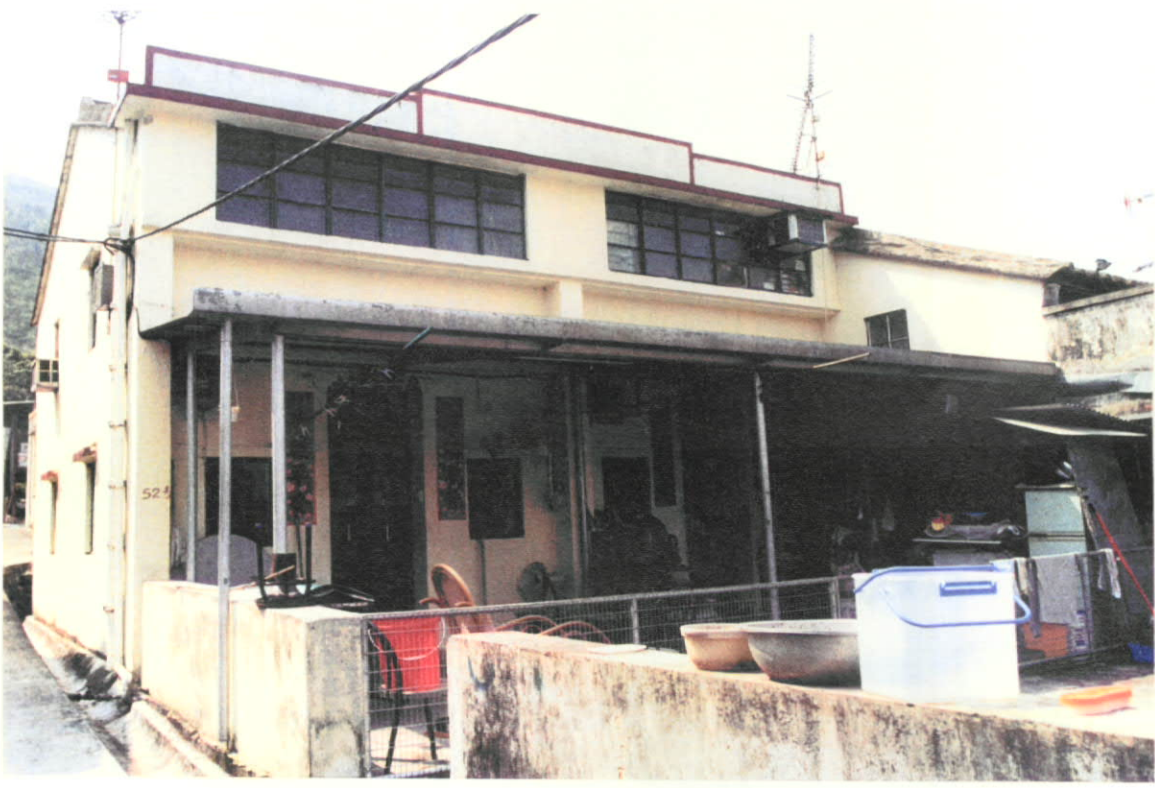
Location / 位置	<u>HO FUI</u>	
Type / 種類	<u>COVER YARD HOUSES (2-3?)</u>	
Map Ref. / 地圖參考檔號		
Arch. Assessment Ref. / 考古通參考檔號	<u>KT13-00</u>	<u>59</u>
AMO Ref. / 古物古蹟辦事處參考檔號		<u>28</u>
Photographic Ref. / 照片參考檔號	<u>#3723 (7.15)</u>

Description / 說明		PLAN:
<ul style="list-style-type: none"> <li>green brick, rubble stone foundation</li> <li>granite concrete steps levelled with tiles + rise</li> <li>molding near eave</li> <li>plain ridged roof</li> </ul>

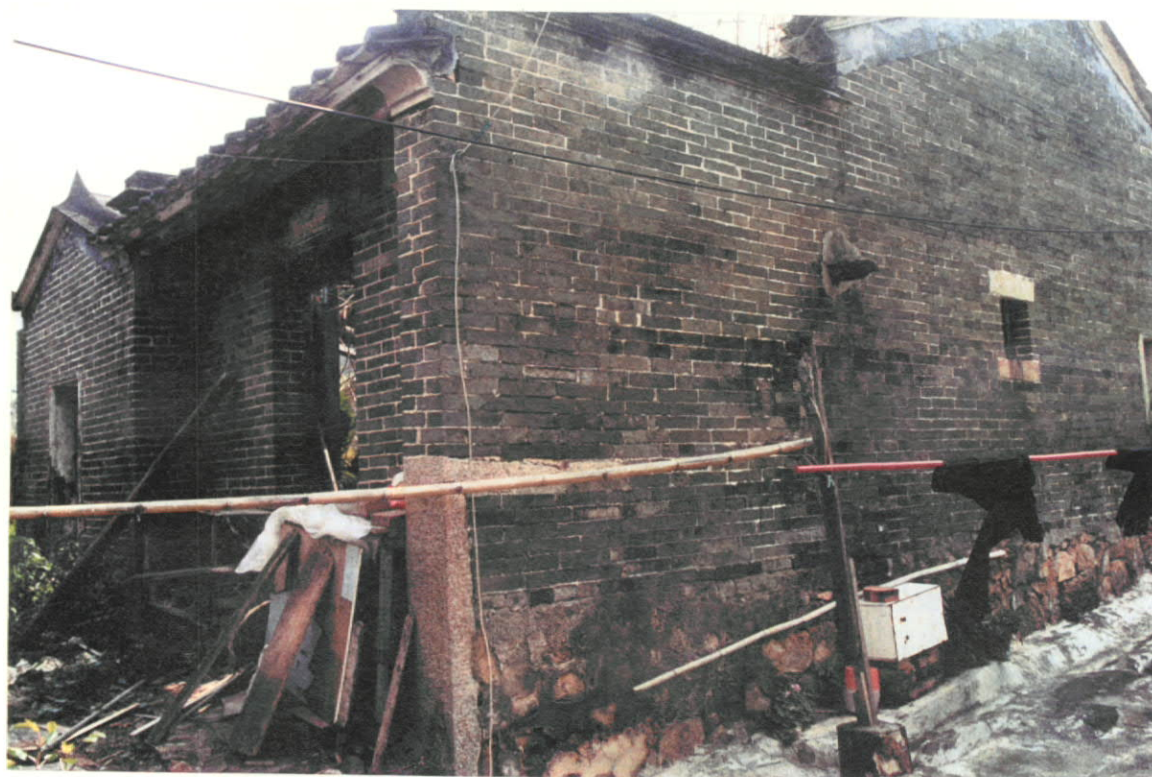
Location / 位置	Ho Pui
Type / 種類	Fung Shui Wall
Map Ref. / 地圖參考檔號	No Street Address (Near #13)
Arch. Assessment Ref. / 考古通參考檔號	KT13-00-29
AMO Ref. / 古物古蹟辦事處參考檔號	
Photographic Ref. / 照片參考檔號	#3723 (10)

Description / 說明	Brick + cement wall with end piers. Incurse burner molding.
------------------	--

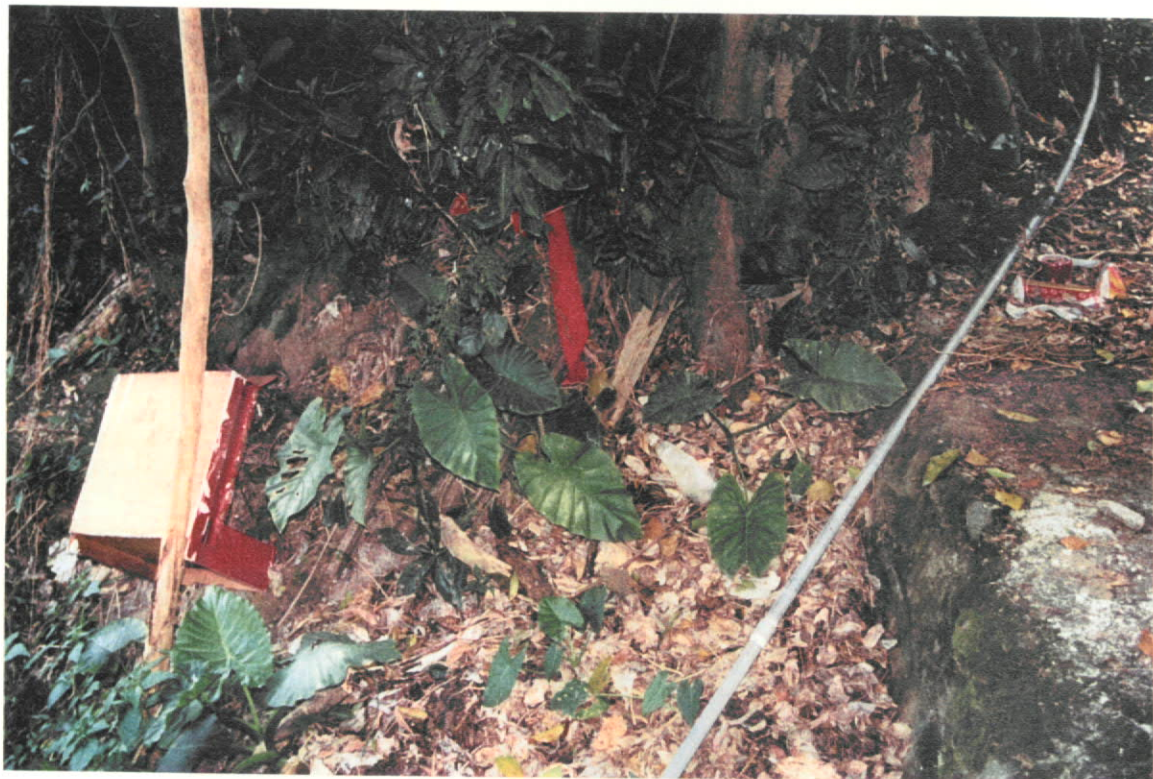
Description / 說明  
Remains of a shrine at foot of large banyan. Not in recent use  
Out of situ son chue pai + incense, vessels etc  
At edge of stream.

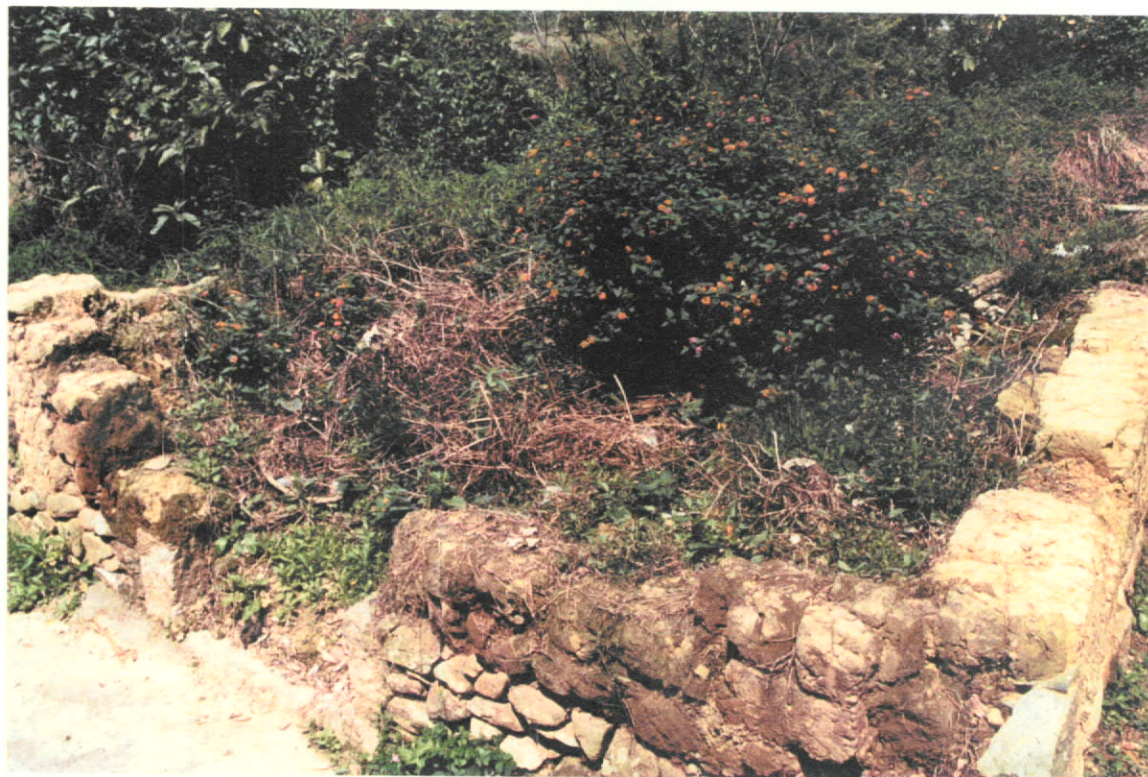
Remains of mud brick structure with  
stone corner slabs & door jambs in situ  
original plan  
uncertain.
