## **Appendix I2**

### **Historical Buildings and Structure Catalogue**

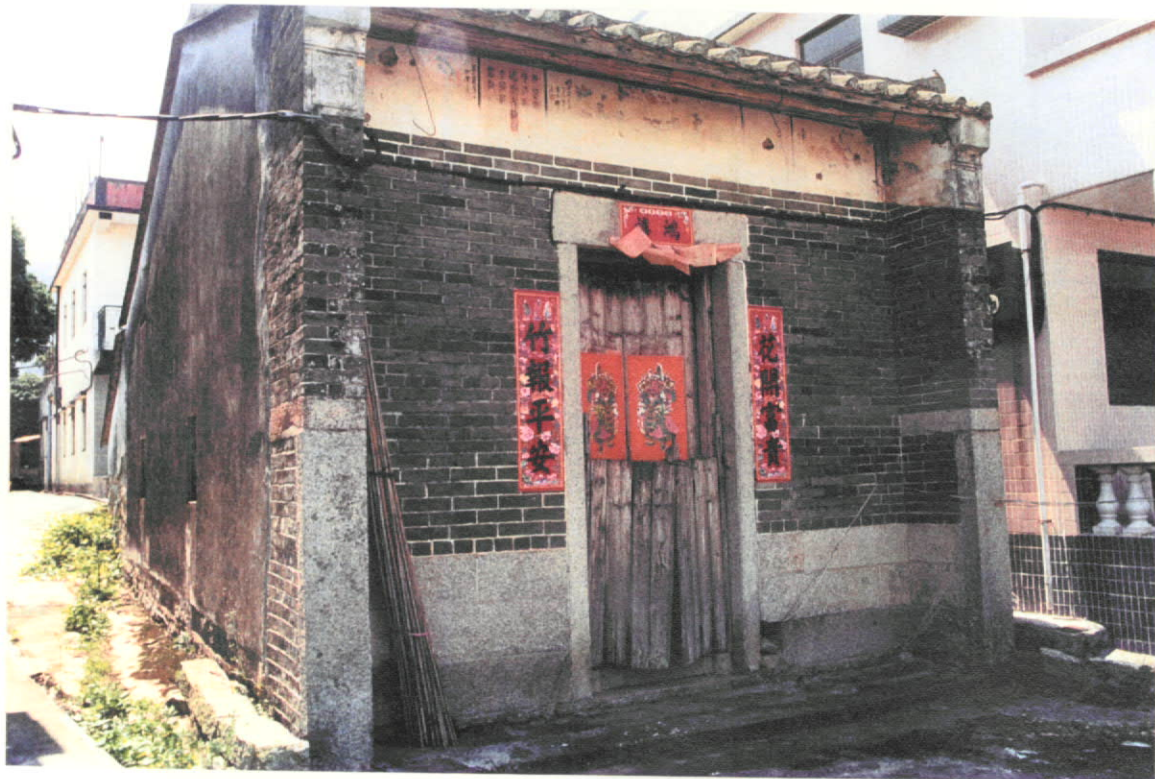
Location / 位置	<i>Tai Kek</i>
Type / 種類	<i>Terraced Village Houses (Tsang)</i>
Map Ref. / 地圖參考檔號	<i>#4, #5, #6</i>
Arch. Assessment Ref. / 考古通參考檔號	<i>KT13-00 .34</i>
AMO Ref. / 古物古蹟辦事處參考檔號	
Photographic Ref. / 照片參考檔號

Description / 說明	<p><i>Three Terraced greenbrick houses, right hand 2 of similar height with piers on Faade-moulded capitals. Stone thresholds in doorways</i></p> <p><i>left hand building is about 1 metro lower in ruinous condition. D.P. Wooden door</i></p> <p><i>Courtyard style with interior doorway. - Large building. Rubble Foundation.</i></p> <p><i>Rear of all buildings have been modified - concrete parapet style. Flat modern roofs.</i></p> <p><i>Not in use.</i></p>
------------------	--

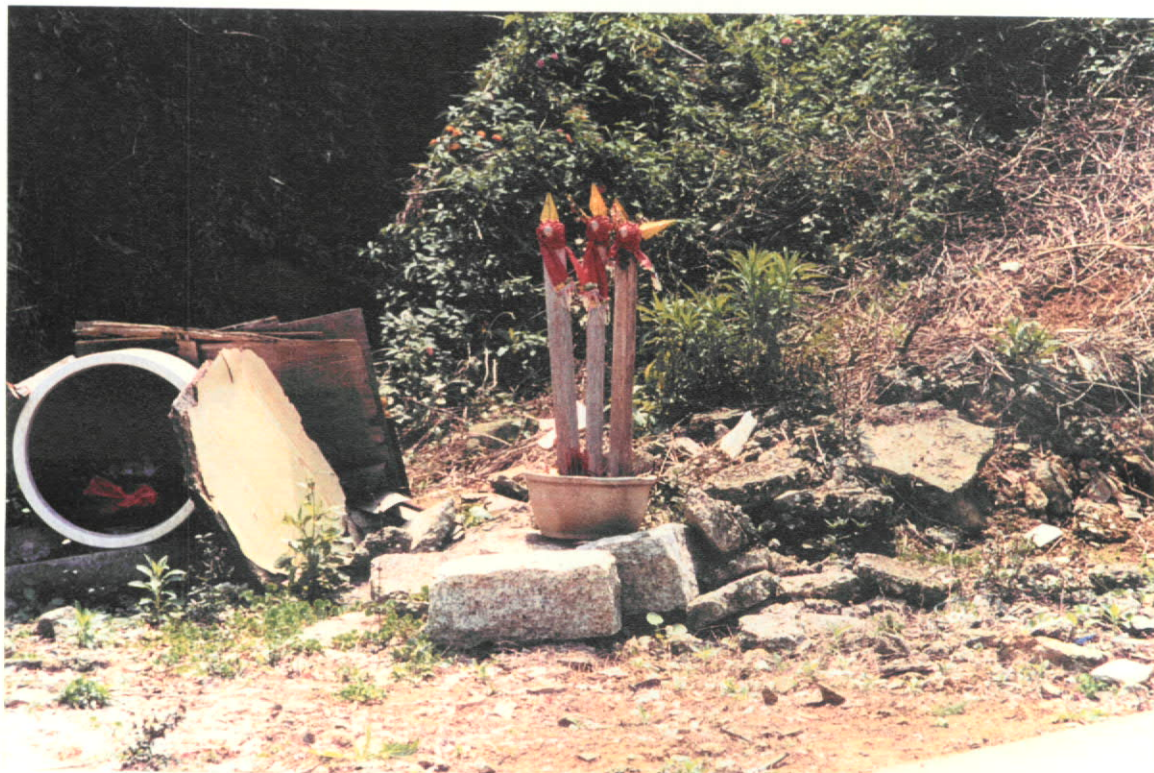
Description / 說明
Shrine at intersection of paths - facing construction

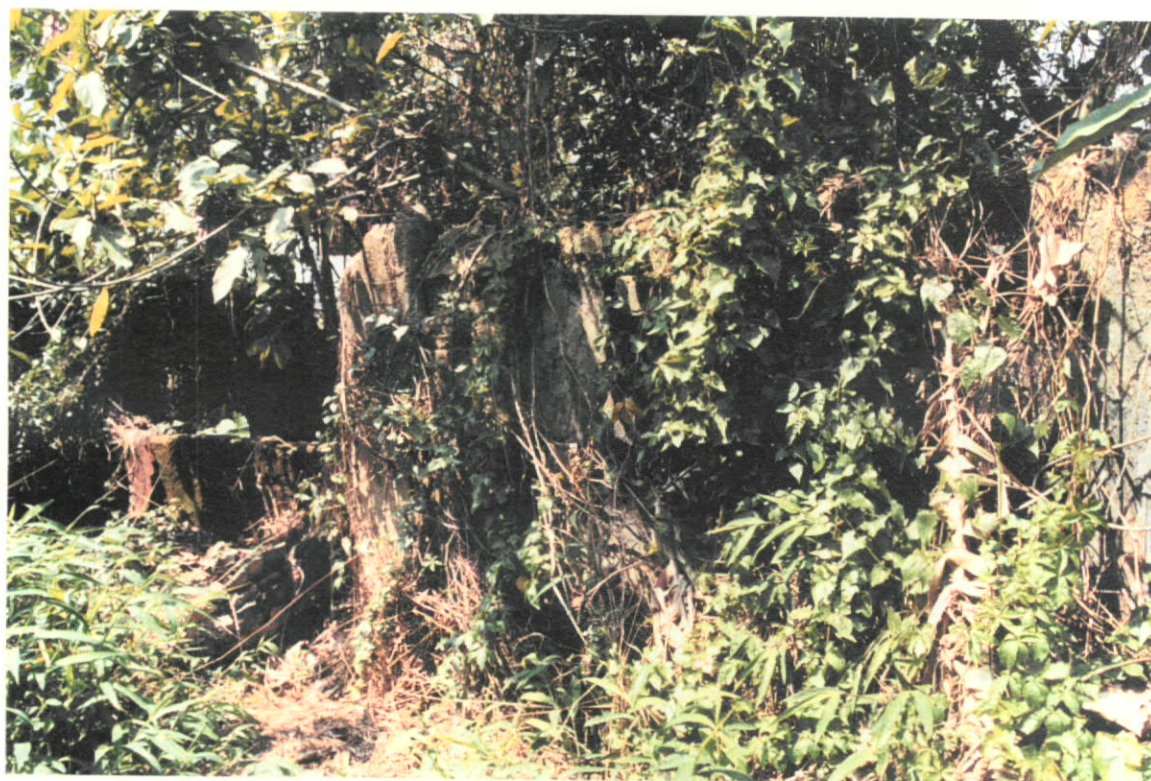
Description / 說明	Remains of animal pens; mudbrick and sections of coarse mud fabric. Banded plain window in situ. No plan discernable.
------------------	---

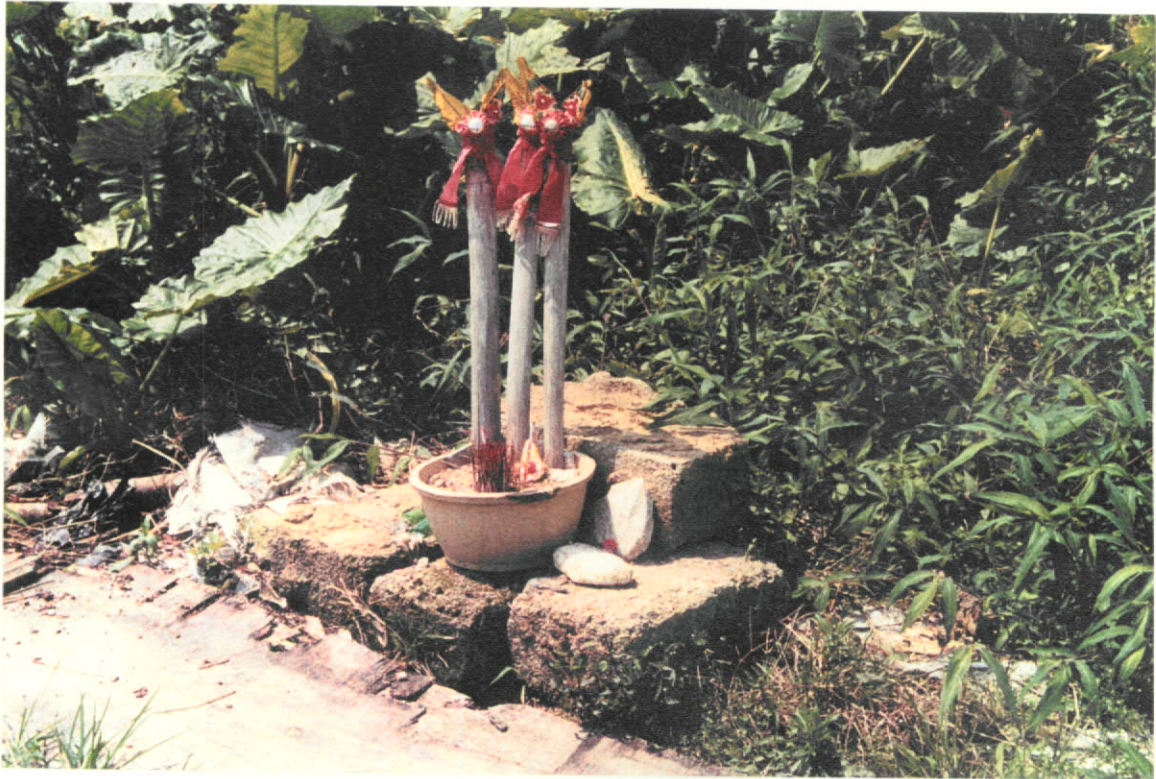
Description / 說明  
located at rear of village. Shrine situated on 3 large stone blocks with one behind. 2 small pieces of granite to right of bowl.

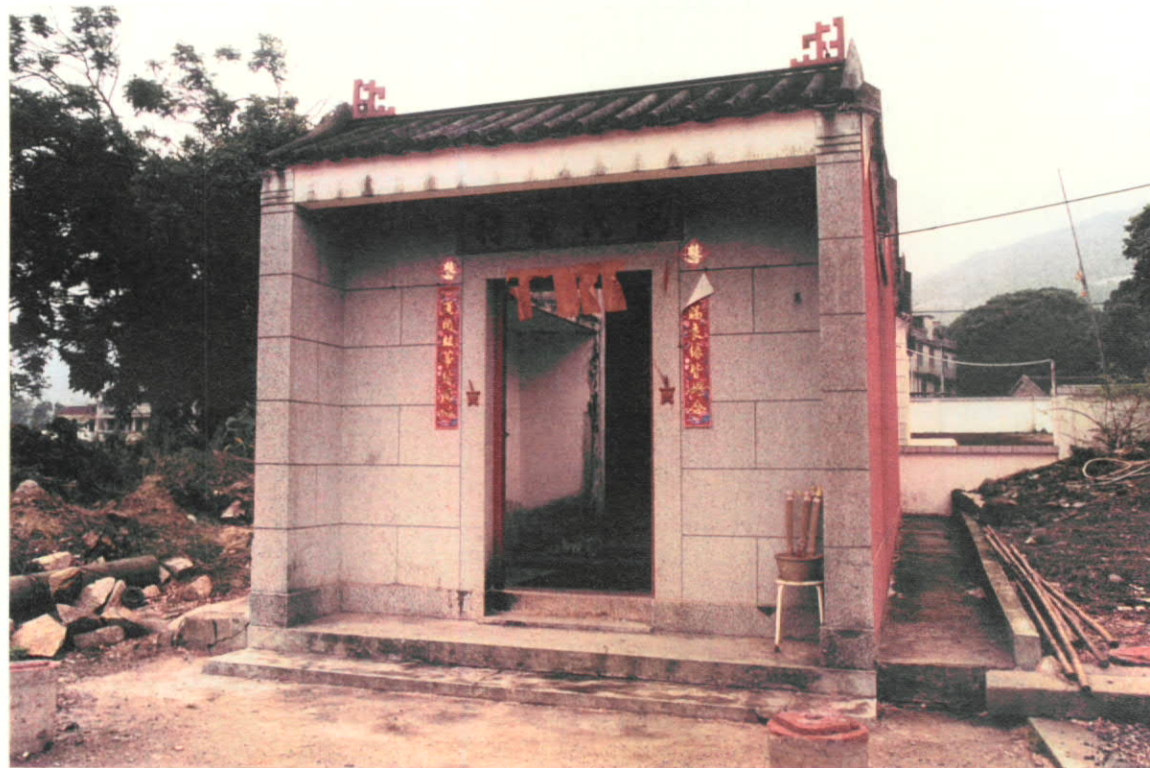
Description / 說明 - COMPLETELY RE FURBISHED REBUILT 10 yrs ago

- wooden round beam ceiling
- curled ridged roof MAIN FRONT  
geometric

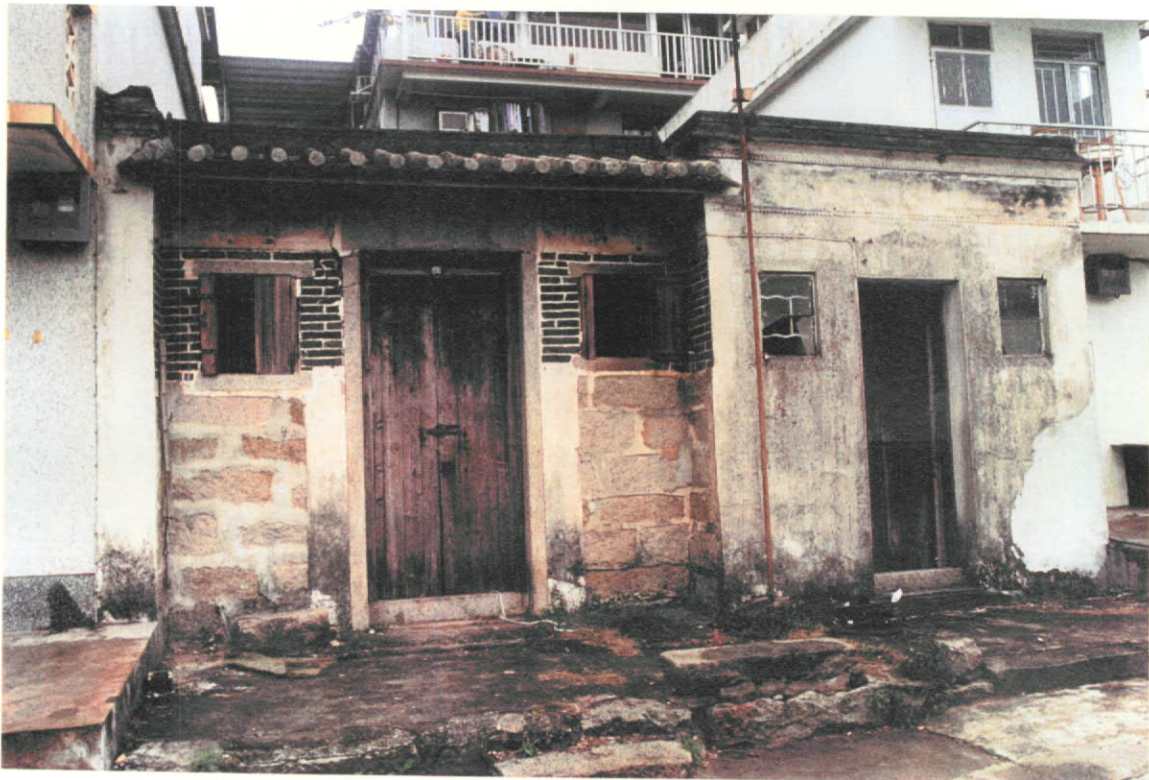
- W DOOR + FRAME
- ST STEP
- OR FINISHING OF WALLS
- 2 SMALL (MODERN) WINDOWS → EACH SIDE DOOR
- SMALL GRANITE PLATFORM IN FRONT (SEPARATE FROM CENTRAL)

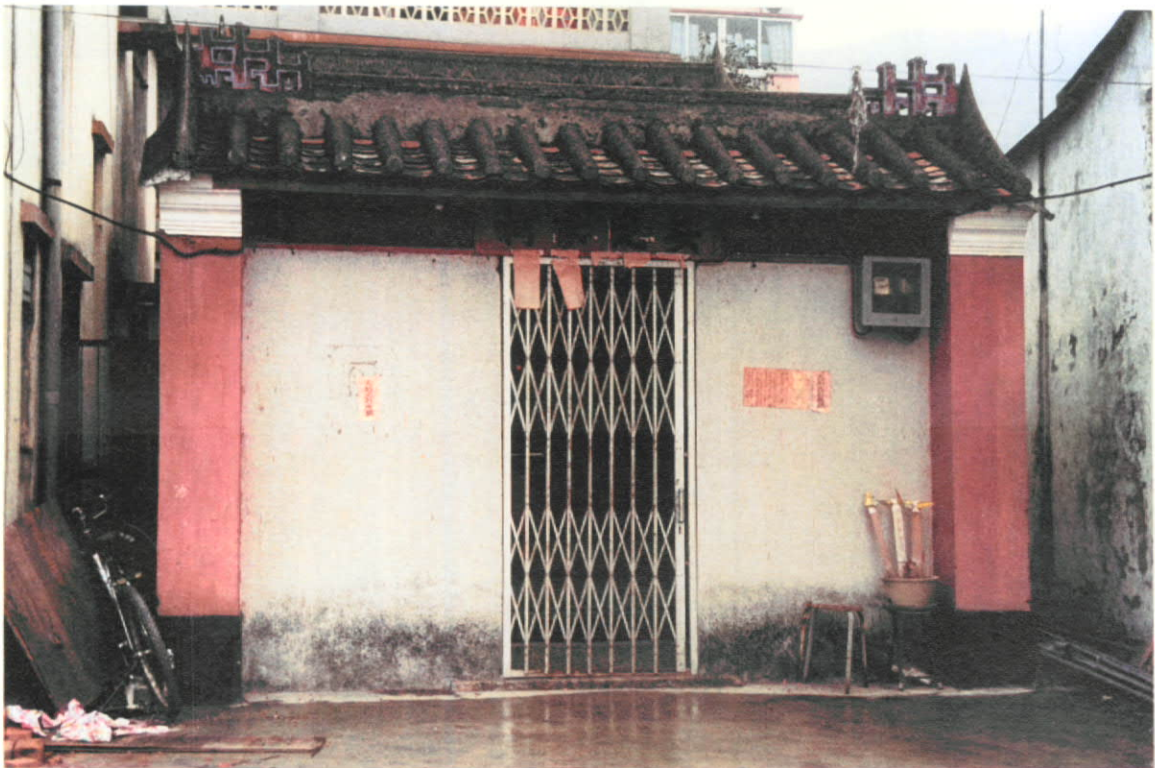
Description / 說明	PLAN	side	REBUILT 20 YRS AGO
<p><u>FRONT PART:</u></p> <ul style="list-style-type: none"> <li>• MODERN FINISH; METAL GATE</li> <li>• ST STEP</li> <li>• painted frieze architrave with inscription</li> <li>• moldings at corners under eaves</li> <li>• green deco ridged roof. H+CR</li> <li>• SURVICEN FLOOR</li> </ul> <p><u>PLAIN PART:</u></p> <ul style="list-style-type: none"> <li>• PLAIN RIDGED ROOF H+CR.</li> <li>• IN SIDE WOODEN BEAMS CEILING</li> <li>• LARGE SHRINE AND SOME WOODEN TABLETS</li> </ul> <p>• IN FRONT OF <del>THE</del> HALL SMALL GRANITE-INED CR platform</p>

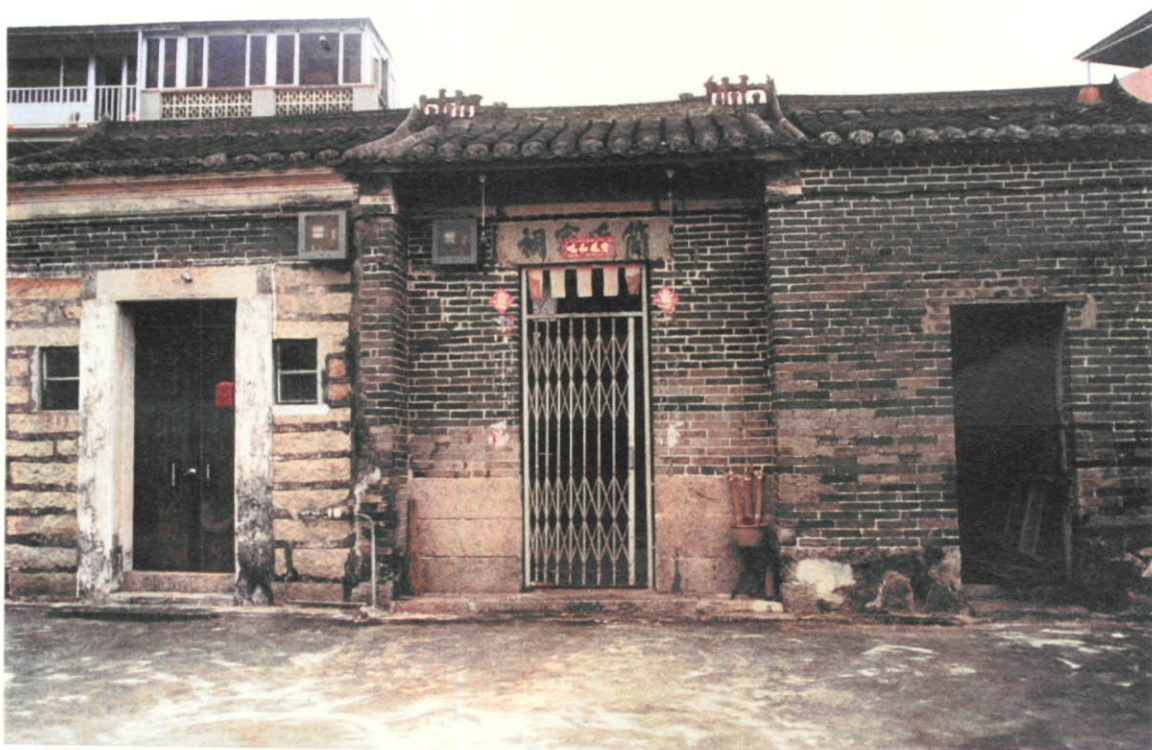
<p>OVER 100 yrs old</p> <p>green bricks on left 3/4 wall granite blocks                  central 3 courses of fine worked granite ashlars                  right rubble stone foundation.</p> <p><u>LEFT</u> modern door                  st step - lintel                  CR frame                  molding under eave                  2 small windows each side door</p> <p><u>CENTRAL</u> modern gate                  granite platform                  w. door frame                  st. inscription above door                  painted frieze architrave</p> <p><u>RIGHT</u> w door + frame + lintel                  vt step                  bricks under eaves</p> <p>WOODEN BEAMS UNDER EAVES                  MODERN RED TILE SHRINE                  GATE SCREEN ON STONE POSTS                  W. BEAMS (4 LINS)</p> <p><u>ROOF</u> <u>FRONT</u> modern main ridged                  actual from deco ridge  <u>MAIN</u> tile + CR                  plain ridged roof</p>

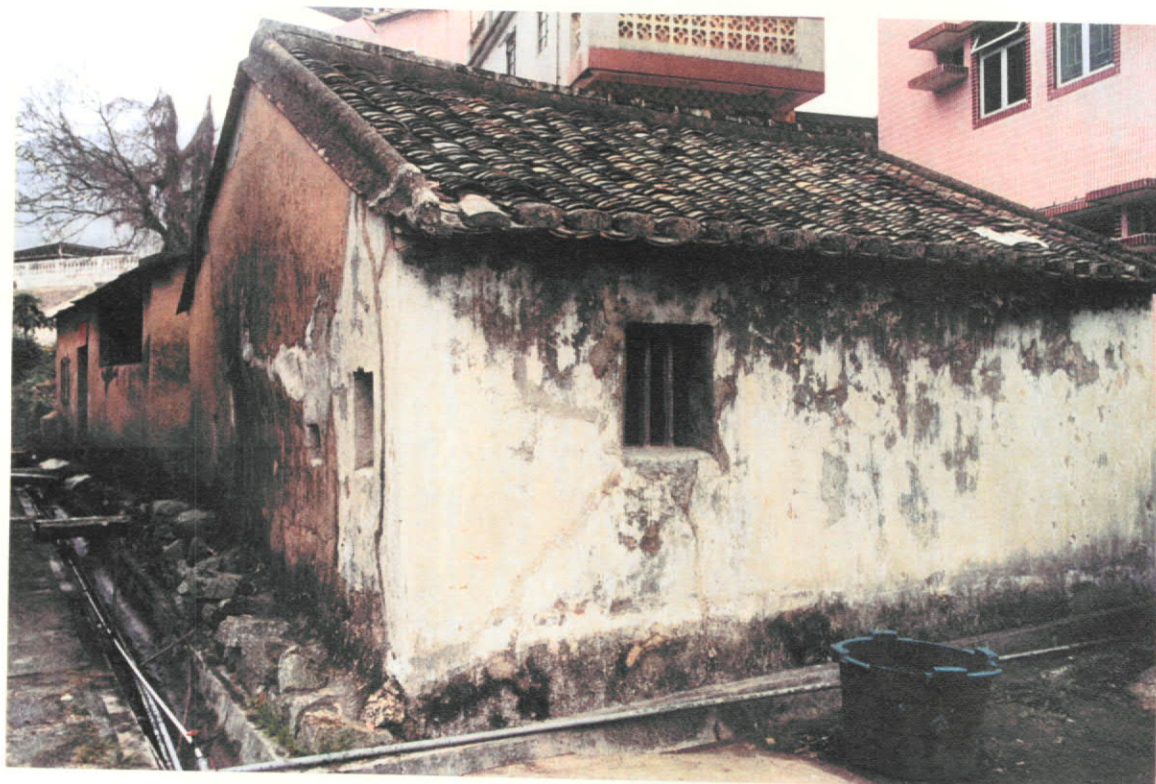
<p>B: tile + CR roof main kidpad (HAKKA TILES) MIXED STYLES                  CR finish of walls very roughly (mudbrick)                  Rubble st foundation                  several small windows around                  small wooden door; st step</p>		
<p>A: 2 doors                  mudbrick.                  MODERN ROOF</p>		
<p>

windows                  HAS BEEN EXTENSIVELY MODIFIED</p>

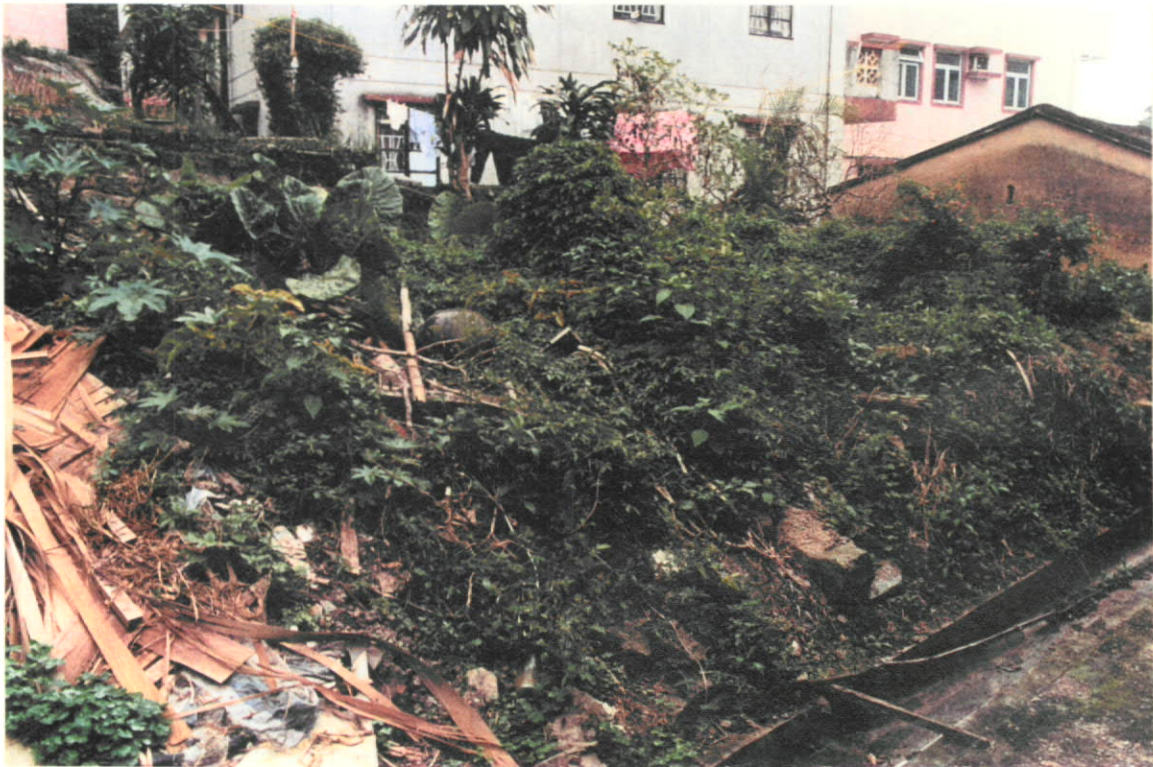
Location / 位置	MA ON KONG
Type / 種類	HOUSE + ANIMAL (?) LGAN TO
Map Ref. / 地圖參考檔號	
Arch. Assessment Ref. / 考古通參考檔號	32B KT13.00 - 44
AMO Ref. / 古物古蹟辦事處參考檔號	
Photographic Ref. / 照片參考檔號	# 3723 (33)

Description / 說明	PLAN	
<ul style="list-style-type: none"> <li>- granite block foundation walls or finish</li> <li>- <u>RIGHT</u> w FRAME + DOOR ST STEP 2 WINDOW WITH METAL BARS EACH SIDE DOOR</li> <li>- <u>CENTRAL</u> w FRAME - DOOR - LINTEL ST STEP MODERN ROOF</li> <li>- <u>LEFT</u> MUD BRICK MODERN ROOF NO ENTRANCE</li> </ul>	<p>NEW ROOF</p> <p>ABANDONED</p>

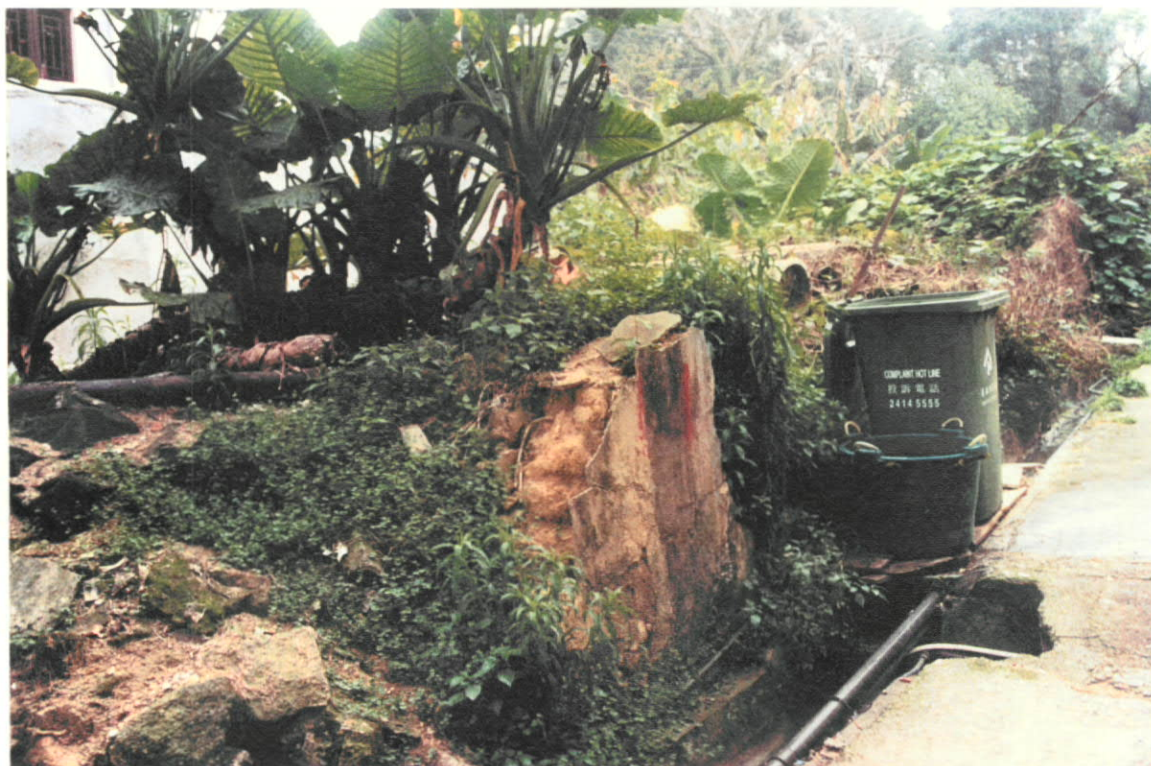
Location / 位置	Ma On Kong
Type / 種類	House (Wu)
Map Ref. / 地圖參考編號	#31
Arch. Assessment Ref. / 考古通參考編號	KT13.00 : 46
AMO Ref. / 古物古蹟辦事處參考編號	
Photographic Ref. / 照片參考編號	#3723 (25)

House (courtyard style) in state of collapse  
green brick facade, rest mud brick.  
Projecting facade end walls. Stone threshold  
+ wooden lintel. Tile & cement roofing. No  
decorative features. Very poor condition &  
full of rubbish.

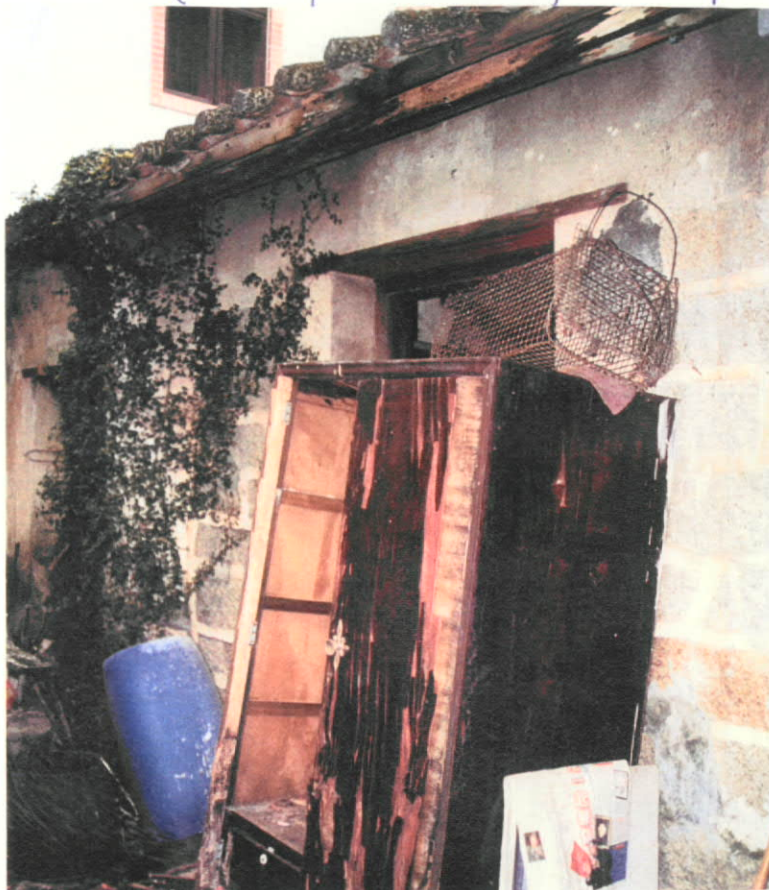
Abandoned & full of rubbish; collapsing

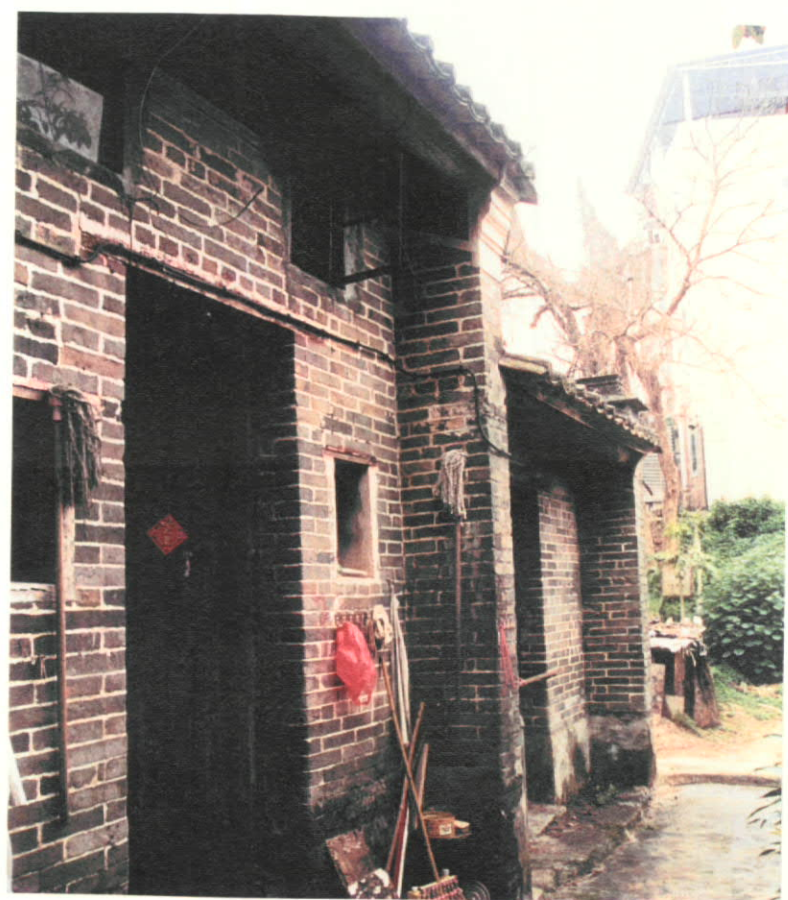
Location / 位置	Ma On Kong
Type / 種類	Village House (over 100 yrs) Kan
Map Ref. / 地圖參考權號	# 23, 24
Arch. Assessment Ref. / 考古通參考權號	KT13-00-49
AMO Ref. / 古物古蹟辦事處參考權號	
Photographic Ref. / 照片參考權號	#3723 (34-35)

Two Terraced green brick and cut stone houses. Both rebuilt 20 years ago. Large cut granite blocks. Facade foundation (left hand structure). Thick re pointing. Green brick 1st stories. Frieze above left hand building (hawk and flowers).

3 piers -> with moulded capitals. eaves on facade with round wooden beams - under tiles. granite lintels and thresholds in each doorway.

(in use)

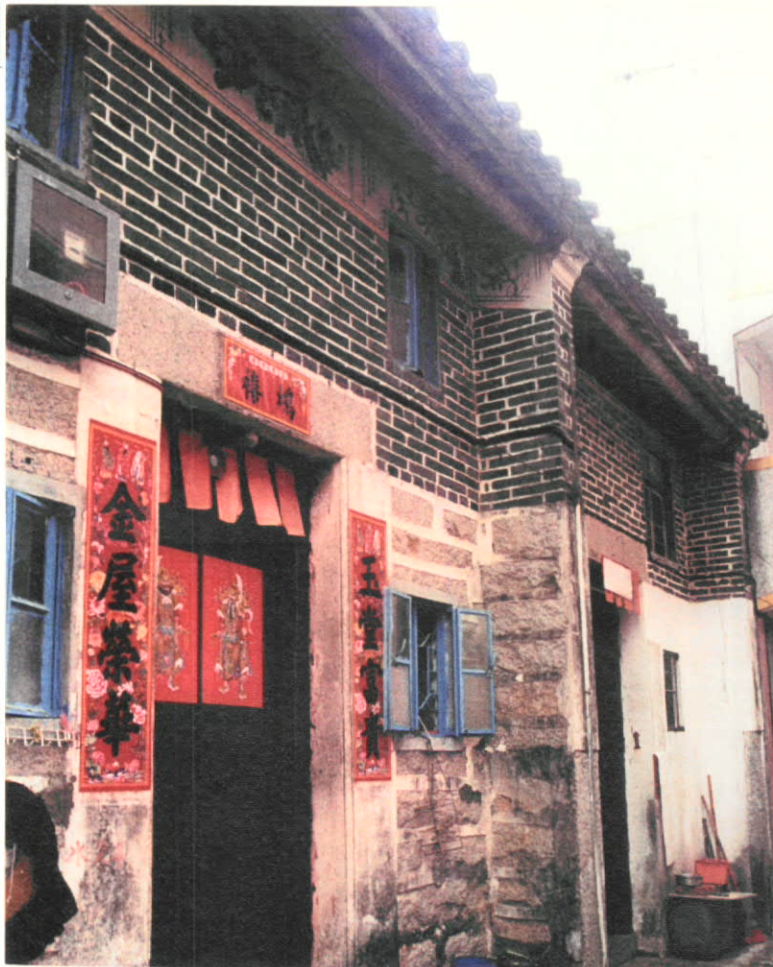
Location / 位置	Ma On Kong
Type / 種類	Village building (animal enclosure/storage)
Map Ref. / 地圖參考檔號	No Street Address (behind #15, 16)
Arch. Assessment Ref. / 考古通參考檔號	KT13.00.50
AMO Ref. / 古物古蹟辦事處參考檔號	
Photographic Ref. / 照片參考檔號	#3773(36)

Single story mud brick and sandy/gravel walls -  
Modern roof - rough pebble foundation. Building  
is elevated on a mound of rough stones with  
concrete covering. Structure is covered in  
render. Kan family.

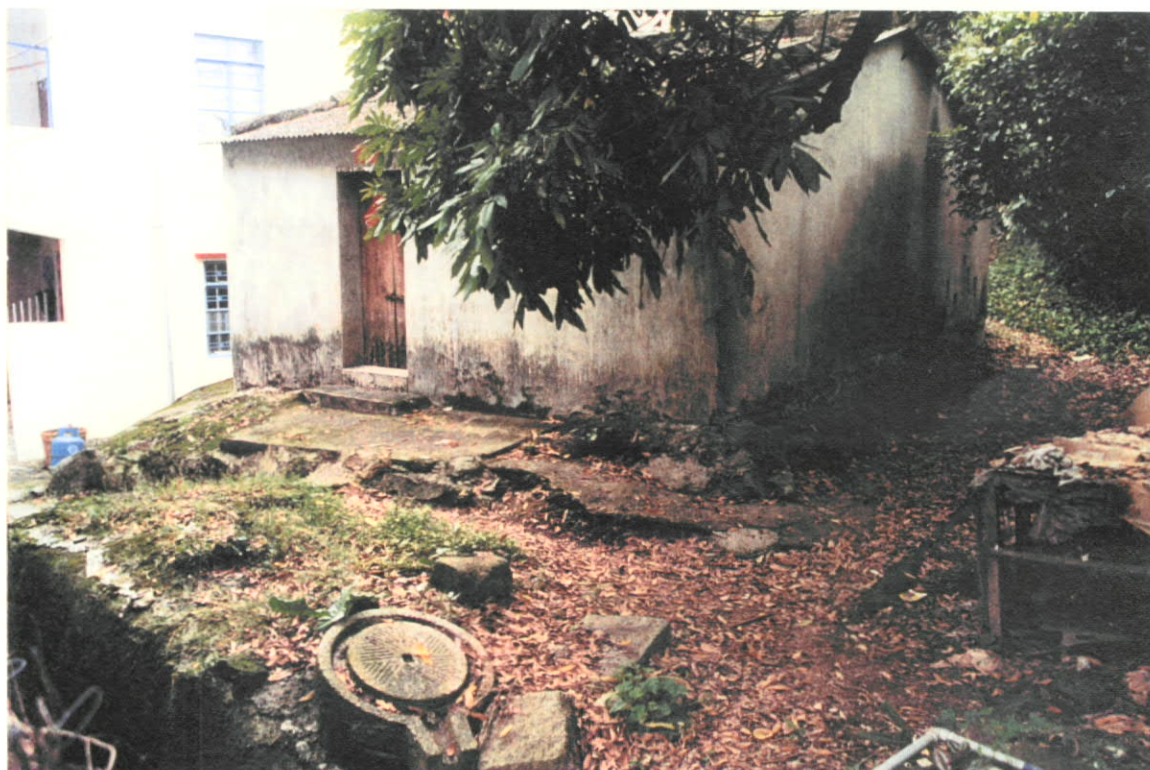
Location / 位置	MA ON KONG
Type / 種類	WU ANCESTRAL HALL 胡氏宗祠
Map Ref. / 地圖參考編號	No Street Address (Nearest Structures # 51, 5A)
Arch. Assessment Ref. / 考古通參考編號	KT13-00-51
AMO Ref. / 古物古蹟辦事處參考編號	
Photographic Ref. / 照片參考編號	#1425 (2, 4)

Description / 說明	SEPARATE ENTRANCE	REBUILT 10 yrs ago
<u>PLAN</u>		NO ENTRY AVAILABLE
<u>MAIN ROOF</u>	PLAIN ridged roof	Hill + CR roof
<u>FRONT "</u>	geometric ridged roof

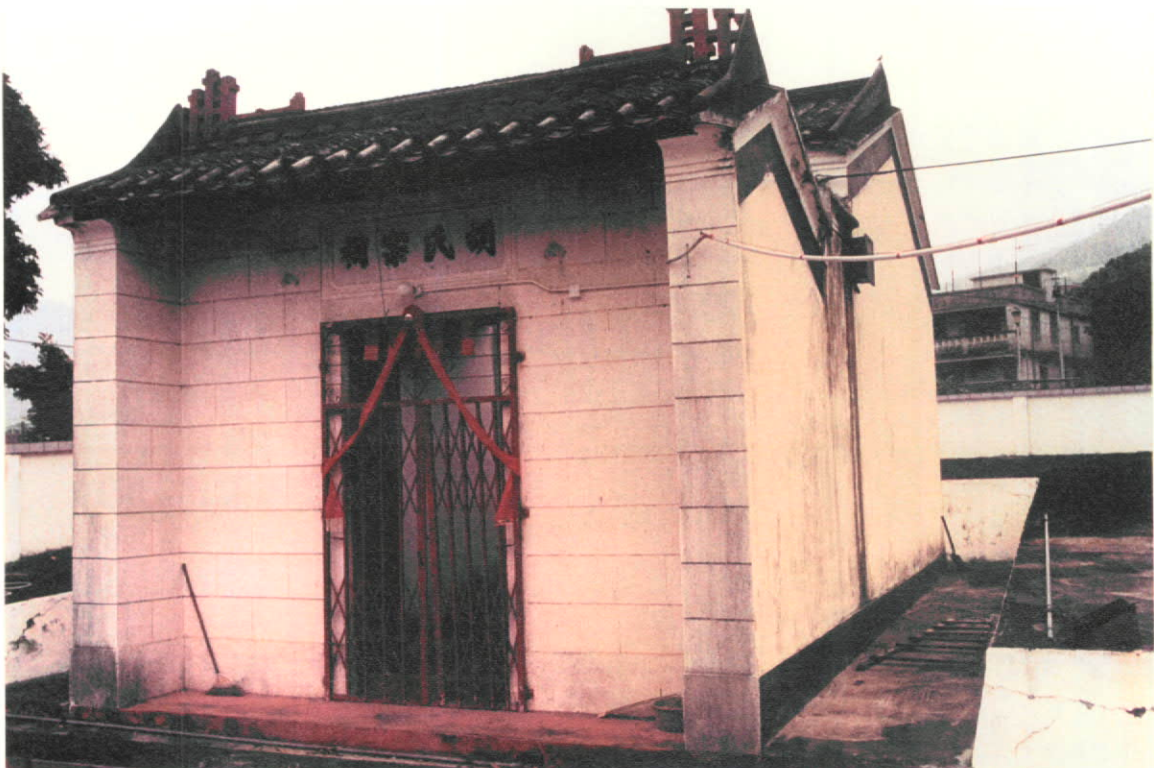
Location / 位置	<i>Ma On Kong</i>
Type / 種類	<i>Village house (Fan) over 100 yrs</i>
Map Ref. / 地圖參考編號	<i># <del>18</del> 18</i>
Arch. Assessment Ref. / 考古通參考編號	<i>KT13.00.52</i>
AMO Ref. / 古物古蹟辦事處參考編號	
Photographic Ref. / 照片參考編號	<i>#1425(3)</i>

Description / 說明	<p><i>1/2 Storey Village house - roof - traditional tiles . 2 entrances with stone (cut) thresholds and door steps . Painted white with render over - (portions) rammed earth . Plain roof ridge (concrete) Concrete courtyard in front .</i></p> <p style="text-align: right;"><i>(in use)</i></p>
------------------	---

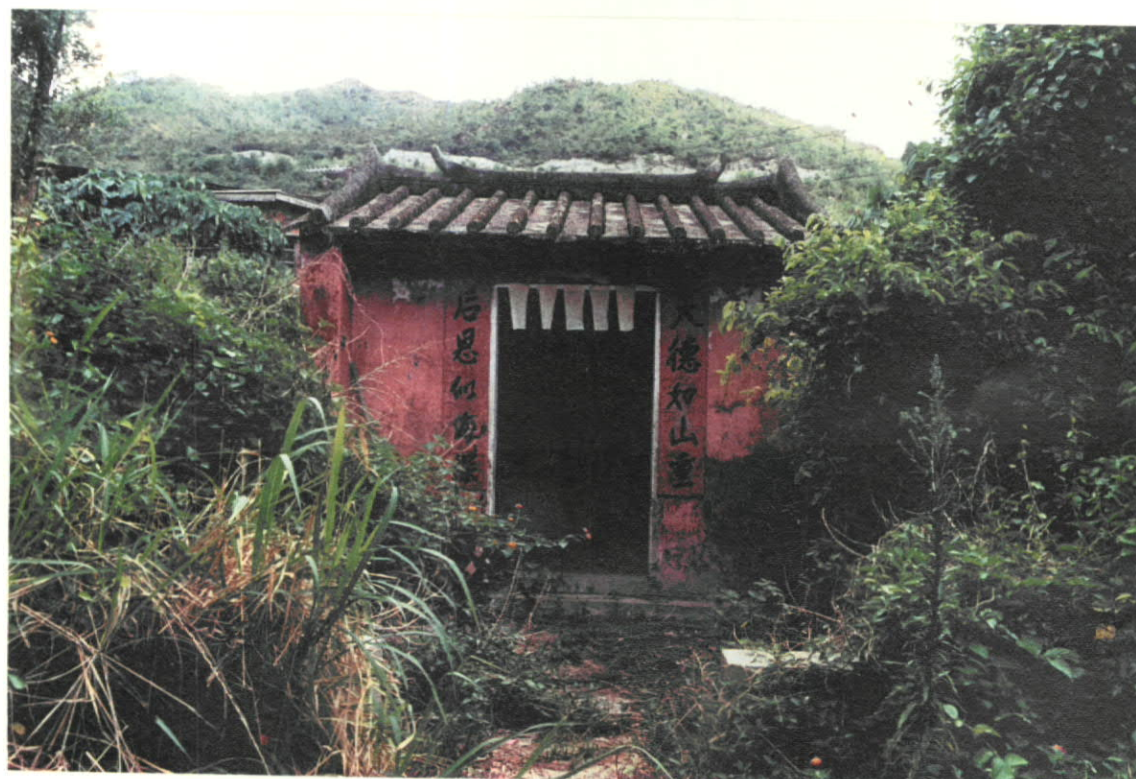
Location / 位置	<i>Near Ho Pui</i>
Type / 種類	<i>Earth god Shrine</i>
Map Ref. / 地圖參考權號	<i>No Street Address (Not near any numbered Structure)</i>
Arch. Assessment Ref. / 考古通參考權號	<i>KT13.00.54</i>
AMO Ref. / 古物古蹟辦事處參考權號	
Photographic Ref. / 照片參考權號	<i>7061#3</i>

Description / 說明	<p><i>irregular shaped rock with rectangular concrete enclosure. Tended but not well kept. Located several metres to the left of Tin Hau Temple (KT13.00.53)</i></p>
------------------	--

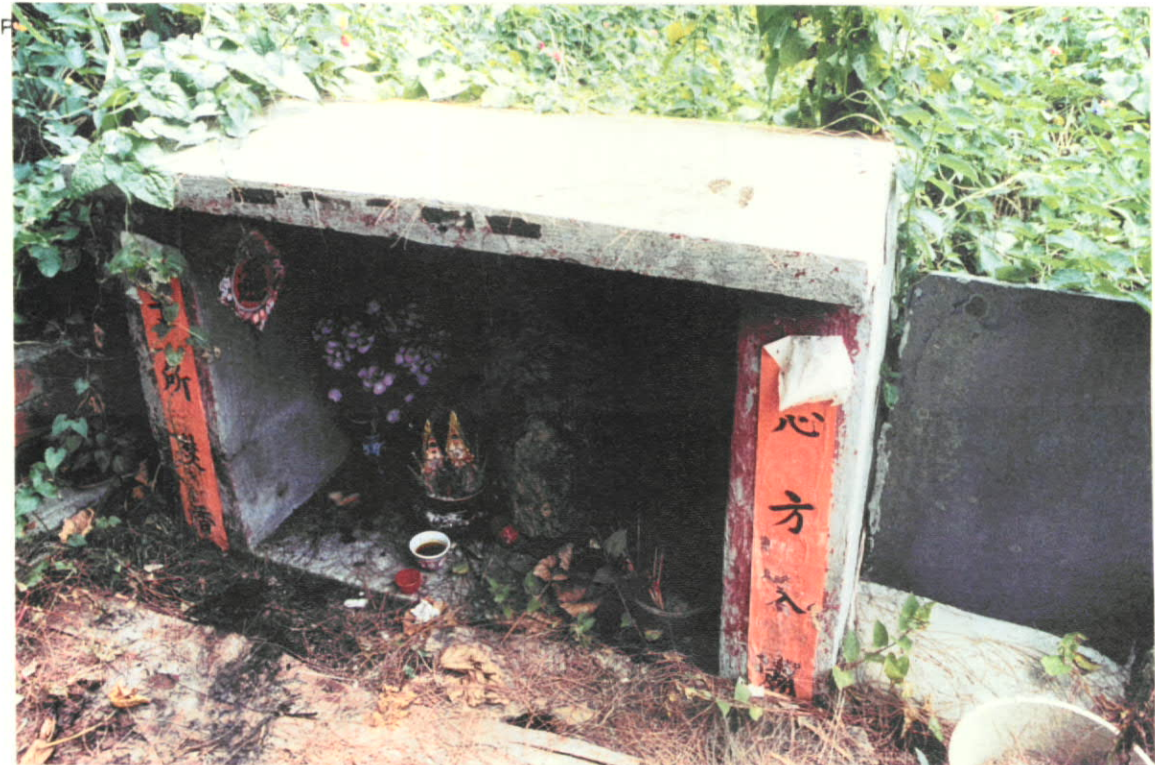
Location / 位置	<i>3 To the South-West of Ho Pi.</i>
Type / 種類	<i>HISTORICAL GRAVE</i>
Map Ref. / 地圖參考權號	<i>No Street Address (Not near any numbered Structure)</i>
Arch. Assessment Ref. / 考古通參考權號	<i>KT13.00. <del>48</del> 55</i>
AMO Ref. / 古物古蹟辦事處參考權號	
Photographic Ref. / 照片參考權號	<i>✓</i>

Description / 說明	<p><i>Horseshoe shaped grave marker, located in over-grown field. Original grave said to be approx 100 years old according to local informant. Direct access not possible due to snakes in vicinity.</i></p>
------------------	--

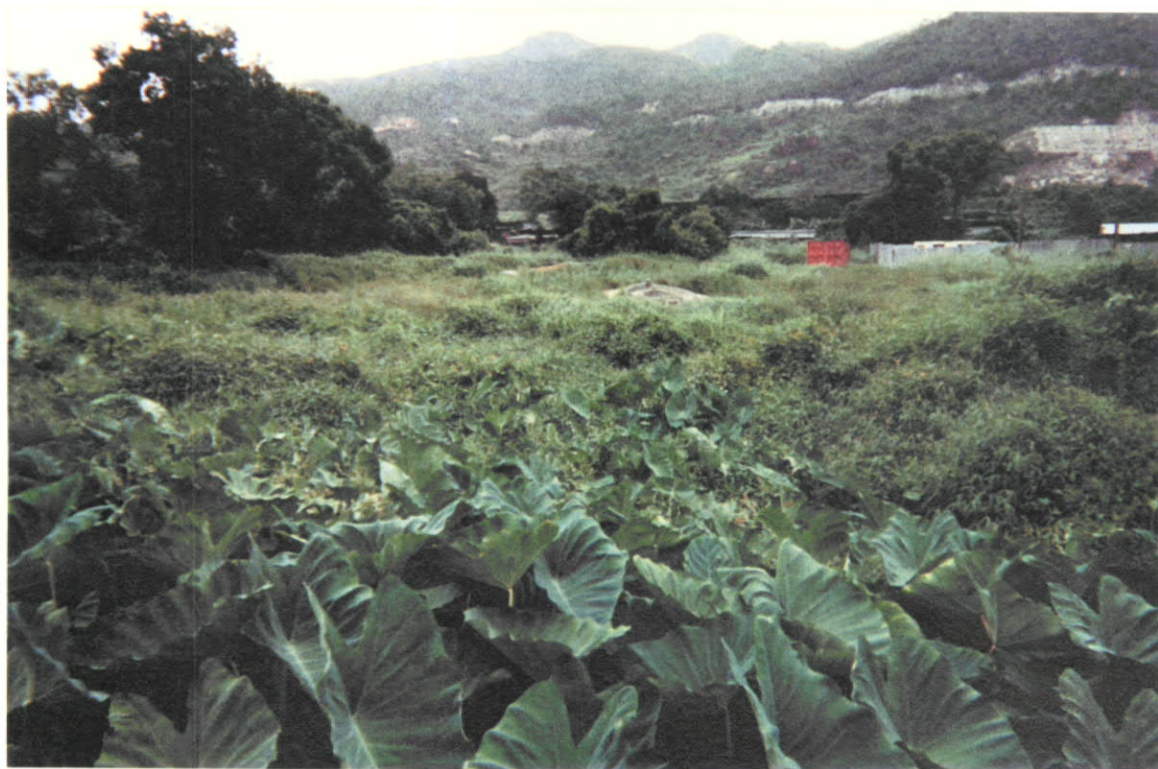
Location / 位置	East of Ma On Kong Village
Type / 種類	Shrine
Map Ref. / 地圖參考檔號	No Street Address (not near any numbered street)
Arch. Assessment Ref. / 考古通參考檔號	KT13-00-56
AMO Ref. / 古物古蹟辦事處參考檔號	
Photographic Ref. / 照片參考檔號	7061 #24

Description / 說明	<p>Tree Shrine and Earth god Shrine located near village houses (modern).</p> <p>3 Section 5 - tree with altar (incense &amp; wine cups), Gate with paper inscription (Tin Wong), small ceramic figure and Dang Fu Shrine.</p>

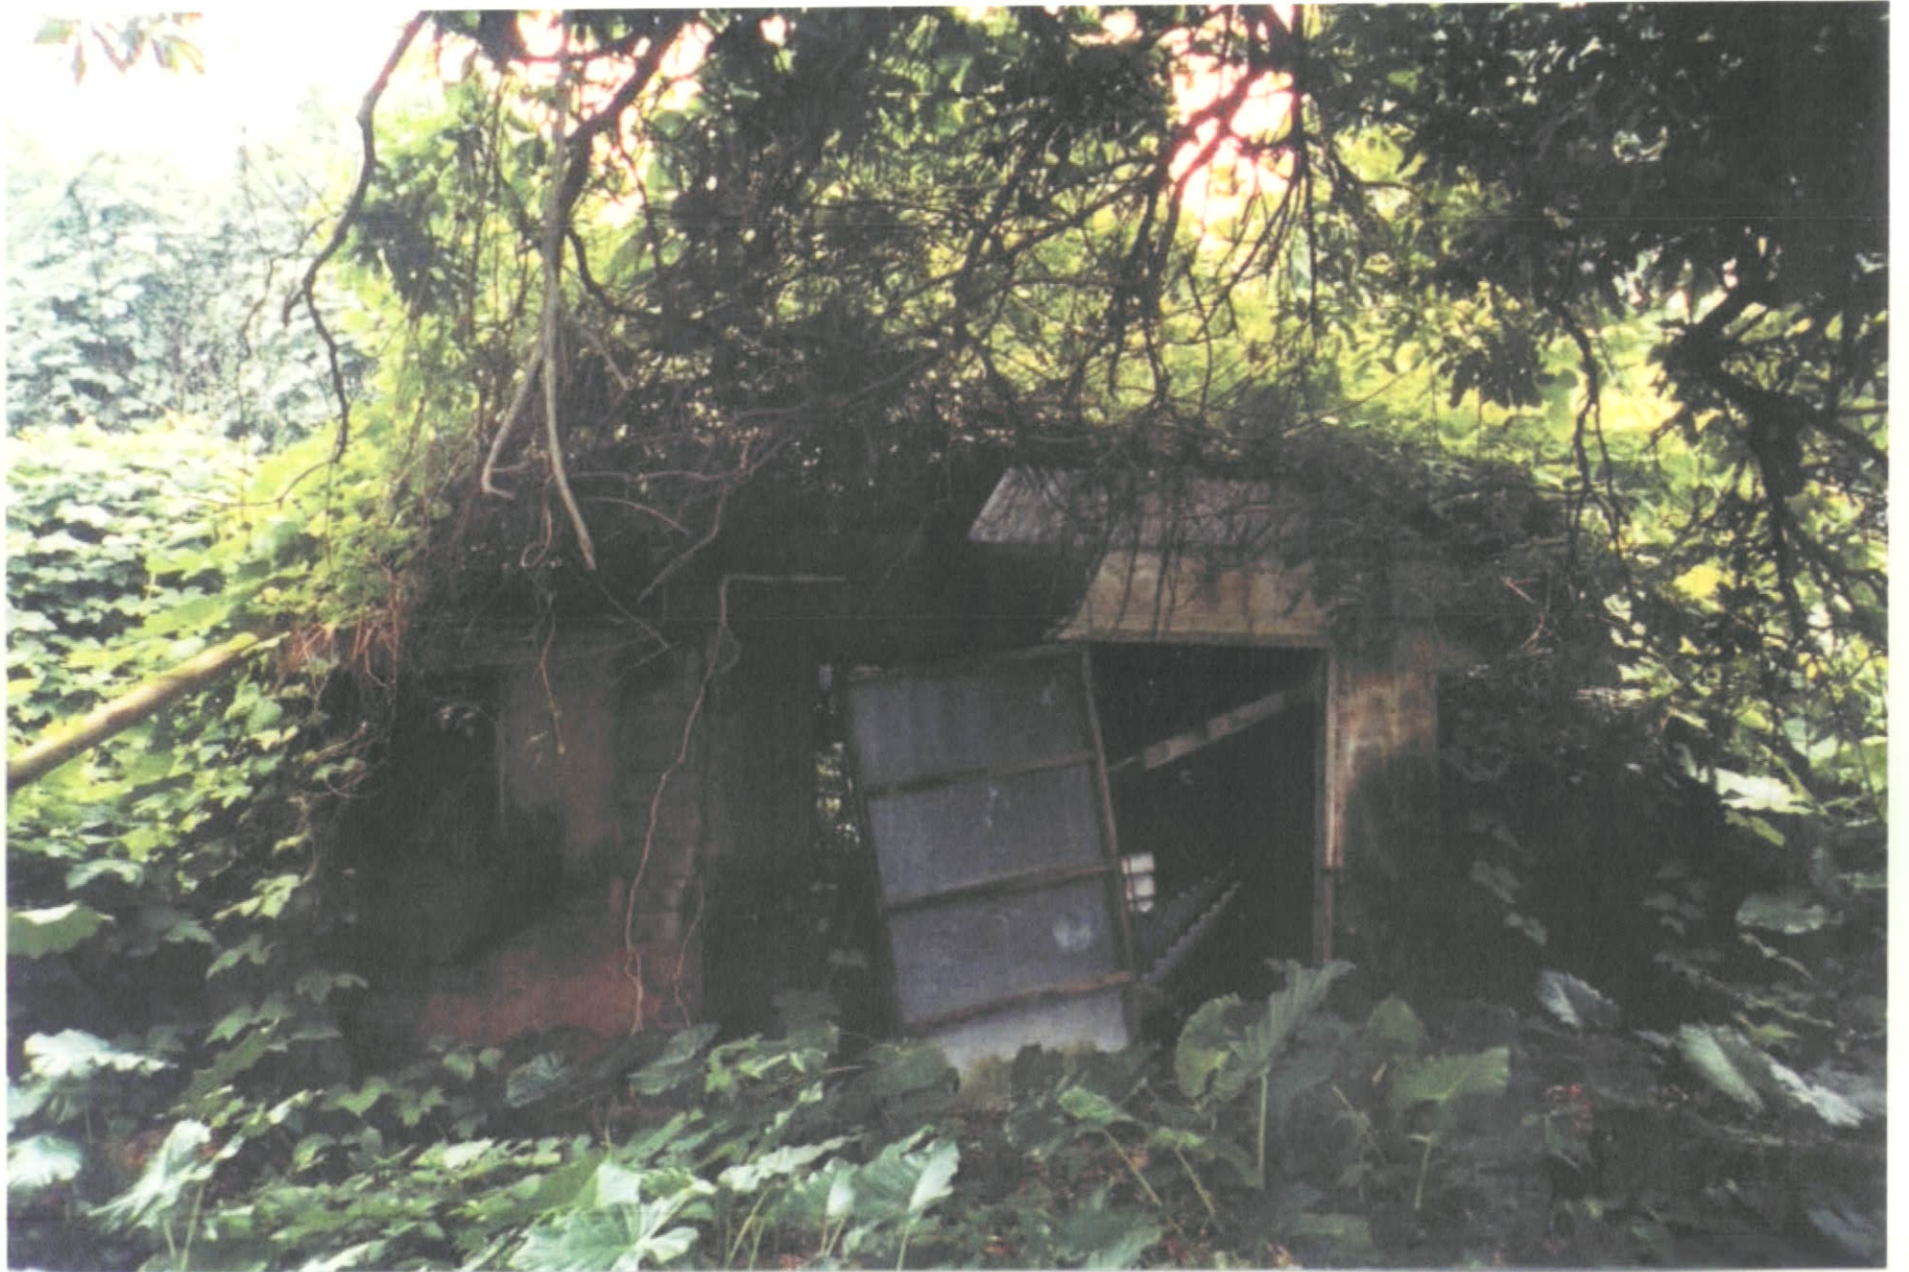
KT13-02-01

Description / 說明	compound of 4 house ruins orientation <del>SE</del> E-W but opening up to North built with mudbrick, grey brick and pounded earth western end some concrete patching overgrown + abandoned
------------------	--
