## **Appendix I2**

### **Historical Buildings and Structure Catalogue**

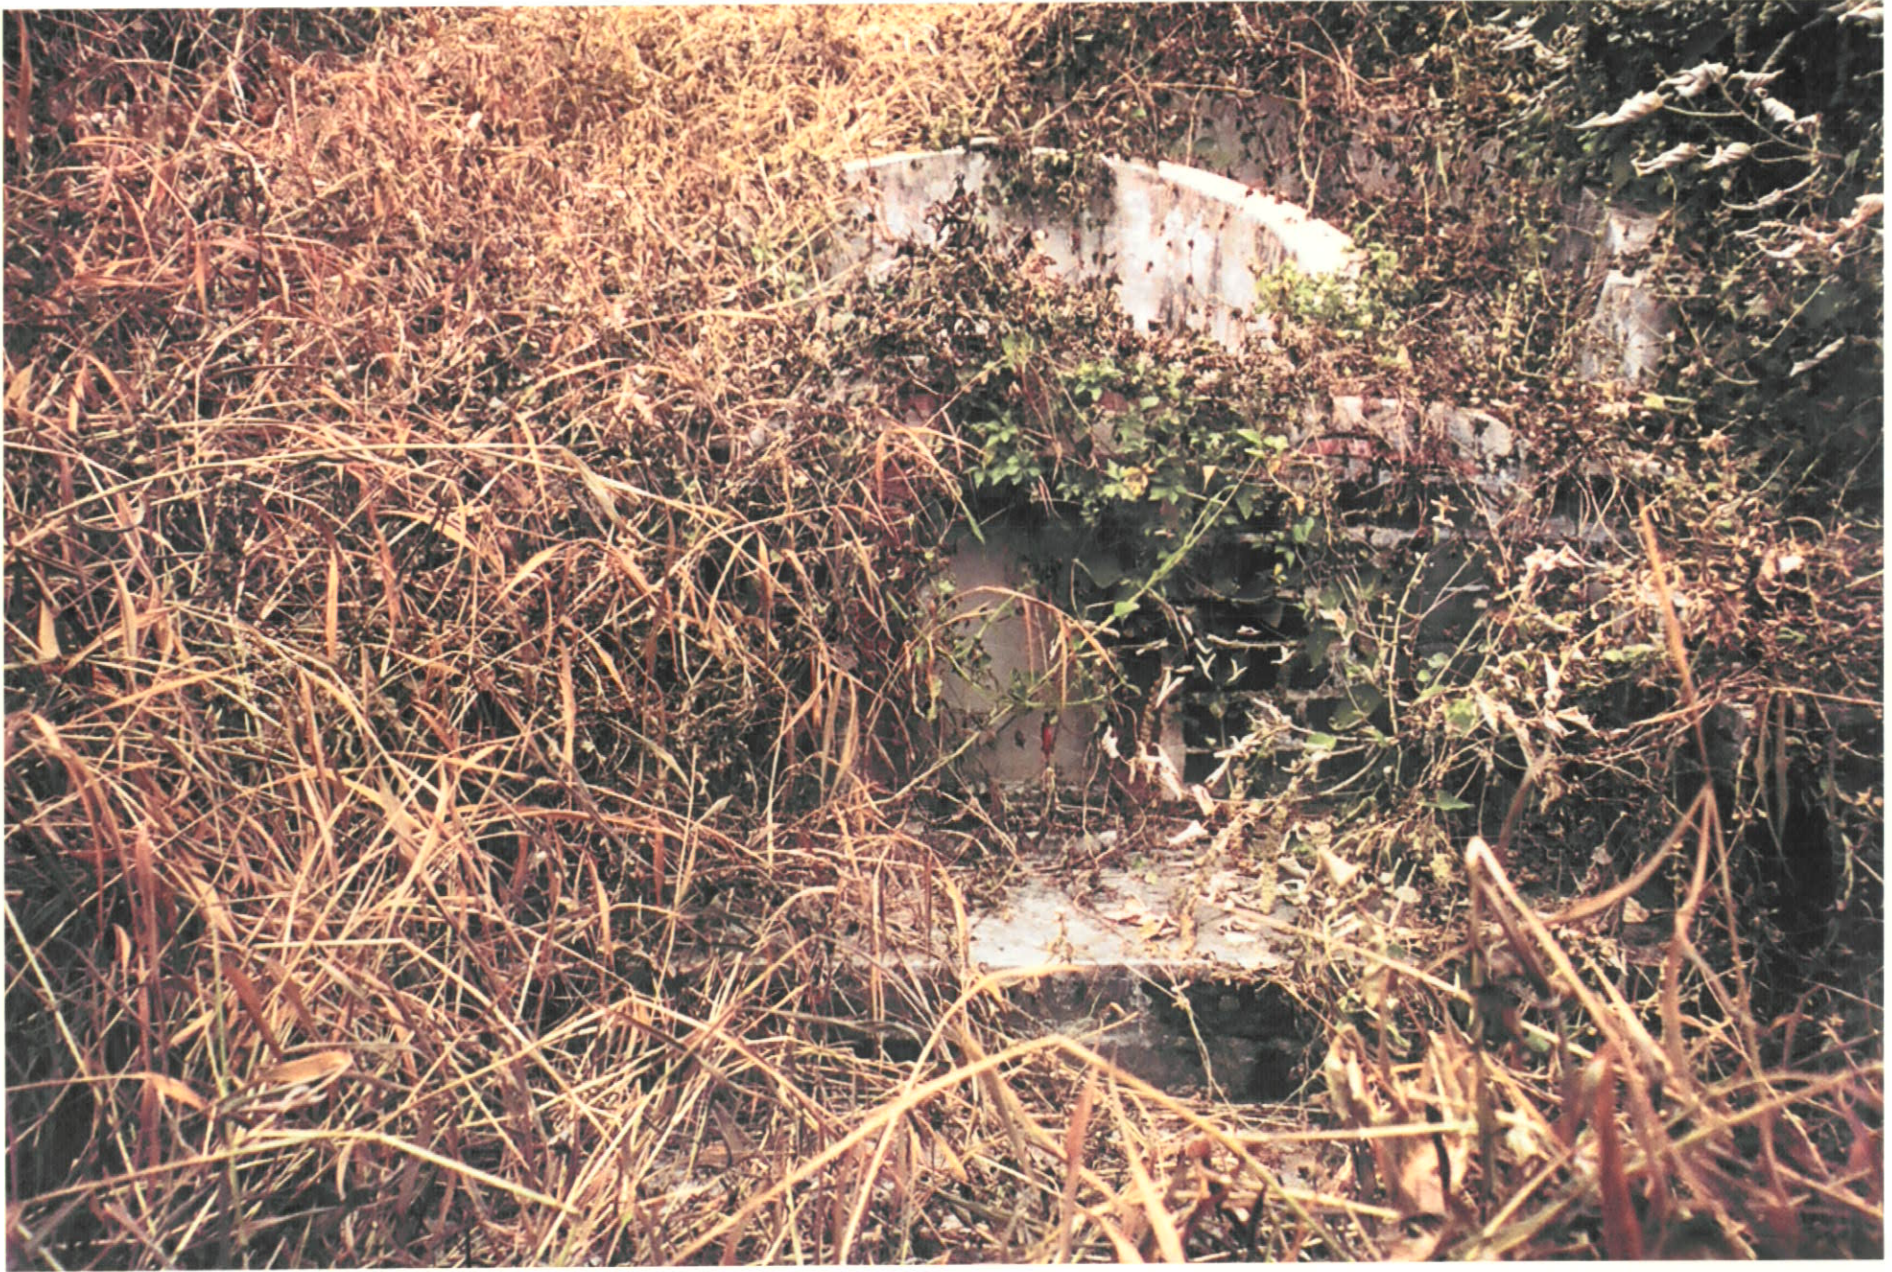
KT13-02-02

<p>Photo:</p>	<p>Inscription:</p> <p>道光十九年壬辰冬月吉日重修          祀男范翁 萬 舞 千 孫 如 棟 如 如          清顯妣張氏淑德孺人之墓          一乃係公之正配 一原葬土名橫邊          一前之形 一後重修 一六世子智吳</p>
<p>Family: Cheung      Dim.: (Height) 150 cm, (Width) 370 cm, (Depth) 300 cm</p> <p>Date: Qing      renovation 70 Kwam 16th yr.</p> <p>Description: covered in concrete &amp; heavily overgrown          NE orientation; more plaque; more bricks (blue)</p> <p style="text-align: right;">Photo Ref.:      KT 13-02-03</p>
