AGREEMENT NO. CE 59/2005 (EP)

Development of a Bathing Beach at Lung Mei, Tai Po  
Environmental, Drainage and Traffic Impact  
Assessments - Investigation

Environmental Impact Assessment Report  
Volume I – Main Text

**The Government of Hong Kong Special  
Administrative Region  
Civil Engineering and Development Department  
Port Works Division**

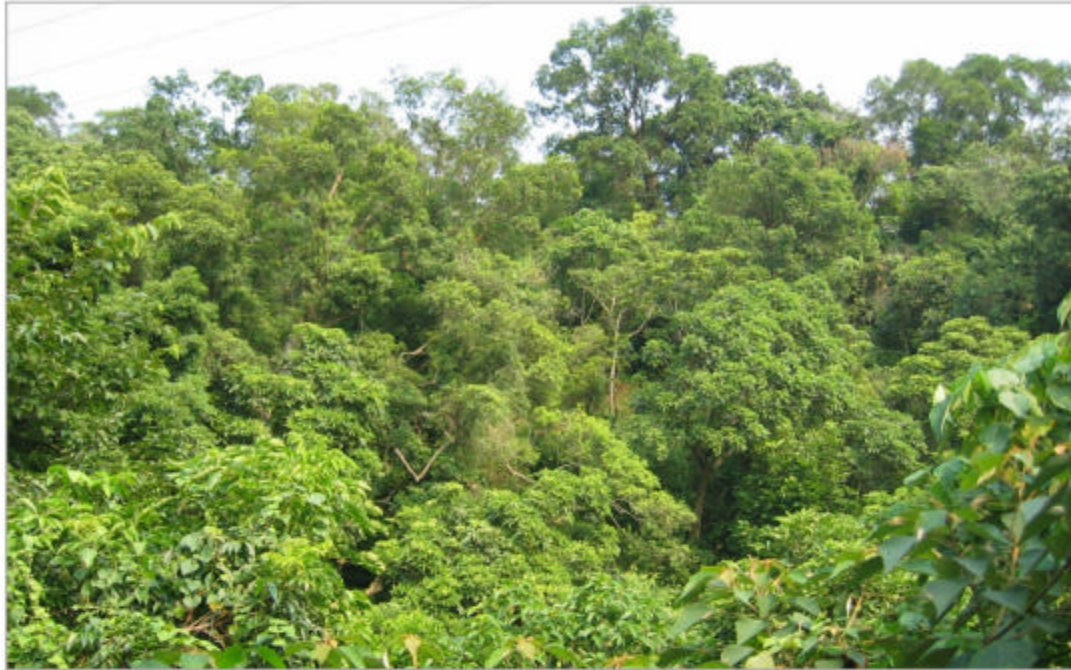
A patch of mature secondary woodland was found at the east of the Study Area, which is located within the Plover Cove Country Park. The structural complexity and ecological value of the woodland are moderate to high.

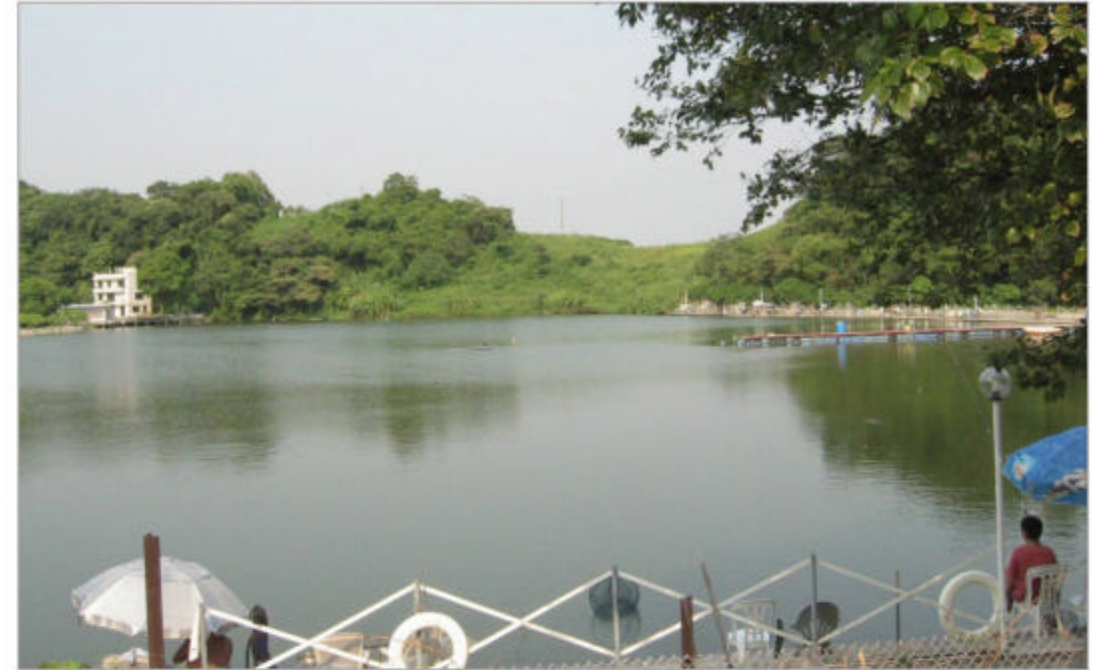
A pond was located at the east of the Study Area, which was under management for recreational purpose. The pond was designated as Conservation Area.

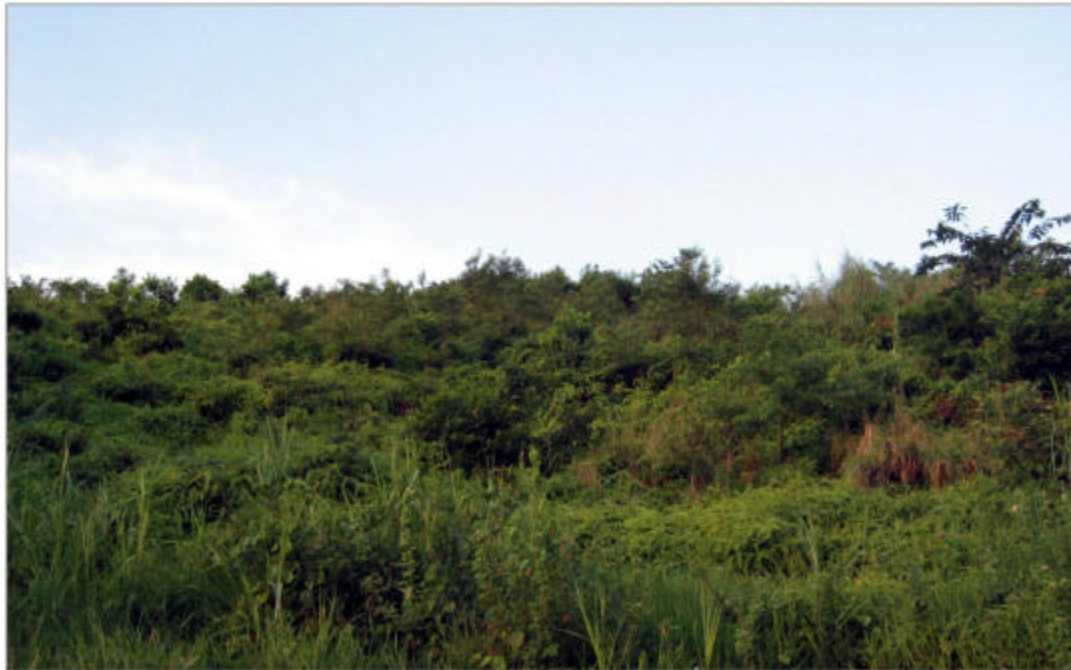
Shrubland was found on the hill and located at the north of the Study Area. The shrubland was dominated by small shrub species with low to moderate species diversity and structural complexity.

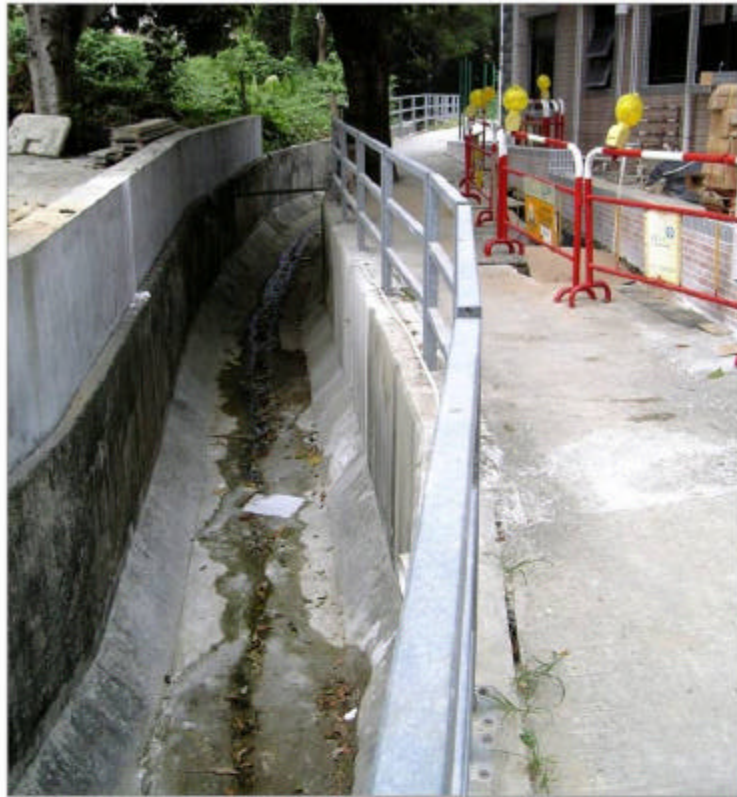
The lower course of S1, located within the village area, was channelised and has negligible ecological value.

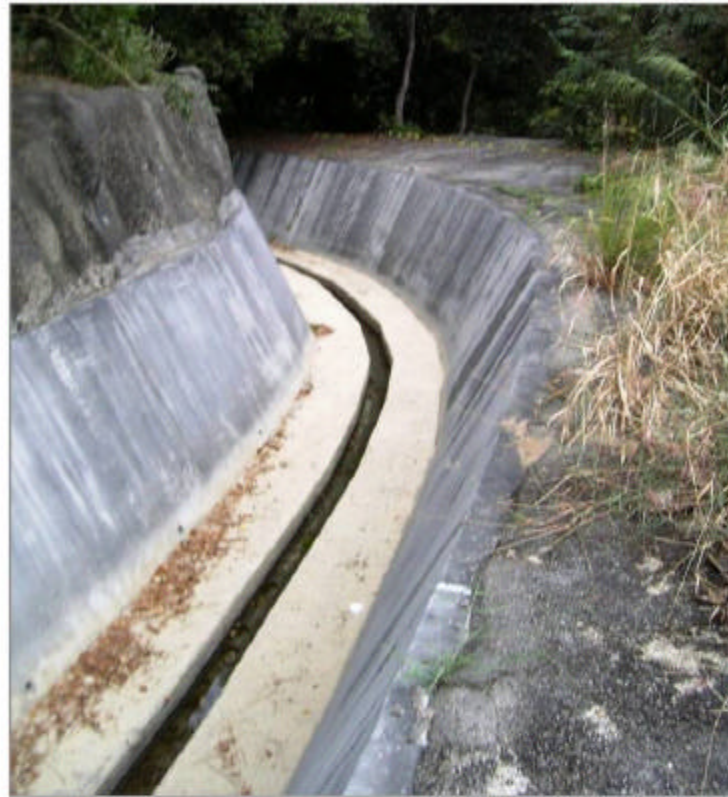
Drainage channel S2 was found at the fringe of Pat Sin Leng Country Park.

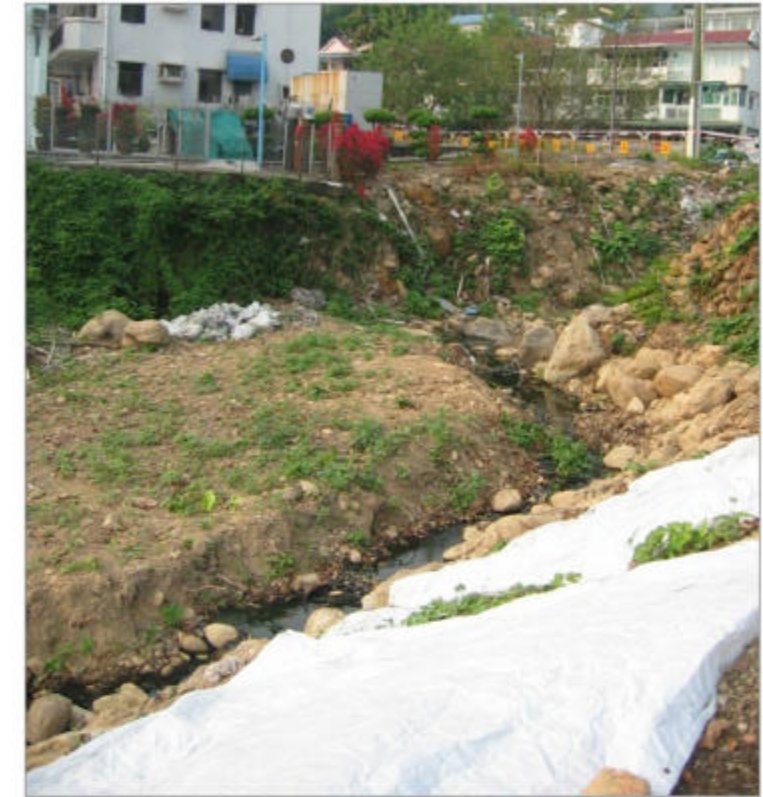
The lower course of stream S3 was highly disturbed by the construction activities of the village area.

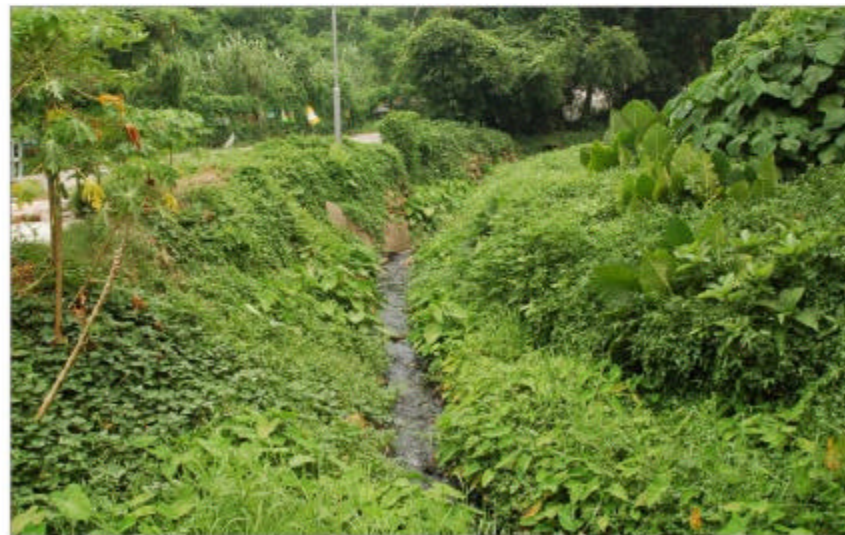
The middle and upper course of Lo Tsz River (S5) was quite narrow with weedy riparian vegetation growing on the stream bank.

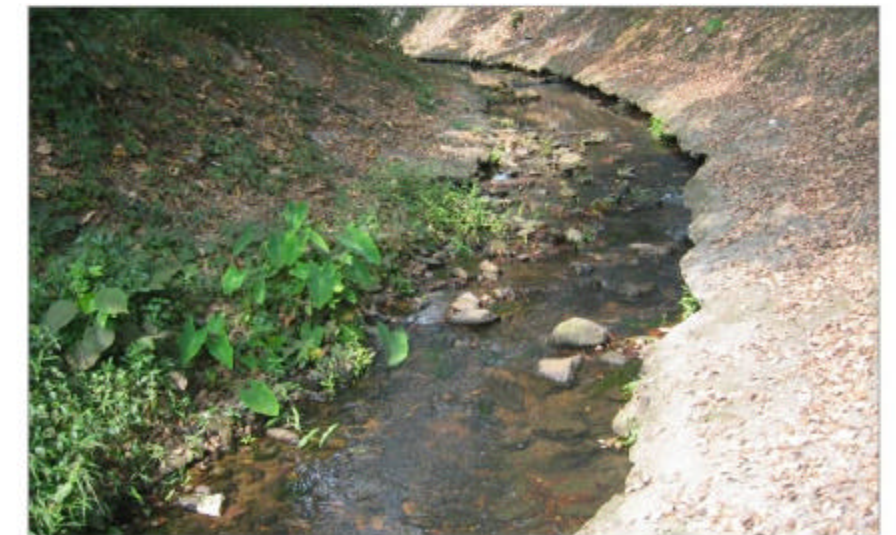
Shan Liu River (S6) was partially channelised with disturbed stream banks. The substratum was undisturbed and with natural gravels and rubbles.

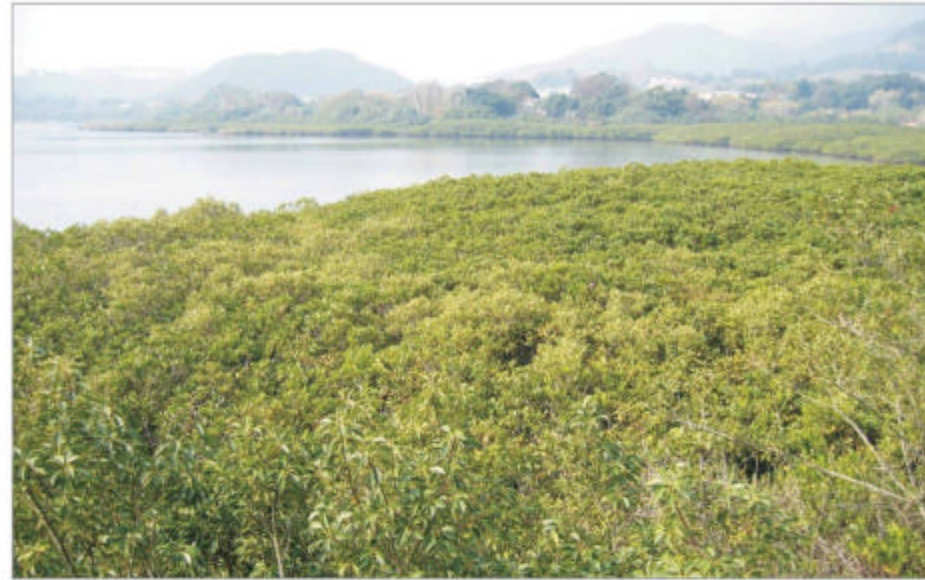
Mangrove habitat within the Ting Kok SSSI was less disturbed by human activities and mature in age. The mangrove was dominated by *Kandelia obovata*, *Excoecaria agallocha*, *Bruguiera gymnorrhiza* and *Aegiceras corniculatum*.

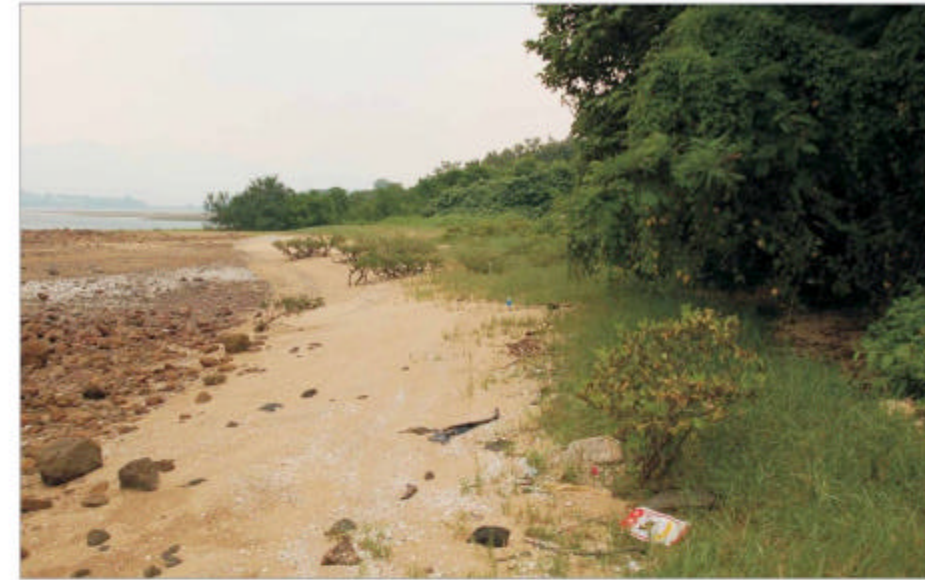
The substratum of the higher intertidal zone of the sandy shore is mainly coarse sand and dominated by backshore vegetation including *Thespesia populnea* and *Macaranga tanarius*. Individual dwarf mangrove plants (< 0.5 m in height) and seedlings such as *Aegiceras corniculatum* were found scattered along the sandy shore.

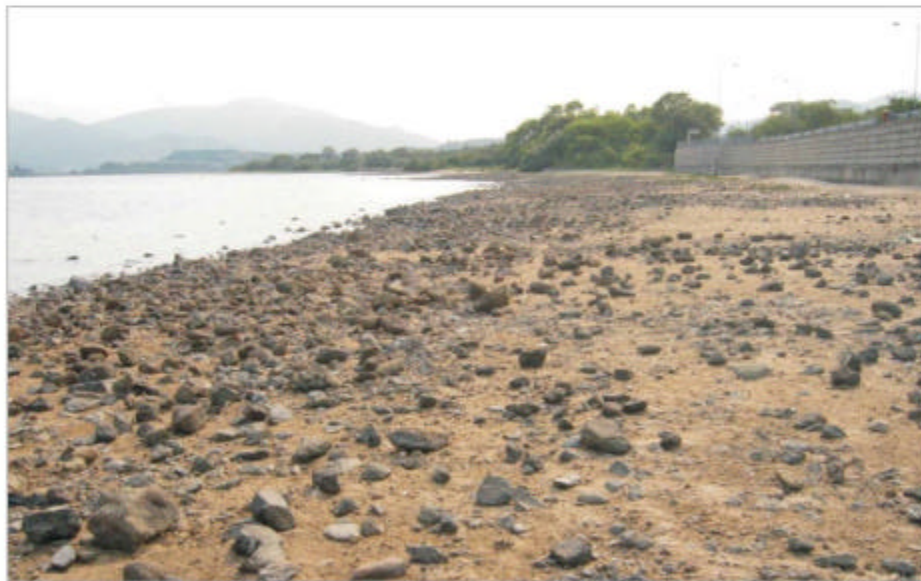
The substratum of the middle and lower intertidal zones of the sandy shore is mixed with pebbles, small boulders and soft substrate (i.e. sand and mud), which exposed during low tide.

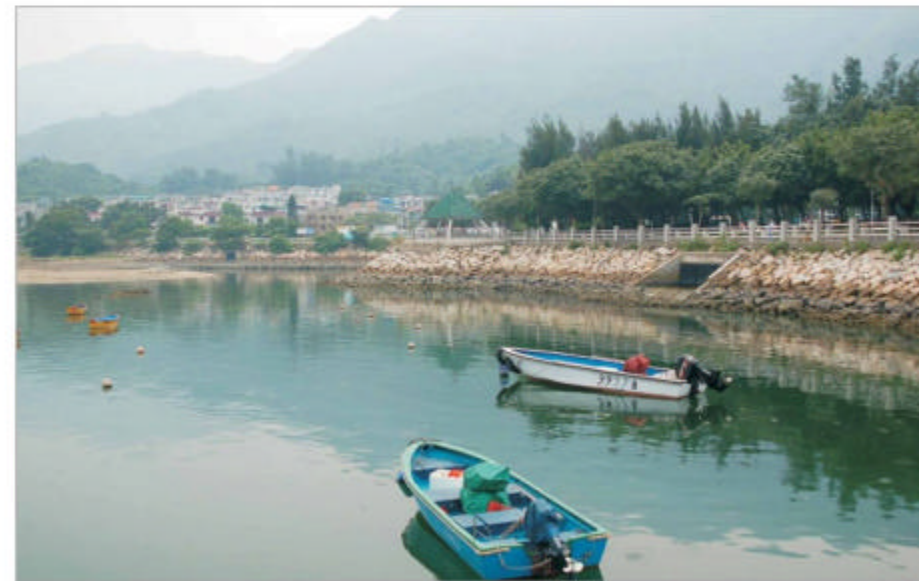
Artificial shoreline was recorded along the coastline close to the BBQ sites at the east of the Study Area.

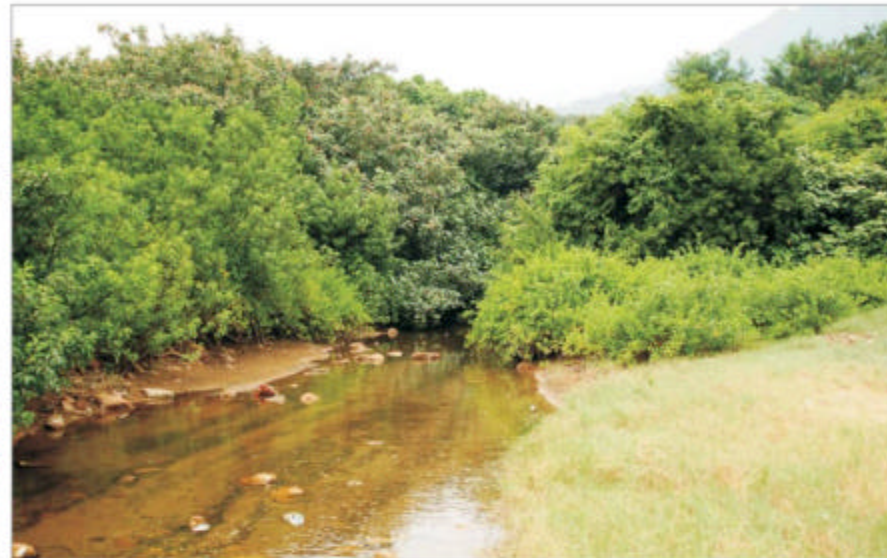
The lower course of Lo Tsz River which located outside the Project Site boundary was densely shaded by the surrounding vegetation such as *Excoecaria agallocha*, *Thespesia populnea* and *Hibiscus tiliaceus*.

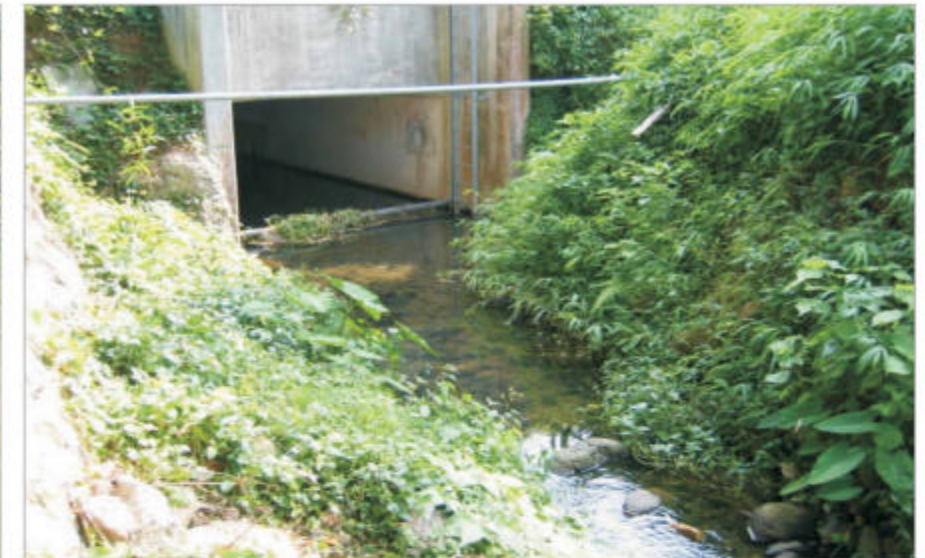
The lower course of Lo Tsz River was were mainly surrounded by village/modified area with human settlement and were observed to be partially channelised and polluted.

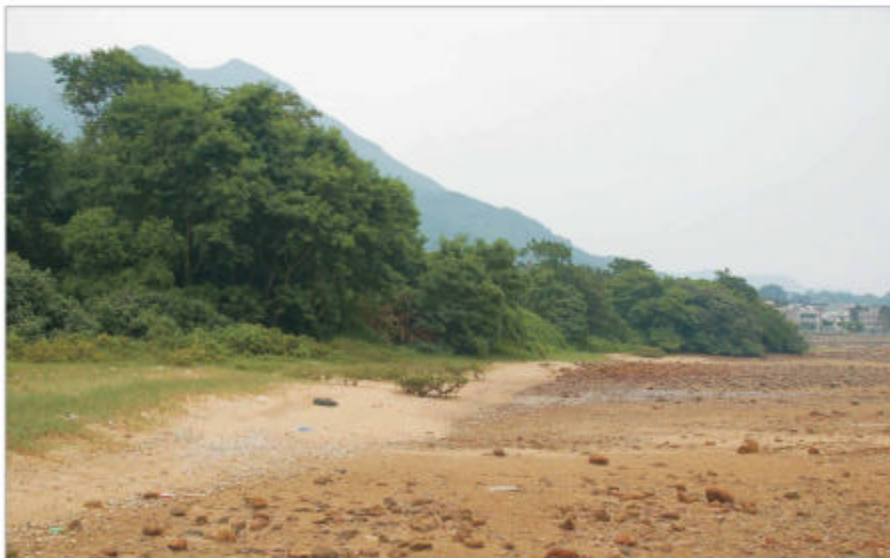
Sandy shore with backshore vegetation was recorded along the shoreline of the Proposed Beach Development Site. The backshore vegetation was susceptible to certain level of disturbance by human activities (i.e. littering).

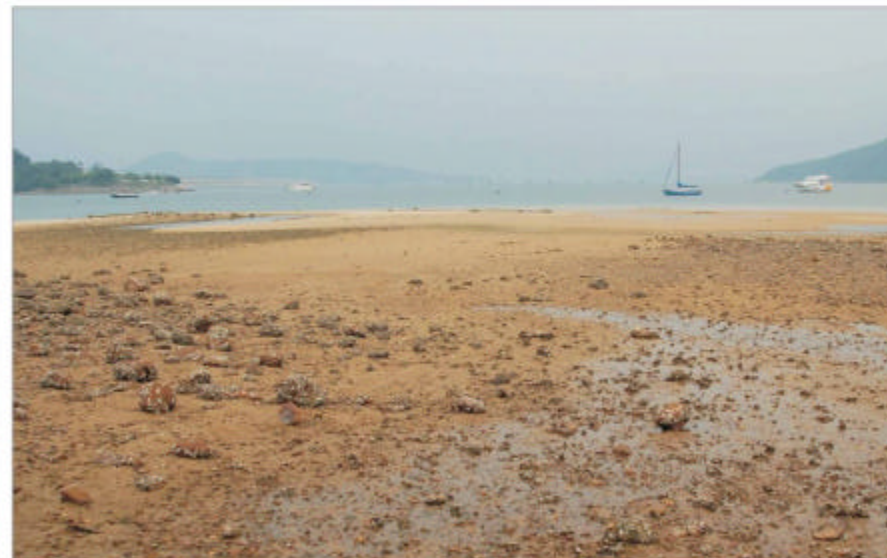
Existing conditions of the nearshore area located within the Proposed Land Requirement Boundary. The sandy bottom scattered with pebbles and small boulders during low tide.

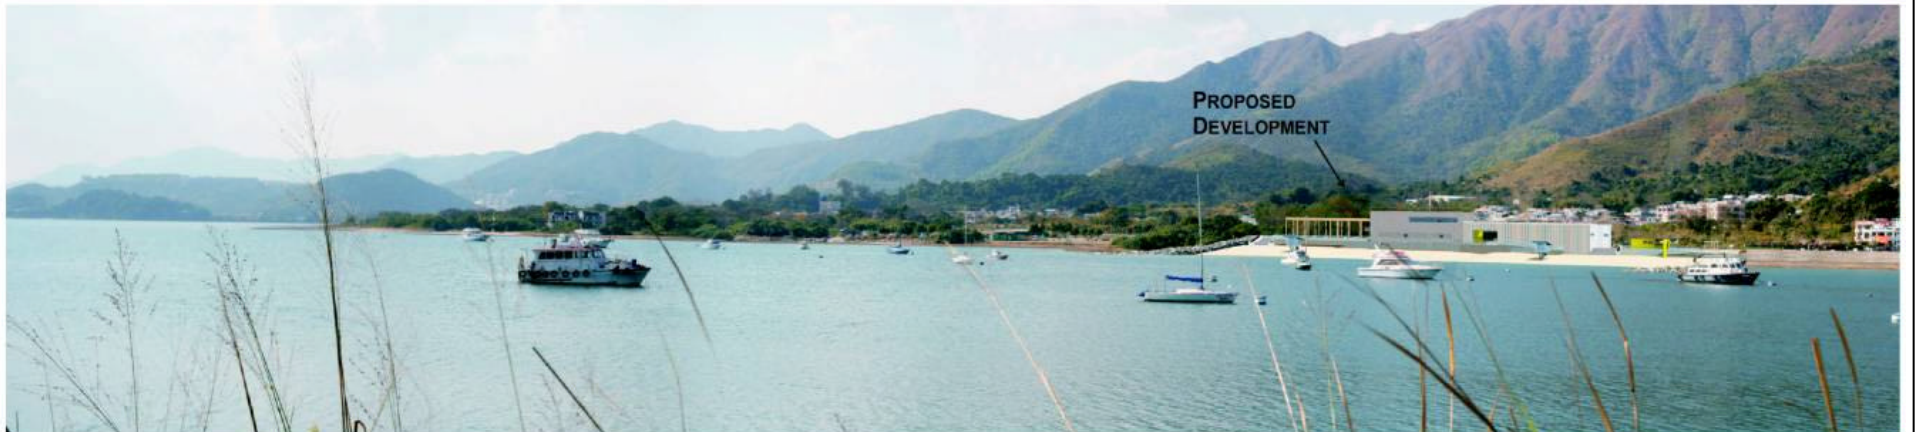
**VIEW DISPLAYING THE 3D MODEL OF THE PROPOSED DEVELOPMENT DAY 1 OPERATION NO MITIGATION**

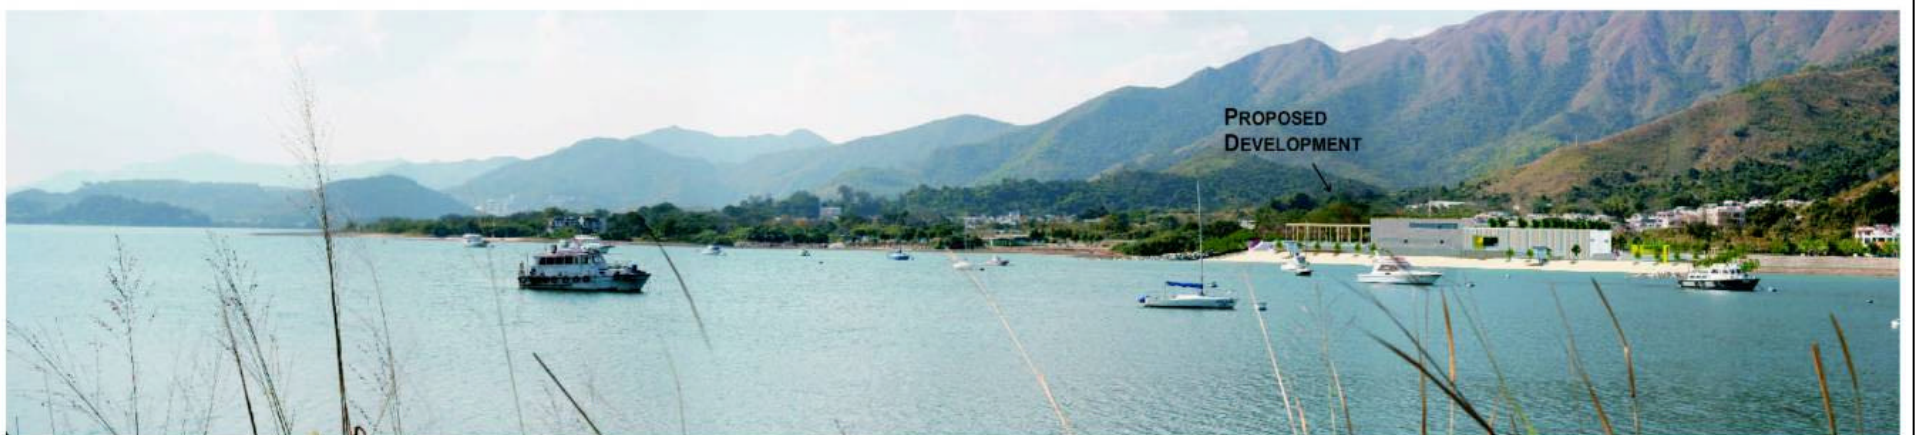
**VIEW DISPLAYING THE 3D MODEL OF THE PROPOSED DEVELOPMENT DAY 1 OPERATION WITH MITIGATION**

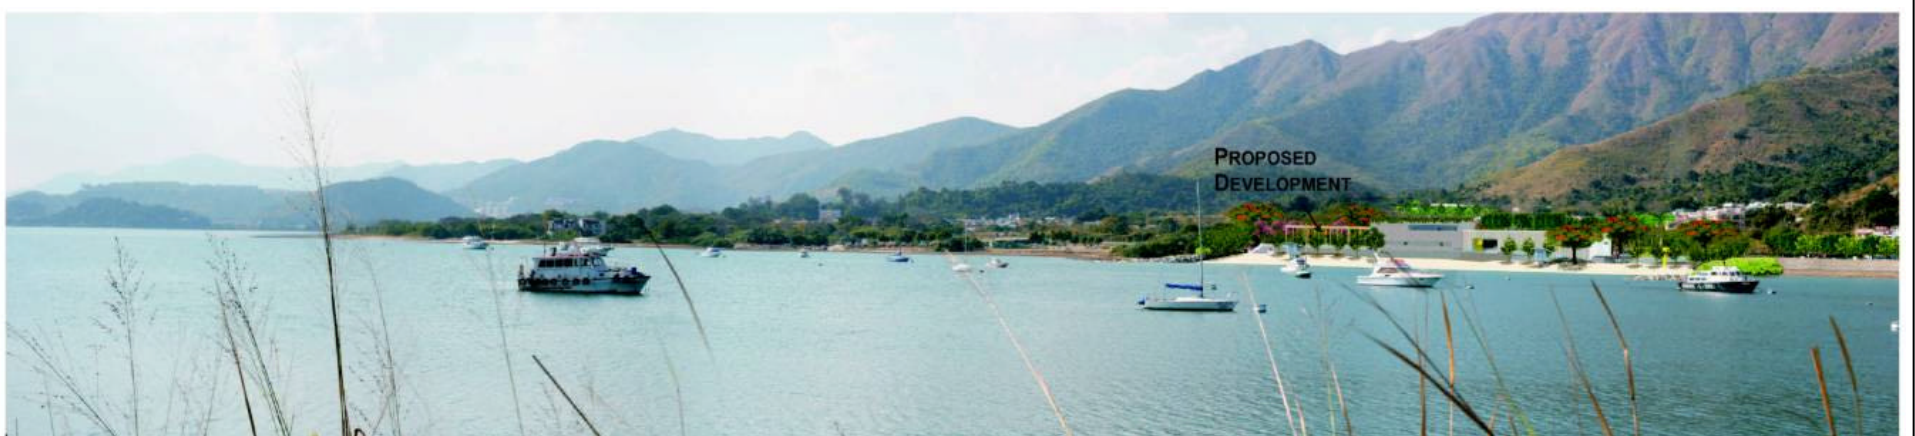
**FIGURE 10.28  
PHOTOMONTAGE  
VISUALLY SENSITIVE  
RECEIVER 1  
VIEW FROM  
TAI MEI TUK BBQ AREA**

The photomontage shown in Figure 10.28 shows that from this viewpoint, the Proposed Beach Development will be visually prominent.

**VIEW DISPLAYING THE 3D MODEL OF THE PROPOSED DEVELOPMENT YEAR 10 OPERATION WITH MITIGATION**

Table 10.10 shows that this VSR has a *High* sensitivity to change. Table 10.11 shows that the magnitude of change of view of VSR 1 will be Large during both of the construction and operation phases. Table 10.12 therefore indicates that the visual impact on VSR 1 in the construction phase is significant. However, this impact will only be experienced for a short period, i.e. 2 years construction period. Further, with the adoption of site hoardings, which will be in comparable colour to match with the surroundings, during the construction phase, it is considered that the impact could be reduced to moderate/significant. The proposed beach development, due to its large development scale on visually prominent waterfront, would have significant visual impact when viewed from VSR 1 (Table 10.13 refers). With the adoption of appropriate architectural design features and screen planting (refer to Section 10.7.9 for details), the visual impact is considered to be moderate/significant at the Operation Day 1. The maturity of the plantings at later stage would further help to soften and break down the bulk of the beach buildings. The visual impact would be reduced to moderate (Figure 10.28 refers) at Operation Year 10.

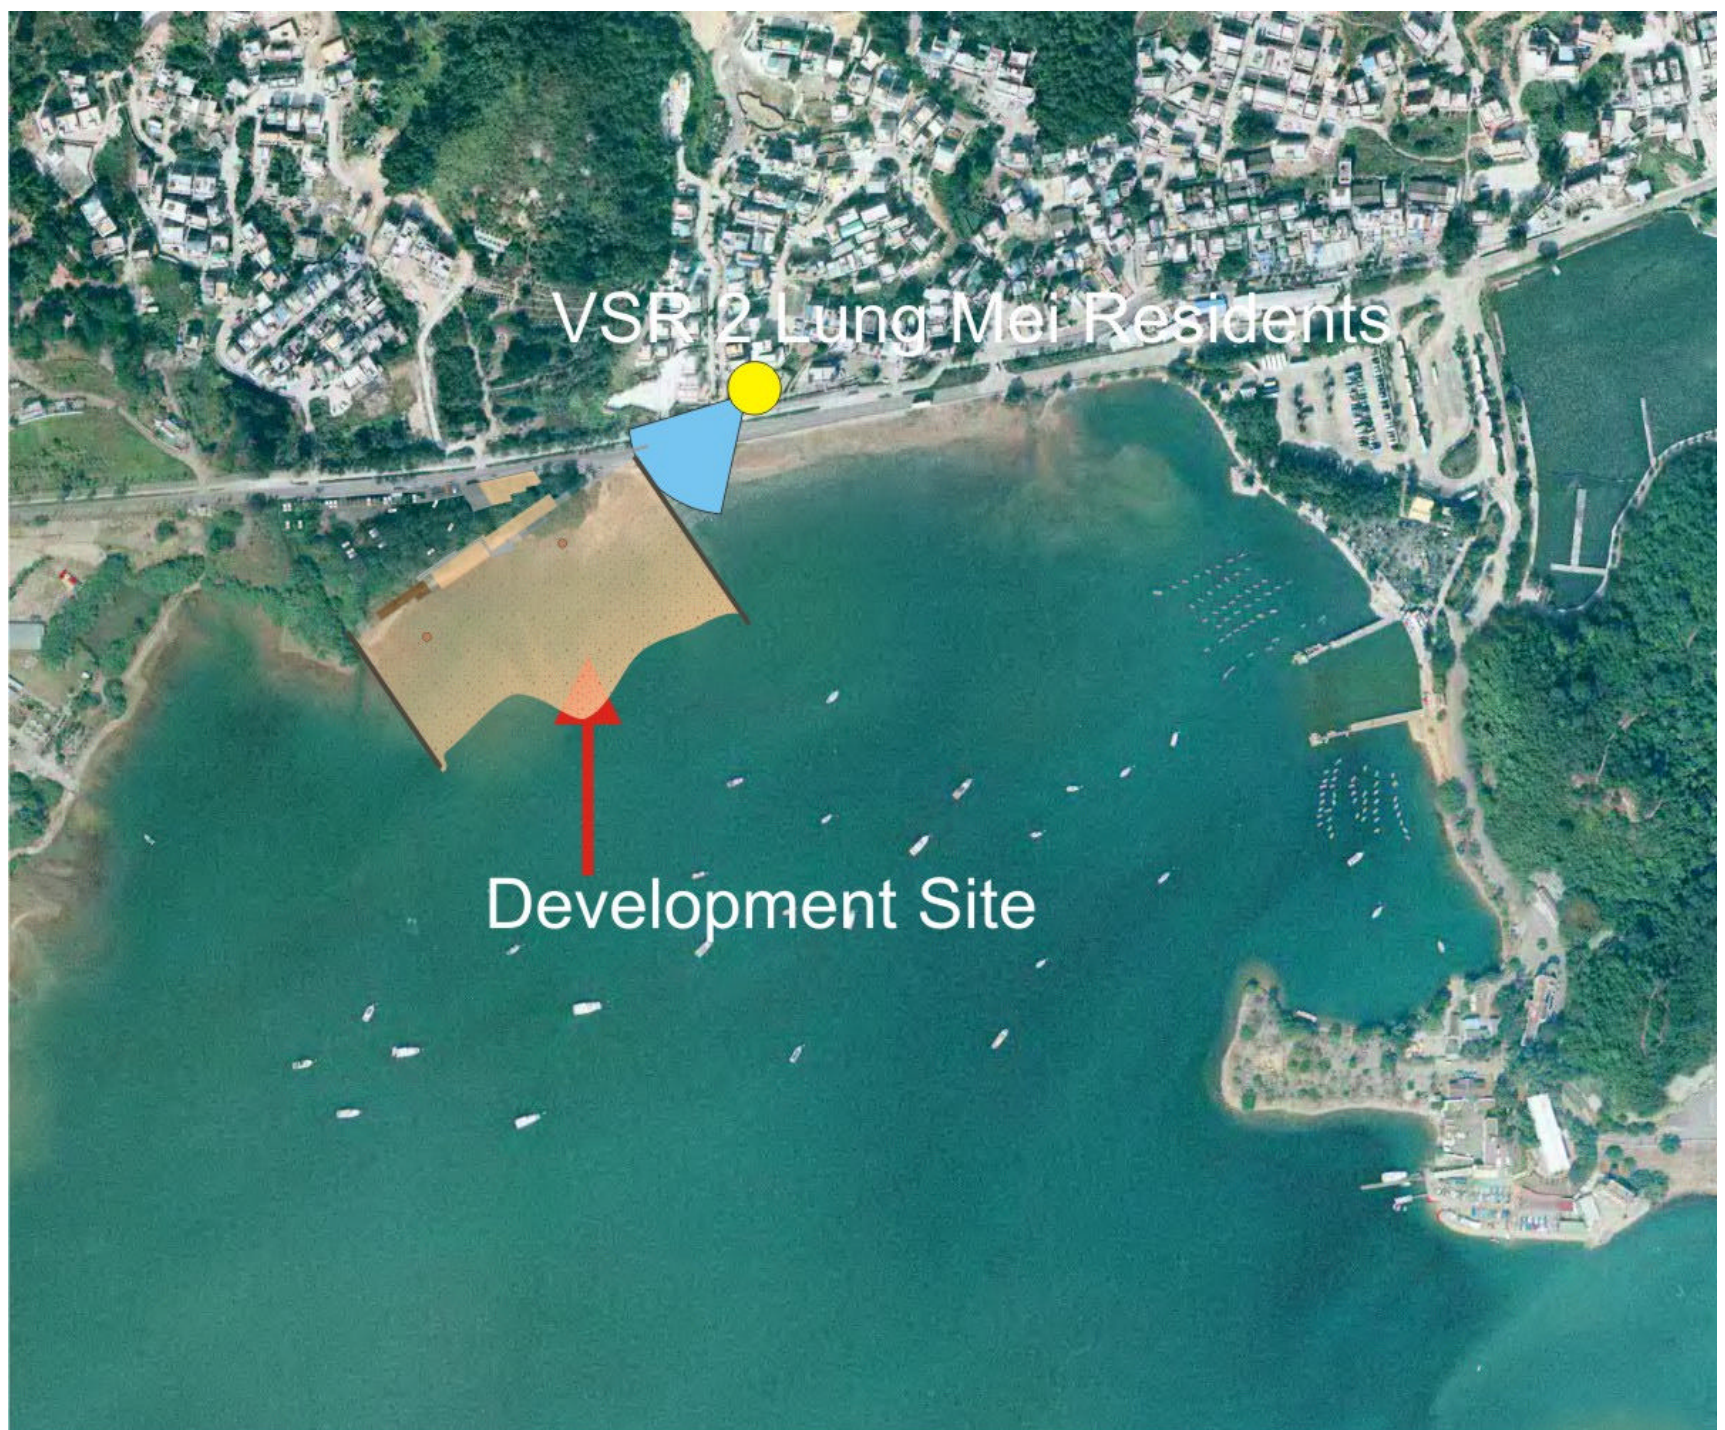
**Figure 10.29: VSR 2 Location**

This VSR represents a worst case-scenario of viewers in the nearby residential areas of Lung Mei as well as road users and visitors to the restaurants. *Figure 10.29* shows that the development is only 75m from this viewpoint, although the largest structure is approximately 165m away.

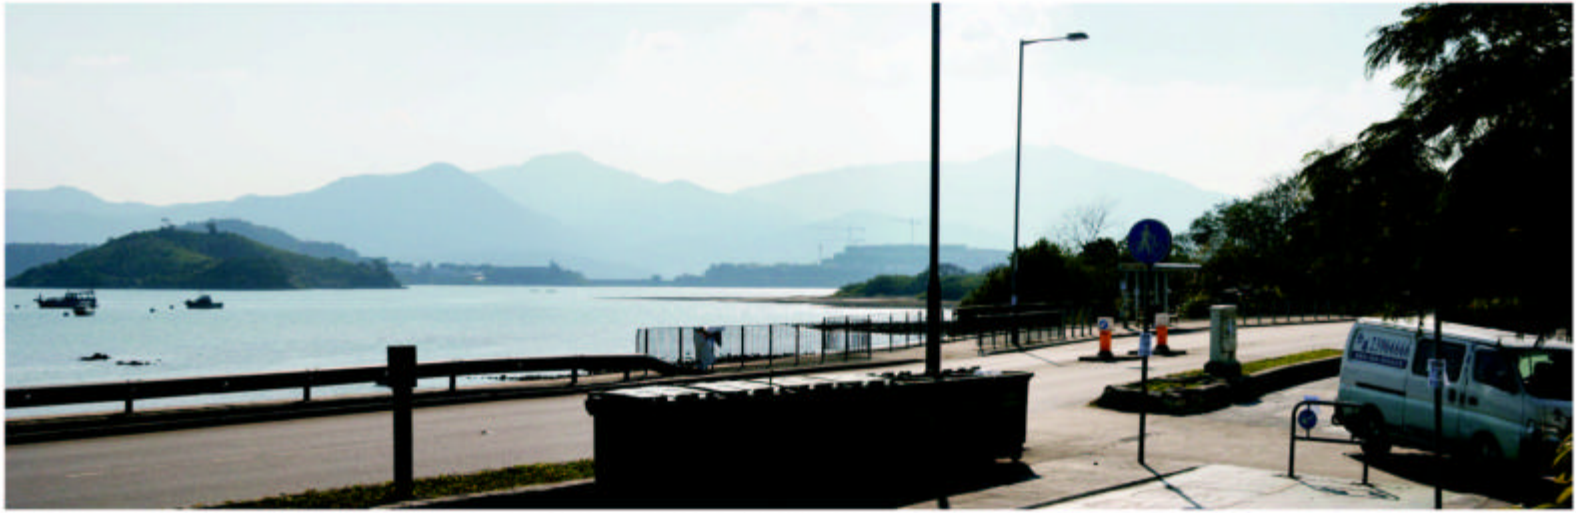
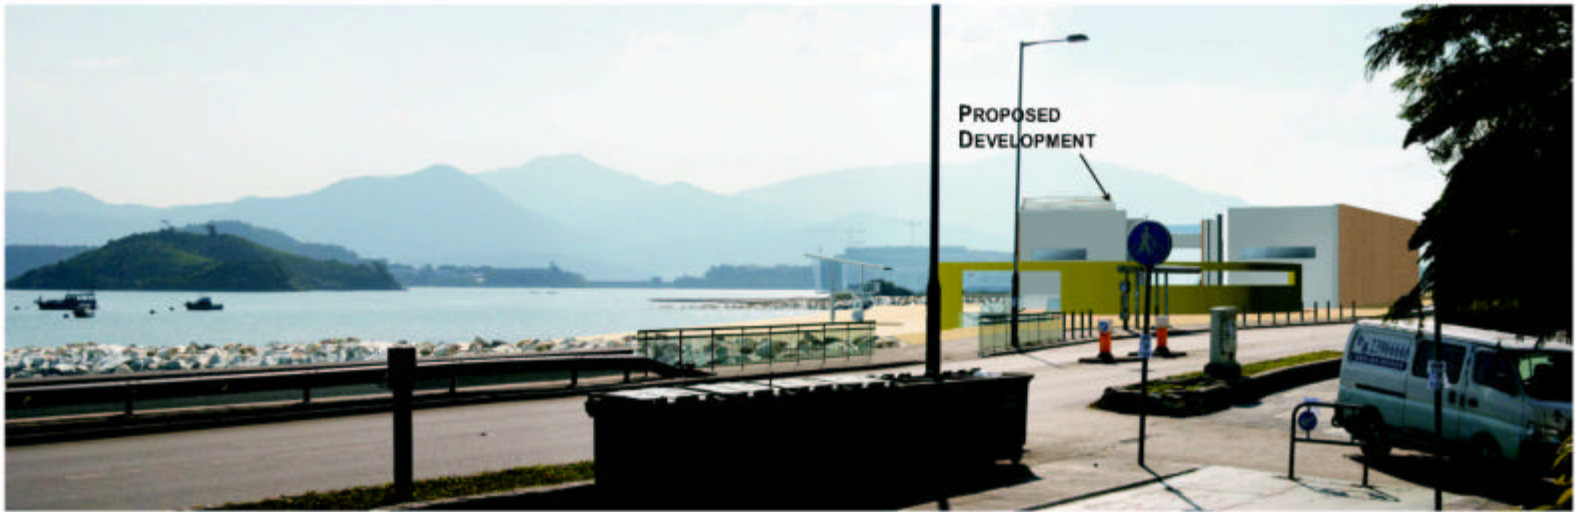
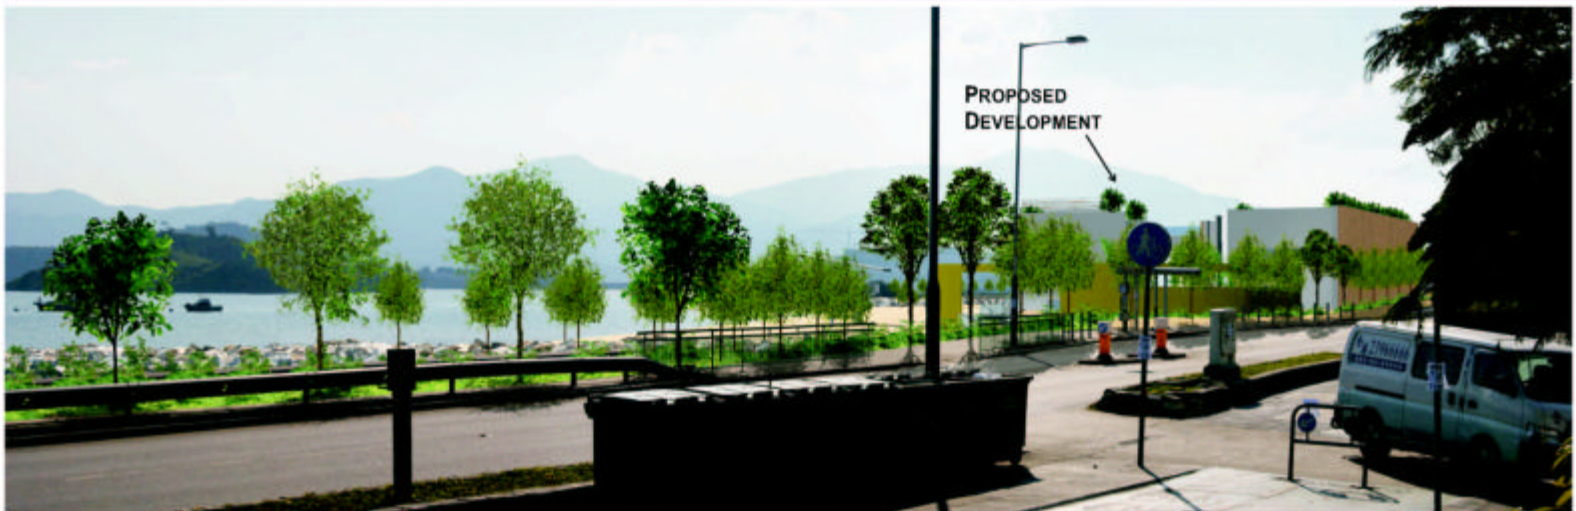
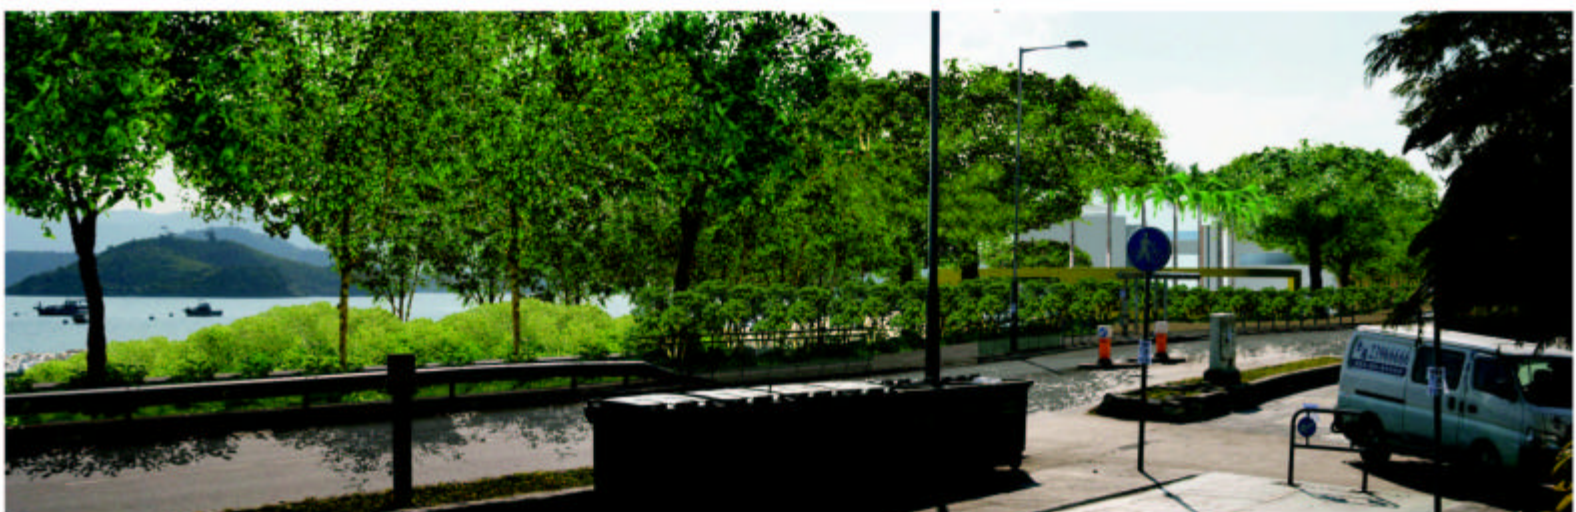
**FIGURE 10.30  
PHOTOMONTAGE  
VISUALLY SENSITIVE  
RECEIVER 2  
VIEW FROM  
LUNG MEI RESIDENTS**

The photomontage shown in *Figure 10.30* illustrates that the Proposed Beach Development will dominate the view from this viewpoint. This represents a worst-case scenario for these VSRs.

**EXISTING VIEW LOOKING TOWARDS THE DEVELOPMENT FROM LUNG MEI RESIDENTS.**

**VIEW DISPLAYING THE 3D MODEL OF THE PROPOSED DEVELOPMENT DAY 1 OPERATION NO MITIGATION**

**VIEW DISPLAYING THE 3D MODEL OF THE PROPOSED DEVELOPMENT DAY 1 OPERATION WITH MITIGATION**

**VIEW DISPLAYING THE 3D MODEL OF THE PROPOSED DEVELOPMENT YEAR 10 OPERATION WITH MITIGATION**

impact could be reduced to moderate/significant in the Operation Day 1 and further reduced to moderate in Operation Year 10 (*Figure 10.30* refers).

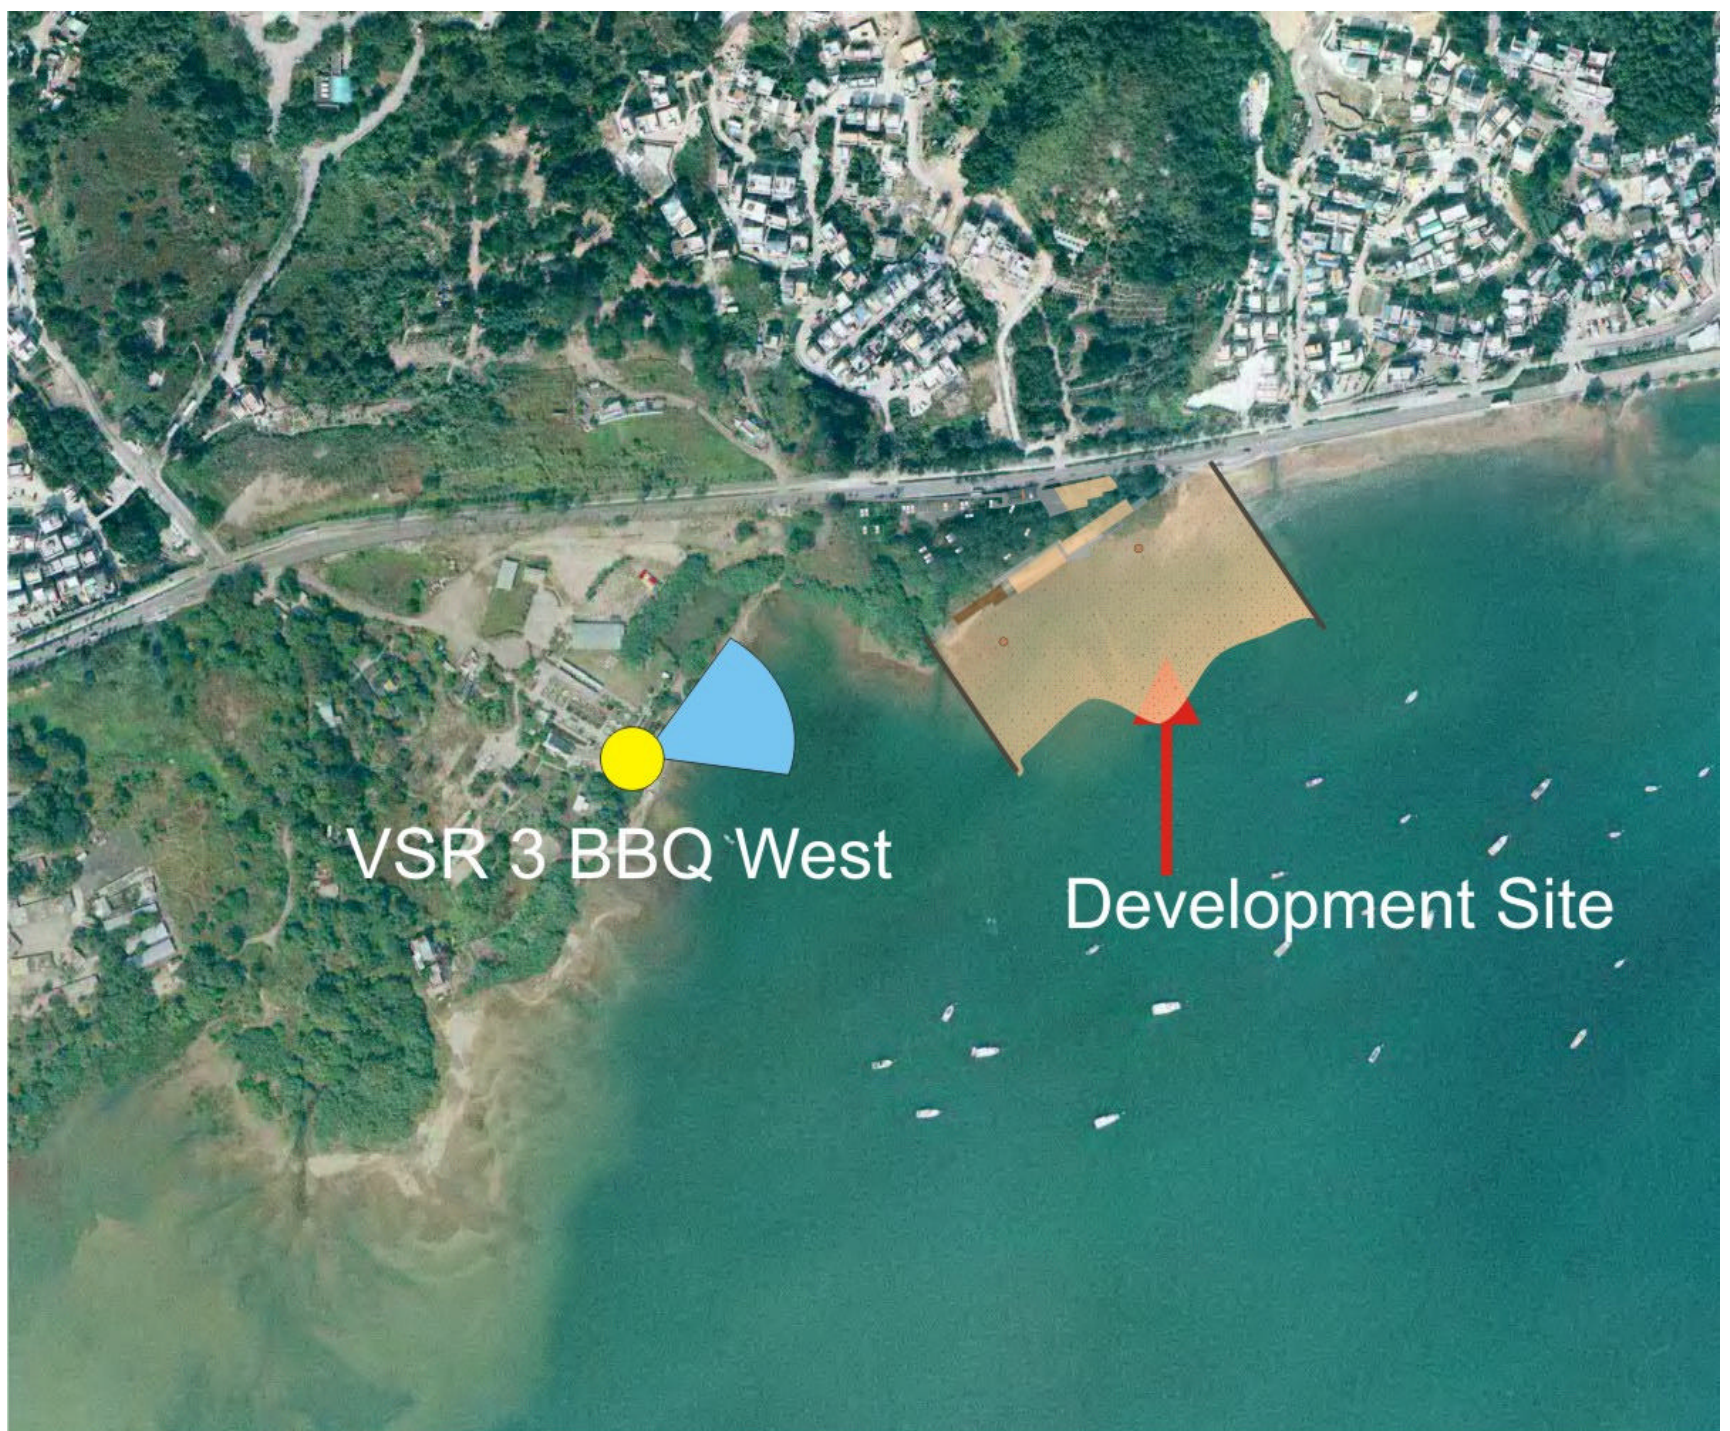
**Figure 10.31 VSR 3 Location**

*Figure 10.31* shows this VSR is located approximately 200m from the development with the largest visible structure being 275m away. The visitors to this area are all recreational users.
