AGREEMENT NO. CE 59/2005 (EP)

Development of a Bathing Beach at Lung Mei, Tai Po  
Environmental, Drainage and Traffic Impact  
Assessments - Investigation

Environmental Impact Assessment Report  
Volume I – Main Text

**The Government of Hong Kong Special  
Administrative Region  
Civil Engineering and Development Department  
Port Works Division**

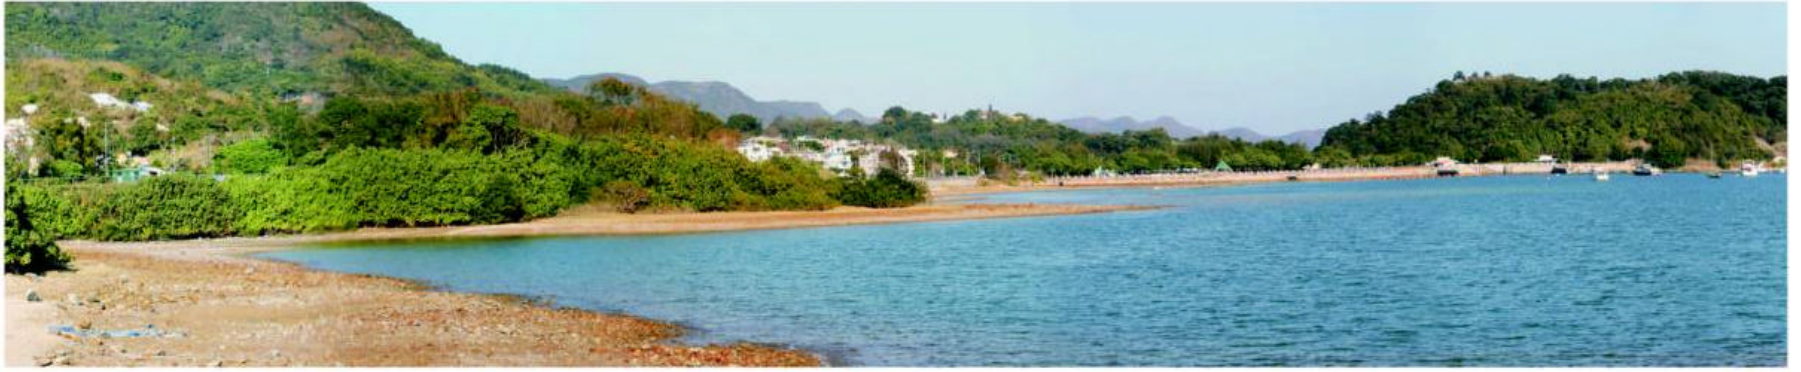
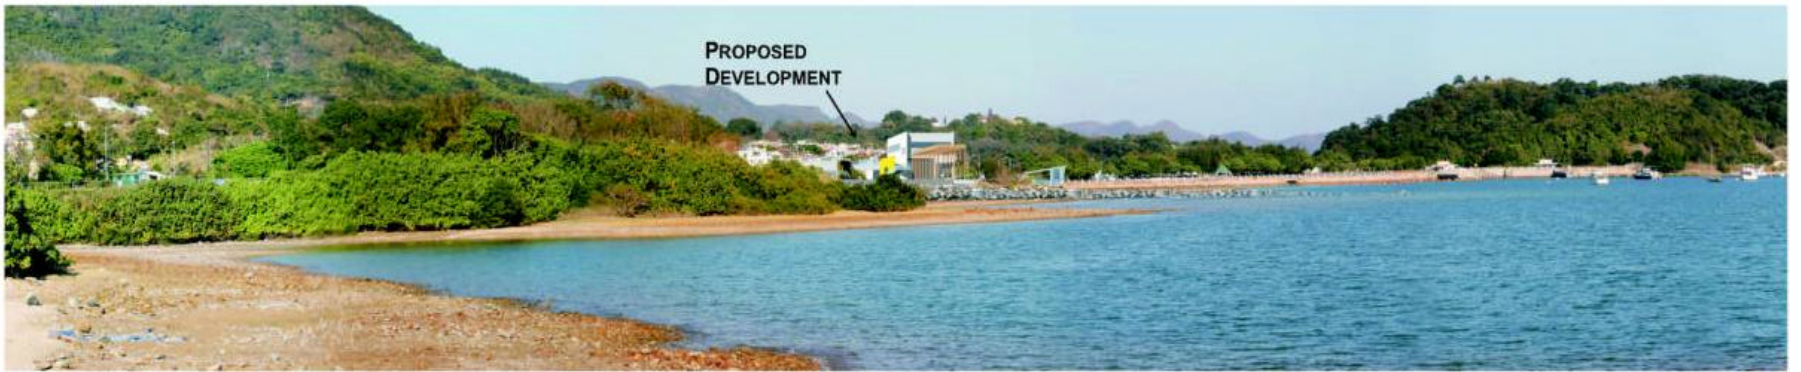
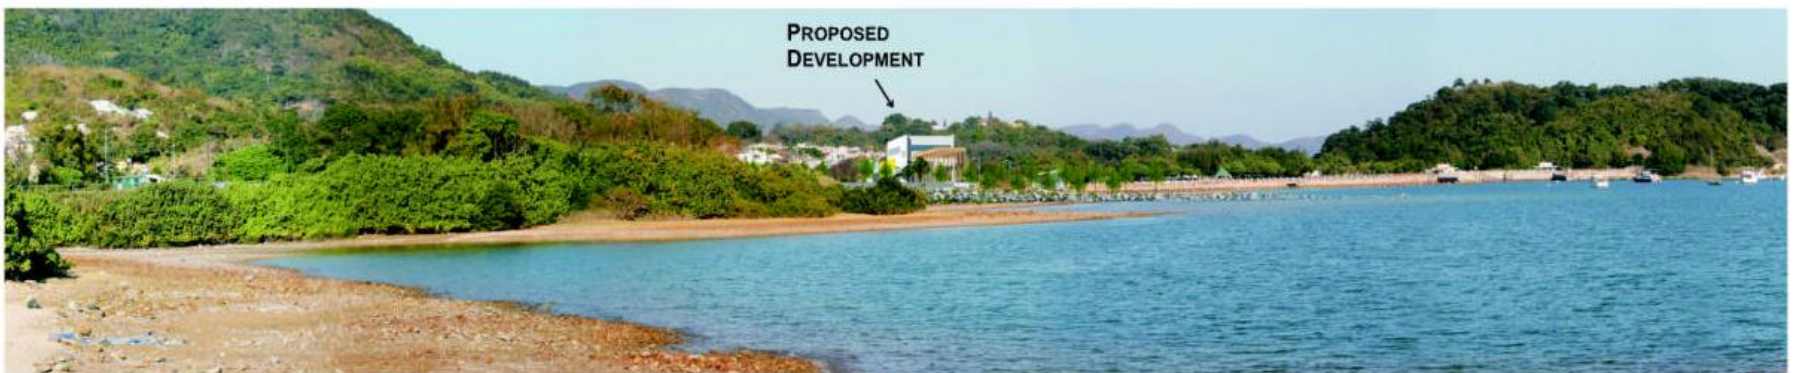
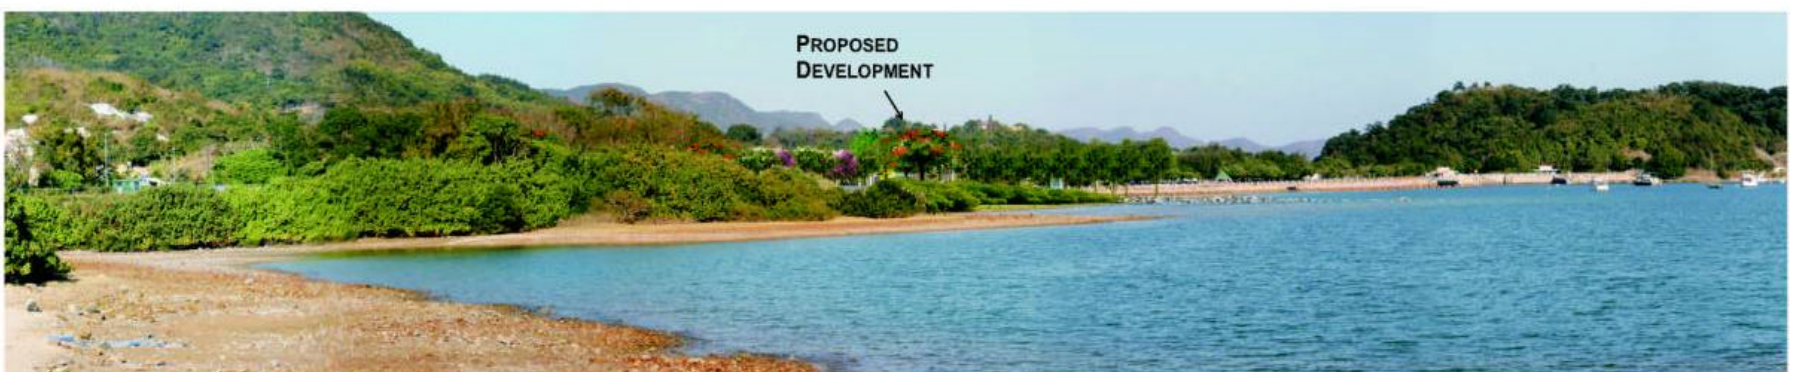
**FIGURE 10.32  
PHOTOMONTAGE  
VISUALLY SENSITIVE  
RECEIVER 3  
VIEW FROM  
BBQ'S WEST OF SITE**

The photomontage in *Figure 10.32* shows that the development will be prominent from this viewpoint.

**EXISTING VIEW LOOKING TOWARDS THE DEVELOPMENT FROM BBQ'S WEST OF SITE.**

**VIEW DISPLAYING THE 3D MODEL OF THE PROPOSED DEVELOPMENT DAY 1 OPERATION NO MITIGATION**

**VIEW DISPLAYING THE 3D MODEL OF THE PROPOSED DEVELOPMENT DAY 1 OPERATION WITH MITIGATION**

**VIEW DISPLAYING THE 3D MODEL OF THE PROPOSED DEVELOPMENT YEAR 10 OPERATION WITH MITIGATION**

Table 10.18 shows that this VSR has a *Medium* sensitivity to change. Table 10.19 shows that the magnitude of change of view of VSR 3 will be Large in both construction and operation phases. Table 10.20 shows that the proposed beach development will result in a moderate/significant visual impact during the construction phase. However, this impact will only be experienced for a short period, i.e. 2 years construction period. Further, with the adoption of site hoardings, which will be in comparable colour to match with the surroundings, during the construction phase, it is considered that the impact could be reduced to moderate. Upon completion, the proposed beach development would have moderate/significant impact on VSR 3 (Table 10.21 refers). With the adoption of mitigation measures, it is expected that the impact could be reduced to moderate in Operation Day 1 and slight in Operation Year 10 (Figure 10.32 refers).

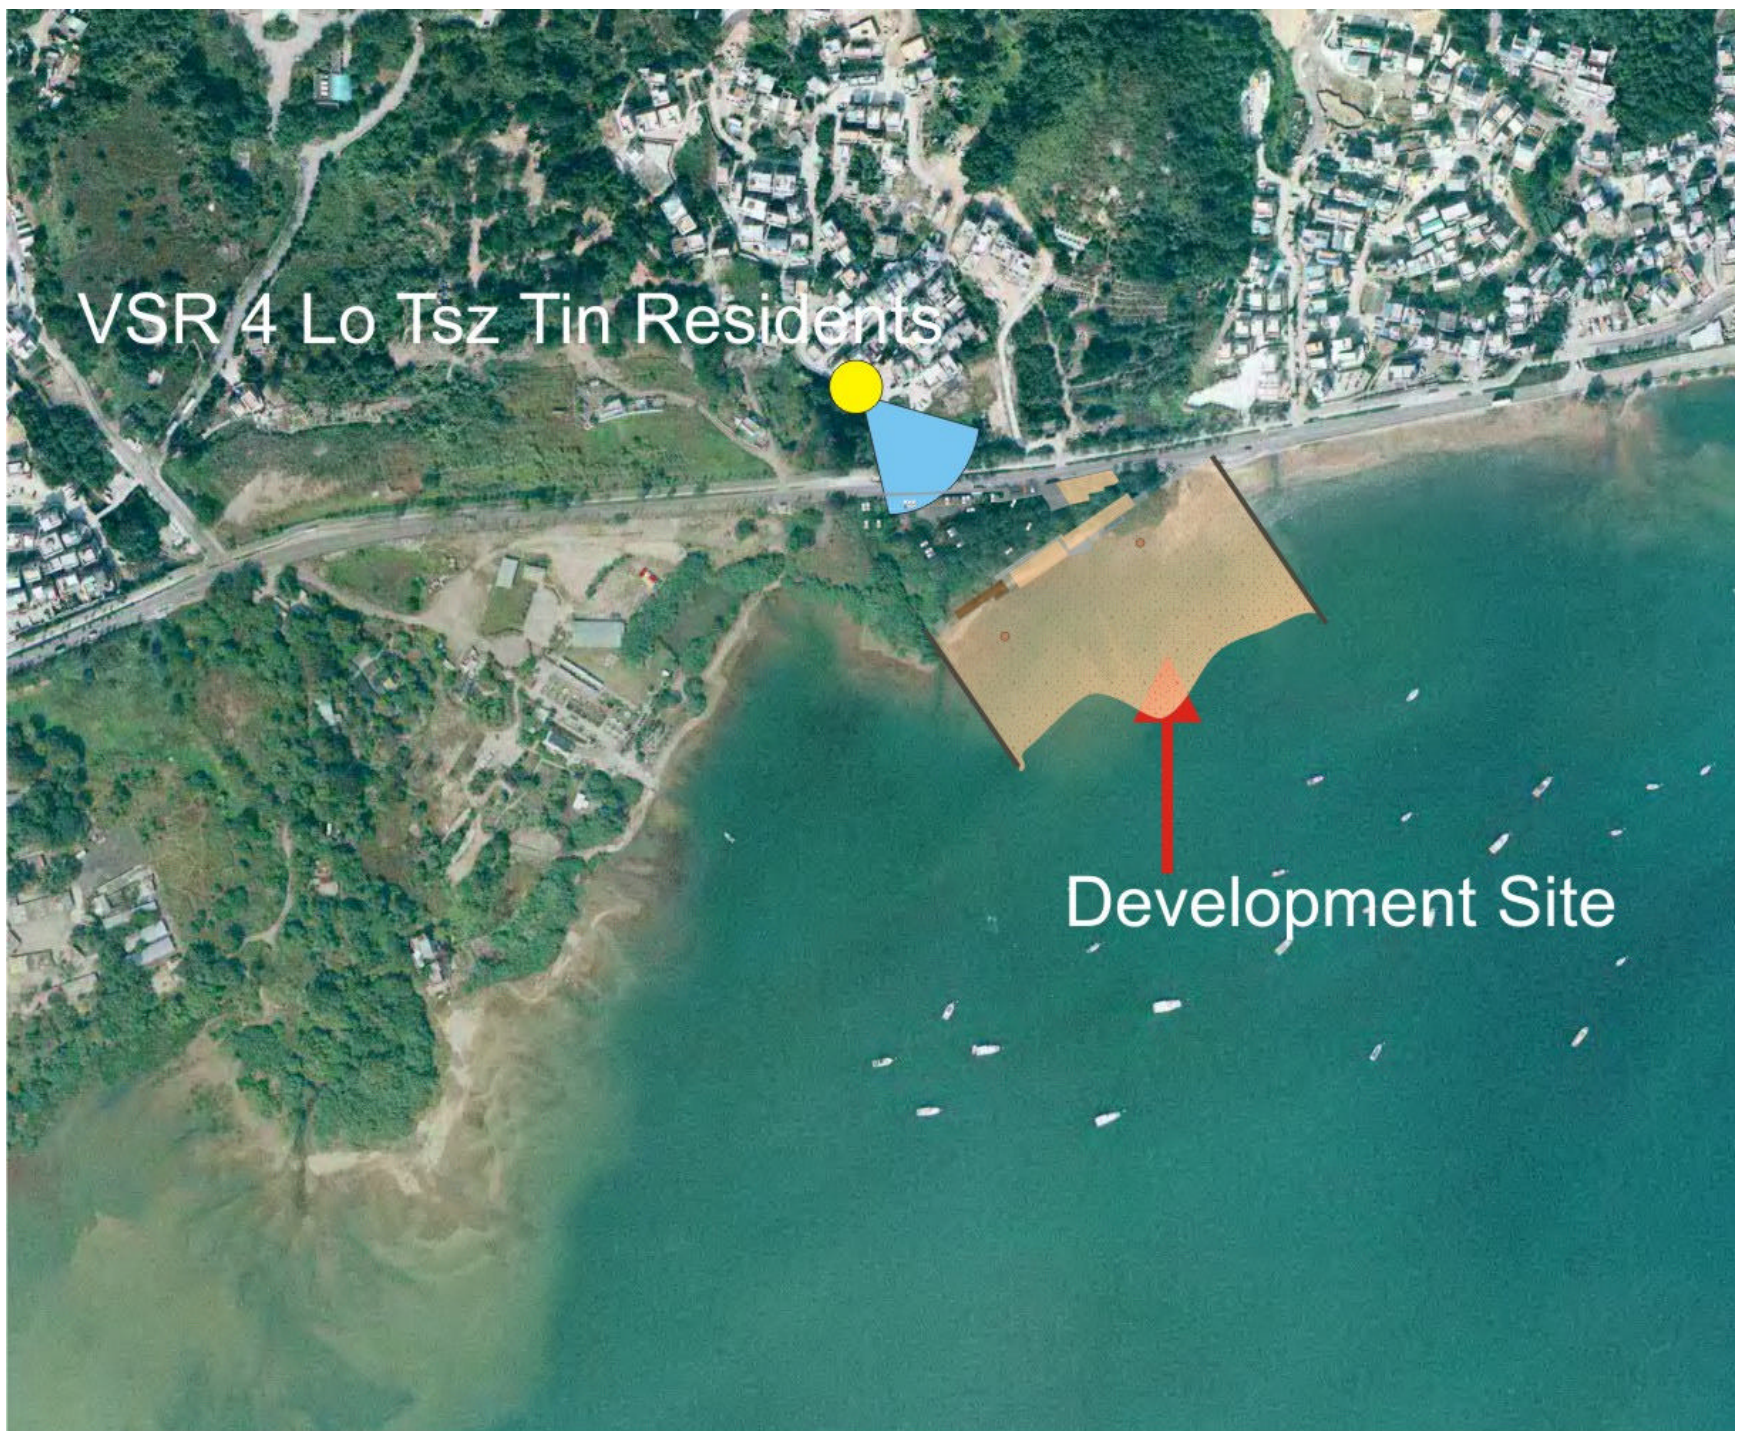
**Figure 10.33 VSR 4 Location**

This VSR represents a worst case-scenario of viewers in the nearby residential areas of Lo Tsz Tin *Figure 10.33* shows that the development is only 80 m from this viewpoint, although the largest structure is approximately 140 m away.

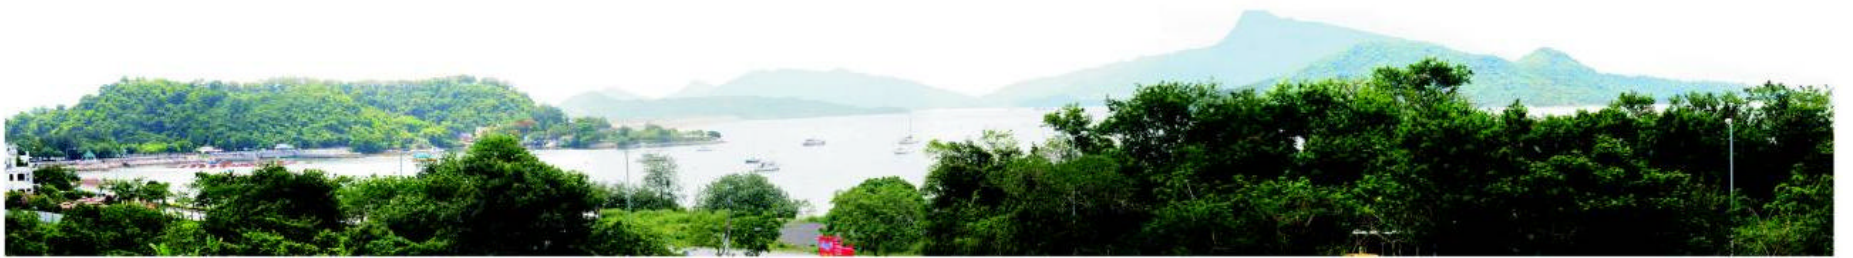
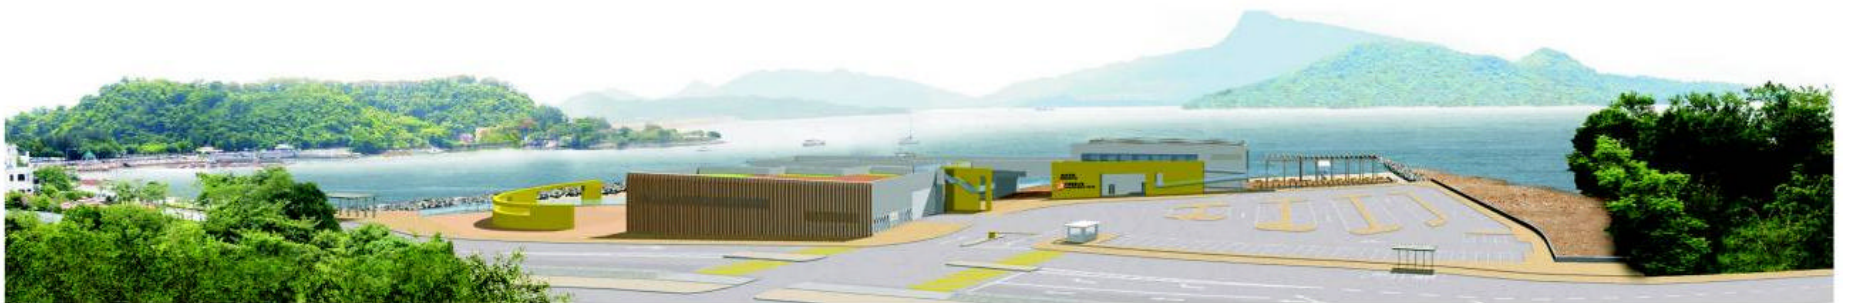
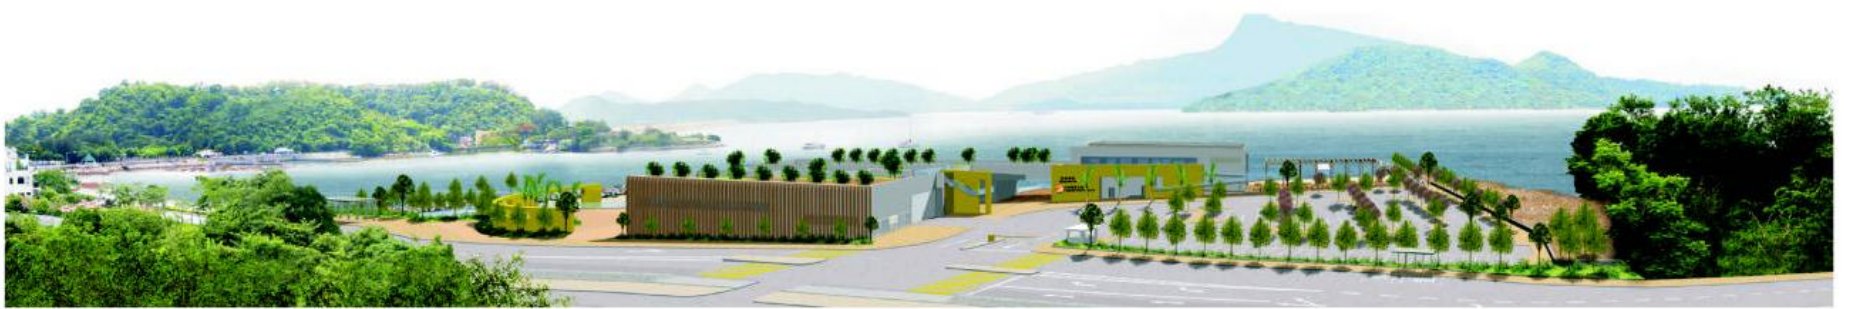
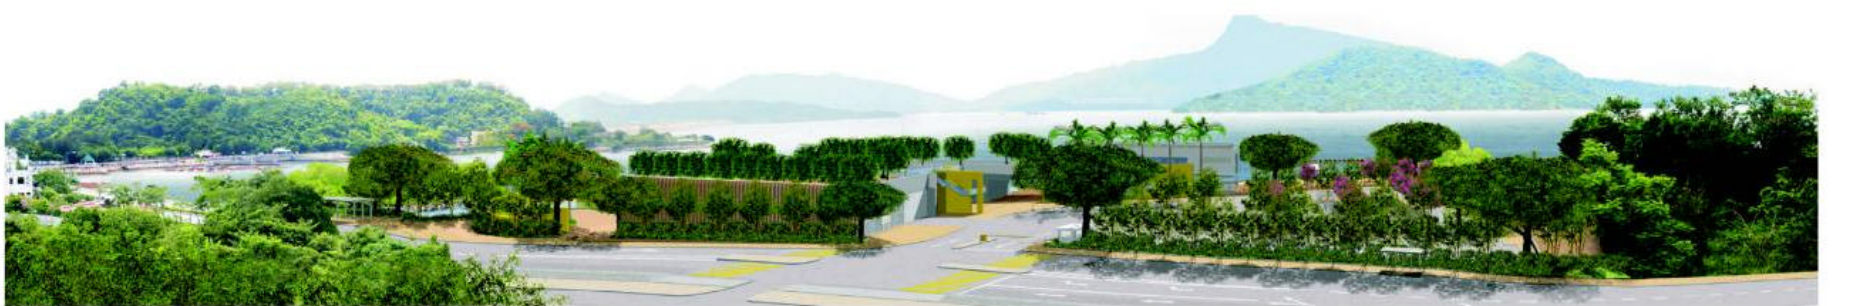
**FIGURE 10.34  
PHOTOMONTAGE  
VISUALLY SENSITIVE  
RECEIVER 4  
VIEW FROM  
LO TSZ TIN RESIDENTS**

The photomontage shown in *Figure 10.34* illustrates that the Proposed Beach Development will dominate the view from this viewpoint. This represents a worst-case scenario for these VSRs.

**EXISTING VIEW LOOKING TOWARDS THE DEVELOPMENT FROM LO TSZ TIN RESIDENTS.**

**VIEW DISPLAYING THE 3D MODEL OF THE PROPOSED DEVELOPMENT DAY 1 OPERATION NO MITIGATION**

**VIEW DISPLAYING THE 3D MODEL OF THE PROPOSED DEVELOPMENT DAY 1 OPERATION WITH MITIGATION**

**VIEW DISPLAYING THE 3D MODEL OF THE PROPOSED DEVELOPMENT YEAR 10 OPERATION WITH MITIGATION**
