Appendix 11.1
Marine Archaeological Investigation

**MARINE ARCHAEOLOGICAL INVESTIGATION FOR
WANCHAI DEVELOPMENT PHASE II
PLANNING AND ENGINEERING REVIEW**

FEBRUARY 2007

JOB NUMBER HKSDA00607

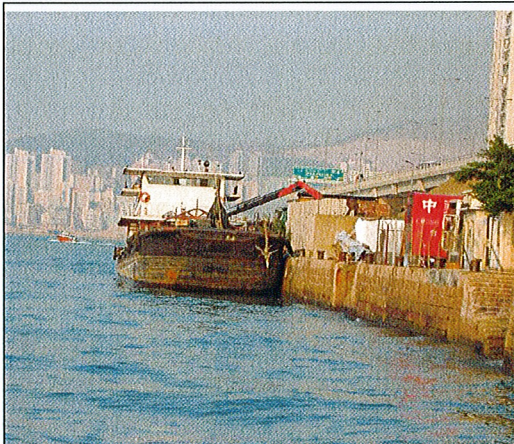
Figure 3: There were a number of vessels performing loading tasks during the surveying period. The survey lines were blocked by these vessels. They survey boat returned to the area once they had been moved.

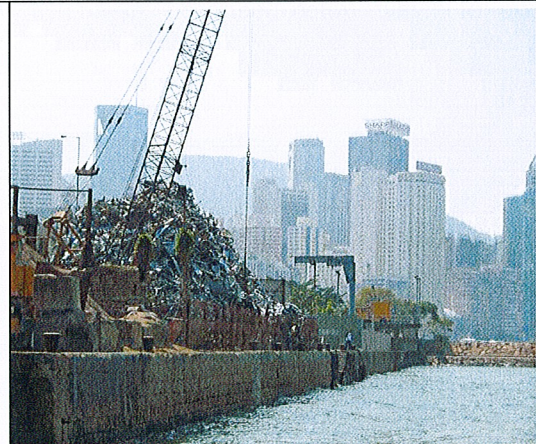
Figure 4: The surveying area was close to the mound of waste metals that could be the source of scattered debris found on the seabed.

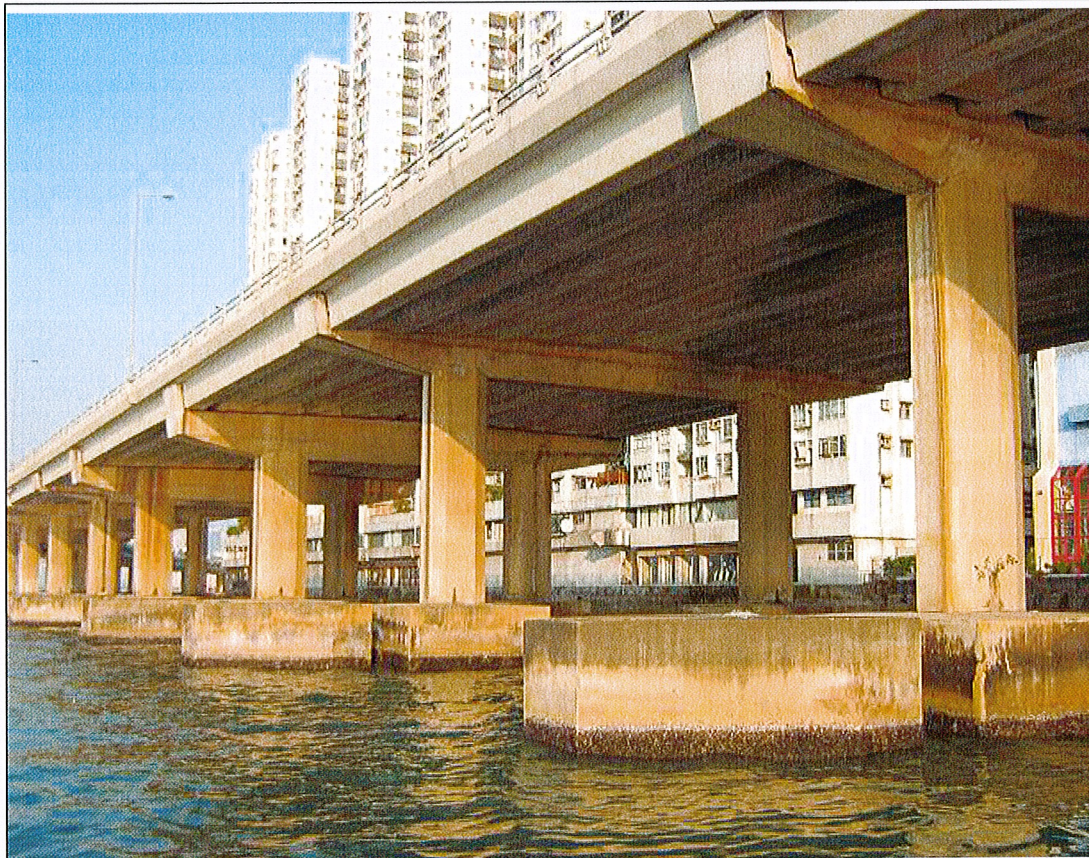
Figure 5: The survey area under the Island Eastern Corridor Bridge was not suitable for survey as the surveying vessel could not get in safely and the positioning system would be interfered with.

The survey area in the North Point end was under the Island Eastern Corridor Bridge and the surveying vessel was unable to get in safely. Moreover, the reception of the positioning data was restricted under the bridge and so no survey lines were run under the bridge. It is assumed that the seabed in the immediate vicinity of the bridge would have been extensively disturbed during construction of the bridge.

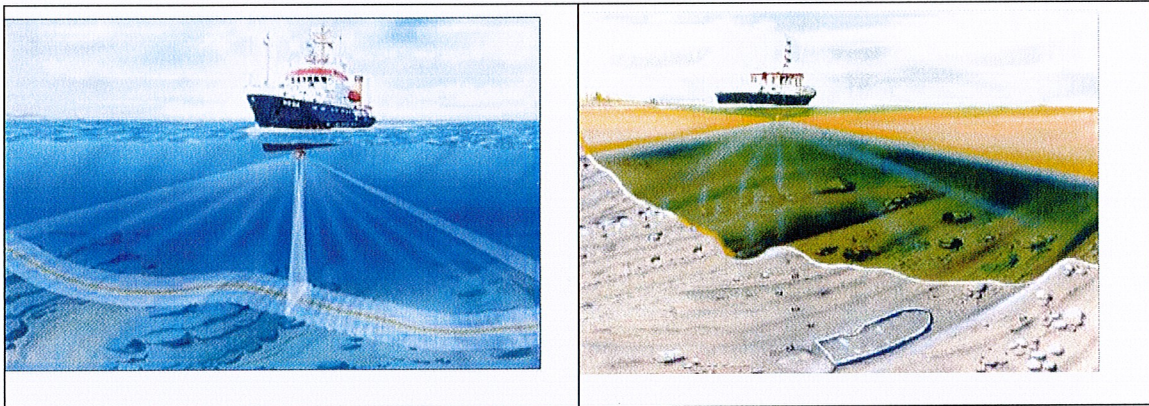
Figure 6: Illustrations of swath bathymetry systems

In the case of the Seabat 8125 system used in this survey, the fan subtends an angle of up to 120° at the survey vessel; the consequence is that water column thickness/sea bed level data is obtained over a swath centred on the vessel track and having a width of some 4 times the water depth. In this area, the data density is about one sounding in every square of side 0.2m to 0.5m, depending on vessel speed.

The accuracy of soundings decreases with increasing distance from the vessel track. Depth accuracy requirements have shown that selection of data within a 120° fan will generate soundings within the accuracy required for this survey, giving a swath width around 4 times the water depth.

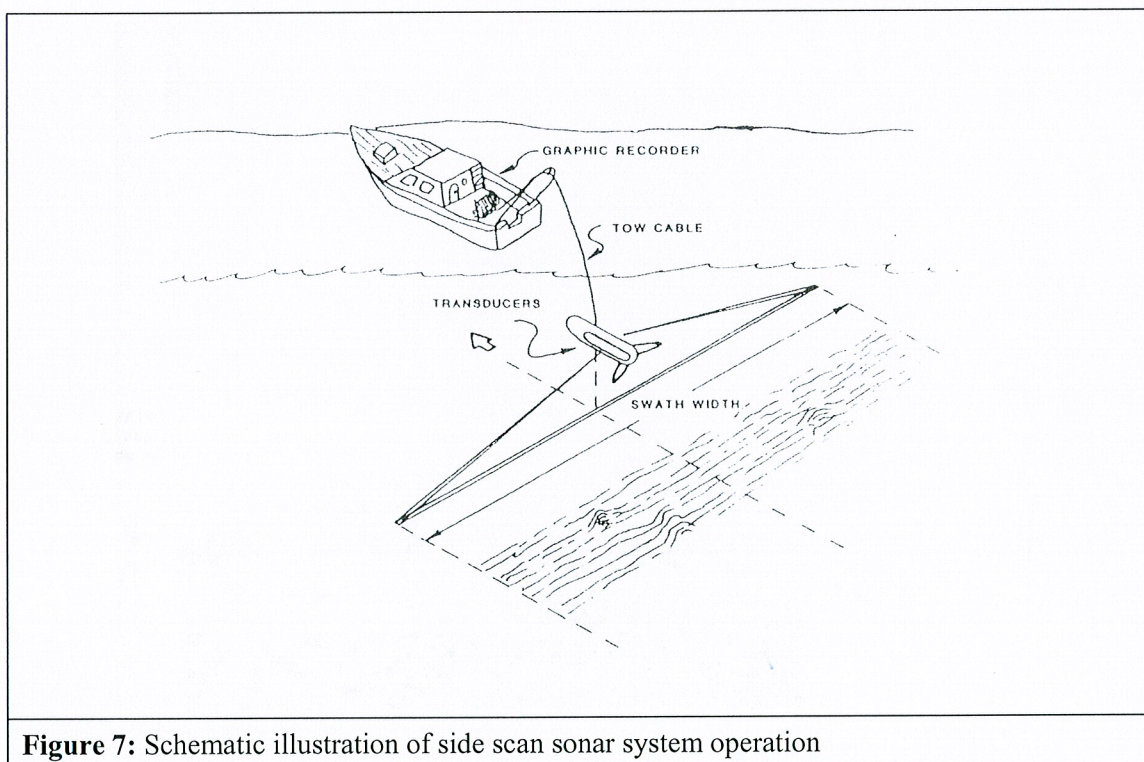
The side scan sonar tow fish was towed from the stern of the survey vessel, at a depth of between 3m beneath the sea surface, depending on the water depth. As it travelled along a survey line, the transducers emitted sound pulses to either side and measured the echoes from features on the seabed. The arrangement is illustrated in Figure 7:

Figure 7: Schematic illustration of side scan sonar system operation

- Vessel Speed: 1.4 – 2.0 m/sec
- Fix Interval: 10 seconds
- Tow fish depth: 3m beneath sea surface
- Source frequency: 100 and 500 kHz
- Gain setting: Manually controlled

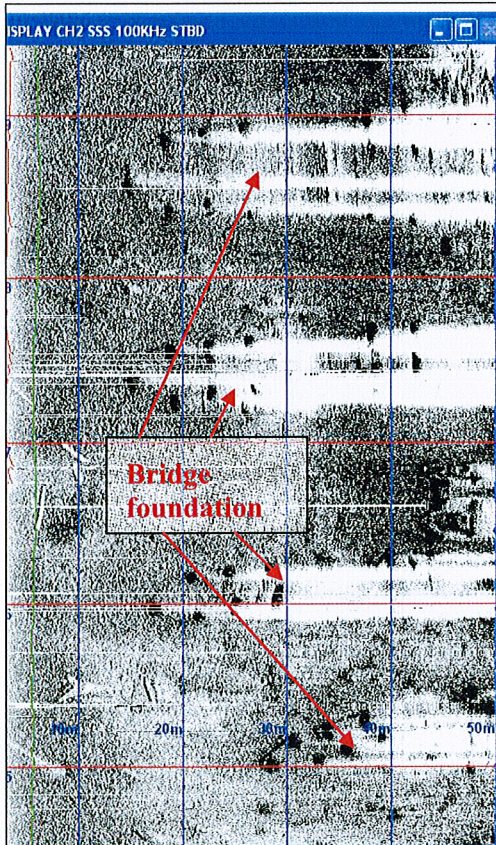
Figure 8: The above image shows the Bridge Foundation of the Island Eastern Corridor and the condition was not favourable for surveying by the vessel.

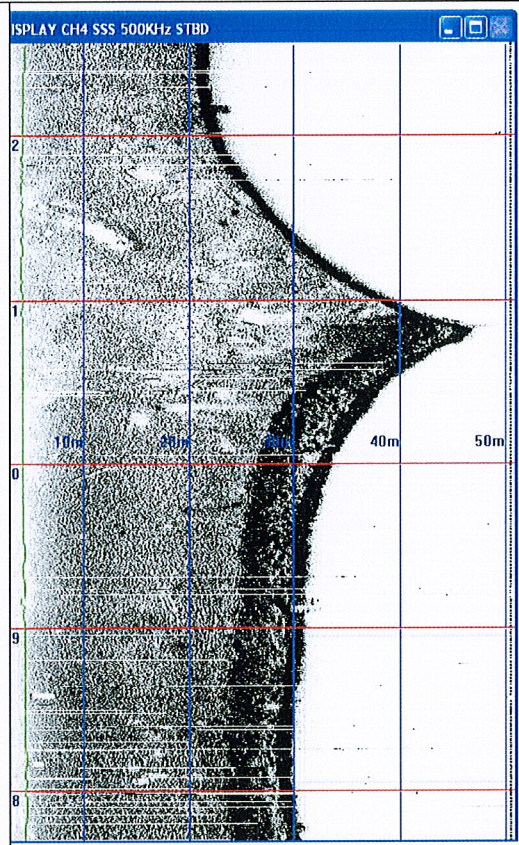
Figure 9: The vessel turned at a right angle from the rubble mount seawall of the typhoon shelter to the vertical seawall of the Watson's Pier.

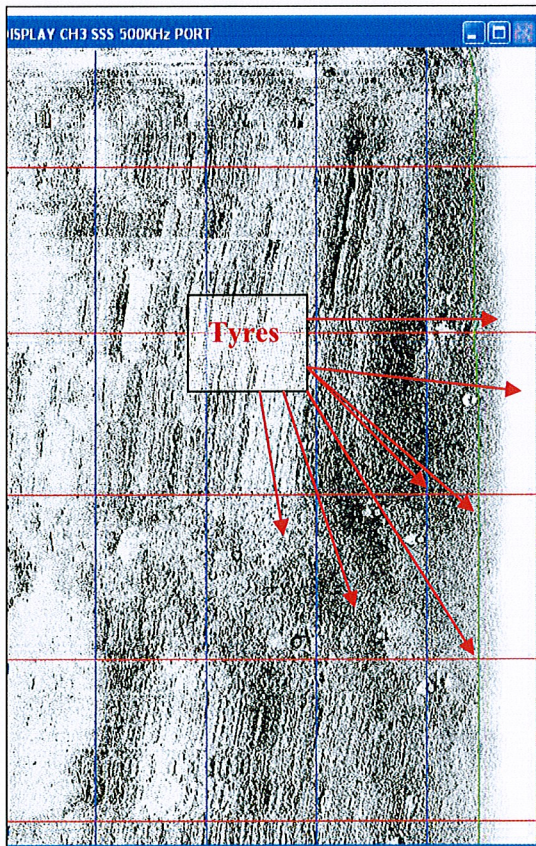
Figure 10: A lot of abandoned tyres were found from the side scan images.

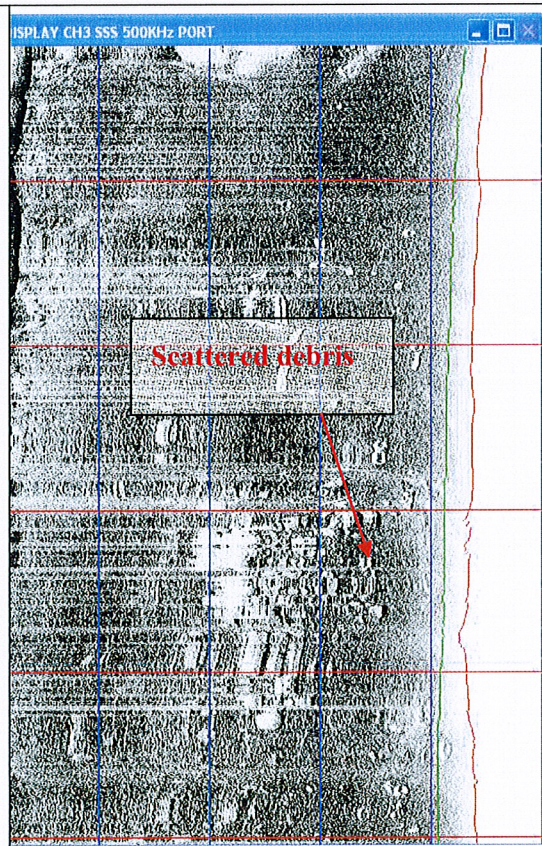
Figure 11: Several lumps of scattered debris, probably dumped building materials were found along the seawall.

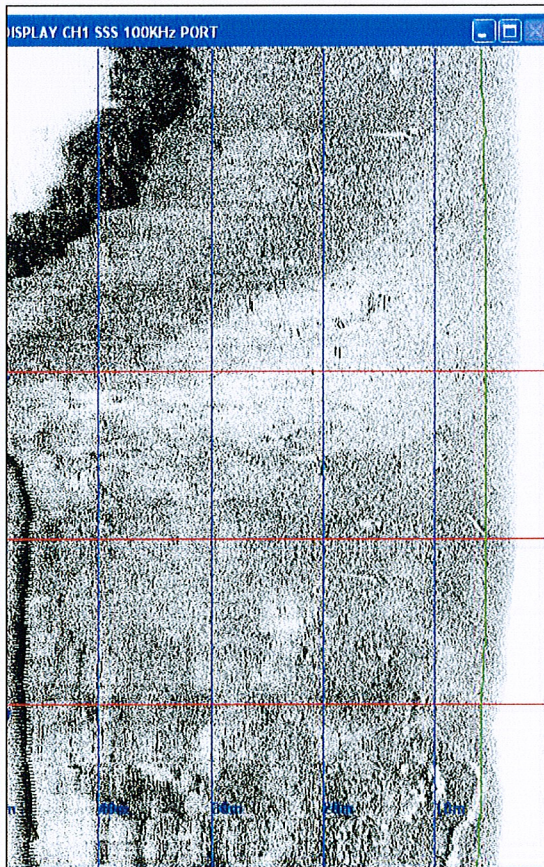
Figure 12: A linear feature found in side scan image but not found in swath. The surrounding seabed is low reflectivity.

- High reflectivity zones caused by coarser sediments (Figure 8)
- Low reflectivity zones caused by finer sediments (Figure 12)
- Numerous scars (Figure 13)
- Scattered debris (Figure 11)
- Disturbed seabed (Figure 8)
- Abandoned tyres (Figure 10)
- Sonar contacts including unknown objects and linear features (Figures 12 & 13)

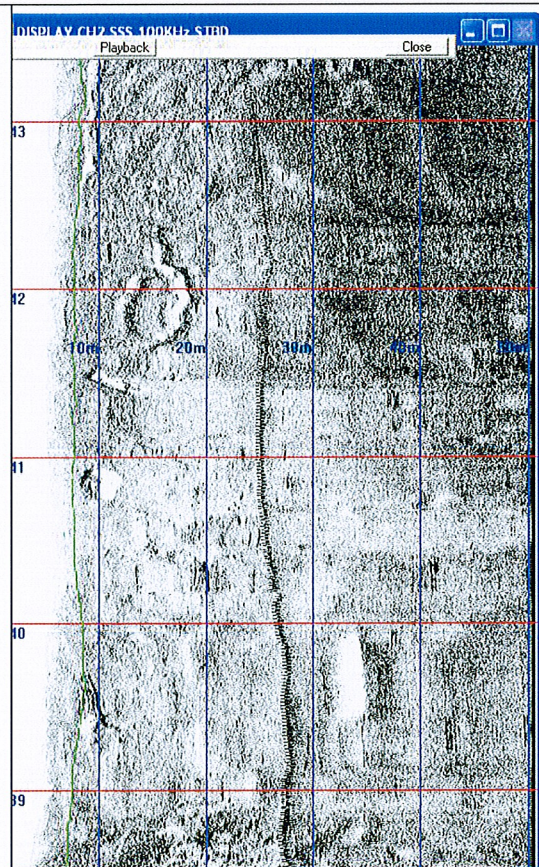
Figure 13: The same linear feature found in side scan image but not found in swath.

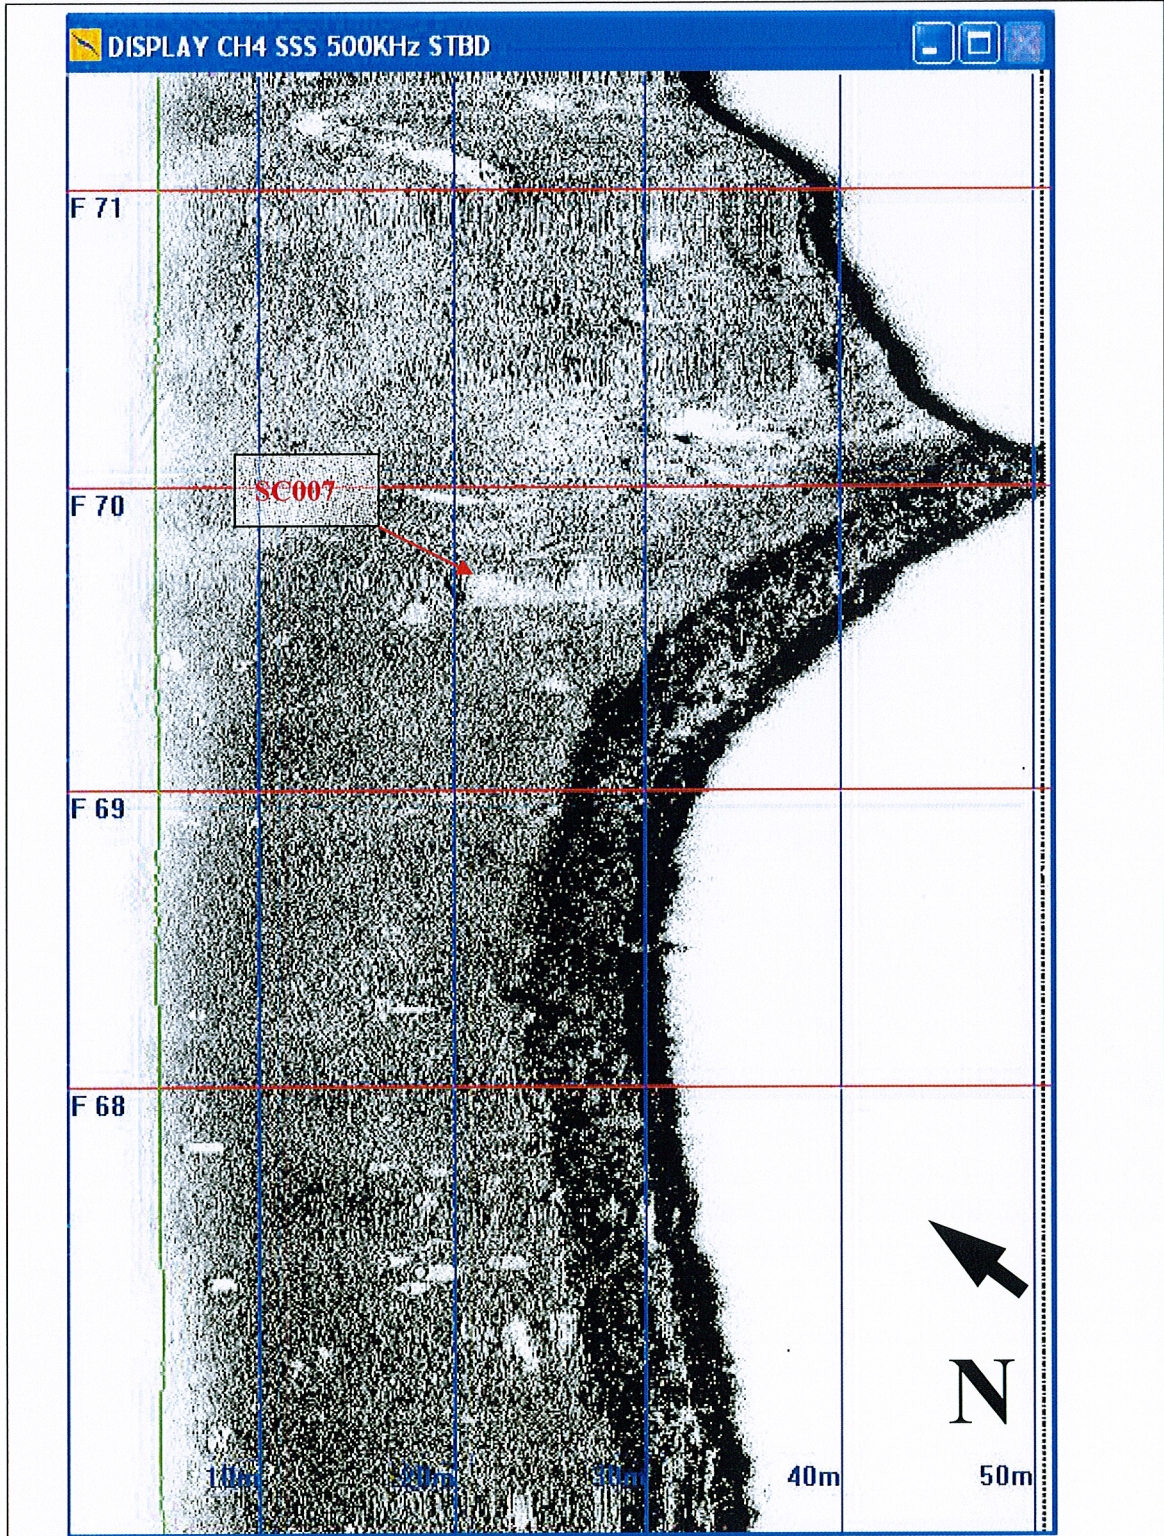
Appendix F, SC007

Multi-beam images are not available for SC007 as it is very close to the rubble mound seawall which causes interference with the equipment.
