Wan Chai Development Phase II

FIELD TRIALS OF GEOSYNTHETIC CONTAINERS ACE REPORT

Revised: October 2003

MAUNSELL CONSULTANTS ASIA LTD

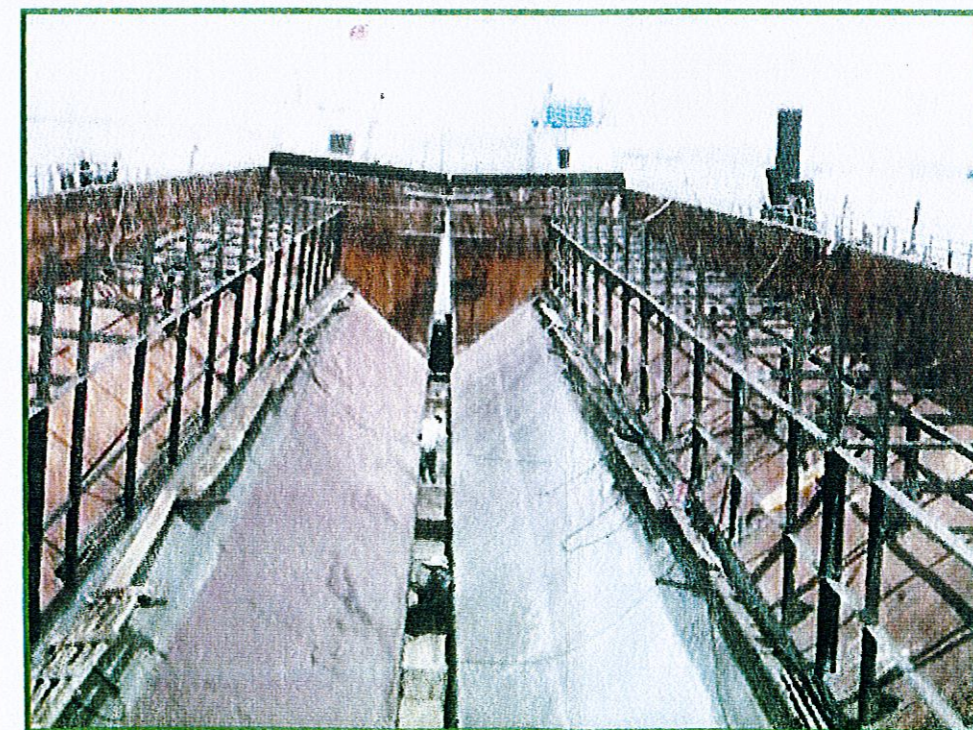
Installation of longitudinal bulkhead to the split bottom hopper barge

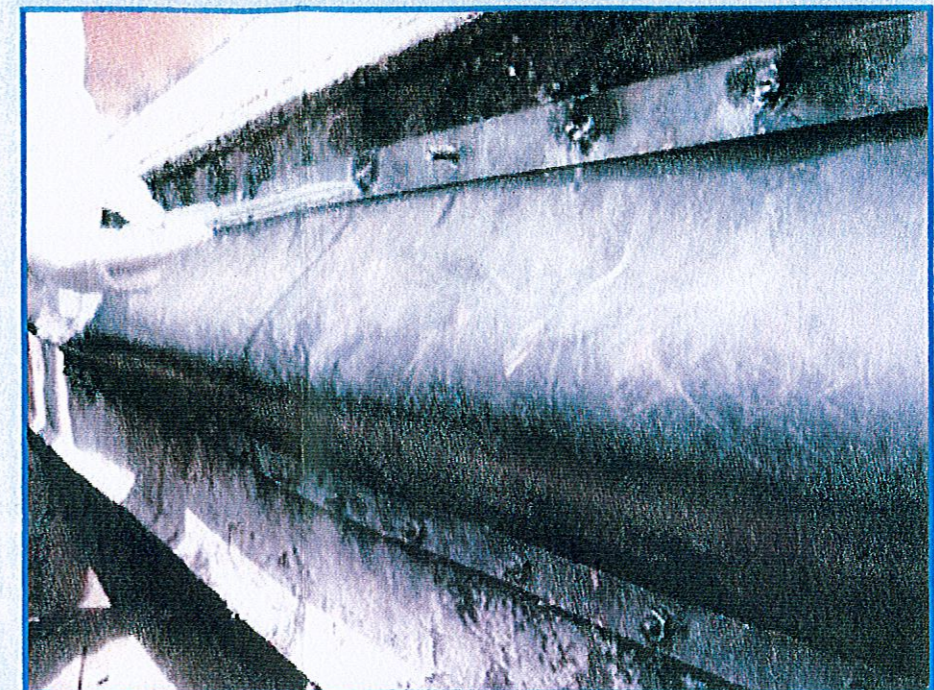
Rubber gaskets installed over the steel angles for the first field trial for Container A

- 5.2.4 The rubber gaskets installed for the first trial (Container A) were found on inspection to be damaged and, in places, displaced after the disposal operation. With the assessment of container performance indicating the hopper gate with the steel 'teeth' as being one of the primary causes of failure of the container, the remedial action was to further modify the hopper gate. Details of the modification work have been explained in Section 3.3.
- 5.2.5 For all subsequent container trials (ie Containers B to E), the modified hopper barge with the steel 'teeth' removed and smooth steel plates welded over the hopper opening to provide a completely smooth surface, was used.

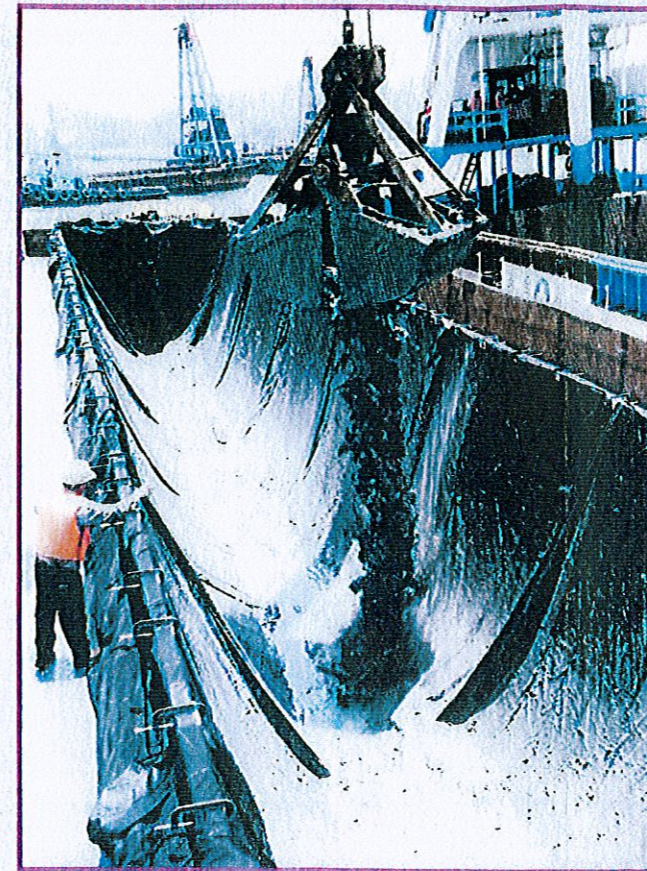
Filling of container with marine sediments by a grab hoisted by the derrick lighter

- 4.5.2 Care was needed during the filling process to avoid damage to the container. The sediments needed to be released from the grab from above the hopper coaming level to avoid possible damage due to the grab hitting the sides of the container; the release was carefully controlled to minimise impact loading on the container, especially when placing the first layers in the bottom of the container. Filling was carried out in even layers along the length of the container.

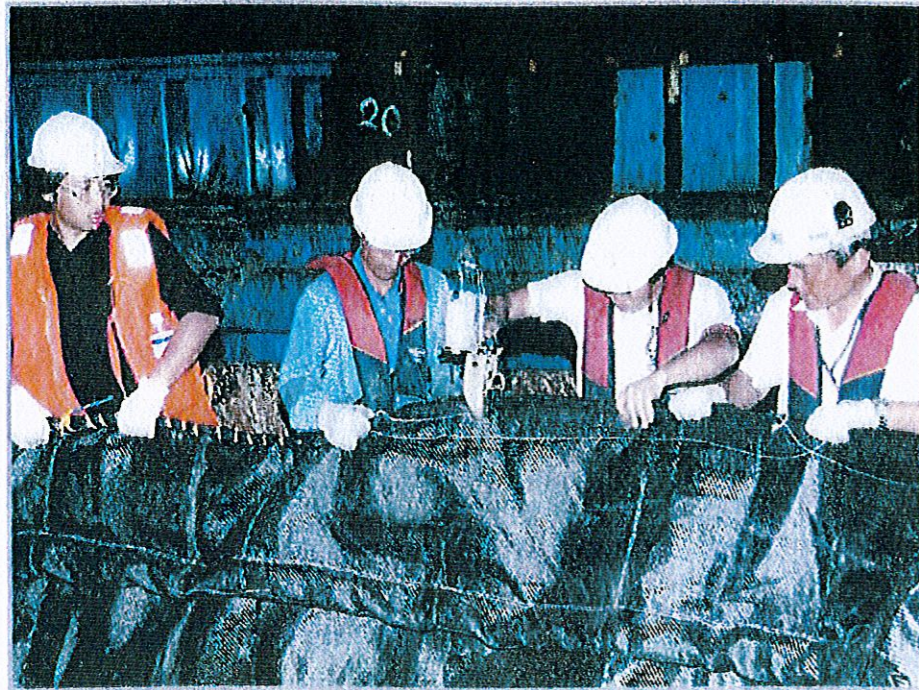
Sealing the container by sewing machine (Container A only)

4.6.2 At the commencement of the trials, in-situ stitching was proposed using a hand-held sewing machine. However, when closing Container A (the first container), problems were encountered at the fabric joints (seams), which were too thick and caused the portable sewing machine to jam. Container A was therefore closed by a combination of sewing machine stitching and hand stitching over the seams. For the remaining Containers B, C, D and E, use of the portable sewing machine was abandoned and the in-situ closing of the containers was done solely by hand stitching.

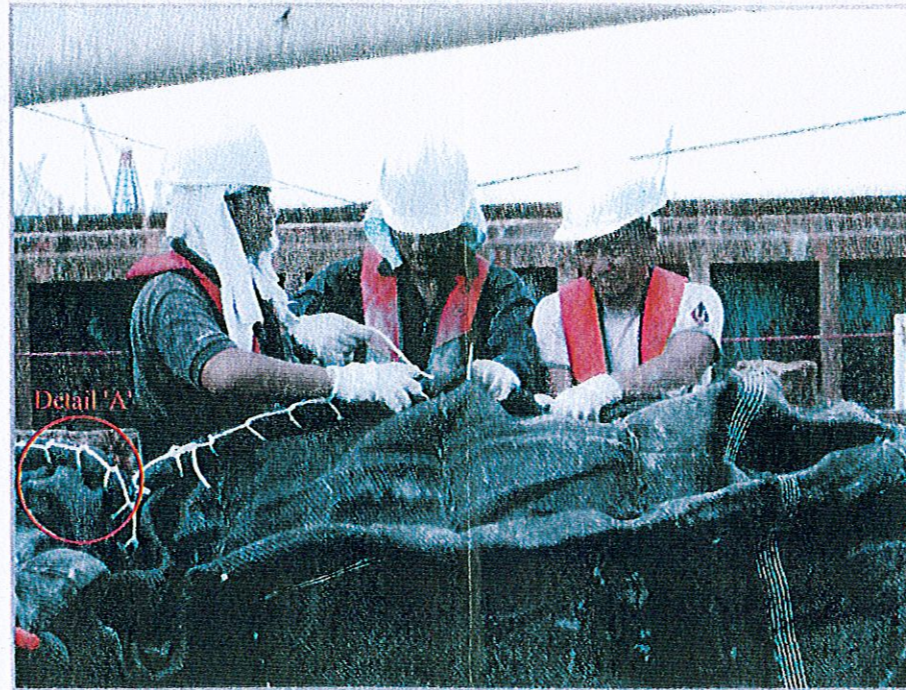
Sealing the container by hand stitching

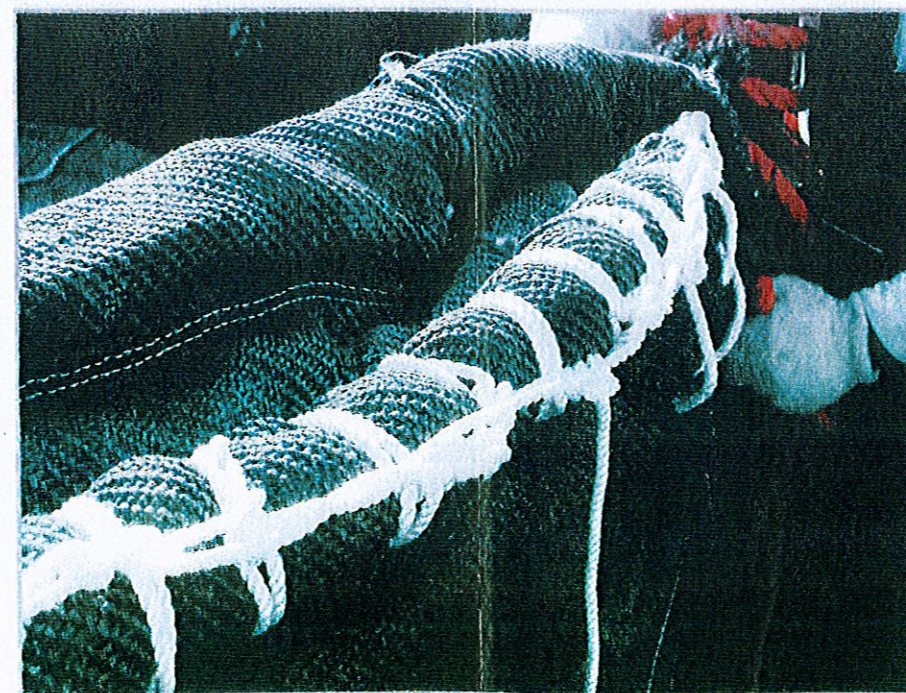
Detail 'B' – Hand stitches at the two ends of the container

- 5.6.6 Remedial actions for the subsequent field trials included the addition of closely packed hand stitches and rope knots at the two ends to ensure that any possible minor openings were closed.
- 5.6.7 To overcome the problem of the pressure bubble, the sides of the geosynthetic container were drawn up in the hopper when it was being placed, to provide a larger void at the top of container in order to better absorb any pressure build up. This resulted in less loose material at the bottom of the hopper, which in turn resulted in the container being held up in the hopper slightly longer when the hopper was opened, as there was less material to drop through the gate initially to pull the container through (refer to Section 4.4). However, this consequence was considered a benefit in itself, as it enabled the hopper to be opened wider before the container fell through.

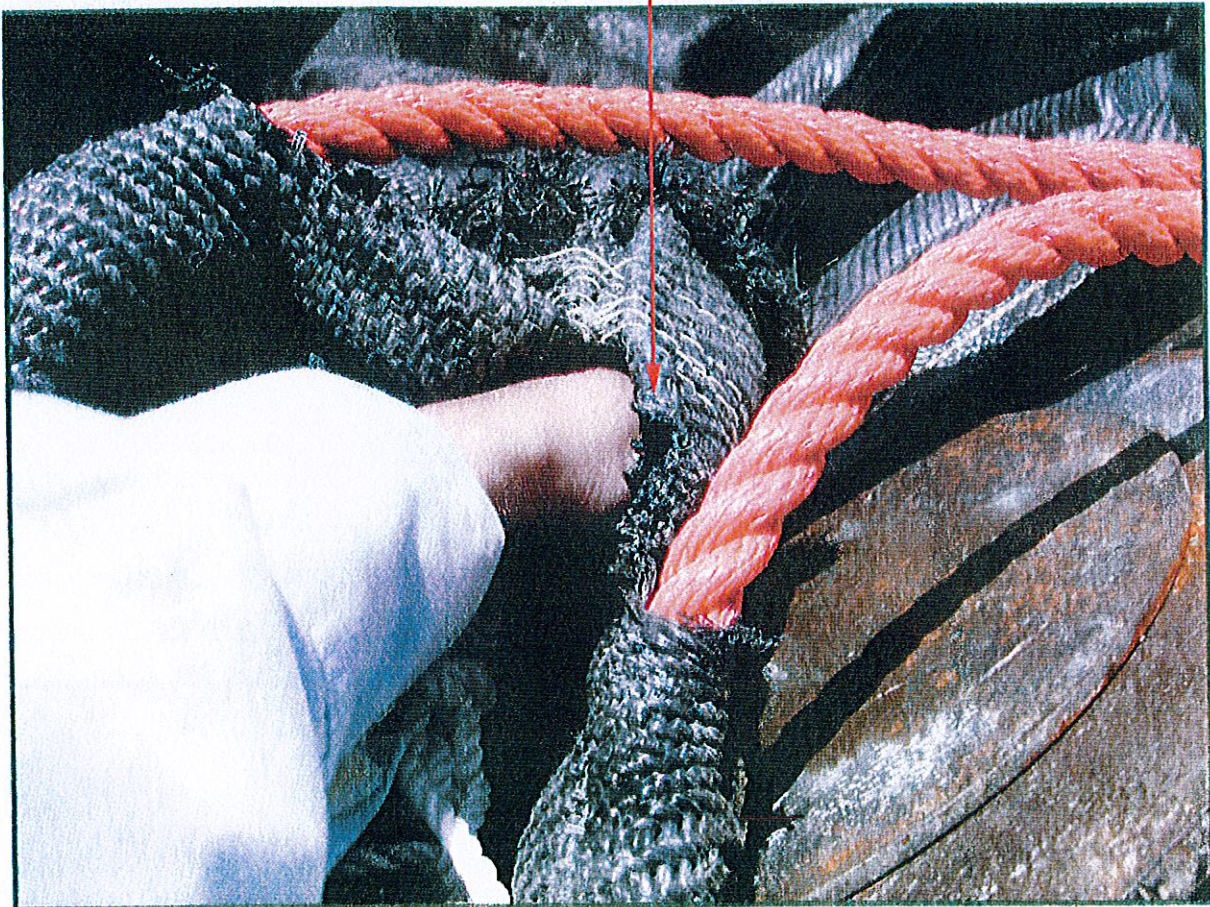
Air bubble

Minor (and unnoticed) gap could have been left in the end closure
