<b>Project:</b> Proposed Development at Fung Lok Wai	<b>Location:</b> Shing Uk Tsuen	<b>Ref #</b> FLW-01
<b>Originally Recorded:</b> 06/02/2001	<b>Updated On:</b> 24/04/2007	
<b>Original Usage:</b> Tsz Tong (Kwing Ling Tong)	<b>Current Usage:</b> Tsz Tong (Kwing Ling Tong)	
<b>Orientation:</b> Southwest	<b>Map Reference:</b> N/A	
<b>Construction Date:</b> 1971	<b>Ownership:</b> Private	
<b>Setting:</b> At the front of the village	<b>Historical Associations:</b> None	
<b>Condition:</b> Good	<b>Degree of Modification:</b> Modern structure	
<b>Architectural Significance:</b> Low	<b>Cultural Significance:</b> High	
<b>Description:</b> Concrete two storey structure with single storey annex room on the left side. Flat roof. Building is painted yellow with grey trim at the base. Balcony across the façade of the first floor.		
<b>Inscriptions:</b> 廣陵堂		
<b>Additional Notes:</b> None

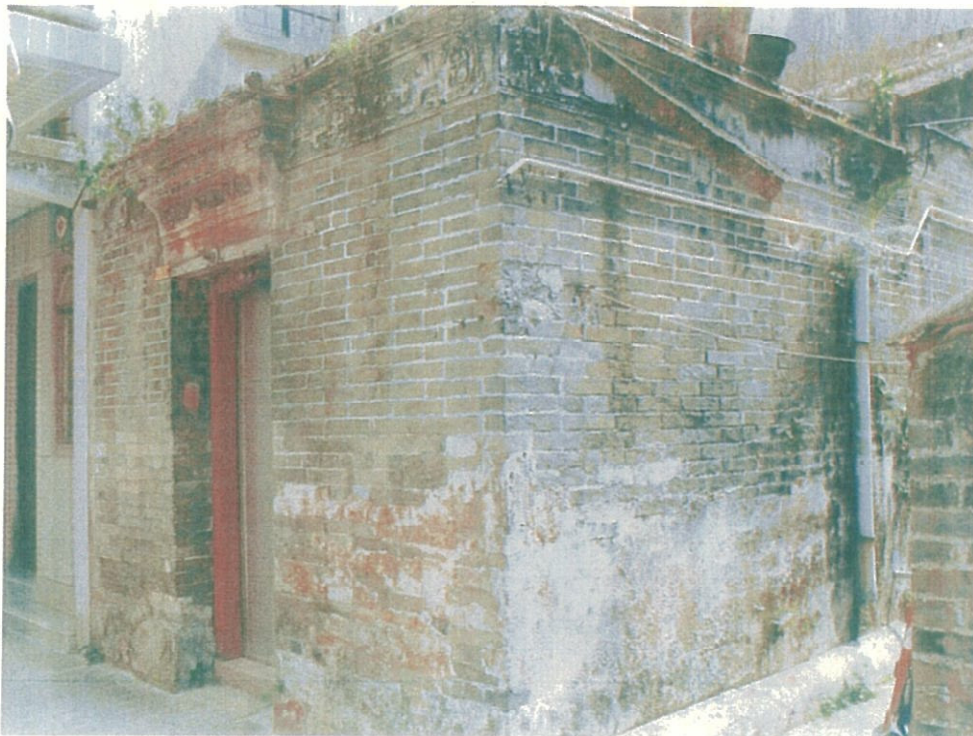
<b>Project:</b> Proposed Development at Fung Lok Wai	<b>Location:</b> Shing Uk Tsuen	<b>Ref #</b> FLW-03
<b>Originally Recorded:</b> 06/02/2001	<b>Updated On:</b> 24/04/2007	
<b>Original Usage:</b> Residential	<b>Current Usage:</b> Closed up	
<b>Orientation:</b> South	<b>Map Reference:</b> N/A	
<b>Construction Date:</b> Pre 1950	<b>Ownership:</b> Private	
<b>Setting:</b> Northern end of second terrace row	<b>Historical Associations:</b> None	
<b>Condition:</b> Poor	<b>Degree of Modification:</b> Low	
<b>Architectural Significance:</b> Moderate	<b>Cultural Significance:</b> Low	
<b>Description:</b> End unit green brick courtyard terrace. Flat roof on the front and pitched tile roof on the main section. Decorative door hood with moulded frieze panel on the façade. Modern wooden door in wooden frame		
<b>Inscriptions:</b> None		
<b>Additional Notes:</b> None

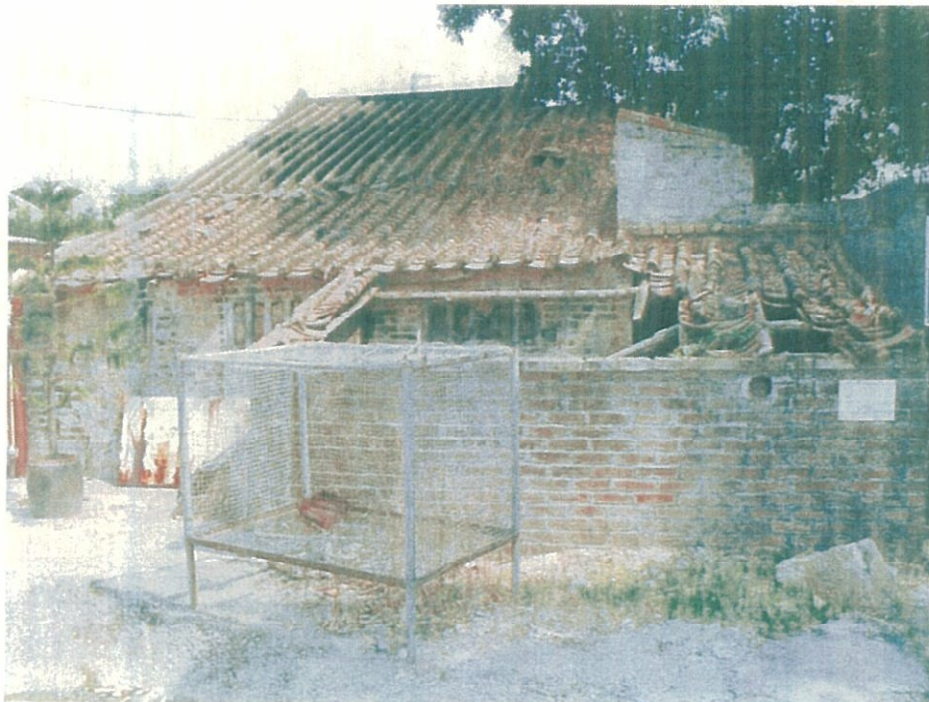
<b>Project: Proposed Development at Fung Lok Wai</b>	<b>Location: Shing Uk Tsuen</b>	<b>Ref# FLW-04</b>
<b>Originally Recorded: 06/02/2001</b>	<b>Updated On: 24/04/2007</b>	
<b>Original Usage: Residential</b>	<b>Current Usage: Abandoned</b>	
<b>Orientation: South</b>	<b>Map Reference: N/A</b>	
<b>Construction Date: Pre 1950</b>	<b>Ownership: Private</b>	
<b>Setting: Just outside the entrance to the village</b>	<b>Historical Associations: None</b>	
<b>Condition: Ruin</b>	<b>Degree of Modification:</b>	
<b>Architectural Significance: Low</b>	<b>Cultural Significance: Low</b>	
<b>Description: Ruins of a green brick building in several sections</b>		
<b>Inscriptions: None</b>		
<b>Additional Notes: None</b>

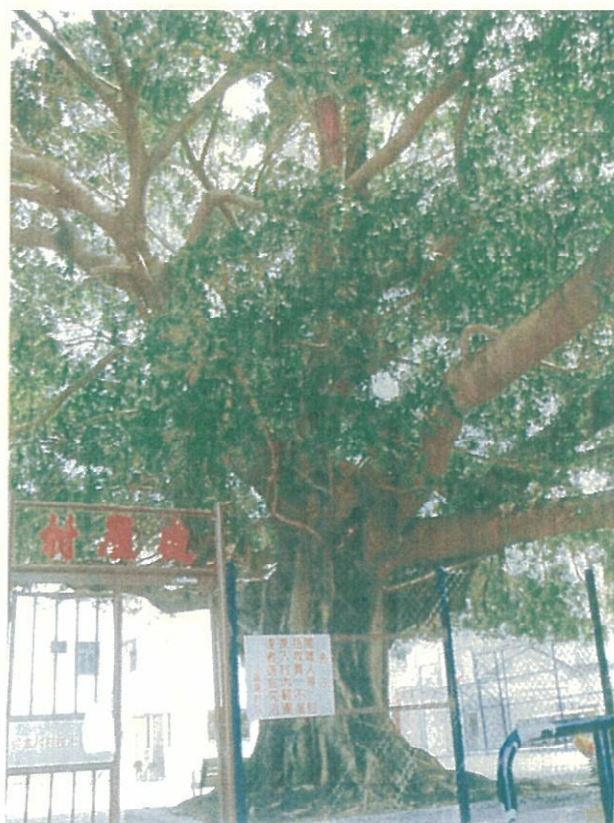
<b>Project:</b> Proposed Development at Fung Lok Wai	<b>Location:</b> Shing Uk Tsuen	<b>Ref #</b> FLW-05
<b>Originally Recorded:</b> 06/02/2001	<b>Updated On:</b> 24/04/2007	
<b>Original Usage:</b> Fung Shui Tree Shrine	<b>Current Usage:</b> Fung Shui Tree Shrine	
<b>Orientation:</b> Southwest	<b>Map Reference:</b> N/A	
<b>Construction Date:</b> N/A	<b>Ownership:</b> Private	
<b>Setting:</b> At the entrance to the village	<b>Historical Associations:</b> None	
<b>Condition:</b> N/A	<b>Degree of Modification:</b>	
<b>Architectural Significance:</b> N/A	<b>Cultural Significance:</b> High	
<b>Description:</b> A large Banyan Tree		
<b>Inscriptions:</b> None		
<b>Additional Notes:</b> None

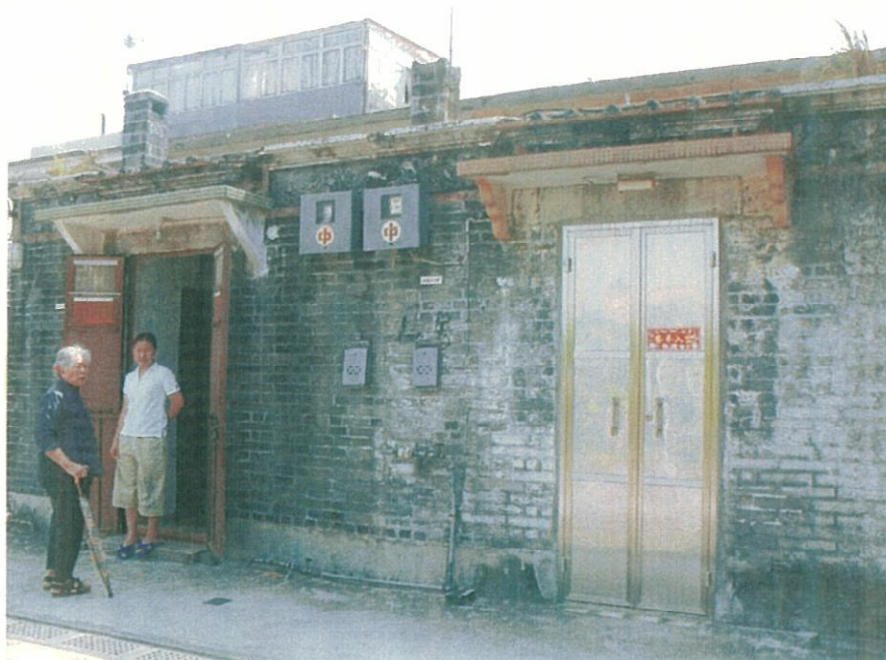
<b>Project:</b> Proposed Development at Fung Lok Wai	<b>Location:</b> Shing Uk Tsuen	<b>Ref #</b> FLW-07
<b>Originally Recorded:</b> 06/02/2001	<b>Updated On:</b> 24/04/2007	
<b>Original Usage:</b> Residential	<b>Current Usage:</b> see additional notes	
<b>Orientation:</b> Southwest	<b>Map Reference:</b> #3 and 4	
<b>Construction Date:</b> Pre 1950	<b>Ownership:</b> Private	
<b>Setting:</b> In the front row of the village	<b>Historical Associations:</b> None	
<b>Condition:</b> Good	<b>Degree of Modification:</b> Moderate	
<b>Architectural Significance:</b> Low	<b>Cultural Significance:</b> Moderate	
<b>Description:</b> Two green brick courtyard style units. Flat roof over the whole building. Modern doors and entranceways. Decorative moulding under the eaves of the façade with traces of paint. All windows are modern.		
<b>Inscriptions:</b> None		
<b>Additional Notes:</b> Building has been demolished as of the 2007 survey

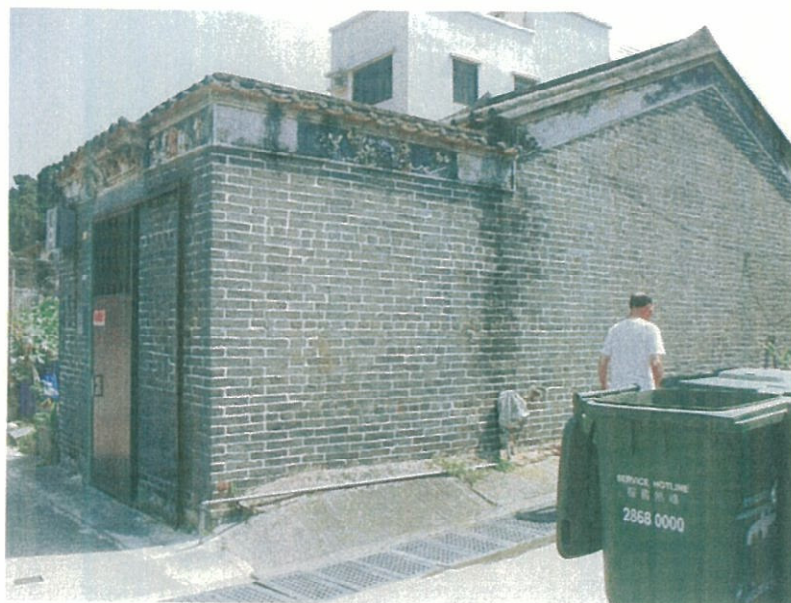
<b>Project: Proposed Development at Fung Lok Wai</b>	<b>Location: Shing Uk Tsuen</b>	<b>Ref # FLW-08</b>
<b>Originally Recorded: 06/02/2001</b>	<b>Updated On: 24/04/2007</b>	
<b>Original Usage: Residential</b>	<b>Current Usage: Closed up</b>	
<b>Orientation: Southwest</b>	<b>Map Reference: #2</b>	
<b>Construction Date: Pre 1950</b>	<b>Ownership: Private</b>	
<b>Setting: In the front terrace row of the village near the southern end.</b>	<b>Historical Associations: None</b>	
<b>Condition: Good</b>	<b>Degree of Modification: Low</b>	
<b>Architectural Significance: Moderate</b>	<b>Cultural Significance: Low</b>	
<b>Description: Green brick courtyard terrace style unit with flat front roof and pitched tile main roof with plain ridge. Decorative door hood and frieze panels across the façade and sides of the building. Concave moulding on the rear of the building under the eaves. Modern metal door/ gate in modern frame.</b>

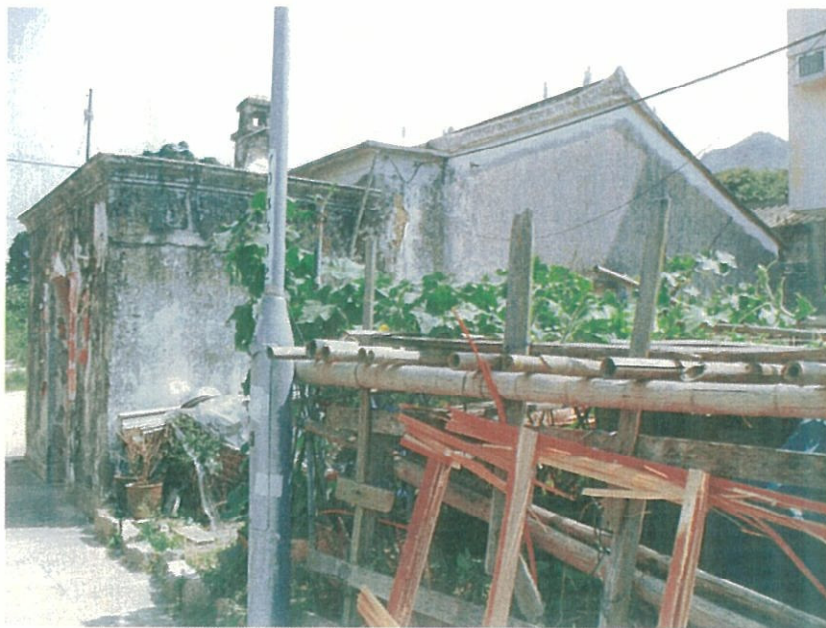
<b>Project:</b> Proposed Development at Fung Lok Wai	<b>Location:</b> Shing Uk Tsuen	<b>Ref #</b> FLW-09
<b>Originally Recorded:</b> 06/02/2001	<b>Updated On:</b> 24/04/2007	
<b>Original Usage:</b> Residential	<b>Current Usage:</b> Closed up	
<b>Orientation:</b> Southwest	<b>Map Reference:</b> #1	
<b>Construction Date:</b> Pre 1950	<b>Ownership:</b> Private	
<b>Setting:</b> At the front southeastern corner of the village	<b>Historical Associations:</b> None	
<b>Condition:</b> Poor	<b>Degree of Modification:</b> Low	
<b>Architectural Significance:</b> Low	<b>Cultural Significance:</b> Low	
<b>Description:</b> Courtyard terrace style unit, pounded earth walls with render covering. Flat front roof and pitched tile main roof with plain ridge. Wooden door in modern frame. Plain frieze panels on the building with concave moulding on the rear of the building. Windows in metal frames have been added to the side and rear of the building.

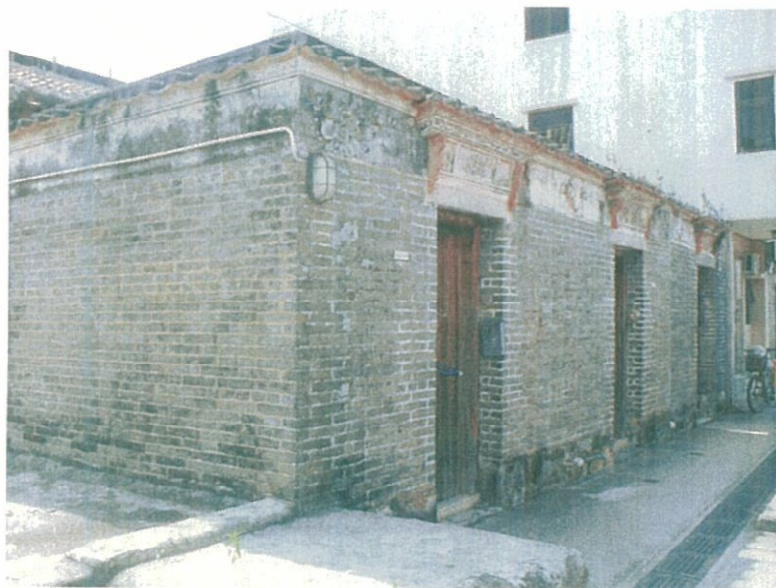
<b>Project: Proposed Development at Fung Lok Wai</b>	<b>Location: Shing Uk Tsuen</b>	<b>Ref # FLW-10</b>
<b>Originally Recorded: 06/02/2001</b>	<b>Updated On: 24/04/2007</b>	
<b>Original Usage: Residential</b>	<b>Current Usage: Closed up</b>	
<b>Orientation: Southwest</b>	<b>Map Reference: #26, 27 and 28</b>	
<b>Construction Date: Pre 1950</b>	<b>Ownership: Private</b>	
<b>Setting: At the southeastern corner of the village</b>	<b>Historical Associations: None</b>	
<b>Condition: #26 (ruin) #27 and 28 (poor)</b>	<b>Degree of Modification: Low</b>	
<b>Architectural Significance: Moderate</b>	<b>Cultural Significance: Low</b>	
<b>Description: Green brick courtyard terrace structures with flat front roofs and pitched main tile roof with plain ridge. All have double panel wooden doors with cut granite lintels and threshold stones. Each unit has a decorative door hood. Windows have been added to the rear of the building. Concave moulding under the eaves on the rear of the building.</b>

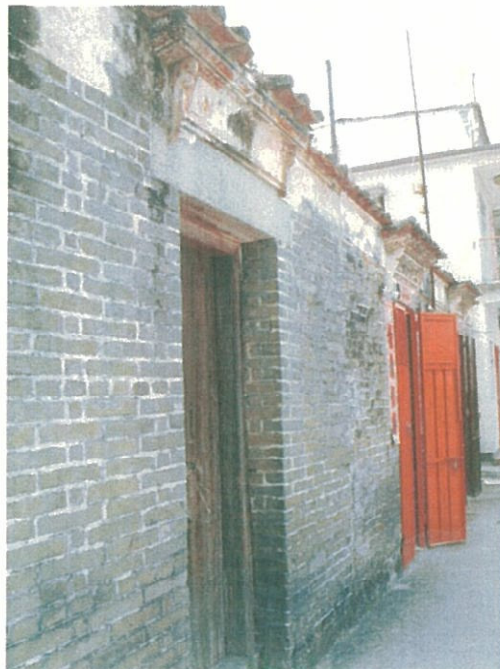
<b>Project:</b> Proposed Development at Fung Lok Wai	<b>Location:</b> Shing Uk Tsuen	<b>Ref #</b> FLW-11
<b>Originally Recorded:</b> 06/02/2001	<b>Updated On:</b> 24/04/2007	
<b>Original Usage:</b> Residential	<b>Current Usage:</b> Closed up/ but may be occupied	
<b>Orientation:</b> Southwest	<b>Map Reference:</b> #23, 24 and 25	
<b>Construction Date:</b> Pre 1950	<b>Ownership:</b> Private	
<b>Setting:</b> Second terrace row at southeastern corner of the village	<b>Historical Associations:</b> None	
<b>Condition:</b> Poor	<b>Degree of Modification:</b> Low	
<b>Architectural Significance:</b> Moderate	<b>Cultural Significance:</b> Moderate	
<b>Description:</b> Three green brick courtyard style units, two mid and one end. Flat front roofs with pitched tile main roof with plain ridge. Decorative door hoods on all units with decorated frieze panel across the façade. Double panel wooden doors with cut granite threshold stones and lintels.

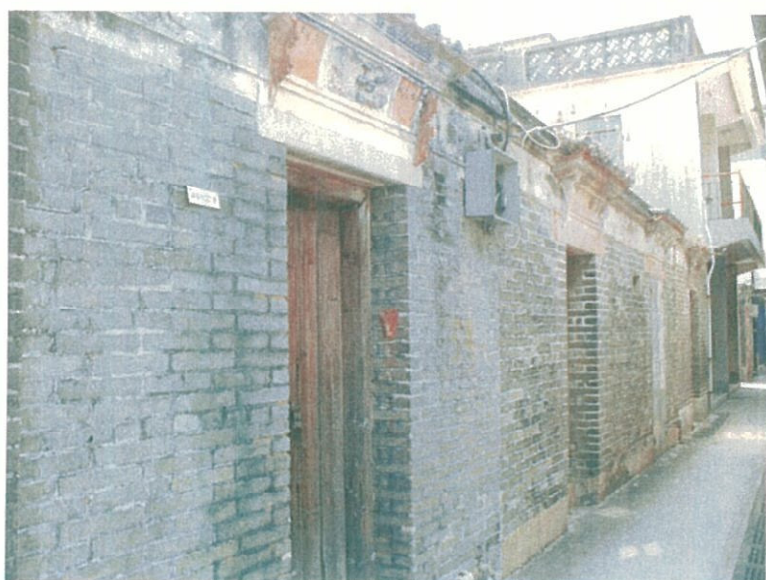
<b>Project: Proposed Development at Fung Lok Wai</b>	<b>Location: Shing Uk Tsuen</b>	<b>Ref # FLW-12</b>
<b>Originally Recorded: 06/02/2001</b>	<b>Updated On: 24/04/2007</b>	
<b>Original Usage: Residential</b>	<b>Current Usage: Closed up</b>	
<b>Orientation: Southwest</b>	<b>Map Reference: #19, 19A, 20</b>	
<b>Construction Date: Pre 1950</b>	<b>Ownership: Private</b>	
<b>Setting: Middle section of the village</b>	<b>Historical Associations: None</b>	
<b>Condition: Poor</b>	<b>Degree of Modification: Low</b>	
<b>Architectural Significance: Moderate</b>	<b>Cultural Significance: Low</b>	
<p><b>Description: Four green brick courtyard terrace style units with flat front roofs on three units and collapsed slanted roof on one and pitched tile main roofs. Double panel wooden doors with cut granite lintels and threshold stones. Course of cut granite along the bottom of the structure. Each unit has a decorative door hood and there are decorated frieze panels across the façade.</b></p>

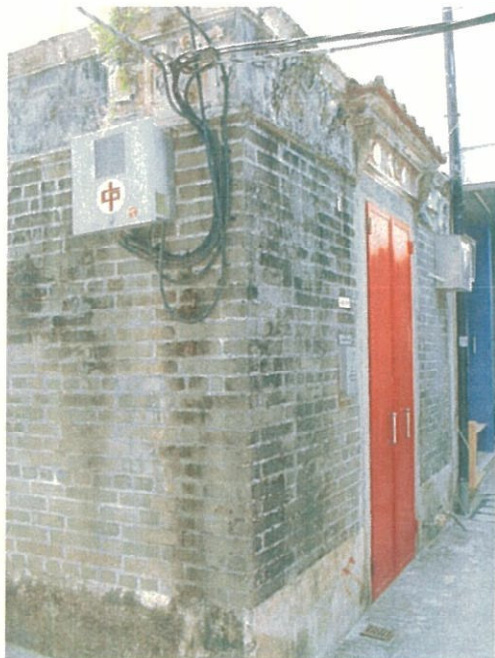
<b>Project:</b> Proposed Development at Fung Lok Wai	<b>Location:</b> Shing Uk Tsuen	<b>Ref #</b> FLW-13
<b>Originally Recorded:</b> 06/02/2001	<b>Updated On:</b> 24/04/2007	
<b>Original Usage:</b> Residential	<b>Current Usage:</b> Residential	
<b>Orientation:</b> Southwest	<b>Map Reference:</b> #15	
<b>Construction Date:</b> Pre 1950	<b>Ownership:</b> Private	
<b>Setting:</b> Middle section of the village	<b>Historical Associations:</b> None	
<b>Condition:</b> Poor	<b>Degree of Modification:</b> Low	
<b>Architectural Significance:</b> Moderate	<b>Cultural Significance:</b> Low	
<b>Description:</b> End unit green brick courtyard terrace with flat front roof and pitched tile main roof with plain ridge. Decorative door hood and frieze panel on the façade. Cut granite door frame and lintel with modern metal gate.		
<b>Inscriptions:</b> None		
<b>Additional Notes:</b> None

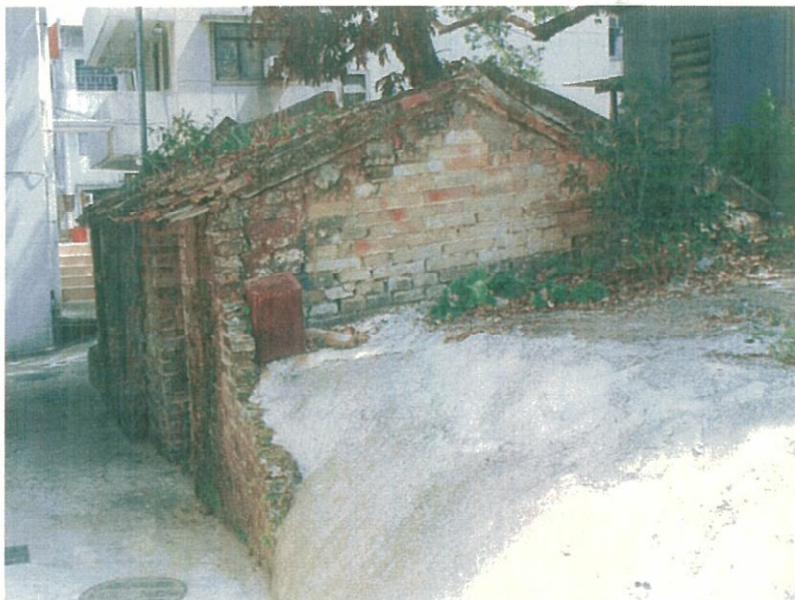
<b>Project:</b> Proposed Development at Fung Lok Wai	<b>Location:</b> Shing Uk Tsuen	<b>Ref #</b> FLW-15
<b>Originally Recorded:</b> 06/02/2001	<b>Updated On:</b> 24/04/2007	
<b>Original Usage:</b> Residential	<b>Current Usage:</b> see Additional Notes	
<b>Orientation:</b> Southwest	<b>Map Reference:</b> N/A	
<b>Construction Date:</b> Pre 1950	<b>Ownership:</b> Private	
<b>Setting:</b> At the northwestern edge of the village	<b>Historical Associations:</b> None	
<b>Condition:</b> Poor	<b>Degree of Modification:</b> Low	
<b>Architectural Significance:</b> Low	<b>Cultural Significance:</b> Low	
<b>Description:</b> Rectangular brick shed with pitched tile roof. Plain brickwork with no decorative features.		
<b>Inscriptions:</b> None		
<b>Additional Notes:</b> There was originally a large ruinous structure in front of this building that was included as the same number in the original survey.

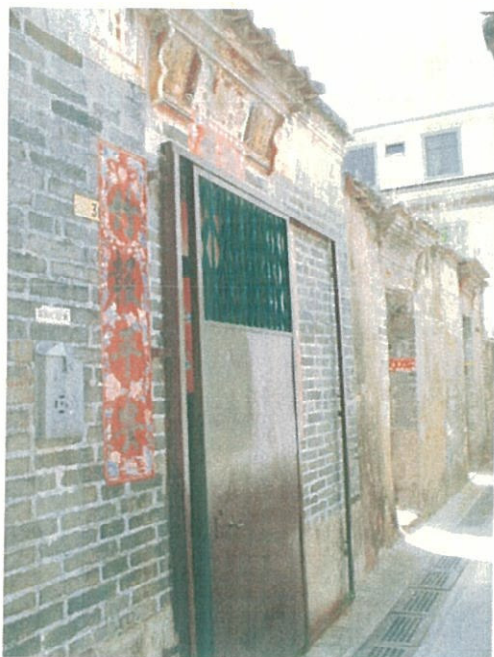
<b>Project: Proposed Development at Fung Lok Wai</b>	<b>Location: Shing Uk Tsuen</b>	<b>Ref # FLW-16</b>
<b>Originally Recorded: 06/02/2001</b>	<b>Updated On: 24/04/2007</b>	
<b>Original Usage: Residential</b>	<b>Current Usage: 1 unit (residential) 2 units(abandoned)</b>	
<b>Orientation: Southwest</b>	<b>Map Reference:</b>	
<b>Construction Date: Pre 1950</b>	<b>Ownership: Private</b>	
<b>Setting: Back central section of the village</b>	<b>Historical Associations: None</b>	
<b>Condition: 1 (Good); 2(ruins)</b>	<b>Degree of Modification: Low</b>	
<b>Architectural Significance: Moderate</b>	<b>Cultural Significance: Low</b>	
<b>Description: Three green brick courtyard terrace units. All units have decorative door hoods over the entrances and stone thresholds. Tile and concrete roof with plain ridge over closed up unit. Modern gate on the closed up unit.</b>		
<b>Inscriptions: None</b>		
<b>Additional Notes: None</b>

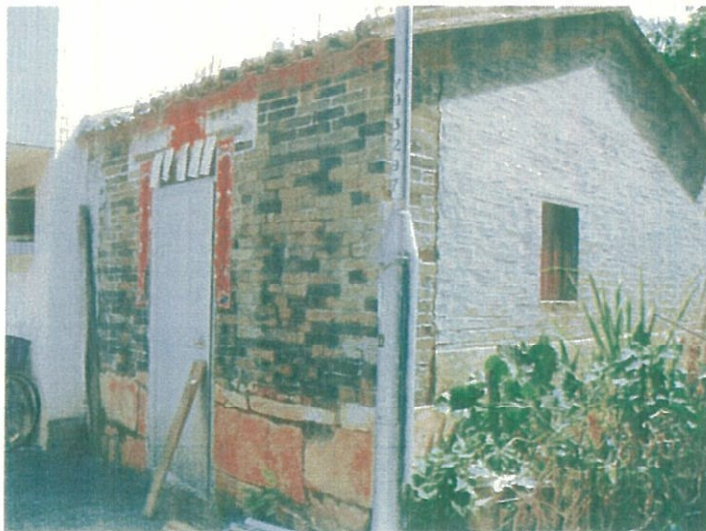
<b>Project:</b> Proposed Development at Fung Lok Wai	<b>Location:</b> Shing Uk Tsuen	<b>Ref #</b> FLW-17
<b>Originally Recorded:</b> 06/02/2001	<b>Updated On:</b> 24/04/2007	
<b>Original Usage:</b> Shed	<b>Current Usage:</b> Closed up	
<b>Orientation:</b> Southwest	<b>Map Reference:</b> Beside #30	
<b>Construction Date:</b> Pre 1950	<b>Ownership:</b> Private	
<b>Setting:</b> Central section of the village	<b>Historical Associations:</b> None	
<b>Condition:</b> Good	<b>Degree of Modification:</b> Low	
<b>Architectural Significance:</b> Low	<b>Cultural Significance:</b> Low	
<b>Description:</b> Small shed, brick walls with pitched roof. Cut stone foundation. Modern wooden door. Small window in side with wooden shutter.		
<b>Inscriptions:</b> None		
<b>Additional Notes:</b> None

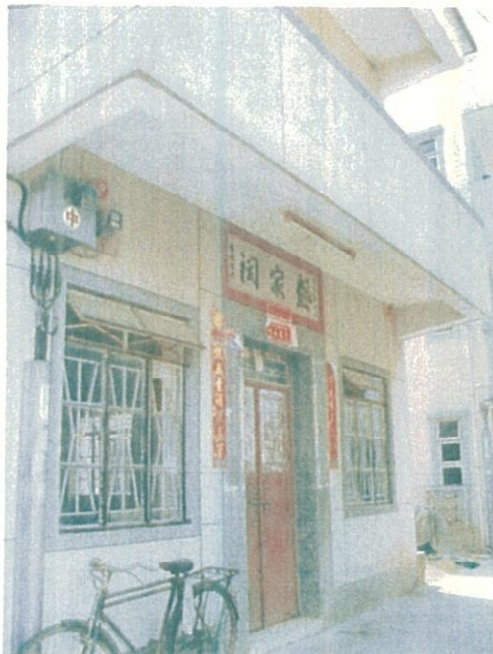
<b>Project:</b> Proposed Development at Fung Lok Wai	<b>Location:</b> Shing Uk Tsuen	<b>Ref #</b> FLW-18
<b>Originally Recorded:</b> 06/02/2001	<b>Updated On:</b> 24/04/2007	
<b>Original Usage:</b> Ancestral Hall	<b>Current Usage:</b> Ancestral Hall	
<b>Orientation:</b> Southwest	<b>Map Reference:</b> Beside #30	
<b>Construction Date:</b> Modern Rebuilt	<b>Ownership:</b> Private	
<b>Setting:</b> Central section of the village	<b>Historical Associations:</b> None	
<b>Condition:</b> Good	<b>Degree of Modification:</b>	
<b>Architectural Significance:</b> Low	<b>Cultural Significance:</b> High	
<b>Description:</b> Modern concrete two storey structure.		
<b>Inscriptions:</b> 盛家祠		
<b>Additional Notes:</b> None

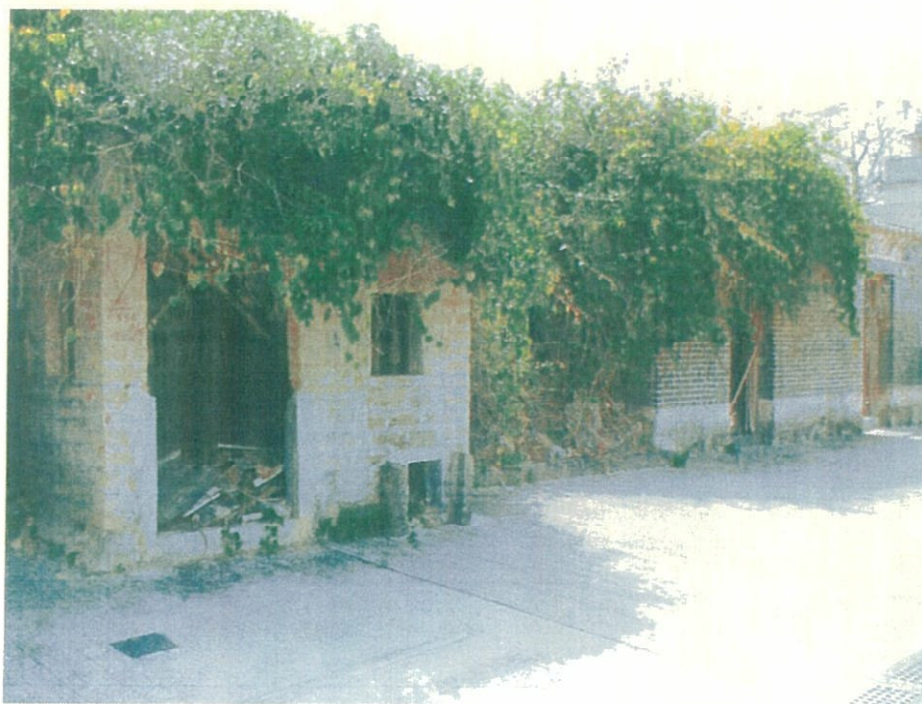
19 in foreground and 20 façade in the right hand side of the picture

<b>Project:</b> Proposed Development at Fung Lok Wai	<b>Location:</b> Shing Uk Tsuen	<b>Ref #</b> FLW-19
<b>Originally Recorded:</b> 06/02/2001	<b>Updated On:</b> 24/04/2007	
<b>Original Usage:</b> Residential	<b>Current Usage:</b> Abandoned	
<b>Orientation:</b> Southwest	<b>Map Reference:</b> N/A	
<b>Construction Date:</b> Pre 1950	<b>Ownership:</b> Private	
<b>Setting:</b> At the southeastern section of the village	<b>Historical Associations:</b> None	
<b>Condition:</b> Ruins	<b>Degree of Modification:</b> Low	
<b>Architectural Significance:</b> Low	<b>Cultural Significance:</b> Low	
<b>Description:</b> Two green brick courtyard style terrace units, walls intact roof partially collapsed. Stone foundation. Decorative door hoods over the entrances and frieze panels on façade. Heavily overgrown.		
<b>Inscriptions:</b> None		
<b>Additional Notes:</b> None

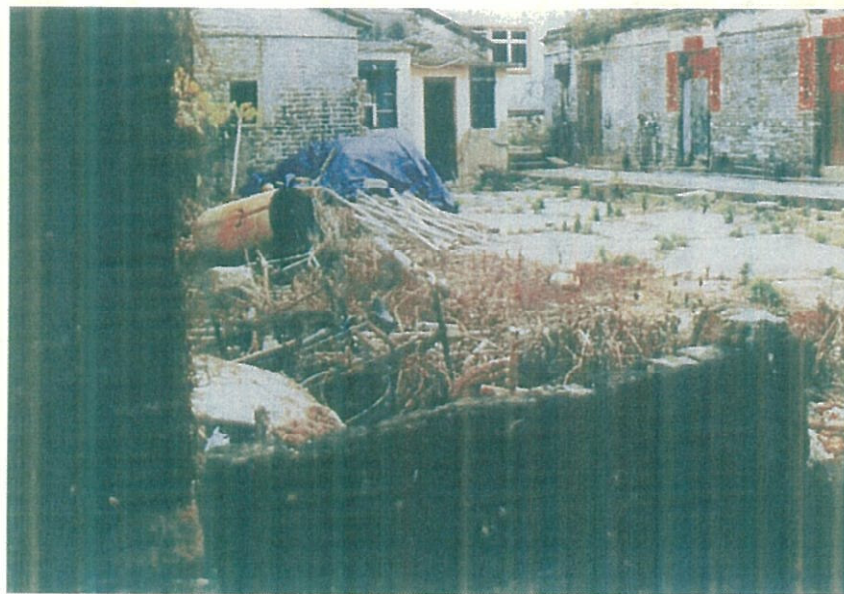
<b>Project:</b> Proposed Development at Fung Lok Wai	<b>Location:</b> Shing Uk Tsuen	<b>Ref #</b> FLW-20
<b>Originally Recorded:</b> 06/02/2001	<b>Updated On:</b> 24/04/2007	
<b>Original Usage:</b> Residential	<b>Current Usage:</b> Abandoned	
<b>Orientation:</b> Southwest	<b>Map Reference:</b> N/A	
<b>Construction Date:</b> Pre 1950	<b>Ownership:</b> Private	
<b>Setting:</b> At the southwestern edge of the village.	<b>Historical Associations:</b> None	
<b>Condition:</b> Ruin	<b>Degree of Modification:</b> Low	
<b>Architectural Significance:</b> Moderate	<b>Cultural Significance:</b> Low	
<b>Description:</b> Green brick courtyard style terrace units with flat front roof and pitched tile main ridge. Decorative door hood above the entrance and frieze panels. Cut granite threshold stone, wooden door and frame. Back sections of the buildings are gone.		
<b>Inscriptions:</b> None		
<b>Additional Notes:</b> None

View of the ruins of #20 from the back in the foreground

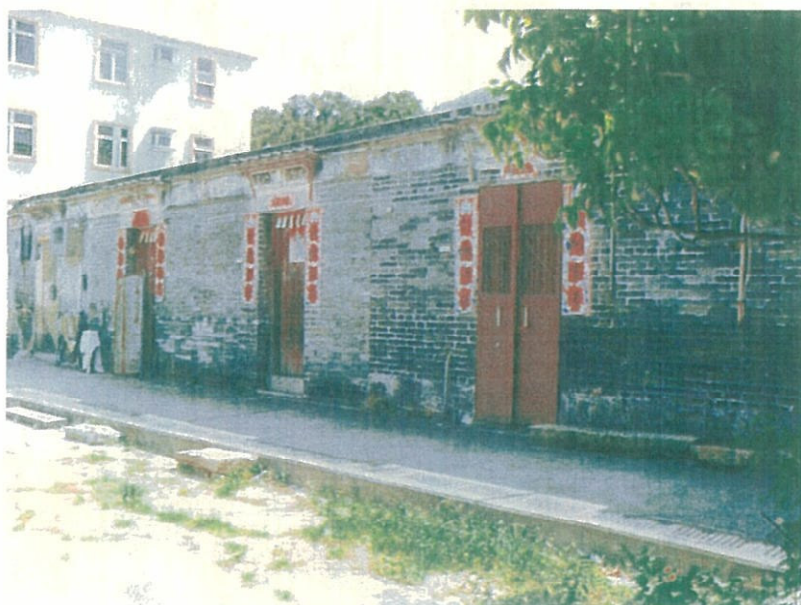
<b>Project:</b> Proposed Development at Fung Lok Wai	<b>Location:</b> Shing Uk Tsuen	<b>Ref #</b> FLW-21
<b>Originally Recorded:</b> 06/02/2001	<b>Updated On:</b> 24/04/2007	
<b>Original Usage:</b> Residential	<b>Current Usage:</b> Closed up	
<b>Orientation:</b> Southwest	<b>Map Reference:</b> #39 to 43	
<b>Construction Date:</b> Pre 1950	<b>Ownership:</b> Private	
<b>Setting:</b> At the back of the village (southwestern edge)	<b>Historical Associations:</b> None	
<b>Condition:</b> Good	<b>Degree of Modification:</b> Low (three of the units have modern doors)	
<b>Architectural Significance:</b> High	<b>Cultural Significance:</b> High	
<b>Description:</b> Five green brick terrace units. Flat roofs over the front courtyard sections and tile roof over the main section with plain ridge. Some units have stone thresholds and lintels. Decorative door hoods over the entrances. Mixture of modern and traditional doors and gates.

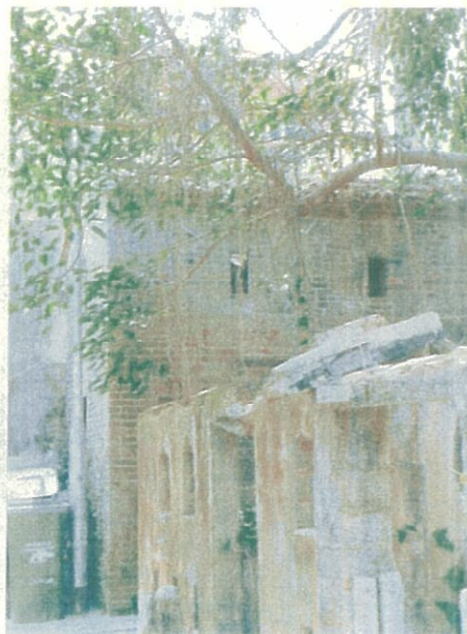
<b>Project:</b> Proposed Development at Fung Lok Wai	<b>Location:</b> Shing Uk Tsuen	<b>Ref #</b> FLW-22
<b>Originally Recorded:</b> 06/02/2001	<b>Updated On:</b> 24/04/2007	
<b>Original Usage:</b> Unknown/ possibly residential	<b>Current Usage:</b> Abandoned	
<b>Orientation:</b> Southwest	<b>Map Reference:</b> N/A	
<b>Construction Date:</b> Pre 1950	<b>Ownership:</b> Private	
<b>Setting:</b> At the back of the village behind animal pens	<b>Historical Associations:</b> None	
<b>Condition:</b> Ruin	<b>Degree of Modification:</b> Low	
<b>Architectural Significance:</b> Low	<b>Cultural Significance:</b> Low	
<b>Description:</b> Narrow rectangular building and annex of brick. Cut granite threshold and lintel in the main building. Annex section has a brick arch entrance. Tile pitched roof.		
<b>Inscriptions:</b> None		
<b>Additional Notes:</b> None

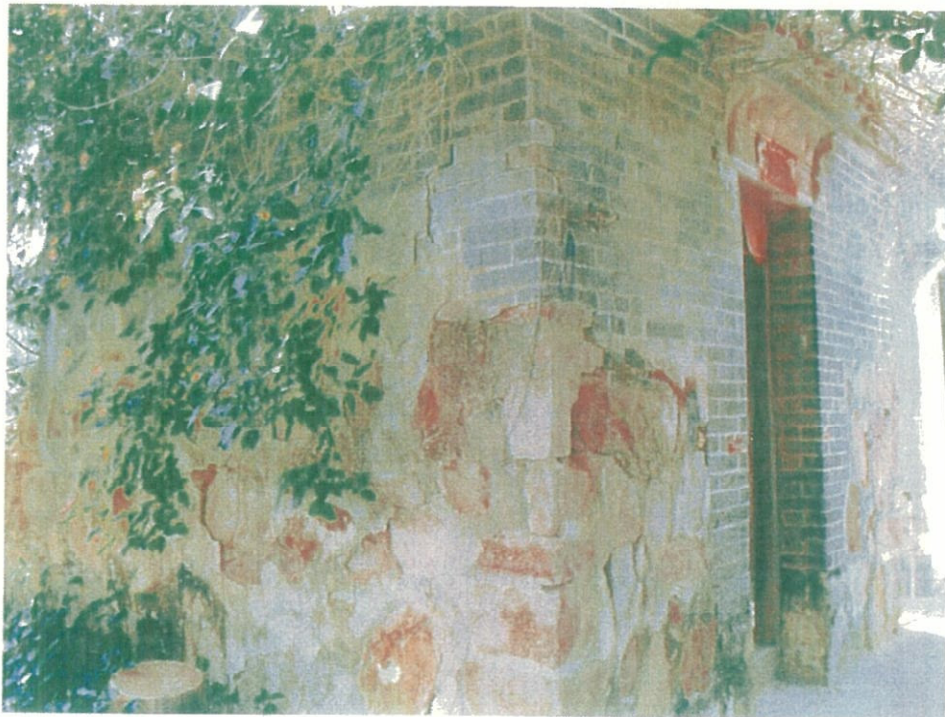
<b>Project:</b> Proposed Development at Fung Lok Wai	<b>Location:</b> Shing Uk Tsuen	<b>Ref #</b> FLW-25
<b>Originally Recorded:</b> 06/02/2001	<b>Updated On:</b> 24/04/2007	
<b>Original Usage:</b> Residential	<b>Current Usage:</b> see additional notes	
<b>Orientation:</b> Southwest	<b>Map Reference:</b> N/A	
<b>Construction Date:</b> Pre 1950	<b>Ownership:</b> Private	
<b>Setting:</b> At the back of the village	<b>Historical Associations:</b> None	
<b>Condition:</b> Ruin	<b>Degree of Modification:</b> Low	
<b>Architectural Significance:</b> Low	<b>Cultural Significance:</b> Low	
<b>Description:</b> Green brick and uncut stone building. Courtyard style with only the front section remaining. Tile and concrete roof. Cut granite threshold stone. Decorative door hood over the entrance. Structure to the rear is completely overgrown		
<b>Inscriptions:</b> None		
<b>Additional Notes:</b> None

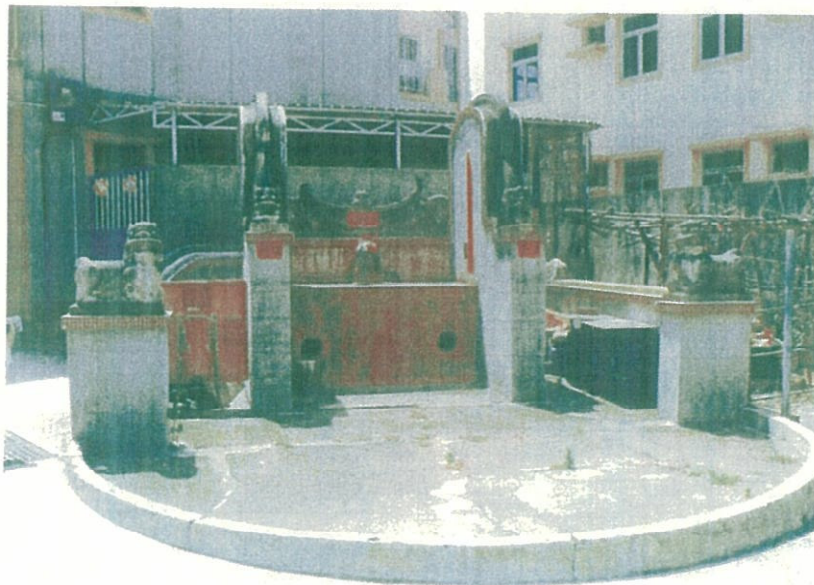
<b>Project:</b> Proposed Development at Fung Lok Wai	<b>Location:</b> Tai Tseng Wai	<b>Ref #</b> FLW-26
<b>Originally Recorded:</b> 06/02/2001	<b>Updated On:</b> 24/04/2007	
<b>Original Usage:</b> Shrine	<b>Current Usage:</b> Shrine	
<b>Orientation:</b> Northeast	<b>Map Reference:</b> N/A	
<b>Construction Date:</b> Unknown	<b>Ownership:</b> Private	
<b>Setting:</b> At the front of the village, northeastern corner	<b>Historical Associations:</b> None	
<b>Condition:</b> Good	<b>Degree of Modification:</b> Moderate	
<b>Architectural Significance:</b> Moderate	<b>Cultural Significance:</b> High	
<b>Description:</b> Concrete shrine with traditional decorative features, including wok yee style gables and curling end ridge (on the back wall). Rectangular shaped enclosure on a rounded shaped platform. Lion statue decorations on the inner and outer enclosure.		
<b>Inscriptions:</b> None		
<b>Additional Notes:</b> None

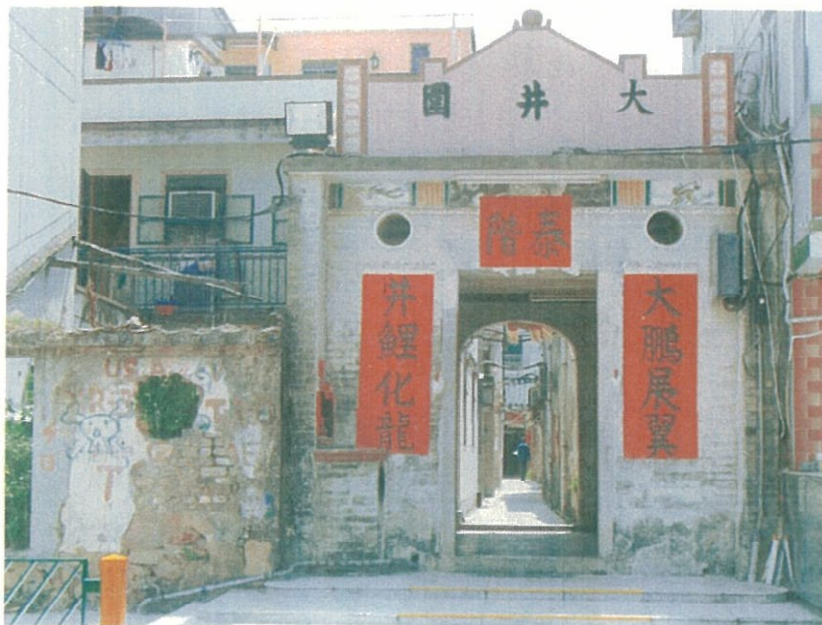
<b>Project:</b> Proposed Development at Fung Lok Wai	<b>Location:</b> Tai Tseng Wai	<b>Ref #</b> FLW-27
<b>Originally Recorded:</b> 06/02/2001	<b>Updated On:</b> 24/04/2007	
<b>Original Usage:</b> Village Gate	<b>Current Usage:</b> Village Gate	
<b>Orientation:</b> Northeast	<b>Map Reference:</b> N/A	
<b>Construction Date:</b> Pre 1950	<b>Ownership:</b> Private	
<b>Setting:</b> At the cente front of the village	<b>Historical Associations:</b> None	
<b>Condition:</b> Good	<b>Degree of Modification:</b>	
<b>Architectural Significance:</b> Moderate	<b>Cultural Significance:</b> High	
<b>Description:</b> Traditional style brick village gate, single room inside with small shrine. Rectangular entrance on the front and rounded opening at the back. Façade has painted frieze under a modern tile parapet/ There are two round ventilation opening under the frieze on the façade. Wooden loft and rafters inside.

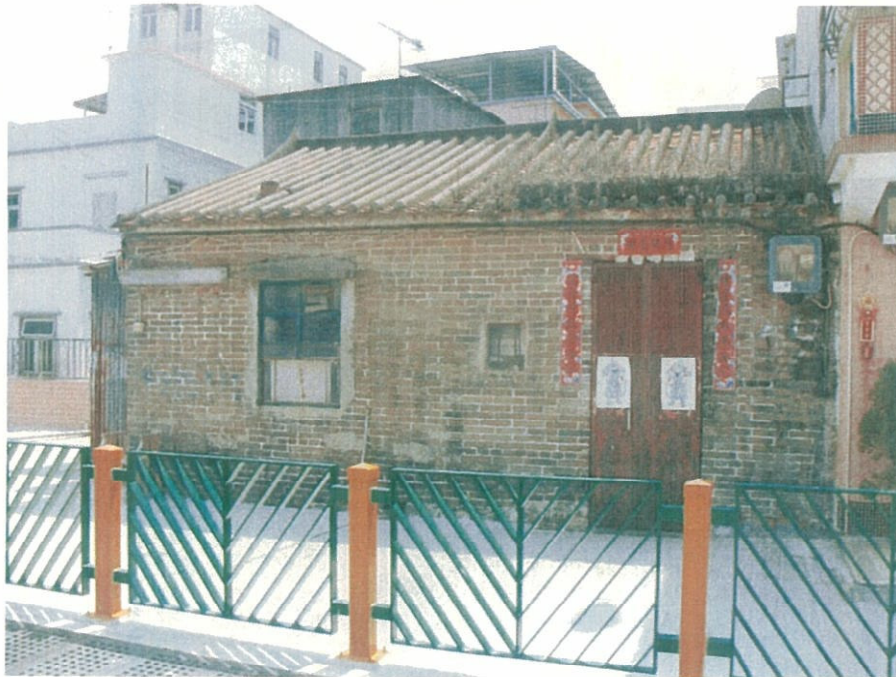
<b>Project: Proposed Development at Fung Lok Wai</b>	<b>Location: Tai Tseng Wai</b>	<b>Ref # FLW-28</b>
<b>Originally Recorded: 06/02/2001</b>	<b>Updated On: 24/04/2007</b>	
<b>Original Usage: Residential</b>	<b>Current Usage: Abandoned</b>	
<b>Orientation: Northeast</b>	<b>Map Reference: N/A</b>	
<b>Construction Date: Pre 1950</b>	<b>Ownership: Private</b>	
<b>Setting: At the front row of the village at the southeastern corner.</b>	<b>Historical Associations: None</b>	
<b>Condition: Poor</b>	<b>Degree of Modification:</b>	
<b>Architectural Significance: Low</b>	<b>Cultural Significance: Moderate</b>	
<b>Description: Rectangular shaped end unit with tile pitched roof and plain ridge. Modern door and windows.</b>		
<b>Inscriptions: None</b>		
<b>Additional Notes: None</b>

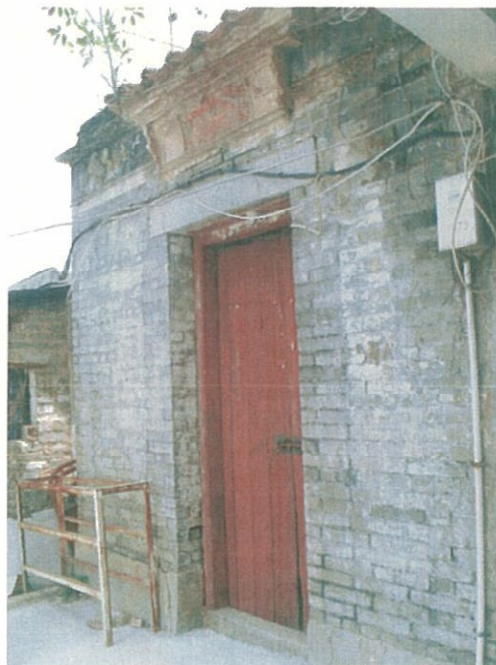
<b>Project:</b> Proposed Development at Fung Lok Wai	<b>Location:</b> Tai Tseng Wai	<b>Ref #</b> FLW-31
<b>Originally Recorded:</b> 06/02/2001	<b>Updated On:</b> 24/04/2007	
<b>Original Usage:</b> Residential	<b>Current Usage:</b> Empty apart from shrine	
<b>Orientation:</b> Northeast	<b>Map Reference:</b> #56	
<b>Construction Date:</b> Pre 1950	<b>Ownership:</b> Private	
<b>Setting:</b> To the south of the main village in an area with approximately 7 other units.	<b>Historical Associations:</b> None	
<b>Condition:</b> Poor	<b>Degree of Modification:</b> Low	
<b>Architectural Significance:</b> Moderate	<b>Cultural Significance:</b> Low	
<b>Description:</b> Green brick courtyard style unit with flat roof over the front courtyard section and tile pitched roof over the main section with plain ridge. Decorative door hood and frieze panel on the façade.		
<b>Inscriptions:</b> None		
<b>Additional Notes:</b> None

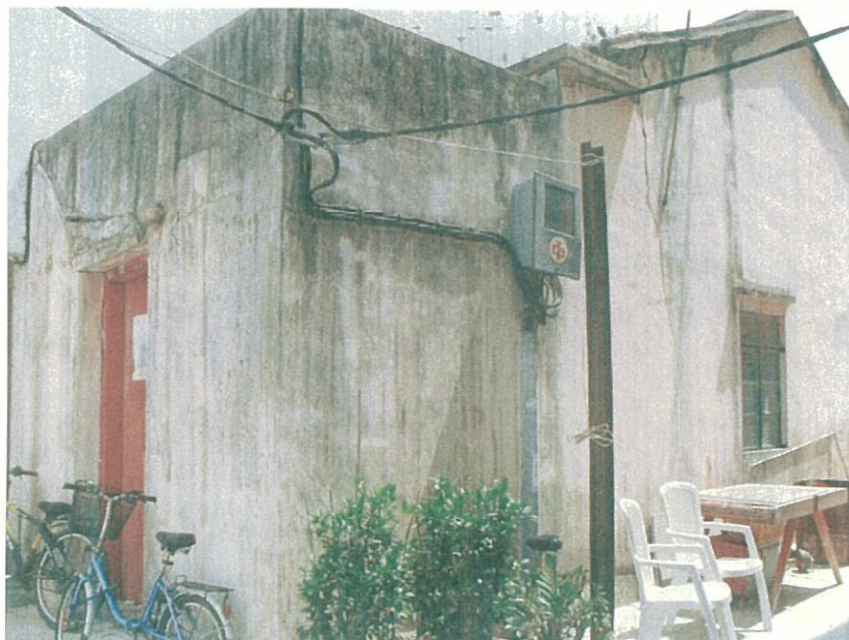
<b>Project: Proposed Development at Fung Lok Wai</b>	<b>Location: Tai Tseng Wai</b>	<b>Ref # FLW-32</b>
<b>Originally Recorded: 06/02/2001</b>	<b>Updated On: 24/04/2007</b>	
<b>Original Usage: Residential</b>	<b>Current Usage: Closed up</b>	
<b>Orientation: Northeast</b>	<b>Map Reference: #54</b>	
<b>Construction Date: Pre 1950</b>	<b>Ownership: Private</b>	
<b>Setting: To the south of the main village in an area with approximately 7 other units.</b>	<b>Historical Associations: None</b>	
<b>Condition: Poor</b>	<b>Degree of Modification: Low</b>	
<b>Architectural Significance: Low</b>	<b>Cultural Significance: Low</b>	
<b>Description: Green brick and pounded earth courtyard terrace unit covered in render on exterior. Rear wall brick.</b>		
<b>Inscriptions: None Courtyard style unit with exterior completely covered in render.</b>		
<b>Additional Notes: None</b>

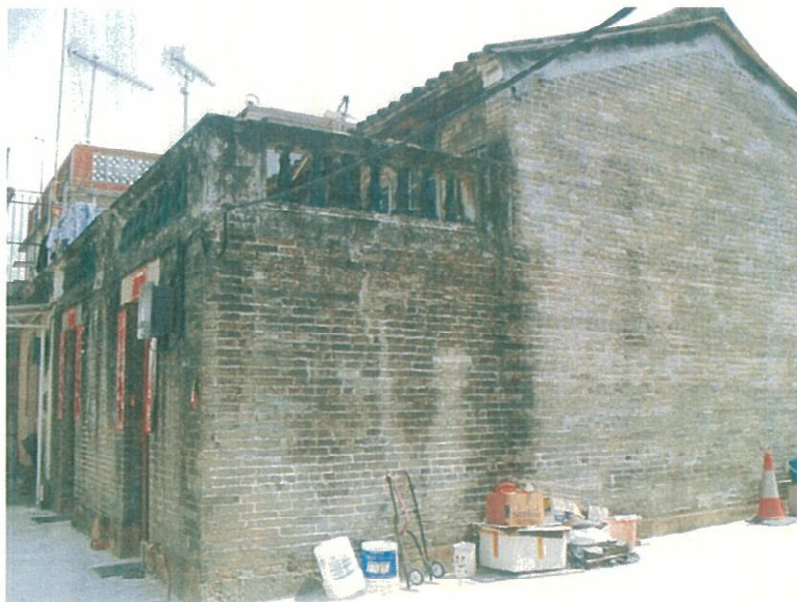
<b>Project:</b> Proposed Development at Fung Lok Wai	<b>Location:</b> Tai Tseng Wai	<b>Ref #</b> FLW-35
<b>Originally Recorded:</b> 06/02/2001	<b>Updated On:</b> 24/04/2007	
<b>Original Usage:</b> Residential	<b>Current Usage:</b> Closed up	
<b>Orientation:</b> Northeast	<b>Map Reference:</b> #50 and 51	
<b>Construction Date:</b> Pre 1950	<b>Ownership:</b> Private	
<b>Setting:</b> To the south of the main village in an area with approximately 7 other units.	<b>Historical Associations:</b> None	
<b>Condition:</b> Good	<b>Degree of Modification:</b> Low	
<b>Architectural Significance:</b> Moderate	<b>Cultural Significance:</b> Low	
<b>Description:</b> Two green brick courtyard style units with flat roof and balustrade (green ceramic balusters in concrete frame) added to the front courtyard sections. Pitched tile main roof with plain ridge. Third unit to the side. Double panel wooden doors with cut granite lintels and thresholds.

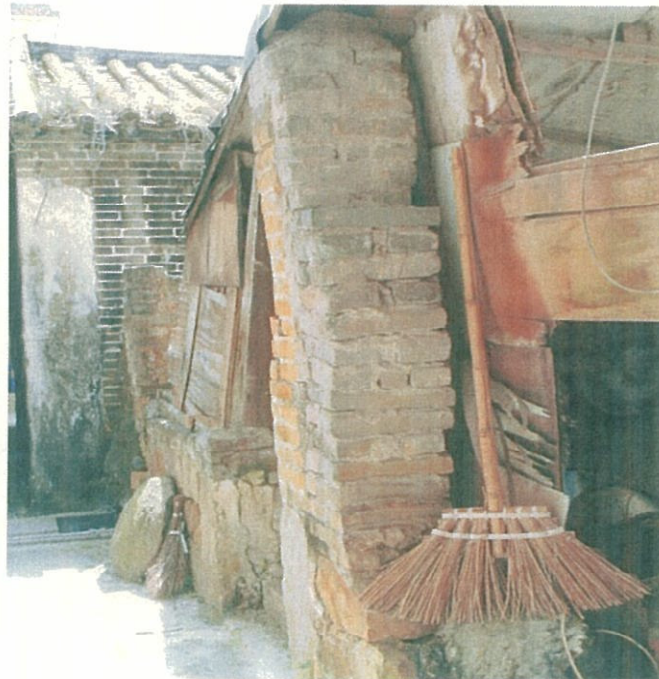
<b>Project: Proposed Development at Fung Lok Wai</b>	<b>Location: Tai Tseng Wai</b>	<b>Ref # FLW-36</b>
<b>Originally Recorded: 06/02/2001</b>	<b>Updated On: 24/04/2007</b>	
<b>Original Usage: Unknown</b>	<b>Current Usage: Abandoned</b>	
<b>Orientation: Northeast</b>	<b>Map Reference: Beside #70</b>	
<b>Construction Date: Unknown</b>	<b>Ownership: Private</b>	
<b>Setting: Back central section of the village</b>	<b>Historical Associations: None</b>	
<b>Condition: Ruin</b>	<b>Degree of Modification: Low</b>	
<b>Architectural Significance: Low</b>	<b>Cultural Significance: Low</b>	
<b>Description: Section of brick walls only remaining historical section.</b>		
<b>Inscriptions: None</b>		
<b>Additional Notes: None</b>

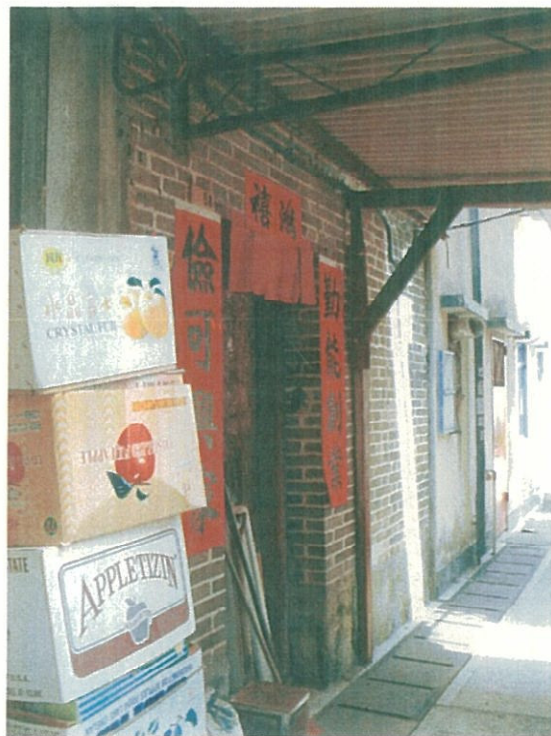
<b>Project: Proposed Development at Fung Lok Wai</b>	<b>Location: Tai Tseng Wai</b>	<b>Ref # FLW-37</b>
<b>Originally Recorded: 06/02/2001</b>	<b>Updated On: 24/04/2007</b>	
<b>Original Usage: Residential</b>	<b>Current Usage: Closed up</b>	
<b>Orientation: Northeast</b>	<b>Map Reference: Behind #74</b>	
<b>Construction Date: Pre 1950</b>	<b>Ownership: Private</b>	
<b>Setting: Back southwestern section of the village</b>	<b>Historical Associations: None</b>	
<b>Condition: Poor</b>	<b>Degree of Modification: Low</b>	
<b>Architectural Significance: Low</b>	<b>Cultural Significance: Low</b>	
<b>Description: Green brick mid terrace unit . Wooden door in wooden frame with modern awning over front.</b>		
<b>Inscriptions: None</b>		
<b>Additional Notes: None</b>

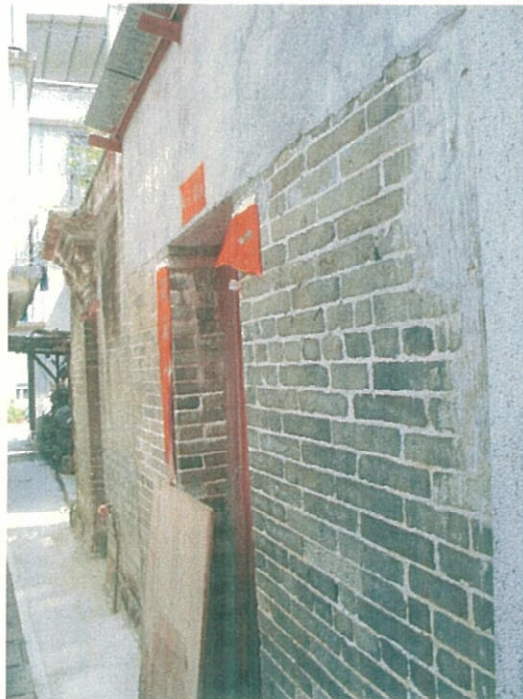
<b>Project: Proposed Development at Fung Lok Wai</b>	<b>Location: Tai Tseng Wai</b>	<b>Ref # FLW-38</b>
<b>Originally Recorded: 06/02/2001</b>	<b>Updated On: 24/04/2007</b>	
<b>Original Usage: Residential</b>	<b>Current Usage: Abandoned</b>	
<b>Orientation: Northeast</b>	<b>Map Reference: #60</b>	
<b>Construction Date: Pre 1950</b>	<b>Ownership: Private</b>	
<b>Setting: At the back of the village, last terrace row</b>	<b>Historical Associations: None</b>	
<b>Condition: Ruin</b>	<b>Degree of Modification: Low</b>	
<b>Architectural Significance: Low</b>	<b>Cultural Significance: Low</b>	
<b>Description: Two green brick courtyard style units front walls are intact, rear walls have partially collapsed. Decorative door hood over one of the units entrances.</b>		
<b>Inscriptions: None</b>		
<b>Additional Notes: None</b>

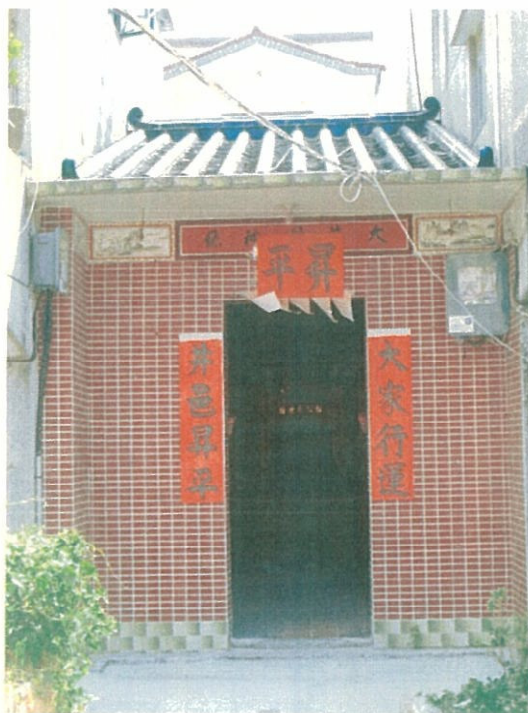
<b>Project:</b> Proposed Development at Fung Lok Wai	<b>Location:</b> Tai Tseng Wai	<b>Ref #</b> FLW-39
<b>Originally Recorded:</b> 06/02/2001	<b>Updated On:</b> 24/04/2007	
<b>Original Usage:</b> Village God's Hall	<b>Current Usage:</b> Village God's Hall	
<b>Orientation:</b> Northeast	<b>Map Reference:</b> N/A	
<b>Construction Date:</b> Unknown	<b>Ownership:</b> Private	
<b>Setting:</b> Centre of the back terrace row of the village, aligned with entrance gate	<b>Historical Associations:</b> None	
<b>Condition:</b> Good	<b>Degree of Modification:</b> Moderate	
<b>Architectural Significance:</b> Low	<b>Cultural Significance:</b> High	
<b>Description:</b> Modern rebuilt gods hall, red tile façade tile roof with green ceramic ridge. Single hall.		
<b>Inscriptions:</b> 大井圍神廳		
<b>Additional Notes:</b> None

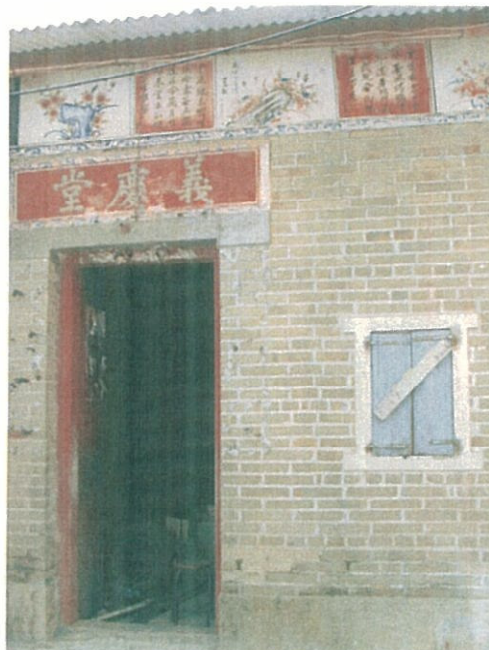
<b>Project:</b> Proposed Development at Fung Lok Wai	<b>Location:</b> Tai Tseng Wai	<b>Ref #</b> FLW-40
<b>Originally Recorded:</b> 06/02/2001	<b>Updated On:</b> 24/04/2007	
<b>Original Usage:</b> Yee Hing Tong Study Hall	<b>Current Usage:</b> Abandoned	
<b>Orientation:</b> Northeast	<b>Map Reference:</b> Beside #18	
<b>Construction Date:</b> Pre 1950	<b>Ownership:</b> Cheng Clan	
<b>Setting:</b> At the back northwestern corner of the village	<b>Historical Associations:</b> None	
<b>Condition:</b> Poor to ruin	<b>Degree of Modification:</b> Low	
<b>Architectural Significance:</b> High	<b>Cultural Significance:</b> High	
<b>Description:</b> Green brick main hall with back annexes in ruinous condition. Painted frieze panel on the façade with inscription over the doorway. Wooden shuttered window on the façade. Modern roof.		
<b>Inscriptions:</b> 義慶堂		
<b>Additional Notes:</b> None

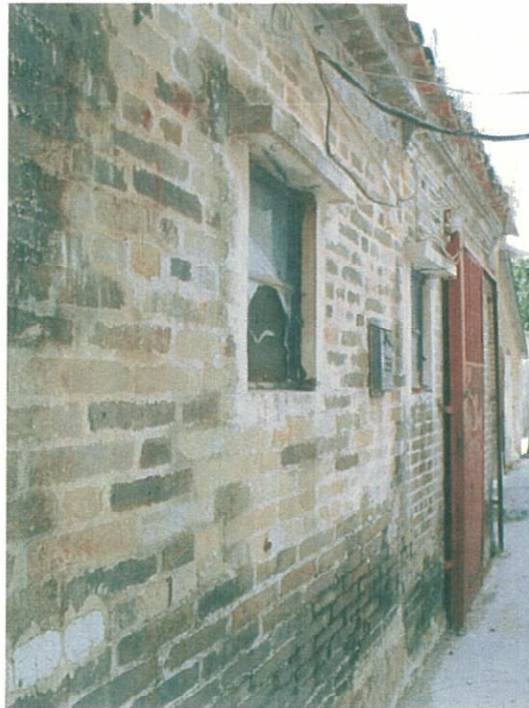
<b>Project:</b> Proposed Development at Fung Lok Wai	<b>Location:</b> Tai Tseng Wai	<b>Ref #</b> FLW-41
<b>Originally Recorded:</b> 06/02/2001	<b>Updated On:</b> 24/04/2007	
<b>Original Usage:</b> Residential	<b>Current Usage:</b> Closed up	
<b>Orientation:</b> Northeast	<b>Map Reference:</b> #18	
<b>Construction Date:</b> Pre 1950	<b>Ownership:</b> Private	
<b>Setting:</b> At the back of the village, northwestern corner	<b>Historical Associations:</b> None	
<b>Condition:</b> Poor to ruin	<b>Degree of Modification:</b> Low	
<b>Architectural Significance:</b> Low	<b>Cultural Significance:</b> Low	
<b>Description:</b> Brick rectangular structure next to the study hall. Modern door and window on façade. No decorative features. Tile and concrete pitched roof.		
<b>Inscriptions:</b> None		
<b>Additional Notes:</b> None
