<b>Project:</b> Proposed Development at Fung Lok Wai	<b>Location:</b> Shing Uk Tsuen	<b>Ref #</b> FLW-01
<b>Originally Recorded:</b> 06/02/2001	<b>Updated On:</b> 24/04/2007	
<b>Original Usage:</b> Tsz Tong (Kwing Ling Tong)	<b>Current Usage:</b> Tsz Tong (Kwing Ling Tong)	
<b>Orientation:</b> Southwest	<b>Map Reference:</b> N/A	
<b>Construction Date:</b> 1971	<b>Ownership:</b> Private	
<b>Setting:</b> At the front of the village	<b>Historical Associations:</b> None	
<b>Condition:</b> Good	<b>Degree of Modification:</b> Modern structure	
<b>Architectural Significance:</b> Low	<b>Cultural Significance:</b> High	
<b>Description:</b> Concrete two storey structure with single storey annex room on the left side. Flat roof. Building is painted yellow with grey trim at the base. Balcony across the façade of the first floor.		
<b>Inscriptions:</b> 廣陵堂		
<b>Additional Notes:</b> None

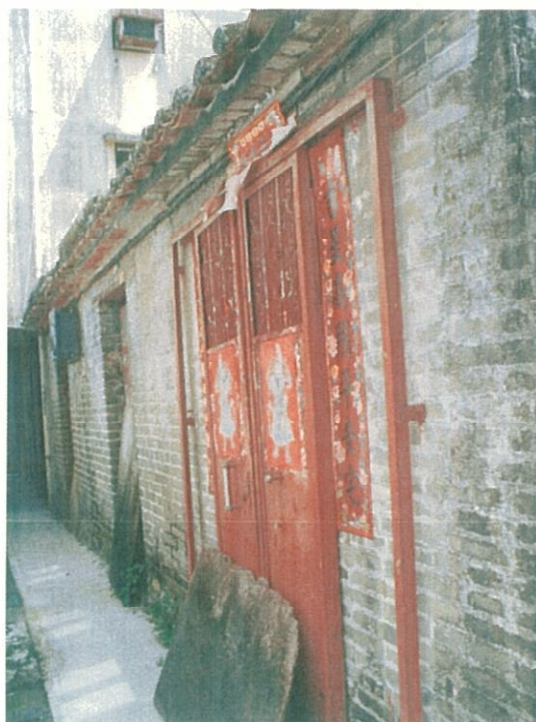
<b>Project: Proposed Development at Fung Lok Wai</b>	<b>Location: Tai Tseng Wai</b>	<b>Ref # FLW-42</b>
<b>Originally Recorded: 06/02/2001</b>	<b>Updated On: 24/04/2007</b>	
<b>Original Usage: Residential</b>	<b>Current Usage: Closed up</b>	
<b>Orientation: Northeast</b>	<b>Map Reference: #47</b>	
<b>Construction Date: Pre 1950</b>	<b>Ownership: Private</b>	
<b>Setting: Back central section of the village</b>	<b>Historical Associations: None</b>	
<b>Condition: Good</b>	<b>Degree of Modification: Low</b>	
<b>Architectural Significance: Low</b>	<b>Cultural Significance: Low</b>	
<b>Description:</b>		
<b>Inscriptions: None</b>		
<b>Additional Notes: None</b>

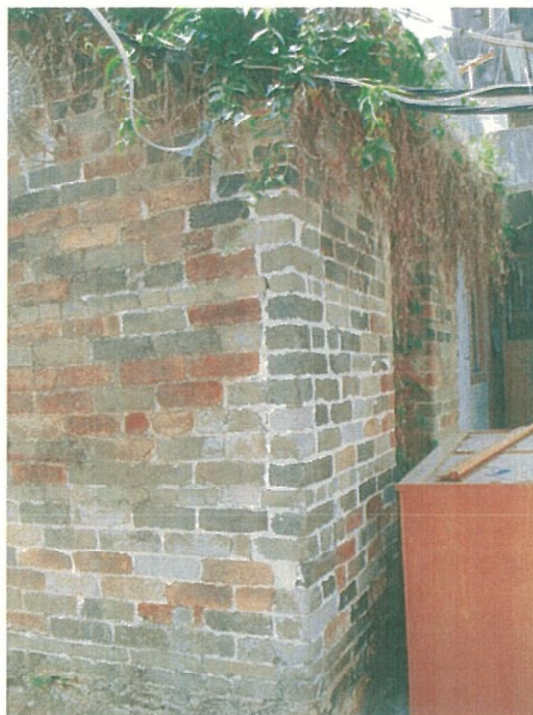
<b>Project: Proposed Development at Fung Lok Wai</b>	<b>Location: Tai Tseng Wai</b>	<b>Ref # FLW-43</b>
<b>Originally Recorded: 06/02/2001</b>	<b>Updated On: 24/04/2007</b>	
<b>Original Usage: Residential</b>	<b>Current Usage: Abandoned</b>	
<b>Orientation: Northeast</b>	<b>Map Reference: Beside #19</b>	
<b>Construction Date: Pre 1950</b>	<b>Ownership: Private</b>	
<b>Setting: Back central section of the village</b>	<b>Historical Associations: None</b>	
<b>Condition: Ruin</b>	<b>Degree of Modification: Low</b>	
<b>Architectural Significance: Low</b>	<b>Cultural Significance: Low</b>	
<b>Description:</b>		
<b>Inscriptions: None</b>		
<b>Additional Notes: None</b>

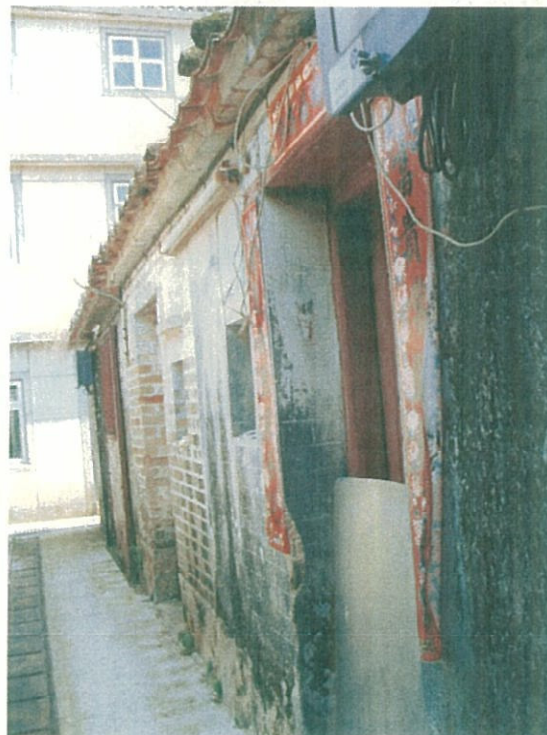
<b>Project: Proposed Development at Fung Lok Wai</b>	<b>Location: Tai Tseng Wai</b>	<b>Ref # FLW-44</b>
<b>Originally Recorded: 06/02/2001</b>	<b>Updated On: 24/04/2007</b>	
<b>Original Usage: Residential</b>	<b>Current Usage: Closed up</b>	
<b>Orientation: Northeast</b>	<b>Map Reference: #24, 25 and 26</b>	
<b>Construction Date: Pre 1950</b>	<b>Ownership: Private</b>	
<b>Setting: Central section of the village</b>	<b>Historical Associations: None</b>	
<b>Condition: Poor</b>	<b>Degree of Modification:</b>	
<b>Architectural Significance: Low</b>	<b>Cultural Significance: Low</b>	
<b>Description: Three brick terrace structures all have wooden doors in wooden door frames, one cut granite threshold stone remaining. Right hand unit has render covering on the façade, other to have brick, eroding away in places. No decorative features.</b>		
<b>Inscriptions: None</b>		
<b>Additional Notes: None</b>

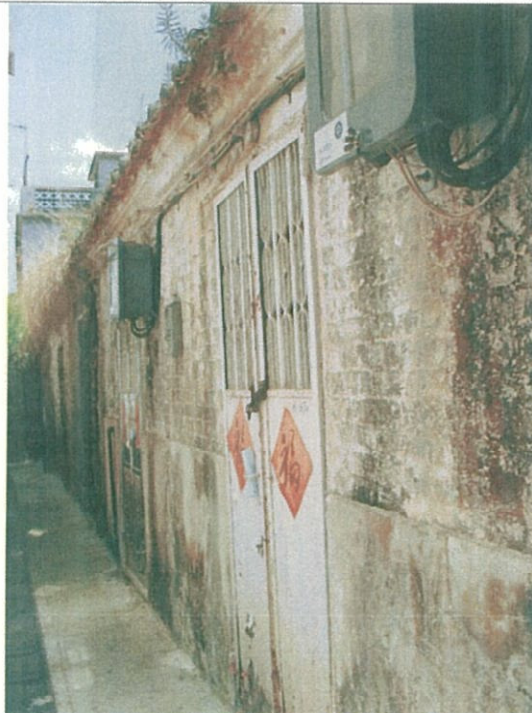
<b>Project: Proposed Development at Fung Lok Wai</b>	<b>Location: Tai Tseng Wai</b>	<b>Ref # FLW-46</b>
<b>Originally Recorded: 06/02/2001</b>	<b>Updated On: 24/04/2007</b>	
<b>Original Usage: Residential</b>	<b>Current Usage: Abandoned or vacant</b>	
<b>Orientation: Northeast</b>	<b>Map Reference: #41, 41a and 43</b>	
<b>Construction Date: Pre 1950</b>	<b>Ownership: Private</b>	
<b>Setting: Central section of the village</b>	<b>Historical Associations: None</b>	
<b>Condition: Good to poor</b>	<b>Degree of Modification: Low</b>	
<b>Architectural Significance: High (as the entire row is intact)</b>	<b>Cultural Significance: Moderate</b>	
<b>Description: Five green brick courtyard style terrace units with concrete covered or stone foundations. Single pitched tile roof over the main sections and flat roofs over the front. Moulding under the eaves on the facade. Mixture of modern doors and traditional.</b>

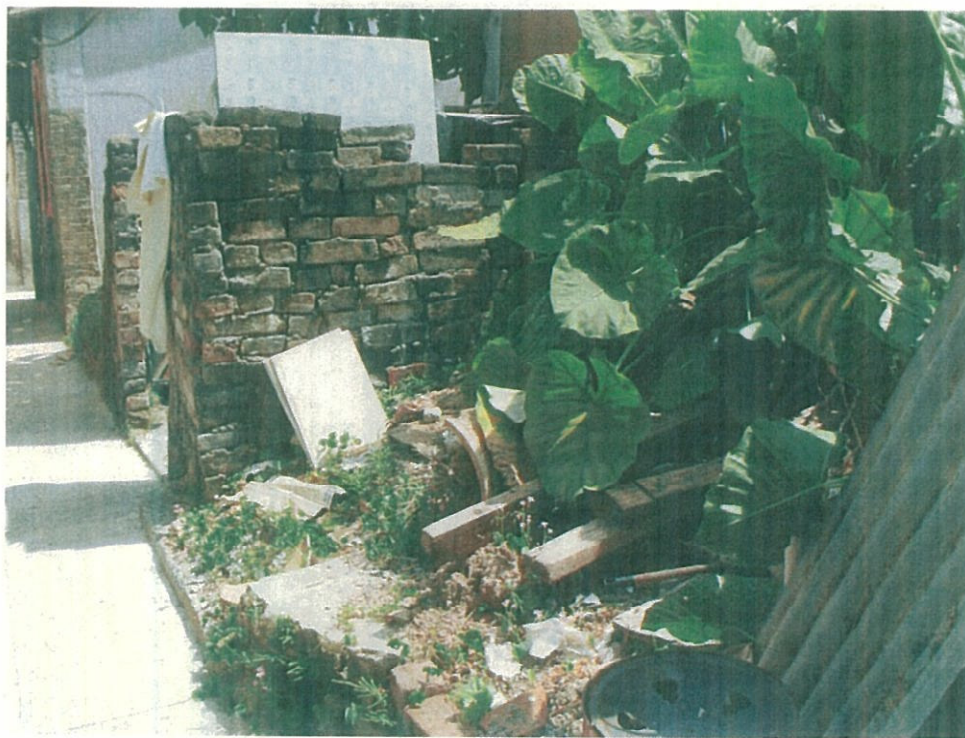
<b>Project: Proposed Development at Fung Lok Wai</b>	<b>Location: Tai Tseng Wai</b>	<b>Ref # FLW-48</b>
<b>Originally Recorded: 06/02/2001</b>	<b>Updated On: 24/04/2007</b>	
<b>Original Usage: Residential?</b>	<b>Current Usage: Abandoned</b>	
<b>Orientation: Northeast</b>	<b>Map Reference: N/A</b>	
<b>Construction Date: Unknown</b>	<b>Ownership: Private</b>	
<b>Setting: Central part of the village</b>	<b>Historical Associations: None</b>	
<b>Condition: Ruin</b>	<b>Degree of Modification: Low</b>	
<b>Architectural Significance: Low</b>	<b>Cultural Significance: Low</b>	
<b>Description: Ruins of three structures with some green brick wall sections remaining and very overgrown with vegetation.</b>		
<b>Inscriptions: None</b>		
<b>Additional Notes: None</b>

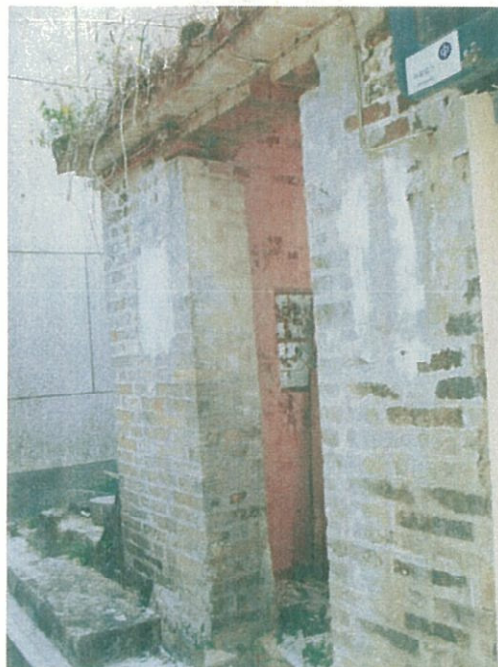
<b>Project: Proposed Development at Fung Lok Wai</b>	<b>Location: Tai Tseng Wai</b>	<b>Ref # FLW-50</b>
<b>Originally Recorded: 06/02/2001</b>	<b>Updated On: 24/04/2007</b>	
<b>Original Usage: Residential</b>	<b>Current Usage: Abandoned</b>	
<b>Orientation: Northeast</b>	<b>Map Reference: N/A</b>	
<b>Construction Date: Pre 1950</b>	<b>Ownership: Private</b>	
<b>Setting: On the Northeastern edge of the village facing into the village.</b>	<b>Historical Associations: None</b>	
<b>Condition: Poor to ruin</b>	<b>Degree of Modification:</b>	
<b>Architectural Significance:</b>	<b>Cultural Significance:</b>	
<b>Description: Small terraced unit with mixture of bricks in walls (with some render over pounded earth) and pitched tile roof, partially collapsed. No door or door frame.</b>		
<b>Inscriptions: None</b>		
<b>Additional Notes: None</b>

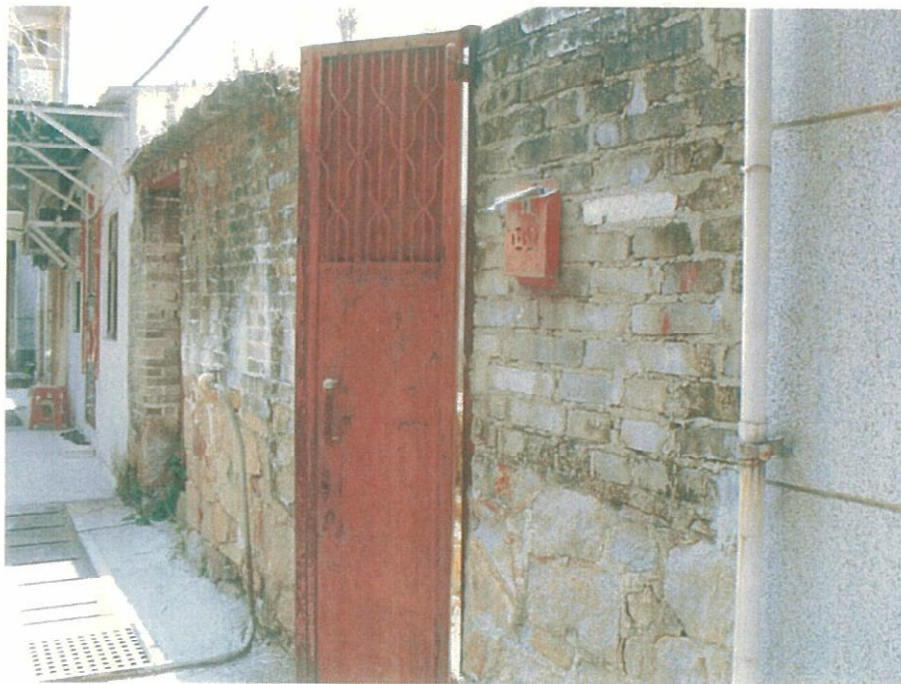
<b>Project: Proposed Development at Fung Lok Wai</b>	<b>Location: Tai Tseng Wai</b>	<b>Ref # FLW-51</b>
<b>Originally Recorded: 06/02/2001</b>	<b>Updated On: 24/04/2007</b>	
<b>Original Usage: Residential</b>	<b>Current Usage: Closed up</b>	
<b>Orientation: Northeast</b>	<b>Map Reference: N/A</b>	
<b>Construction Date: Pre 1950</b>	<b>Ownership: Private</b>	
<b>Setting: On the northeastern edge of the village outer row facing into the village.</b>	<b>Historical Associations: None</b>	
<b>Condition: Poor</b>	<b>Degree of Modification: Low</b>	
<b>Architectural Significance: Low</b>	<b>Cultural Significance: Low</b>	
<b>Description: Two green brick walls on uncut stone foundation, only small section of roof. Double panel wooden door in wooden frame and also one metal gate. Pitched tile roof. No decorative features.</b>		
<b>Inscriptions: None</b>		
<b>Additional Notes: None</b>

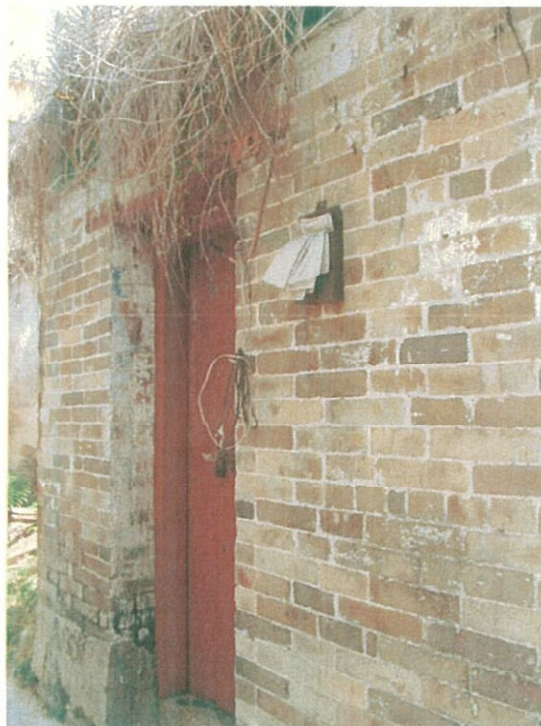
<b>Project: Proposed Development at Fung Lok Wai</b>	<b>Location: Tai Tseng Wai</b>	<b>Ref # FLW-52</b>
<b>Originally Recorded: 06/02/2001</b>	<b>Updated On: 24/04/2007</b>	
<b>Original Usage: Residential</b>	<b>Current Usage: Closed up/ storage</b>	
<b>Orientation: Northeast</b>	<b>Map Reference: #9</b>	
<b>Construction Date: Pre 1950</b>	<b>Ownership: Private</b>	
<b>Setting: Central part of the village</b>	<b>Historical Associations: None</b>	
<b>Condition: Poor</b>	<b>Degree of Modification: Low</b>	
<b>Architectural Significance: Low</b>	<b>Cultural Significance: Low</b>	
<b>Description: Green brick courtyard style end terrace unit. Pitched tile roof on main section, flat roof on the front. Double panel wooden door in wooden frame. No decorative features.</b>		
<b>Inscriptions: None</b>		
<b>Additional Notes: None</b>

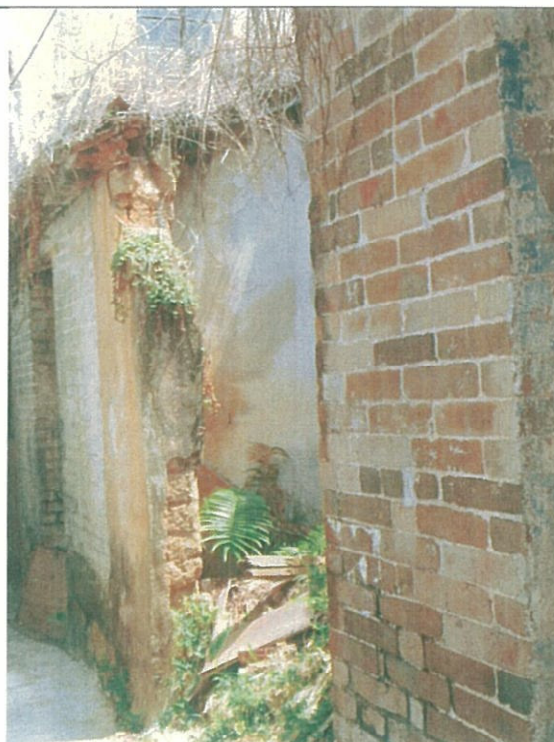
<b>Project: Proposed Development at Fung Lok Wai</b>	<b>Location: Tai Tseng Wai</b>	<b>Ref # FLW-53</b>
<b>Originally Recorded: 06/02/2001</b>	<b>Updated On: 24/04/2007</b>	
<b>Original Usage: Residential</b>	<b>Current Usage: (see Additional Notes)</b>	
<b>Orientation: Northeast</b>	<b>Map Reference: N/A</b>	
<b>Construction Date: Unknown</b>	<b>Ownership: Private</b>	
<b>Setting: Near the back of the village</b>	<b>Historical Associations: None</b>	
<b>Condition: Ruins</b>	<b>Degree of Modification: Low</b>	
<b>Architectural Significance: Low</b>	<b>Cultural Significance: Low</b>	
<b>Description: Brick wall sections with stone foundations with interior wall sections of mud brick. Entrance way still discernable with brick doorstep.</b>		
<b>Inscriptions: None</b>		
<b>Additional Notes: None</b>

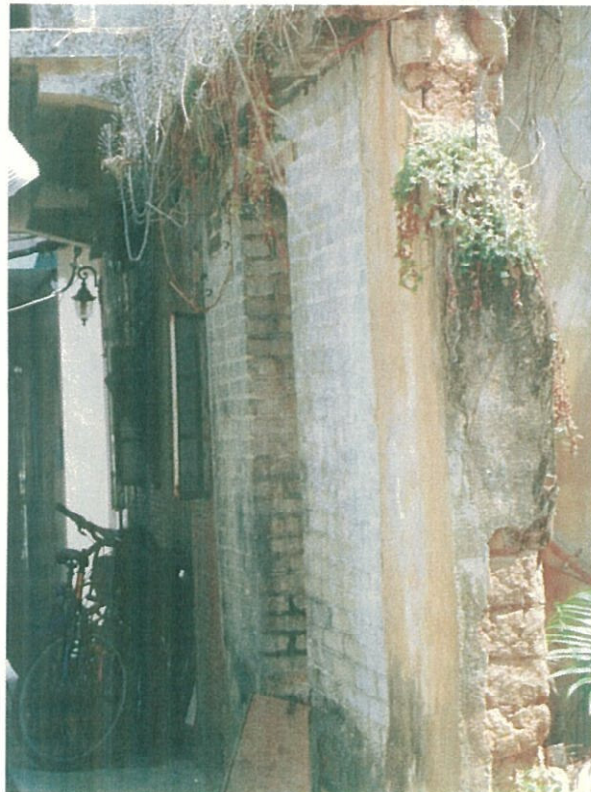
<b>Project: Proposed Development at Fung Lok Wai</b>	<b>Location: Tai Tseng Wai</b>	<b>Ref # FLW-54</b>
<b>Originally Recorded: 06/02/2001</b>	<b>Updated On: 24/04/2007</b>	
<b>Original Usage: Residential?</b>	<b>Current Usage: Abandoned</b>	
<b>Orientation: Northeast</b>	<b>Map Reference: N/A</b>	
<b>Construction Date: Unknown</b>	<b>Ownership: Private</b>	
<b>Setting: Central section of the village</b>	<b>Historical Associations: None</b>	
<b>Condition: Ruin</b>	<b>Degree of Modification: Low</b>	
<b>Architectural Significance: Low</b>	<b>Cultural Significance: Low</b>	
<b>Description: Some brick and mud brick walls and sections of collapsed roof are only remaining features.</b>		
<b>Inscriptions: None</b>		
<b>Additional Notes: None</b>

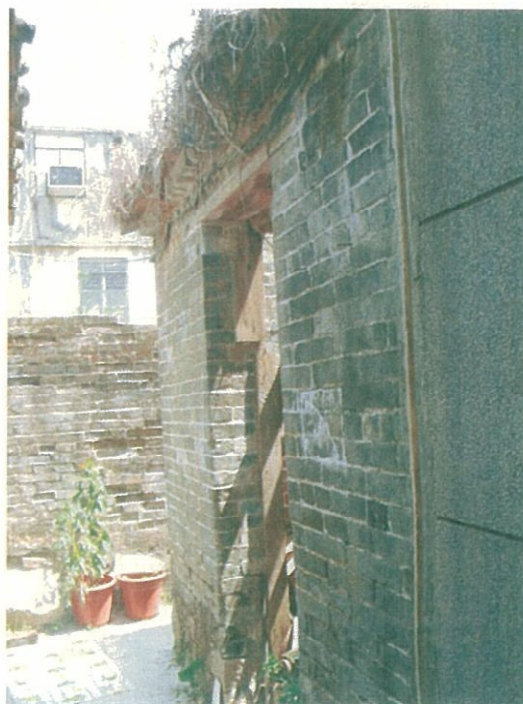
<b>Project: Proposed Development at Fung Lok Wai</b>	<b>Location: Tai Tseng Wai</b>	<b>Ref # FLW-55</b>
<b>Originally Recorded: 06/02/2001</b>	<b>Updated On: 24/04/2007</b>	
<b>Original Usage: Residential</b>	<b>Current Usage: Closed up</b>	
<b>Orientation: Northeast</b>	<b>Map Reference: #8</b>	
<b>Construction Date: Pre 1950</b>	<b>Ownership: Private</b>	
<b>Setting: Central part of the village</b>	<b>Historical Associations: None</b>	
<b>Condition: Poor</b>	<b>Degree of Modification: Low</b>	
<b>Architectural Significance: Low</b>	<b>Cultural Significance: Low</b>	
<b>Description: Green brick courtyard style mid terrace unit. Pitched tile roof over main section and flat roof over the front courtyard section. Uncut stone foundations on the faced and rear walls. Window has been added in the rear wall.</b>		
<b>Inscriptions: None</b>		
<b>Additional Notes: None</b>

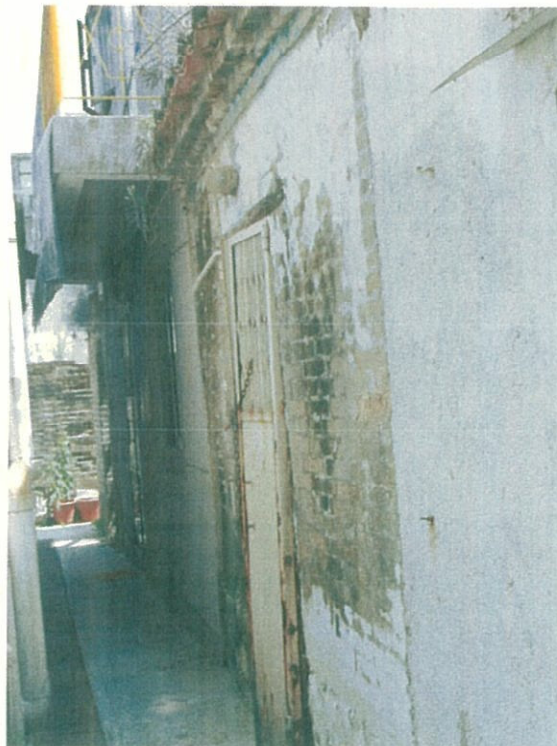
<b>Project: Proposed Development at Fung Lok Wai</b>	<b>Location: Tai Tseng Wai</b>	<b>Ref # FLW-56</b>
<b>Originally Recorded: 06/02/2001</b>	<b>Updated On: 24/04/2007</b>	
<b>Original Usage: Residential</b>	<b>Current Usage: Storage</b>	
<b>Orientation: Northeast</b>	<b>Map Reference: #33</b>	
<b>Construction Date: Pre 1950</b>	<b>Ownership: Private</b>	
<b>Setting: Near the back of the village</b>	<b>Historical Associations: None</b>	
<b>Condition: Poor</b>	<b>Degree of Modification: Low</b>	
<b>Architectural Significance: Low</b>	<b>Cultural Significance: Low</b>	
<b>Description: Green brick walls with stone foundation. Traditional roof and supporting beams in very poor condition. Vegetation growth on the roof. No decorative features.</b>		
<b>Inscriptions: None</b>		
<b>Additional Notes: None</b>

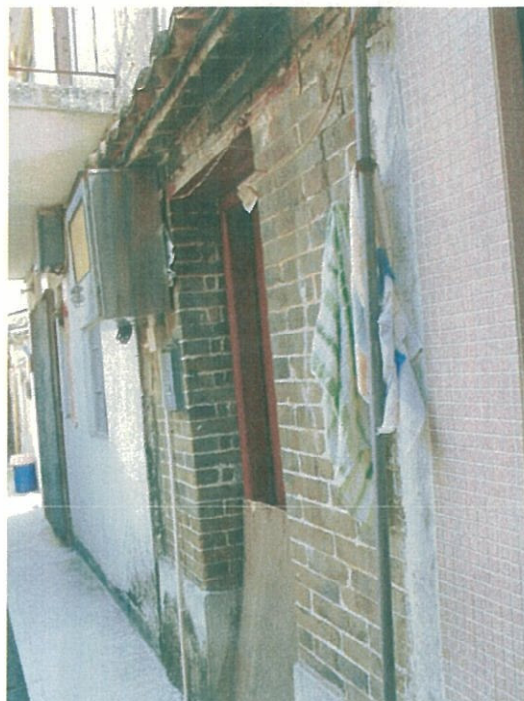
<b>Project: Proposed Development at Fung Lok Wai</b>	<b>Location: Tai Tseng Wai</b>	<b>Ref # FLW-57</b>
<b>Originally Recorded: 06/02/2001</b>	<b>Updated On: 24/04/2007</b>	
<b>Original Usage: Residential</b>	<b>Current Usage: Residential/ storage (closed up)</b>	
<b>Orientation: Northeast</b>	<b>Map Reference: # 34</b>	
<b>Construction Date: Pre 1950</b>	<b>Ownership: Private</b>	
<b>Setting: Near the back of the village</b>	<b>Historical Associations: None</b>	
<b>Condition: Poor</b>	<b>Degree of Modification: Moderate</b>	
<b>Architectural Significance: Low</b>	<b>Cultural Significance: Low</b>	
<b>Description: Brick courtyard style terrace unit with pitched main roof and flat front roof. No decorative features.</b>		
<b>Inscriptions: None</b>		
<b>Additional Notes: None</b>

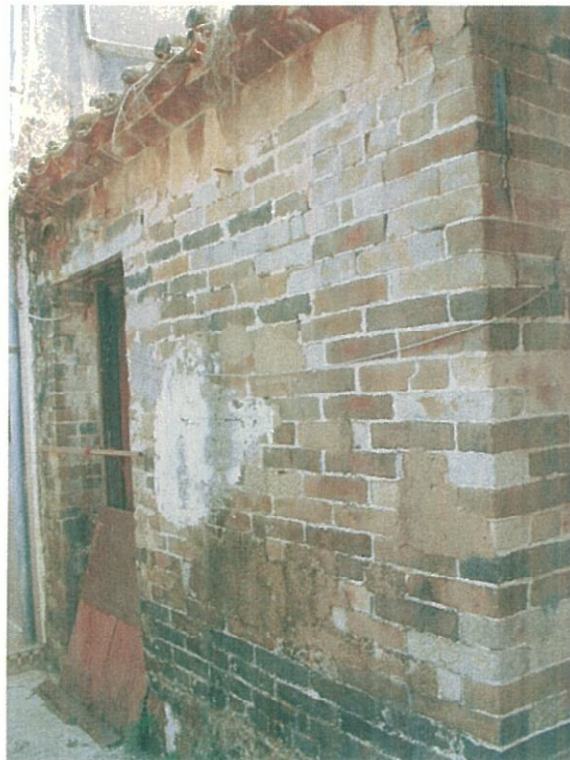
<b>Project: Proposed Development at Fung Lok Wai</b>	<b>Location: Tai Tseng Wai</b>	<b>Ref # FLW-58</b>
<b>Originally Recorded: 06/02/2001</b>	<b>Updated On: 24/04/2007</b>	
<b>Original Usage: Residential</b>	<b>Current Usage: Residential</b>	
<b>Orientation: Northeast</b>	<b>Map Reference: N/A</b>	
<b>Construction Date: Pre 1950</b>	<b>Ownership: Private</b>	
<b>Setting: Near the back of the village</b>	<b>Historical Associations: None</b>	
<b>Condition: Good</b>	<b>Degree of Modification: Low</b>	
<b>Architectural Significance: Low</b>	<b>Cultural Significance: Low</b>	
<b>Description: Brick end terrace unit. No decorative features. Tile roof.</b>		
<b>Inscriptions: None</b>		
<b>Additional Notes: None</b>

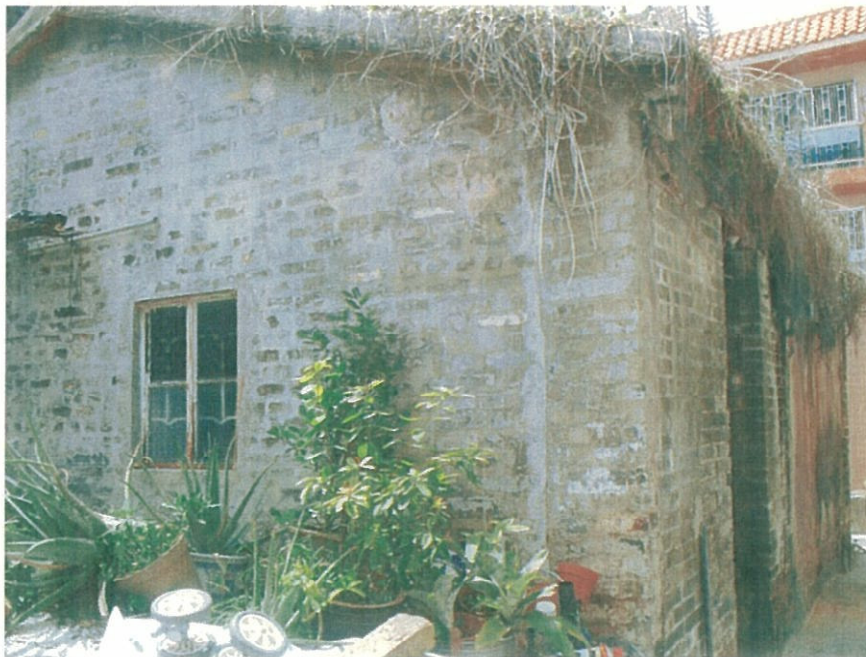
<b>Project: Proposed Development at Fung Lok Wai</b>	<b>Location: Tai Tseng Wai</b>	<b>Ref # FLW-59</b>
<b>Originally Recorded: 06/02/2001</b>	<b>Updated On: 24/04/2007</b>	
<b>Original Usage: Residential</b>	<b>Current Usage: Vacant/ Abandoned</b>	
<b>Orientation: Northeast</b>	<b>Map Reference: N/A</b>	
<b>Construction Date: Unknown</b>	<b>Ownership: Private</b>	
<b>Setting: Near the back of the village</b>	<b>Historical Associations: None</b>	
<b>Condition: Poor to ruin</b>	<b>Degree of Modification: Low</b>	
<b>Architectural Significance: Low</b>	<b>Cultural Significance: Low</b>	
<b>Description: Structure made of a mixture of different coloured bricks with pitched roof partially collapsed. Foundation is made of rubble stone.</b>		
<b>Inscriptions: None</b>		
<b>Additional Notes: None</b>

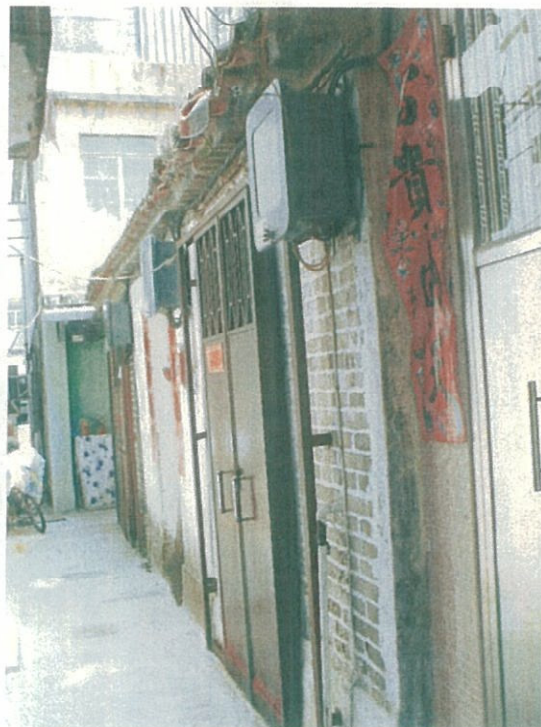
<b>Project: Proposed Development at Fung Lok Wai</b>	<b>Location: Tai Tseng Wai</b>	<b>Ref # FLW-60</b>
<b>Originally Recorded: 06/02/2001</b>	<b>Updated On: 24/04/2007</b>	
<b>Original Usage: Residential</b>	<b>Current Usage: Vacant/ Closed up</b>	
<b>Orientation: Northeast</b>	<b>Map Reference: N/A</b>	
<b>Construction Date: Pre 1950</b>	<b>Ownership: Private</b>	
<b>Setting: Near the back of the village</b>	<b>Historical Associations: None</b>	
<b>Condition: Poor</b>	<b>Degree of Modification: Low</b>	
<b>Architectural Significance: Low</b>	<b>Cultural Significance: Low</b>	
<b>Description: Three green brick (and pounded earth walls) courtyard terraced units, one end unit and one mid unit. One unit has sandstone foundation and the other has stone foundation. Pitched tile roofs on main sections and flat roofs on front.</b>		
<b>Inscriptions: None</b>		
<b>Additional Notes: None</b>

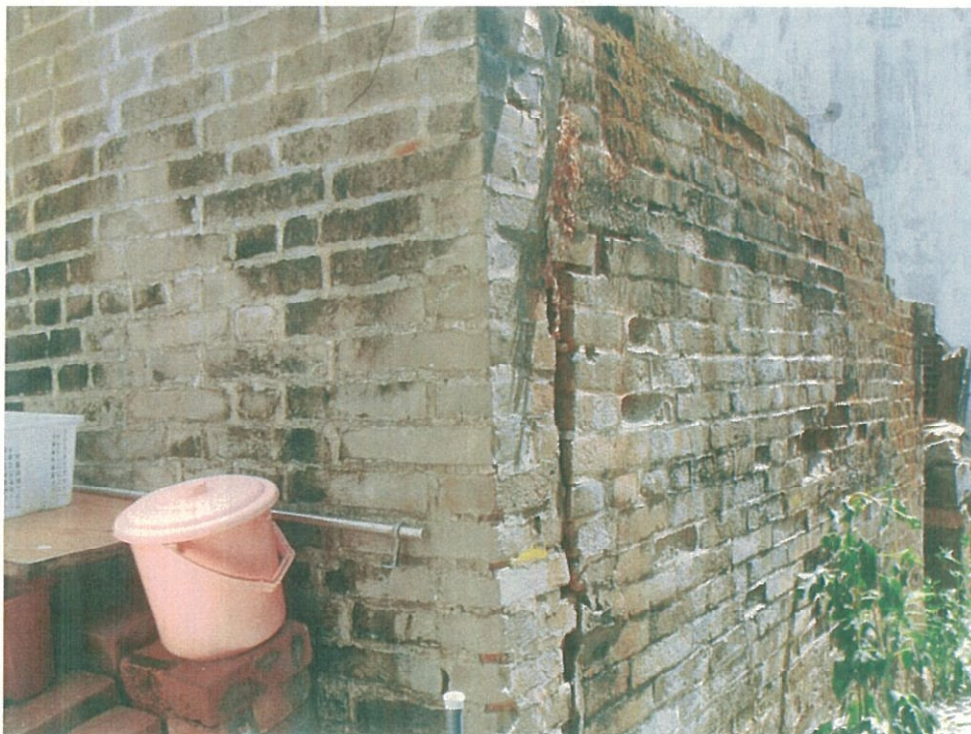
<b>Project: Proposed Development at Fung Lok Wai</b>	<b>Location: Tai Tseng Wai</b>	<b>Ref # FLW-61</b>
<b>Originally Recorded: 06/02/2001</b>	<b>Updated On: 24/04/2007</b>	
<b>Original Usage: Unknown</b>	<b>Current Usage: Abandoned</b>	
<b>Orientation: Northeast</b>	<b>Map Reference: N/A</b>	
<b>Construction Date: Unknown</b>	<b>Ownership: Private</b>	
<b>Setting: Front central section of the village</b>	<b>Historical Associations: None</b>	
<b>Condition: Ruin</b>	<b>Degree of Modification:</b>	
<b>Architectural Significance: Low</b>	<b>Cultural Significance: Low</b>	
<b>Description: Section of brick walls only remaining feature.</b>		
<b>Inscriptions: None</b>		
<b>Additional Notes: None</b>

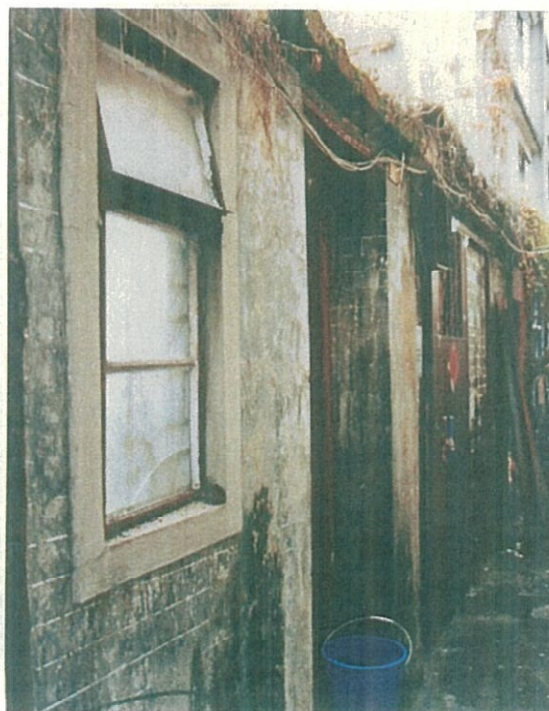
<b>Project: Proposed Development at Fung Lok Wai</b>	<b>Location: Tai Tseng Wai</b>	<b>Ref # FLW-62</b>
<b>Originally Recorded: 06/02/2001</b>	<b>Updated On: 24/04/2007</b>	
<b>Original Usage: Residential</b>	<b>Current Usage: Vacant/ Closed up</b>	
<b>Orientation: Northeast</b>	<b>Map Reference: #30 to 32</b>	
<b>Construction Date: Pre 1950</b>	<b>Ownership: Private</b>	
<b>Setting: Near the back of the village</b>	<b>Historical Associations: None</b>	
<b>Condition: Good</b>	<b>Degree of Modification:</b>	
<b>Architectural Significance: Moderate</b>	<b>Cultural Significance: Moderate</b>	
<b>Description: Three green brick courtyard terrace units. Central unit has render covering on façade. Pitched tile roofs on main section, flat roofs on the front. Windows have been added in two of the units rear walls.</b>		
<b>Inscriptions: None</b>		
<b>Additional Notes: None</b>

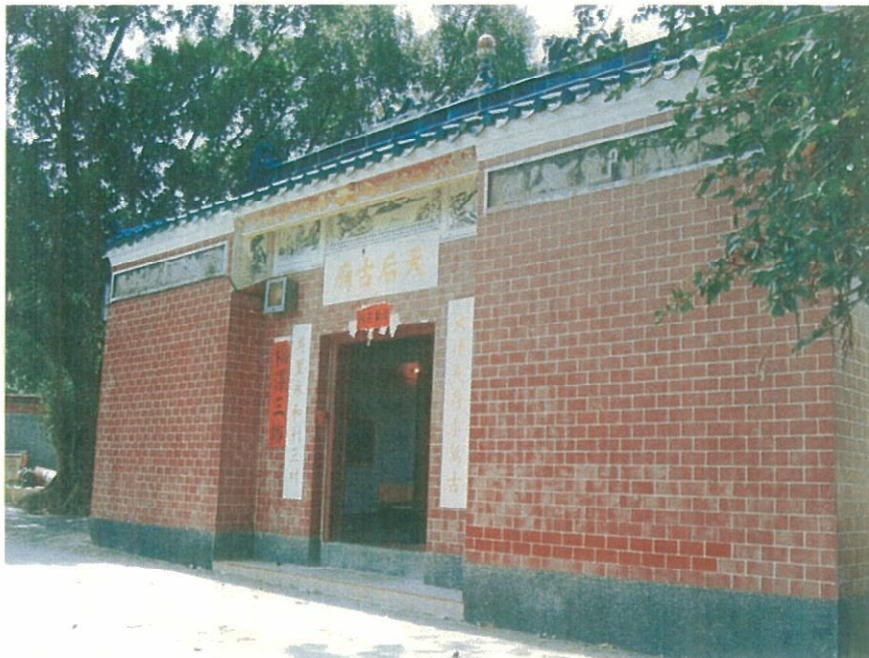
<b>Project:</b> Proposed Development at Fung Lok Wai	<b>Location:</b> Ng Uk Tsuen	<b>Ref #</b> FLW-63
<b>Originally Recorded:</b> 06/02/2001	<b>Updated On:</b> 24/04/2007	
<b>Original Usage:</b> Tin Hau Temple	<b>Current Usage:</b> Tin Hau Temple	
<b>Orientation:</b> South southwest	<b>Map Reference:</b> N/A	
<b>Construction Date:</b> Rebuilt in 1981	<b>Ownership:</b> Private	
<b>Setting:</b> To the west of the village in an open area	<b>Historical Associations:</b> None	
<b>Condition:</b> Good	<b>Degree of Modification:</b> High	
<b>Architectural Significance:</b> Moderate	<b>Cultural Significance:</b> High	
<b>Description:</b> Two halls with central courtyard. Tiles in red brick style on the exterior. Green ceramic decorative ridge. Decorative frieze panels on the façade under the eaves.		
<b>Inscriptions:</b> 天后古廟		
<b>Additional Notes:</b> The temple is shared by all three of the villages.

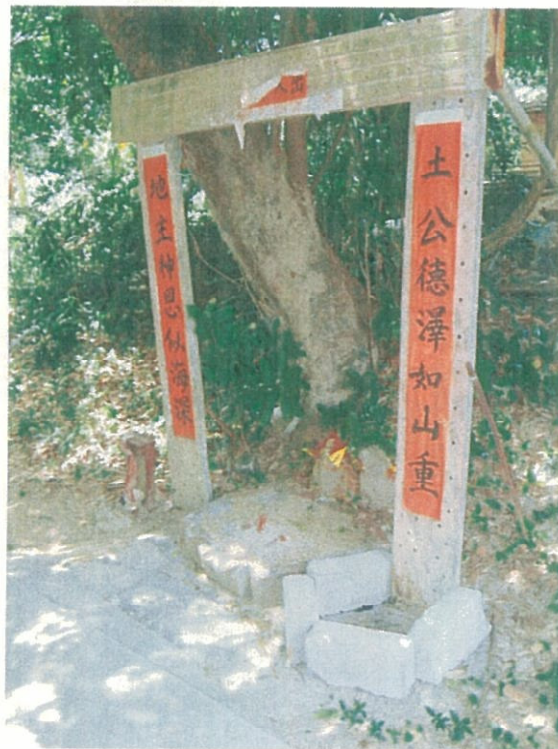
<b>Project:</b> Proposed Development at Fung Lok Wai	<b>Location:</b> Near Ng Uk Tsuen	<b>Ref #</b> FLW-64
<b>Originally Recorded:</b> 06/02/2001	<b>Updated On:</b> 24/04/2007	
<b>Original Usage:</b> Shrine	<b>Current Usage:</b> Shrine	
<b>Orientation:</b> Northeast	<b>Map Reference:</b> N/A	
<b>Construction Date:</b> Unknown	<b>Ownership:</b> Private	
<b>Setting:</b> Along the path between Ng Uk Tsuen and the Tin Hau Temple	<b>Historical Associations:</b> None	
<b>Condition:</b> Good	<b>Degree of Modification:</b> Low	
<b>Architectural Significance:</b> Low	<b>Cultural Significance:</b> High	
<b>Description:</b> Large Banyan tree with three wooden slats in a rectangle placed in front.		
<b>Inscriptions:</b> None		
<b>Additional Notes:</b> None

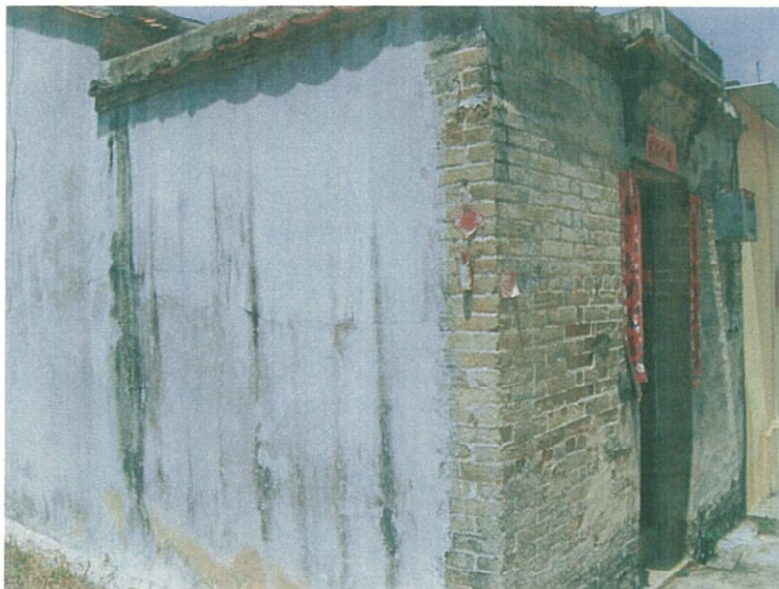
<b>Project: Proposed Development at Fung Lok Wai</b>	<b>Location: Ng Uk Tsuen</b>	<b>Ref # FLW-65</b>
<b>Originally Recorded: 06/02/2001</b>	<b>Updated On: 24/04/2007</b>	
<b>Original Usage: Residential</b>	<b>Current Usage: Closed up</b>	
<b>Orientation: South southwest</b>	<b>Map Reference: #85</b>	
<b>Construction Date: Pre 1950</b>	<b>Ownership: Private</b>	
<b>Setting: At the back of the village</b>	<b>Historical Associations: None</b>	
<b>Condition: Poor</b>	<b>Degree of Modification:</b>	
<b>Architectural Significance: Low</b>	<b>Cultural Significance: Low</b>	
<b>Description: Green brick and pounded earth courtyard style building. Brick on the façade and render covered pounded earth on the side. Flat roof on the front section and pitched tile roof on the main section. Decorative door hood over entrance.</b>		
<b>Inscriptions: None</b>		
<b>Additional Notes: None</b>

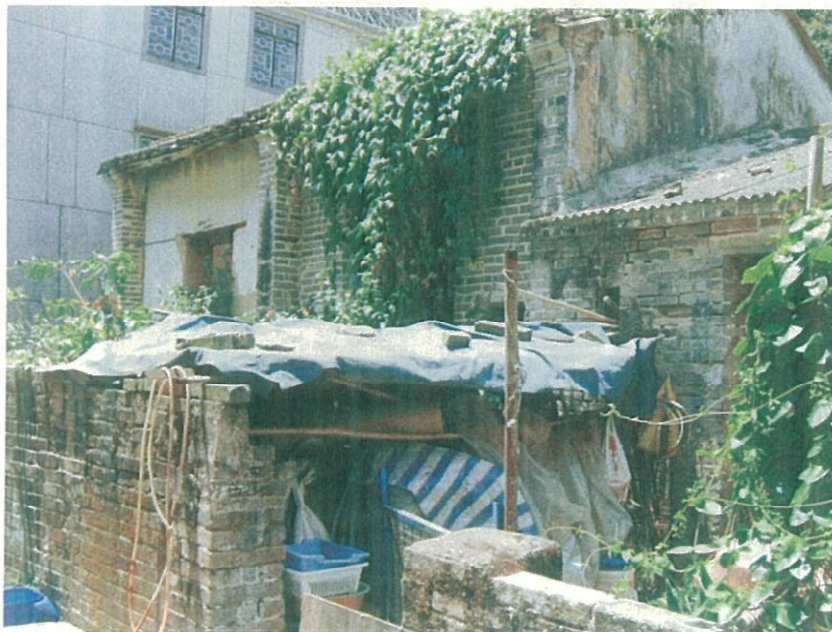
<b>Project: Proposed Development at Fung Lok Wai</b>	<b>Location: Ng Uk Tsuen</b>	<b>Ref # FLW-66</b>
<b>Originally Recorded: 06/02/2001</b>	<b>Updated On: 24/04/2007</b>	
<b>Original Usage: Residential</b>	<b>Current Usage: Closed up</b>	
<b>Orientation: South southwest</b>	<b>Map Reference: #67 and 68</b>	
<b>Construction Date: Pre 1950</b>	<b>Ownership: Private</b>	
<b>Setting: On the western edge of the village, not in a terrace row</b>	<b>Historical Associations: None</b>	
<b>Condition: Good</b>	<b>Degree of Modification: Low</b>	
<b>Architectural Significance: Moderate</b>	<b>Cultural Significance: Moderate</b>	
<b>Description: Two units with side annex. Pitched tile roof and green brick and pounded earth walls. Piers at centre and on ends of the façade, moulded decoration on the pier capitals only decorative feature.</b>		
<b>Inscriptions: None</b>		
<b>Additional Notes: None</b>

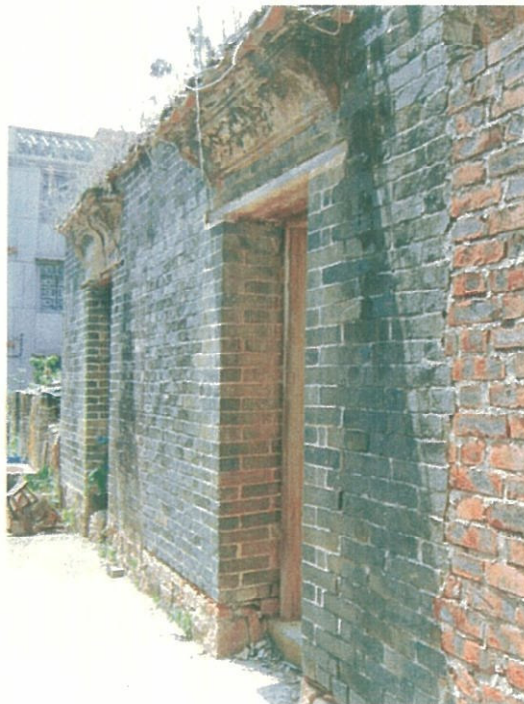
<b>Project: Proposed Development at Fung Lok Wai</b>	<b>Location: Ng Uk Tsuen</b>	<b>Ref # FLW-67</b>
<b>Originally Recorded: 06/02/2001</b>	<b>Updated On: 24/04/2007</b>	
<b>Original Usage: Residential</b>	<b>Current Usage: Abandoned</b>	
<b>Orientation: South southwest</b>	<b>Map Reference: Behind #76</b>	
<b>Construction Date:</b>	<b>Ownership: Private</b>	
<b>Setting: At the back of the village</b>	<b>Historical Associations: None</b>	
<b>Condition: Ruins</b>	<b>Degree of Modification: Low</b>	
<b>Architectural Significance: Low</b>	<b>Cultural Significance: Low</b>	
<b>Description: Two Green brick façade walls with decorative door hoods. Pondered earth inner wall sections. Wooden door frames. Doors missing.</b>		
<b>Inscriptions: None</b>		
<b>Additional Notes: None</b>

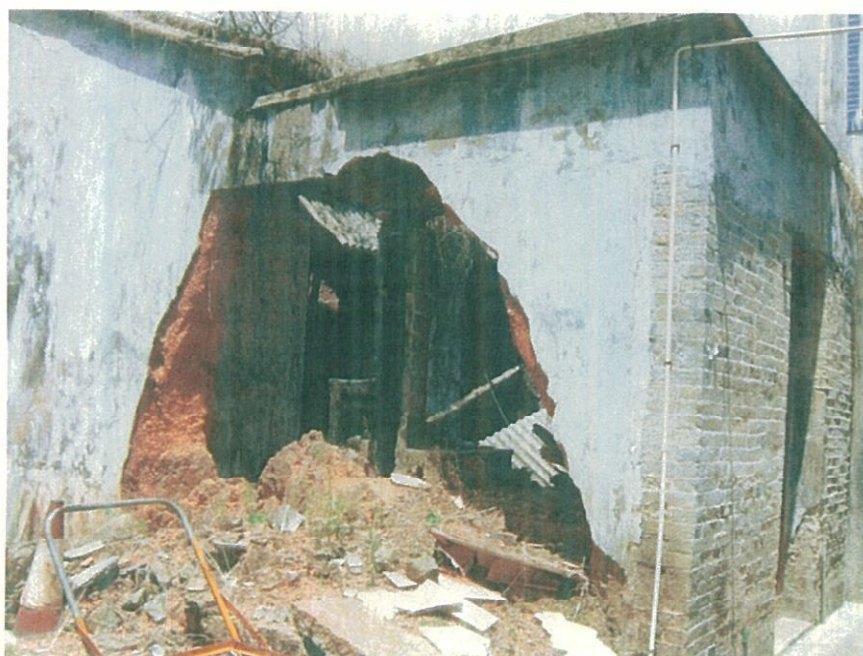
<b>Project:</b> Proposed Development at Fung Lok Wai	<b>Location:</b> Ng Uk Tsuen	<b>Ref #</b> FLW-68
<b>Originally Recorded:</b> 06/02/2001	<b>Updated On:</b> 24/04/2007	
<b>Original Usage:</b> Residential	<b>Current Usage:</b> Abandoned	
<b>Orientation:</b> South southwest	<b>Map Reference:</b> Behind #74	
<b>Construction Date:</b> Unknown	<b>Ownership:</b> Private	
<b>Setting:</b> At the back of the village	<b>Historical Associations:</b> None	
<b>Condition:</b> Ruin	<b>Degree of Modification:</b> Low	
<b>Architectural Significance:</b> Low	<b>Cultural Significance:</b> Low	
<b>Description:</b> Green brick and pounded earth courtyard terrace unit front section wall collapsed. Walls of main unit mostly intact but in poor condition.		
<b>Inscriptions:</b> None		
<b>Additional Notes:</b> None

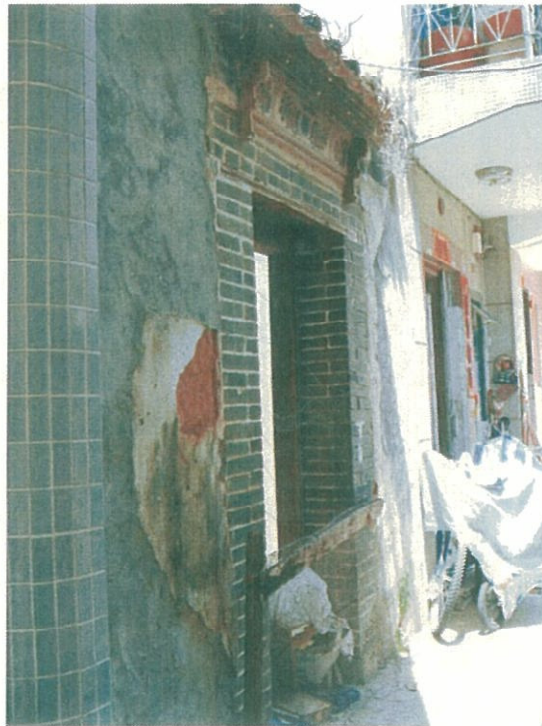
<b>Project: Proposed Development at Fung Lok Wai</b>	<b>Location: Ng Uk Tsuen</b>	<b>Ref # FLW-69</b>
<b>Originally Recorded: 06/02/2001</b>	<b>Updated On: 24/04/2007</b>	
<b>Original Usage: Unknown</b>	<b>Current Usage: Abandoned</b>	
<b>Orientation: South southwest</b>	<b>Map Reference: Beside #83</b>	
<b>Construction Date: Unknown</b>	<b>Ownership: Private</b>	
<b>Setting: At the back of the village</b>	<b>Historical Associations: None</b>	
<b>Condition: Ruin</b>	<b>Degree of Modification: Low</b>	
<b>Architectural Significance: Low</b>	<b>Cultural Significance: Low</b>	
<b>Description: Green brick and pounded earth façade with decorative door hood, painted decoration in good shape. No door or roof.</b>		
<b>Inscriptions: None</b>		
<b>Additional Notes: None</b>

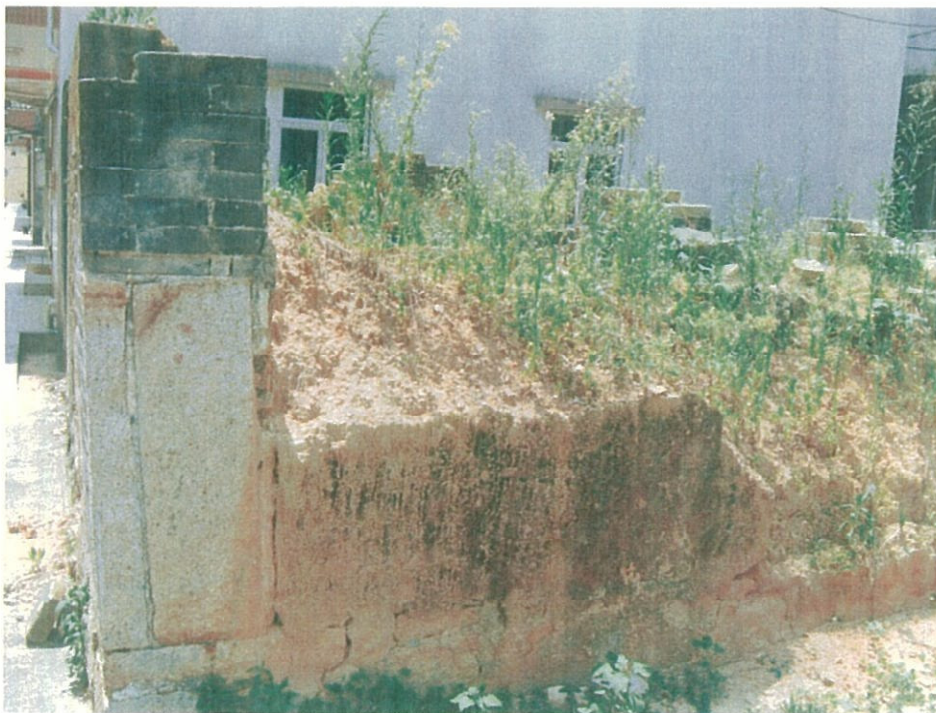
<b>Project: Proposed Development at Fung Lok Wai</b>	<b>Location: Ng Uk Tsuen</b>	<b>Ref # FLW-70</b>
<b>Originally Recorded: 06/02/2001</b>	<b>Updated On: 24/04/2007</b>	
<b>Original Usage: Unknown</b>	<b>Current Usage: Abandoned</b>	
<b>Orientation: South southwest</b>	<b>Map Reference: Beside #72</b>	
<b>Construction Date: Unknown</b>	<b>Ownership: Private</b>	
<b>Setting: At the back of the village (second to last row)</b>	<b>Historical Associations: None</b>	
<b>Condition: Ruin</b>	<b>Degree of Modification: Low</b>	
<b>Architectural Significance: Low</b>	<b>Cultural Significance: Low</b>	
<b>Description: Section of brick wall and collapsed pounded earth section.</b>		
<b>Inscriptions: None</b>		
<b>Additional Notes: None</b>

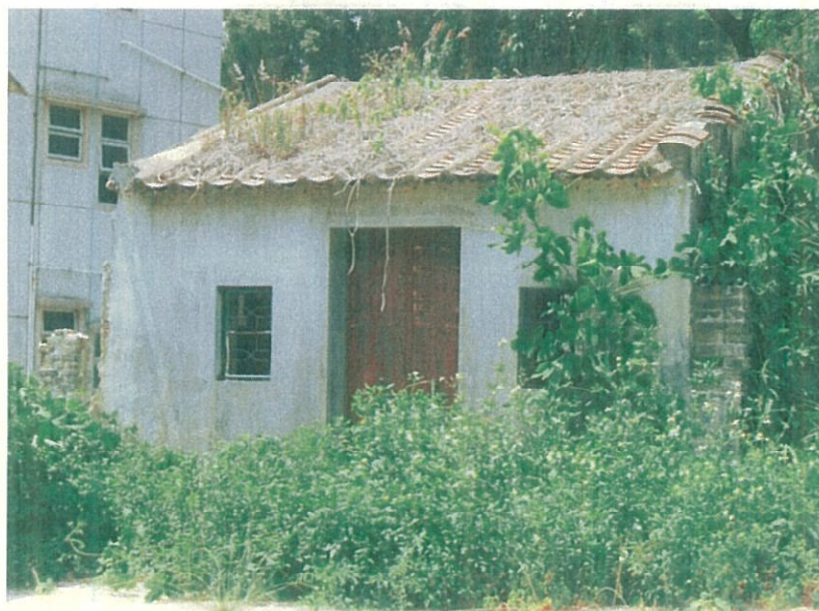
<b>Project: Proposed Development at Fung Lok Wai</b>	<b>Location: Ng Uk Tsuen</b>	<b>Ref # FLW-72</b>
<b>Originally Recorded: 06/02/2001</b>	<b>Updated On: 24/04/2007</b>	
<b>Original Usage: Residential</b>	<b>Current Usage: Closed up</b>	
<b>Orientation: South southwest</b>	<b>Map Reference: Behind #69</b>	
<b>Construction Date: Pre 1950</b>	<b>Ownership: Private</b>	
<b>Setting: To the east of the main village at the back</b>	<b>Historical Associations: None</b>	
<b>Condition: Poor</b>	<b>Degree of Modification: Low</b>	
<b>Architectural Significance: Low</b>	<b>Cultural Significance: Low</b>	
<b>Description: Small single room pounded earth and render covered shed. Pitched tile roof. Modern door and windows.</b>		
<b>Inscriptions: None</b>		
<b>Additional Notes: None</b>

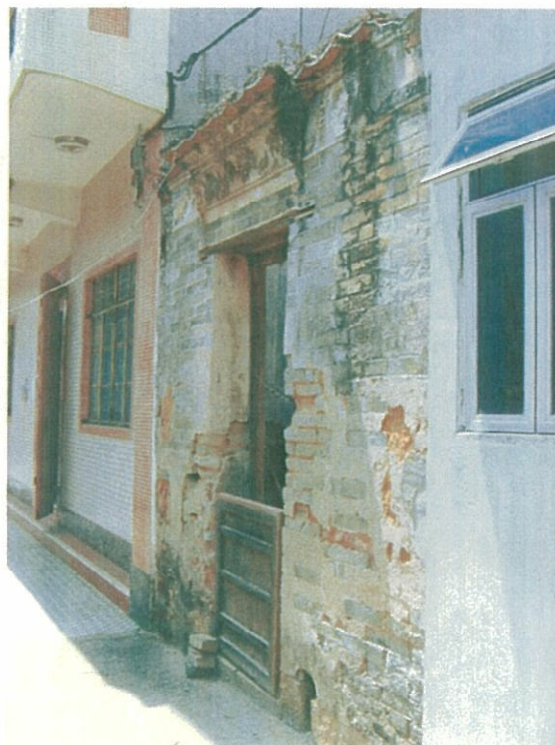
<b>Project:</b> Proposed Development at Fung Lok Wai	<b>Location:</b> Ng Uk Tsuen	<b>Ref #</b> FLW-73
<b>Originally Recorded:</b> 06/02/2001	<b>Updated On:</b> 24/04/2007	
<b>Original Usage:</b> Unknown	<b>Current Usage:</b> Abandoned	
<b>Orientation:</b> South southwest	<b>Map Reference:</b> #76	
<b>Construction Date:</b> Unknown	<b>Ownership:</b> Private	
<b>Setting:</b> At the back of the village (second to last row)	<b>Historical Associations:</b> None	
<b>Condition:</b> Ruin	<b>Degree of Modification:</b> Low	
<b>Architectural Significance:</b> Low	<b>Cultural Significance:</b> Low	
<b>Description:</b> Brick courtyard style terrace unit with decorative door hood and frieze panels on the façade. No roof over the front section		
<b>Inscriptions:</b> None		
<b>Additional Notes:</b> Were two units during the 2001 survey

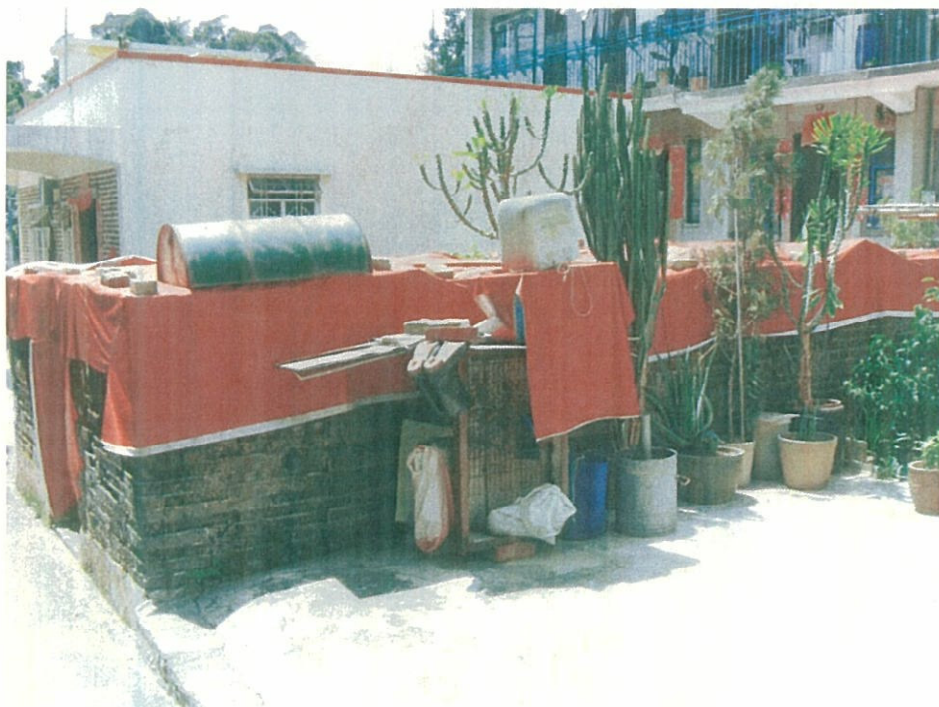
<b>Project: Proposed Development at Fung Lok Wai</b>	<b>Location: Ng Uk Tsuen</b>	<b>Ref # FLW-74</b>
<b>Originally Recorded: 06/02/2001</b>	<b>Updated On: 24/04/2007</b>	
<b>Original Usage: Unknown</b>	<b>Current Usage: Abandoned</b>	
<b>Orientation: South southwest</b>	<b>Map Reference: In front of #79-80</b>	
<b>Construction Date: Unknown</b>	<b>Ownership: Private</b>	
<b>Setting: Central section of the village</b>	<b>Historical Associations: None</b>	
<b>Condition: Ruin</b>	<b>Degree of Modification: Low</b>	
<b>Architectural Significance: Low</b>	<b>Cultural Significance: Low</b>	
<b>Description: Lower sections of brick walls.</b>		
<b>Inscriptions: None</b>		
<b>Additional Notes: None</b>

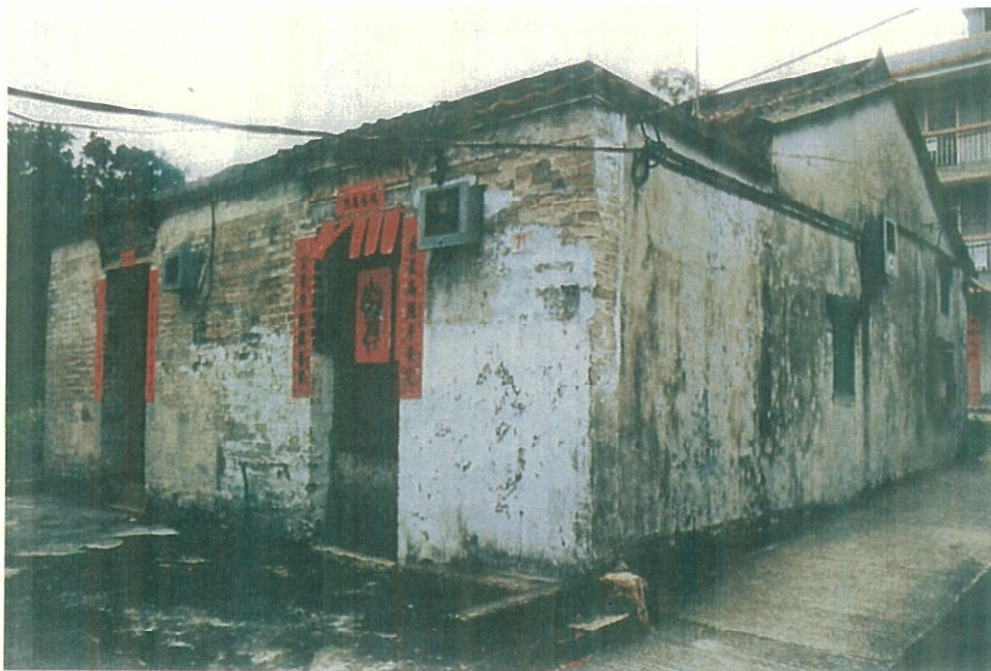
<b>Project:</b> Proposed Development at Fung Lok Wai	<b>Location:</b> Ng Uk Tsuen	<b>Ref #</b> FLW-75
<b>Originally Recorded:</b> 06/02/2001	<b>Updated On:</b> 24/04/2007	
<b>Original Usage:</b> Residential	<b>Current Usage:</b> Closed up	
<b>Orientation:</b> South southwest	<b>Map Reference:</b> #67 and 68	
<b>Construction Date:</b> Pre 1950	<b>Ownership:</b> Private	
<b>Setting:</b> On the western edge of the village, not in a terrace row	<b>Historical Associations:</b> None	
<b>Condition:</b> Good	<b>Degree of Modification:</b> Low	
<b>Architectural Significance:</b> Moderate	<b>Cultural Significance:</b> Moderate	
<b>Description:</b> Two units with side annex. Pitched tile roof and green brick and pounded earth walls. Piers at centre and on ends of the façade, moulded decoration on the pier capitals only decorative feature.		
<b>Inscriptions:</b> None		
<b>Additional Notes:</b> None

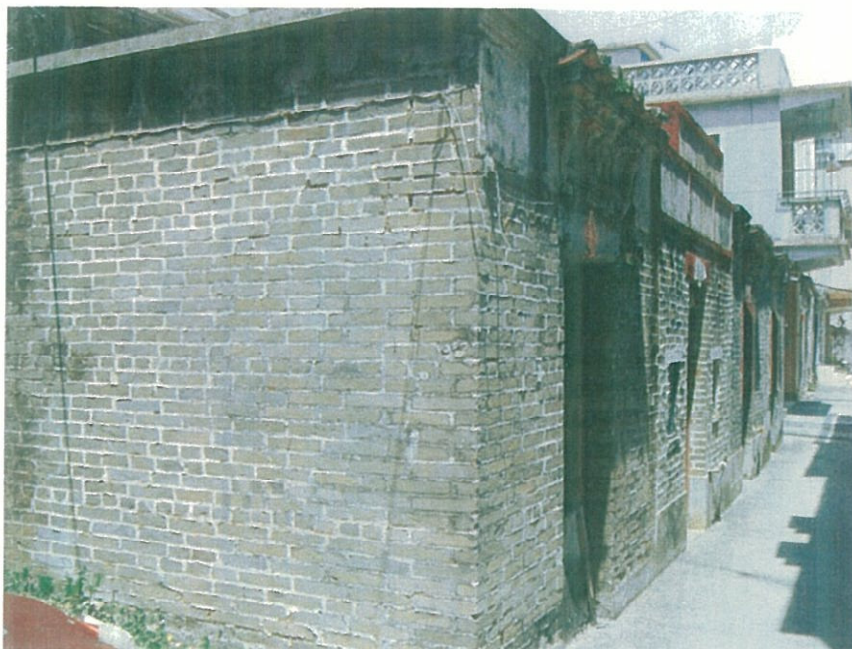
<b>Project:</b> Proposed Development at Fung Lok Wai	<b>Location:</b> Ng Uk Tsuen	<b>Ref #</b> FLW-77
<b>Originally Recorded:</b> 06/02/2001	<b>Updated On:</b> 24/04/2007	
<b>Original Usage:</b> Residential	<b>Current Usage:</b> Closed up	
<b>Orientation:</b> South southwest	<b>Map Reference:</b> #61 to 64	
<b>Construction Date:</b> Pre 1950	<b>Ownership:</b> Private	
<b>Setting:</b> Central section of the village	<b>Historical Associations:</b> None	
<b>Condition:</b> Good to poor	<b>Degree of Modification:</b> Moderate	
<b>Architectural Significance:</b> Moderate	<b>Cultural Significance:</b> Low	
<b>Description:</b> Four green brick courtyard style units, three have traditional decorative door hoods and one has a modern parapet (Plain). Flat roofs over the front sections and pitched tile roof over the main section.		
<b>Inscriptions:</b> None		
<b>Additional Notes:</b> None
