<b>Project:</b> Proposed Development at Fung Lok Wai	<b>Location:</b> Shing Uk Tsuen	<b>Ref #</b> FLW-01
<b>Originally Recorded:</b> 06/02/2001	<b>Updated On:</b> 24/04/2007	
<b>Original Usage:</b> Tsz Tong (Kwing Ling Tong)	<b>Current Usage:</b> Tsz Tong (Kwing Ling Tong)	
<b>Orientation:</b> Southwest	<b>Map Reference:</b> N/A	
<b>Construction Date:</b> 1971	<b>Ownership:</b> Private	
<b>Setting:</b> At the front of the village	<b>Historical Associations:</b> None	
<b>Condition:</b> Good	<b>Degree of Modification:</b> Modern structure	
<b>Architectural Significance:</b> Low	<b>Cultural Significance:</b> High	
<b>Description:</b> Concrete two storey structure with single storey annex room on the left side. Flat roof. Building is painted yellow with grey trim at the base. Balcony across the façade of the first floor.		
<b>Inscriptions:</b> 廣陵堂		
<b>Additional Notes:</b> None

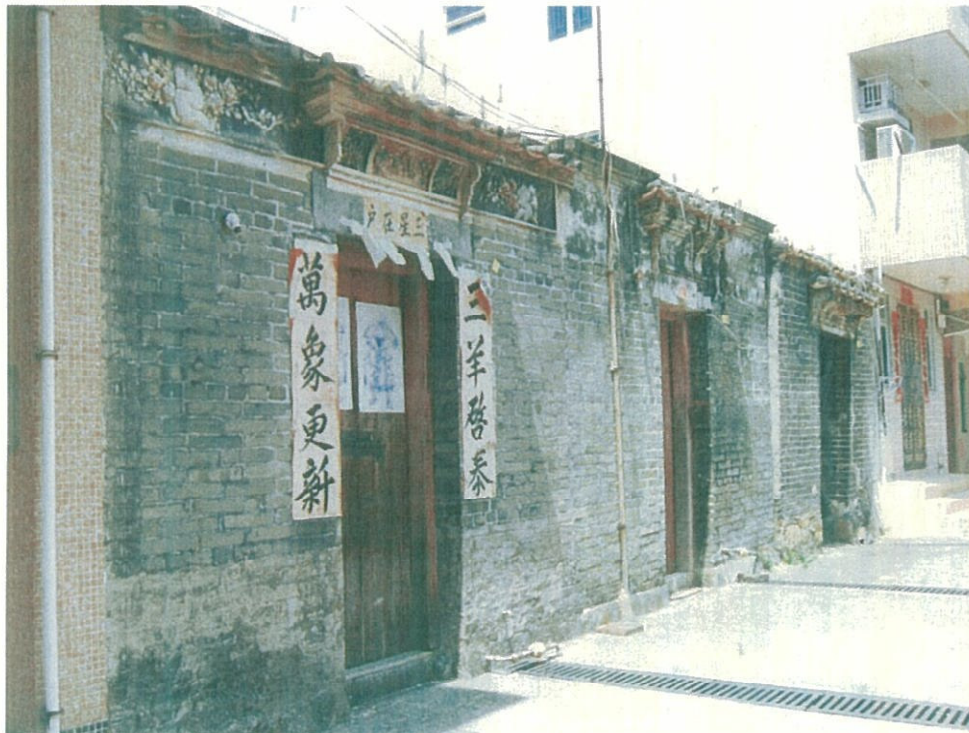
<b>Project:</b> Proposed Development at Fung Lok Wai	<b>Location:</b> Ng Uk Tsuen	<b>Ref #</b> FLW-78
<b>Originally Recorded:</b> 06/02/2001	<b>Updated On:</b> 24/04/2007	
<b>Original Usage:</b> Residential	<b>Current Usage:</b> Closed up	
<b>Orientation:</b> South southwest	<b>Map Reference:</b> #57 to 59	
<b>Construction Date:</b> Pre 1950	<b>Ownership:</b> Private	
<b>Setting:</b> Central section of the village	<b>Historical Associations:</b> None	
<b>Condition:</b> Good	<b>Degree of Modification:</b> Low	
<b>Architectural Significance:</b> Moderate	<b>Cultural Significance:</b> Low	
<b>Description:</b> Row of three green brick courtyard style units. Double panel wooden doors. Decorative door hoods over the entrances with some sections of decorative frieze panels intact.		
<b>Inscriptions:</b> None		
<b>Additional Notes:</b> Were four units in 2001 survey.

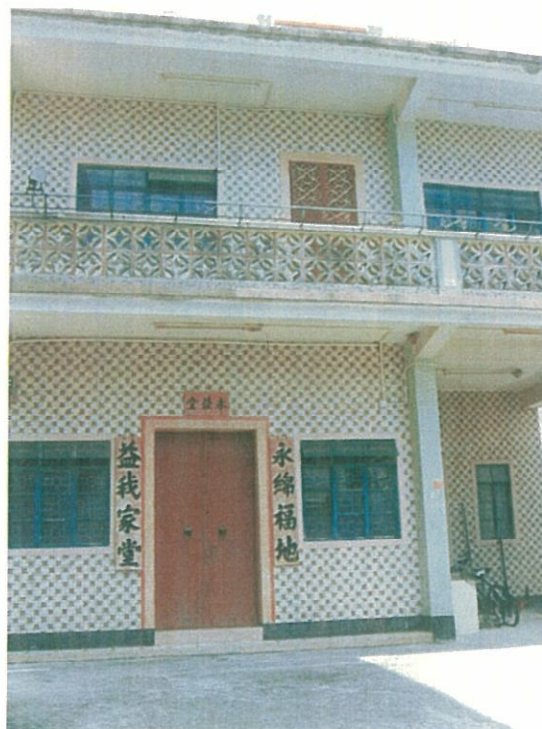
<b>Project:</b> Proposed Development at Fung Lok Wai	<b>Location:</b> Ng Uk Tsuen	<b>Ref #</b> FLW-79
<b>Originally Recorded:</b> 06/02/2001	<b>Updated On:</b> 24/04/2007	
<b>Original Usage:</b> Tsz Tong	<b>Current Usage:</b> Tsz Tong	
<b>Orientation:</b> South southwest	<b>Map Reference:</b> #35	
<b>Construction Date:</b> Unknown	<b>Ownership:</b> Private	
<b>Setting:</b> Eastern side of the village, middle terrace row	<b>Historical Associations:</b> None	
<b>Condition:</b> Good	<b>Degree of Modification:</b> High	
<b>Architectural Significance:</b> Low	<b>Cultural Significance:</b> High	
<b>Description:</b> Modern two storey village terrace structure. Tile façade with balcony on the first floor.		
<b>Inscriptions:</b> 永益堂		
<b>Additional Notes:</b> None

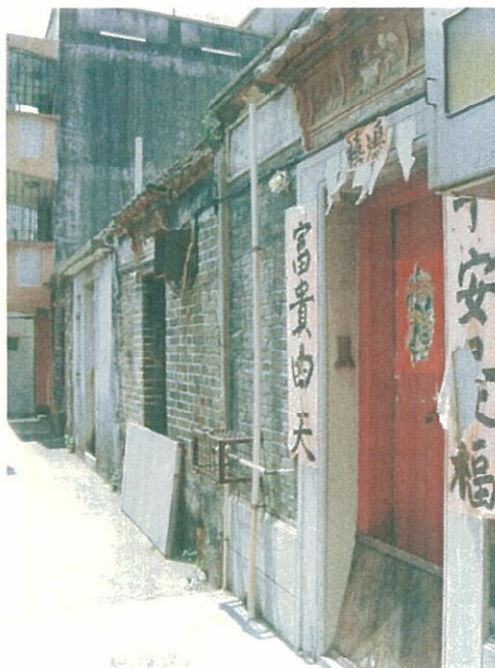
<b>Project:</b> Proposed Development at Fung Lok Wai	<b>Location:</b> Ng Uk Tsuen	<b>Ref #</b> FLW-80
<b>Originally Recorded:</b> 06/02/2001	<b>Updated On:</b> 24/04/2007	
<b>Original Usage:</b> Residential	<b>Current Usage:</b> Closed up	
<b>Orientation:</b> South southwest	<b>Map Reference:</b> #36 and 37	
<b>Construction Date:</b> Pre 1950	<b>Ownership:</b> Private	
<b>Setting:</b> Central section of the village	<b>Historical Associations:</b> None	
<b>Condition:</b> Good	<b>Degree of Modification:</b> Moderate	
<b>Architectural Significance:</b> Moderate	<b>Cultural Significance:</b> Low	
<b>Description:</b> Four green brick courtyard terrace units. One with traditional façade and door hoods. One has modern door frame with traditional decorative door hood. One has modified façade and the last is a green brick façade with no decorative features in ruinous condition.		
<b>Inscriptions:</b> None

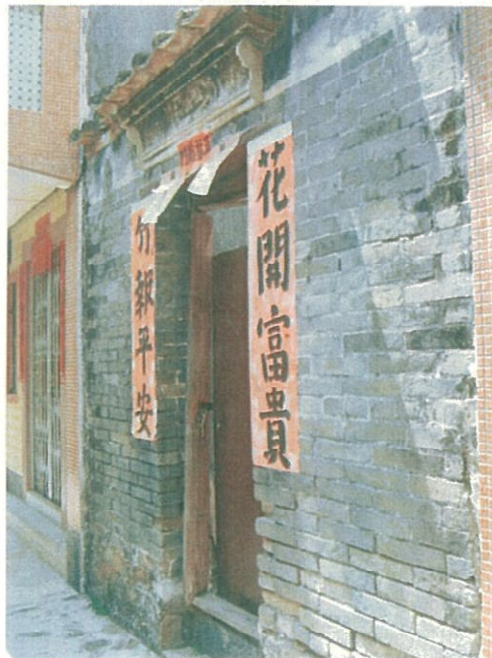
<b>Project: Proposed Development at Fung Lok Wai</b>	<b>Location: Ng Uk Tsuen</b>	<b>Ref # FLW-81</b>
<b>Originally Recorded: 06/02/2001</b>	<b>Updated On: 24/04/2007</b>	
<b>Original Usage: Residential</b>	<b>Current Usage: Closed up</b>	
<b>Orientation: South southwest</b>	<b>Map Reference: #44</b>	
<b>Construction Date: Pre 1950</b>	<b>Ownership: Private</b>	
<b>Setting: Central section of the village</b>	<b>Historical Associations: None</b>	
<b>Condition: Poor to ruin</b>	<b>Degree of Modification: Low</b>	
<b>Architectural Significance: Low</b>	<b>Cultural Significance: Low</b>	
<b>Description: Green brick façade with no roof over front courtyard section. Main section has pitched tile roof with plain ridge. Decorative door good over the entrance and plain frieze panels on façade.</b>		
<b>Inscriptions: None</b>		
<b>Additional Notes: None</b>

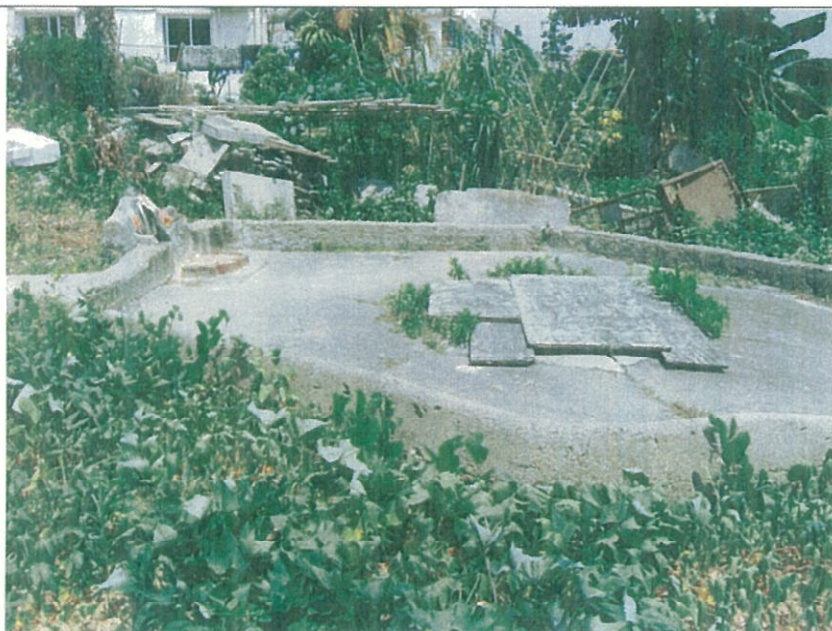
<b>Project: Proposed Development at Fung Lok Wai</b>	<b>Location: Ng Uk Tsuen</b>	<b>Ref # FLW-82</b>
<b>Originally Recorded: 06/02/2001</b>	<b>Updated On: 24/04/2007</b>	
<b>Original Usage: Well</b>	<b>Current Usage: Not in use</b>	
<b>Orientation: South southwest</b>	<b>Map Reference: N/A</b>	
<b>Construction Date: Unknown</b>	<b>Ownership: Private</b>	
<b>Setting: To the southwest of the village</b>	<b>Historical Associations: None</b>	
<b>Condition: Good</b>	<b>Degree of Modification: Moderate</b>	
<b>Architectural Significance: Low</b>	<b>Cultural Significance: High</b>	
<b>Description: Well enclosure has been covered in concrete. Small shrine with incense holder.</b>		
<b>Inscriptions: None</b>		
<b>Additional Notes: None</b>

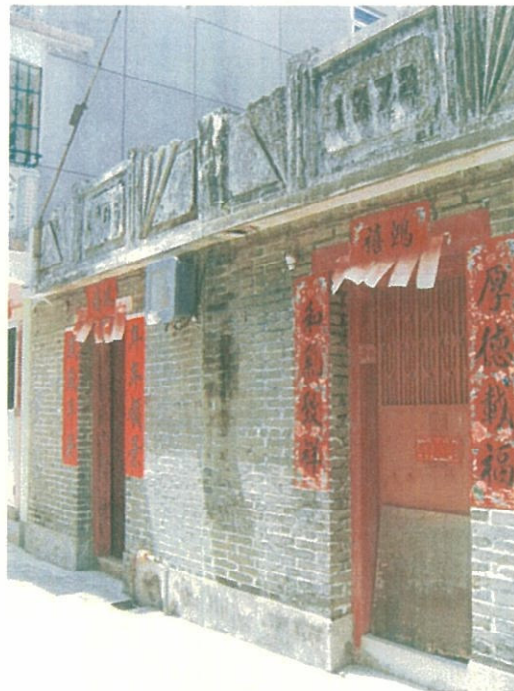
<b>Project:</b> Proposed Development at Fung Lok Wai	<b>Location:</b> Ng Uk Tsuen	<b>Ref #</b> FLW-83
<b>Originally Recorded:</b> 06/02/2001	<b>Updated On:</b> 24/04/2007	
<b>Original Usage:</b> Residential	<b>Current Usage:</b> Closed up	
<b>Orientation:</b> South southwest	<b>Map Reference:</b> #30	
<b>Construction Date:</b> Pre 1950	<b>Ownership:</b> Private	
<b>Setting:</b> Front central section of the village	<b>Historical Associations:</b> None	
<b>Condition:</b> Good	<b>Degree of Modification:</b>	
<b>Architectural Significance:</b> Low	<b>Cultural Significance:</b> Low	
<b>Description:</b> Two green brick courtyard terrace style structures. Modern parapet across the front with 1972 renovation date. Double panel wooden door on one unit and modern gate on the other unit.		
<b>Inscriptions:</b> "1972" on parapet		
<b>Additional Notes:</b> None

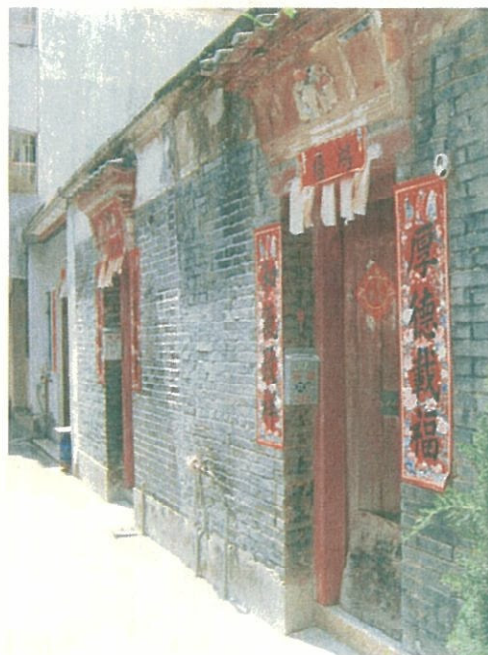
<b>Project: Proposed Development at Fung Lok Wai</b>	<b>Location: Ng Uk Tsuen</b>	<b>Ref # FLW-84</b>
<b>Originally Recorded: 06/02/2001</b>	<b>Updated On: 24/04/2007</b>	
<b>Original Usage: Residential</b>	<b>Current Usage:</b>	
<b>Orientation: South southwest</b>	<b>Map Reference: #26 and 25</b>	
<b>Construction Date: Pre 1950</b>	<b>Ownership: Private</b>	
<b>Setting: At the southeastern (front section) of the main village</b>	<b>Historical Associations: None</b>	
<b>Condition: Good</b>	<b>Degree of Modification:</b>	
<b>Architectural Significance: Moderate</b>	<b>Cultural Significance: Moderate</b>	
<b>Description: Two green brick courtyard style terrace mid units. Both units have decorative door hoods with moulded and painted decoration and cut granite thresholds with traditional wooden doors in wooden frames. Frieze panels are present under the eaves on the façade but the decoration has faded.</b>

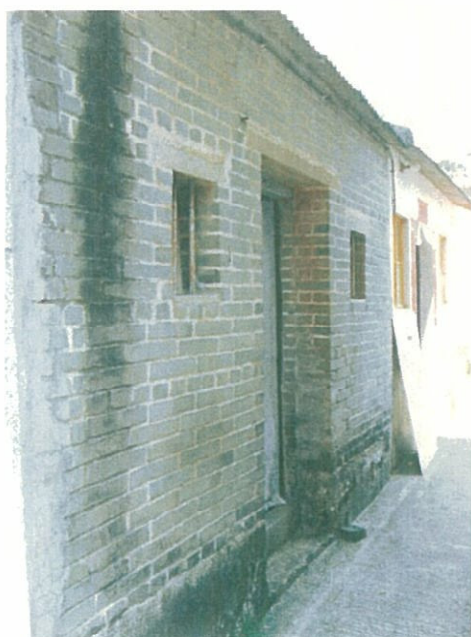
<b>Project:</b> Proposed Development at Fung Lok Wai	<b>Location:</b> Ng Uk Tsuen	<b>Ref #</b> FLW-85
<b>Originally Recorded:</b> 06/02/2001	<b>Updated On:</b> 24/04/2007	
<b>Original Usage:</b> Residential	<b>Current Usage:</b> Residential / vacant/ storage	
<b>Orientation:</b> South southwest	<b>Map Reference:</b> Behind row 7 to 10	
<b>Construction Date:</b> According to local informants they were built during the Japanese Occupation as village housing	<b>Ownership:</b> Private	
<b>Setting:</b> At the back of the southeastern end of the village, away from the main village.	<b>Historical Associations:</b> None	
<b>Condition:</b> Poor to good	<b>Degree of Modification:</b> Low to moderate	
<b>Architectural Significance:</b> Low	<b>Cultural Significance:</b> Moderate	
<b>Description:</b> Two small terraced units constructed of mud brick, green brick mixture. Single story with pitched roofs. No decorative features.

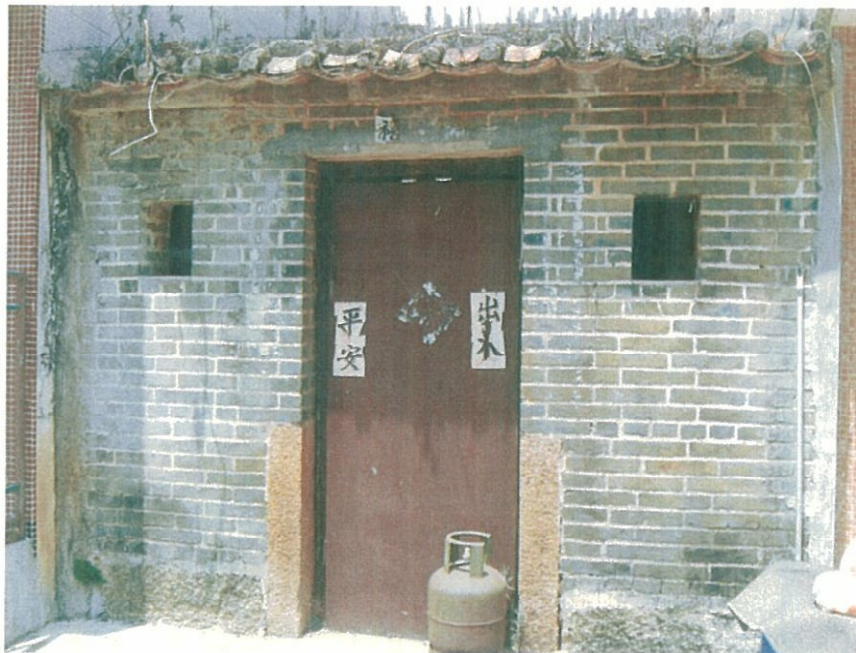
<b>Project:</b> Proposed Development at Fung Lok Wai	<b>Location:</b> Ng Uk Tsuen	<b>Ref #</b> FLW-87
<b>Originally Recorded:</b> 06/02/2001	<b>Updated On:</b> 24/04/2007	
<b>Original Usage:</b> Residential	<b>Current Usage:</b> Storage/ closed up	
<b>Orientation:</b> Southwest	<b>Map Reference:</b> Between 8 and 9	
<b>Construction Date:</b> Pre 1950	<b>Ownership:</b> Private	
<b>Setting:</b> At the southeastern side of the village near the entrance gate.	<b>Historical Associations:</b> None	
<b>Condition:</b> Poor	<b>Degree of Modification:</b> Low	
<b>Architectural Significance:</b> Low	<b>Cultural Significance:</b> Low	
<b>Description:</b> Green brick mid terrace unit pitched roof (with vegetation growth). Cut granite at façade foundation and at sides of the doorway. Two small rectangular openings on the façade. No decorative features.		
<b>Inscriptions:</b> None		
<b>Additional Notes:</b> None

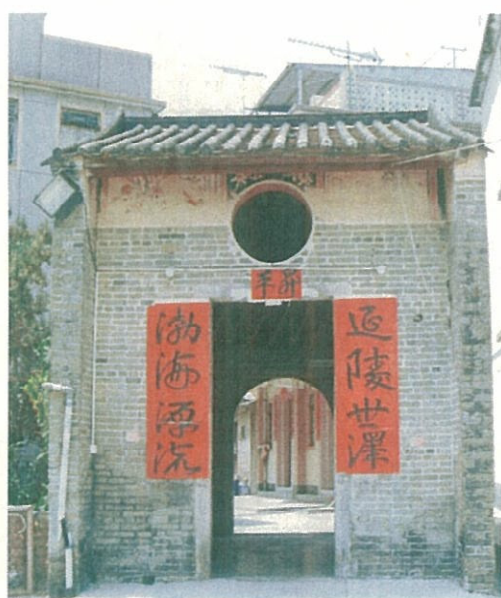
<b>Project:</b> Proposed Development at Fung Lok Wai	<b>Location:</b> Ng Uk Tsuen	<b>Ref #</b> FLW-88
<b>Originally Recorded:</b> 06/02/2001	<b>Updated On:</b> 24/04/2007	
<b>Original Usage:</b> Village gate	<b>Current Usage:</b> Village gate	
<b>Orientation:</b> South	<b>Map Reference:</b> Beside # 5-6	
<b>Construction Date:</b> Unknown	<b>Ownership:</b> Private	
<b>Setting:</b> At the southeastern section of the village away from the main section.	<b>Historical Associations:</b> None	
<b>Condition:</b> Good	<b>Degree of Modification:</b>	
<b>Architectural Significance:</b> High (rare for a gate to be freestanding)	<b>Cultural Significance:</b> High	
<b>Description:</b> Detached entrance gate of green brick. Tile and chunam pitched roof with plain ridge. Rectangular entrance on front and brick arch on rear entrance. Single room with storage area above.		
<b>Inscriptions:</b> None		
<b>Additional Notes:</b> The gate faces south south east whilst the majority of the village structures face South southwest.

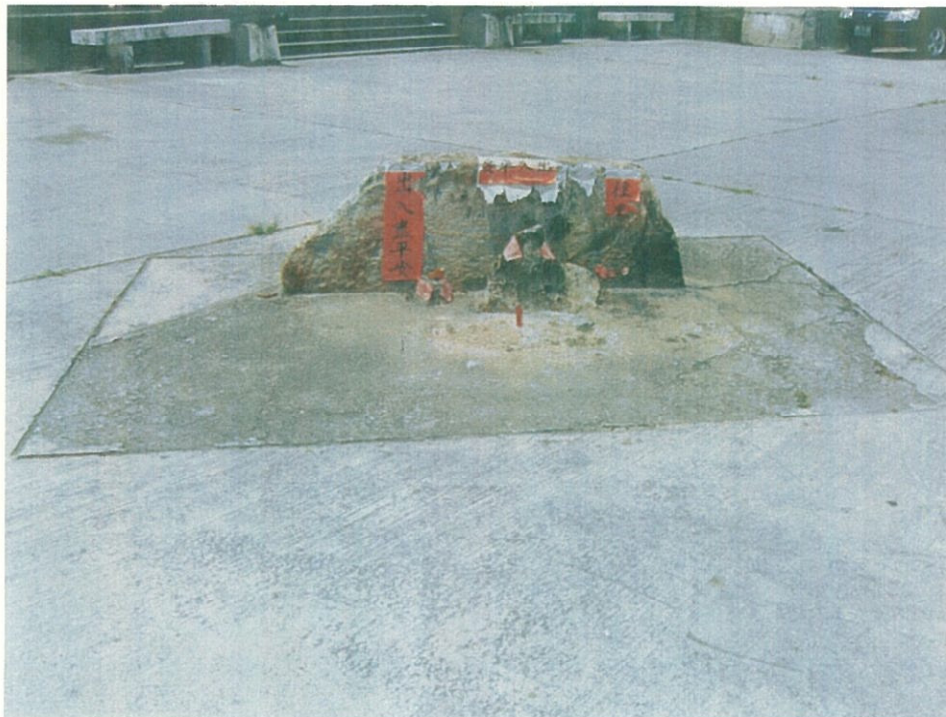
<b>Project: Proposed Development at Fung Lok Wai</b>	<b>Location: Ng Uk Tsuen</b>	<b>Ref # FLW-89</b>
<b>Originally Recorded: 06/02/2001</b>	<b>Updated On: 24/04/2007</b>	
<b>Original Usage: Shrine</b>	<b>Current Usage: Shrine</b>	
<b>Orientation: South southwest</b>	<b>Map Reference: N/A</b>	
<b>Construction Date: Unknown</b>	<b>Ownership: Private</b>	
<b>Setting: To the southeast of the village, currently located in a paved car park village entry area.</b>	<b>Historical Associations: None</b>	
<b>Condition: Good</b>	<b>Degree of Modification: Low</b>	
<b>Architectural Significance: Low</b>	<b>Cultural Significance: High</b>	
<b>Description: Consists of small stones set in concrete with concrete incense holder.</b>		
<b>Inscriptions: None</b>		
<b>Additional Notes: None</b>

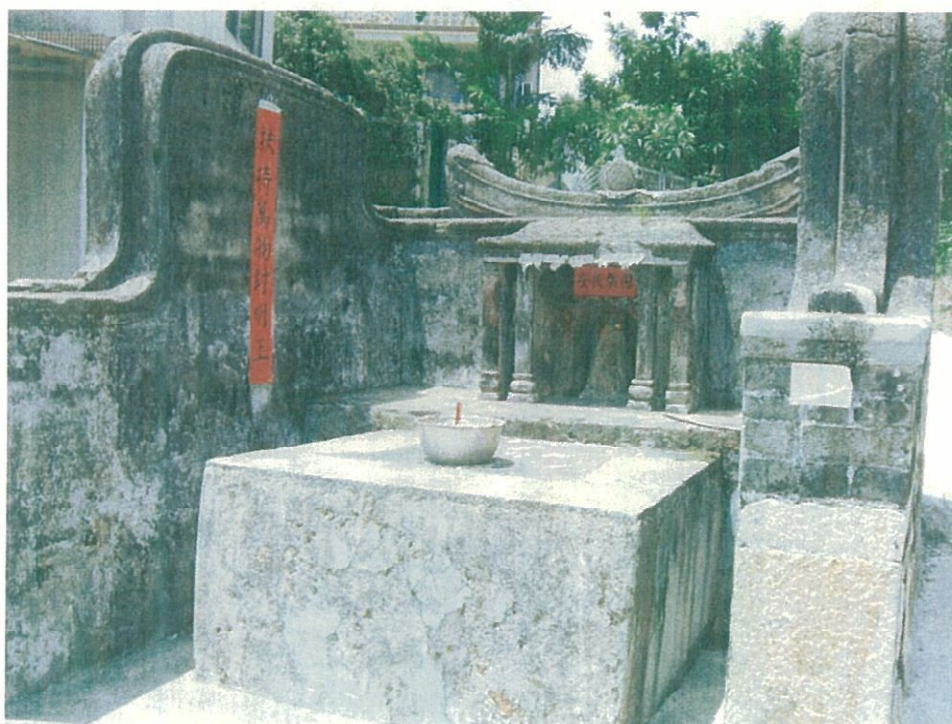
<b>Project:</b> Proposed Development at Fung Lok Wai	<b>Location:</b> Ng Uk Tsuen	<b>Ref #</b> FLW-90
<b>Originally Recorded:</b> 06/02/2001	<b>Updated On:</b> 24/04/2007	
<b>Original Usage:</b> Shrine	<b>Current Usage:</b> Shrine	
<b>Orientation:</b> South southwest	<b>Map Reference:</b> N/A	
<b>Construction Date:</b> Unknown	<b>Ownership:</b> Private	
<b>Setting:</b> To the southeast of the village	<b>Historical Associations:</b> None	
<b>Condition:</b> Good	<b>Degree of Modification:</b>	
<b>Architectural Significance:</b>	<b>Cultural Significance:</b>	
<b>Description:</b> Green brick shrine with wok yee style gable sides and decorative ridge on back wall. Cut granite base and corner stones. Triangular stone set in frame in the centre of the back wall. Cut granite incense holder.		
<b>Inscriptions:</b> None		
<b>Additional Notes:</b> None

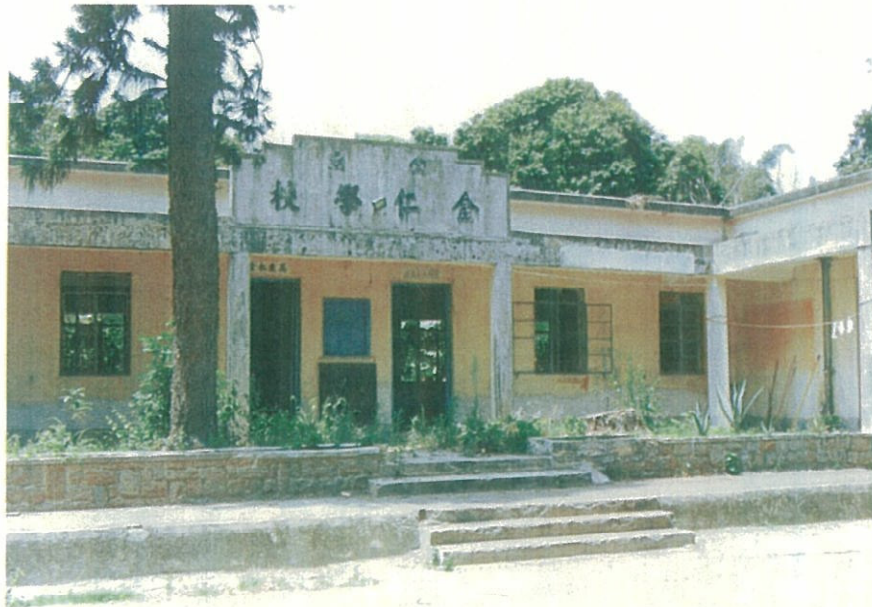
<b>Project:</b> Proposed Development at Fung Lok Wai	<b>Location:</b> Ng Uk Tsuen	<b>Ref #</b> FLW-91
<b>Originally Recorded:</b> 06/02/2001	<b>Updated On:</b> 24/04/2007	
<b>Original Usage:</b> School	<b>Current Usage:</b> Abandoned (and see additional notes)	
<b>Orientation:</b> South southeast	<b>Map Reference:</b> N/A	
<b>Construction Date:</b> Unknown	<b>Ownership:</b> Private	
<b>Setting:</b> To the southeast of the village in a wooded area.	<b>Historical Associations:</b> None	
<b>Condition:</b> Poor	<b>Degree of Modification:</b>	
<b>Architectural Significance:</b>	<b>Cultural Significance:</b>	
<b>Description:</b> Rectangular concrete structure with recessed entrance on façade. Single story with flat roof. Stepped parapet on the façade with inscription of the school name. The southwestern wing of the school building has been replaced with a modern structure as of the 2007 survey.		
<b>Inscriptions:</b> 公立 金仁學校

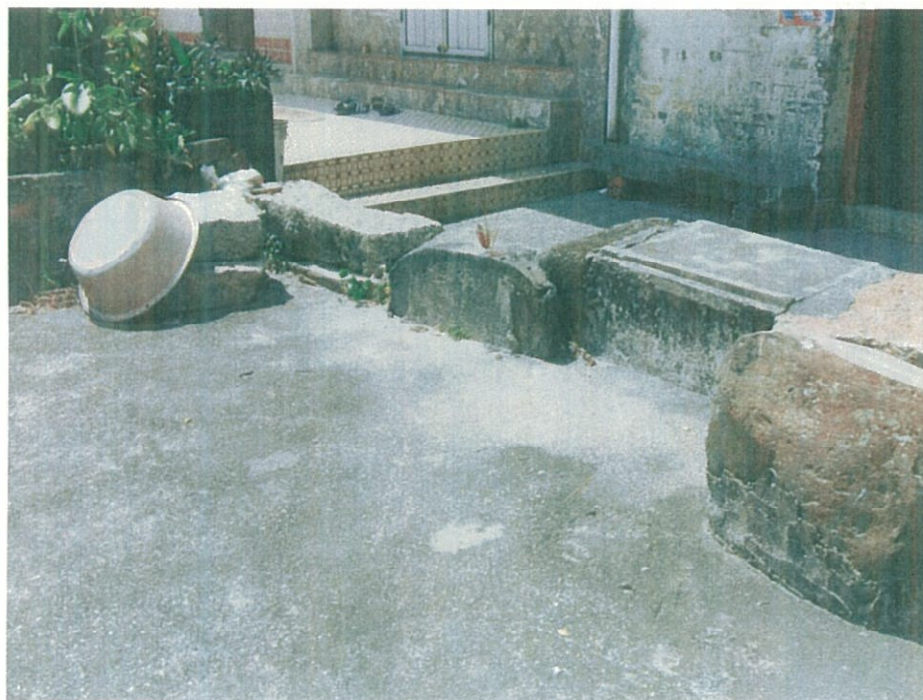
<b>Project: Proposed Development at Fung Lok Wai</b>	<b>Location: Ng Uk Tsuen</b>	<b>Ref # FLW-92</b>
<b>Originally Recorded: 06/02/2001</b>	<b>Updated On: 24/04/2007</b>	
<b>Original Usage: Shrine</b>	<b>Current Usage:</b>	
<b>Orientation: South southwest</b>	<b>Map Reference: N/A</b>	
<b>Construction Date: Unknown</b>	<b>Ownership: Private</b>	
<b>Setting: At the southwestern edge of the village.</b>	<b>Historical Associations: None</b>	
<b>Condition: Good</b>	<b>Degree of Modification: Low</b>	
<b>Architectural Significance: Low</b>	<b>Cultural Significance: High</b>	
<b>Description: Building stones and moulded blocks with concrete incense holder. Plain with no decorative features.</b>		
<b>Inscriptions: None</b>		
<b>Additional Notes: None</b>

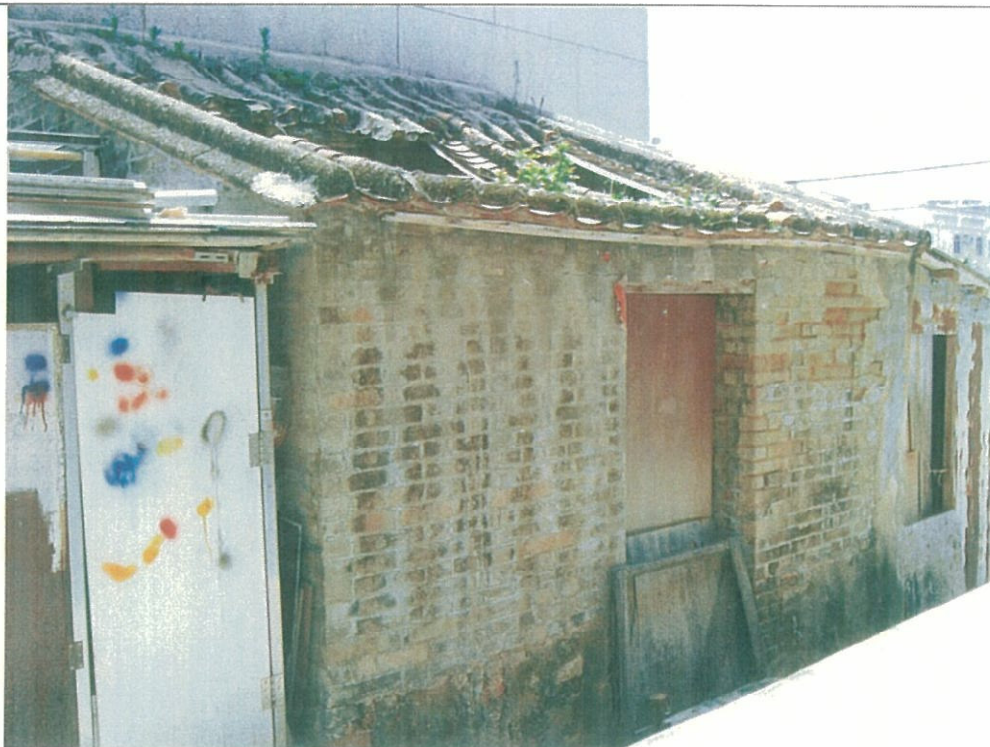
<b>Project:</b> Proposed Development at Fung Lok Wai	<b>Location:</b> Ng Uk Tsuen	<b>Ref #</b> FLW-93
<b>Originally Recorded:</b> 06/02/2001	<b>Updated On:</b> 24/04/2007	
<b>Original Usage:</b> Shed/ possibly residential	<b>Current Usage:</b> Storage	
<b>Orientation:</b> North	<b>Map Reference:</b>	
<b>Construction Date:</b> Pre 1950	<b>Ownership:</b> Private	
<b>Setting:</b> To the east of the main village near the front.	<b>Historical Associations:</b> None	
<b>Condition:</b> Good	<b>Degree of Modification:</b> Low	
<b>Architectural Significance:</b> Low	<b>Cultural Significance:</b> Low	
<b>Description:</b> Grey brick rectangular structure with uncut stone foundation. Pitched tile roof. Double panel wooden door. No decorative features.		
<b>Inscriptions:</b> None		
<b>Additional Notes:</b> None
