## **Appendix 2: Landscape Master Plan**

**Section 16 Planning Application for  
Proposed Tai Po Kau Nature Academy at Tai Po Kau, Tai Po**

**Landscape Master Plan**

Prepared by:  
2 Square Metres Design Limited

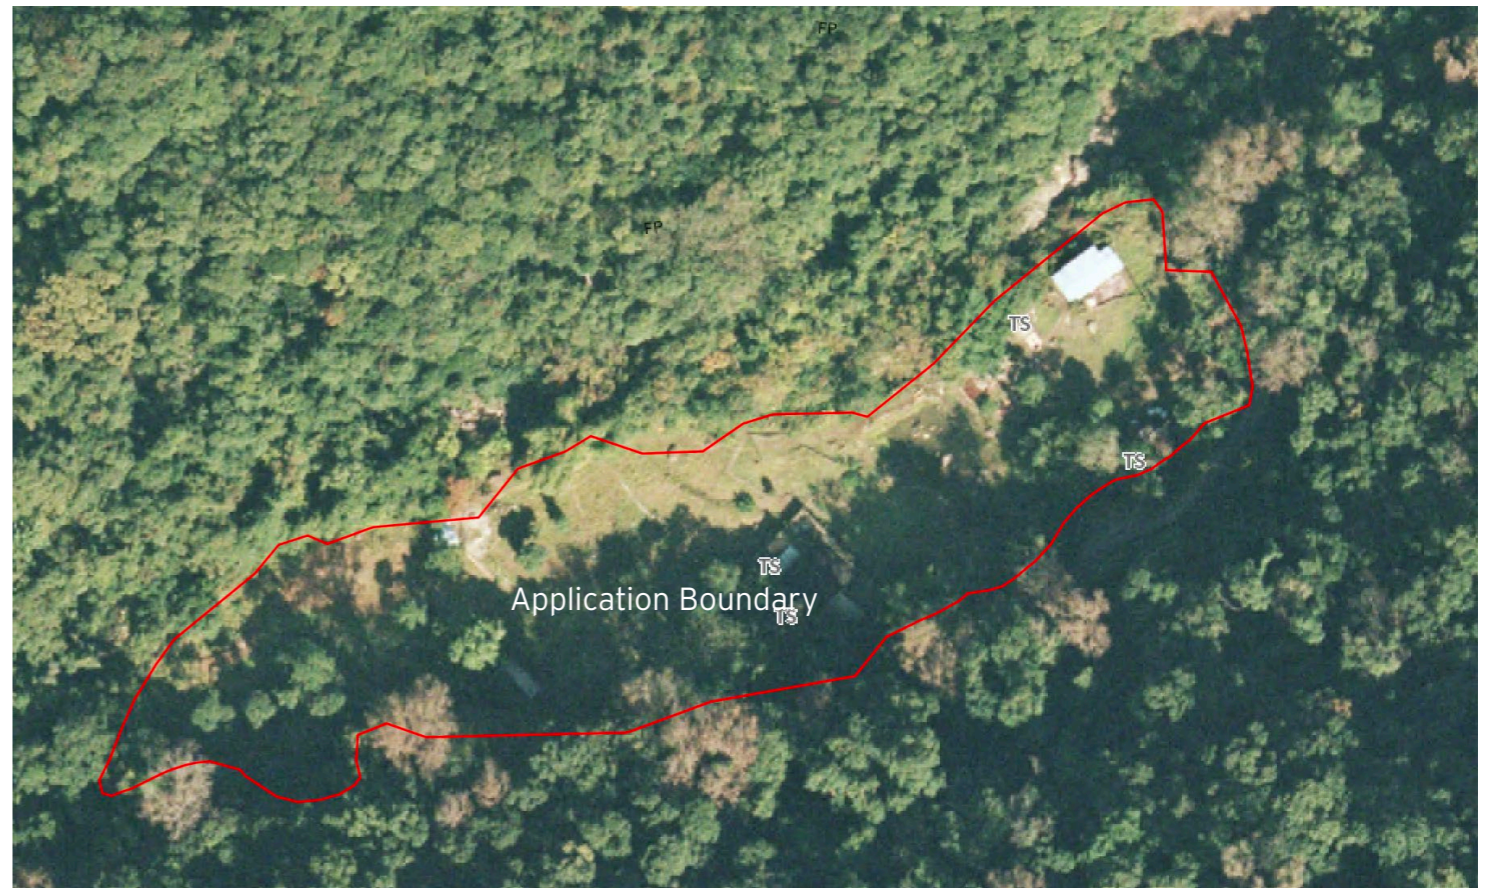
Figure 2.1 Site Map

- 2.1 The Application Site has a total area of about 0.9ha and ranges in elevation from approximately +99 mPD in the northeast to +123mPD in the southwest. It is located between Tai Po Kau Forest Track - Kau Lead Section and a natural stream. It is adjacent to the Tai Po Kau Nature Reserve on 3 sides. The site was an abandoned farmland. Its surrounding has dense tree coverage whilst tree coverage within the Application Site is comparatively low (Refer to **Figure 2.1**). The site falls into Upland and Hillside Landscape and Settled Valley Landscape according to Landscape Character Map of Hong Kong.

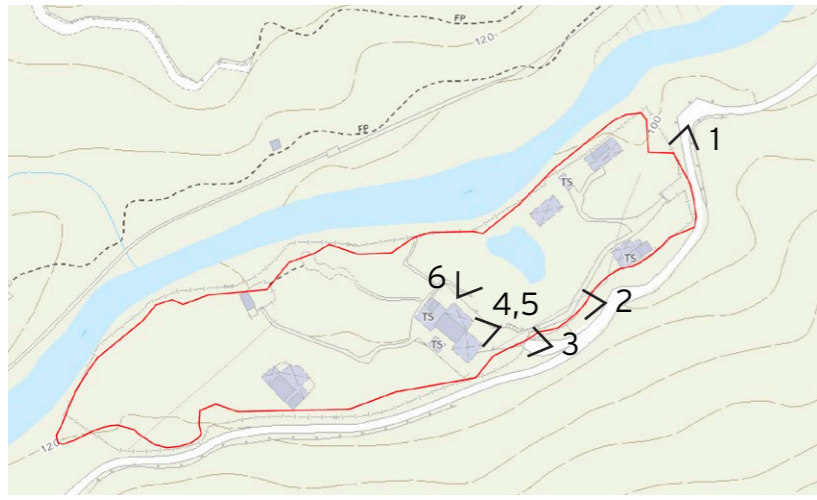
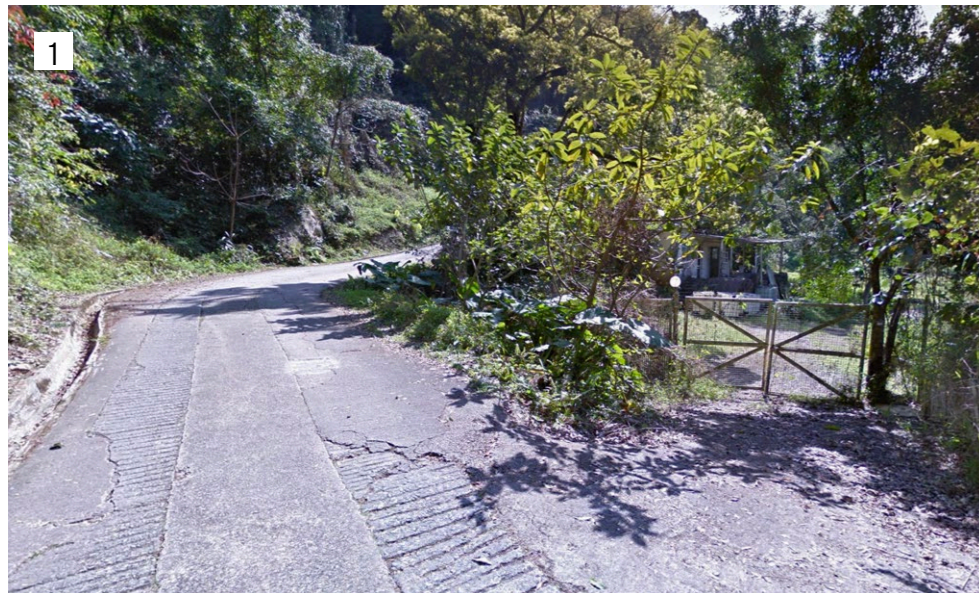
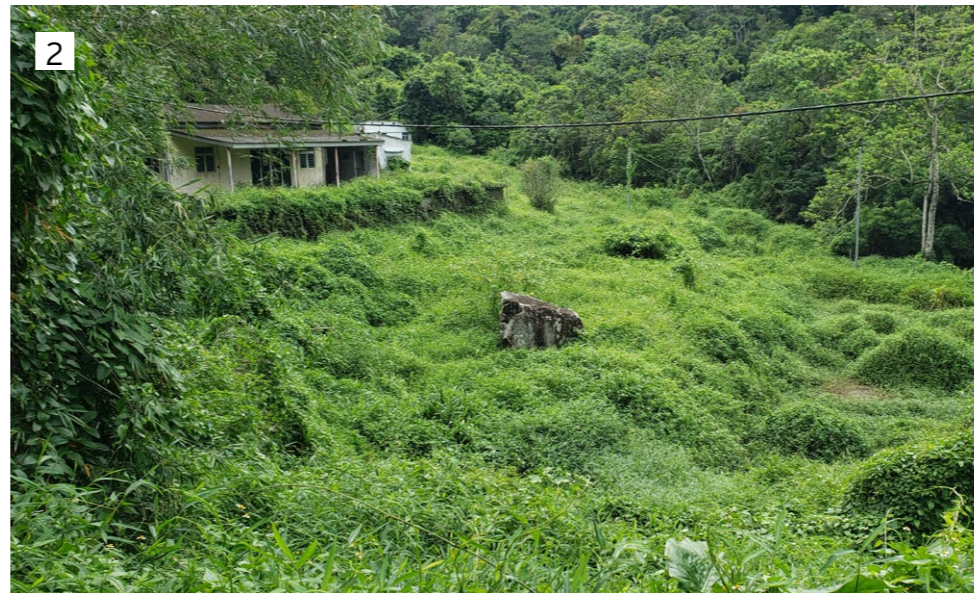
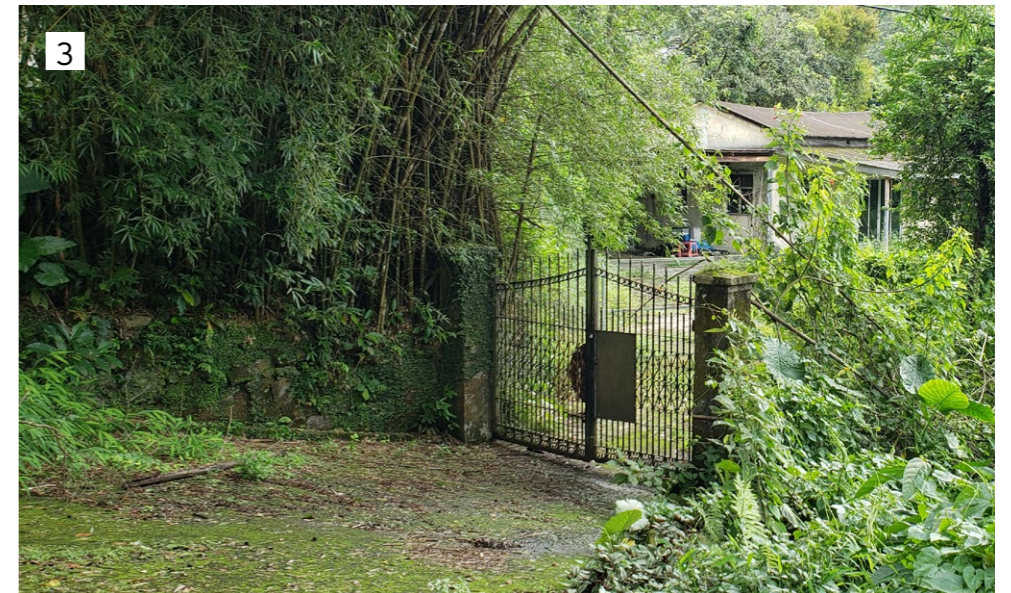
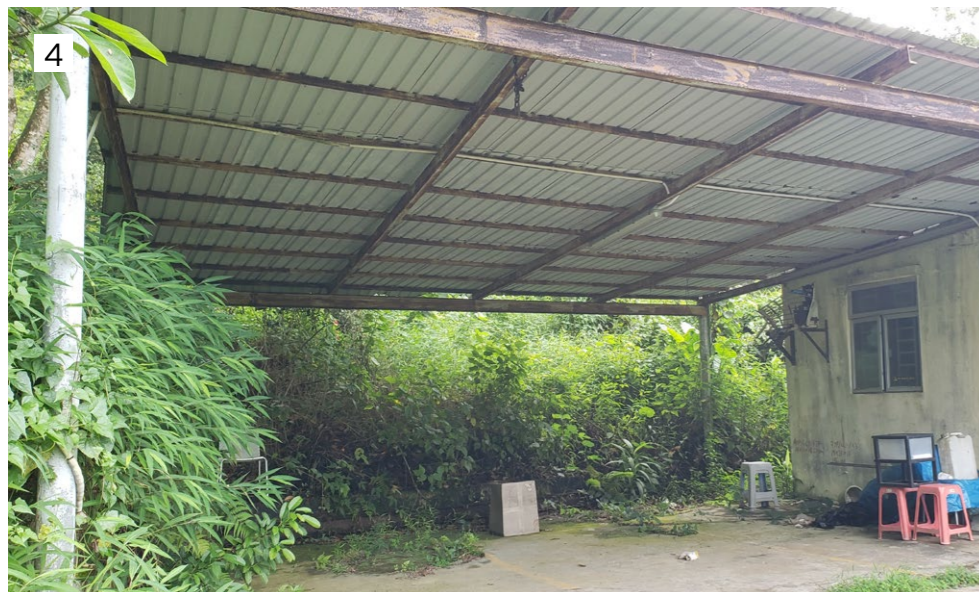
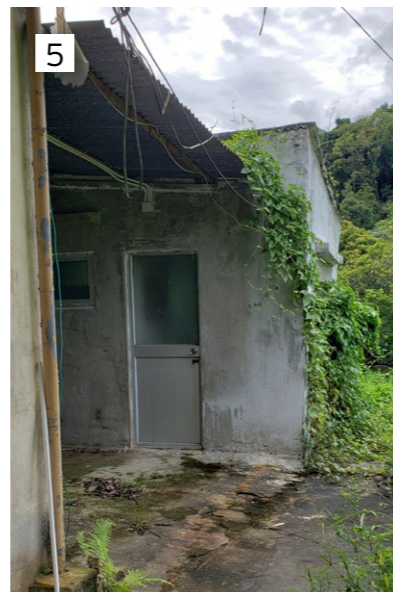
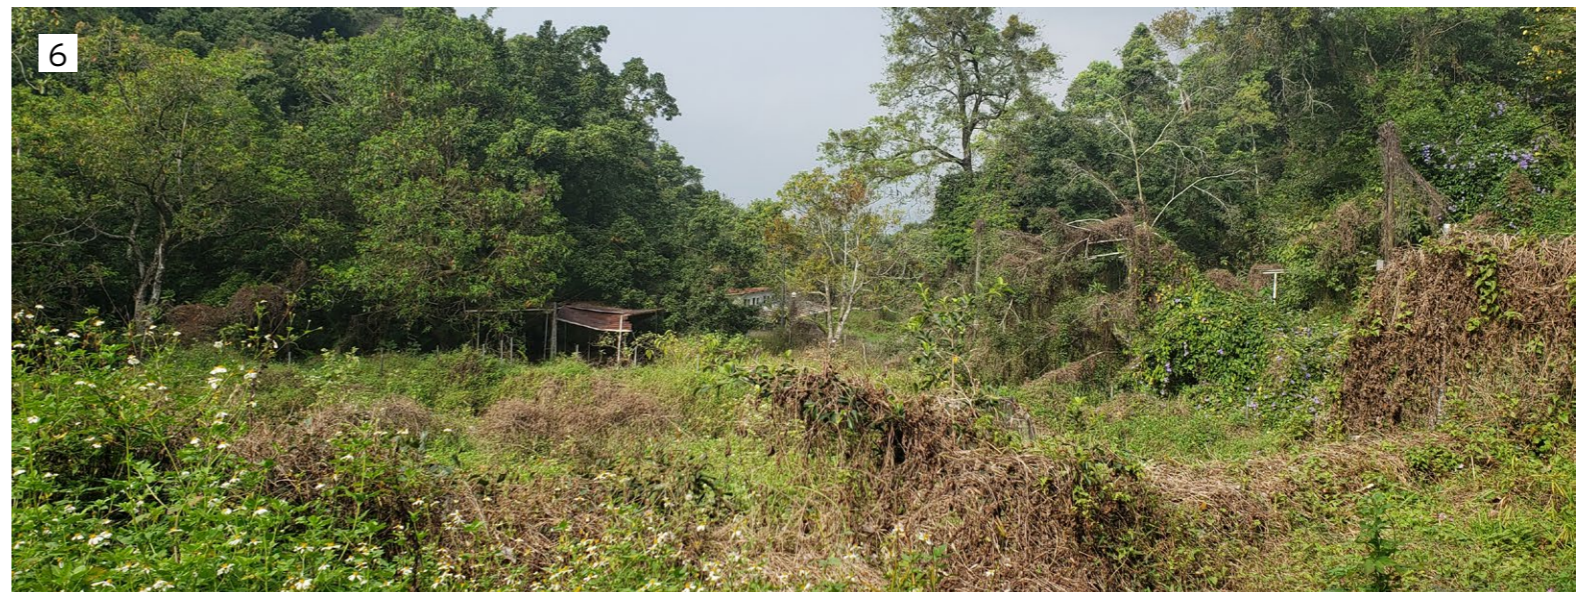
Figure 2.2  
Existing Site Photos (Sheet 1 of 3)

- 2.2 **Figure 2.2 to 2.4** shows existing site conditions. Tai Po Kau Forest Track - Kau Lead Section is a concrete road (View 1). There are 2 site access points with metal fence erected (View 1 & 3). Site edge abutting the road is heavily vegetated by typical woodland shrub. There are occasional openings offering views to inside the site (View 2).

- 2.3 There are 3 major clusters of buildings / structures inside the site, including:
- A few severely deteriorated metal structures with metal sheet roof and a small building to the northeast (View 10 & 11)

- A building with metal sheet roof at the centre (View 2, 4, 5, 8 & 12)
  - A building with metal sheet roof and a smaller building to the southwest (View 13, 14 & 15)

- 2.4 The site is currently covered by overgrown vegetation – mostly weed, groundcover and low-lying shrubs (View 2, 6, 8, 12 & 15). A tree survey was done in September 2021 by Outdoor Wildlife Leaning Hong Kong. The survey identified 70 nos. trees inside the Application Site. Result of the tree survey and proposed treatment are detailed in Section 5.

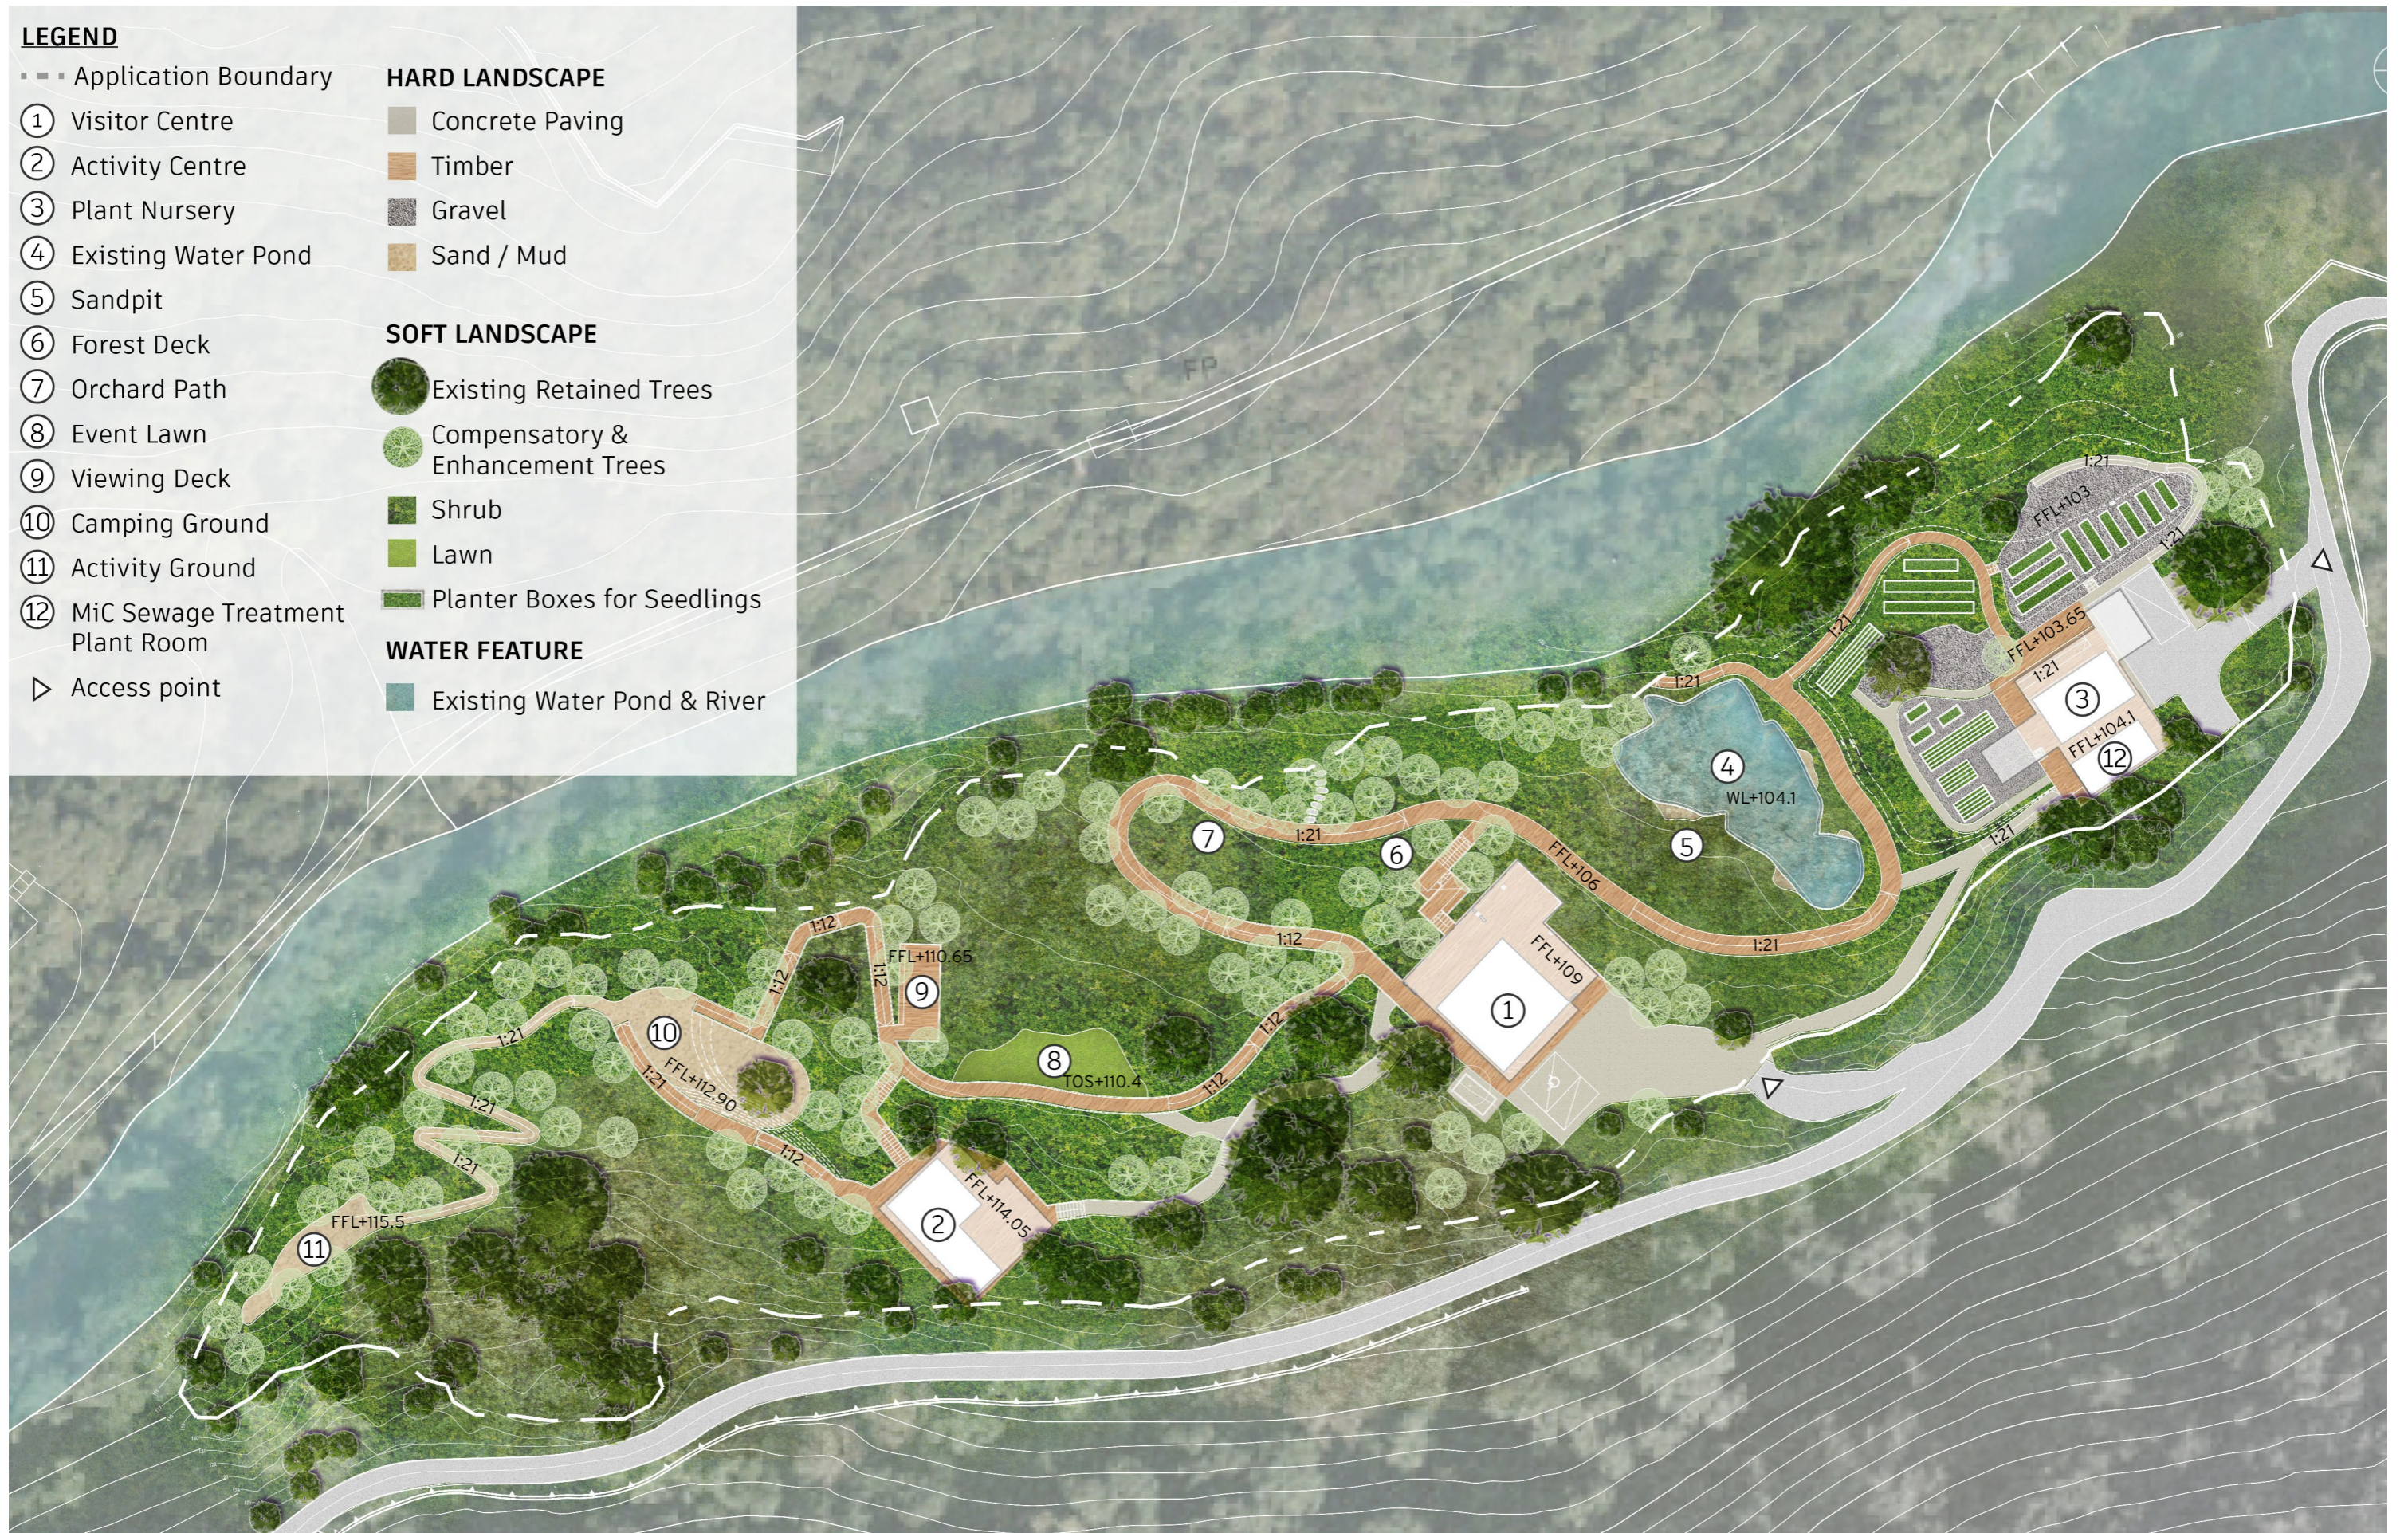
Figure 4.1  
Landscape Master Plan

The Landscape Master Plan is shown in **Figure 4.1**. Landscape Section is shown in **Figure 4.2**. The concept of the landscape design is to provide a complete educational journey for visitors to experience the nature of Tai Po Kau. Since the site is an enclave surrounded by the Tai Po Kau Nature Reserve, the design is largely driven by the site context, aiming to loosely replicate the characteristics of hillside landscape in Tai Po Kau while hinting the site's historical use of a farmland. Ecological design principles are adopted in this landscape design.

Existing access points at northeast and south of the site are proposed to be kept. These are the only points where vehicles are allowed in the site (Refer to **Figure 4.1**).

Existing paths are retained and used in the proposed design. Additional paths complying with universal accessibility are introduced to connect the 3 buildings and other activity zones. The sinuous paths along site topography also offer rich visitor experience inside the site.

Path layout is designed with respect to the existing site contour such that minimal earth works will be needed to archive compliance with universal accessibility. Soil level around all retained trees remain unchanged.

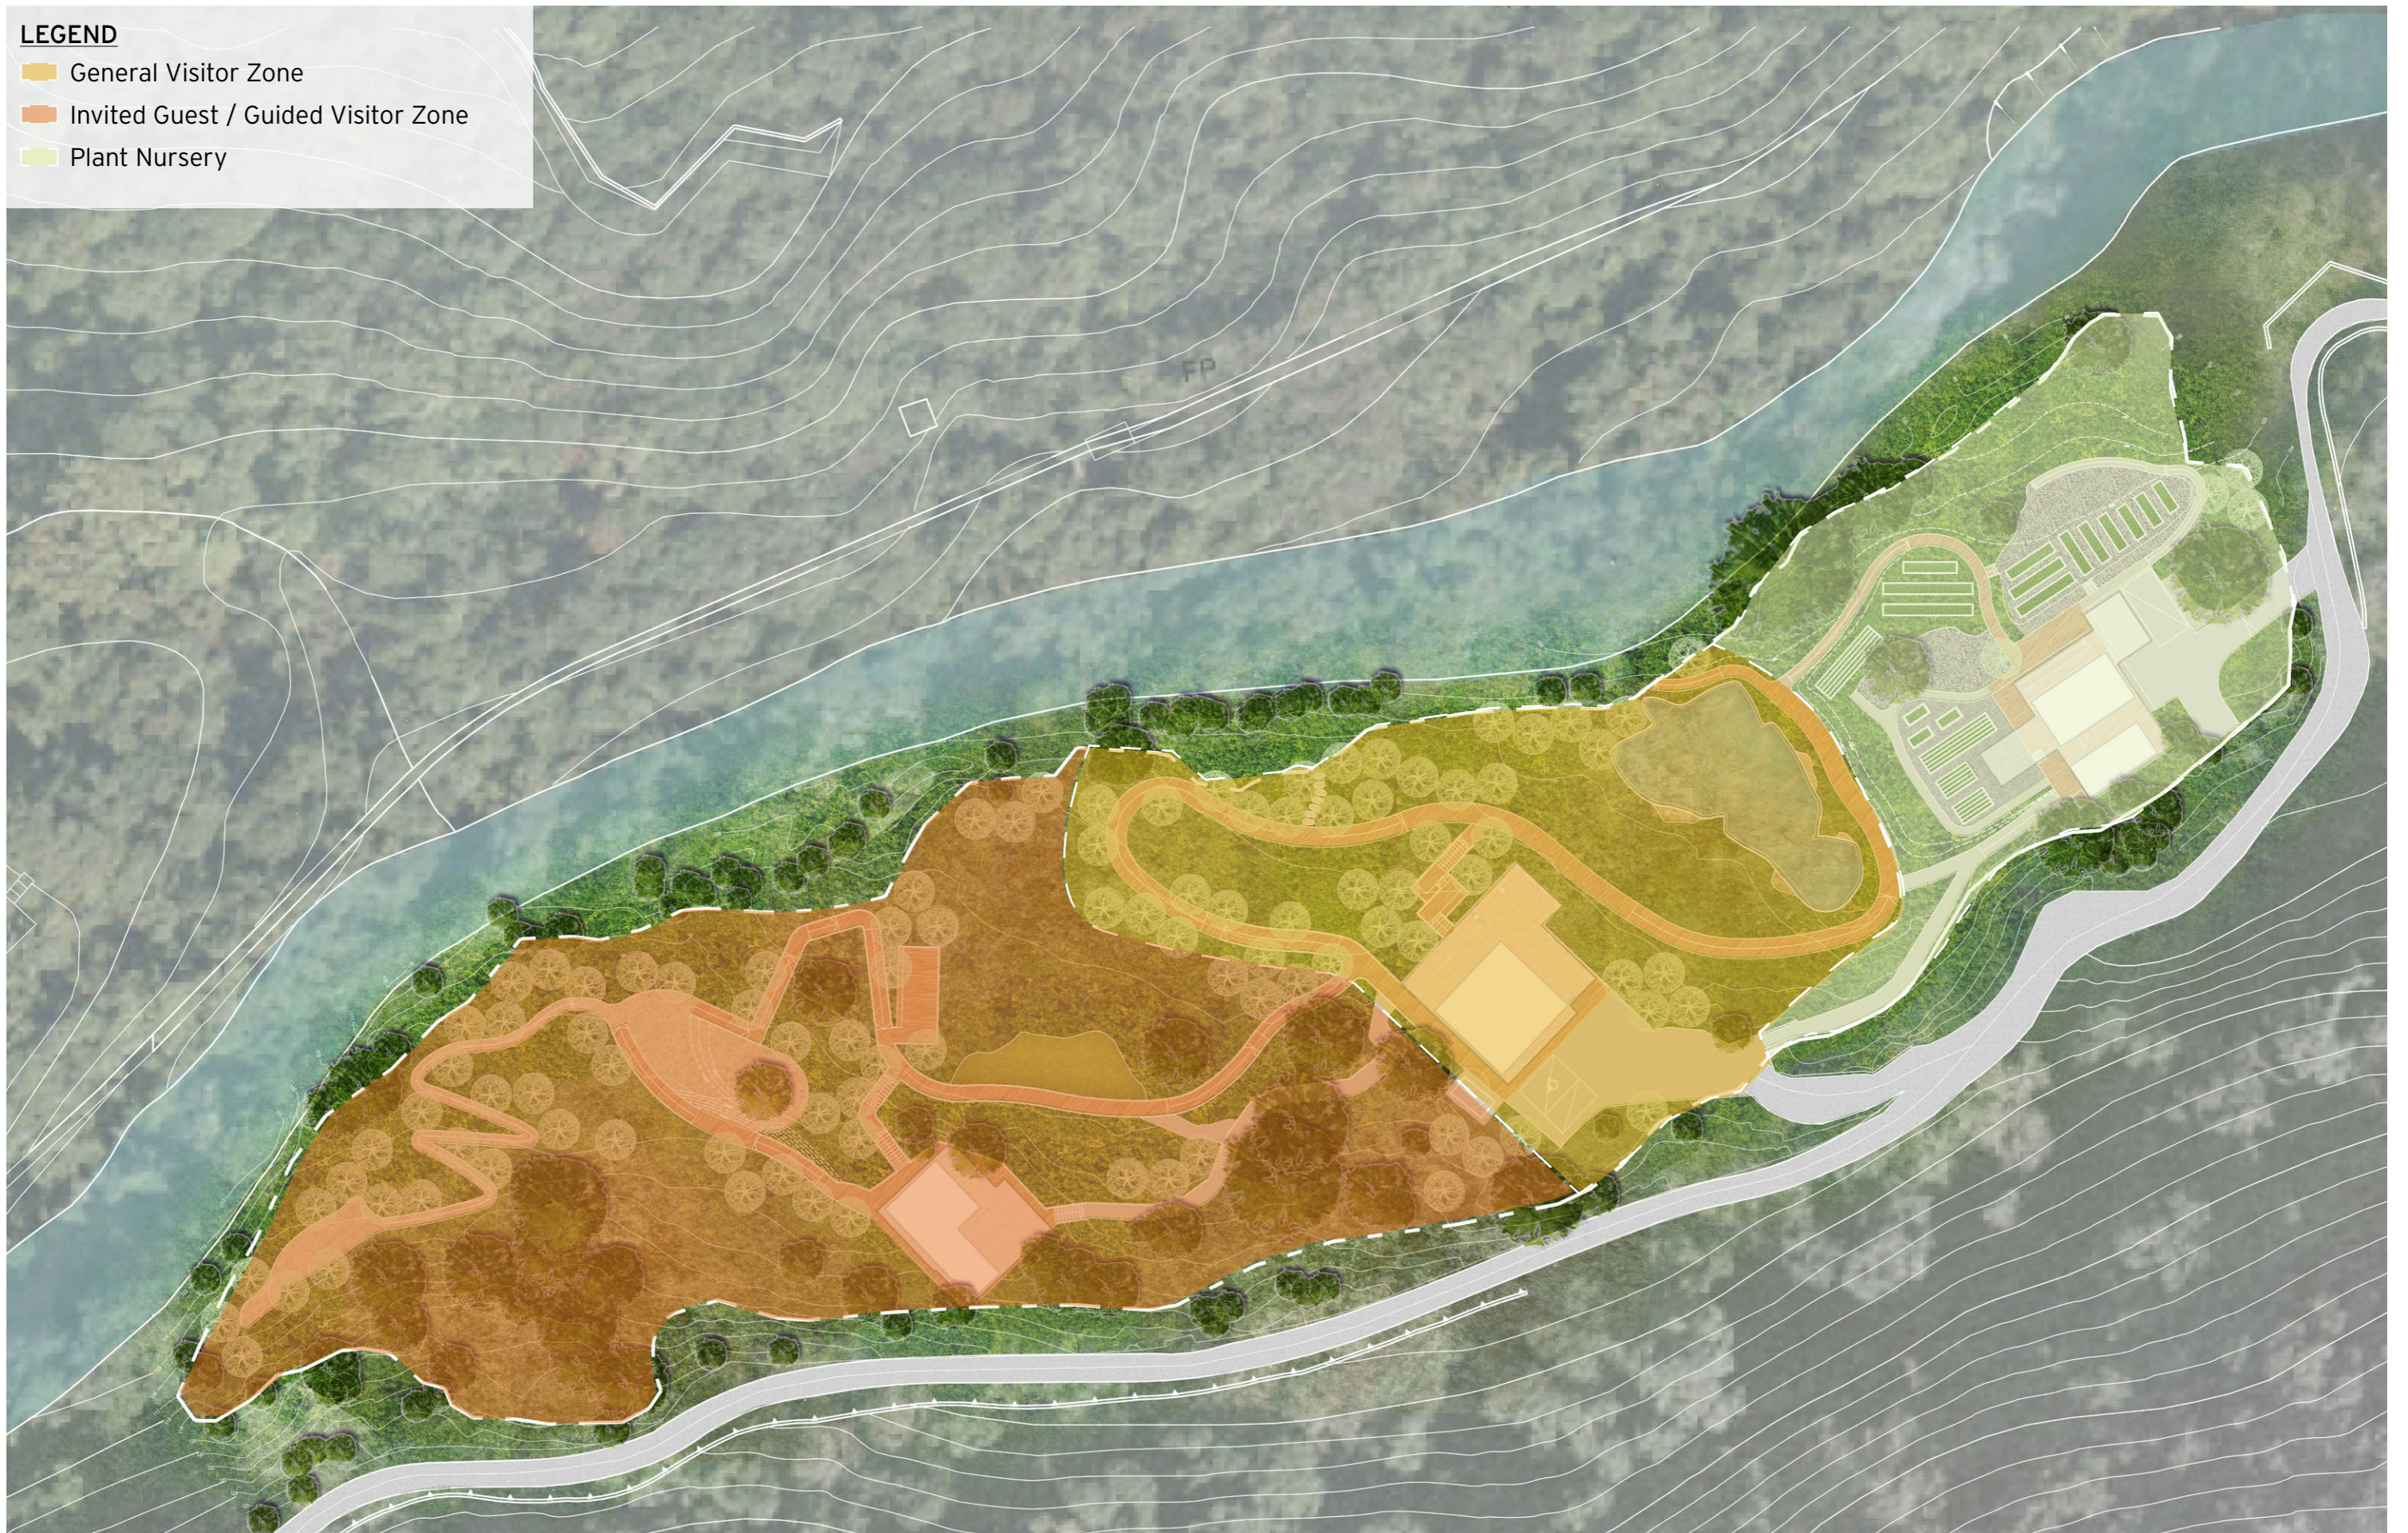
Figure 4.3  
Functional Zoning

The site is divided into 3 zones for visitor management in order to minimise human disturbance to the nature environment (Refer to **Figure 4.3**).

General Visitor Zone: This zone is anticipated to be the key visiting loop in which all general public are welcomed. This zone includes the visitor centre, an orchard path with fruit trees, a forest deck (connecting the visitor centre to lower part of the orchard path), and a strolling path around the water pond. This is the most easily accessible part of the site.

Invited Guest / Guided Visitor Zone: This zone is located uphill and is anticipated to have less general public. This zone includes an activity centre, event lawn, viewing deck, camping ground and an activity ground inside forest. Visitors to this zone will likely be those coming for guided tour or educational events.

Operation / Nursery Zone: This zone is located downhill and is anticipated to be a plant nursery. Most of the landscape areas here are designated as plant nursery to propagate and grow species local to Tai Po Kau area.

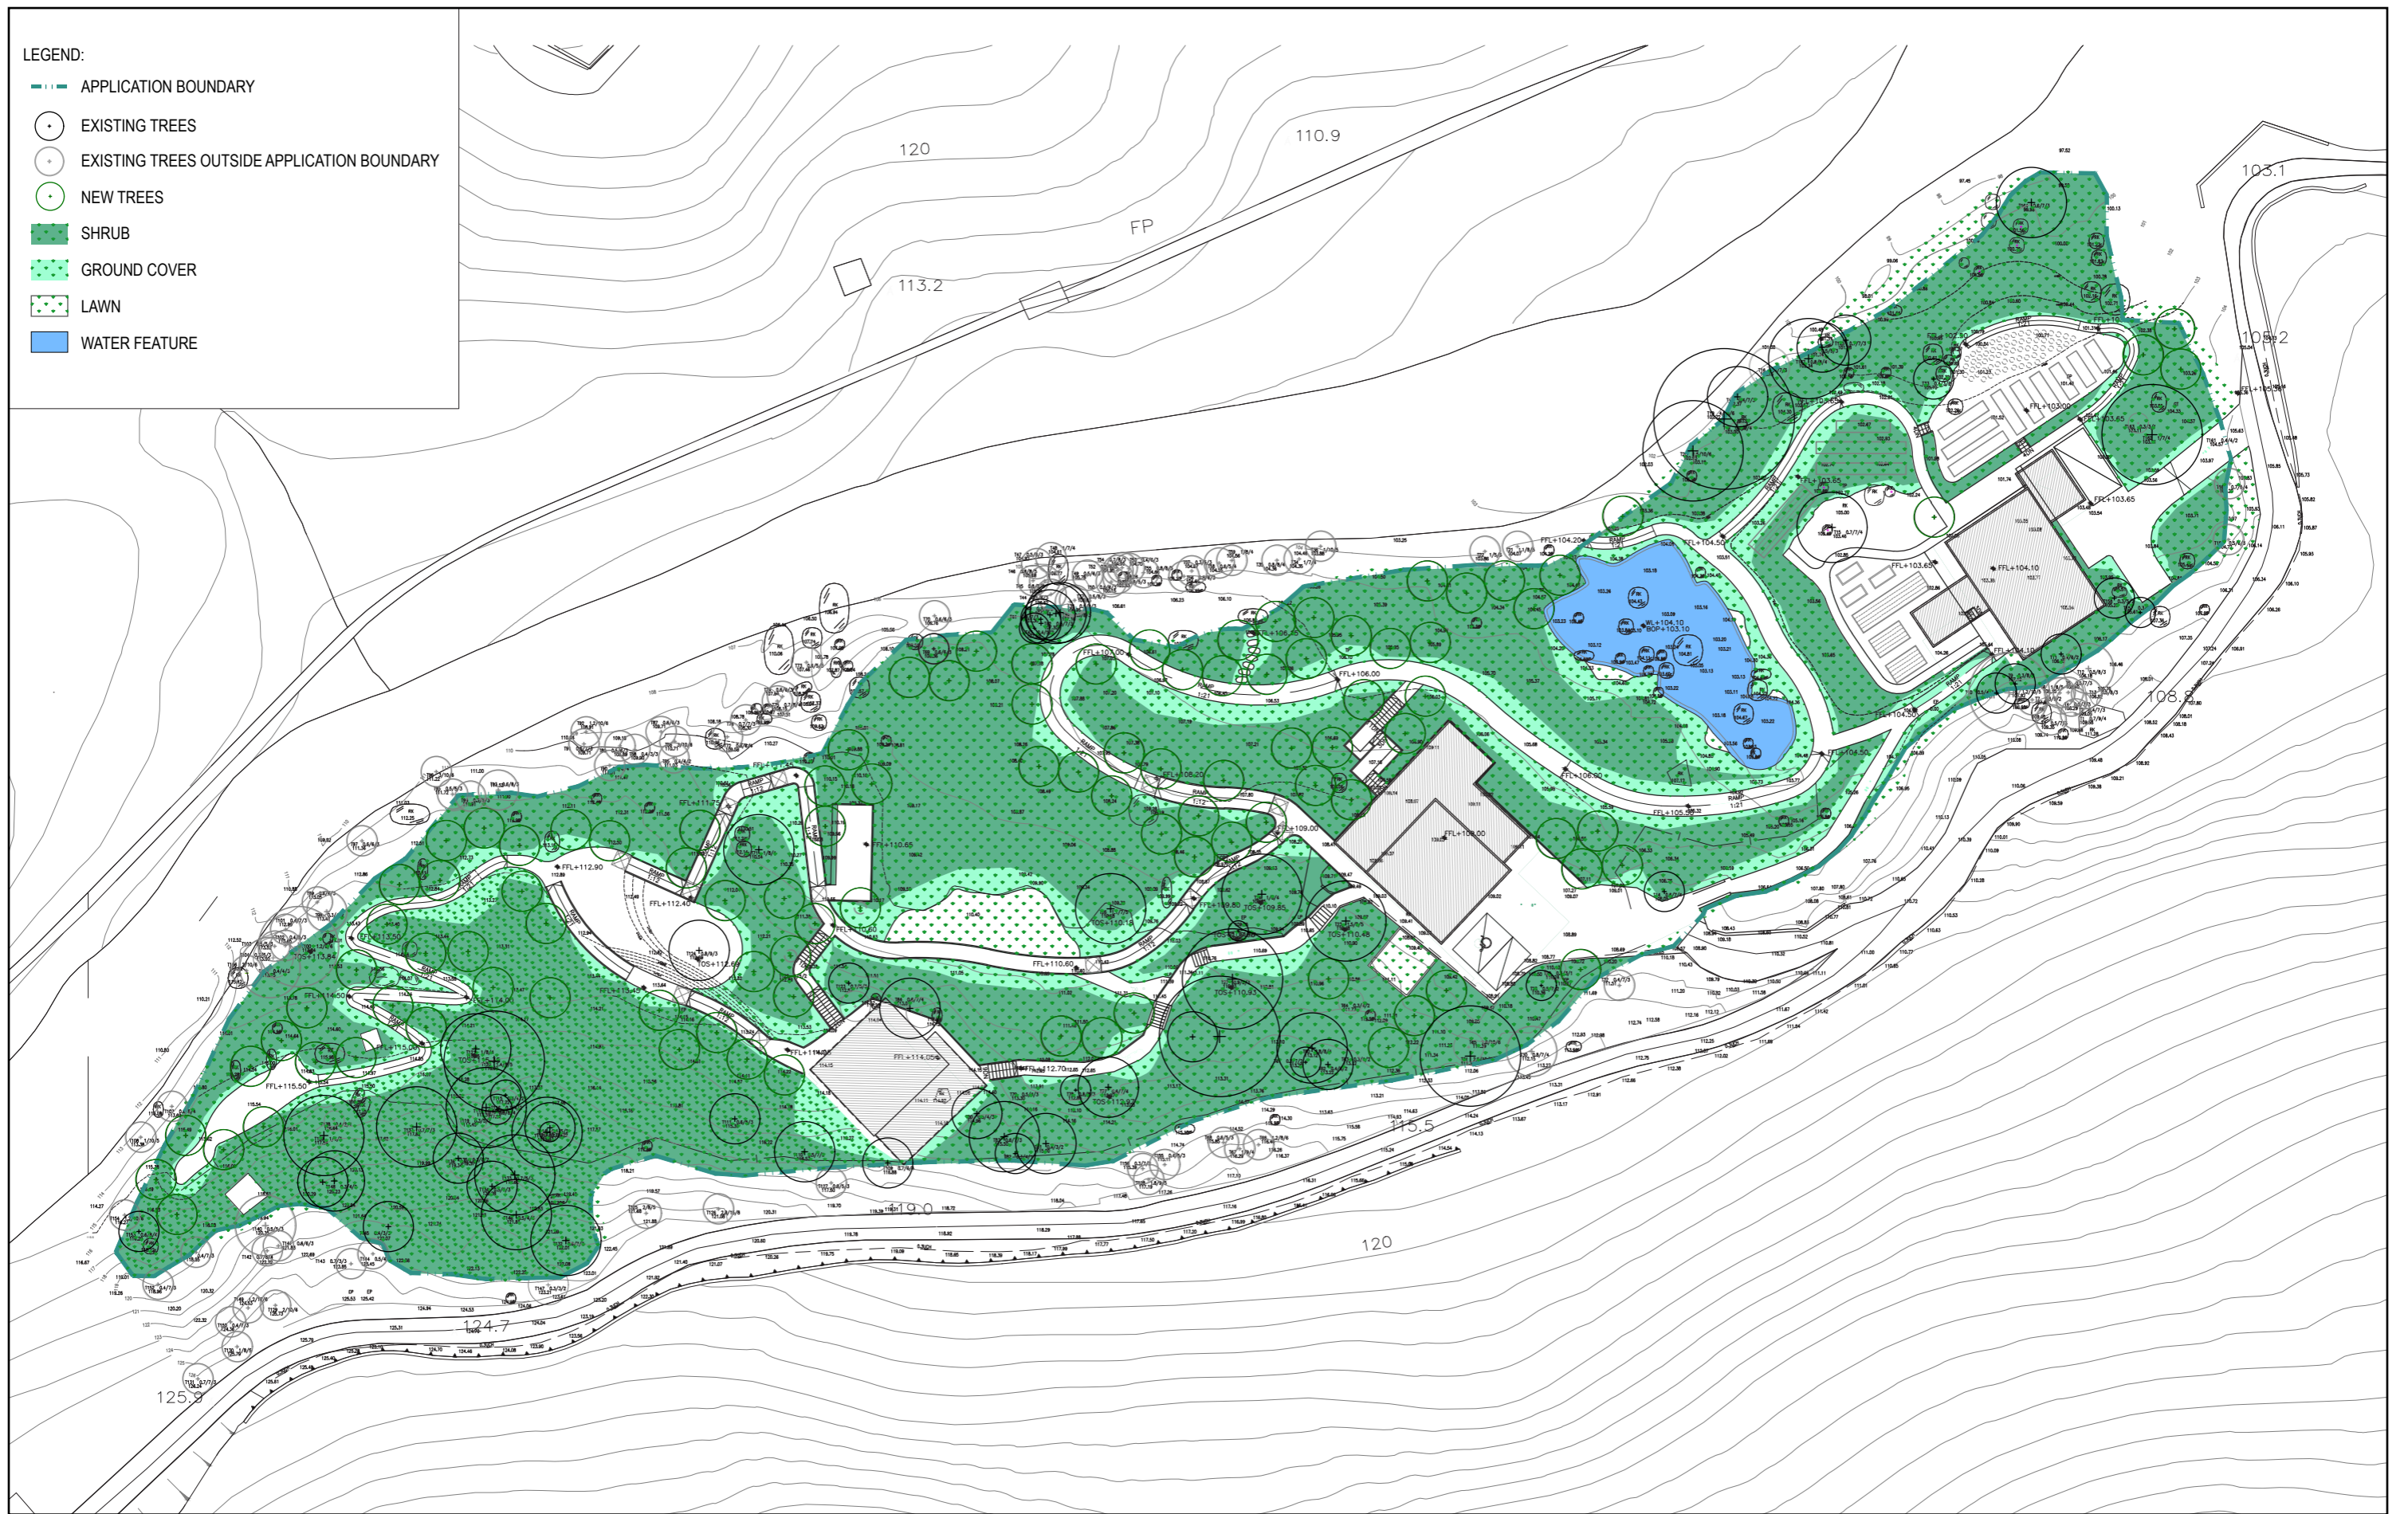
Figure 4.4  
Tree, Shrub and Groundcover Plan

Existing water pond will be kept with its water depth remain unchanged to retain the current habitat. Sandpits are introduced to pond edges to attract dragonfly and butterfly. Proposed tree, shrub, and groundcover demarcation plan is included in **Figure 4.4**.

In close collaboration with ecologist, plants proposed for this design comprises a range of species which can enhance ecological performance of the site. These includes species commonly found in the Tai Po Kau Nature Reserve and those that provide food and habitat for wildlife.

The existing vegetation inside the site mainly consisted of invasive species such as *Mikania micrantha* and *Bidens pilosa*. Other native herbaceous plants such as *Microstegium ciliatum* are very common and fast growing. The only floral species of conservation importance recorded within the Application Site is the protected fern *Neottopteris nidus* found either singly or in groups on tree trunks or rock. This protected fern will be retained. Other invasive species and common species will be replaced by the proposed shrub species as a part of the ecological enhancement proposal.

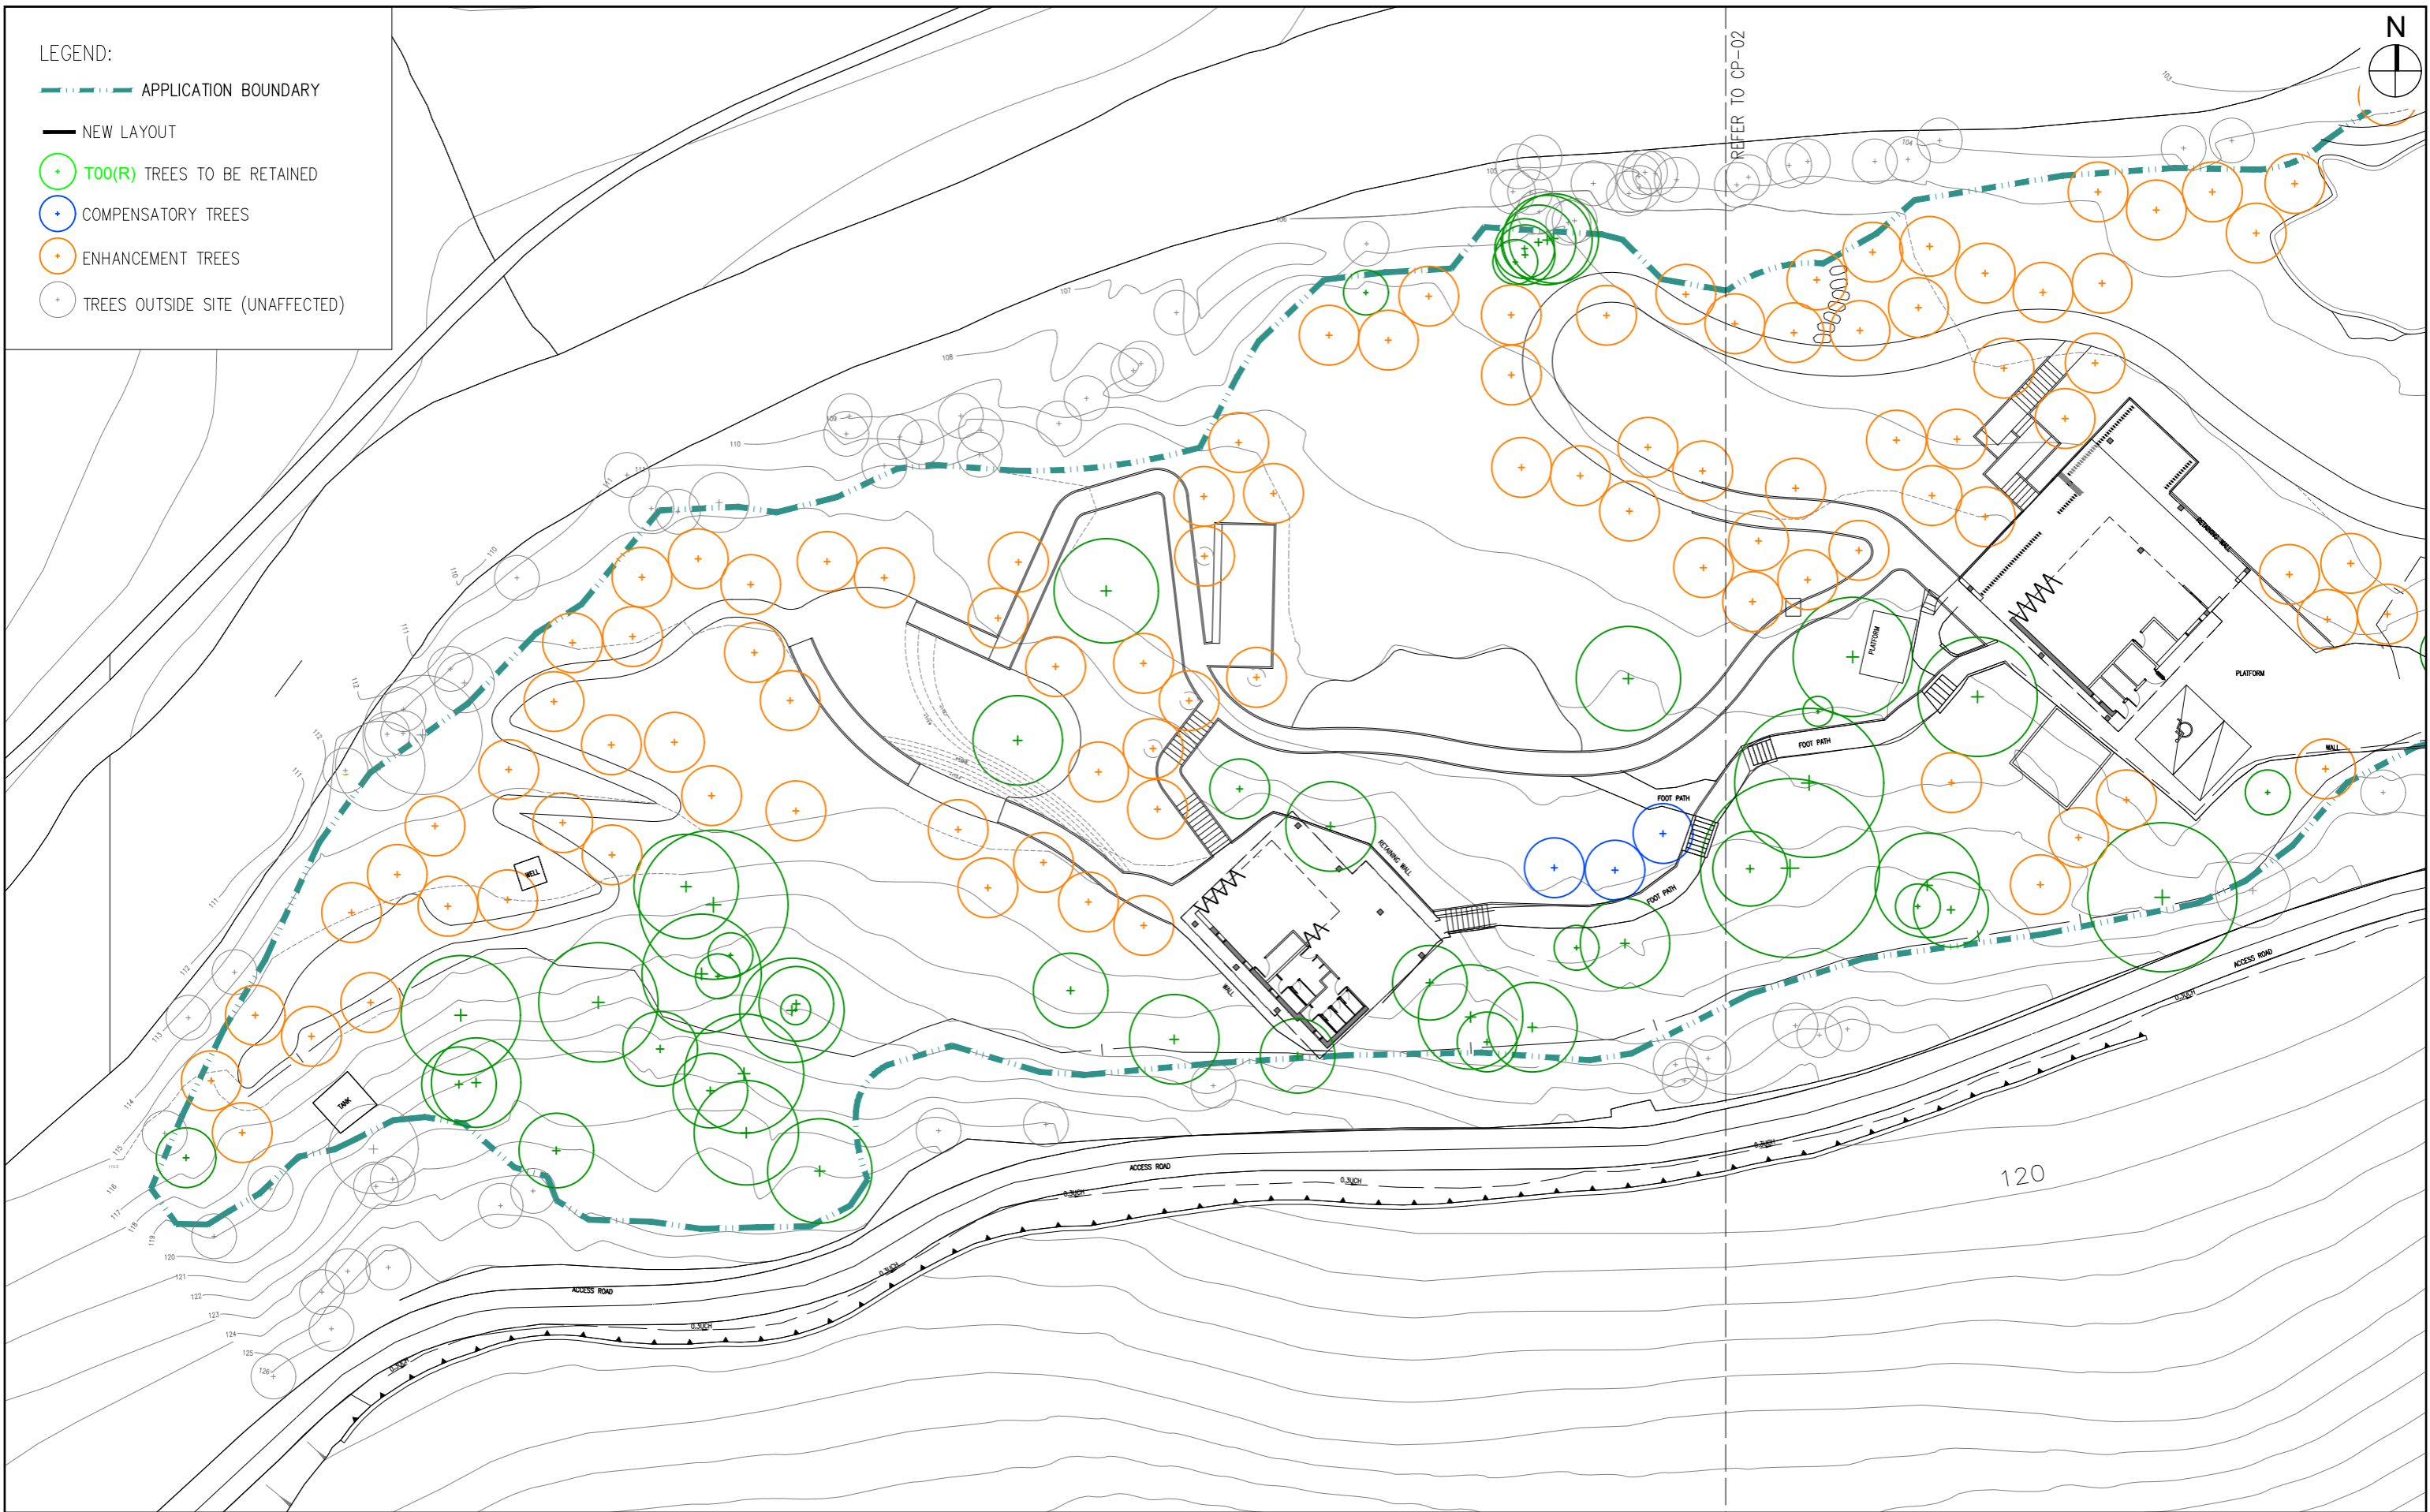
Figure 5.6  
Compensatory Tree Planting and Enhancement Tree Planting Plan (Sheet 1 of 2)

**Figure 5.6 and 5.7** show the Compensatory Tree Planting and Enhancement Tree Planting Proposal. The 3 felled trees are compensated with 3 nos. tree in 1:1 ratio in terms of quantity. The proposed species is *Syzygium hancei*.

There are additional over 100 nos. of enhancement tree planting proposed inside the site.
