Agreement No. CE 92/2017 (CE) Site Formation and Infrastructure Works for Public Housing Development near Tan Kwai Tsuen, Yuen Long – Investigation, Design and Construction

Proposed Planning Application to the Approved Tong Yan San Tsuen Outline Zoning Plan No. S/YL-TYST/14

APPENDIX F
LANDSCAPE AND VISUAL IMPACT ASSESSMENT
REPORT

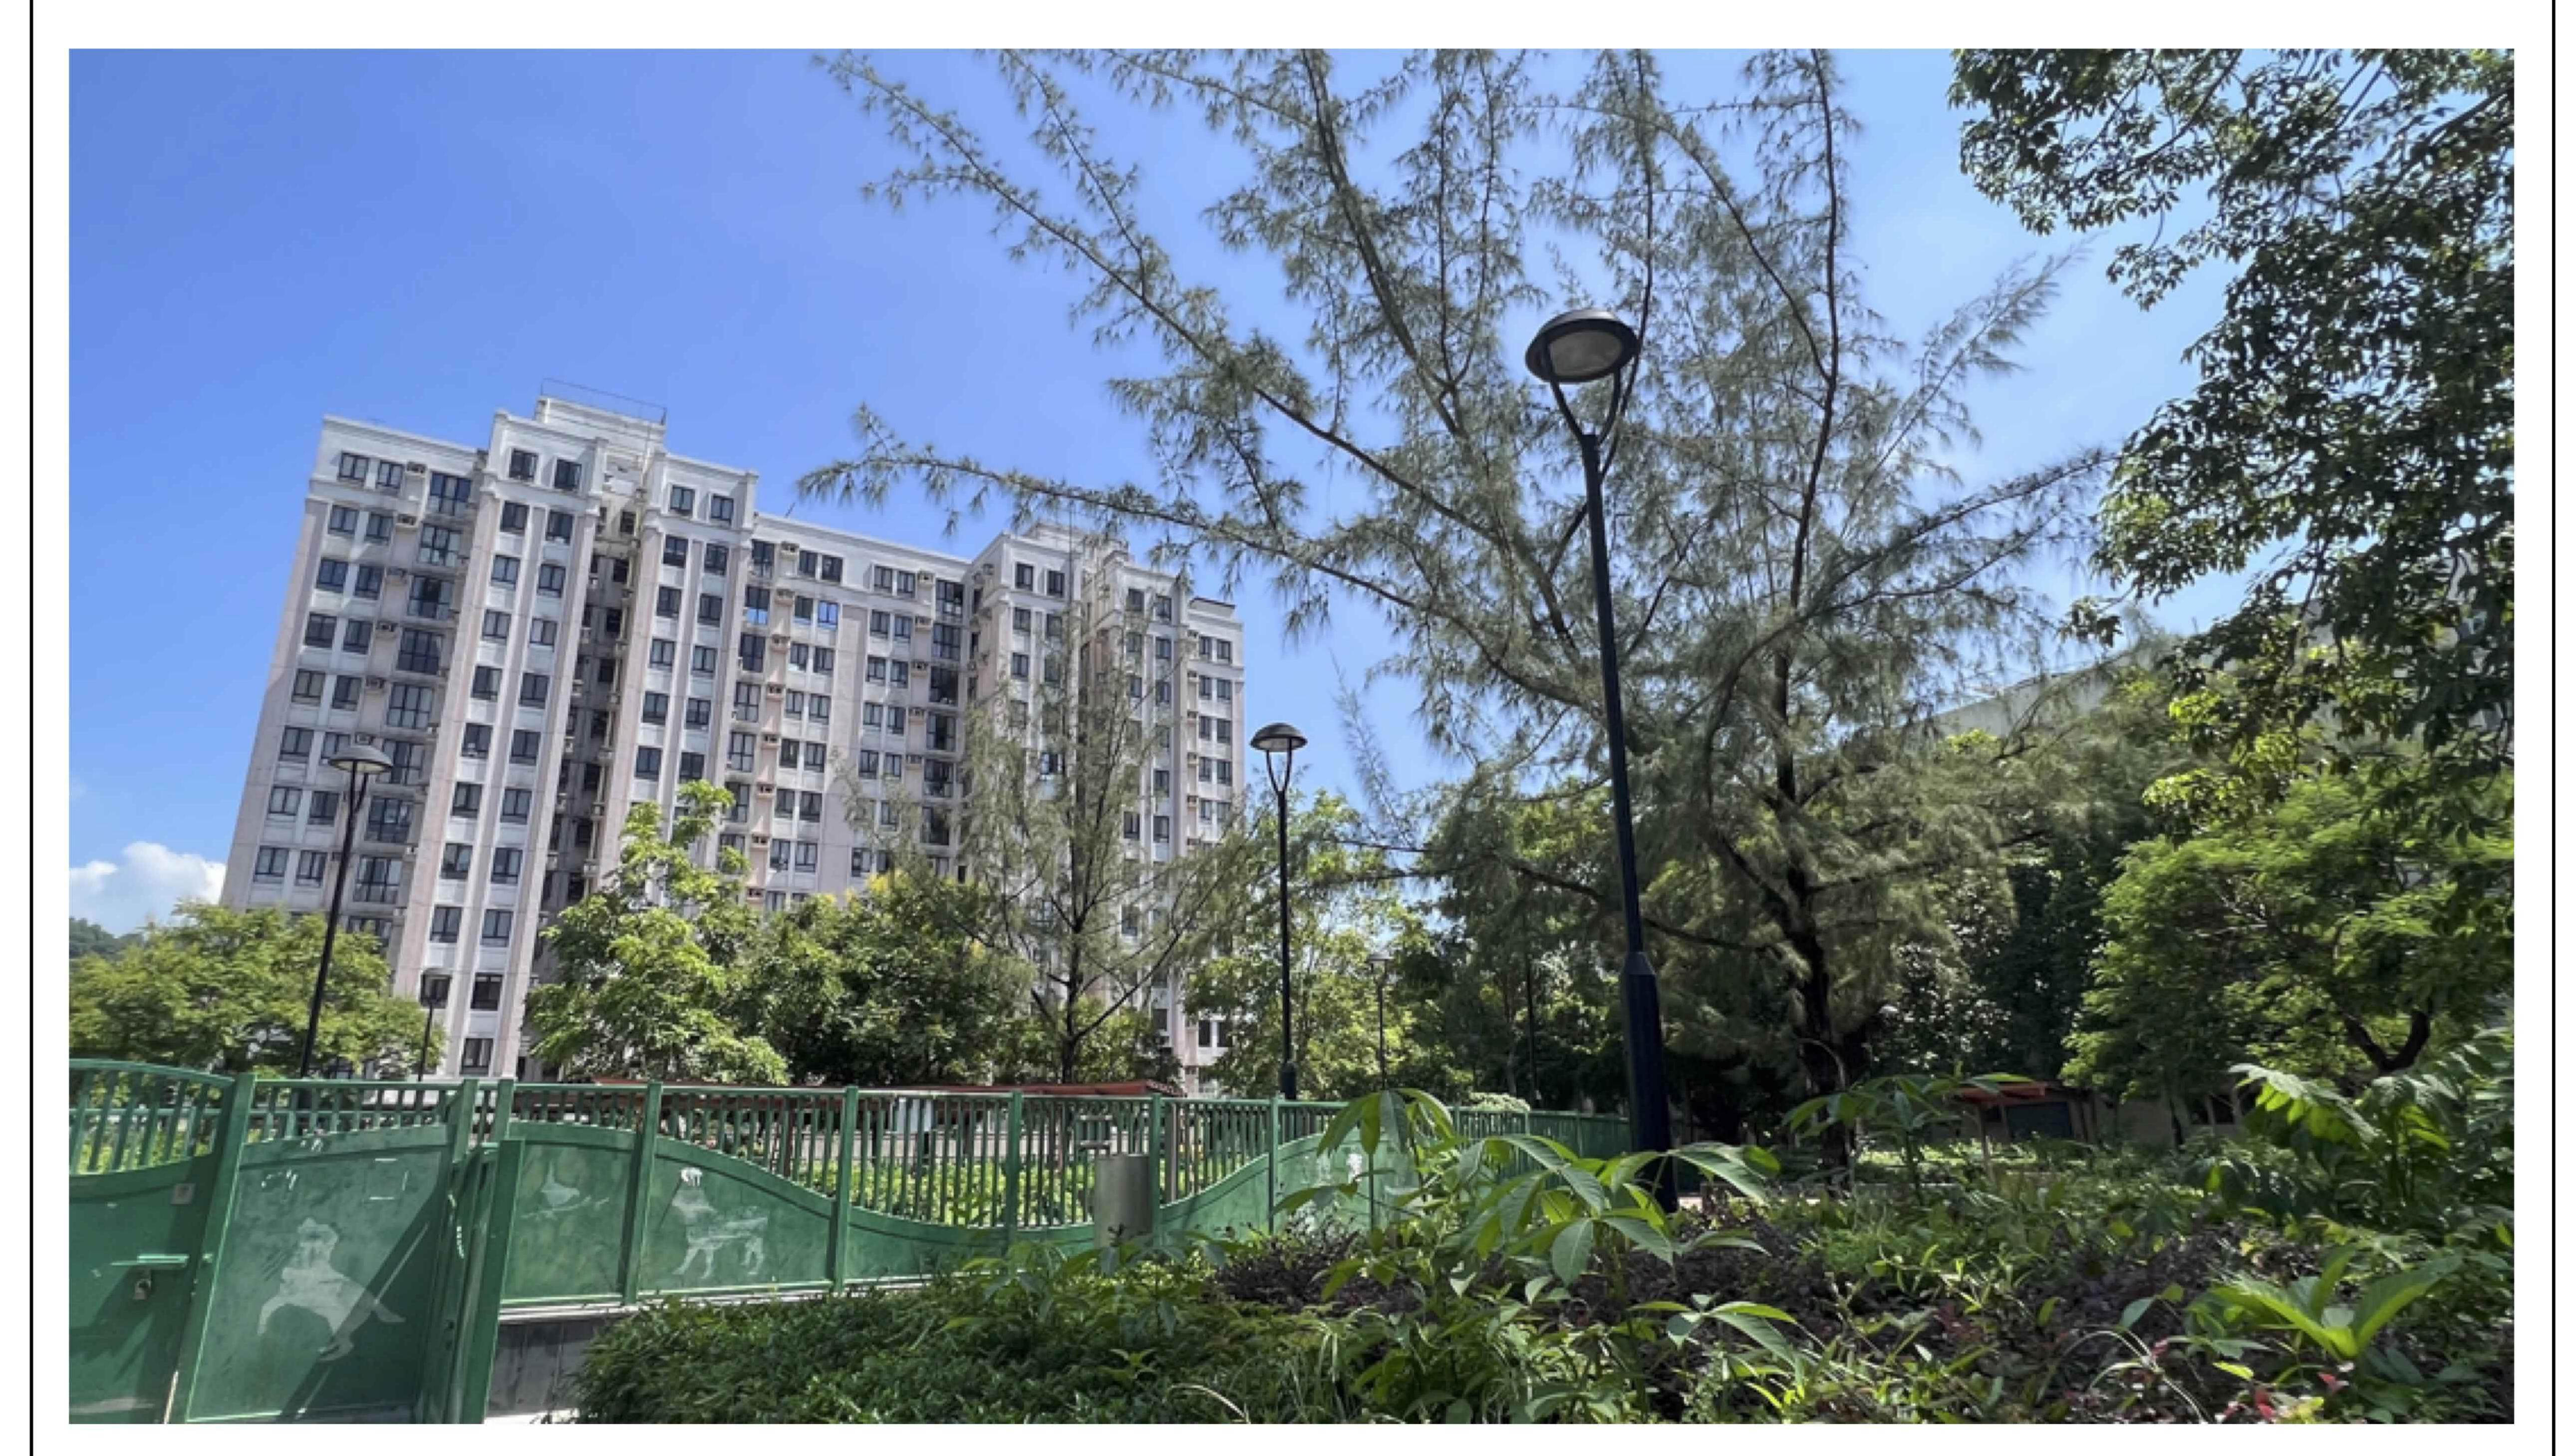
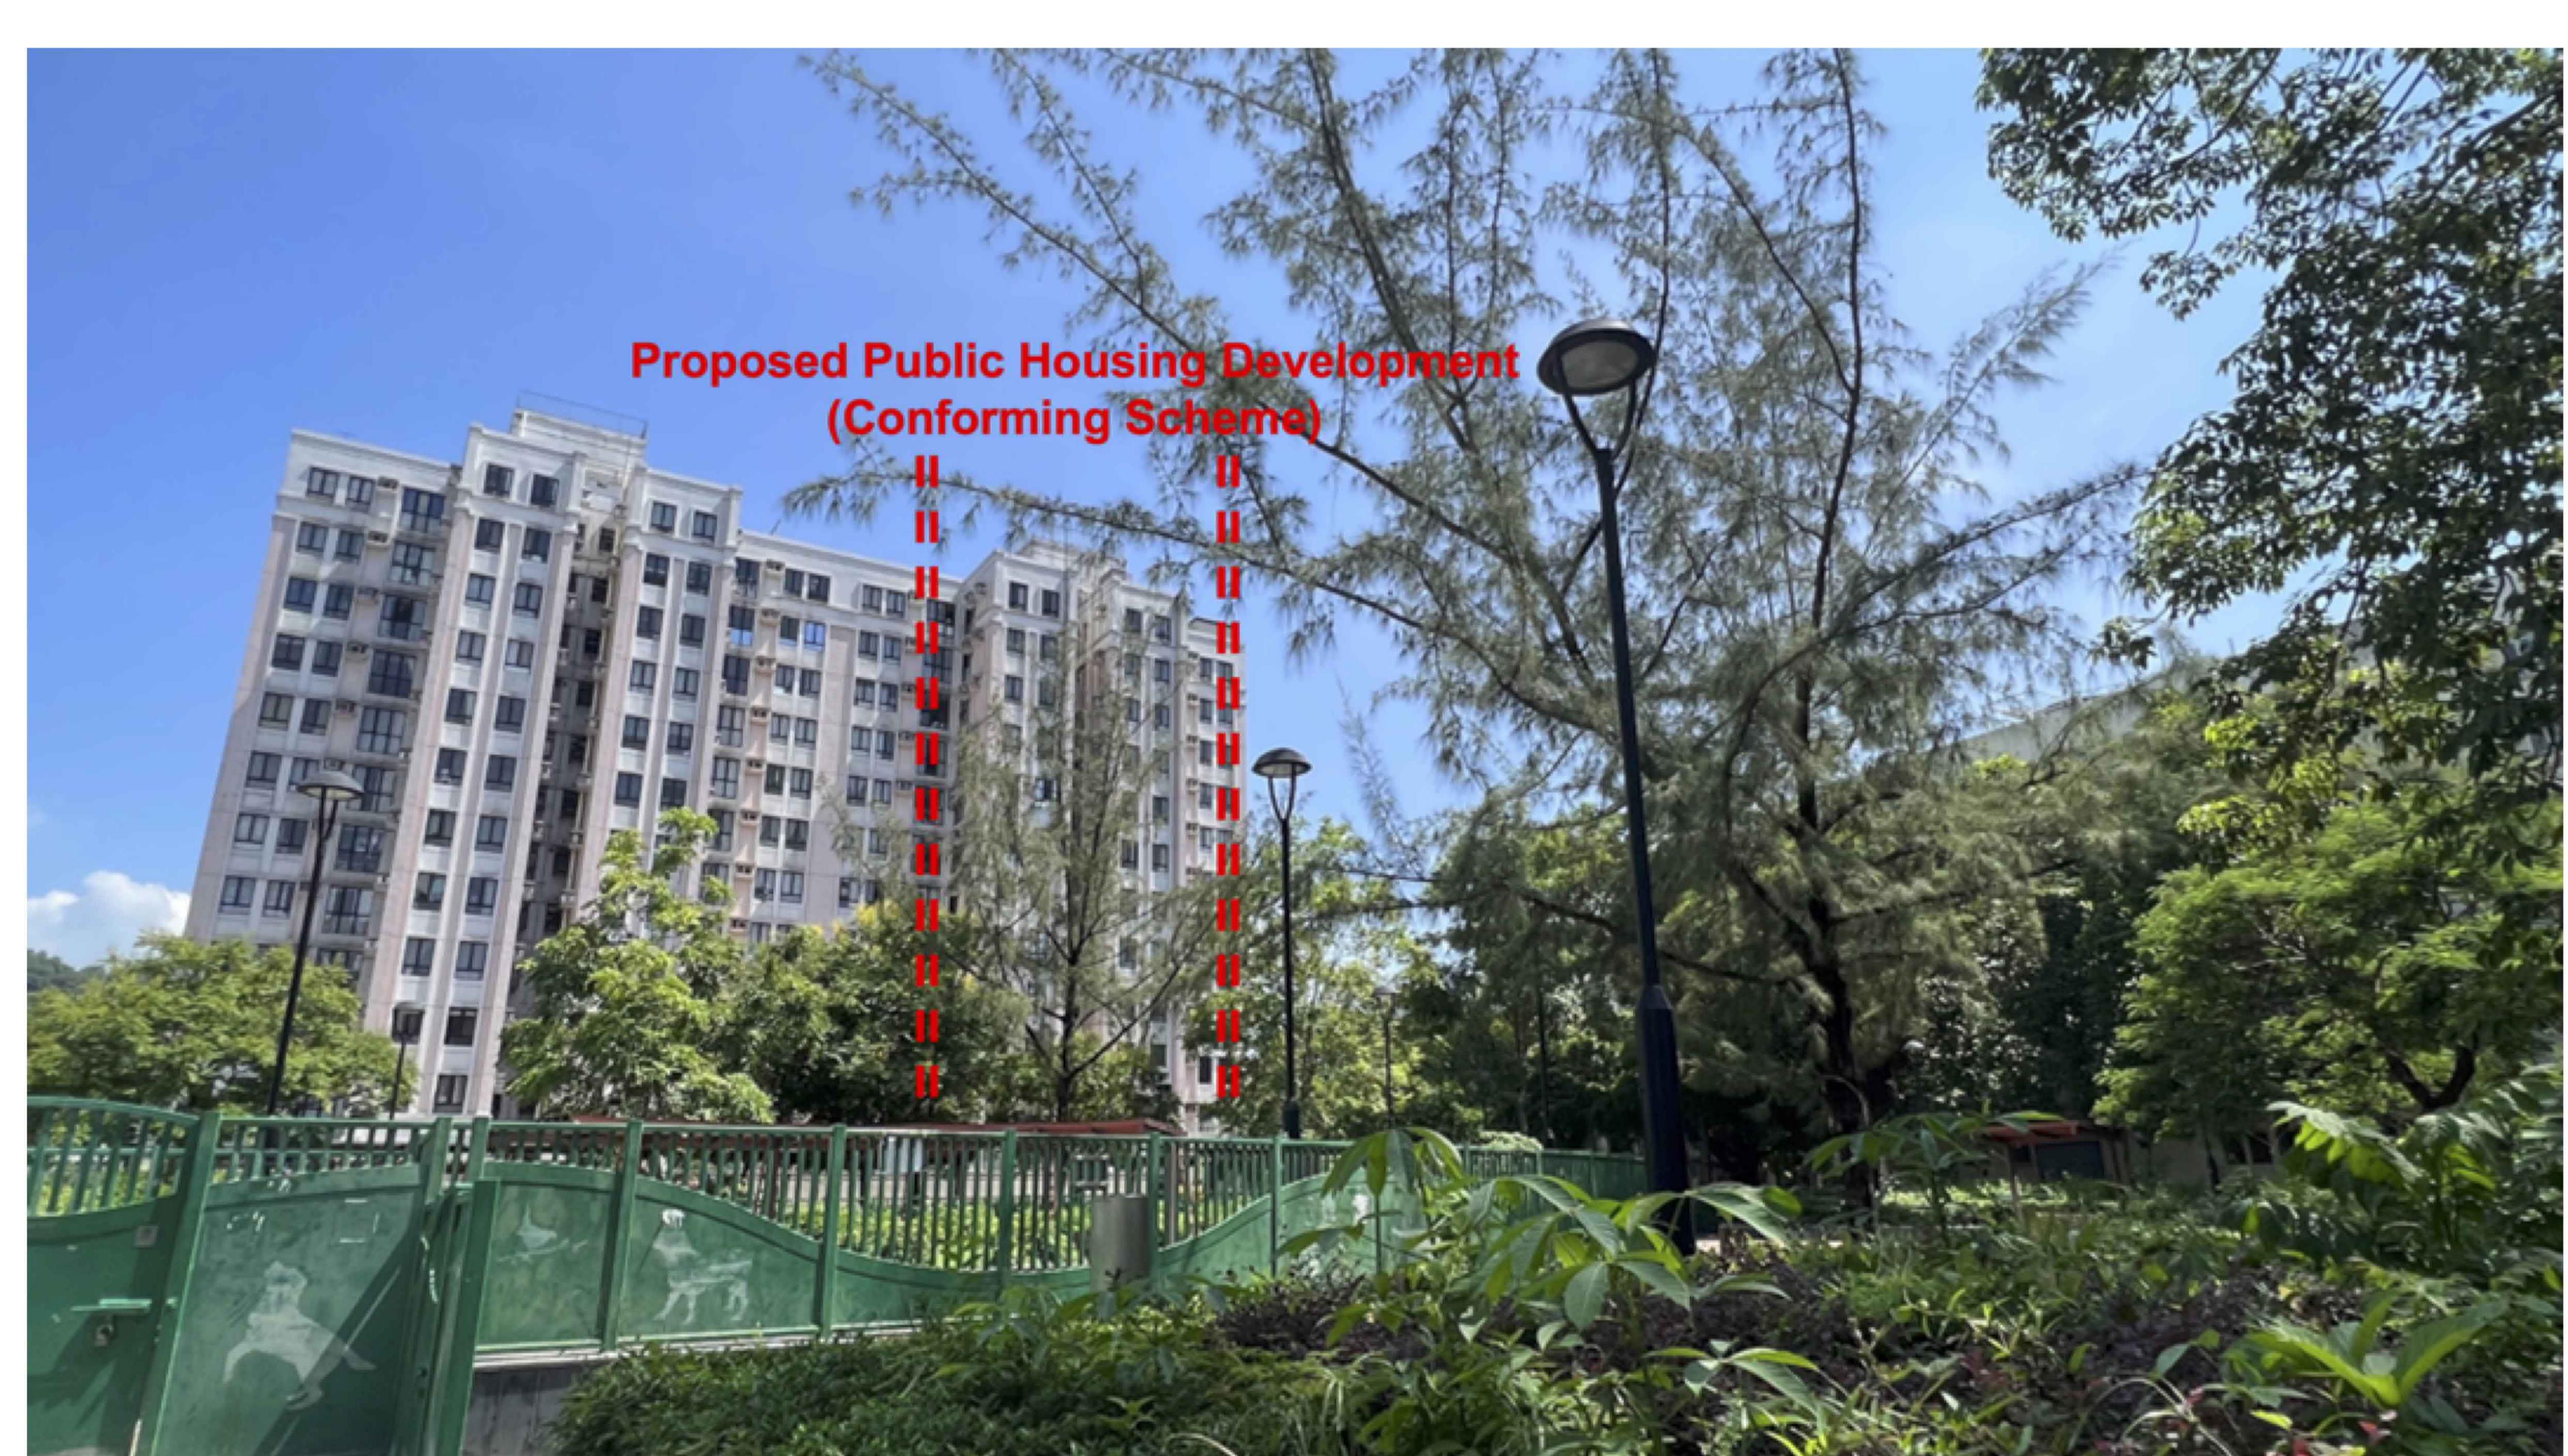
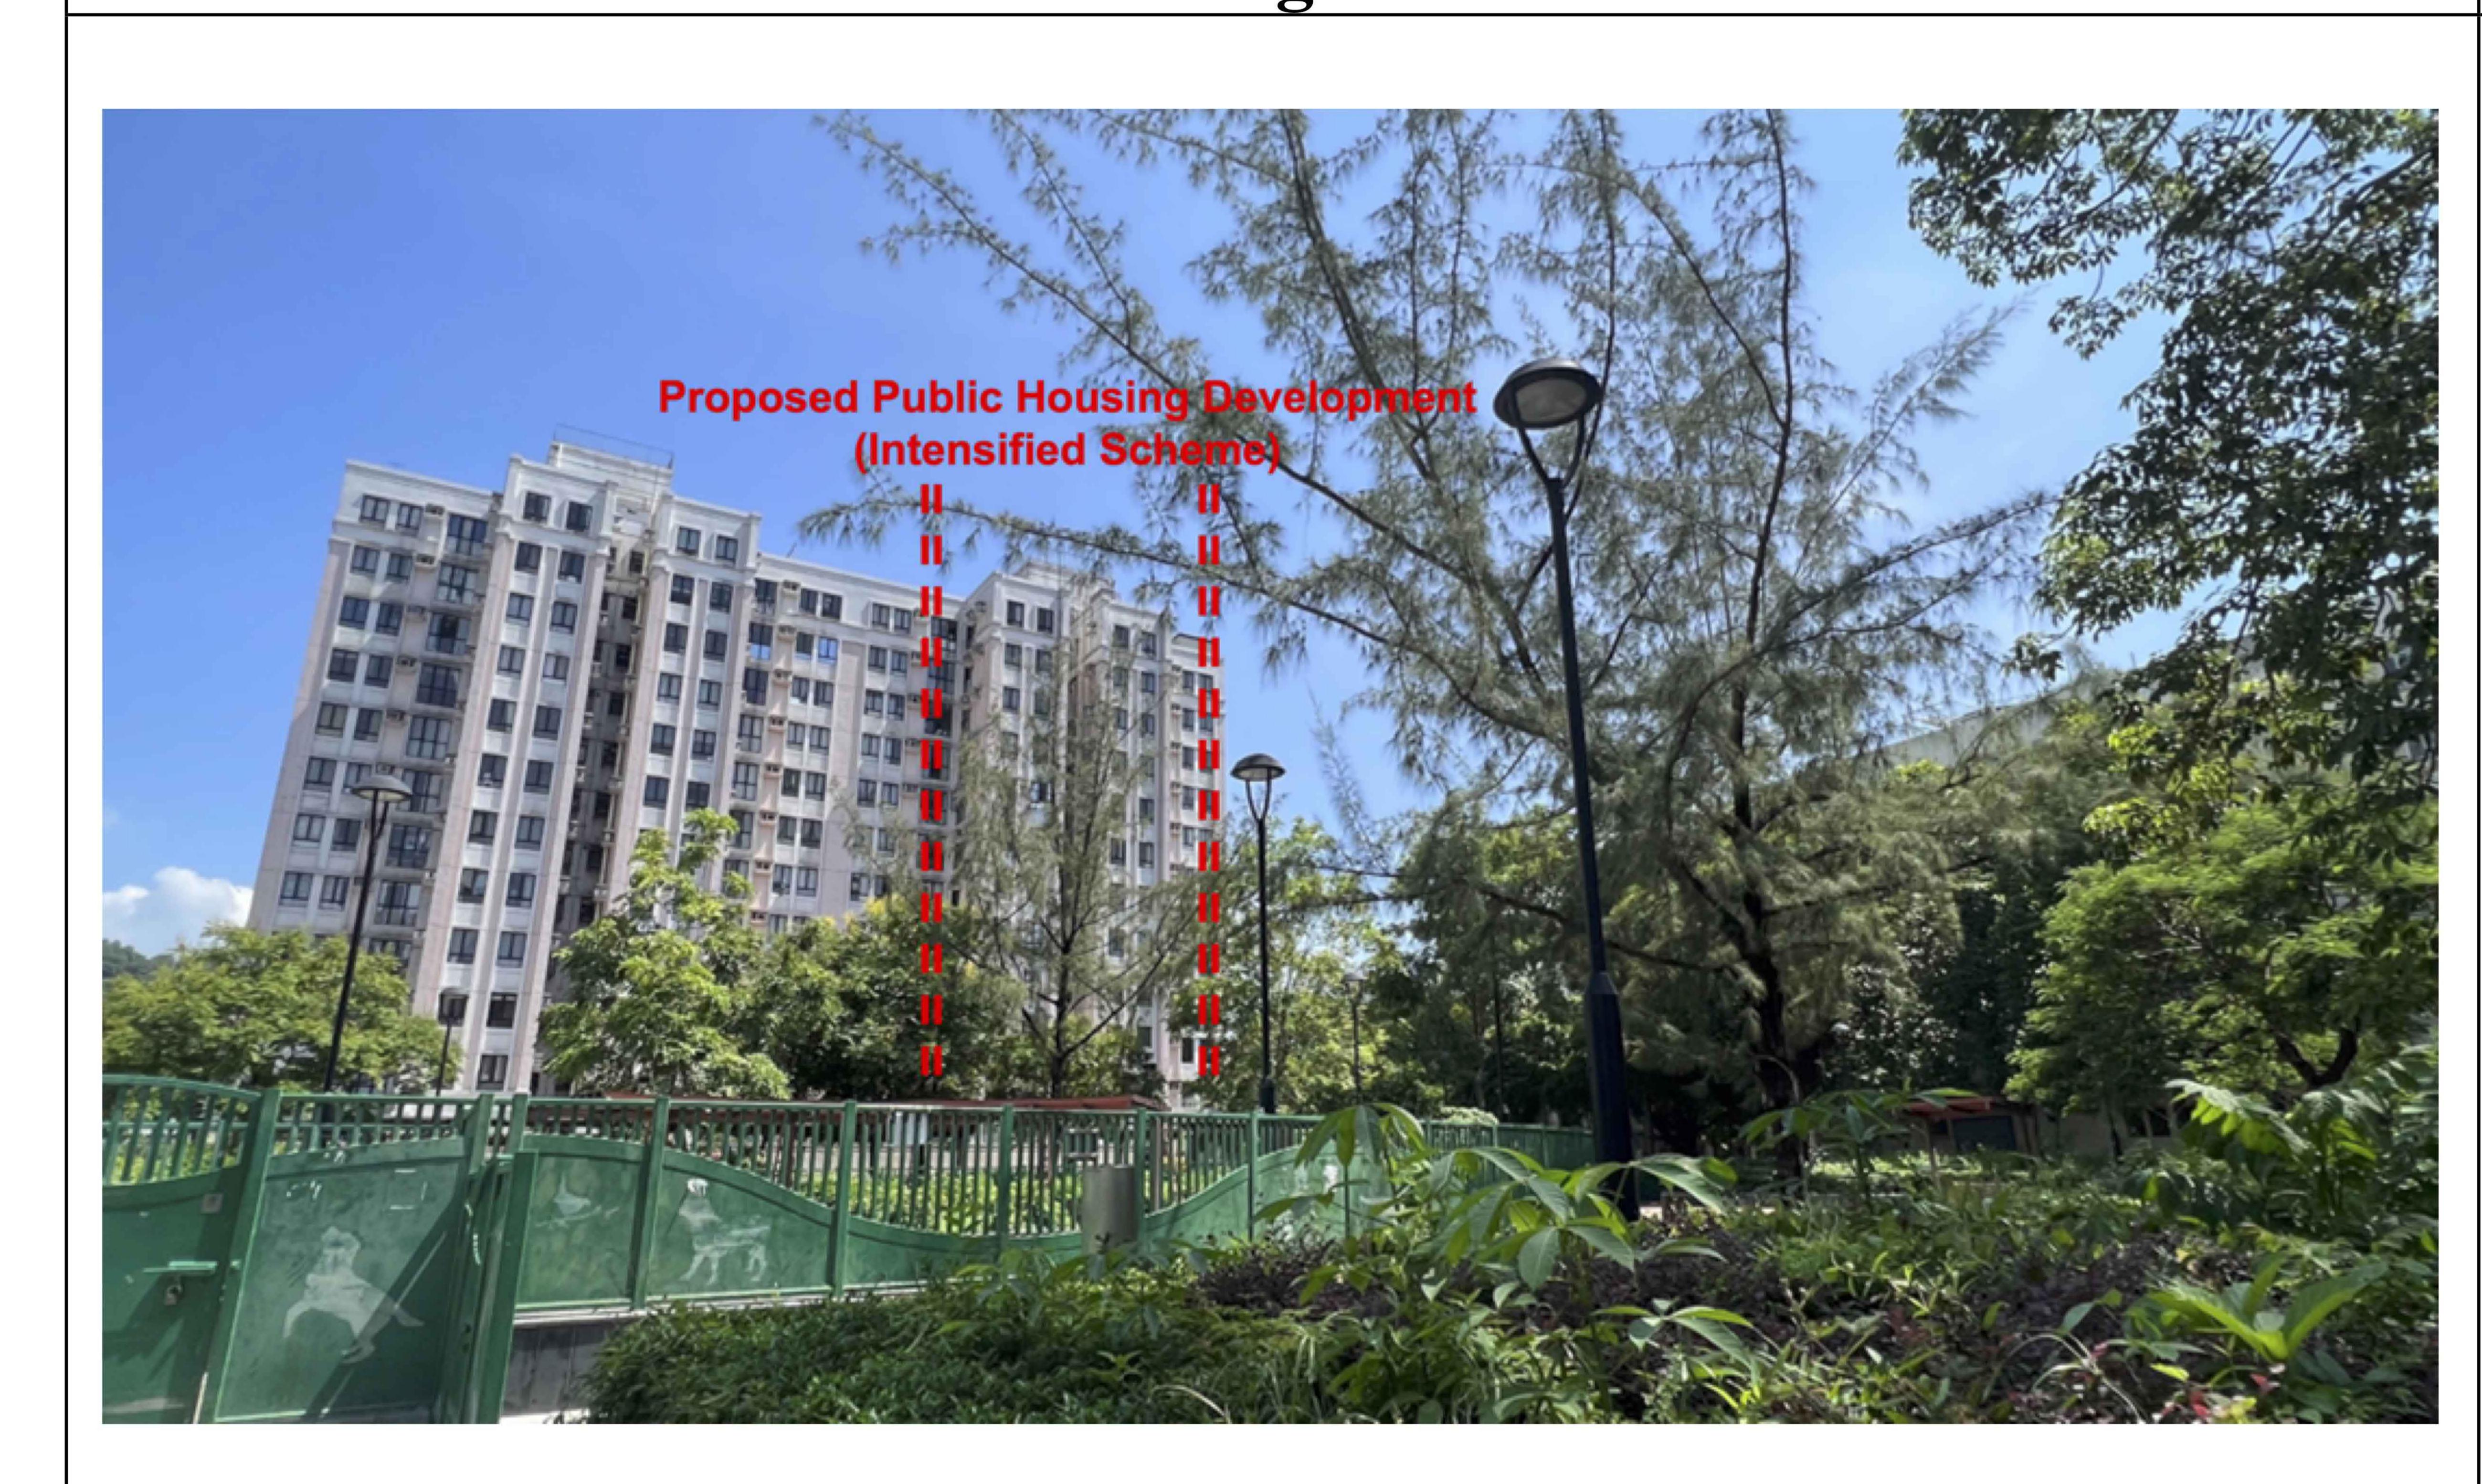
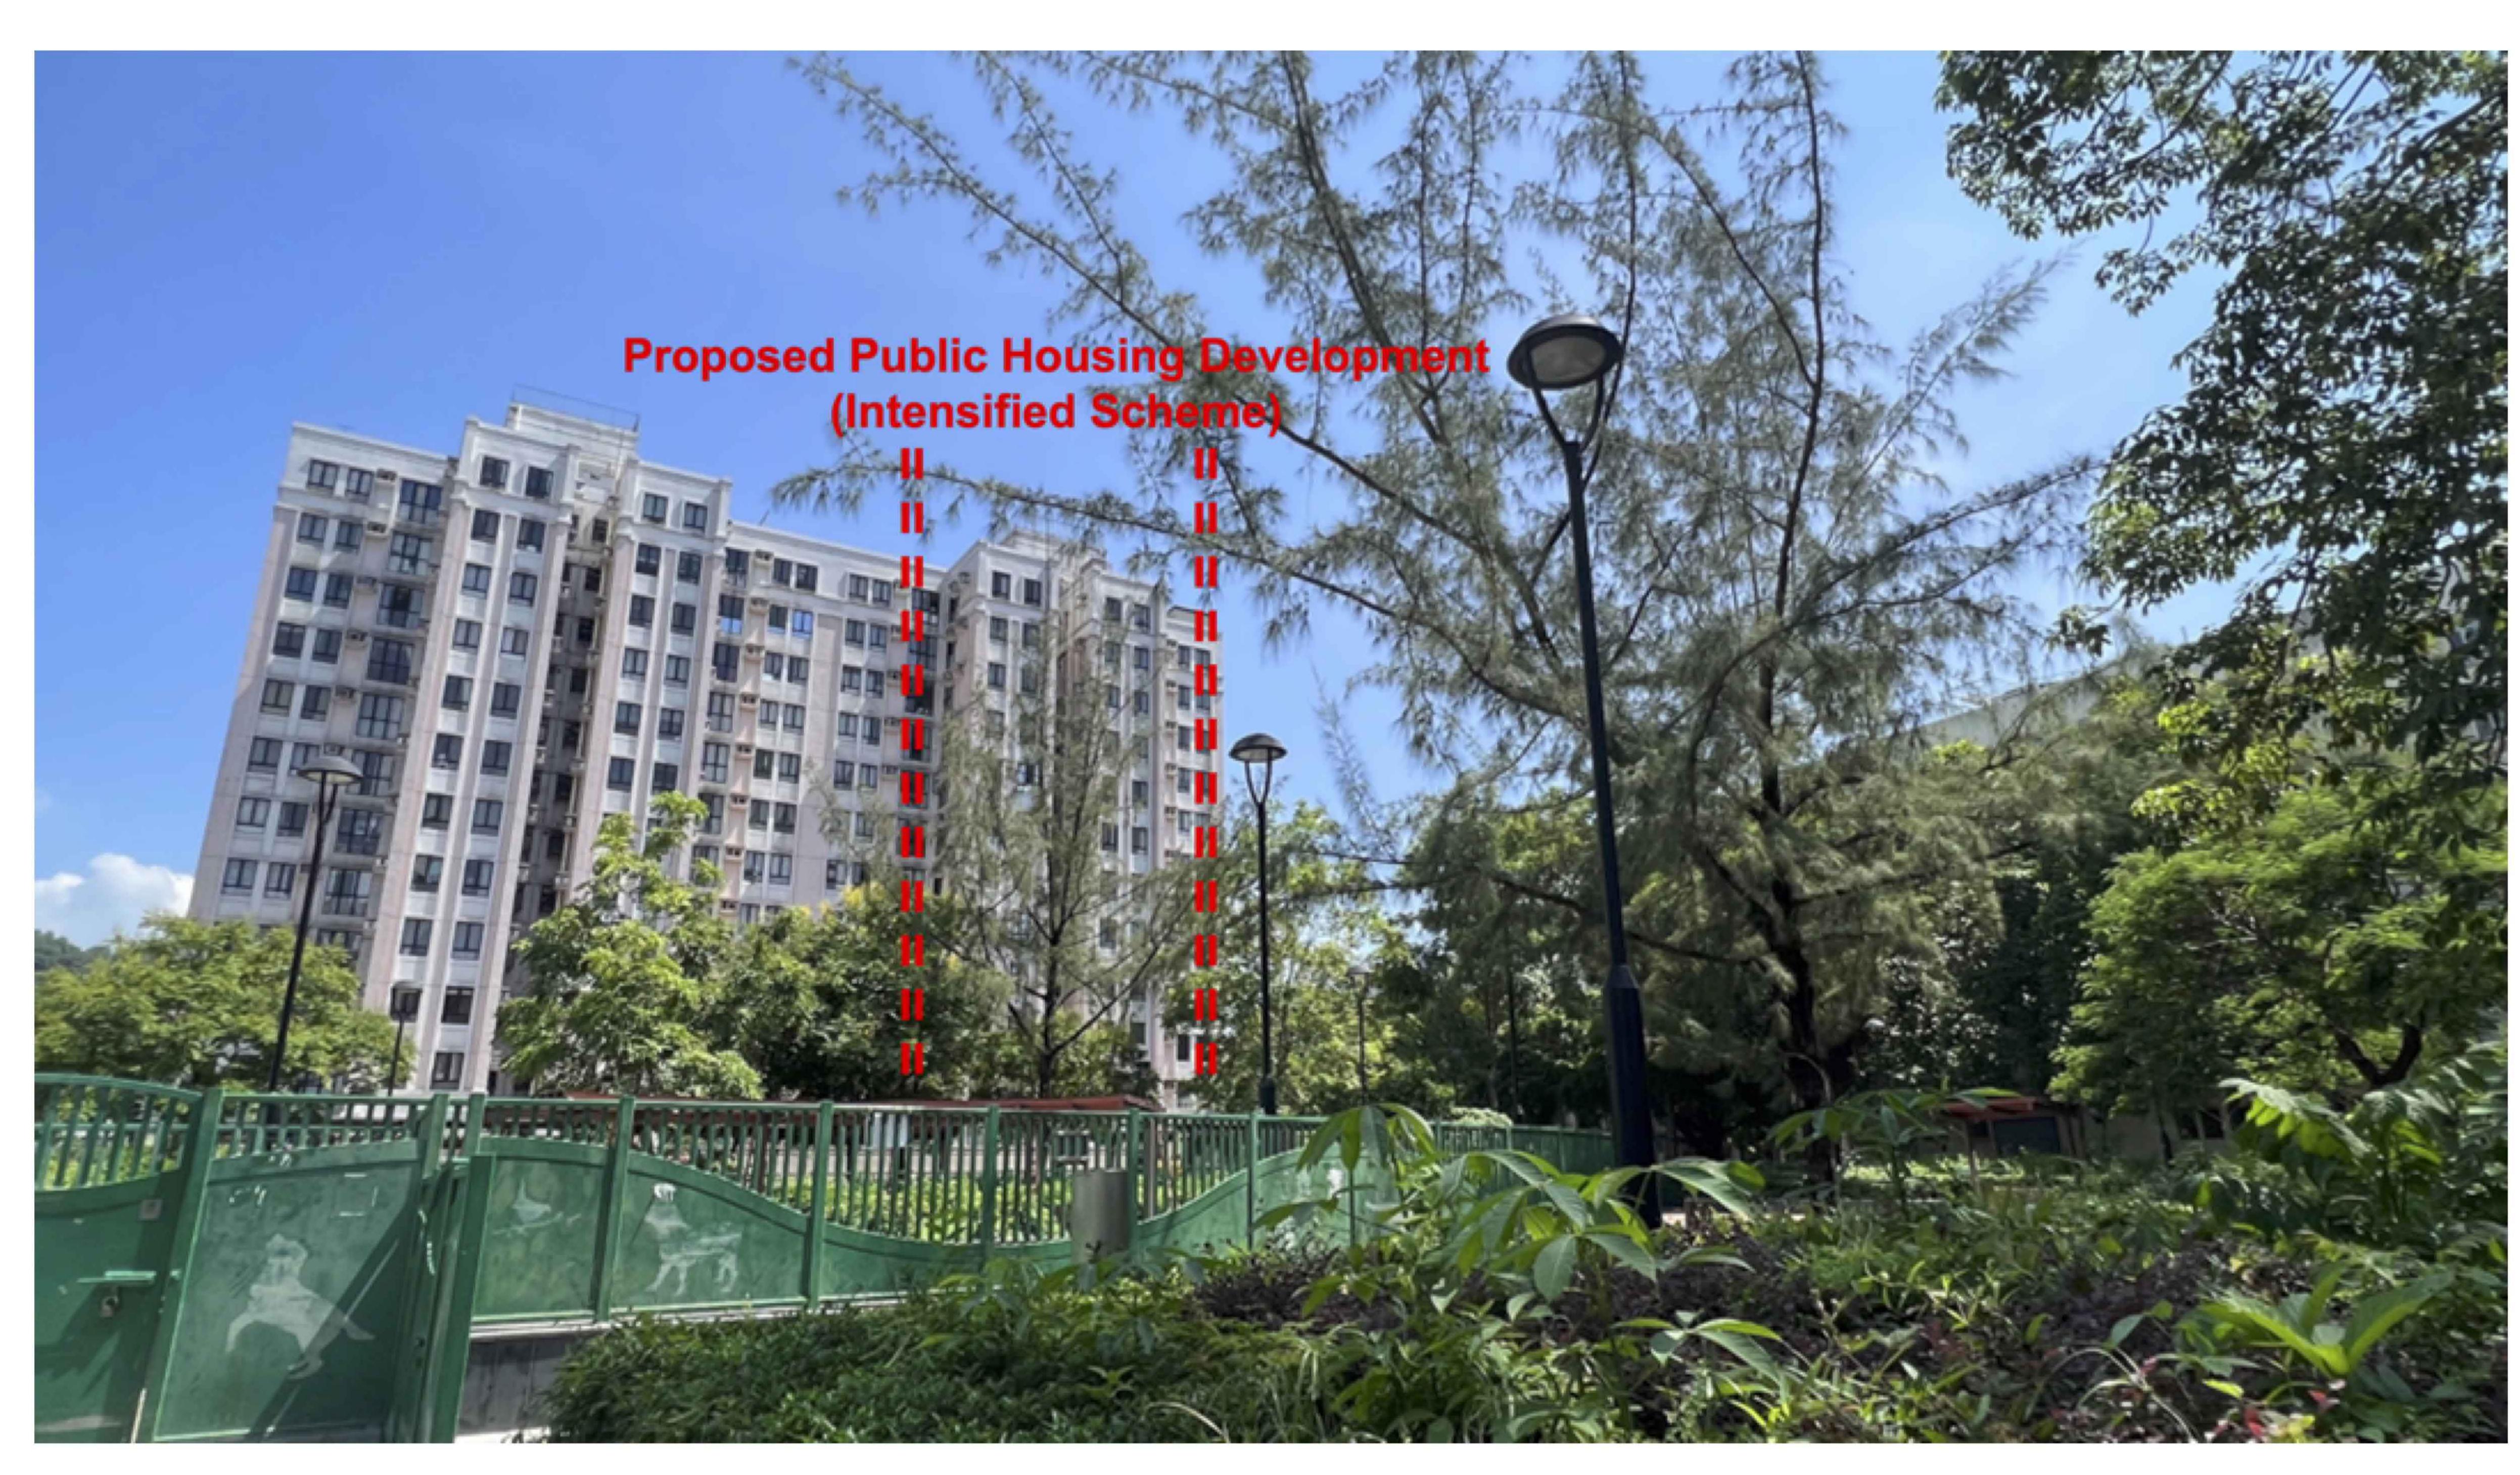
Figure 3.2.d Photomontage of Visually Sensitive Receiver VP4 Public Users of Tan Kwai Tsuen Road Garden

Existing View

Photomontage (Conforming Scheme) with Mitigation Measures

Photomontage (Intensified Scheme) without Mitigation Measures

Photomontage (Intensified Scheme) with Mitigation Measures

- 3.11.1 The assessment of the unmitigated visual impacts during the construction and operation phases are given in **Table 3.6**.
- 3.11.2 Photomontages are illustrated in **Figure 3.2a-k**. Each plan shows the existing view, photomontage of conforming scheme with mitigation measures, photomontage of Intensification scheme without mitigation measures and photomontage of Intensification scheme with mitigation measures.
