Agreement No. CE 92/2017 (CE) Site Formation and Infrastructure Works for Public Housing Development near Tan Kwai Tsuen, Yuen Long – Investigation, Design and Construction

Proposed Planning Application to the Approved Tong Yan San Tsuen Outline Zoning Plan No. S/YL-TYST/14

APPENDIX F
LANDSCAPE AND VISUAL IMPACT ASSESSMENT
REPORT

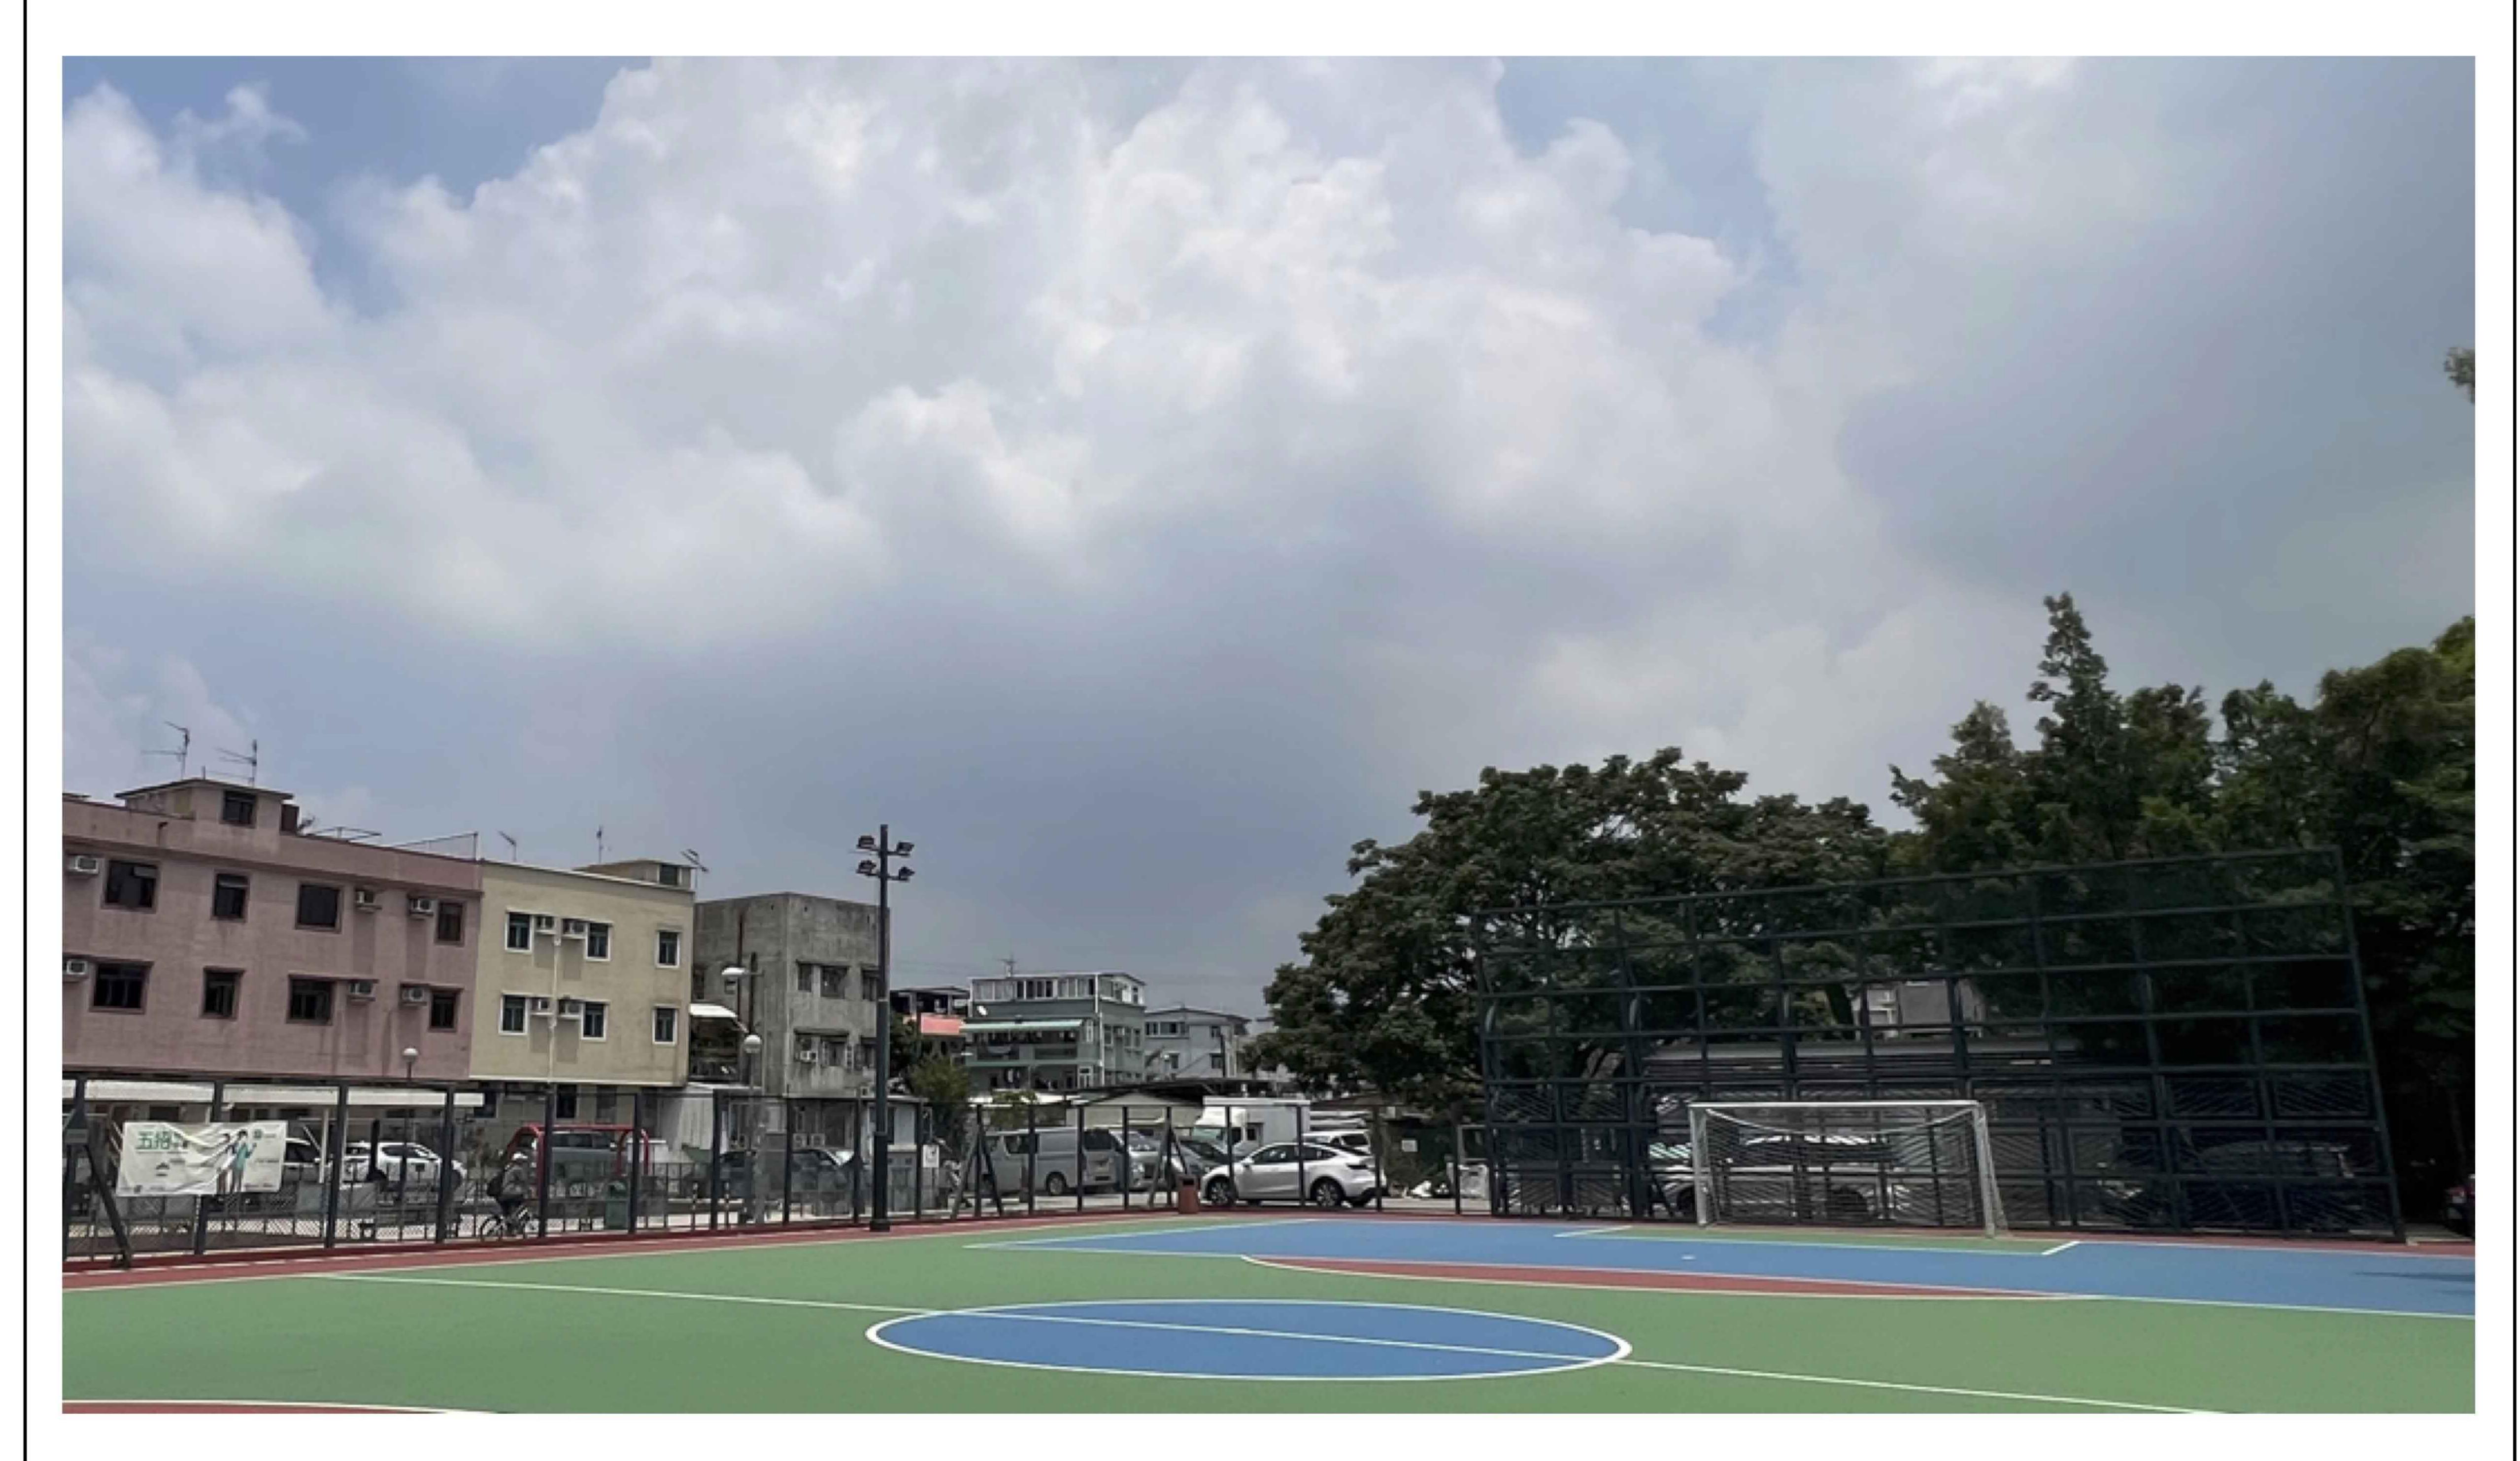
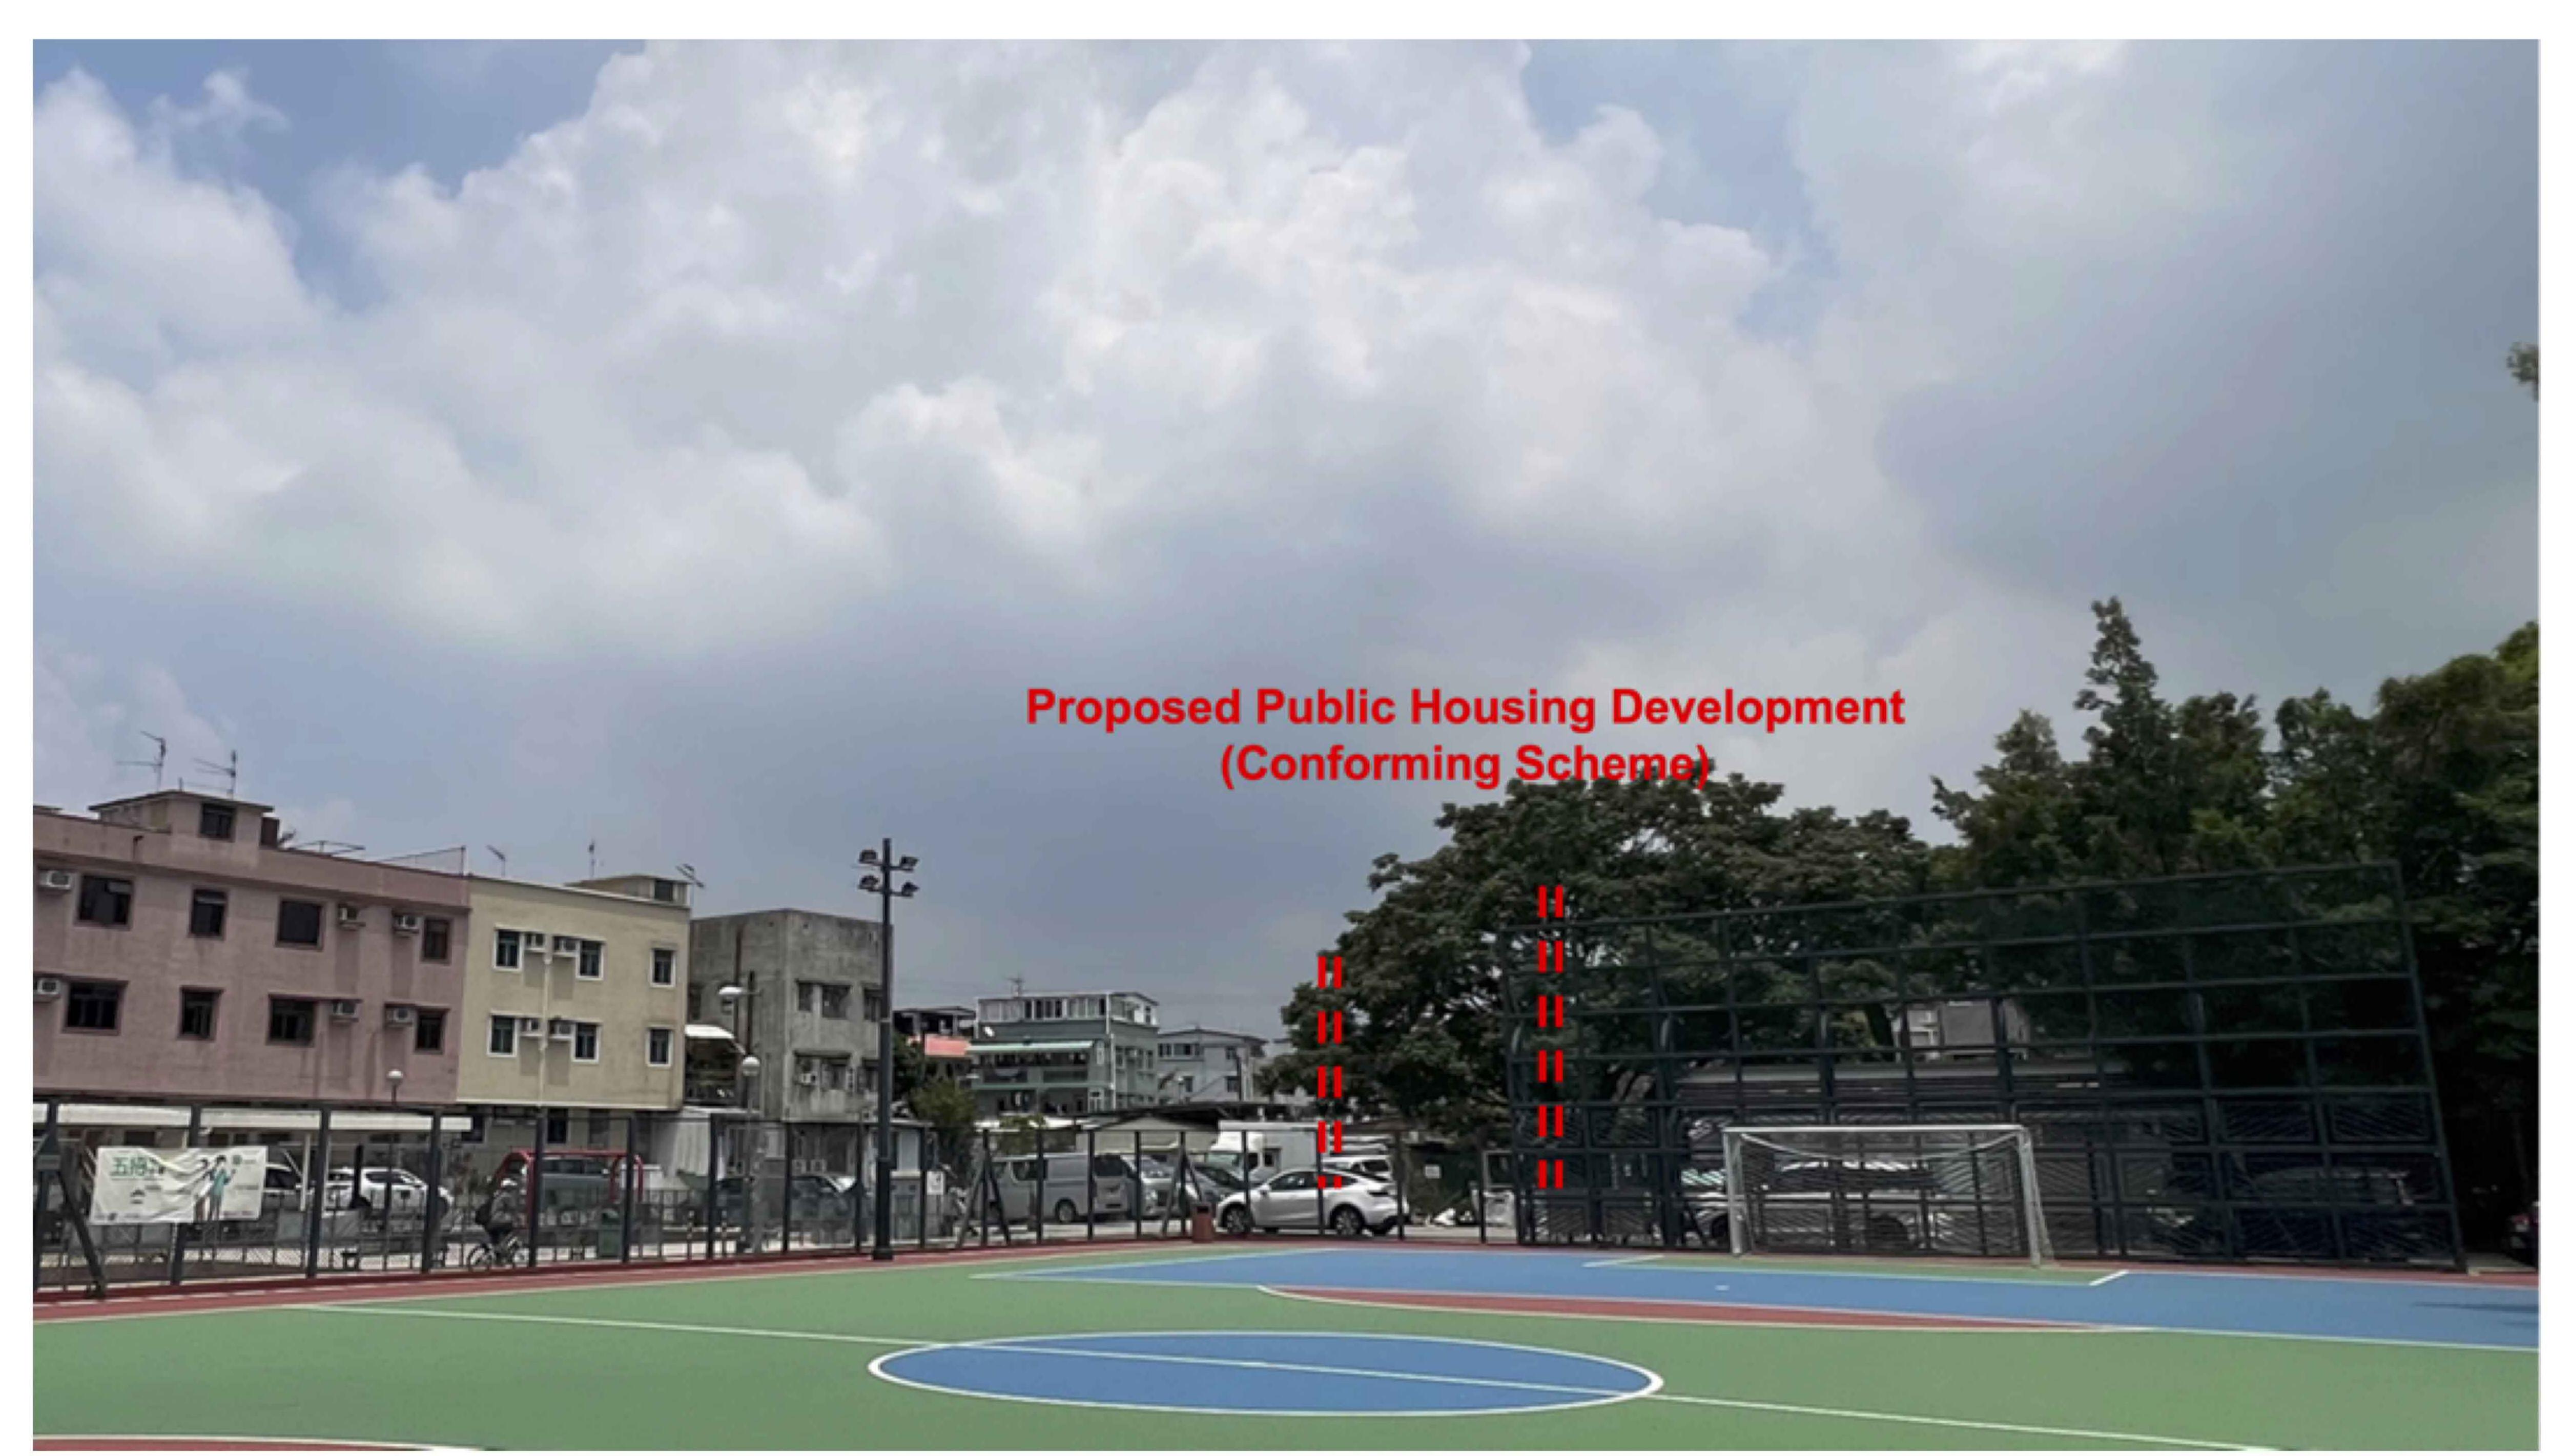
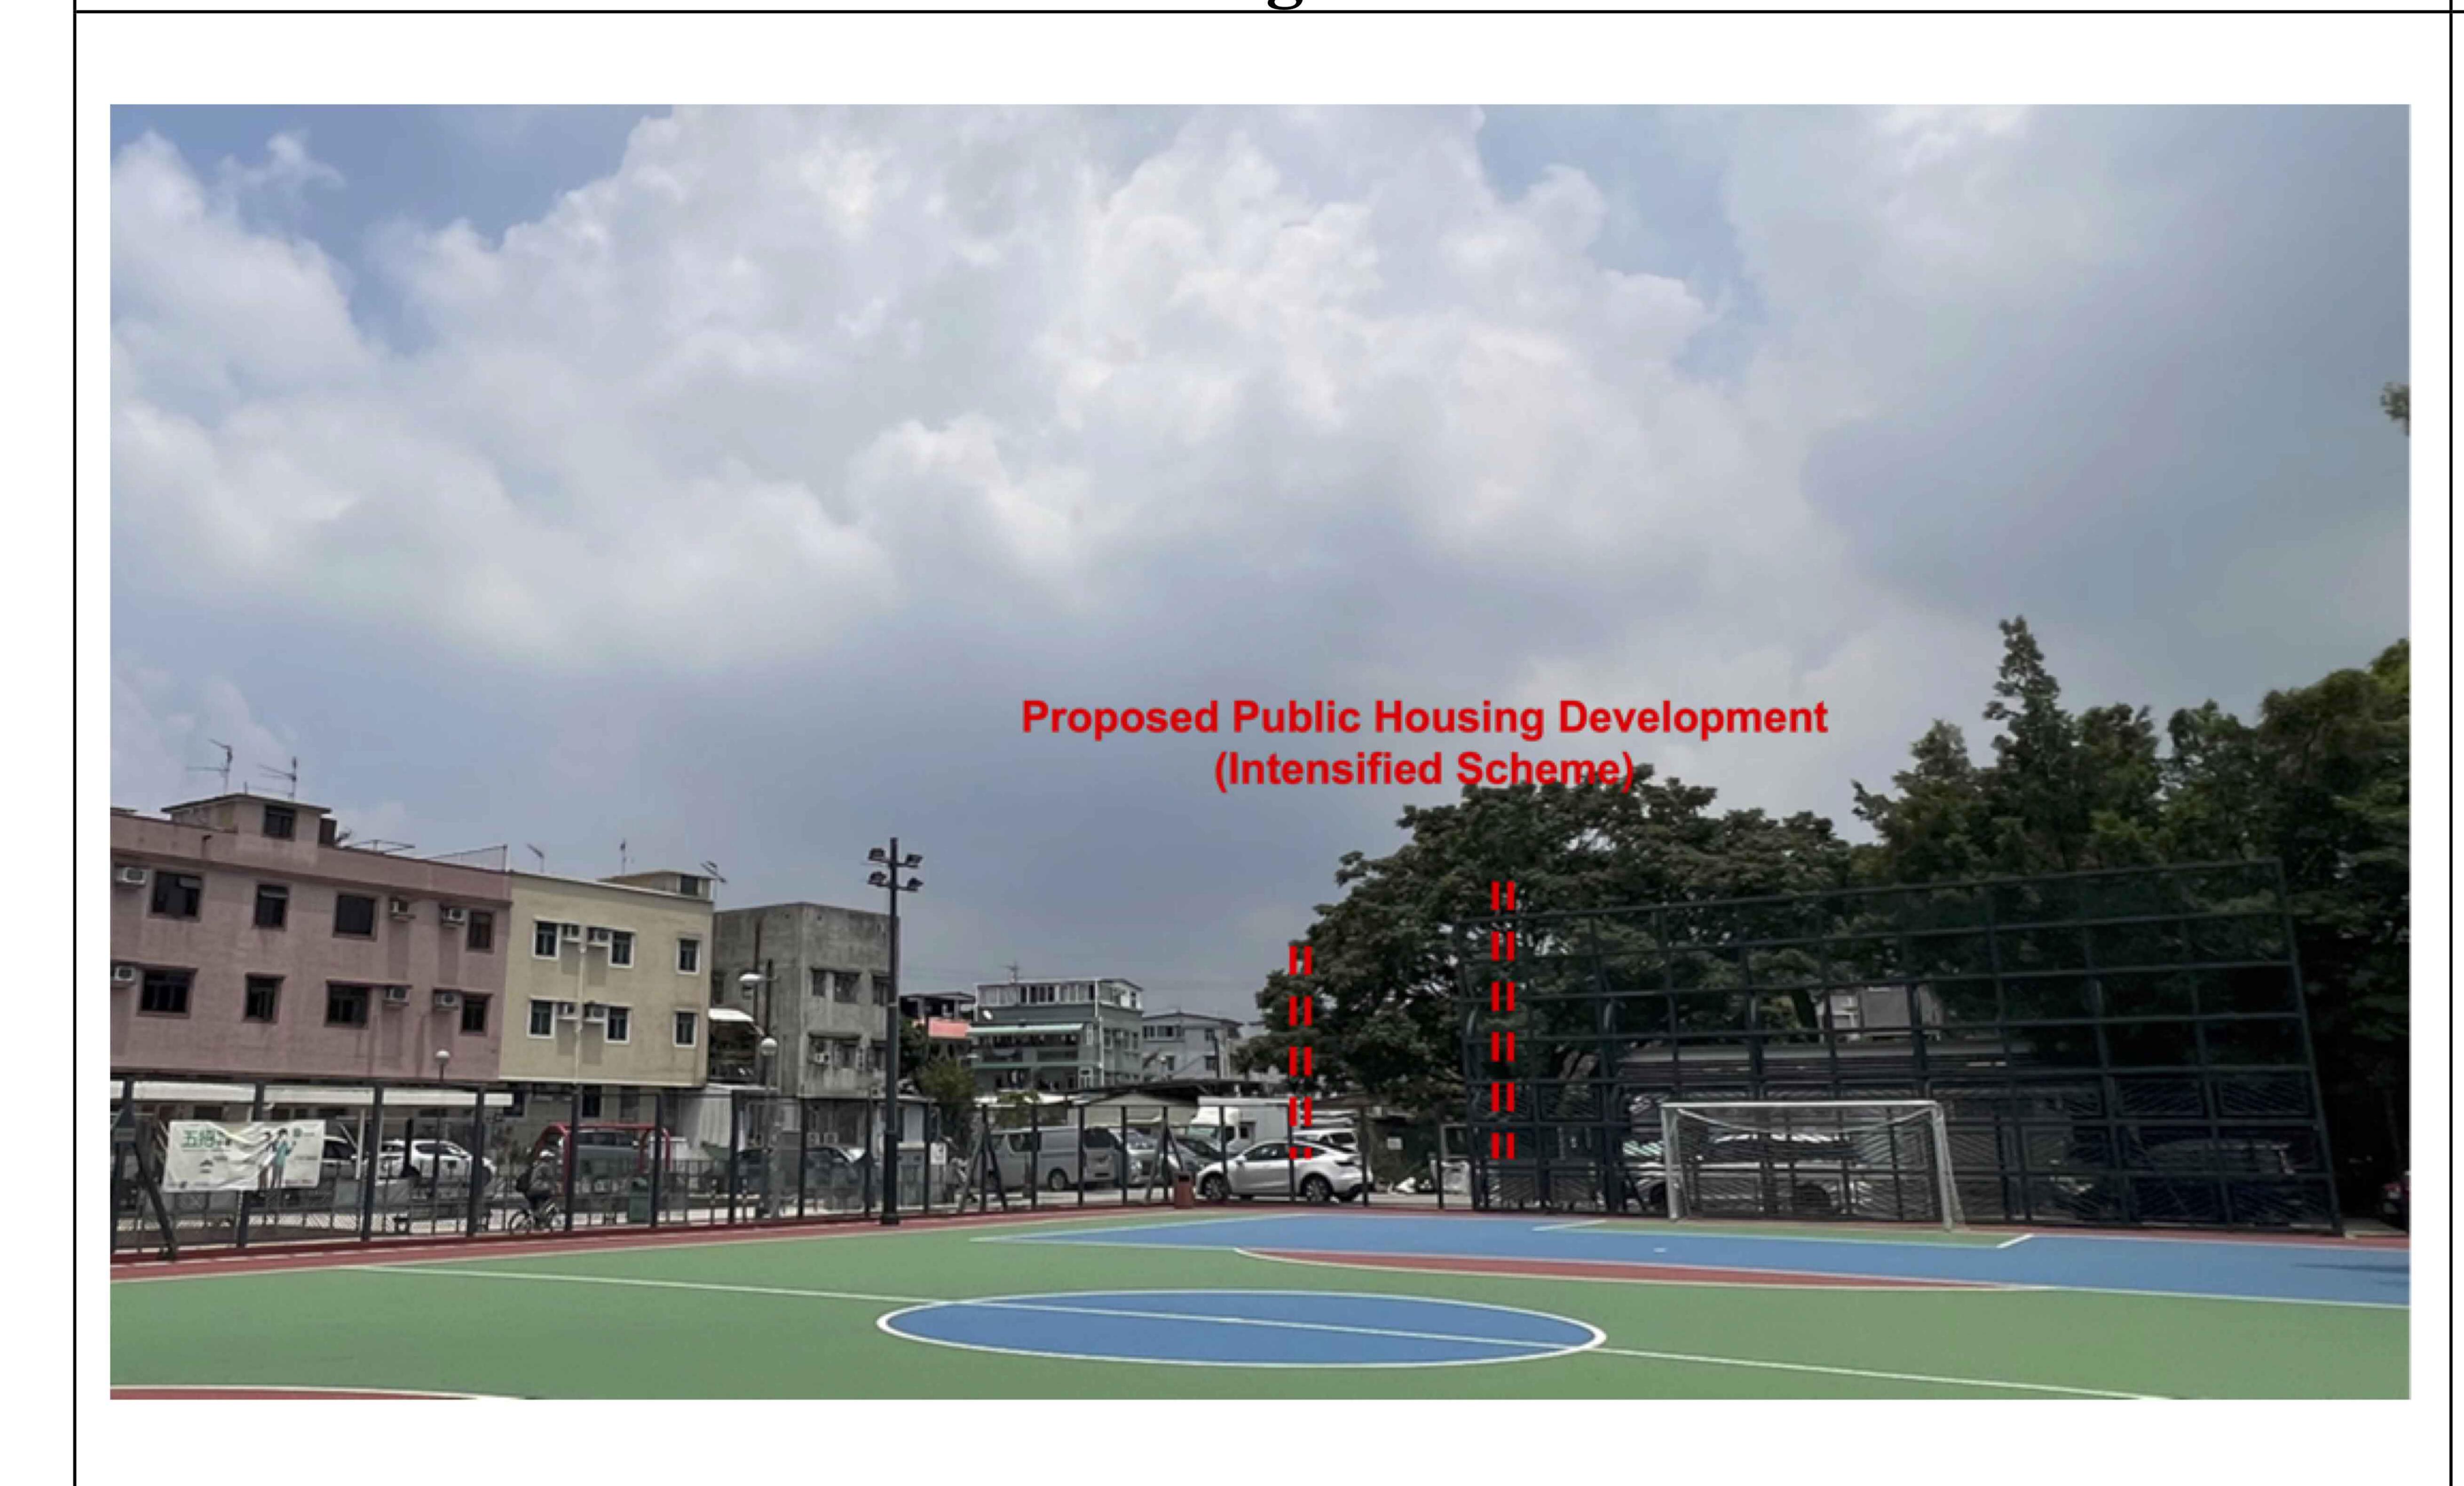
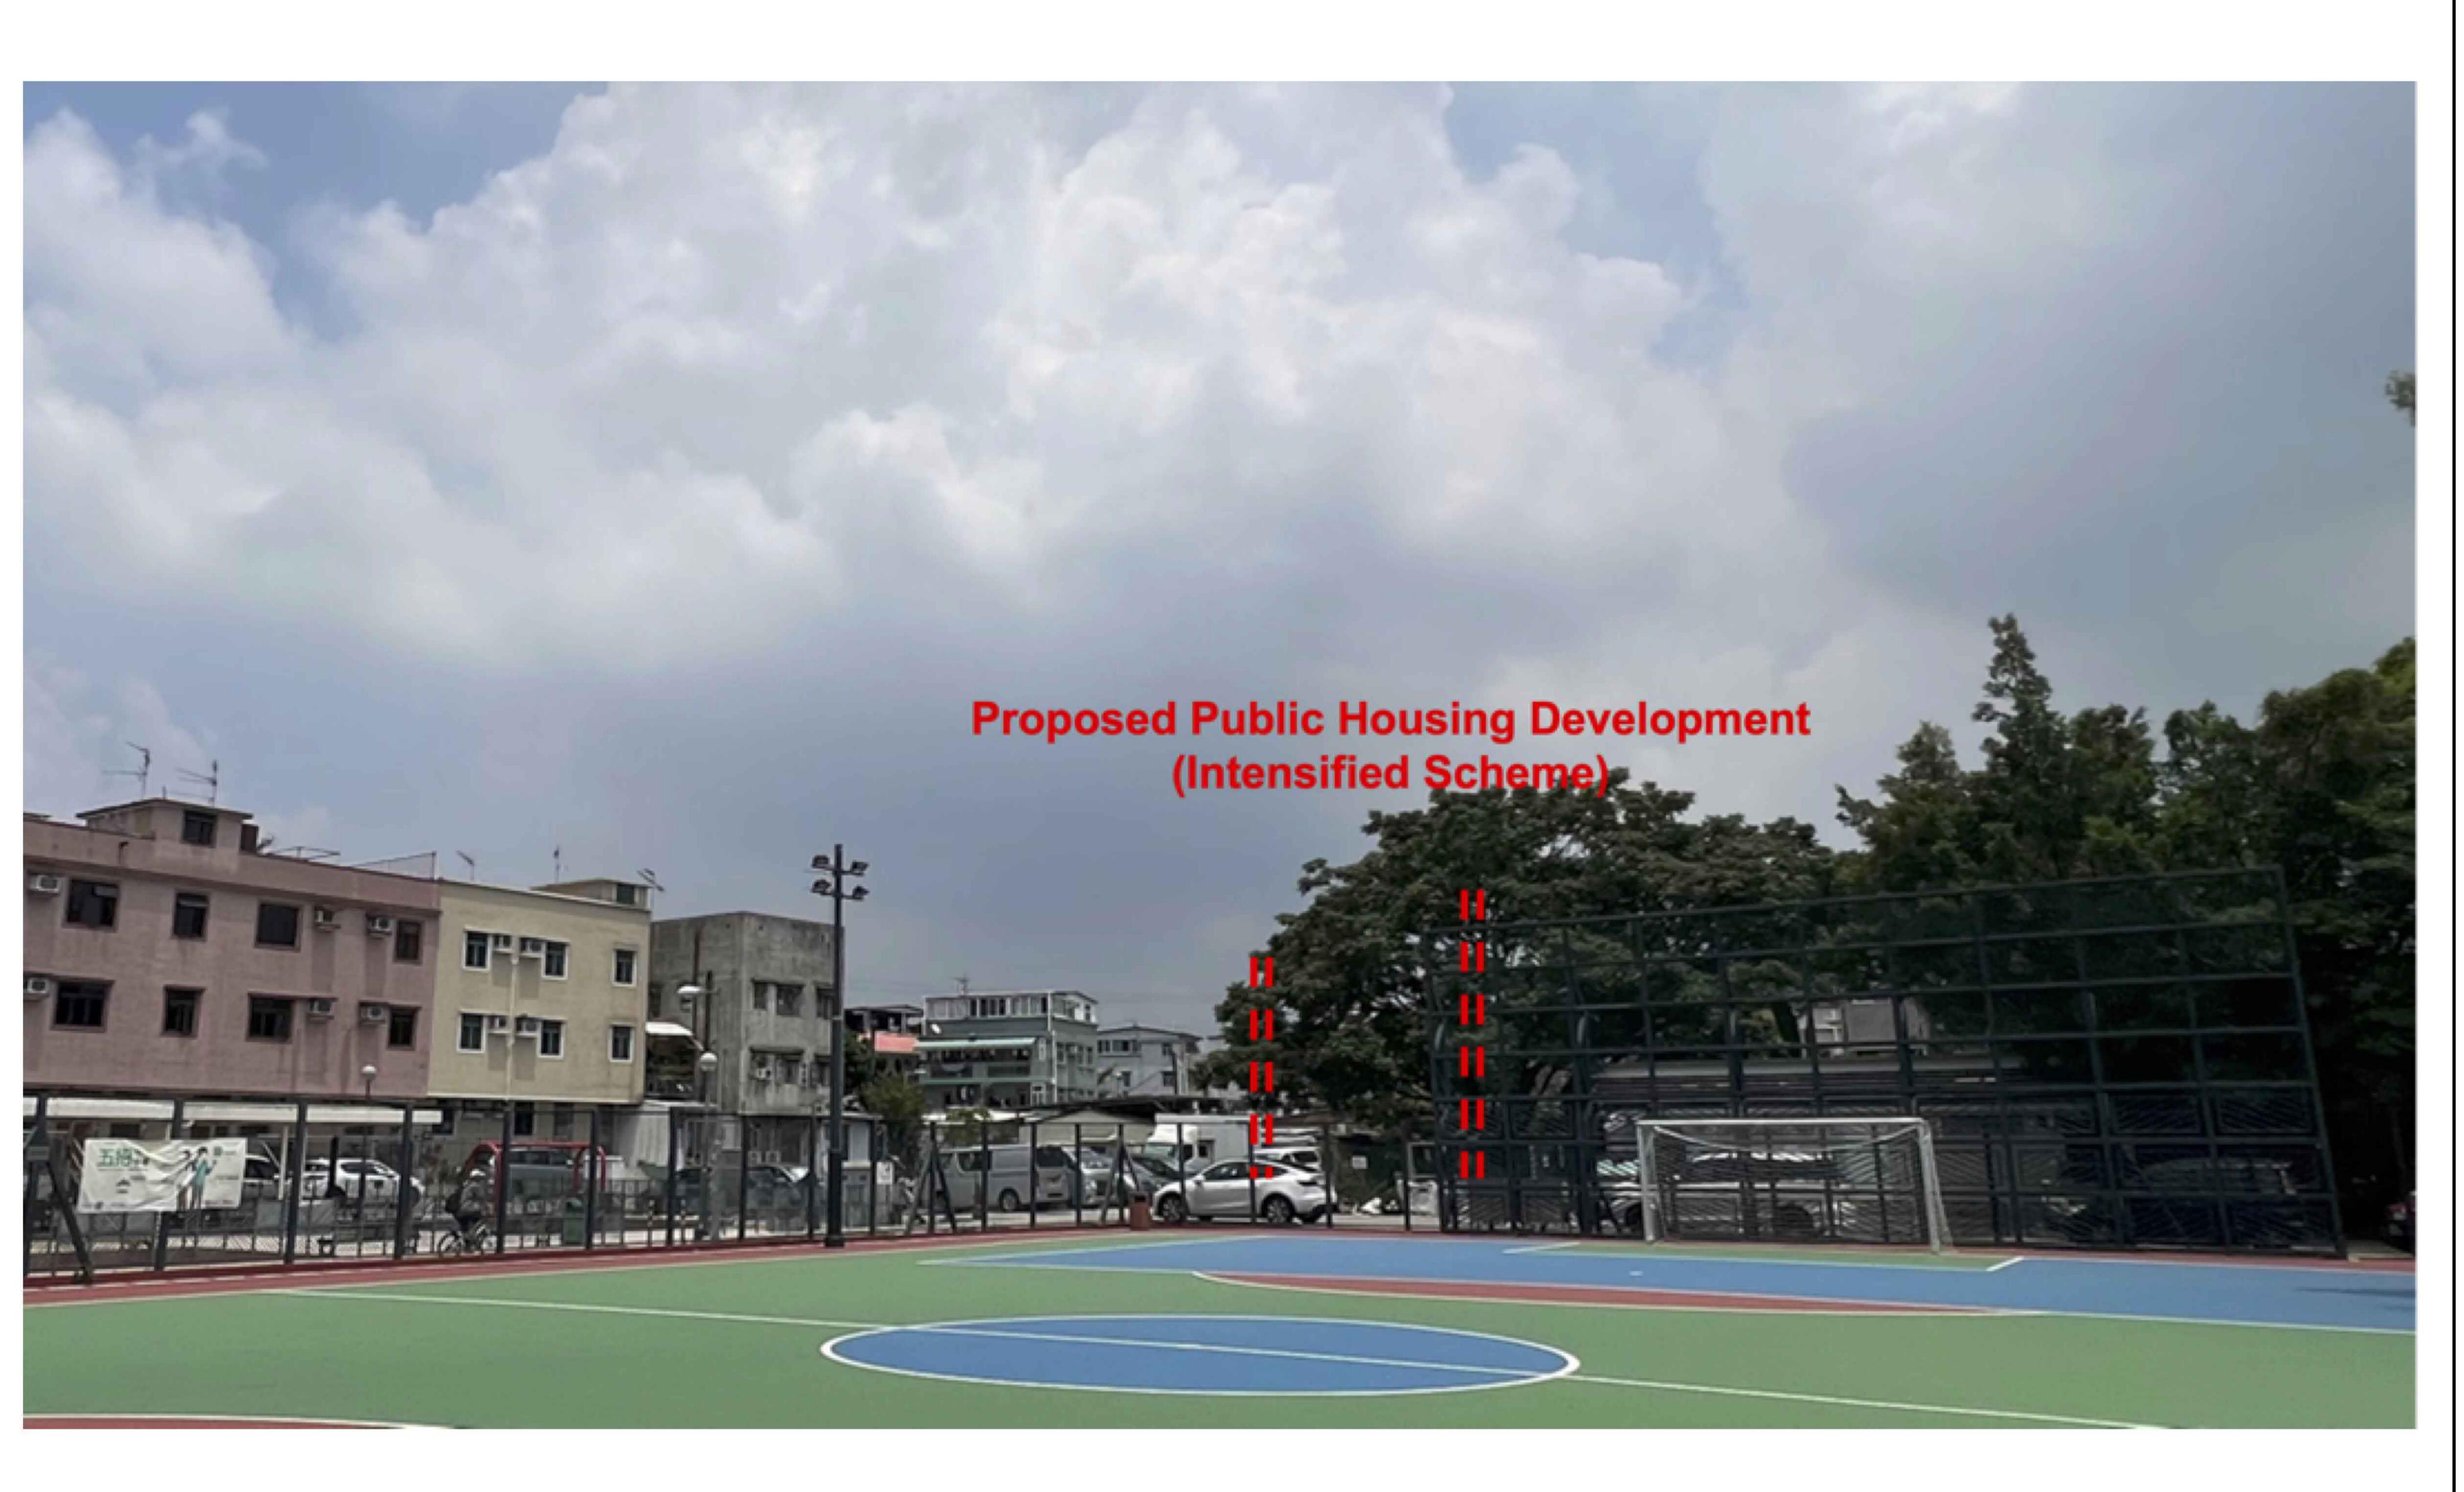
Existing View

Photomontage (Conforming Scheme) with Mitigation Measures

Photomontage (Intensified Scheme) without Mitigation Measures

Photomontage (Intensified Scheme) with Mitigation Measures

- 3.11.1 The assessment of the unmitigated visual impacts during the construction and operation phases are given in **Table 3.6**.
- 3.11.2 Photomontages are illustrated in **Figure 3.2a-k**. Each plan shows the existing view, photomontage of conforming scheme with mitigation measures, photomontage of Intensification scheme without mitigation measures and photomontage of Intensification scheme with mitigation measures.
