Agreement No. CE 92/2017 (CE) Site Formation and Infrastructure Works for Public Housing Development near Tan Kwai Tsuen, Yuen Long – Investigation, Design and Construction

Proposed Planning Application to the Approved Tong Yan San Tsuen Outline Zoning Plan No. S/YL-TYST/14

APPENDIX F
LANDSCAPE AND VISUAL IMPACT ASSESSMENT
REPORT

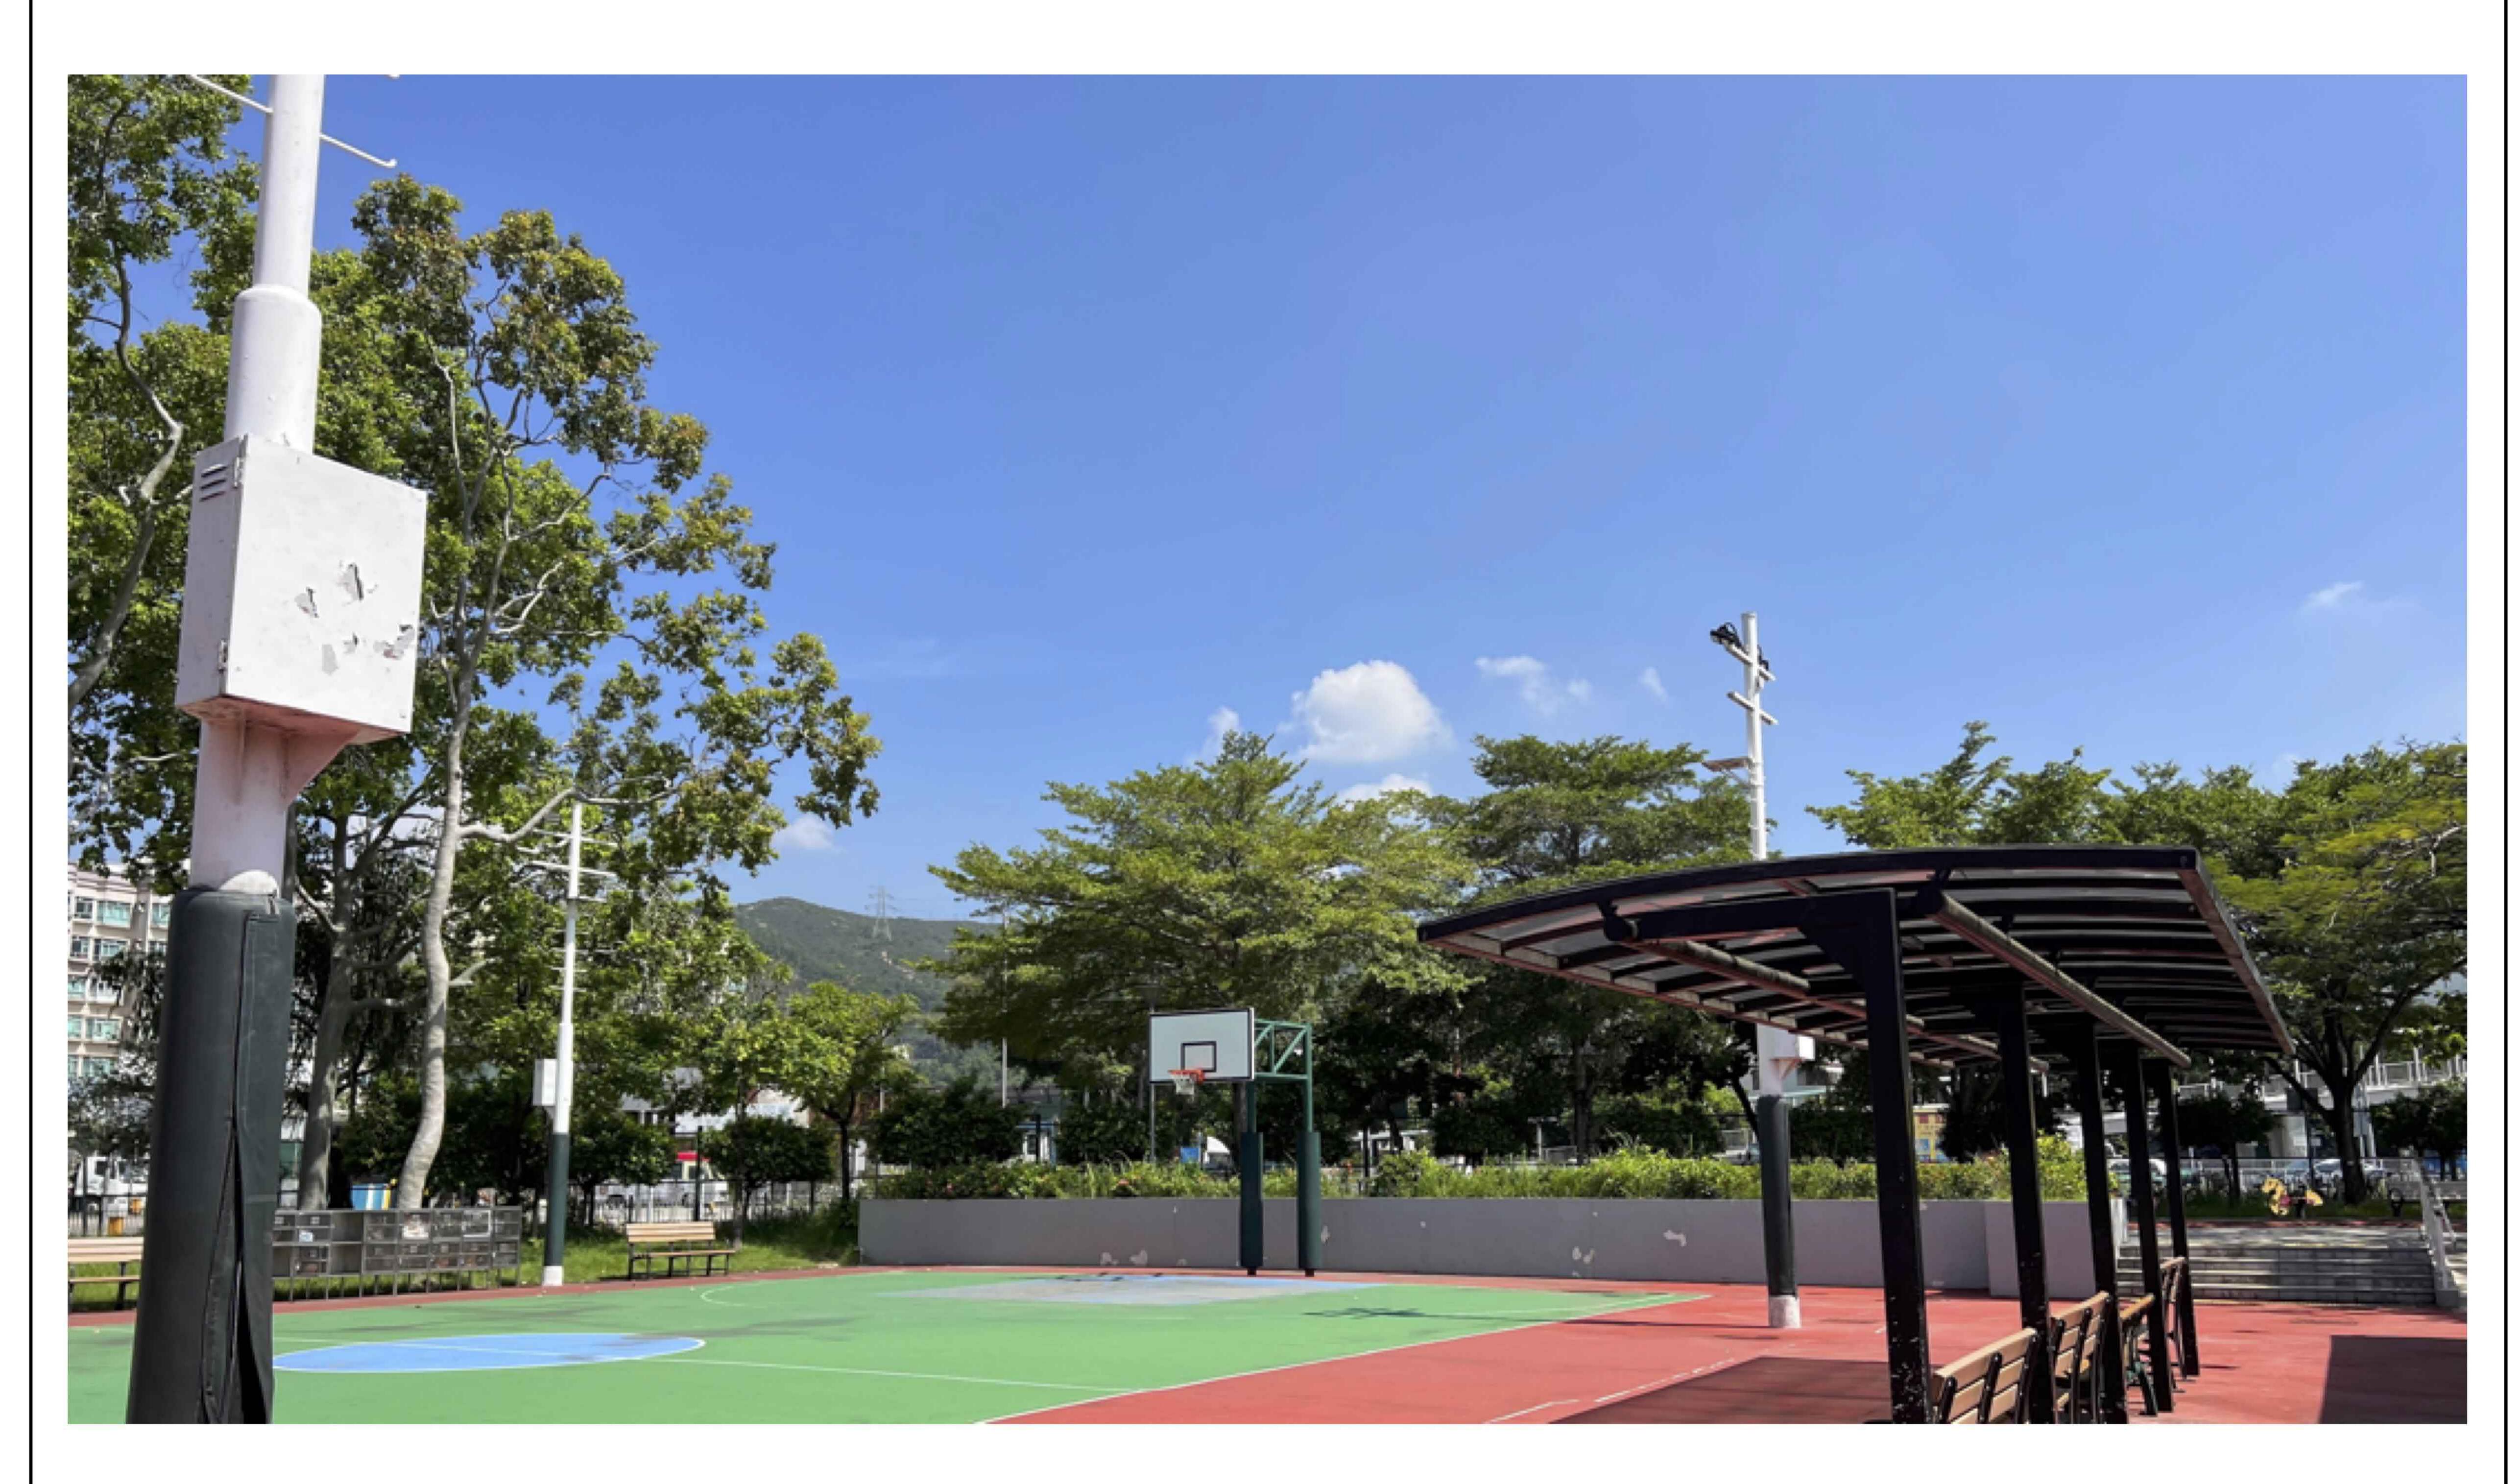
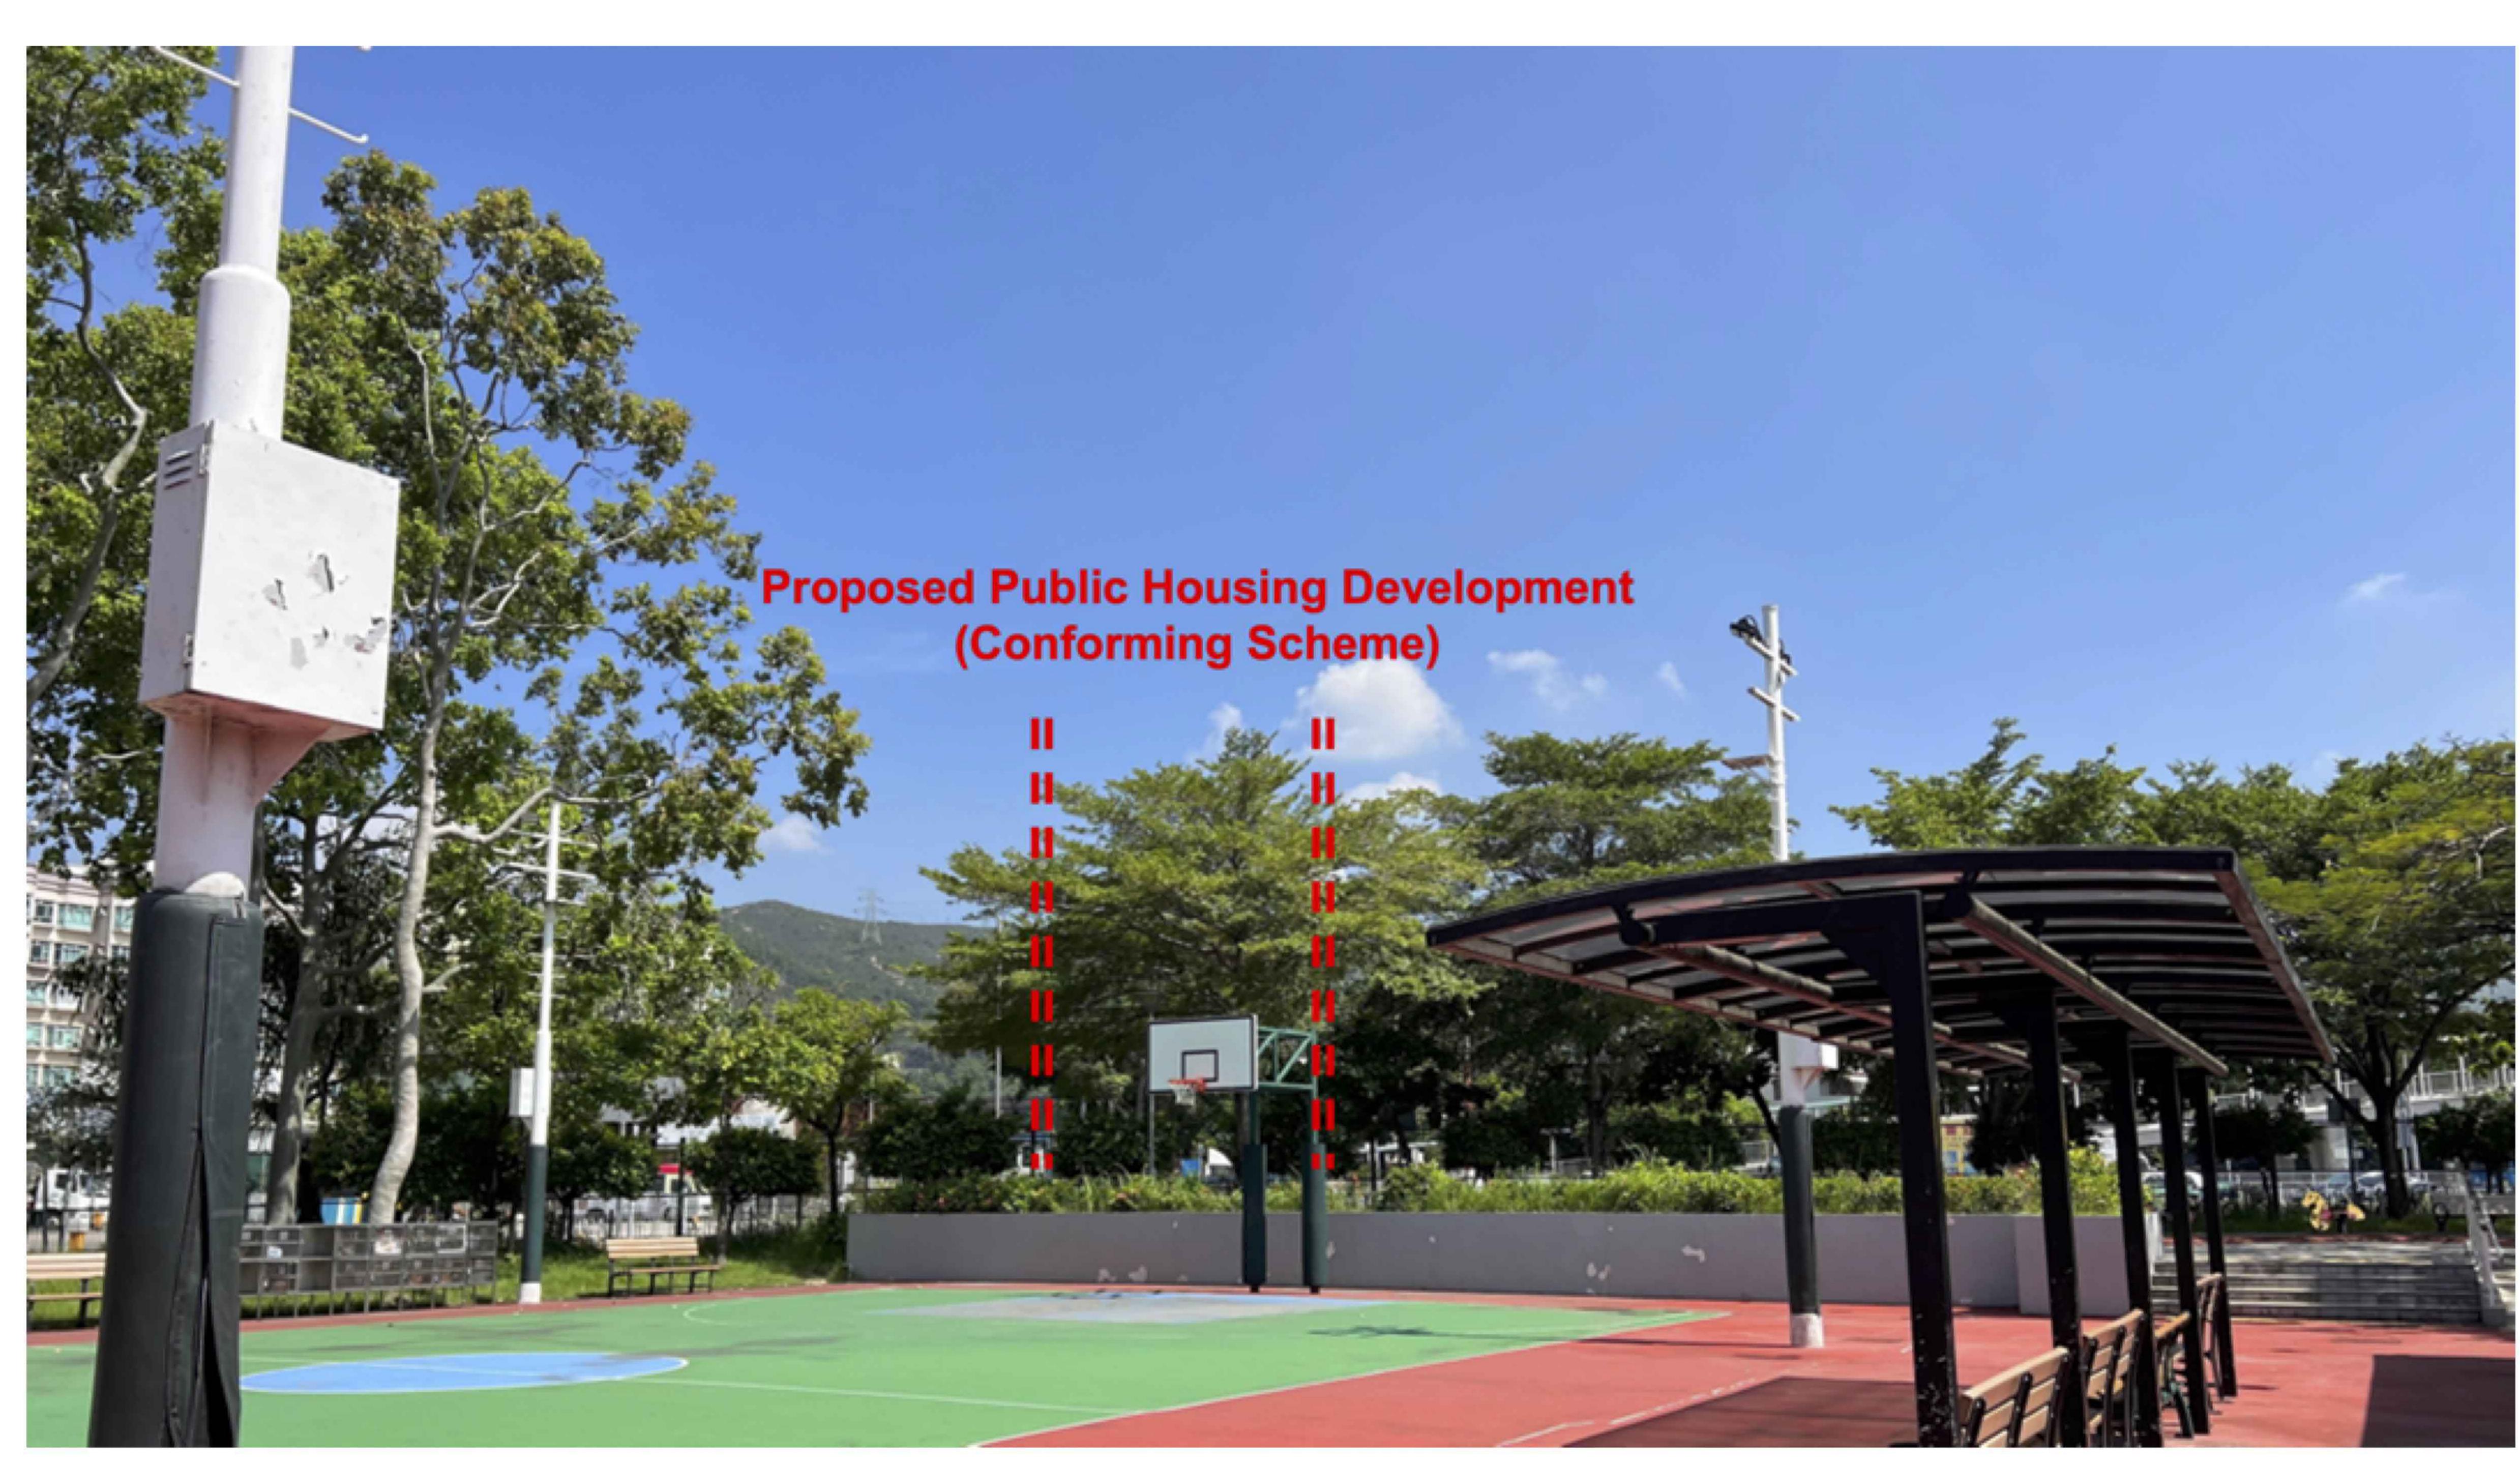
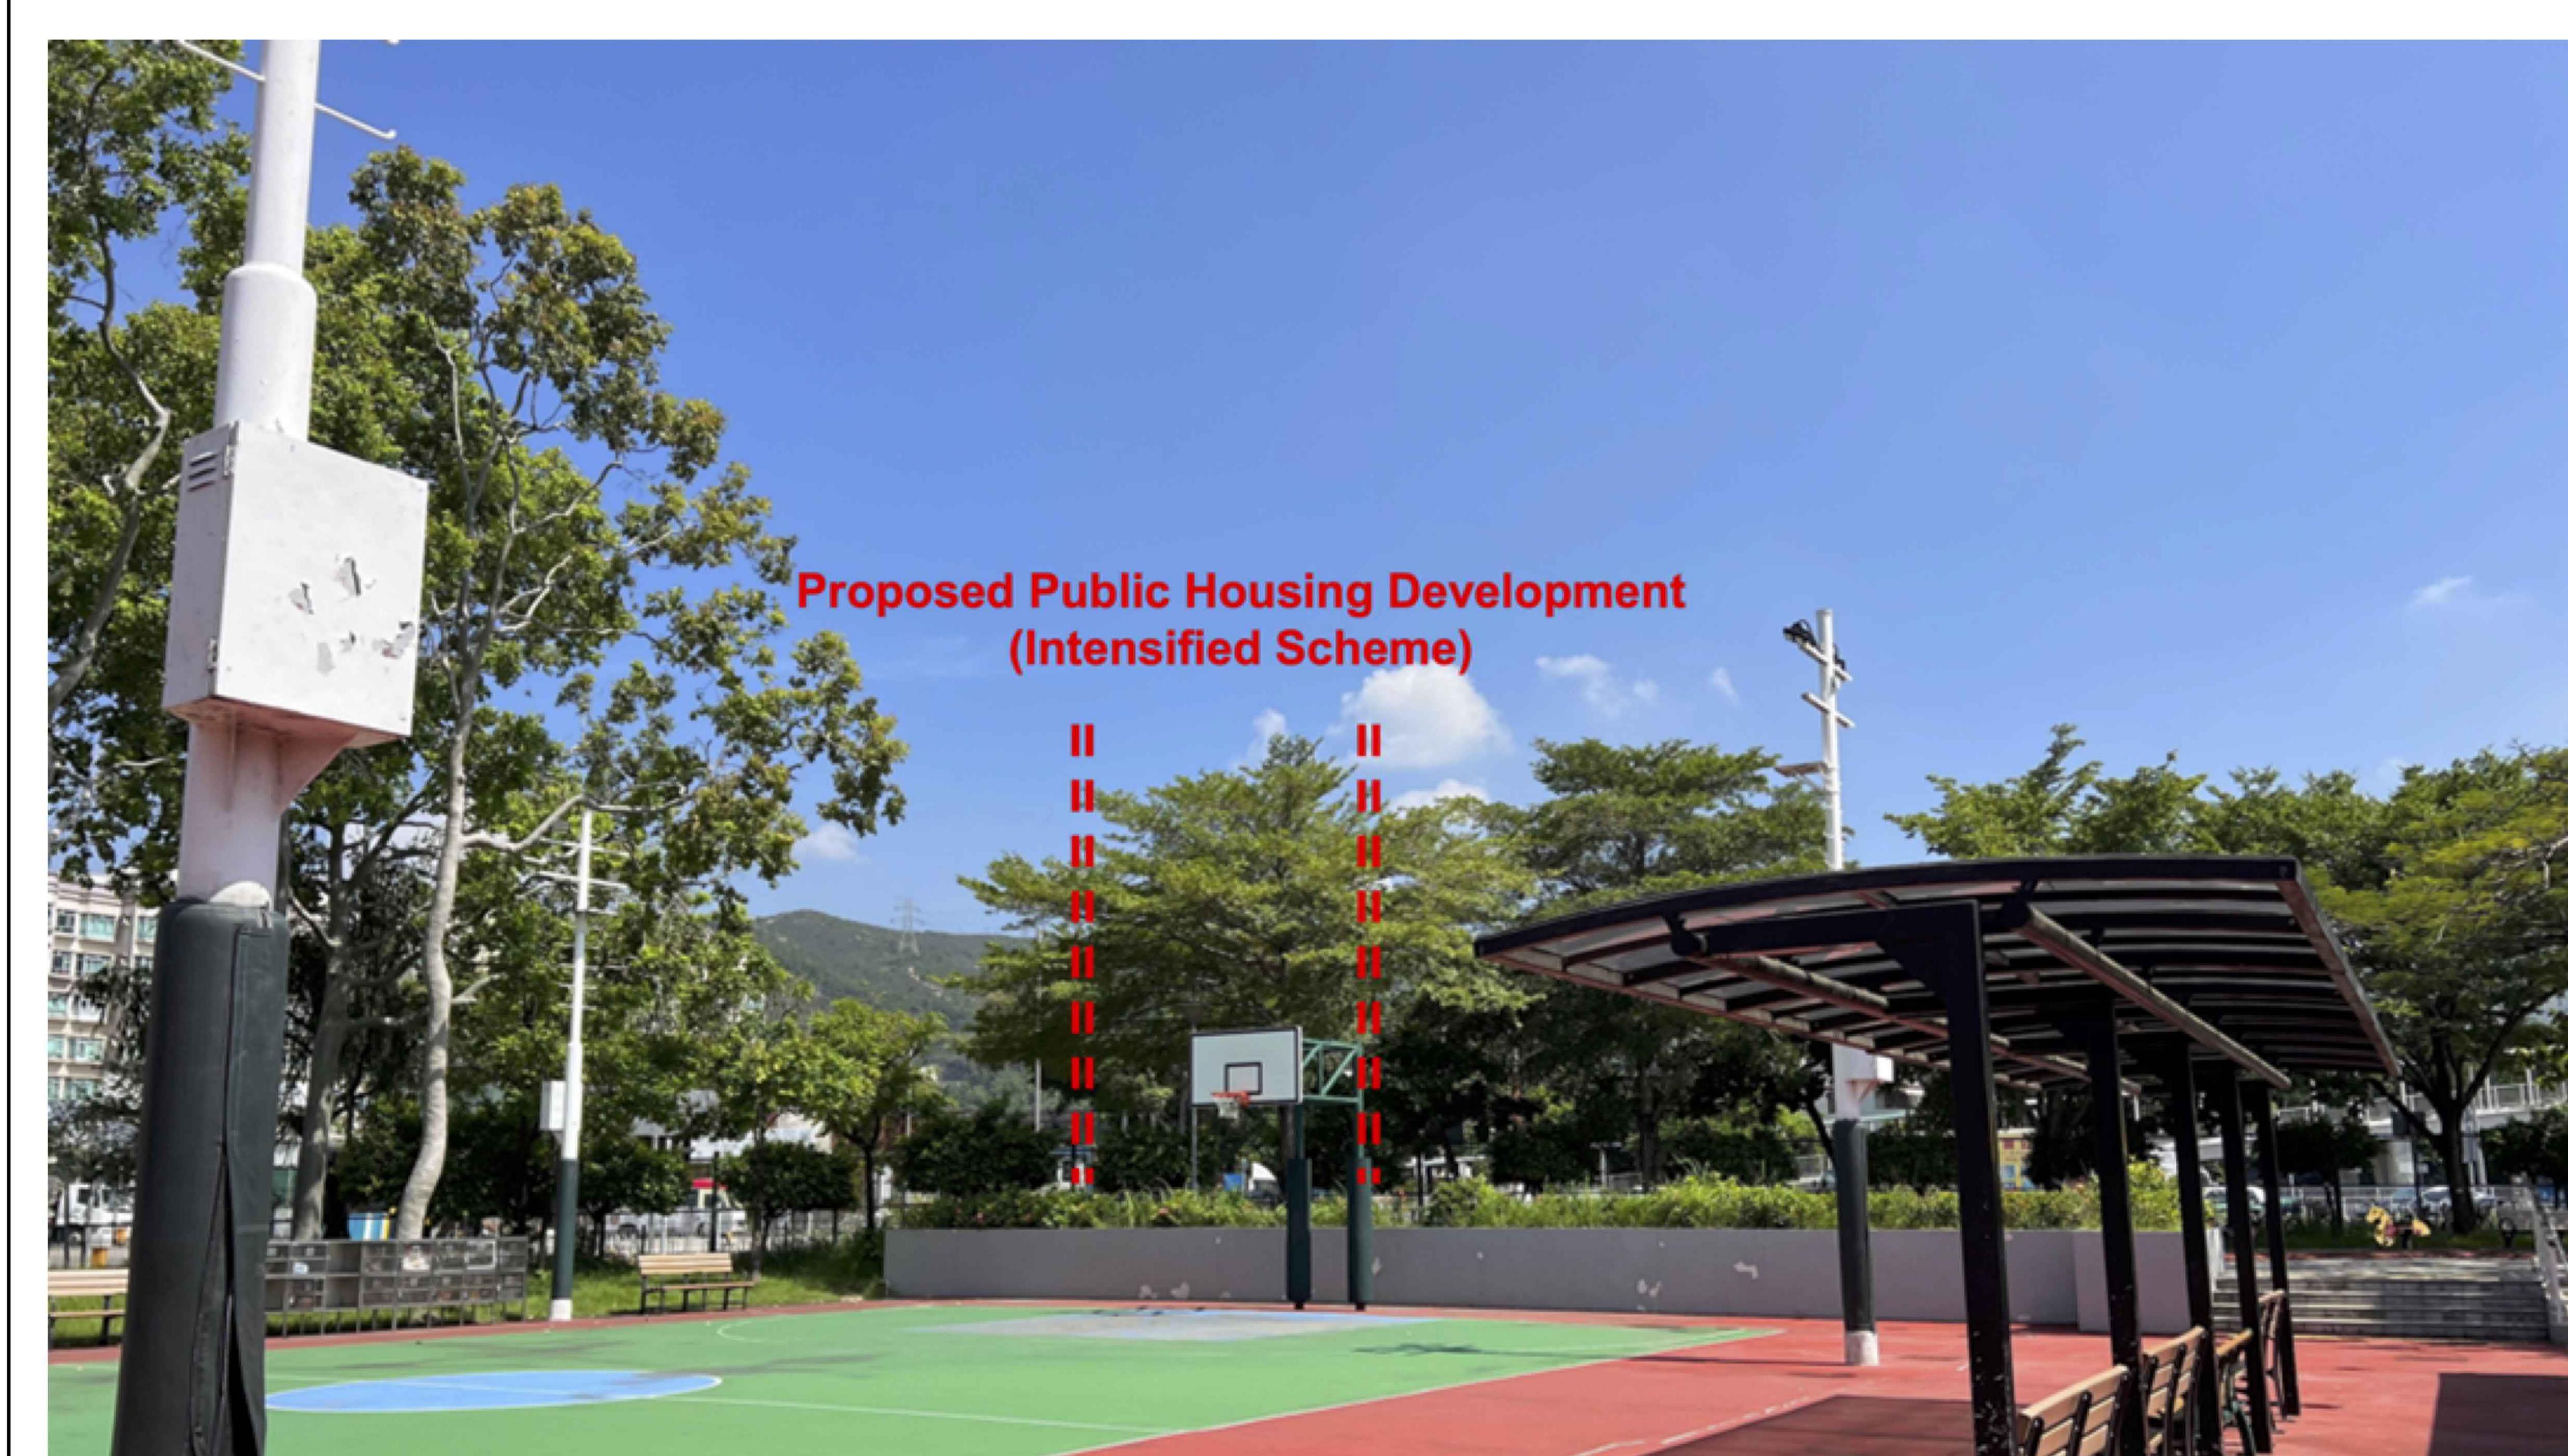
Existing View

Photomontage (Conforming Scheme) with Mitigation Measures

Photomontage (Intensified Scheme) without Mitigation Measures

- 3.11.1 The assessment of the unmitigated visual impacts during the construction and operation phases are given in **Table 3.6**.
- 3.11.2 Photomontages are illustrated in **Figure 3.2a-k**. Each plan shows the existing view, photomontage of conforming scheme with mitigation measures, photomontage of Intensification scheme without mitigation measures and photomontage of Intensification scheme with mitigation measures.
