AIRCRAFT ACCIDENT REPORT 1/2010

**Civil Aviation Department
Hong Kong**

**Report on the accident to
Robinson R22 helicopter, B-LAT,
at a parking lot adjacent to the Hong Kong Aviation Club Limited,
Sung Wong Toi Road, Hong Kong
on 1 May 2009**

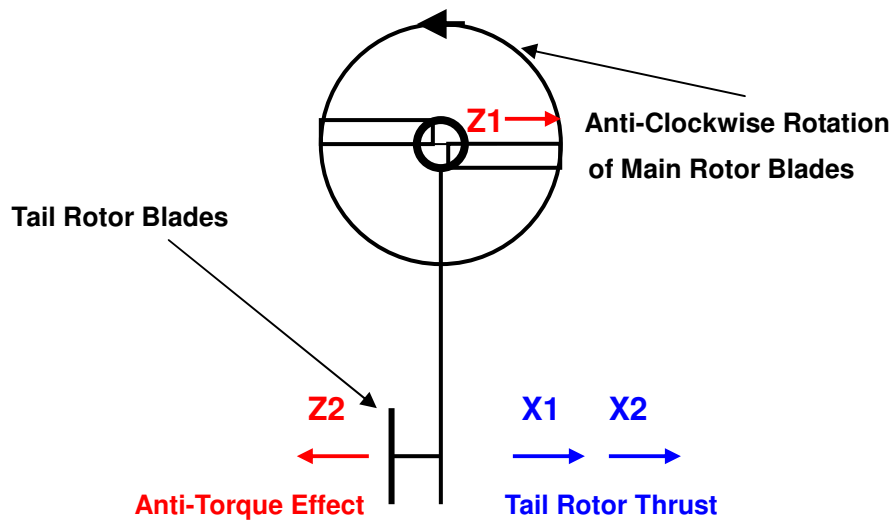
Figure 1 Anti-Torque Effect and Tail Rotor Thrust

Figure 1 is an illustration of the Anti-Torque Effect of the helicopter in the hover. With the main rotor blades rotating anti-clockwise, the helicopter would have a tendency to turn clockwise. This phenomenon is known as the Anti-Torque Effect, which can be seen in Figure 1 as Force Z1 and Z2 (of equal magnitude) acting on the fuselage and forcing the helicopter to yaw to the right. To prevent the helicopter from yawing to the right, the tail rotor of the helicopter must produce a Tail Rotor Thrust (i.e. Forces X1 and X2) to counteract the effect of Z1 and Z2. The tail rotor thrust is the result of the application of the anti-torque pedal by the pilot. If the tail rotor generates more thrust (left pedal) than that is required to counteract the main rotor torque, the helicopter will yaw or turn to the left about the vertical axis. If less tail rotor thrust (right pedal) is generated the helicopter will yaw to the right. By varying the thrust generated by the tail rotor, the pilot controls the heading when hovering and at low forward airspeed.

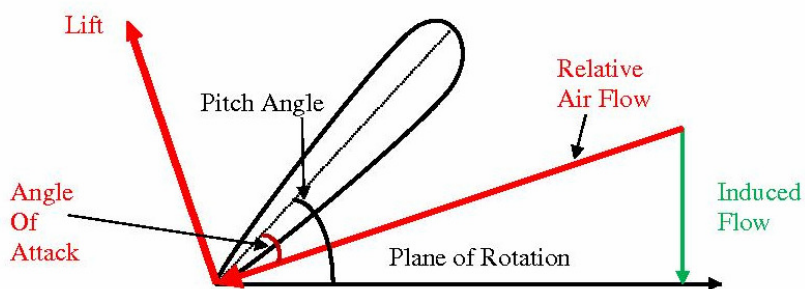
Figure 2 Induced Flow

Newton's Third Law of action and reaction supports the principle that during helicopter flight the rotor must force down a volume of air. This volume of air is known as the Induced Flow. As a helicopter blade rotates along the Plane of Rotation it creates an airflow on its leading edge. The resultant of the Induced Flow and the Plane of Rotation will be the Relative Air Flow as shown in Figure 2.

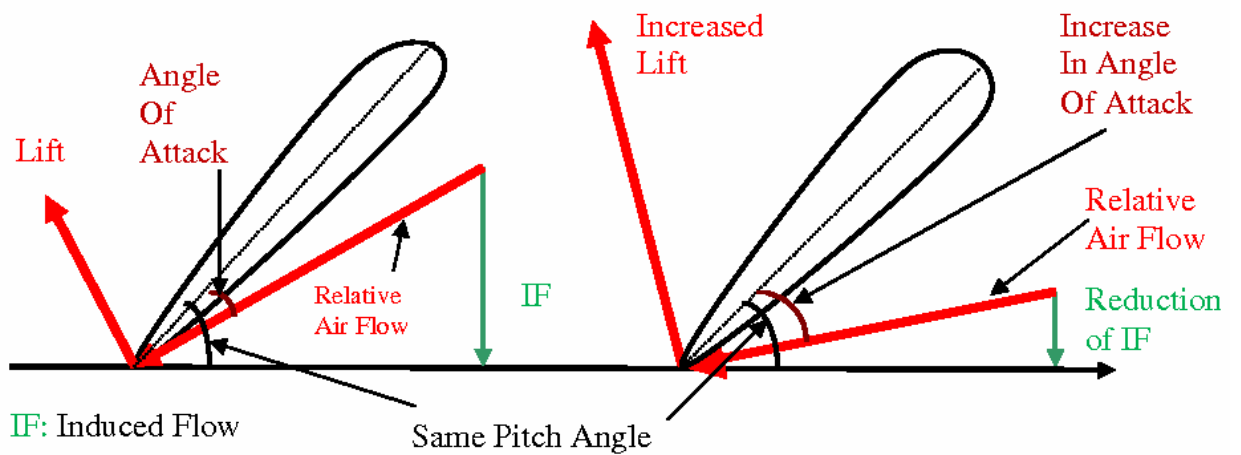
Figure 3 Reduction of Induced Flow

It can be seen from Figure 3 that without moving the collective to alter the pitch angle and the power used, a reduction of Induced Flow, will rotate the Relative Air Flow clockwise resulting in a larger angle of attack and an increase in lift, and vice versa, an increase of Induced Flow will rotate the Relative Air Flow anti-clockwise resulting in a smaller angle of attack and a reduction in lift.

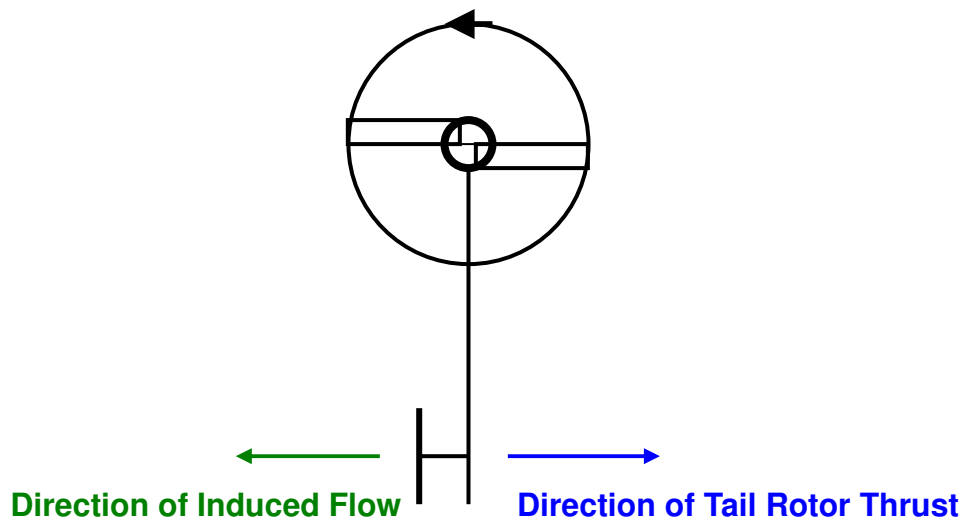
Figure 4 Induced Flow and Tail Rotor Thrust

As with the main rotors, there will be Induced Flow produced by the tail rotors in the opposite direction of the Tail Rotor Thrust to counter the anti-torque effect as shown in Figure 4.

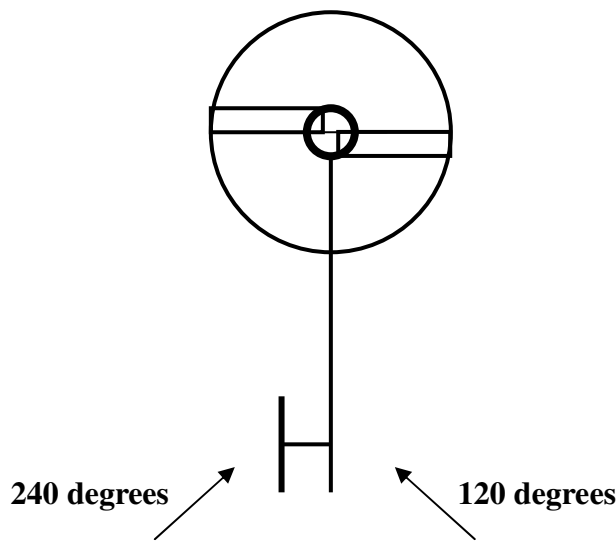
Figure 5 Weathercock Effect

With a wind blowing, the helicopter at low airspeed tends to behave like a weathervane and will turn the aircraft to face into wind. The weathercock effect will be most prominent when the tailwind is at 120 degrees to 240 degrees from the helicopter heading.
