Enclosure to: B-H200-17041-ASI

MDC-00K1121

**Sequence and Characteristics of the Structural Failure of the Mandarin Airlines  
(China Airlines) MD-11 Fuselage Number 518 – August 22, 1999 Accident at  
Hong Kong International Airport**

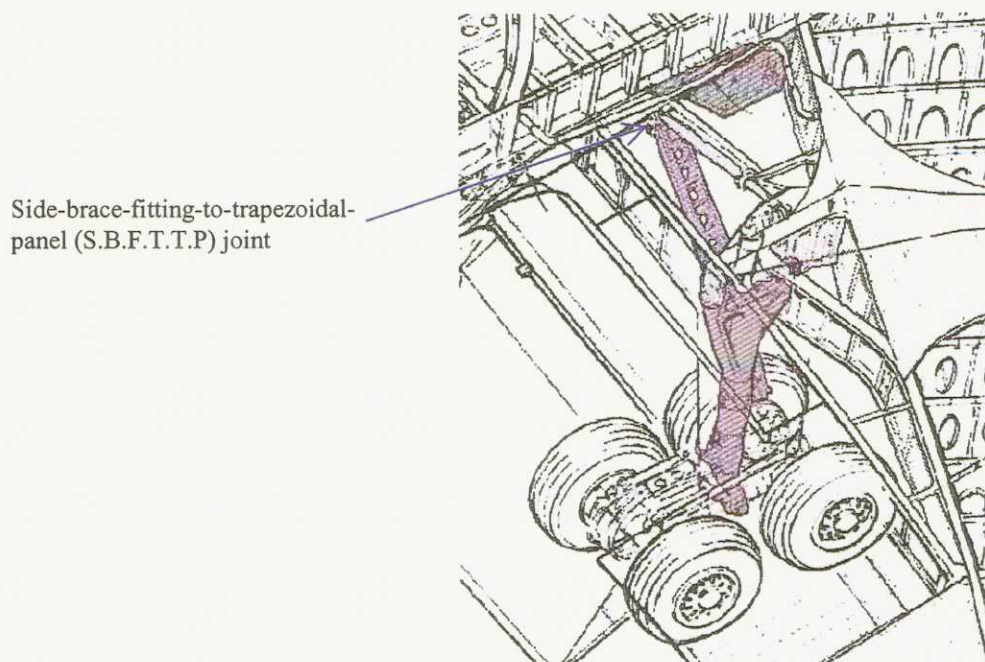
Figure 19. Location of the side-brace-fitting-to-trap-panel joint

The location of the side-brace-fitting-to-trap-panel (S-B-F-T-T-P) joint is highlighted in Figure 19. A photograph of a this area (taken from inside the landing gear wheel well) is included as Figure 20 along with a sketch of the joint (with the fixed and folding side braces removed).

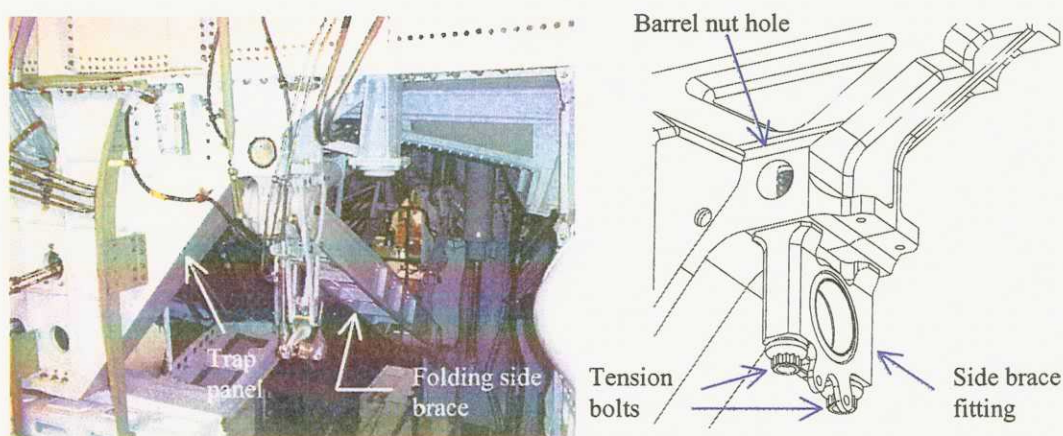
Figure 20. Side-brace-fitting-to-trap-panel joint (from inside the right wheel well)

The fixed brace and folding side brace are connected to one another and to the side brace fitting via a large pin. The side brace fitting is attached to the trap panel with two long tension bolts and mating barrel nuts. As discussed in Section 1.0 this joint is designed to take primarily vertical loads; the fore-and-aft and inboard/outboard loads are nominally small.

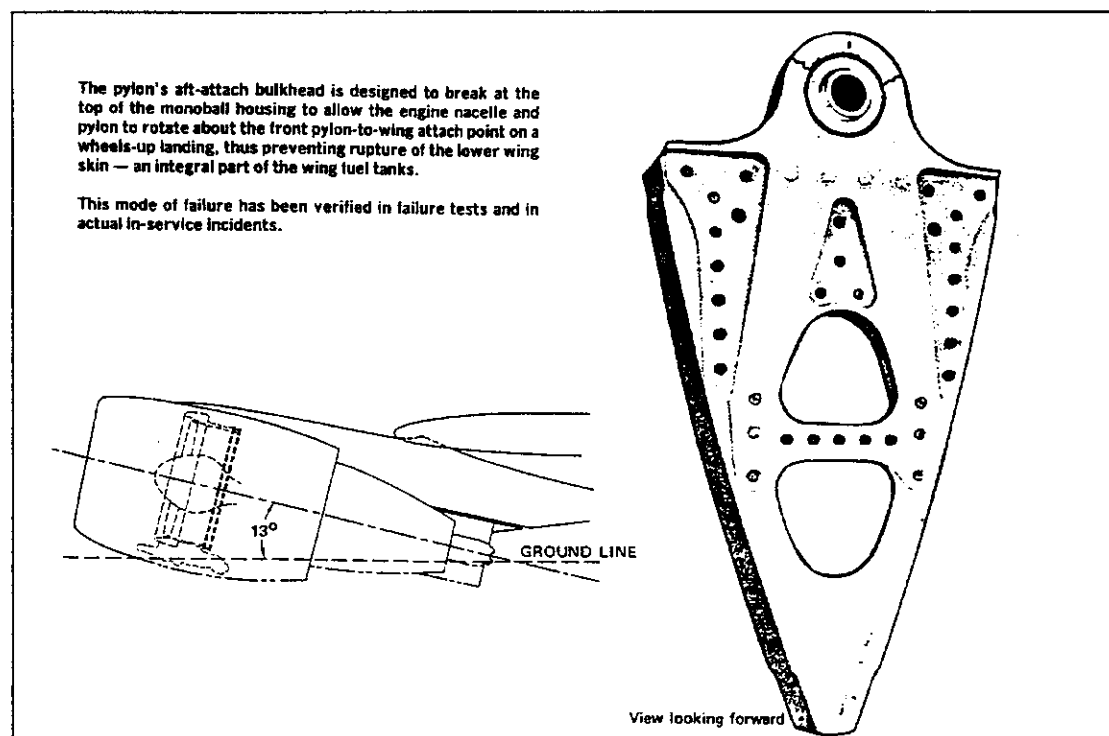
Figure 36. Wing pylon "fusing" mechanism

Figure 35 illustrates and describes the key elements of the attachment of the engine pylon to the wing. Figure 36 shows how the wing engine pylons are designed to “fuse” in the event of a wheels up landing to protect against rupture of the wing fuel tanks.

Figure 37 shows that the right pylon failure mode was different for the China Airlines accident aircraft; the right engine pylon aft-attach bulkhead is still attached to the right wing. Figure 38 shows the right engine pylon. The observed failures suggest that the loads on the nacelle included a significant sideways

component. This is thought to have occurred because the outboard wing, as the failure progressed, began to sweep further and further aft.
