**Slope Upgrading Works at
Feature No. 11SW-A/R526,
King's College,
Bonham Road, Hong Kong**

Project Profile for Slope Upgrading Works at
Feature No. 11SW-A/R526, King's College

May 2018

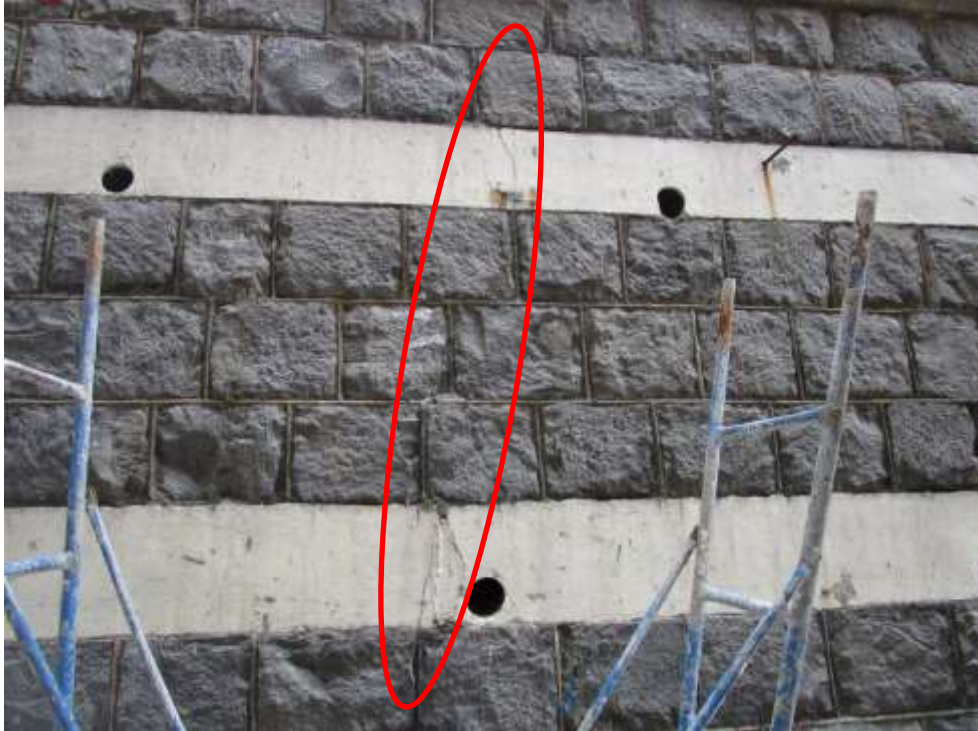
Photo No. 1003

Defect No.	2	Location	North wing, North elevation exterior	Component	retaining wall
-------------------	---	-----------------	--------------------------------------	------------------	----------------

Description A wide crack was observed on retaining wall

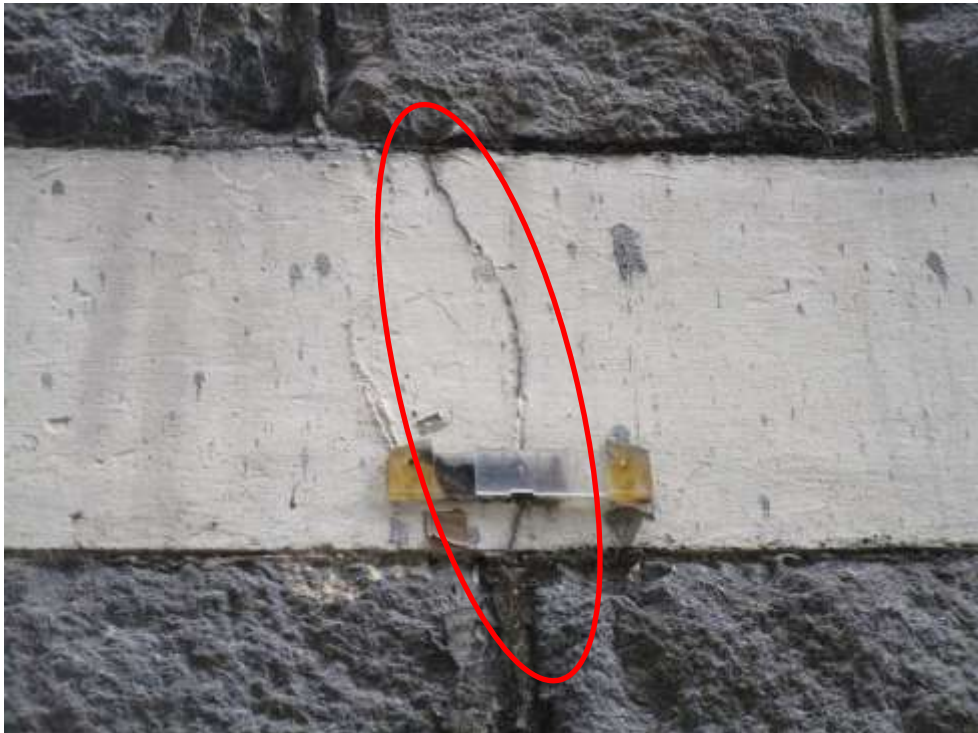
Photo No. 1004

Defect No.	2	Location	North wing, North elevation exterior	Component	retaining wall
-------------------	---	-----------------	--------------------------------------	------------------	----------------

Description A wide crack was observed on retaining wall

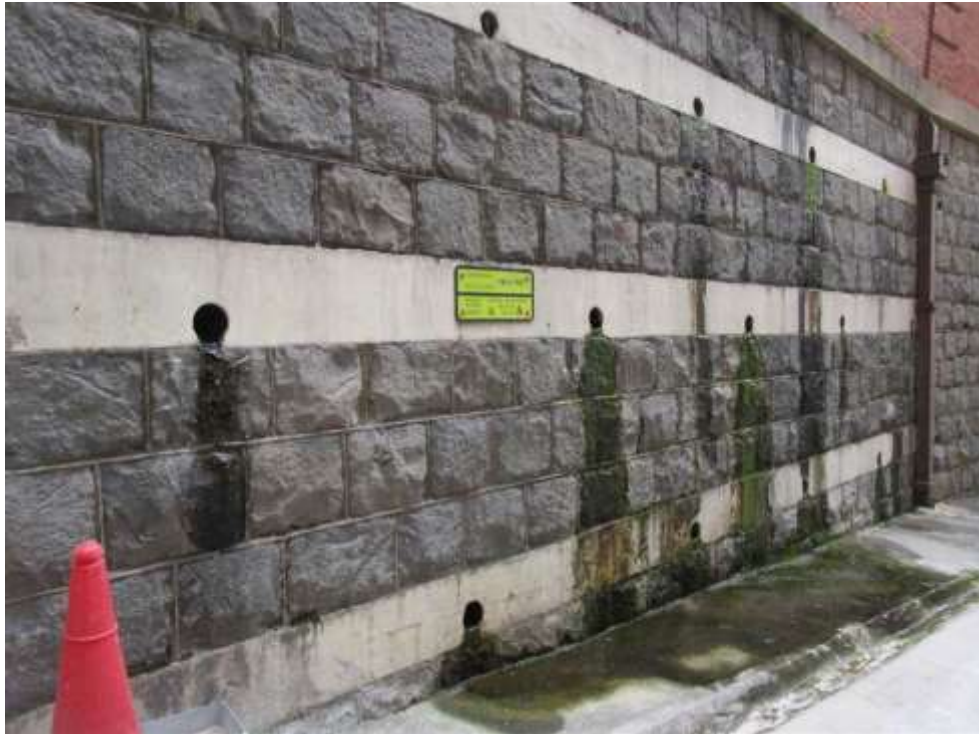
Photo No. 1005

Defect No.	3	Location	North wing, North elevation exterior	Component	retaining wall
-------------------	---	-----------------	--------------------------------------	------------------	----------------

Description	Water seepage through drain holes
--------------------	-----------------------------------

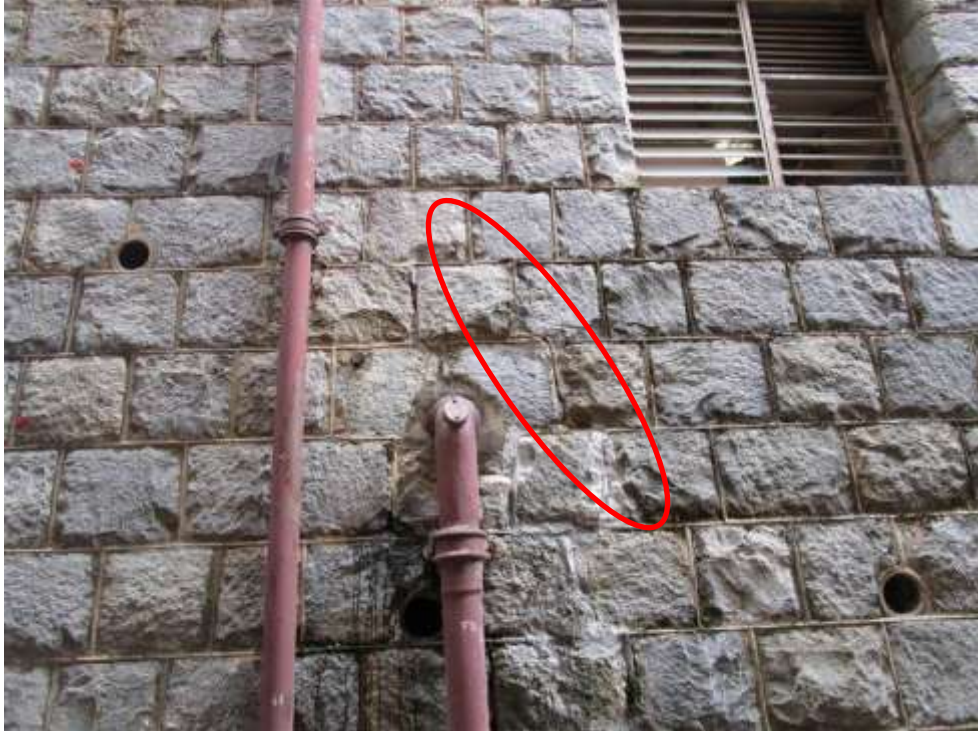
Photo No. 1009

Defect No. 5	Location North wing, North elevation exterior	Component retaining wall
---------------------	------------------------------------------------------	---------------------------------

Description A wide crack was observed on retaining wall mortar joint

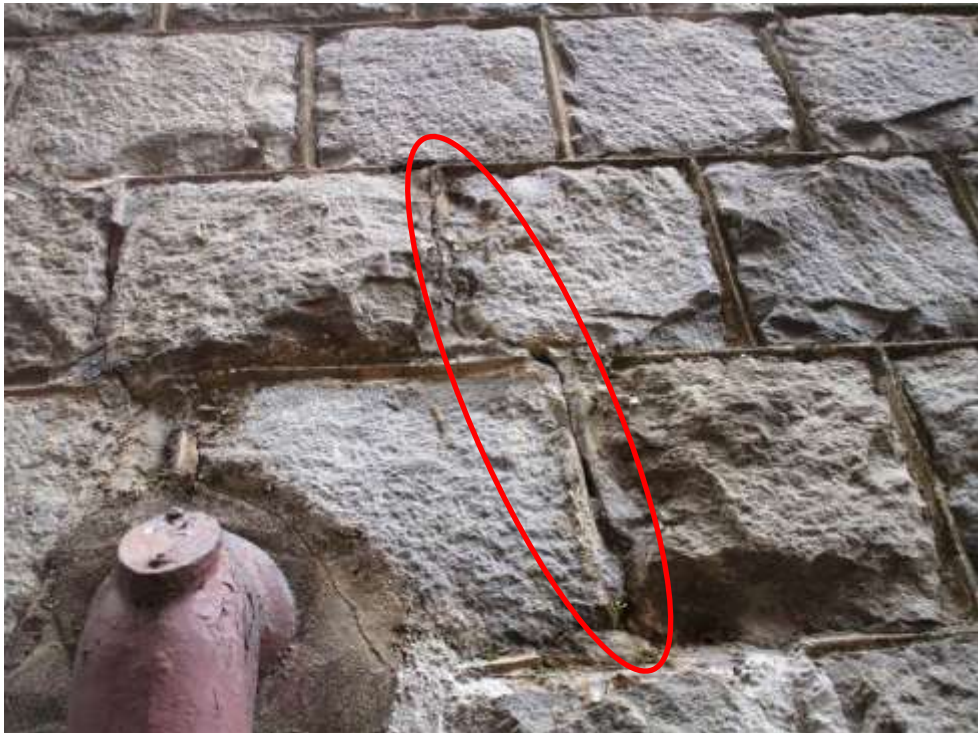
Photo No. 1010

Defect No. 5	Location North wing, North elevation exterior	Component retaining wall
---------------------	------------------------------------------------------	---------------------------------

Description A wide crack was observed on retaining wall mortar joint

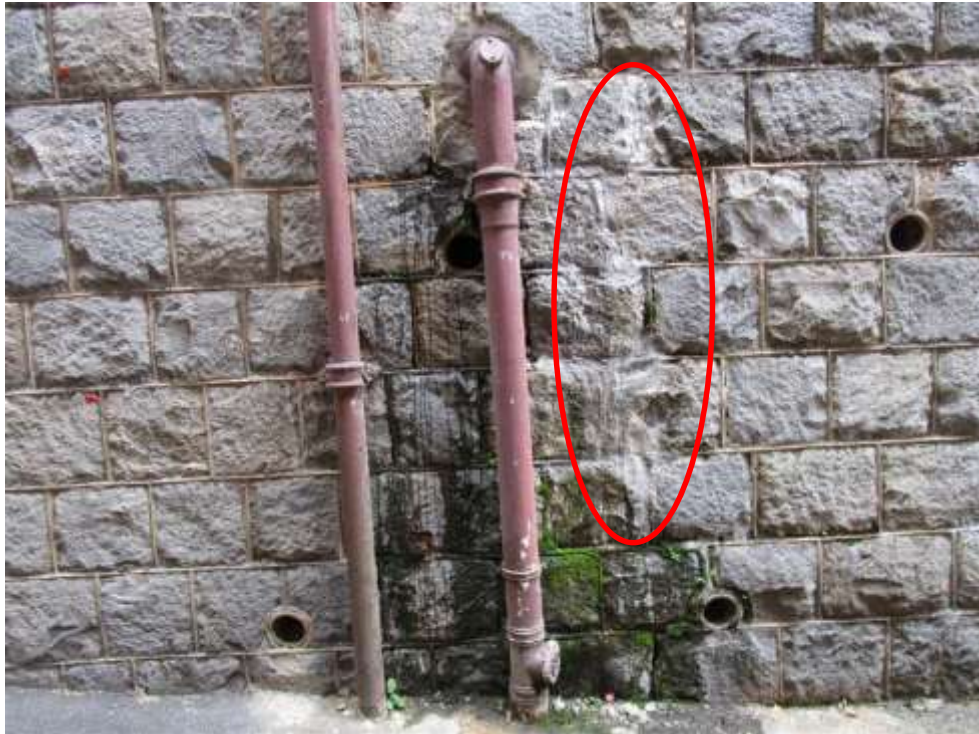
Photo No. 1011

Defect No.	6	Location	North wing, North elevation exterior	Component	retaining wall
-------------------	---	-----------------	--------------------------------------	------------------	----------------

Description Water seepage through granite mortar joint

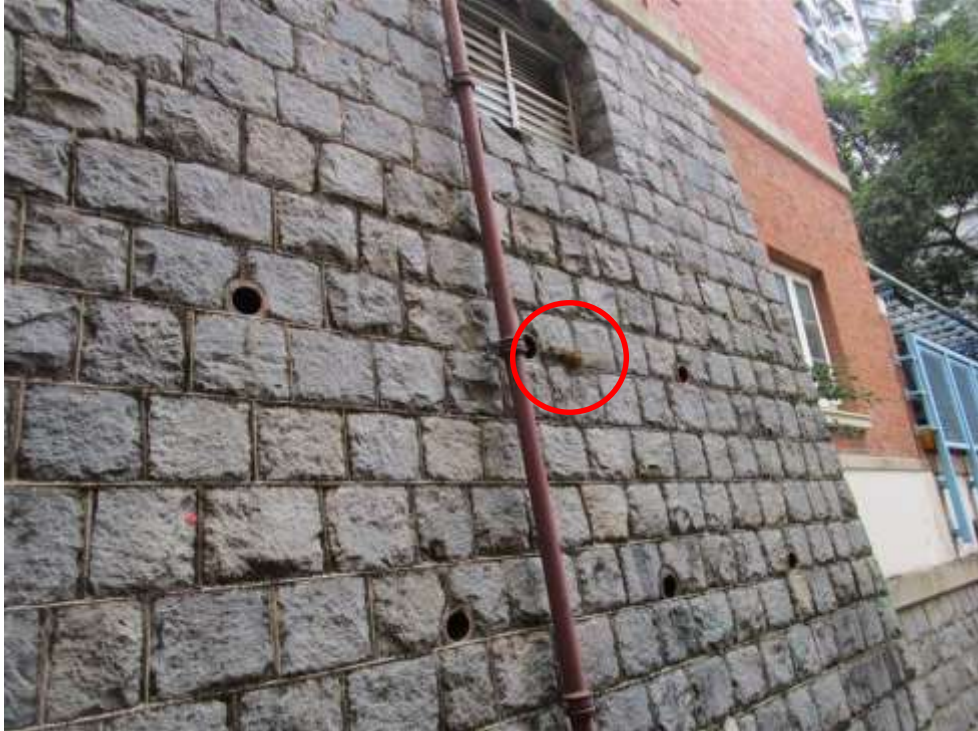
Photo No. 1013

Defect No. 7	Location North wing, North elevation exterior	Component retaining wall
---------------------	------------------------------------------------------	---------------------------------

Description A vegetation growth was observed on retaining wall

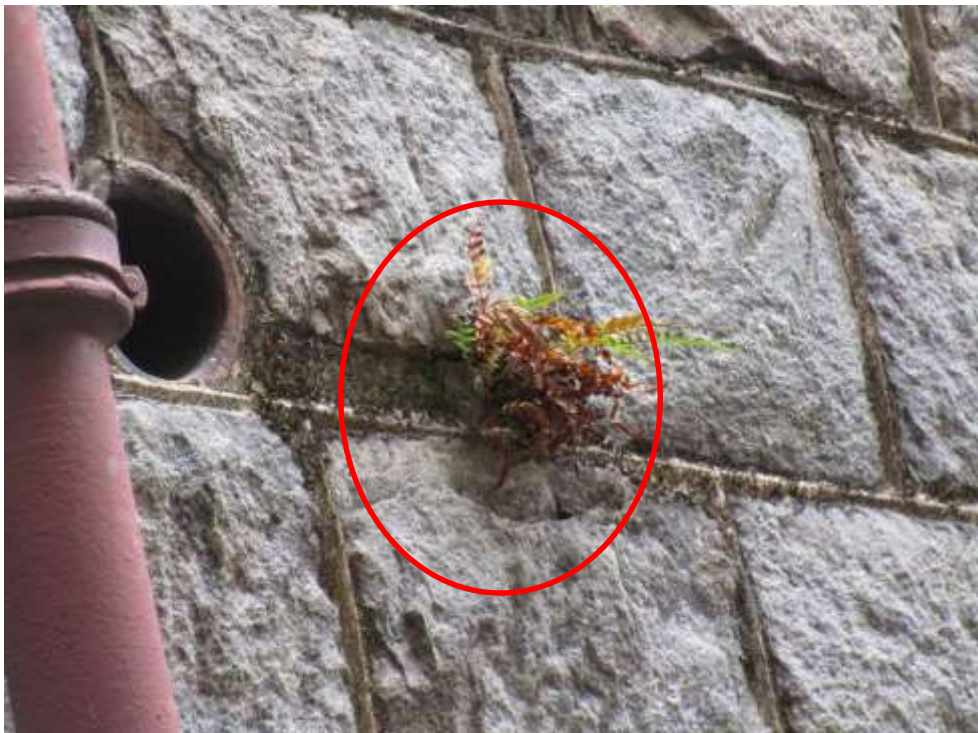
Photo No. 1014

Defect No. 7	Location North wing, North elevation exterior	Component retaining wall
---------------------	------------------------------------------------------	---------------------------------

Description A vegetation growth was observed on retaining wall

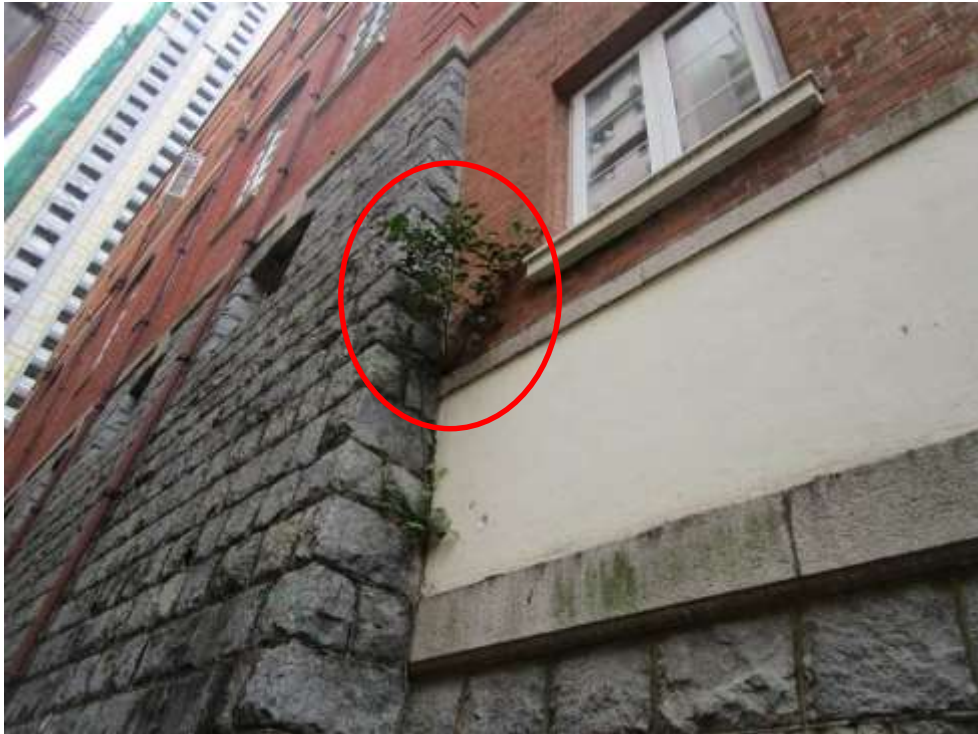
Photo No. 1015

Defect No.	8	Location	North wing, North elevation exterior	Component	retaining wall
-------------------	---	-----------------	--------------------------------------	------------------	----------------

Description A vegetation growth was observed on retaining wall

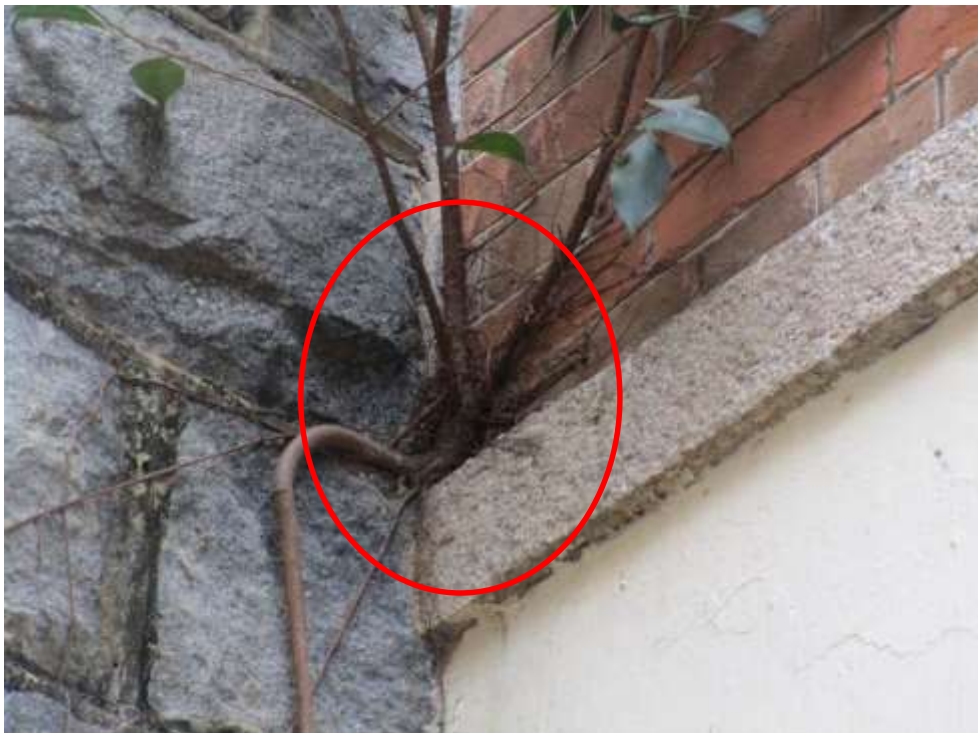
Photo No. 1016

Defect No.	8	Location	North wing, North elevation exterior	Component	retaining wall
-------------------	---	-----------------	--------------------------------------	------------------	----------------

Description A vegetation growth was observed on retaining wall

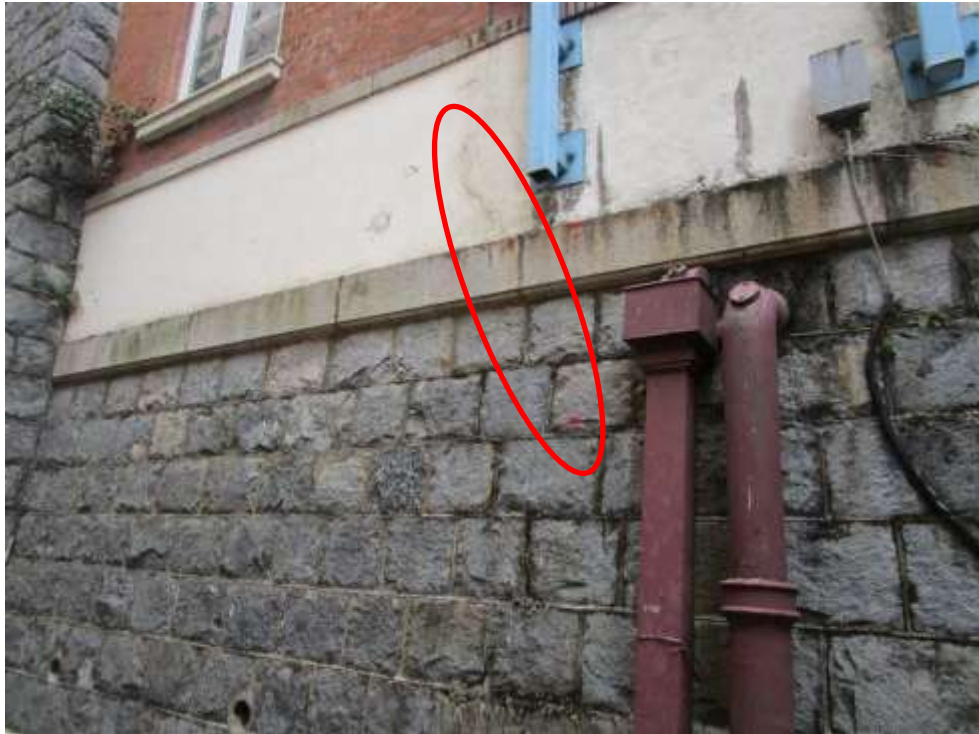
Photo No. 1017

Defect No.	9	Location	North wing, North elevation exterior	Component	retaining wall
-------------------	---	-----------------	--------------------------------------	------------------	----------------

Description A medium crack was observed on retaining wall

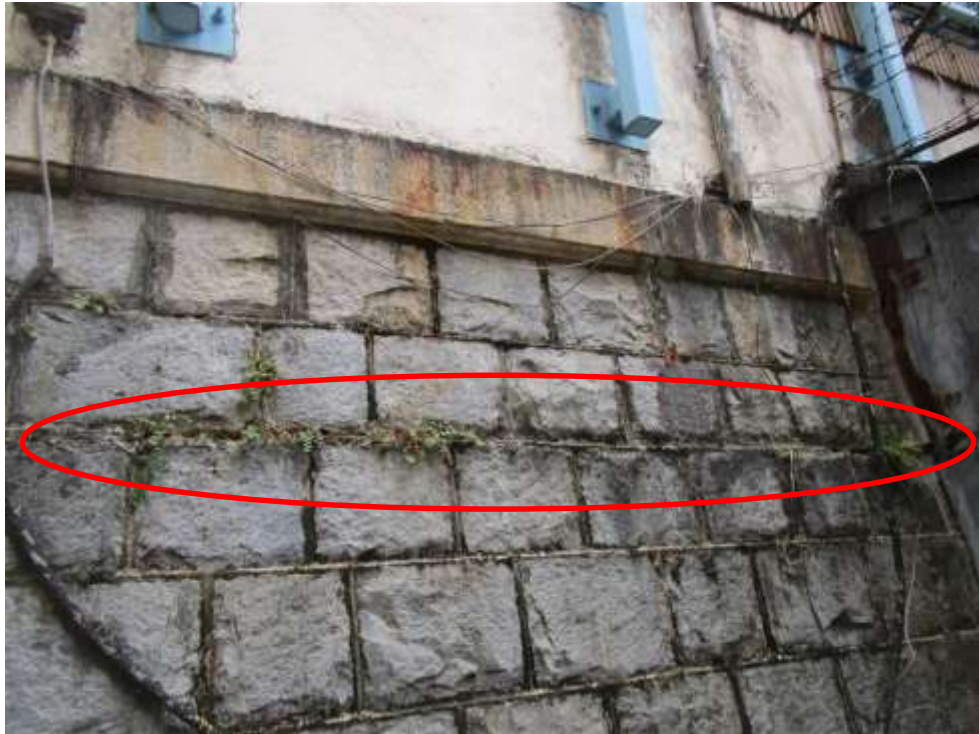
Photo No. 1019

Defect No.	10	Location	North wing, North elevation exterior	Component	retaining wall
-------------------	----	-----------------	--------------------------------------	------------------	----------------

Description A vegetation growth was observed on retaining wall

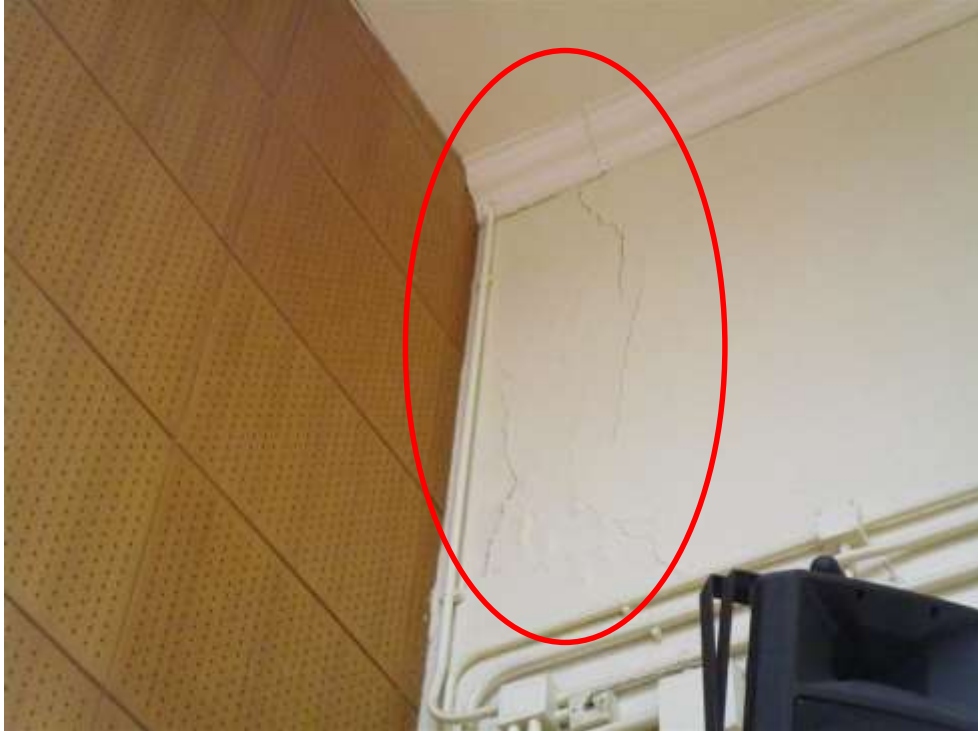
Photo No. 1021

Defect No.	11	Location	1/F East wing, Assembly hall	Component	wall
-------------------	----	-----------------	------------------------------	------------------	------

Description	2 wide cracks with apparent damp patch were observed on wall				
--------------------	--------------------------------------------------------------	--	--	--	--

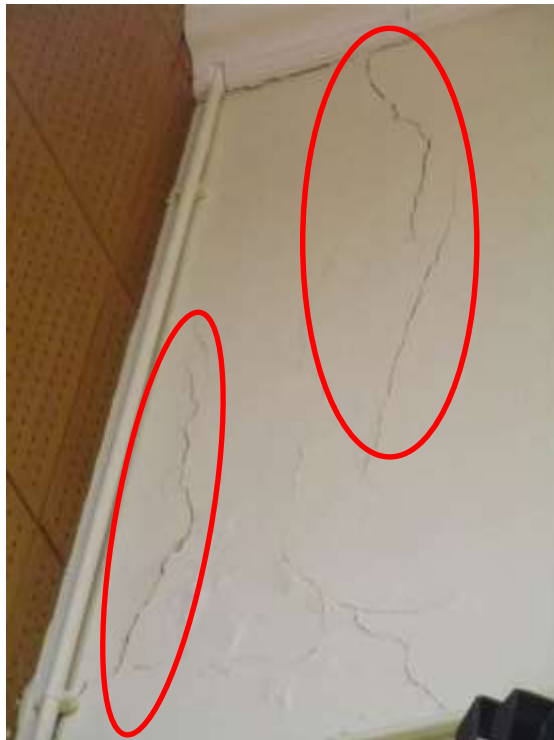
Photo No. 1022

Defect No.	11	Location	1/F East wing, Assembly hall	Component	wall
-------------------	----	-----------------	------------------------------	------------------	------

Description	2 wide cracks with apparent damp patch were observed on wall				
--------------------	--------------------------------------------------------------	--	--	--	--

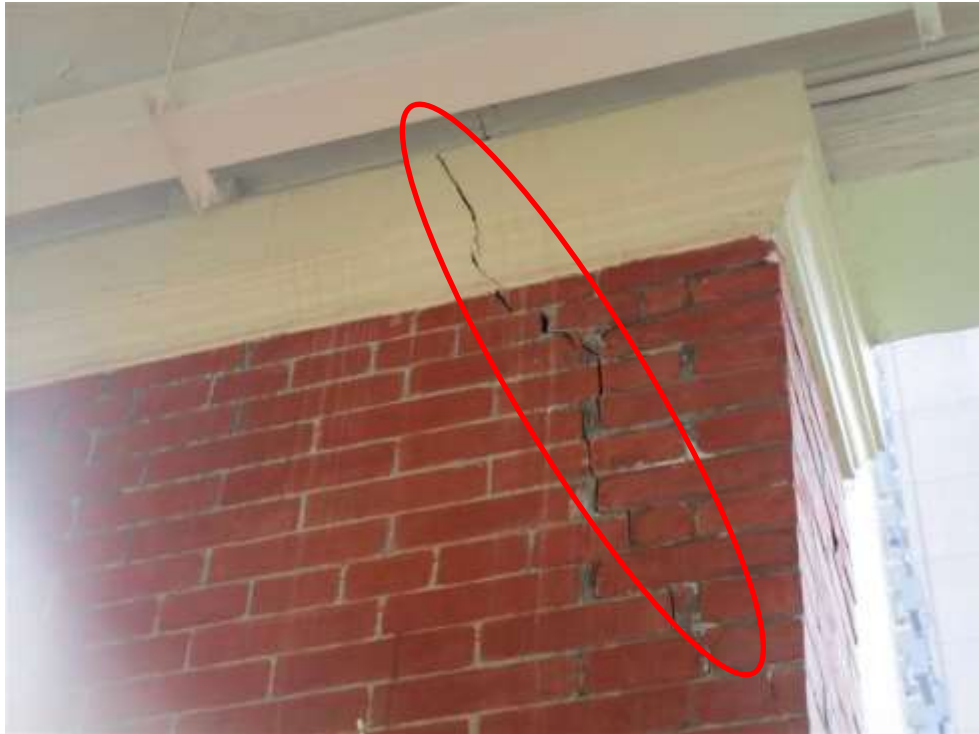
Photo No. 1023

Defect No.	12	Location	1/F East wing, Corridor	Component	brick column
-------------------	----	-----------------	-------------------------	------------------	--------------

Description	A wide crack was observed on brick column				
--------------------	-------------------------------------------	--	--	--	--

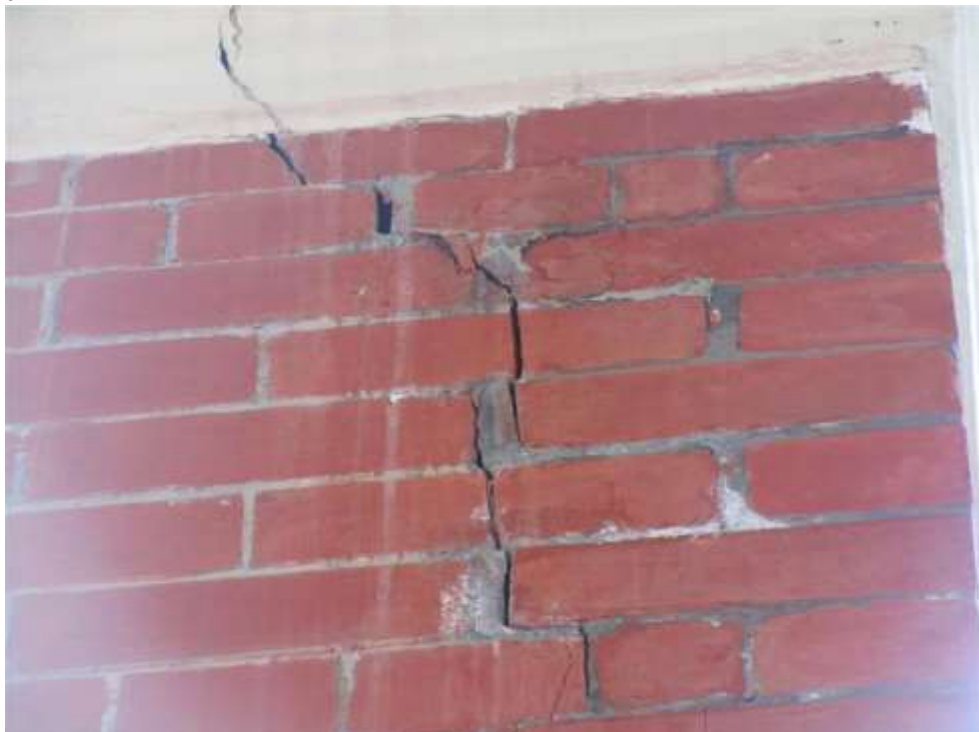
Photo No. 1024

Defect No.	12	Location	1/F East wing, Corridor	Component	brick column
-------------------	----	-----------------	-------------------------	------------------	--------------

Description	A wide crack was observed on brick column				
--------------------	-------------------------------------------	--	--	--	--

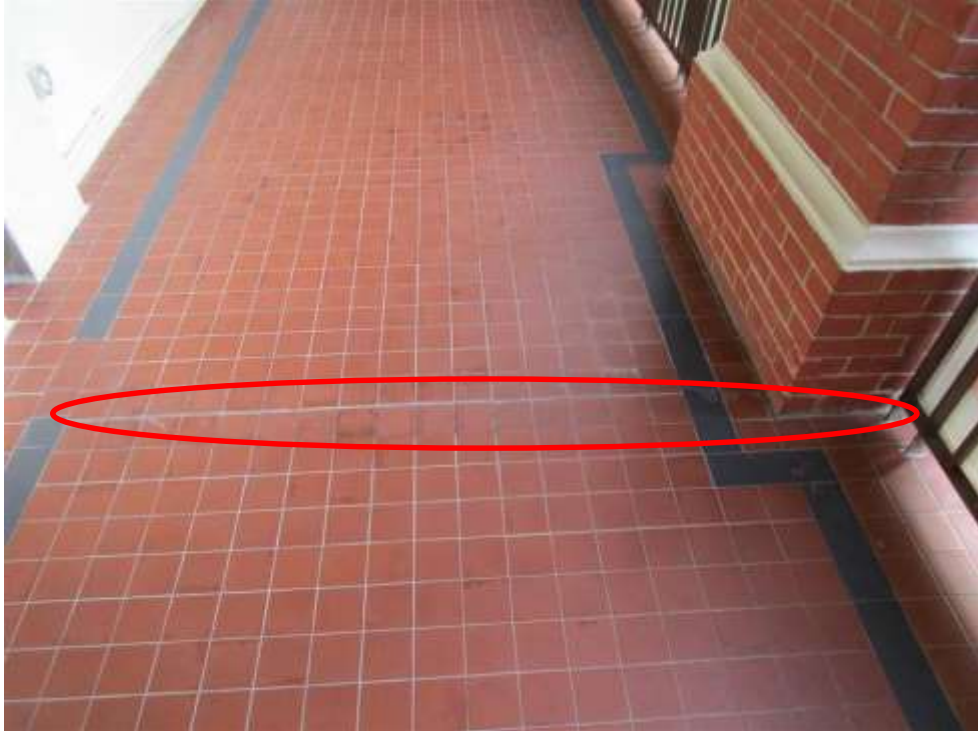
Photo No. 1025

Defect No.	13	Location	1/F East wing, Corridor	Component	slab
-------------------	----	-----------------	-------------------------	------------------	------

Description	A wide crack was observed on slab floor tiles				
--------------------	-----------------------------------------------	--	--	--	--

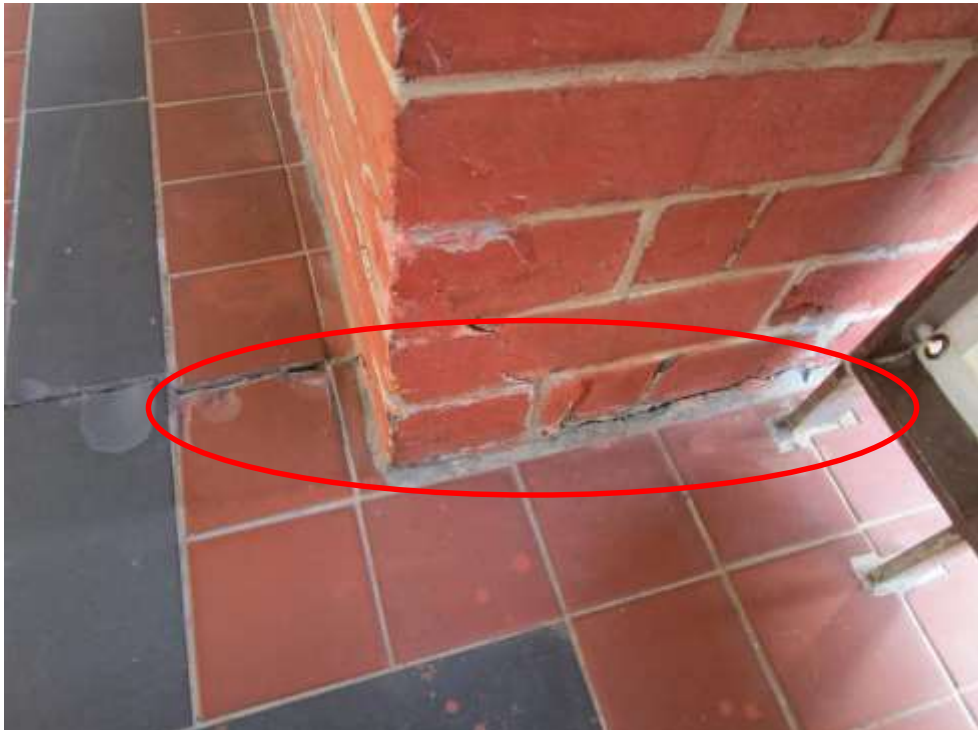
Photo No. 1026

Defect No.	13	Location	1/F East wing, Corridor	Component	slab
-------------------	----	-----------------	-------------------------	------------------	------

Description	A wide crack was observed on slab floor tiles				
--------------------	-----------------------------------------------	--	--	--	--

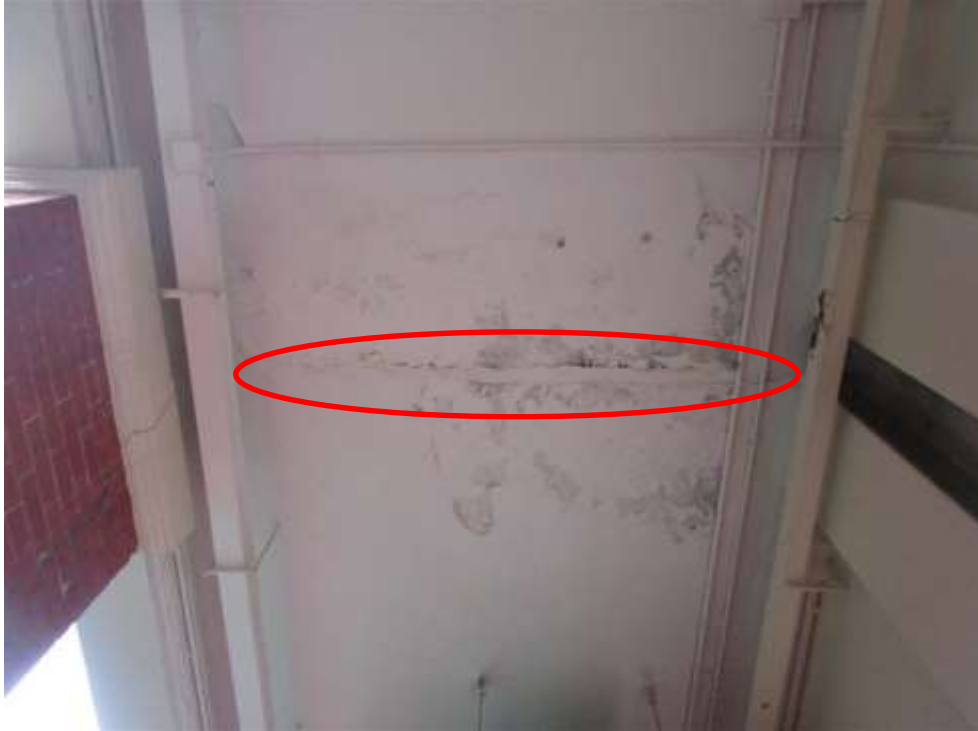
Photo No. 1027

Defect No.	14	Location	1/F East wing, Corridor	Component	slab
-------------------	----	-----------------	-------------------------	------------------	------

Description	A wide crack was observed on slab soffit				
--------------------	------------------------------------------	--	--	--	--

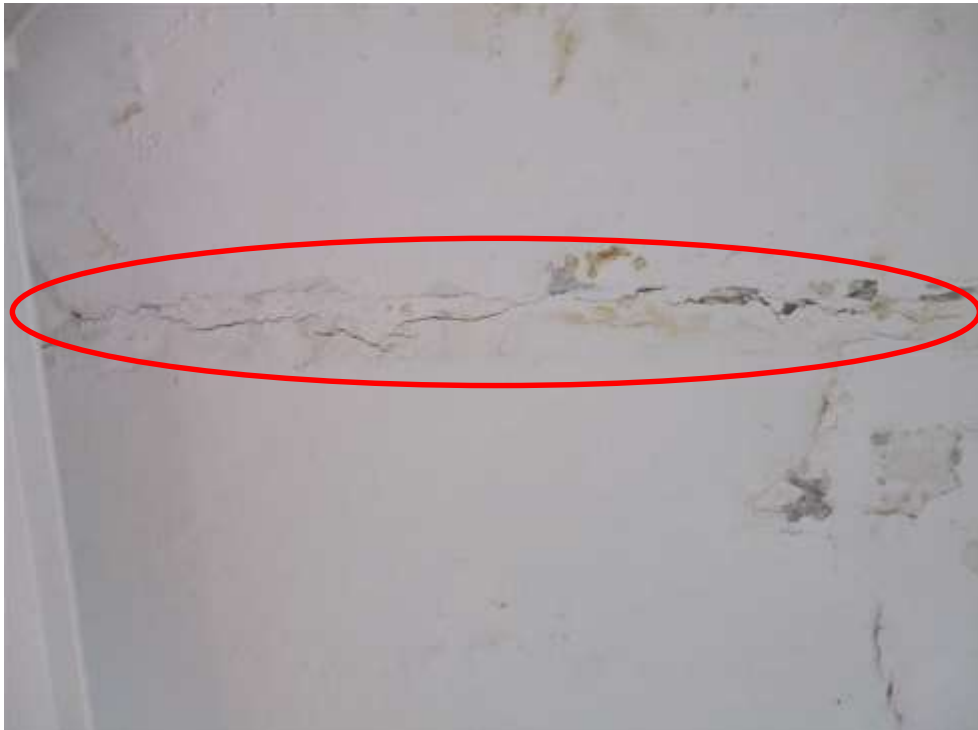
Photo No. 1028

Defect No.	14	Location	1/F East wing, Corridor	Component	slab
-------------------	----	-----------------	-------------------------	------------------	------

Description	A wide crack was observed on slab soffit				
--------------------	------------------------------------------	--	--	--	--

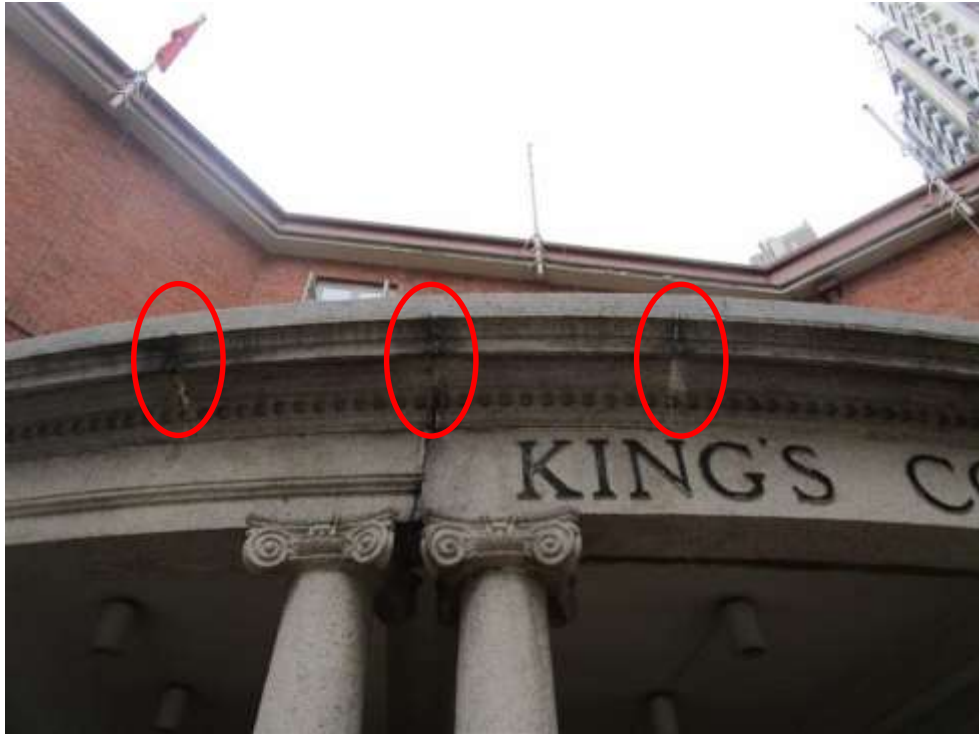
Photo No. 1029

Defect No. 15	Location East wing, South elevation entrance	Component canopy
----------------------	-----------------------------------------------------	-------------------------

Description Medium cracks were observed on canopy (2/F)

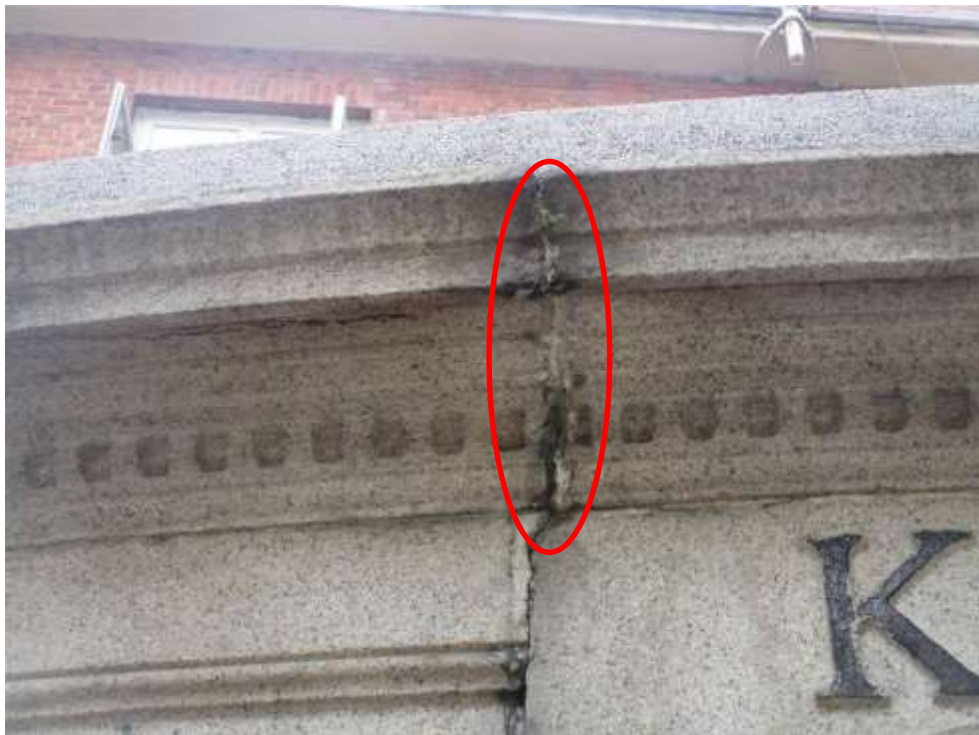
Photo No. 1030

Defect No. 15	Location East wing, South elevation entrance	Component canopy
----------------------	-----------------------------------------------------	-------------------------

Description Medium cracks were observed on canopy (2/F)

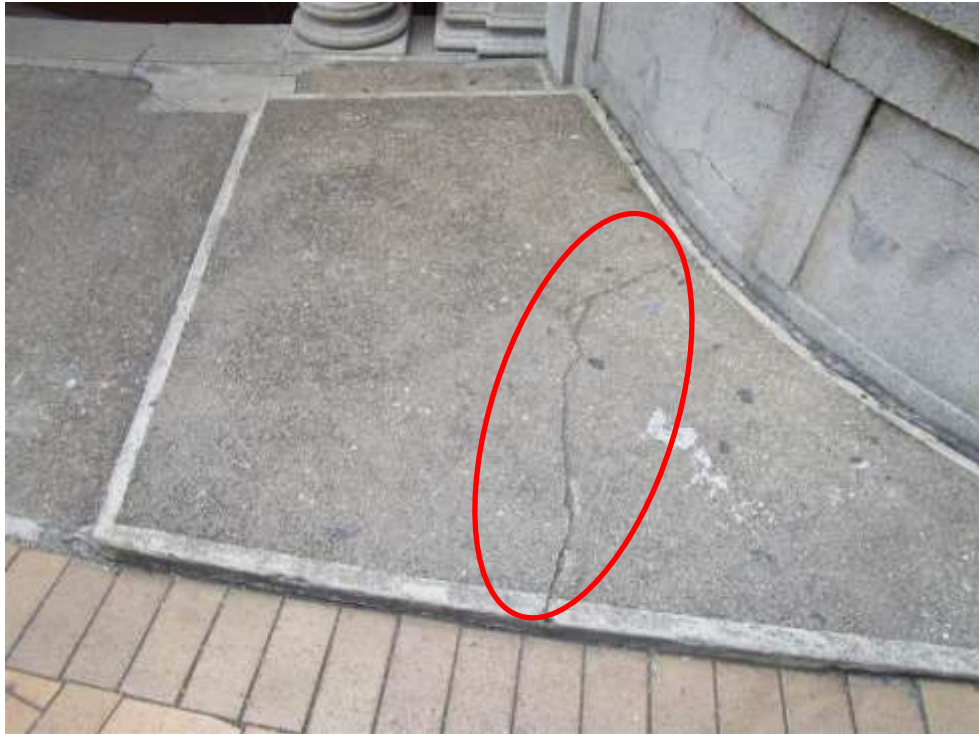
Photo No. 1031

Defect No.	16	Location	East wing, South elevation entrance	Component	slab
-------------------	----	-----------------	-------------------------------------	------------------	------

Description A wide crack was observed on slab

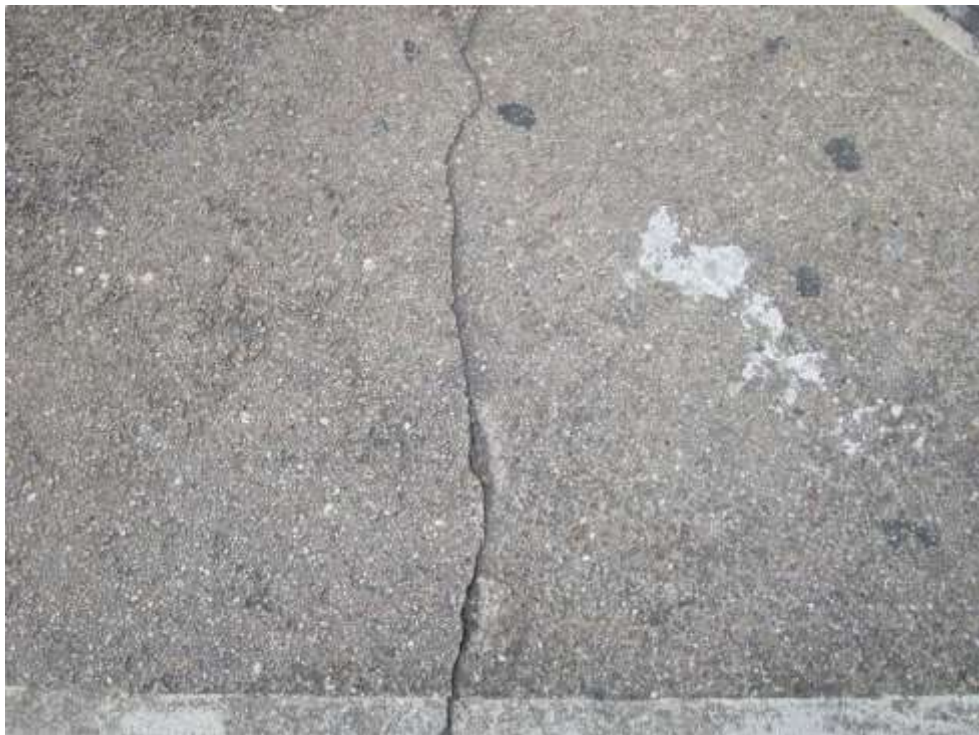
Photo No. 1032

Defect No.	16	Location	East wing, South elevation entrance	Component	slab
-------------------	----	-----------------	-------------------------------------	------------------	------

Description A wide crack was observed on slab

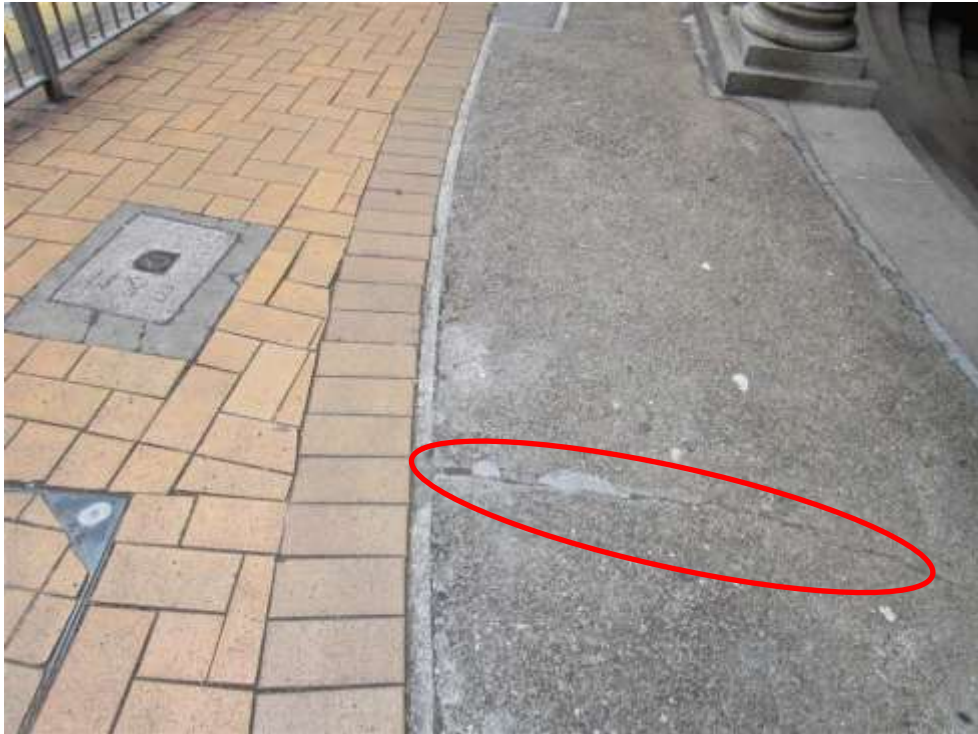
Photo No. 1033

Defect No. 17	Location East wing, South elevation entrance	Component slab
----------------------	-----------------------------------------------------	-----------------------

Description A wide crack was observed on slab

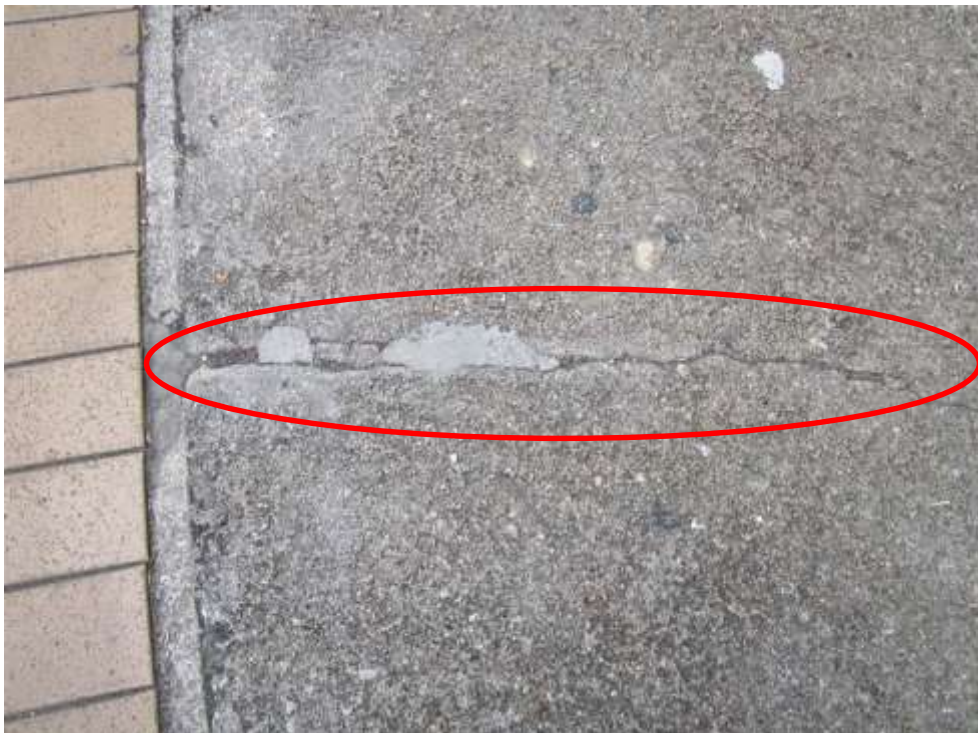
Photo No. 1034

Defect No. 17	Location East wing, South elevation entrance	Component slab
----------------------	-----------------------------------------------------	-----------------------

Description A wide crack was observed on slab

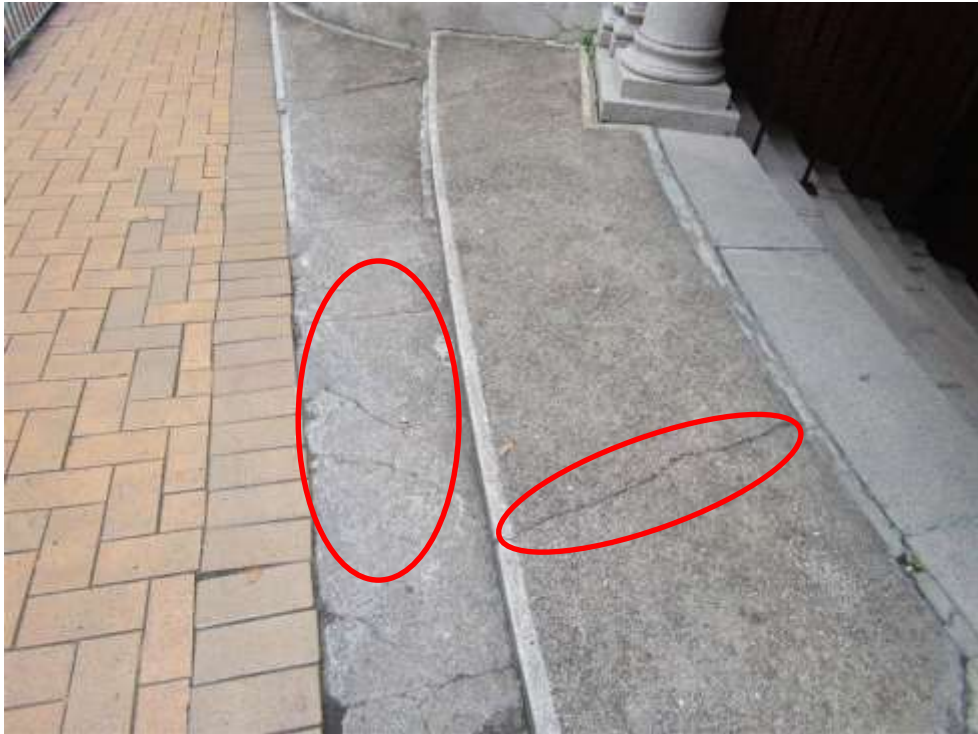
Photo No. 1035

Defect No. 18	Location East wing, South elevation entrance	Component slab
----------------------	-----------------------------------------------------	-----------------------

Description An area of cracks was observed on slab

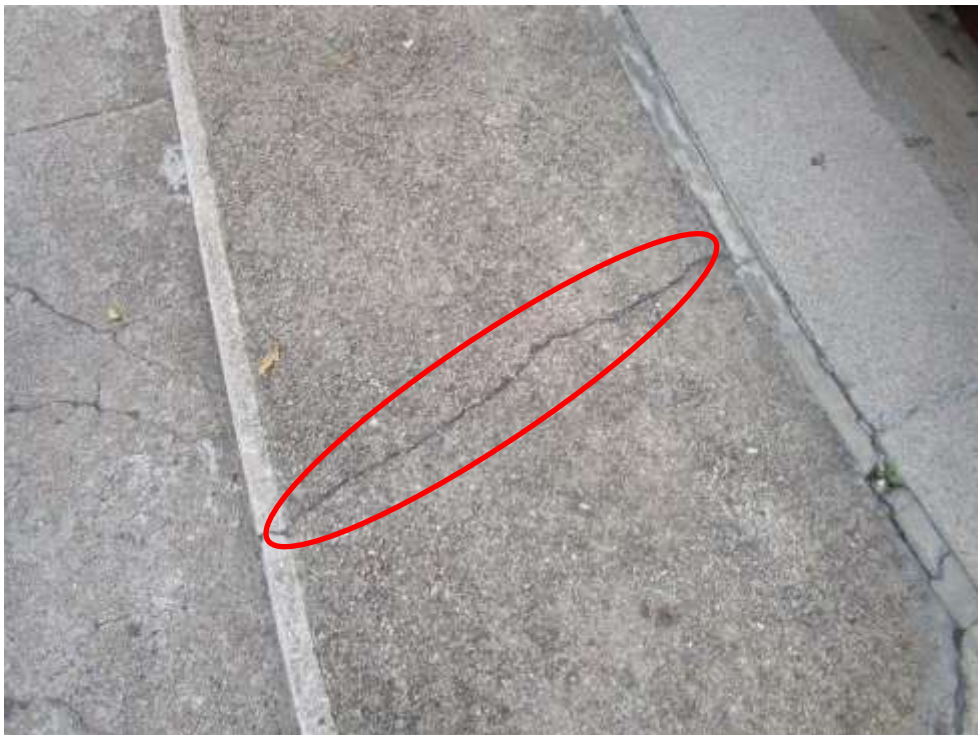
Photo No. 1036

Defect No. 18	Location East wing, South elevation entrance	Component slab
----------------------	-----------------------------------------------------	-----------------------

Description An area of cracks was observed on slab

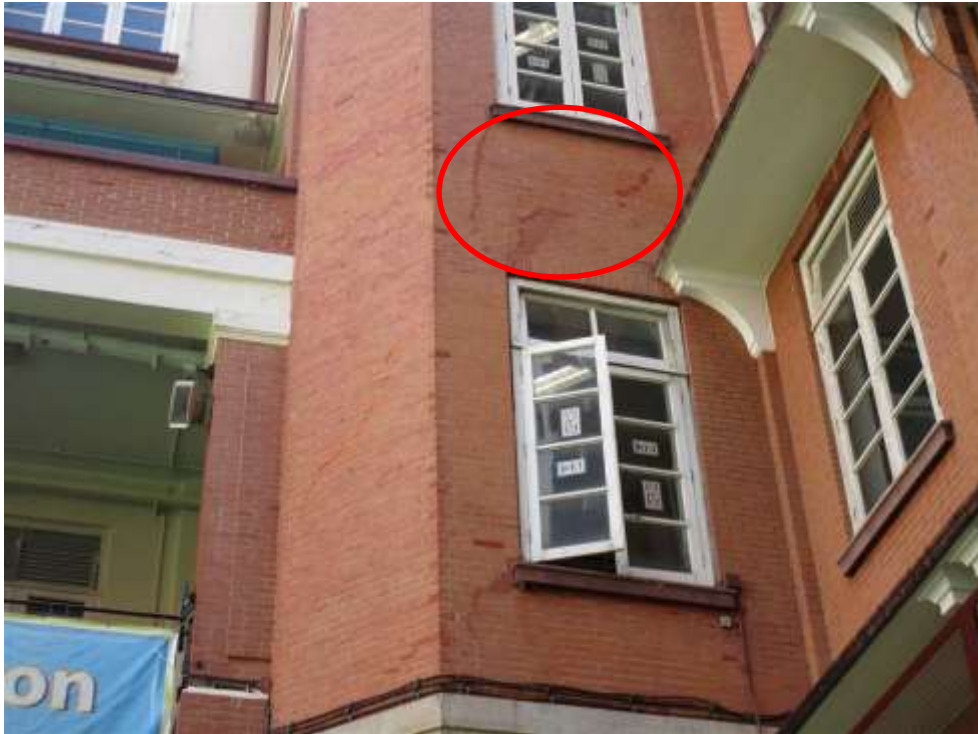
Photo No. 1037

Defect No.	19	Location	1/F East wing, West elevation	Component	brick wall
-------------------	----	-----------------	-------------------------------	------------------	------------

Description	A previous repair was observed on brick wall				
--------------------	----------------------------------------------	--	--	--	--
