**Slope Upgrading Works at
Feature No. 11SW-A/R526,
King's College,
Bonham Road, Hong Kong**

Project Profile for Slope Upgrading Works at
Feature No. 11SW-A/R526, King's College

May 2018

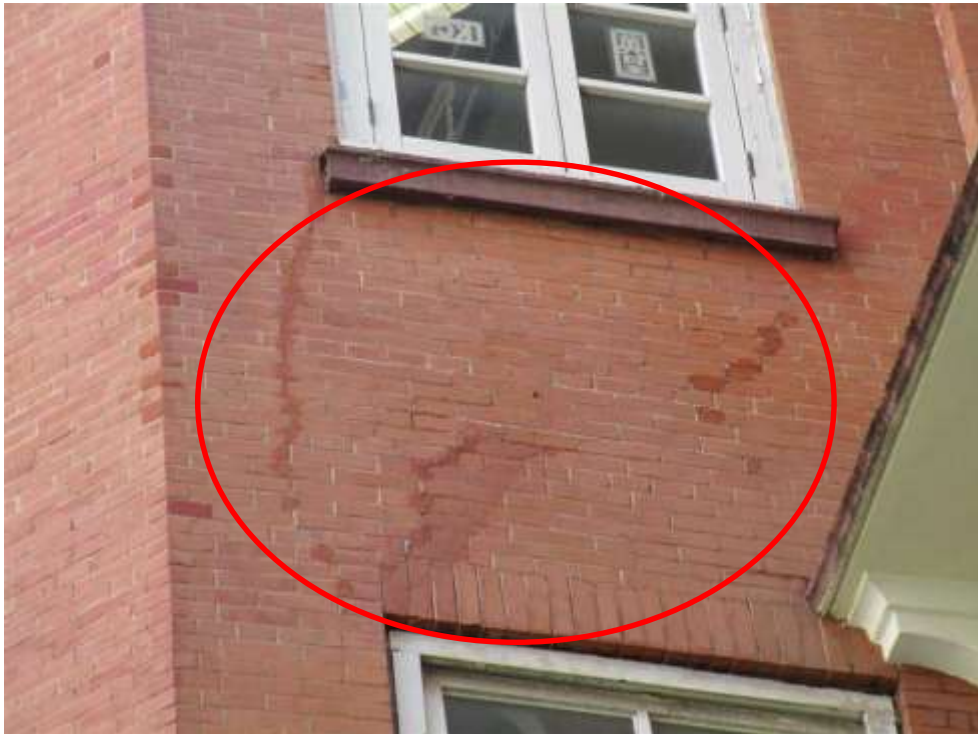
Photo No. 1038

Defect No.	19	Location	1/F East wing, West elevation	Component	brick wall
-------------------	----	-----------------	-------------------------------	------------------	------------

Description	A previous repair was observed on brick wall				
--------------------	----------------------------------------------	--	--	--	--

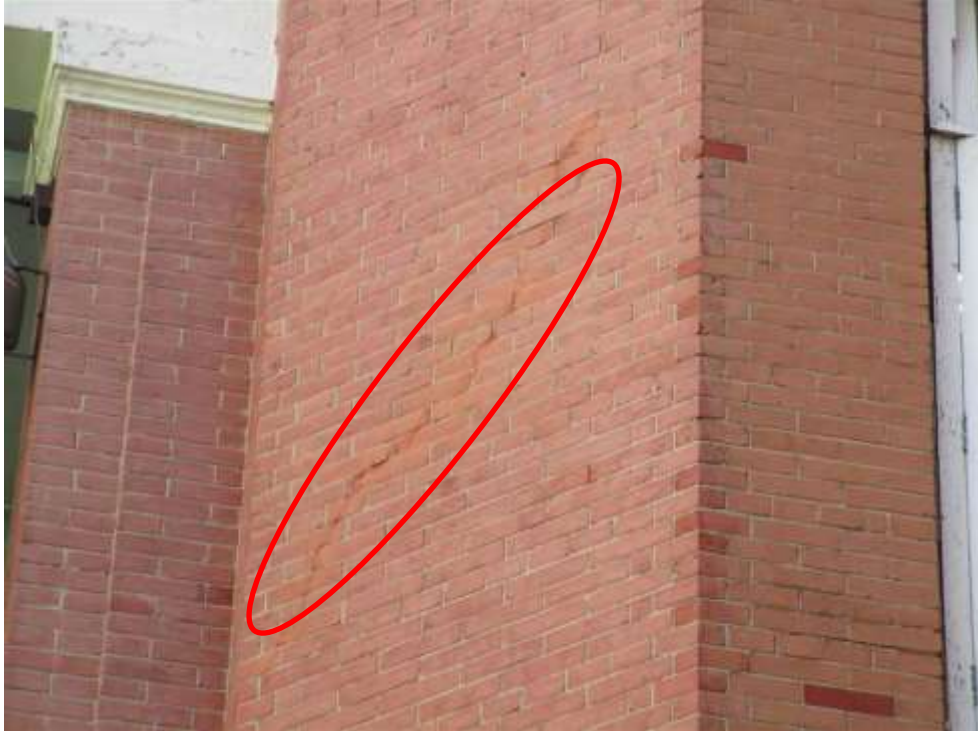
Photo No. 1039

Defect No.	20	Location	1/F East wing, West elevation	Component	brick wall
-------------------	----	-----------------	-------------------------------	------------------	------------

Description	A medium crack was observed on brick wall				
--------------------	-------------------------------------------	--	--	--	--

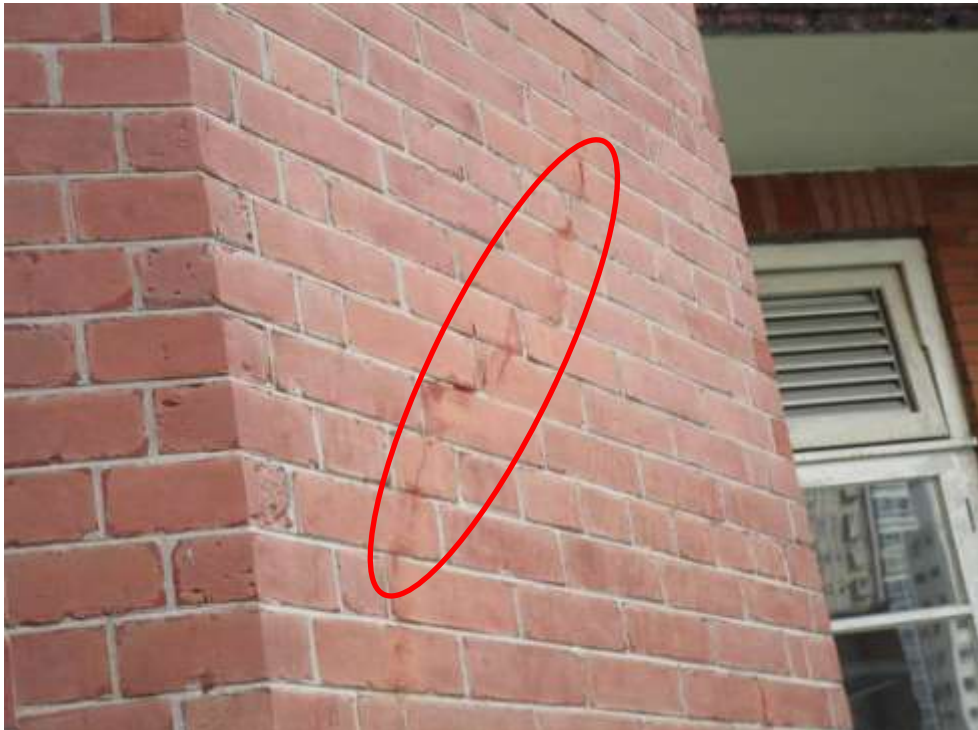
Photo No. 1040

Defect No.	20	Location	1/F East wing, West elevation	Component	brick wall
-------------------	----	-----------------	-------------------------------	------------------	------------

Description	A medium crack was observed on brick wall				
--------------------	-------------------------------------------	--	--	--	--

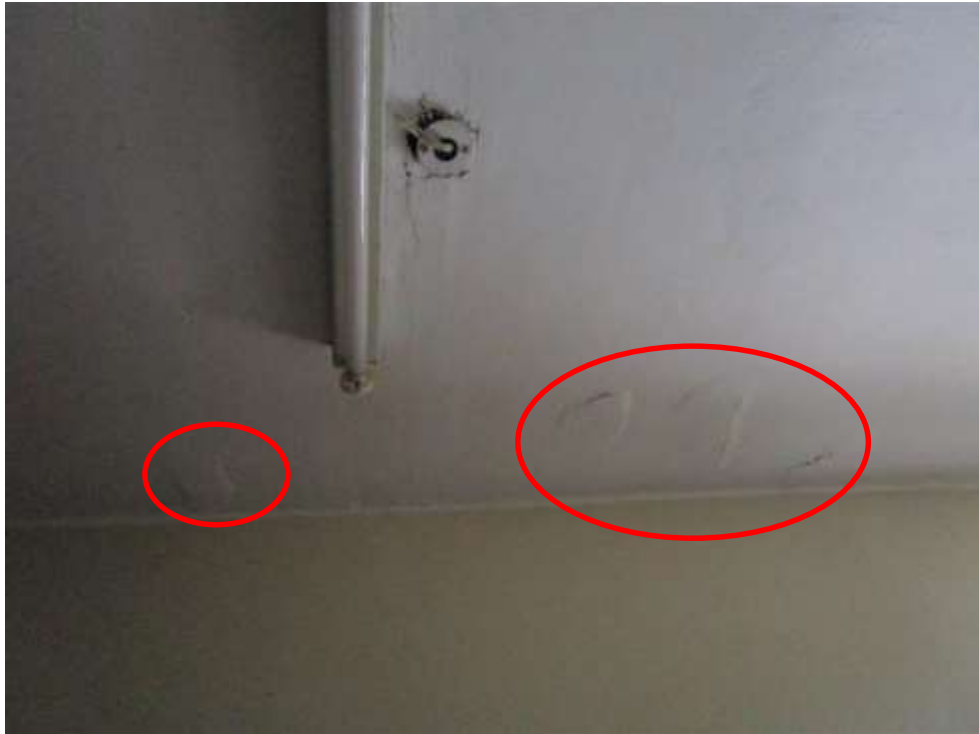
Photo No. 1041

Defect No.	21	Location	2/F North wing, Room behind assembly hall stage	Component	slab
-------------------	----	-----------------	-------------------------------------------------	------------------	------

Description Paint delamination was observed on slab soffit

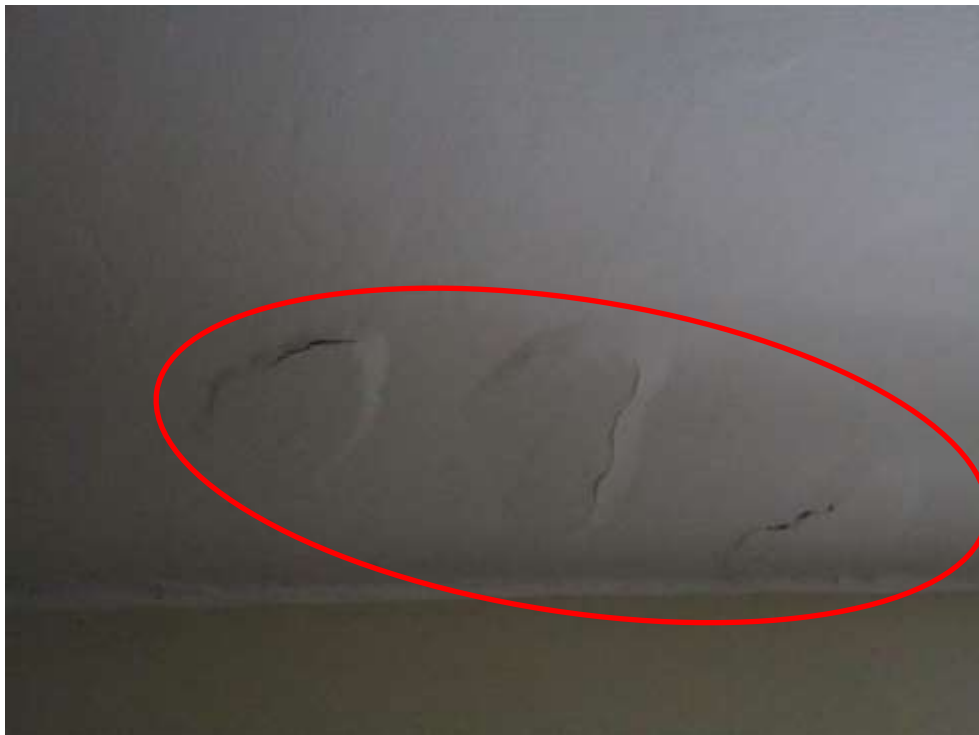
Photo No. 1042

Defect No.	21	Location	2/F North wing, Room behind assembly hall stage	Component	slab
-------------------	----	-----------------	-------------------------------------------------	------------------	------

Description Paint delamination was observed on slab soffit

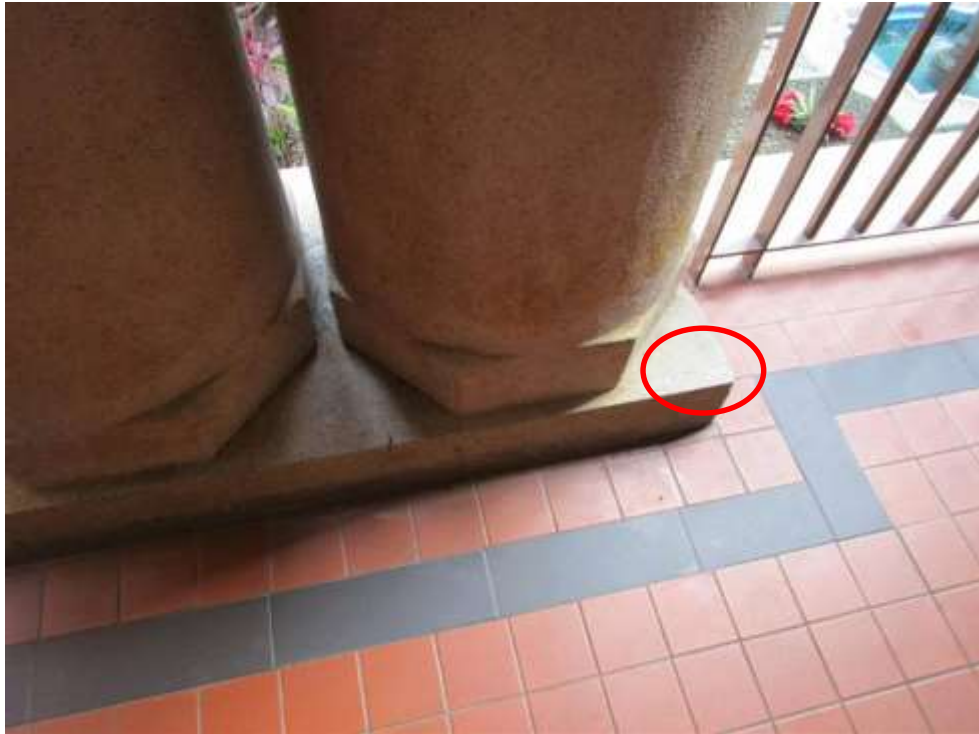
Photo No. 1043

Defect No.	22	Location	1/F South wing, Corridor	Component	column
-------------------	----	-----------------	--------------------------	------------------	--------

Description	A medium crack was observed on column footing				
--------------------	-----------------------------------------------	--	--	--	--

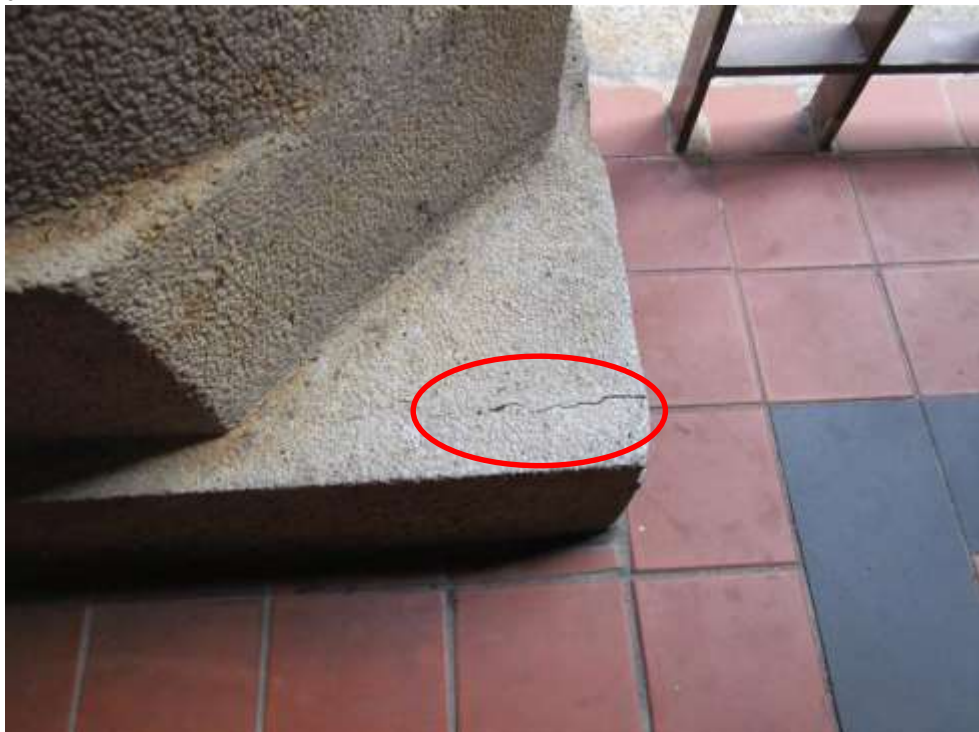
Photo No. 1044

Defect No.	22	Location	1/F South wing, Corridor	Component	column
-------------------	----	-----------------	--------------------------	------------------	--------

Description	A medium crack was observed on column footing				
--------------------	-----------------------------------------------	--	--	--	--

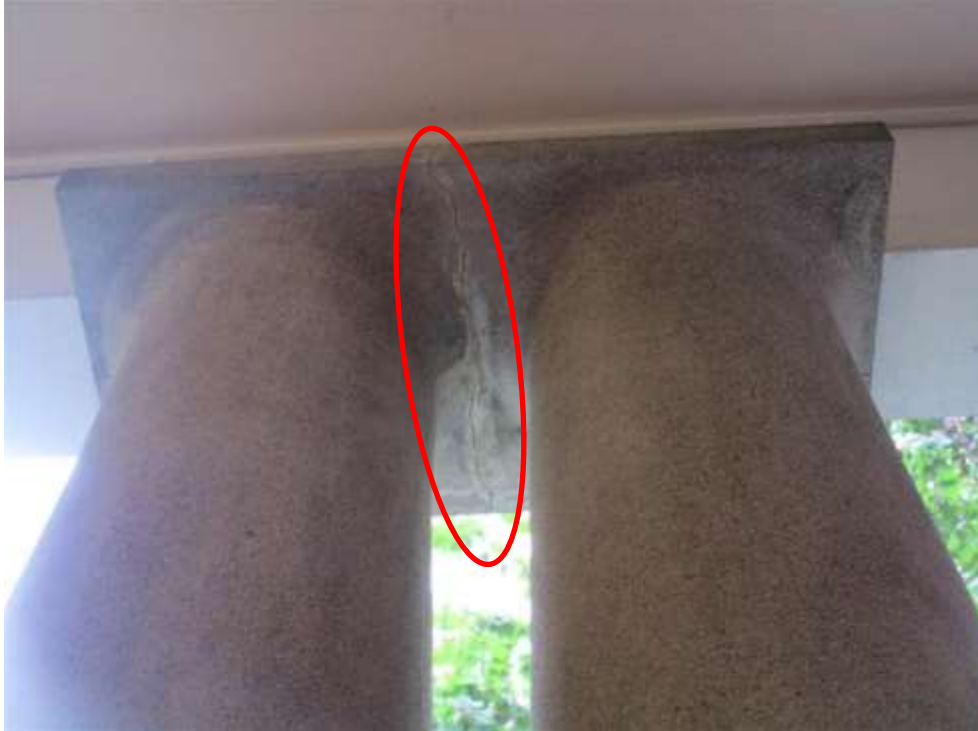
Photo No. 1045

Defect No.	23	Location	1/F South wing, Corridor	Component	column
-------------------	----	-----------------	--------------------------	------------------	--------

Description	A wide crack was observed on the top plate between 2 column				
--------------------	-------------------------------------------------------------	--	--	--	--

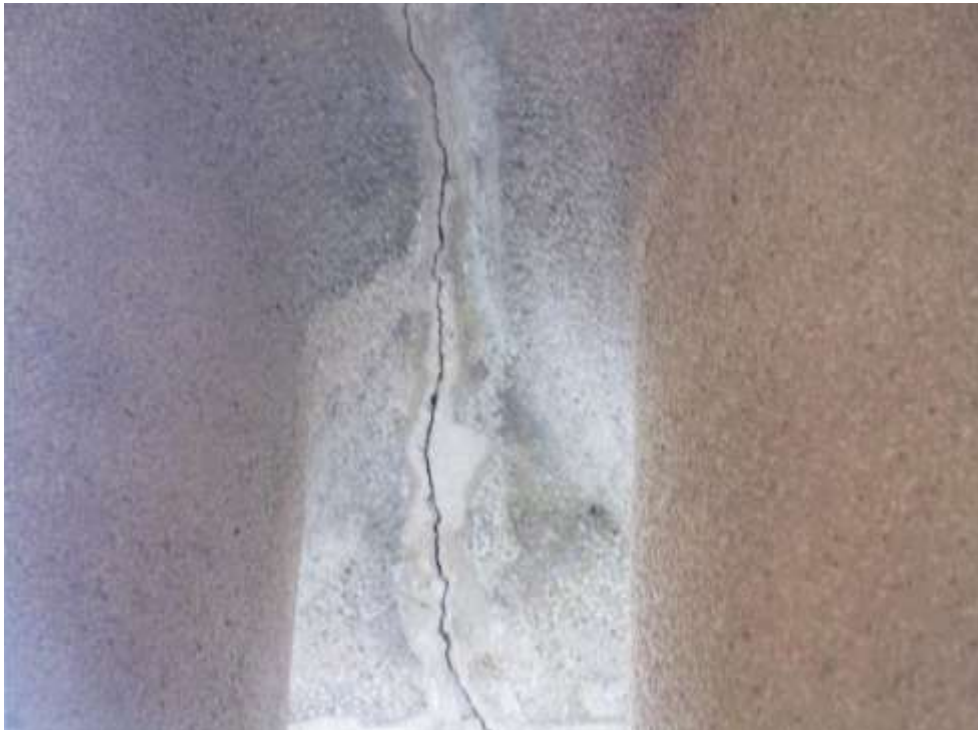
Photo No. 1046

Defect No.	23	Location	1/F South wing, Corridor	Component	column
-------------------	----	-----------------	--------------------------	------------------	--------

Description	A wide crack was observed on the top plate between 2 column				
--------------------	-------------------------------------------------------------	--	--	--	--

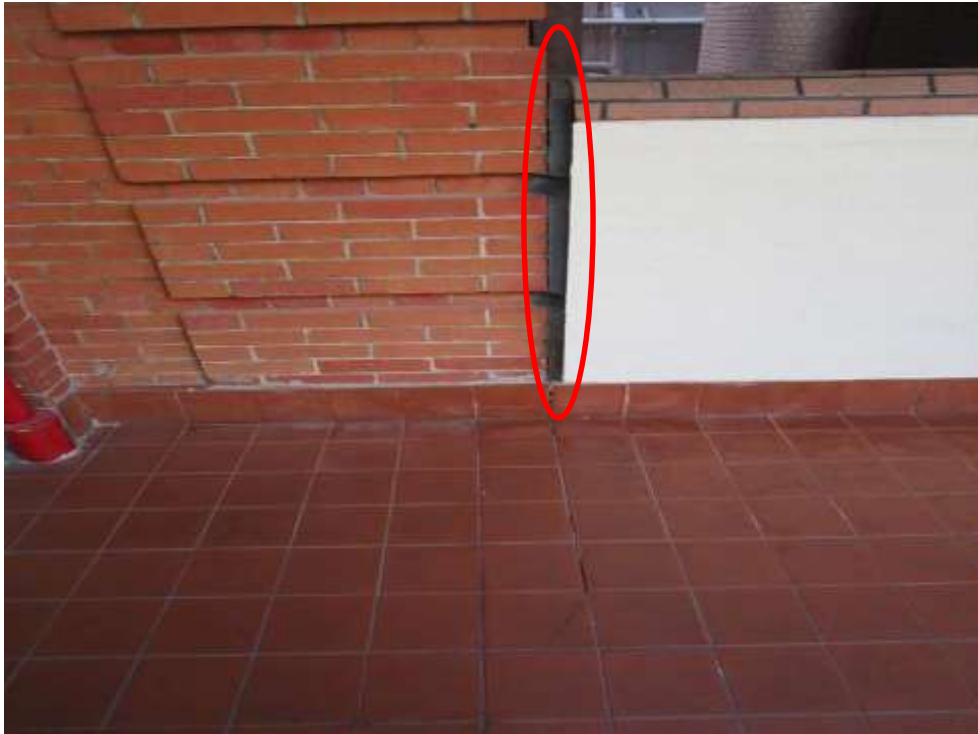
Photo No. 1047

Defect No. 24 **Location** 1/F South wing, Corridor **Component** parapet

Description Debonded joint sealant was observed on parapet between the old and new structure

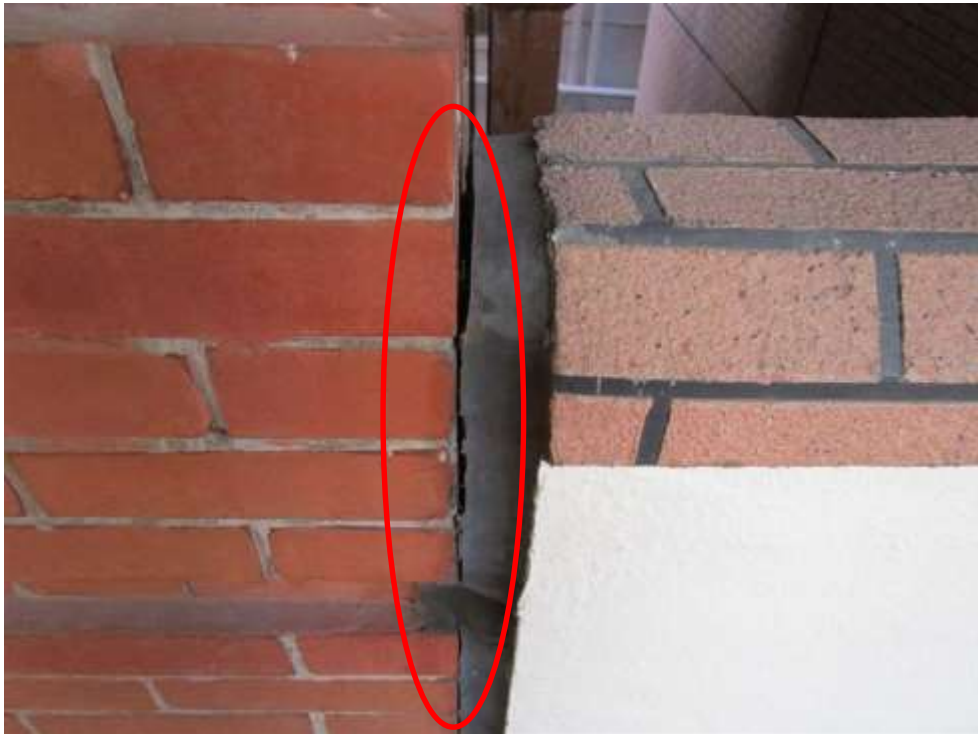
Photo No. 1048

Defect No. 24 **Location** 1/F South wing, Corridor **Component** parapet

Description Debonded joint sealant was observed on parapet between the old and new structure

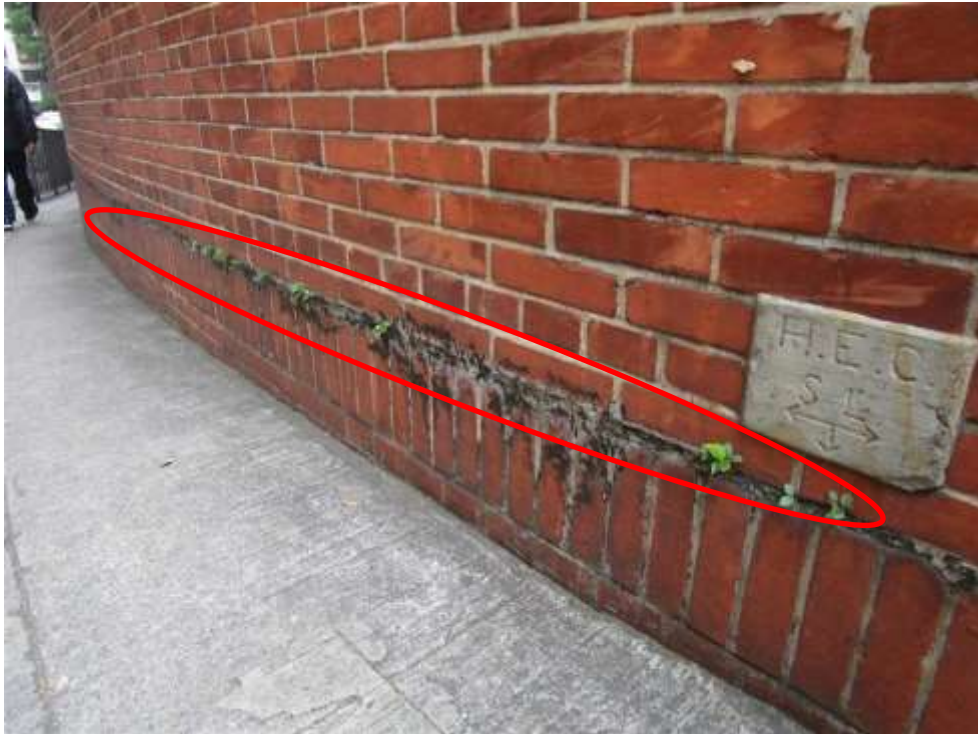
Photo No. 1049

Defect No. 25 **Location** South wing, School Garden **Component** parapet wall

Description A vegetation growth was observed on parapet wall

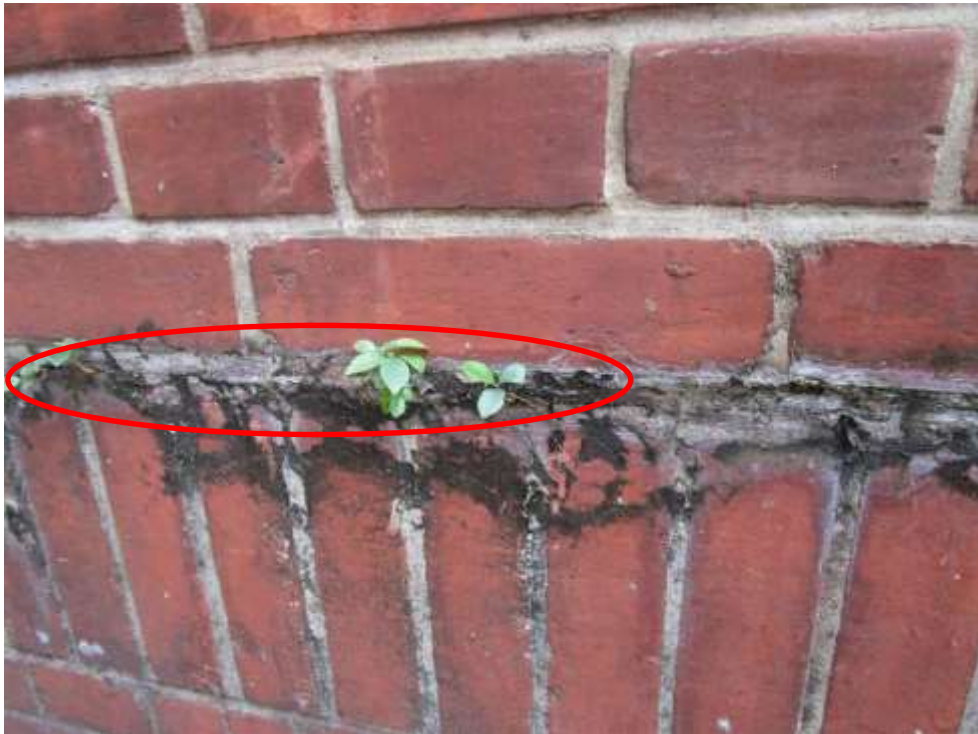
Photo No. 1050

Defect No. 25 **Location** South wing, School Garden **Component** parapet wall

Description A vegetation growth was observed on parapet wall

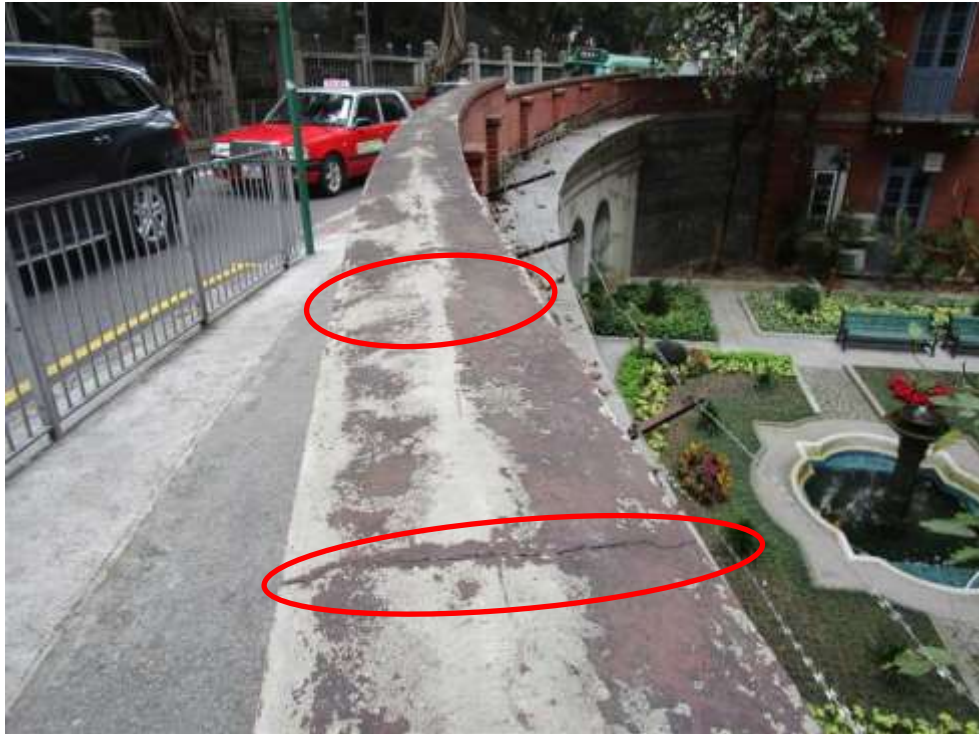
Photo No. 1051

Defect No. 26 **Location** South wing, School Garden **Component** parapet wall top

Description Medium cracks were observed on parapet wall top

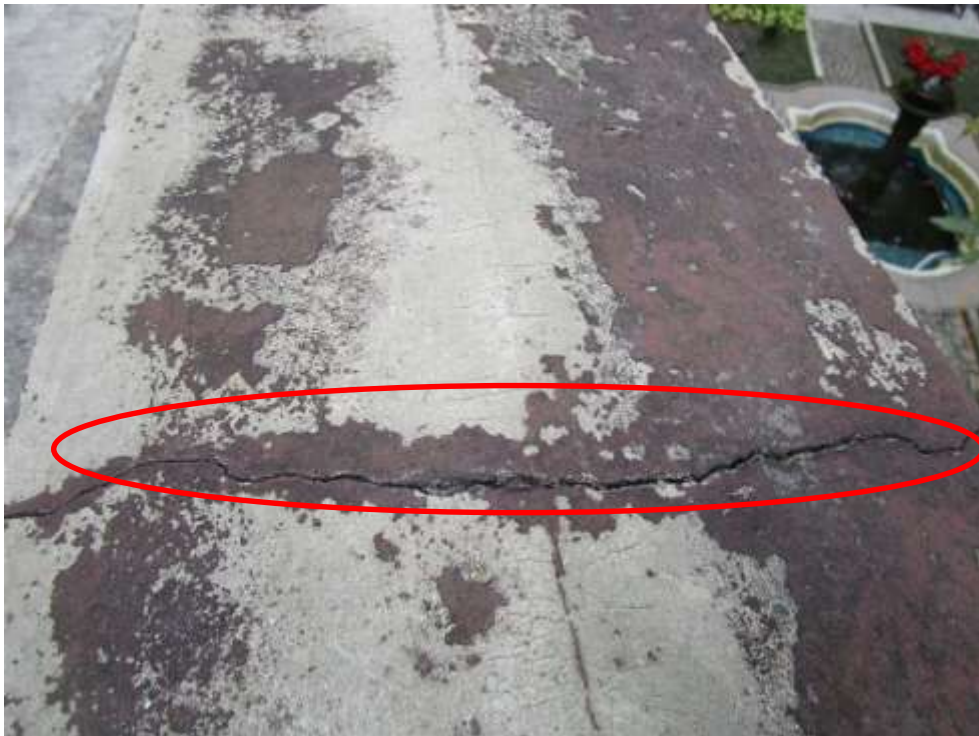
Photo No. 1052

Defect No. 26 **Location** South wing, School Garden **Component** parapet wall top

Description Medium cracks were observed on parapet wall top

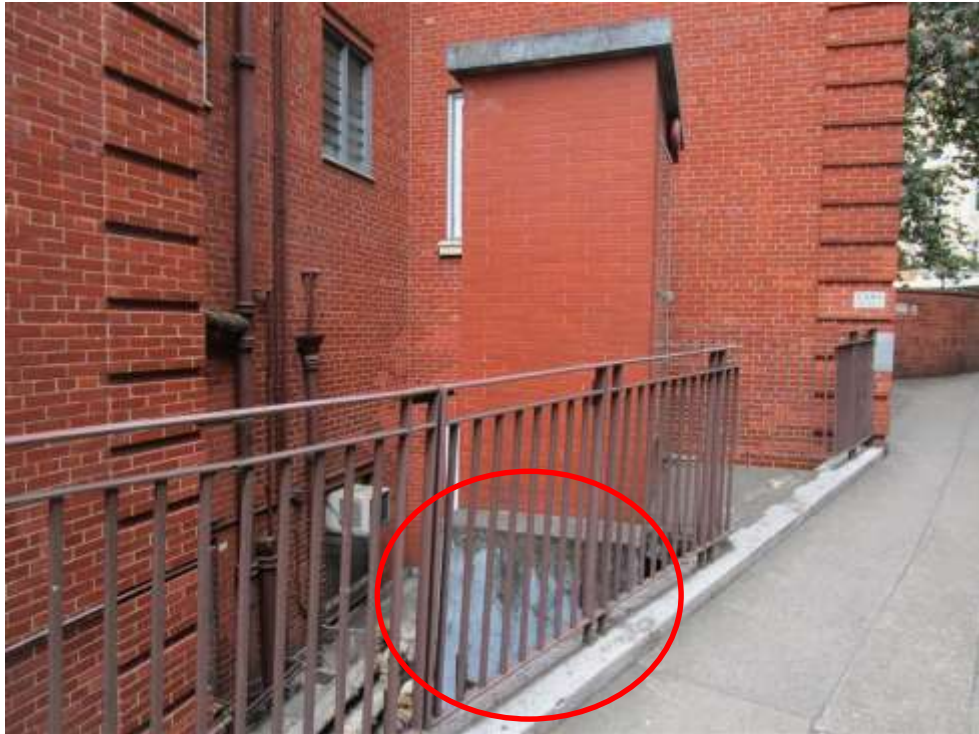
Photo No. 1053

Defect No.	27	Location	South wing, Standalone pump valve structure	Component	concrete plinth
-------------------	----	-----------------	---------------------------------------------	------------------	-----------------

Description	Crazing cracks were observed on the concrete plinth of the standalone pump valve structure				
--------------------	--------------------------------------------------------------------------------------------	--	--	--	--

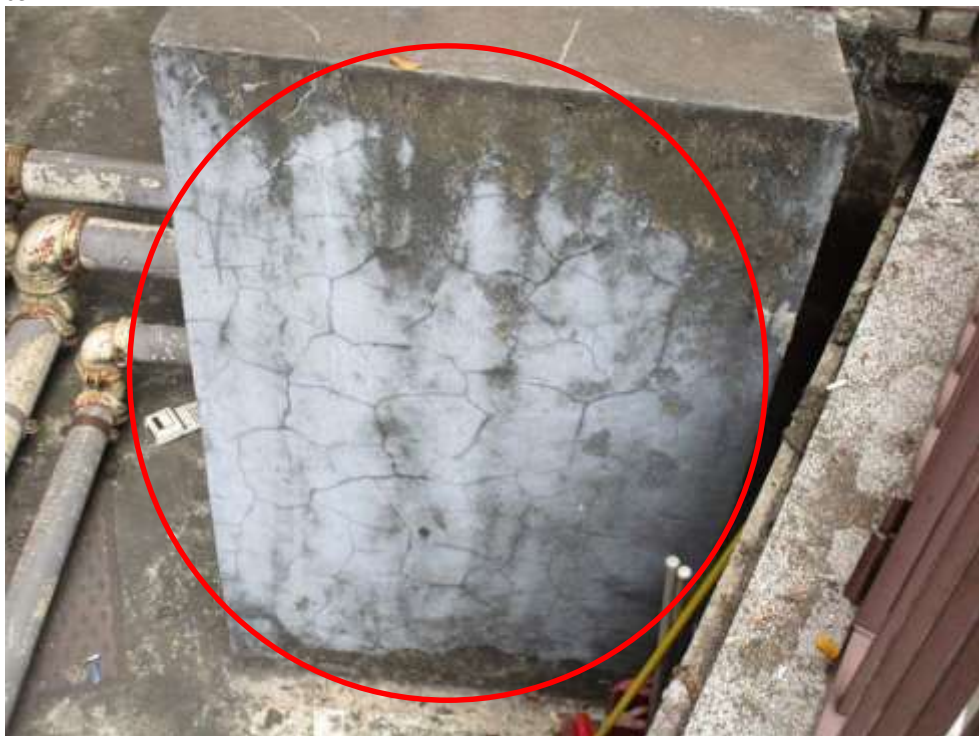
Photo No. 1054

Defect No.	27	Location	South wing, Standalone pump valve structure	Component	concrete plinth
-------------------	----	-----------------	---------------------------------------------	------------------	-----------------

Description	Crazing cracks were observed on the concrete plinth of the standalone pump valve structure				
--------------------	--------------------------------------------------------------------------------------------	--	--	--	--

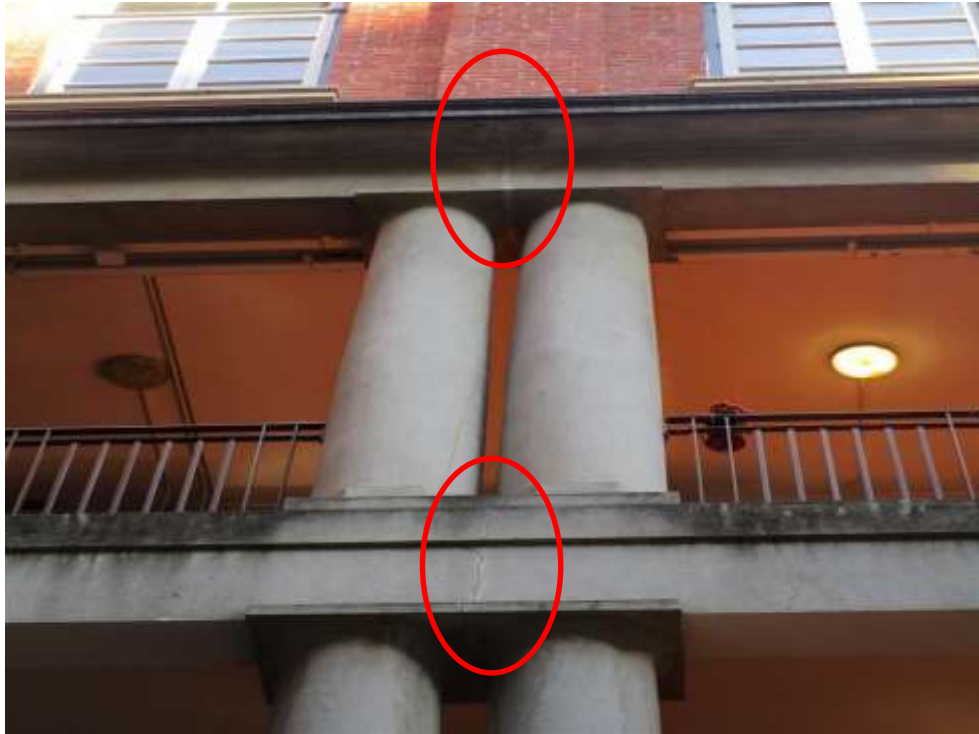
Photo No. 1055

Defect No.	28	Location	1/F & 2/F South wing, South elevation	Component	beam
-------------------	----	-----------------	---------------------------------------	------------------	------

Description A medium crack was observed on the beams at south elevation

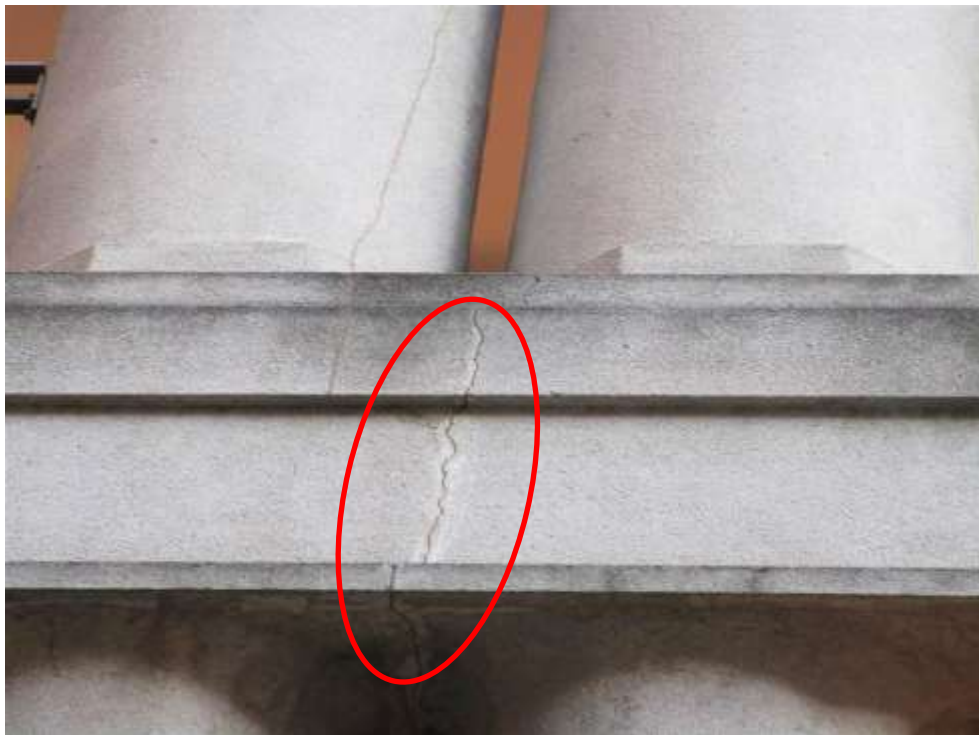
Photo No. 1056

Defect No.	28	Location	1/F & 2/F South wing, South elevation	Component	beam
-------------------	----	-----------------	---------------------------------------	------------------	------

Description A medium crack was observed on the beams at south elevation

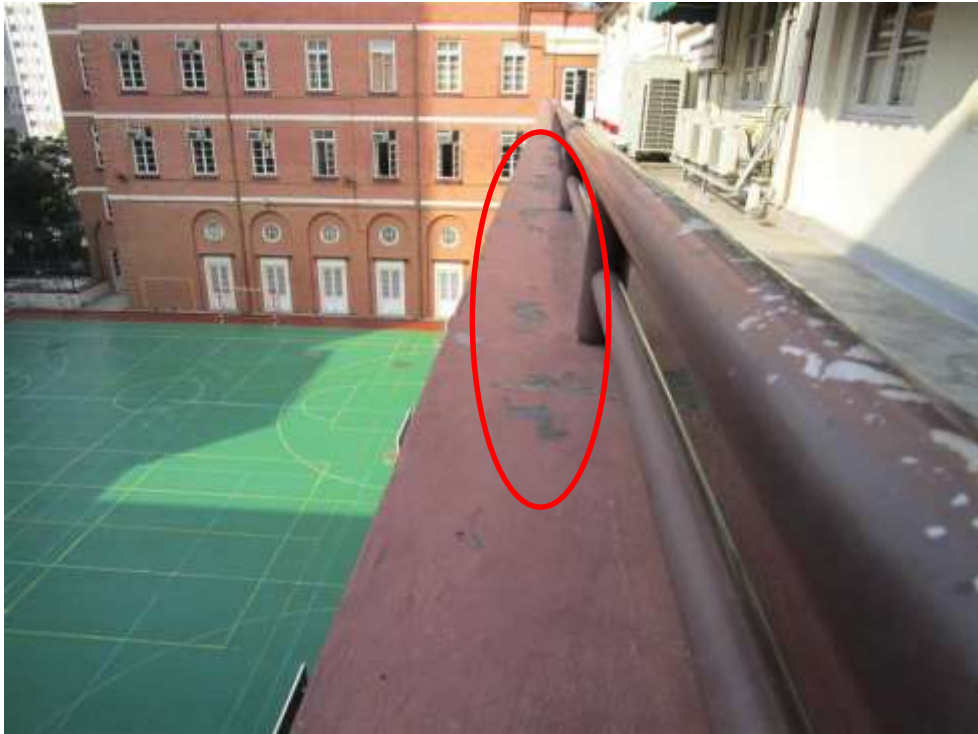
Photo No. 1057

Defect No. 29	Location 2/F East wing, Corridor	Component parapet
----------------------	-----------------------------------------	--------------------------

Description A paint peeling was observed on parapet

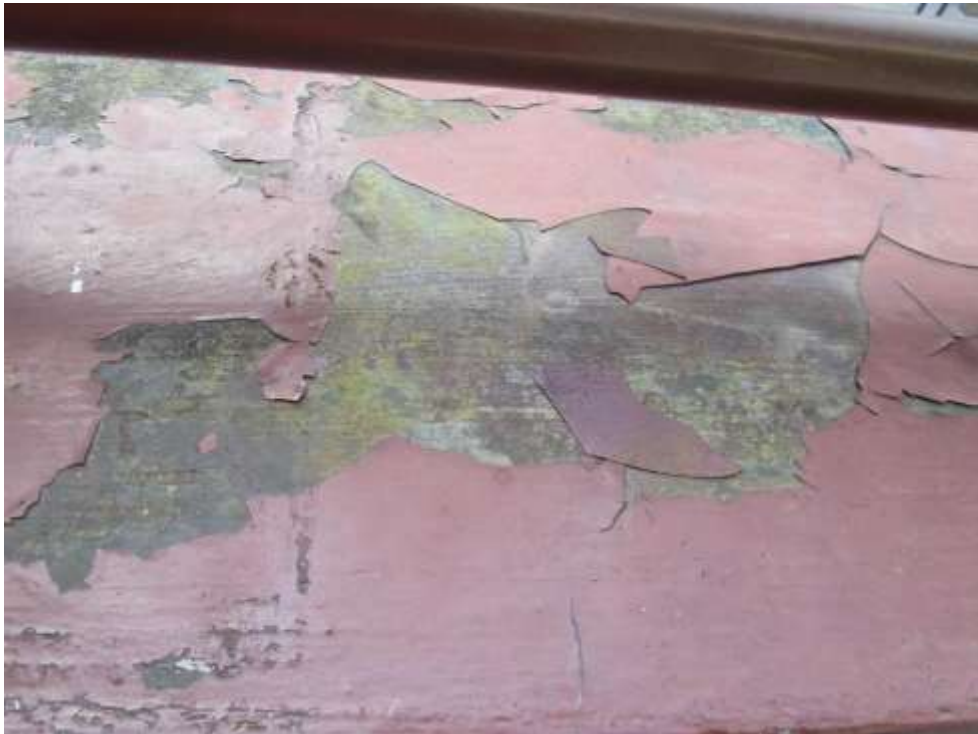
Photo No. 1058

Defect No. 29	Location 2/F East wing, Corridor	Component parapet
----------------------	-----------------------------------------	--------------------------

Description A paint peeling was observed on parapet

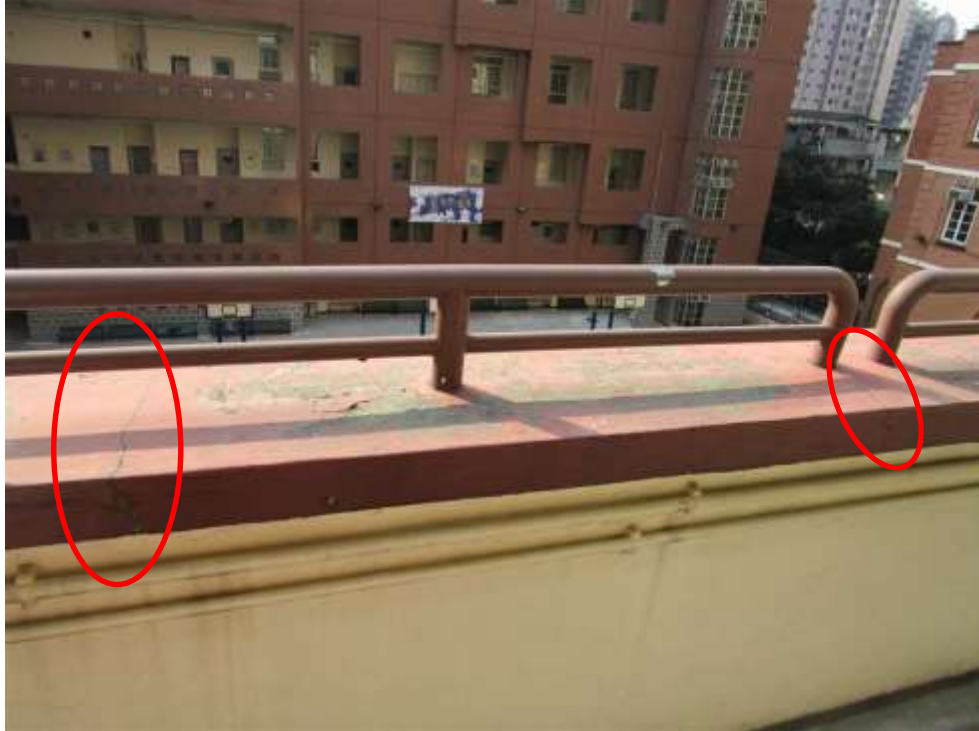
Photo No. 1059

Defect No. 30 **Location** 2/F East wing, Corridor **Component** parapet

Description 2 medium cracks were observed on parapet finishing

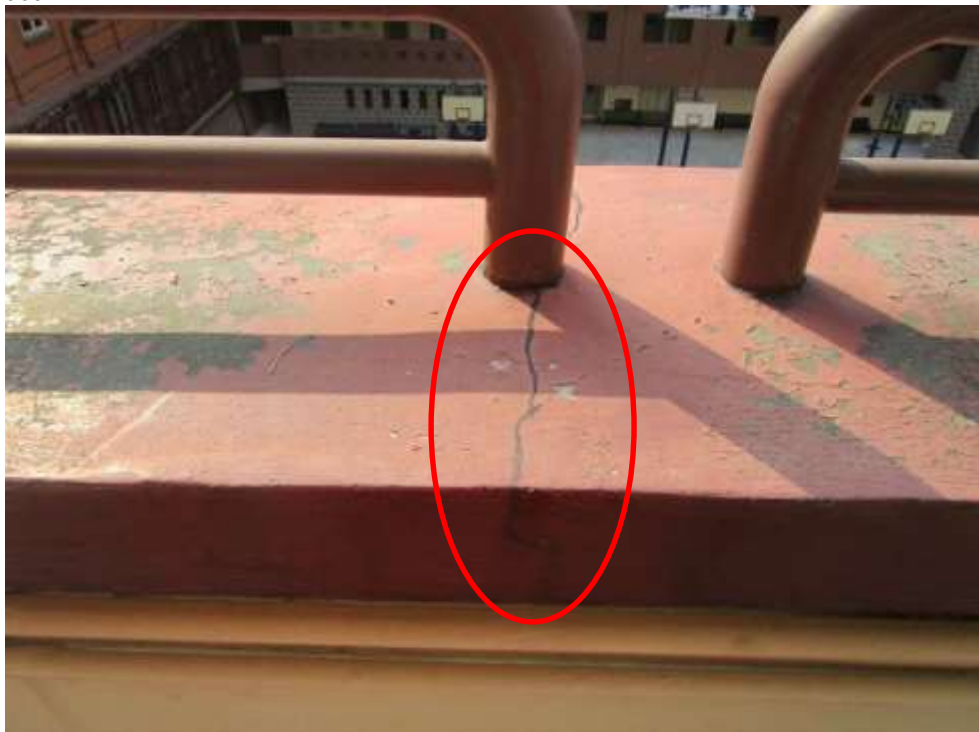
Photo No. 1060

Defect No. 30 **Location** 2/F East wing, Corridor **Component** parapet

Description 2 medium cracks were observed on parapet finishing

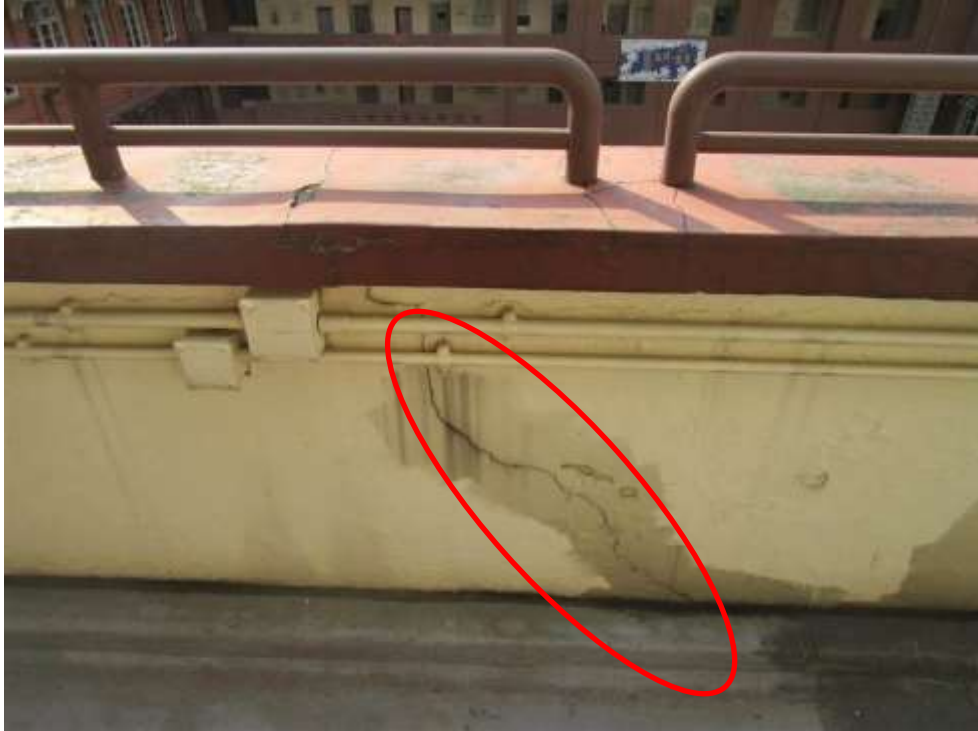
Photo No. 1061

Defect No.	31	Location	2/F East wing, Corridor	Component	parapet
-------------------	----	-----------------	-------------------------	------------------	---------

Description	A medium crack was observed on parapet finishing				
--------------------	--------------------------------------------------	--	--	--	--

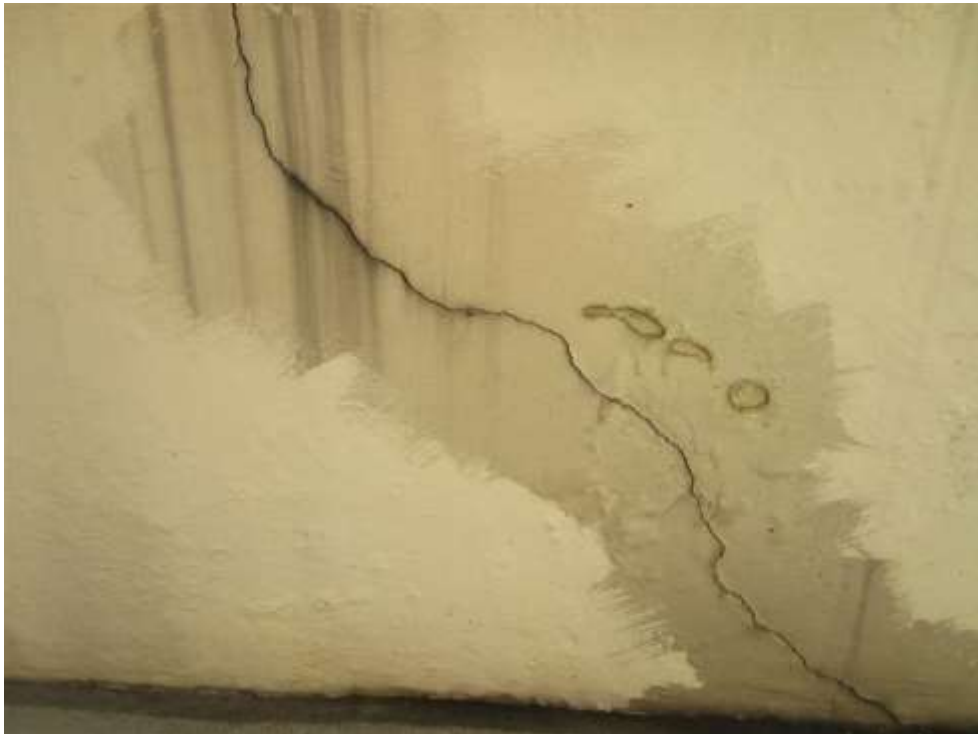
Photo No. 1062

Defect No.	31	Location	2/F East wing, Corridor	Component	parapet
-------------------	----	-----------------	-------------------------	------------------	---------

Description	A medium crack was observed on parapet finishing				
--------------------	--------------------------------------------------	--	--	--	--

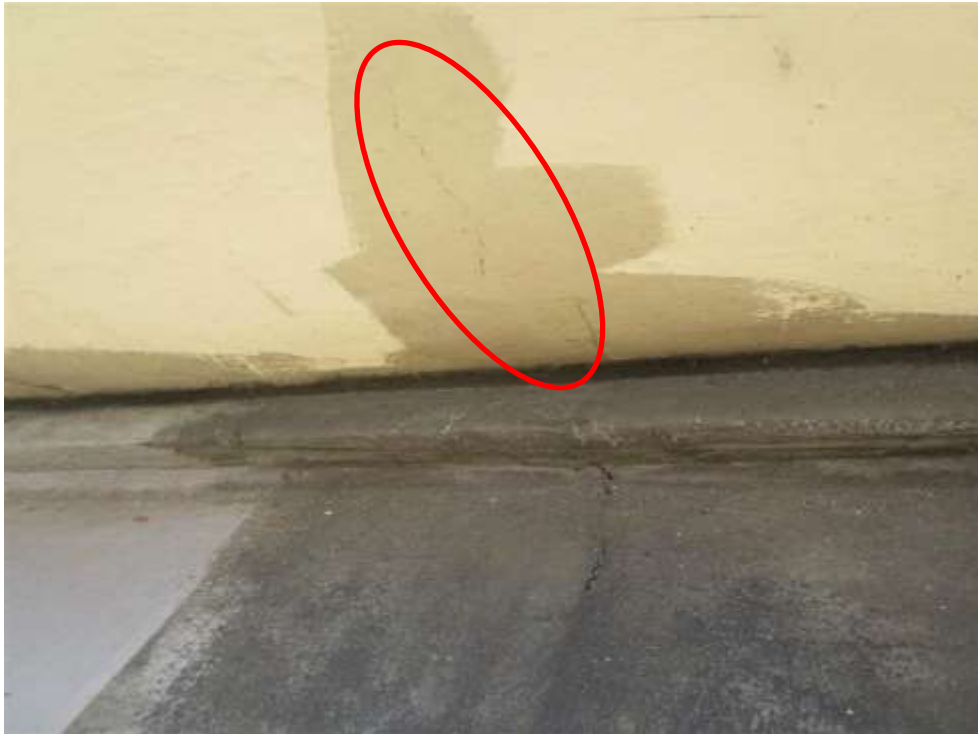
Photo No. 1063

Defect No. 32	Location 2/F East wing, Corridor	Component parapet
----------------------	-----------------------------------------	--------------------------

Description A wide crack was observed on parapet finishing

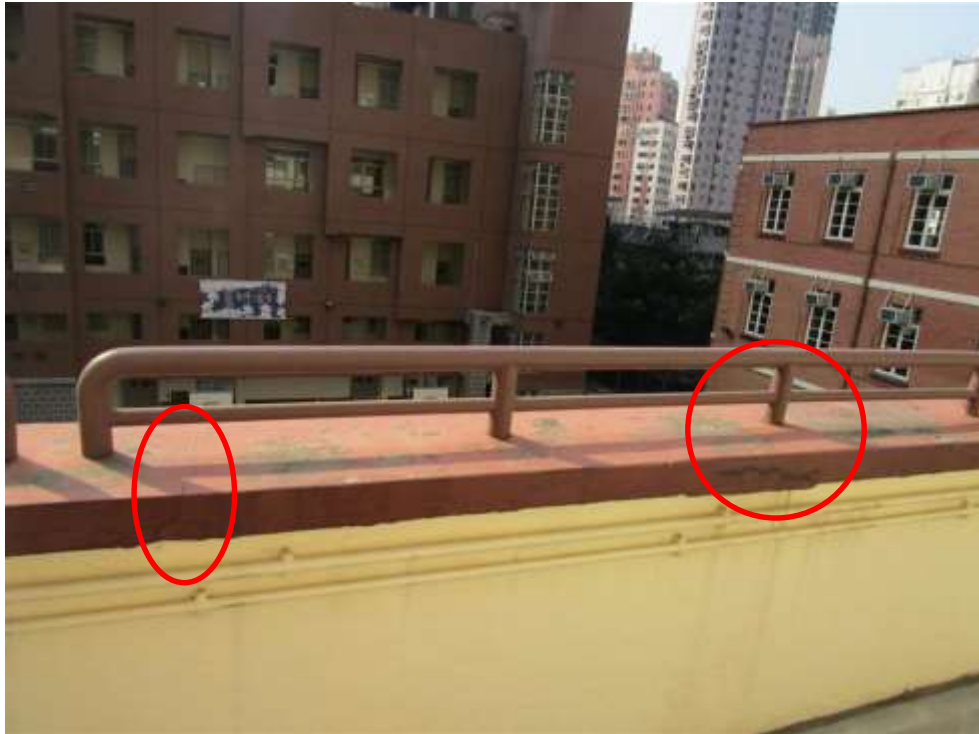
Photo No. 1065

Defect No. 32	Location 2/F East wing, Corridor	Component parapet
----------------------	-----------------------------------------	--------------------------

Description A wide crack was observed on parapet finishing

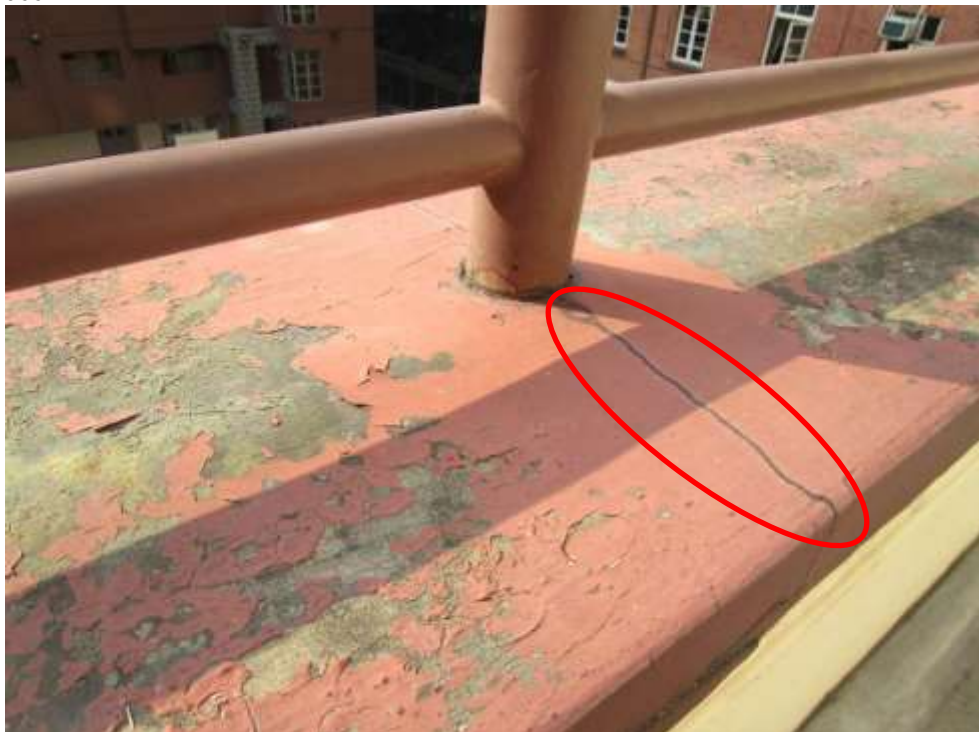
Photo No. 1066

Defect No. 33	Location 2/F East wing, Corridor	Component parapet
----------------------	-----------------------------------------	--------------------------

Description 2 wide cracks were observed on parapet finishing

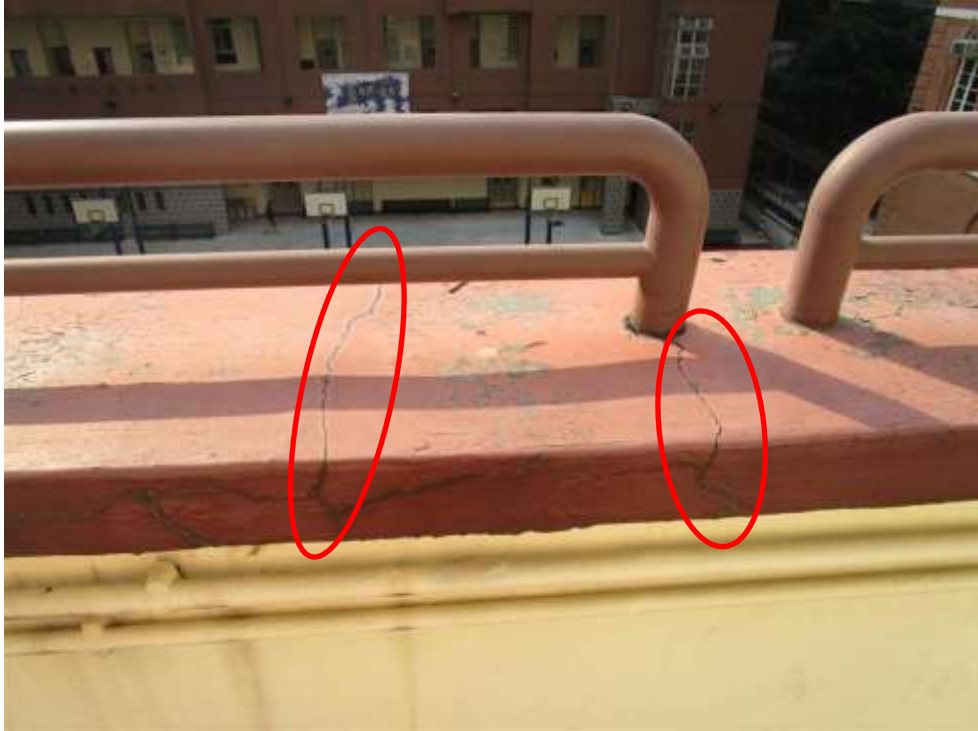
Photo No. 1067

Defect No. 33	Location 2/F East wing, Corridor	Component parapet
----------------------	-----------------------------------------	--------------------------

Description 2 wide cracks were observed on parapet finishing
