**Slope Upgrading Works at
Feature No. 11SW-A/R526,
King's College,
Bonham Road, Hong Kong**

Project Profile for Slope Upgrading Works at
Feature No. 11SW-A/R526, King's College

May 2018

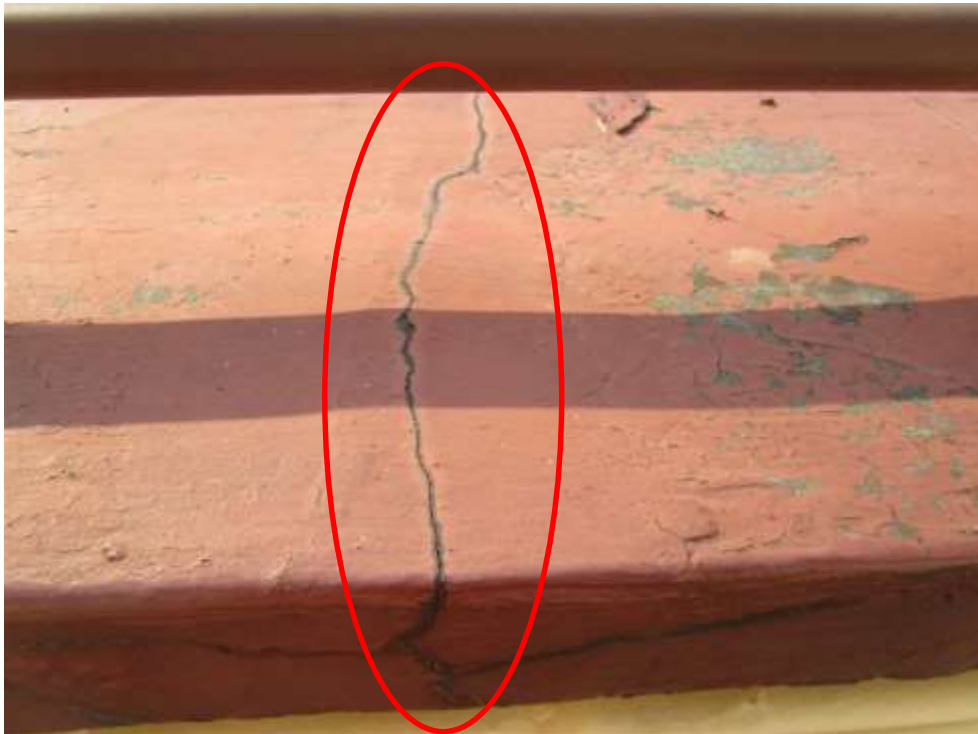
Photo No. 1068

Defect No. 34	Location 2/F East wing, Corridor	Component parapet
----------------------	-----------------------------------------	--------------------------

Description 2 wide cracks were observed on parapet finishing

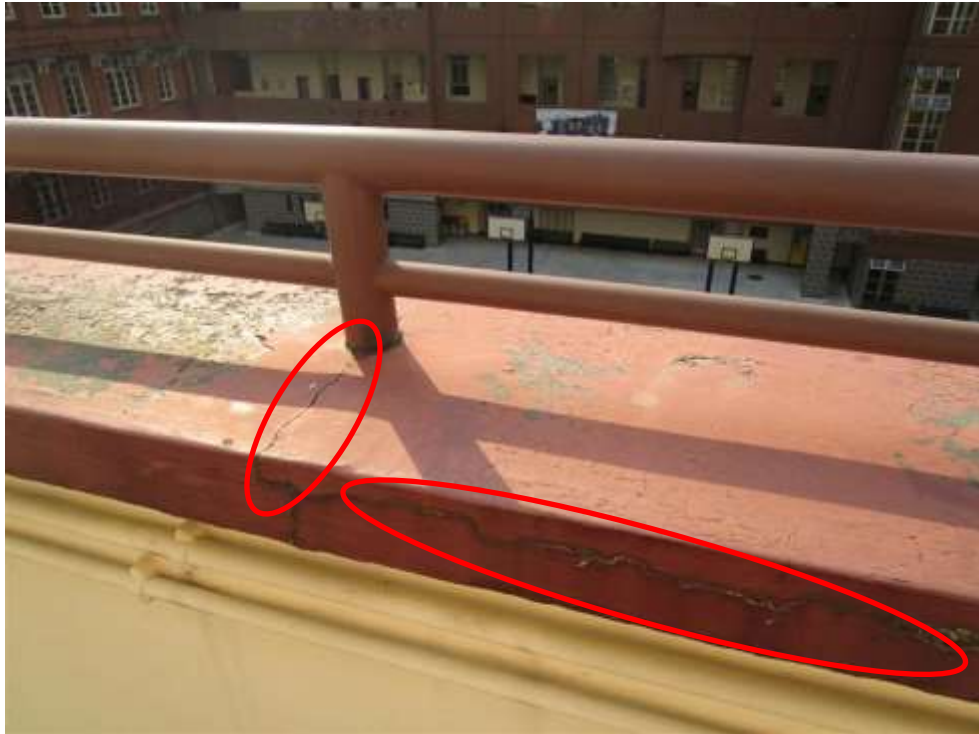
Photo No. 1069

Defect No. 34	Location 2/F East wing, Corridor	Component parapet
----------------------	-----------------------------------------	--------------------------

Description 2 wide cracks were observed on parapet finishing

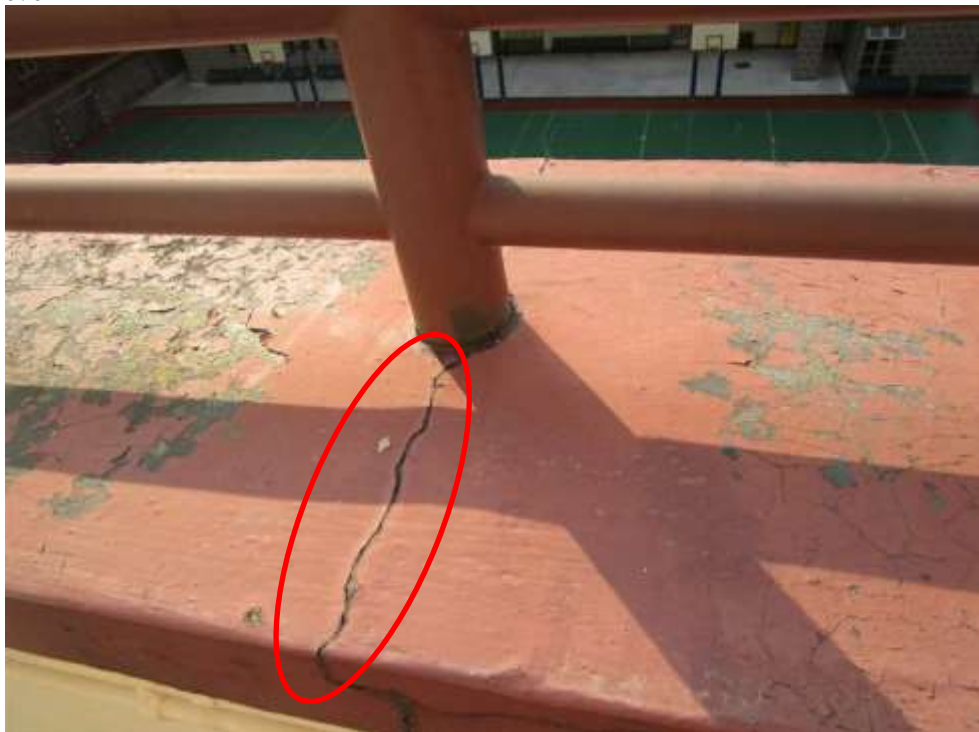
Photo No. 1070

Defect No.	35	Location	2/F East wing, Corridor	Component	parapet
-------------------	----	-----------------	-------------------------	------------------	---------

Description	2 wide cracks were observed on parapet finishing				
--------------------	--------------------------------------------------	--	--	--	--

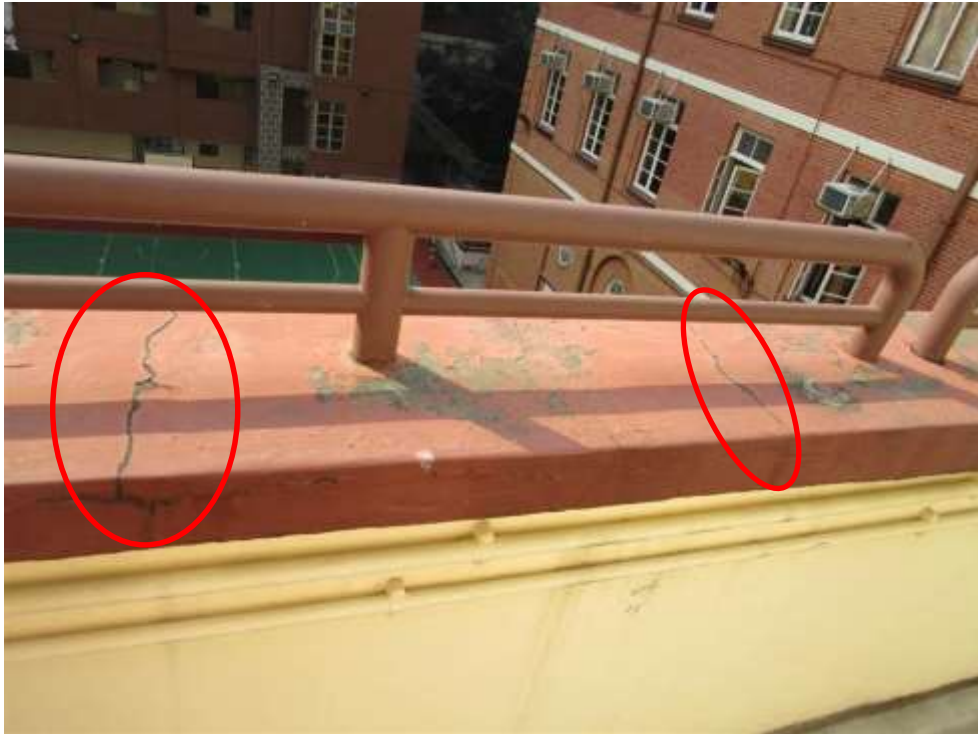
Photo No. 1071

Defect No.	35	Location	2/F East wing, Corridor	Component	parapet
-------------------	----	-----------------	-------------------------	------------------	---------

Description	2 wide cracks were observed on parapet finishing				
--------------------	--------------------------------------------------	--	--	--	--

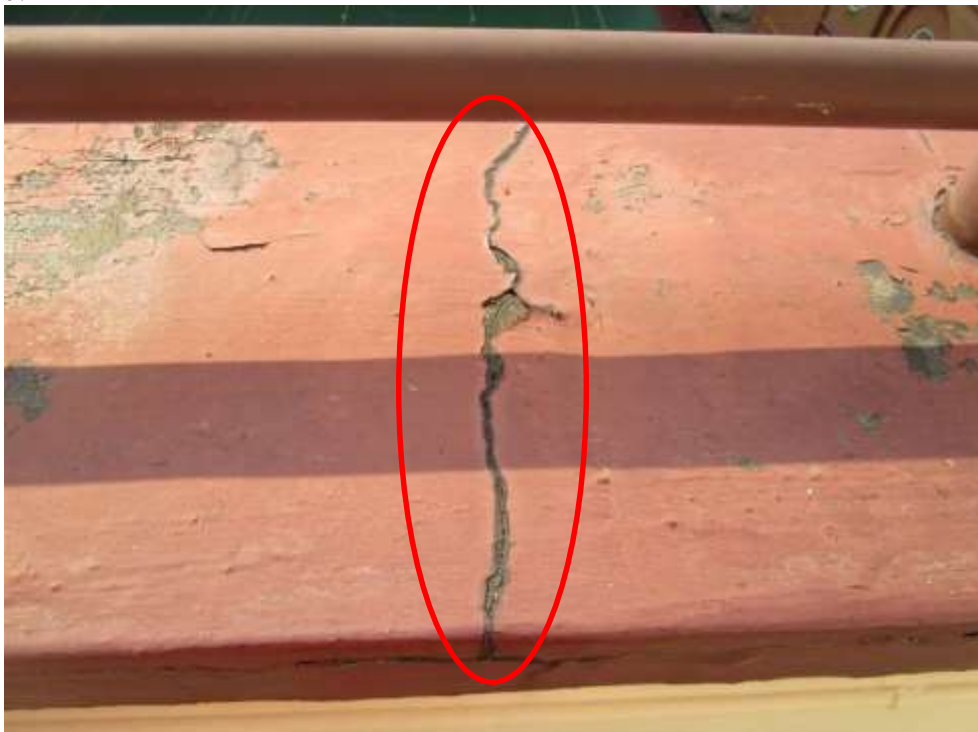
Photo No. 1072

Defect No.	36	Location	2/F East wing, Corridor	Component	parapet
-------------------	----	-----------------	-------------------------	------------------	---------

Description	3 medium cracks were observed on parapet finishing				
--------------------	----------------------------------------------------	--	--	--	--

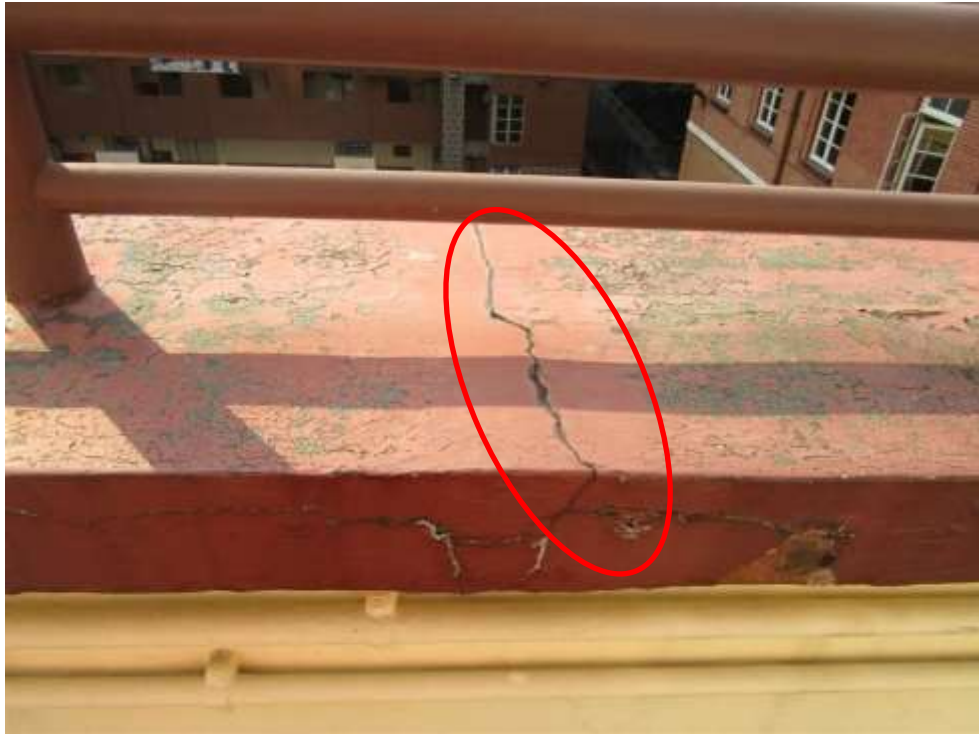
Photo No. 1073

Defect No.	36	Location	2/F East wing, Corridor	Component	parapet
-------------------	----	-----------------	-------------------------	------------------	---------

Description	3 medium cracks were observed on parapet finishing				
--------------------	----------------------------------------------------	--	--	--	--

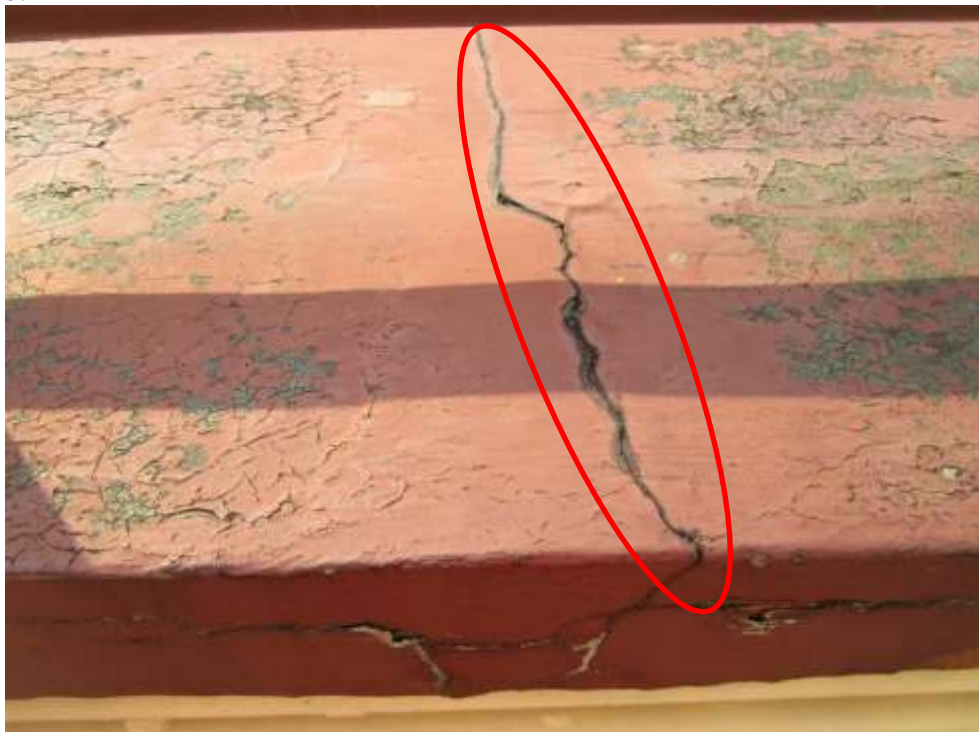
Photo No. 1074

Defect No. 37	Location 2/F East wing, Corridor	Component parapet
----------------------	-----------------------------------------	--------------------------

Description A medium crack was observed on parapet finishing

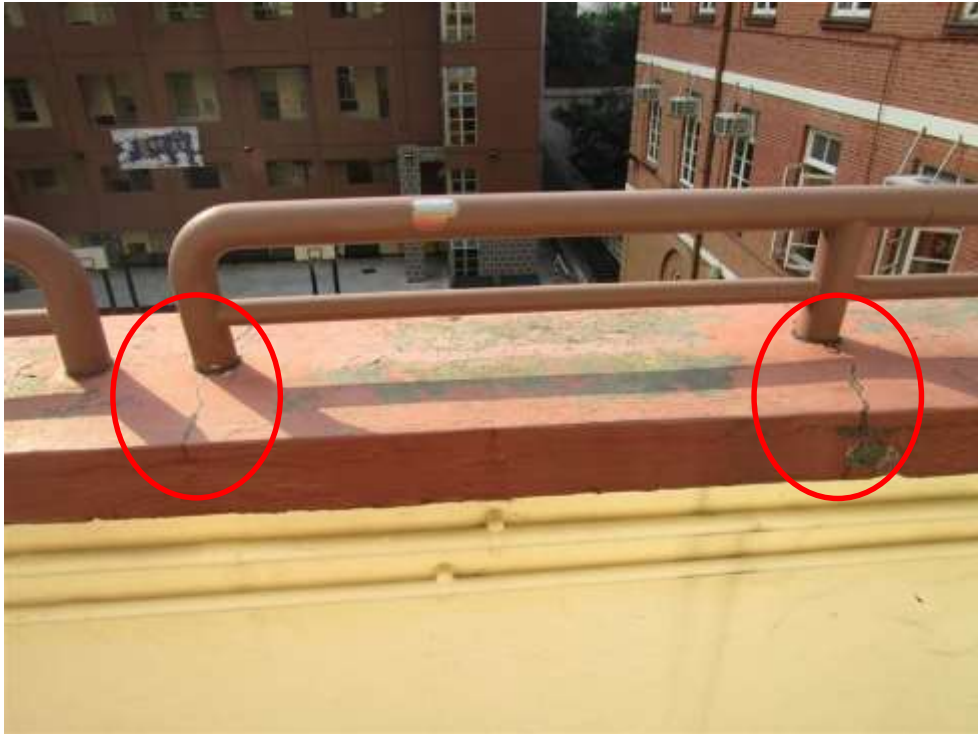
Photo No. 1075

Defect No. 37	Location 2/F East wing, Corridor	Component parapet
----------------------	-----------------------------------------	--------------------------

Description A medium crack was observed on parapet finishing

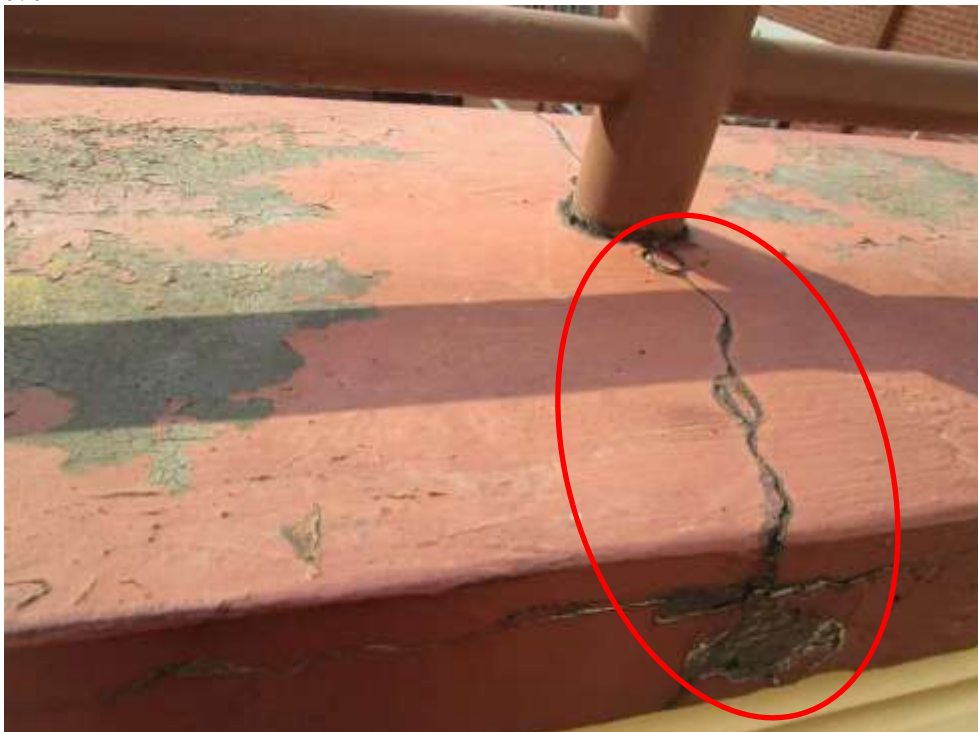
Photo No. 1076

Defect No. 38	Location 2/F East wing, Corridor	Component parapet
----------------------	-----------------------------------------	--------------------------

Description 2 wide cracks were observed on parapet finishing

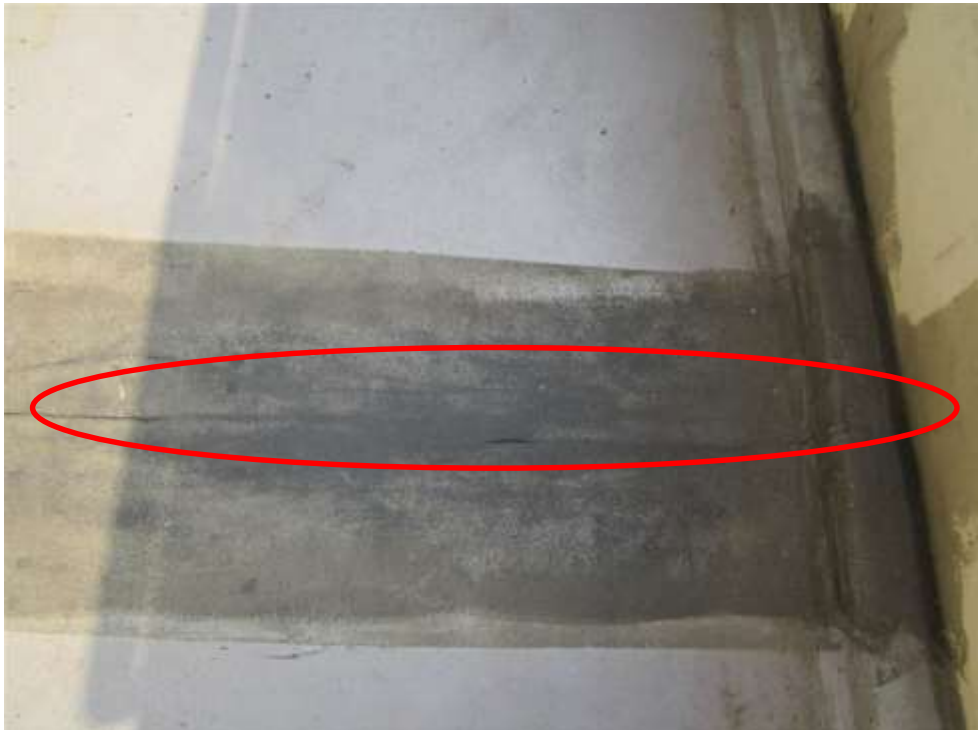
Photo No. 1078

Defect No. 39	Location 2/F East wing, Corridor	Component slab
----------------------	-----------------------------------------	-----------------------

Description A wide crack was observed on slab

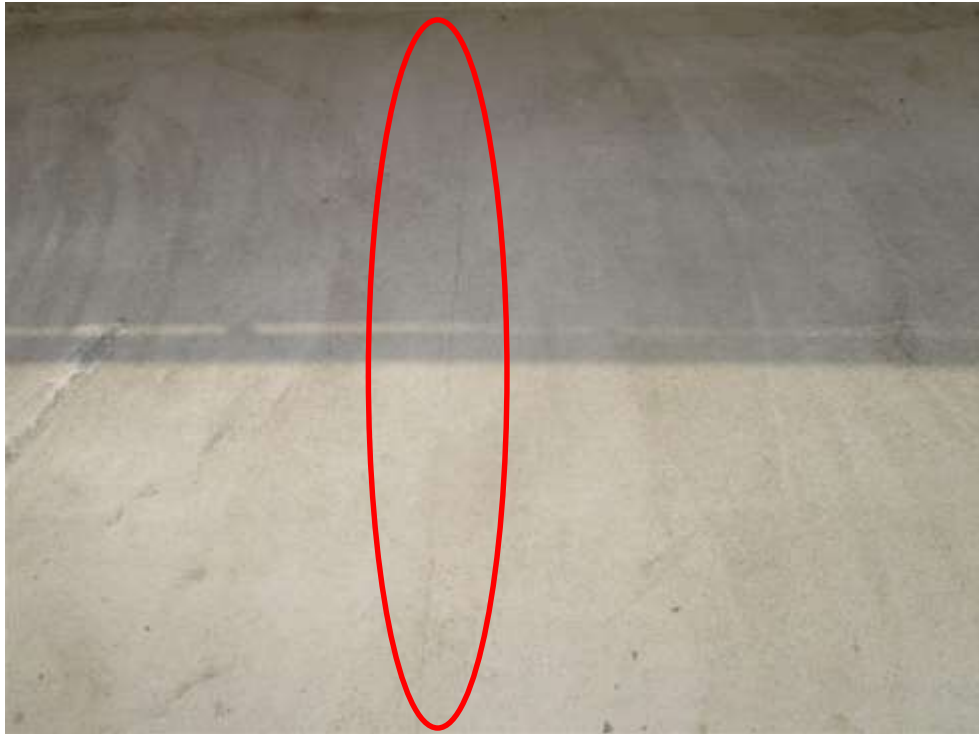
Photo No. 1079

Defect No. 39	Location 2/F East wing, Corridor	Component slab
----------------------	-----------------------------------------	-----------------------

Description A wide crack was observed on slab

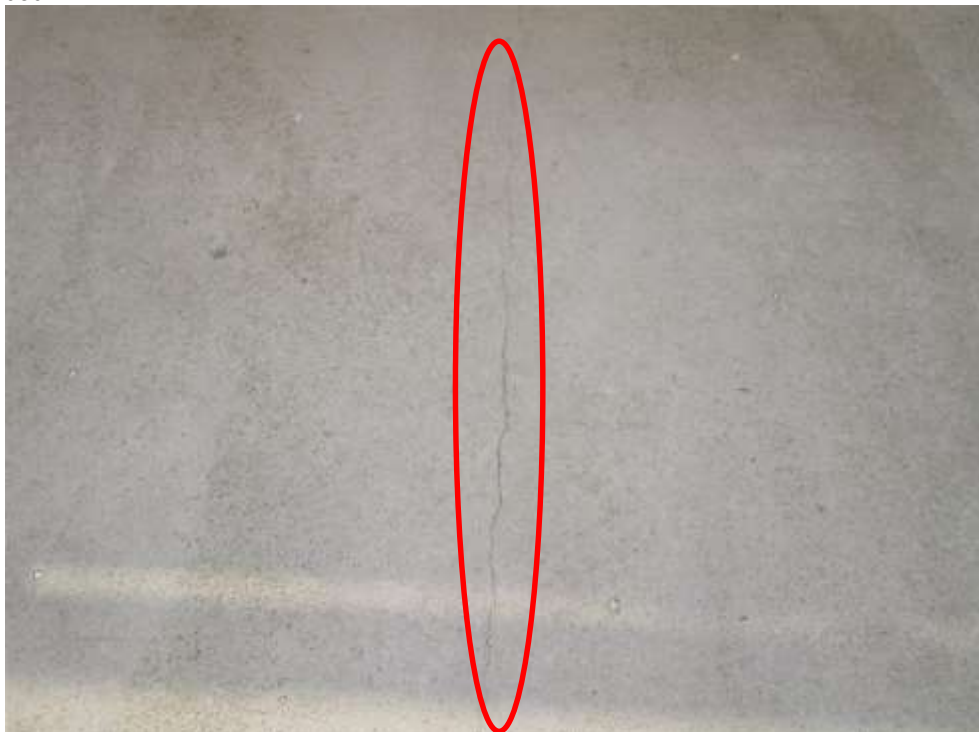
Photo No. 1080

Defect No.	40	Location	2/F East wing, Corridor	Component	slab
-------------------	----	-----------------	-------------------------	------------------	------

Description	A medium crack was observed on slab				
--------------------	-------------------------------------	--	--	--	--

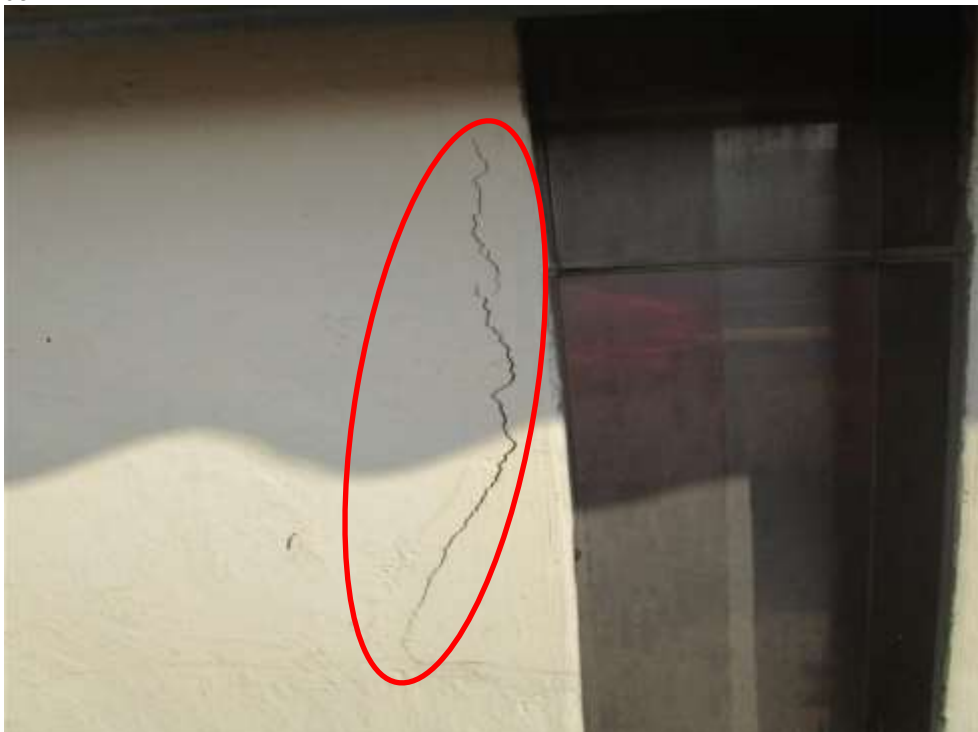
Photo No. 1082

Defect No. 41	Location 2/F East wing, Corridor	Component wall
----------------------	-----------------------------------------	-----------------------

Description A wide crack was observed on wall

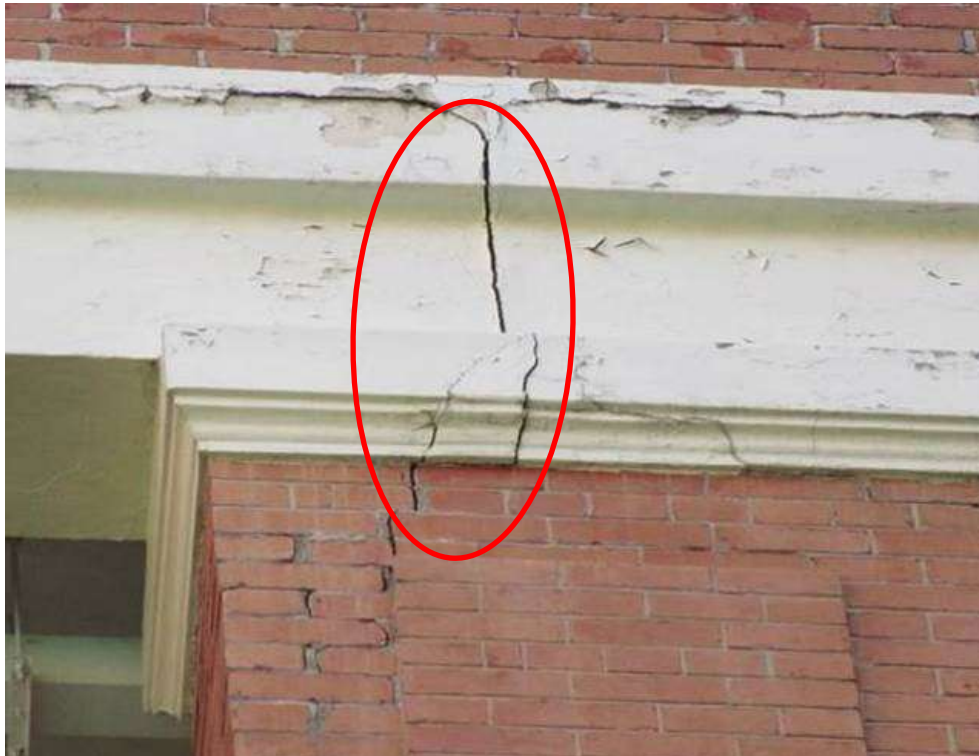
Photo No. 1084

Defect No.	42	Location	2/F East wing, East elevation	Component	beam
-------------------	----	-----------------	-------------------------------	------------------	------

Description	A wide crack was observed on brick column				
--------------------	-------------------------------------------	--	--	--	--

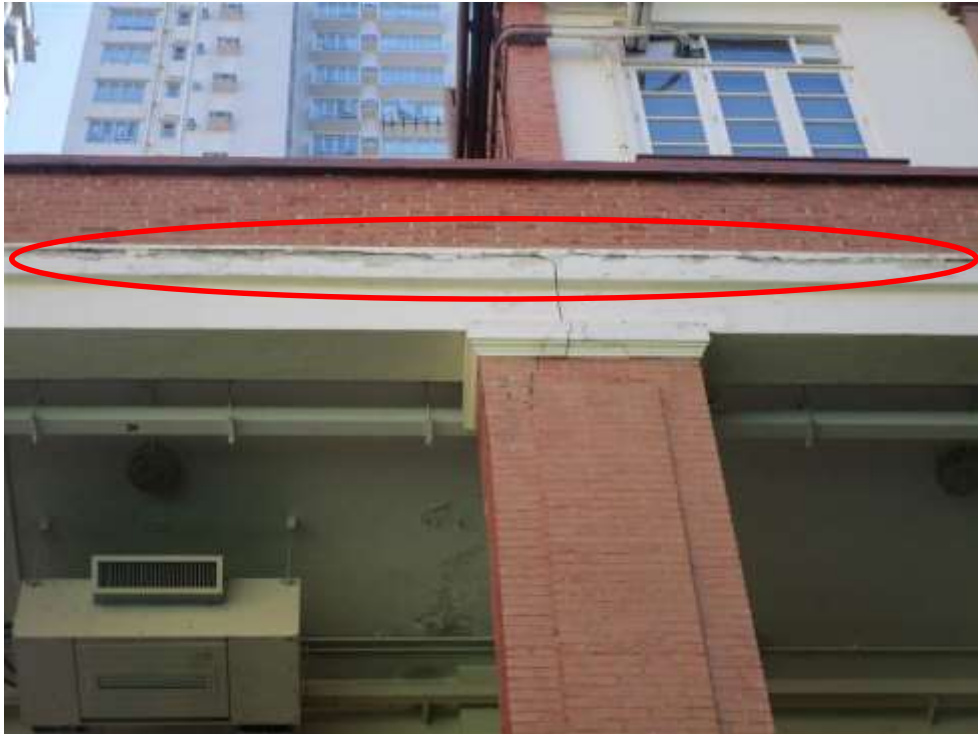
Photo No. 1085

Defect No.	42	Location	2/F East wing, East elevation	Component	beam
-------------------	----	-----------------	-------------------------------	------------------	------

Description	A wide crack was observed on brick column				
--------------------	-------------------------------------------	--	--	--	--

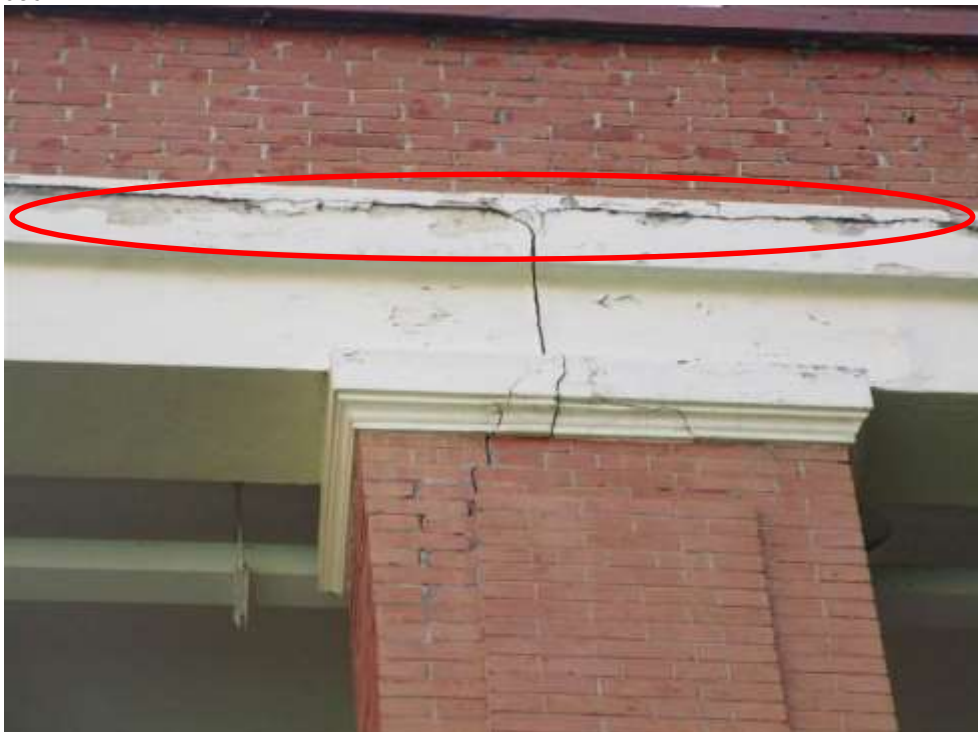
Photo No. 1086

Defect No. 43 **Location** 2/F East wing, East elevation **Component** beam

Description A wide crack was observed on concrete beam above brick column

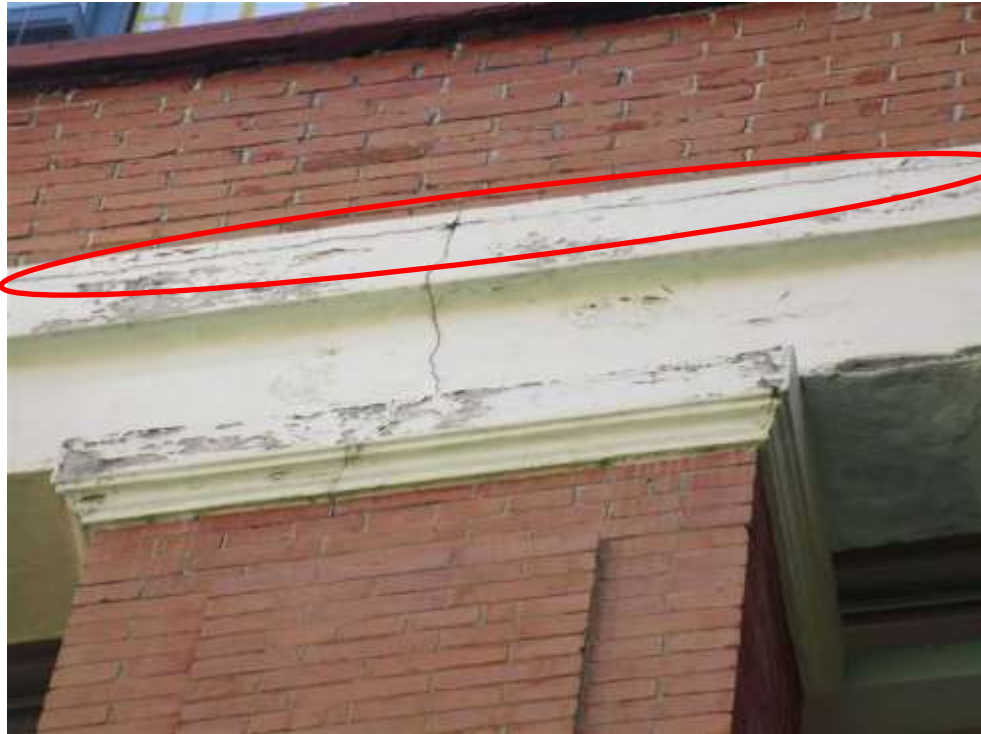
Photo No. 1087

Defect No. 43 **Location** 2/F East wing, East elevation **Component** beam

Description A wide crack was observed on concrete beam above brick column

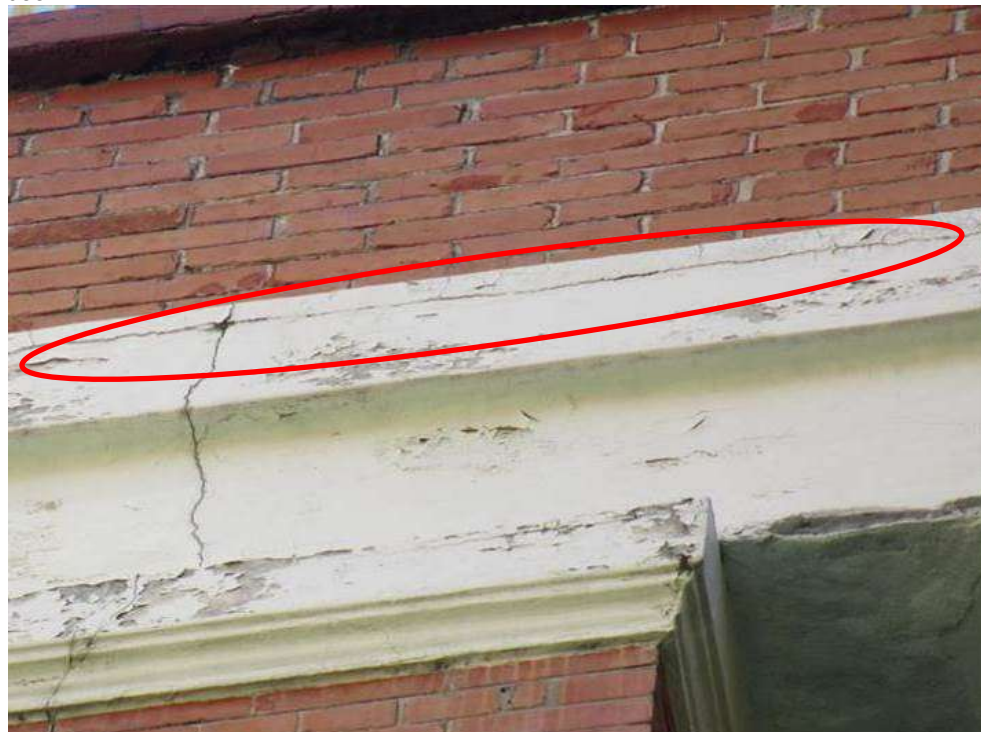
Photo No. 1088

Defect No.	44	Location	2/F East wing, East elevation	Component	beam
-------------------	----	-----------------	-------------------------------	------------------	------

Description	A wide crack was observed on concrete beam above brick column				
--------------------	---------------------------------------------------------------	--	--	--	--

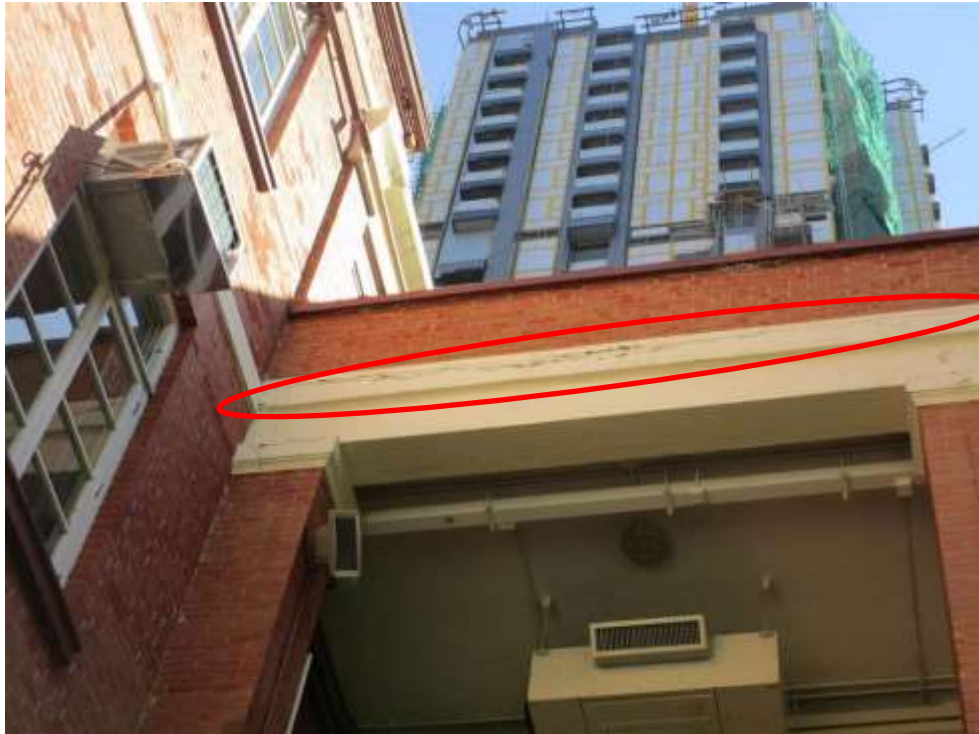
Photo No. 1089

Defect No.	44	Location	2/F East wing, East elevation	Component	beam
-------------------	----	-----------------	-------------------------------	------------------	------

Description	A wide crack was observed on concrete beam above brick column				
--------------------	---------------------------------------------------------------	--	--	--	--

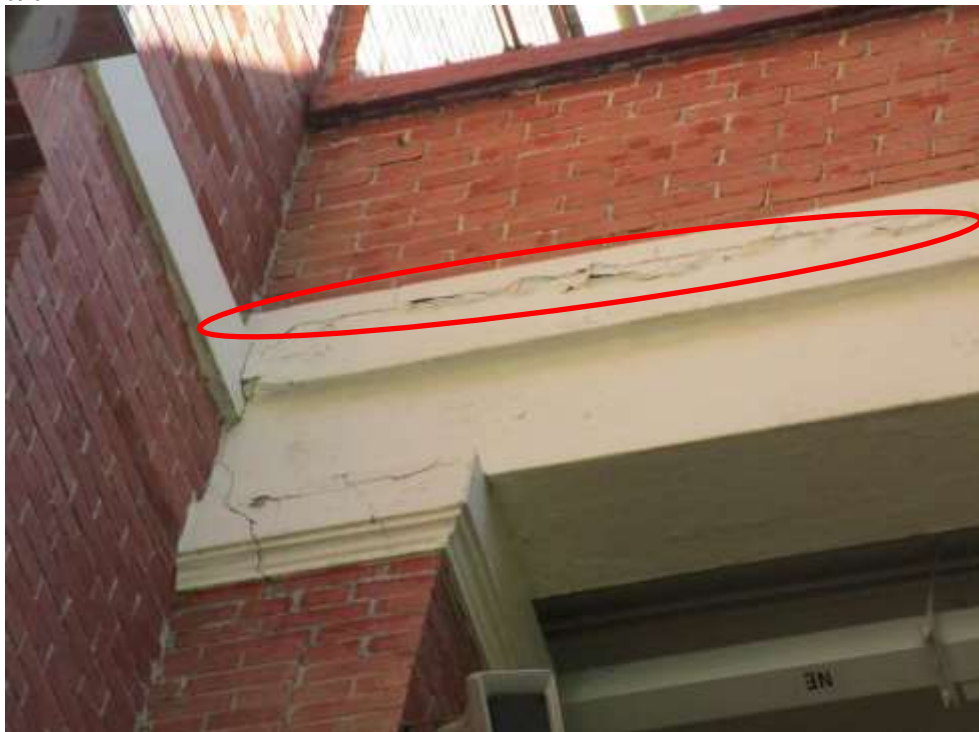
Photo No. 1090

Defect No. 45 **Location** 2/F East wing, East elevation **Component** beam

Description A wide crack was observed on concrete beam above brick column

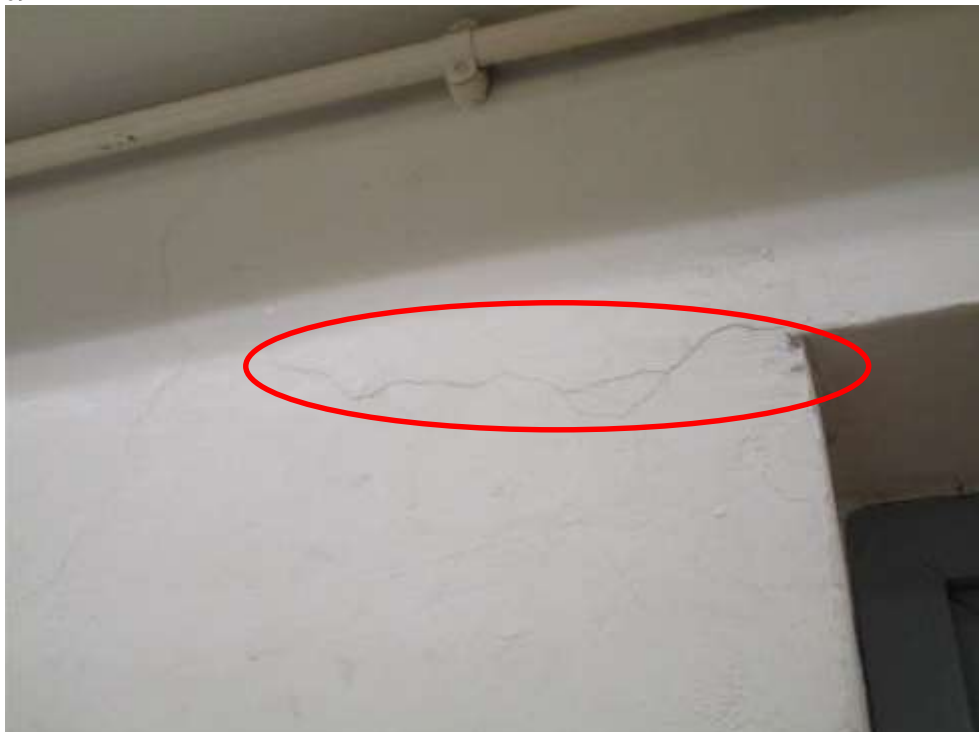
Photo No. 1092

Defect No. 46	Location 2/F East wing, Staff room	Component wall
----------------------	-------------------------------------------	-----------------------

Description A medium crack was observed on wall finishing

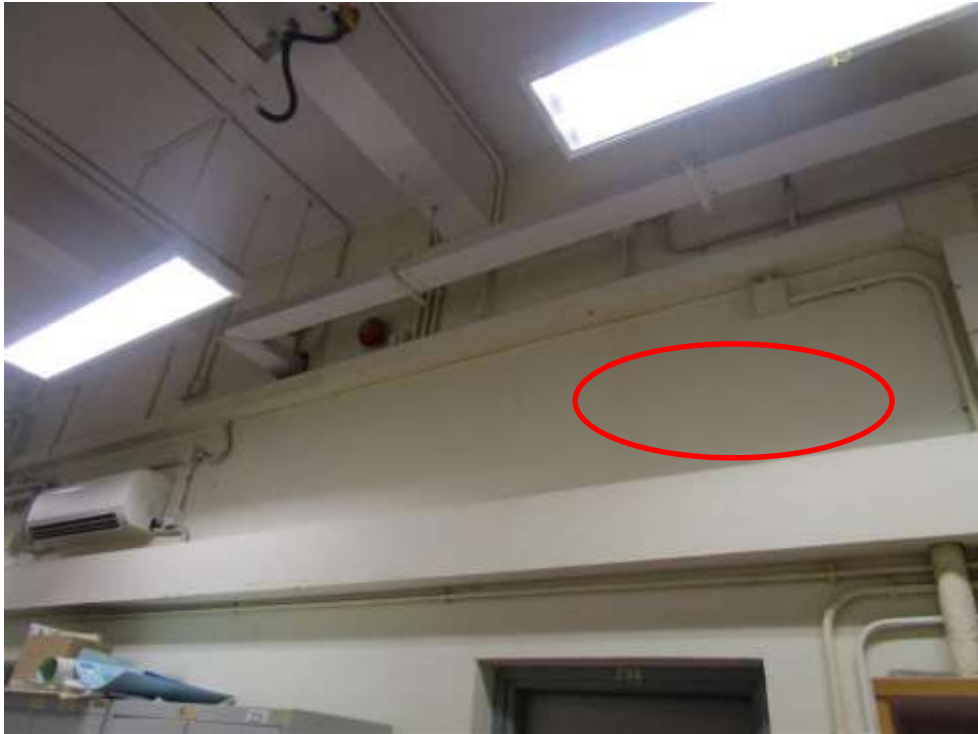
Photo No. 1093

Defect No. 46	Location 2/F East wing, Staff room	Component wall
----------------------	-------------------------------------------	-----------------------

Description A medium crack was observed on wall finishing

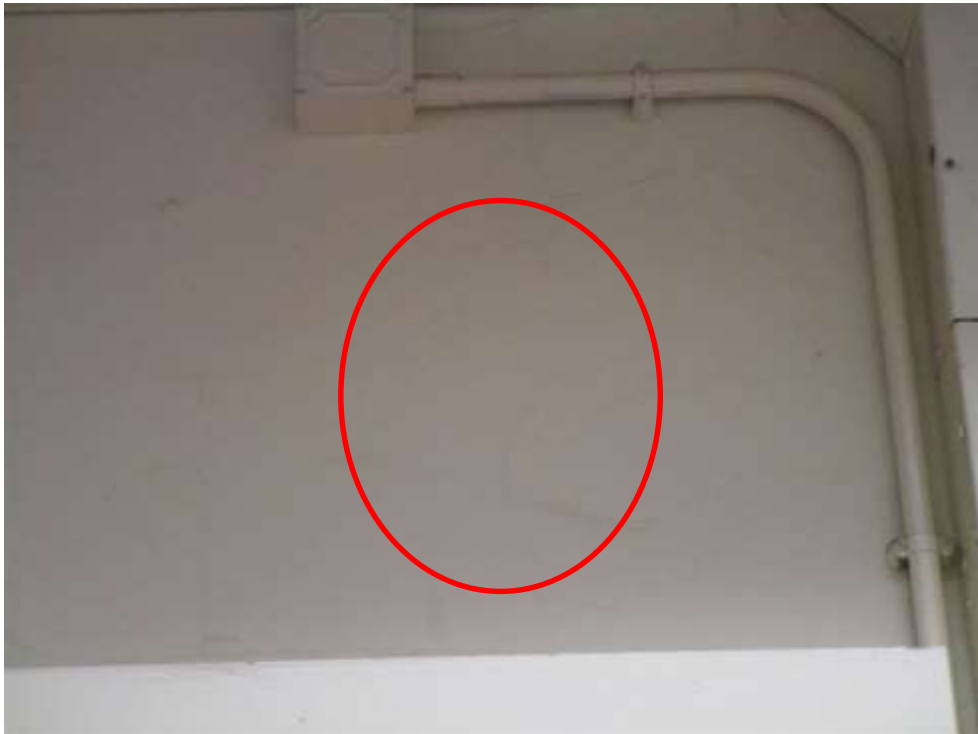
Photo No. 1094

Defect No.	47	Location	2/F East wing, Staff room	Component	wall
-------------------	----	-----------------	---------------------------	------------------	------

Description	An area of hairline crack was observed on wall finishing				
--------------------	----------------------------------------------------------	--	--	--	--

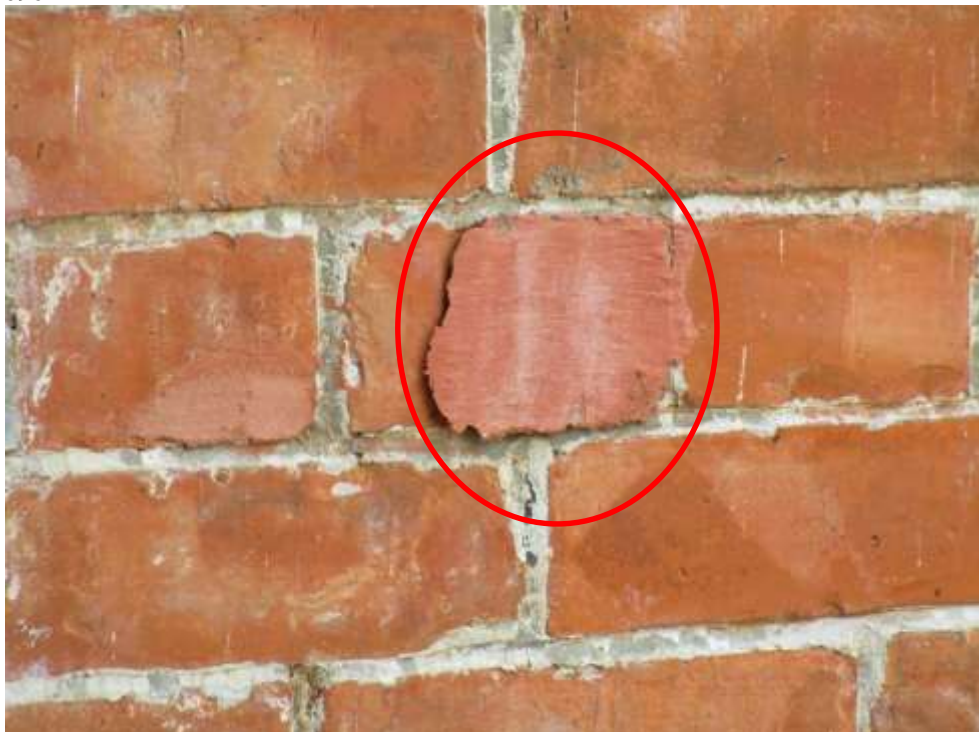
Photo No. 1096

Defect No.	48	Location	2/F North wing, East elevation	Component	brick wall
-------------------	----	-----------------	--------------------------------	------------------	------------

Description	Delaminated previous repair was observed on brick wall				
--------------------	--------------------------------------------------------	--	--	--	--

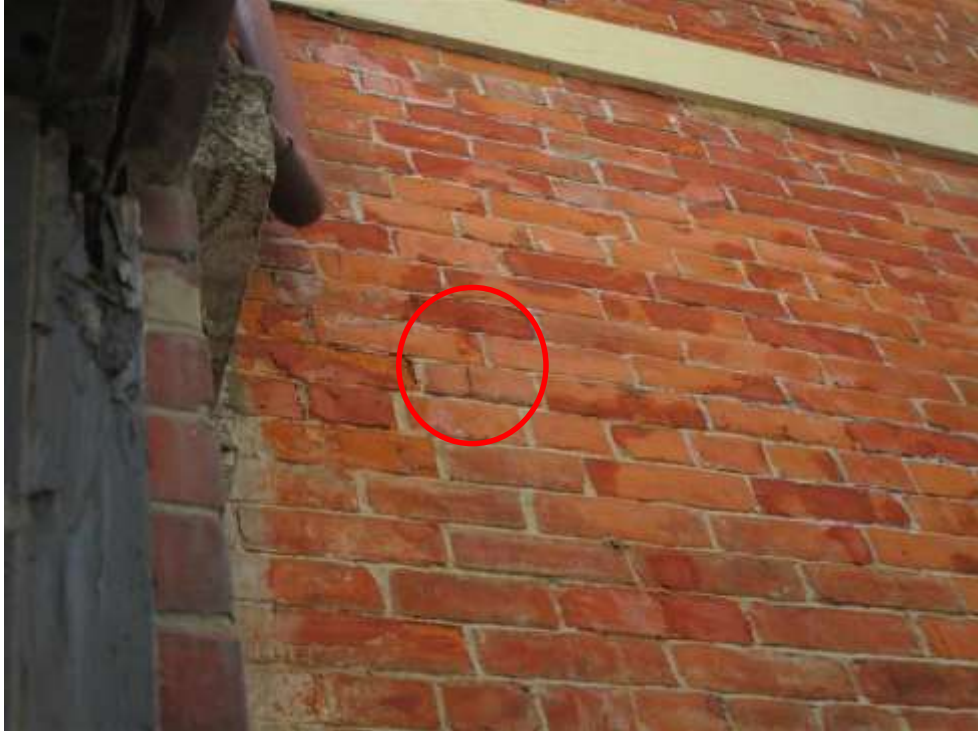
Photo No. 1097

Defect No.	48	Location	2/F North wing, East elevation	Component	brick wall
-------------------	----	-----------------	--------------------------------	------------------	------------

Description	Delaminated previous repair was observed on brick wall				
--------------------	--------------------------------------------------------	--	--	--	--

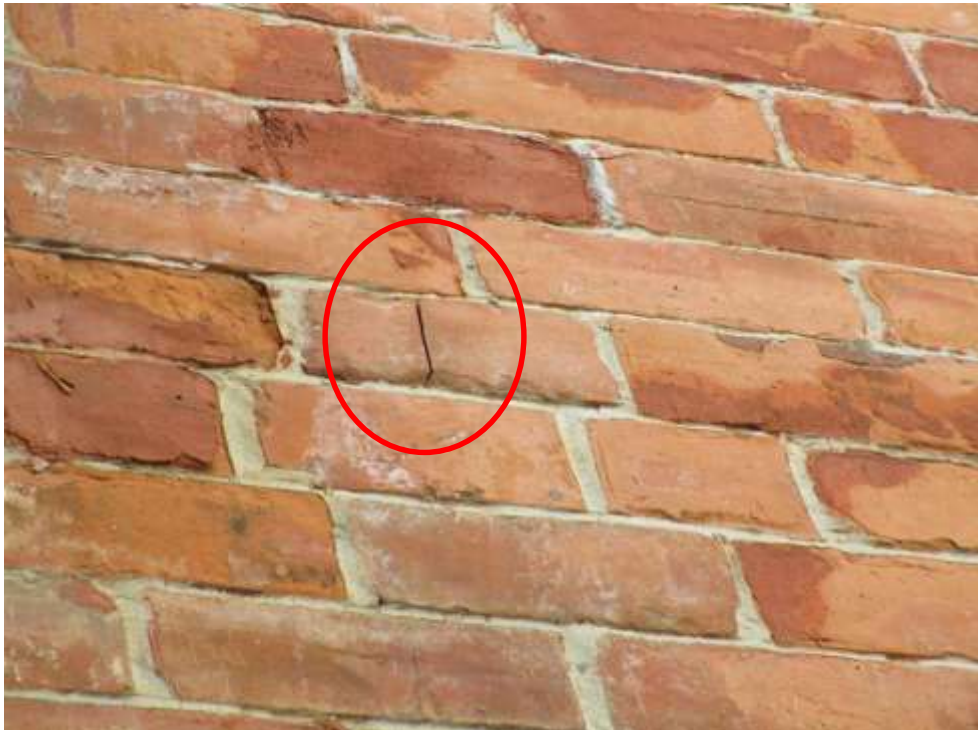
Photo No. 1098

Defect No. 49	Location 2/F North wing, East elevation	Component brick wall
----------------------	------------------------------------------------	-----------------------------

Description A wide crack was observed on brick

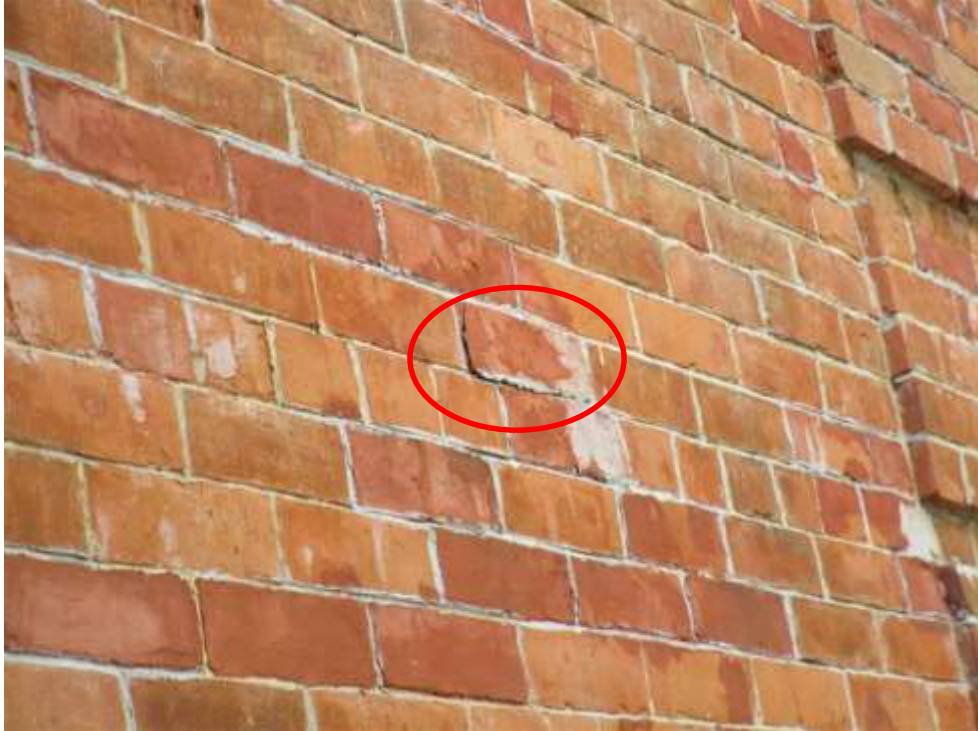
Photo No. 1099

Defect No. 49	Location 2/F North wing, East elevation	Component brick wall
----------------------	------------------------------------------------	-----------------------------

Description A wide crack was observed on brick

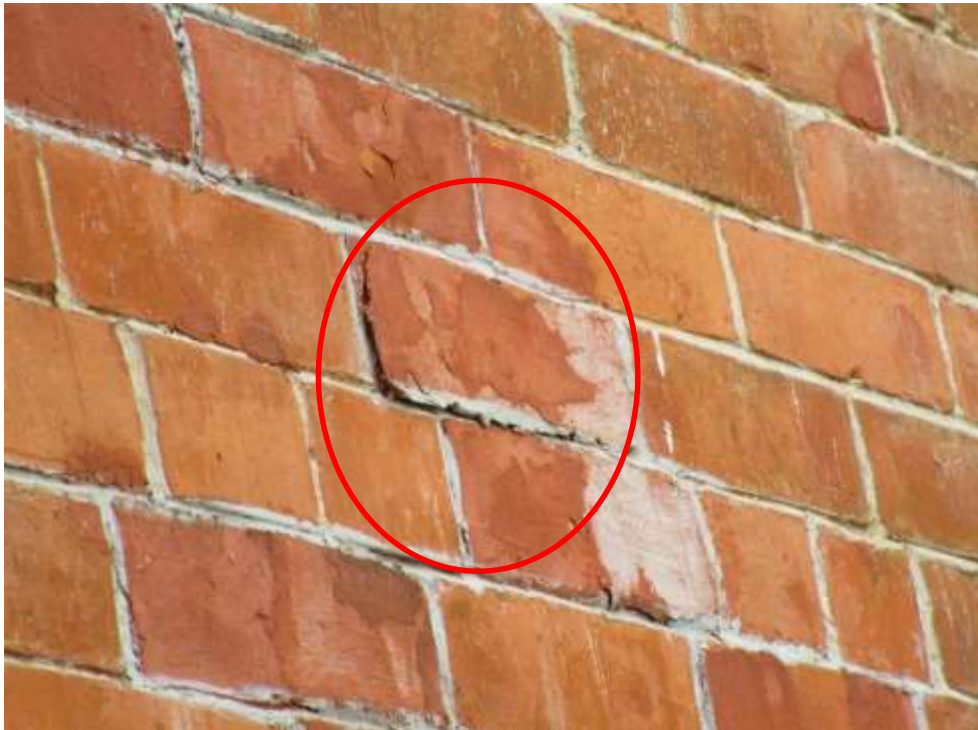
Photo No. 1100

Defect No. 50 **Location** 2/F North wing, East elevation **Component** brick wall

Description Spalling of probable previous repair was observed on brick wall

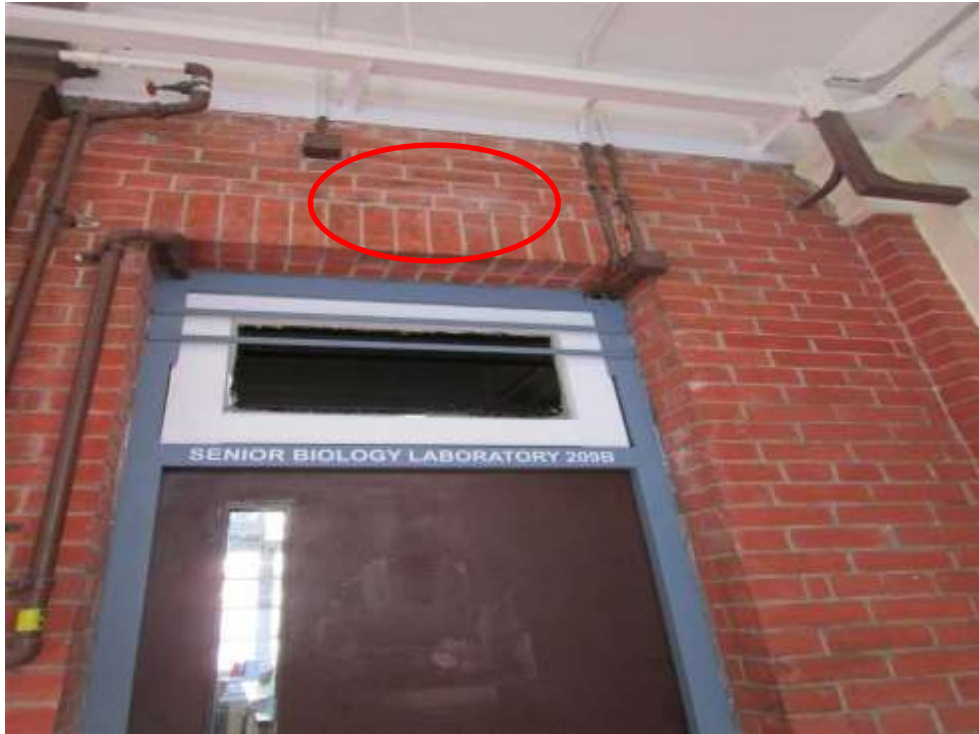
Photo No. 1101

Defect No. 50 **Location** 2/F North wing, East elevation **Component** brick wall

Description Spalling of probable previous repair was observed on brick wall
