**Slope Upgrading Works at
Feature No. 11SW-A/R526,
King's College,
Bonham Road, Hong Kong**

Project Profile for Slope Upgrading Works at
Feature No. 11SW-A/R526, King's College

May 2018

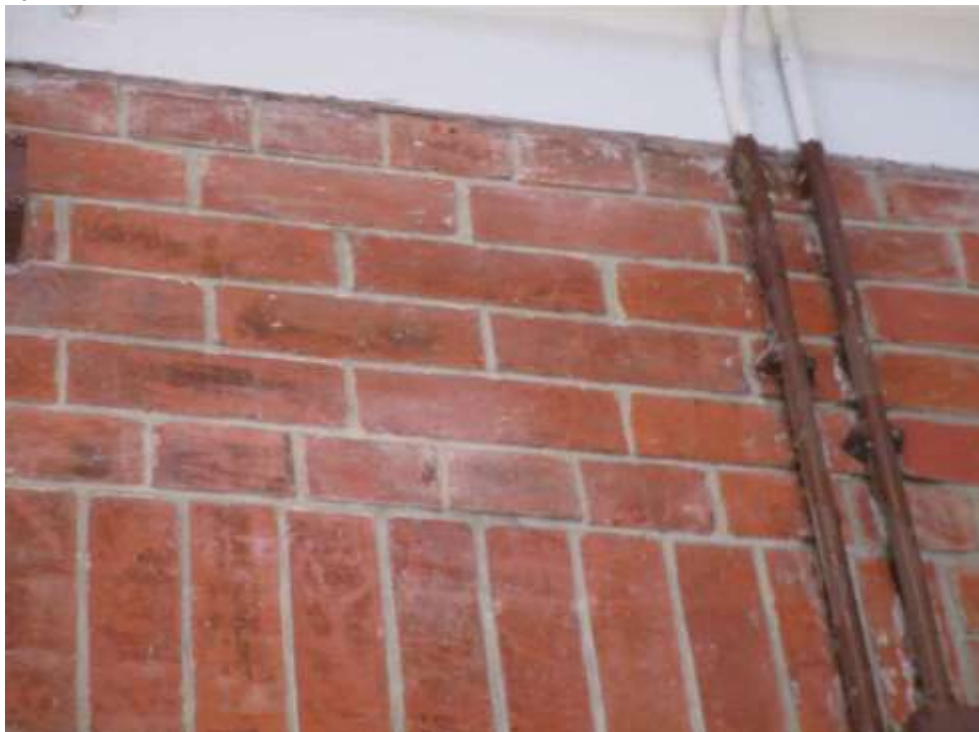
Photo No. 1102

Defect No. 51	Location 2/F South wing, Corridor	Component brick wall
----------------------	------------------------------------------	-----------------------------

Description Minor surface leaching was observed on brick wall

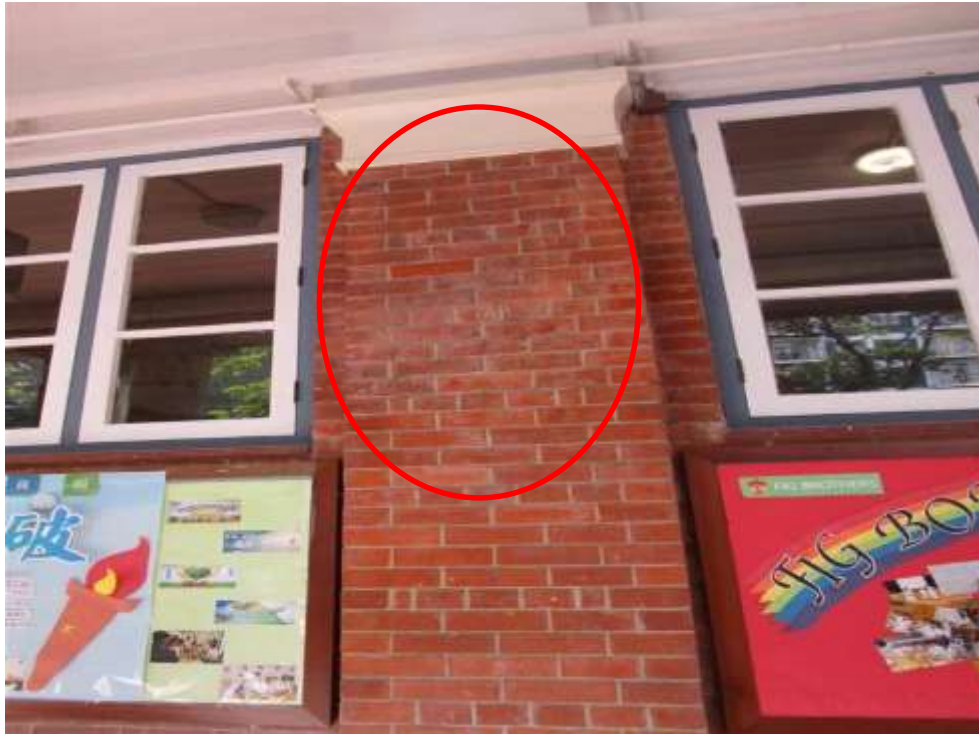
Photo No. 1103

Defect No. 51	Location 2/F South wing, Corridor	Component brick wall
----------------------	------------------------------------------	-----------------------------

Description Minor surface leaching was observed on brick wall

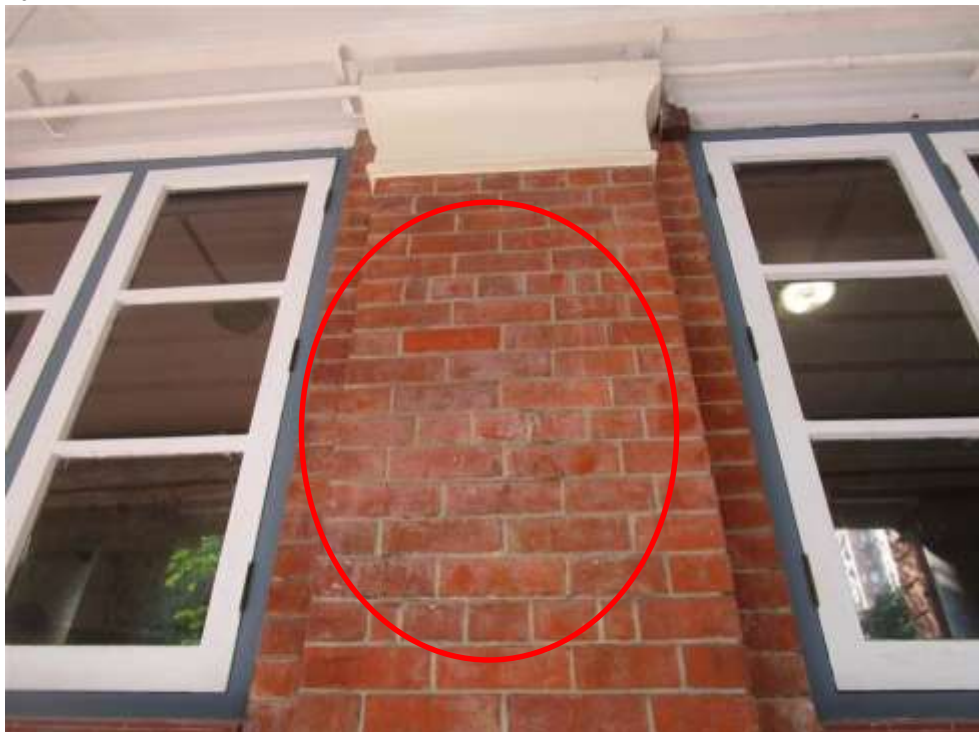
Photo No. 1104

Defect No. 52 **Location** 2/F South wing, Corridor **Component** brick wall

Description Minor surface leaching was observed on brick wall

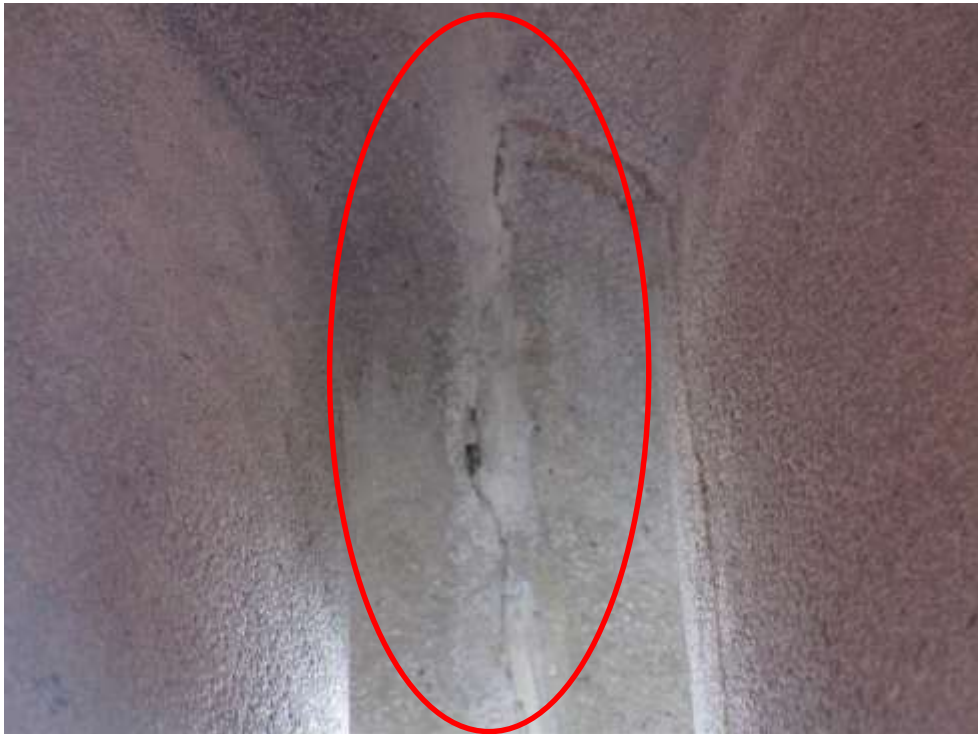
Photo No. 1106

Defect No. 53 **Location** 2/F South wing, Corridor **Component** brick wall

Description A wide crack was observed on the top concrete plate between columns

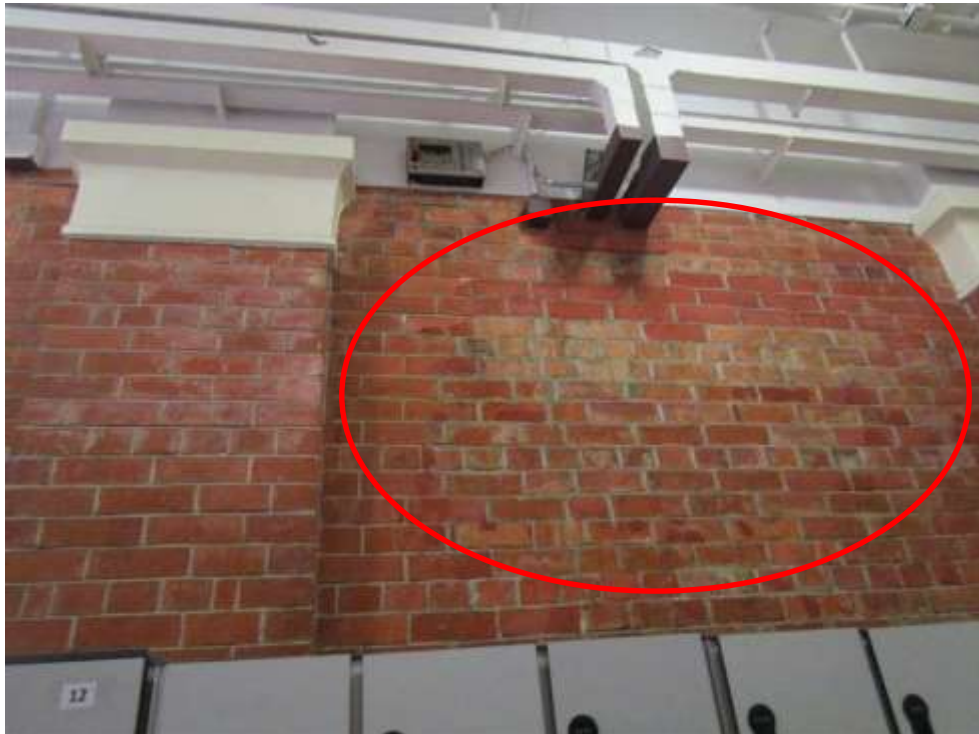
Photo No. 1108

Defect No. 54 **Location** 2/F South wing, Corridor **Component** brick wall

Description Minor surface leaching was observed on brick wall

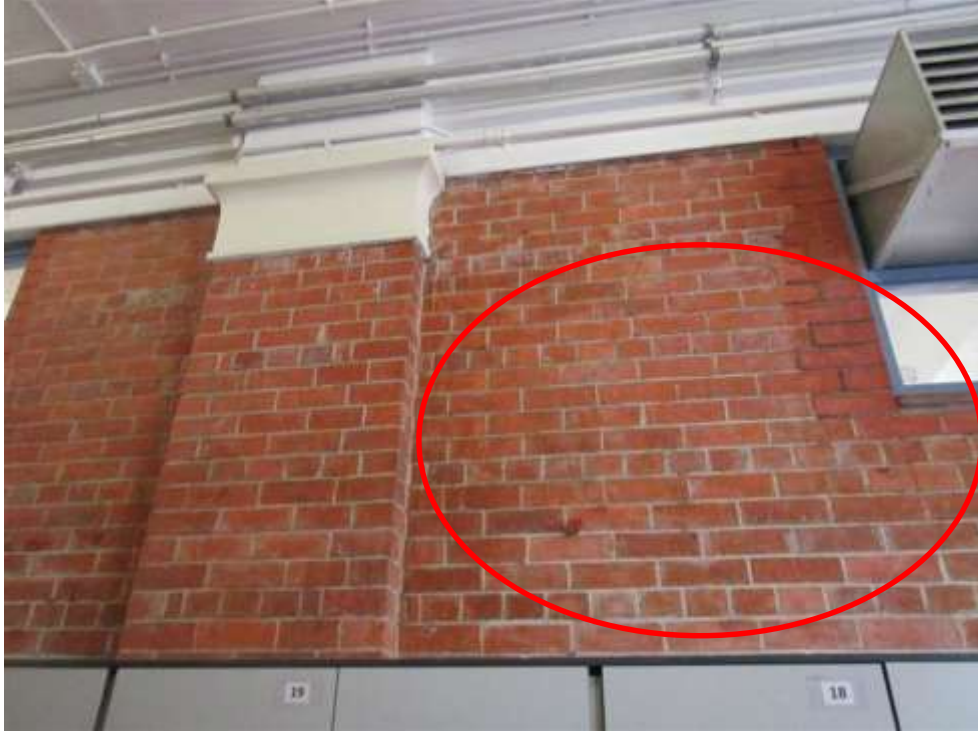
Photo No. 1109

Defect No. 54 **Location** 2/F South wing, Corridor **Component** brick wall

Description Minor surface leaching was observed on brick wall

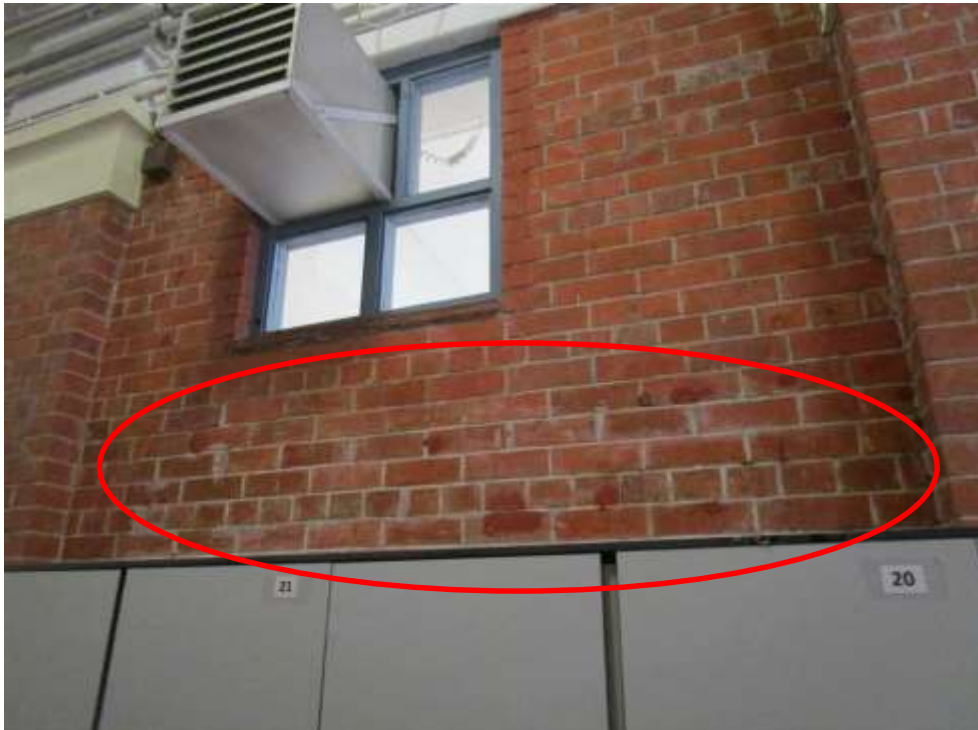
Photo No. 1110

Defect No. 55 **Location** 2/F South wing, Corridor **Component** brick wall

Description Minor surface leaching was observed on brick wall

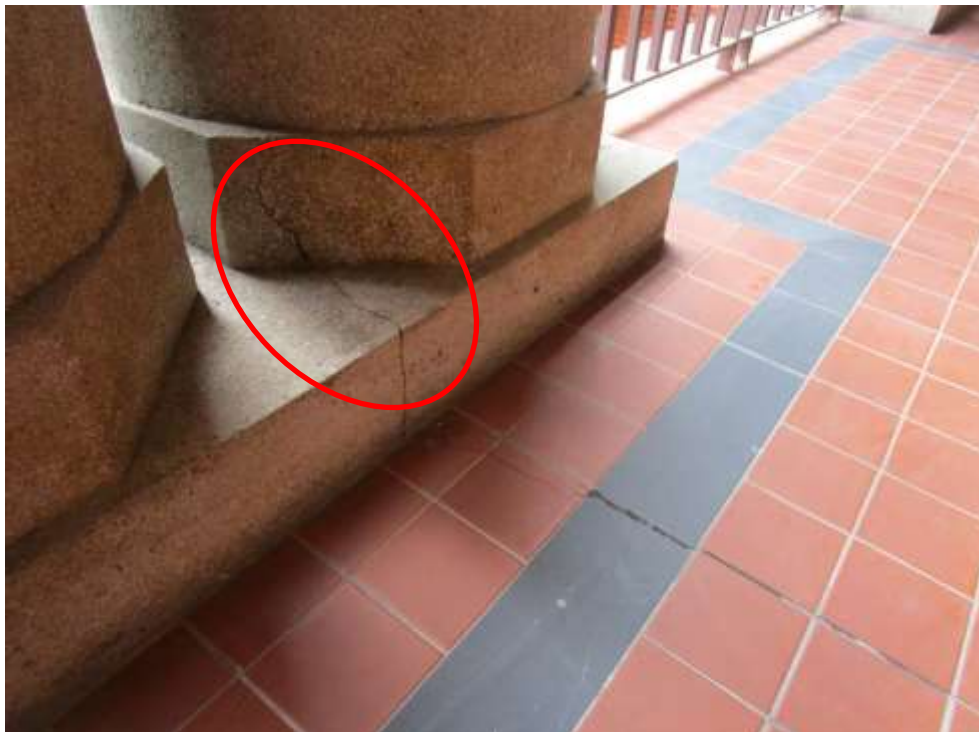
Photo No. 1112

Defect No. 56	Location 2/F South wing, Corridor	Component column
----------------------	------------------------------------------	-------------------------

Description A wide crack was observed on column footing plate

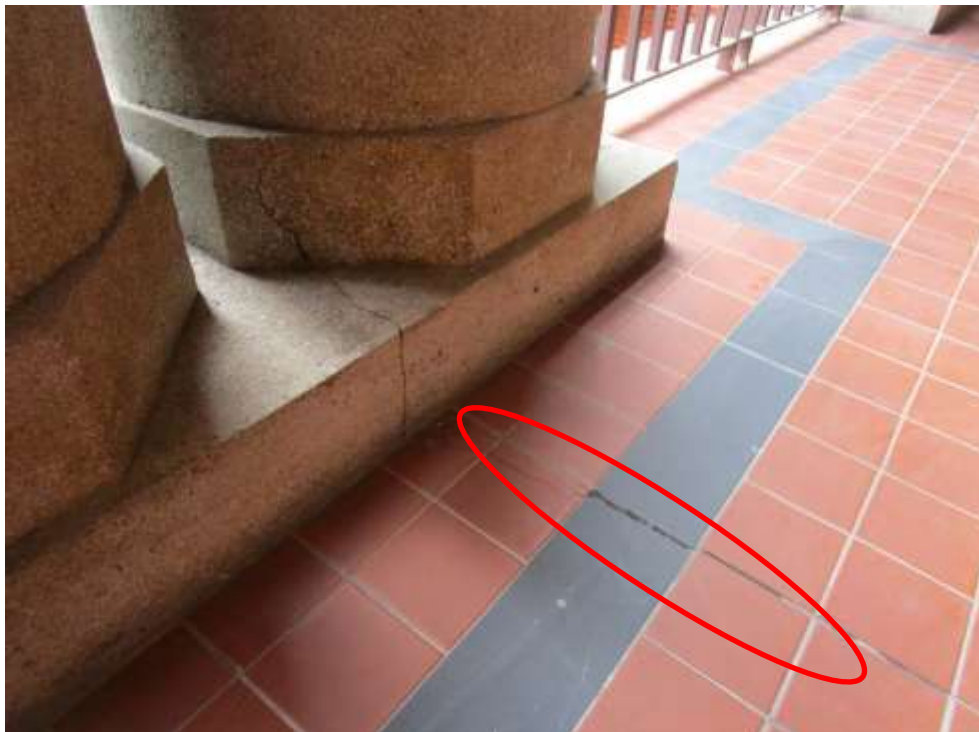
Photo No. 1114

Defect No. 57 **Location** 2/F South wing, Corridor **Component** slab

Description A wide crack was observed on floor tile joint

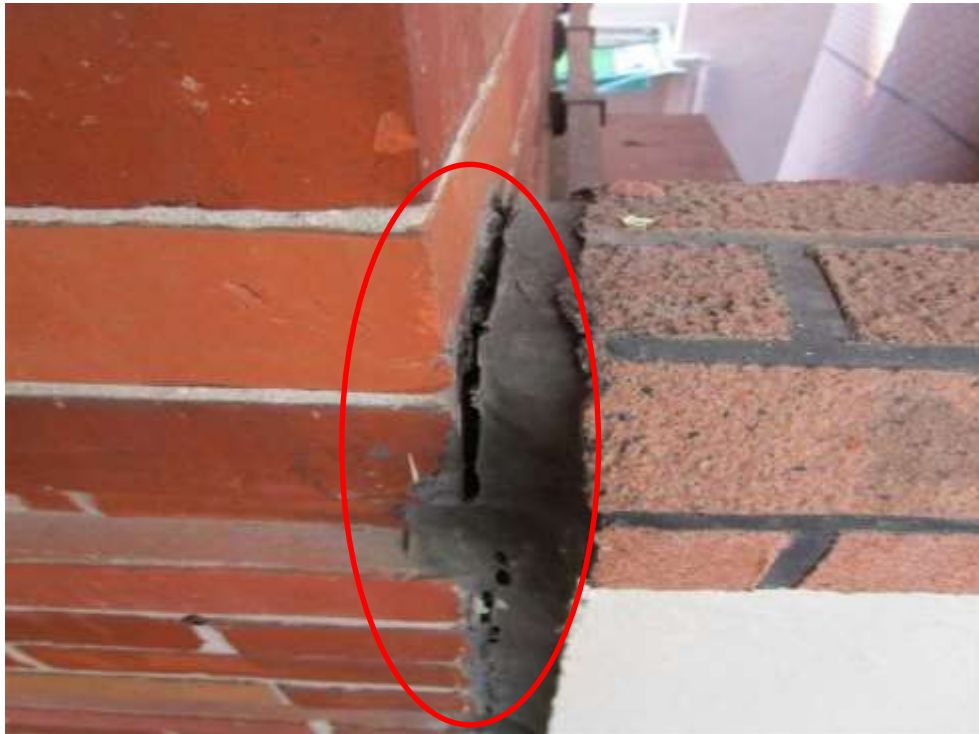
Photo No. 1116

Defect No. 58 **Location** 2/F South wing, Corridor **Component** parapet

Description Debonded joint sealant was observed on parapet between old and new structure

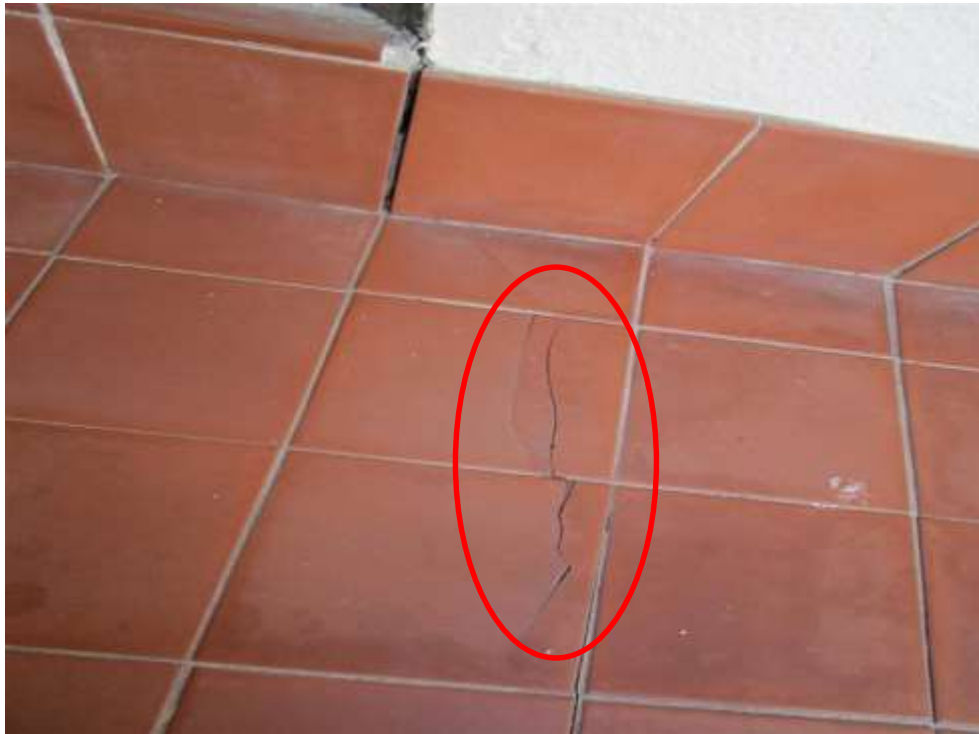
Photo No. 1118

Defect No. 59	Location 2/F South wing, Corridor	Component slab
----------------------	------------------------------------------	-----------------------

Description A wide crack was observed on slab floor tile finish

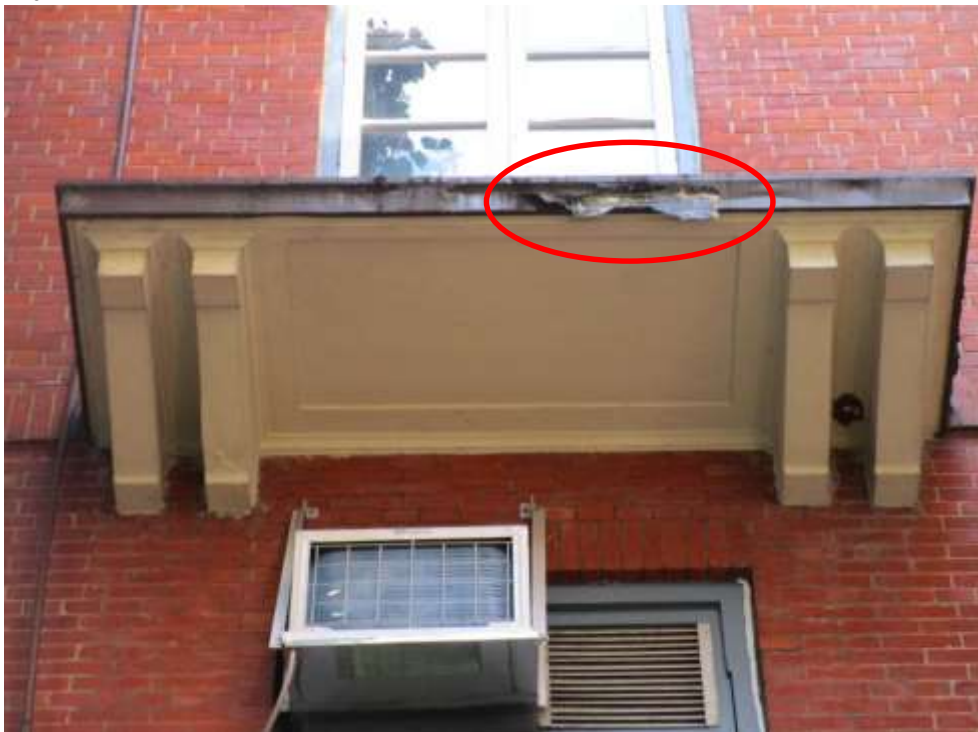
Photo No. 1120

Defect No. 60 **Location** 2/F South wing, East elevation **Component** canopy

Description A paint peeling was observed on canopy soffit

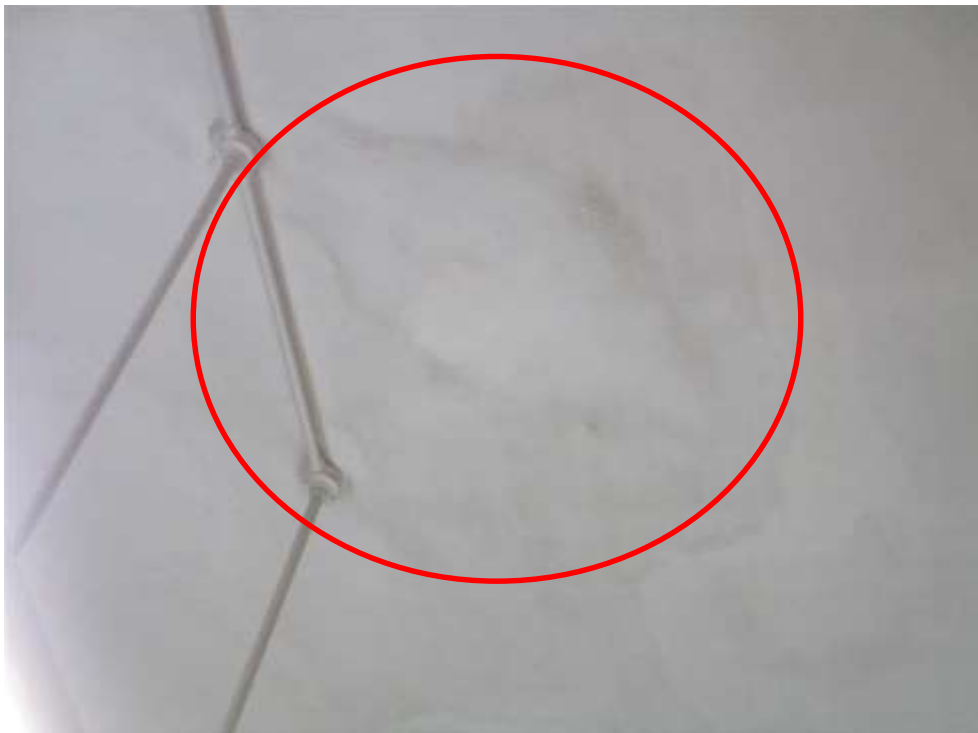
Photo No. 1122

Defect No. 61	Location 2/F South wing, Musical instrument store room	Component slab
----------------------	---------------------------------------------------------------	-----------------------

Description Water stain was observed on slab soffit

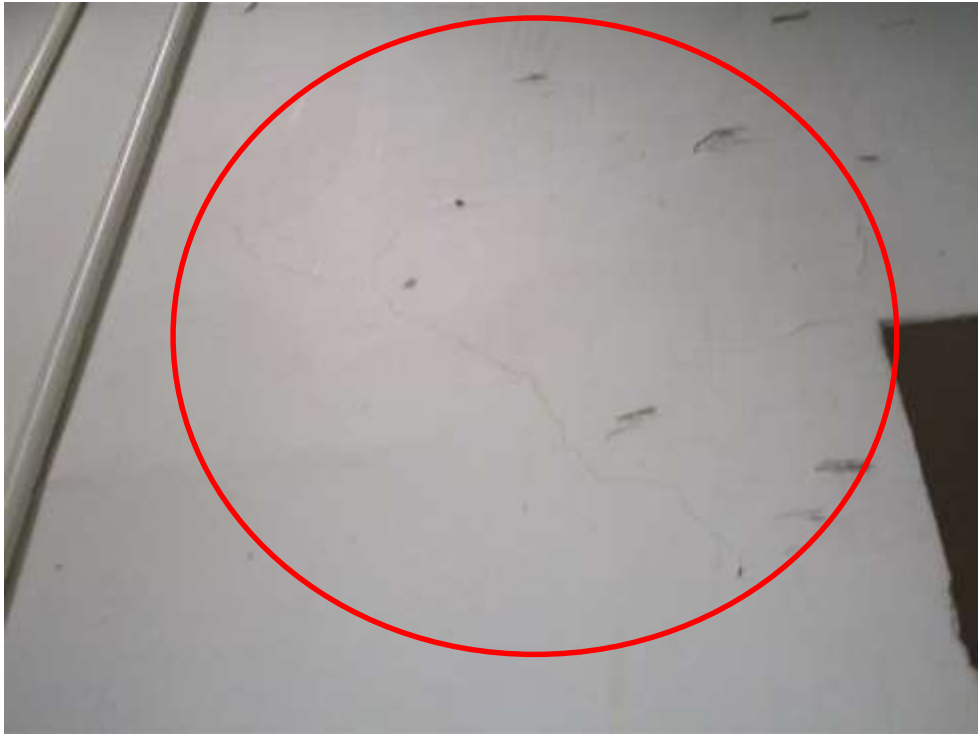
Photo No. 1123

Defect No. 61	Location 2/F South wing, Musical instrument store room	Component slab
----------------------	---------------------------------------------------------------	-----------------------

Description Water stain was observed on slab soffit

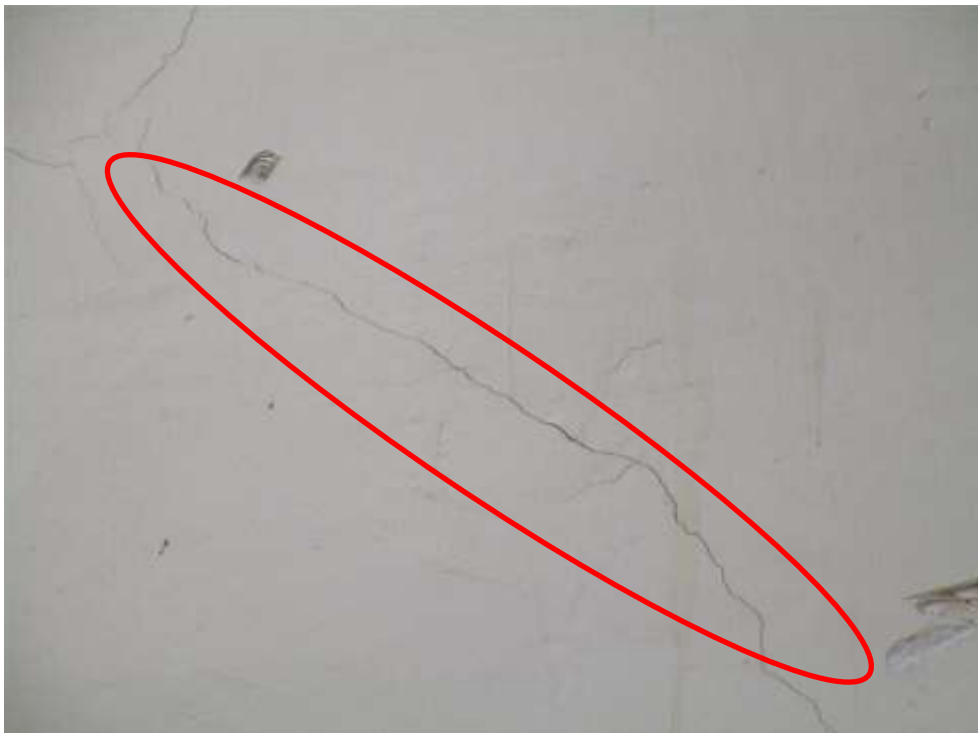
Photo No. 1124

Defect No. 62	Location 2/F South wing, Musical instrument store room	Component wall
----------------------	---------------------------------------------------------------	-----------------------

Description An area of medium crack was observed on wall finishing

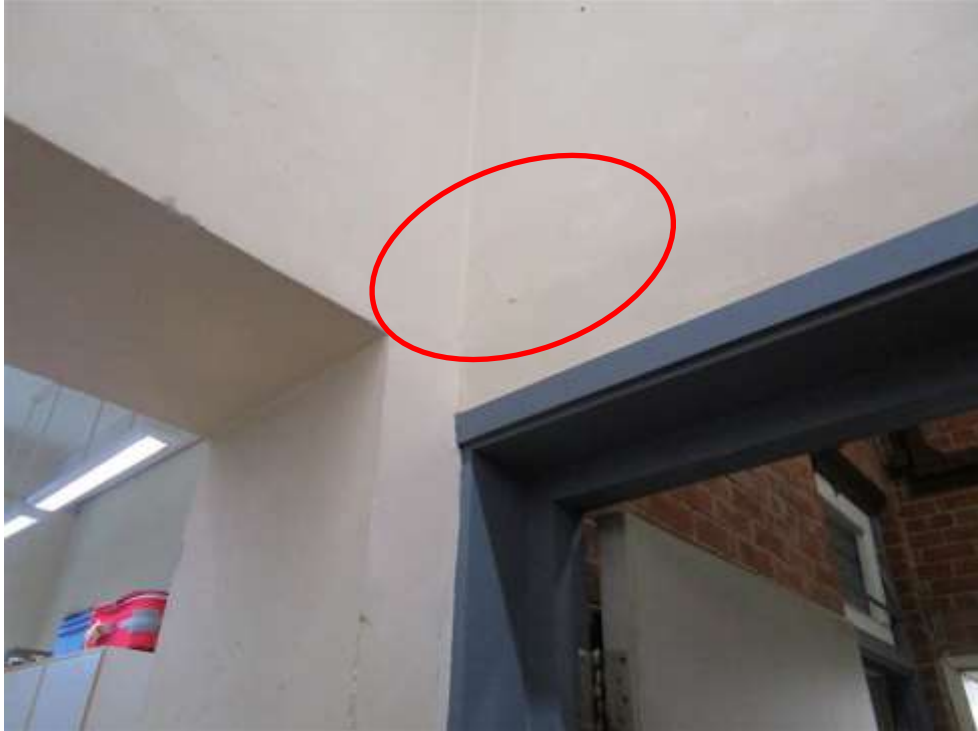
Photo No. 1125

Defect No. 62	Location 2/F South wing, Musical instrument store room	Component wall
----------------------	---------------------------------------------------------------	-----------------------

Description An area of medium crack was observed on wall finishing

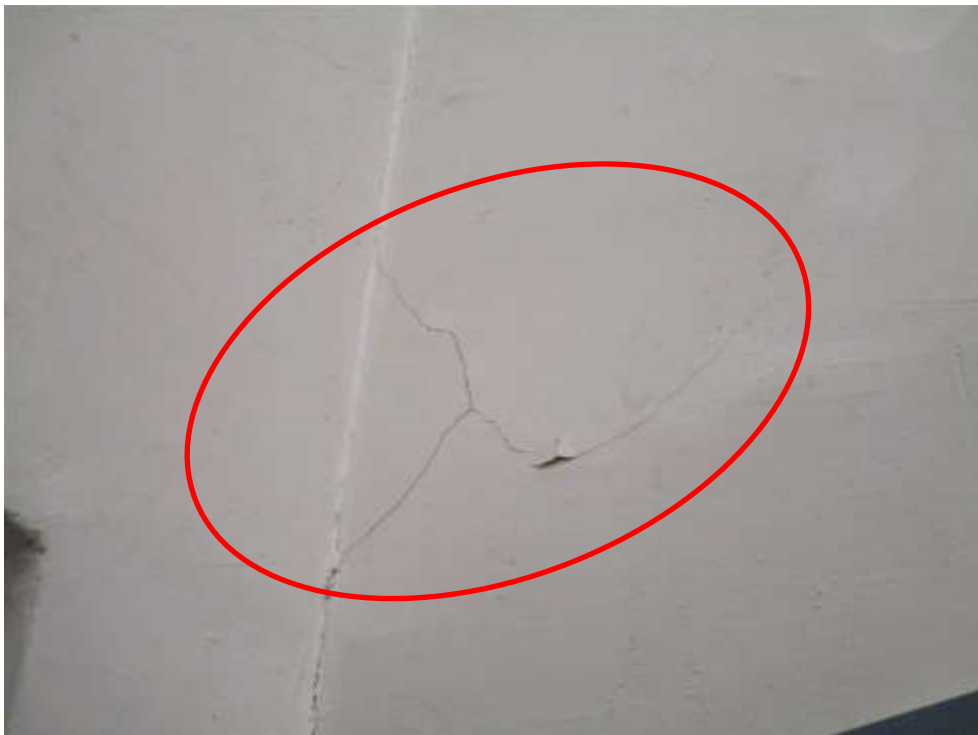
Photo No. 1126

Defect No. 63	Location 2/F South wing, Musical instrument store room	Component wall
----------------------	---------------------------------------------------------------	-----------------------

Description An area of medium crack was observed on wall finishing

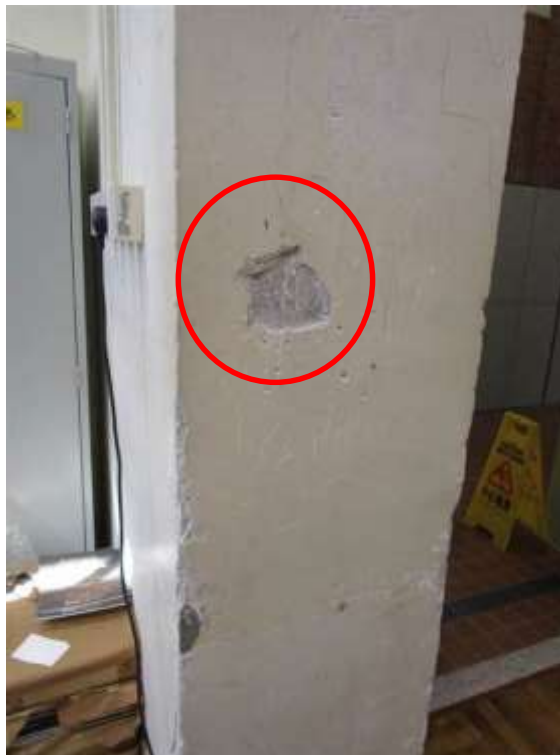
Photo No. 1128

Defect No. 64	Location 2/F South wing, Musical instrument store room	Component wall
----------------------	---------------------------------------------------------------	-----------------------

Description Chipping off of concrete finishing was observed on wall

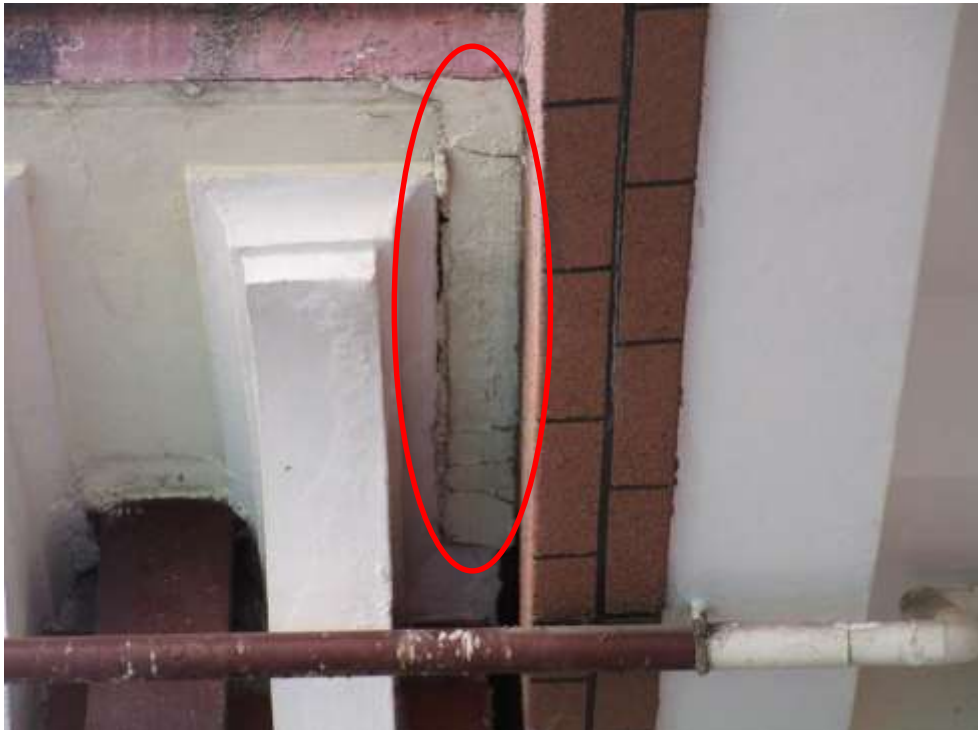
Photo No. 1130

Defect No. 65 **Location** 2/F South wing, North elevation **Component** canopy

Description 4 hairline cracks were observed on canopy soffit

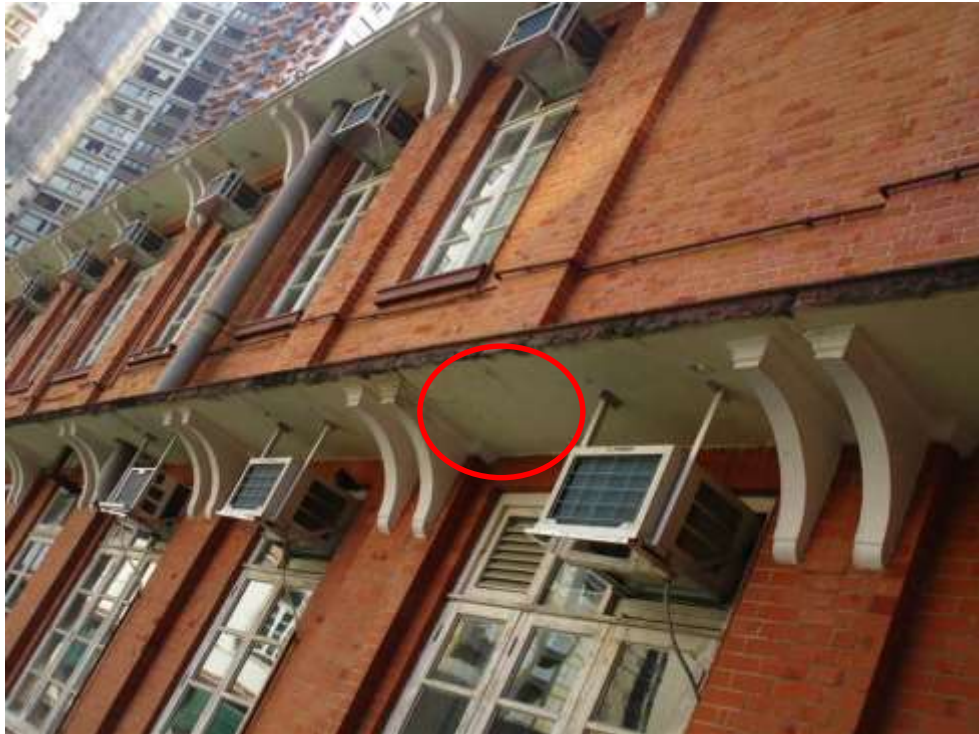
Photo No. 1131

Defect No. 65 **Location** 2/F South wing, North elevation **Component** canopy

Description 4 hairline cracks were observed on canopy soffit

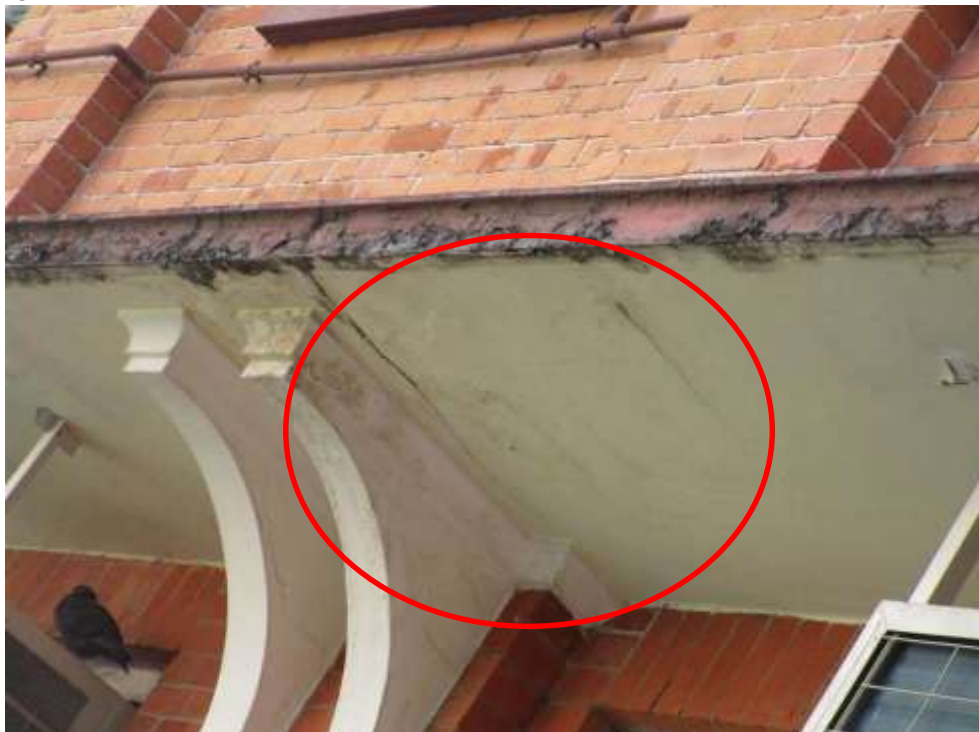
Photo No. 1132

Defect No. 66 **Location** 2/F South wing, North elevation **Component** canopy

Description 3 medium cracks were observed on canopy soffit

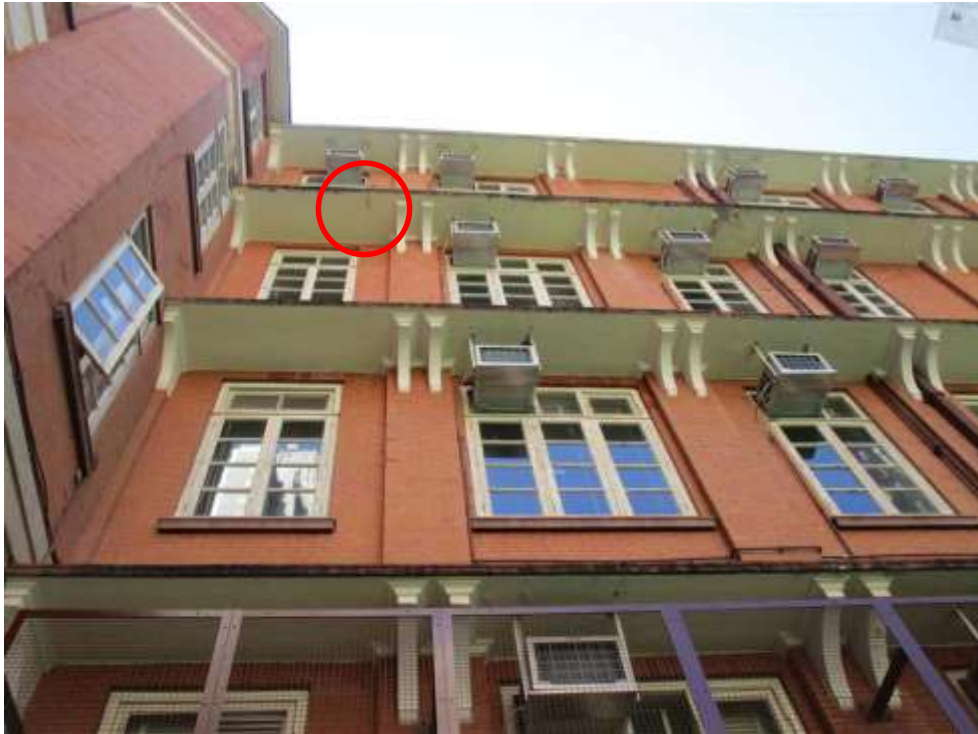
Photo No. 1133

Defect No. 66 **Location** 2/F South wing, North elevation **Component** canopy

Description 3 medium cracks were observed on canopy soffit

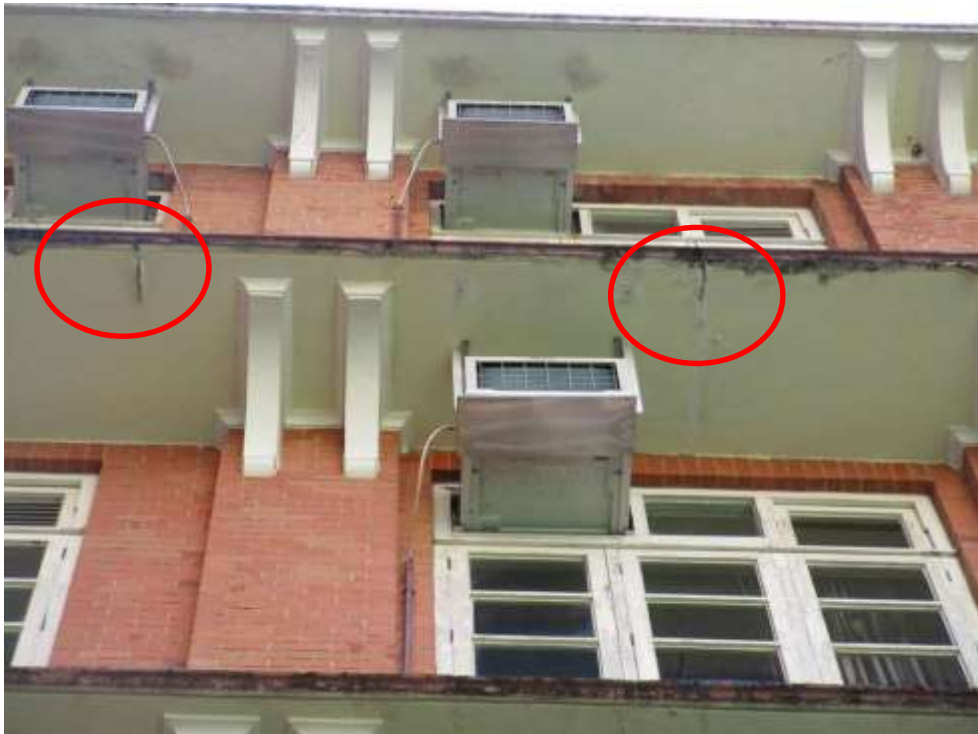
Photo No. 1134

Defect No. 67 **Location** 2/F South wing, North elevation **Component** canopy

Description 2 wide cracks were observed on canopy soffit

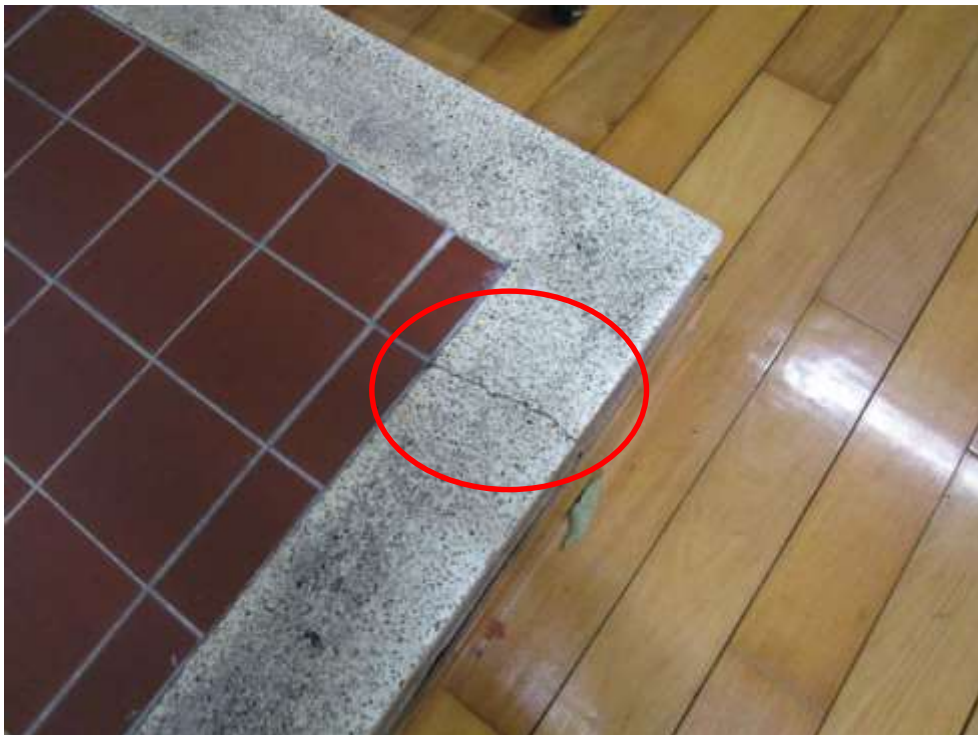
Photo No. 1136

Defect No. 68	Location 3/F East wing, RM302 SALC room	Component step
----------------------	------------------------------------------------	-----------------------

Description A hairline crack was observed on step

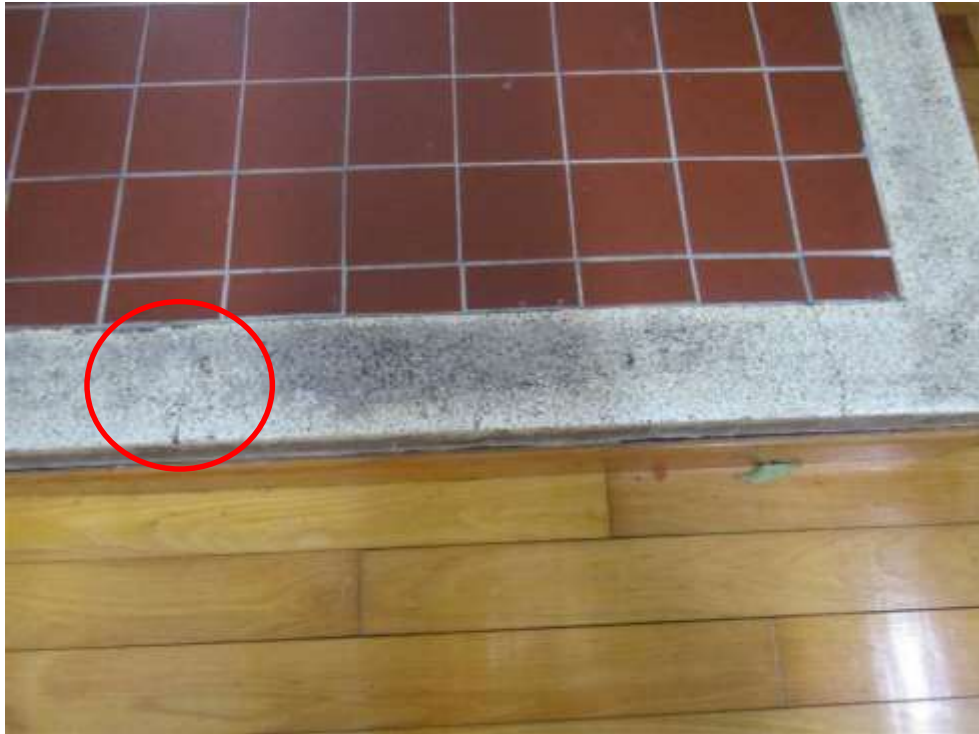
Photo No. 1137

Defect No. 68	Location 3/F East wing, RM302 SALC room	Component step
----------------------	------------------------------------------------	-----------------------

Description A hairline crack was observed on step

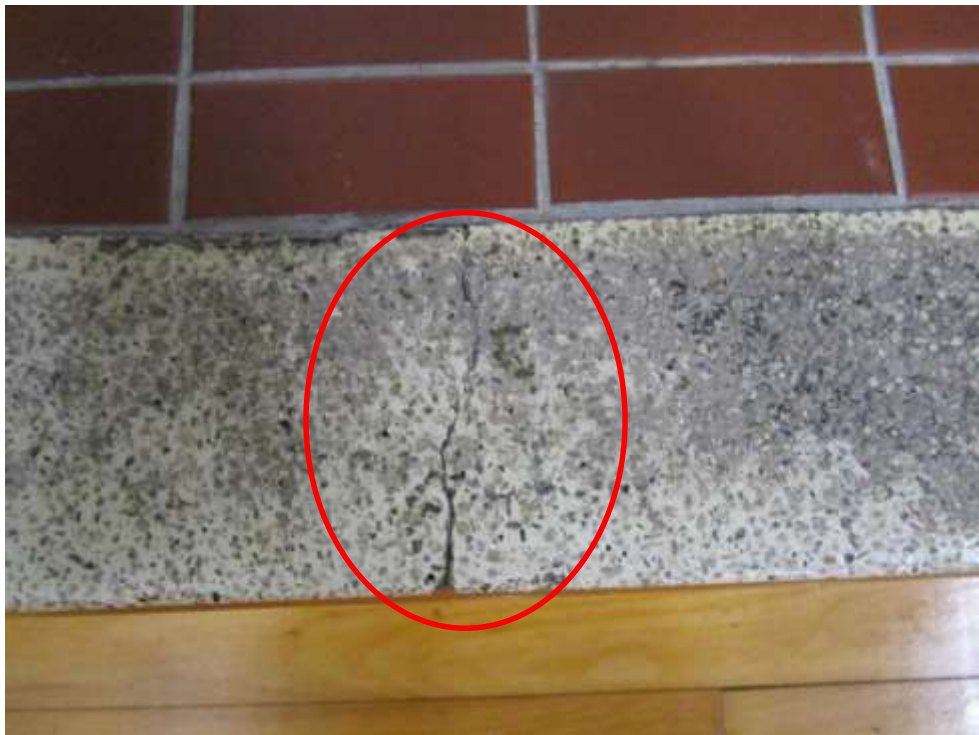
Photo No. 1138

Defect No. 69	Location 3/F East wing, RM302 SALC room	Component step
----------------------	------------------------------------------------	-----------------------

Description A hairline crack was observed on step

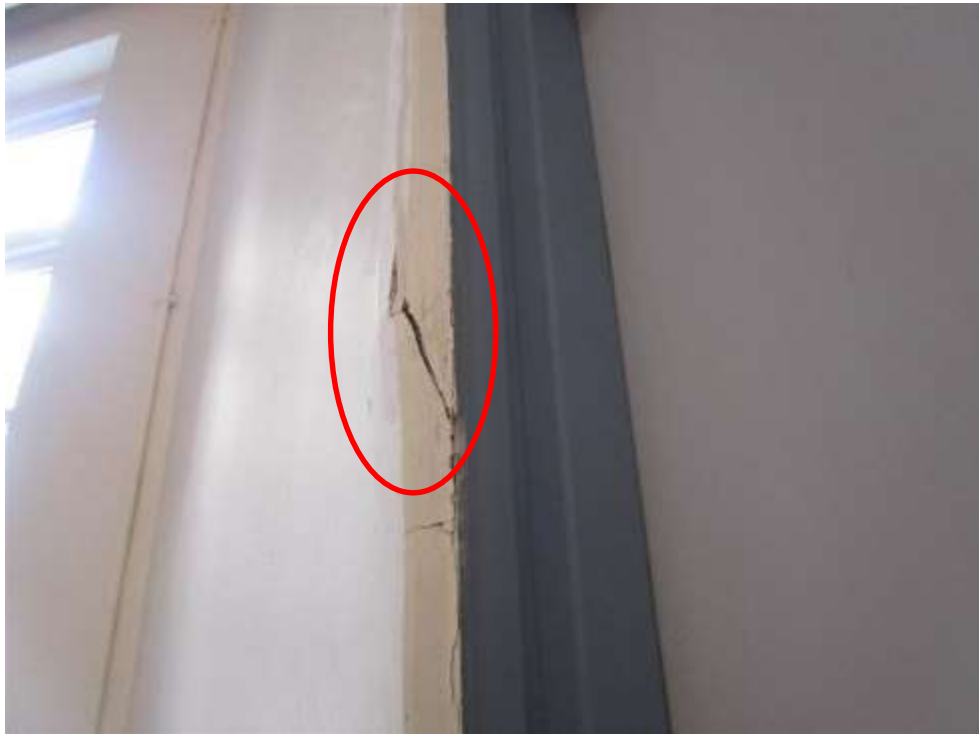
Photo No. 1140

Defect No. 70 **Location** 3/F East wing, RM303 classroom **Component** door jamb

Description A crack was observed on door jamb

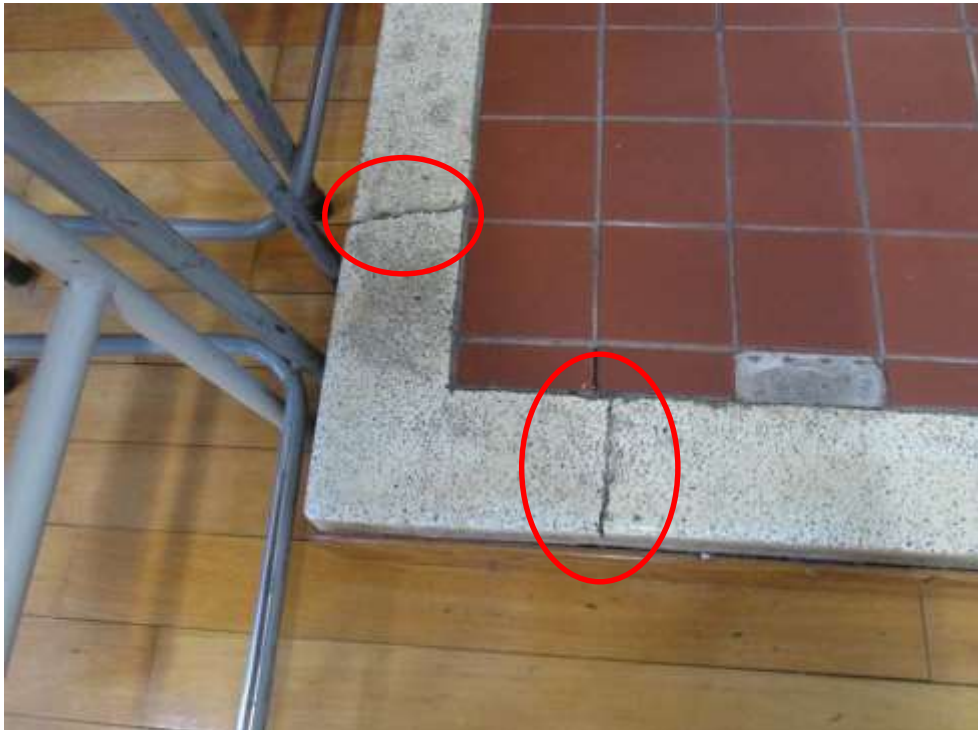
Photo No. 1142

Defect No. 71 **Location** 3/F East wing, RM303 classroom **Component** step

Description Wide cracks were observed on step

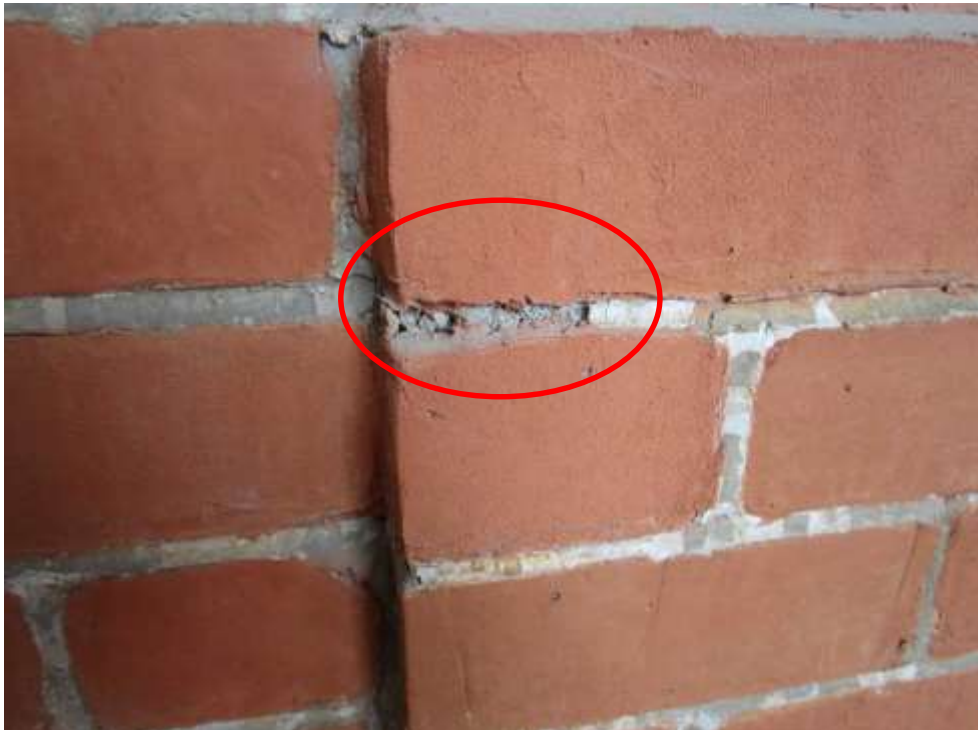
Photo No. 1144

Defect No.	72	Location	3/F South wing, Corridor	Component	brick wall
-------------------	----	-----------------	--------------------------	------------------	------------

Description	Minor chipped off of joint mortar was observed on brick wall				
--------------------	--------------------------------------------------------------	--	--	--	--

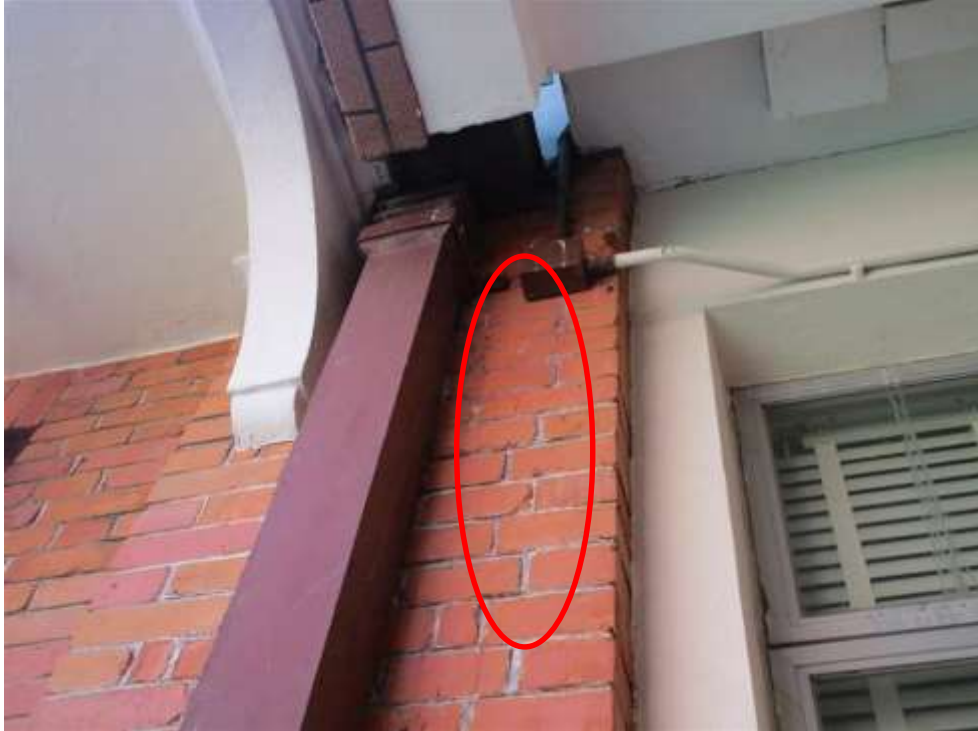
Photo No. 1145

Defect No.	72	Location	3/F South wing, Corridor	Component	brick wall
-------------------	----	-----------------	--------------------------	------------------	------------

Description	Minor chipped off of joint mortar was observed on brick wall				
--------------------	--------------------------------------------------------------	--	--	--	--
