**Slope Upgrading Works at
Feature No. 11SW-A/R526,
King's College,
Bonham Road, Hong Kong**

Project Profile for Slope Upgrading Works at
Feature No. 11SW-A/R526, King's College

May 2018

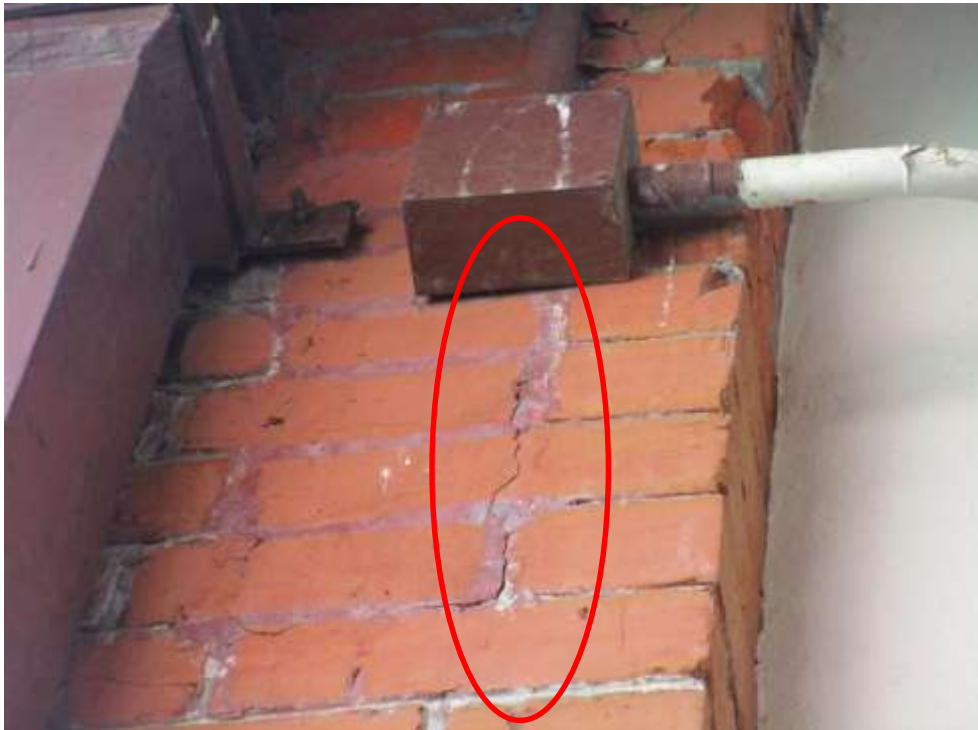
Photo No. 1146

Defect No. 73	Location 3/F South wing, Corridor	Component brick wall
----------------------	------------------------------------------	-----------------------------

Description A medium crack was observed on brick wall

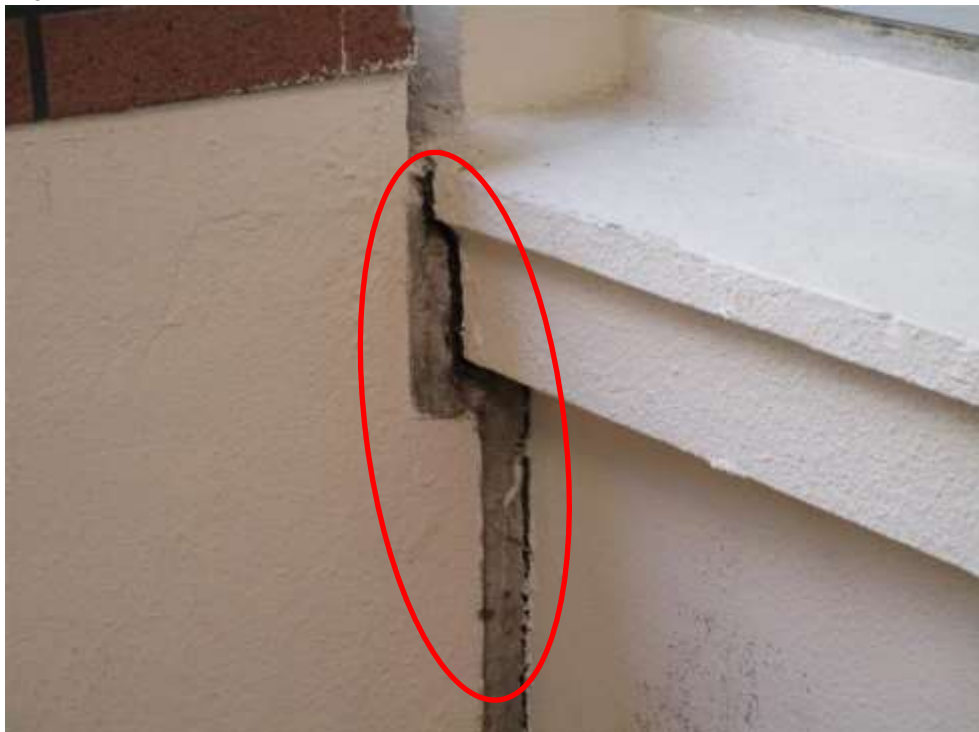
Photo No. 1148

Defect No. 74 **Location** 3/F South wing, Corridor **Component** parapet

Description Debonded joint sealant was observed on parapet between new and old structure

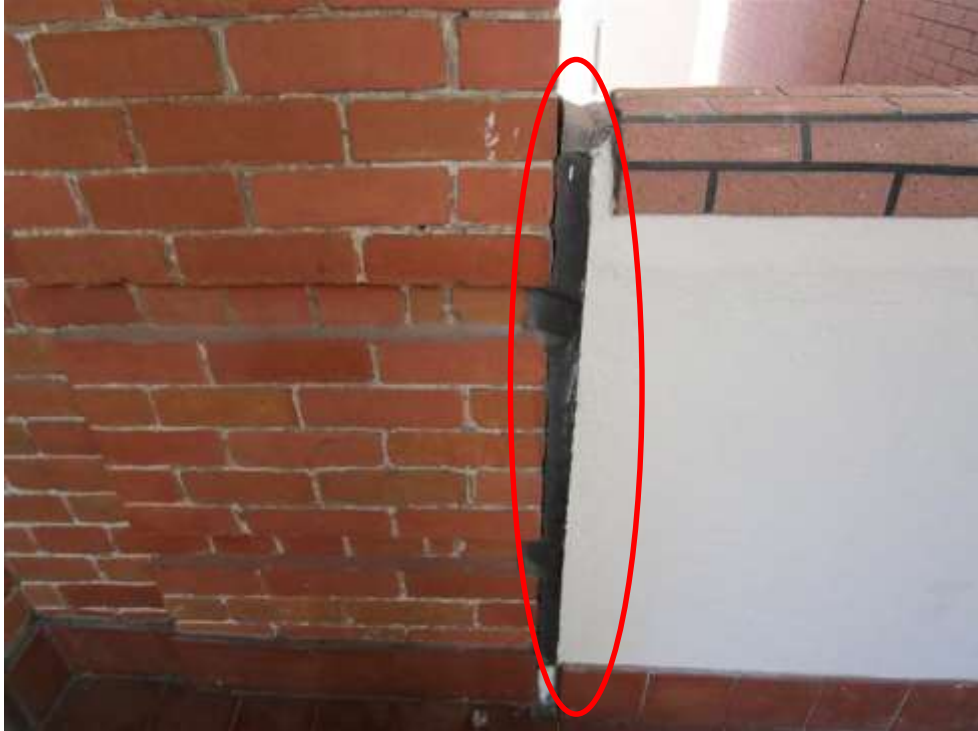
Photo No. 1149

Defect No. 74 **Location** 3/F South wing, Corridor **Component** parapet

Description Debonded joint sealant was observed on parapet between new and old structure

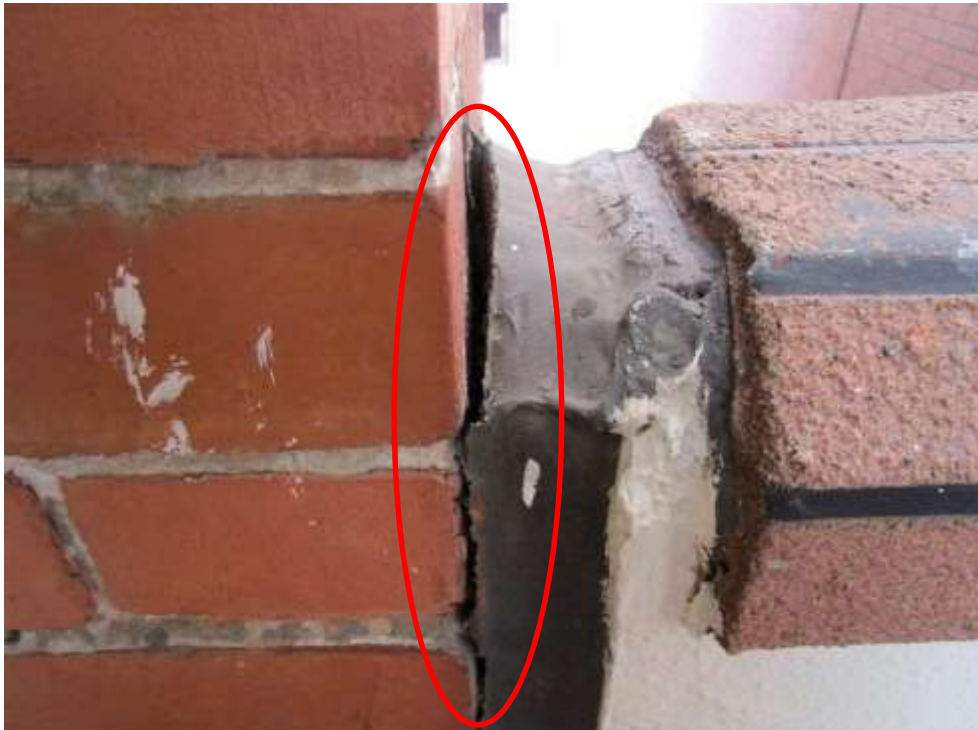
Photo No. 1150

Defect No. 75 **Location** 3/F South wing, Corridor **Component** parapet

Description Debonded joint sealant was observed on parapet between new and old structure

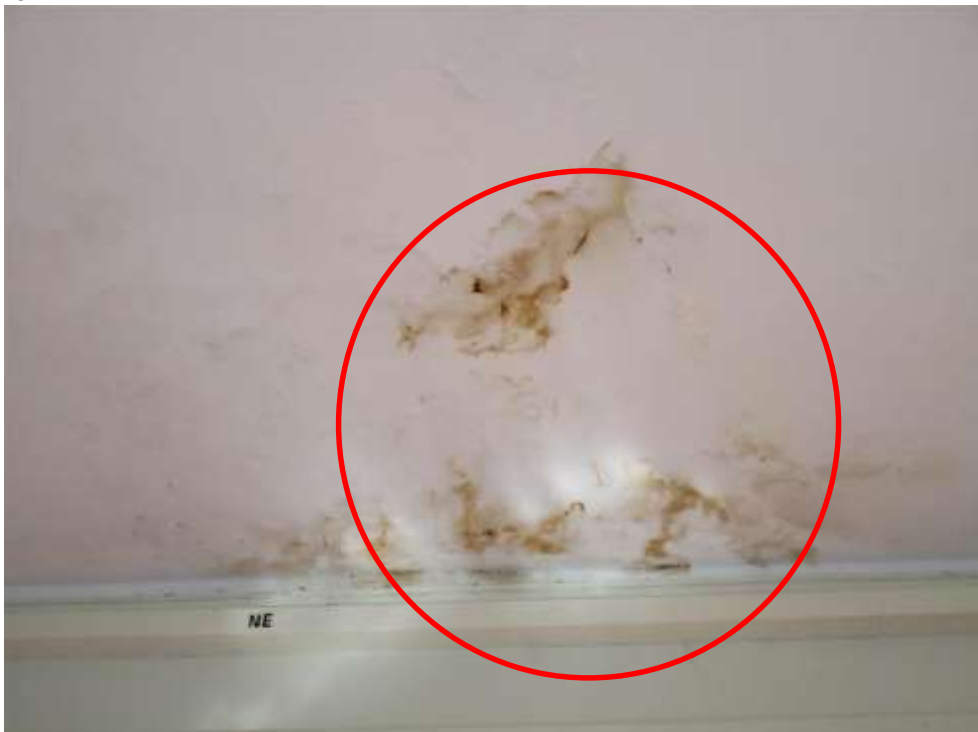
Photo No. 1152

Defect No.	76	Location	3/F South wing, Corridor	Component	slab
-------------------	----	-----------------	--------------------------	------------------	------

Description	A damp patch was observed on slab soffit				
--------------------	------------------------------------------	--	--	--	--

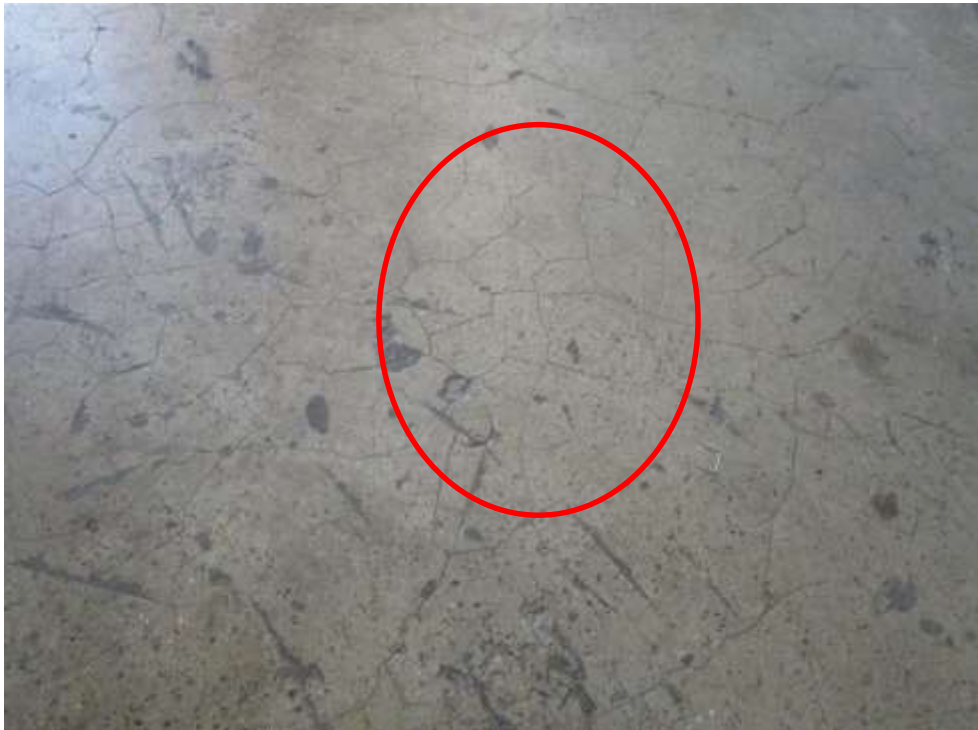
Photo No. 1154

Defect No. 77	Location 3/F South wing, Corridor	Component slab
----------------------	------------------------------------------	-----------------------

Description An area of hairline crack was observed on floor slab

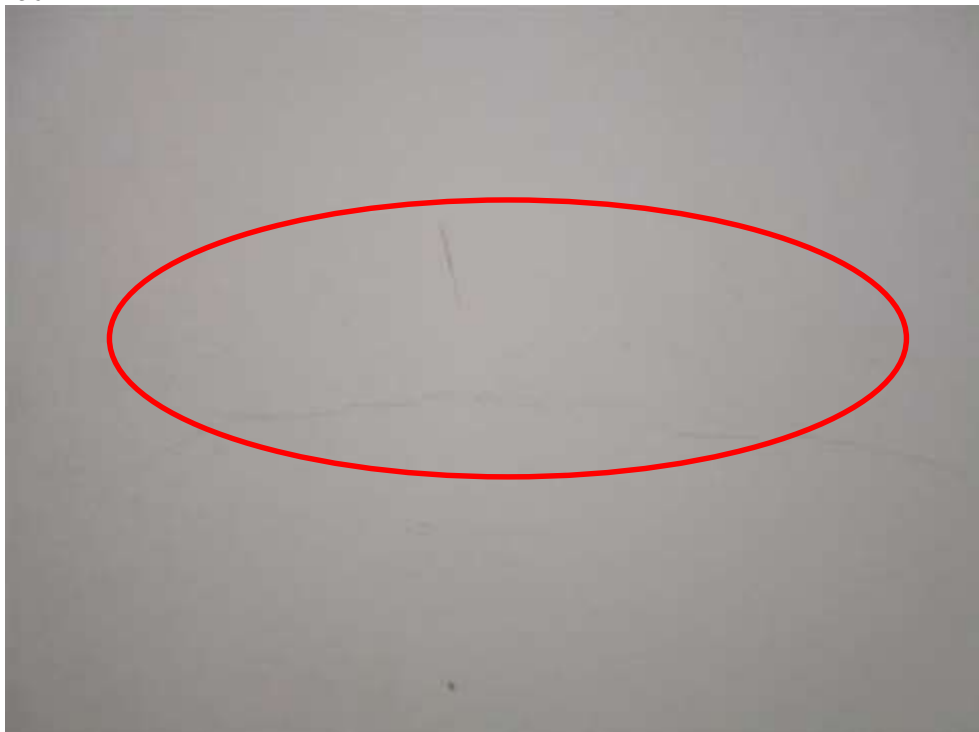
Photo No. 1156

Defect No.	78	Location	3/F South wing, Corridor	Component	wall
-------------------	----	-----------------	--------------------------	------------------	------

Description	A hairline crack was observed on wall finishing				
--------------------	-------------------------------------------------	--	--	--	--

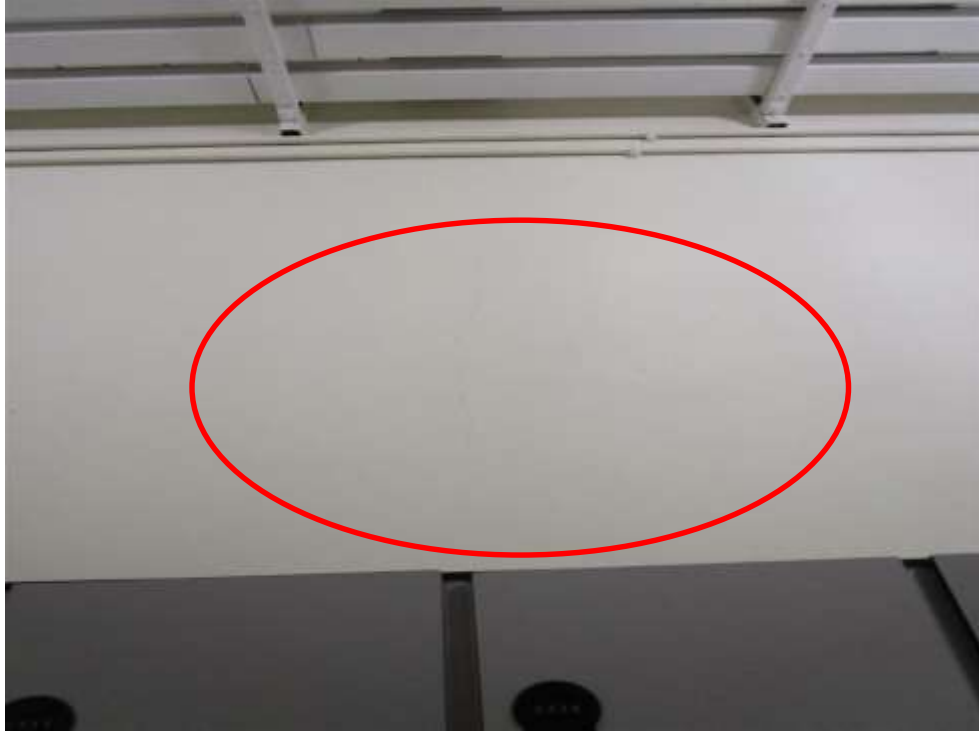
Photo No. 1157

Defect No.	78	Location	3/F South wing, Corridor	Component	wall
-------------------	----	-----------------	--------------------------	------------------	------

Description	A hairline crack was observed on wall finishing				
--------------------	-------------------------------------------------	--	--	--	--

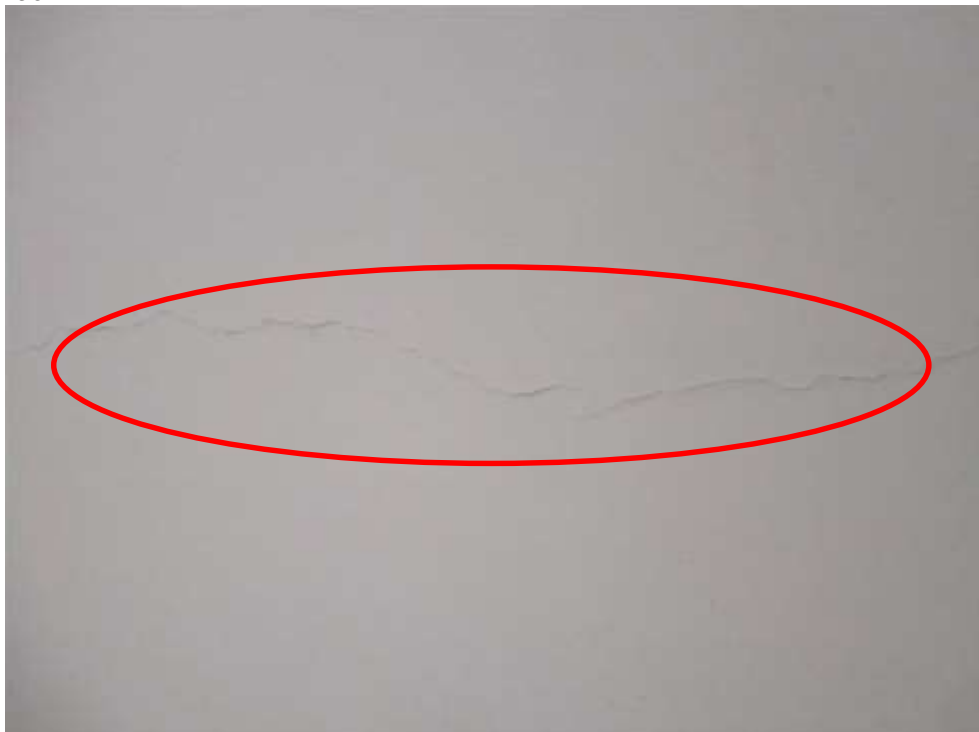
Photo No. 1158

Defect No.	79	Location	3/F South wing, Corridor	Component	wall
-------------------	----	-----------------	--------------------------	------------------	------

Description	A hairline crack was observed on wall finishing				
--------------------	-------------------------------------------------	--	--	--	--

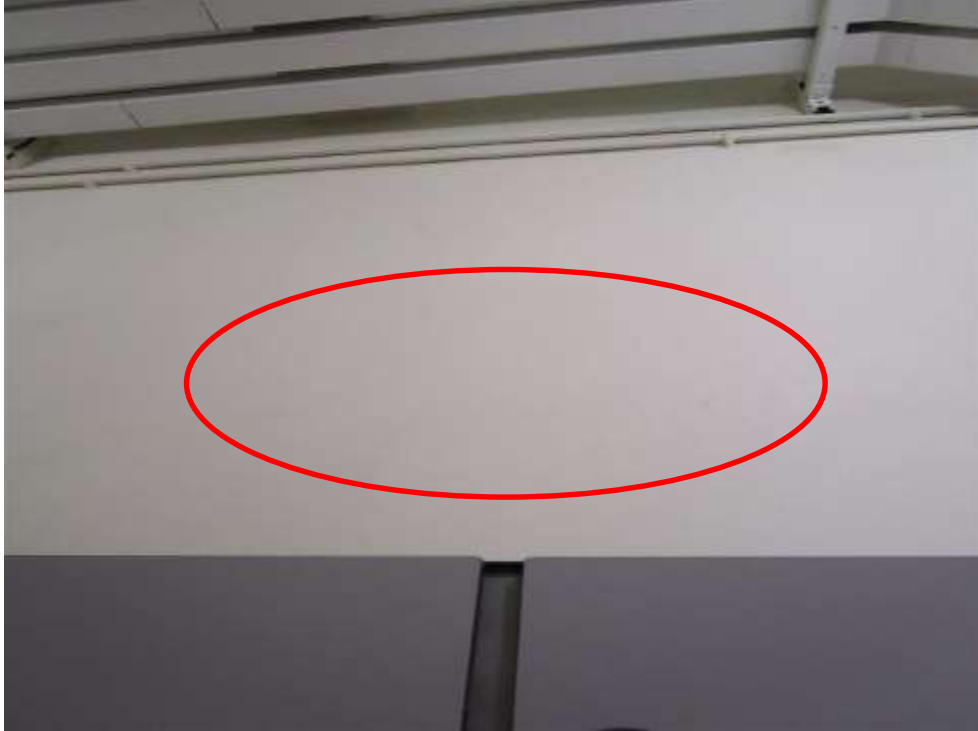
Photo No. 1159

Defect No.	79	Location	3/F South wing, Corridor	Component	wall
-------------------	----	-----------------	--------------------------	------------------	------

Description	A hairline crack was observed on wall finishing				
--------------------	-------------------------------------------------	--	--	--	--

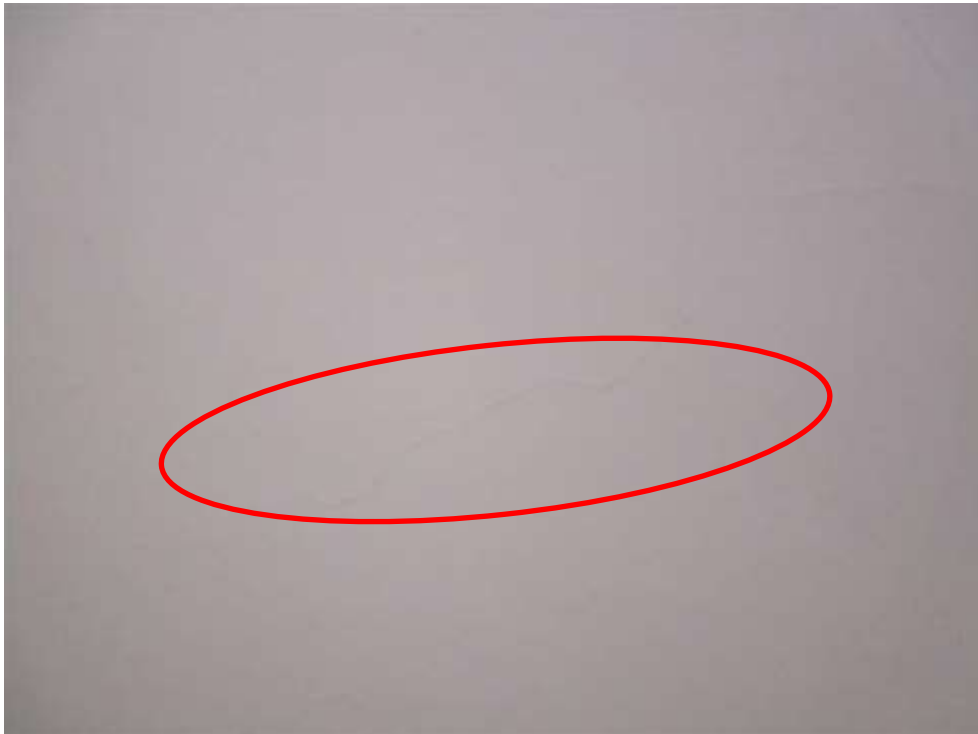
Photo No. 1160

Defect No.	80	Location	3/F South wing, Corridor	Component	wall
-------------------	----	-----------------	--------------------------	------------------	------

Description	A hairline crack was observed on wall finishing				
--------------------	-------------------------------------------------	--	--	--	--

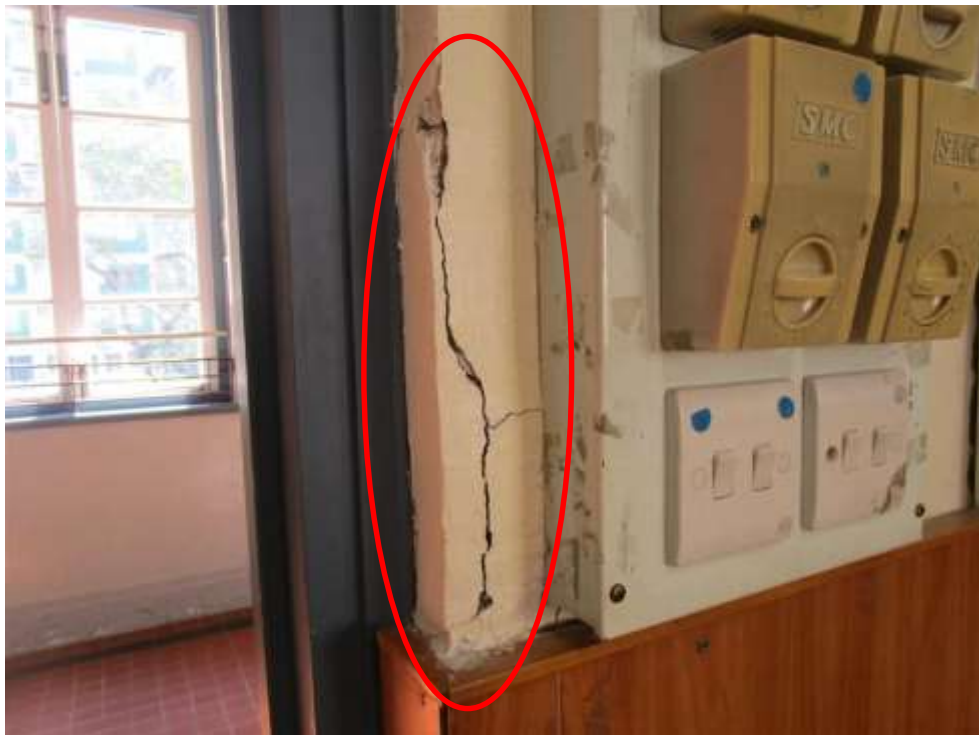
Photo No. 1162

Defect No.	81	Location	3/F South wing, RM304 classroom	Component	door jamb
-------------------	----	-----------------	------------------------------------	------------------	-----------

Description A crack was observed on door jamb

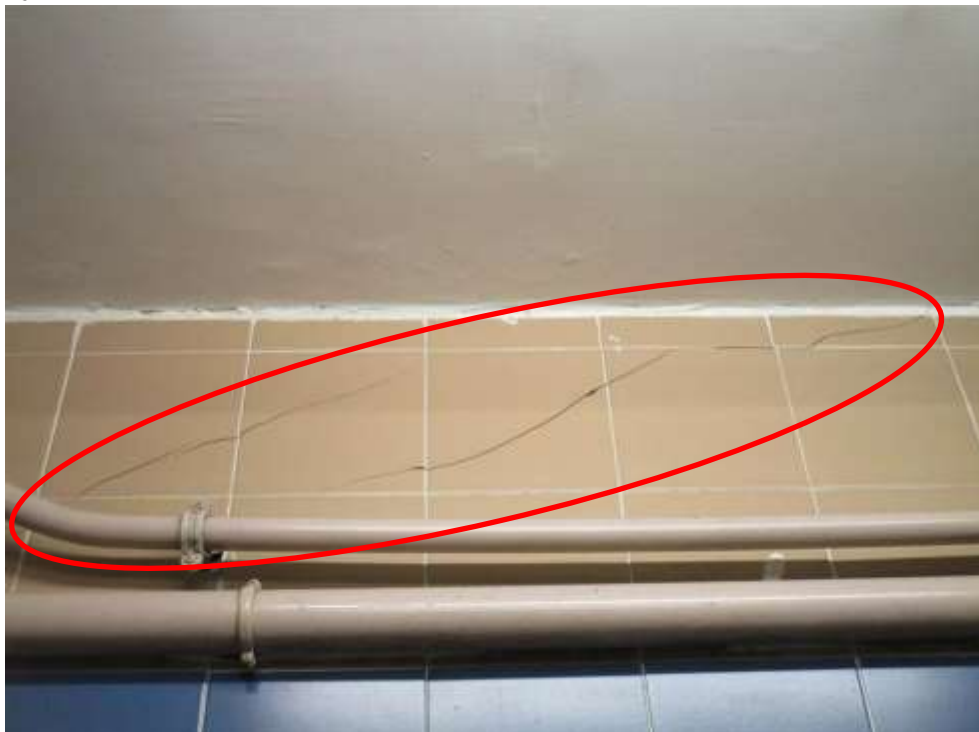
Photo No. 1164

Defect No. 82 **Location** B/F North wing, Changing room **Component** wall

Description 2 wide cracks were observed on wall tile

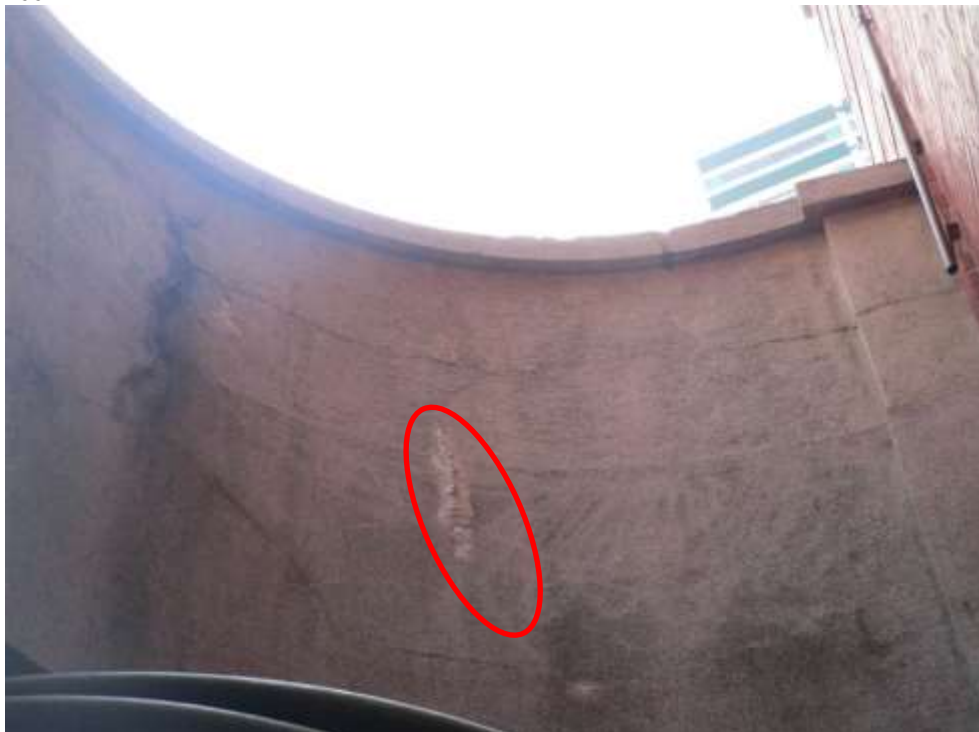
Photo No. 1166

Defect No.	83	Location	G/F East wing, Main entrance	Component	parapet
-------------------	----	-----------------	------------------------------	------------------	---------

Description	A medium crack was observed on parapet wall				
--------------------	---------------------------------------------	--	--	--	--

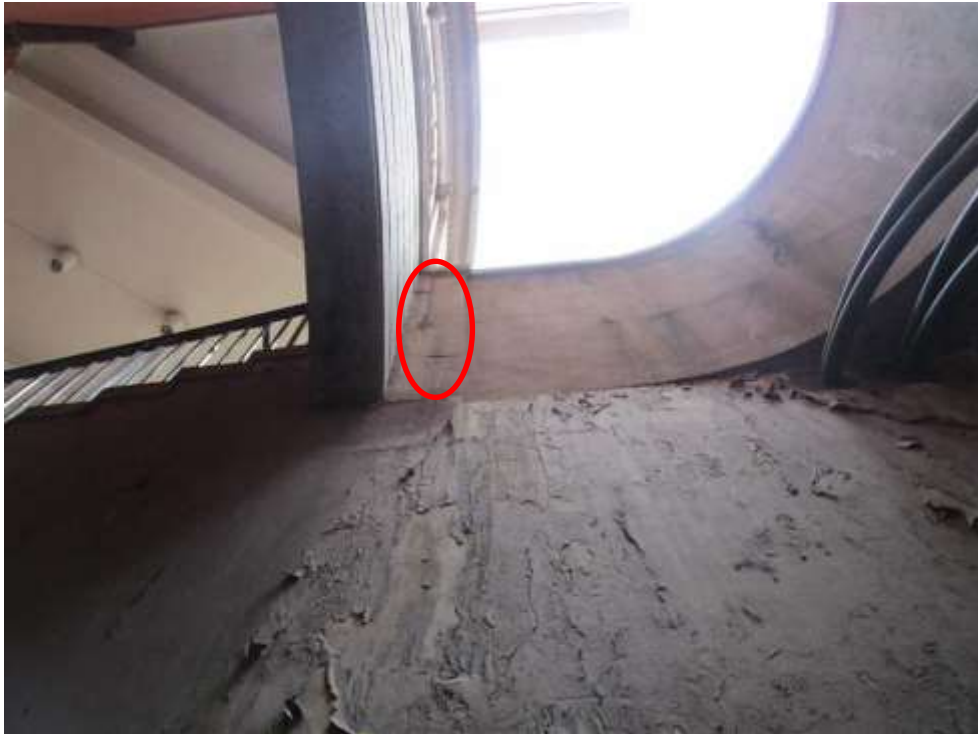
Photo No. 1167

Defect No.	83	Location	G/F East wing, Main entrance	Component	parapet
-------------------	----	-----------------	------------------------------	------------------	---------

Description	A medium crack was observed on parapet wall				
--------------------	---------------------------------------------	--	--	--	--

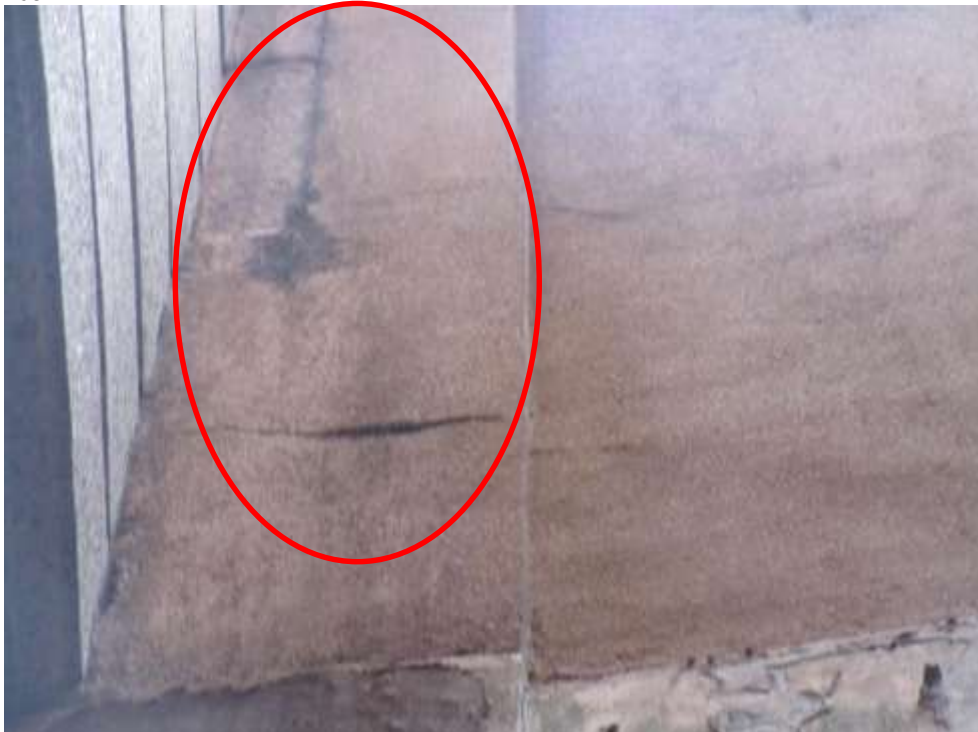
Photo No. 1168

Defect No. 84 **Location** G/F East wing, Main entrance **Component** parapet

Description A wide crack was observed on parapet wall

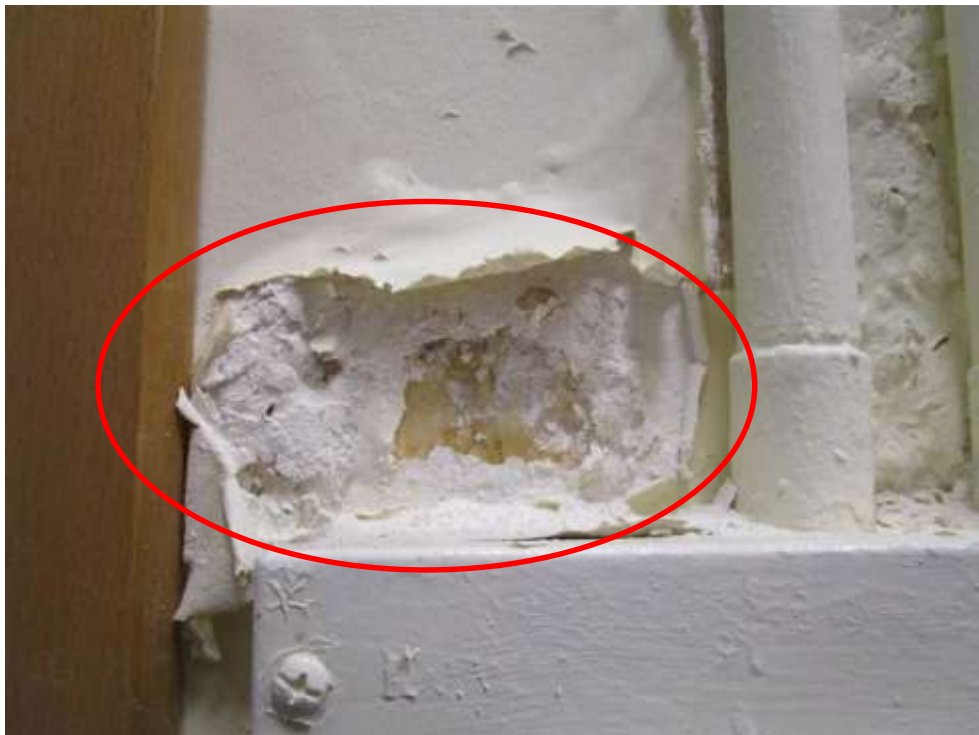
Photo No. 1170

Defect No.	85	Location	G/F East wing, Social worker room	Component	wall
-------------------	----	-----------------	-----------------------------------	------------------	------

Description Deteriorated surface finishing was observed on wall

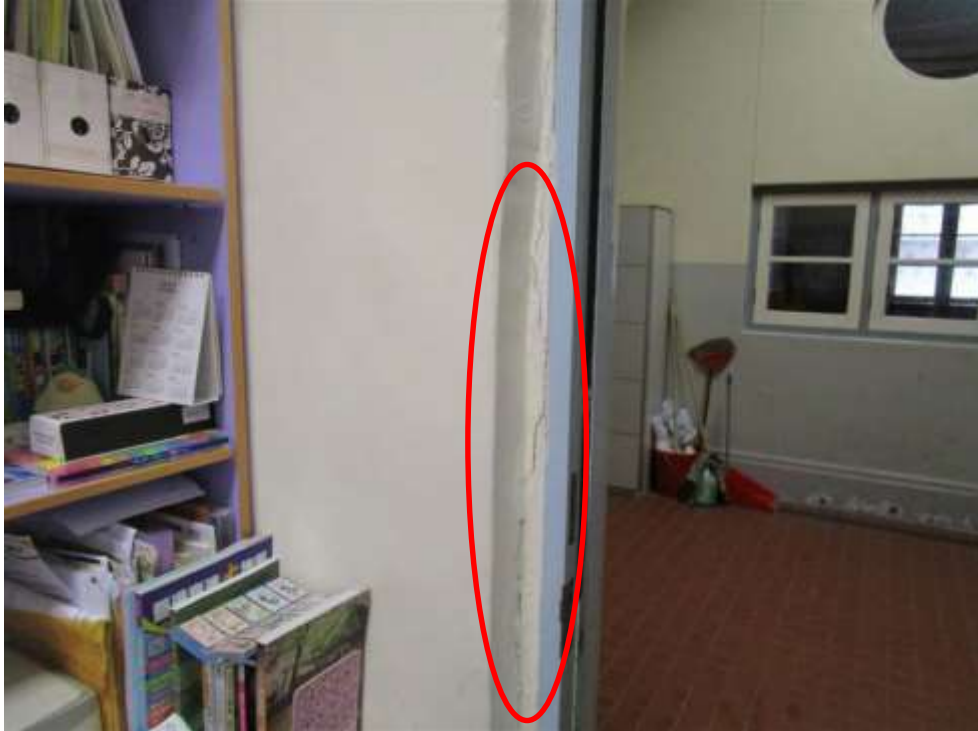
Photo No. 1171

Defect No.	85	Location	G/F East wing, Social worker room	Component	wall
-------------------	----	-----------------	-----------------------------------	------------------	------

Description Deteriorated surface finishing was observed on wall

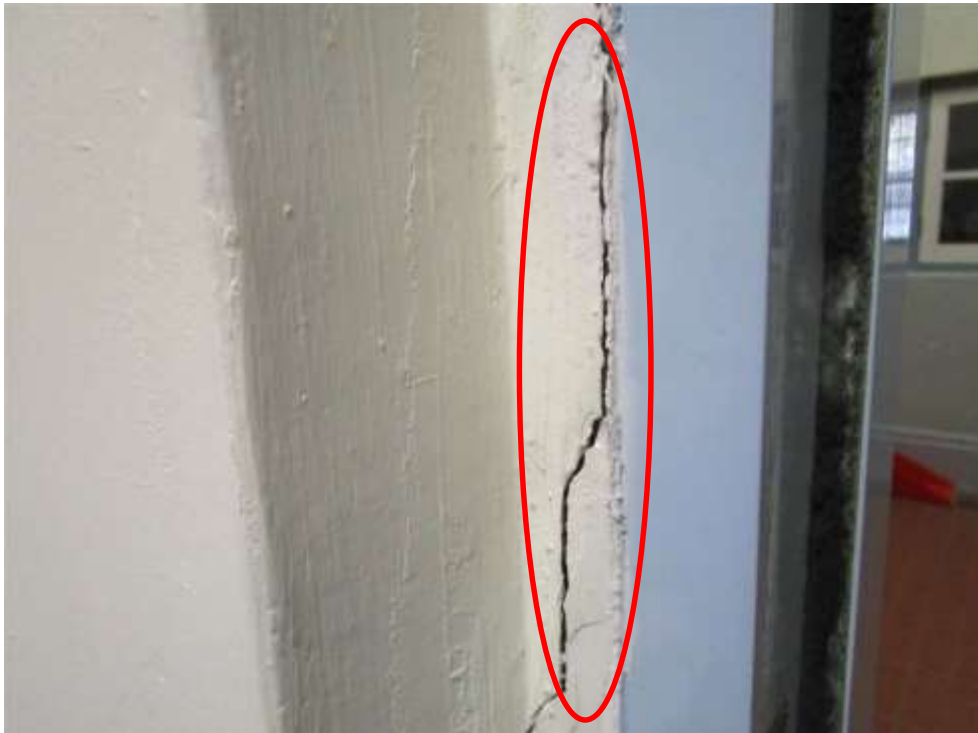
Photo No. 1172

Defect No. 86	Location G/F East wing, Social worker room	Component wall
----------------------	---------------------------------------------------	-----------------------

Description A wide crack was observed on door jamb

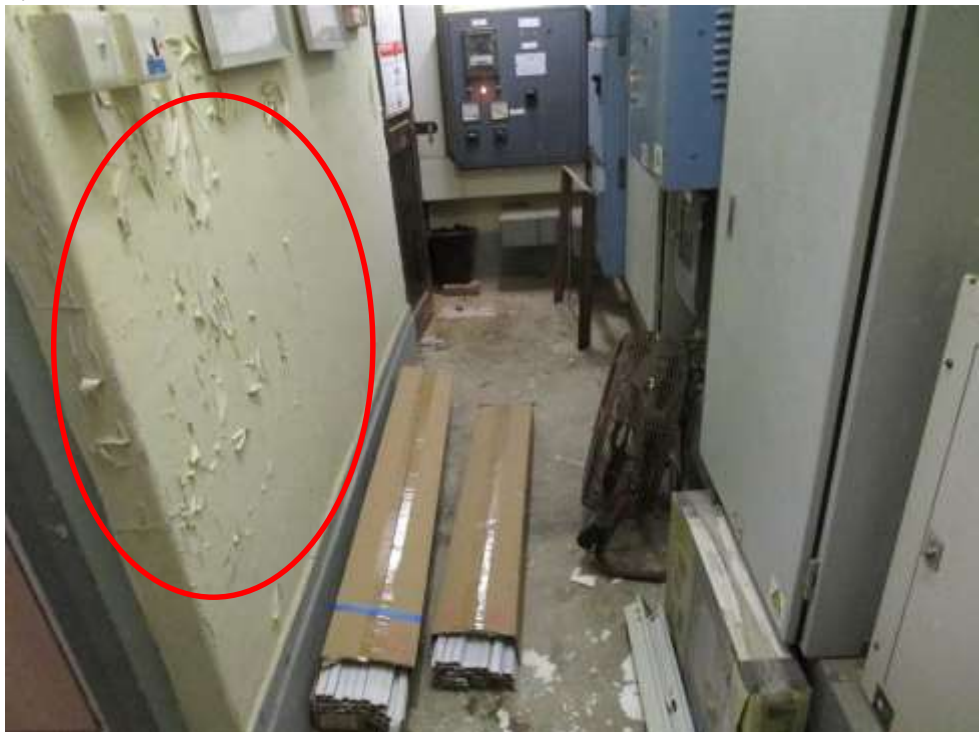
Photo No. 1174

Defect No. 87 **Location** G/F East wing, Switchgear room **Component** wall

Description Paint peeling was observed on wall

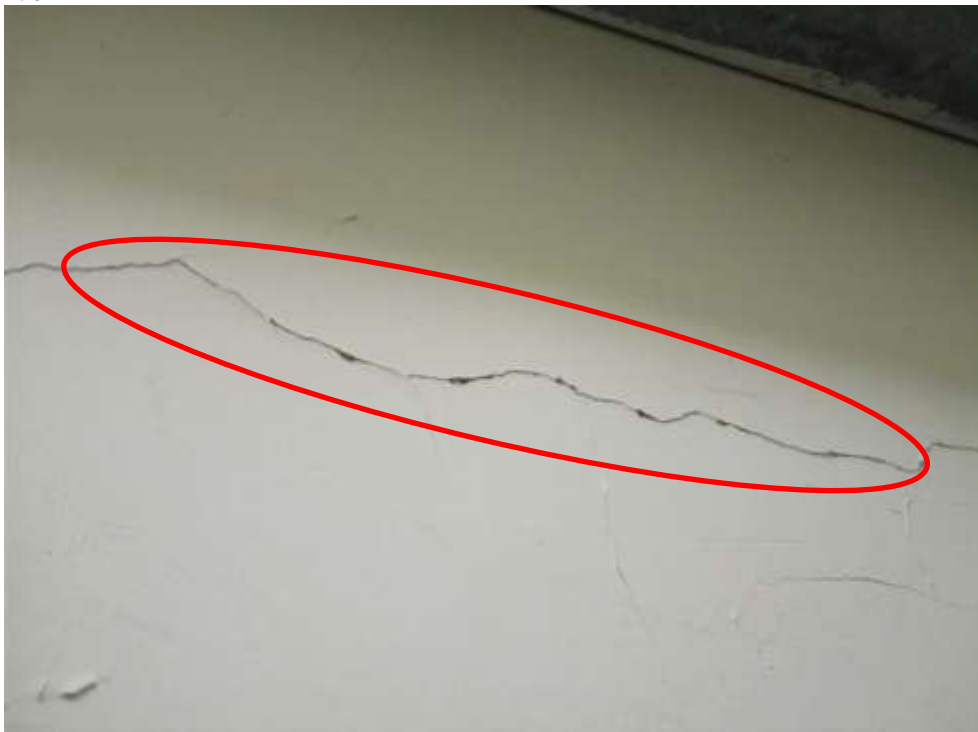
Photo No. 1176

Defect No. 88 **Location** G/F East wing, Switchgear room **Component** wall

Description A wide crack was observed on wall finishing

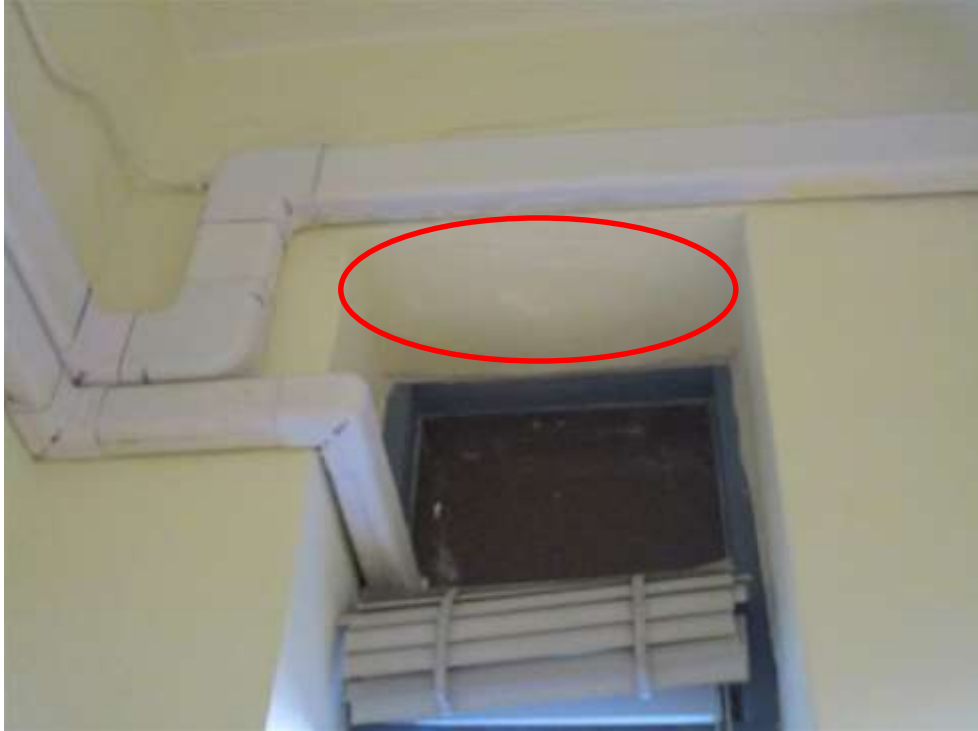
Photo No. 1177

Defect No. 88 **Location** G/F East wing, Switchgear room **Component** wall

Description A wide crack was observed on wall finishing

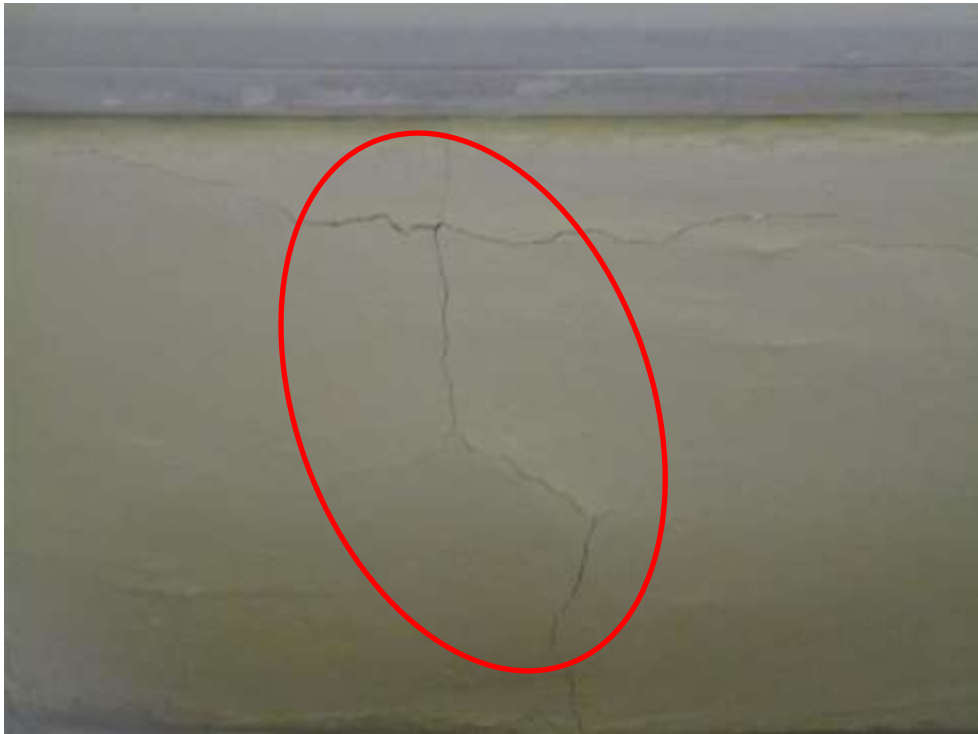
Photo No. 1178

Defect No. 89 **Location** G/F East wing, UG08 classroom **Component** window sill

Description An area of medium crack was observed on soffit finishing

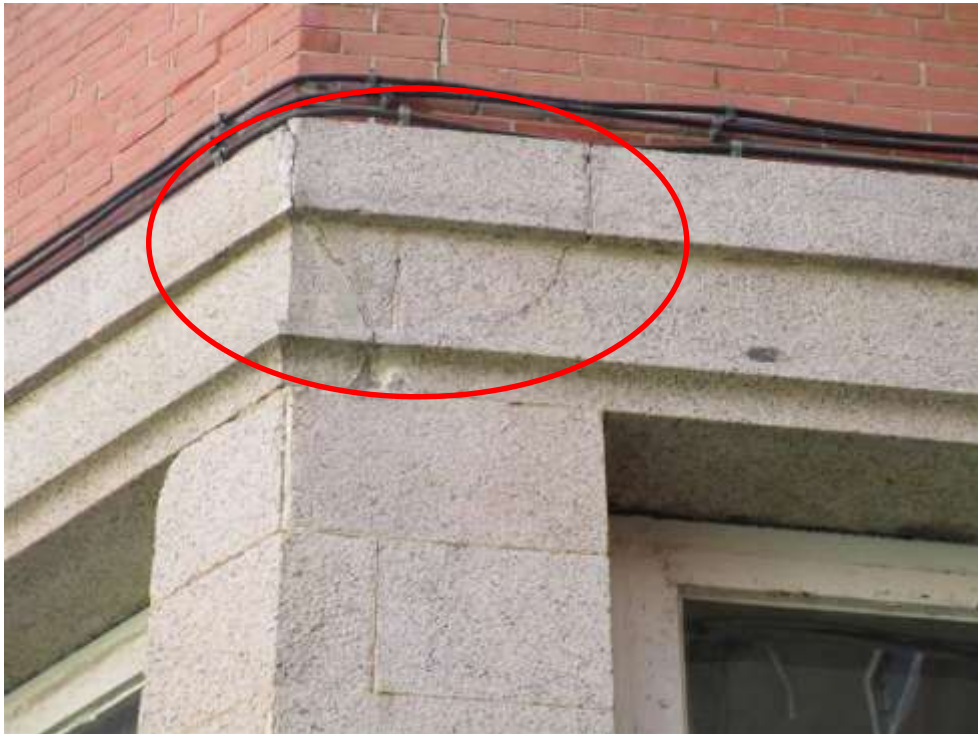
Photo No. 1180

Defect No. 90 **Location** G/F East wing, West elevation **Component** granite wall

Description 2 wide cracks were observed on granite wall

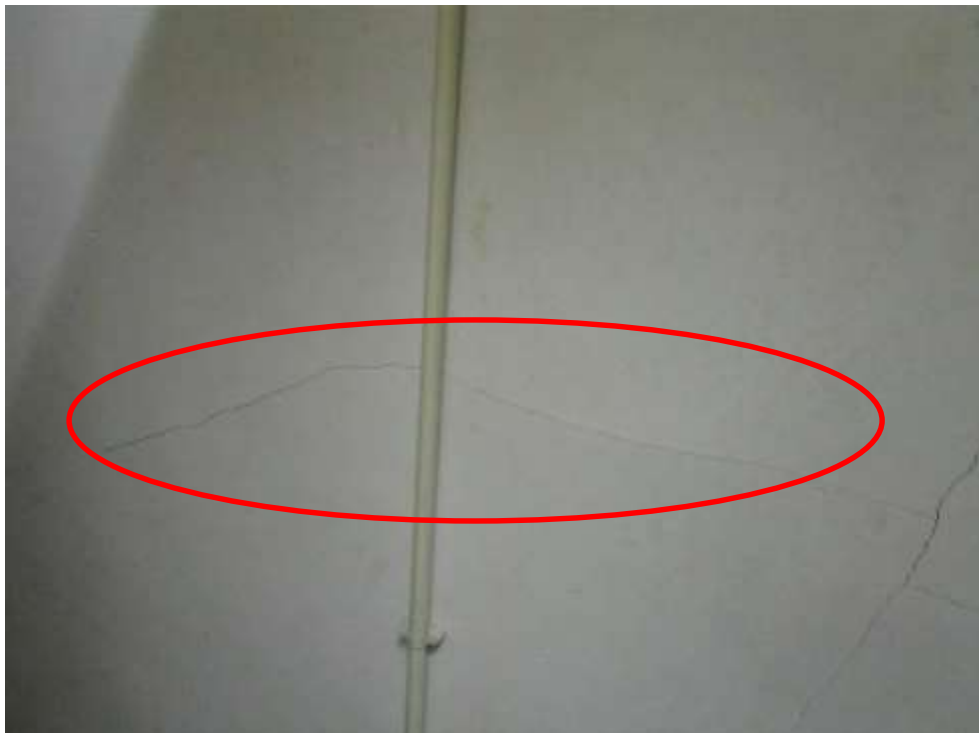
Photo No. 1182

Defect No. 91	Location G/F South wing, Bonham road store room	Component wall
----------------------	--------------------------------------------------------	-----------------------

Description An area of wide crack was observed on wall finishing

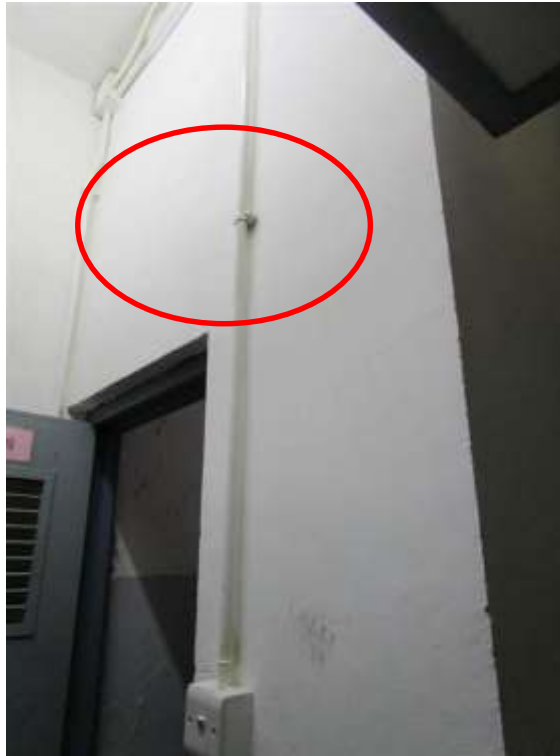
Photo No. 1183

Defect No. 91	Location G/F South wing, Bonham road store room	Component wall
----------------------	--------------------------------------------------------	-----------------------

Description An area of wide crack was observed on wall finishing

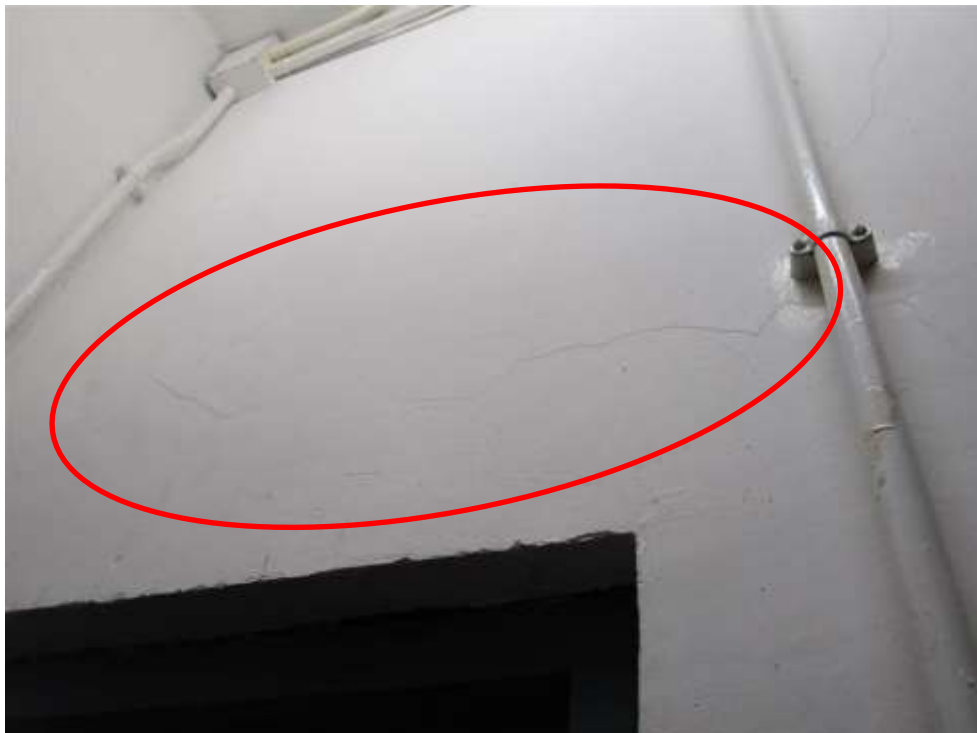
Photo No. 1184

Defect No.	92	Location	G/F South wing, Bonham road store room	Component	wall
-------------------	----	-----------------	----------------------------------------	------------------	------

Description An area of medium crack was observed on wall finishing

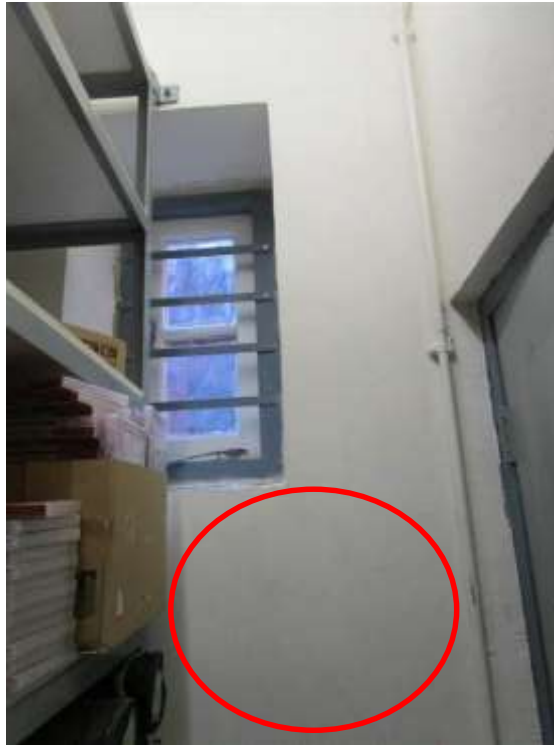
Photo No. 1185

Defect No.	92	Location	G/F South wing, Bonham road store room	Component	wall
-------------------	----	-----------------	----------------------------------------	------------------	------

Description An area of medium crack was observed on wall finishing

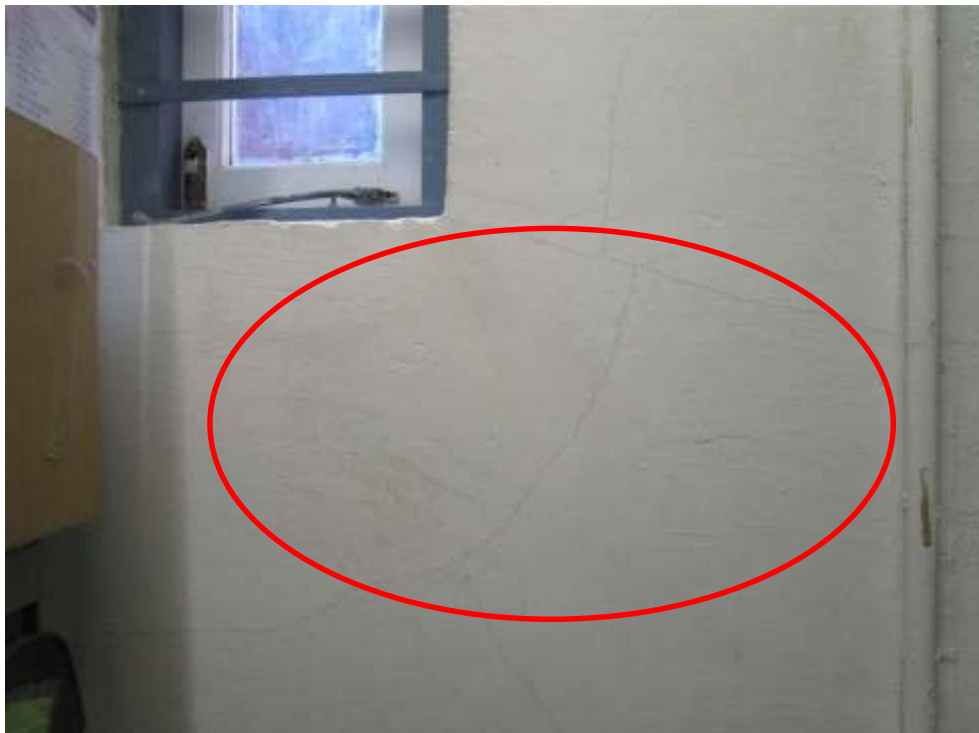
Photo No. 1186

Defect No. 93	Location G/F South wing, Bonham road store room	Component wall
----------------------	--------------------------------------------------------	-----------------------

Description An area of wide crack was observed on wall finishing

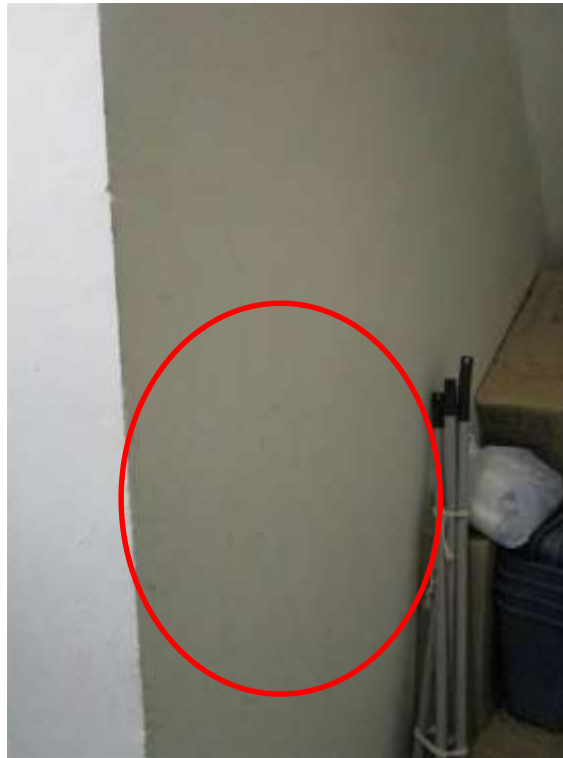
Photo No. 1187

Defect No. 93	Location G/F South wing, Bonham road store room	Component wall
----------------------	--------------------------------------------------------	-----------------------

Description An area of wide crack was observed on wall
