**Slope Upgrading Works at
Feature No. 11SW-A/R526,
King's College,
Bonham Road, Hong Kong**

Project Profile for Slope Upgrading Works at
Feature No. 11SW-A/R526, King's College

May 2018

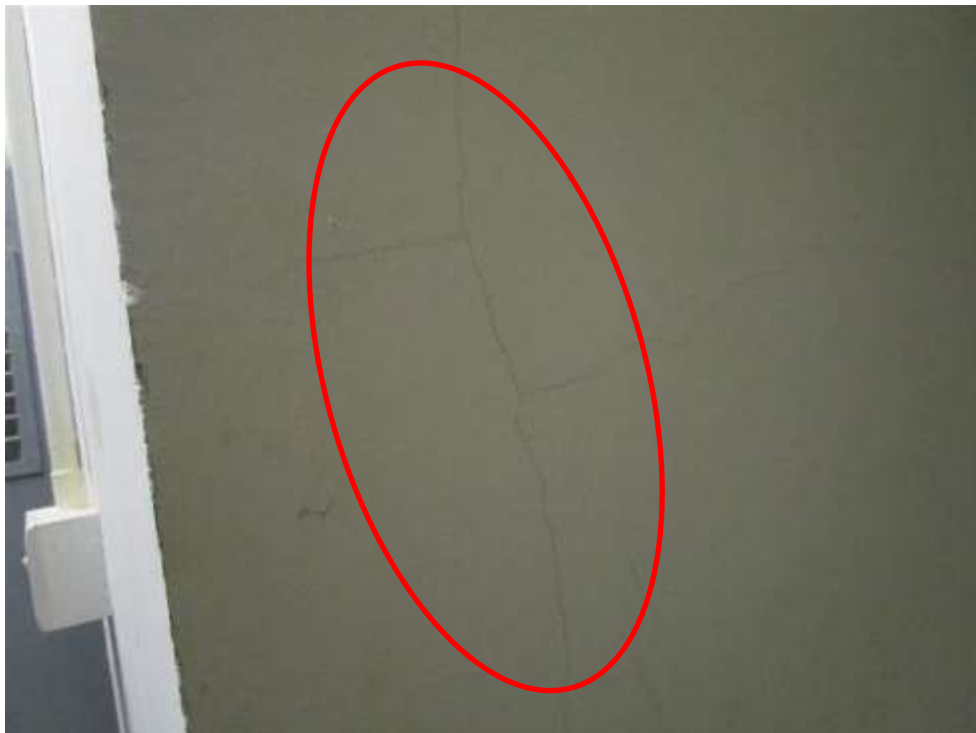
Photo No. 1188

Defect No. 94	Location G/F South wing, Bonham road store room	Component wall
----------------------	--------------------------------------------------------	-----------------------

Description An area of wide crack was observed on wall finishing

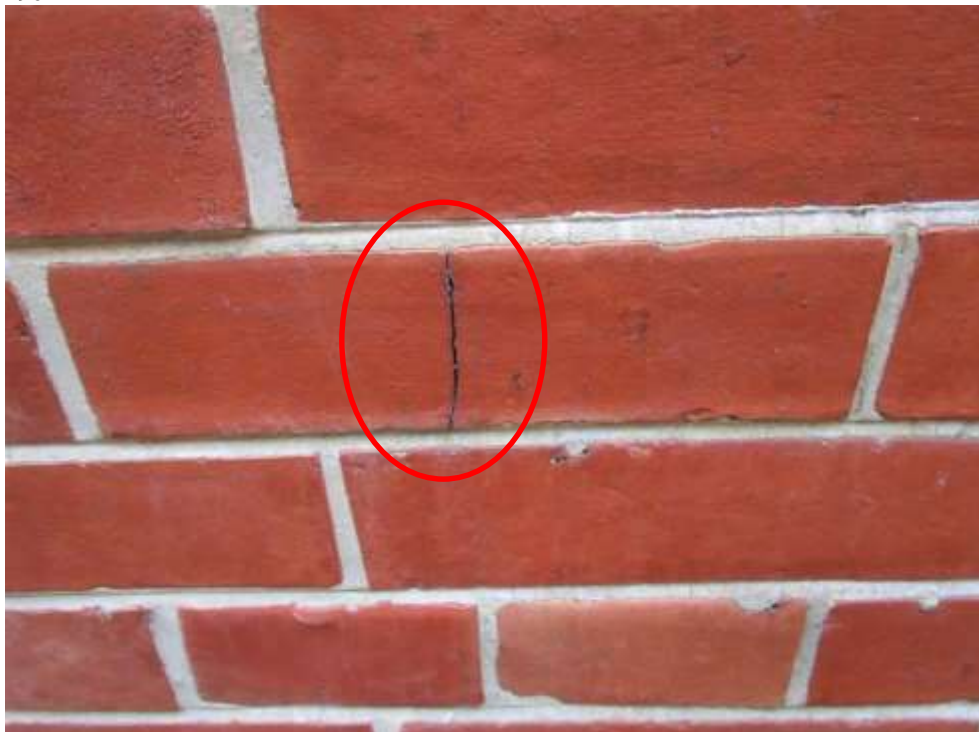
Photo No. 1190

Defect No. 95 **Location** G/F South wing, Corridor **Component** brick column

Description A medium crack was observed on brick column

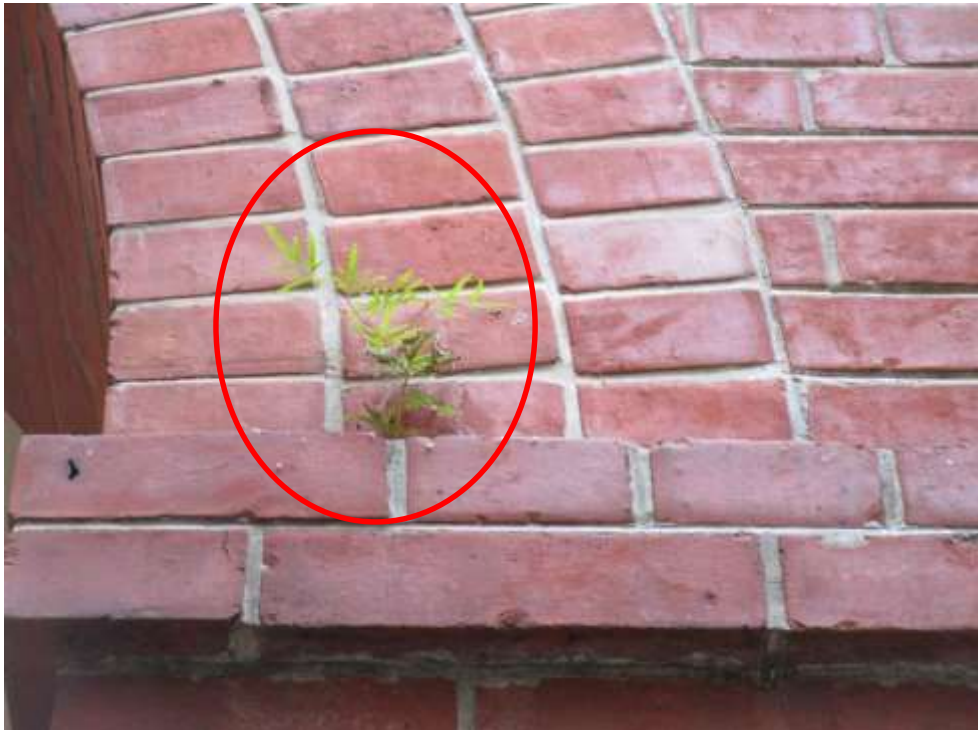
Photo No. 1192

Defect No.	96	Location	G/F South wing, Corridor	Component	brick column
-------------------	----	-----------------	--------------------------	------------------	--------------

Description	A vegetation growth was observed on brick column				
--------------------	--------------------------------------------------	--	--	--	--

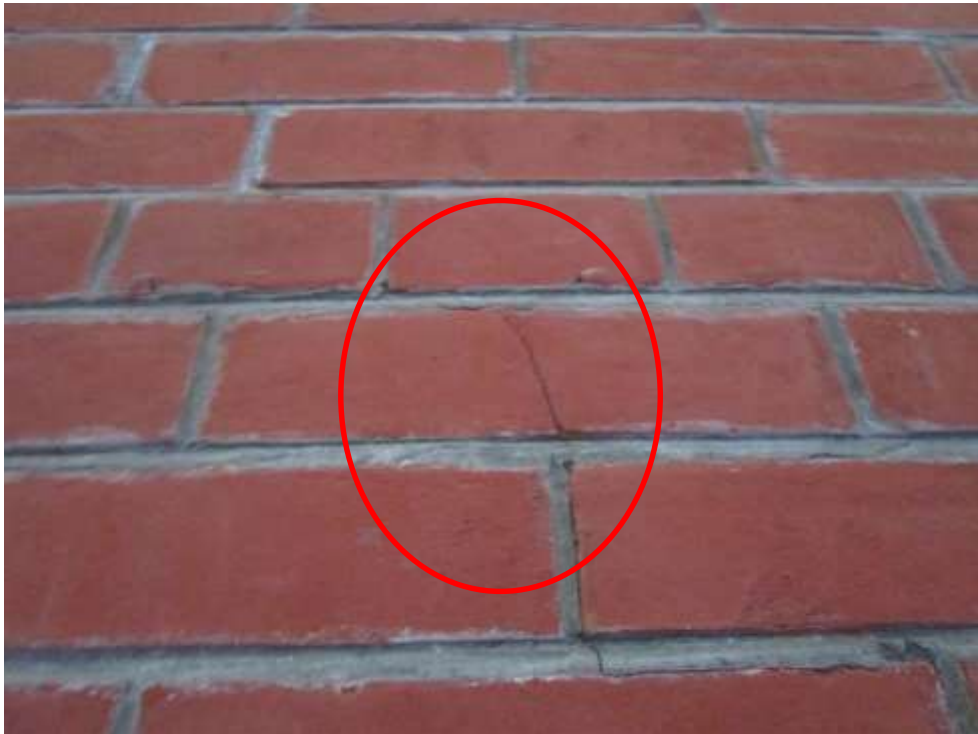
Photo No. 1194

Defect No.	97	Location	G/F South wing, Corridor	Component	brick wall
-------------------	----	-----------------	--------------------------	------------------	------------

Description	A medium crack was observed on brick wall				
--------------------	-------------------------------------------	--	--	--	--

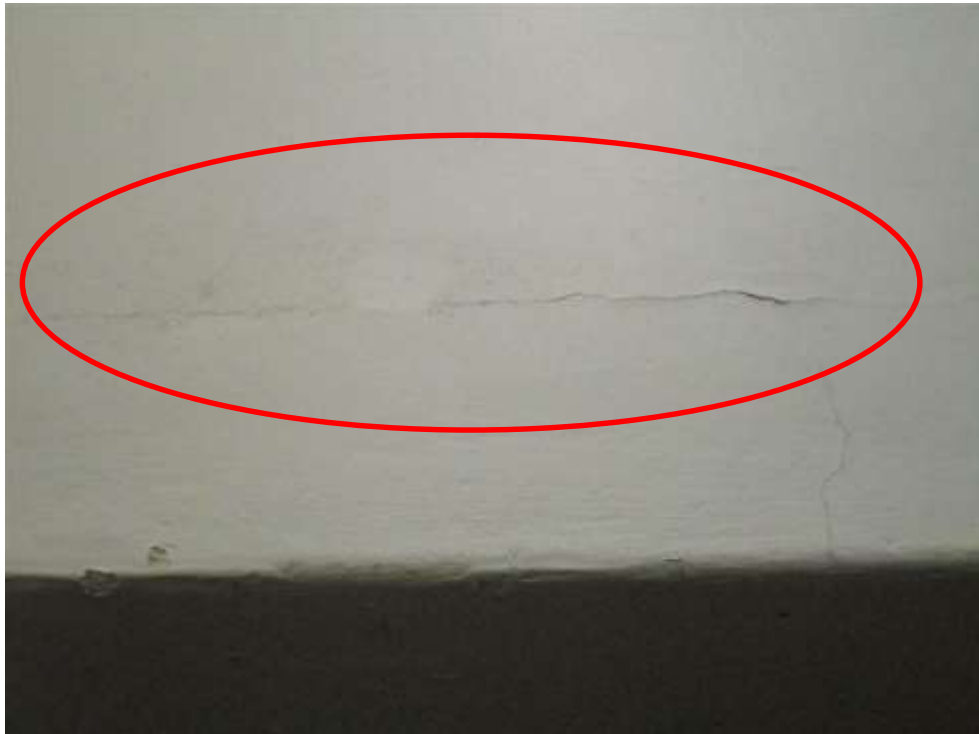
Photo No. 1196

Defect No.	98	Location	G/F South wing, Corridor	Component	door lintel
-------------------	----	-----------------	--------------------------	------------------	-------------

Description	A hairline crack was observed on door lintel				
--------------------	----------------------------------------------	--	--	--	--

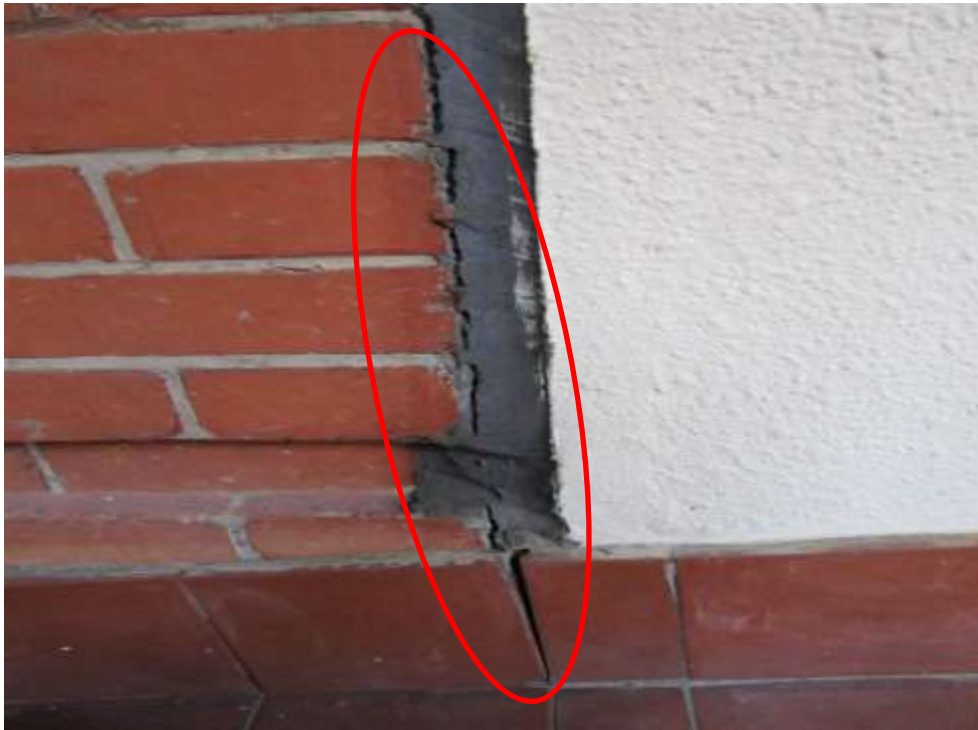
Photo No. 1198

Defect No. 99 **Location** G/F South wing, Corridor **Component** parapet

Description Debonded joint sealant was observed on parapet between new and old structure

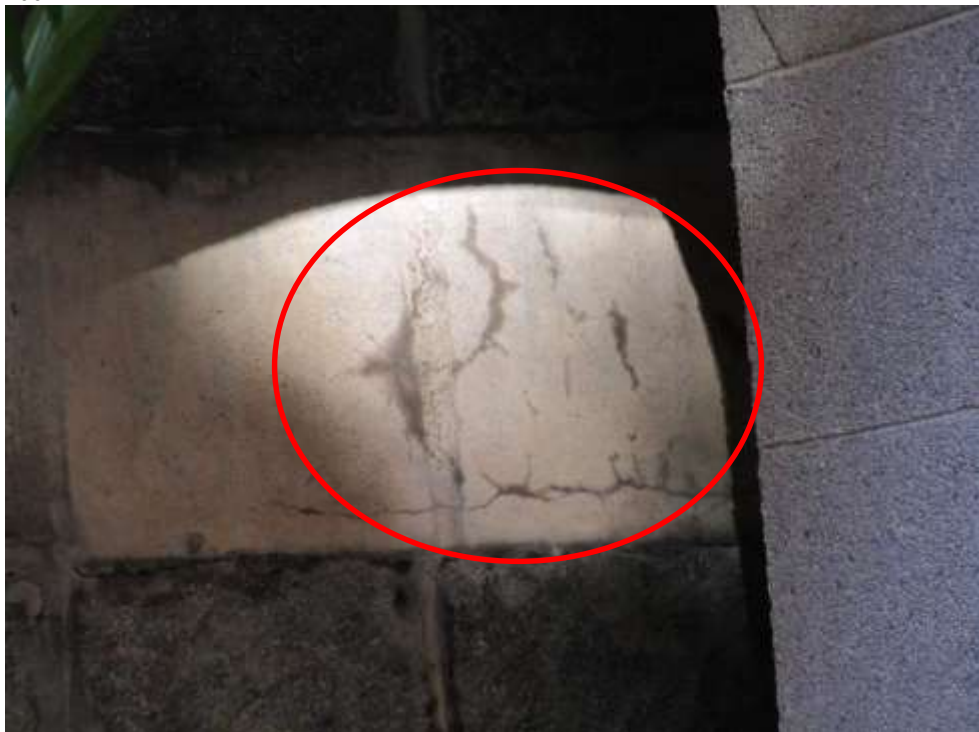
Photo No. 1200

Defect No. 100 **Location** G/F South wing, School Garden **Component** retaining wall

Description An area of medium crack was observed on concrete surface of retaining wall

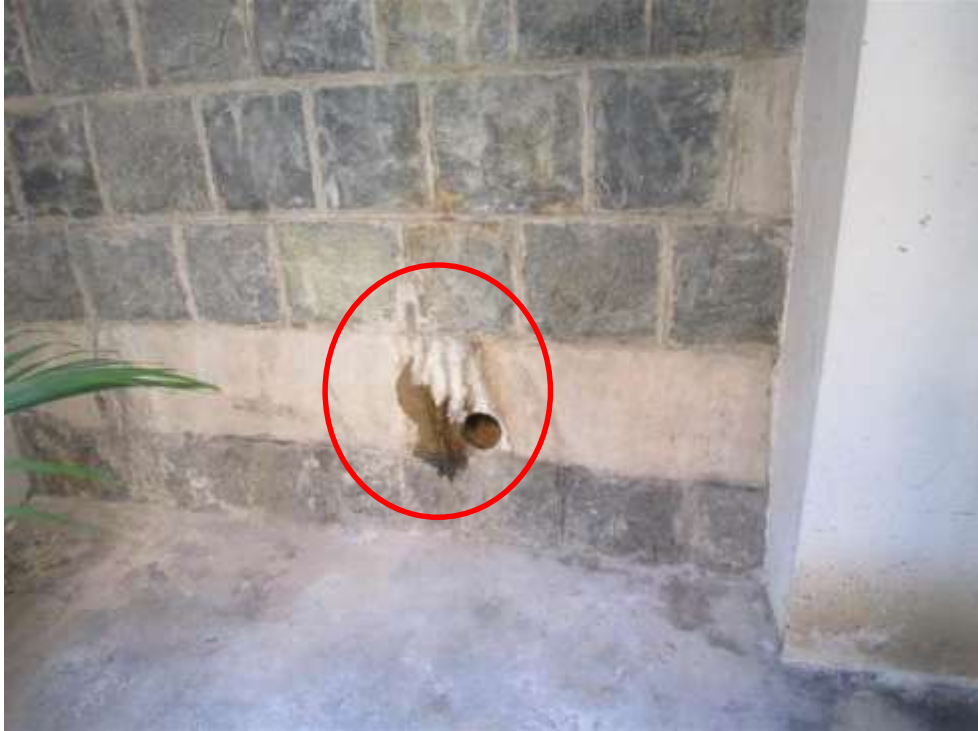
Photo No. 1201

Defect No. 100 **Location** G/F South wing, School Garden **Component** retaining wall

Description An area of medium crack was observed on concrete surface of retaining wall

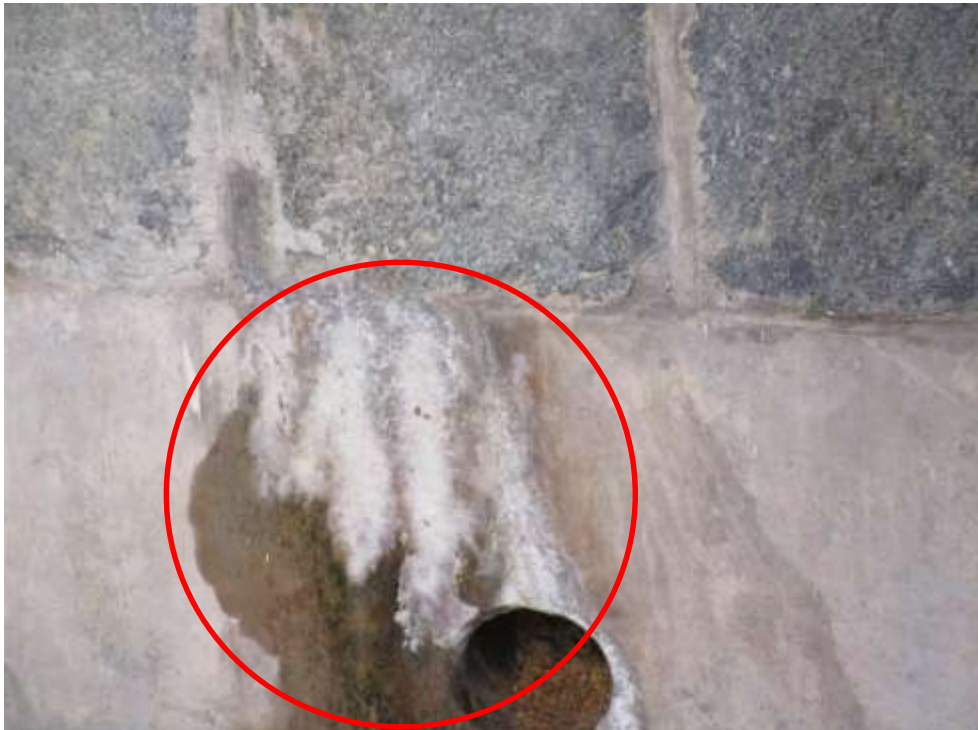
Photo No. 1202

Defect No. 101 **Location** G/F South wing, School Garden **Component** retaining wall

Description A leaching with seepage was observed on concrete surface of retaining wall

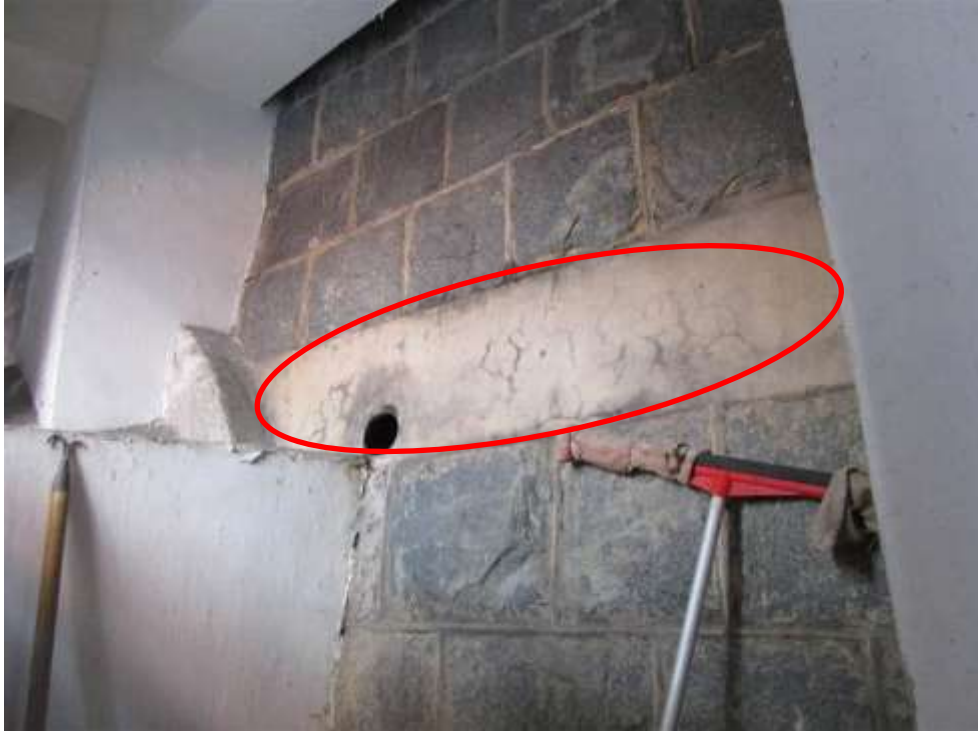
Photo No. 1203

Defect No. 101 **Location** G/F South wing, School Garden **Component** retaining wall

Description A leaching with seepage was observed on concrete surface of retaining wall

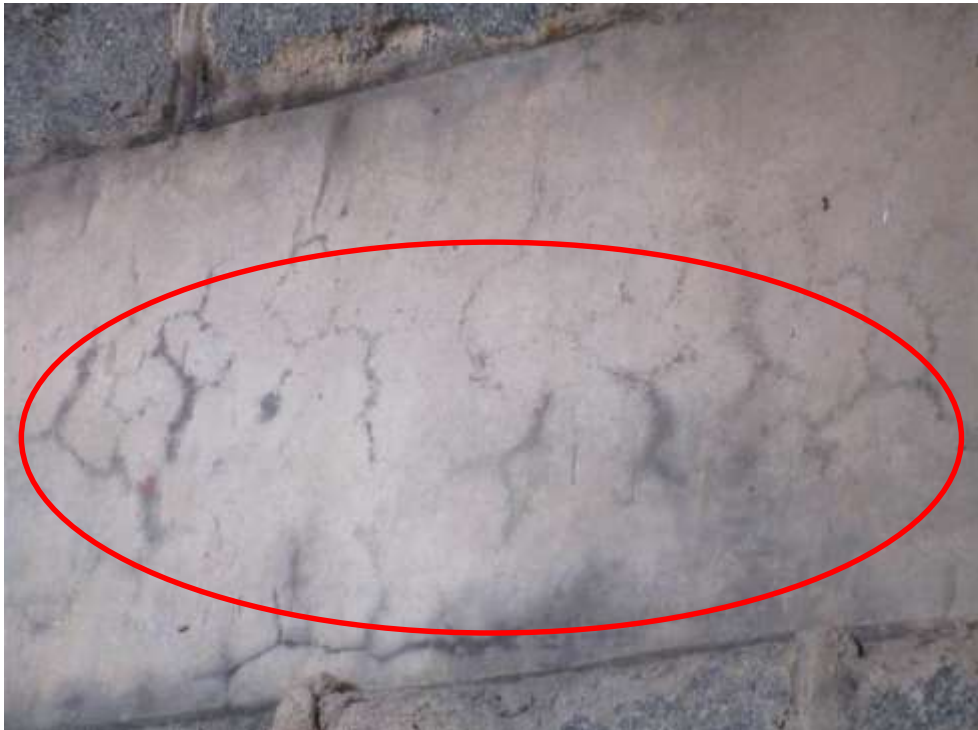
Photo No. 1204

Defect No.	102	Location	G/F South wing, School Garden	Component	retaining wall
Description	An area of hairline crack was observed on concrete surface of retaining wall

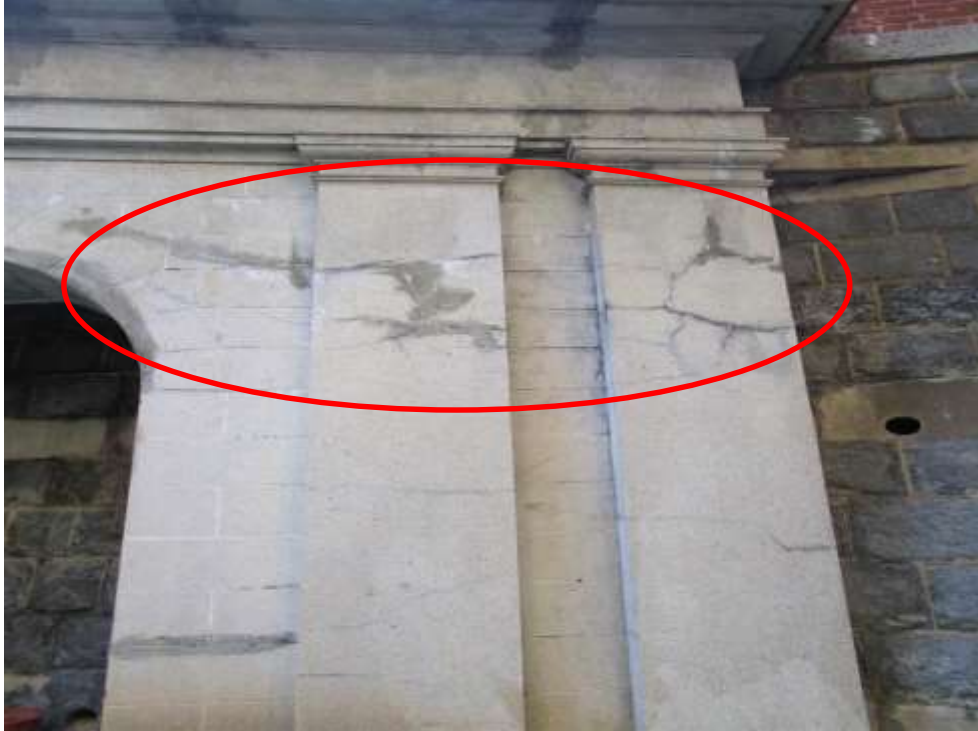
Photo No. 1205

Defect No.	102	Location	G/F South wing, School Garden	Component	retaining wall
Description	An area of hairline crack was observed on concrete surface of retaining wall

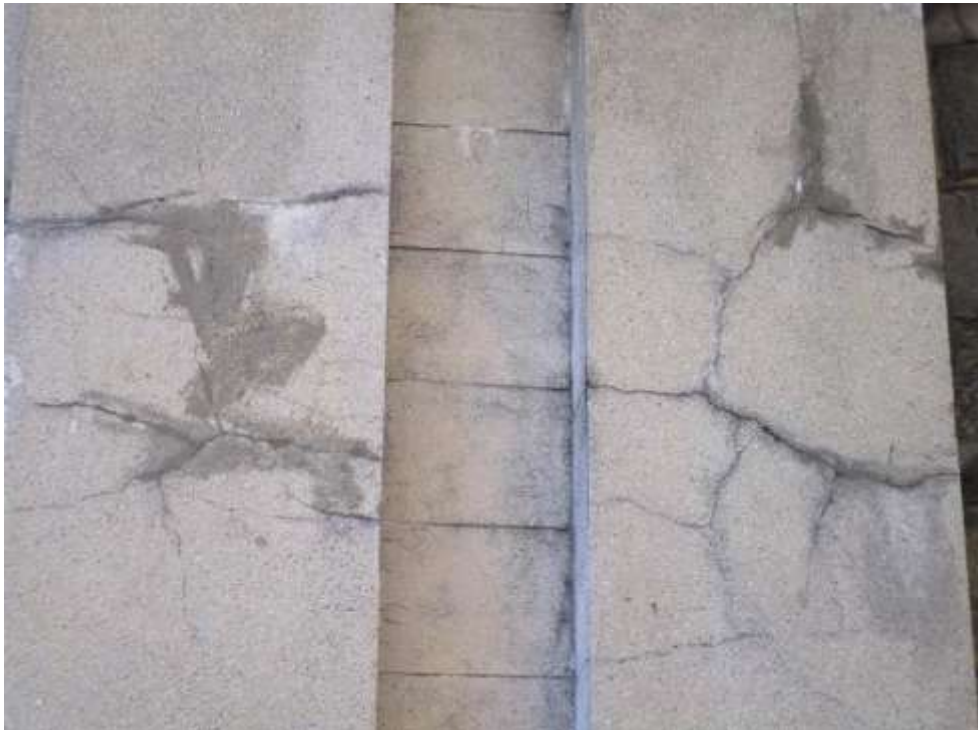
Photo No. 1206

Defect No. 103 **Location** G/F South wing, School Garden **Component** column

Description An area of wide cracks was observed on the finishing of column

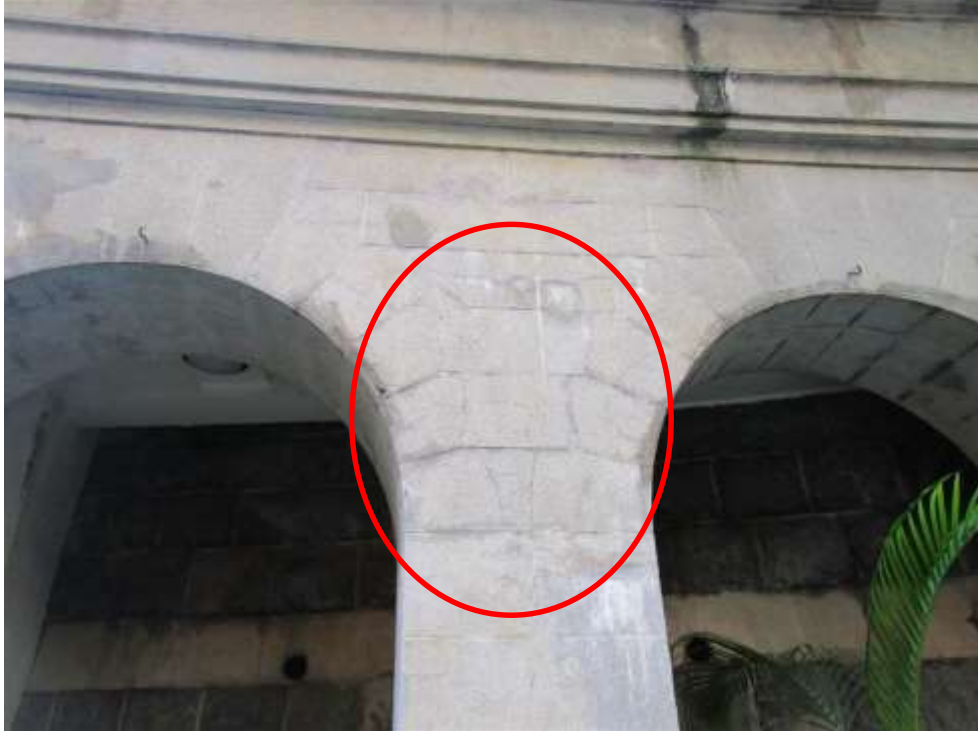
Photo No. 1207

Defect No. 103 **Location** G/F South wing, School Garden **Component** column

Description An area of wide cracks was observed on the finishing of column

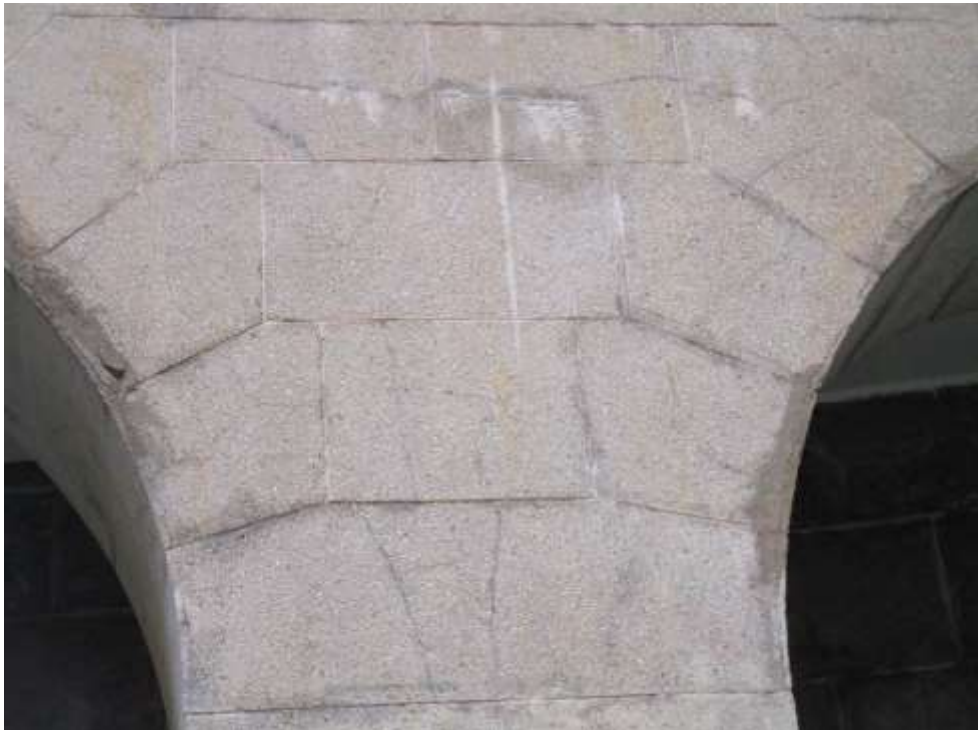
Photo No. 1208

Defect No. 104 **Location** G/F South wing, School Garden **Component** column

Description An area of medium crack with leaching was observed on column finishing

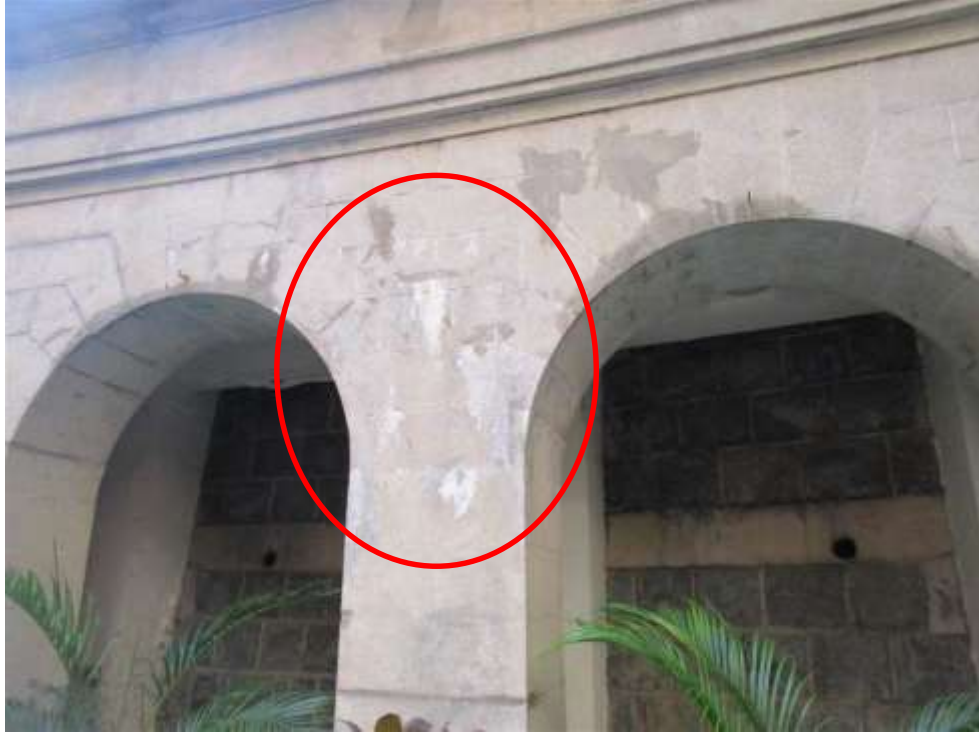
Photo No. 1209

Defect No. 104 **Location** G/F South wing, School Garden **Component** column

Description An area of medium crack with leaching was observed on column finishing

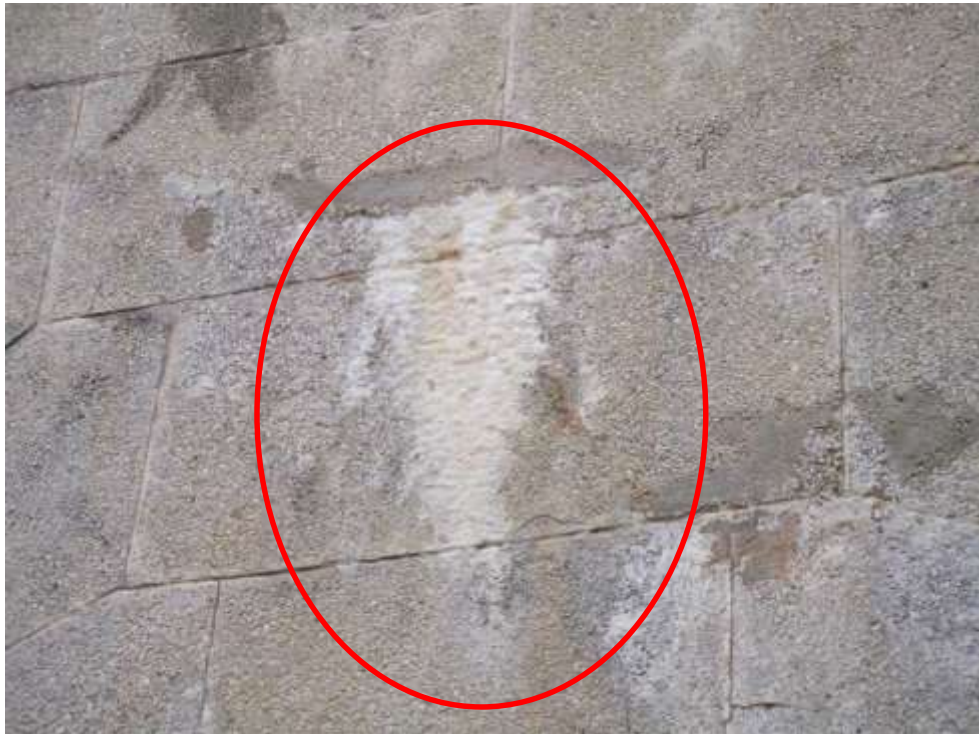
Photo No. 1210

Defect No. 105 **Location** G/F South wing, School Garden **Component** column

Description An area of medium crack with leaching was observed on column finishing

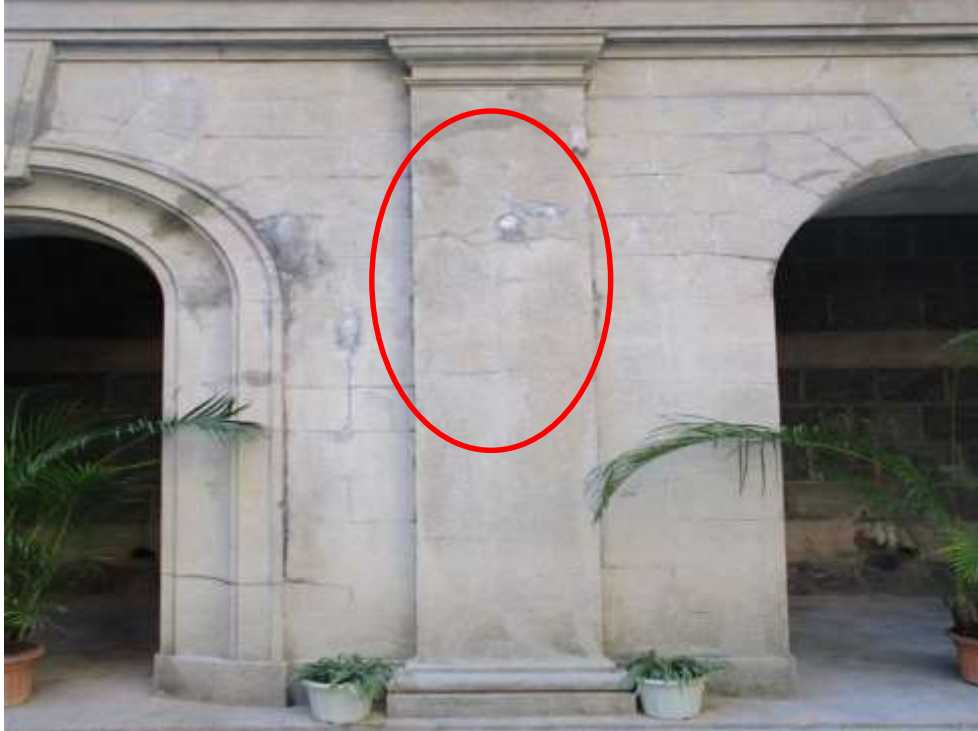
Photo No. 1211

Defect No. 105 **Location** G/F South wing, School Garden **Component** column

Description An area of medium crack with leaching was observed on column finishing

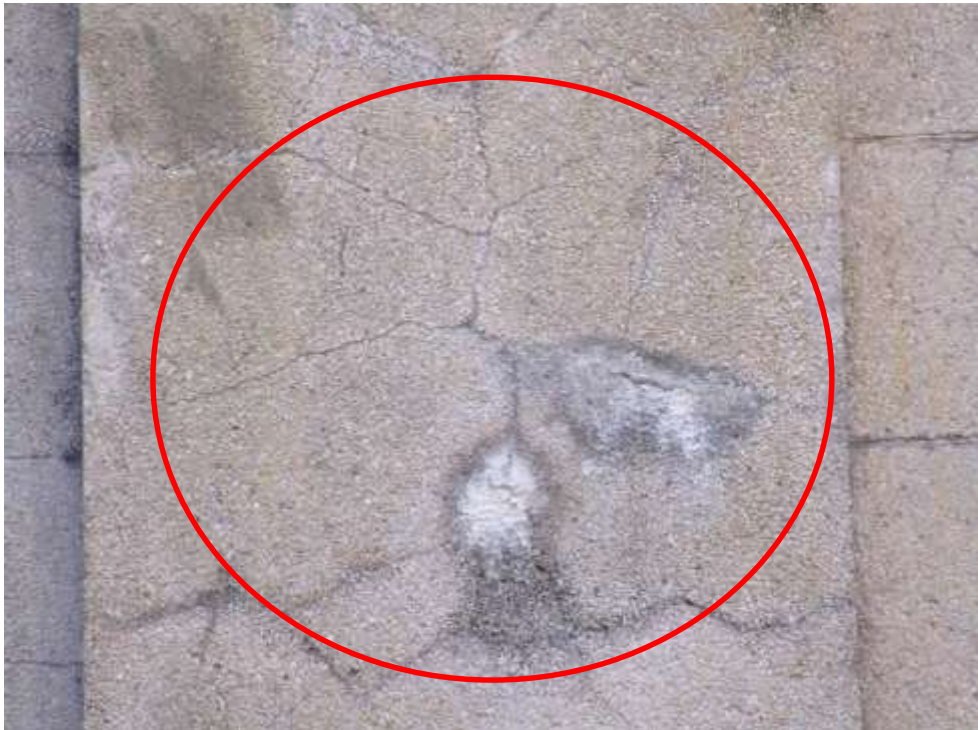
Photo No. 1212

Defect No. 106 **Location** G/F South wing, School Garden **Component** column

Description An area of medium crack with leaching was observed on column finishing

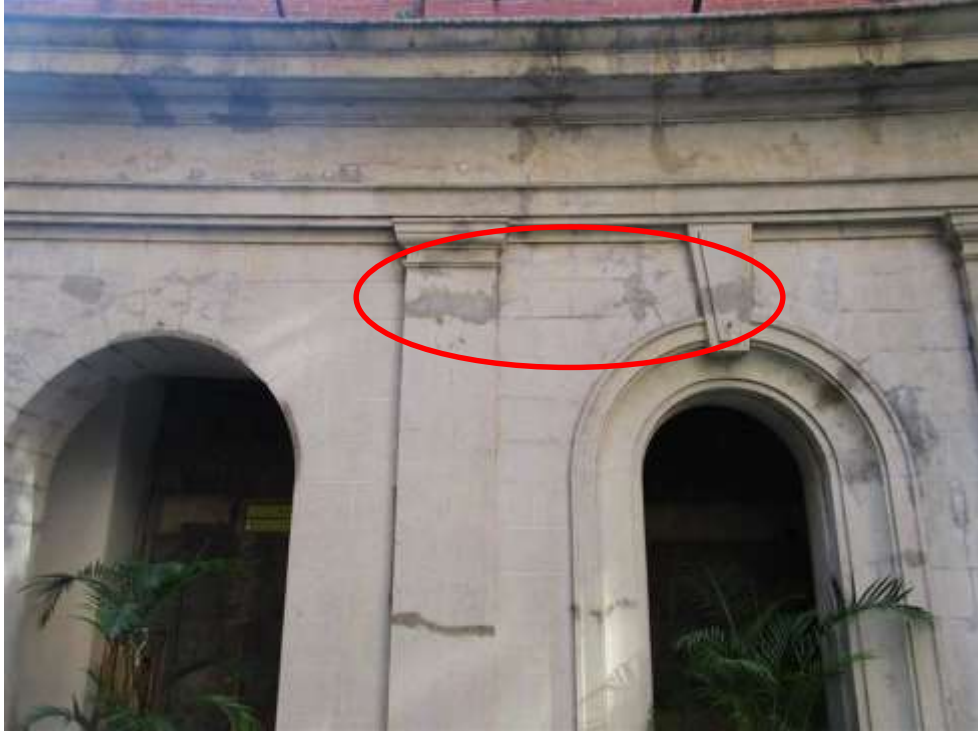
Photo No. 1213

Defect No. 106 **Location** G/F South wing, School Garden **Component** column

Description An area of medium crack with leaching was observed on column finishing

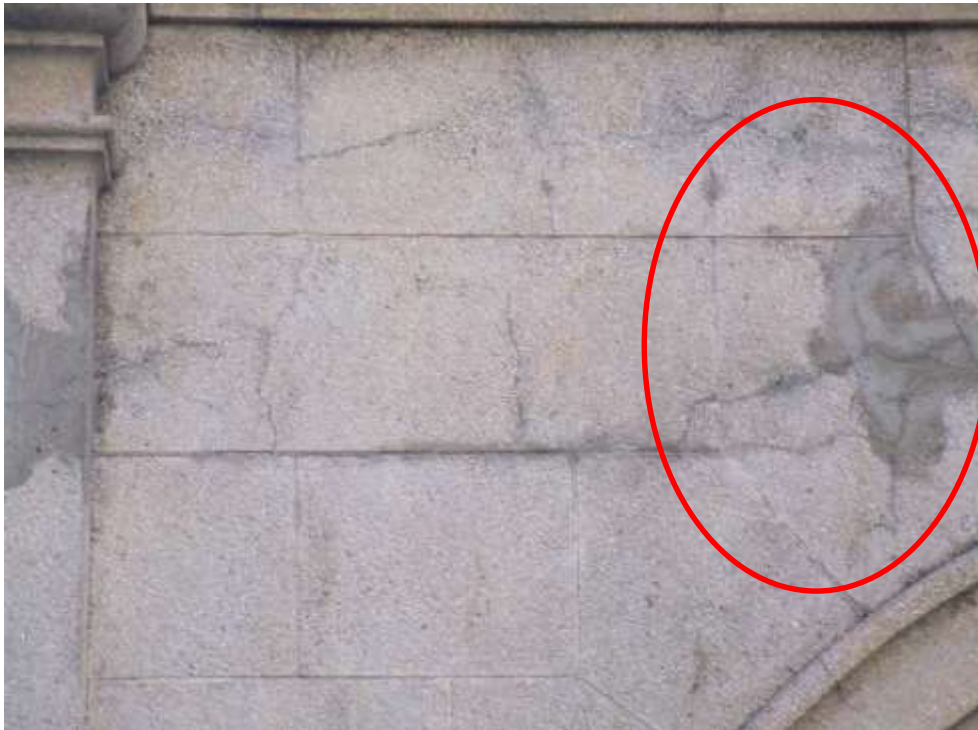
Photo No. 1214

Defect No. 107 **Location** G/F South wing, School Garden **Component** column

Description An area of medium crack was observed on column finishing

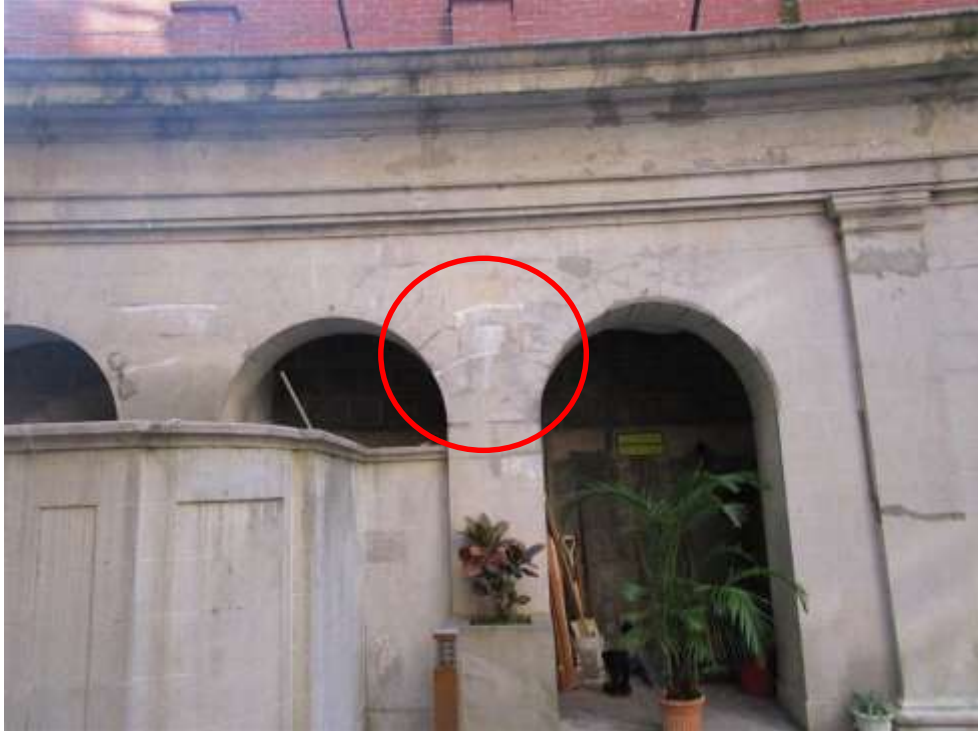
Photo No. 1215

Defect No. 107 **Location** G/F South wing, School Garden **Component** column

Description An area of medium crack was observed on column finishing

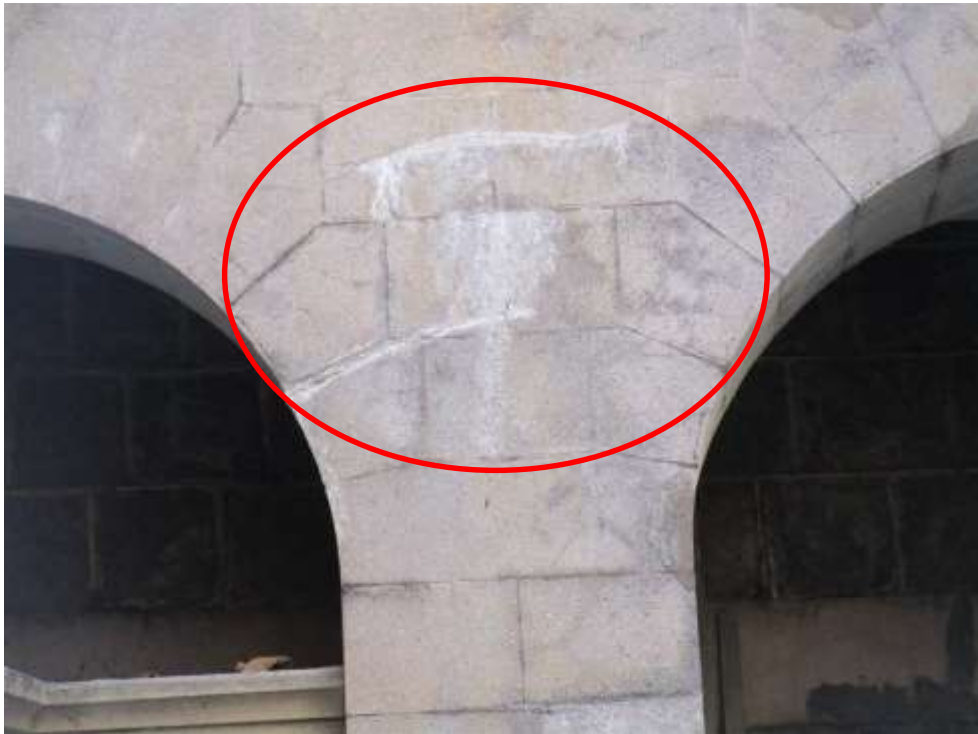
Photo No. 1216

Defect No. 108 **Location** G/F South wing, School Garden **Component** column

Description An area of medium crack with leaching was observed on column finishing

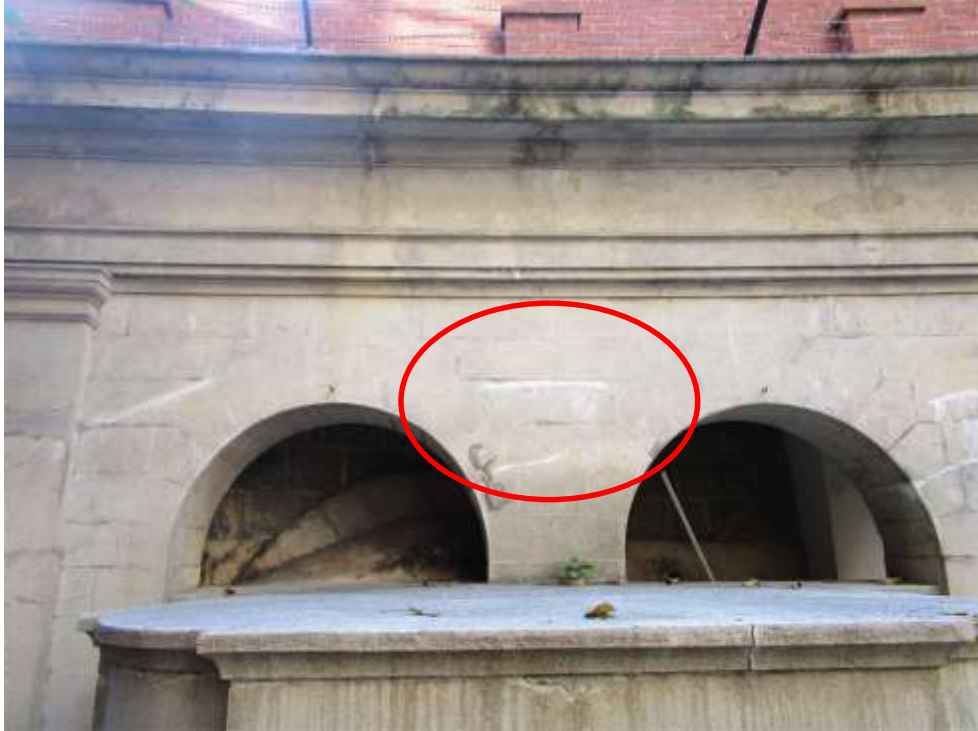
Photo No. 1217

Defect No. 108 **Location** G/F South wing, School Garden **Component** column

Description An area of medium crack with leaching was observed on column finishing

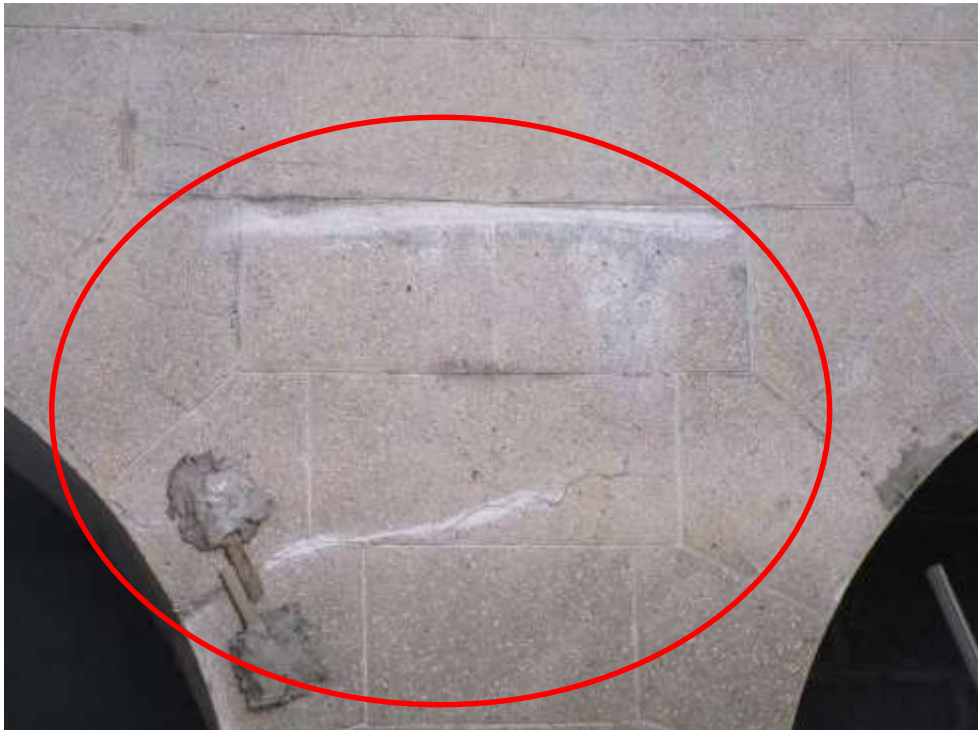
Photo No. 1218

Defect No. 109 **Location** G/F South wing, School Garden **Component** column

Description An area of medium crack was observed on column finishing

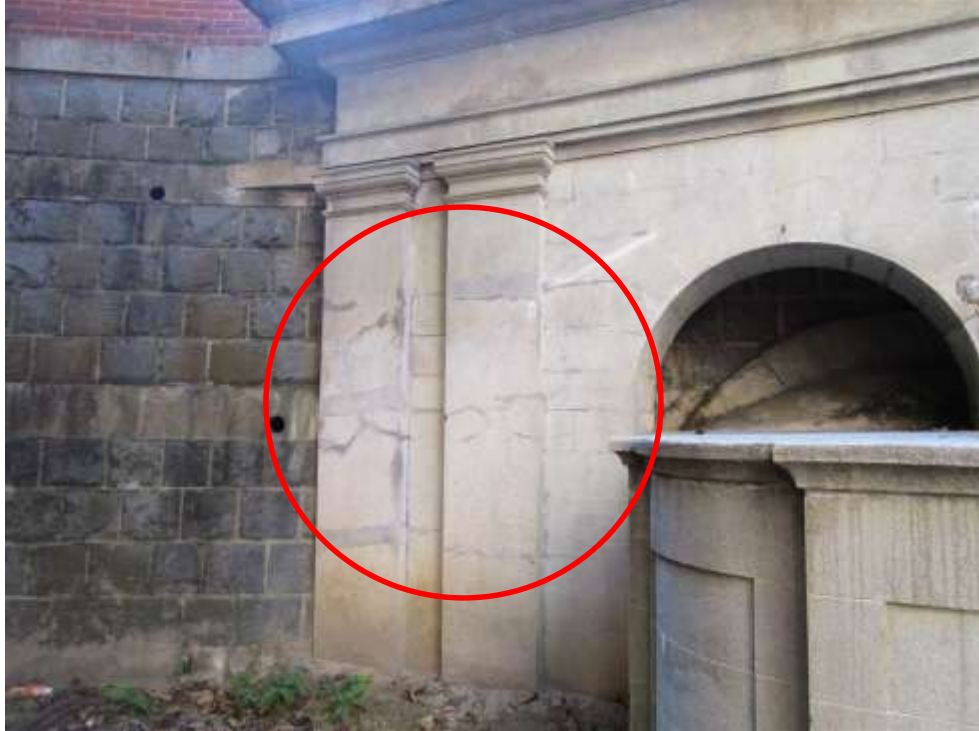
Photo No. 1219

Defect No. 109 **Location** G/F South wing, School Garden **Component** column

Description An area of medium crack was observed on column finishing

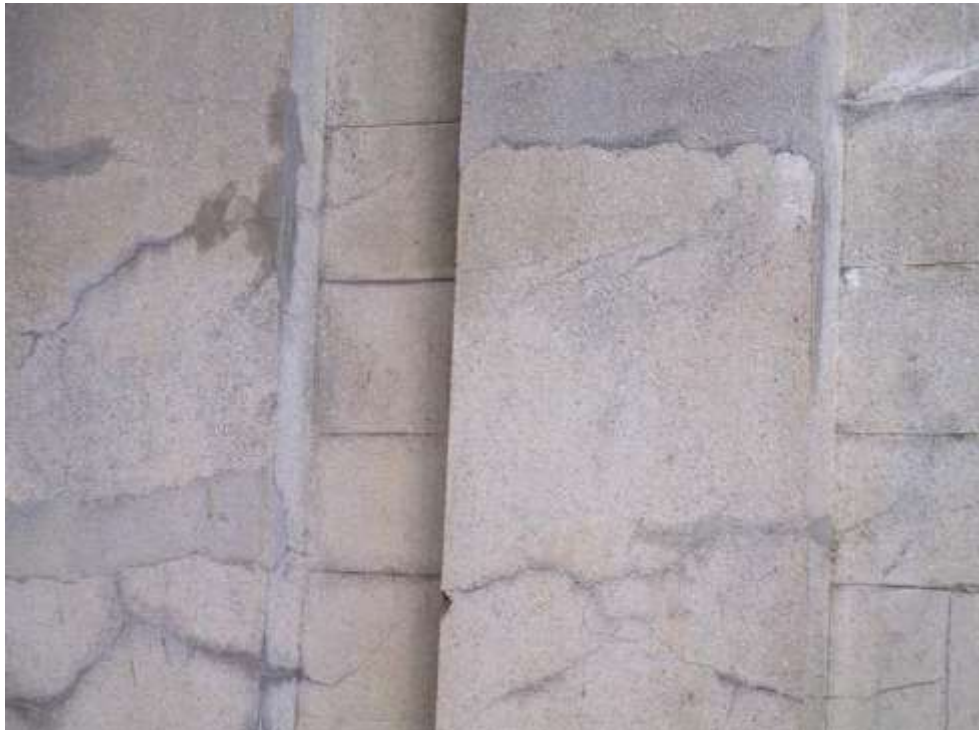
Photo No. 1220

Defect No. 110 **Location** G/F South wing, School Garden **Component** column

Description An area of wide crack was observed on column finishing

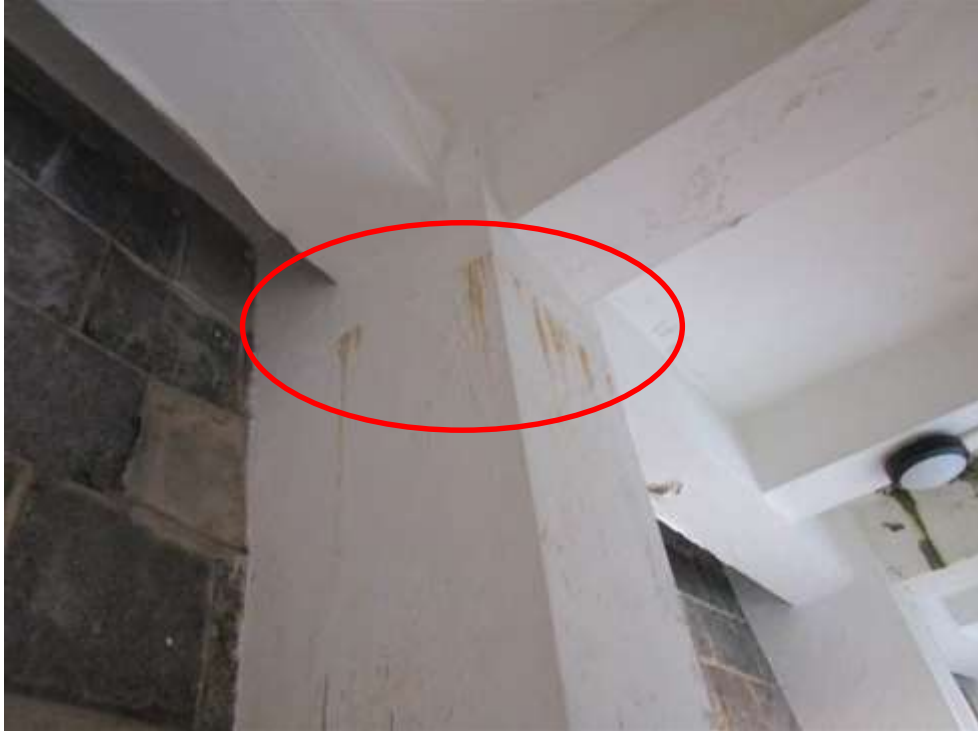
Photo No. 1221

Defect No. 110 **Location** G/F South wing, School Garden **Component** column

Description An area of wide crack was observed on column finishing

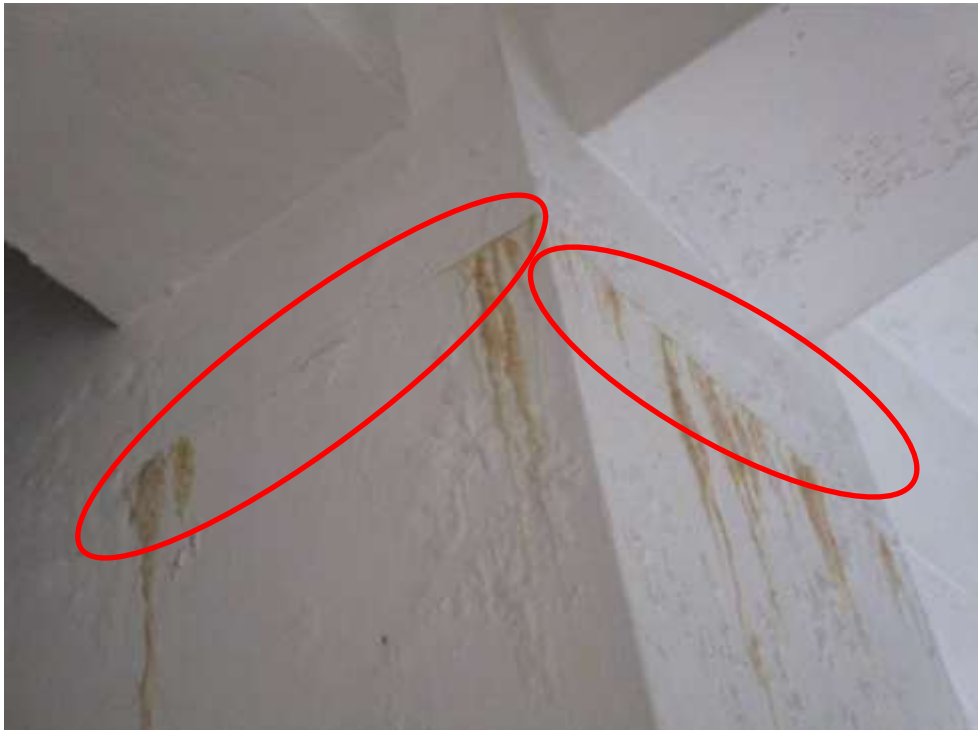
Photo No. 1222

Defect No. 111 **Location** G/F South wing, School Garden **Component** column

Description A hairline crack with yellow stain was observed on column

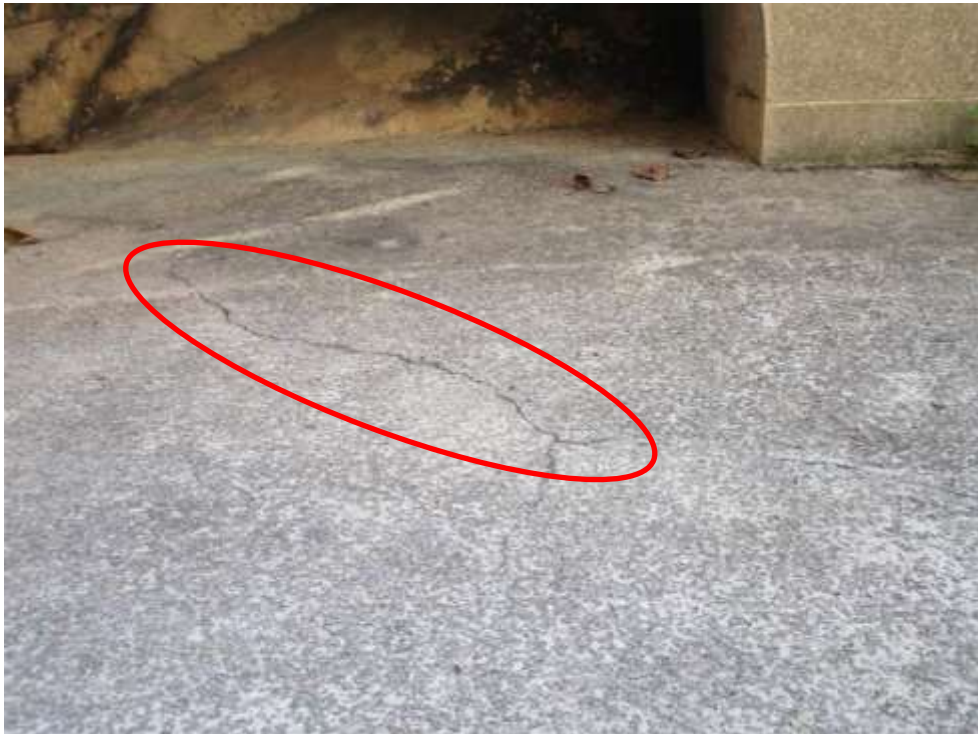
Photo No. 1224

Defect No.	112	Location	G/F South wing, School Garden	Component	mass block
-------------------	-----	-----------------	-------------------------------	------------------	------------

Description	An area of medium crack was observed on mass block				
--------------------	----------------------------------------------------	--	--	--	--
