**Slope Upgrading Works at
Feature No. 11SW-A/R526,
King's College,
Bonham Road, Hong Kong**

Project Profile for Slope Upgrading Works at
Feature No. 11SW-A/R526, King's College

May 2018

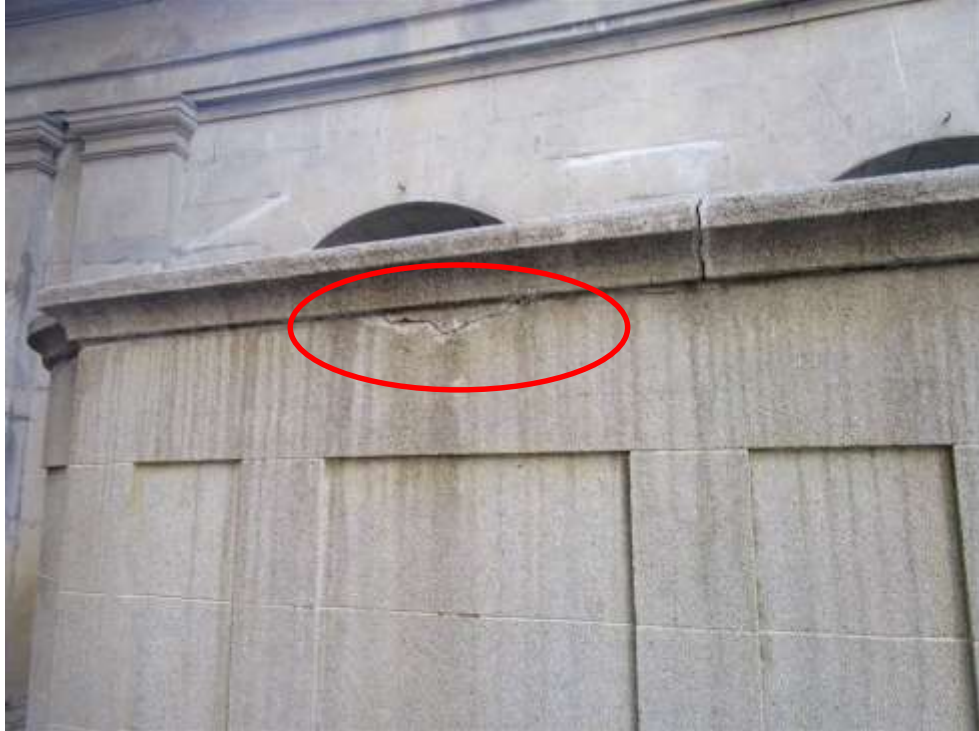
Photo No. 1225

Defect No.	112	Location	G/F South wing, School Garden	Component	mass block
-------------------	-----	-----------------	-------------------------------	------------------	------------

Description	An area of medium crack was observed on mass block				
--------------------	----------------------------------------------------	--	--	--	--

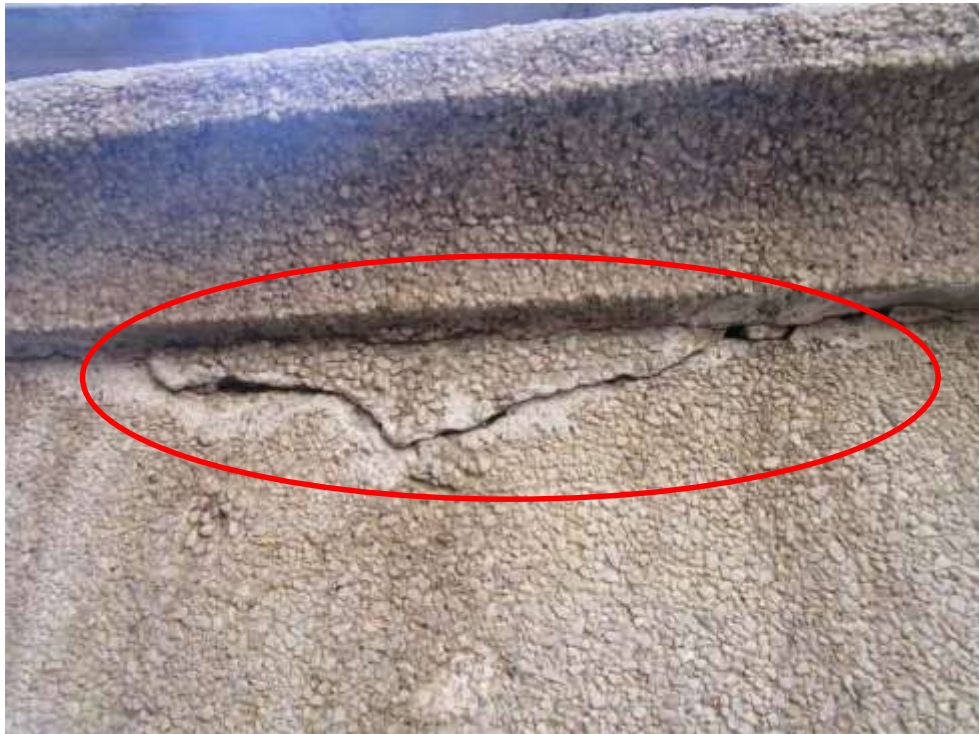
Photo No. 1226

Defect No. 113 **Location** G/F South wing, School Garden **Component** mass block

Description A wide crack was observed on the mass block

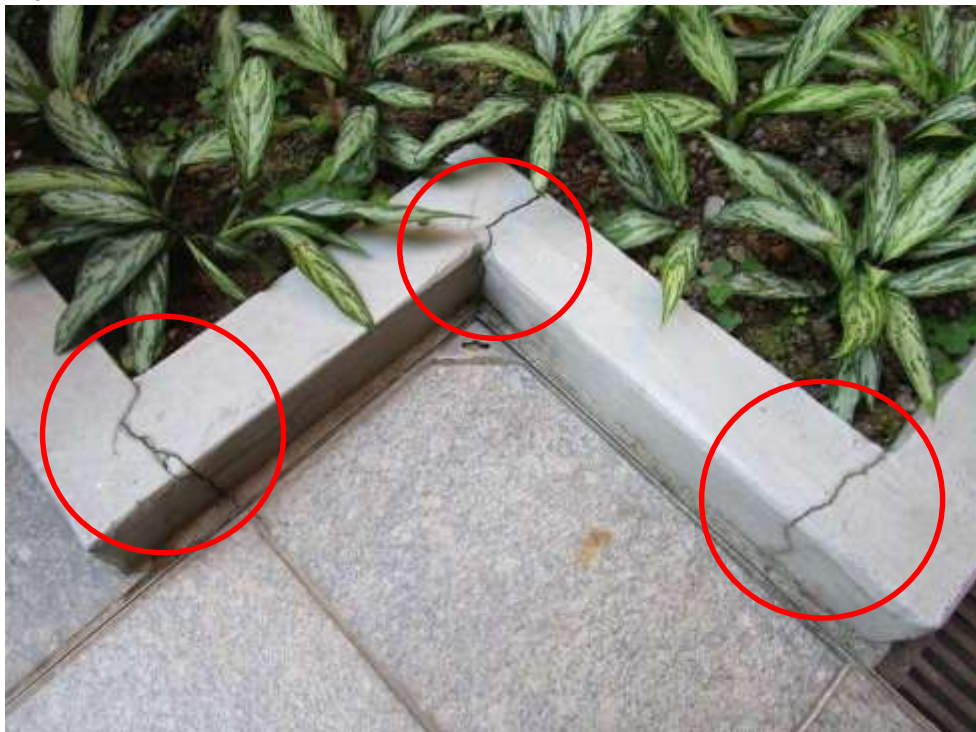
Photo No. 1228

Defect No. 114 **Location** G/F South wing, School Garden **Component** upstand curb

Description An area of cracks was observed on upstand curb

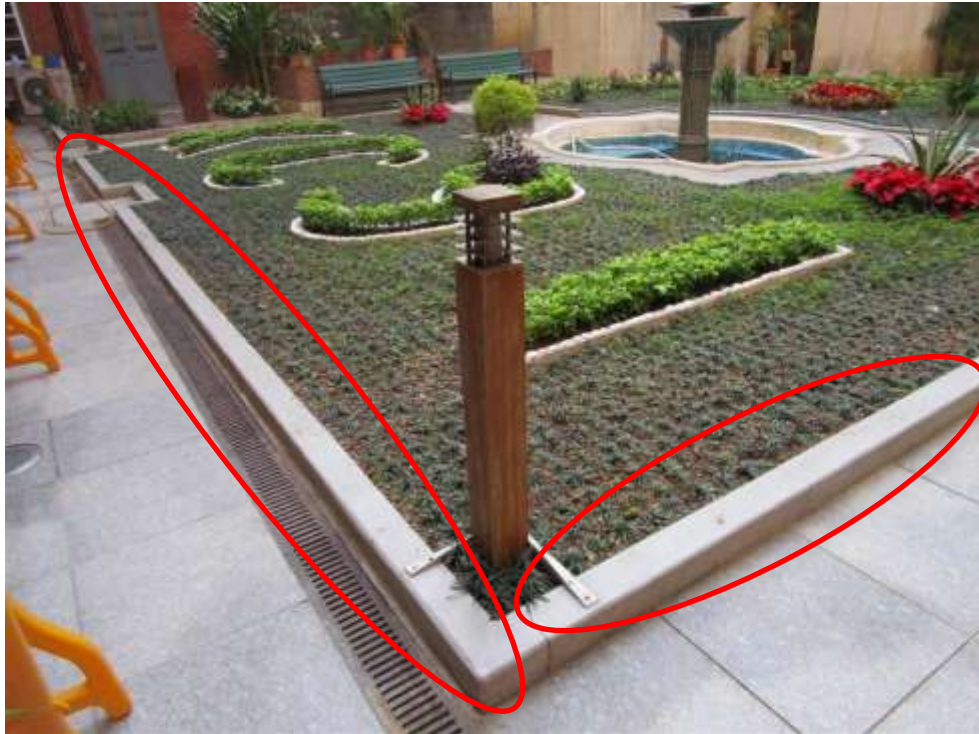
Photo No. 1229

Defect No. 114 **Location** G/F South wing, School Garden **Component** upstand curb

Description An area of cracks was observed on upstand curb

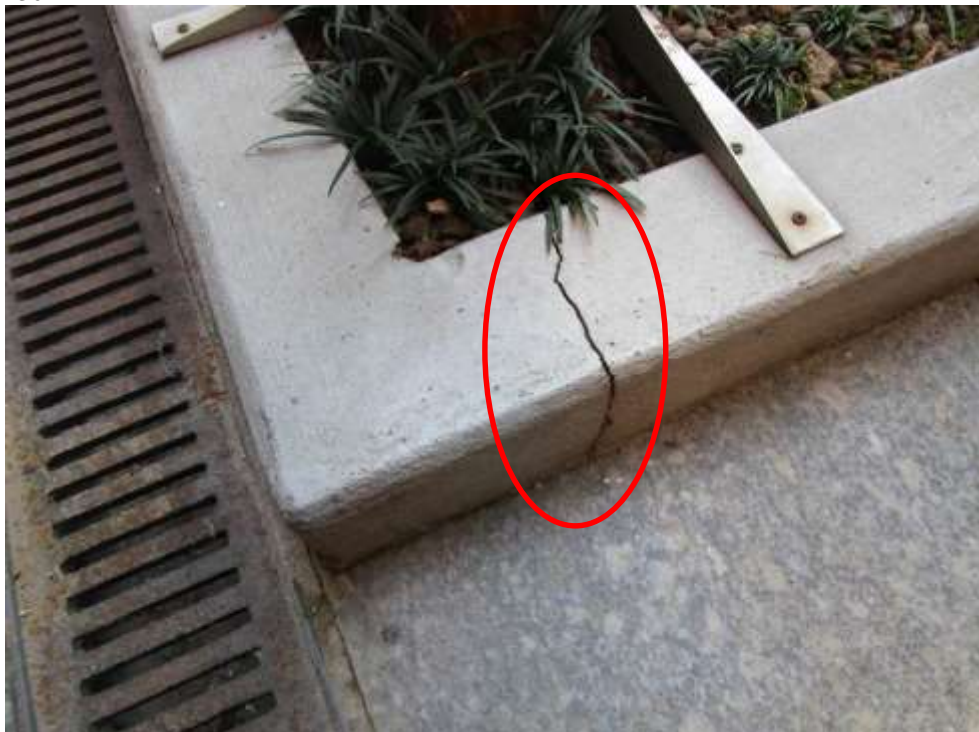
Photo No. 1230

Defect No. 115 **Location** G/F South wing, School Garden **Component** upstand curb

Description An area of cracks was observed on upstand curb

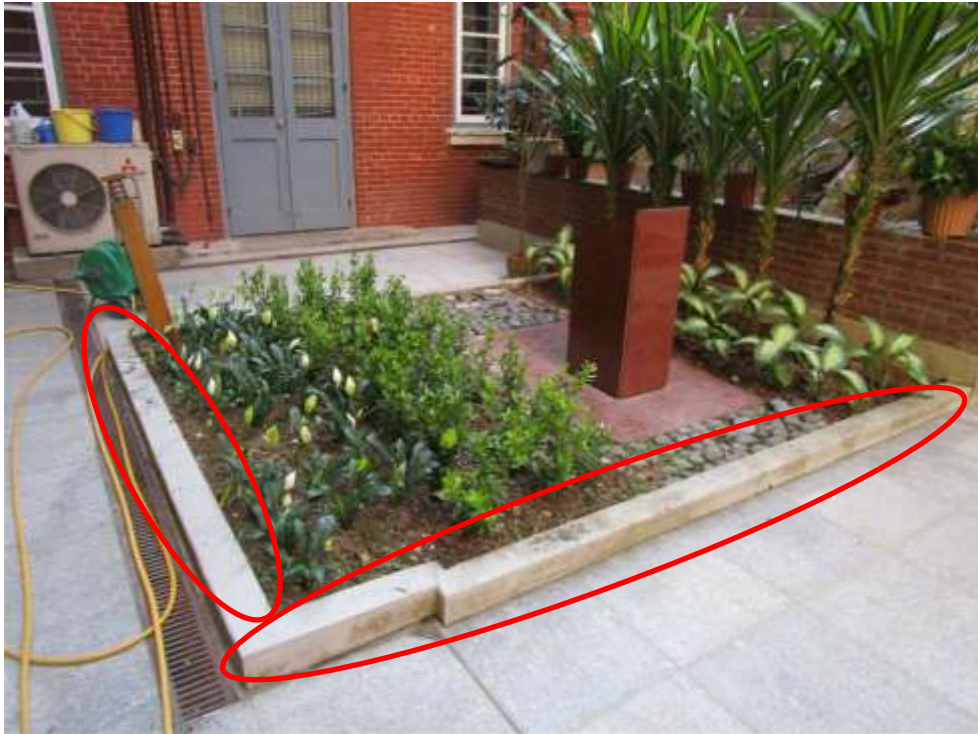
Photo No. 1231

Defect No. 115 **Location** G/F South wing, School Garden **Component** upstand curb

Description An area of cracks was observed on upstand curb

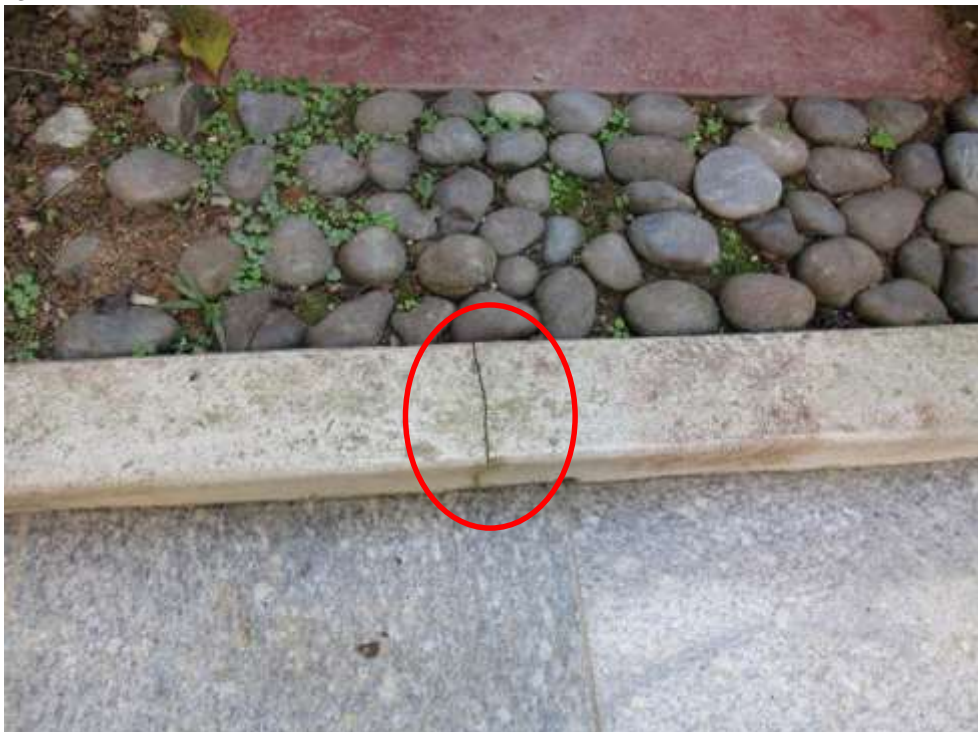
Photo No. 1232

Defect No. 116 **Location** G/F South wing, School Garden **Component** upstand curb

Description An area of cracks was observed on upstand curb

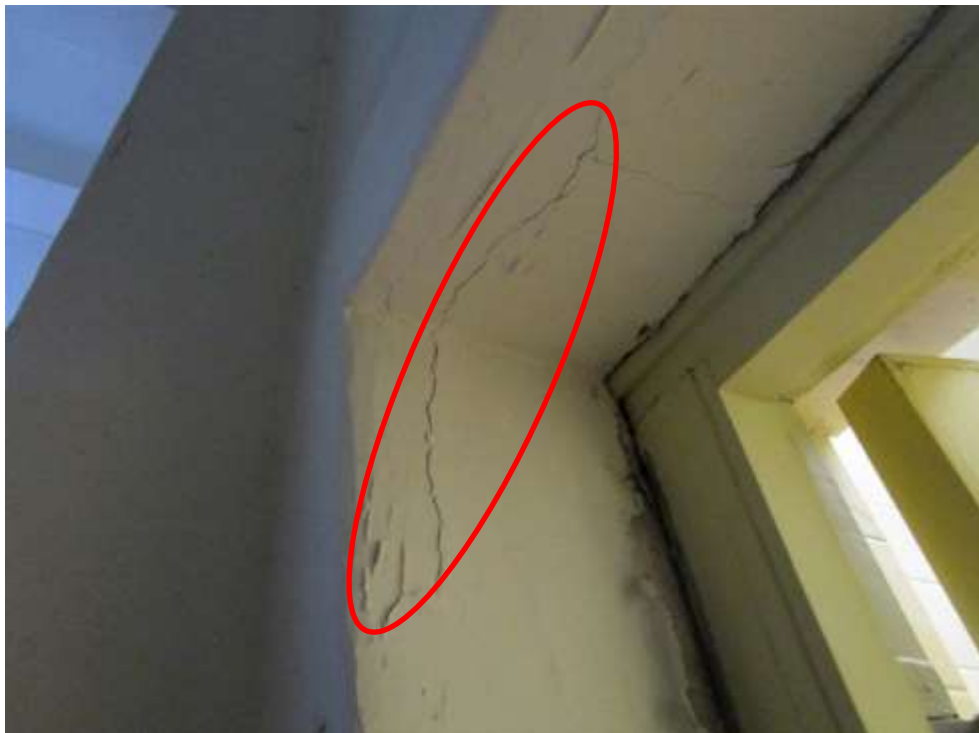
Photo No. 1234

Defect No. 117	Location G/F South wing, Medical inspection room	Component door lintel
-----------------------	---------------------------------------------------------	------------------------------

Description A medium crack was observed on door lintel

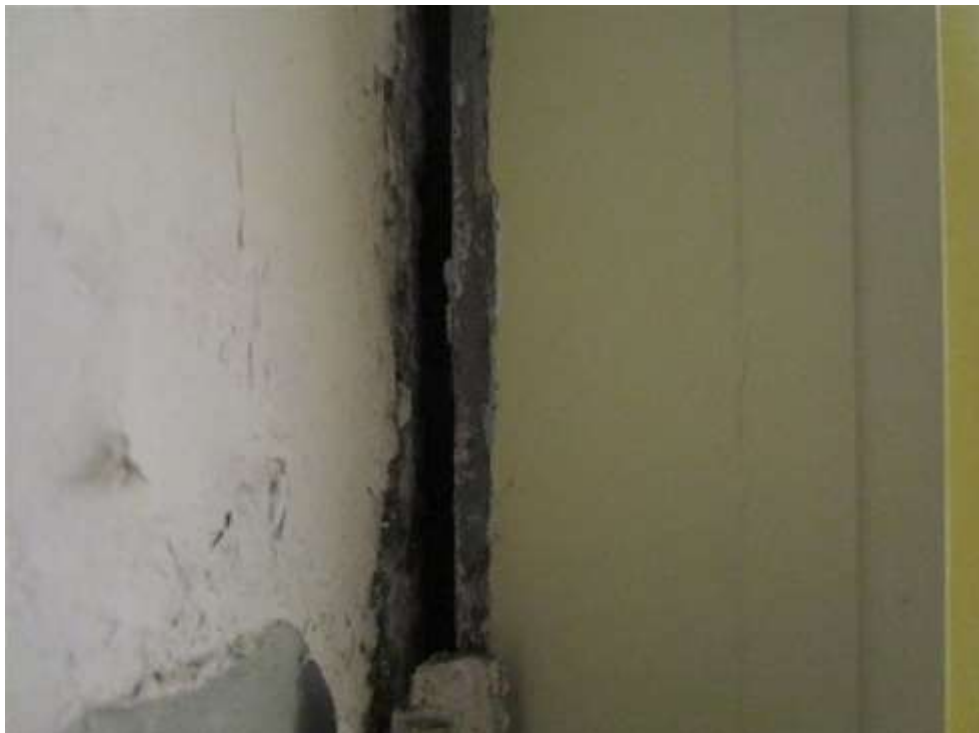
Photo No. 1236

Defect No. 118	Location G/F South wing, Medical inspection room	Component door jamb
-----------------------	---------------------------------------------------------	----------------------------

Description A gap was observed between the wall and door jamb

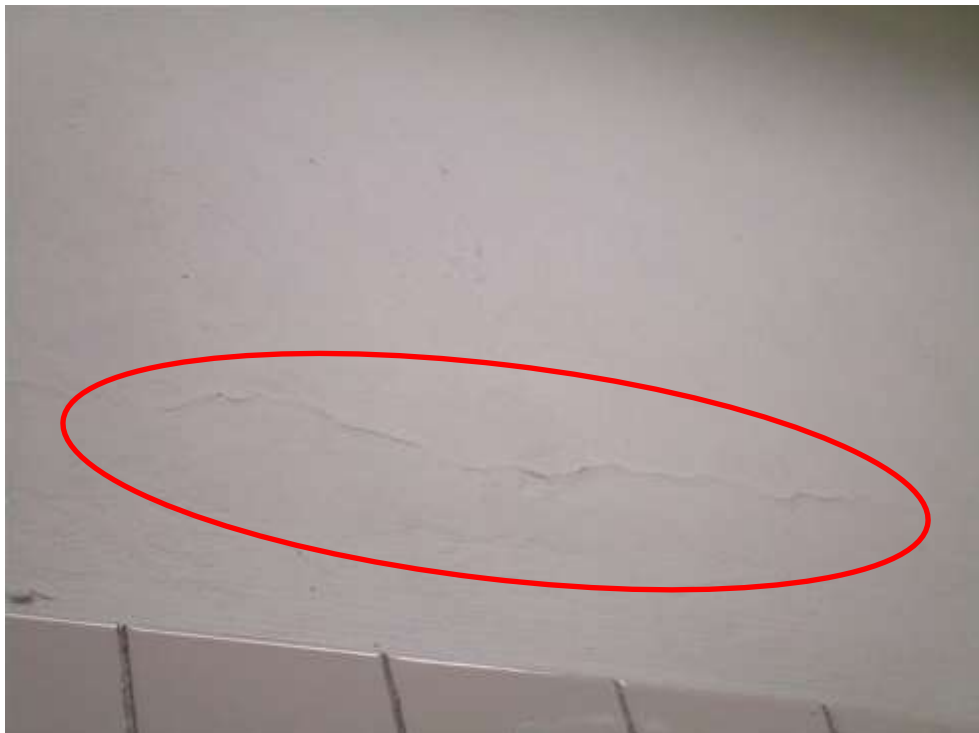
Photo No. 1238

Defect No.	119	Location	G/F South wing, Medical inspection room	Component	wall
-------------------	-----	-----------------	-----------------------------------------	------------------	------

Description A hairline crack was observed on wall finishing

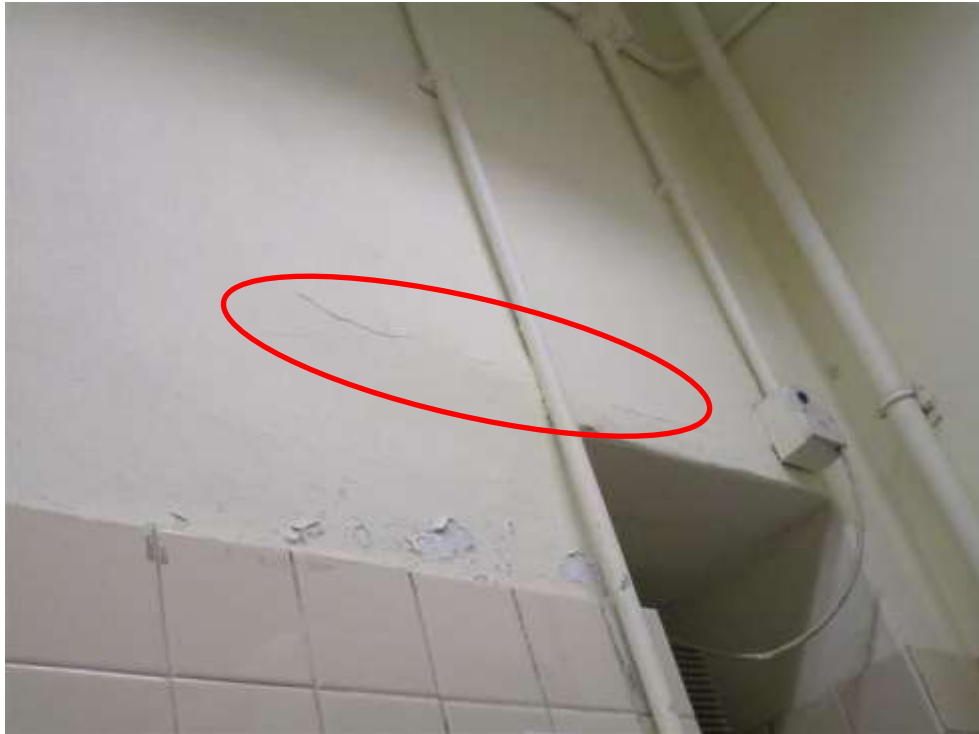
Photo No. 1239

Defect No.	119	Location	G/F South wing, Medical inspection room	Component	wall
-------------------	-----	-----------------	-----------------------------------------	------------------	------

Description A hairline crack was observed on wall finishing

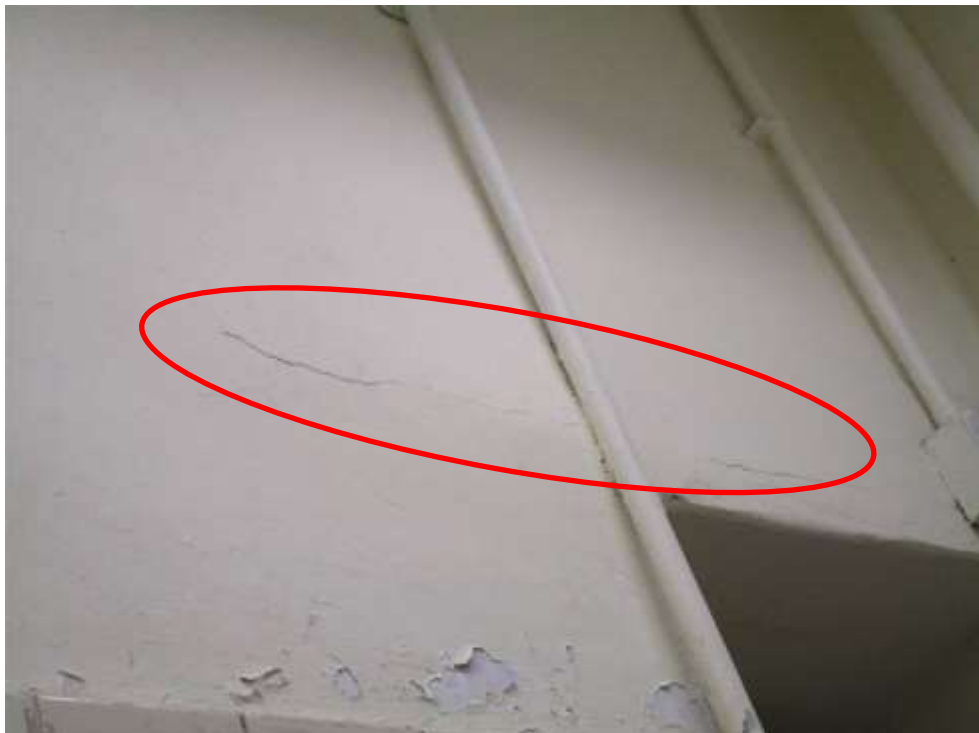
Photo No. 1240

Defect No. 120	Location G/F South wing, Medical inspection room	Component wall
-----------------------	---------------------------------------------------------	-----------------------

Description A medium crack was observed on wall finishing

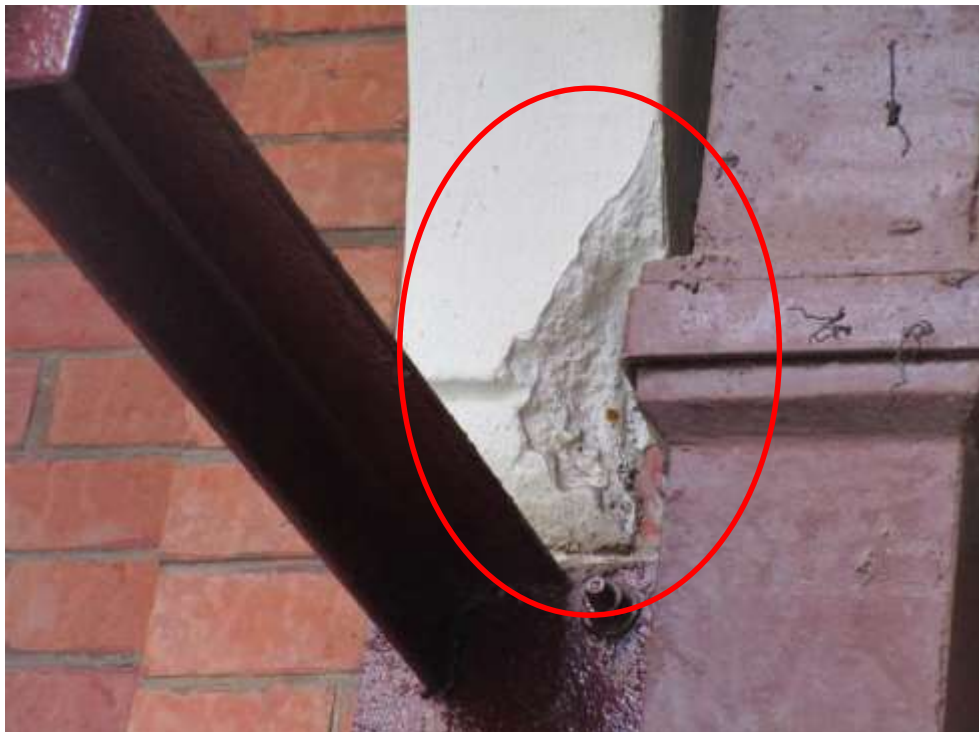
Photo No. 1242

Defect No.	121	Location	G/F South wing, north elevation	Component	canopy bracing
Description	A canopy bracing was found chipped off

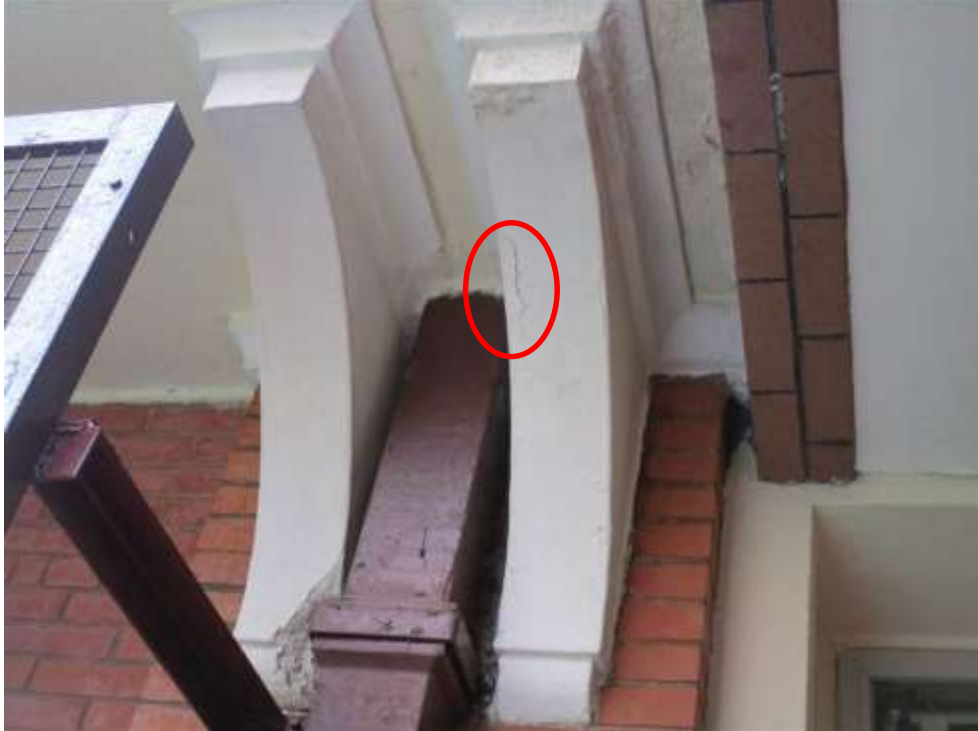
Photo No. 1243

Defect No.	121	Location	G/F South wing, north elevation	Component	canopy bracing
Description	A canopy bracing was found chipped off

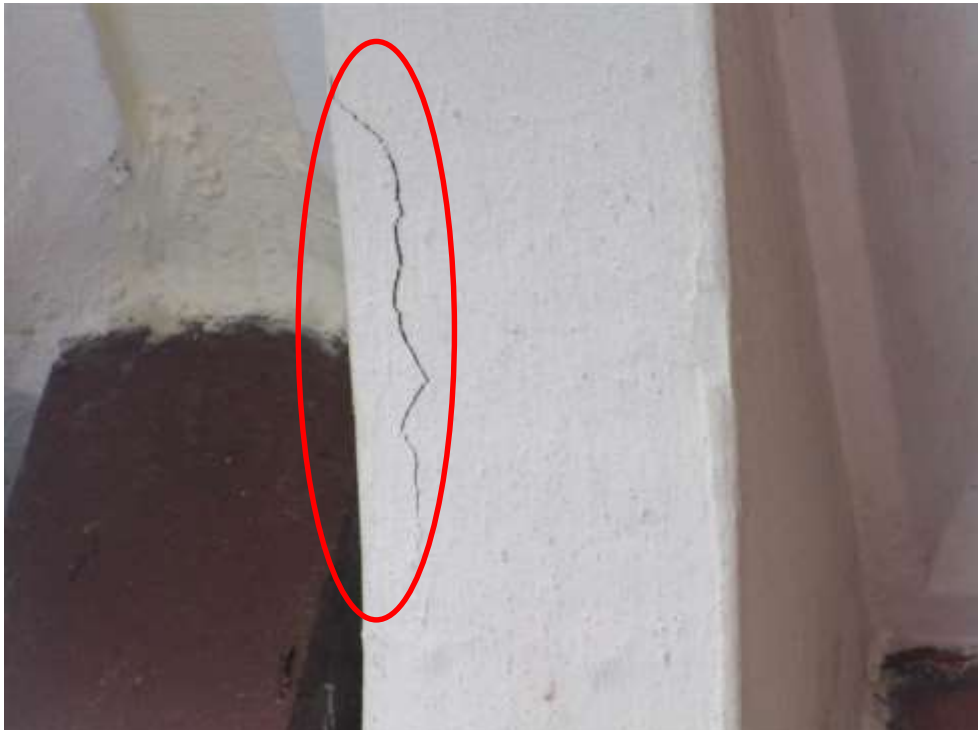
Photo No. 1244

Defect No. 122 **Location** G/F South wing, north elevation **Component** canopy bracing

Description A medium crack was observed on finishing of canopy bracing

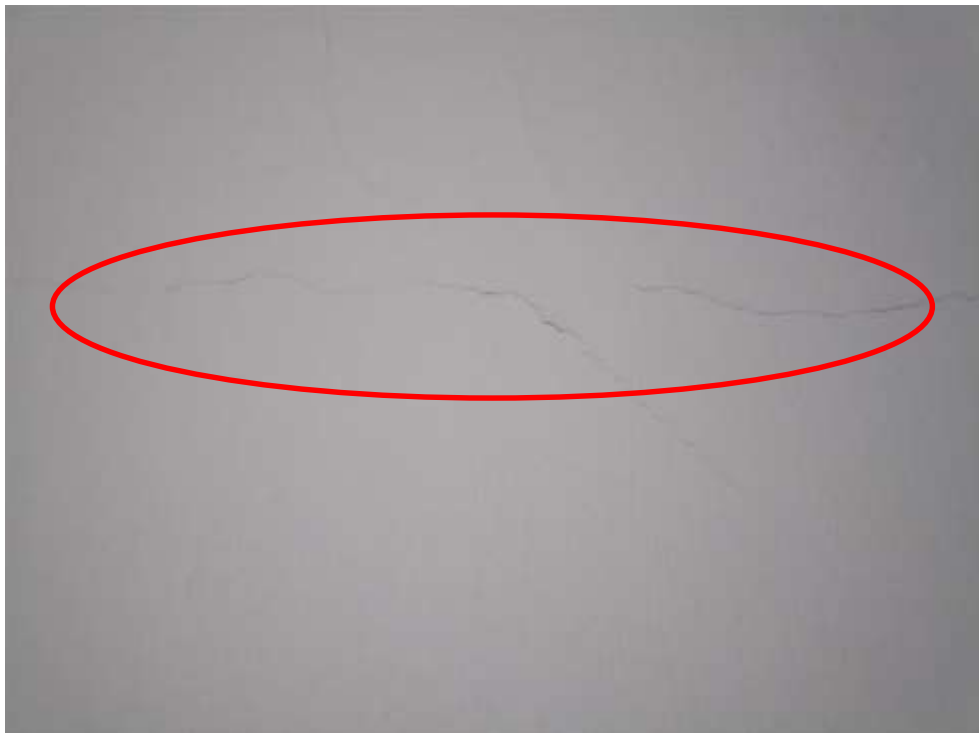
Photo No. 1246

Defect No.	123	Location	G/F-1/F North wing, NW staircase	Component	wall
-------------------	-----	-----------------	----------------------------------	------------------	------

Description A hairline crack was observed on wall finishing

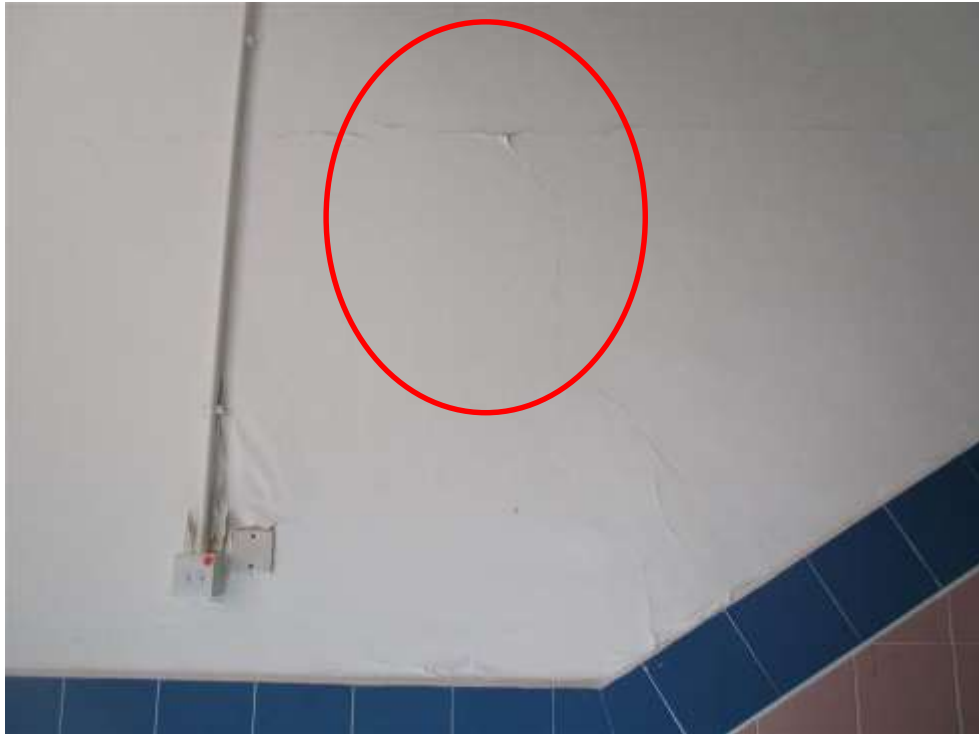
Photo No. 1247

Defect No.	123	Location	G/F-1/F North wing, NW staircase	Component	wall
-------------------	-----	-----------------	----------------------------------	------------------	------

Description A hairline crack was observed on wall finishing

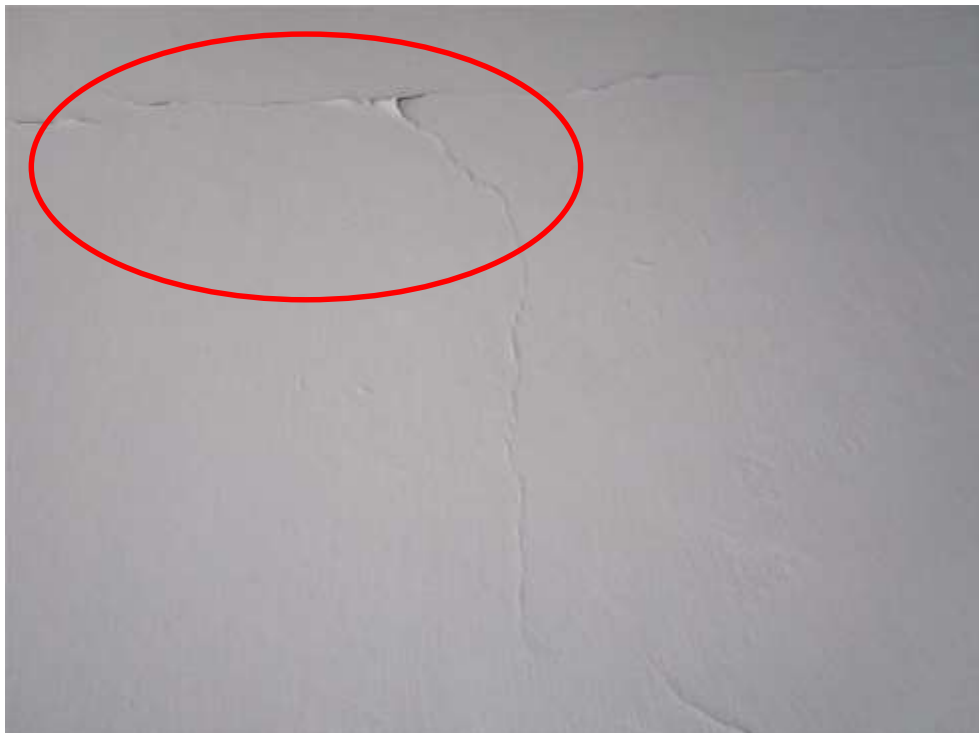
Photo No. 1248

Defect No. 124	Location G/F-1/F North wing, NW staircase	Component wall
-----------------------	--------------------------------------------------	-----------------------

Description A hairline crack was observed on wall finishing

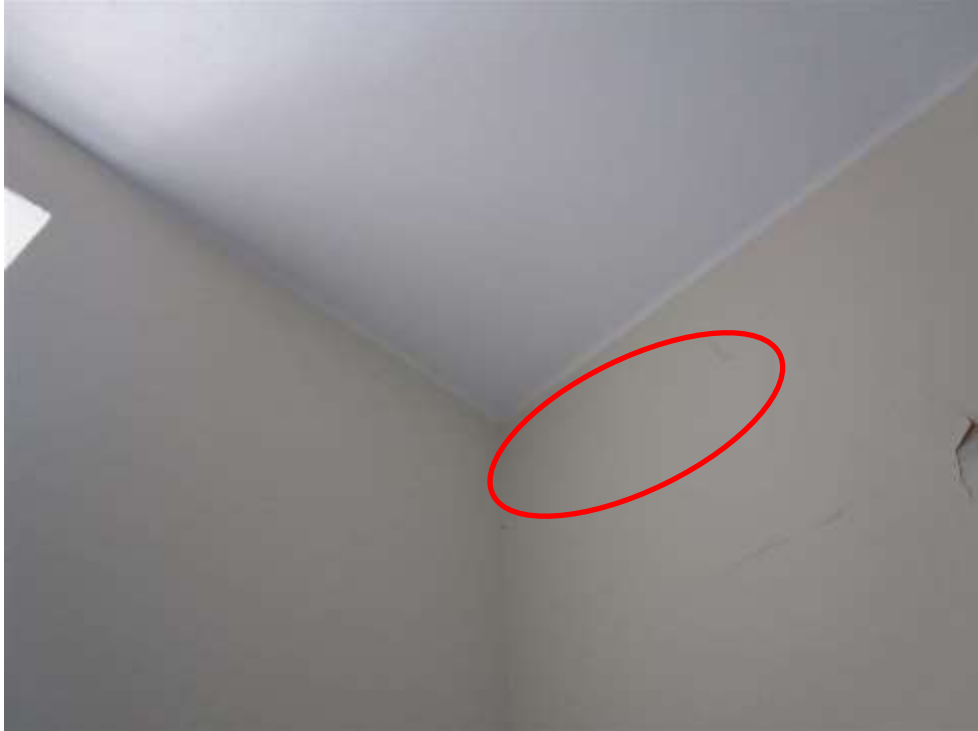
Photo No. 1249

Defect No. 124	Location G/F-1/F North wing, NW staircase	Component wall
-----------------------	--------------------------------------------------	-----------------------

Description A hairline crack was observed on wall finishing

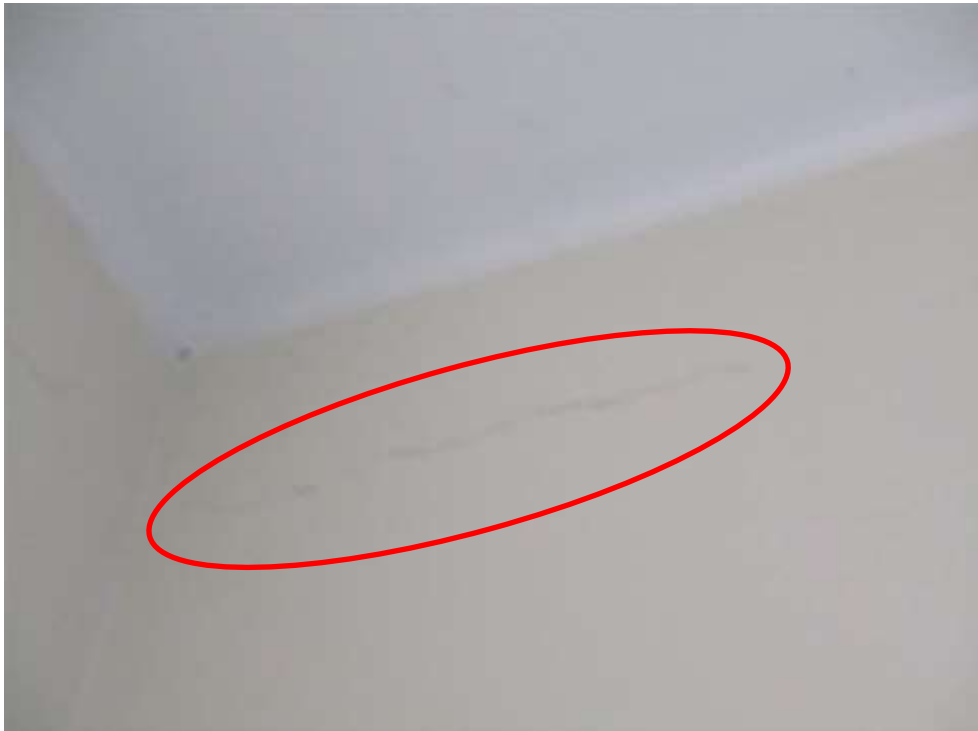
Photo No. 1250

Defect No. 125	Location G/F-1/F North wing, NW staircase	Component wall
-----------------------	--------------------------------------------------	-----------------------

Description A hairline crack was observed on wall finishing

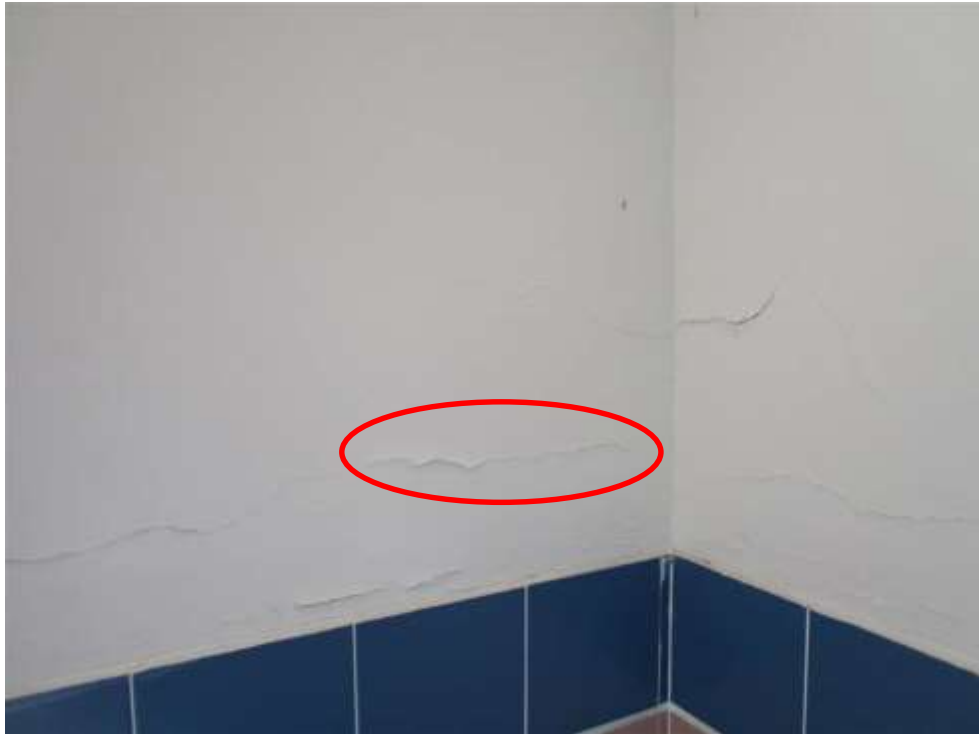
Photo No. 1251

Defect No. 125	Location G/F-1/F North wing, NW staircase	Component wall
-----------------------	--------------------------------------------------	-----------------------

Description A hairline crack was observed on wall finishing

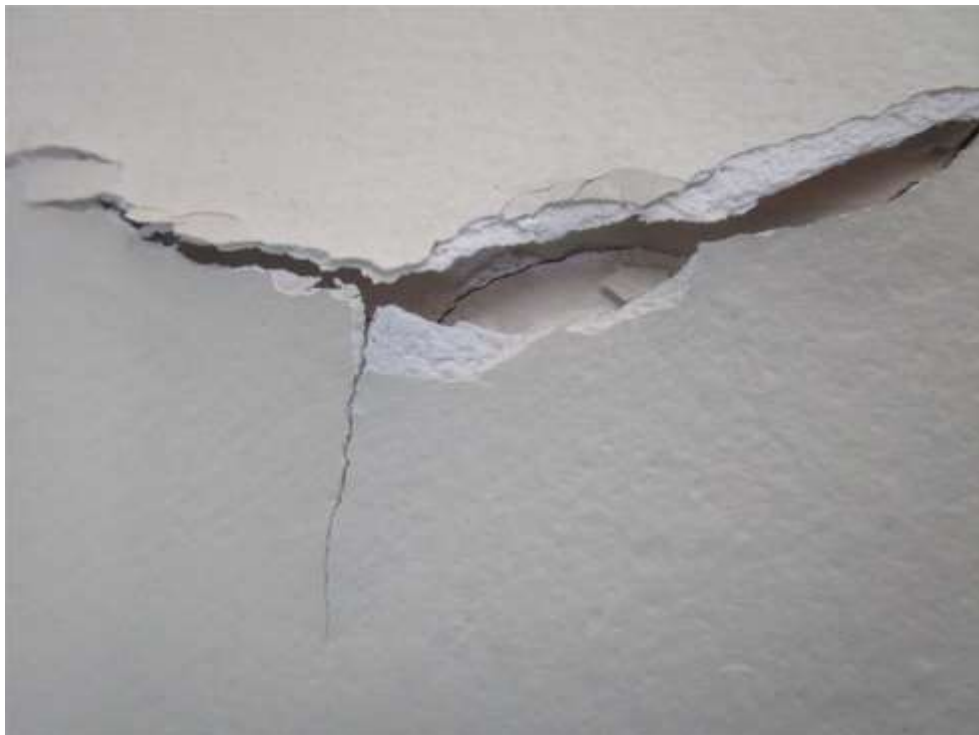
Photo No. 1252

Defect No. 126	Location G/F-1/F North wing, NW staircase	Component wall
-----------------------	--------------------------------------------------	-----------------------

Description A hairline crack was observed on wall finishing

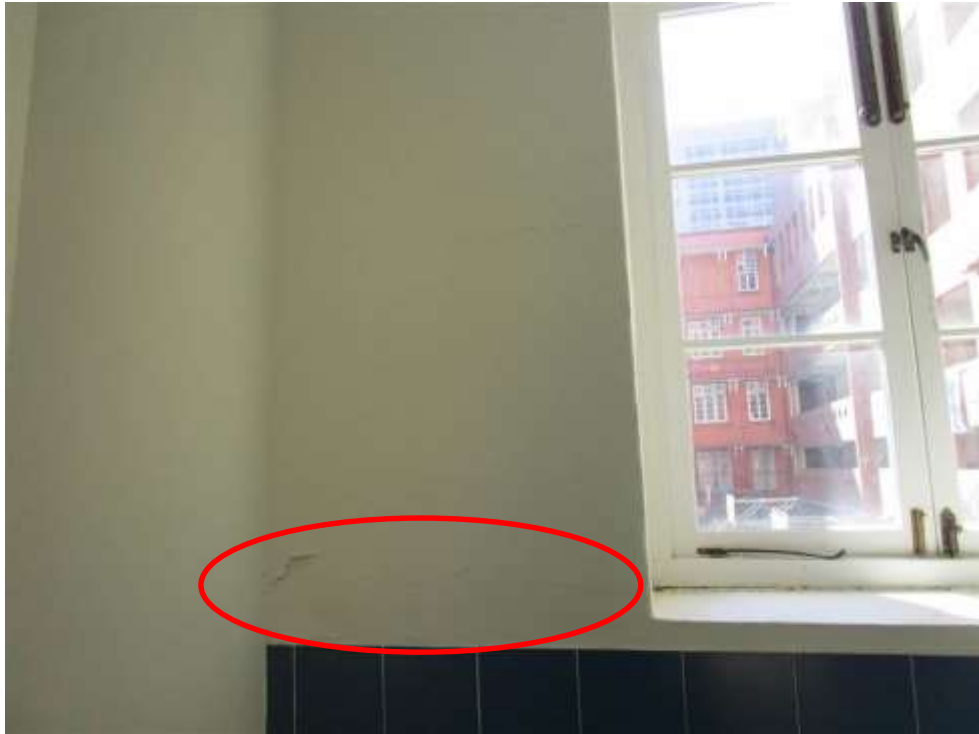
Photo No. 1253

Defect No. 126	Location G/F-1/F North wing, NW staircase	Component wall
-----------------------	--------------------------------------------------	-----------------------

Description A hairline crack was observed on wall finishing

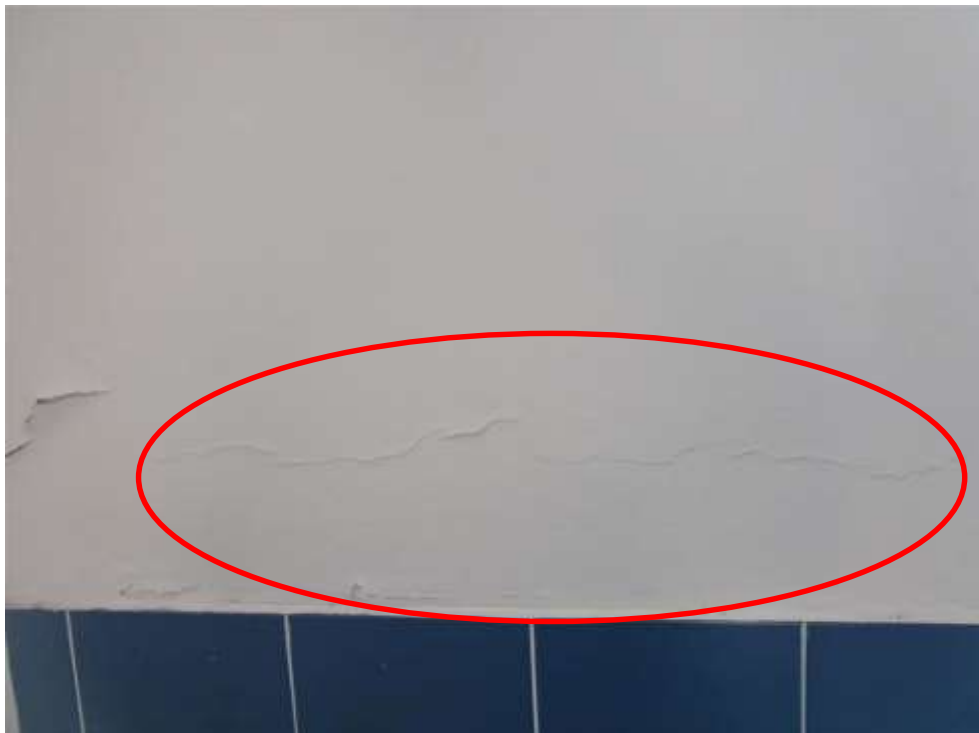
Photo No. 1254

Defect No. 127	Location G/F-1/F North wing, NW staircase	Component wall
-----------------------	--------------------------------------------------	-----------------------

Description A medium crack was observed on wall finishing

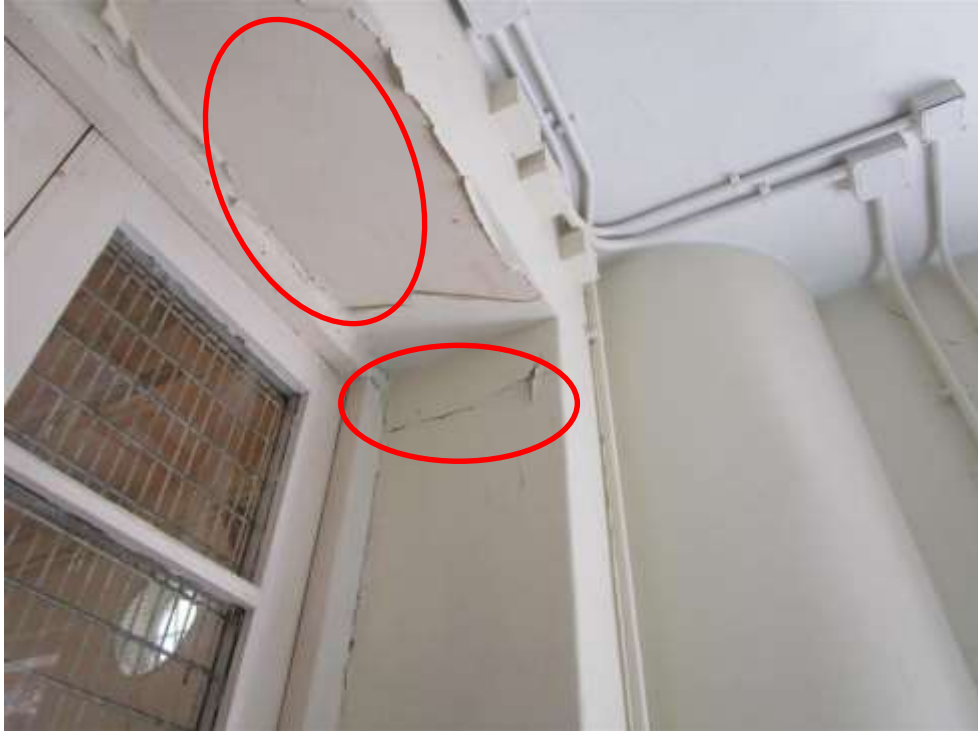
Photo No. 1255

Defect No. 127	Location G/F-1/F North wing, NW staircase	Component wall
-----------------------	--------------------------------------------------	-----------------------

Description A medium crack was observed on wall finishing

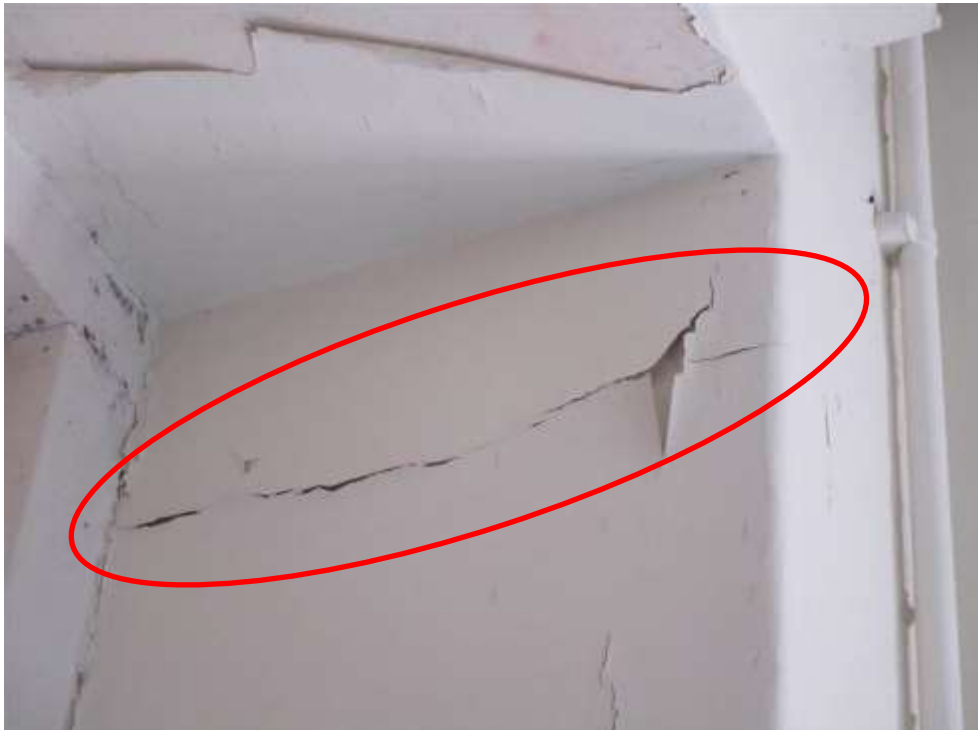
Photo No. 1256

Defect No. 128 **Location** LG/F North wing, NW staircase **Component** wall

Description Paint peeling was observed on wall

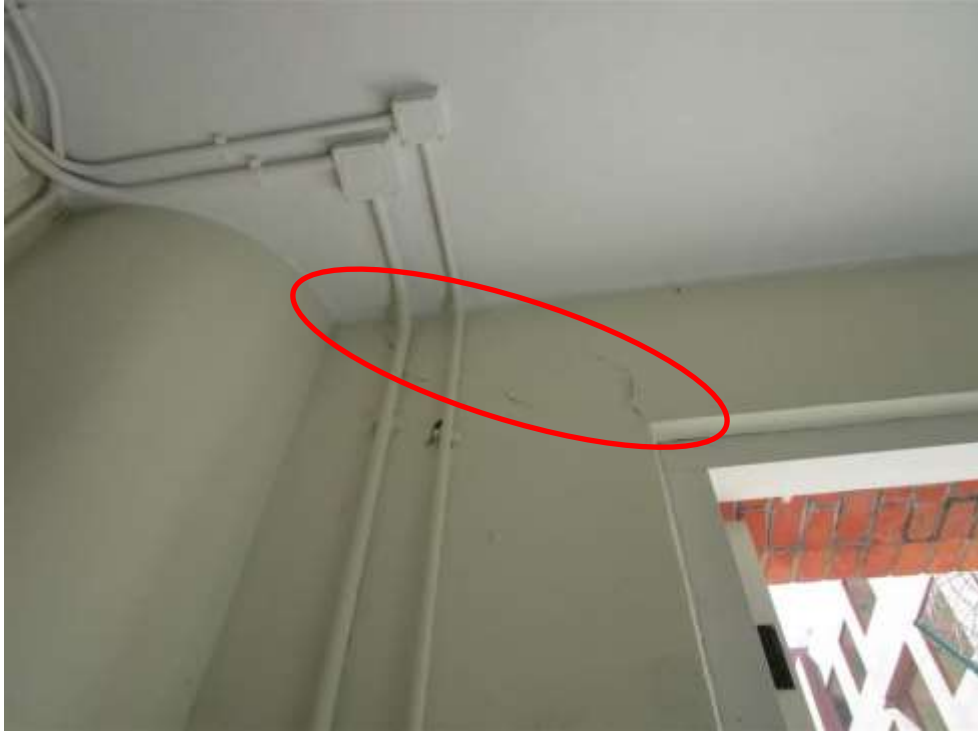
Photo No. 1257

Defect No. 128 **Location** LG/F North wing, NW staircase **Component** wall

Description Paint peeling was observed on wall

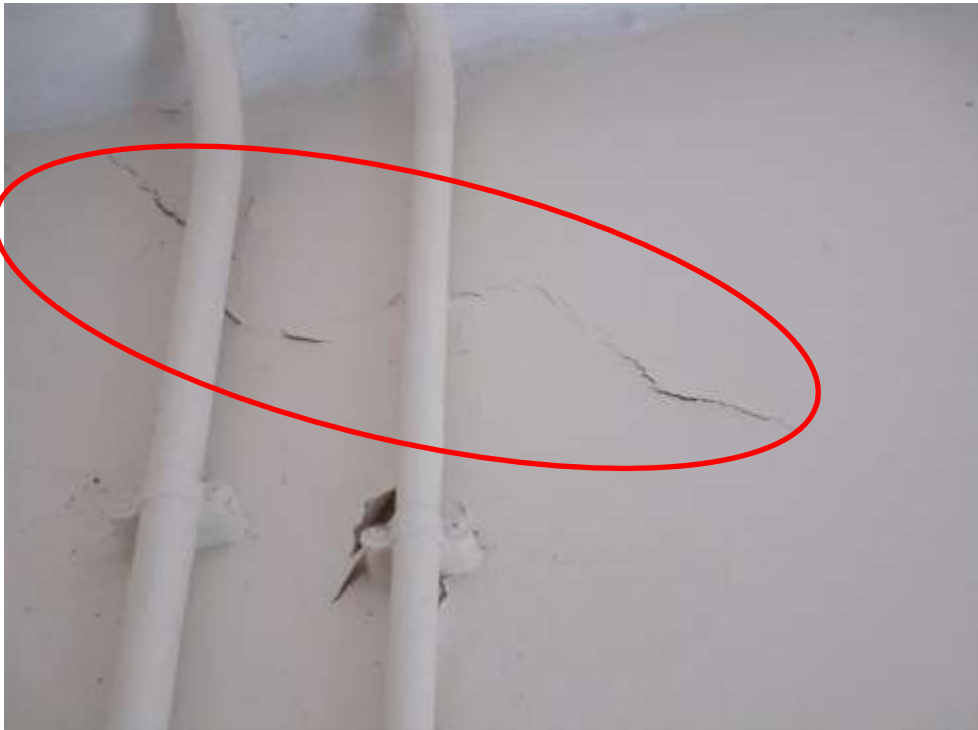
Photo No. 1258

Defect No.	129	Location	LG/F North wing, NW staircase	Component	wall
-------------------	-----	-----------------	-------------------------------	------------------	------

Description	A medium crack was observed on wall finishing				
--------------------	-----------------------------------------------	--	--	--	--

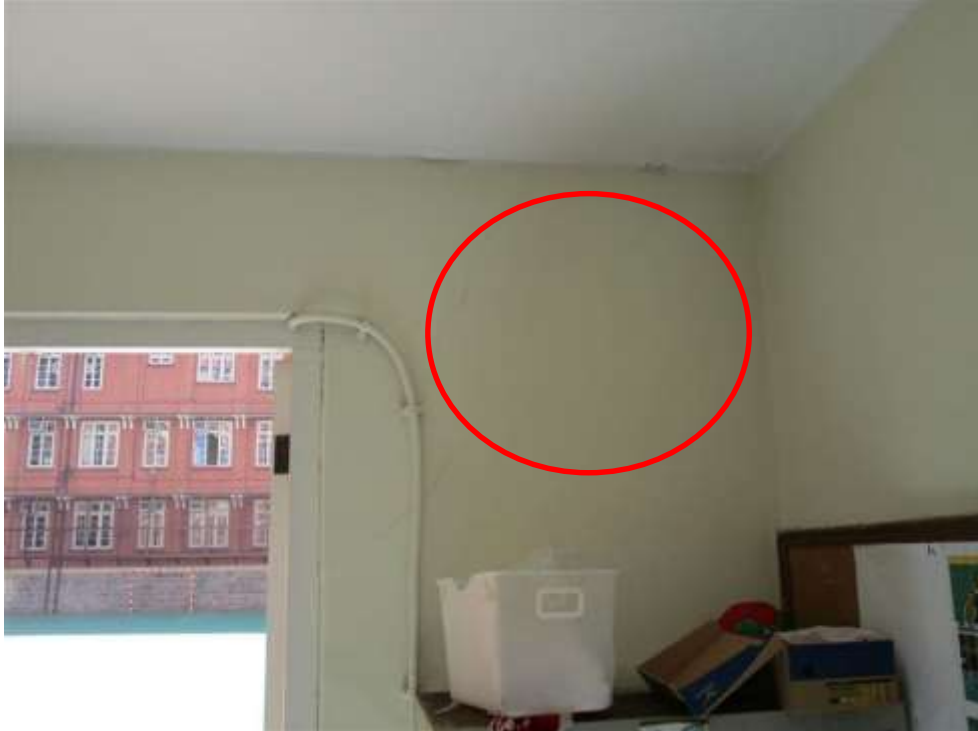
Photo No. 1259

Defect No.	129	Location	LG/F North wing, NW staircase	Component	wall
-------------------	-----	-----------------	-------------------------------	------------------	------

Description	A medium crack was observed on wall finishing				
--------------------	-----------------------------------------------	--	--	--	--
