**Slope Upgrading Works at
Feature No. 11SW-A/R526,
King's College,
Bonham Road, Hong Kong**

Project Profile for Slope Upgrading Works at
Feature No. 11SW-A/R526, King's College

May 2018

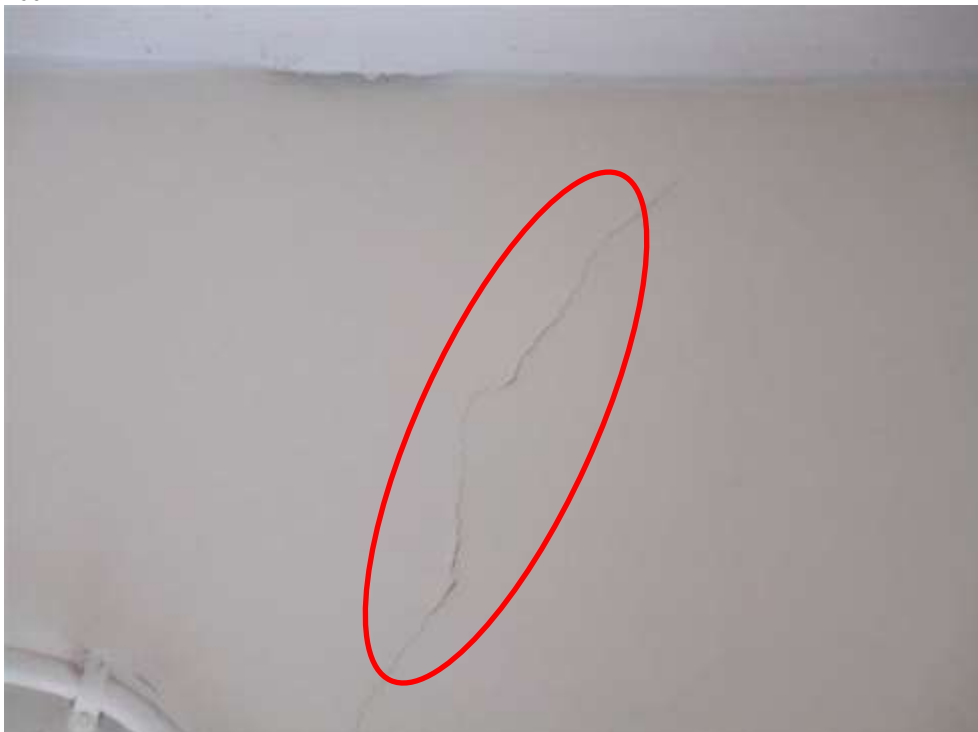
Photo No. 1260

Defect No.	130	Location	LG/F North wing, NW staircase	Component	wall
-------------------	-----	-----------------	-------------------------------	------------------	------

Description	A medium crack was observed on wall finishing				
--------------------	-----------------------------------------------	--	--	--	--

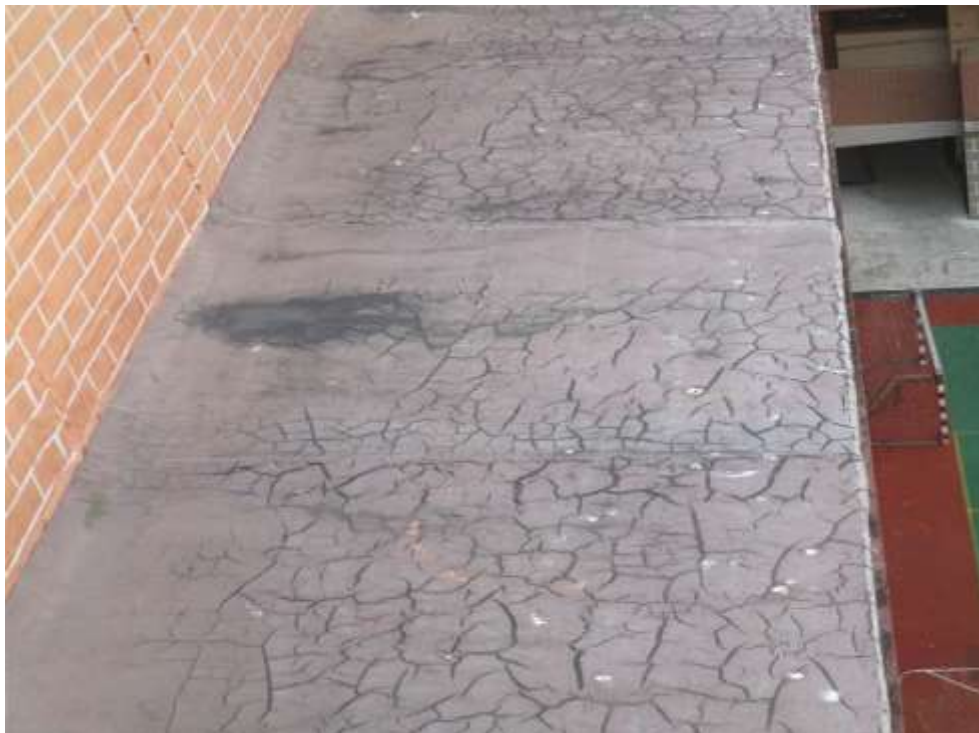
Photo No. 1262

Defect No. 131	Location G/F-R/F South wing, North elevation	Component canopy
-----------------------	-----------------------------------------------------	-------------------------

Description Paint deterioration was observed on the top face of canopies

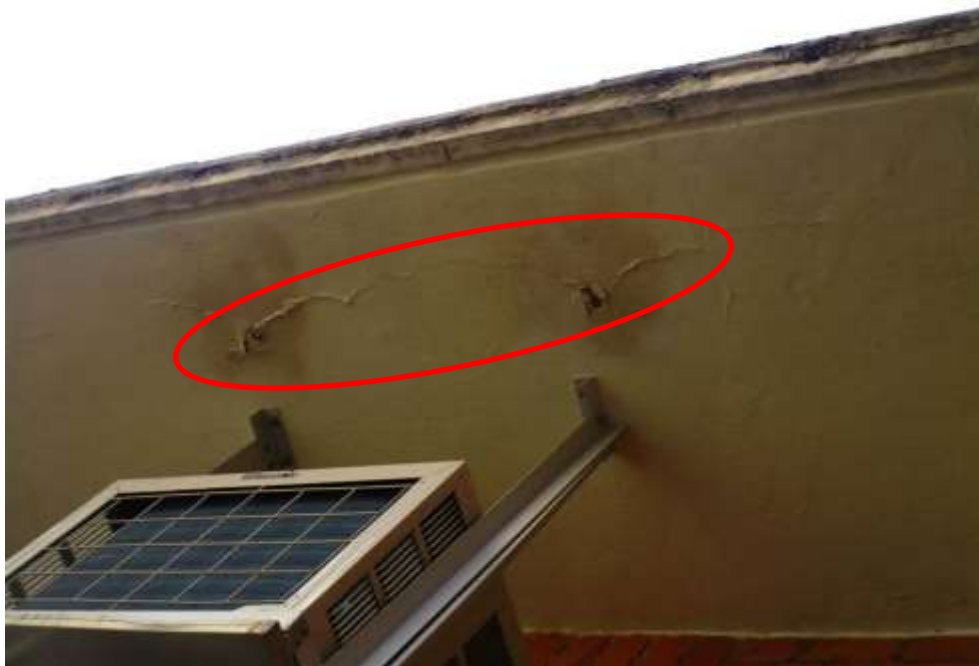
Photo No. 1264

Defect No. 132 **Location** R/F South wing, North elevation **Component** canopy

Description A medium crack was observed on canopy soffit finishing

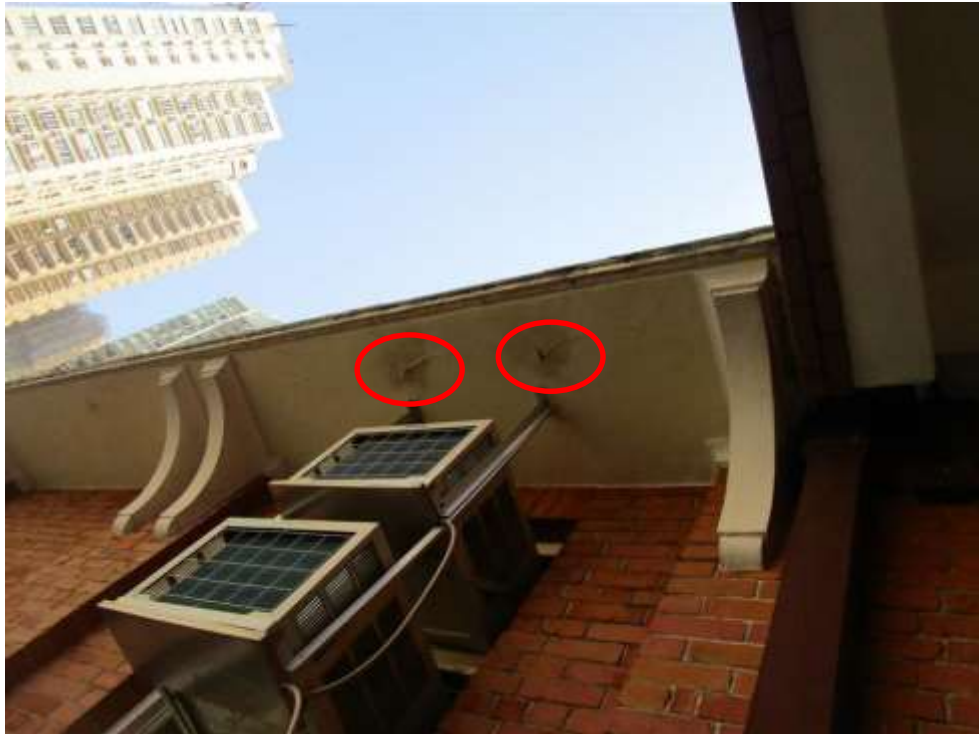
Photo No. 1265

Defect No. 132 **Location** R/F South wing, North elevation **Component** canopy

Description A medium crack was observed on canopy soffit finishing

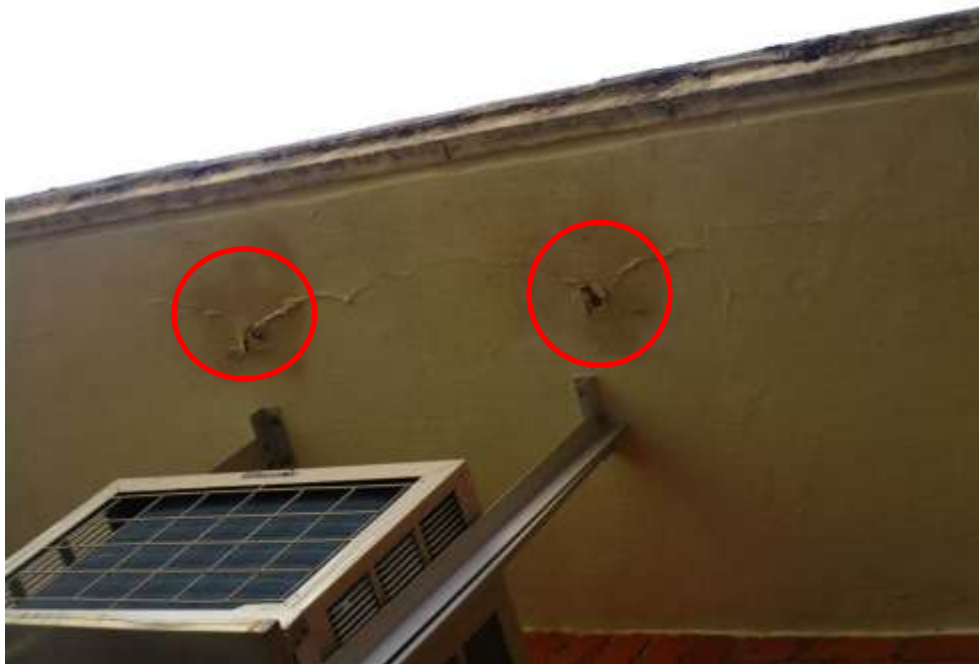
Photo No. 1266

Defect No. 133	Location G/F-R/F South wing, North elevation	Component canopy
-----------------------	-----------------------------------------------------	-------------------------

Description Minor damp patches were observed on canopy soffit

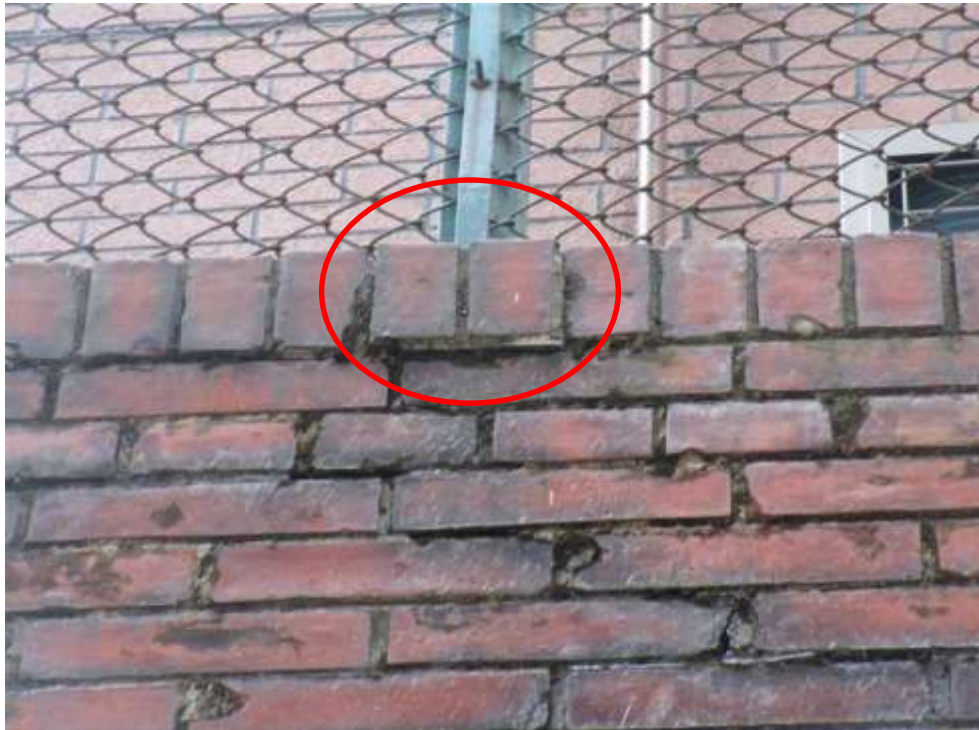
Photo No. 1268

Defect No. 134	Location LB/F Swimming pool	Component brick wall
-----------------------	------------------------------------	-----------------------------

Description Loose bricks were observed on parapet brick wall

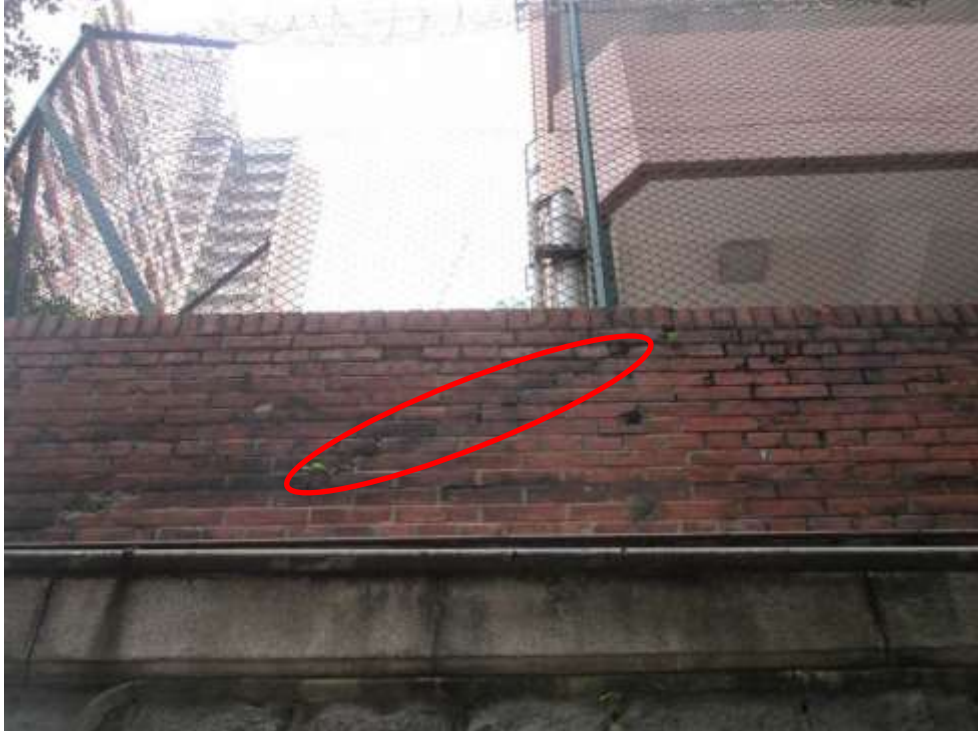
Photo No. 1269

Defect No. 134	Location LB/F Swimming pool	Component brick wall
-----------------------	------------------------------------	-----------------------------

Description Loose bricks were observed on parapet brick wall

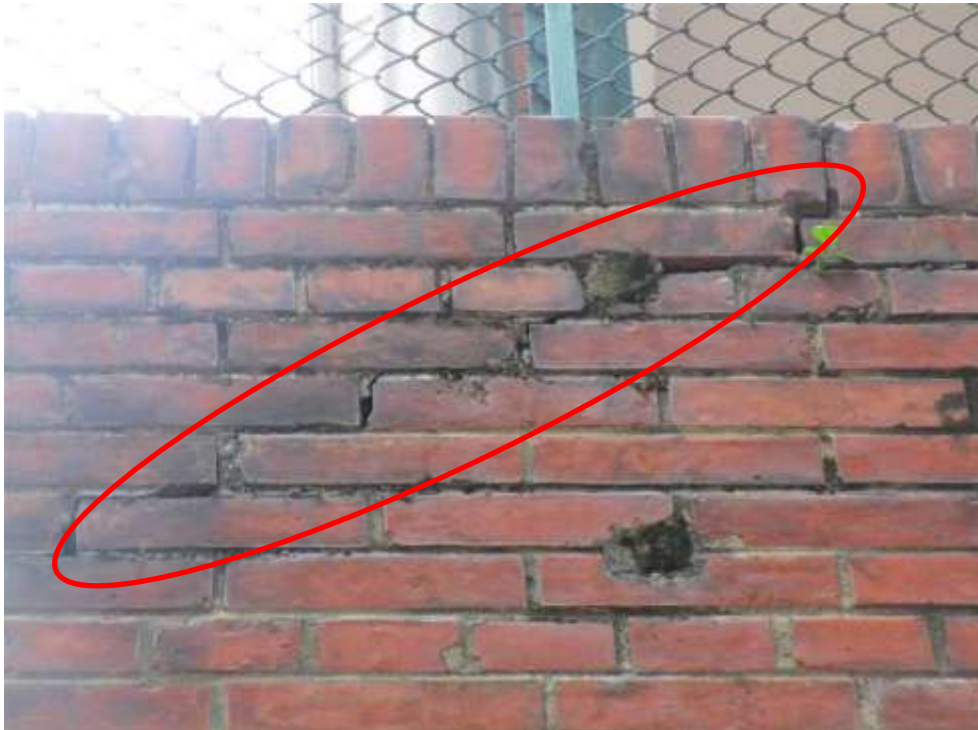
Photo No. 1270

Defect No. 135 **Location** LB/F Swimming pool **Component** brick wall

Description A wide crack was observed on parapet brick wall mortar joint

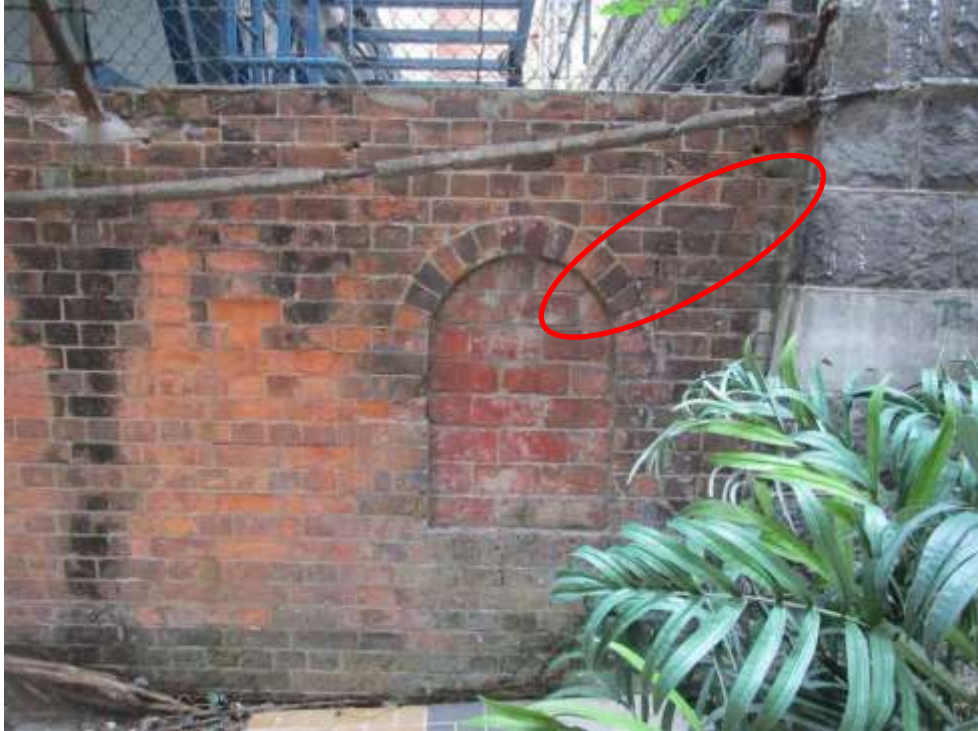
Photo No. 1271

Defect No. 135 **Location** LB/F Swimming pool **Component** brick wall

Description A wide crack was observed on parapet brick wall mortar joint

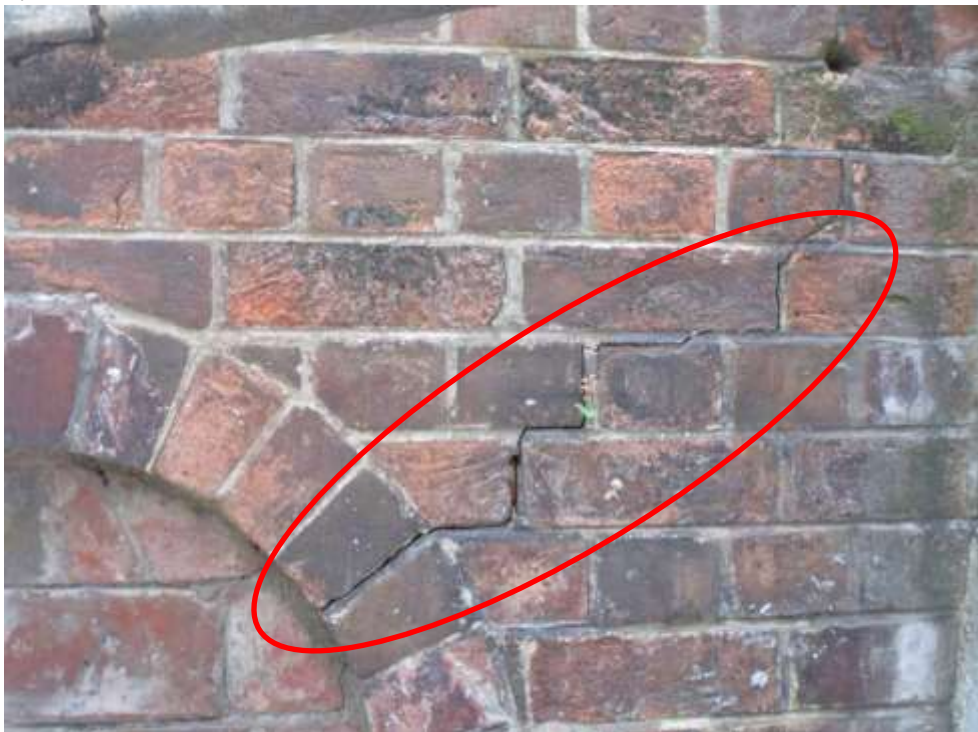
Photo No. 1272

Defect No. 136	Location LB/F Swimming pool	Component brick wall
-----------------------	------------------------------------	-----------------------------

Description A wide crack was observed on brick wall mortar joint

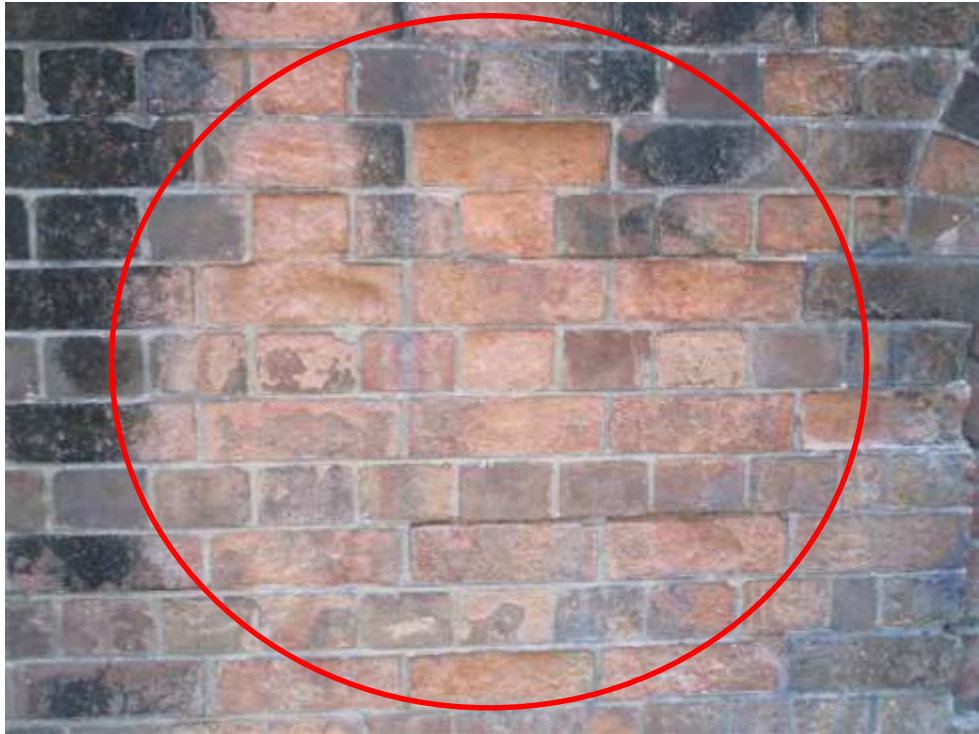
Photo No. 1273

Defect No. 136	Location LB/F Swimming pool	Component brick wall
-----------------------	------------------------------------	-----------------------------

Description A wide crack was observed on brick wall mortar joint

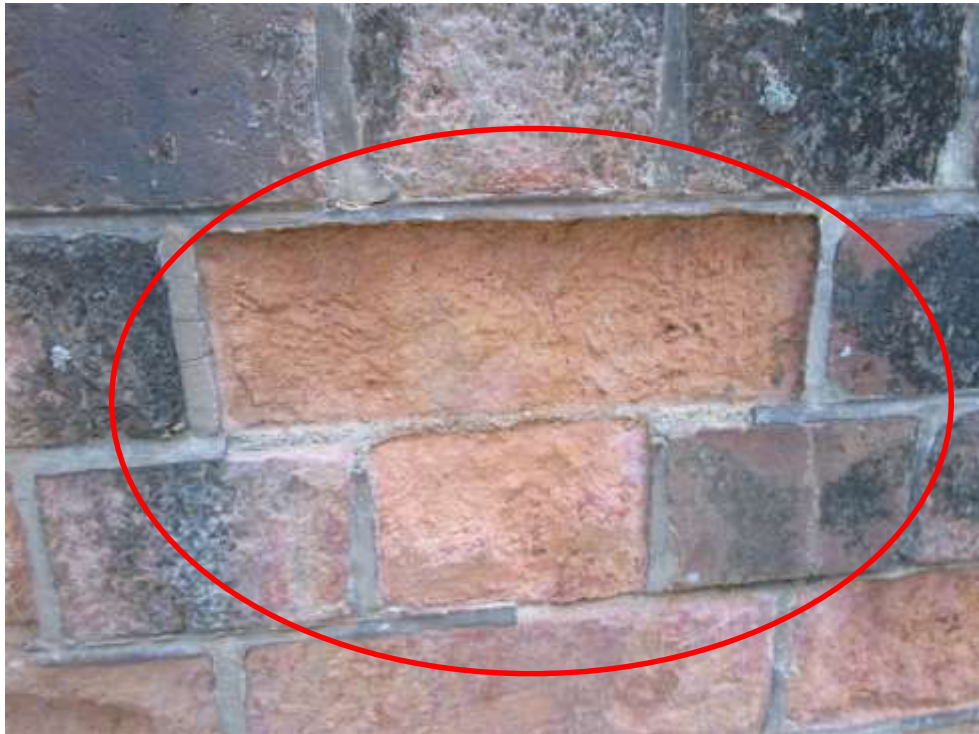
Photo No. 1274

Defect No. 137	Location LB/F Swimming pool	Component brick wall
-----------------------	------------------------------------	-----------------------------

Description Spalled bricks were observed on brick wall

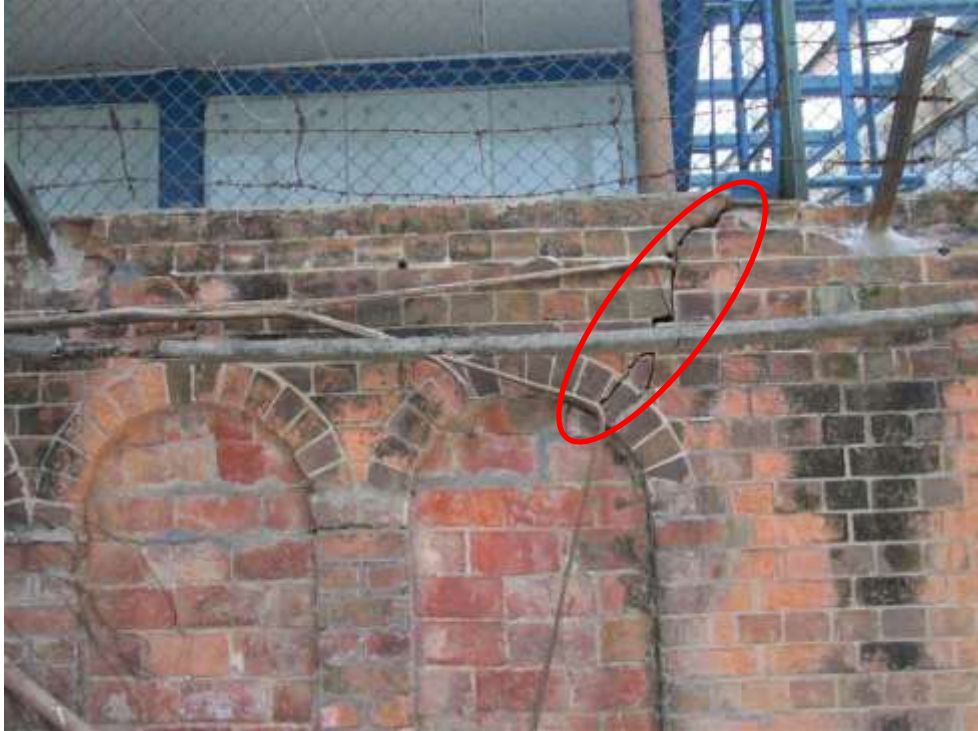
Photo No. 1275

Defect No. 137	Location LB/F Swimming pool	Component brick wall
-----------------------	------------------------------------	-----------------------------

Description Spalled bricks were observed on brick wall

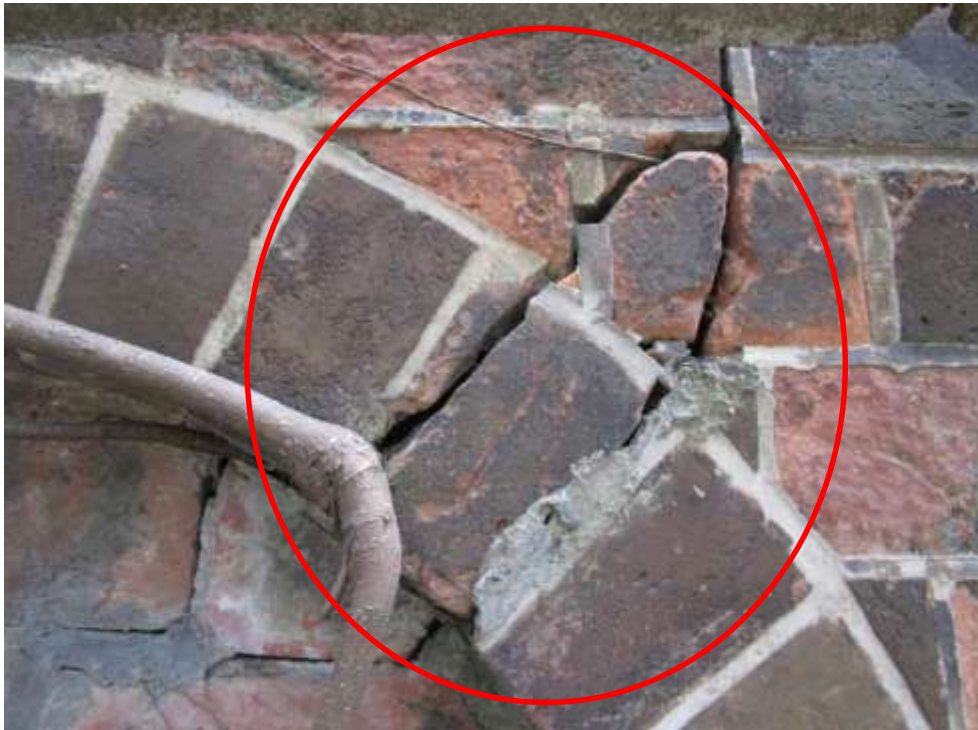
Photo No. 1276

Defect No.	138	Location	LB/F Swimming pool	Component	brick wall
-------------------	-----	-----------------	--------------------	------------------	------------

Description	Wide crack with loose bricks on brick wall				
--------------------	--------------------------------------------	--	--	--	--

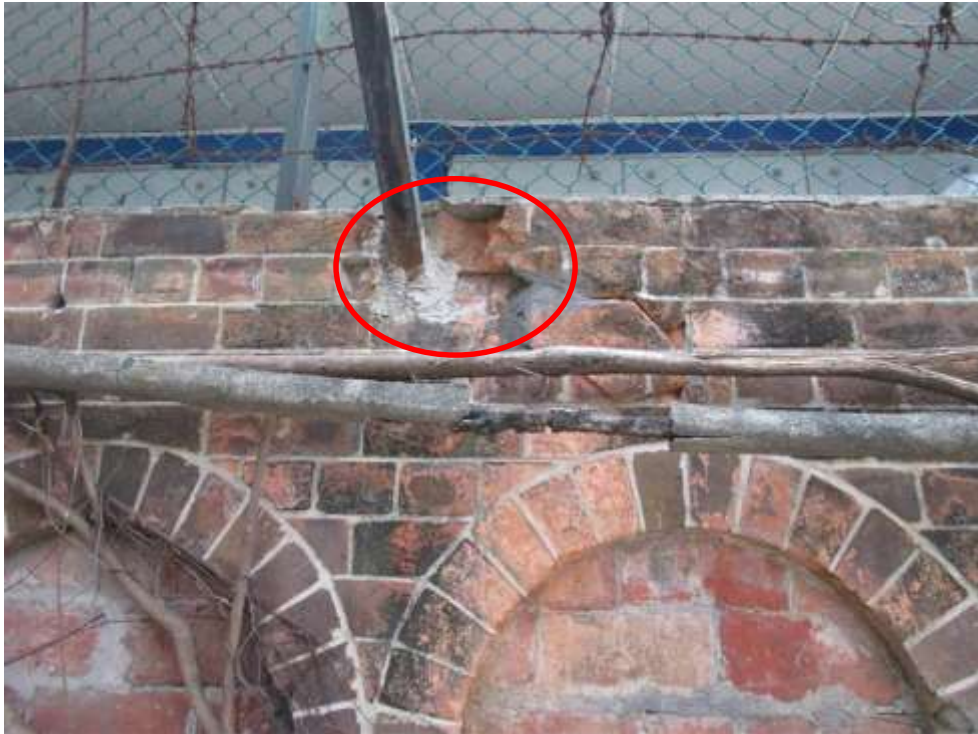
Photo No. 1277

Defect No.	138	Location	LB/F Swimming pool	Component	brick wall
-------------------	-----	-----------------	--------------------	------------------	------------

Description	Wide crack with loose bricks on brick wall				
--------------------	--------------------------------------------	--	--	--	--

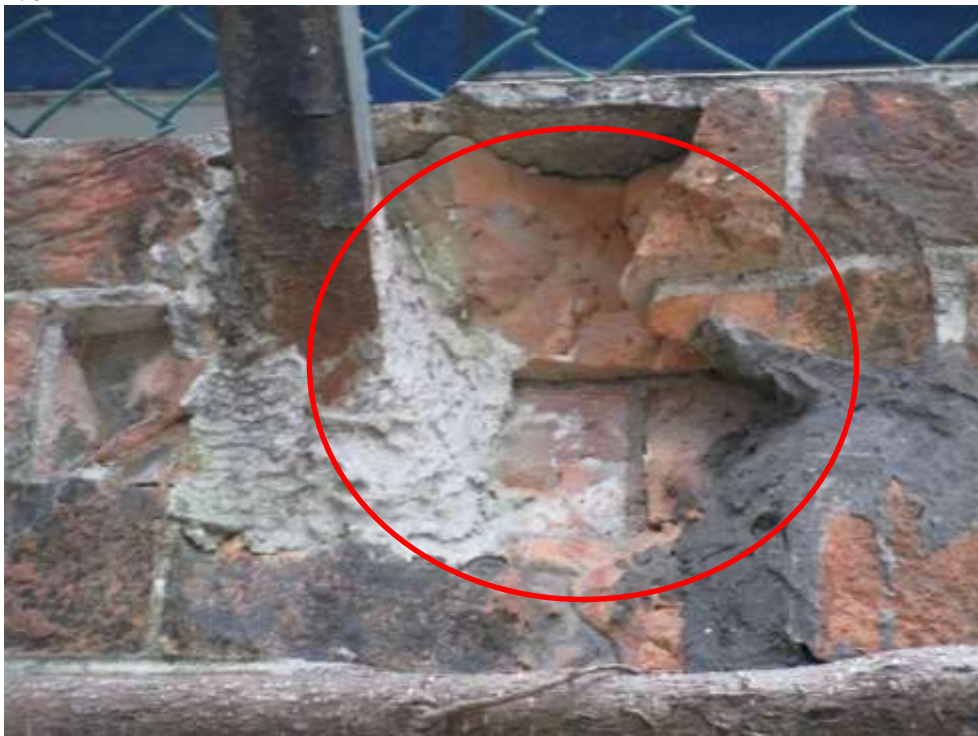
Photo No. 1278

Defect No. 139	Location LB/F Swimming pool	Component brick wall
-----------------------	------------------------------------	-----------------------------

Description Spalled bricks were observed on brick wall

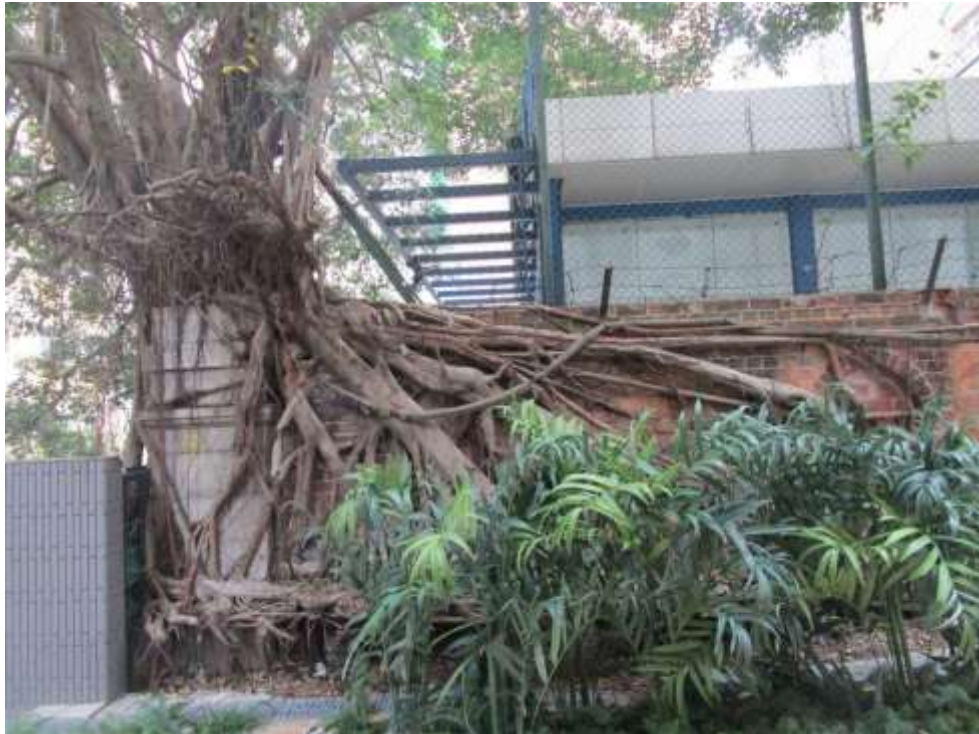
Photo No. 1279

Defect No. 139	Location LB/F Swimming pool	Component brick wall
-----------------------	------------------------------------	-----------------------------

Description Spalled bricks were observed on brick wall

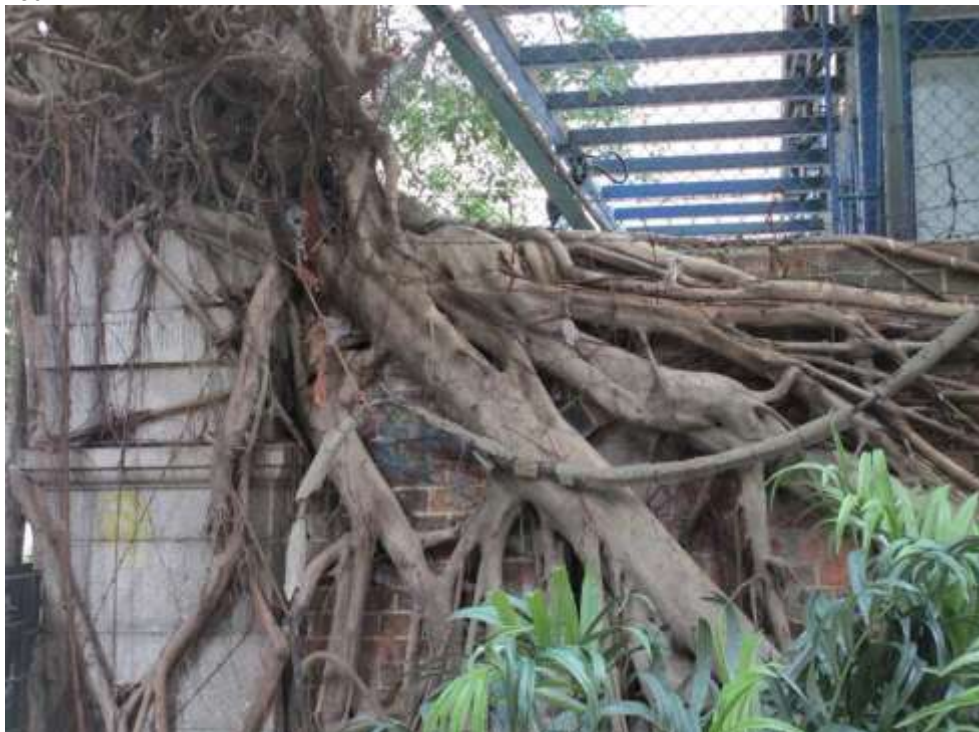
Photo No. 1280

Defect No.	140	Location	LB/F Swimming pool	Component	brick wall
-------------------	-----	-----------------	--------------------	------------------	------------

Description	A large tree was grown on top of the brick wall				
--------------------	-------------------------------------------------	--	--	--	--

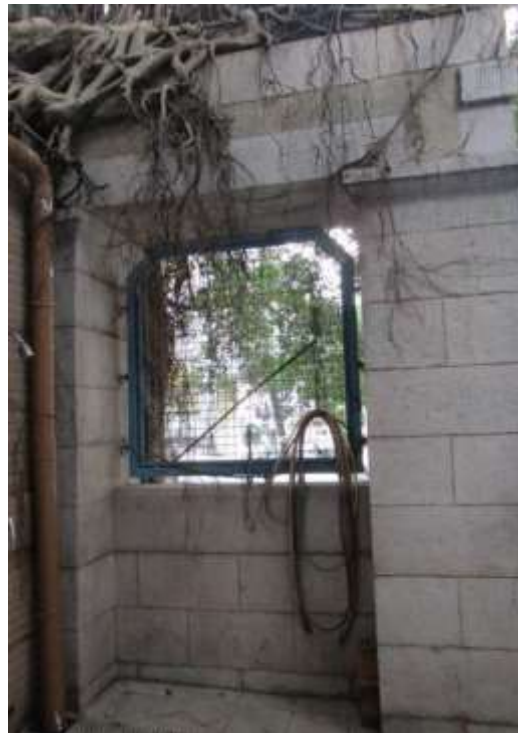
Photo No. 1281

Defect No.	140	Location	LB/F Swimming pool	Component	brick wall
-------------------	-----	-----------------	--------------------	------------------	------------

Description	A large tree was grown on top of the brick wall				
--------------------	-------------------------------------------------	--	--	--	--

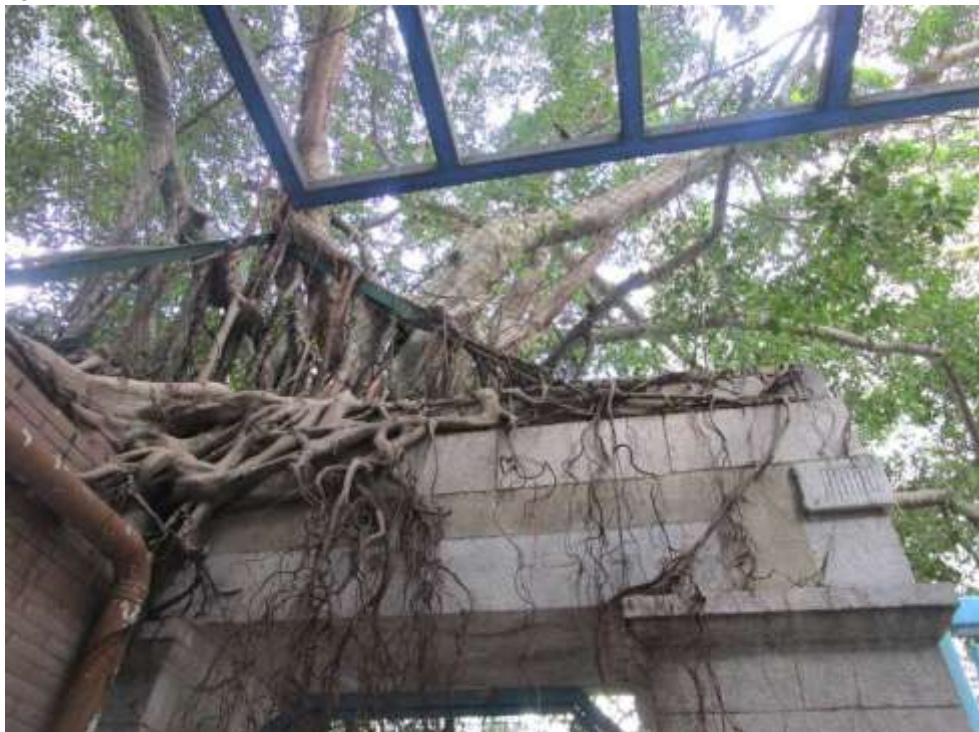
Photo No. 1282

Defect No.	141	Location	LB/F Swimming pool	Component	granite portal
-------------------	-----	-----------------	--------------------	------------------	----------------

Description	A vegetation growth was observed on granite portal				
--------------------	----------------------------------------------------	--	--	--	--

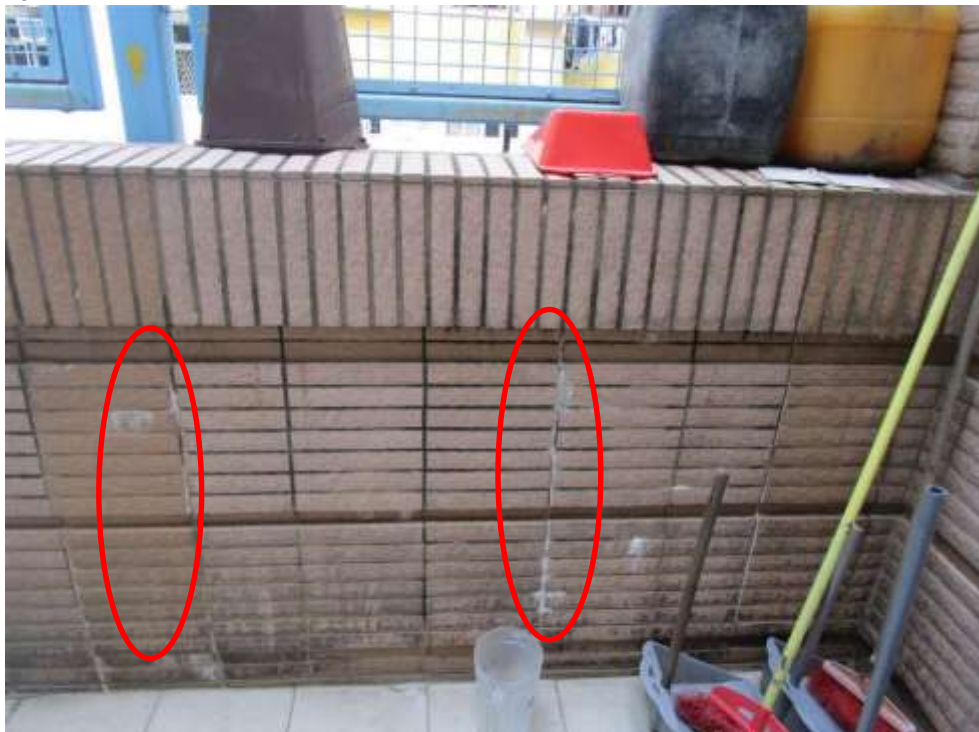
Photo No. 1284

Defect No.	142	Location	LB/F Swimming pool	Component	parapet
-------------------	-----	-----------------	--------------------	------------------	---------

Description	Patches of leaching were observed on parapet				
--------------------	----------------------------------------------	--	--	--	--

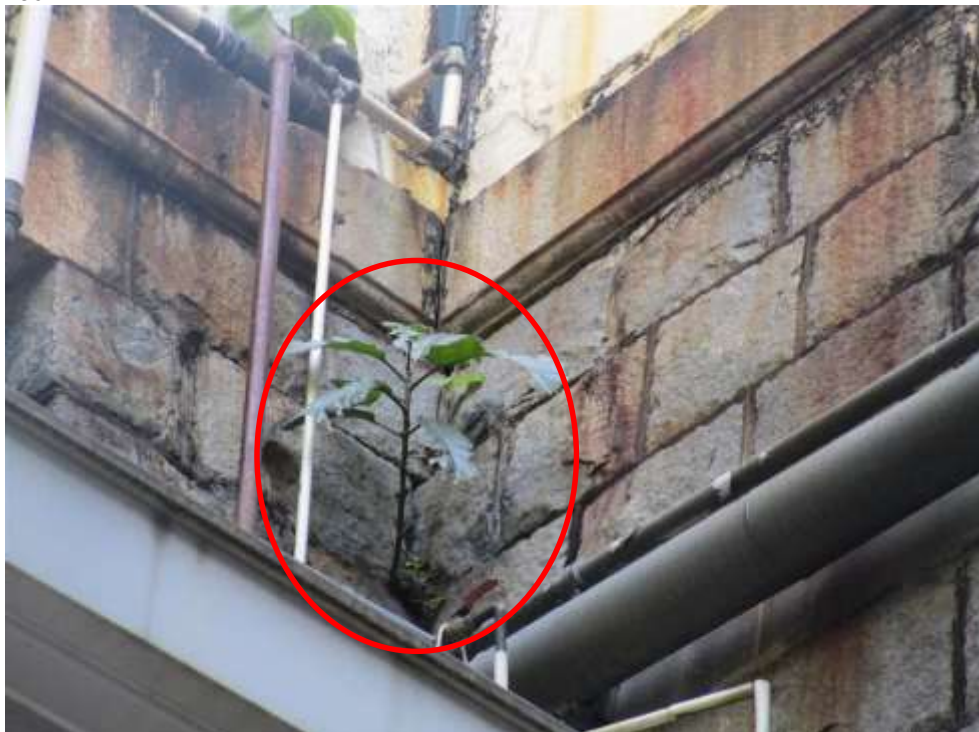
Photo No. 1286

Defect No. 143 **Location** LB/F Swimming pool **Component** retaining wall

Description A vegetation growth was observed on stone retaining wall

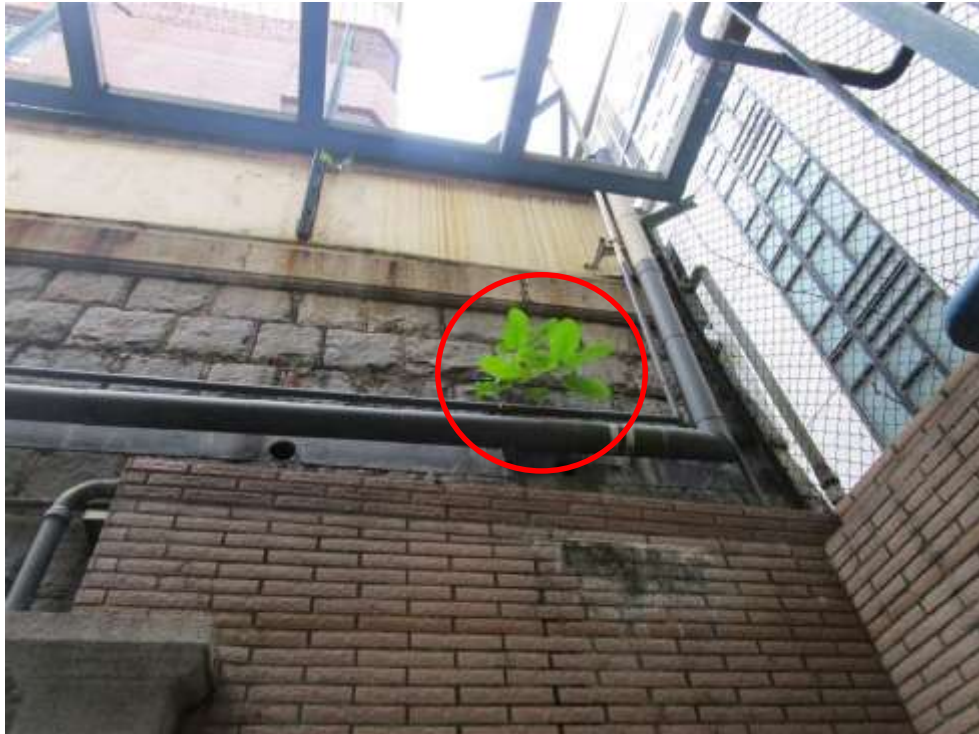
Photo No. 1287

Defect No. 143 **Location** LB/F Swimming pool **Component** retaining wall

Description A vegetation growth was observed on stone retaining wall

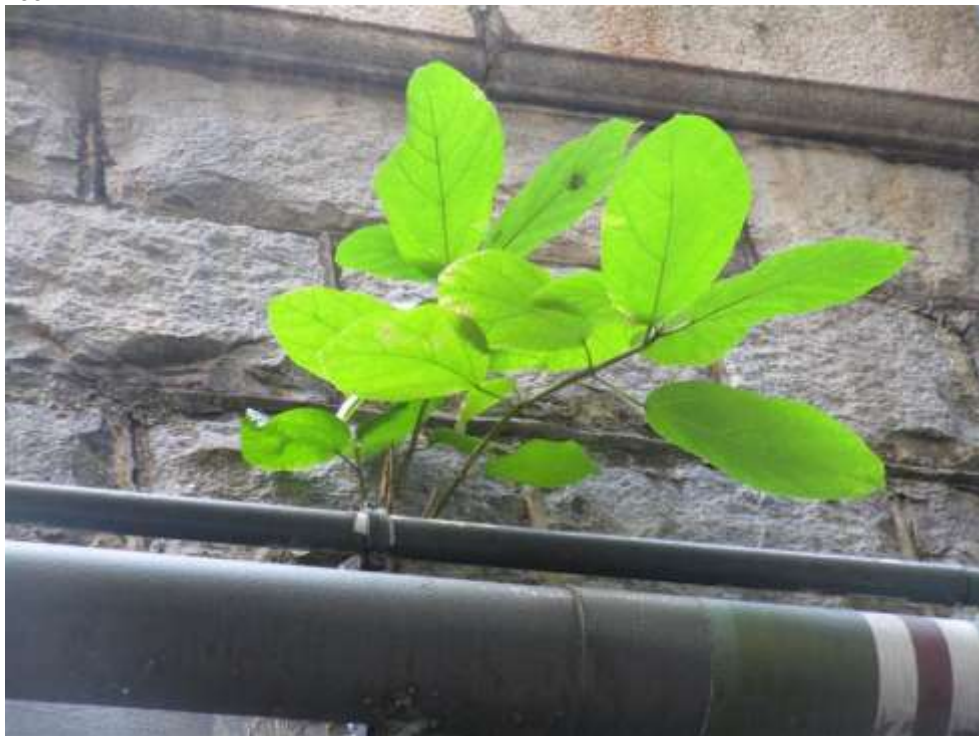
Photo No. 1288

Defect No. 144 **Location** LB/F Swimming pool **Component** retaining wall

Description A vegetation growth was observed on retaining wall

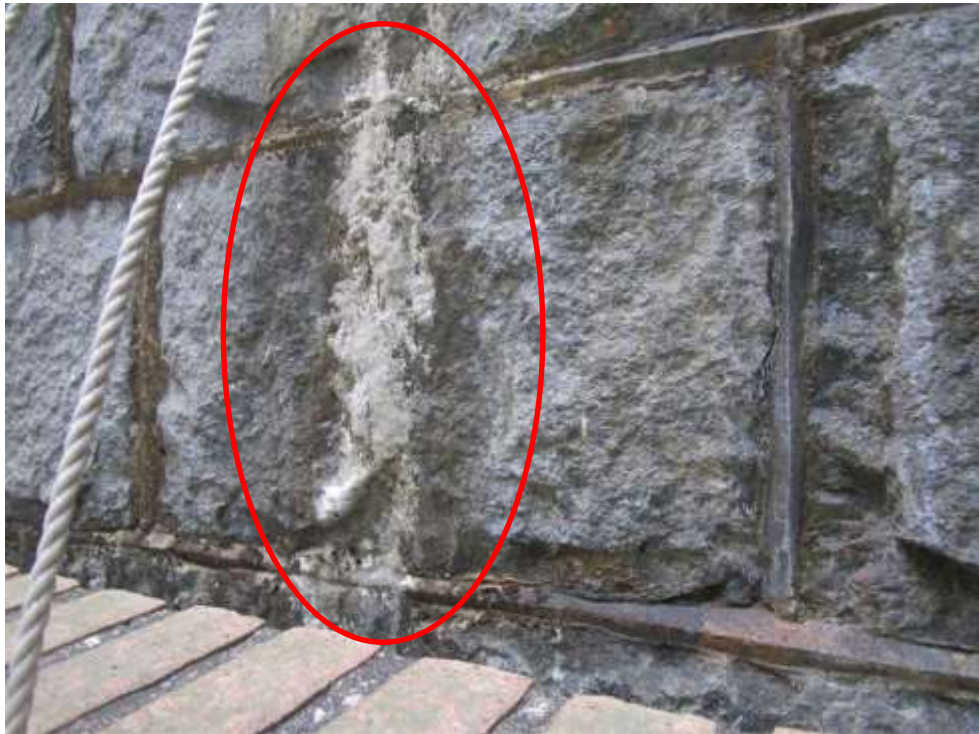
Photo No. 1290

Defect No. 145 **Location** LB/F Swimming pool **Component** retaining wall

Description A leaching was observed on retaining wall

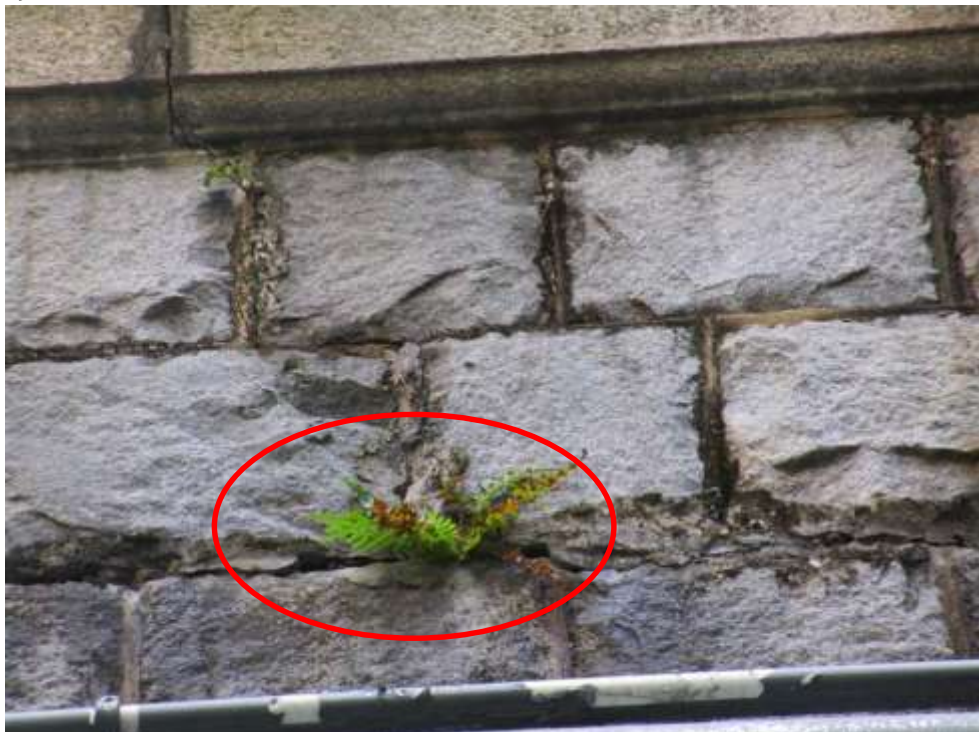
Photo No. 1292

Defect No. 146 **Location** LB/F Swimming pool **Component** retaining wall

Description Vegetation growths were observed on retaining wall

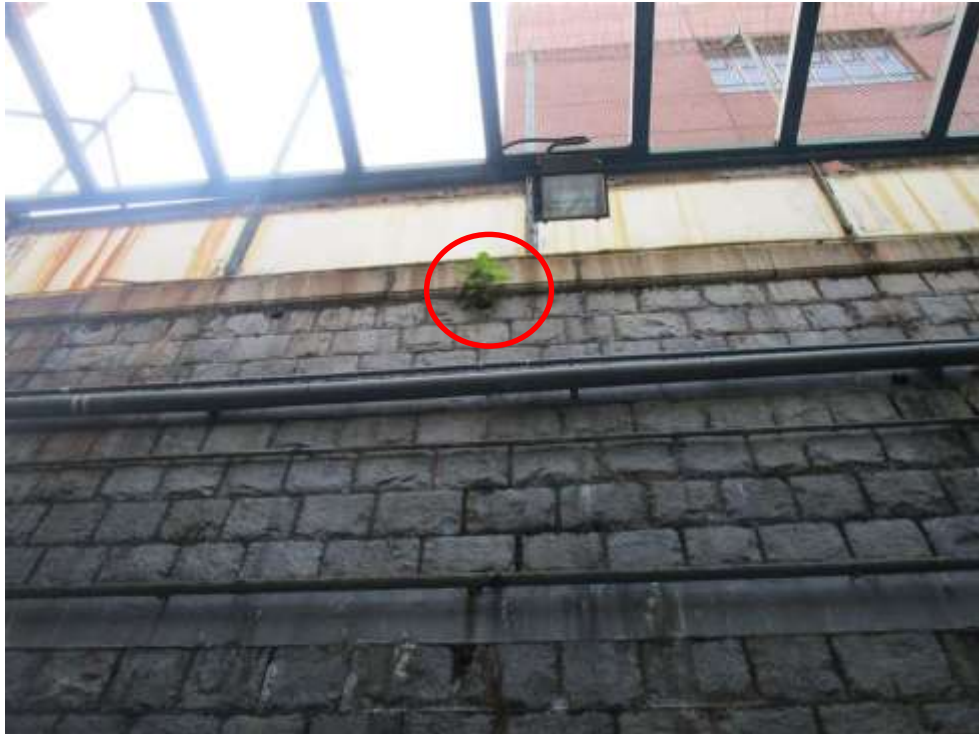
Photo No. 1293

Defect No. 146 **Location** LB/F Swimming pool **Component** retaining wall

Description Vegetation growths were observed on retaining wall

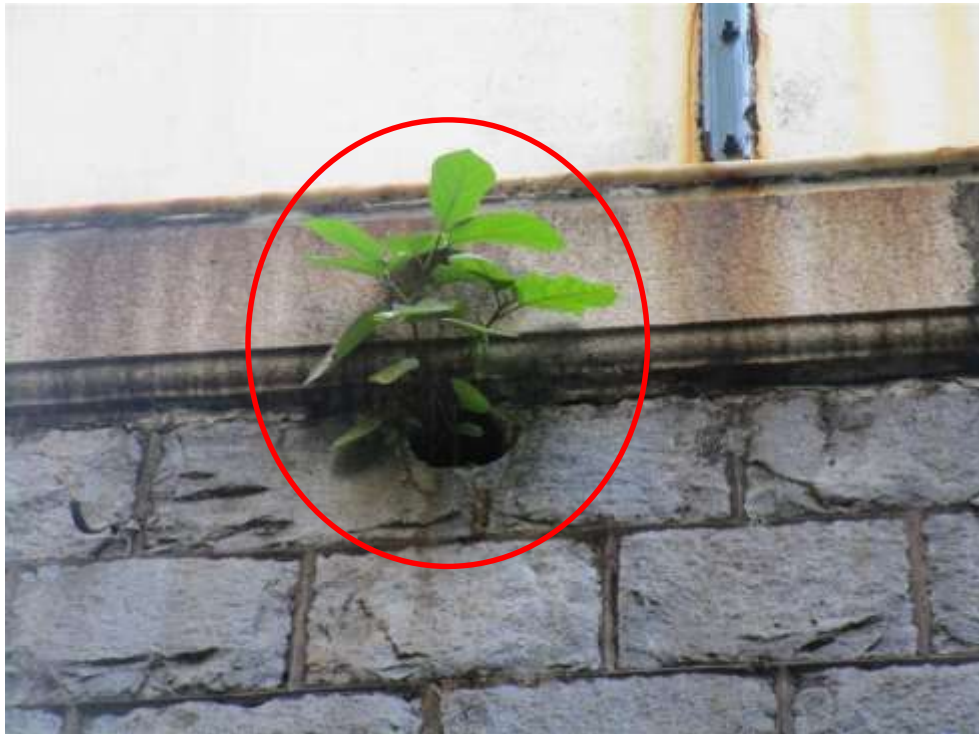
Photo No. 1294

Defect No. 147 **Location** LB/F Swimming pool **Component** retaining wall

Description A vegetation growth was observed on retaining wall

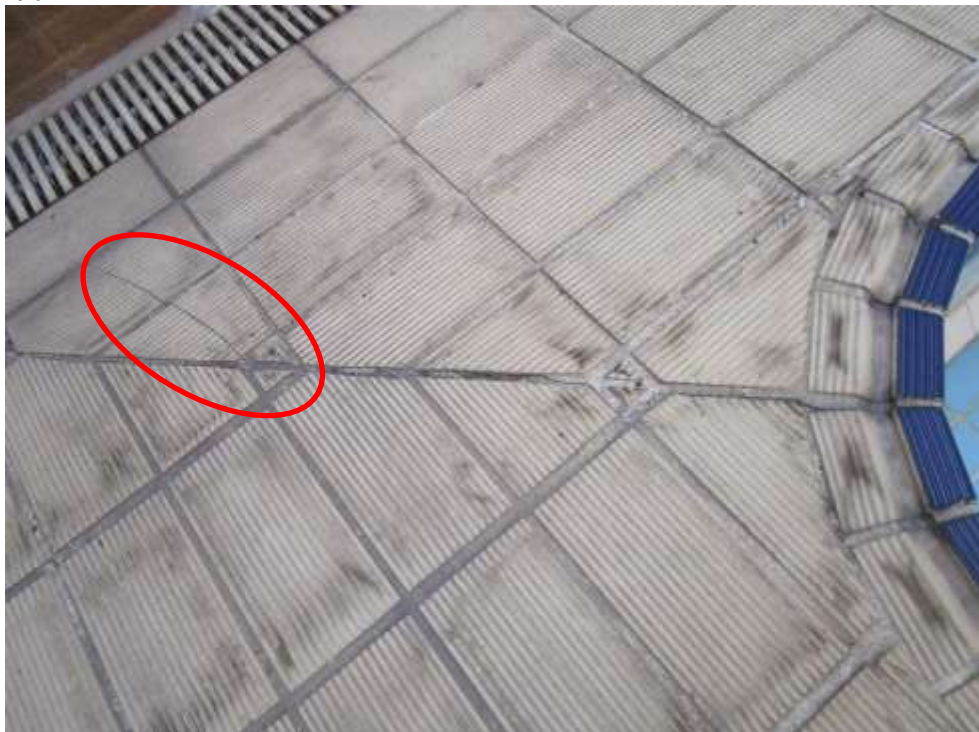
Photo No. 1296

Defect No. 148	Location LB/F Swimming pool	Component slab
-----------------------	------------------------------------	-----------------------

Description A medium crack was observed on tiled slab

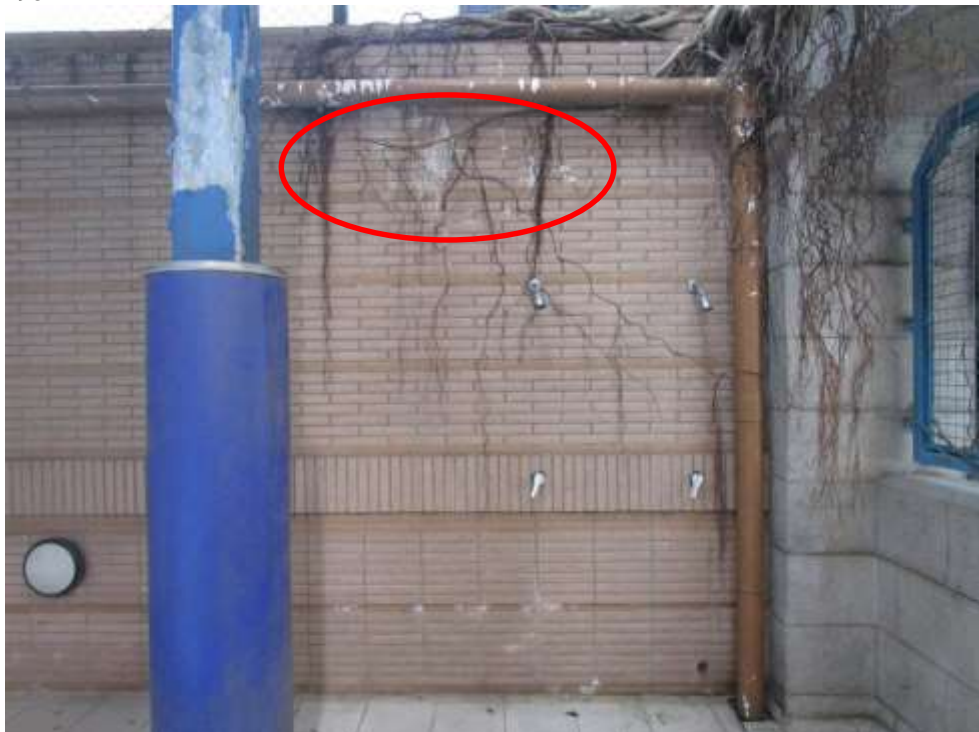
Photo No. 1298

Defect No. 149	Location LB/F Swimming pool	Component wall
-----------------------	------------------------------------	-----------------------

Description Patches of leaching were observed on wall
