**Slope Upgrading Works at
Feature No. 11SW-A/R526,
King's College,
Bonham Road, Hong Kong**

Project Profile for Slope Upgrading Works at
Feature No. 11SW-A/R526, King's College

May 2018

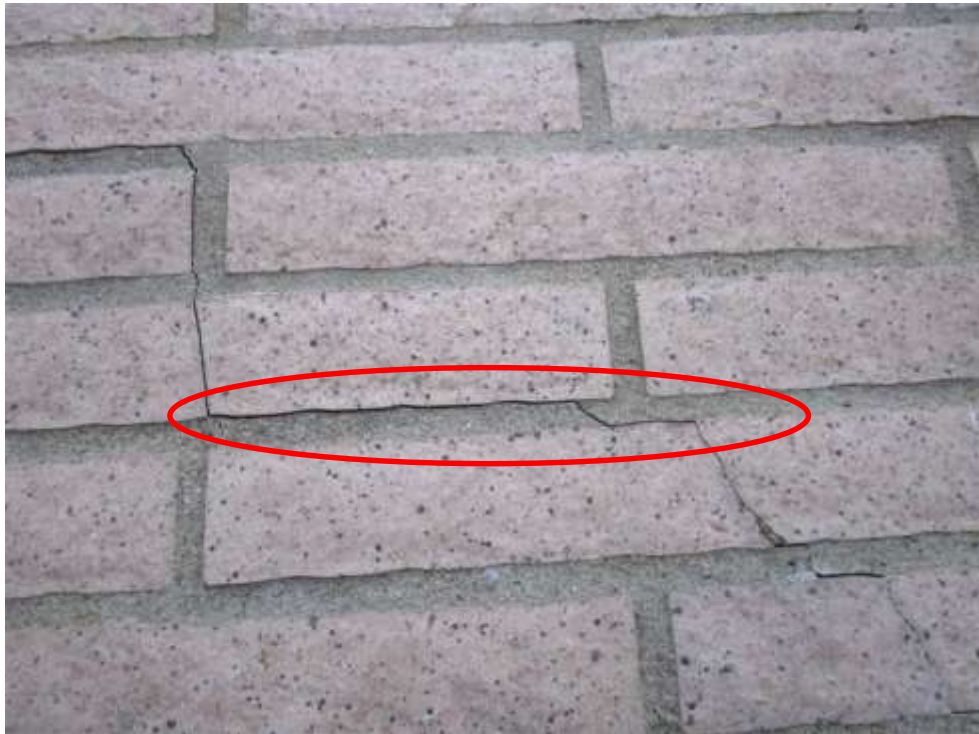
Photo No. 1300

Defect No. 150	Location LB/F Swimming pool	Component wall
-----------------------	------------------------------------	-----------------------

Description A medium crack was observed on wall tile finishing

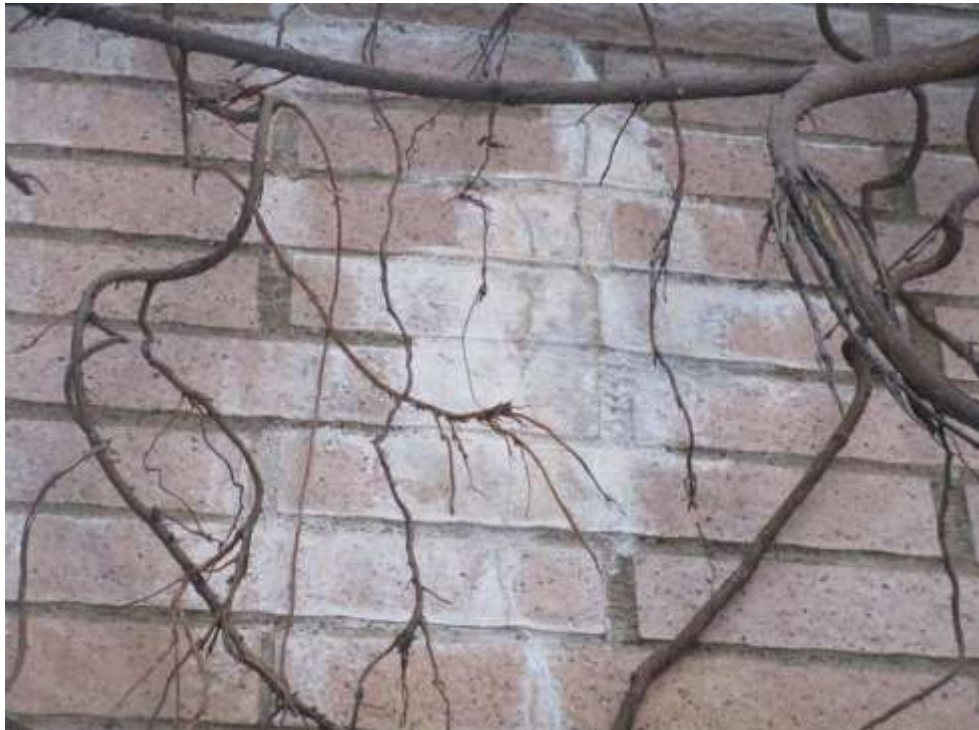
Photo No. 1302

Defect No. 151 **Location** LB/F Swimming pool **Component** wall

Description A vegetation growth was observed on wall with leaching

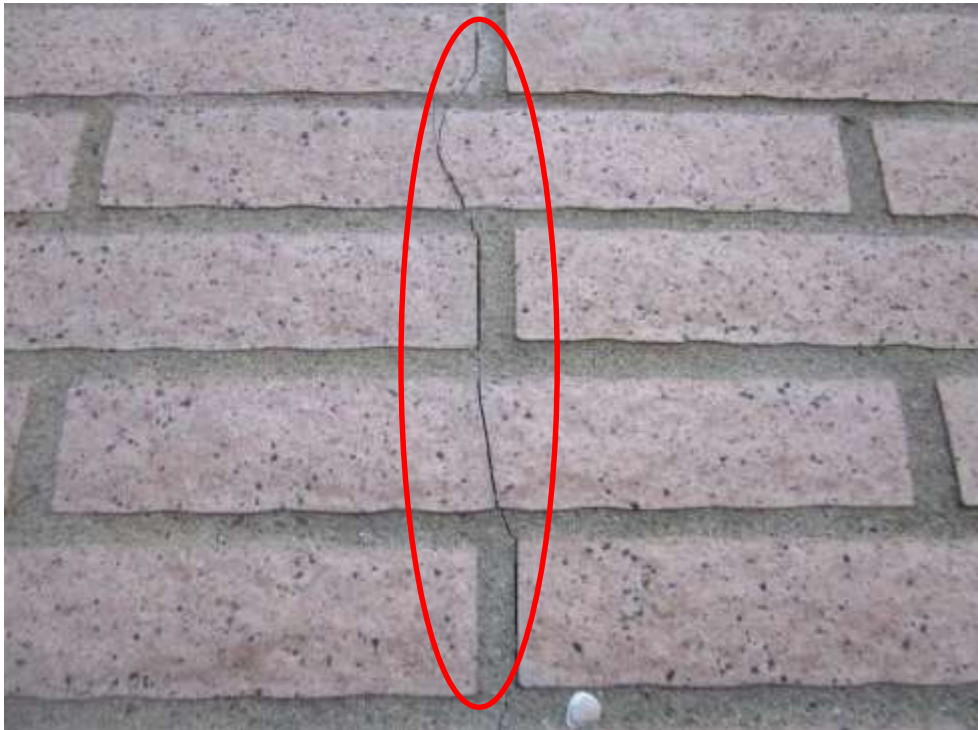
Photo No. 1304

Defect No. 152	Location LB/F Swimming pool	Component wall
-----------------------	------------------------------------	-----------------------

Description A medium crack was observed on wall tile finishing

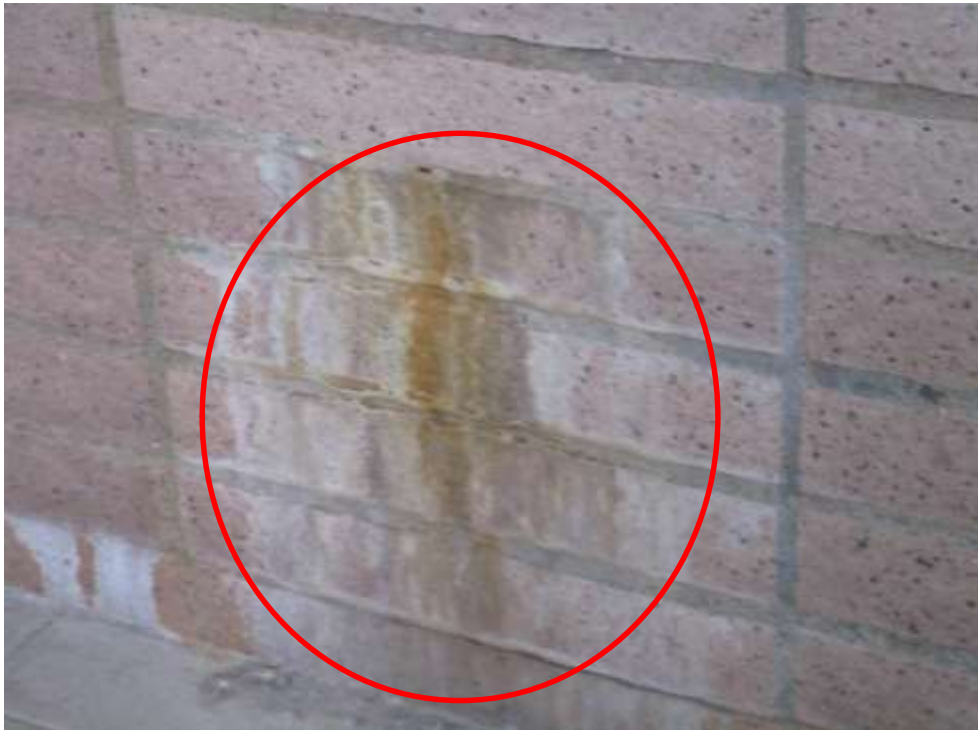
Photo No. 1306

Defect No.	153	Location	LB/F Swimming pool	Component	wall
-------------------	-----	-----------------	--------------------	------------------	------

Description	Areas of leaching were observed on wall				
--------------------	-----------------------------------------	--	--	--	--

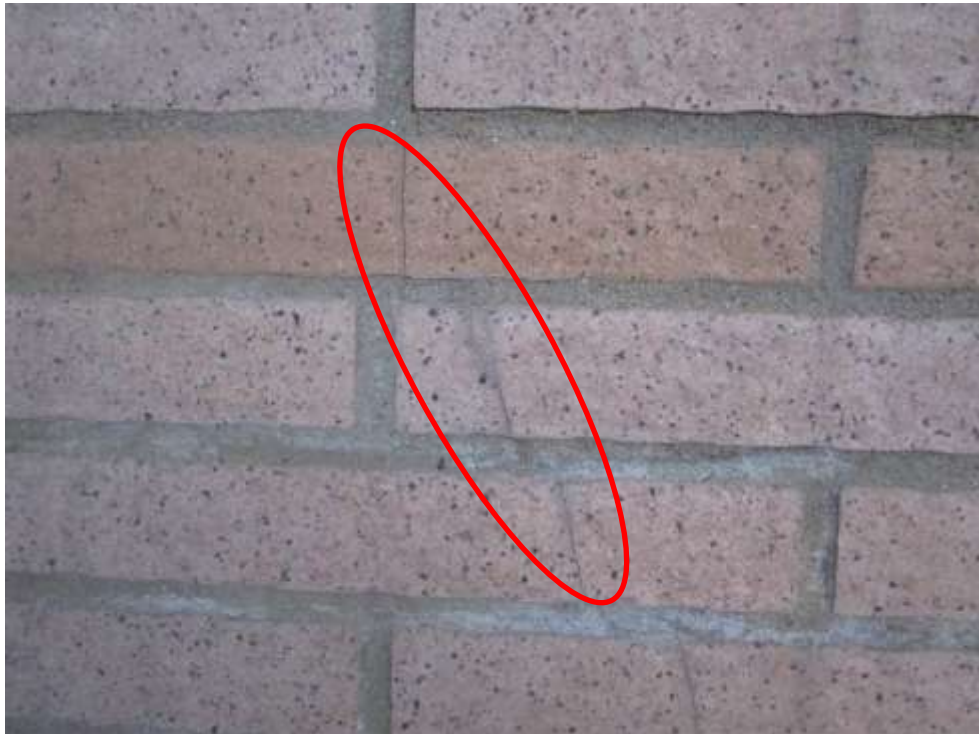
Photo No. 1308

Defect No.	154	Location	LB/F Swimming pool	Component	wall
-------------------	-----	-----------------	--------------------	------------------	------

Description	A hairline crack was observed on wall tile finishing				
--------------------	------------------------------------------------------	--	--	--	--

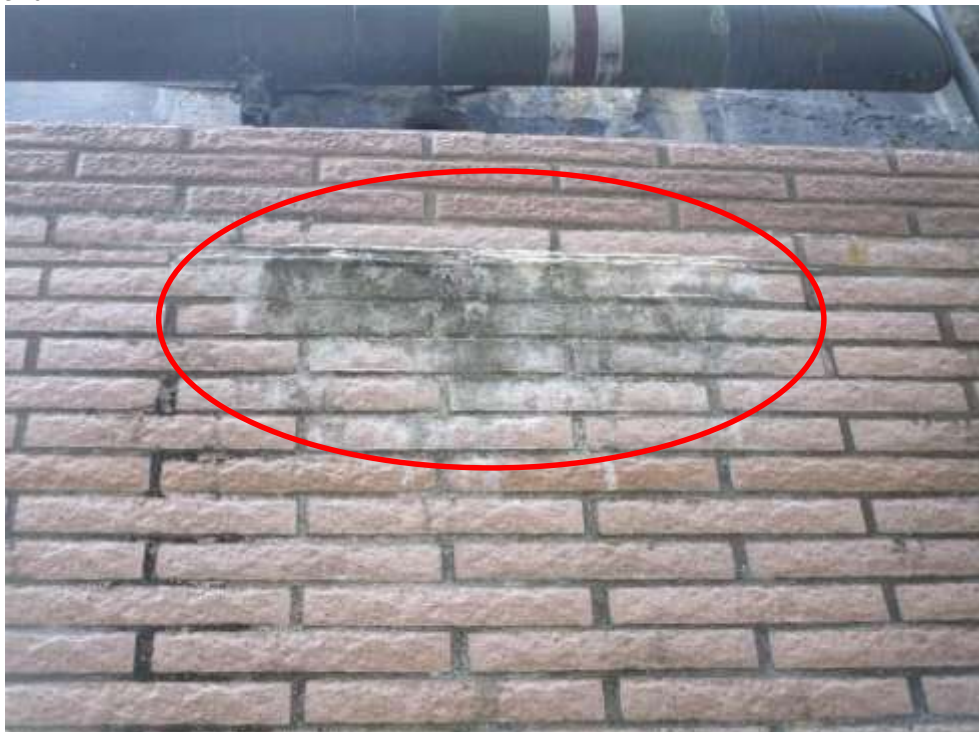
Photo No. 1310

Defect No. 155	Location LB/F Swimming pool	Component wall
-----------------------	------------------------------------	-----------------------

Description A leaching was observed on wall

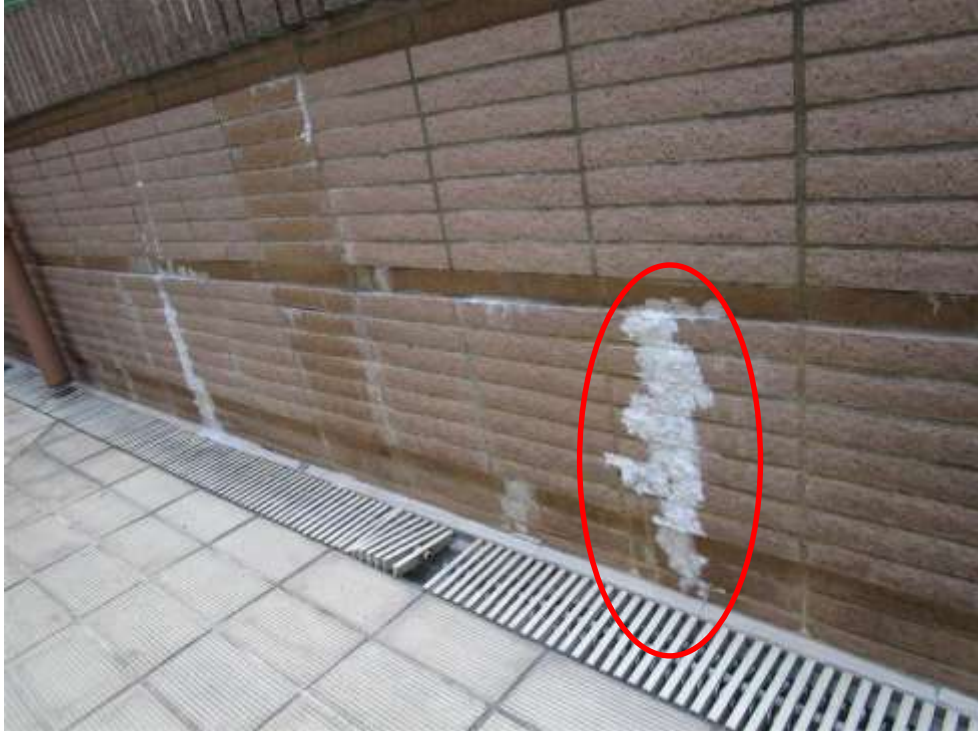
Photo No. 1311

Defect No. 155	Location LB/F Swimming pool	Component wall
-----------------------	------------------------------------	-----------------------

Description A leaching was observed on wall

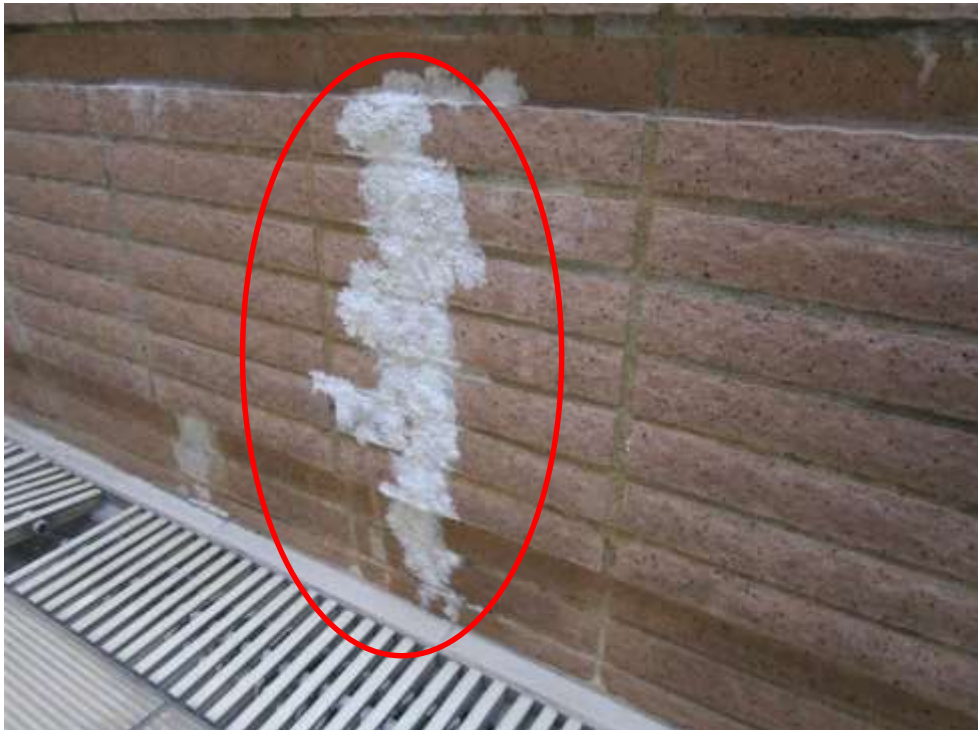
Photo No. 1312

Defect No.	156	Location	LB/F Swimming pool	Component	wall
-------------------	-----	-----------------	--------------------	------------------	------

Description	An area of leaching was observed on wall				
--------------------	------------------------------------------	--	--	--	--

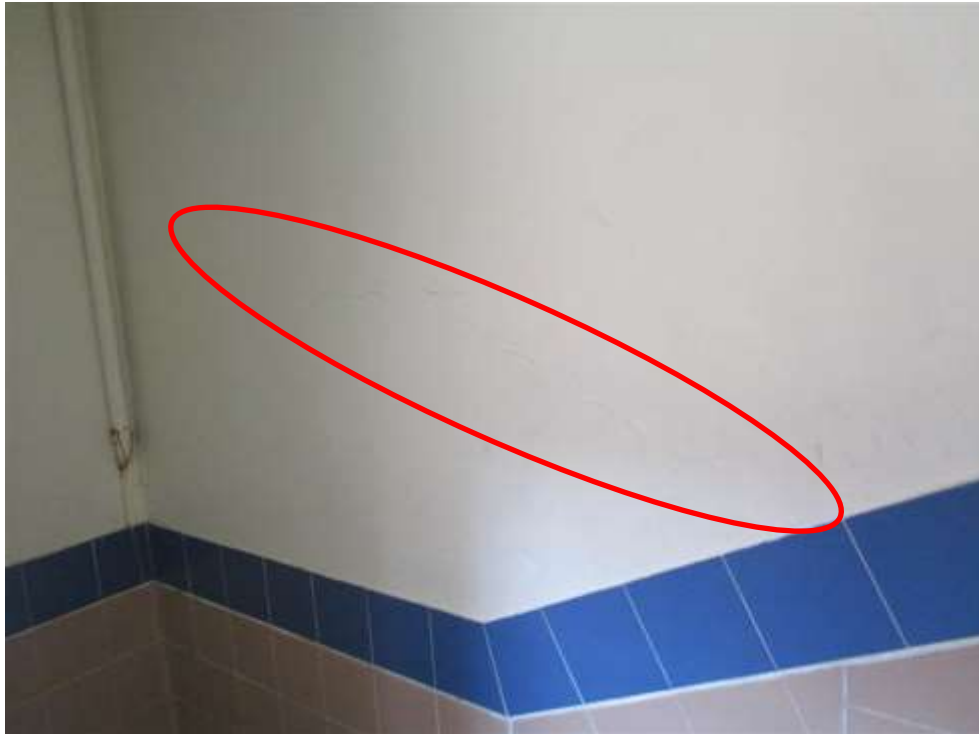
Photo No. 1313

Defect No.	156	Location	LB/F Swimming pool	Component	wall
-------------------	-----	-----------------	--------------------	------------------	------

Description	An area of leaching was observed on wall				
--------------------	------------------------------------------	--	--	--	--

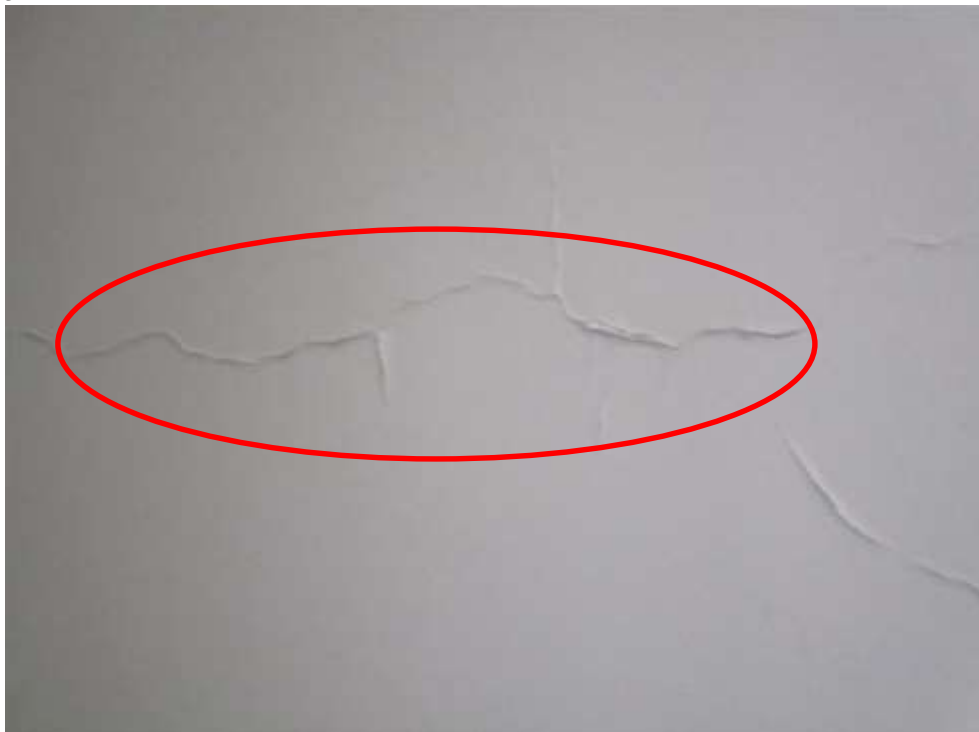
Photo No. 1314

Defect No.	157	Location	LB/F Swimming pool	Component	wall
-------------------	-----	-----------------	--------------------	------------------	------

Description	Paint peeling was observed on wall				
--------------------	------------------------------------	--	--	--	--

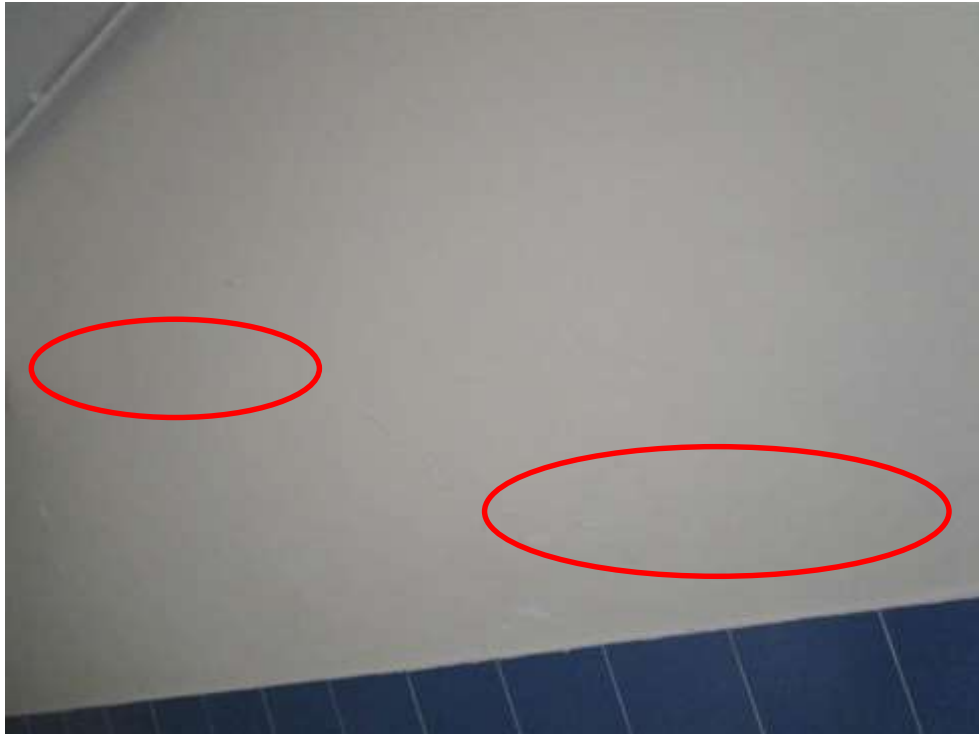
Photo No. 1315

Defect No.	157	Location	LB/F Swimming pool	Component	wall
-------------------	-----	-----------------	--------------------	------------------	------

Description	Paint peeling was observed on wall				
--------------------	------------------------------------	--	--	--	--

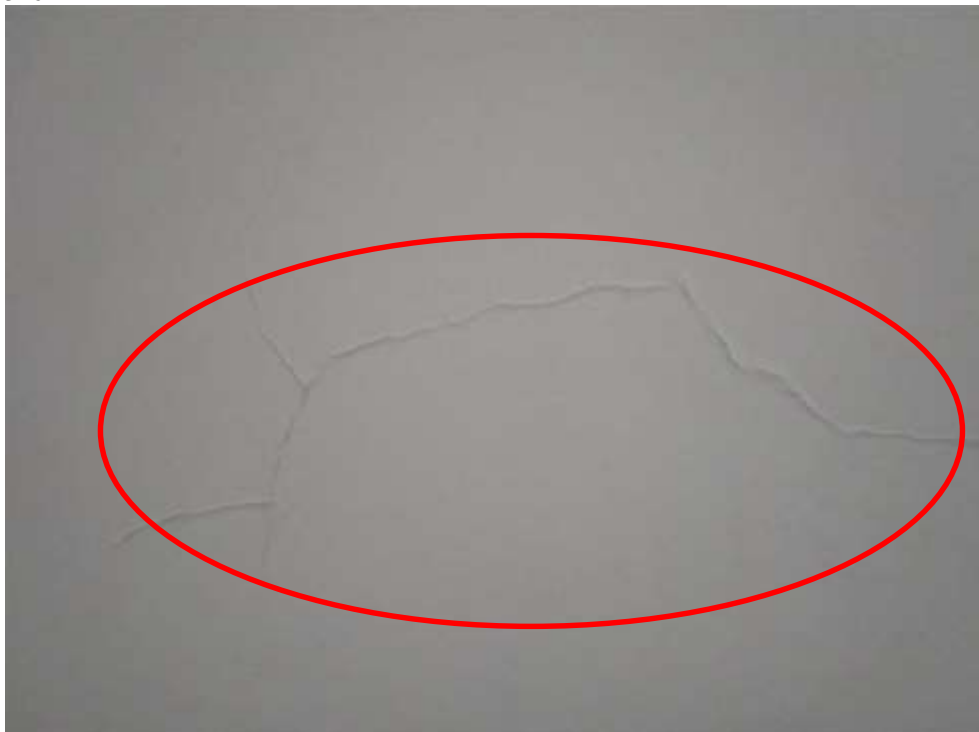
Photo No. 1316

Defect No. 158	Location LB/F Swimming pool	Component wall
-----------------------	------------------------------------	-----------------------

Description Paint peeling was observed on wall

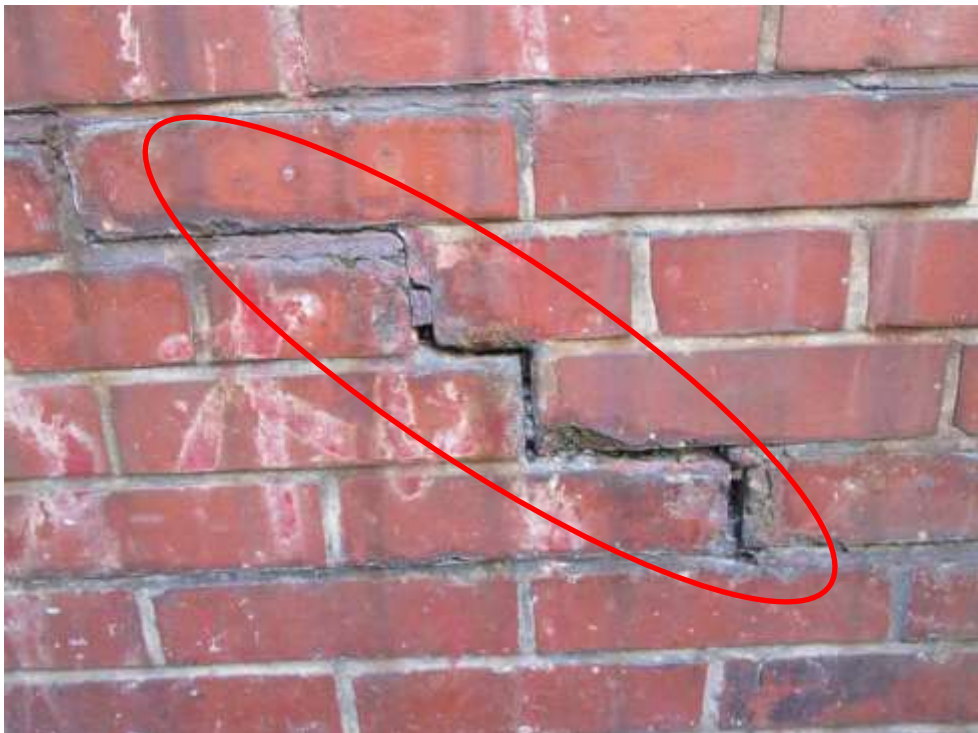
Photo No. 1318

Defect No.	159	Location	LG/F Parapet wall behind new extension	Component	brick parapet
-------------------	-----	-----------------	----------------------------------------	------------------	---------------

Description A wide crack was observed on mortar joint of brick parapet

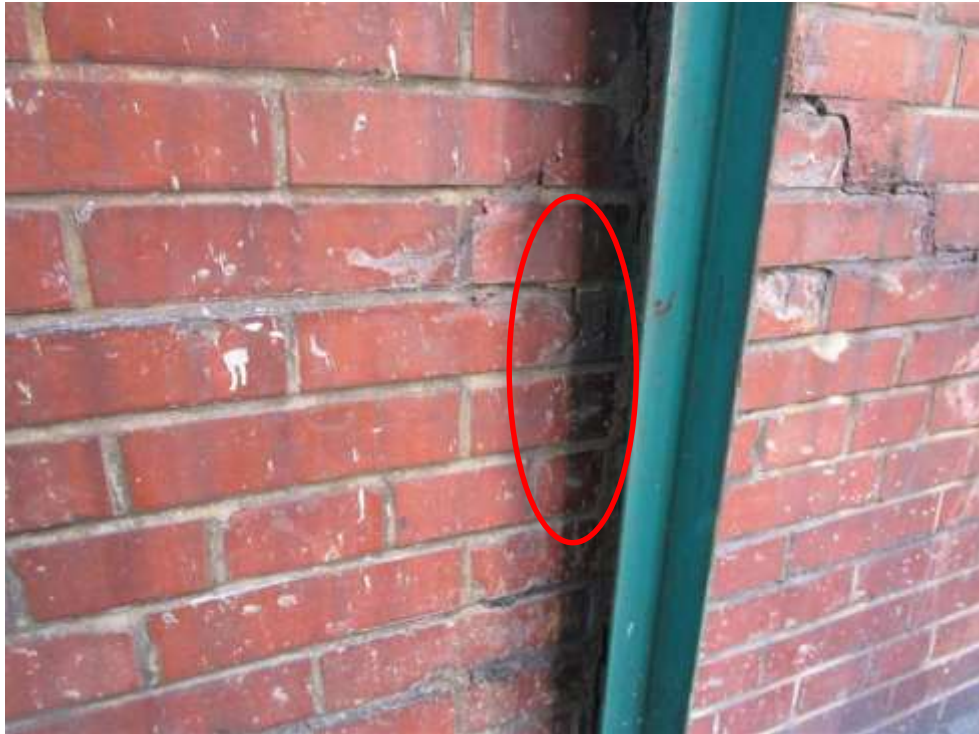
Photo No. 1319

Defect No.	159	Location	LG/F Parapet wall behind new extension	Component	brick parapet
-------------------	-----	-----------------	----------------------------------------	------------------	---------------

Description A wide crack was observed on mortar joint of brick parapet

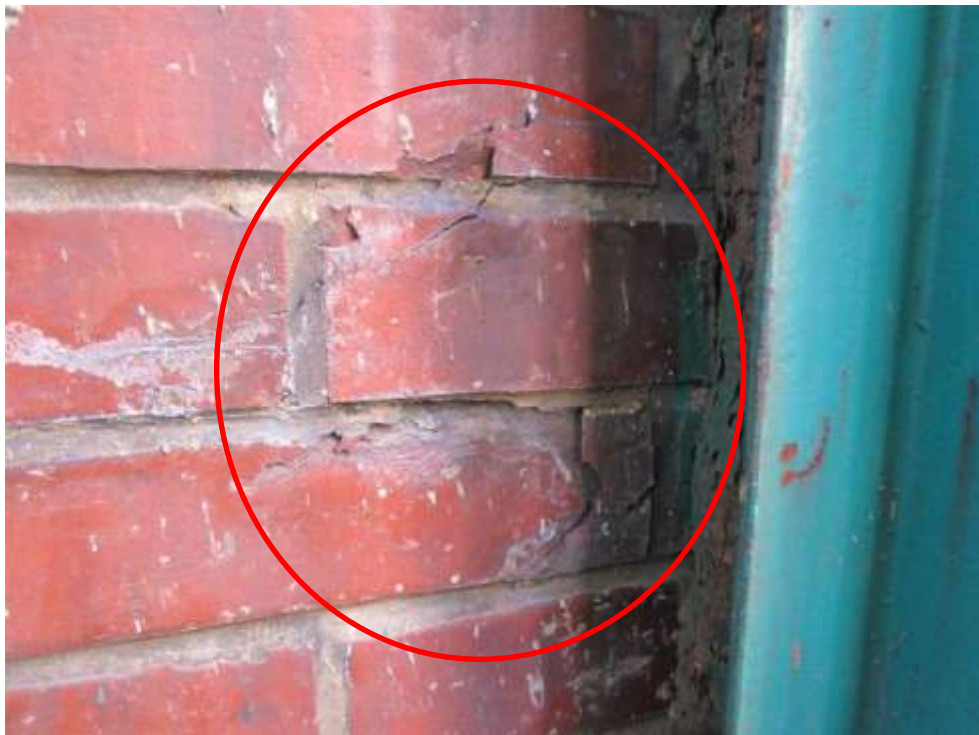
Photo No. 1320

Defect No. 160	Location LG/F Parapet wall behind new extension	Component brick parapet
-----------------------	--------------------------------------------------------	--------------------------------

Description Delaminated bricks were observed on parapet

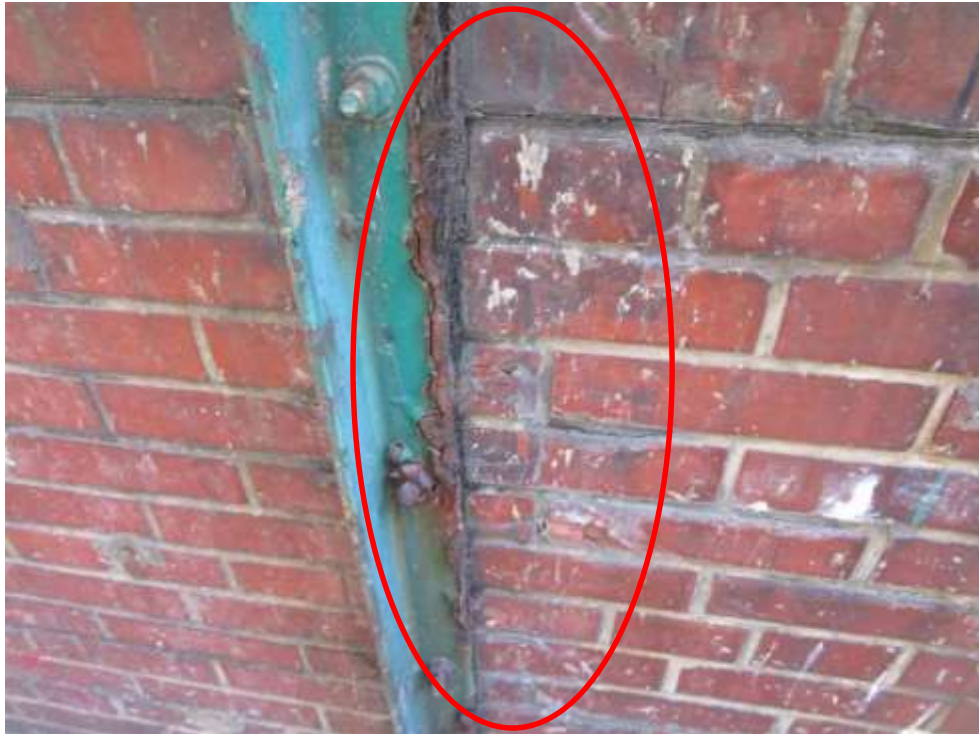
Photo No. 1321

Defect No. 160	Location LG/F Parapet wall behind new extension	Component brick parapet
-----------------------	--------------------------------------------------------	--------------------------------

Description Delaminated bricks were observed on parapet

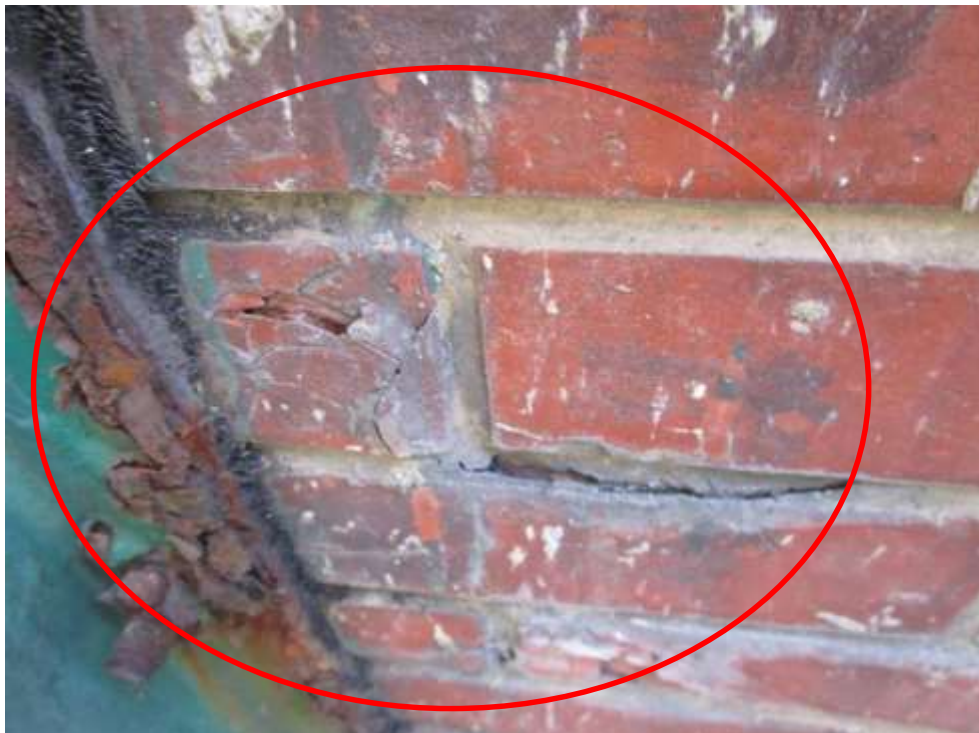
Photo No. 1322

Defect No. 161	Location LG/F Parapet wall behind new extension	Component brick parapet
-----------------------	--------------------------------------------------------	--------------------------------

Description Delaminated bricks were observed on parapet

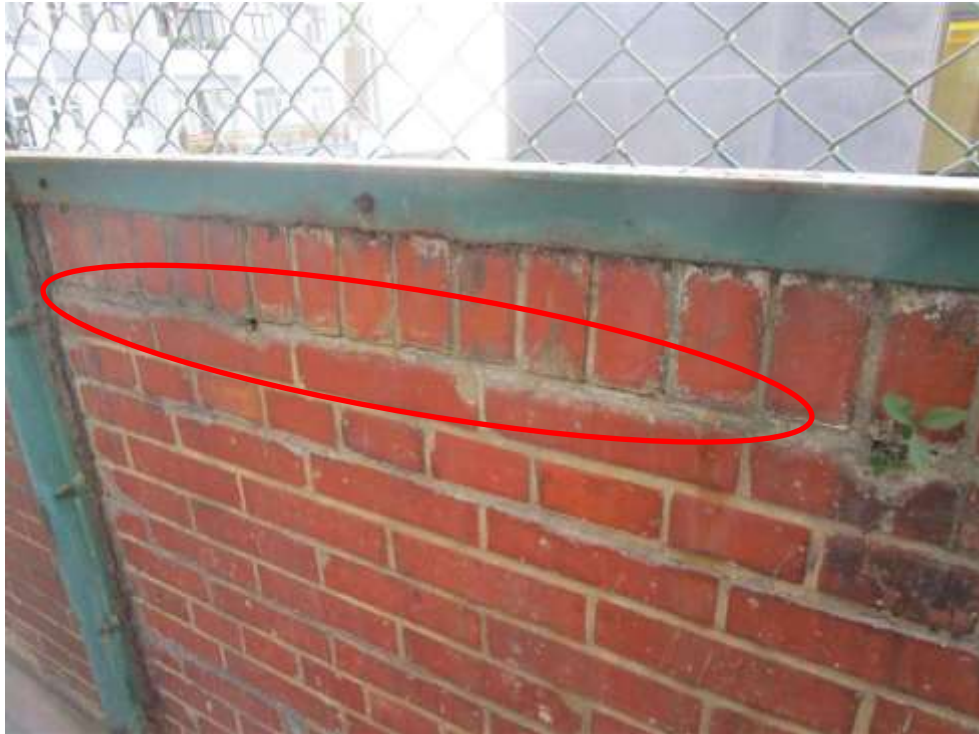
Photo No. 1323

Defect No. 161	Location LG/F Parapet wall behind new extension	Component brick parapet
-----------------------	--------------------------------------------------------	--------------------------------

Description Delaminated bricks were observed on parapet

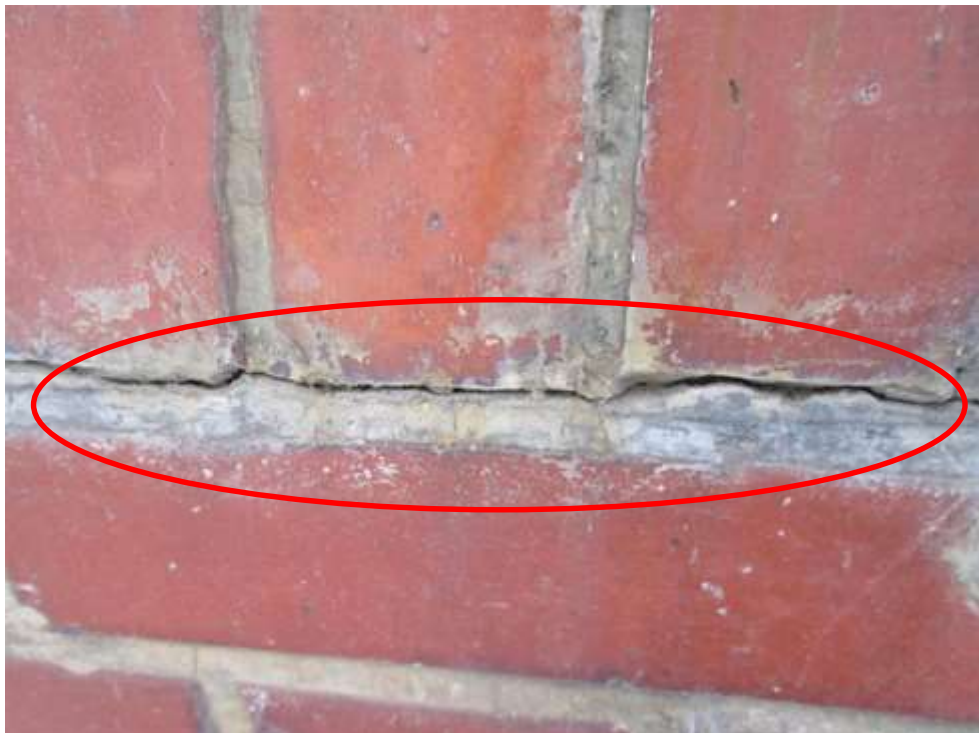
Photo No. 1324

Defect No. 162	Location LG/F Parapet wall behind new extension	Component brick parapet
-----------------------	--------------------------------------------------------	--------------------------------

Description A wide crack was observed on brick parapet mortar joint

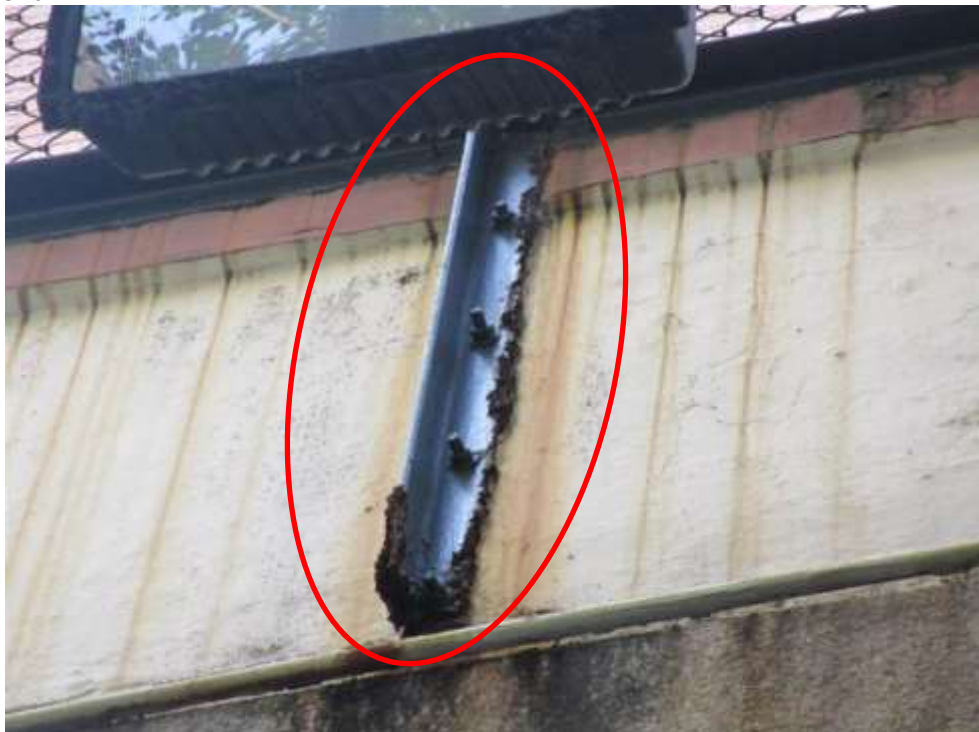
Photo No. 1326

Defect No. 163	Location LG/F Playground	Component fence post
-----------------------	---------------------------------	-----------------------------

Description A minor rusting was observed on fence post

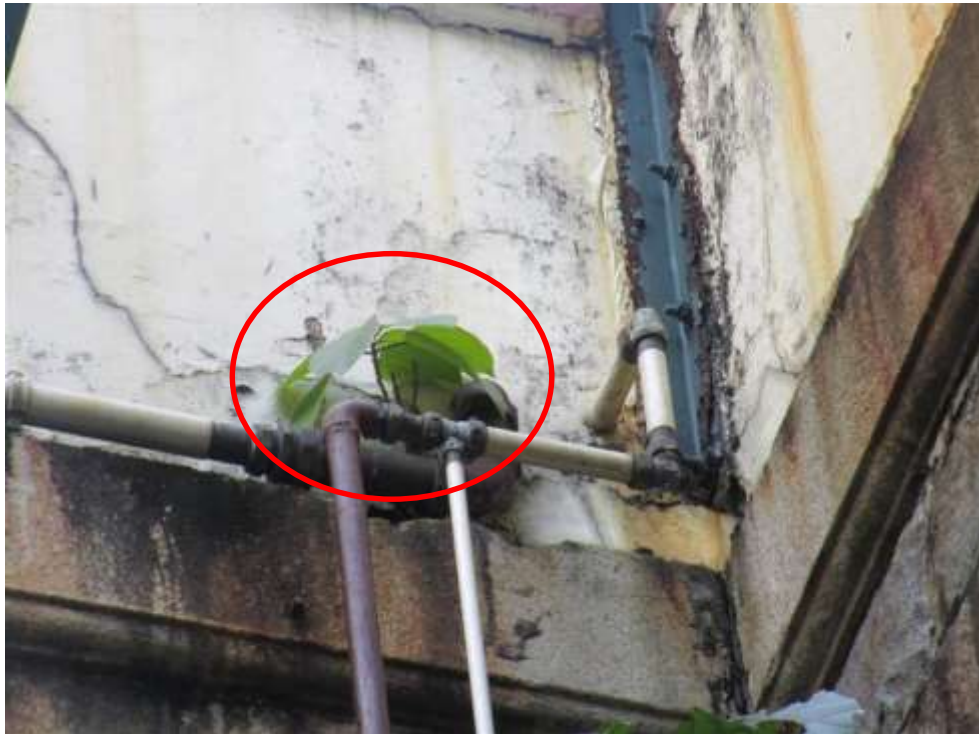
Photo No. 1328

Defect No. 164 **Location** LG/F Playground **Component** parapet

Description A vegetation growth was observed on parapet

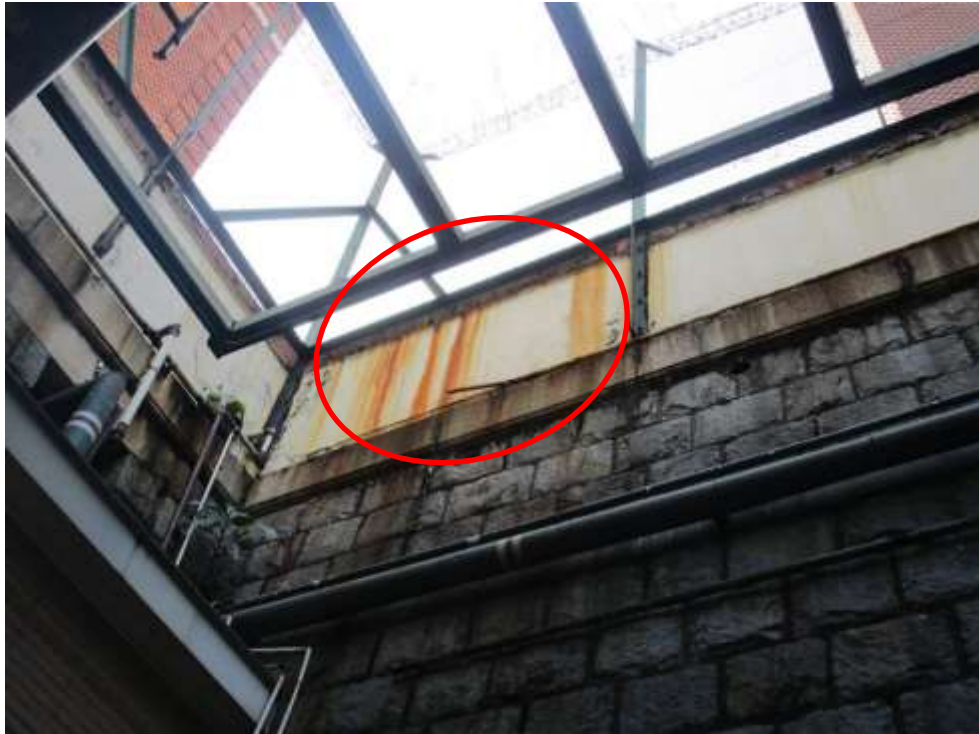
Photo No. 1329

Defect No. 164 **Location** LG/F Playground **Component** parapet

Description A vegetation growth was observed on parapet

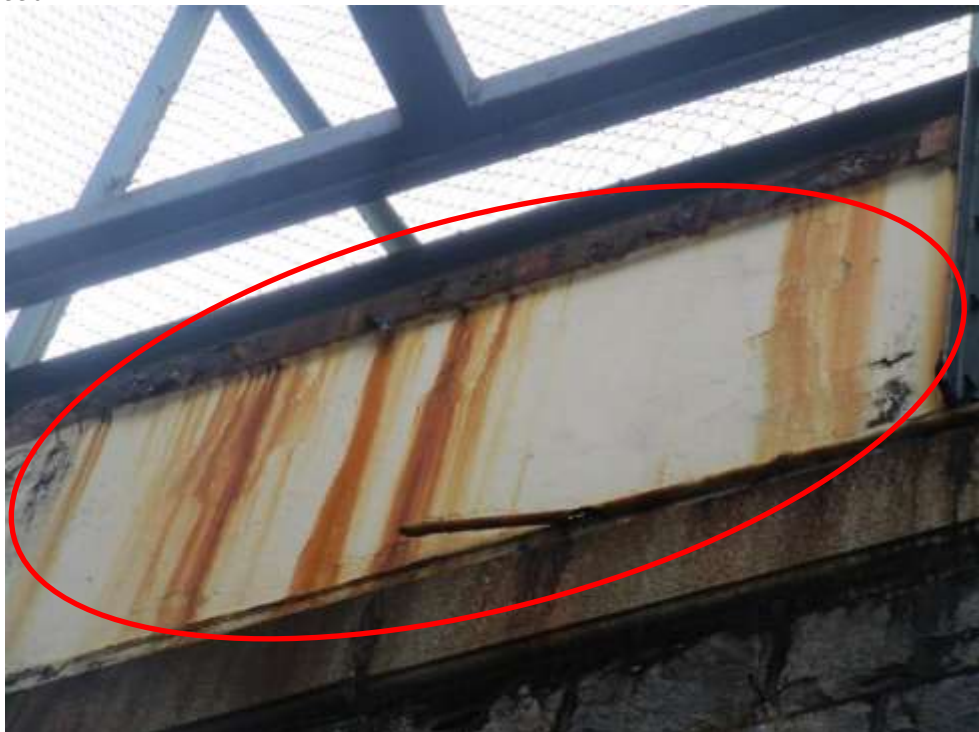
Photo No. 1330

Defect No. 165 **Location** LG/F Playground **Component** parapet

Description Rust stain was observed on parapet

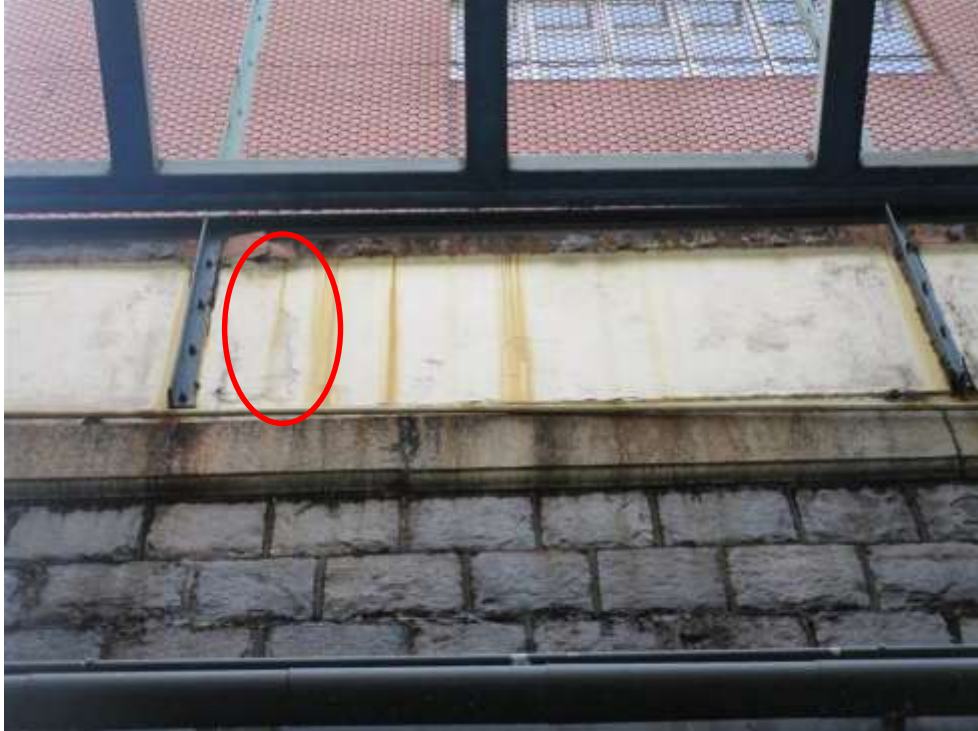
Photo No. 1331

Defect No. 165 **Location** LG/F Playground **Component** parapet

Description Rust stain was observed on parapet

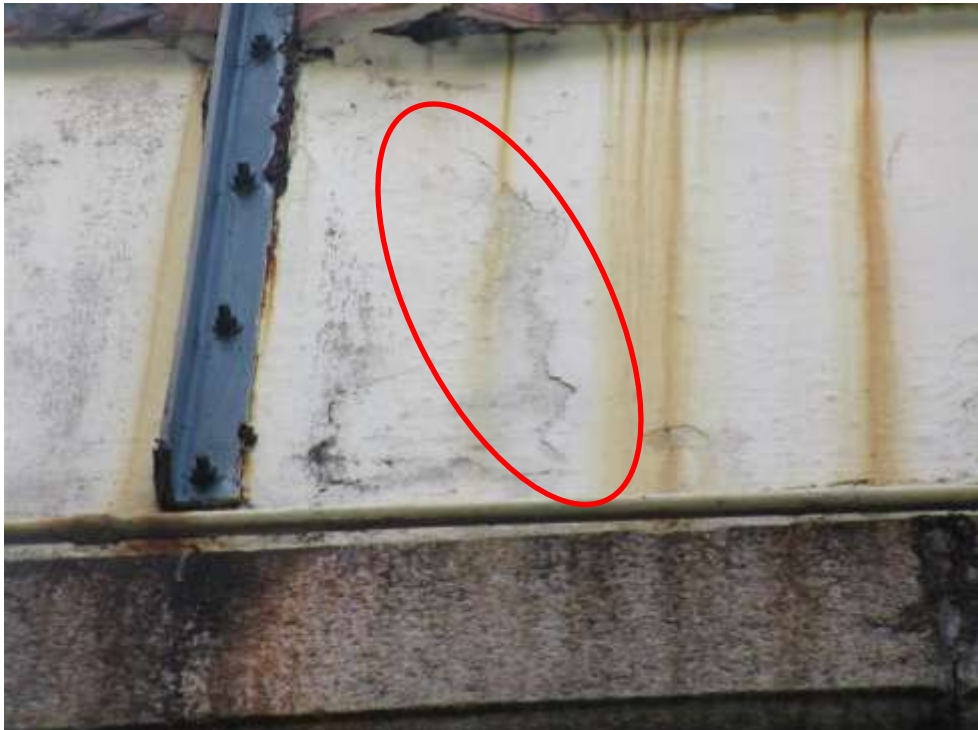
Photo No. 1332

Defect No. 166	Location LG/F Playground	Component parapet
-----------------------	---------------------------------	--------------------------

Description A wide crack was observed on parapet finishing

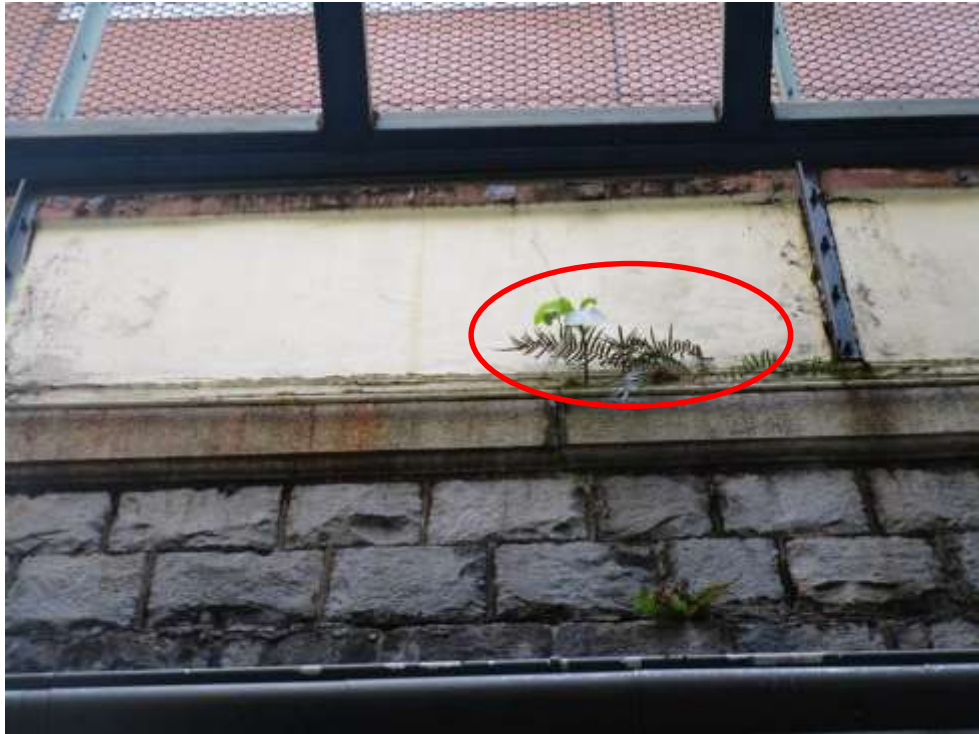
Photo No. 1333

Defect No. 166	Location LG/F Playground	Component parapet
-----------------------	---------------------------------	--------------------------

Description A wide crack was observed on parapet finishing

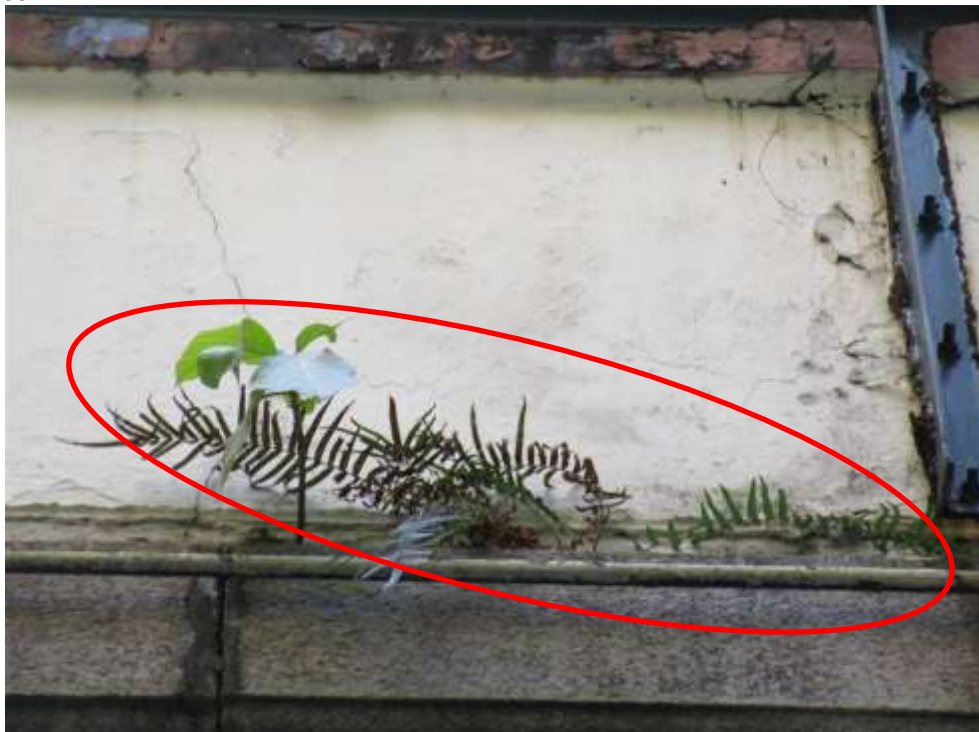
Photo No. 1334

Defect No. 167	Location LG/F Playground	Component parapet
-----------------------	---------------------------------	--------------------------

Description A vegetation growth was observed on parapet

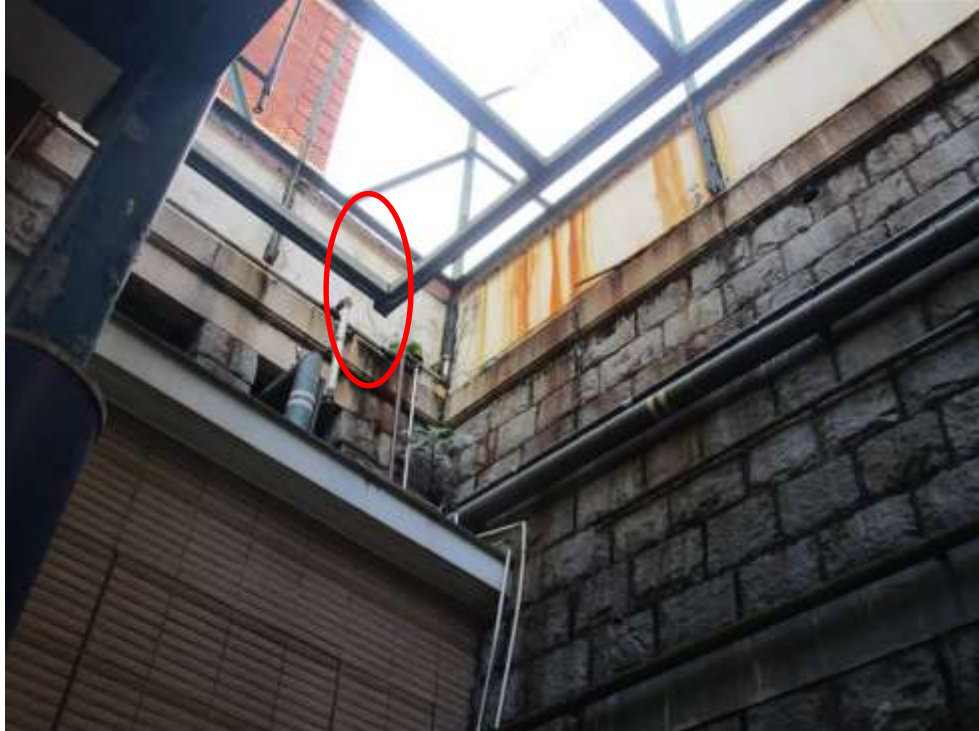
Photo No. 1335

Defect No. 167	Location LG/F Playground	Component parapet
-----------------------	---------------------------------	--------------------------

Description A vegetation growth was observed on parapet

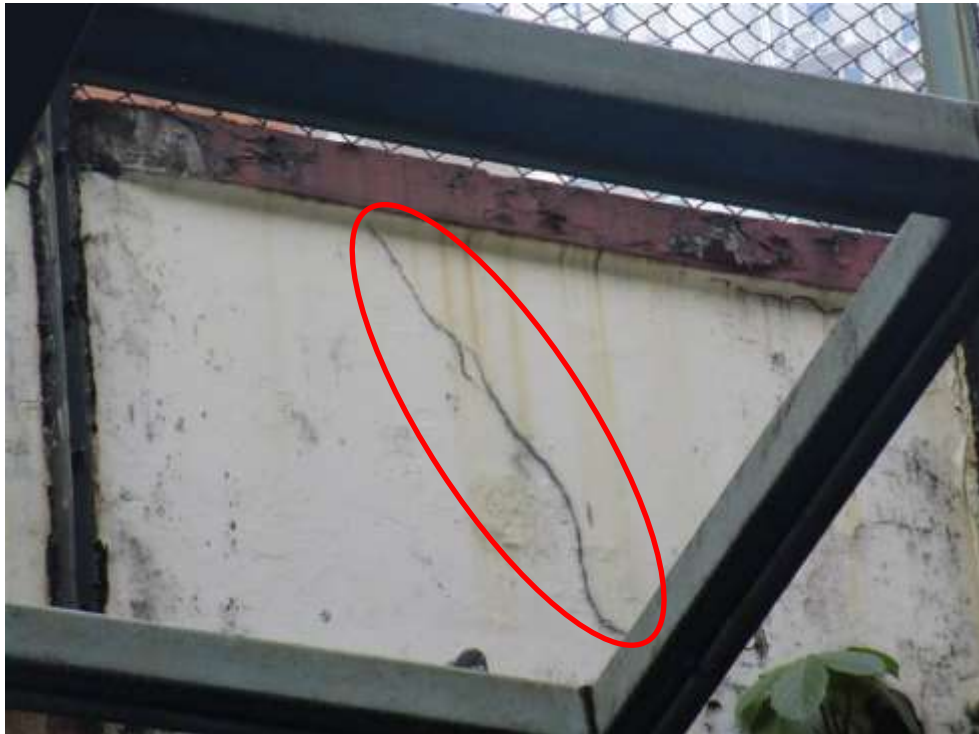
Photo No. 1336

Defect No. 168 **Location** LG/F Playground **Component** parapet

Description A wide crack was observed on parapet finishing
