**Slope Upgrading Works at
Feature No. 11SW-A/R526,
King's College,
Bonham Road, Hong Kong**

Project Profile for Slope Upgrading Works at
Feature No. 11SW-A/R526, King's College

May 2018

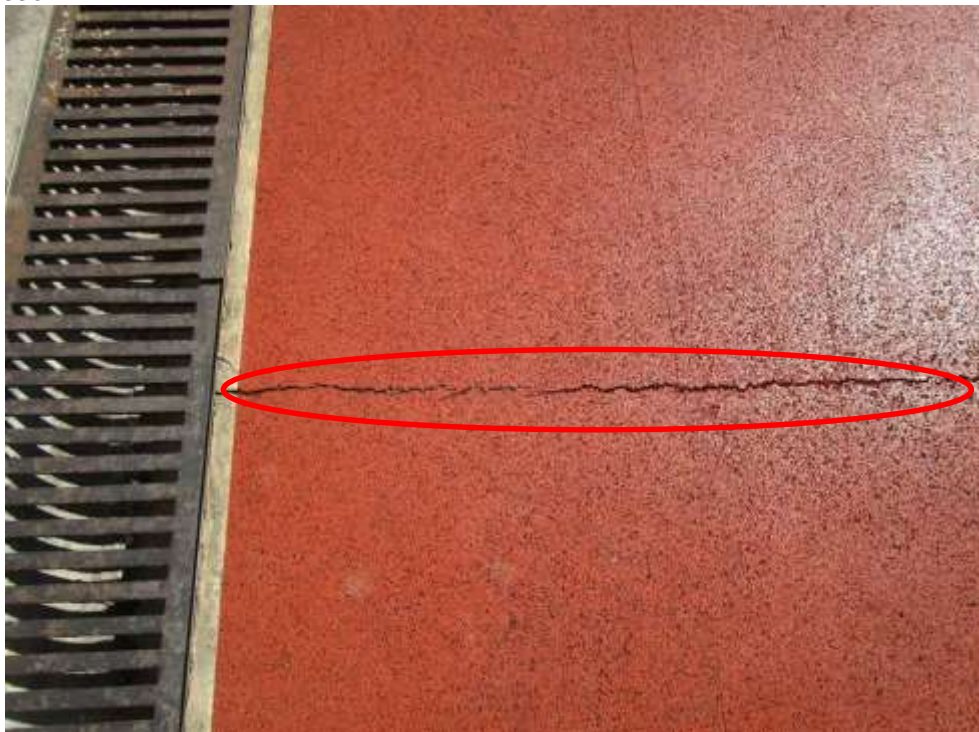
Photo No. 1338

Defect No. 169	Location LG/F Playground	Component pavement
-----------------------	---------------------------------	---------------------------

Description A wide crack was observed on playground pavement

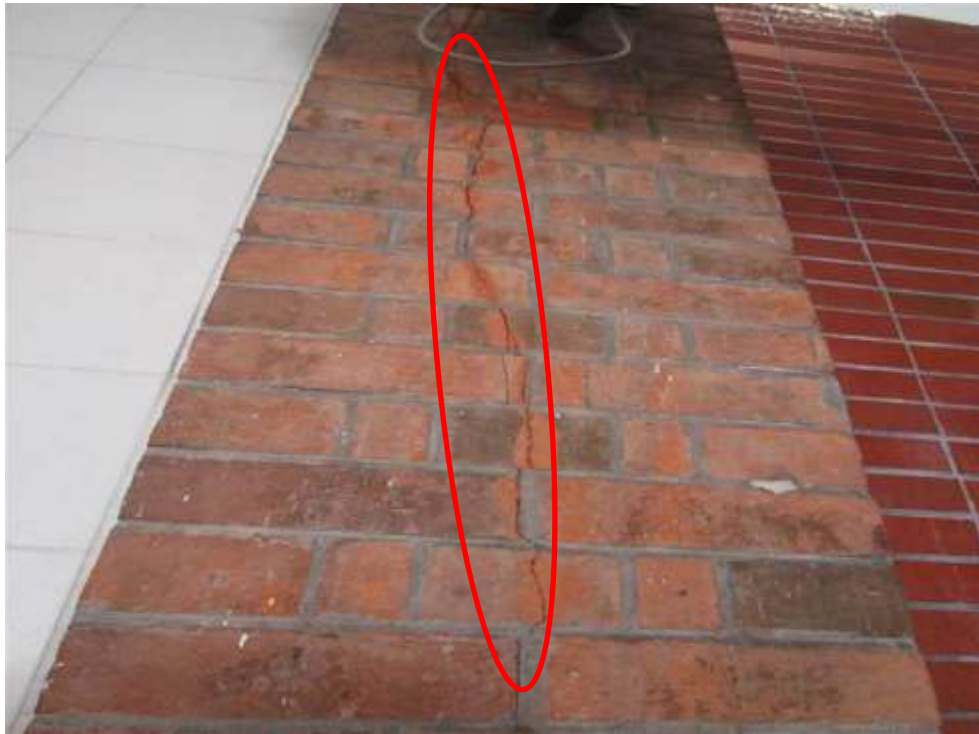
Photo No. 1340

Defect No.	170	Location	LG/F East wing, Canteen	Component	brick column
-------------------	-----	-----------------	-------------------------	------------------	--------------

Description	A wide crack through bricks was observed on brick column				
--------------------	----------------------------------------------------------	--	--	--	--

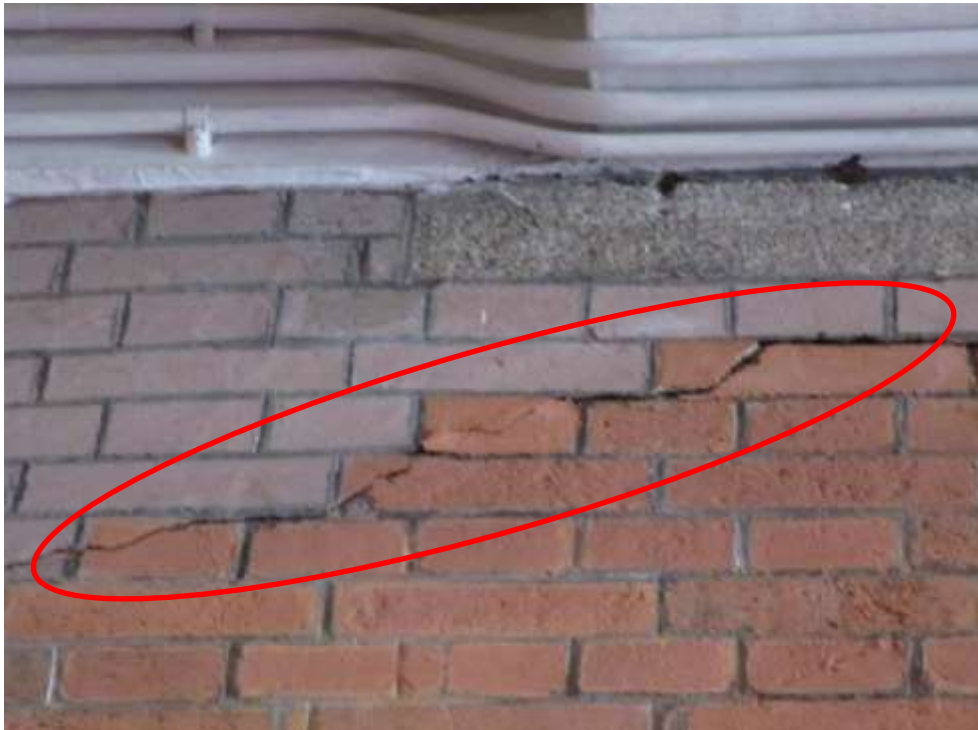
Photo No. 1342

Defect No.	171	Location	LG/F East wing, Canteen	Component	brick wall
-------------------	-----	-----------------	-------------------------	------------------	------------

Description	A crack was observed between previous repair and old bricks on wall				
--------------------	---------------------------------------------------------------------	--	--	--	--

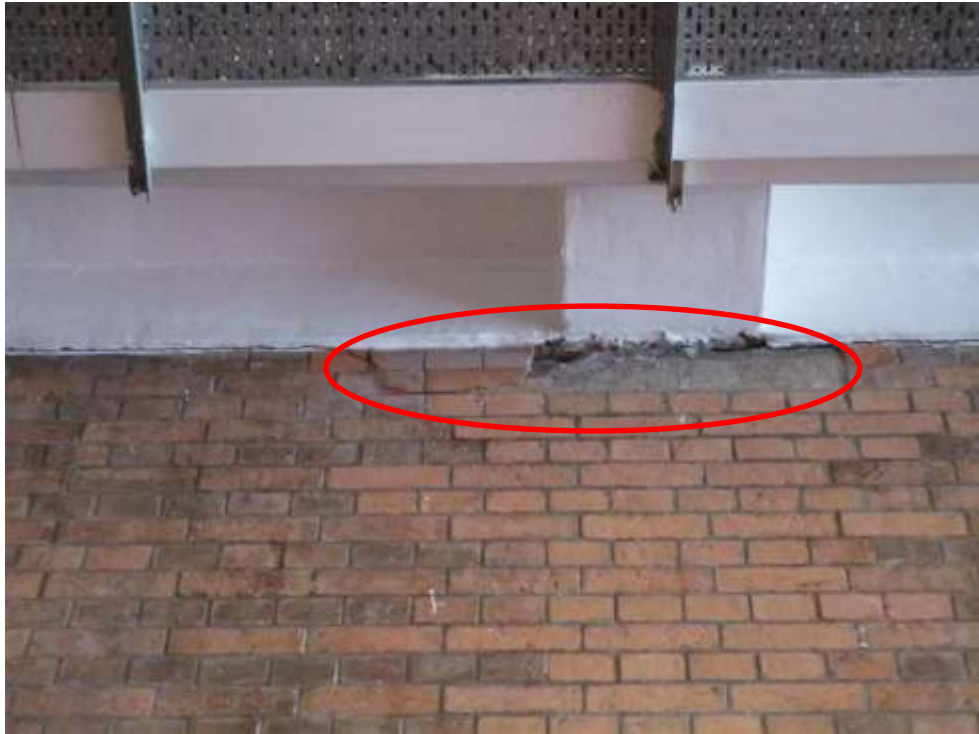
Photo No. 1343

Defect No.	171	Location	LG/F East wing, Canteen	Component	brick wall
-------------------	-----	-----------------	-------------------------	------------------	------------

Description	A crack was observed between previous repair and old bricks on wall				
--------------------	---------------------------------------------------------------------	--	--	--	--

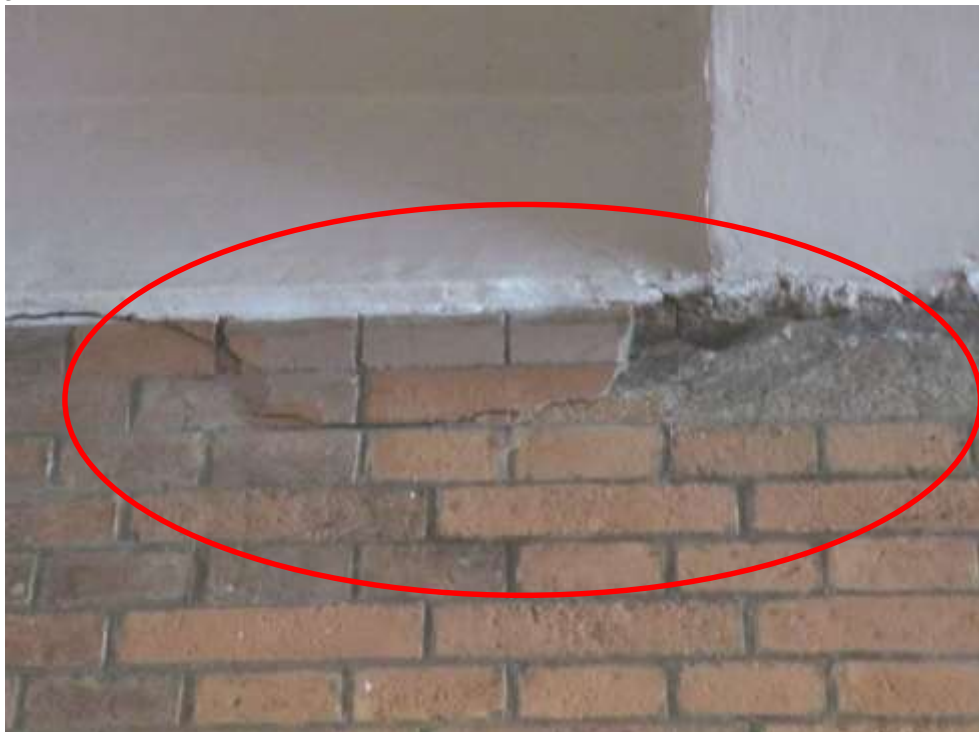
Photo No. 1344

Defect No.	172	Location	LG/F East wing, Canteen	Component	brick wall
-------------------	-----	-----------------	-------------------------	------------------	------------

Description	Area of delaminated bricks was observed on the brick wall				
--------------------	-----------------------------------------------------------	--	--	--	--

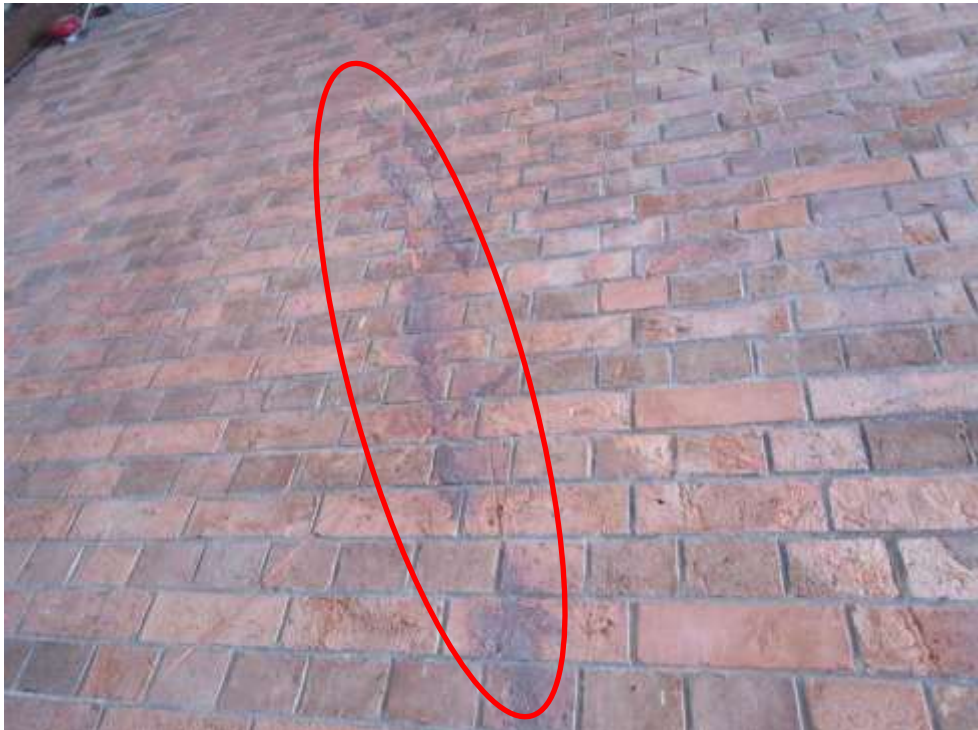
Photo No. 1346

Defect No. 173	Location LG/F East wing, Canteen	Component brick wall
-----------------------	-----------------------------------------	-----------------------------

Description A previous repair mark was observed on brick wall

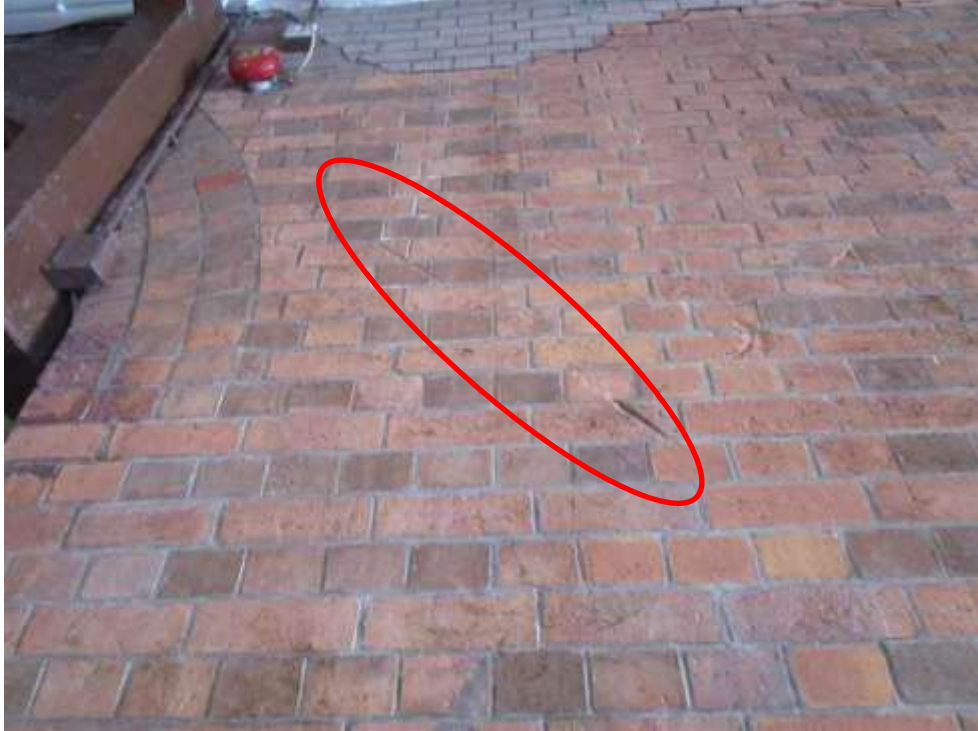
Photo No. 1347

Defect No. 173	Location LG/F East wing, Canteen	Component brick wall
-----------------------	-----------------------------------------	-----------------------------

Description A previous repair mark was observed on brick wall

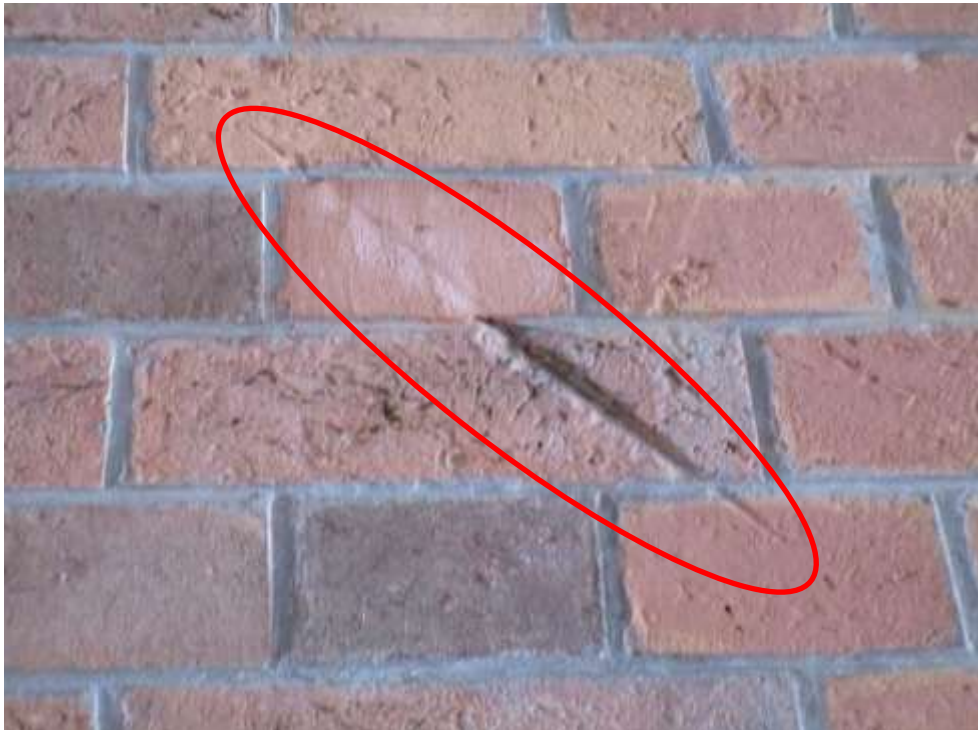
Photo No. 1348

Defect No. 174	Location LG/F East wing, Canteen	Component brick wall
-----------------------	-----------------------------------------	-----------------------------

Description A scratch mark was observed on brick wall

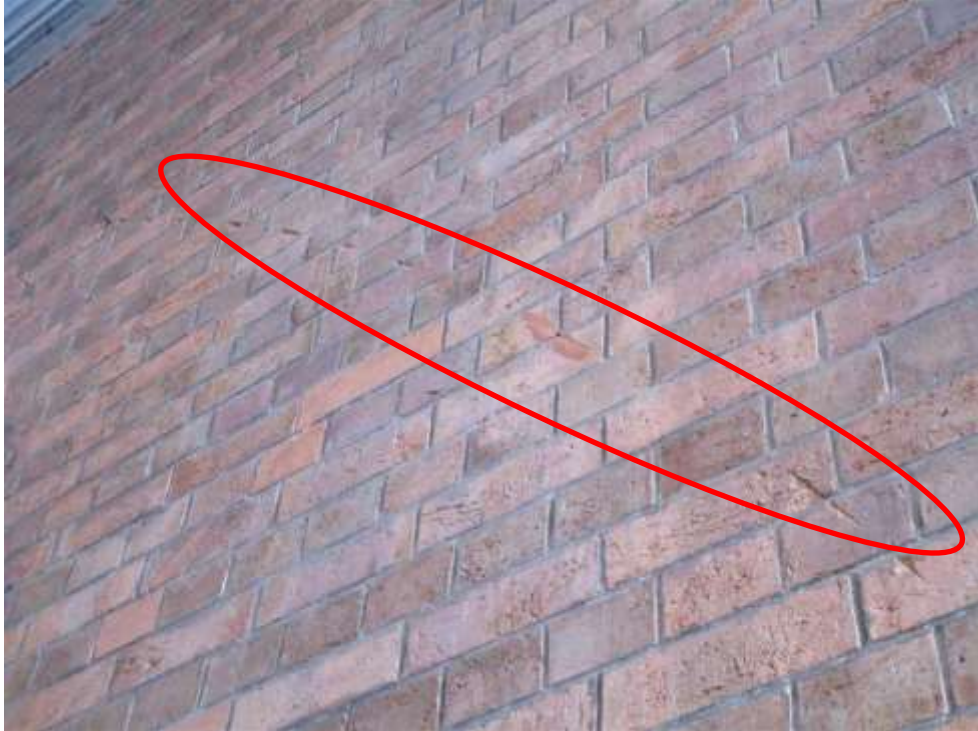
Photo No. 1349

Defect No. 174	Location LG/F East wing, Canteen	Component brick wall
-----------------------	-----------------------------------------	-----------------------------

Description A scratch mark was observed on brick wall

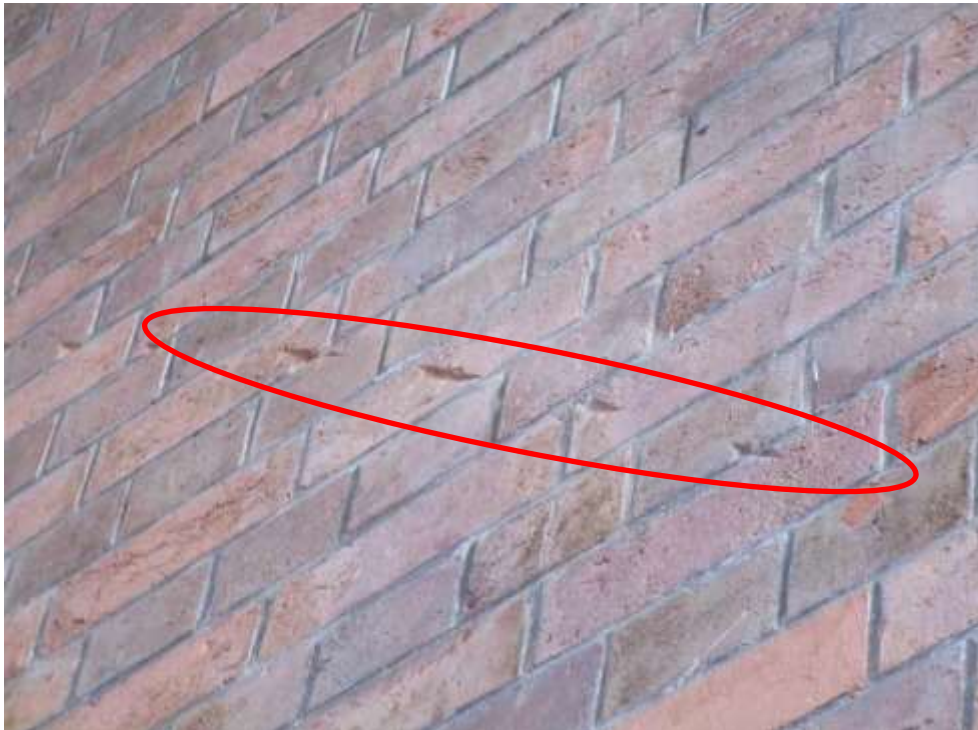
Photo No. 1350

Defect No. 175	Location LG/F East wing, Canteen	Component brick wall
-----------------------	-----------------------------------------	-----------------------------

Description A scratch mark was observed on brick wall

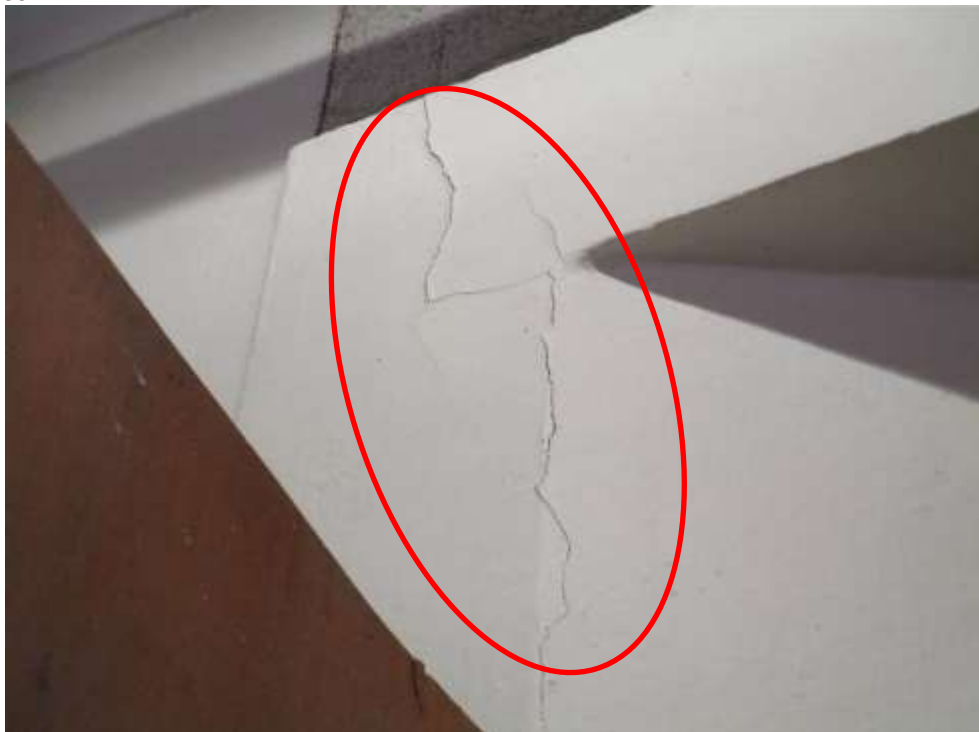
Photo No. 1352

Defect No.	176	Location	LG/F East wing, Canteen	Component	wall
-------------------	-----	-----------------	-------------------------	------------------	------

Description	A wide crack was observed on wall finishing				
--------------------	---------------------------------------------	--	--	--	--

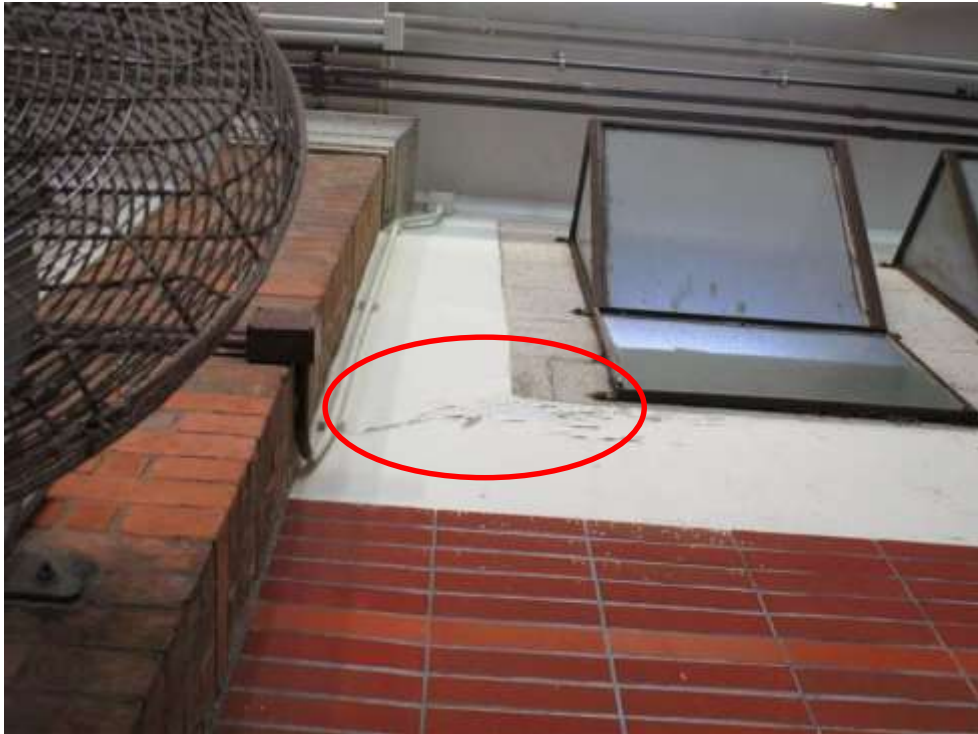
Photo No. 1353

Defect No.	176	Location	LG/F East wing, Canteen	Component	wall
-------------------	-----	-----------------	-------------------------	------------------	------

Description	A wide crack was observed on wall finishing				
--------------------	---------------------------------------------	--	--	--	--

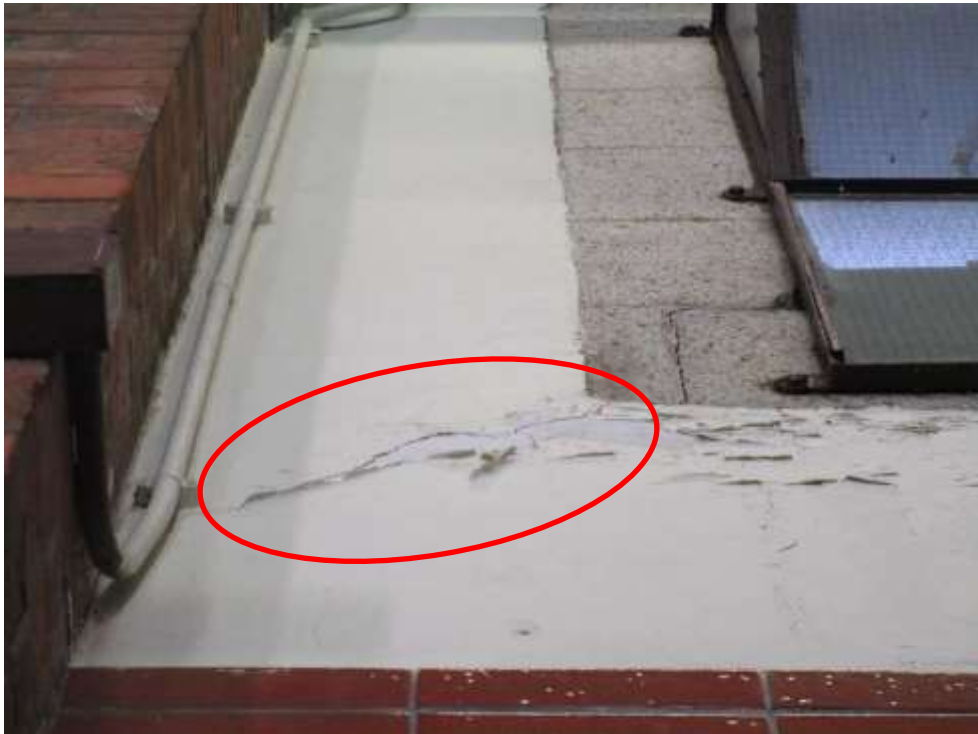
Photo No. 1354

Defect No. 177	Location LG/F East wing, Canteen	Component wall
-----------------------	-----------------------------------------	-----------------------

Description A wide crack was observed on wall finishing

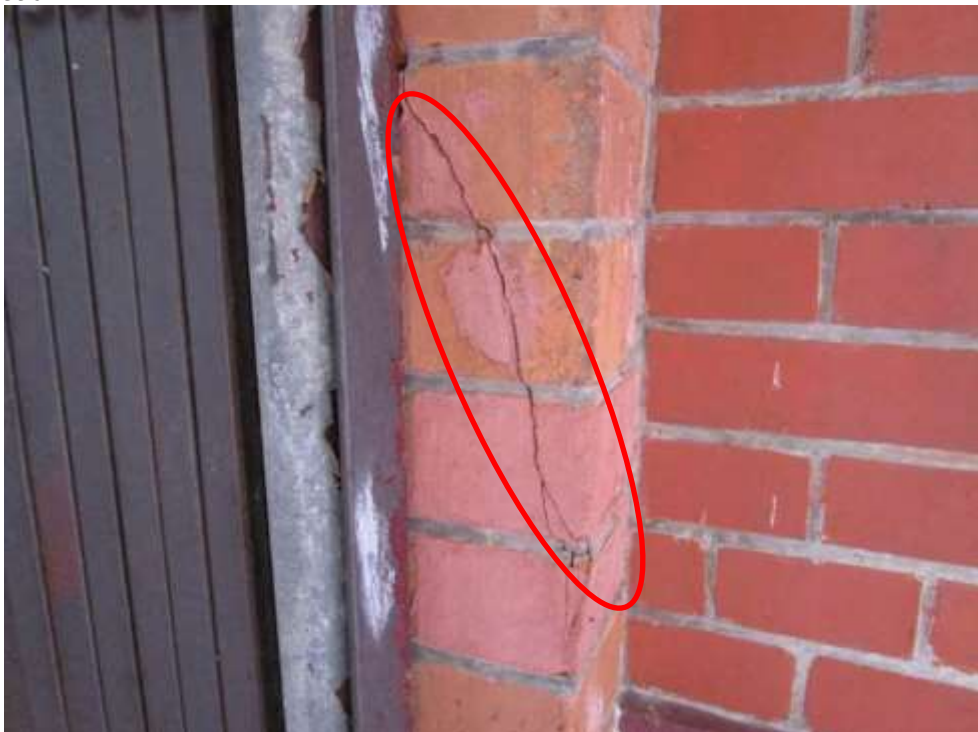
Photo No. 1356

Defect No. 178	Location LG/F East wing, Corridor	Component brick column
-----------------------	------------------------------------------	-------------------------------

Description A wide crack was observed on brick column

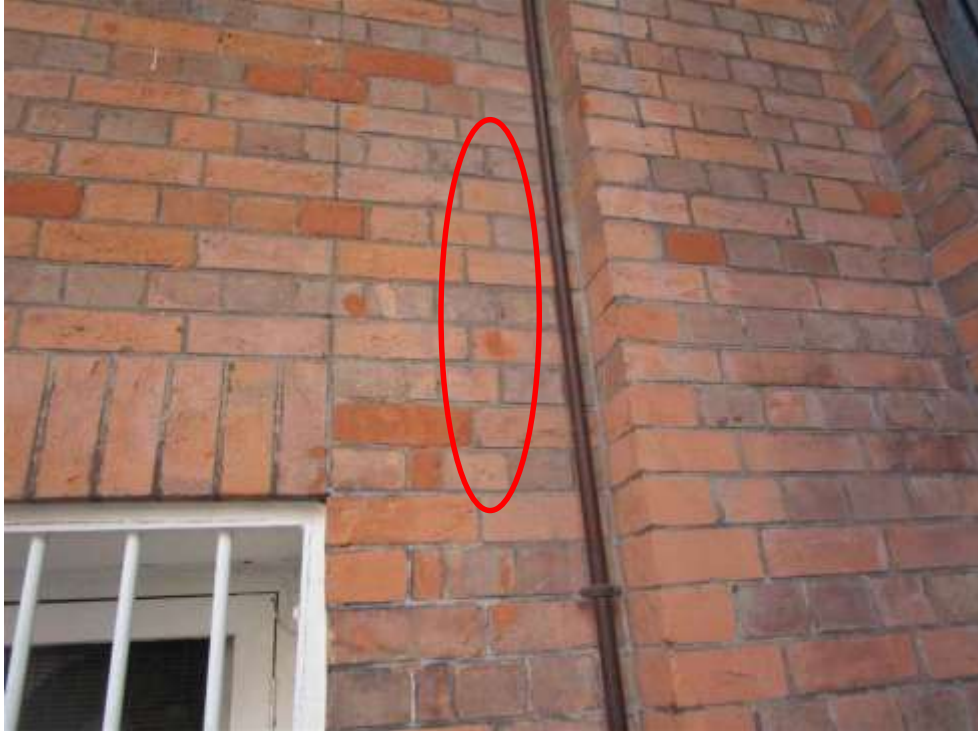
Photo No. 1357

Defect No. 178	Location LG/F East wing, Corridor	Component brick column
-----------------------	------------------------------------------	-------------------------------

Description A wide crack was observed on brick column

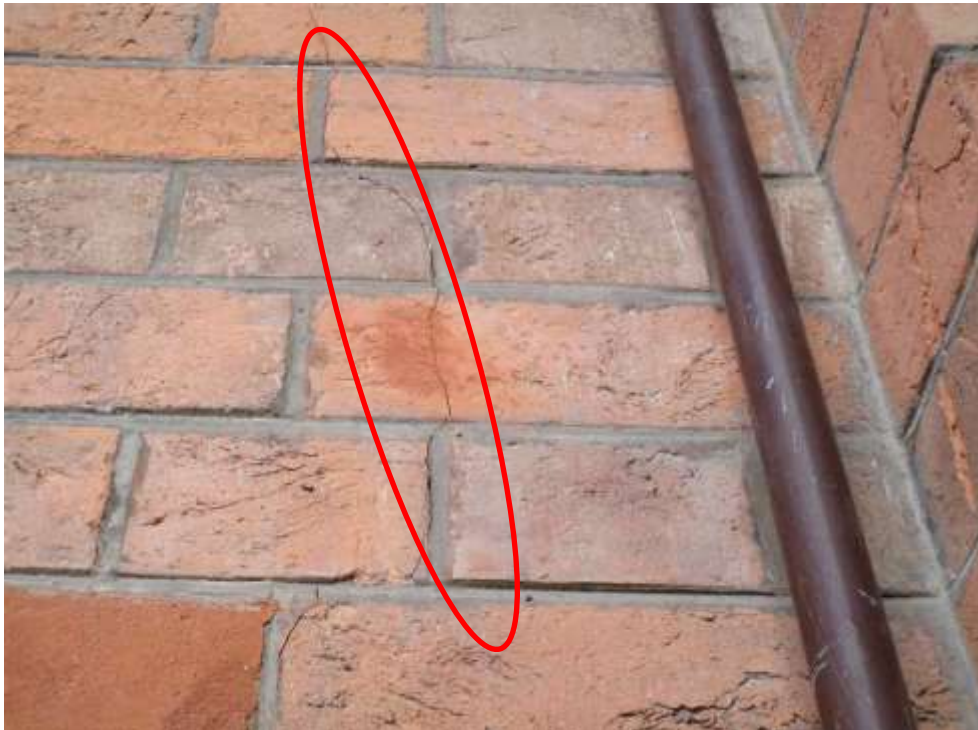
Photo No. 1358

Defect No. 179	Location LG/F East wing, Corridor	Component brick wall
-----------------------	------------------------------------------	-----------------------------

Description A hairline crack was observed on brick wall

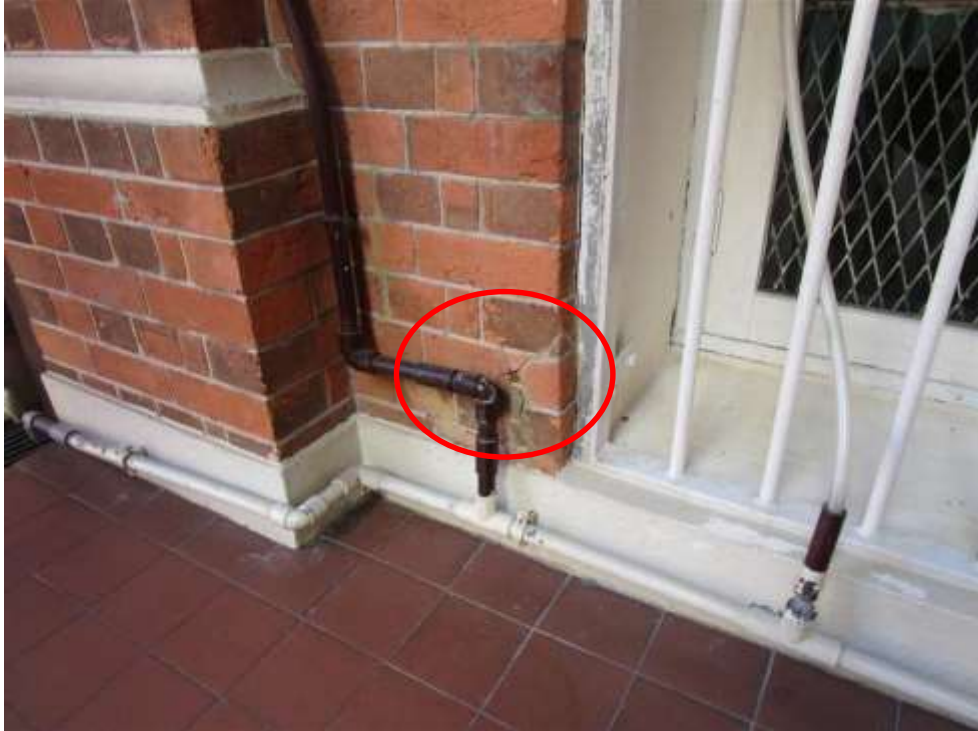
Photo No. 1359

Defect No. 179	Location LG/F East wing, Corridor	Component brick wall
-----------------------	------------------------------------------	-----------------------------

Description A hairline crack was observed on brick wall

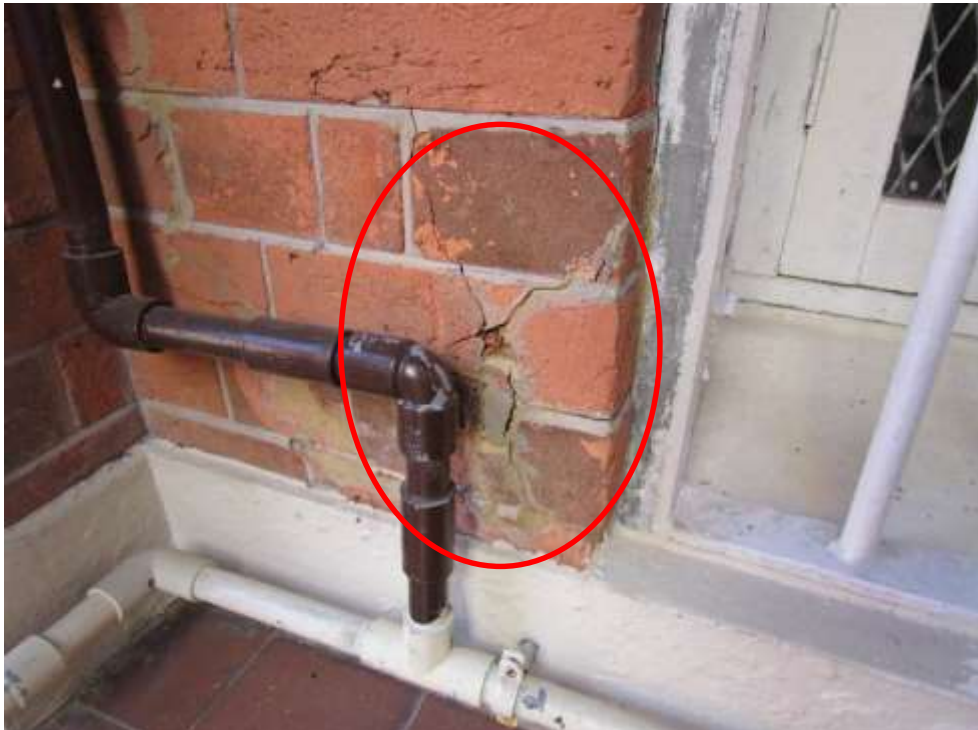
Photo No. 1360

Defect No. 180 **Location** LG/F East wing, Corridor **Component** brick column

Description An area of wide crack was observed on brick column

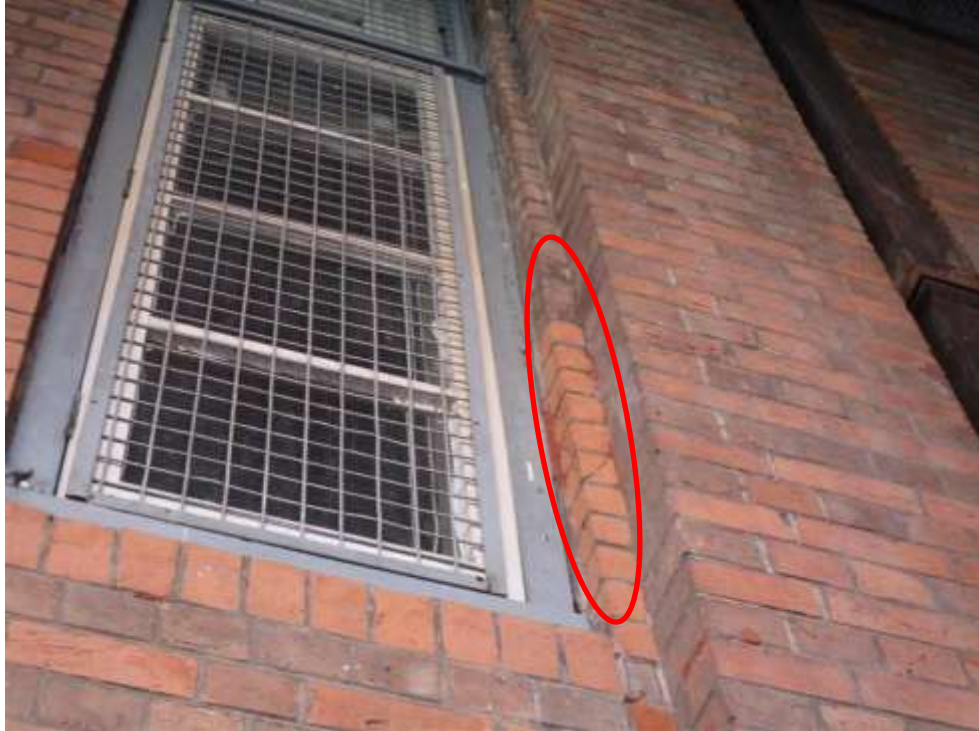
Photo No. 1361

Defect No. 180 **Location** LG/F East wing, Corridor **Component** brick column

Description An area of wide crack was observed on brick column

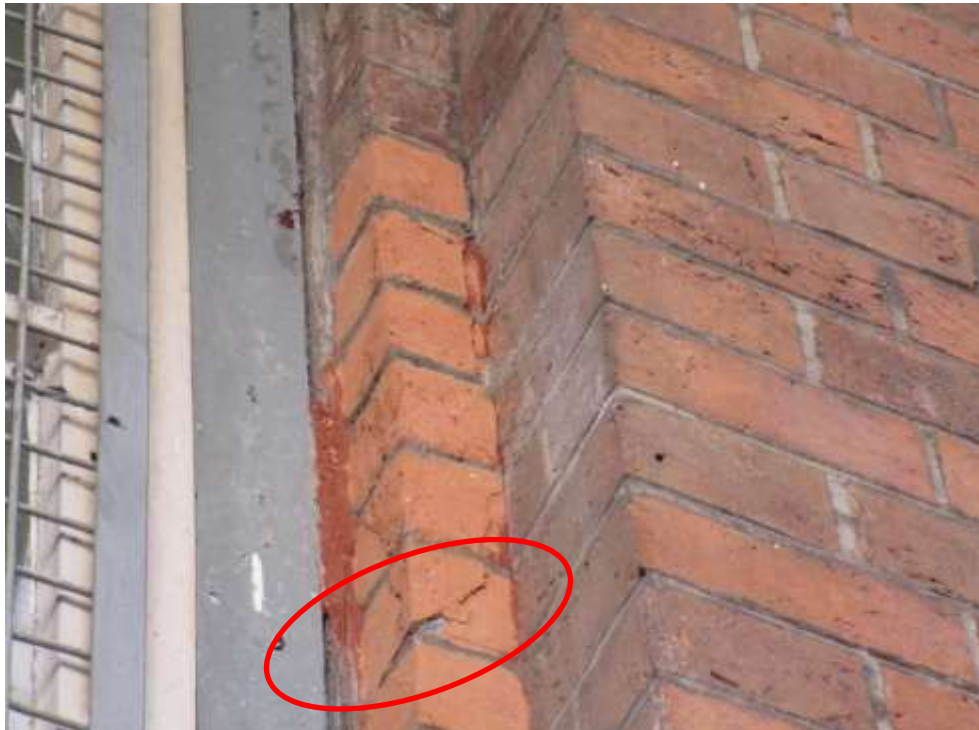
Photo No. 1362

Defect No. 181	Location LG/F East wing, Corridor	Component brick column
-----------------------	------------------------------------------	-------------------------------

Description A wide crack was observed on brick column

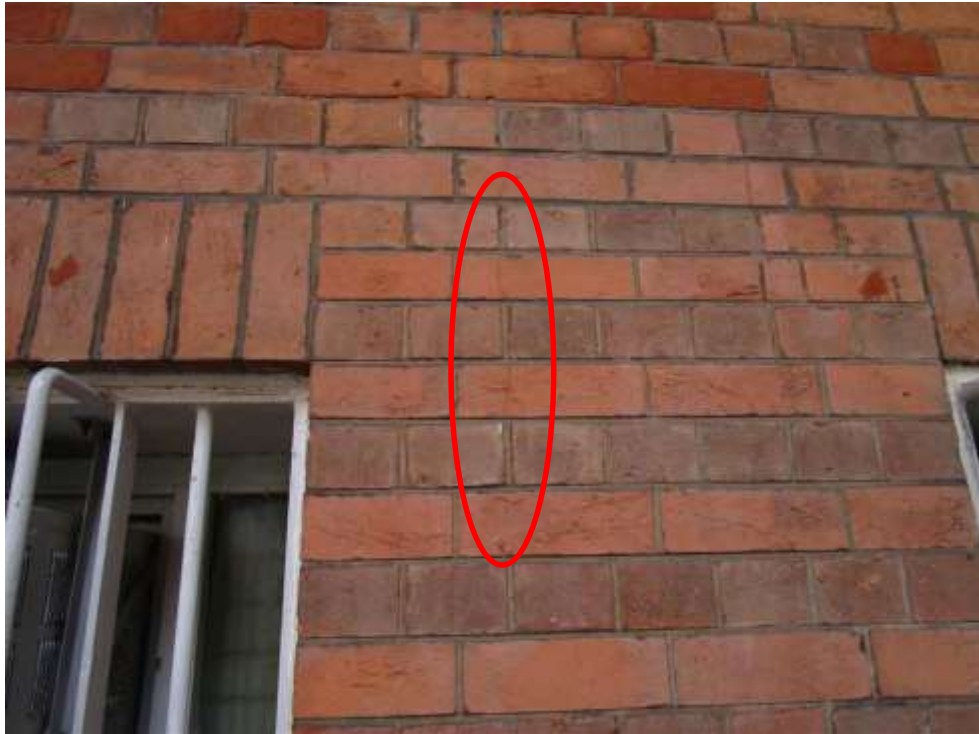
Photo No. 1363

Defect No. 181	Location LG/F East wing, Corridor	Component brick column
-----------------------	------------------------------------------	-------------------------------

Description A wide crack was observed on brick column

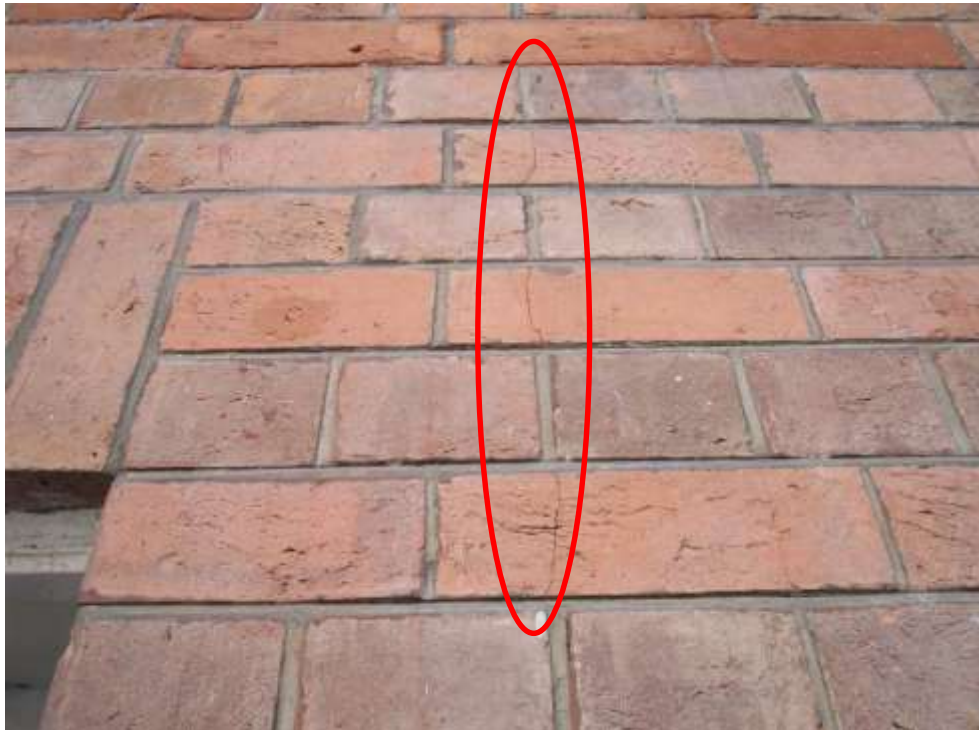
Photo No. 1364

Defect No.	182	Location	LG/F East wing, Corridor	Component	brick wall
-------------------	-----	-----------------	--------------------------	------------------	------------

Description	A hairline crack was observed on brick wall				
--------------------	---------------------------------------------	--	--	--	--

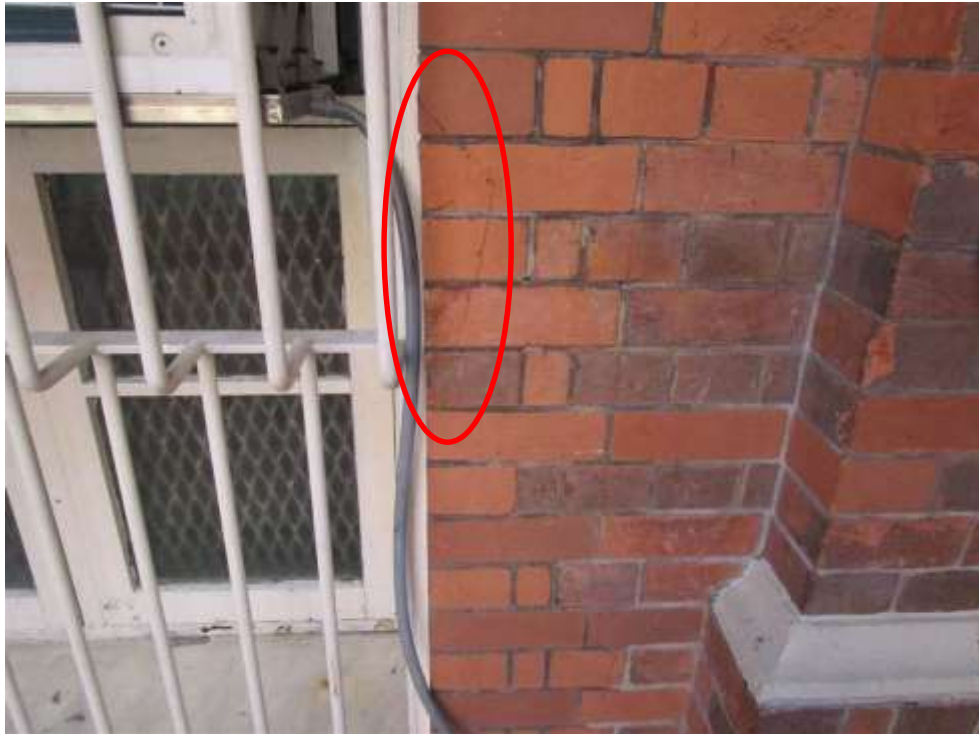
Photo No. 1365

Defect No.	182	Location	LG/F East wing, Corridor	Component	brick wall
-------------------	-----	-----------------	--------------------------	------------------	------------

Description	A hairline crack was observed on brick wall				
--------------------	---------------------------------------------	--	--	--	--

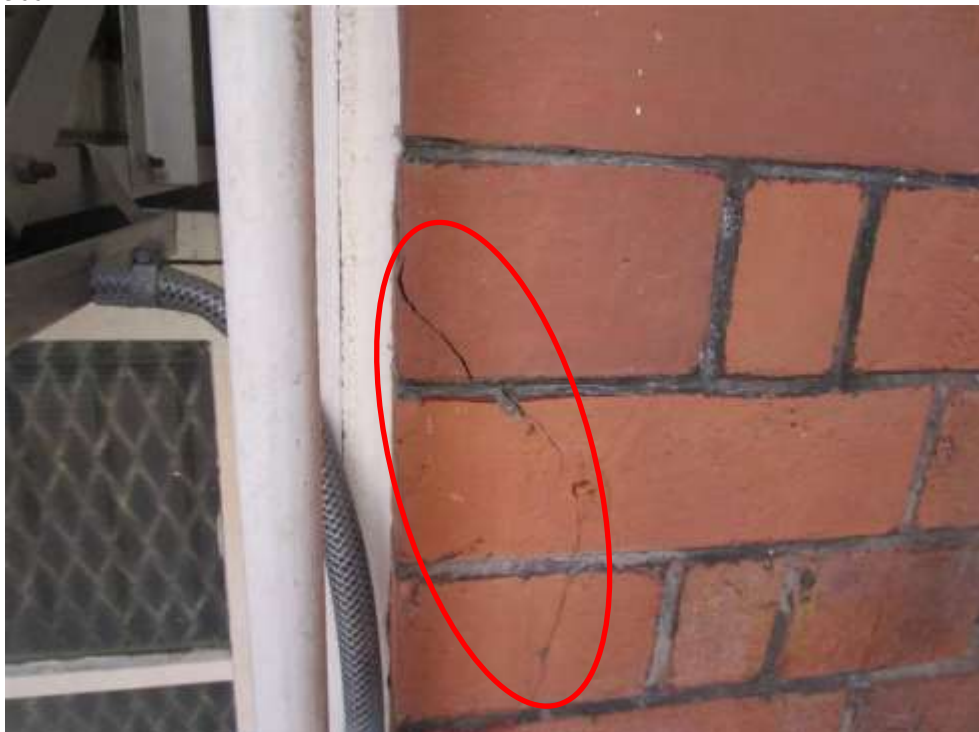
Photo No. 1366

Defect No. 183	Location LG/F East wing, Corridor	Component brick column
-----------------------	------------------------------------------	-------------------------------

Description A wide crack was observed on brick column

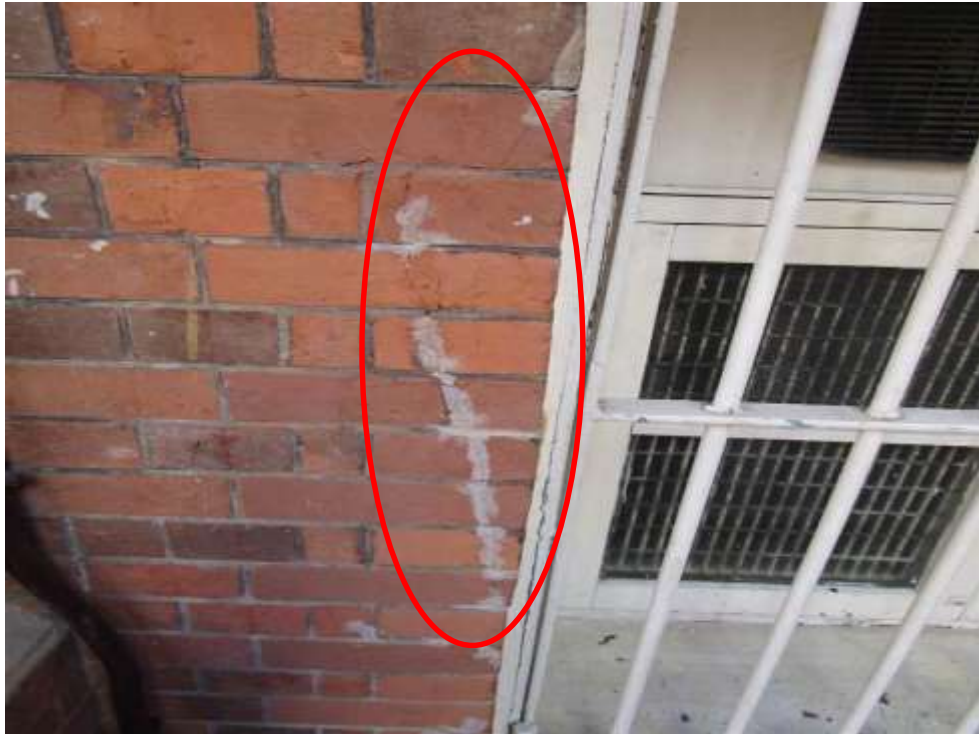
Photo No. 1367

Defect No. 183	Location LG/F East wing, Corridor	Component brick column
-----------------------	------------------------------------------	-------------------------------

Description A wide crack was observed on brick column

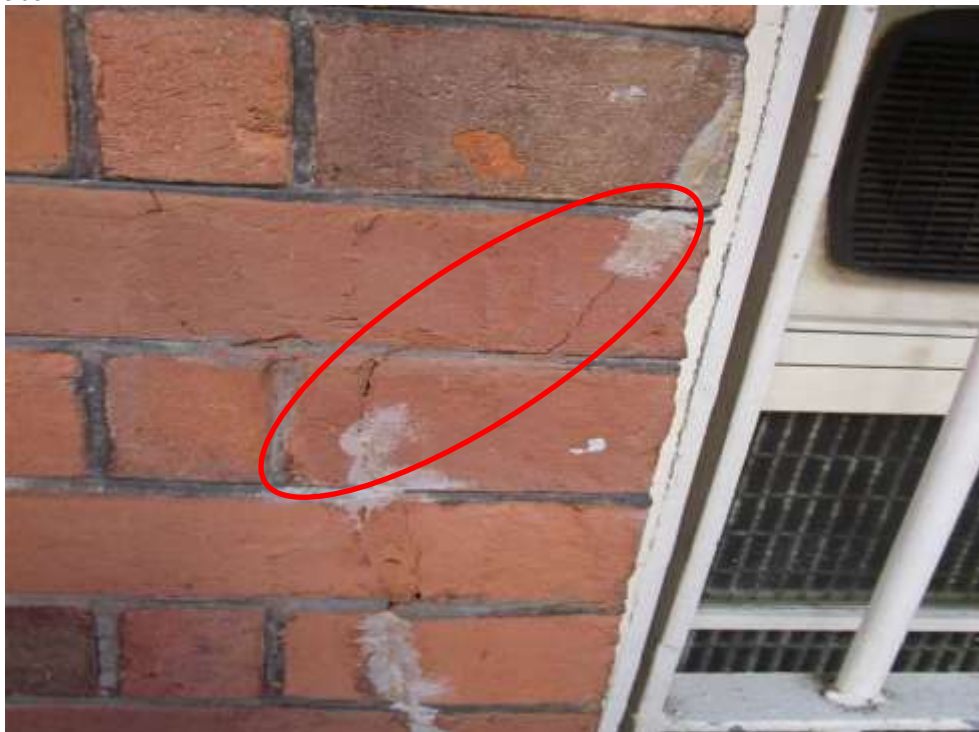
Photo No. 1368

Defect No.	184	Location	LG/F East wing, Corridor	Component	brick column
-------------------	-----	-----------------	--------------------------	------------------	--------------

Description	A medium crack with sign of previous repair was observed on brick column				
--------------------	--------------------------------------------------------------------------	--	--	--	--

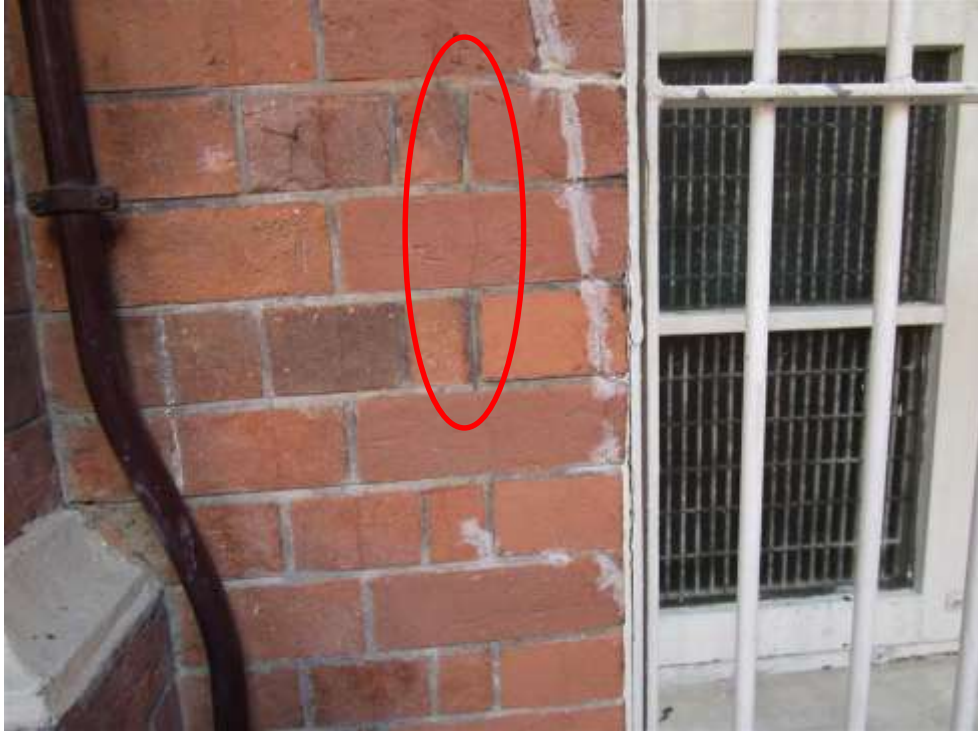
Photo No. 1369

Defect No.	184	Location	LG/F East wing, Corridor	Component	brick column
-------------------	-----	-----------------	--------------------------	------------------	--------------

Description	A medium crack with sign of previous repair was observed on brick column				
--------------------	--------------------------------------------------------------------------	--	--	--	--

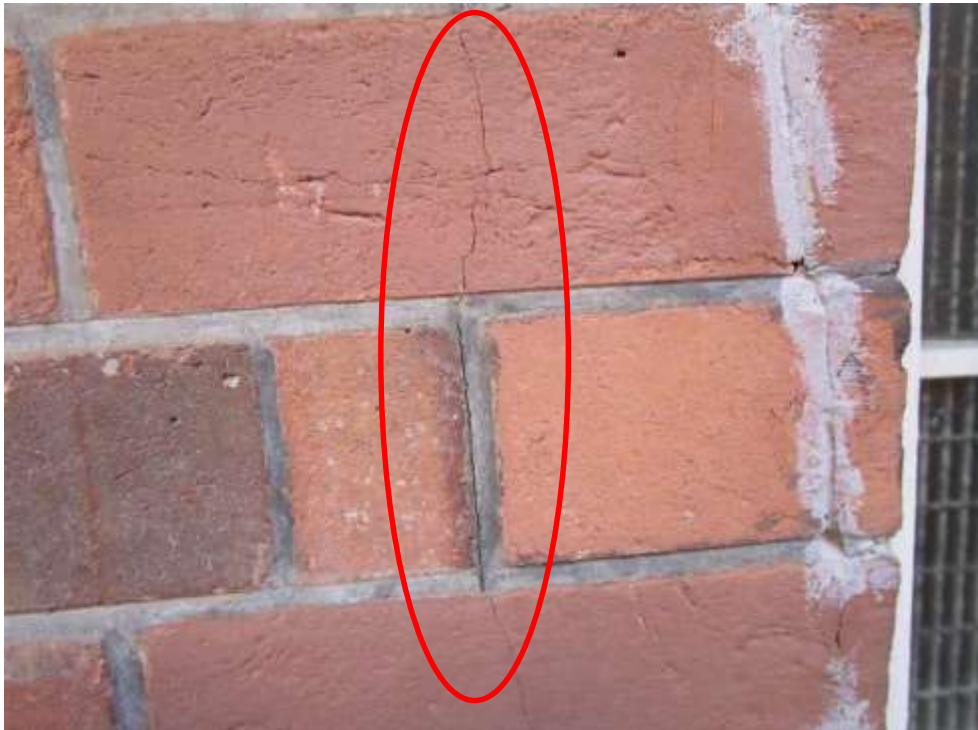
Photo No. 1370

Defect No.	185	Location	LG/F East wing, Corridor	Component	brick column
-------------------	-----	-----------------	--------------------------	------------------	--------------

Description	A hairline crack was observed on brick column				
--------------------	-----------------------------------------------	--	--	--	--

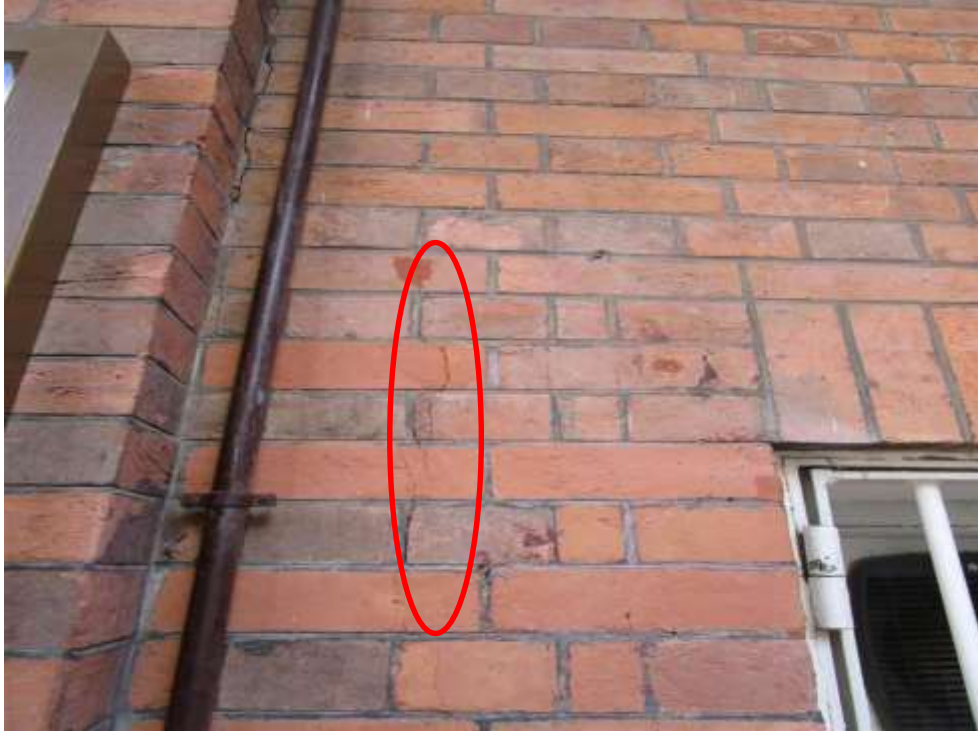
Photo No. 1371

Defect No.	185	Location	LG/F East wing, Corridor	Component	brick column
-------------------	-----	-----------------	--------------------------	------------------	--------------

Description	A hairline crack was observed on brick column				
--------------------	-----------------------------------------------	--	--	--	--
