**Slope Upgrading Works at
Feature No. 11SW-A/R526,
King's College,
Bonham Road, Hong Kong**

Project Profile for Slope Upgrading Works at
Feature No. 11SW-A/R526, King's College

May 2018

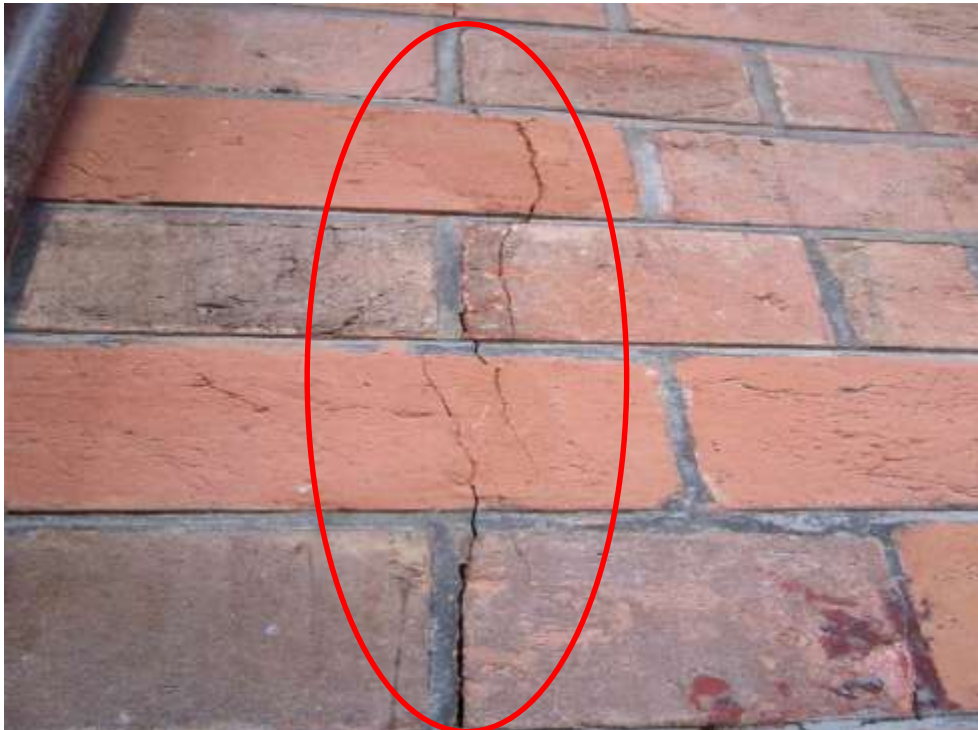
Photo No. 1372

Defect No. 186	Location LG/F East wing, Corridor	Component brick column
-----------------------	------------------------------------------	-------------------------------

Description A wide crack was observed on brick column

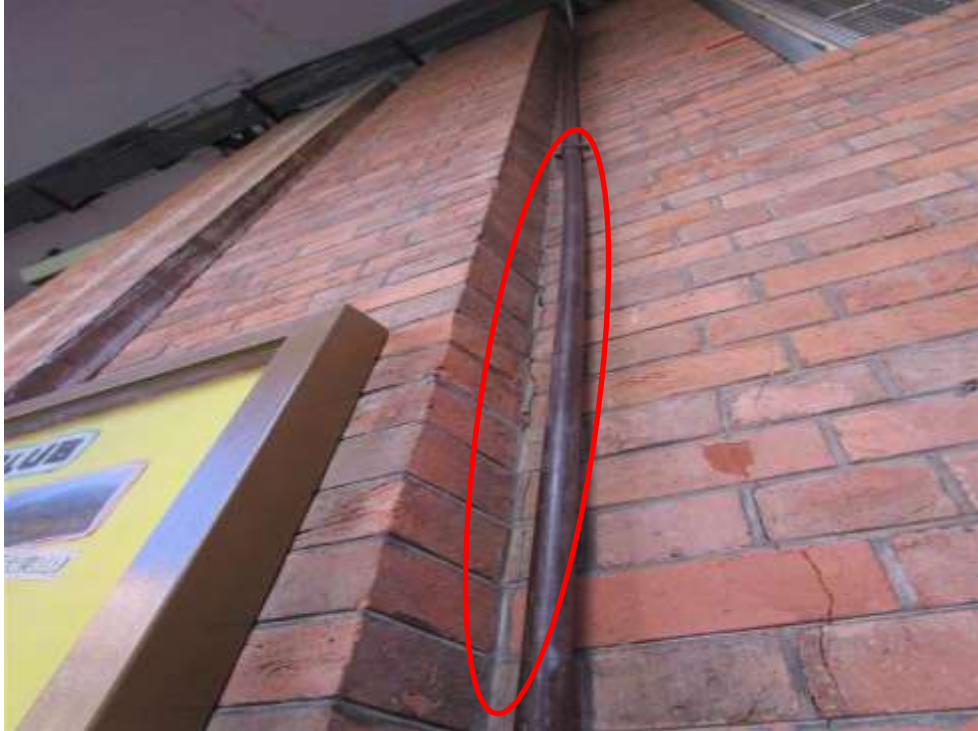
Photo No. 1373

Defect No. 186	Location LG/F East wing, Corridor	Component brick column
-----------------------	------------------------------------------	-------------------------------

Description A wide crack was observed on brick column

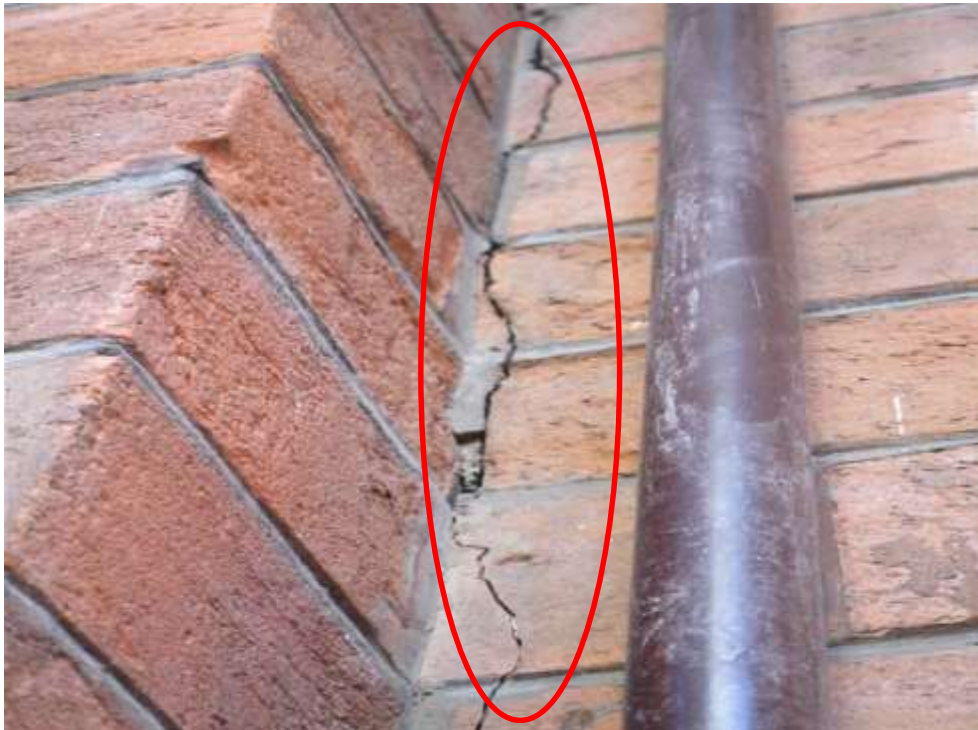
Photo No. 1374

Defect No. 187	Location LG/F East wing, Corridor	Component brick column
-----------------------	------------------------------------------	-------------------------------

Description A wide crack was observed on brick column

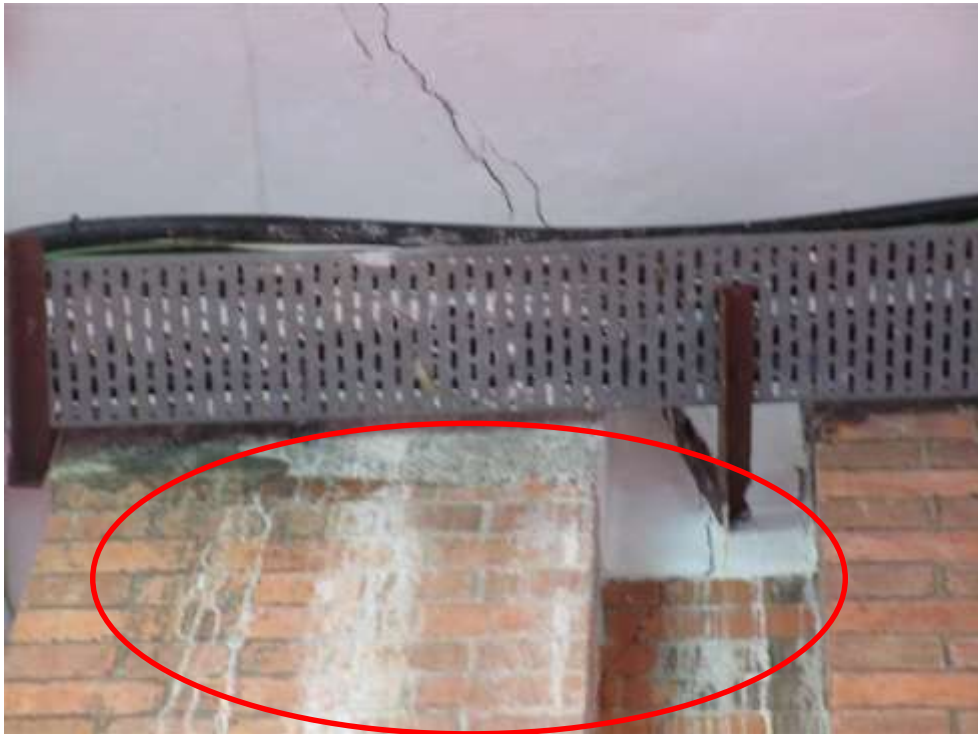
Photo No. 1376

Defect No. 188	Location LG/F East wing, Corridor	Component brick column
Description Leaching stain was observed on brick column

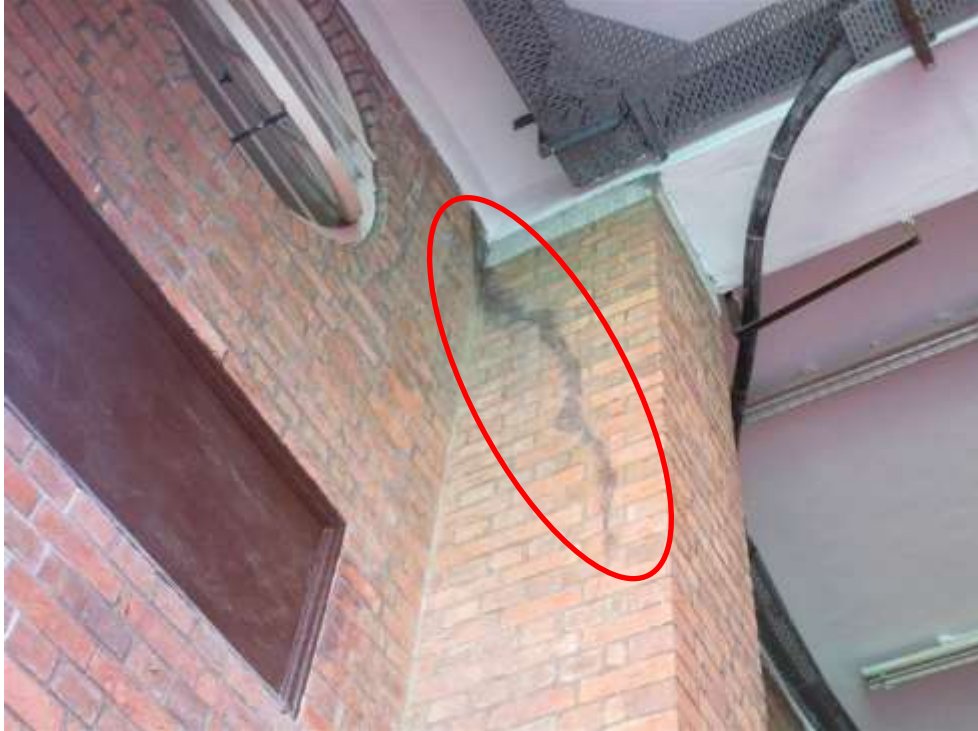
Photo No. 1377

Defect No. 188	Location LG/F East wing, Corridor	Component brick column
Description Leaching stain was observed on brick column

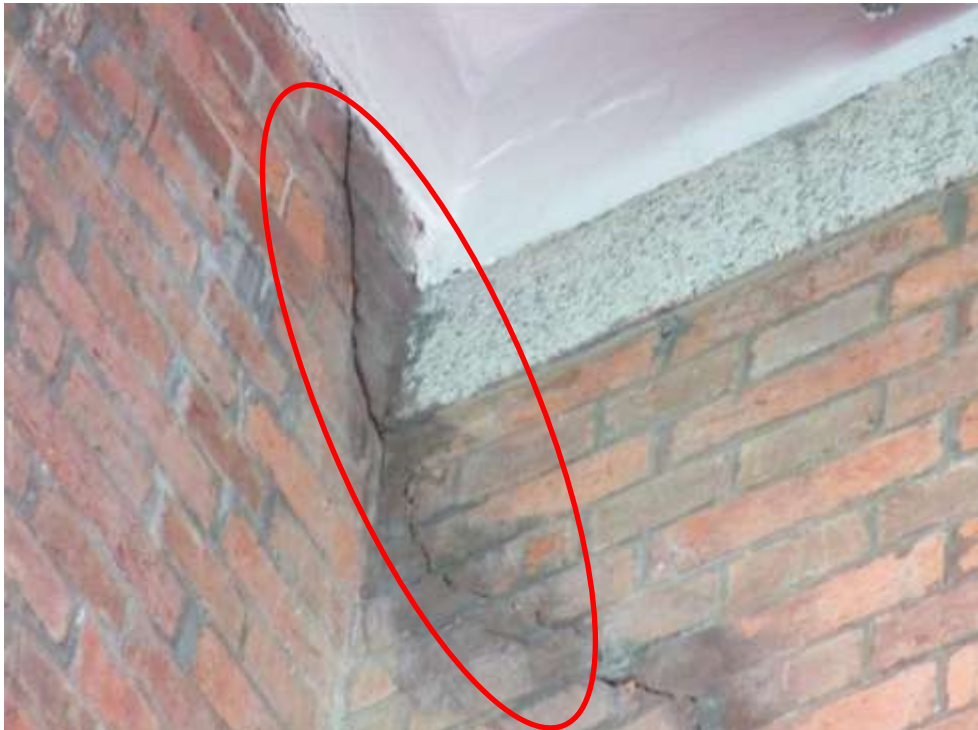
Photo No. 1378

Defect No.	189	Location	LG/F East wing, Corridor	Component	brick column
-------------------	-----	-----------------	--------------------------	------------------	--------------

Description	A diagonal wide crack was observed on brick column				
--------------------	----------------------------------------------------	--	--	--	--

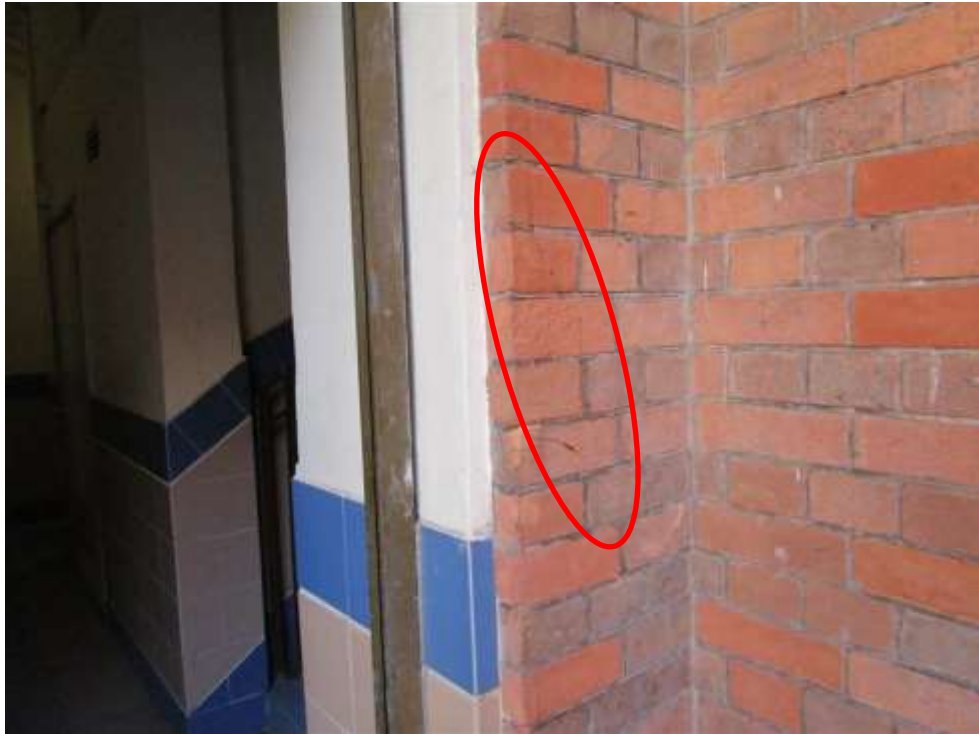
Photo No. 1379

Defect No.	189	Location	LG/F East wing, Corridor	Component	brick column
-------------------	-----	-----------------	--------------------------	------------------	--------------

Description	A diagonal wide crack was observed on brick column				
--------------------	----------------------------------------------------	--	--	--	--

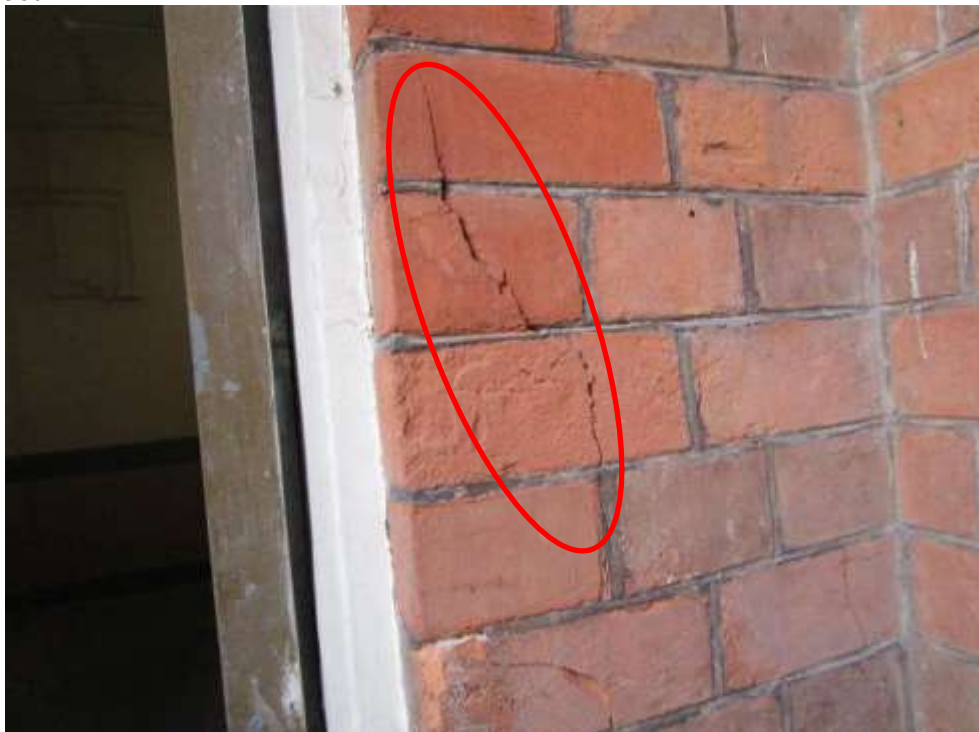
Photo No. 1380

Defect No. 190 **Location** LG/F East wing, Corridor **Component** brick column

Description A wide crack was observed on brick column

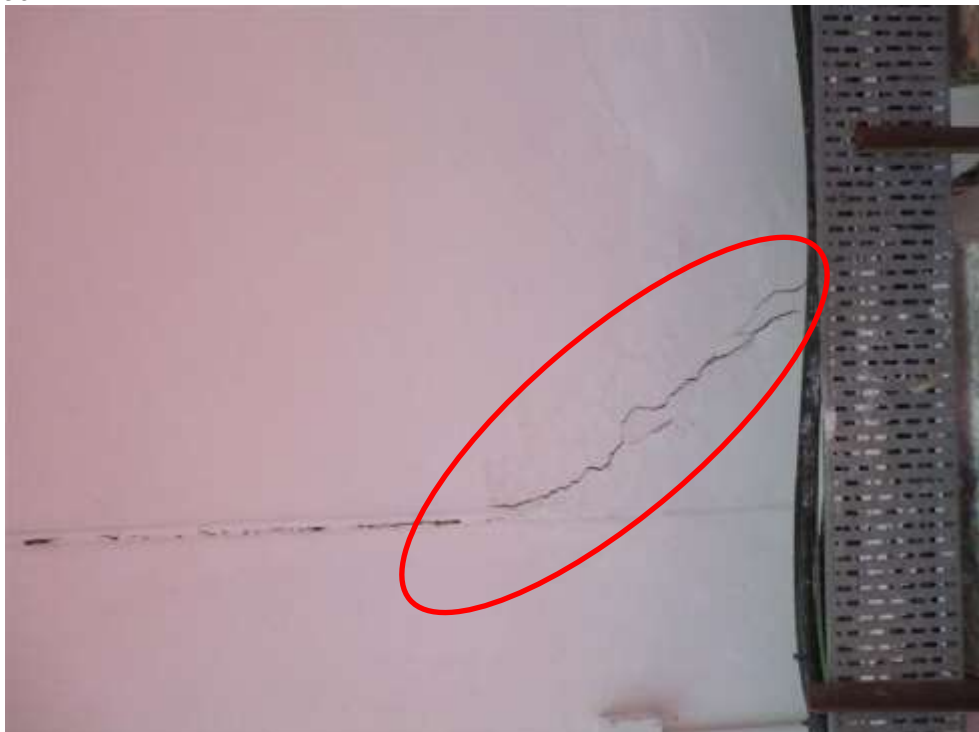
Photo No. 1382

Defect No. 191 **Location** LG/F East wing, Corridor **Component** slab

Description A wide crack was observed on slab soffit finishing

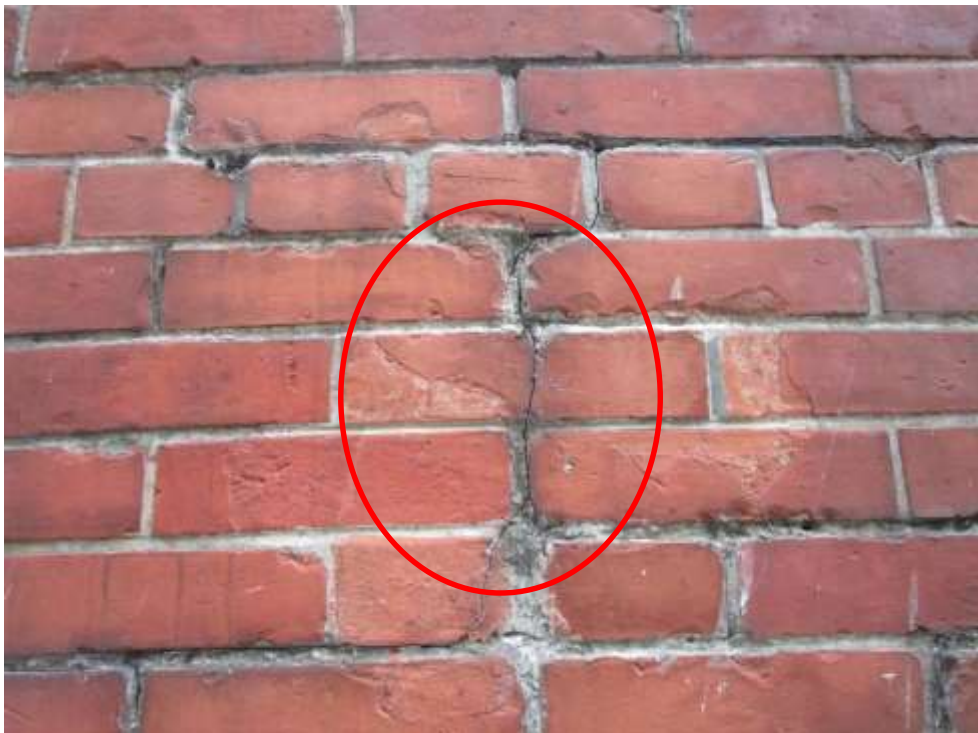
Photo No. 1384

Defect No. 192	Location LG/F East wing, East elevation exterior	Component brick wall
-----------------------	---------------------------------------------------------	-----------------------------

Description A wide crack was observed on brick wall along mortar joint

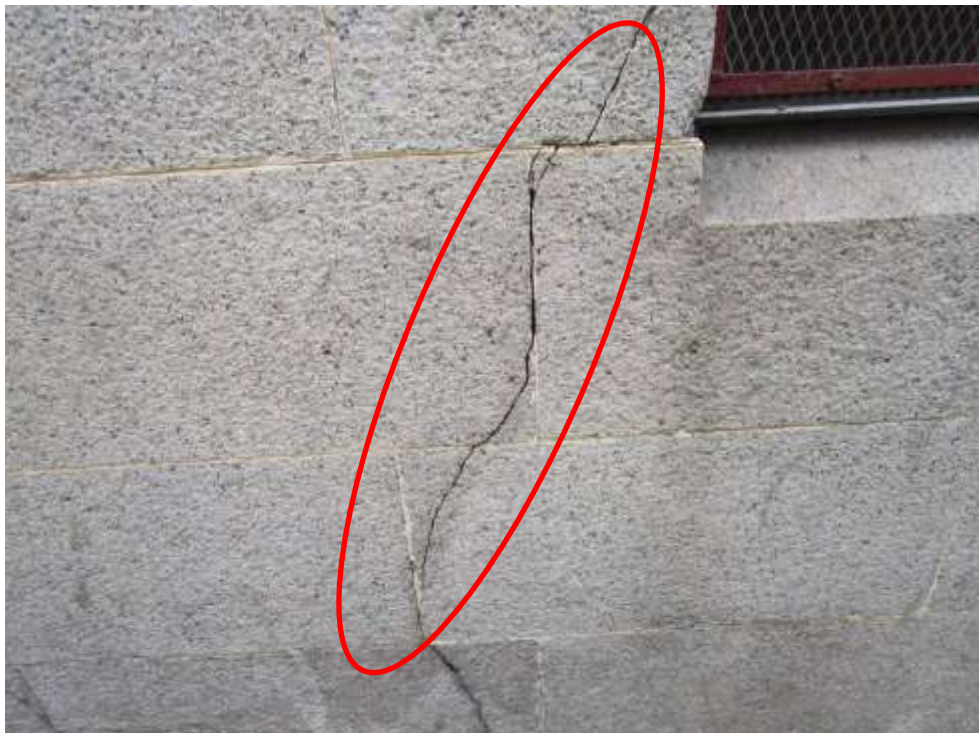
Photo No. 1386

Defect No. 193	Location LG/F East wing, East elevation exterior	Component granite block
-----------------------	---------------------------------------------------------	--------------------------------

Description 2 wide cracks were observed on exterior granite block

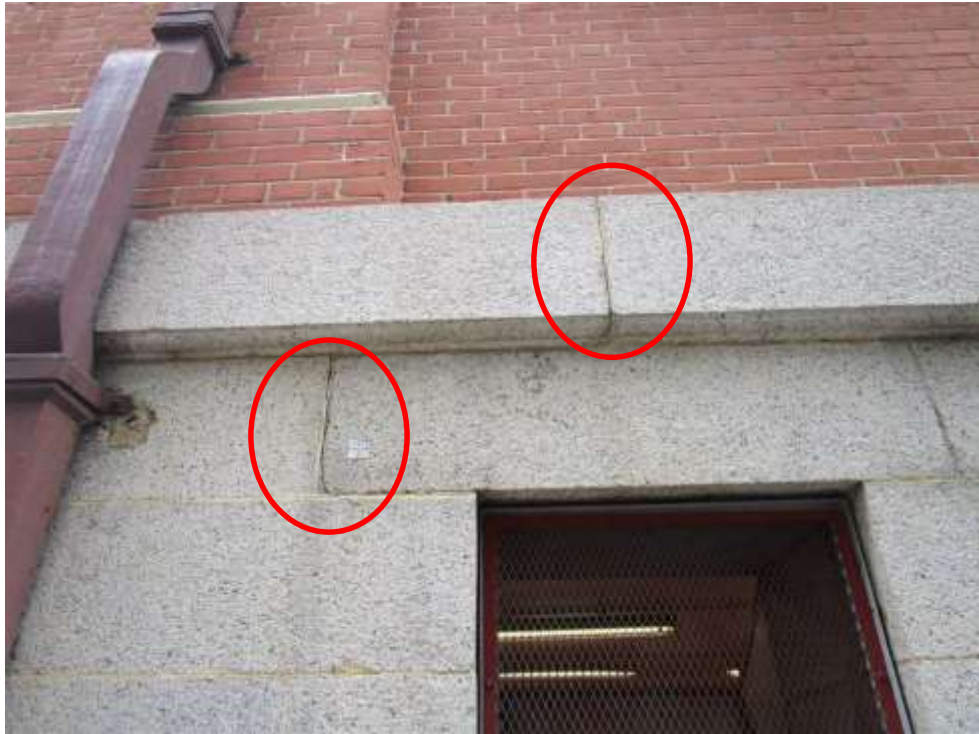
Photo No. 1387

Defect No. 193	Location LG/F East wing, East elevation exterior	Component granite block
-----------------------	---------------------------------------------------------	--------------------------------

Description 2 wide cracks were observed on exterior granite block

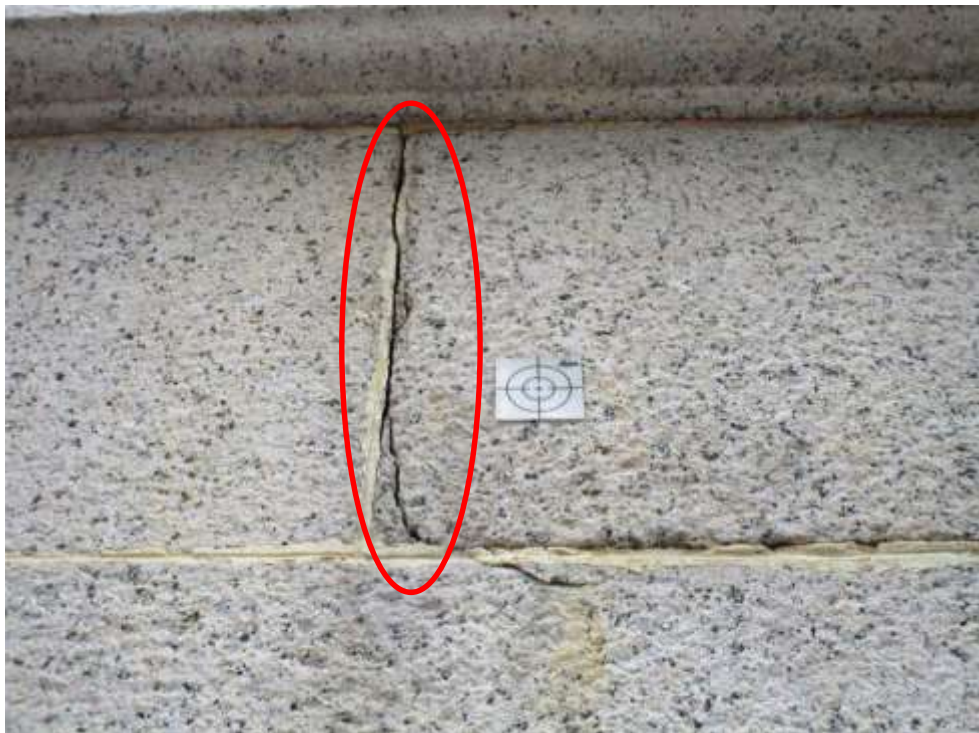
Photo No. 1388

Defect No.	194	Location	LG/F East wing, East elevation exterior	Component	granite block
-------------------	-----	-----------------	-----------------------------------------	------------------	---------------

Description 2 wide cracks were observed on granite block mortar joint

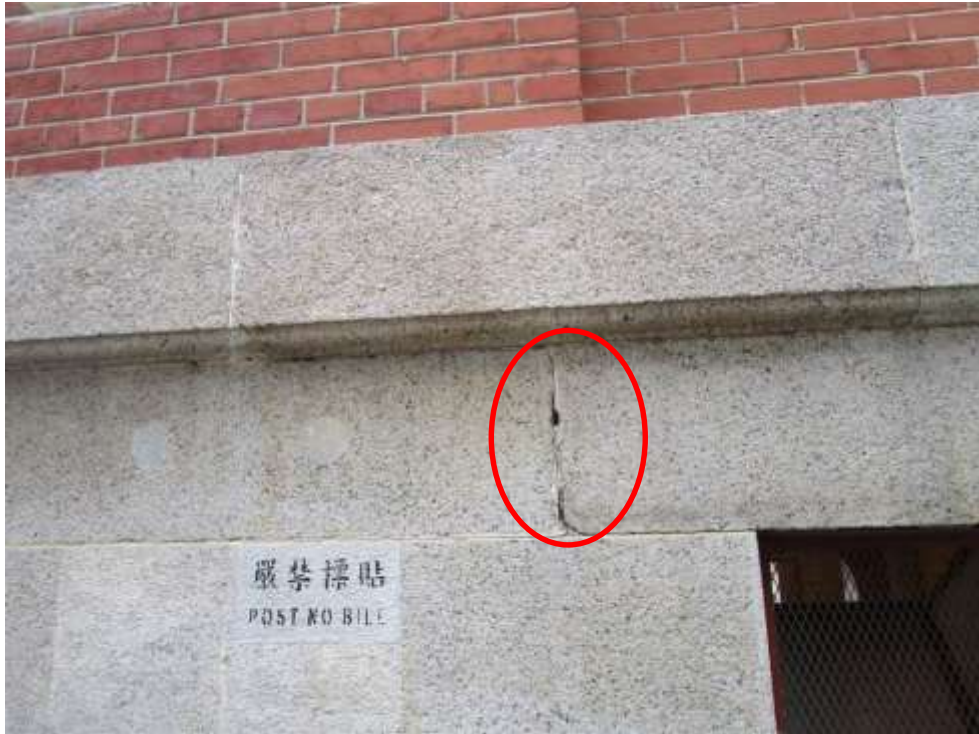
Photo No. 1389

Defect No.	194	Location	LG/F East wing, East elevation exterior	Component	granite block
-------------------	-----	-----------------	-----------------------------------------	------------------	---------------

Description 2 wide cracks were observed on granite block mortar joint

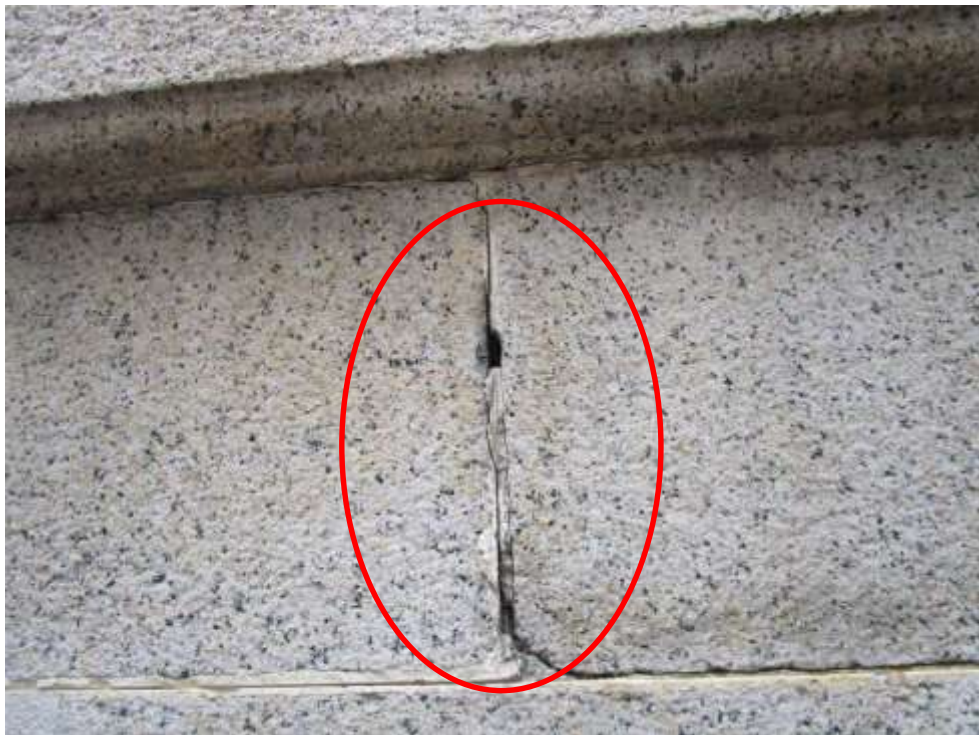
Photo No. 1390

Defect No.	195	Location	LG/F East wing, East elevation exterior	Component	granite block
-------------------	-----	-----------------	-----------------------------------------	------------------	---------------

Description A wide crack was observed on granite block mortar joint

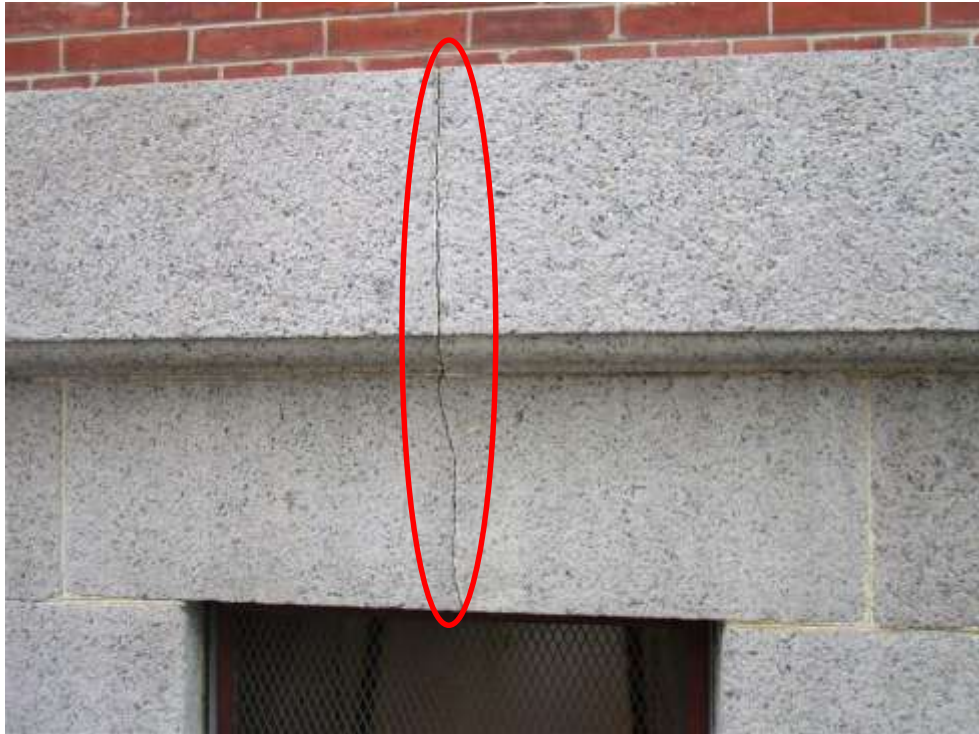
Photo No. 1391

Defect No.	195	Location	LG/F East wing, East elevation exterior	Component	granite block
-------------------	-----	-----------------	-----------------------------------------	------------------	---------------

Description A wide crack was observed on granite block mortar joint

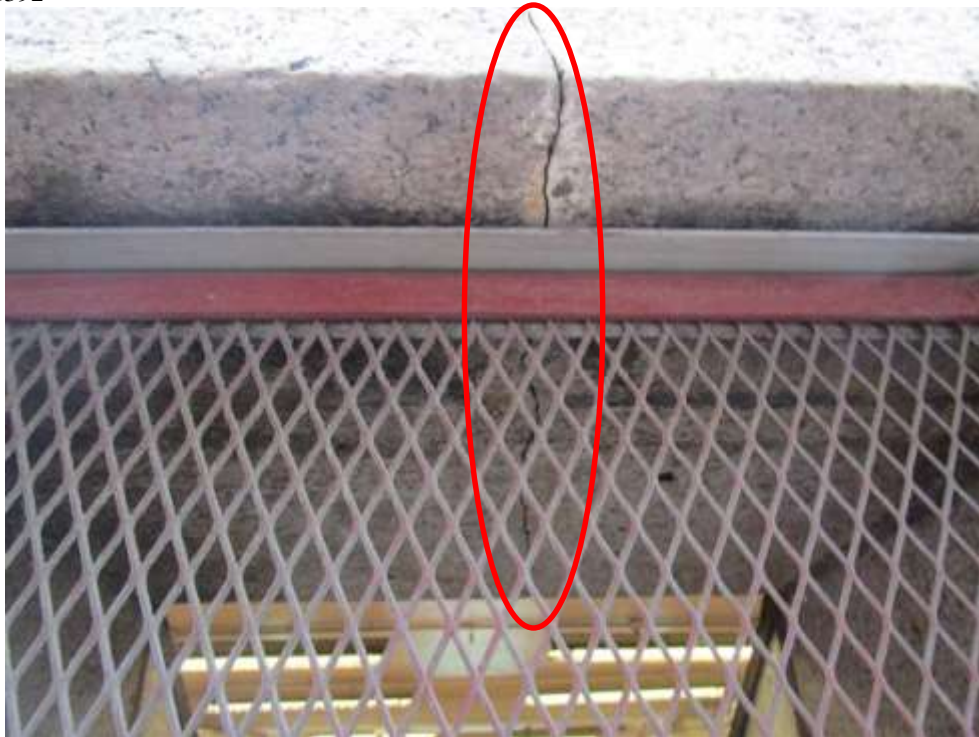
Photo No. 1392

Defect No.	196	Location	LG/F East wing, East elevation exterior	Component	granite block
-------------------	-----	-----------------	-----------------------------------------	------------------	---------------

Description A wide crack was observed on granite block

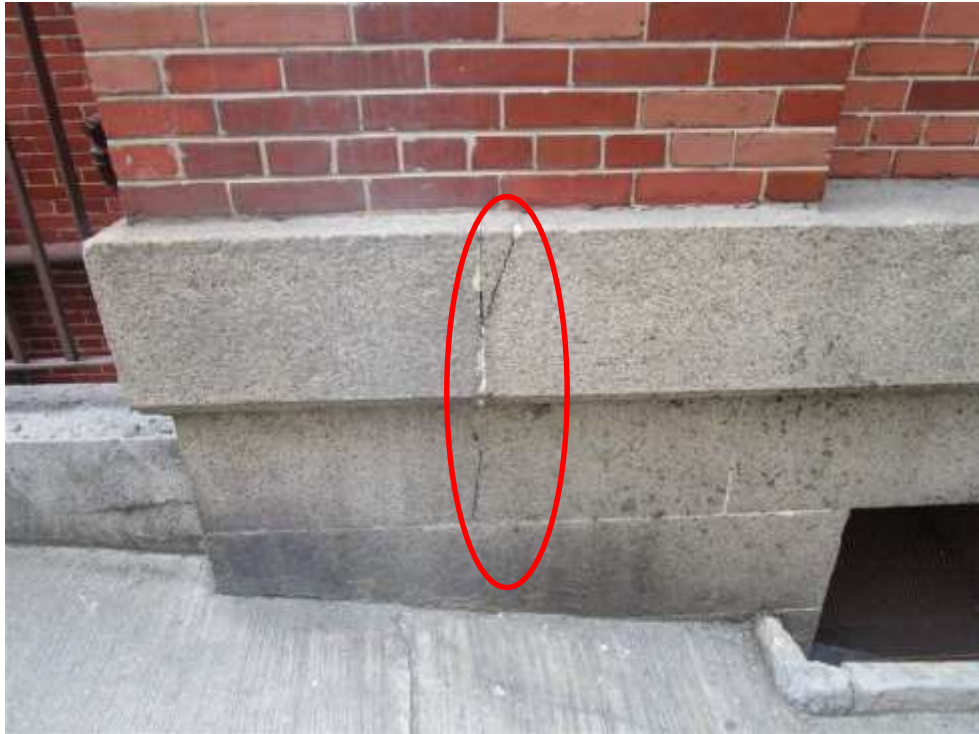
Photo No. 1393

Defect No.	196	Location	LG/F East wing, East elevation exterior	Component	granite block
-------------------	-----	-----------------	-----------------------------------------	------------------	---------------

Description A wide crack was observed on granite block

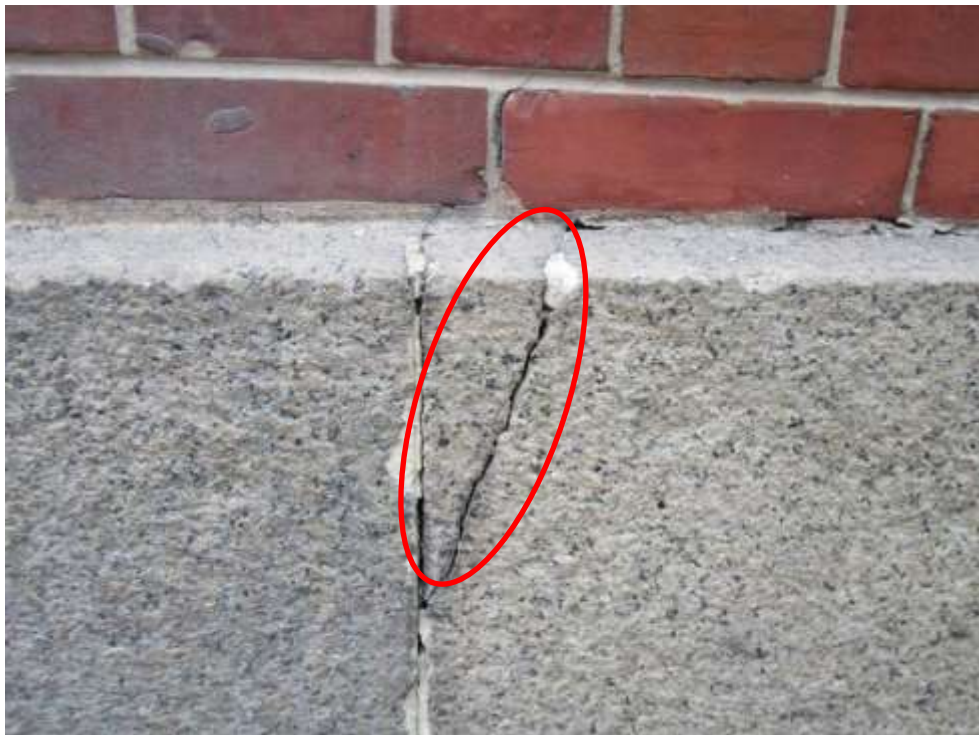
Photo No. 1394

Defect No.	197	Location	LG/F East wing, East elevation exterior	Component	granite block
-------------------	-----	-----------------	-----------------------------------------	------------------	---------------

Description A wide crack was observed on granite block

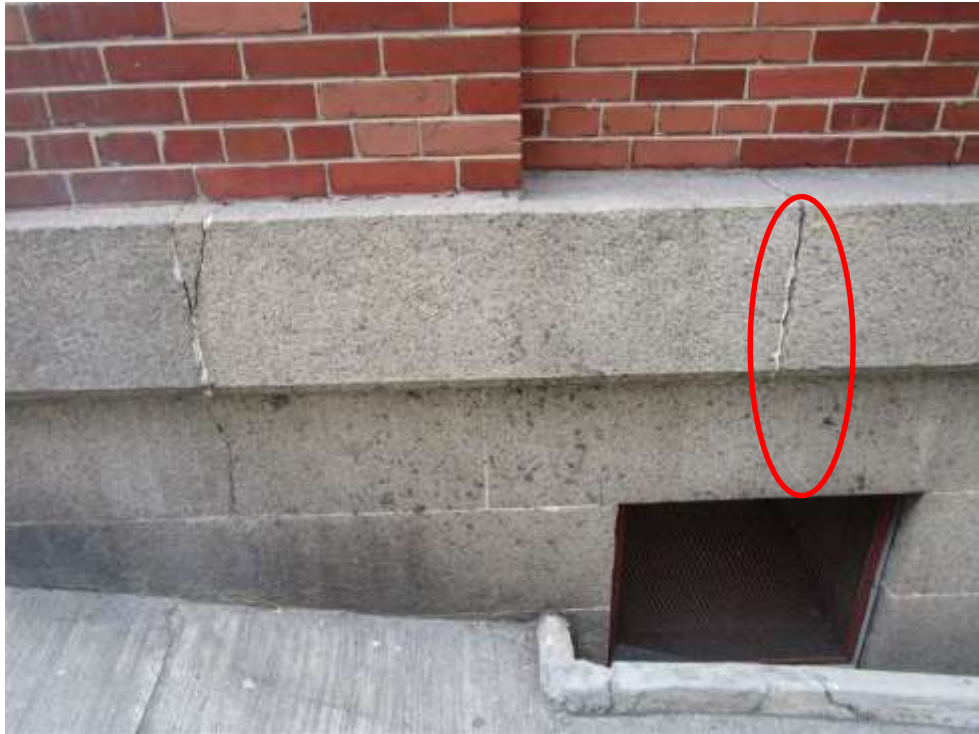
Photo No. 1395

Defect No.	197	Location	LG/F East wing, East elevation exterior	Component	granite block
-------------------	-----	-----------------	-----------------------------------------	------------------	---------------

Description A wide crack was observed on granite block

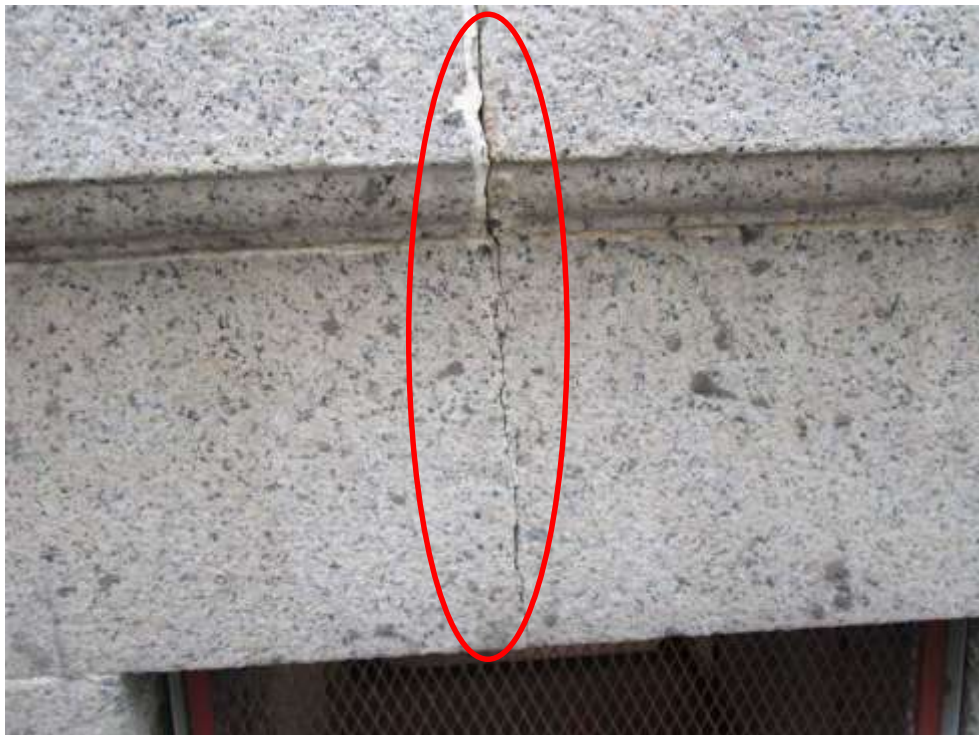
Photo No. 1396

Defect No.	198	Location	LG/F East wing, East elevation exterior	Component	granite block
-------------------	-----	-----------------	-----------------------------------------	------------------	---------------

Description A wide crack was observed on granite block

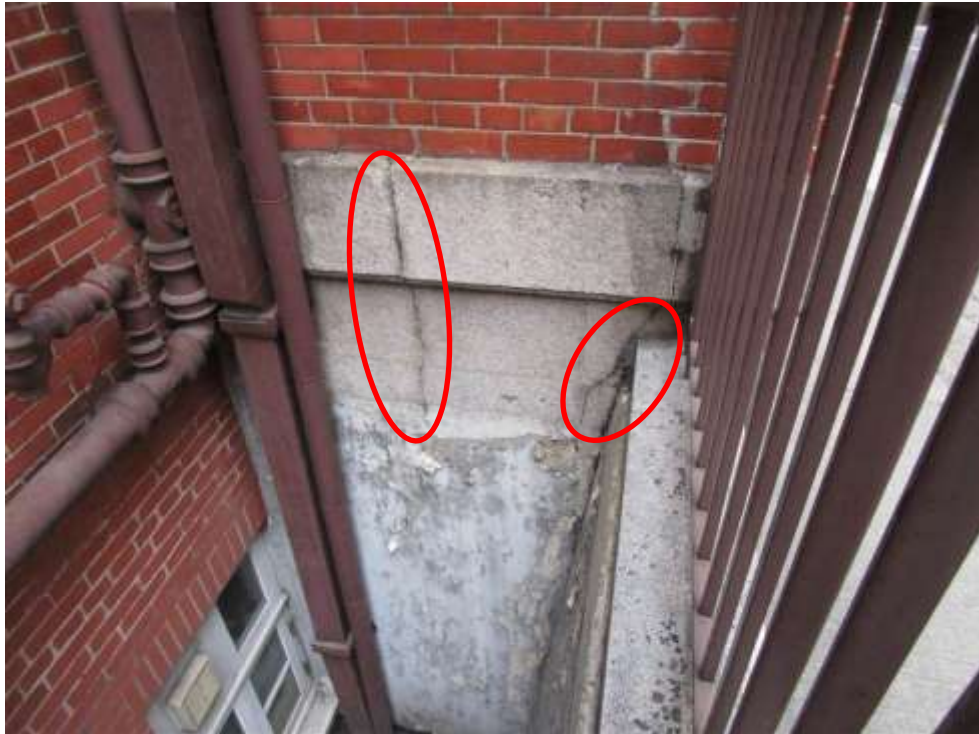
Photo No. 1397

Defect No.	198	Location	LG/F East wing, East elevation exterior	Component	granite block
-------------------	-----	-----------------	-----------------------------------------	------------------	---------------

Description A wide crack was observed on granite block

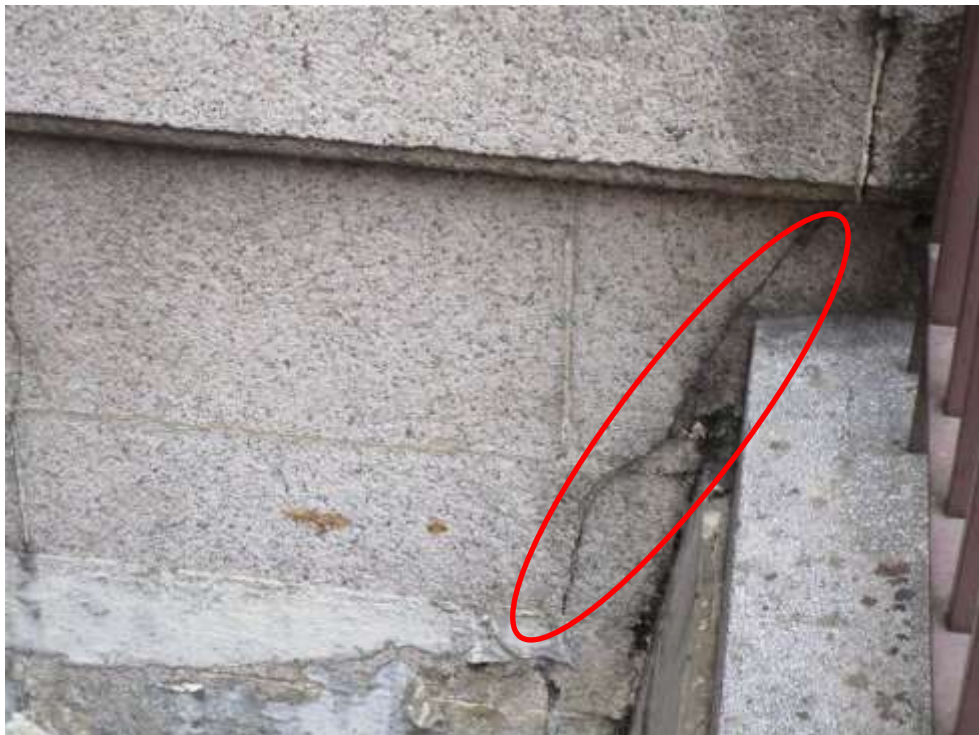
Photo No. 1398

Defect No. 199	Location LG/F East wing, East elevation exterior	Component granite block
-----------------------	---------------------------------------------------------	--------------------------------

Description 2 wide cracks were observed on granite block

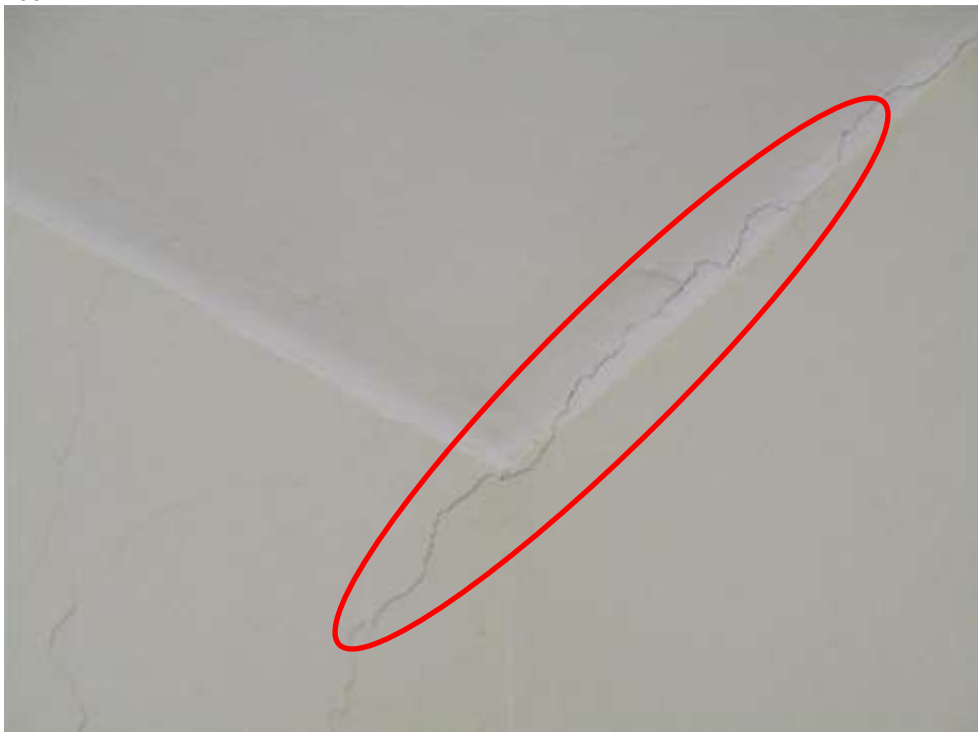
Photo No. 1400

Defect No.	200	Location	LG/F East wing, IT room	Component	wall
-------------------	-----	-----------------	-------------------------	------------------	------

Description	A medium crack was observed on wall finishing				
--------------------	-----------------------------------------------	--	--	--	--

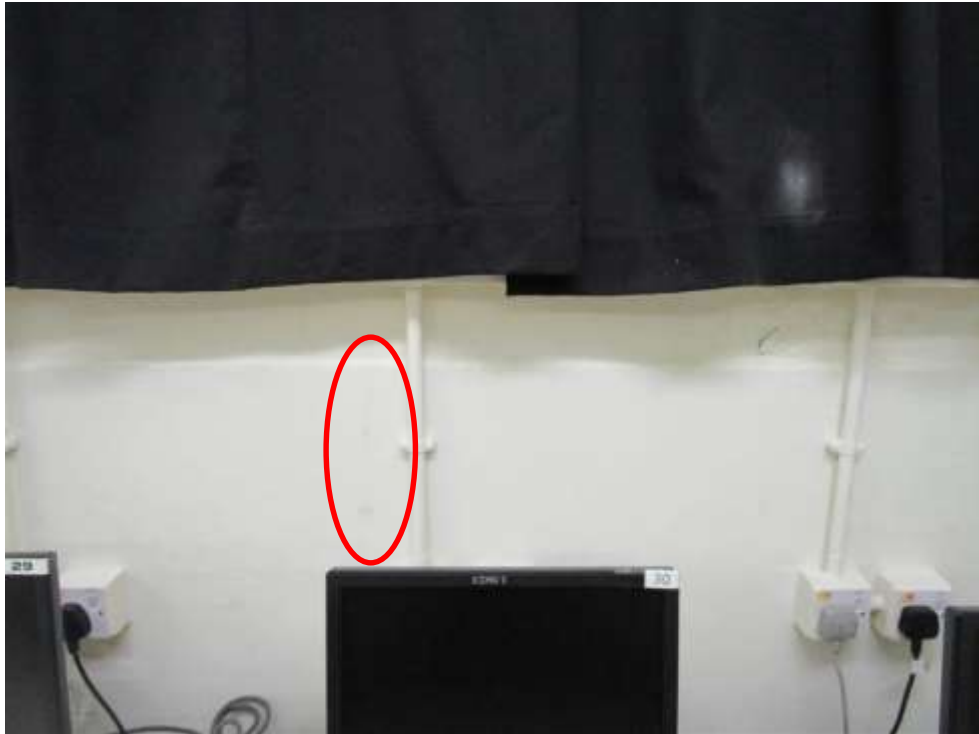
Photo No. 1401

Defect No.	200	Location	LG/F East wing, IT room	Component	wall
-------------------	-----	-----------------	-------------------------	------------------	------

Description	A medium crack was observed on wall finishing				
--------------------	-----------------------------------------------	--	--	--	--

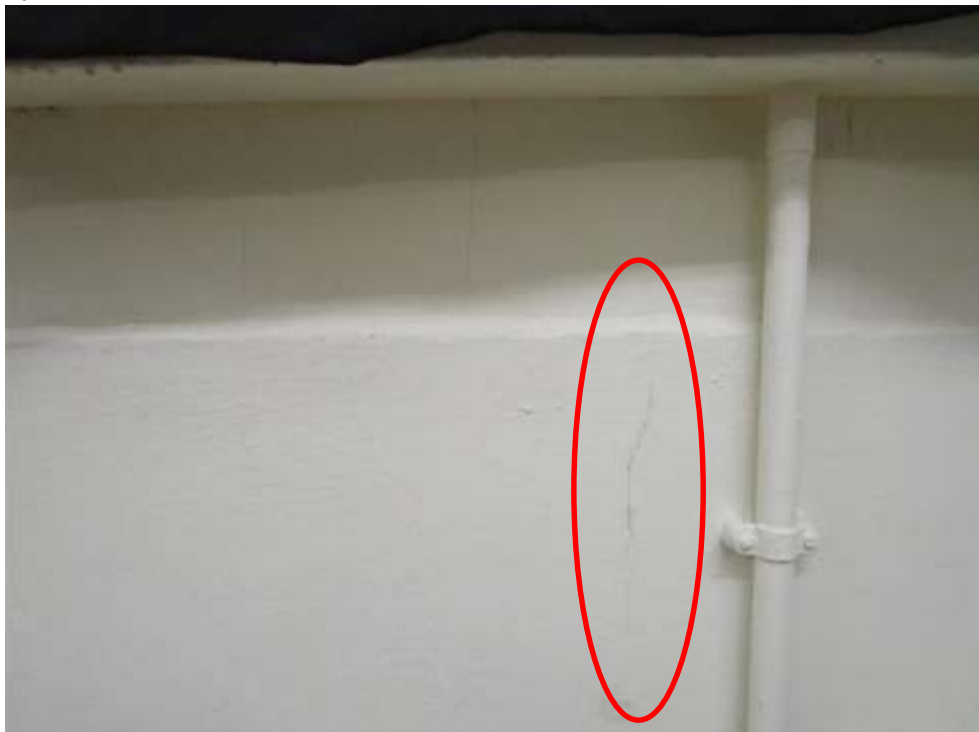
Photo No. 1402

Defect No.	201	Location	LG/F East wing, IT room	Component	wall
-------------------	-----	-----------------	-------------------------	------------------	------

Description	A medium crack was observed on wall finishing				
--------------------	-----------------------------------------------	--	--	--	--

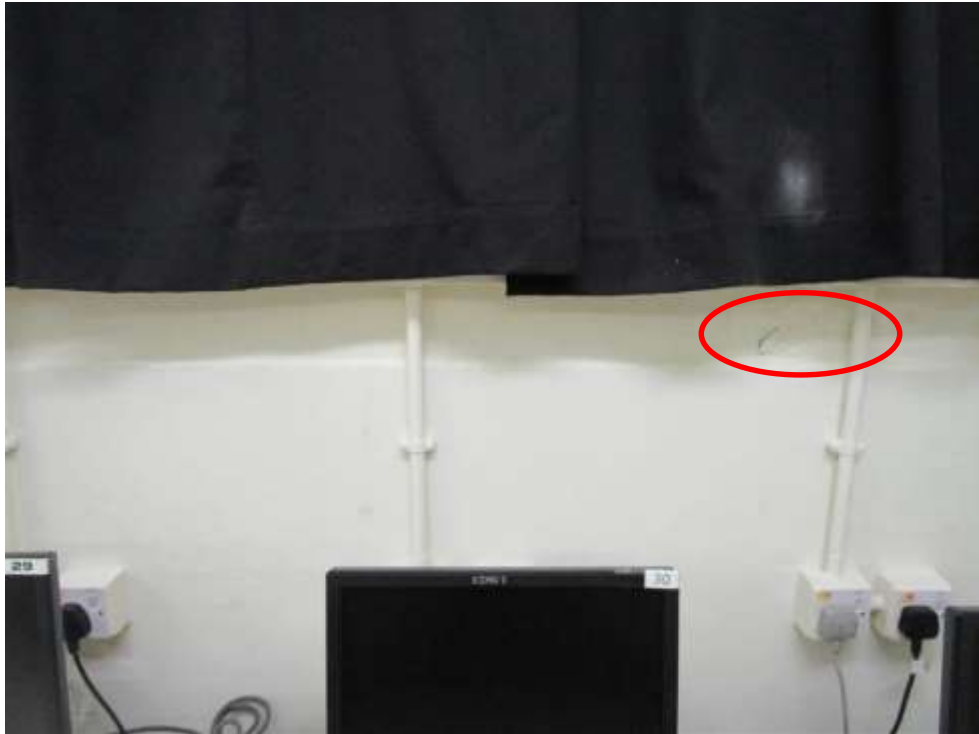
Photo No. 1403

Defect No.	201	Location	LG/F East wing, IT room	Component	wall
-------------------	-----	-----------------	-------------------------	------------------	------

Description	A medium crack was observed on wall finishing				
--------------------	-----------------------------------------------	--	--	--	--

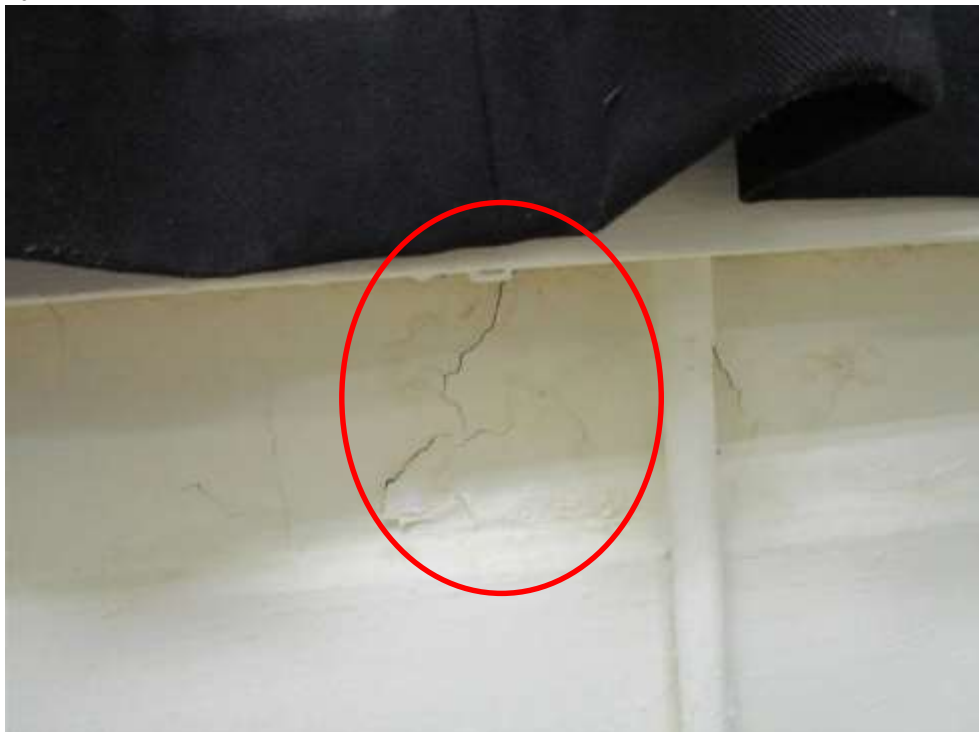
Photo No. 1404

Defect No.	202	Location	LG/F East wing, IT room	Component	wall
-------------------	-----	-----------------	-------------------------	------------------	------

Description	A damp patch with delaminated finishes was observed on wall				
--------------------	-------------------------------------------------------------	--	--	--	--

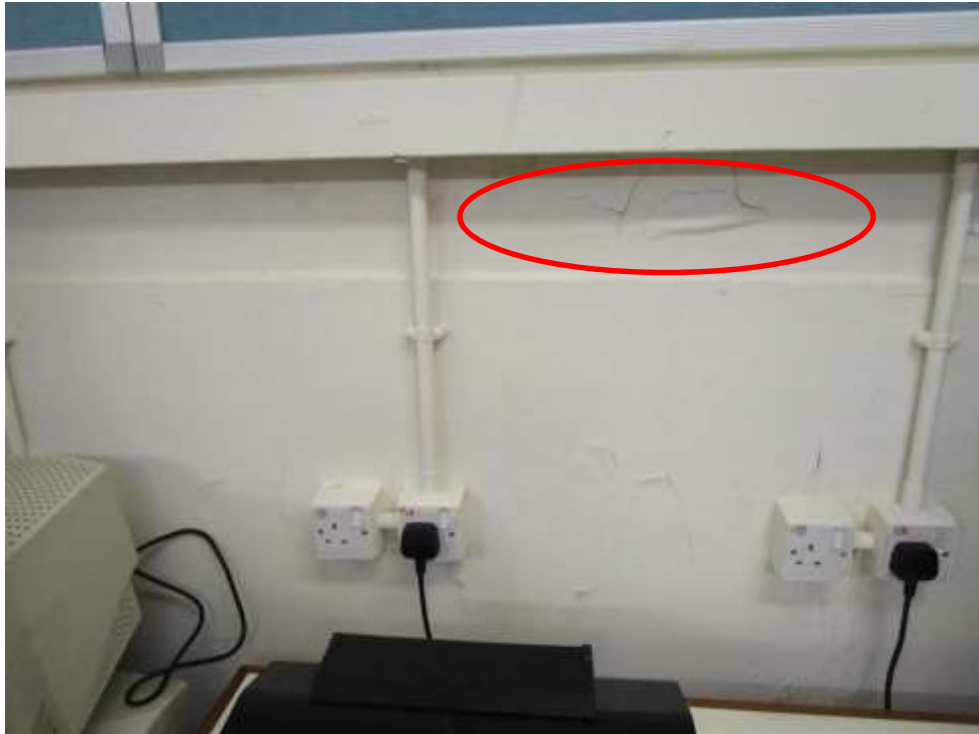
Photo No. 1405

Defect No.	202	Location	LG/F East wing, IT room	Component	wall
-------------------	-----	-----------------	-------------------------	------------------	------

Description	A damp patch with delaminated finishes was observed on wall				
--------------------	-------------------------------------------------------------	--	--	--	--
