**Slope Upgrading Works at
Feature No. 11SW-A/R526,
King's College,
Bonham Road, Hong Kong**

Project Profile for Slope Upgrading Works at
Feature No. 11SW-A/R526, King's College

May 2018

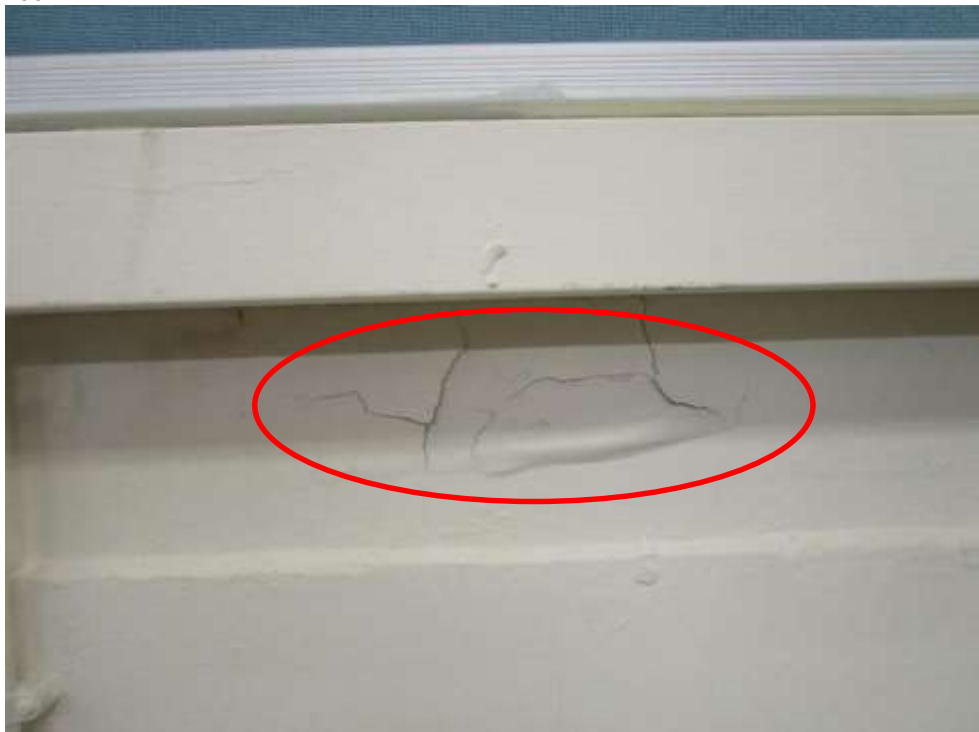
Photo No. 1406

Defect No. 203 **Location** LG/F East wing, IT room **Component** wall

Description A paint peeling was observed on wall

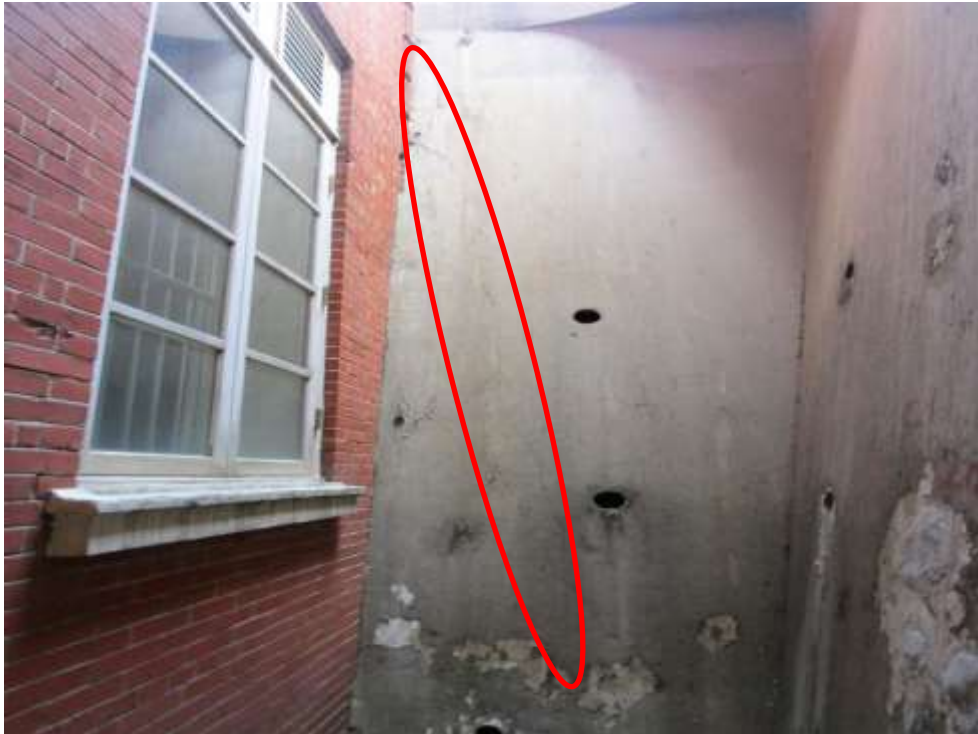
Photo No. 1407

Defect No. 203 **Location** LG/F East wing, IT room **Component** wall

Description A paint peeling was observed on wall

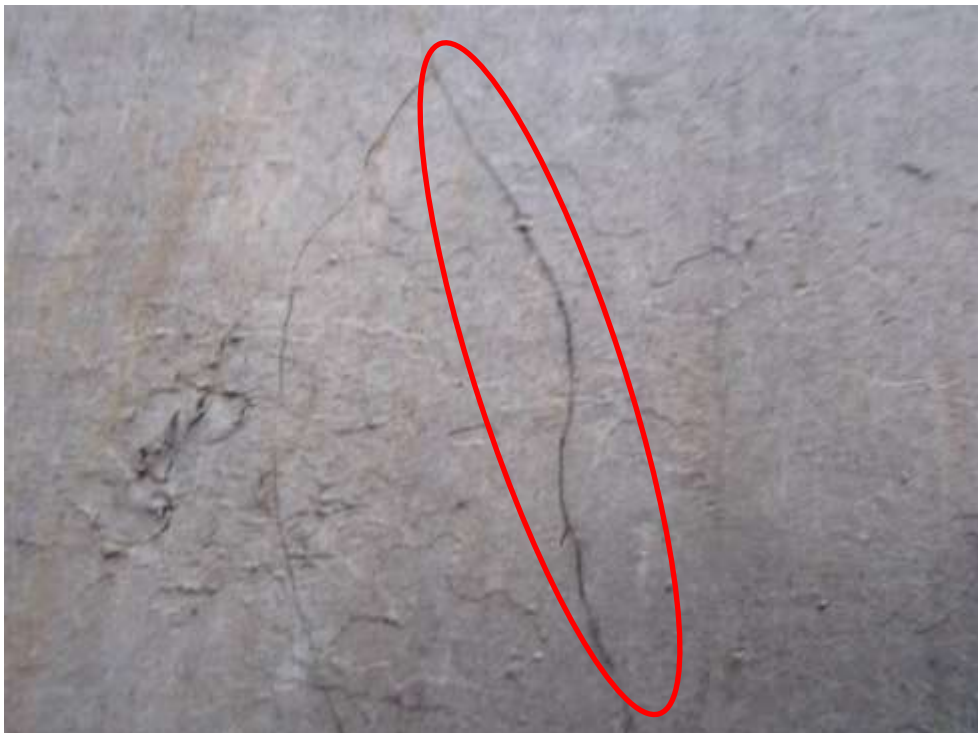
Photo No. 1408

Defect No. 204	Location G/F East wing, Main entrance retaining wall	Component wall
-----------------------	-------------------------------------------------------------	-----------------------

Description A diagonal medium crack was observed on wall

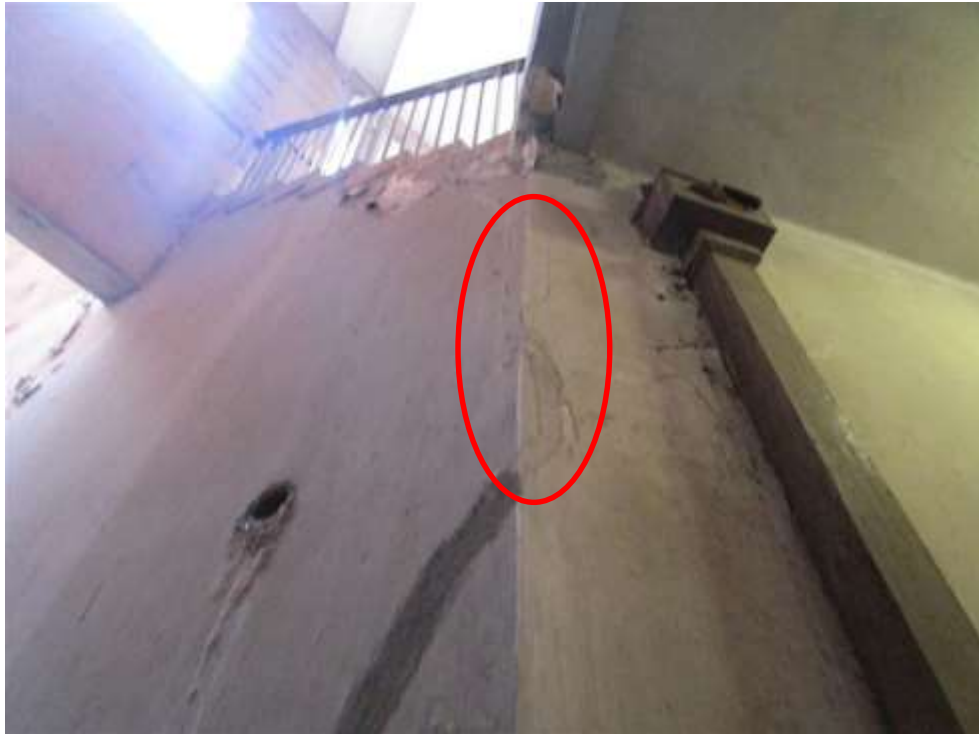
Photo No. 1409

Defect No. 204	Location G/F East wing, Main entrance retaining wall	Component wall
-----------------------	-------------------------------------------------------------	-----------------------

Description A diagonal medium crack was observed on wall

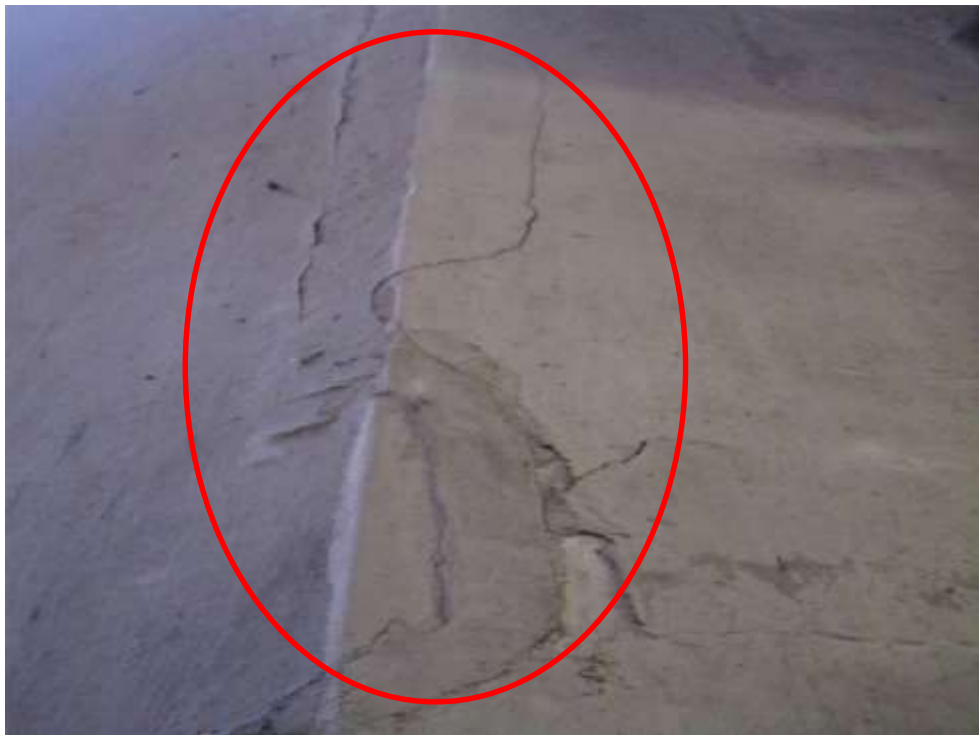
Photo No. 1410

Defect No.	205	Location	G/F East wing, Main entrance retaining wall	Component	wall
-------------------	-----	-----------------	---------------------------------------------	------------------	------

Description	Area of hairline cracks was observed on wall				
--------------------	----------------------------------------------	--	--	--	--

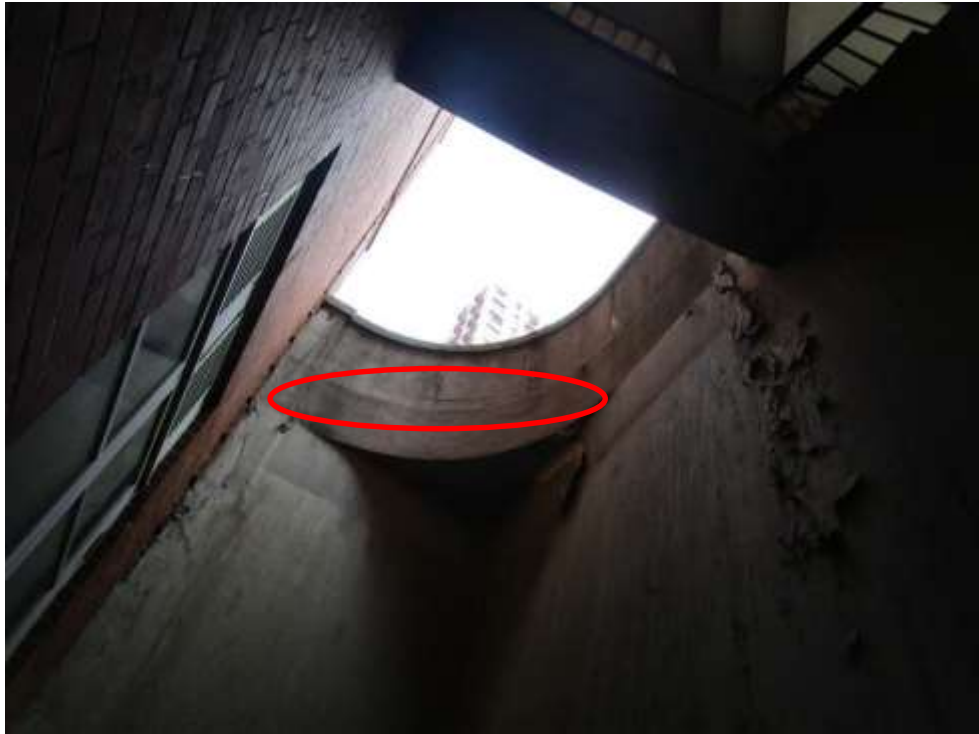
Photo No. 1411

Defect No.	205	Location	G/F East wing, Main entrance retaining wall	Component	wall
-------------------	-----	-----------------	---------------------------------------------	------------------	------

Description	Area of hairline cracks was observed on wall				
--------------------	----------------------------------------------	--	--	--	--

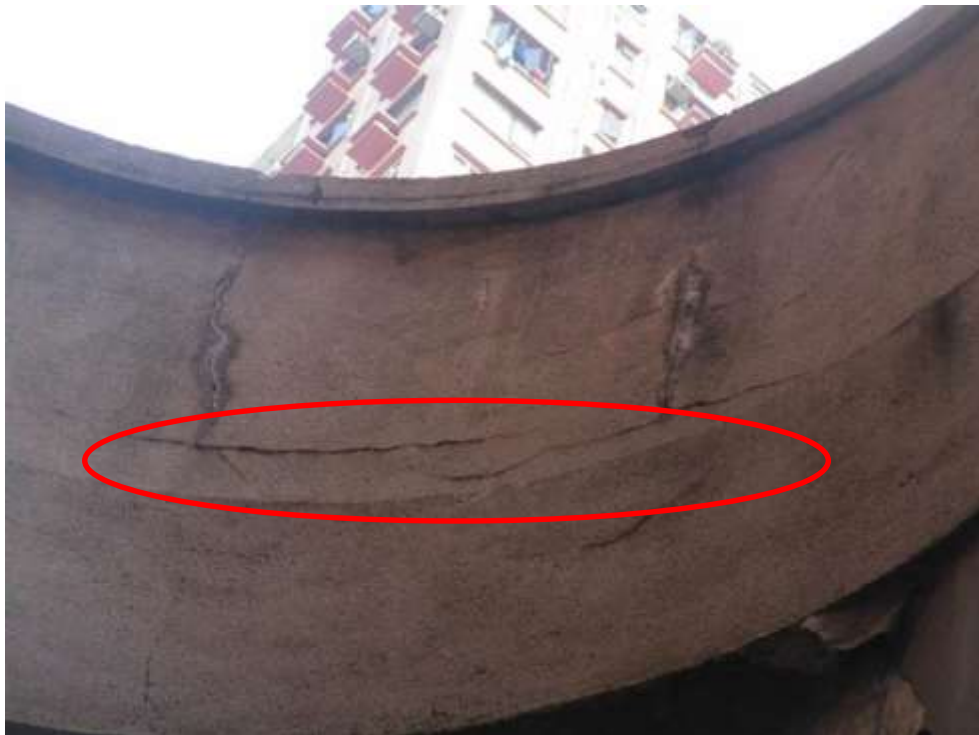
Photo No. 1412

Defect No.	206	Location	G/F East wing, Main entrance retaining wall	Component	parapet wall
-------------------	-----	-----------------	---------------------------------------------	------------------	--------------

Description A medium crack was observed on parapet wall

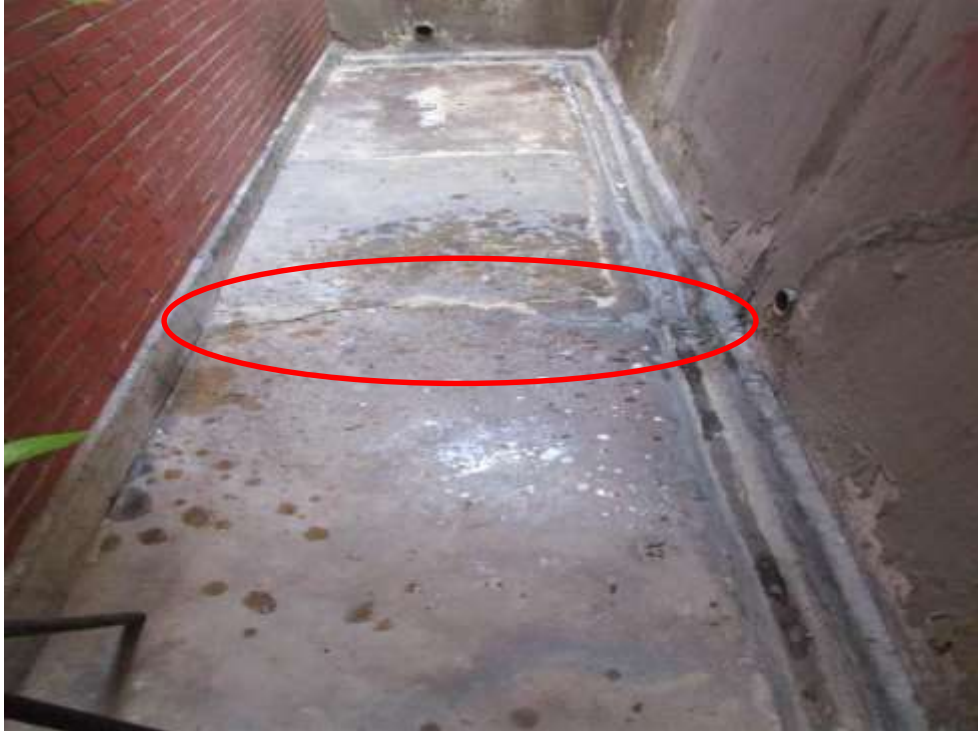
Photo No. 1413

Defect No.	206	Location	G/F East wing, Main entrance retaining wall	Component	parapet wall
-------------------	-----	-----------------	---------------------------------------------	------------------	--------------

Description A medium crack was observed on parapet wall

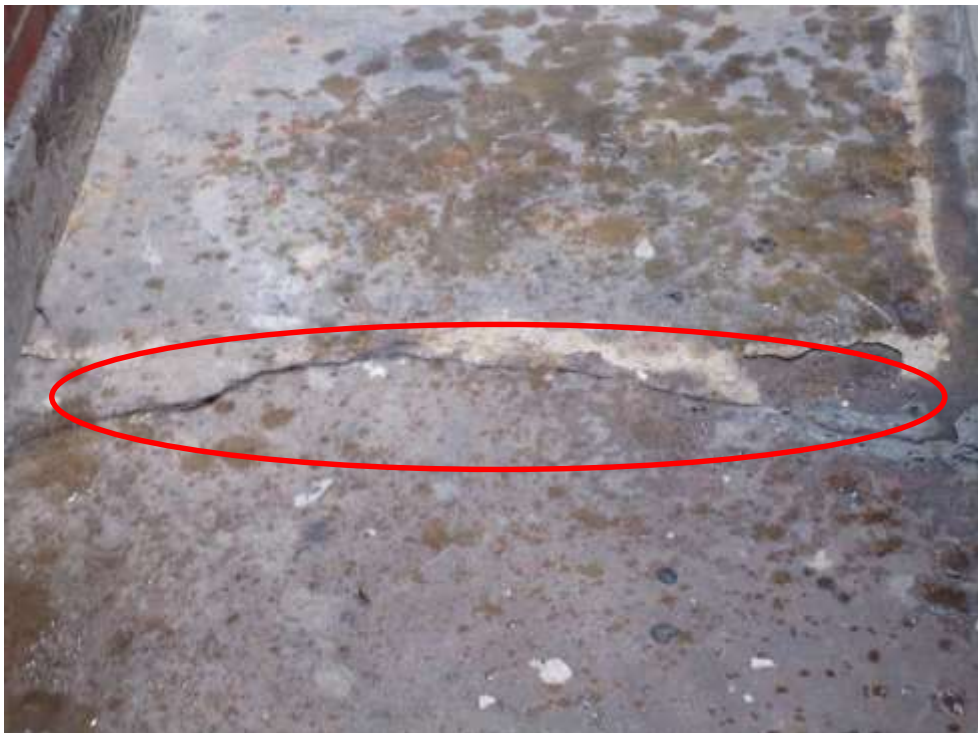
Photo No. 1414

Defect No. 207	Location G/F East wing, Main entrance retaining wall	Component slab
-----------------------	-------------------------------------------------------------	-----------------------

Description A wide crack was observed on floor slab

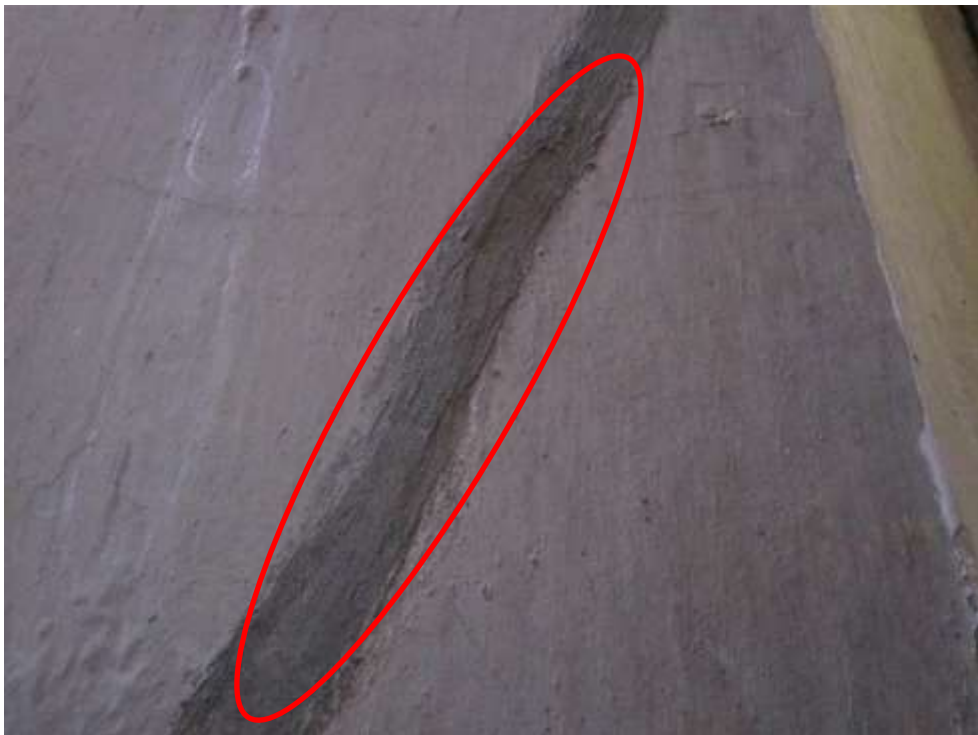
Photo No. 1416

Defect No. 208	Location G/F East wing, Main entrance retaining wall	Component wall
-----------------------	-------------------------------------------------------------	-----------------------

Description A previous repair was observed on wall

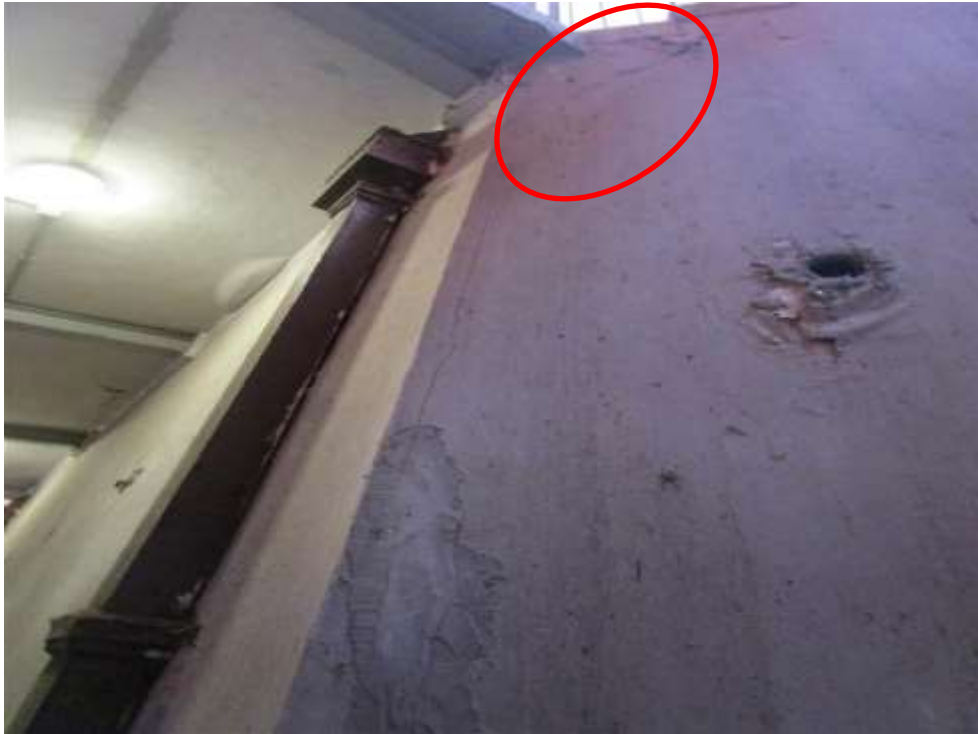
Photo No. 1417

Defect No. 208	Location G/F East wing, Main entrance retaining wall	Component wall
-----------------------	-------------------------------------------------------------	-----------------------

Description A previous repair was observed on wall

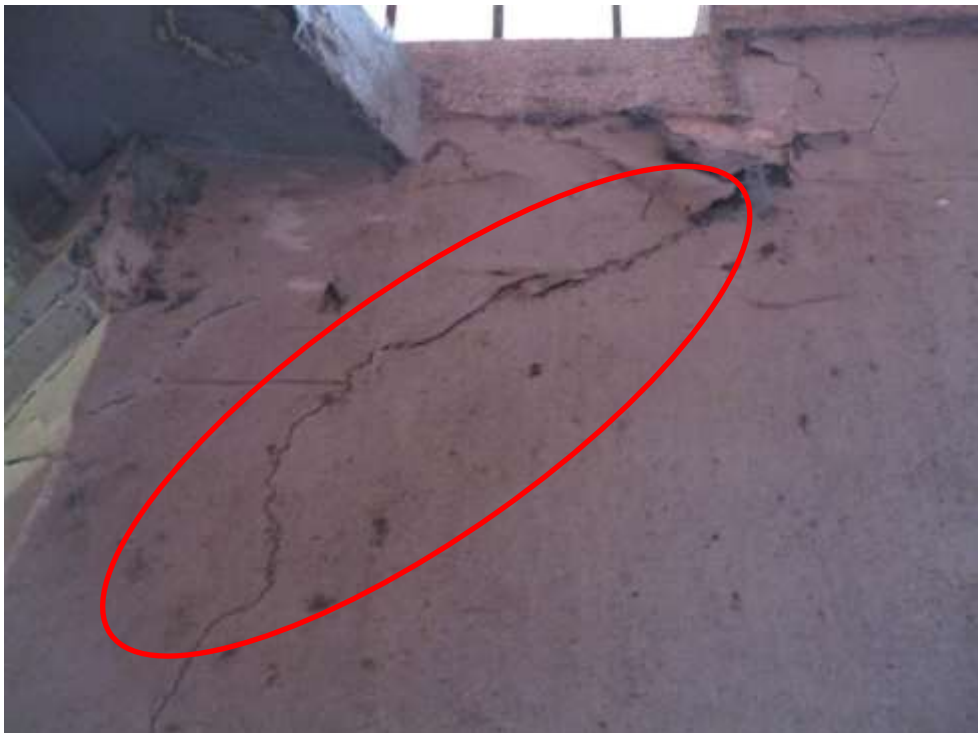
Photo No. 1418

Defect No. 209	Location G/F East wing, Main entrance retaining wall	Component wall
-----------------------	-------------------------------------------------------------	-----------------------

Description A medium crack was observed on wall

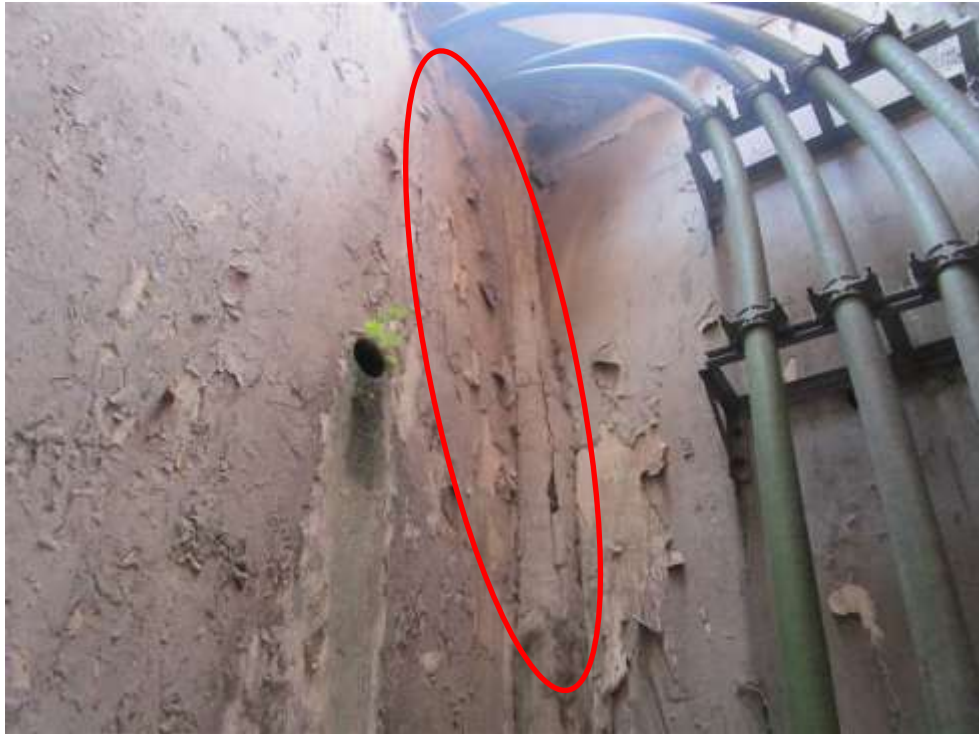
Photo No. 1419

Defect No. 209	Location G/F East wing, Main entrance retaining wall	Component wall
-----------------------	-------------------------------------------------------------	-----------------------

Description A medium crack was observed on wall

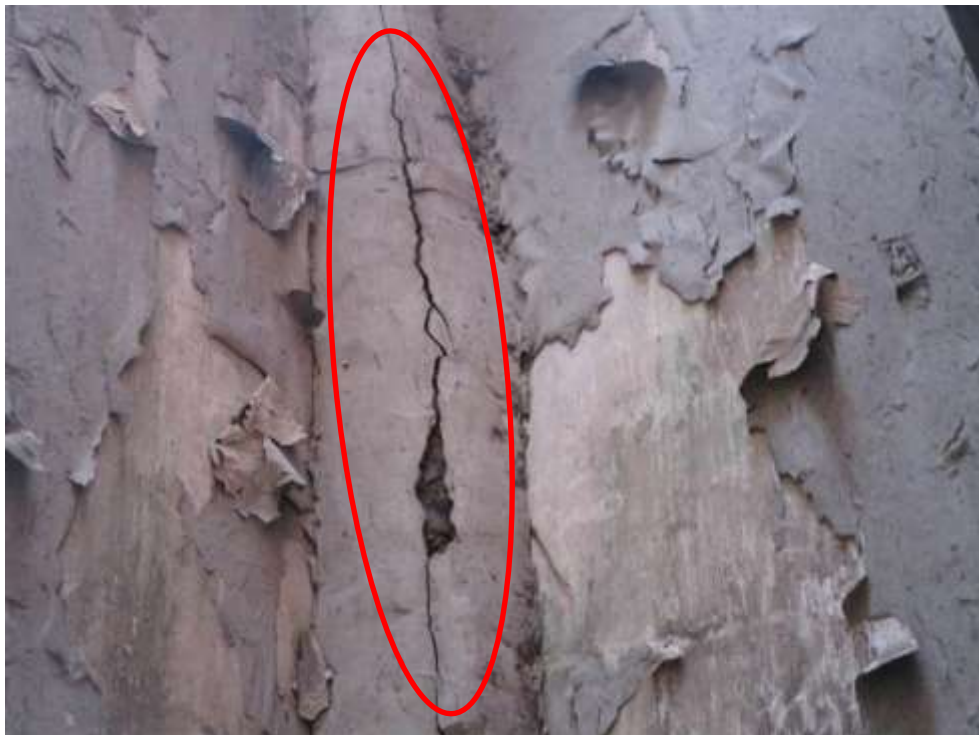
Photo No. 1420

Defect No. 210	Location G/F East wing, Main entrance retaining wall	Component wall
-----------------------	-------------------------------------------------------------	-----------------------

Description A wide crack was observed on wall

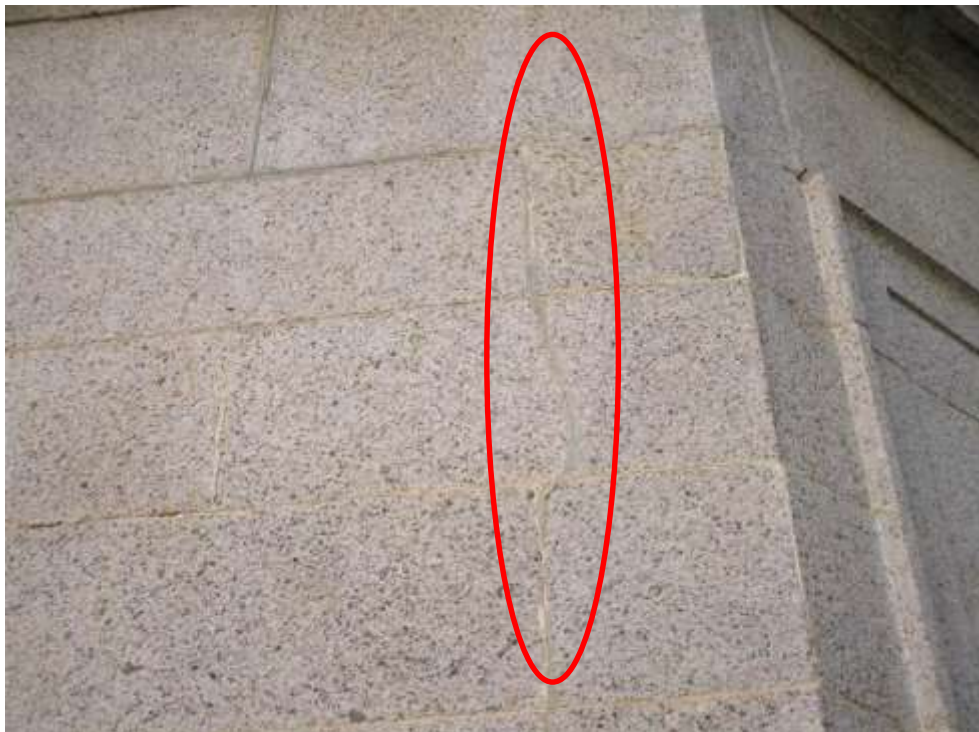
Photo No. 1422

Defect No. 211 **Location** LG/F East wing, West elevation **Component** granite wall

Description A wide crack was observed on granite wall

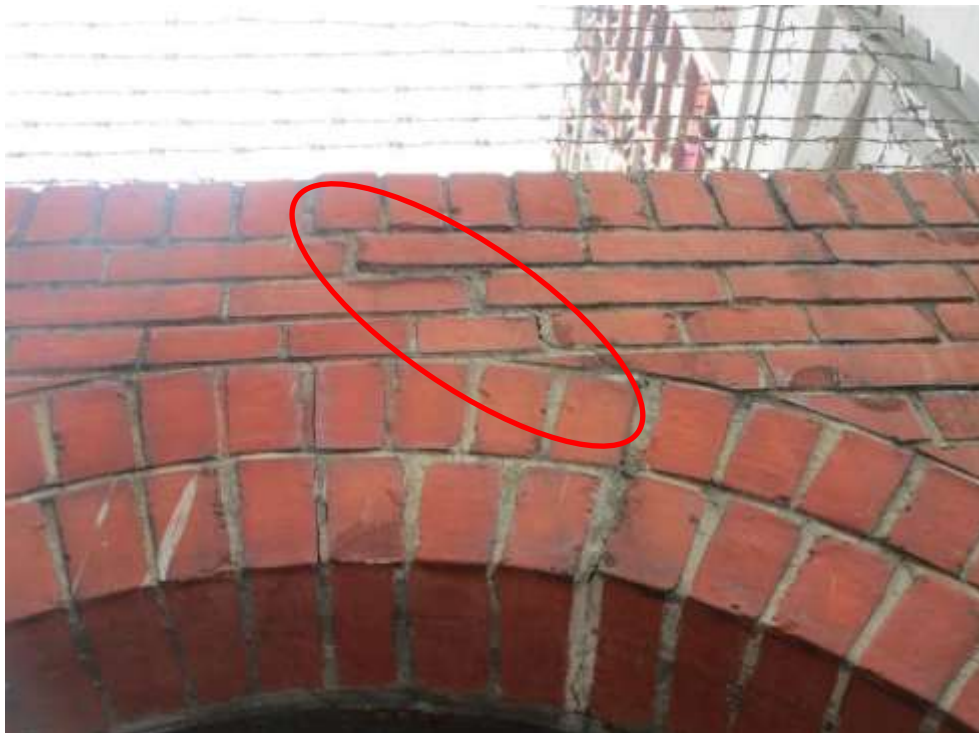
Photo No. 1424

Defect No. 212	Location North wing, East elevation exterior	Component brick wall
-----------------------	-----------------------------------------------------	-----------------------------

Description 2 wide cracks were observed on brick wall mortar joint

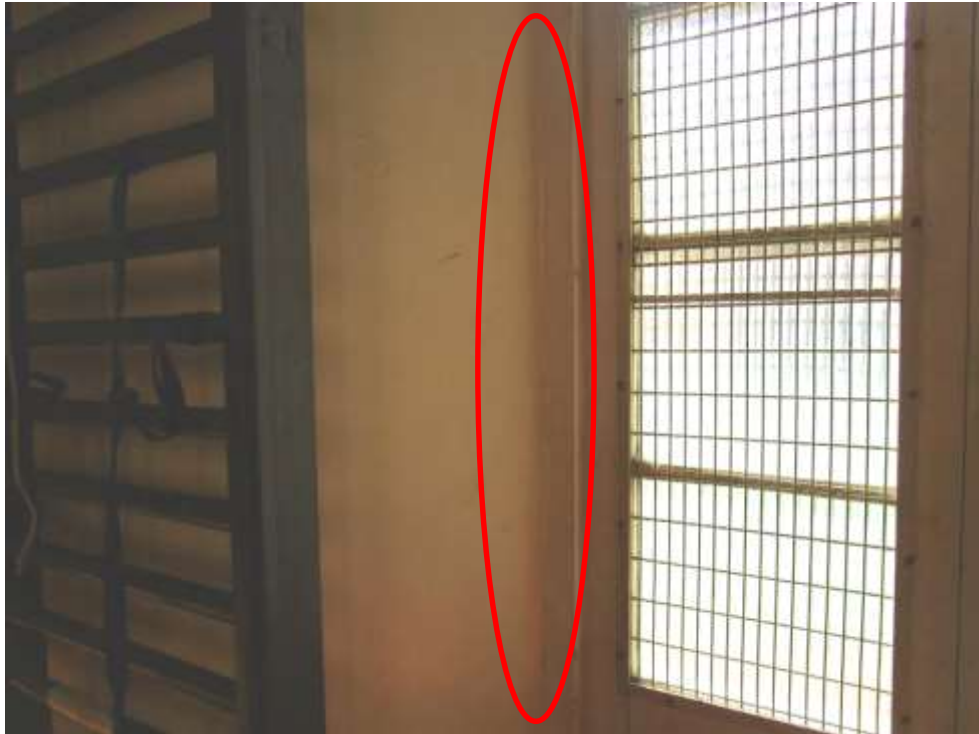
Photo No. 1425

Description 2 wide cracks were observed on brick wall mortar joint

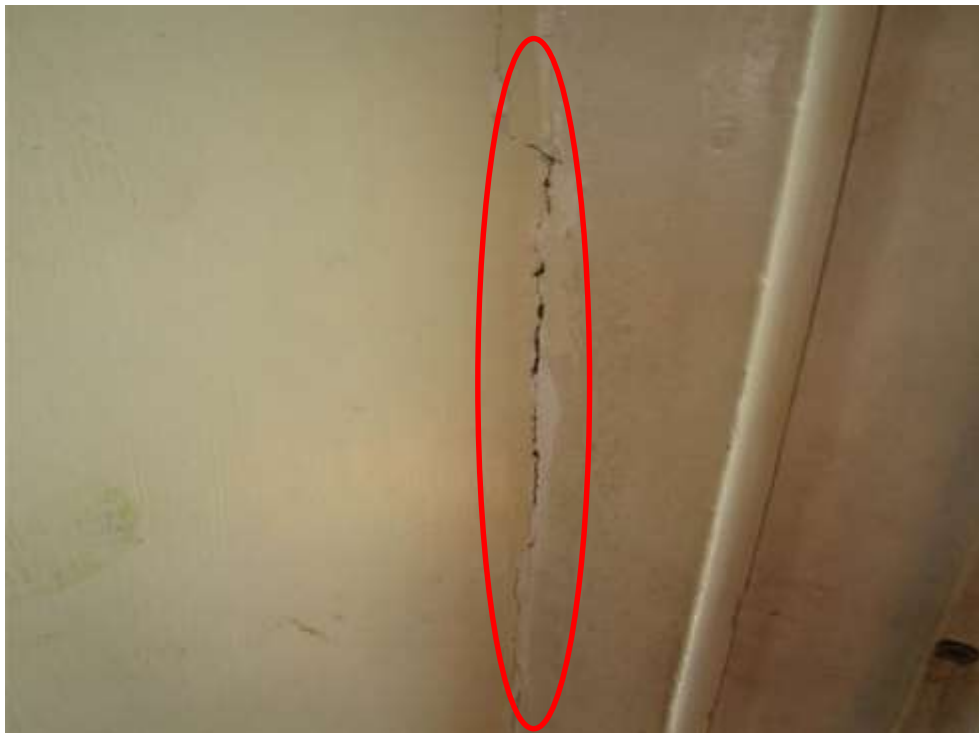
Photo No. 1426

Description A wide crack was observed on joint of wall and door jamb

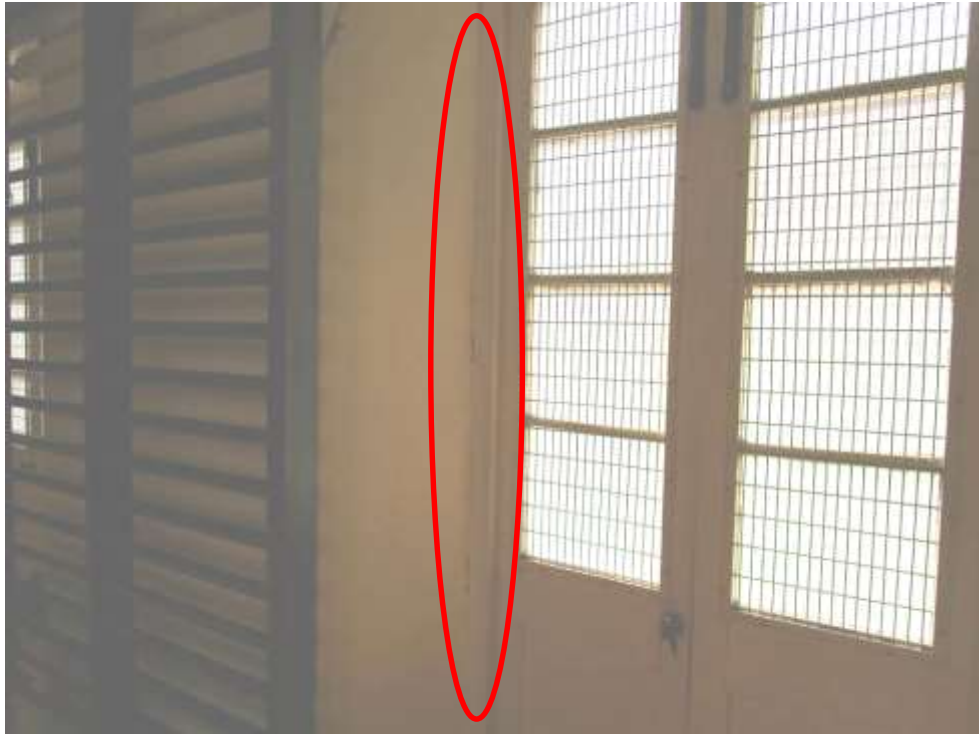
Photo No. 1427

Description A wide crack was observed on joint of wall and door jamb

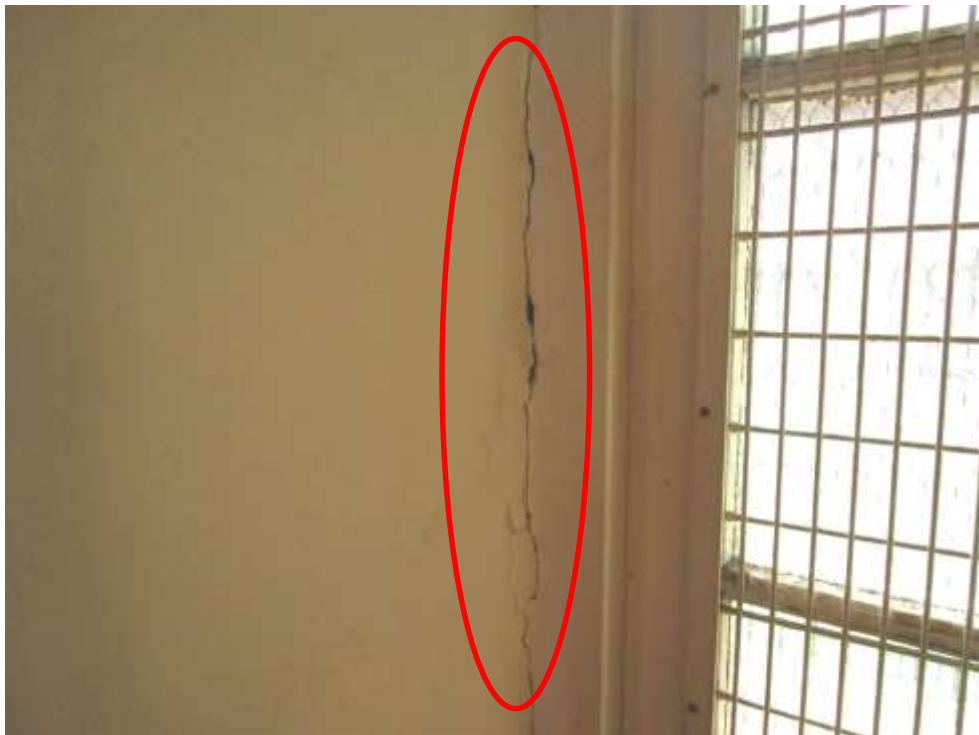
Photo No. 1428

Description A wide crack was observed on joint of wall and door jamb

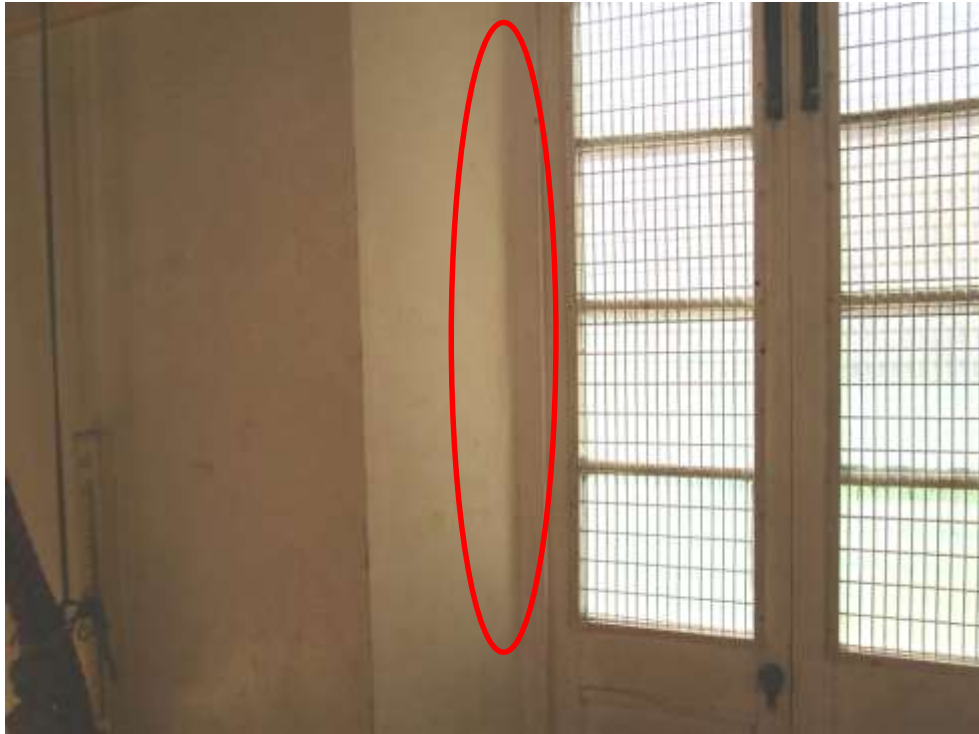
Photo No. 1429

Description A wide crack was observed on joint of wall and door jamb

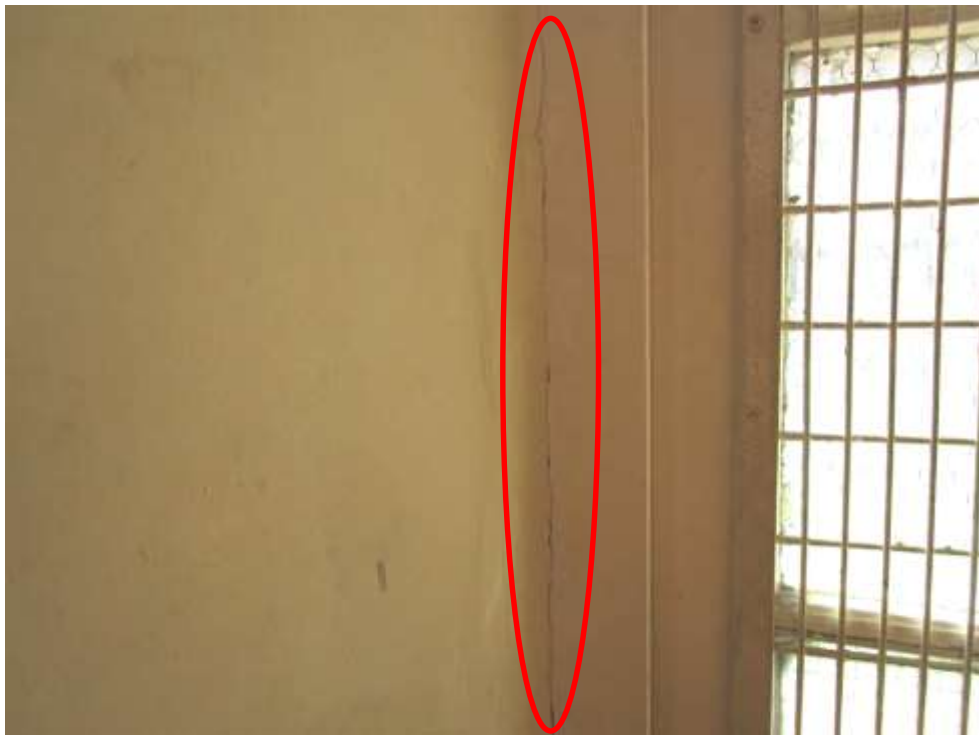
Photo No. 1430

Description A medium crack was observed on joint of wall and door jamb

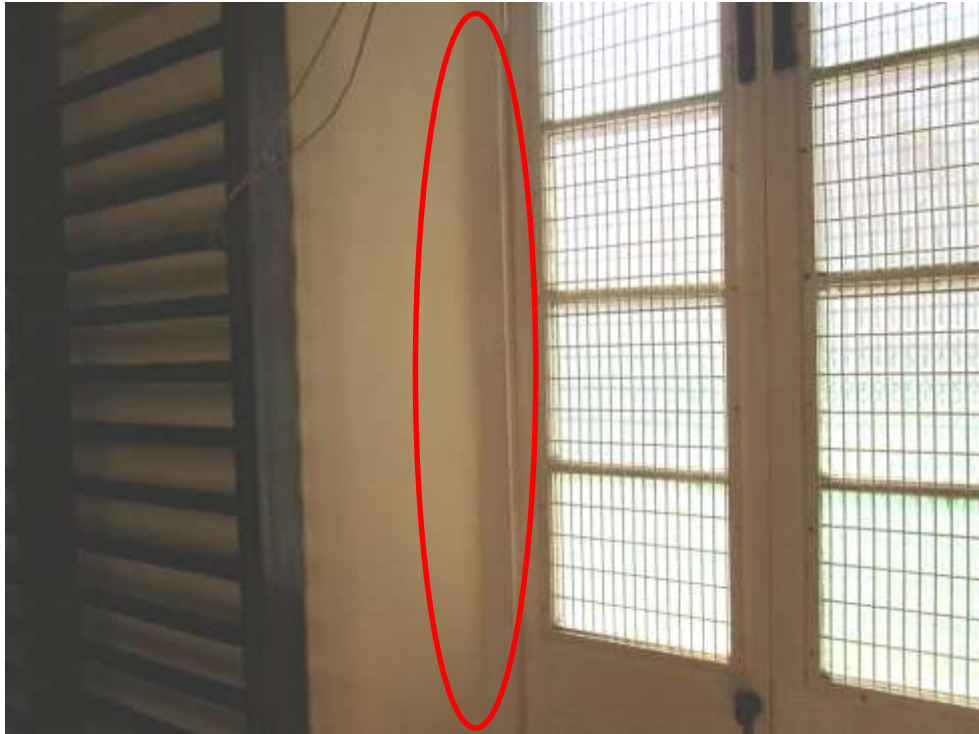
Photo No. 1431

Description A medium crack was observed on joint of wall and door jamb

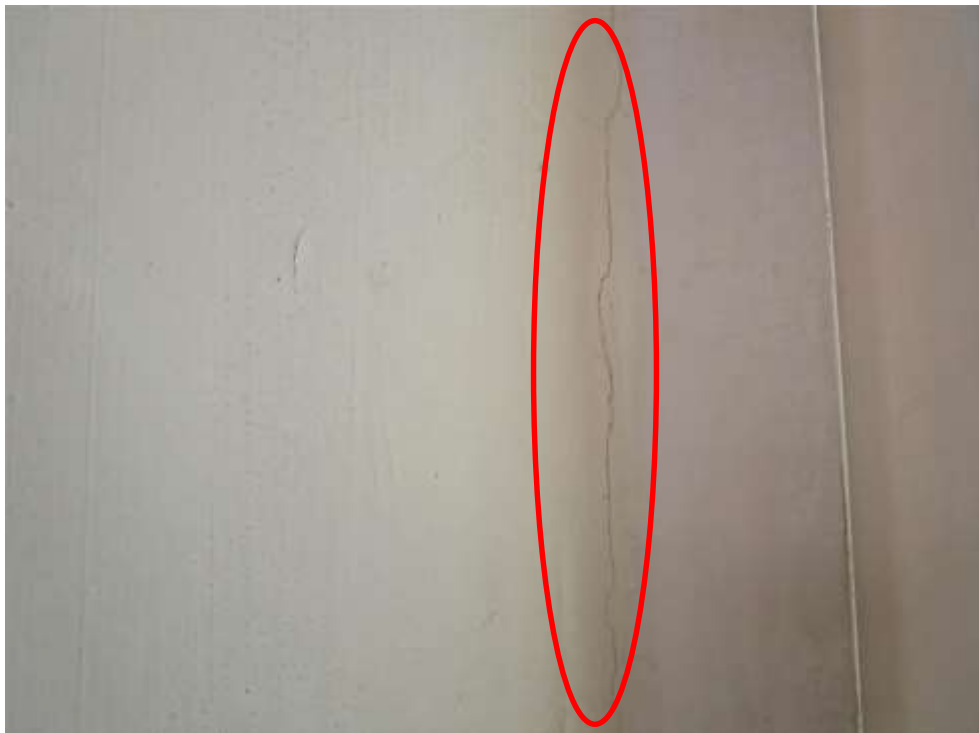
Photo No. 1432

Description A hairline crack was observed on joint of wall and door jamb

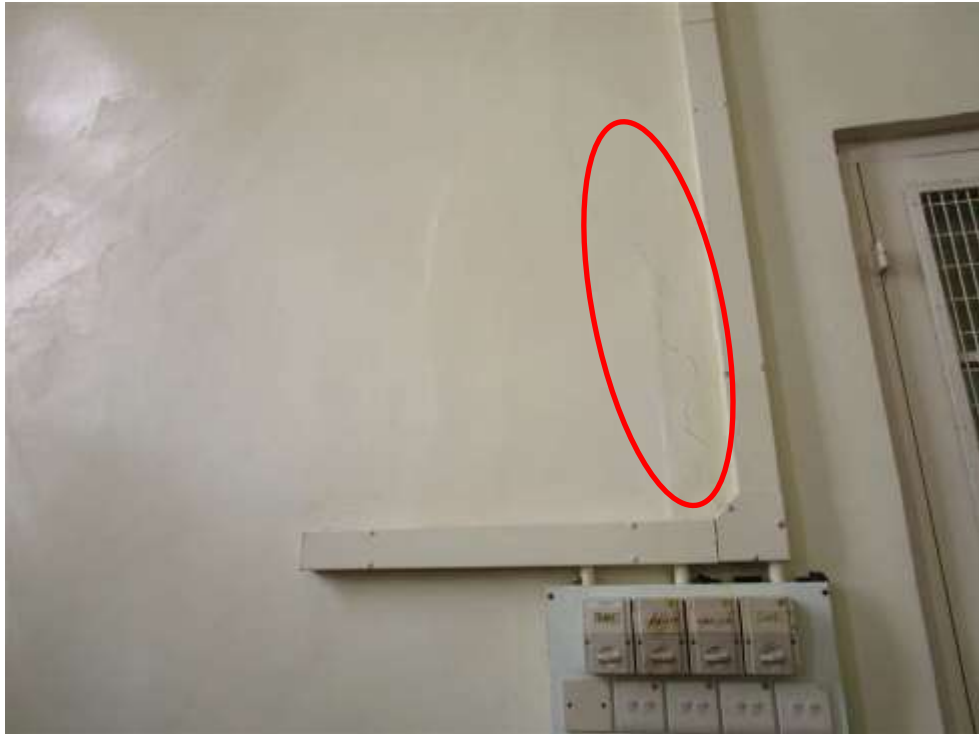
Photo No. 1433

Description A hairline crack was observed on joint of wall and door jamb

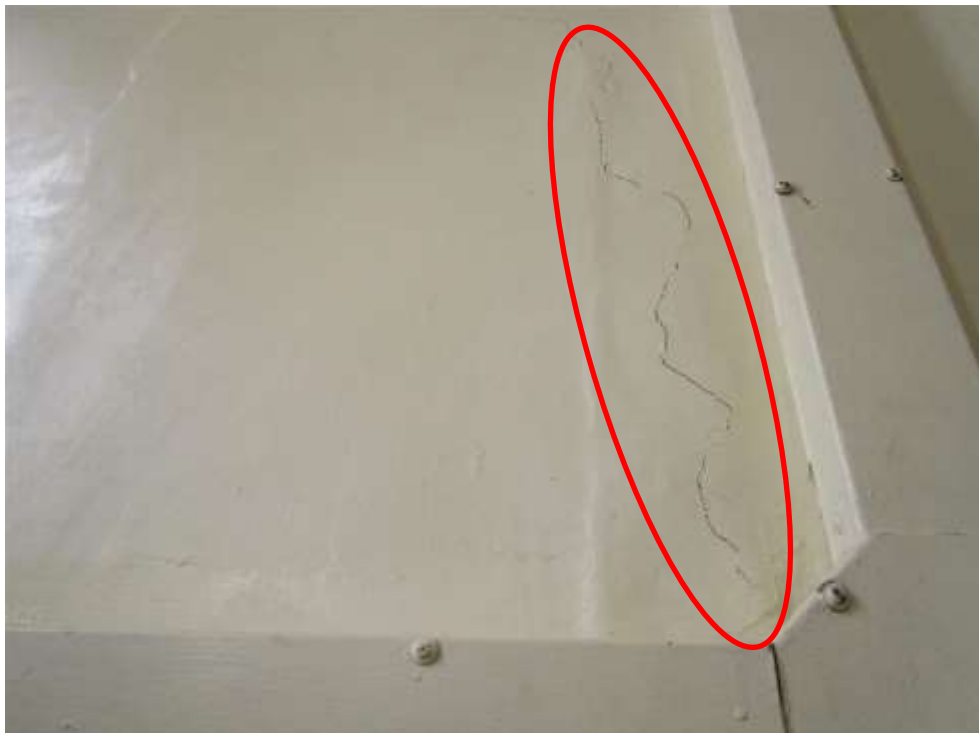
Photo No. 1434

Description A medium crack was observed on wall finishing

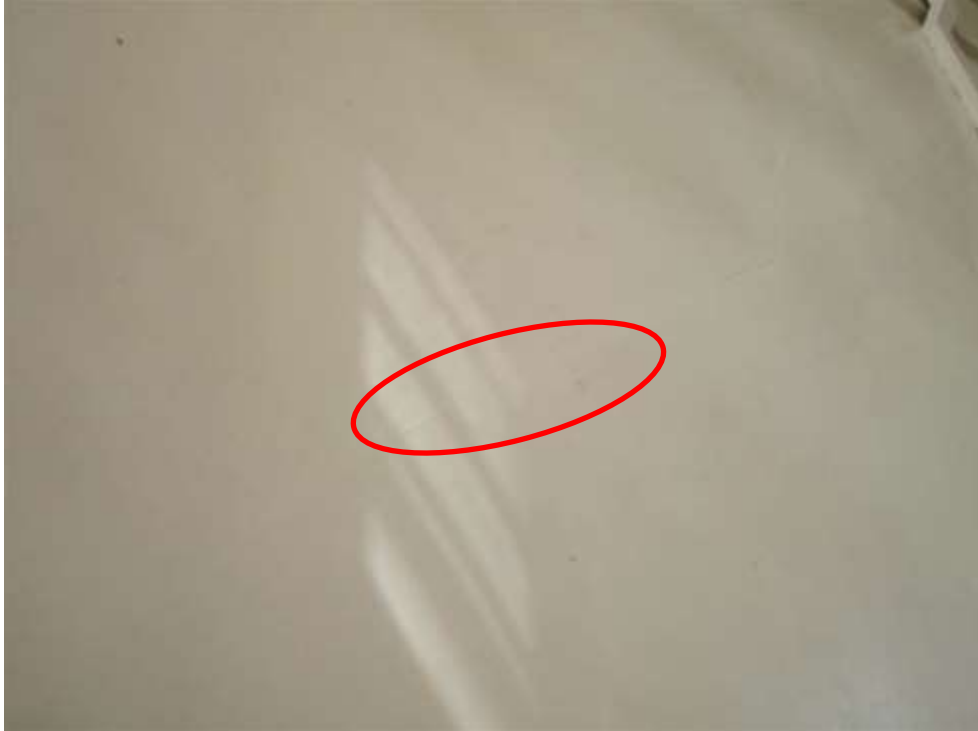
Photo No. 1435

Description A medium crack was observed on wall finishing

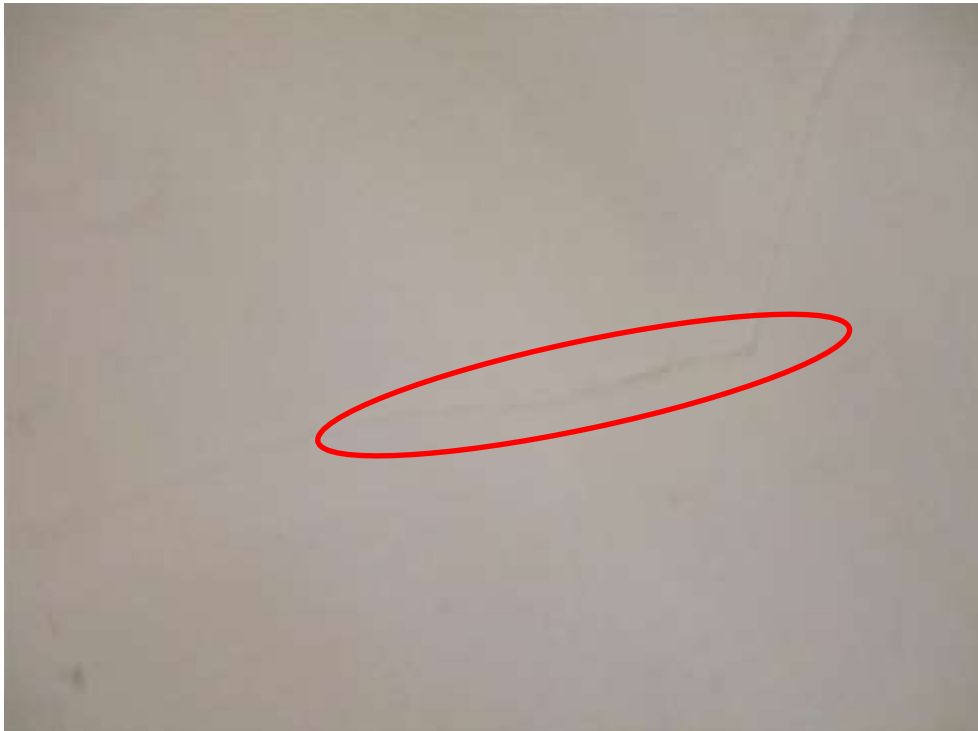
Photo No. 1436

Description A previous repair was observed on wall finishing

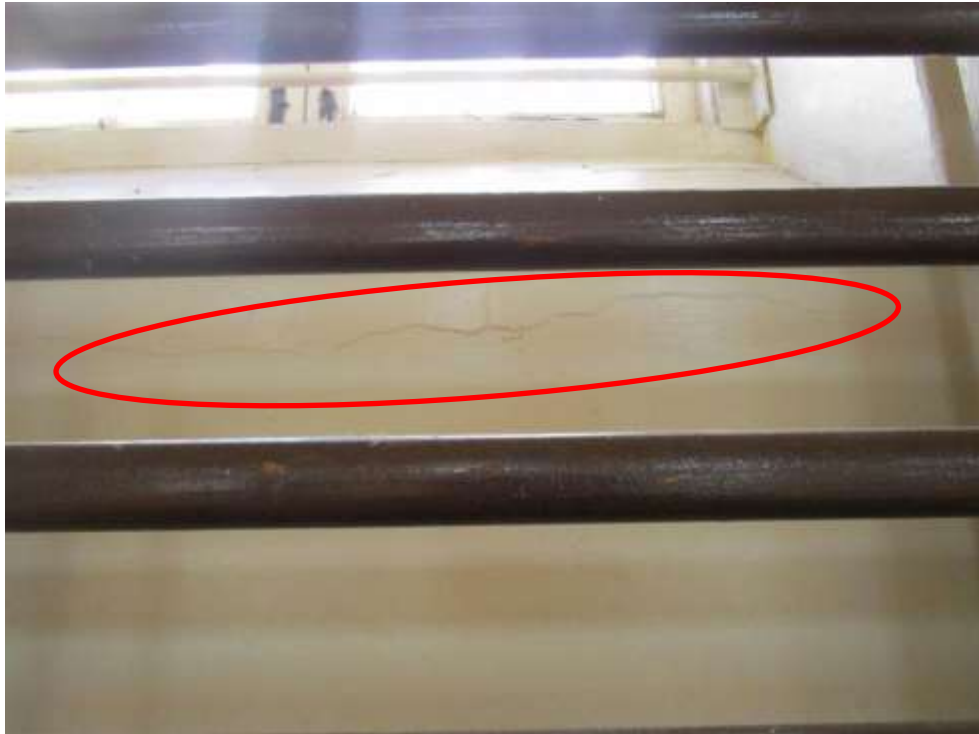
Photo No. 1437

Description A previous repair was observed on wall finishing

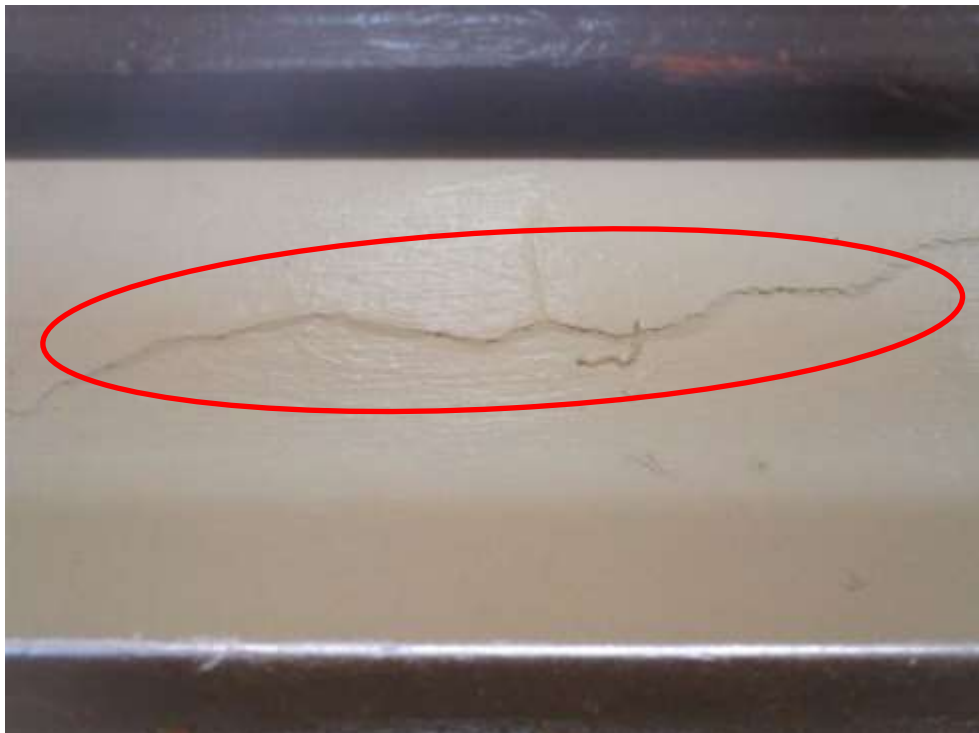
Photo No. 1438

Description A hairline crack was observed on wall finishing
