**Slope Upgrading Works at
Feature No. 11SW-A/R526,
King's College,
Bonham Road, Hong Kong**

Project Profile for Slope Upgrading Works at
Feature No. 11SW-A/R526, King's College

May 2018

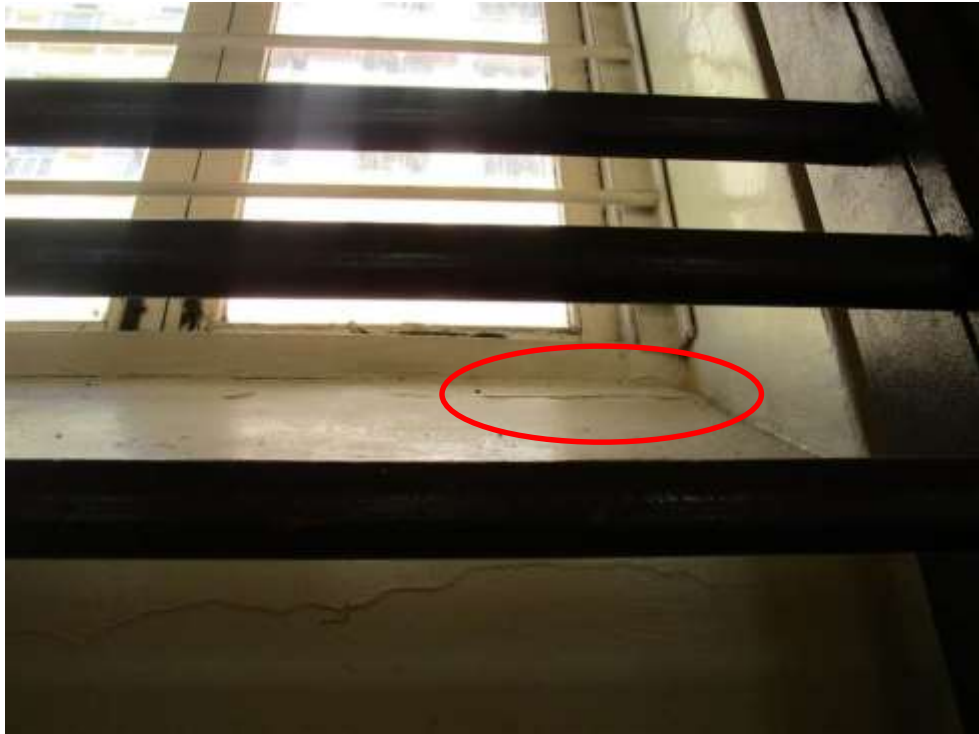
Photo No. 1439

Description A hairline crack was observed on wall finishing

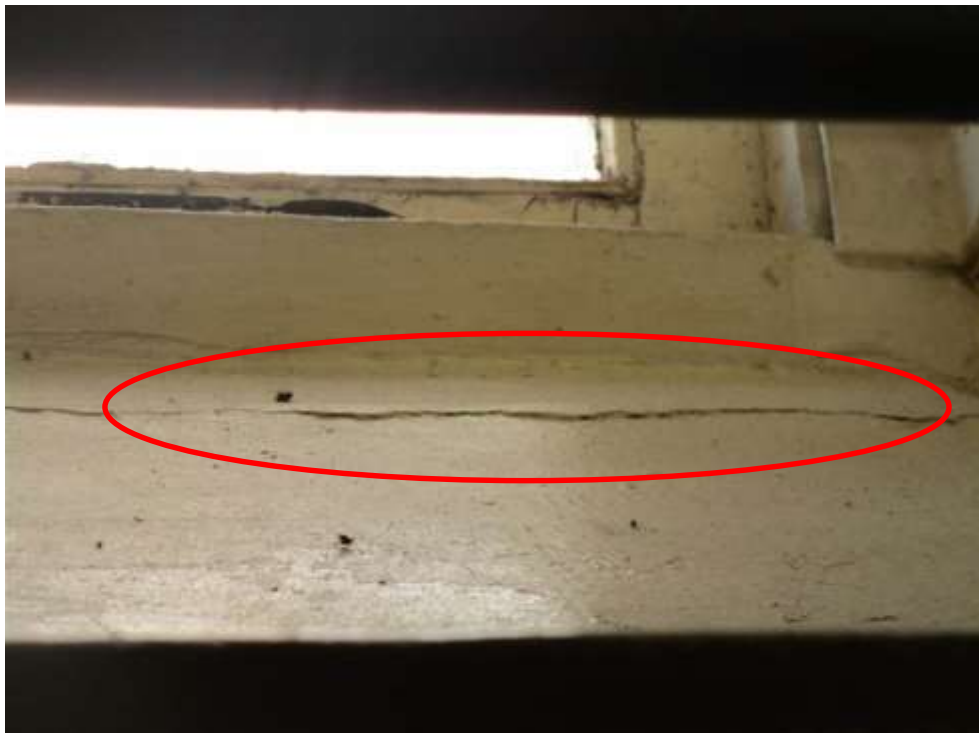
Photo No. 1440

Description A wide crack was observed on window sill finishing

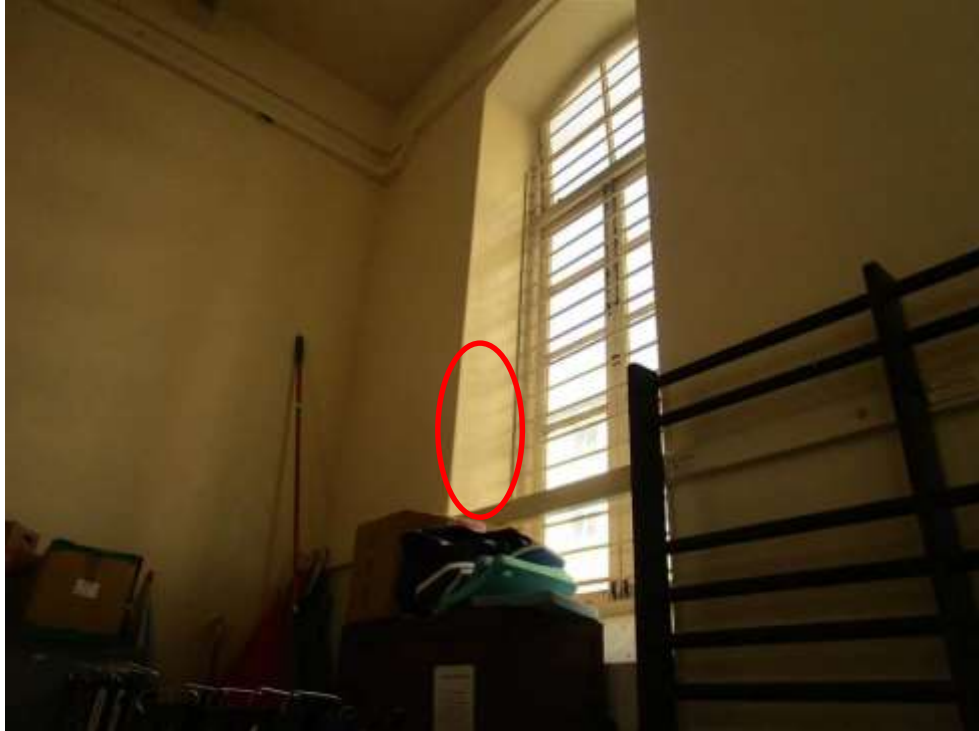
Photo No. 1441

Description A wide crack was observed on window sill finishing

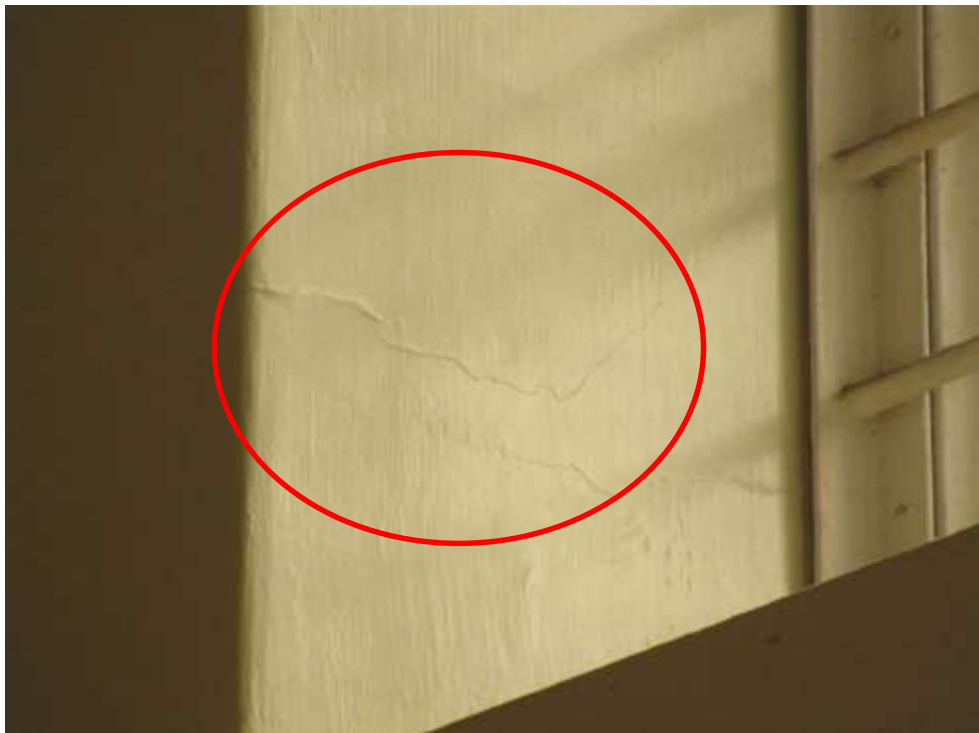
Photo No. 1442

Description 2 hairline cracks were observed on window sill finishing

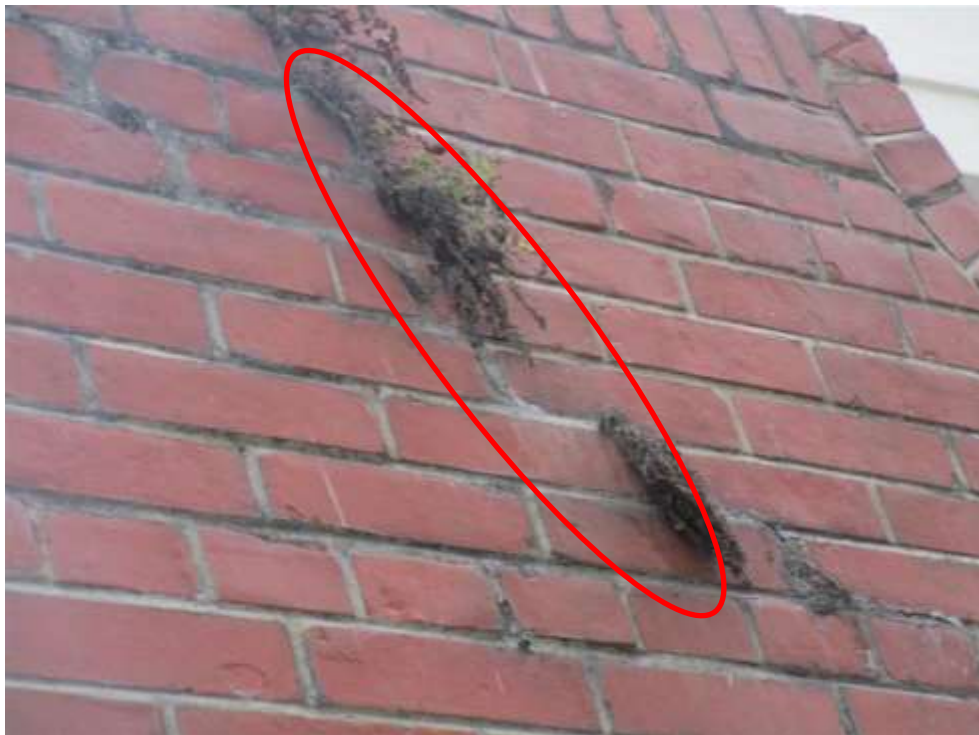
Photo No. 1444

Description A wide crack was observed on brick wall mortar joint

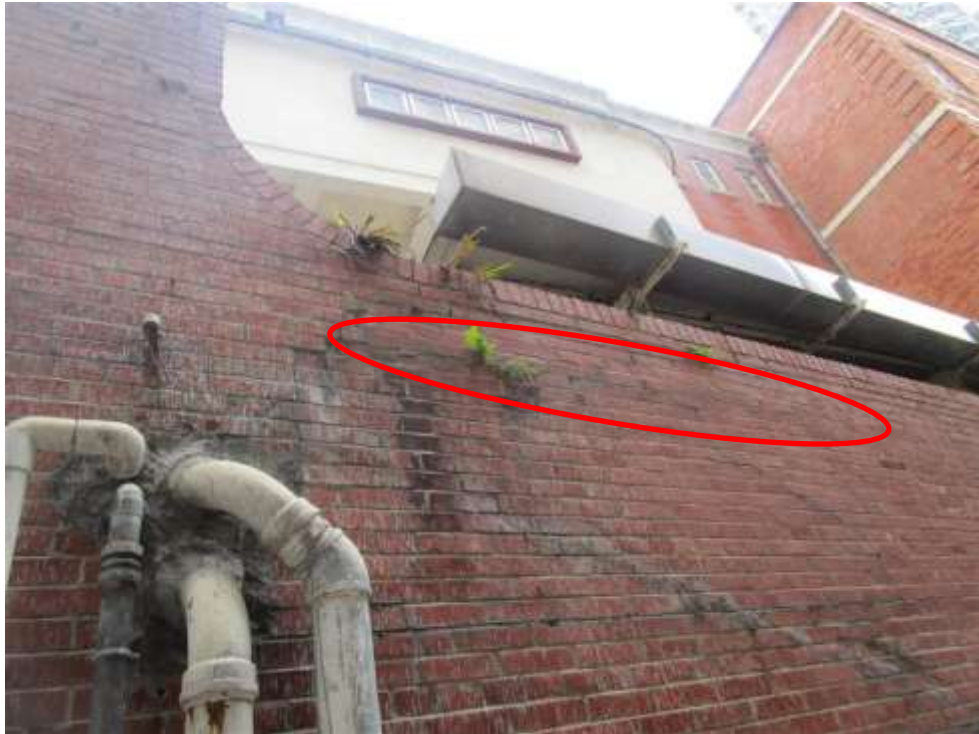
Photo No. 1445

Description A wide crack was observed on brick wall mortar joint

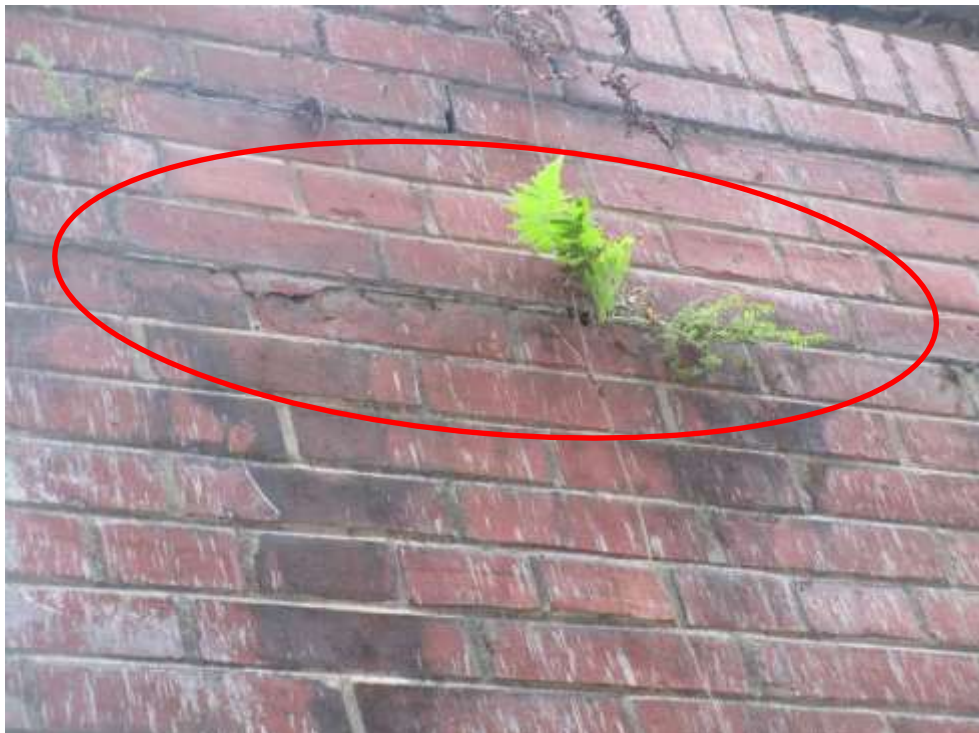
Photo No. 1446

Description A wide crack was observed on brick wall mortar joint

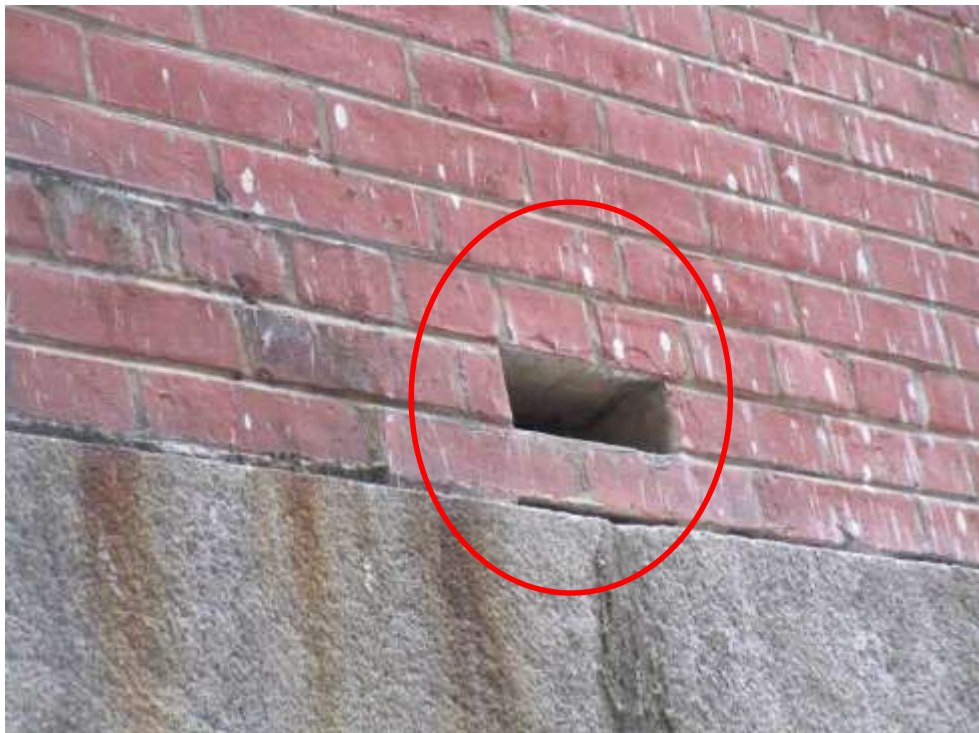
Photo No. 1448

Description 3 nos. of missing bricks were observed on the wall

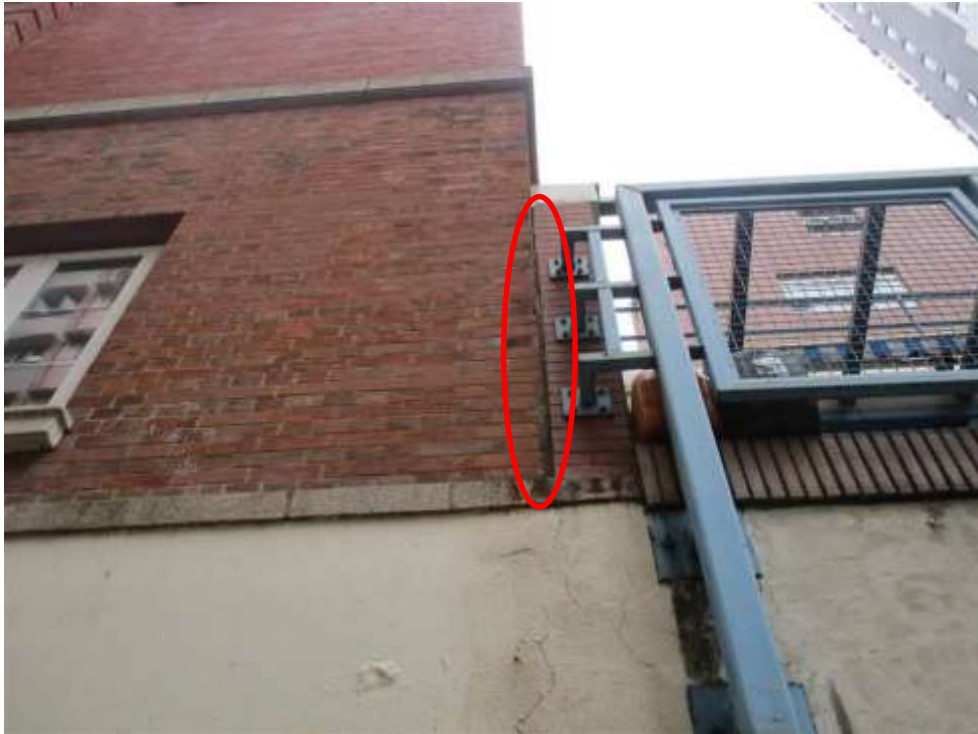
Photo No. 1449

Description 3 nos. of missing bricks were observed on the wall

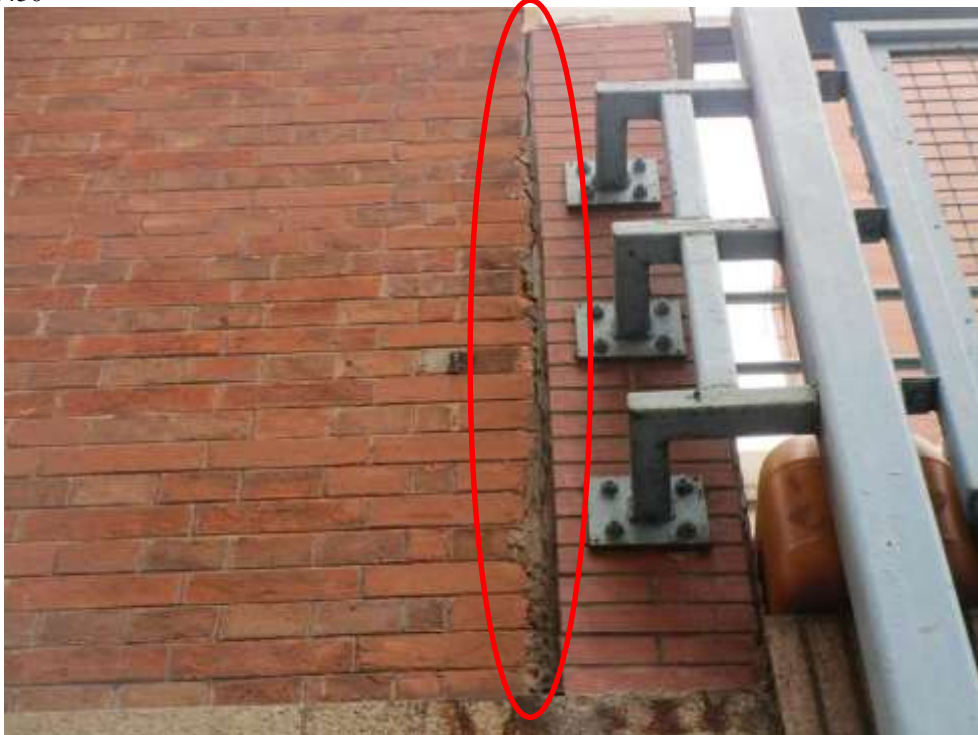
Photo No. 1450

Description Debonded joint sealant between brick walls

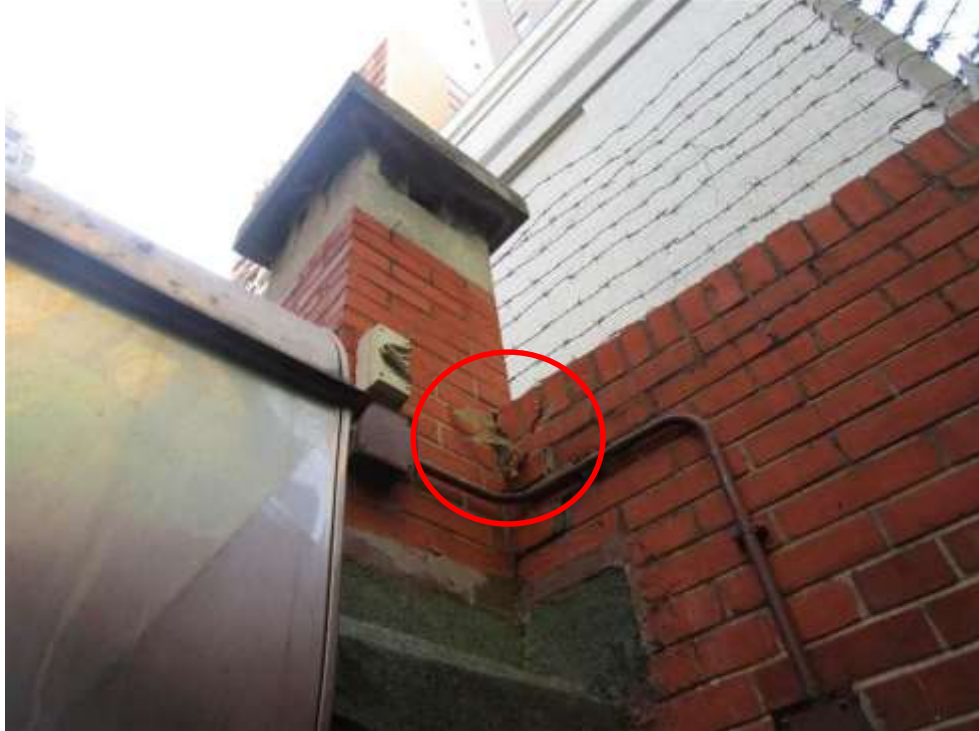
Photo No. 1451

Description Debonded joint sealant between brick walls

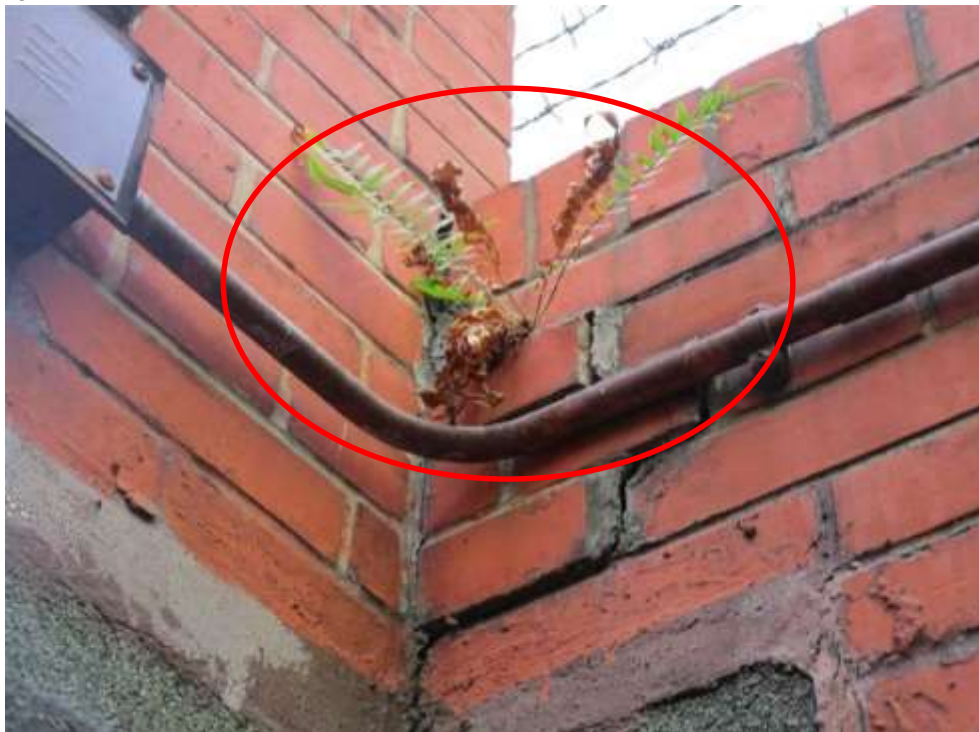
Photo No. 1452

Description A mortar joint wide crack with vegetation was observed on brick wall

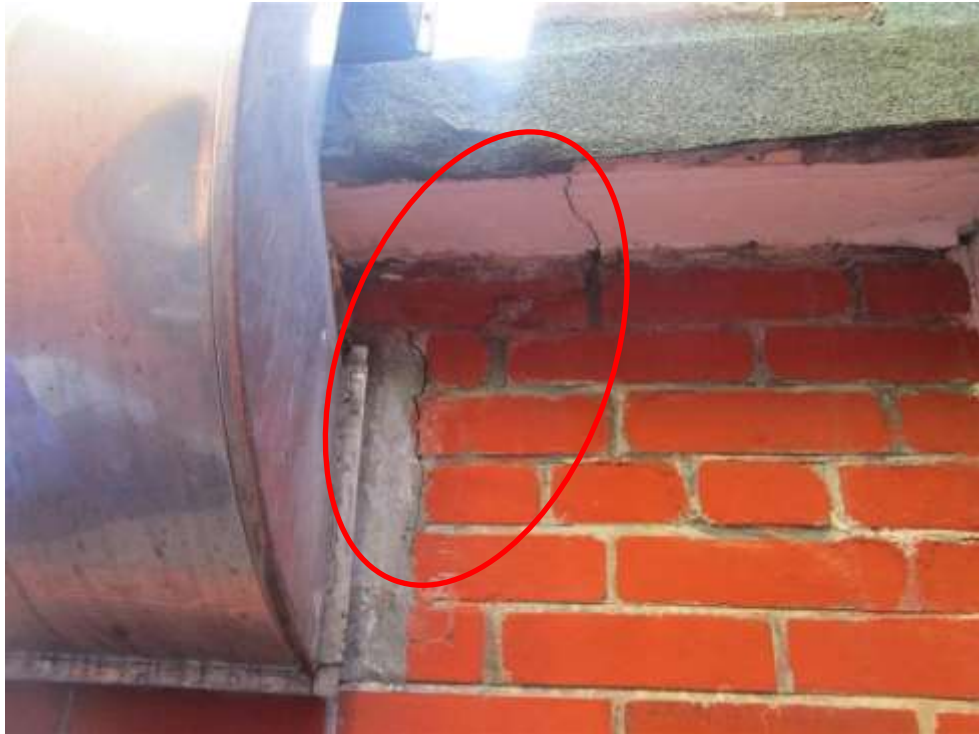
Photo No. 1453

Description A mortar joint wide crack with vegetation was observed on brick wall

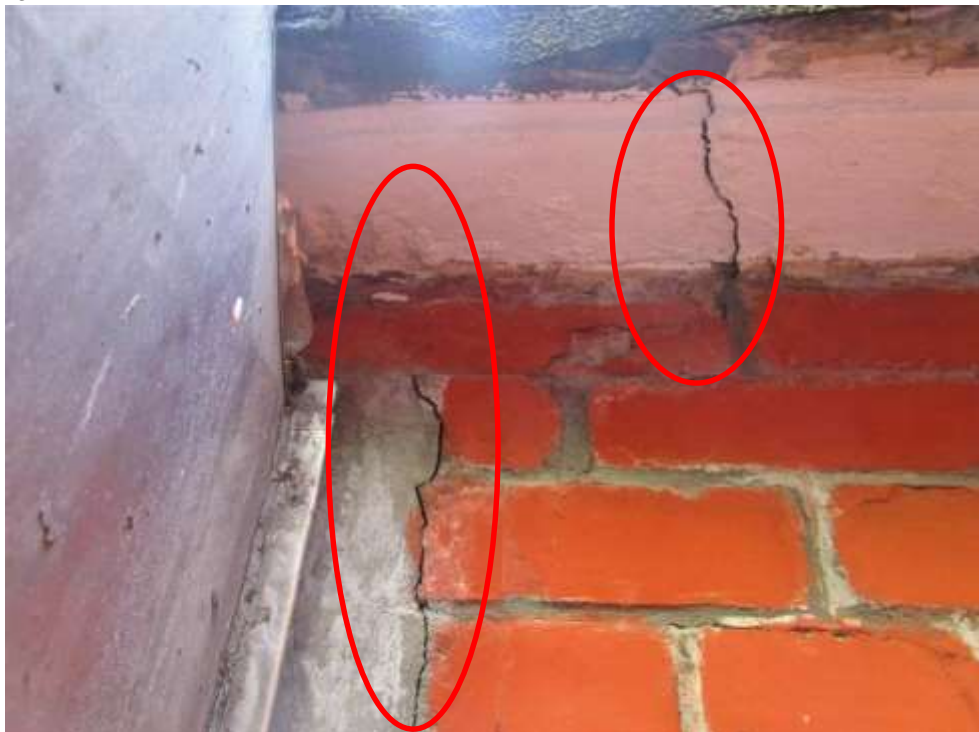
Photo No. 1454

Description A crack was observed on brick wall

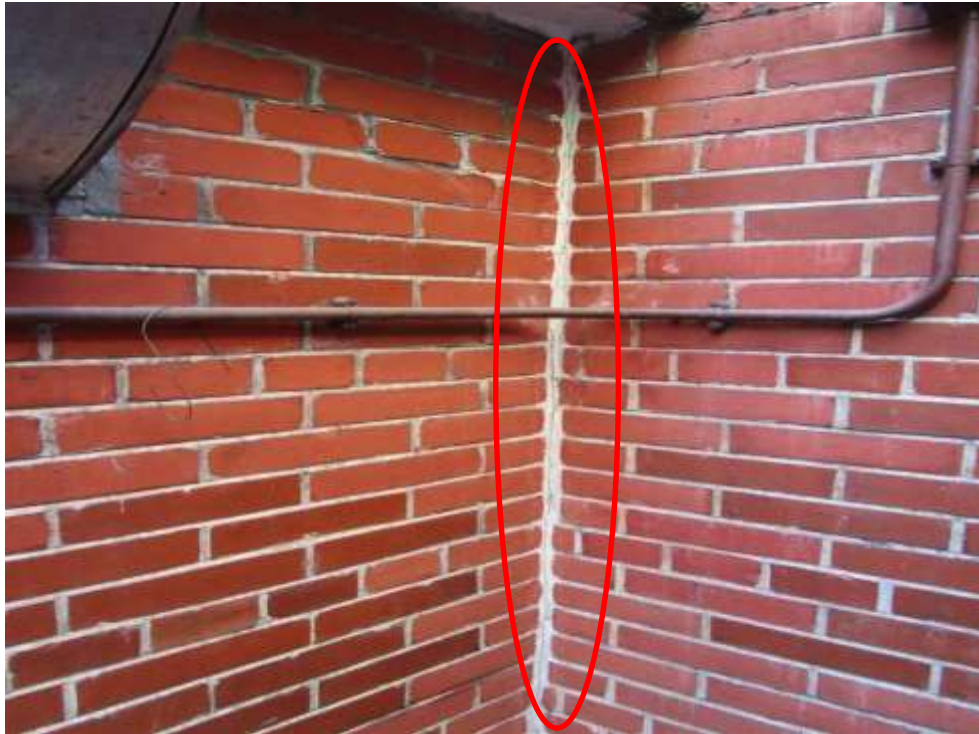
Photo No. 1455

Description A crack was observed on brick wall

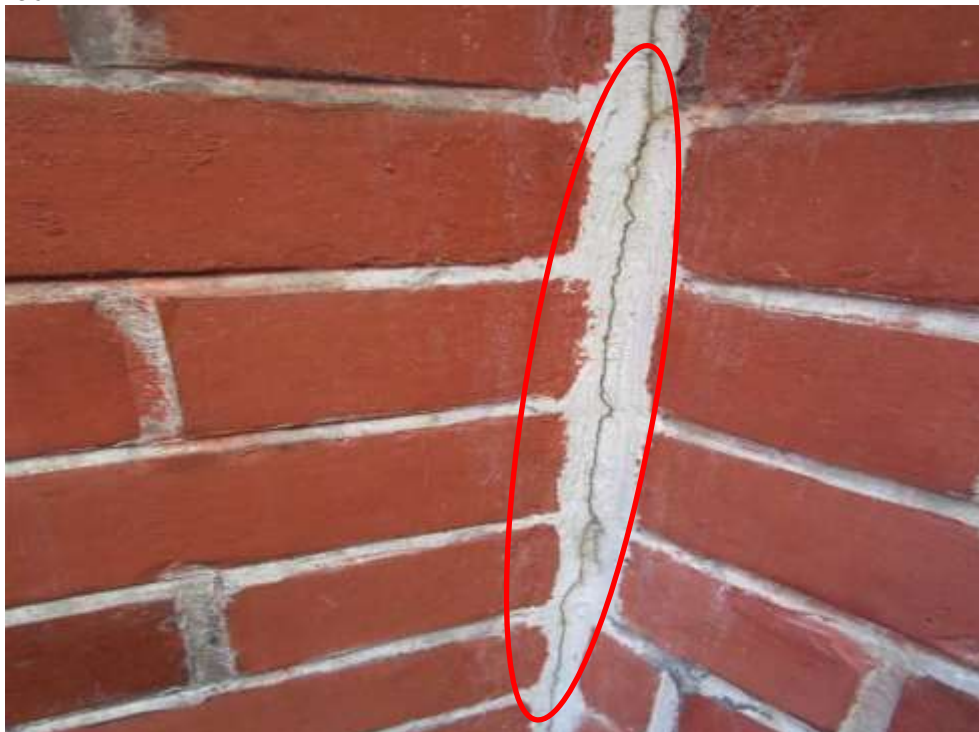
Photo No. 1456

Description A mortar joint medium crack was observed on brick wall

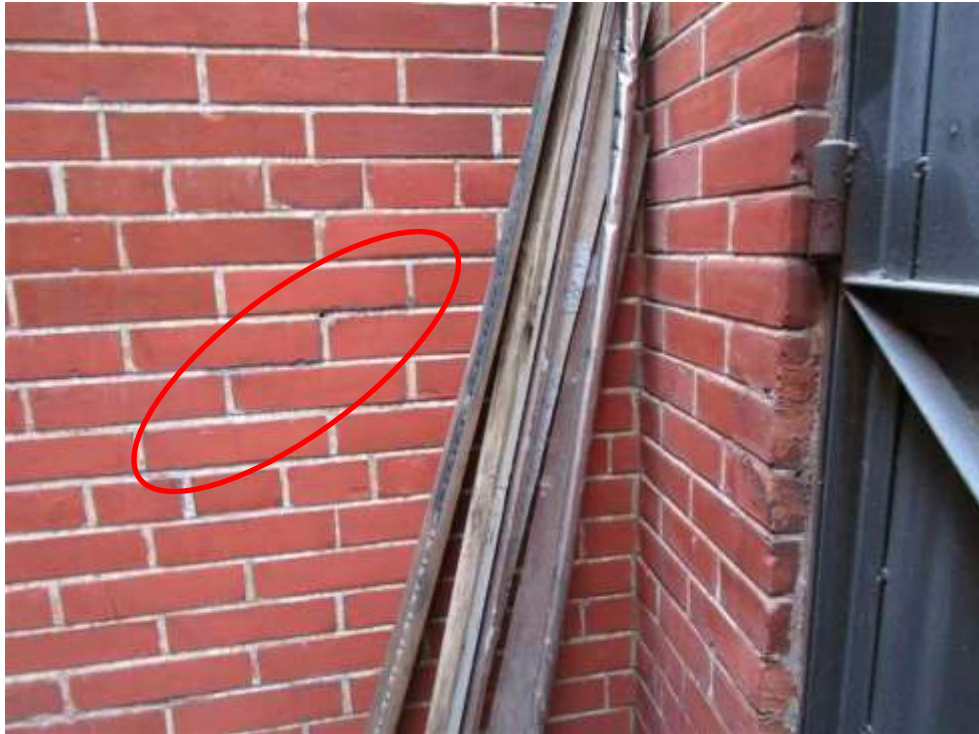
Photo No. 1457

Description A mortar joint medium crack was observed on brick wall

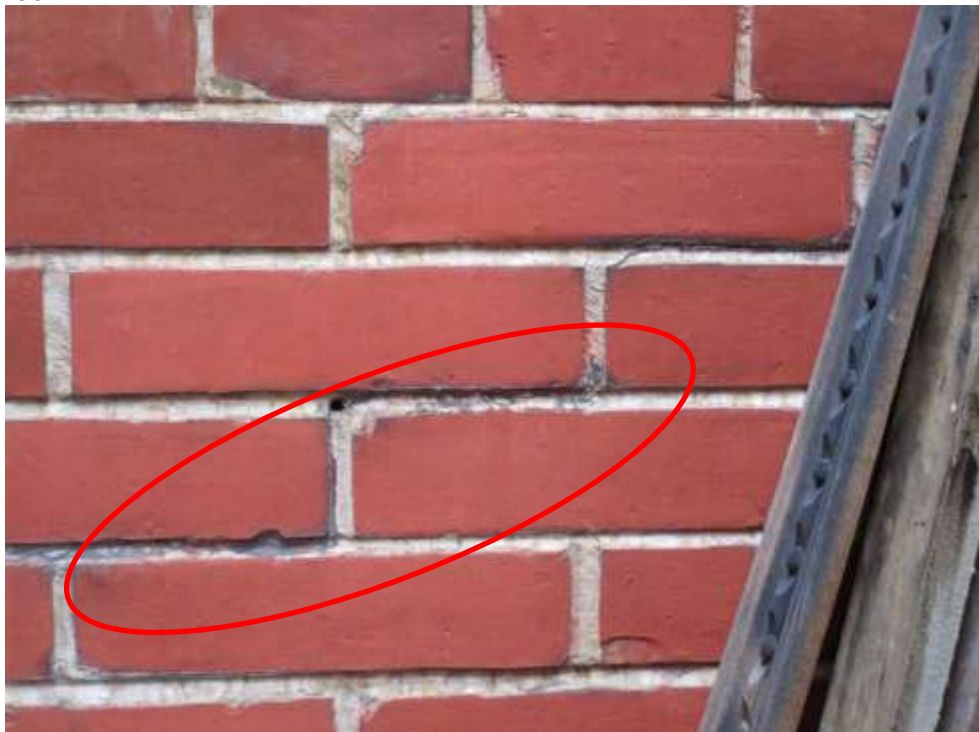
Photo No. 1458

Description	A mortar joint medium crack was observed on brick wall				
--------------------	--------------------------------------------------------	--	--	--	--

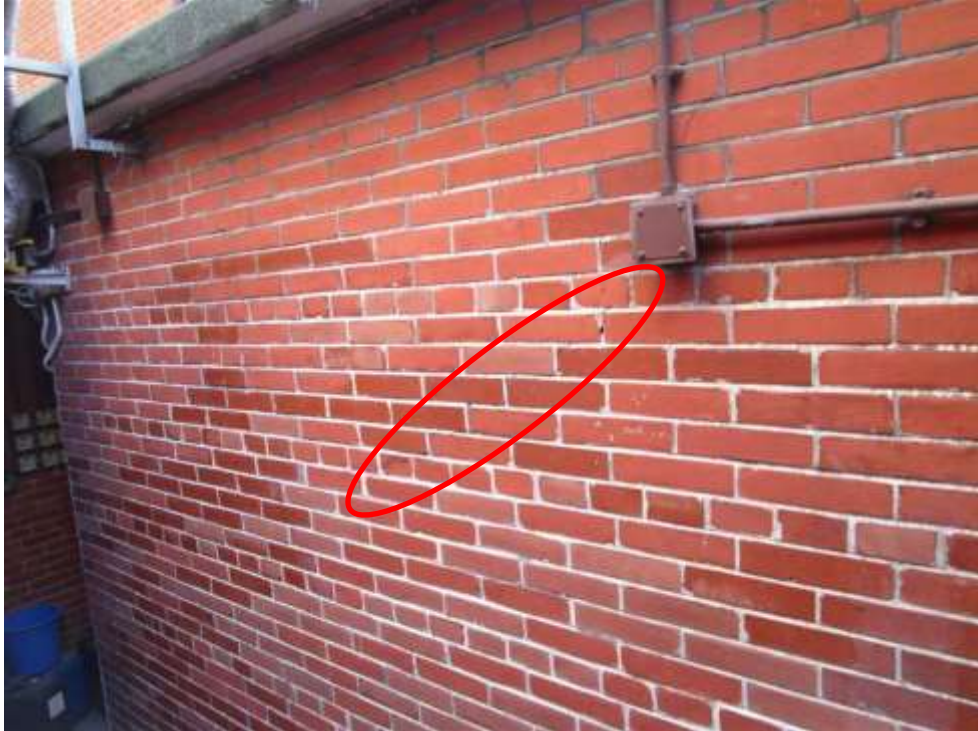
Photo No. 1459

Description	A mortar joint medium crack was observed on brick wall				
--------------------	--------------------------------------------------------	--	--	--	--

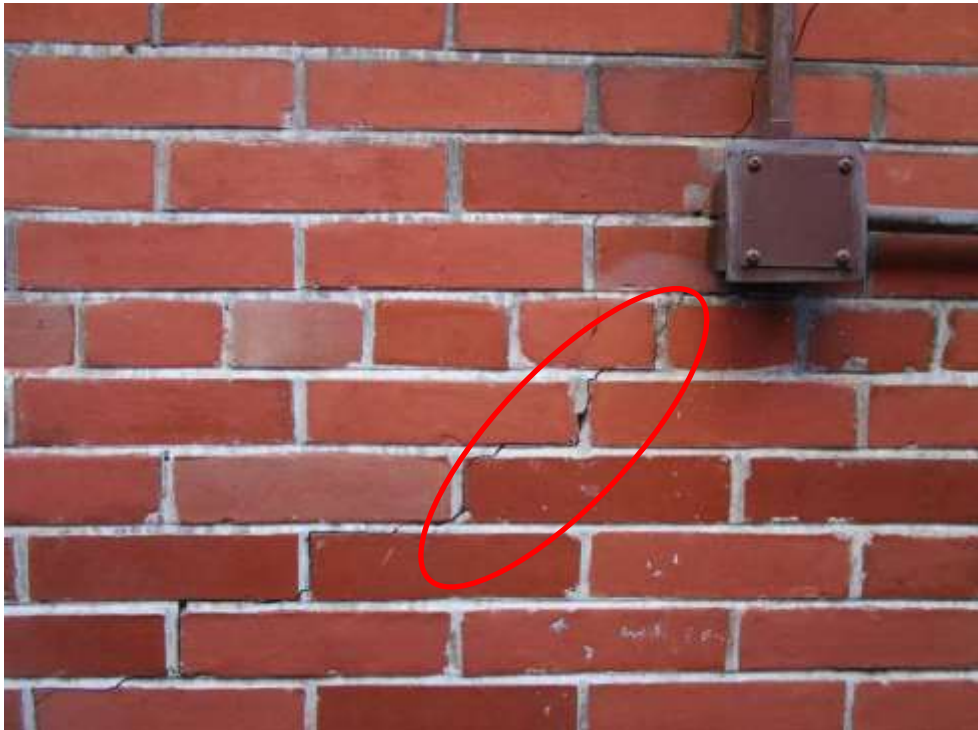
Photo No. 1460

Description	A mortar joint wide crack was observed on brick wall				
--------------------	------------------------------------------------------	--	--	--	--

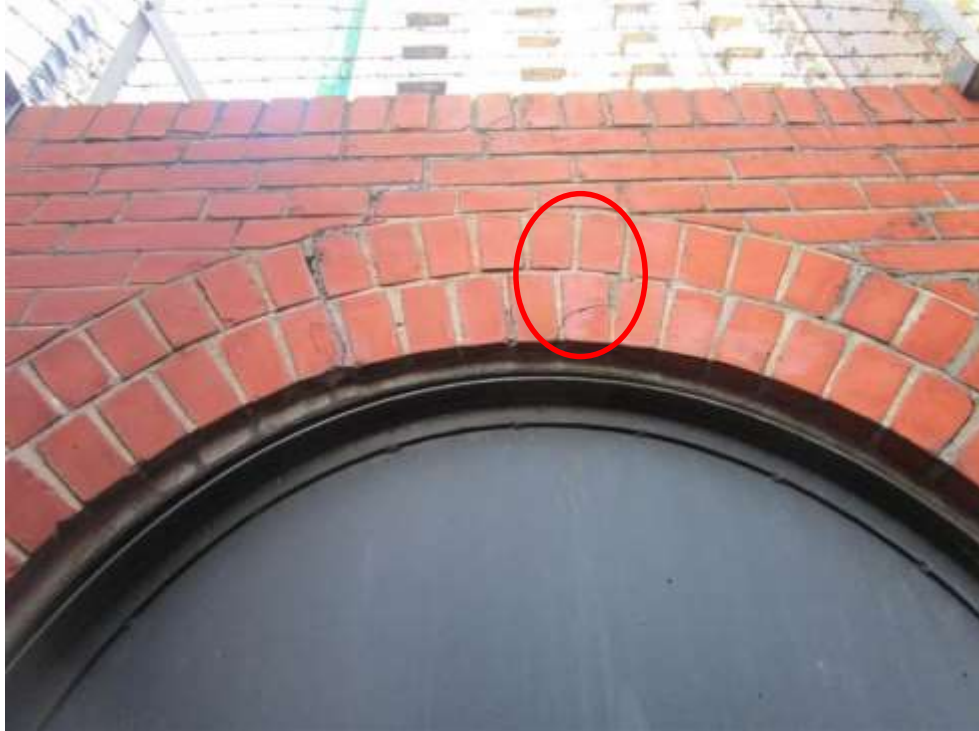
Photo No. 1461

Description	A mortar joint wide crack was observed on brick wall				
--------------------	------------------------------------------------------	--	--	--	--

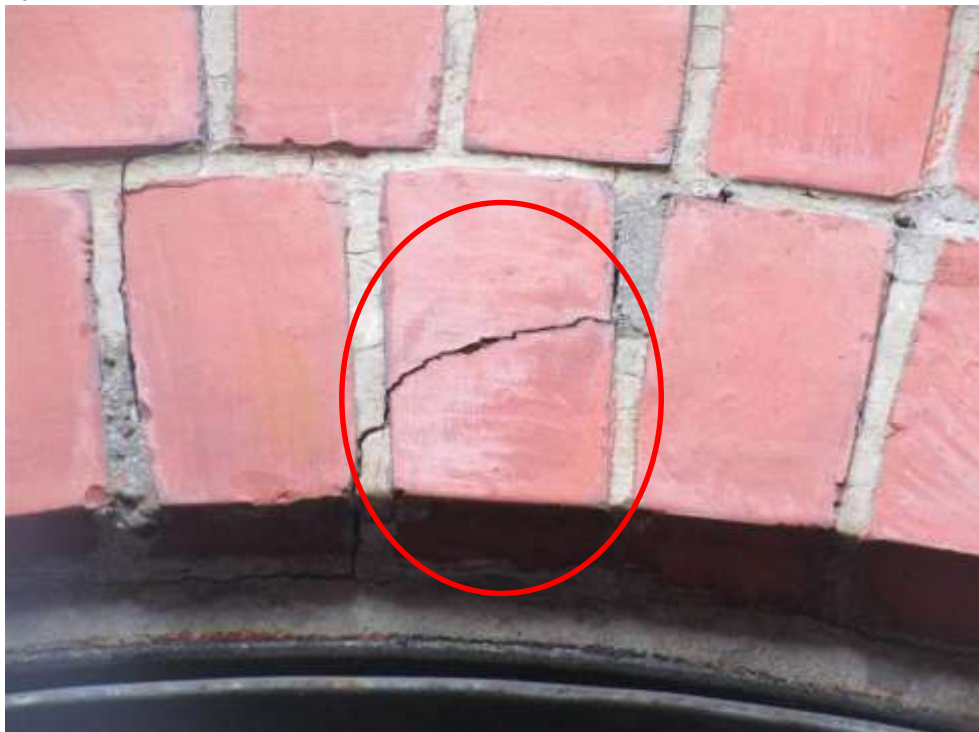
Photo No. 1462

Description A wide crack through brick was observed on brick arch

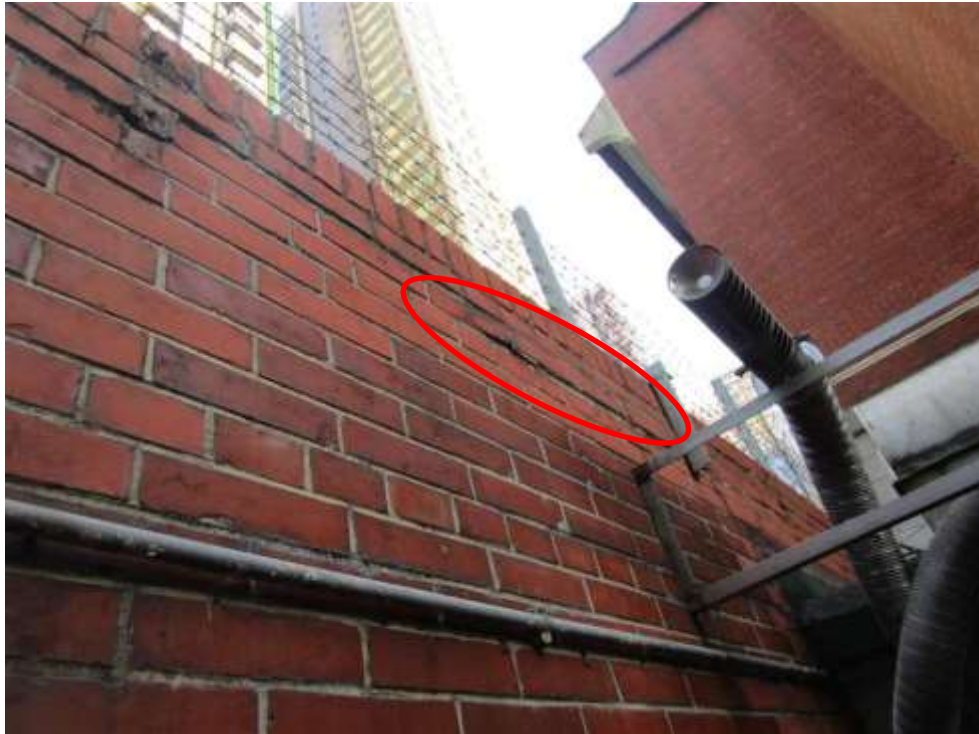
Photo No. 1465

Description A mortar joint wide crack was observed on brick wall

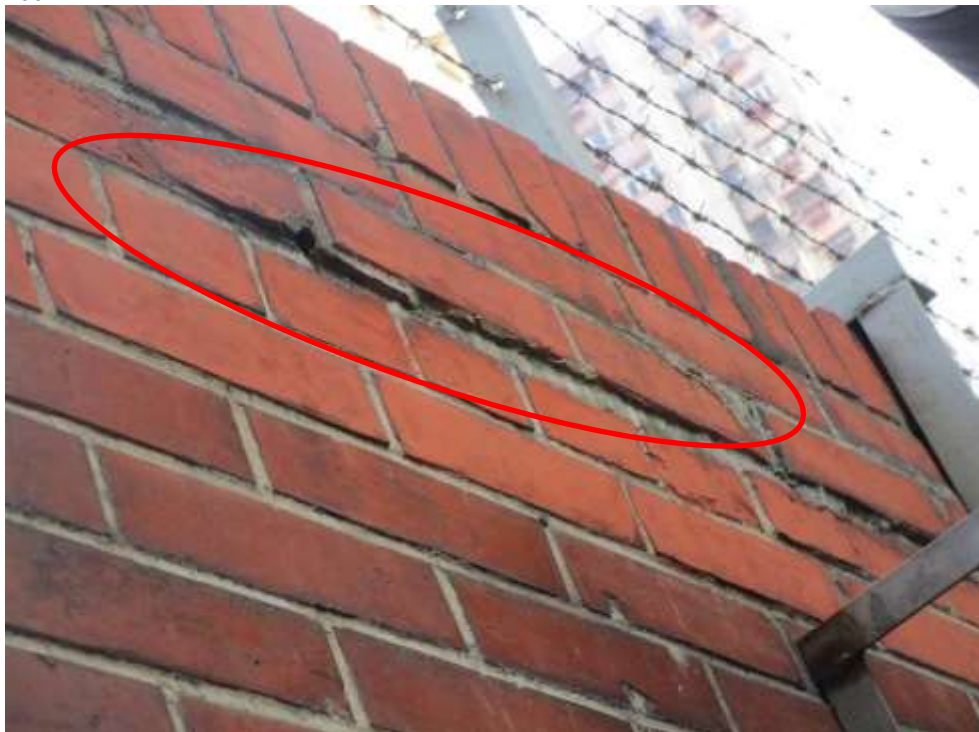
Photo No. 1466

Description	Delaminated bricks were observed on brick wall				
--------------------	------------------------------------------------	--	--	--	--

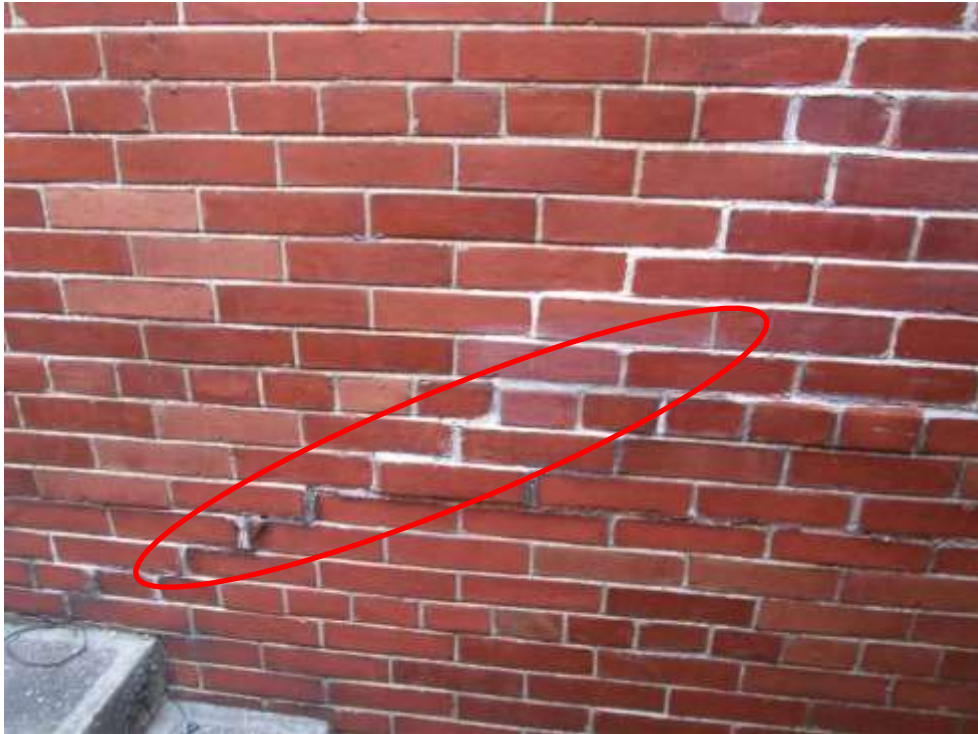
Photo No. 1467

Defect No.	233	Location	LG/F North wing, Staff quarter	Component	brick wall
-------------------	-----	-----------------	--------------------------------	------------------	------------

Description	Delaminated bricks were observed on brick wall				
--------------------	------------------------------------------------	--	--	--	--

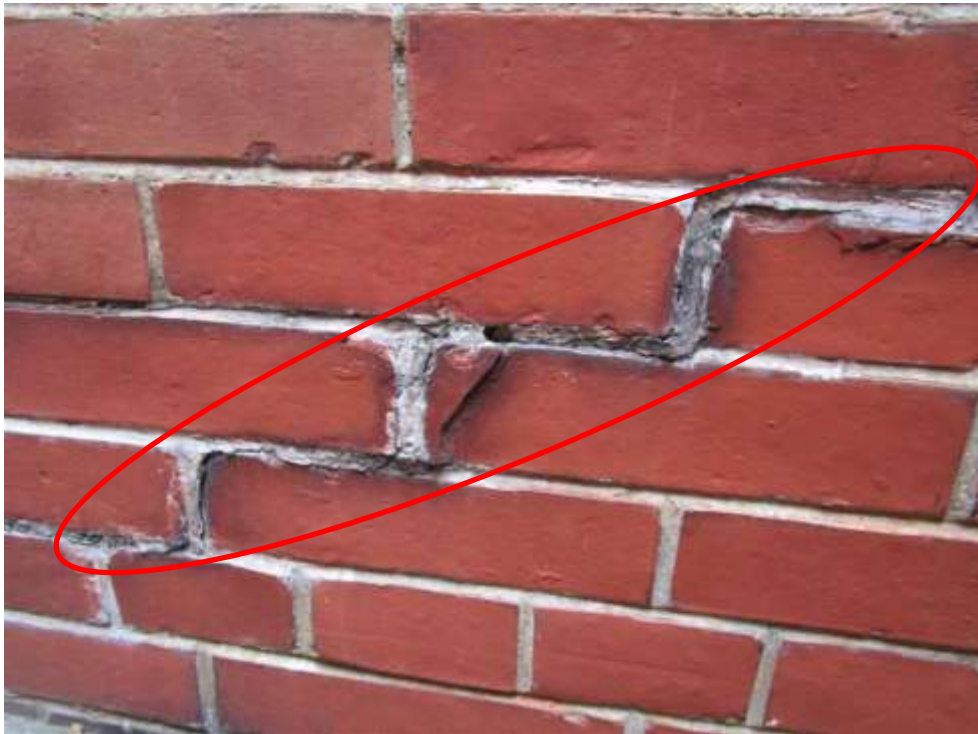
Photo No. 1468

Defect No. 234	Location LG/F North wing, Staff quarter	Component brick wall
-----------------------	------------------------------------------------	-----------------------------

Description A wide crack was observed on brick wall mortar joint

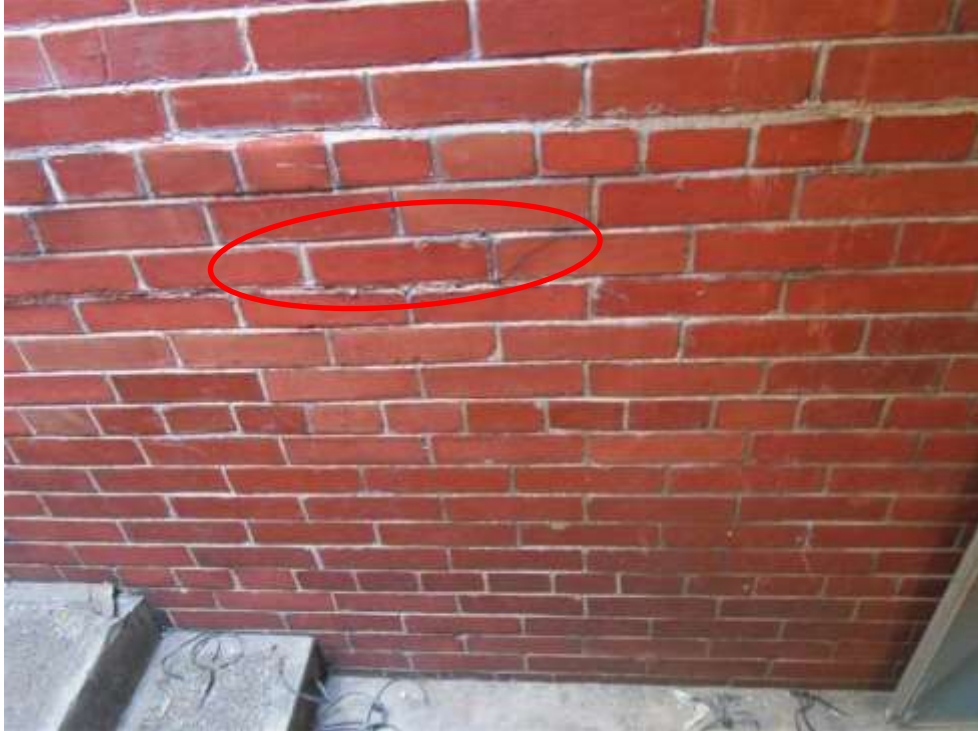
Photo No. 1469

Defect No. 234	Location LG/F North wing, Staff quarter	Component brick wall
-----------------------	------------------------------------------------	-----------------------------

Description A wide crack was observed on brick wall mortar joint

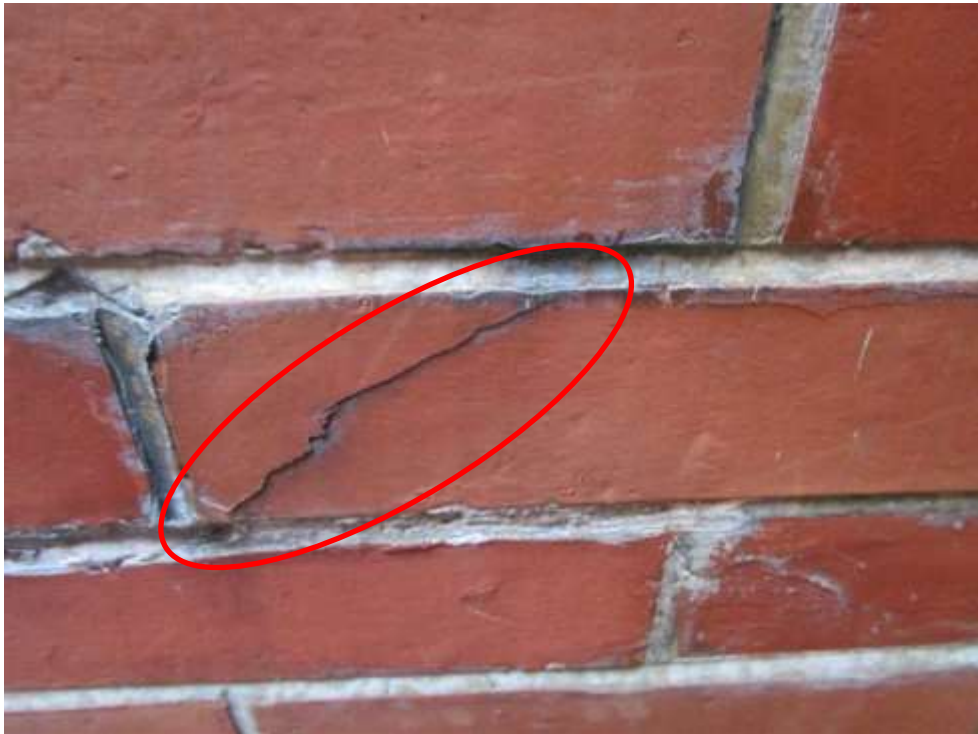
Photo No. 1470

Defect No.	235	Location	LG/F North wing, Staff quarter	Component	brick wall
-------------------	-----	-----------------	--------------------------------	------------------	------------

Description	A medium crack through brick was observed on brick wall				
--------------------	---------------------------------------------------------	--	--	--	--

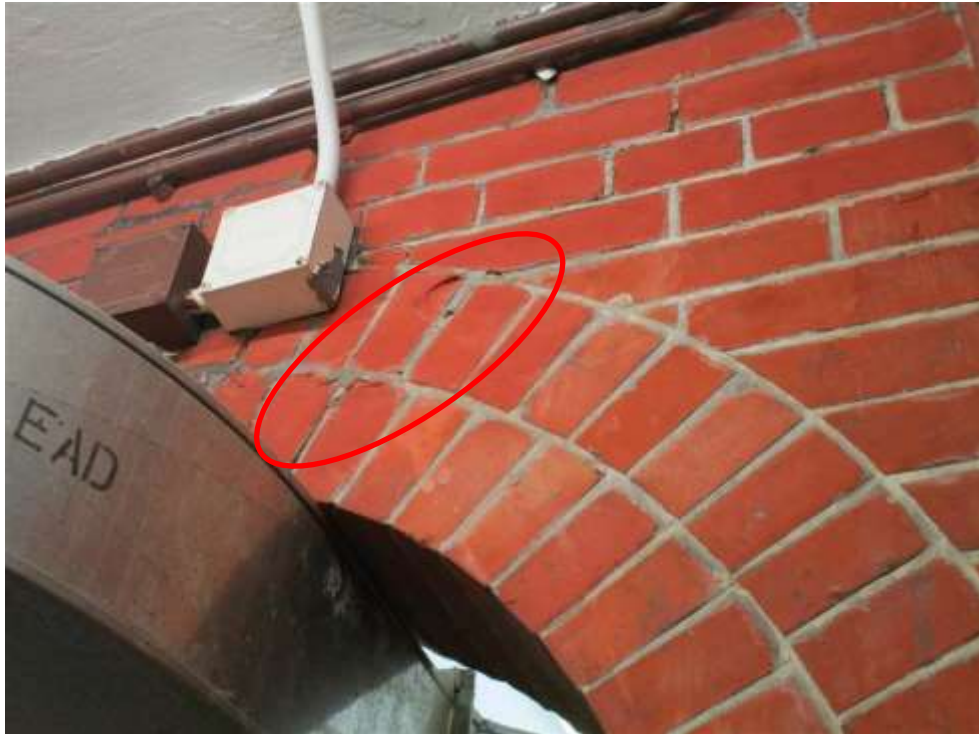
Photo No. 1471

Defect No.	235	Location	LG/F North wing, Staff quarter	Component	brick wall
-------------------	-----	-----------------	--------------------------------	------------------	------------

Description	A medium crack through brick was observed on brick wall				
--------------------	---------------------------------------------------------	--	--	--	--

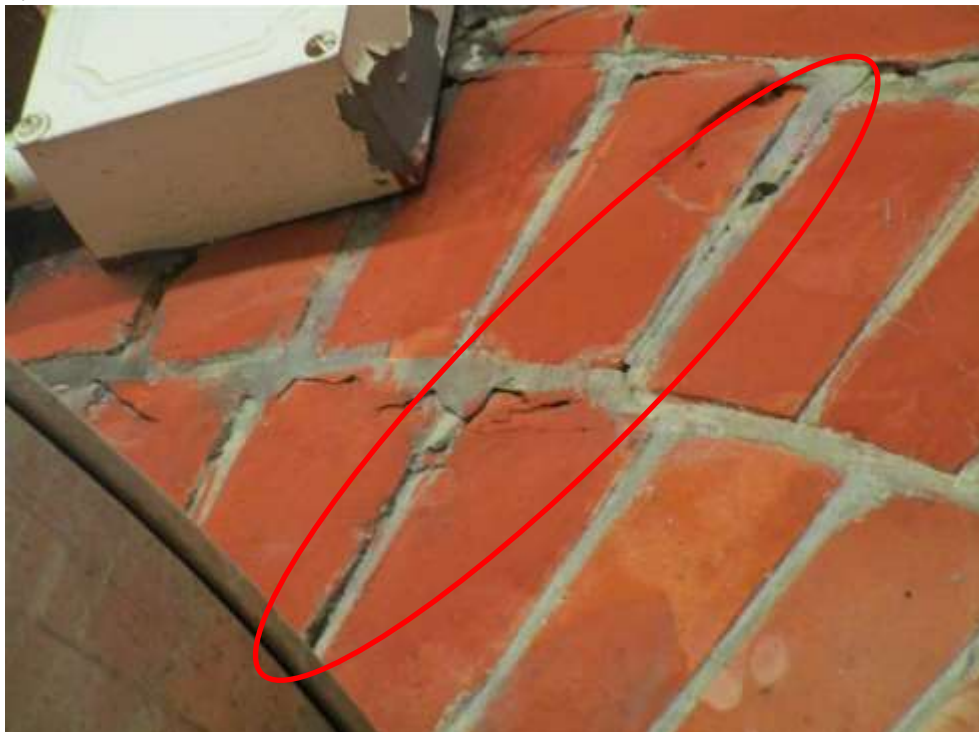
Photo No. 1472

Defect No.	236	Location	LG/F North wing, Staff quarter	Component	brick wall
-------------------	-----	-----------------	--------------------------------	------------------	------------

Description	A mortar joint medium crack was observed on brick wall				
--------------------	--------------------------------------------------------	--	--	--	--
