**Slope Upgrading Works at
Feature No. 11SW-A/R526,
King's College,
Bonham Road, Hong Kong**

Project Profile for Slope Upgrading Works at
Feature No. 11SW-A/R526, King's College

May 2018

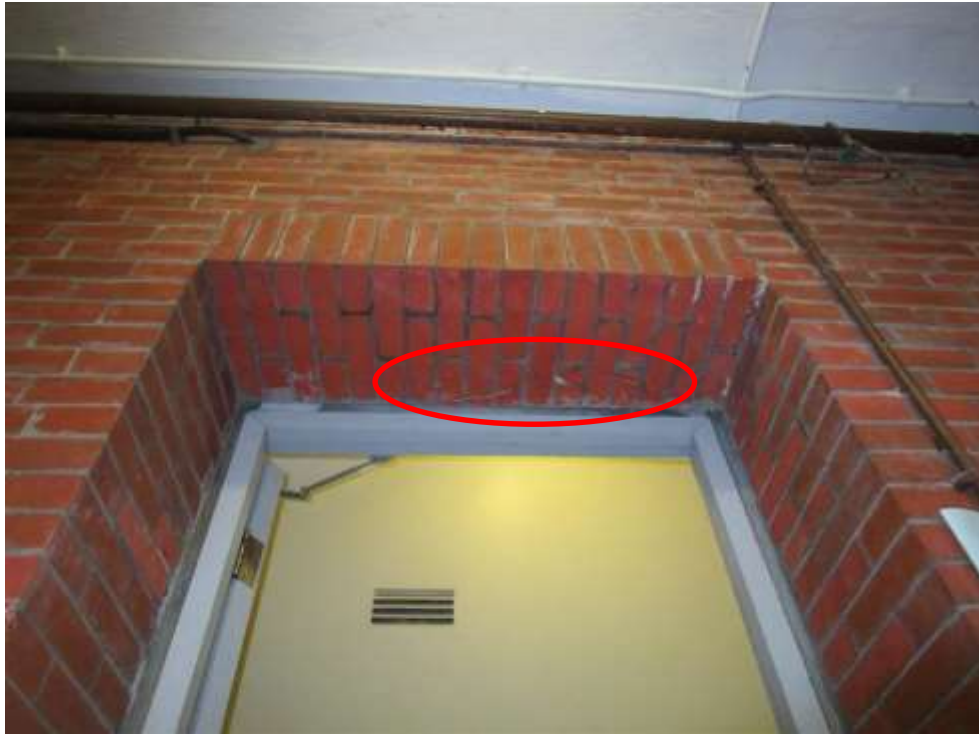
Photo No. 1473

Defect No.	236	Location	LG/F North wing, Staff quarter	Component	brick wall
-------------------	-----	-----------------	--------------------------------	------------------	------------

Description	A mortar joint medium crack was observed on brick wall				
--------------------	--------------------------------------------------------	--	--	--	--

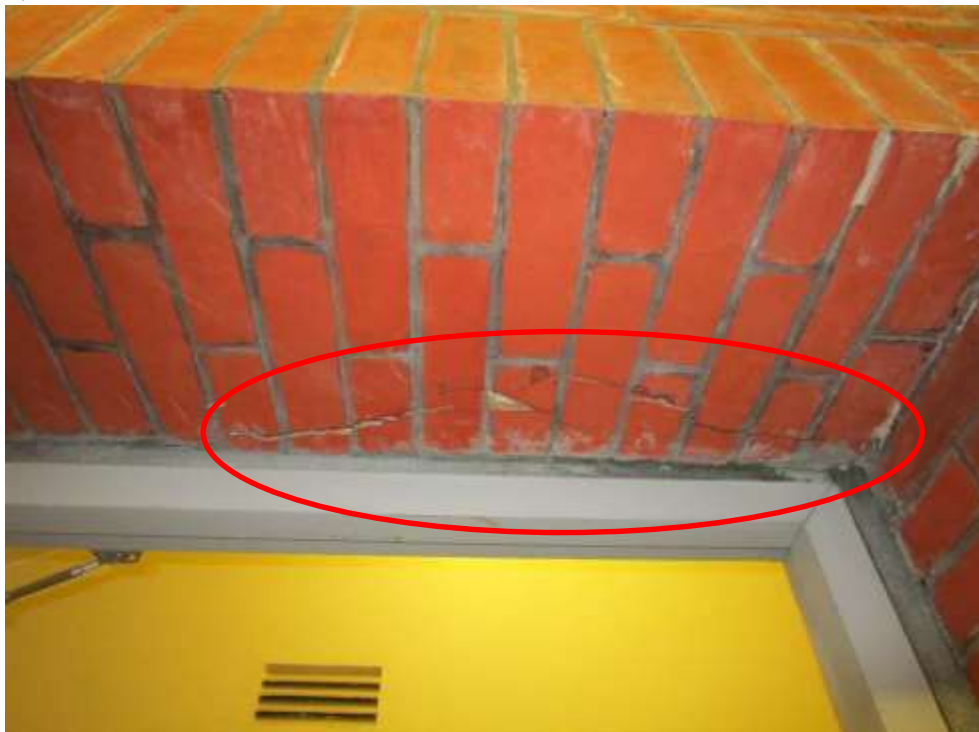
Photo No. 1474

Defect No. 237	Location LG/F North wing, Staff quarter	Component brick wall
-----------------------	------------------------------------------------	-----------------------------

Description A wide crack was observed on brick wall

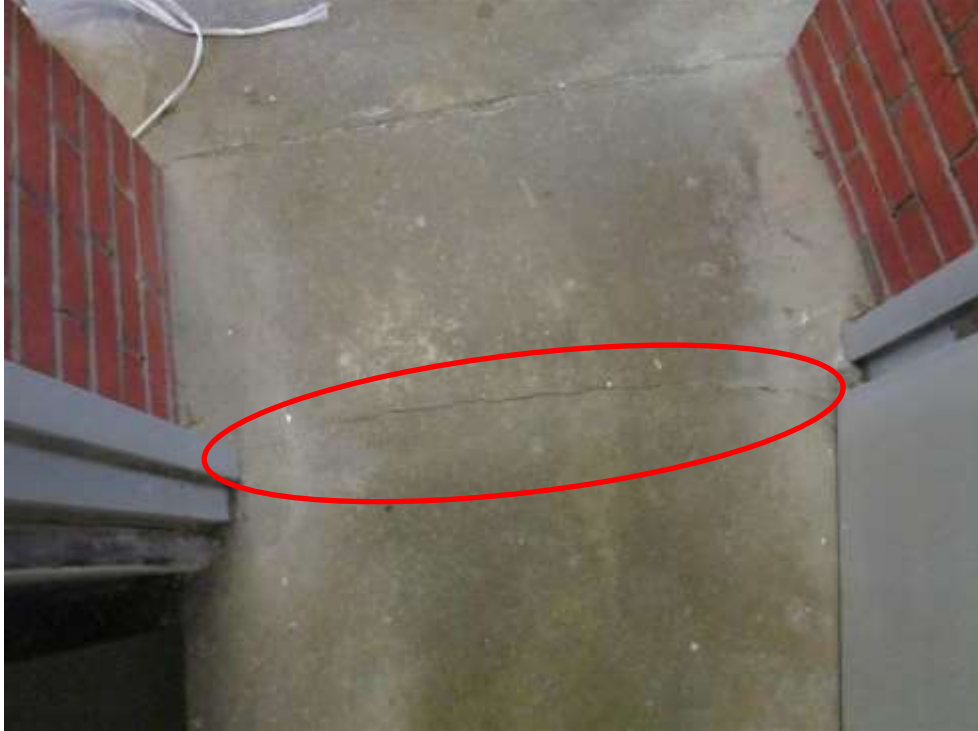
Photo No. 1475

Defect No. 237	Location LG/F North wing, Staff quarter	Component brick wall
-----------------------	------------------------------------------------	-----------------------------

Description A wide crack was observed on brick wall

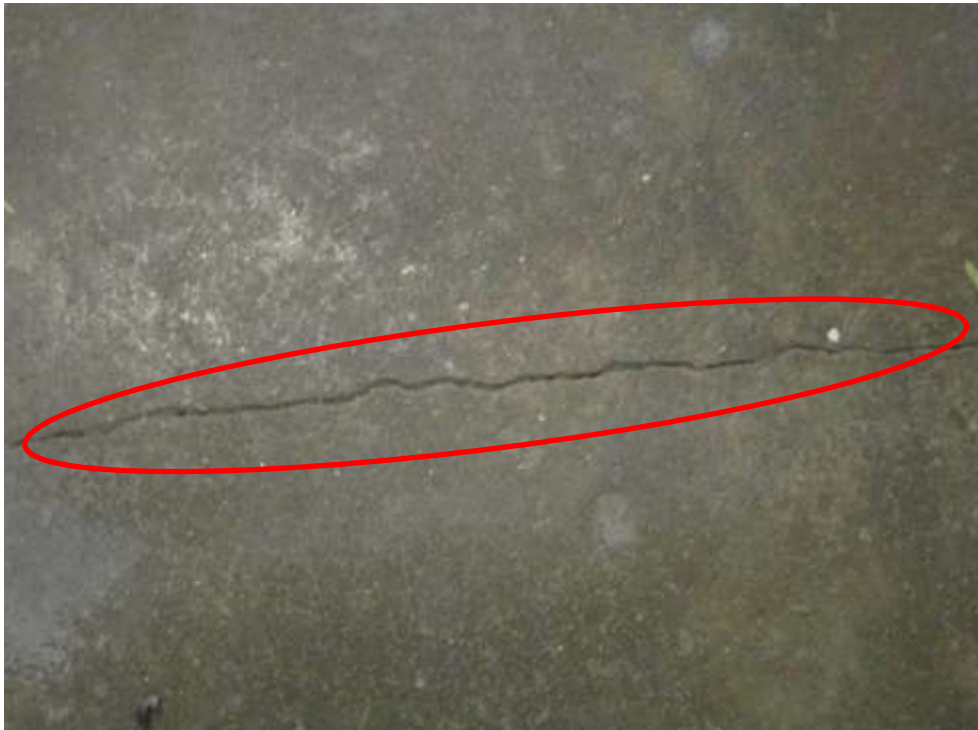
Photo No. 1476

Defect No.	238	Location	LG/F North wing, Staff quarter	Component	slab
-------------------	-----	-----------------	--------------------------------	------------------	------

Description	A wide crack was observed on slab				
--------------------	-----------------------------------	--	--	--	--

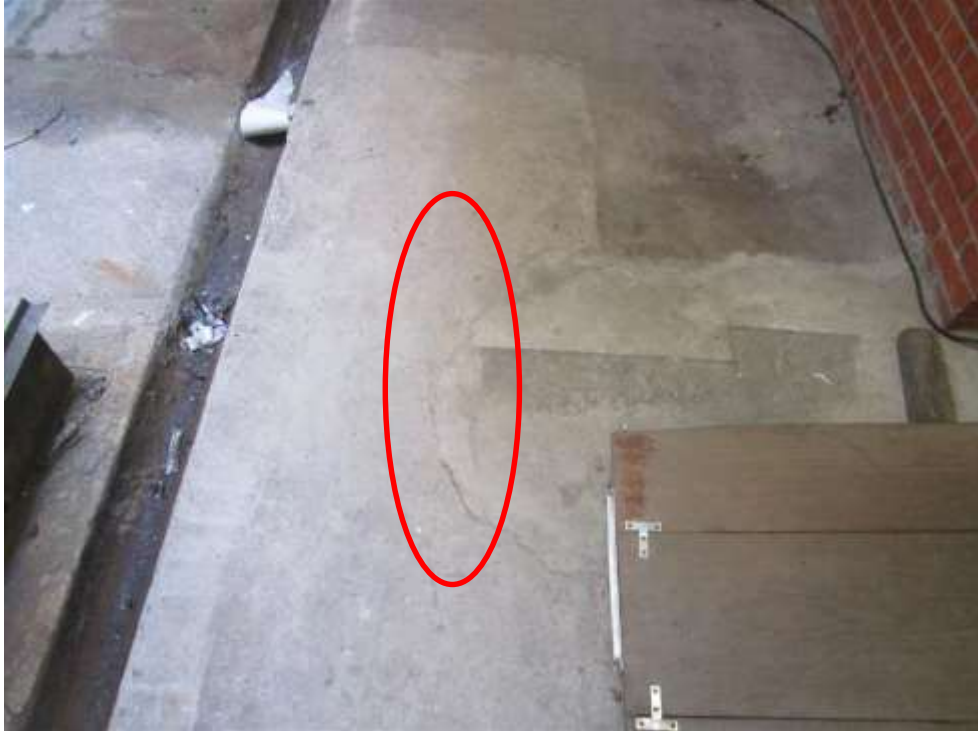
Photo No. 1477

Defect No.	238	Location	LG/F North wing, Staff quarter	Component	slab
-------------------	-----	-----------------	--------------------------------	------------------	------

Description	A wide crack was observed on slab				
--------------------	-----------------------------------	--	--	--	--

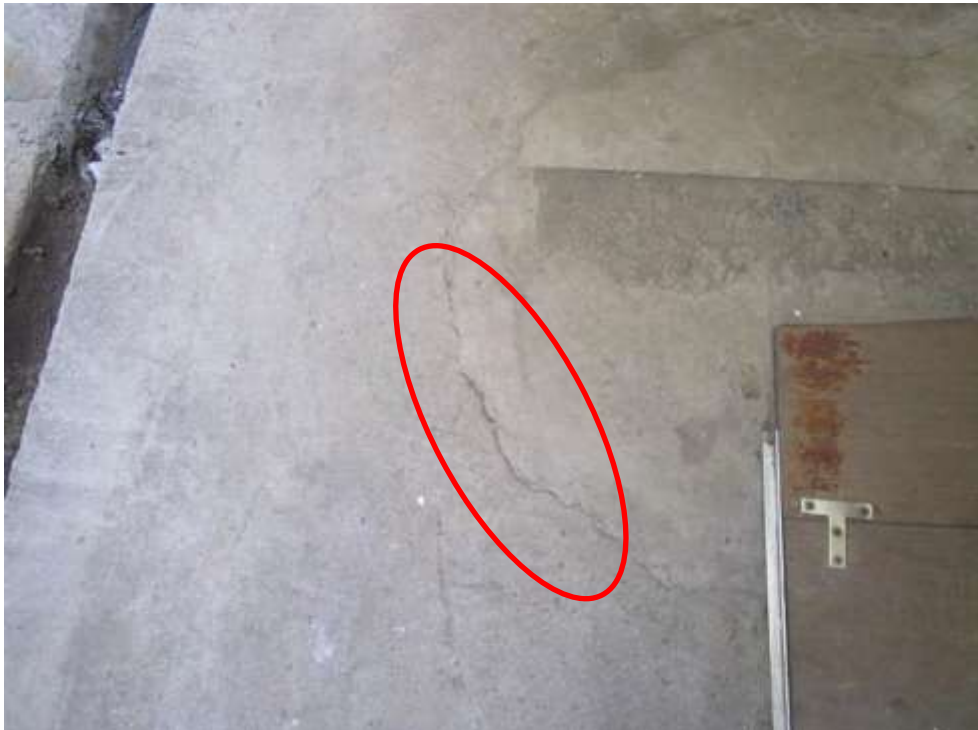
Photo No. 1478

Defect No. 239	Location LG/F North wing, Staff quarter	Component slab
-----------------------	------------------------------------------------	-----------------------

Description A medium crack was observed on slab

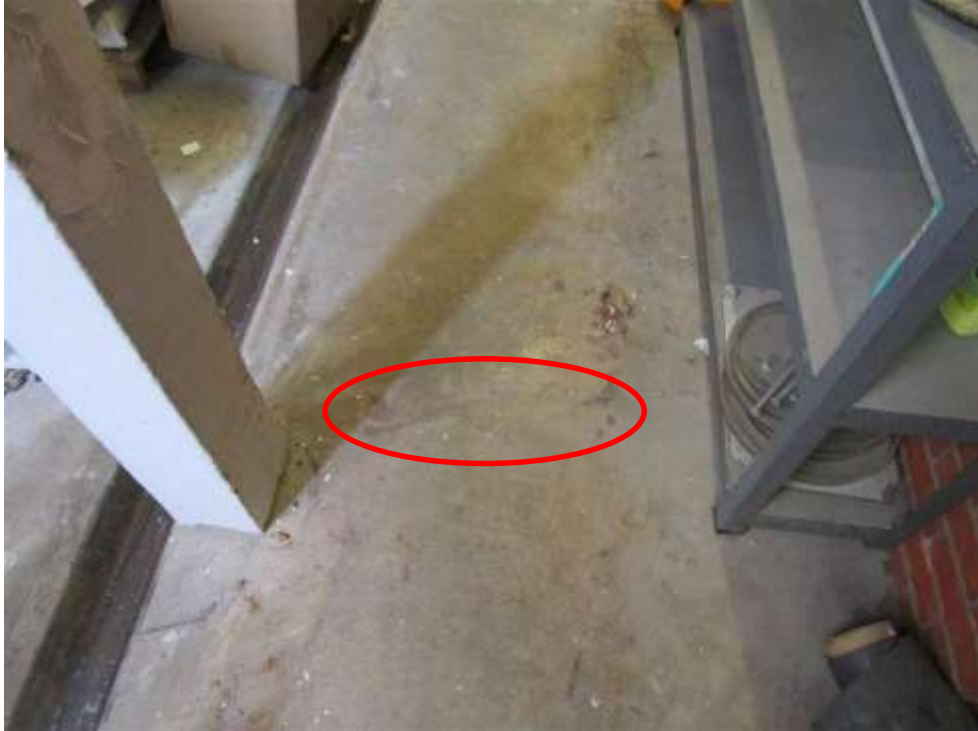
Photo No. 1479

Defect No. 239	Location LG/F North wing, Staff quarter	Component slab
-----------------------	------------------------------------------------	-----------------------

Description A medium crack was observed on slab

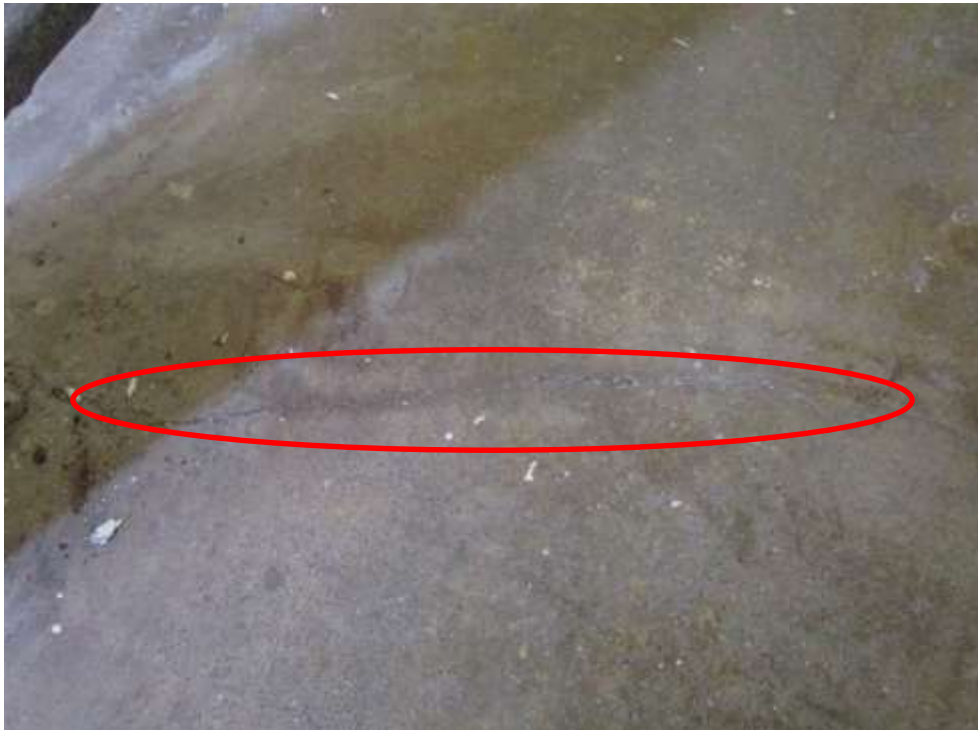
Photo No. 1480

Defect No. 240	Location LG/F North wing, Staff quarter	Component slab
-----------------------	------------------------------------------------	-----------------------

Description A medium crack was observed on slab

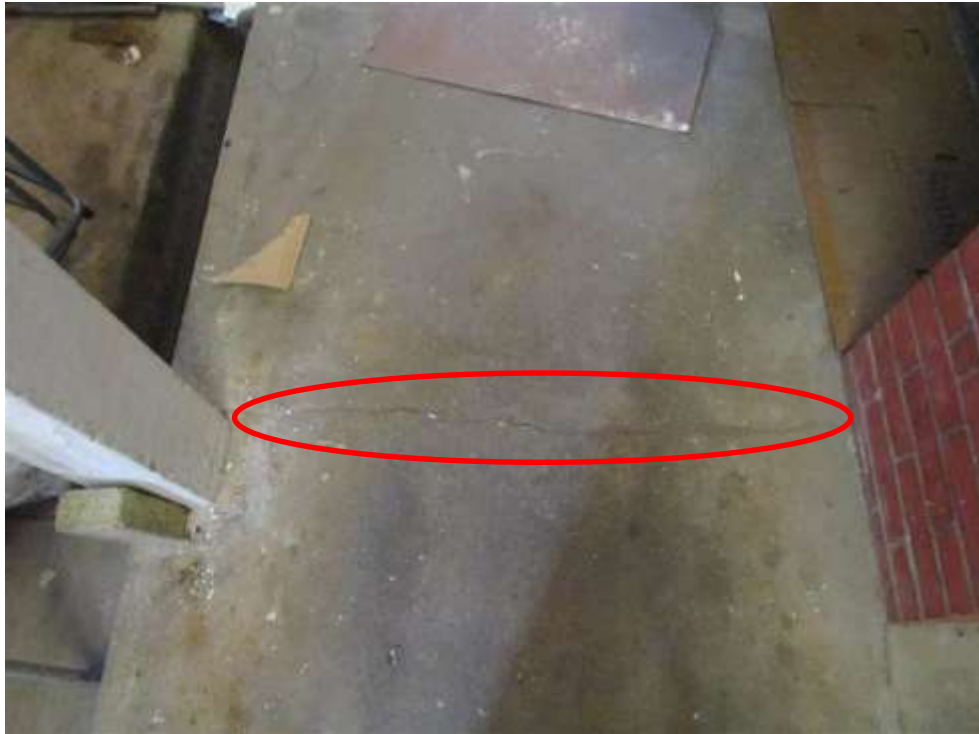
Photo No. 1481

Defect No. 240	Location LG/F North wing, Staff quarter	Component slab
-----------------------	------------------------------------------------	-----------------------

Description A medium crack was observed on slab

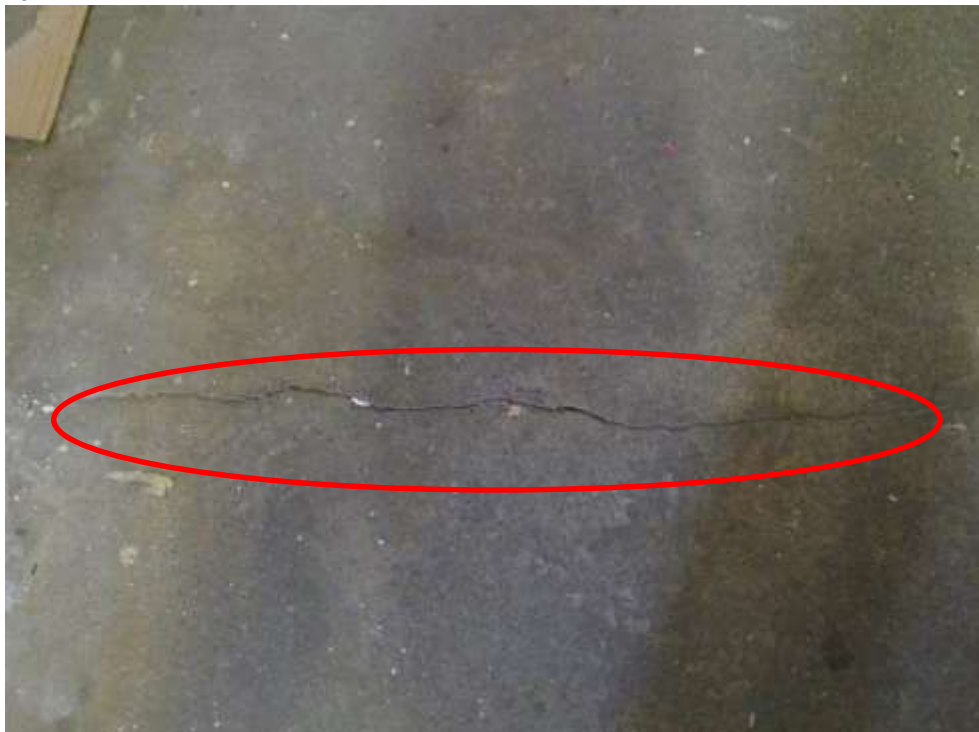
Photo No. 1482

Defect No.	241	Location	LG/F North wing, Staff quarter	Component	slab
-------------------	-----	-----------------	--------------------------------	------------------	------

Description	A medium crack was observed on slab				
--------------------	-------------------------------------	--	--	--	--

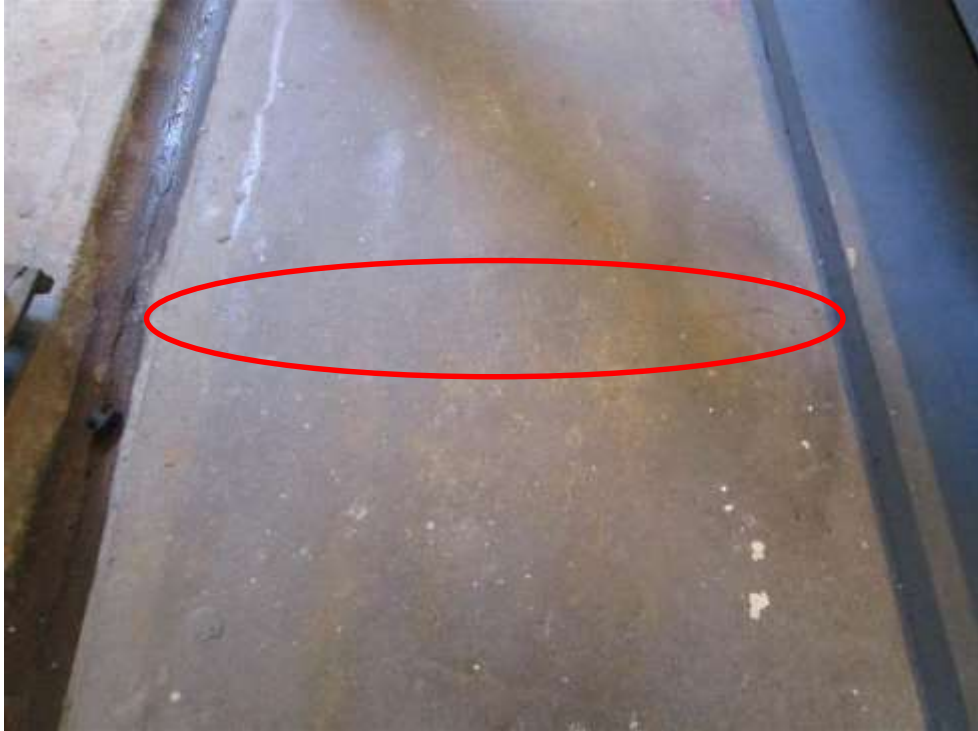
Photo No. 1483

Defect No.	241	Location	LG/F North wing, Staff quarter	Component	slab
-------------------	-----	-----------------	--------------------------------	------------------	------

Description	A medium crack was observed on slab				
--------------------	-------------------------------------	--	--	--	--

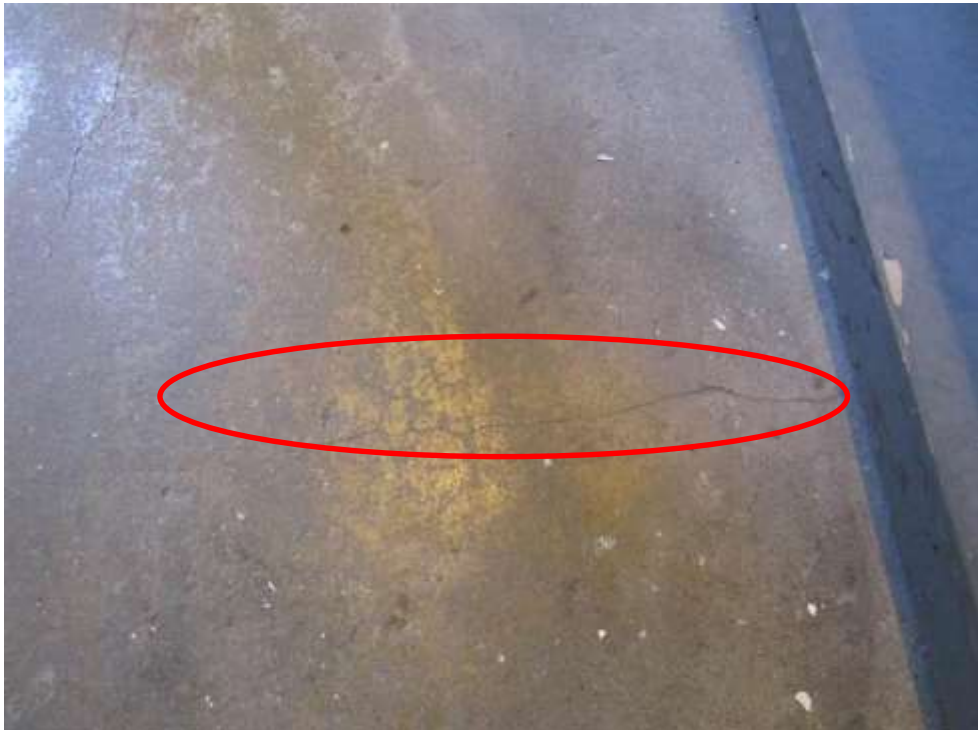
Photo No. 1484

Defect No.	242	Location	LG/F North wing, Staff quarter	Component	slab
-------------------	-----	-----------------	--------------------------------	------------------	------

Description	A medium crack was observed on slab				
--------------------	-------------------------------------	--	--	--	--

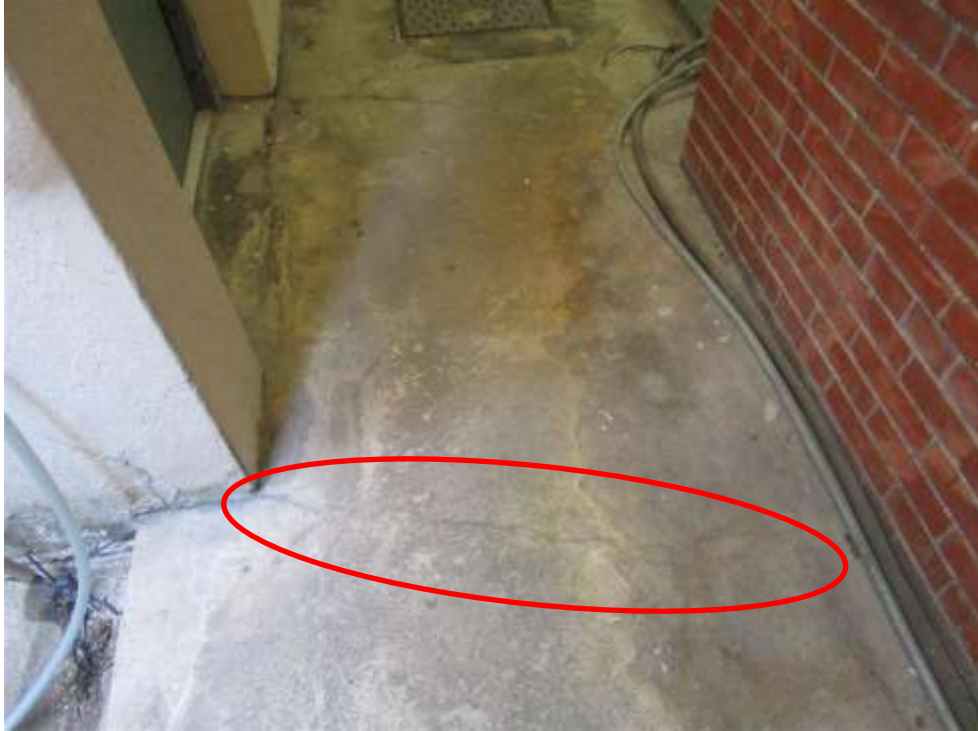
Photo No. 1485

Defect No.	242	Location	LG/F North wing, Staff quarter	Component	slab
-------------------	-----	-----------------	--------------------------------	------------------	------

Description	A medium crack was observed on slab				
--------------------	-------------------------------------	--	--	--	--

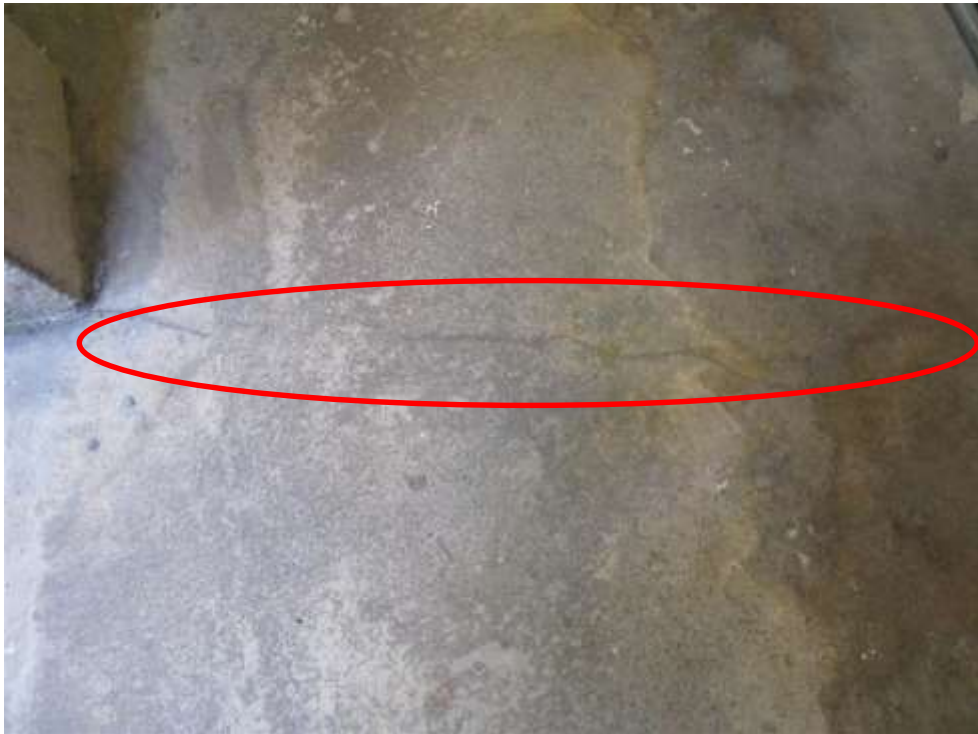
Photo No. 1486

Defect No. 243	Location LG/F North wing, Staff quarter	Component slab
-----------------------	------------------------------------------------	-----------------------

Description 2 wide cracks were observed on slab

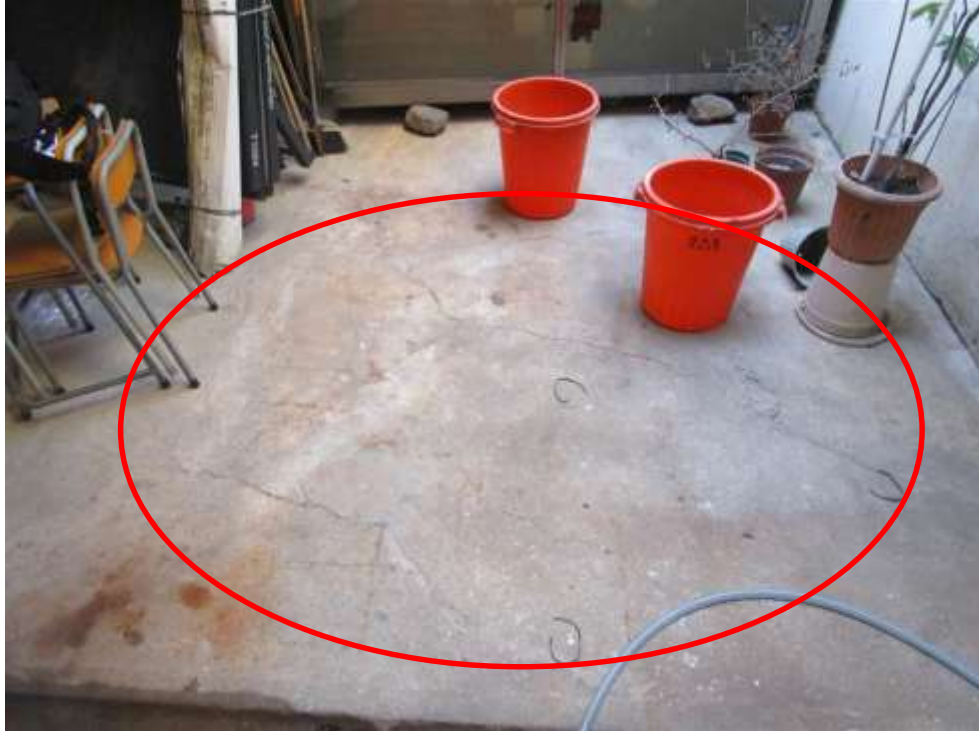
Photo No. 1487

Defect No. 243	Location LG/F North wing, Staff quarter	Component slab
-----------------------	------------------------------------------------	-----------------------

Description 2 wide cracks were observed on slab

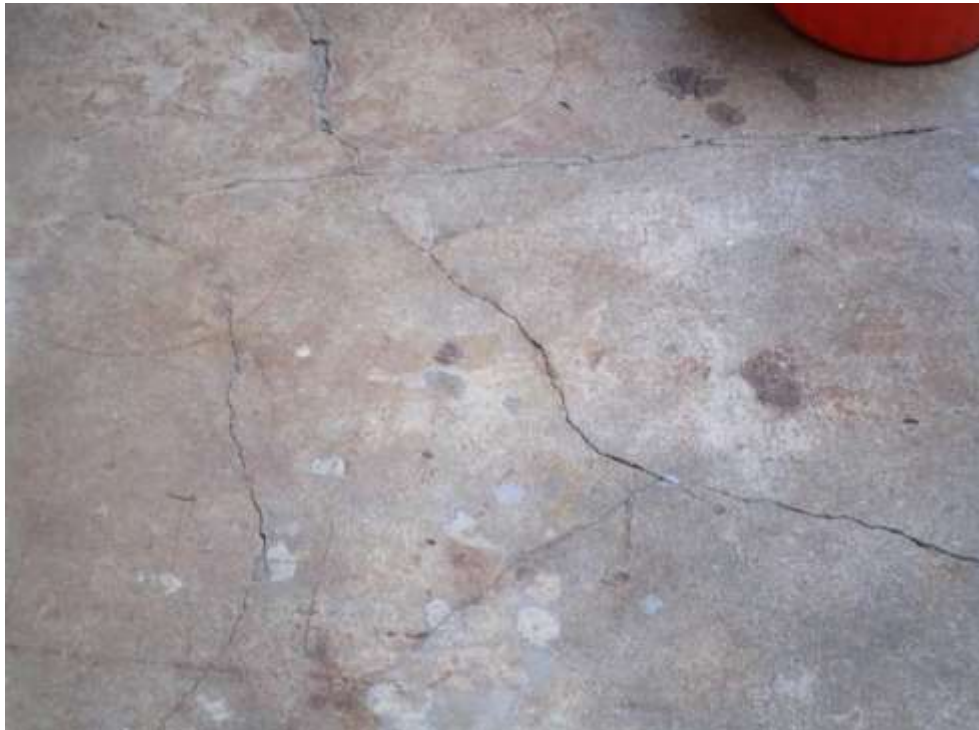
Photo No. 1488

Defect No. 244 **Location** LG/F North wing, Staff quarter **Component** slab

Description An area of wide crack was observed on slab

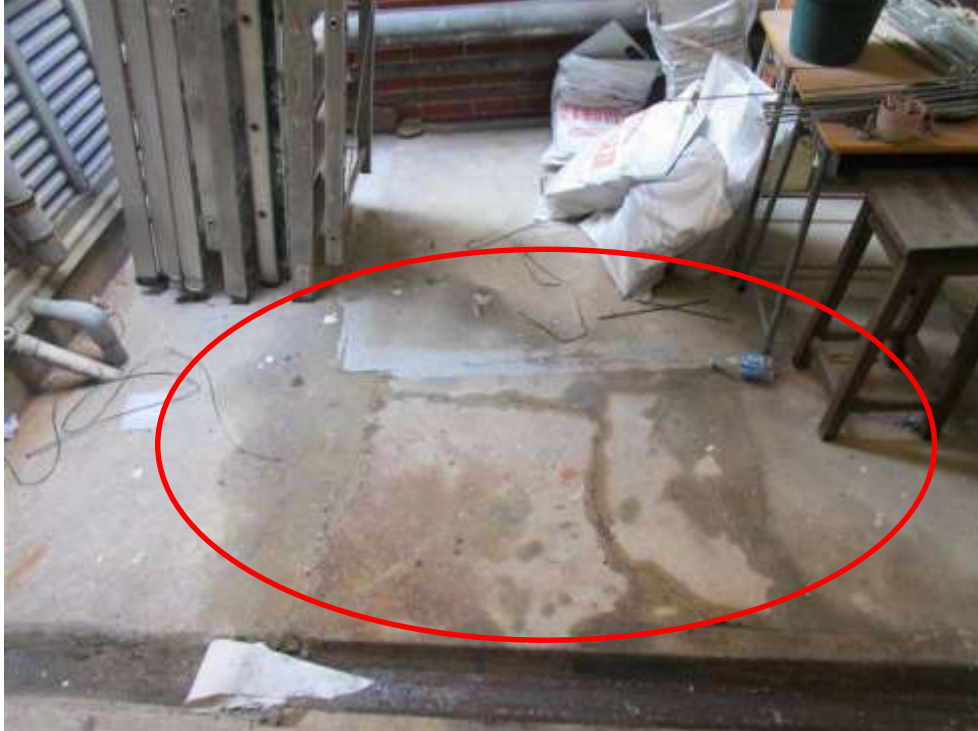
Photo No. 1489

Defect No. 244 **Location** LG/F North wing, Staff quarter **Component** slab

Description An area of wide crack was observed on slab

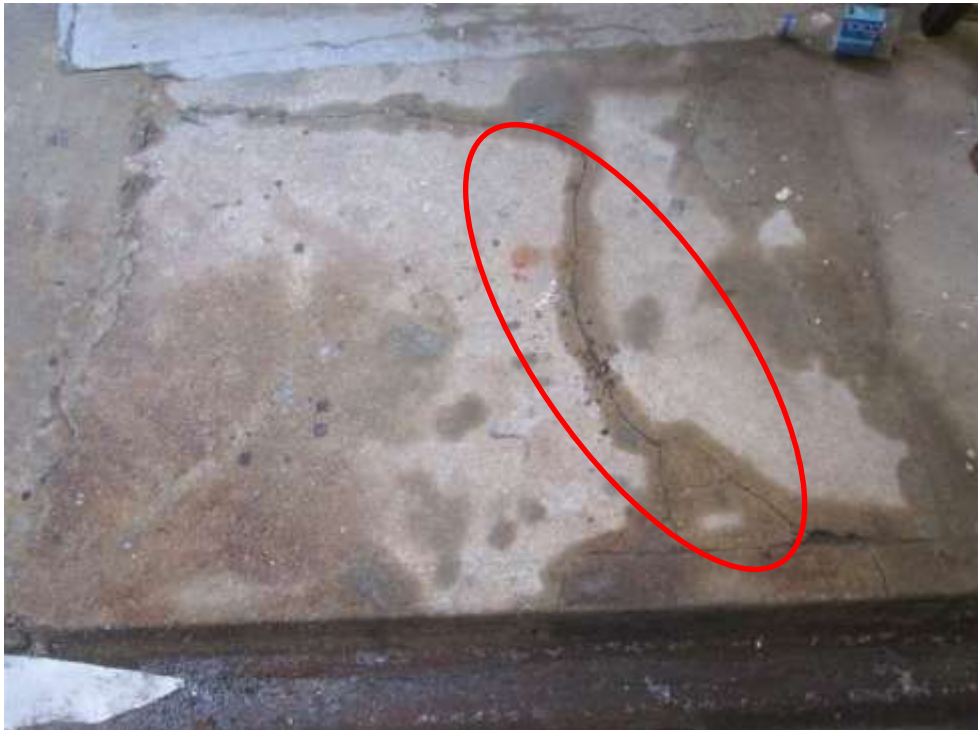
Photo No. 1490

Defect No.	245	Location	LG/F North wing, Staff quarter	Component	slab
-------------------	-----	-----------------	--------------------------------	------------------	------

Description	An area of wide crack was observed on slab				
--------------------	--------------------------------------------	--	--	--	--

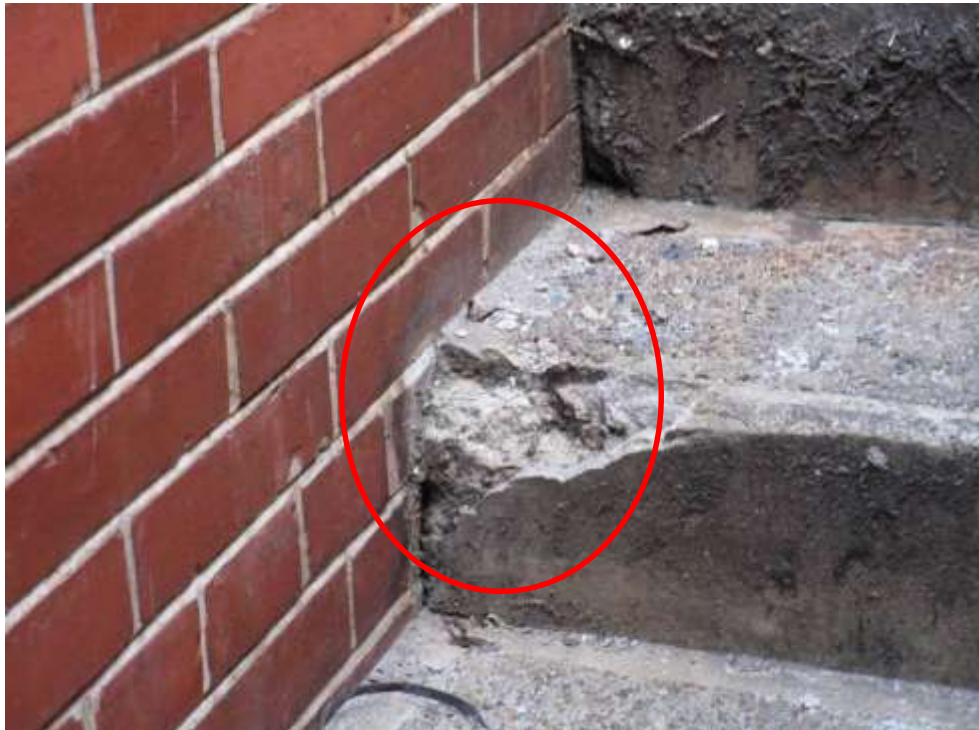
Photo No. 1492

Defect No.	246	Location	LG/F North wing, Staff quarter	Component	stair
-------------------	-----	-----------------	--------------------------------	------------------	-------

Description	Chipping at the stair edges were observed				
--------------------	-------------------------------------------	--	--	--	--

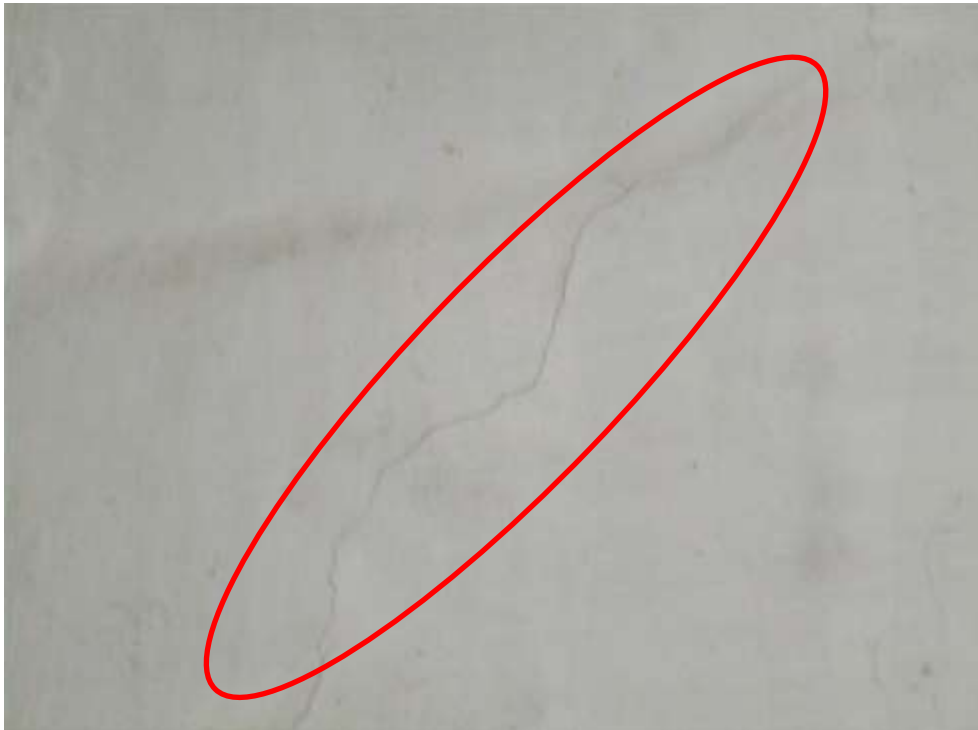
Photo No. 1494

Defect No.	247	Location	LG/F North wing, Staff quarter	Component	wall
-------------------	-----	-----------------	--------------------------------	------------------	------

Description	A medium crack was observed on wall finishing				
--------------------	-----------------------------------------------	--	--	--	--

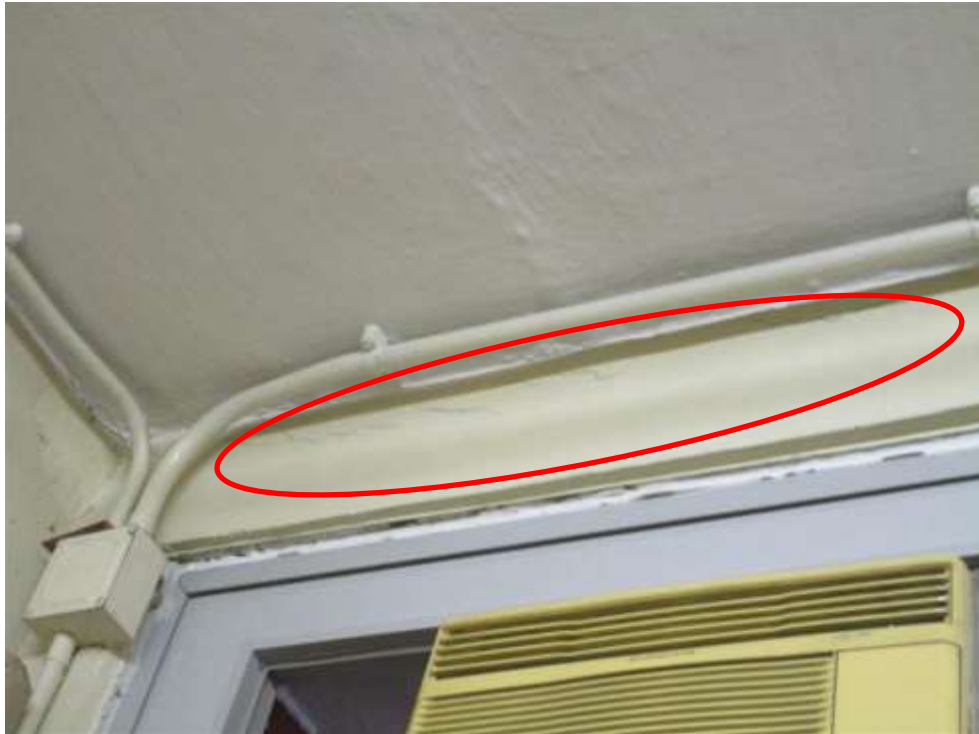
Photo No. 1495

Defect No.	247	Location	LG/F North wing, Staff quarter	Component	wall
-------------------	-----	-----------------	--------------------------------	------------------	------

Description	A medium crack was observed on wall finishing				
--------------------	-----------------------------------------------	--	--	--	--

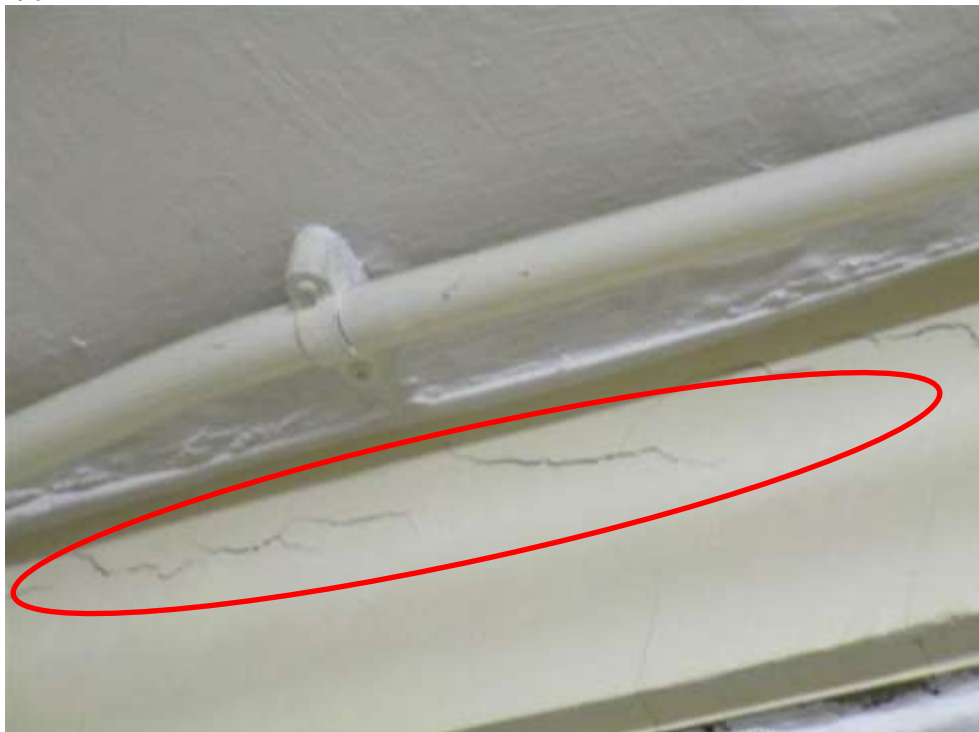
Photo No. 1496

Defect No. 248 **Location** LG/F North wing, Staff quarter **Component** wall

Description A wide crack was observed on wall finishing

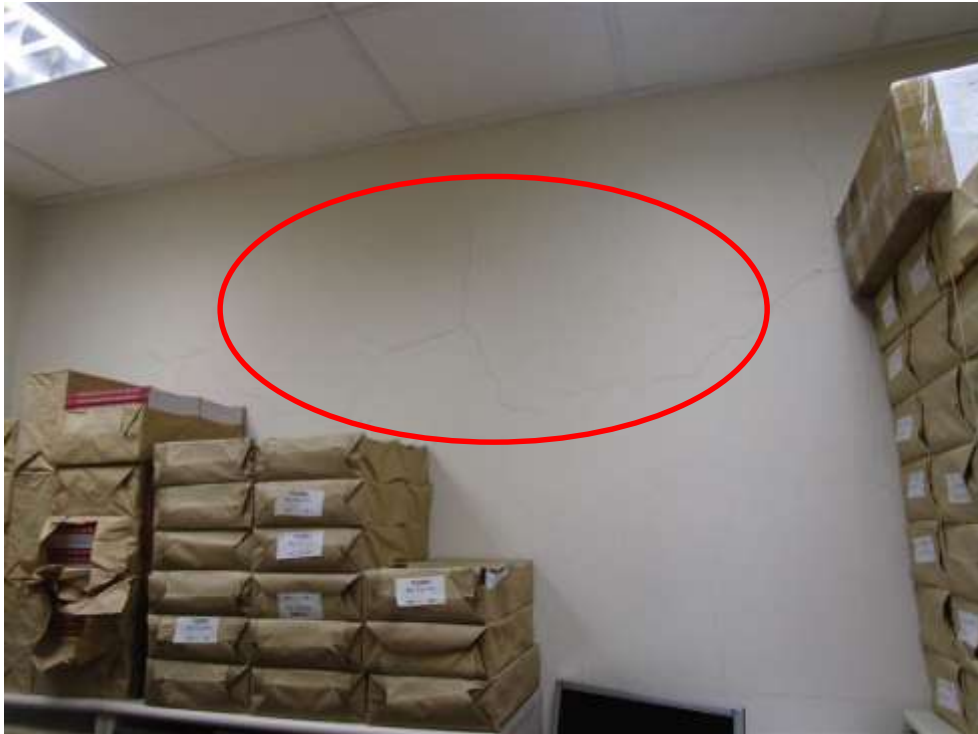
Photo No. 1497

Defect No. 248 **Location** LG/F North wing, Staff quarter **Component** wall

Description A wide crack was observed on wall finishing

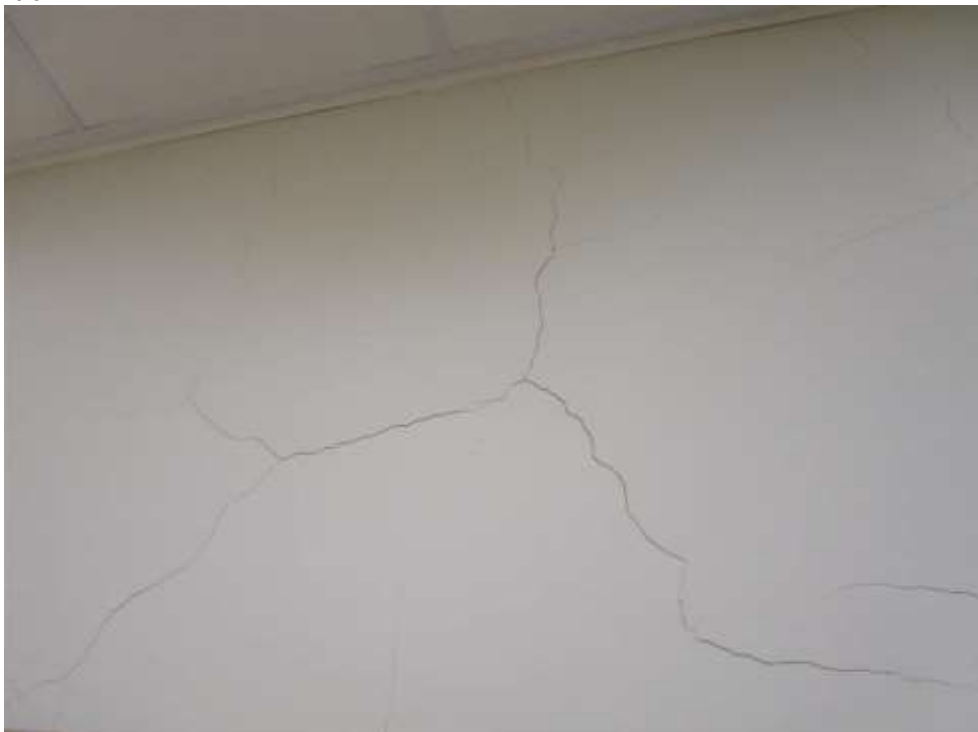
Photo No. 1498

Defect No. 249 **Location** LG/F North wing, Staff quarter **Component** wall

Description An area of wide cracks was observed on wall finishing

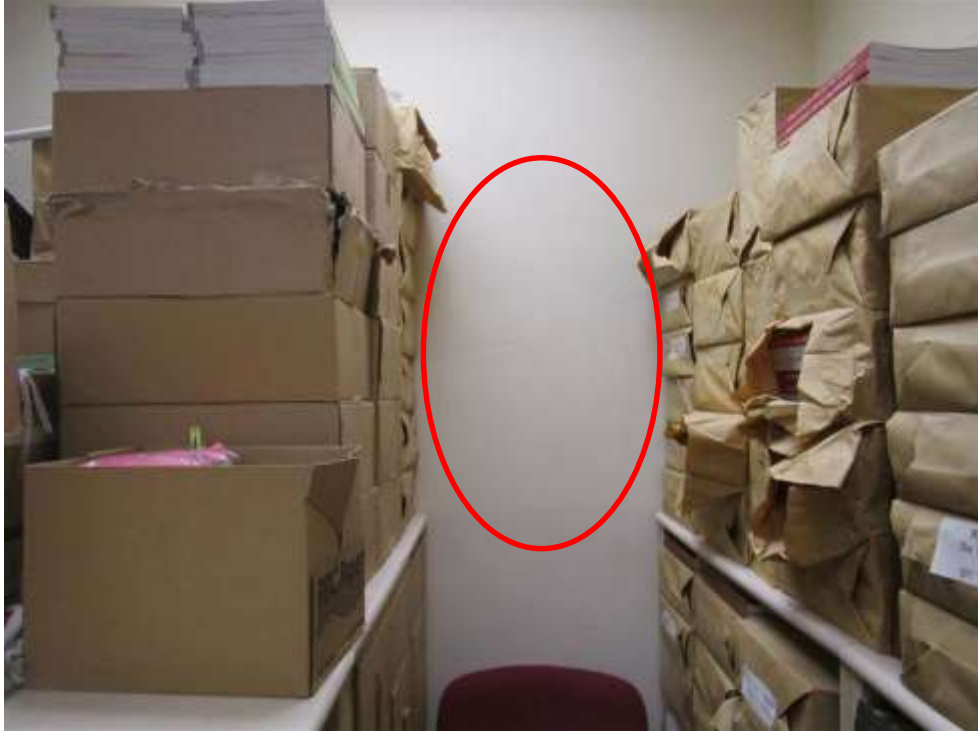
Photo No. 1499

Defect No. 249 **Location** LG/F North wing, Staff quarter **Component** wall

Description An area of wide cracks was observed on wall finishing

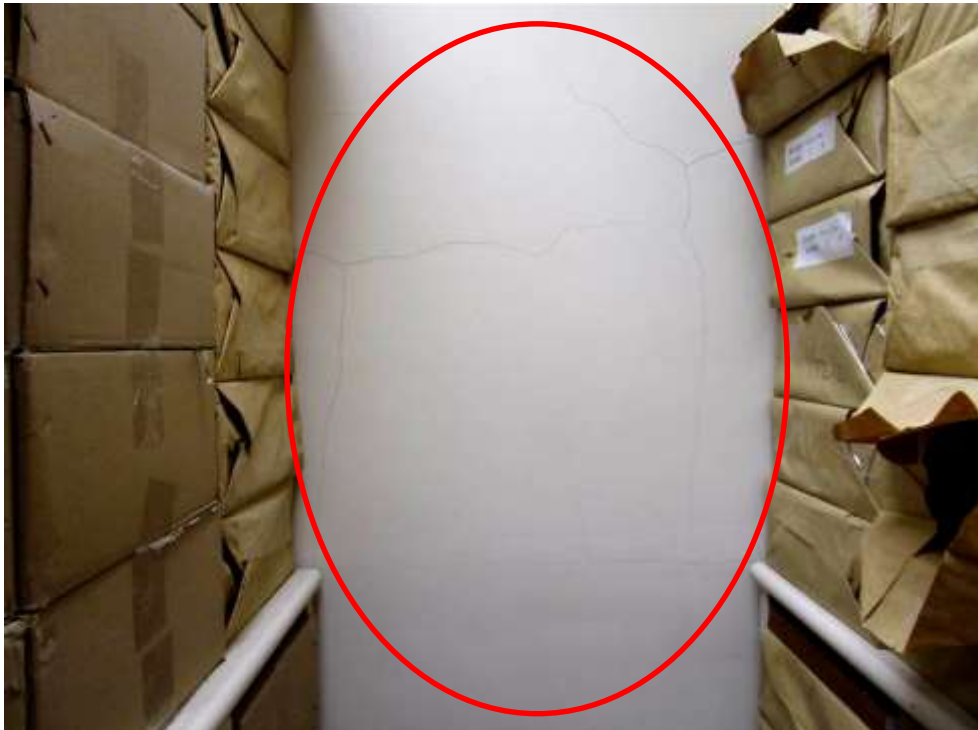
Photo No. 1500

Defect No. 250 **Location** LG/F North wing, Staff quarter **Component** wall

Description An area of wide cracks was observed on wall finishing

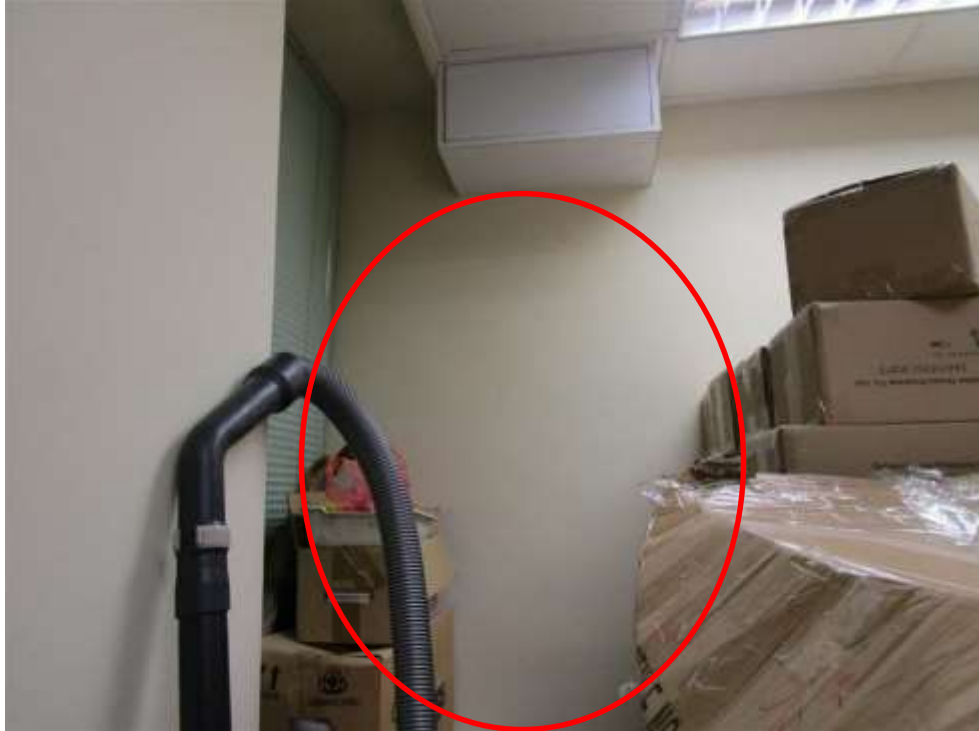
Photo No. 1501

Defect No. 250 **Location** LG/F North wing, Staff quarter **Component** wall

Description An area of wide cracks was observed on wall finishing

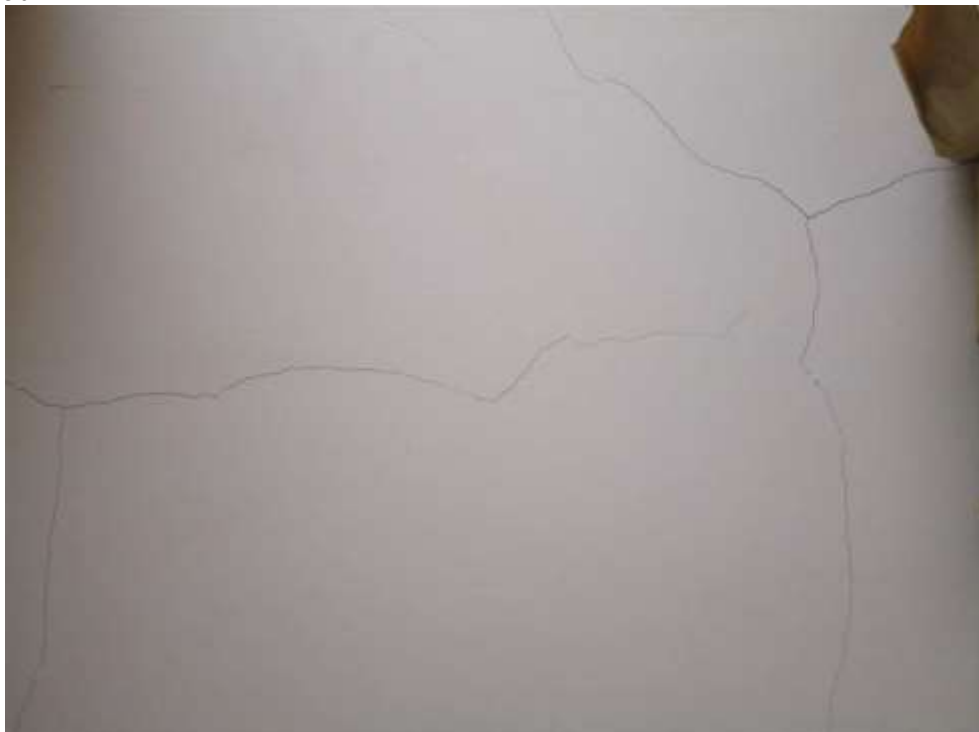
Photo No. 1502

Defect No.	251	Location	LG/F North wing, Staff quarter	Component	wall
-------------------	-----	-----------------	--------------------------------	------------------	------

Description	An area of wide cracks was observed on wall finishing				
--------------------	-------------------------------------------------------	--	--	--	--

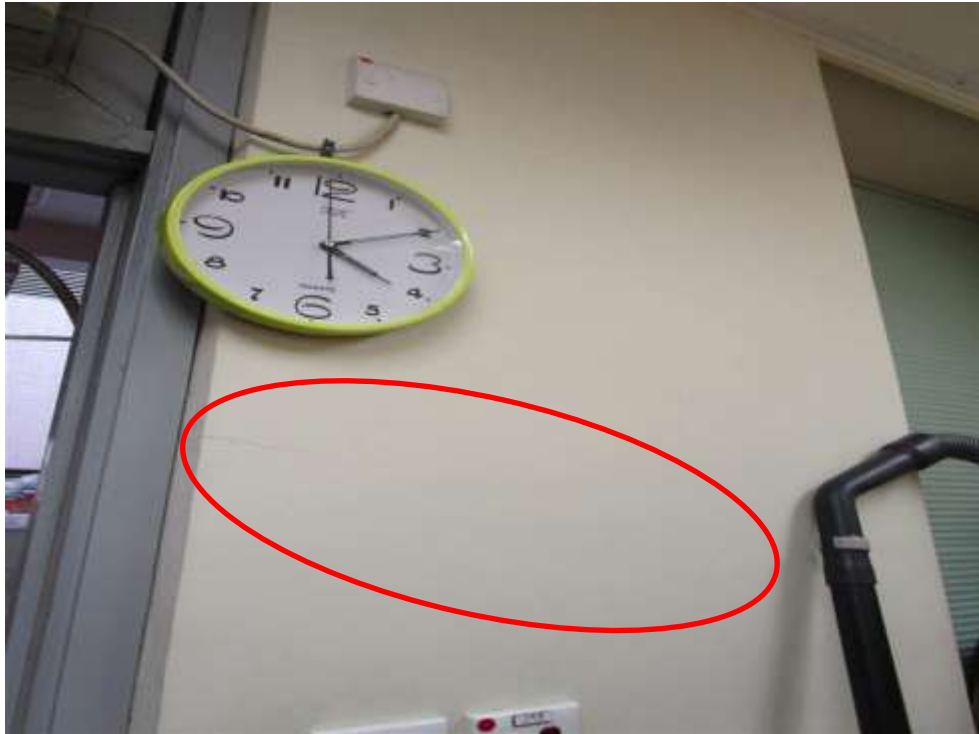
Photo No. 1503

Defect No.	251	Location	LG/F North wing, Staff quarter	Component	wall
-------------------	-----	-----------------	--------------------------------	------------------	------

Description	An area of wide cracks was observed on wall finishing				
--------------------	-------------------------------------------------------	--	--	--	--
